BEHAVIOR OF MIXED-OXIDE FUEL ELEMENTS DURING AN OVERPOWER TRANSIENT

H. Tsai and L. A. Neimark

To be submitted to the 1992 Intl. Symposium on Reliable Fuels for Liquid Metal Reactors, November 15-20, 1992, Chicago, IL.

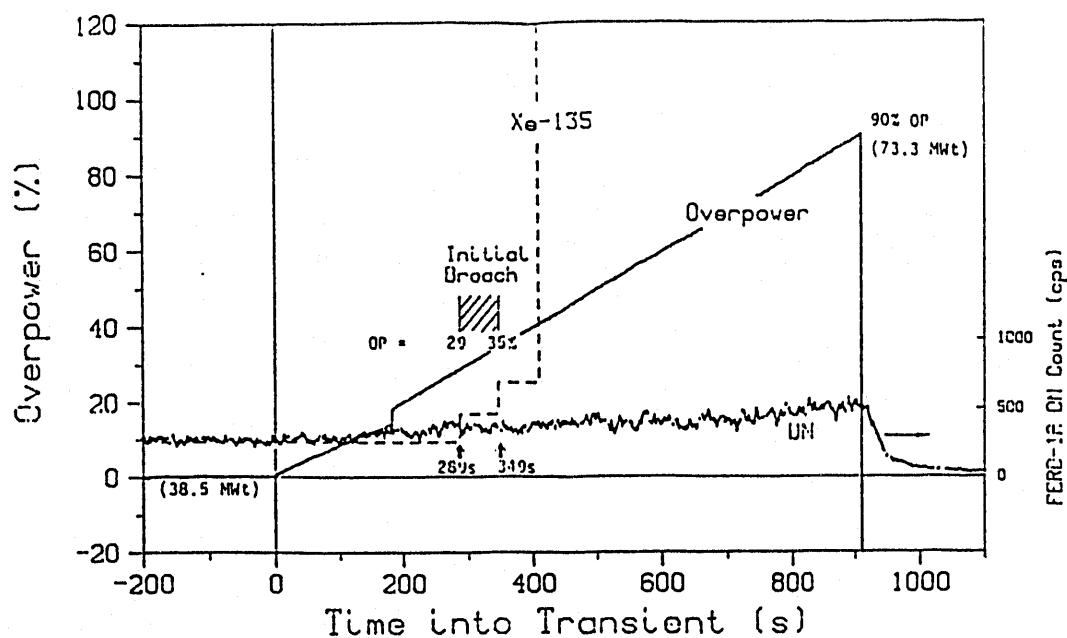
Fig. 1. Summary of the TOPI-1D Test Operations.

Because the TOPI-1D test assembly had no built-in instrumentation, monitoring of fuel element breaching during the test relied on the EBR-II's two fuel element rupture detectors (FERDs) and a Ge-Li argon scanning system (GLASS) -- FERDs for detecting released delayed-neutron (DN) precursors in the primary coolant and GLASS for detecting released fission gases in the reactor plenum. Based on the GLASS data of  $^{135}\text{Xe}$  ( $t_{1/2} = 9.14$  h) release, shown in Fig. 1, there was fuel element breaching during the TOPI-1D test. The initial breach occurred between 289 and 349 s, approximately one-third into the transient. The breach, however, did not cause any discernible DN release during or after the test. The longer-term fission-gas release histories for  $^{135}\text{Xe}$  and  $^{138}\text{Xe}$  ( $t_{1/2} = 14.2$  min) are shown in Fig. 2. It is significant to note that the release of the shorter half-life  $^{138}\text{Xe}$  gas did not occur until after the reactor scram, suggesting the release was associated with the cracking of the fuel during shutdown. Both the GLASS and FERD data shown in Figs. 1 and 2 have been corrected for their respective transport delays.

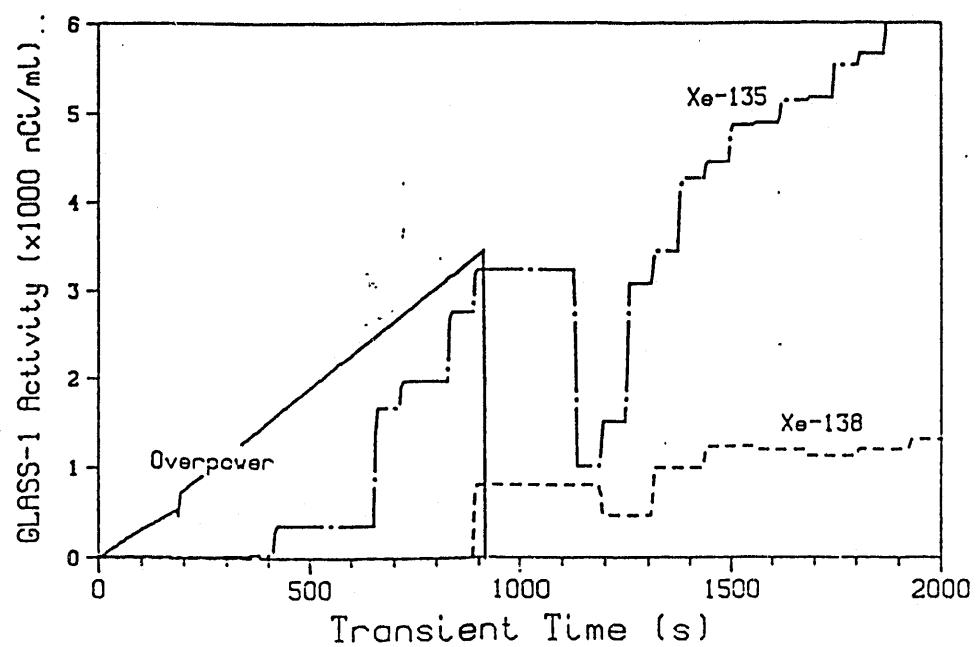
Fig. 2. Fission-Gas Release during the TOPI-1D Test.

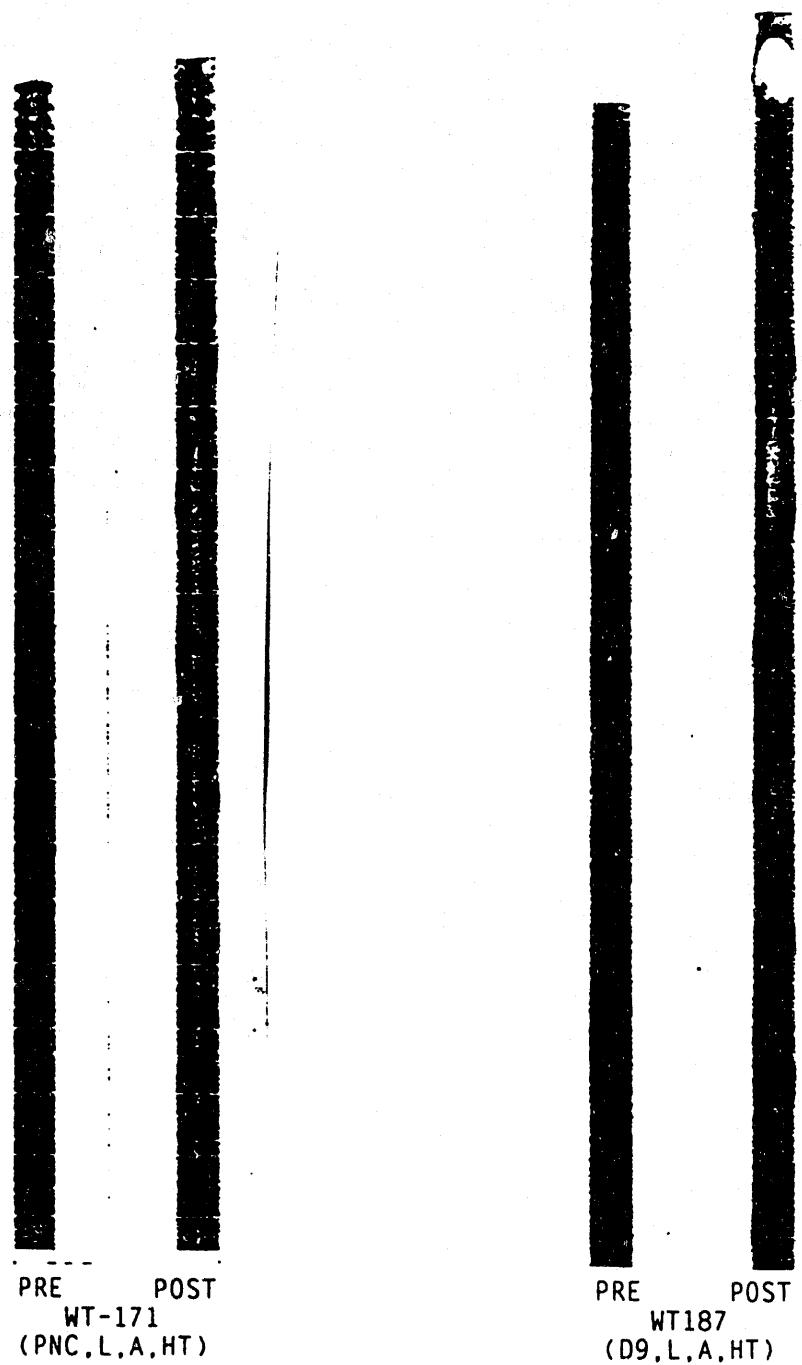
Fig. 3. Pre- and Posttransient Neutron Radiographs of TOPI-1D Elements WT171 and WT187 between  $X/L = 0.5$  and 1.

marized in Table 3. The maximum elongation was 3.6% in element WT187. In general, the greatest elongation occurred in fuel elements with the greatest transient linear power. All of the measurable elongation took place at the top end of the fuel column, in the form of either transverse fuel pellet cracking or lifting of the fuel top by molten fuel. These features are illustrated in Fig. 3, which shows the radiographs of elements WT171 (1.1% dL/L, transverse pellet cracking) and WT187 (3.6% dL/L, molten fuel liftoff). The formation of an enlarged, irregular, or discontinuous central void as seen in the neutron radiographs is evidence of fuel melting and motion.

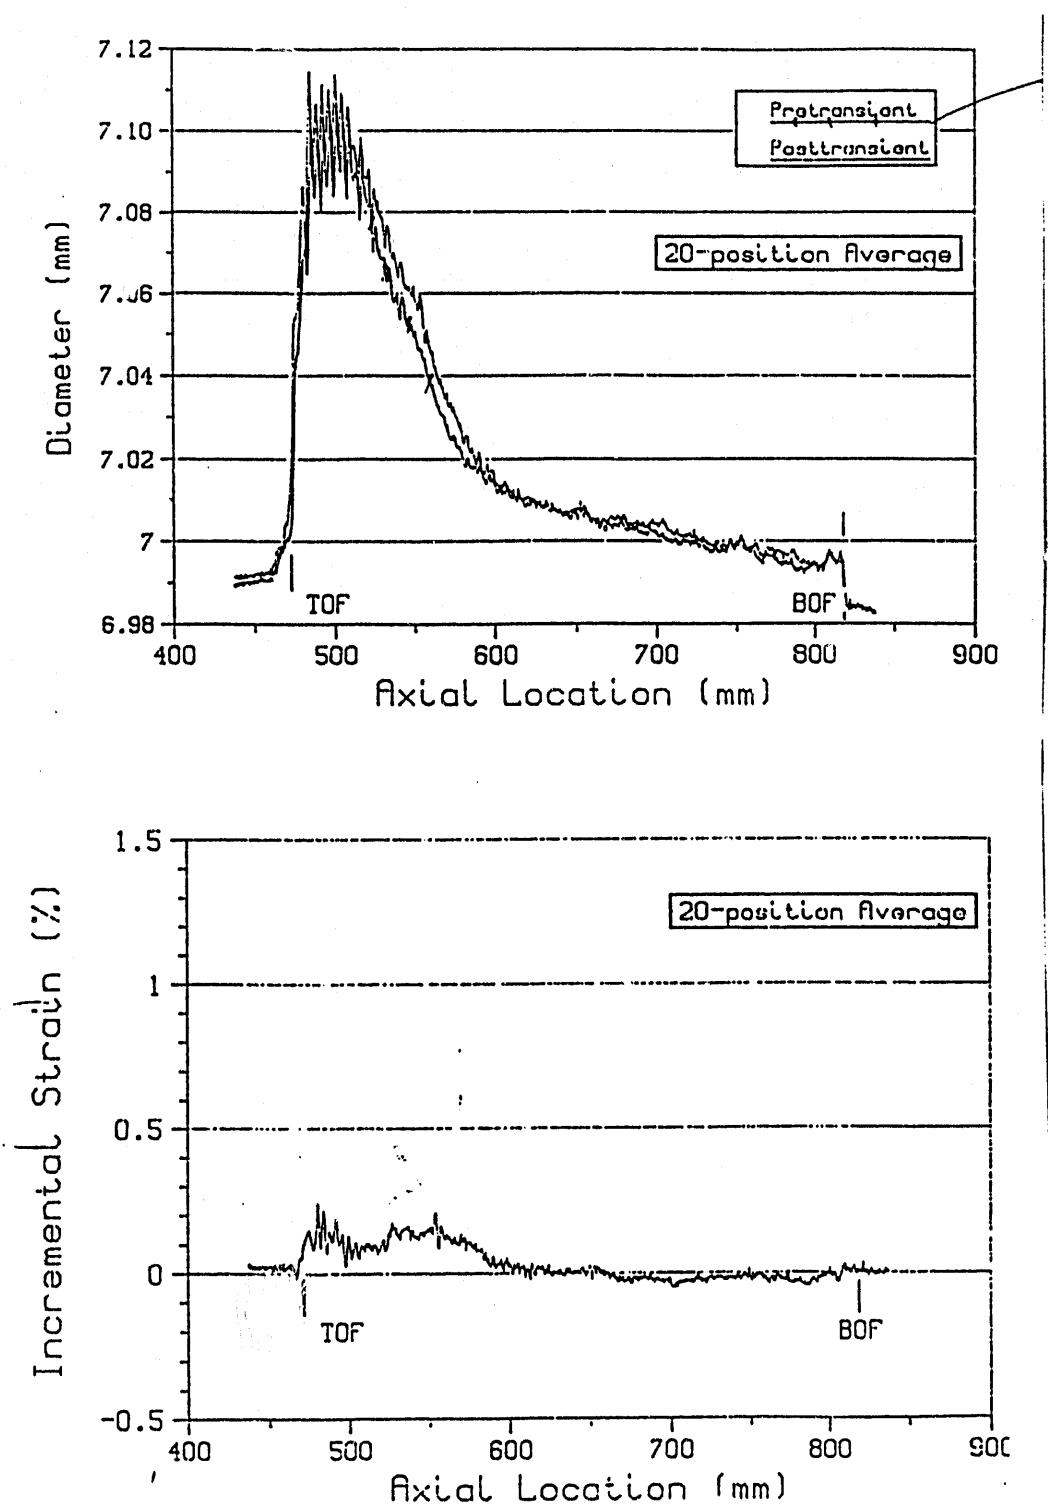
Fig. 4. Cladding Diameter and Incremental Strain Profiles for TOPI-1D Element WT182 (D9,L,A,HT).

Transient-induced cladding strains for the TOPI-1D fuel elements ranged from <0.1% for conservative elements, 0.06 - 0.32% for moderate elements, and 0.05 to 1.50% for aggressive elements. The data are summarized in Table 3. To illustrate the performance differences of the D9 and PNC-316 cladding materials, the cladding diameter and strain profiles of elements WT182 (D9-clad) and WT171 (PNC-316-clad) are compared in Figs. 4 and 5. The two elements had the same aggressive design features and operated under comparable preirradiation and transient conditions (see Tables 1 and 2). The PNC-316 cladding material appeared to have a superior strain behavior to the D9 cladding during steady-state operation; the transient behavior of the ma-

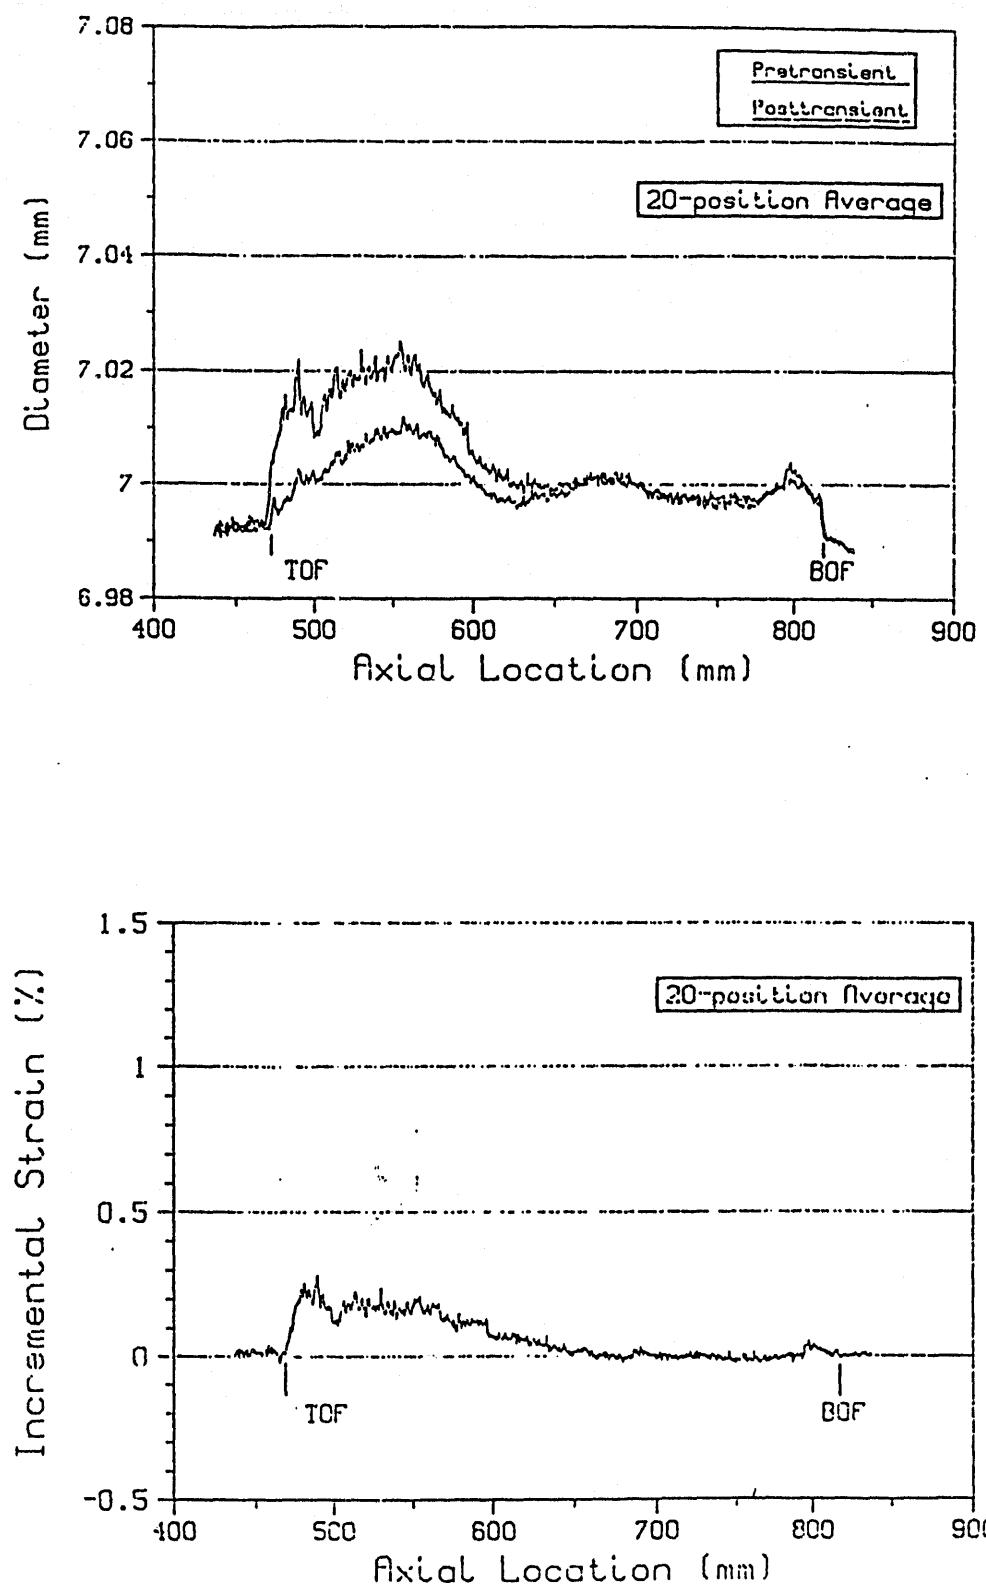
Fig. 5 Cladding Diameter and Incremental Strain Profiles for TOP1-1D Element WT171 (PNC,L,A,HT).

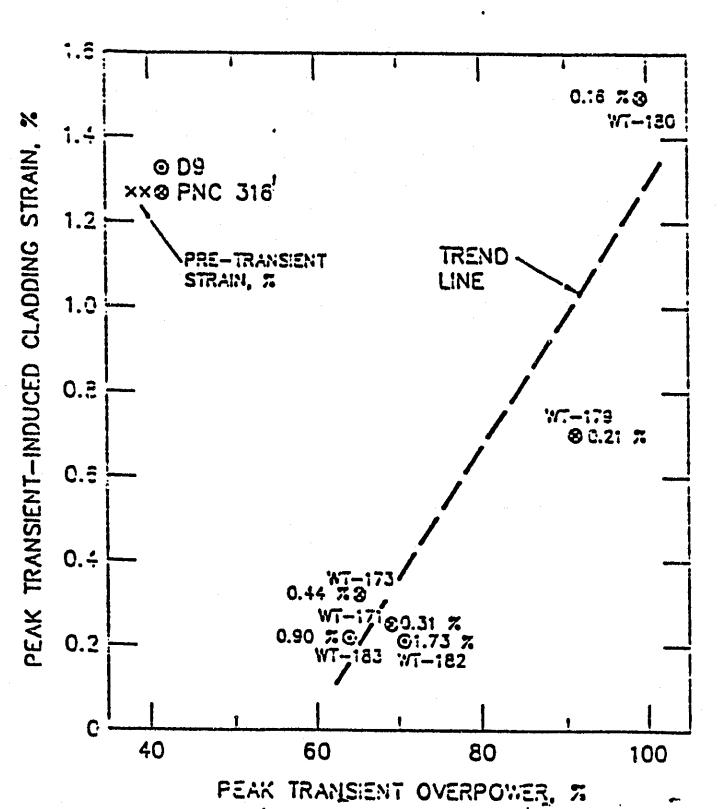
Fig. 6. Dependence of Transient Cladding Strain on Element Overpower for a Group of Aggressive, Large-diameter Elements.

terials, however, was comparable. Within a group of large-diameter, aggressive D9- and PNC-316-clad elements, the transient-induced strain is a strong function of the overpower, as shown in Fig. 6.

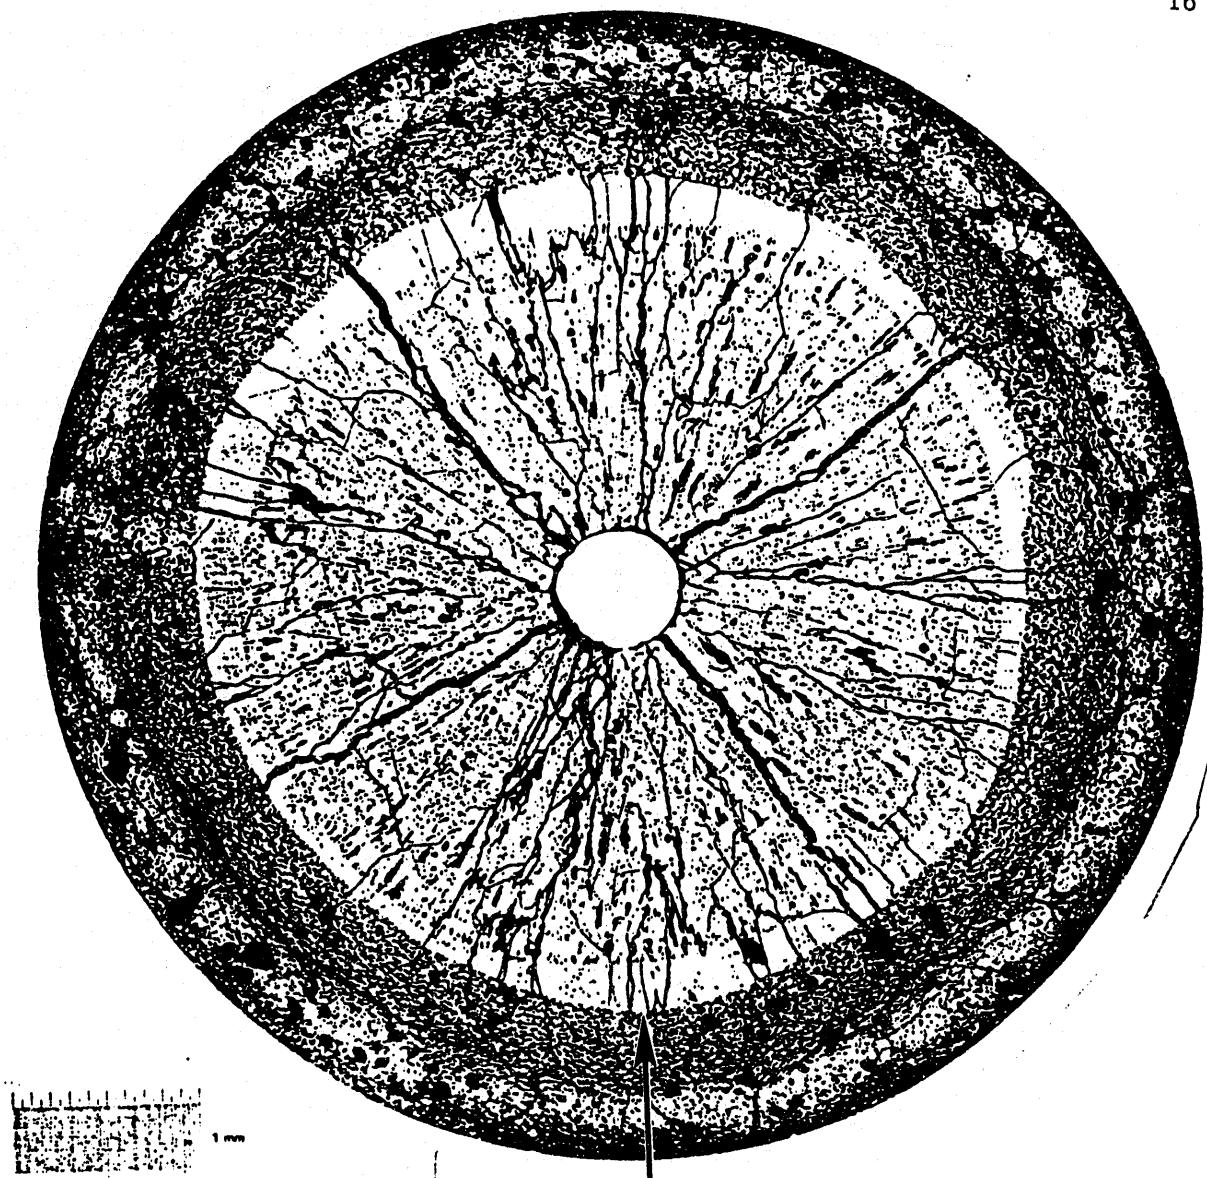
Fig. 7. Transverse Photomicrograph of Element WT036R at the Axial Midplane. Arrow denotes the boundary of fuel melting. The bright particle at the center is a metallic fission-product ingot.

Centerline fuel melting occurred in all test elements during the transient, as evidenced on the posttest neutron radiographs. This was confirmed metallographically in all five elements destructively examined. Figure 7 shows the transverse midplane section of element WT036R, which had D9 cladding, low fuel smear density (81.1% TD), low burnup (3.4 at.%), and high transient power (79.8 kW/m). Centerline fuel melting was extensive ( $\approx 50\%$

areal melt fraction), owing to the low smear-density, hence low conductivity, fuel. Melting apparently extended partly into the gaseous, equiaxed-grain-growth region, contributing to the aforementioned transient fission-gas release. At the top of the WT036R element, shown in Fig. 8, the molten fuel lifted the top insulator pellet and filled the resultant void space. Molten fuel resolidified on the cladding inside surface and caused limited cladding melting (Fig. 9). The driving force for the upward movement of the molten fuel was evidently the fission-gas pressure in the central cavity.

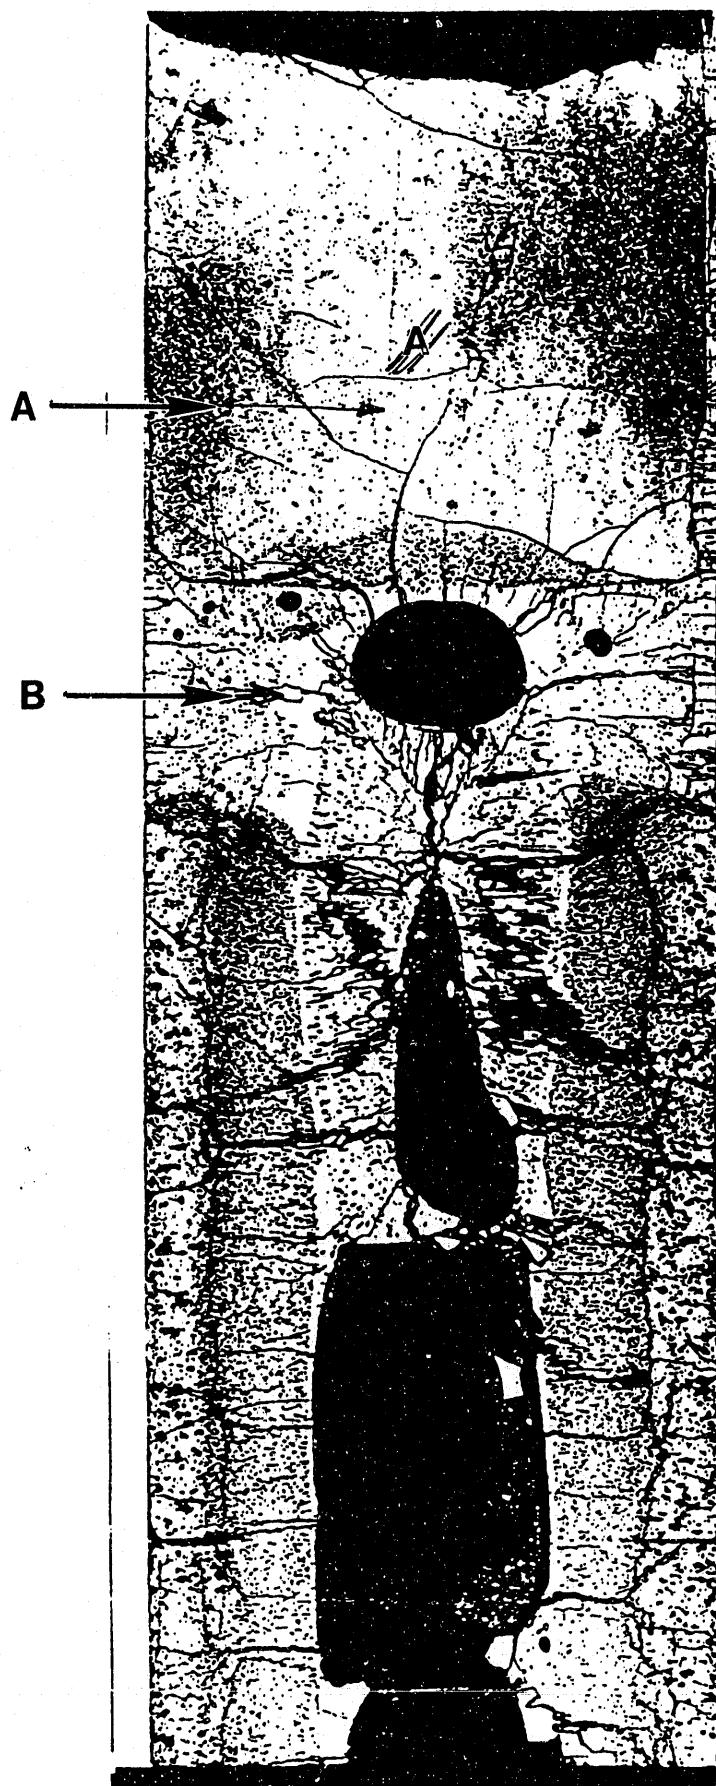
Fig. .8

Longitudinal Section of  
Element WT036R at the Fuel  
Top Showing the Lifting of  
the UO<sub>2</sub> Insulator Pellet  
(A) by Molten Fuel (B).

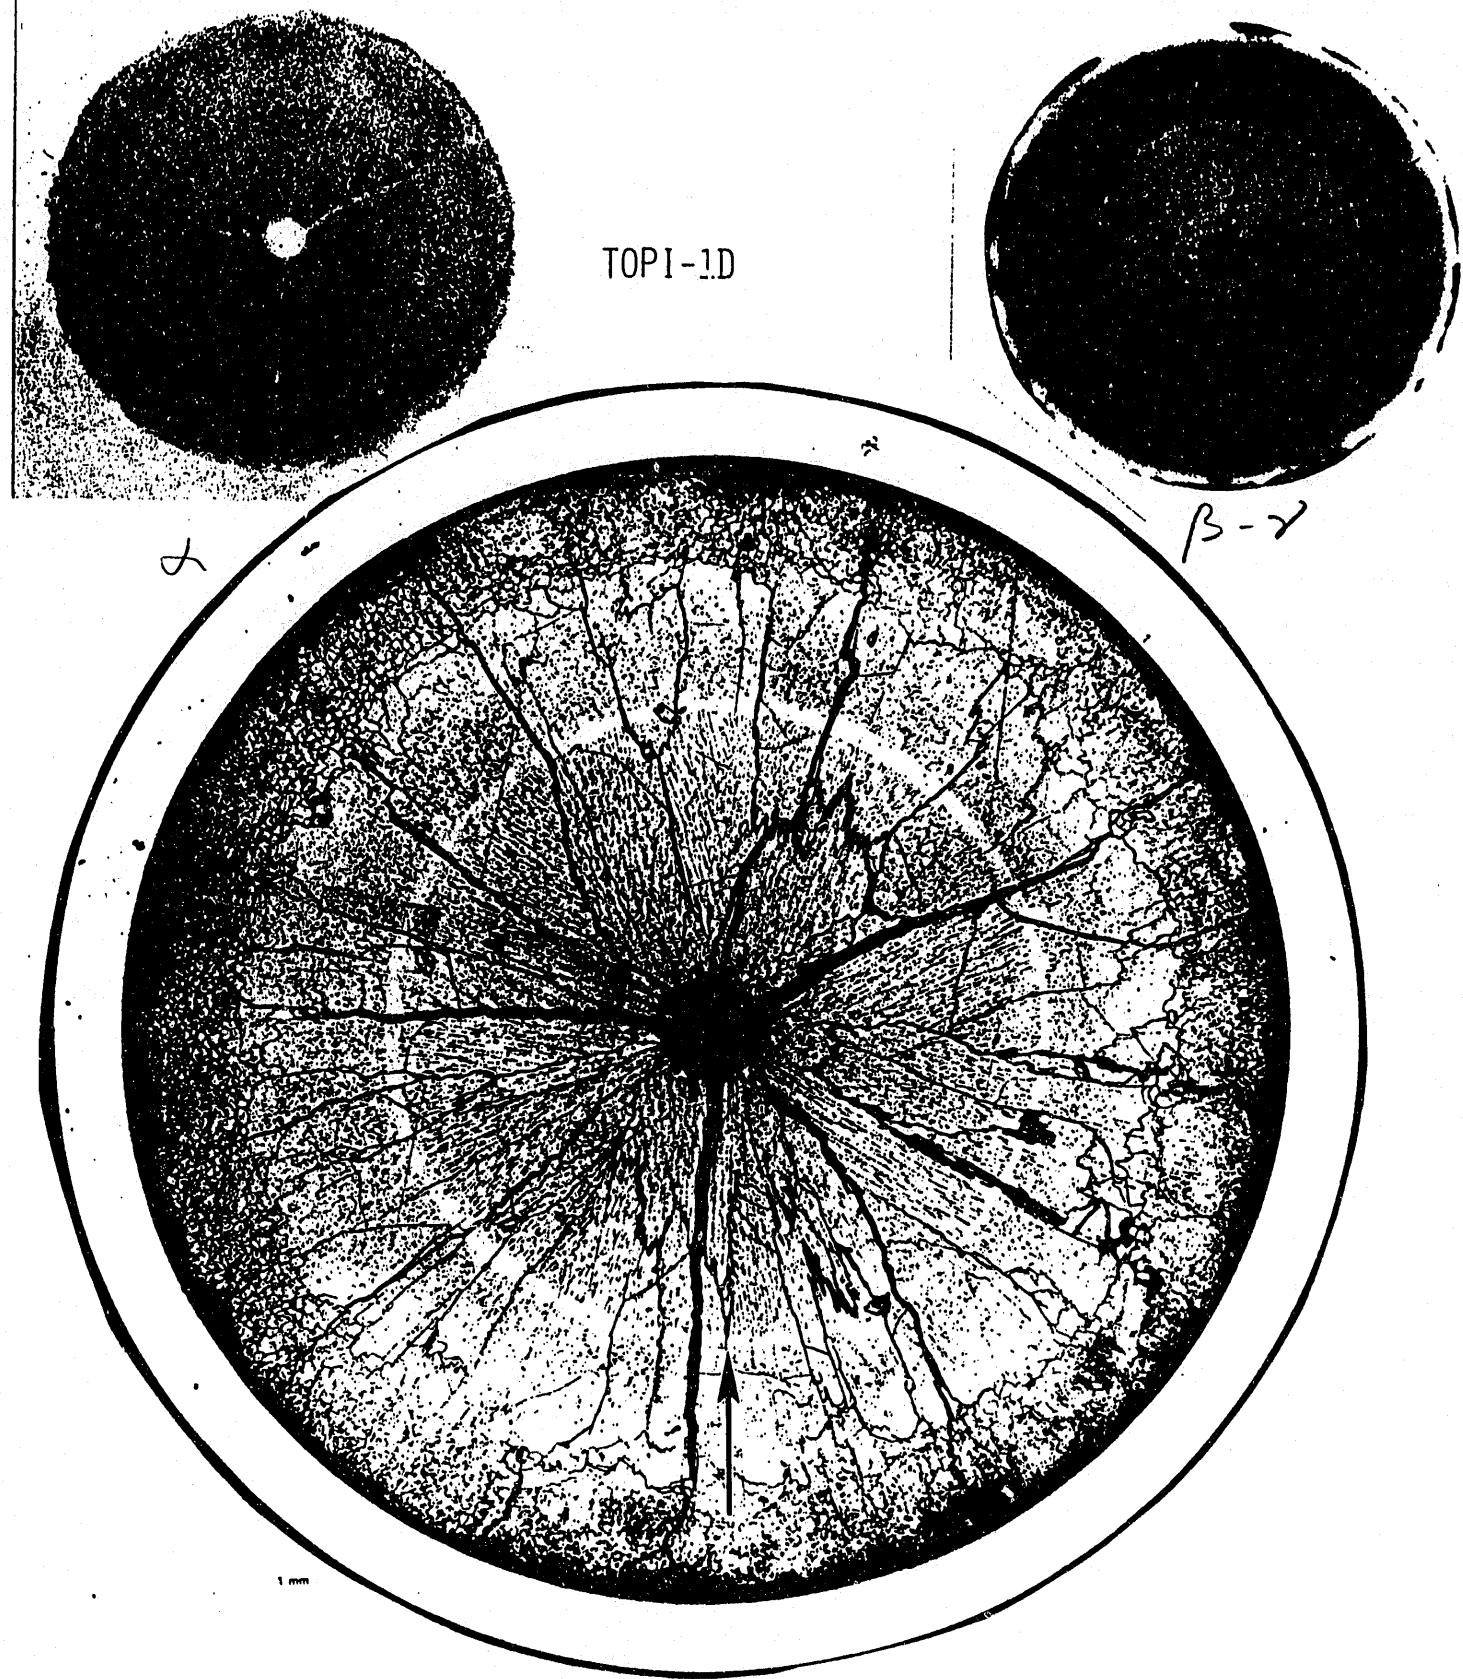
Fig. 10. Transverse Section of Element WT179 at the Axial Midplane. Arrow denotes the radial extent of fuel centerline melting.

The microstructure of the midplane section of a higher burnup (7.1 at.%) element WT179, with PNC-316 cladding, high fuel smear density (89.7% TD), and high transient power (74.4 kW/m), is shown in Fig. 10. Attributable to the higher fuel density, centerline melting was less extensive ( $\approx 32\%$  areal) and did not extend beyond the columnar-grain region. Plutonium migration to the fuel periphery and cesium migration to the fuel periphery and fuel/cladding interface is evident on the alpha and beta-gamma autoradiographs (Fig. 10). Further evidence of cesium migration was the dark, loose appearance of the fuel periphery. Intergranular cladding penetration due to fuel/cladding chemical interaction, to a depth of  $25\ \mu\text{m}$ , is shown in Fig. 11. The longitudinal section at the top of the WT179 fuel column, Fig. 12, shows the  $\text{UO}_2$  insulator pellets were raised  $\approx 9\ \text{mm}$  with molten fuel up around the bottom insulator pellet. Fission-gas in the central cavity could account for the upward molten fuel movement. Fragments of the top of the fuel column were present in the molten fuel.

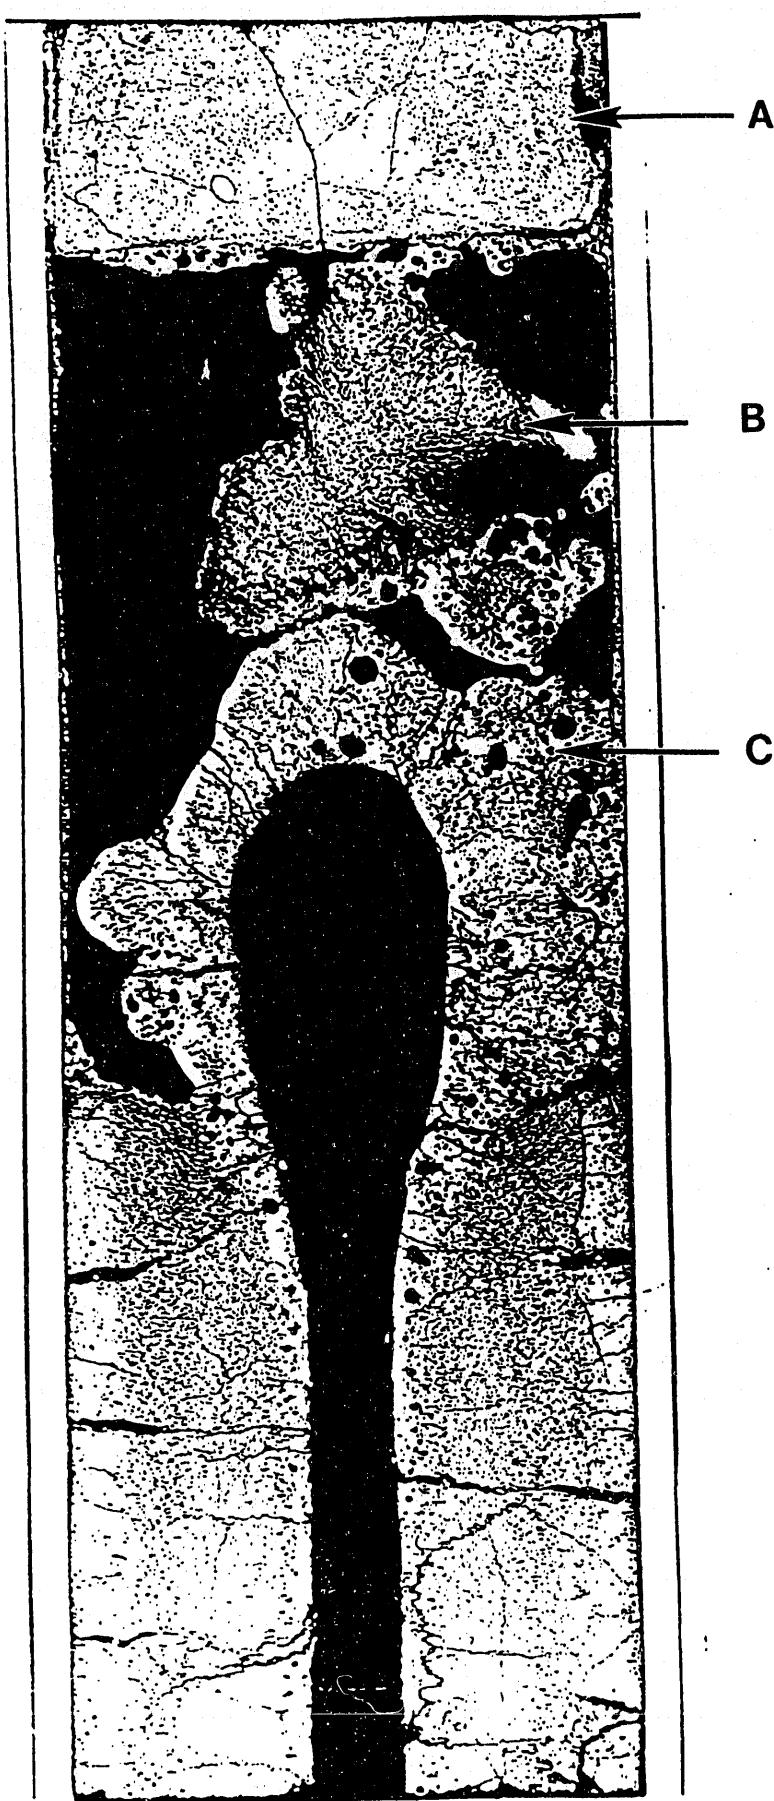
Fig. 12

Longitudinal Section of Element WT179 at the Top of Fuel. A: raised UO<sub>2</sub> insulator pellet; B: remnant of the previous fuel top; C: once-molten fuel.
