WELDABILITY OF TRITIUM-CHARGED 304L STAINLESS STEEL

DP-1740

Attempts to repair the wall of C-Reactor Tank at the Savannah River Plant were halted when Gas Tungsten Arc (GTA) welds joining patches to the wall developed toe cracks in the heat affected zone (HAZ). The cause of the toe cracks was investigated by welding on 304L samples that were tritium charged and aged to produce helium.

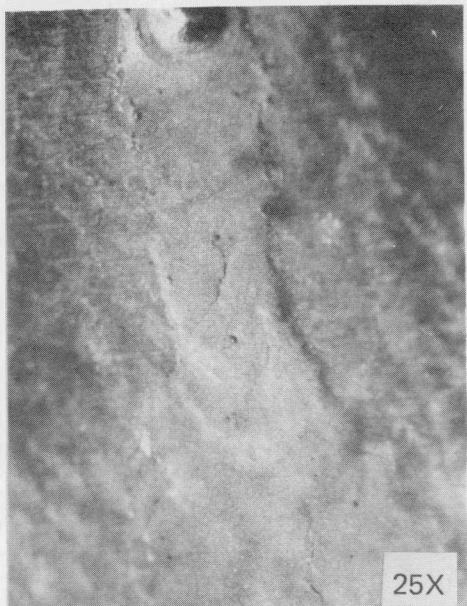
FIGURE 5. Cracking Produced by Low Heat Welds, Piece B-1

Welds made on piece B-1 showed that the double bead is not necessary for cracking, that low heat welds crack like high heat welds, and that cracking occurs beyond the end of melting. On this piece, beads A and B, Figure 5, were made at the same parameters as those for piece A-1 but were not overlayed with a second bead. Beads C through E were made with lower heat inputs produced by lower currents and faster travel speeds, Table 1. The lowest heat input (Bead E) did not result in continuous melting. The dye penetrant test showed cracks around all five welds, Figure 6.

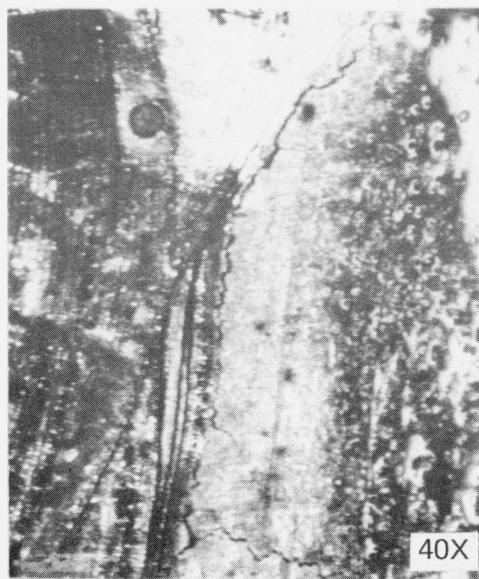
FIGURE 9. Toe Cracks Caused by Helium Alone, Piece A-2

Both high and low heat input welds caused cracking in piece A-2, which had been off-gassed to remove 90% of the hydrogen, Figures 9 and 10. This result suggests that helium embrittlement is the principal cause of the cracking. As with the samples containing both helium and hydrogen (A-1 and B-1), cracks were intergranular and were deeper around high heat welds than those around the low heat weld (0.032 inch compared to 0.020 inch), Figure 11. The degree of porosity within the weld bead was not noticeably different. Two spot welds made at different heat inputs, Table 1, also resulted in cracking.

a — Section shown top left Figure 11
b — Section shown top right Figure 11
c — Section shown bottom Figure 11
