ORNL/TM-7571

**Characterization of SiC
Coatings on HTGR Fuel
Particles: Final Report**

HTGR BASE TECHNOLOGY PROGRAM
Fueled Graphite Development (FTP/A 01330)

Date Published: January 1981

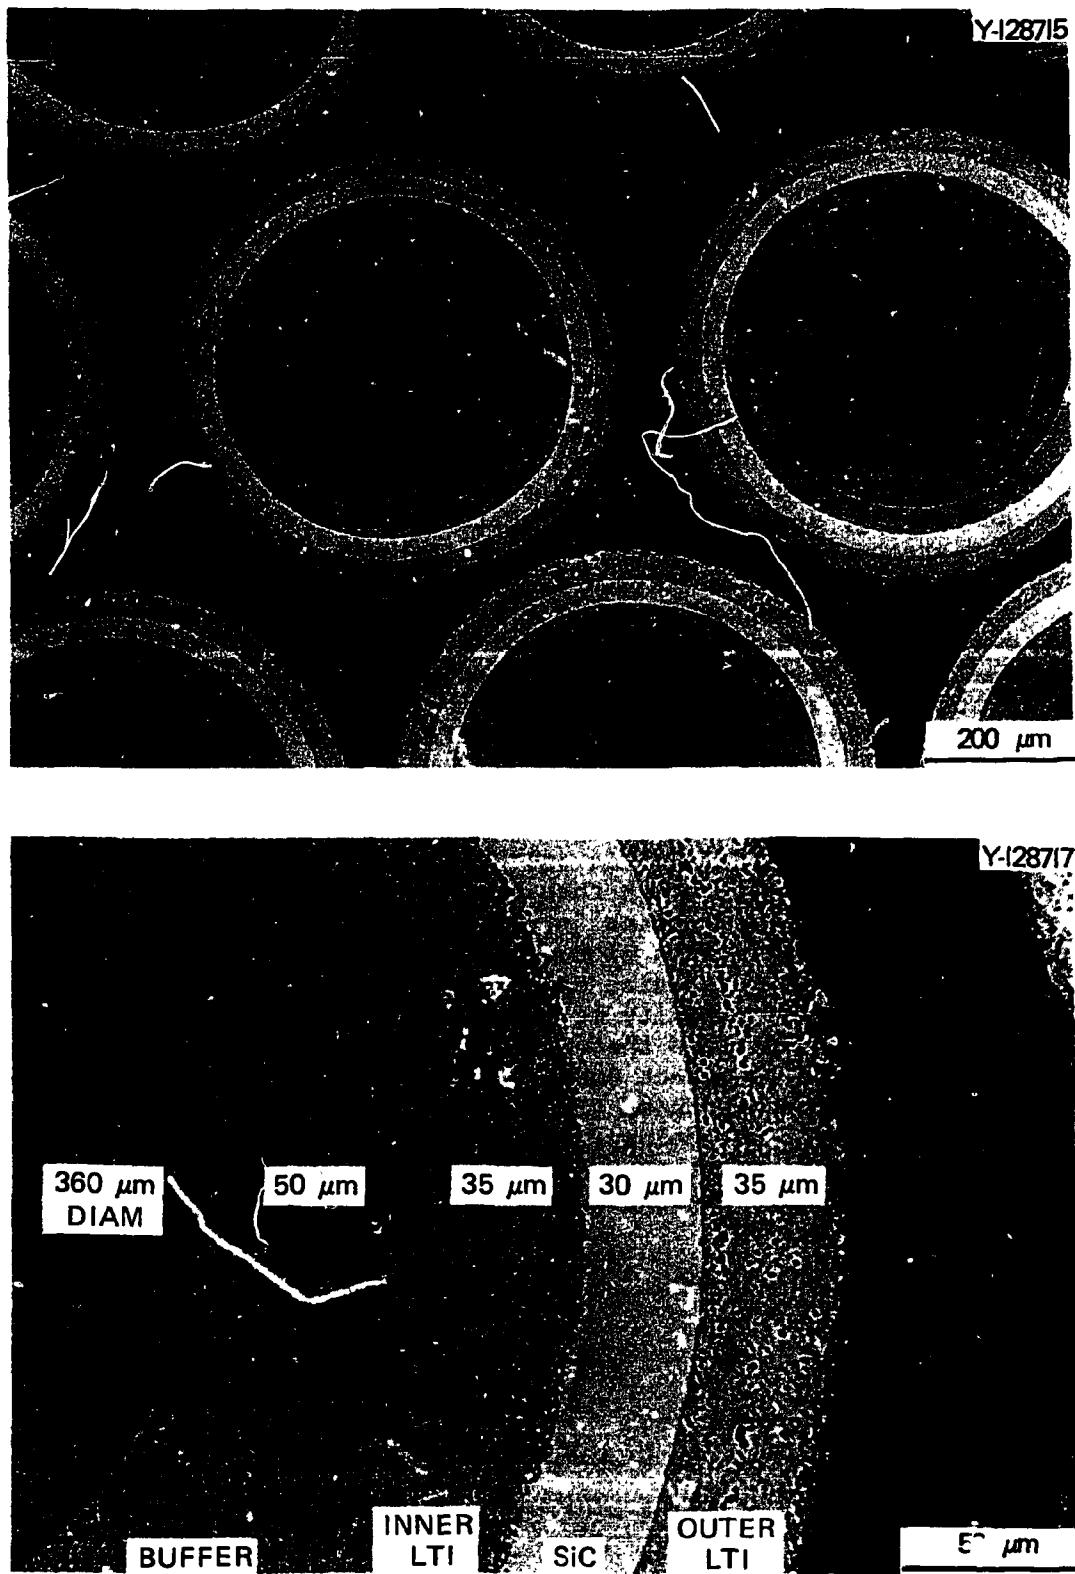
Fig. 1. Coated HTGR Fuel Particles.

Fuel particles for the High-Temperature Gas-Cooled Reactor (HTGR) consist of uranium-containing microspheres coated with layers of pyrolytic carbon and silicon carbide as shown in Fig. 1. The coatings form a

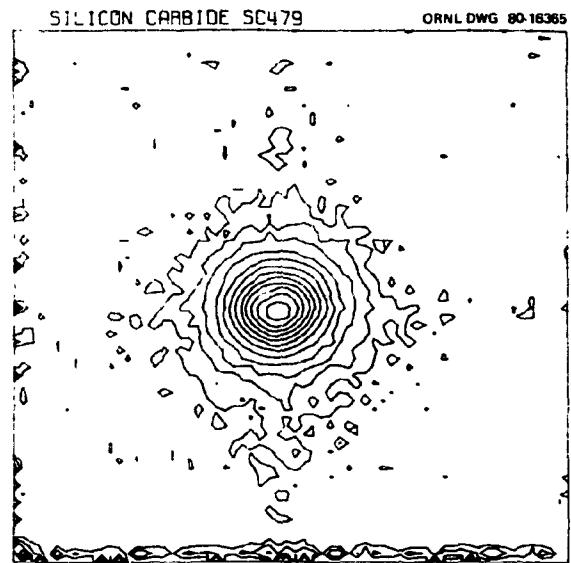
Fig. 2. Scattered X-Ray Intensity from SiC Batch SC479. The lines are isointensity contours, with each contour representing a doubling in intensity level.

The SAXS camera has a two-dimensional position sensitive detector with a 64 by 64 element array. The data from each run were stored on disk for later processing. At that time the data were recalled, corrected for detector sensitivity and background scattering, and plotted as a two-dimensional map, as shown in Fig. 2. Each contour line represents a doubling in intensity (decreasing from the center outward). After the corrected intensity was displayed as a contour map and shown to be isotropic, a circular average was calculated by the computer. This reduced the data to the form shown in Fig. 3, where scattered intensity is shown as a function of scattering angle. In that form the data are used to determine the defect size range in the material.

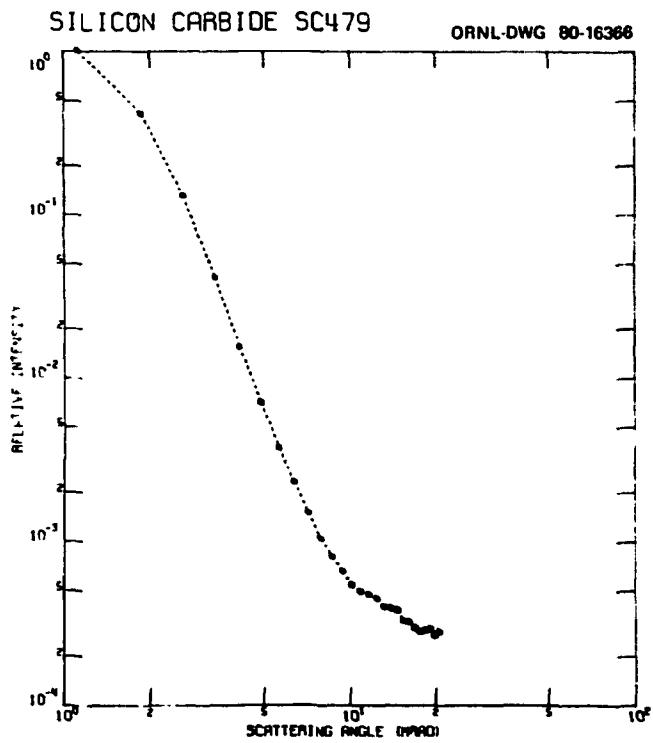
Fig. 3. Small-Angle X-Ray Scattering Curve for SiC Batch SC479. The size range of defects (e.g., voids) present can be calculated from the scattering curve.

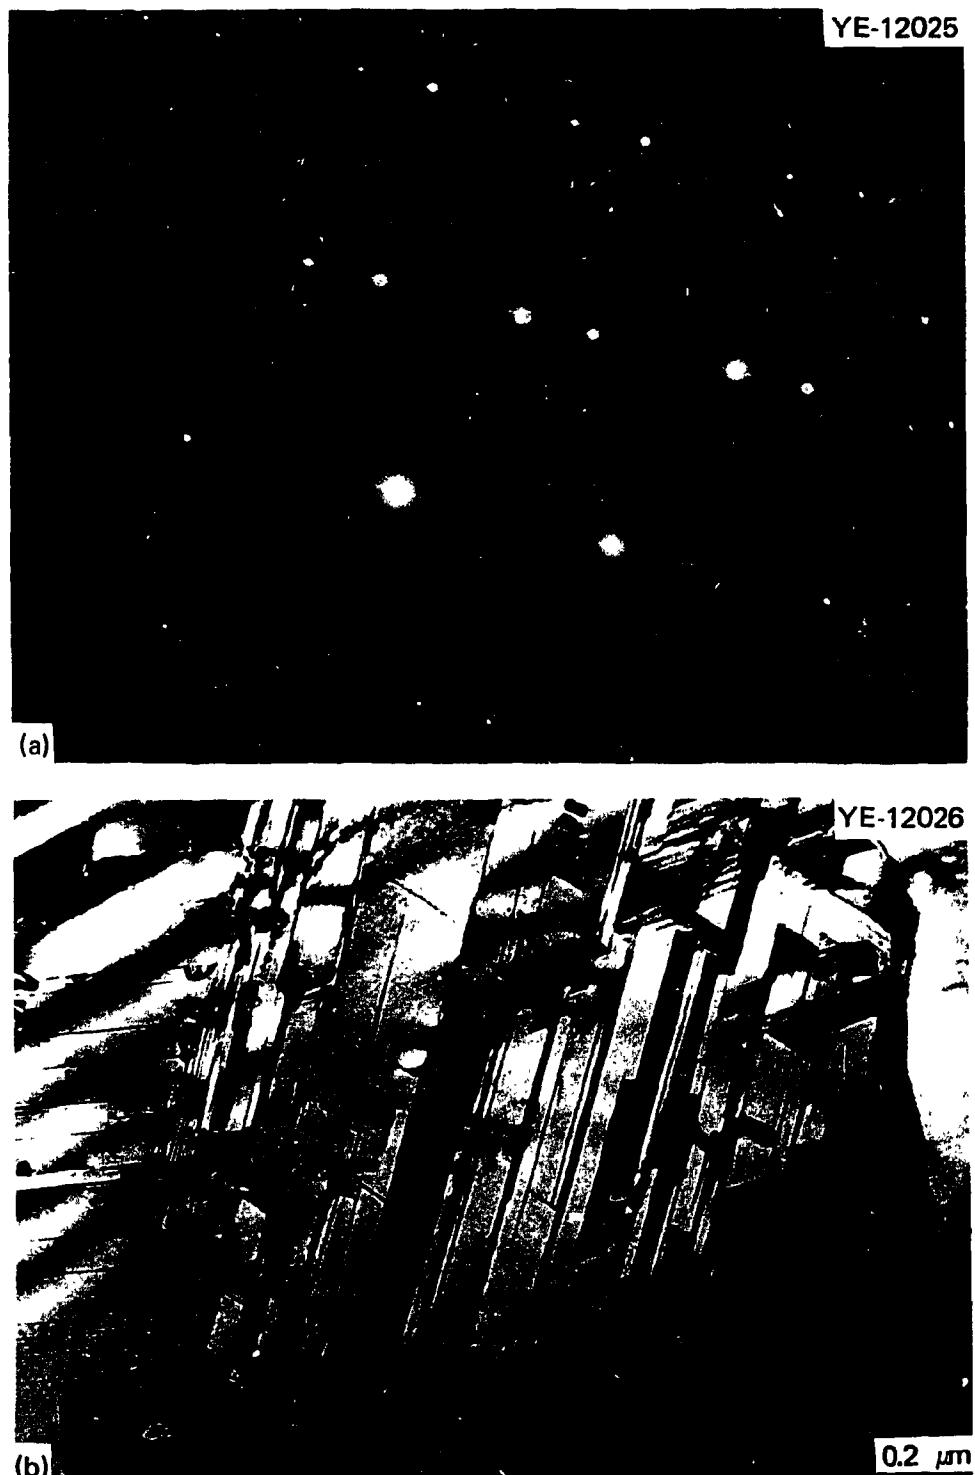
Fig. 6. Transmission Electron Micrograph of Coating SC472, Showing a Heavily Faulted Grain (Below) and the Diffraction Pattern from This Region (Above). The streaks in the diffraction pattern result from the high stacking fault density.

Selected-area electron diffraction patterns were used to identify the phases present. The coatings were almost exclusively the 3C (cubic) or β -SiC polytype. However, the high stacking fault density gave rise to streaking in some diffraction patterns (Fig. 6), and occasionally the streaks could be resolved into spots,² for which the spacing could possibly be indexed as several noncubic polytypes. Lattice fringe images in one small region had a spacing of 15 nm, which is characteristic of the 6H polytype.² It is important to note that stacking faults in SiC are relatively low-energy structures and occur frequently during growth of SiC by chemical vapor deposition. When the stacking faults have a certain sequence in a very localized region of the coating, that region becomes,

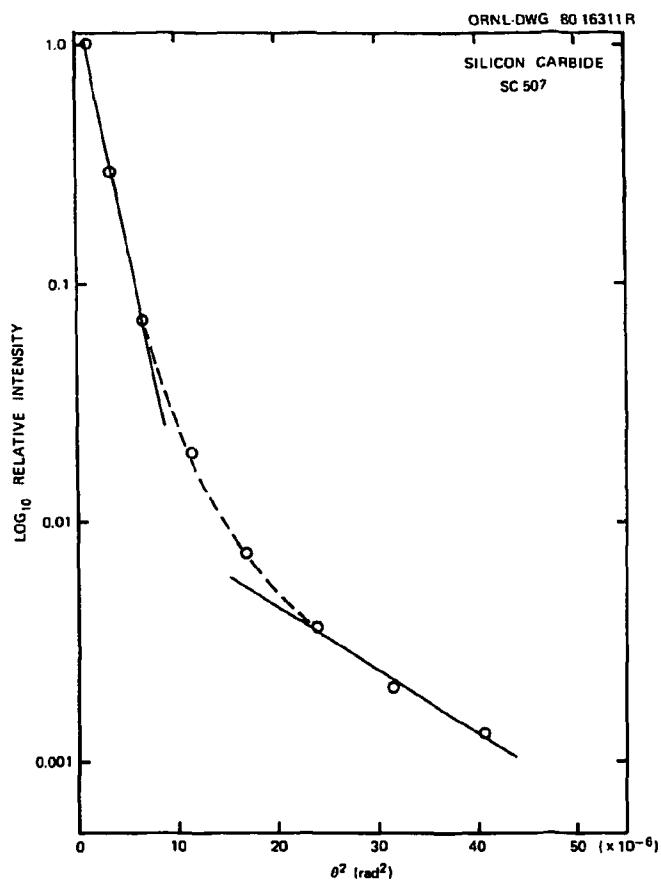
Fig. 8. Guinier Plot of Small-Angle X-Ray Scattering Curve for Coating SC507. The two slopes indicate that the defects (voids) mostly range from 22.0 to 76.0 nm in diameter.

pronounced curvature, as shown by Fig. 8. This implies either a multimodal or a continuous distribution of defect sizes. The size range of the defects in each sample can be estimated by approximating the two ends of the curve by straight line segments. From the two slopes shown in Fig. 8, $R_{\max} \approx 38.0$ nm and $R_{\min} \approx 11.0$ nm. This implies that the majority of the defects lie in the range 22.0 to 76.0 nm in diameter. These values are in reasonable agreement with those presented on p. 11 when one recalls that the voids are rarely spherical. They are at best polygonal and sometimes lens- or dumbbell-shaped. Another point to remember is that TEM cannot achieve the comprehensive sampling that SAXS does.

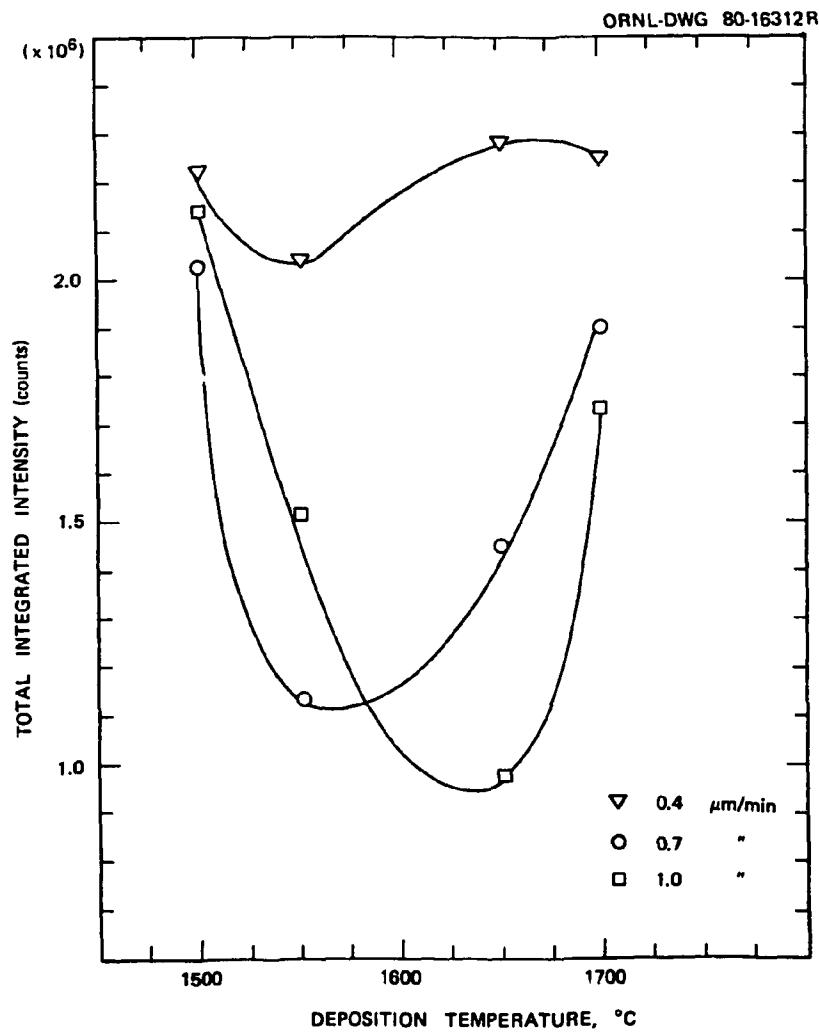
Fig. 9. Total Integrated Small-Angle X-Ray Scattering Intensity for the 12 SiC Batches. The total intensity (and hence void concentration) varies by as much as a factor of 2 when coating parameters are changed.

All coatings examined by SAXS had very similar values for R_{\max} and R_{\min} , and defect size vs coating conditions had no discernable trend. To compare one coating batch with another, therefore, the total integrated intensities (corrected for specimen attenuation) are plotted in Fig. 9. The figure shows that the total intensity varies from batch to batch by up to a factor of 2. This implies a similar variation in void concentrations.

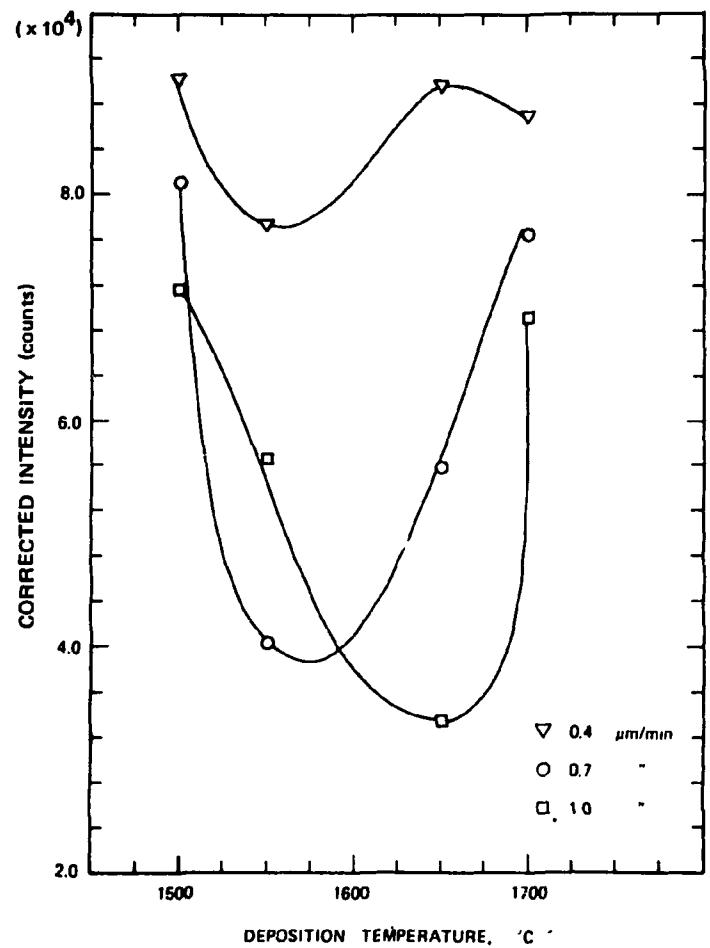
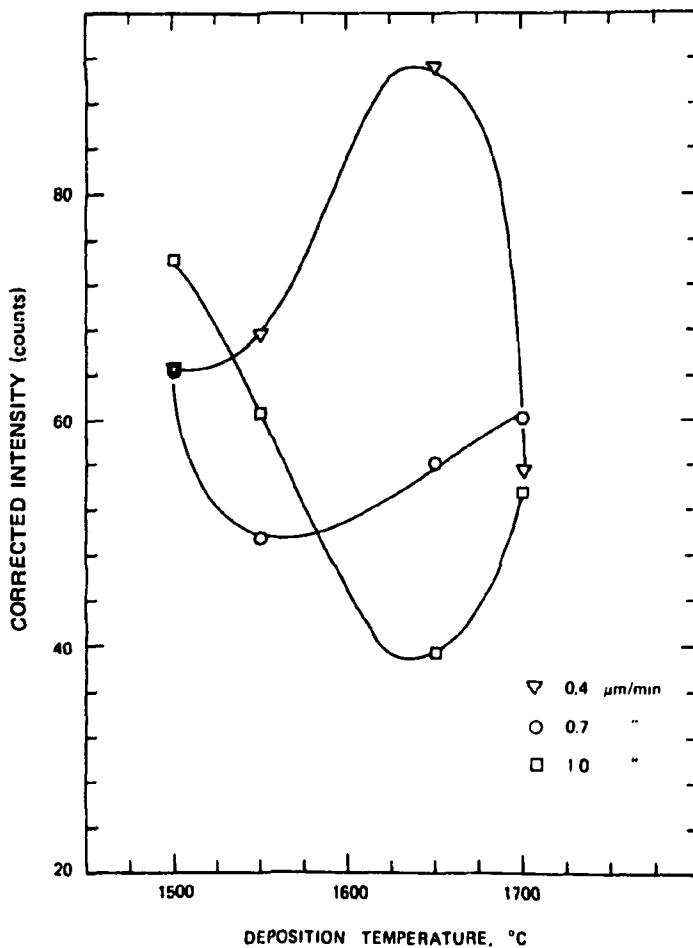
ORNL-DWG 80-16315R

Fig. 10. Comparison of the 12 Coatings by Using X-Ray Scattering at a Single Angle Must Be Interpreted with Care. Apparent relative quality depends strongly on the scattering angle chosen.

Another possible way to compare batches is by comparing scattered intensity at one particular angle.⁷ Figure 10 shows, however, that data taken at a single scattering angle must be interpreted with care. Taking the three batches deposited at 1500°C as an example, a coating that appears to have fewer defects than another at one angle might appear to have more defects at another angle. Clearly, the entire scattering curve must be examined to adequately characterize the distribution of defects.

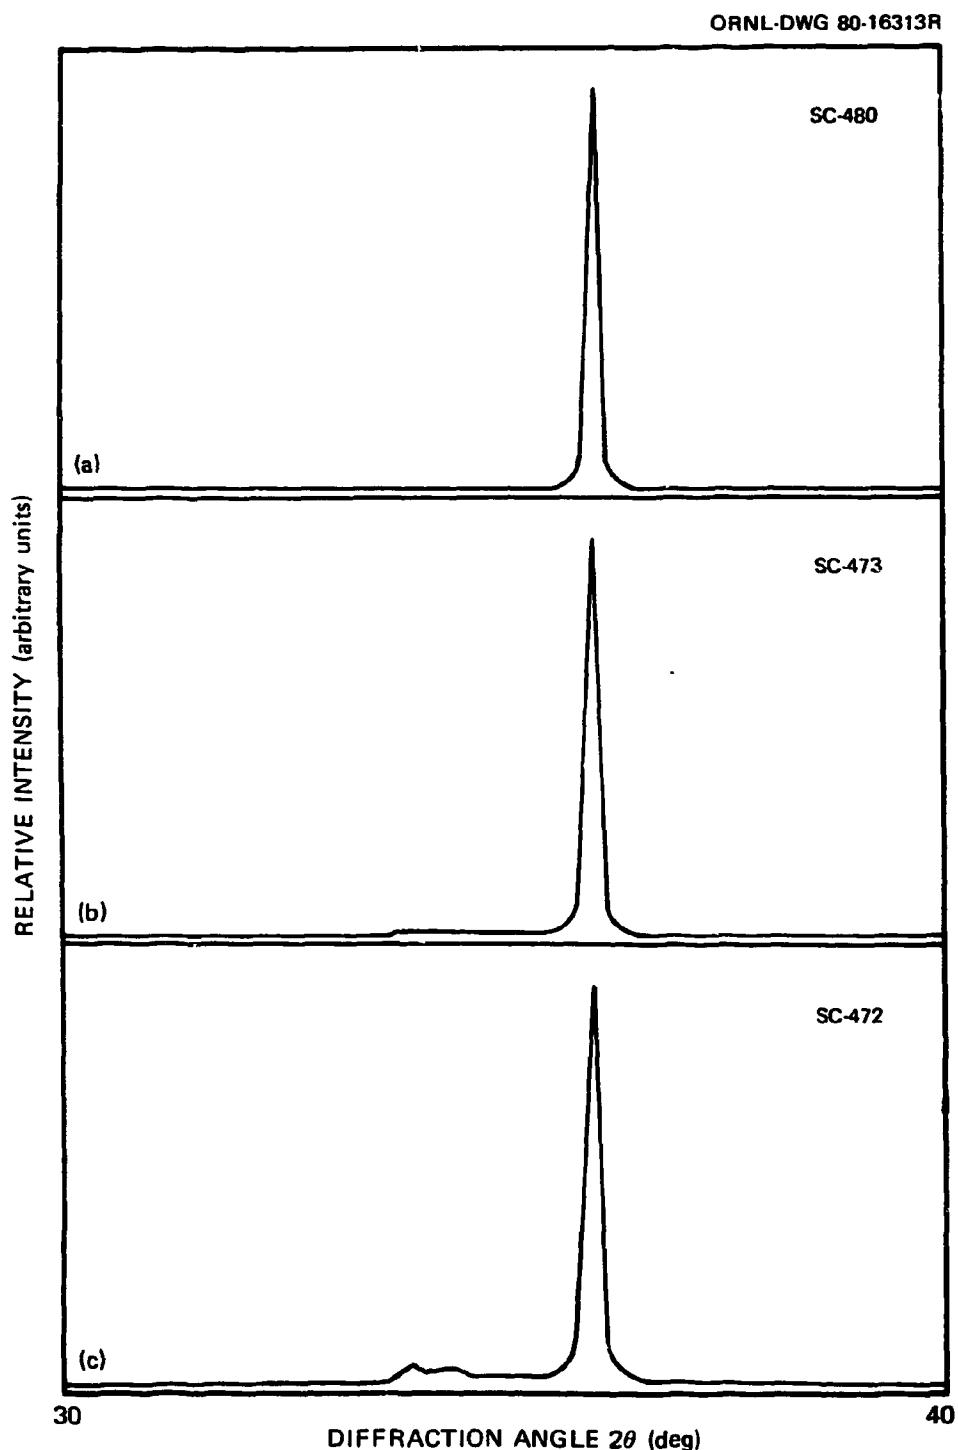
Fig. 11. Schematic X-Ray Diffraction Patterns for SiC Coatings.
(a) Pure β -SiC. (b) Pure β -SiC with diffuse plateau, presumably resulting from high stacking fault density. (c) Mostly β -SiC with a trace of "a-SiC."

Figure 11 illustrates these three XRD pattern types schematically. When the diffraction patterns are related to the coating deposition variables (Fig. 12), it becomes apparent that very high coating rates and/or low temperatures favor traces of α -SiC, while low coating rates and high temperatures favor β -SiC. Between the two extremes lie those conditions that produce the broad, low-intensity diffraction plateau characteristic of a heavily faulted material. This diffraction effect is seen as streaking in electron diffraction [Fig. 6(a)] where the faults are nearly parallel to the electron beam. This observation reinforces the belief that high coating rates favor a high stacking fault density, which in turn increases the chance that small regions can have structures identifiable as particular noncubic polytypes of SiC. The actual mechanism by which these small regions approach the hexagonal structure is probably associated with growth of the coating, and none of these coatings is a two-phase mixture in the thermodynamic sense.

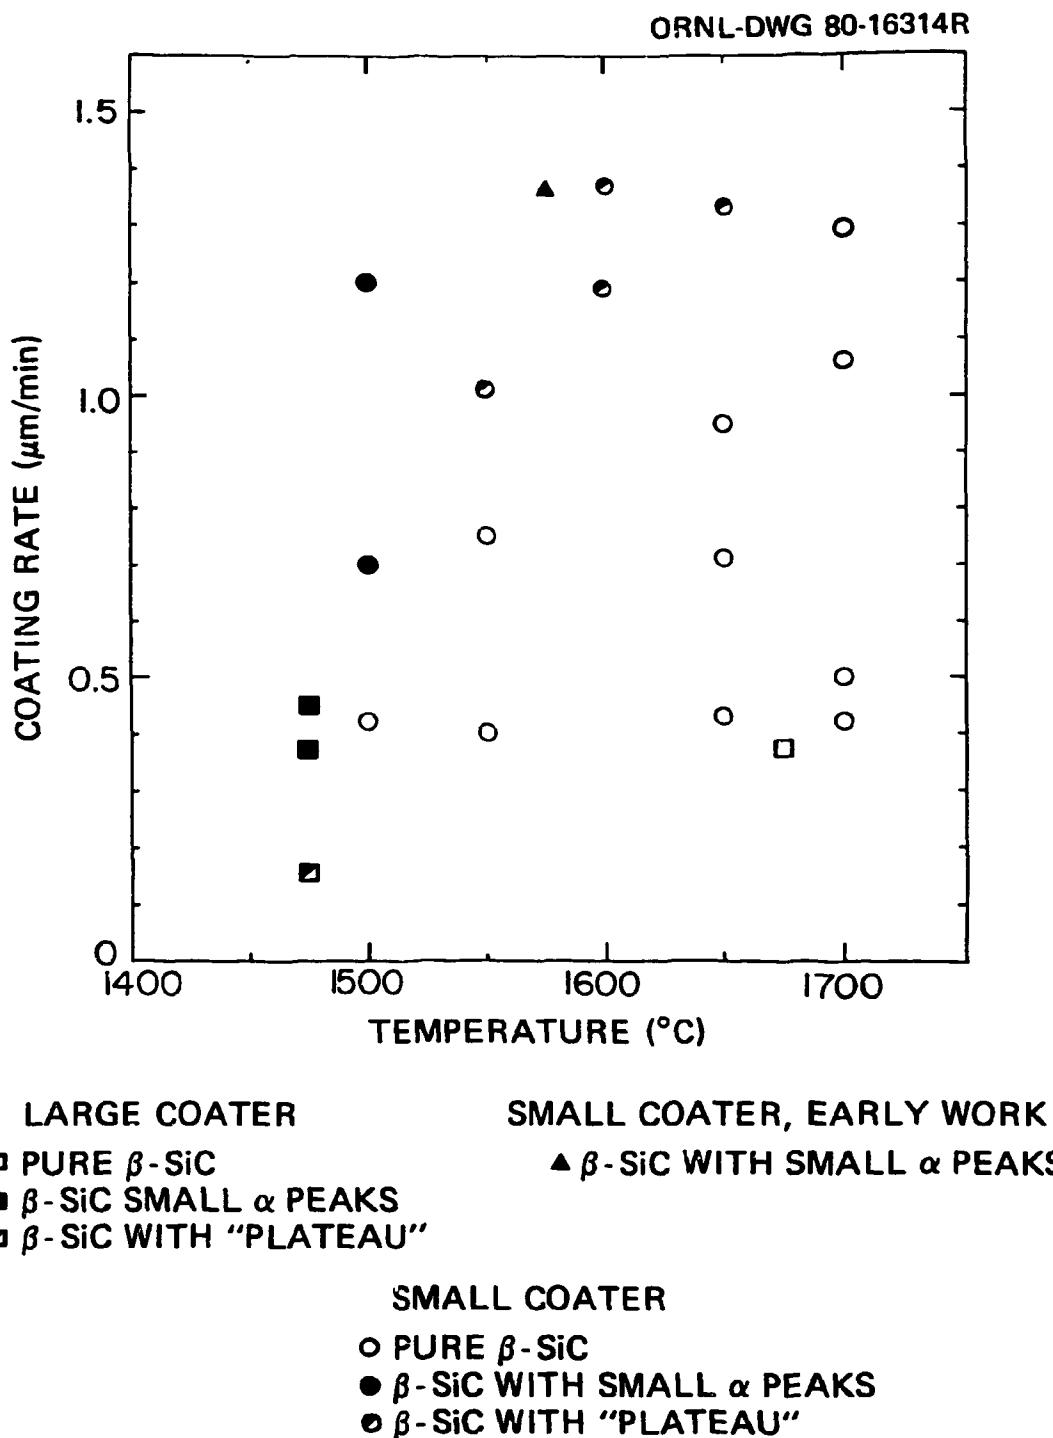
Fig. 12. X-Ray Diffraction Results Are Strongly Related to SiC Deposition Parameters.

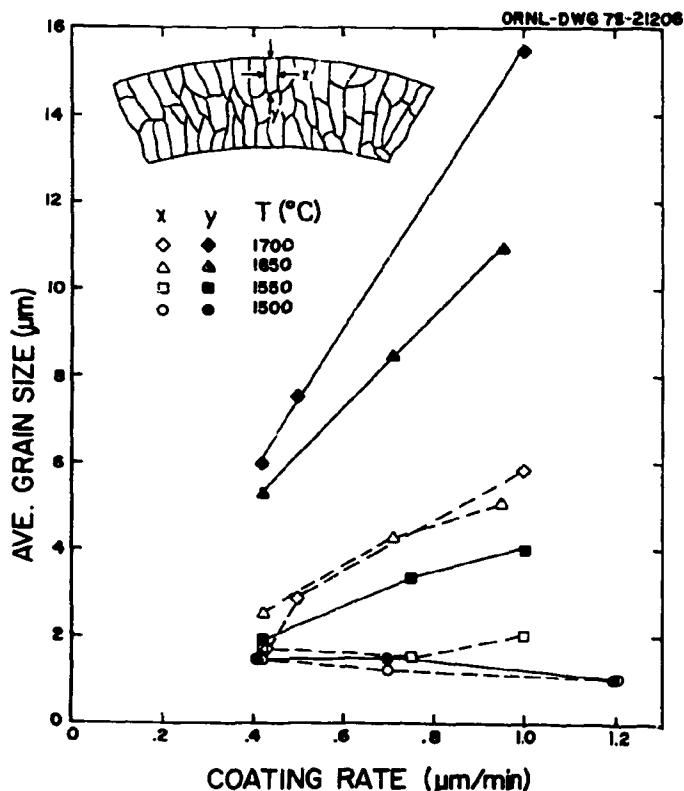
Fig. 13. Silicon Carbide Grain Size and Shape as a Function of Coating Parameters.

While most microstructural features in the coatings are too small to resolve optically, the measurement of average grain size is relatively simple. The grain size could be a key parameter with respect to fission product transport, which might involve grain boundaries. Figure 13 shows that grain size as well as shape (equiaxed or columnar) depend strongly on temperature and coating rate.

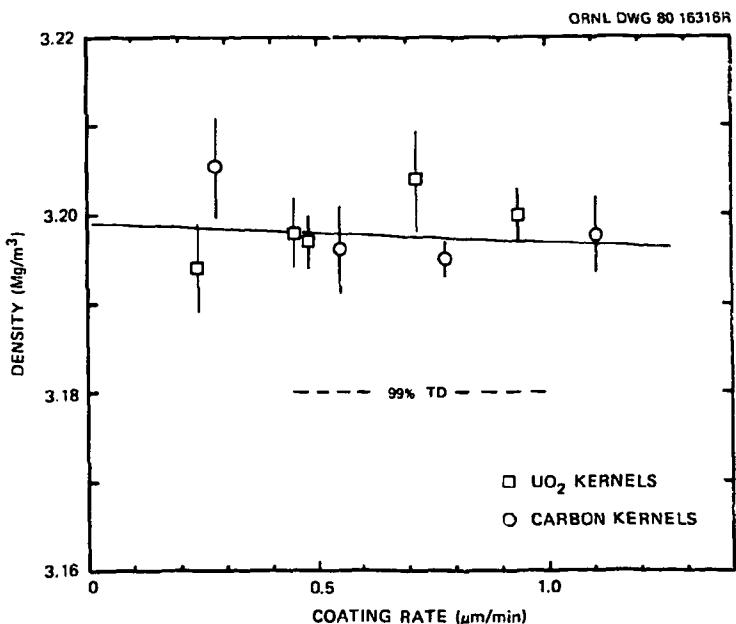
Fig. 14. Densities of SiC Batches for Capsule HT-35. The data show no clear correlation between density and coating rate.

Density measurement can distinguish unquestionably between very good coatings (near theoretical density) and very bad ones. But when a series of "good" coatings is fabricated under varying conditions, density is not a sensitive measure of their relative quality. Figure 14 shows the densities of SiC batches fabricated for irradiation capsule HT-35 as a function of coating rate. All coatings are well above the specified minimum density. There is virtually no correlation between density and coating rate, and the uncertainty in many of the values is greater than the differences between them.

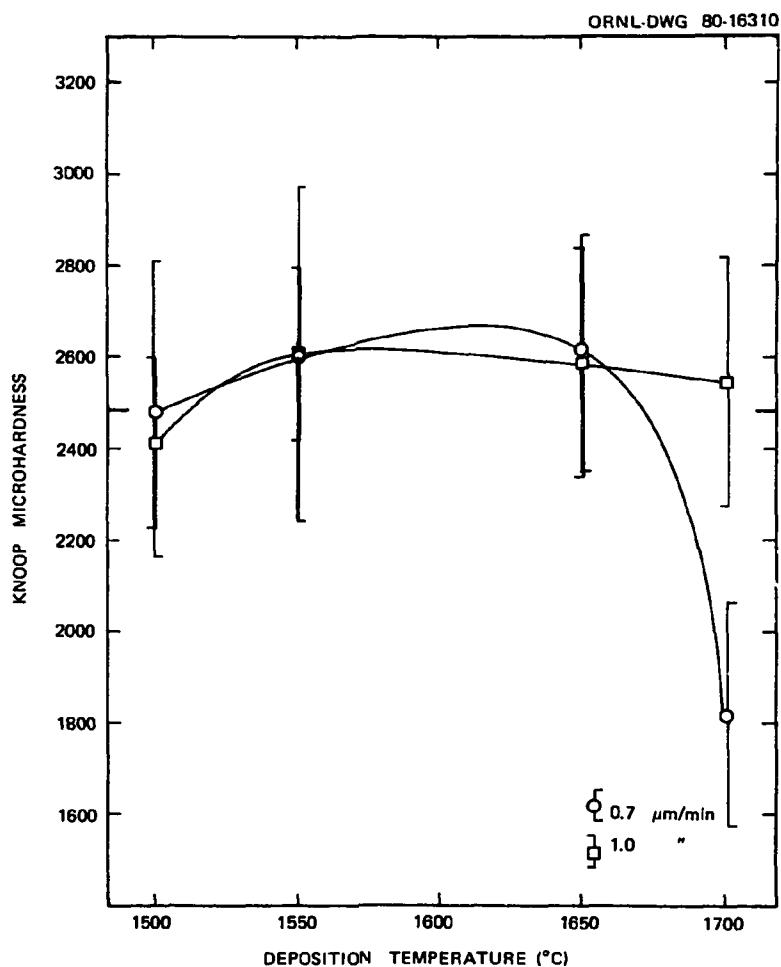
Fig. 15. Knoop Microhardness of SiC Coatings vs Deposition Temperature for Two Different Coating Rates.

Microhardness of coatings deposited at 0.7 $\mu\text{m}/\text{min}$ reaches a maximum at a deposition temperature of about 1600°C and decreases rapidly above 1650°C as shown in Fig. 15. The uncertainty in the data is still appreciable, but not as severe as in those coatings deposited at lower

coating rates. Coatings deposited at 1.0 $\mu\text{m}/\text{min}$ show approximately the same behavior as those deposited at 0.7 $\mu\text{m}/\text{min}$, but the data scatter has narrowed somewhat. Some of these coatings were slightly thicker than usual, and the added thickness could have helped prevent cracking during hardness testing. The hardness data for coatings deposited at 0.7 and 1.0 $\mu\text{m}/\text{min}$ suggest that microhardness is not a sensitive measure of coating quality. Batch-to-batch variations in hardness are smaller than particle-to-particle variations. In qualitative terms, it is not surprising that microhardness appears to reach a maximum in the same temperature range where density reaches a maximum.
