PILOT DEMONSTRATION OF CERIUM OXIDE COATED ANODES

**Final Report for the Period
April 1990 to October 1992**

**Prepared by
ELTECH Research Corporation
Fairport Harbor, OH**

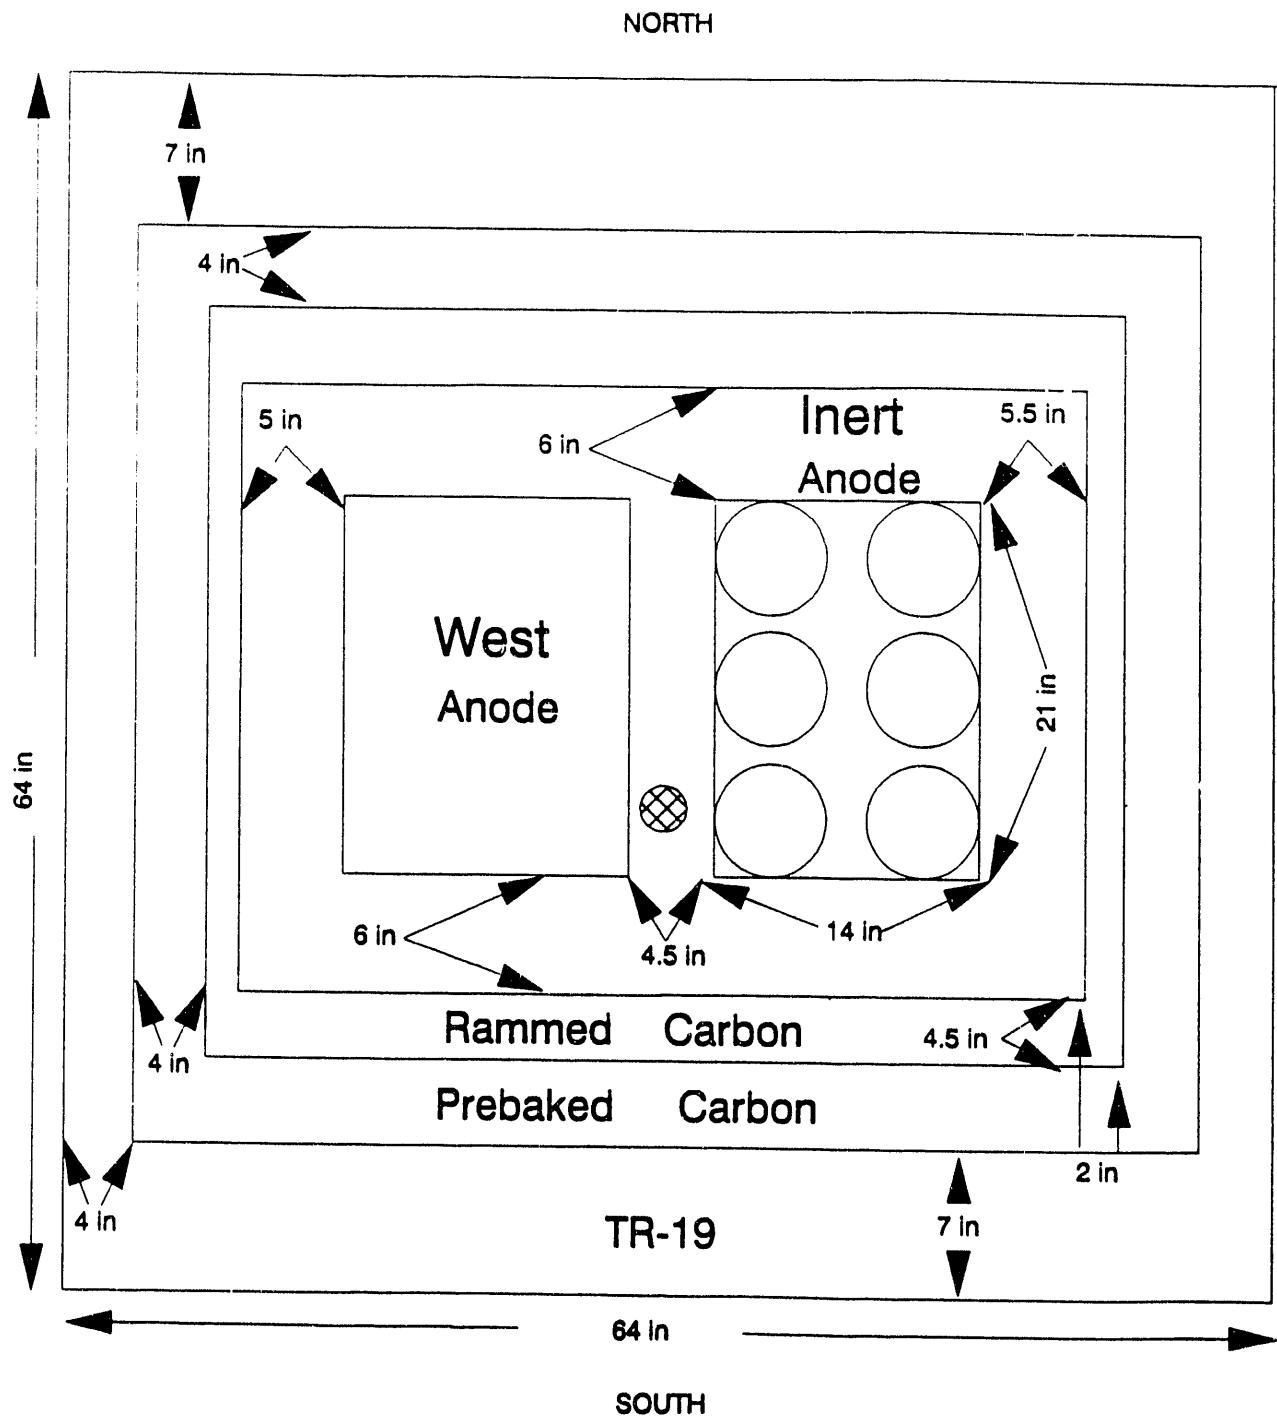
Figure 1.

Plan View

The self heated pilot cell had inside dimensions of 44 x 33 x 17 in., as shown in Figures 1 and 2. The sidewalls consisted of rammed carbon, prebake carbon blocks, and TR-19 vermiculite insulation. The cell normally operated with two industrial sized carbon anodes (15.5 x 21.5 in.), one of which was replaced with an inert anode cluster for this test. The cermet anode positions were labeled A through F (Figure 3). Each cermet anode could be individually removed.

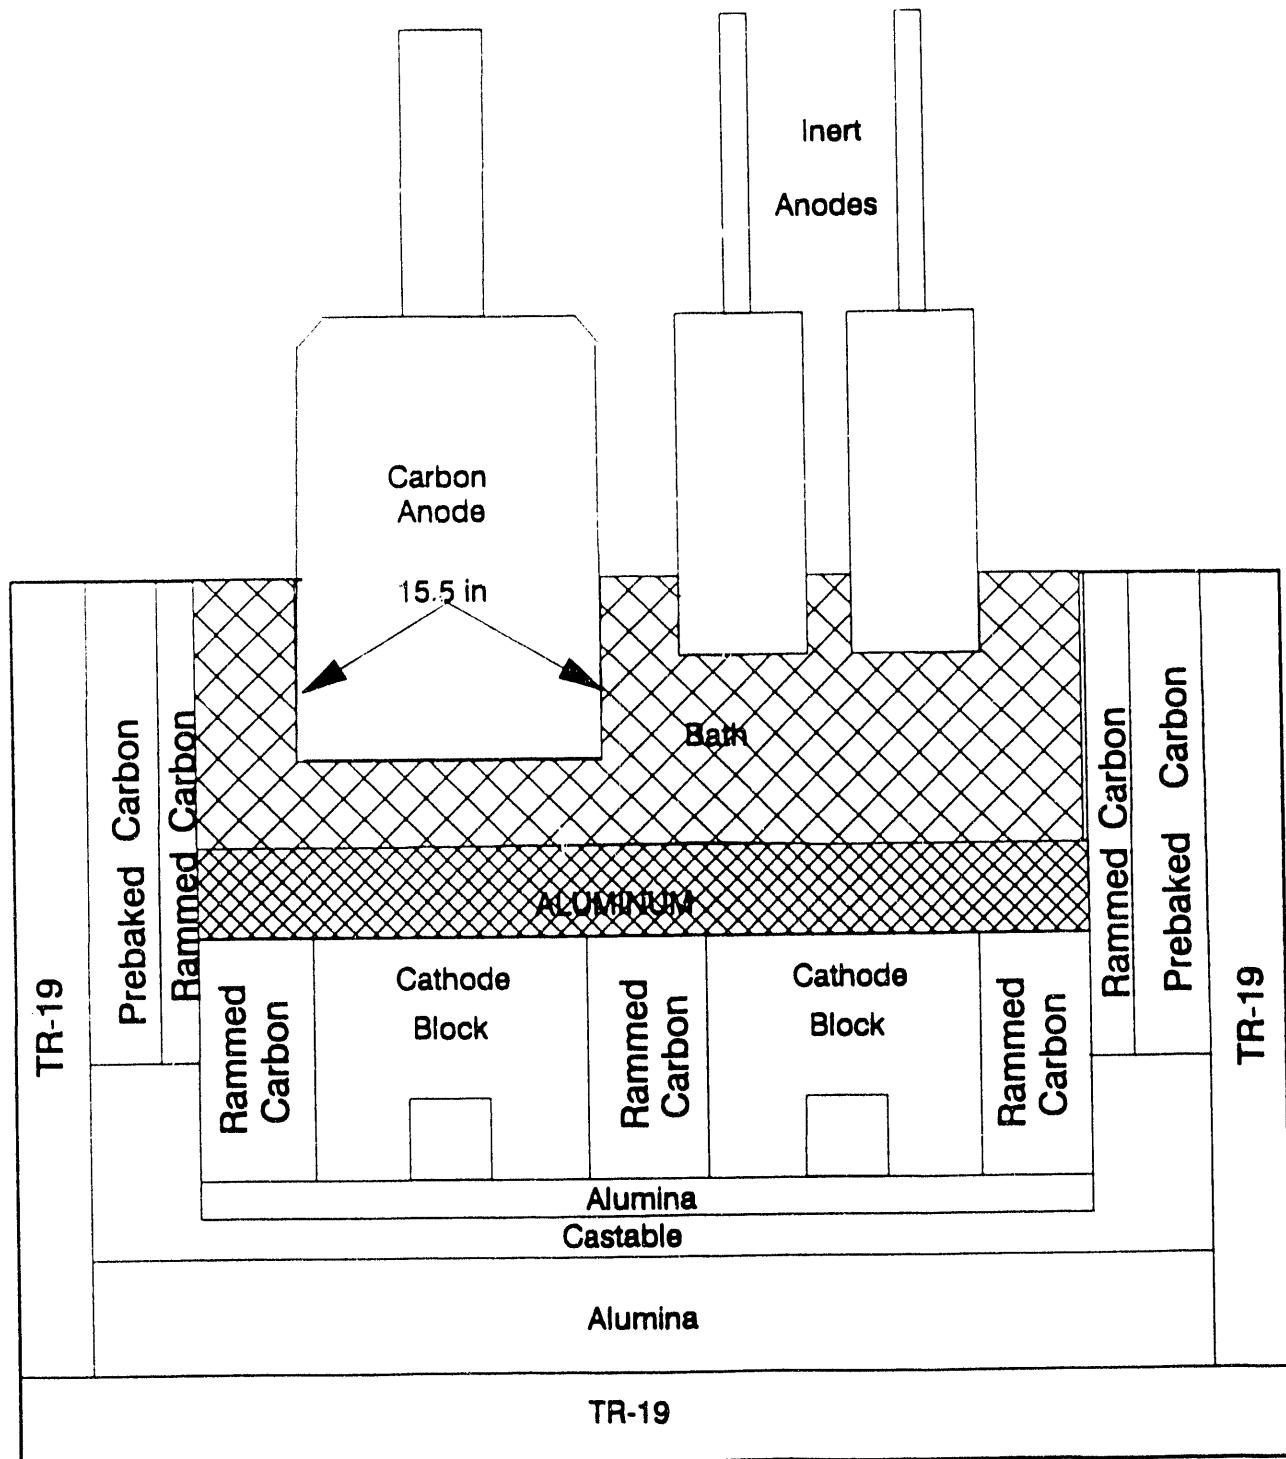
Figure 2. Pilot cell design, cross section.

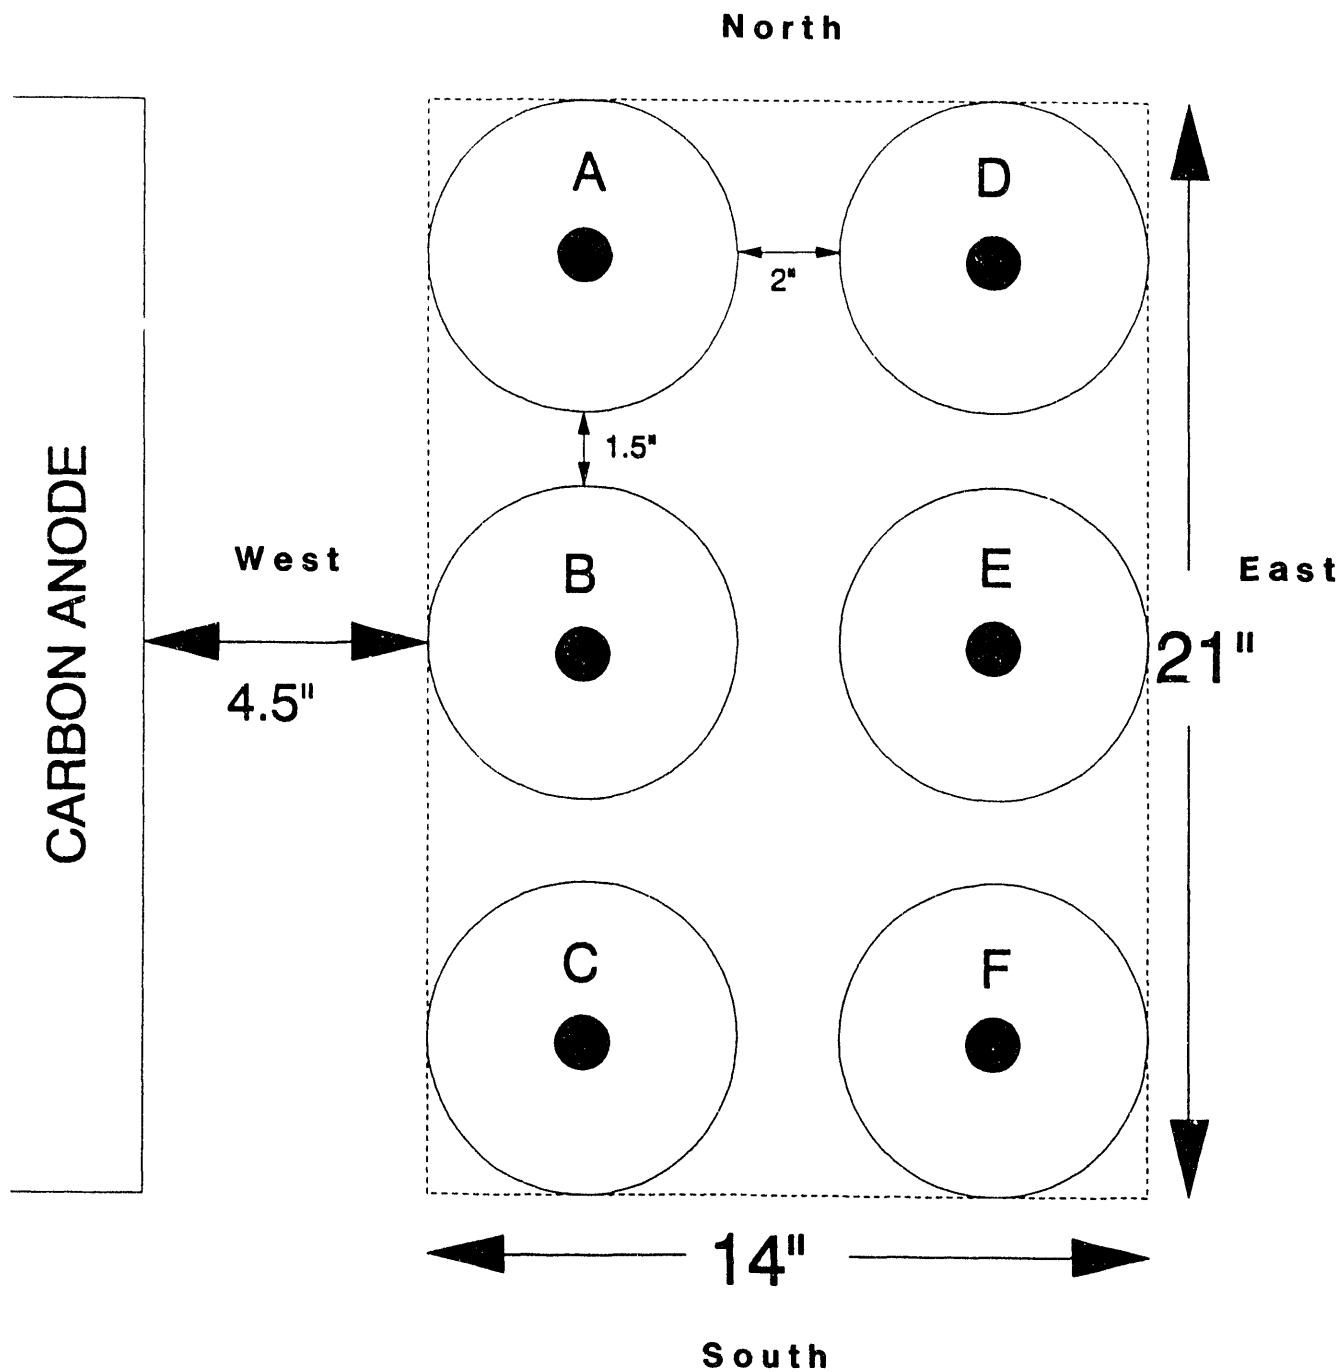
Figure 3. Position of inert anodes in the pilot cell.

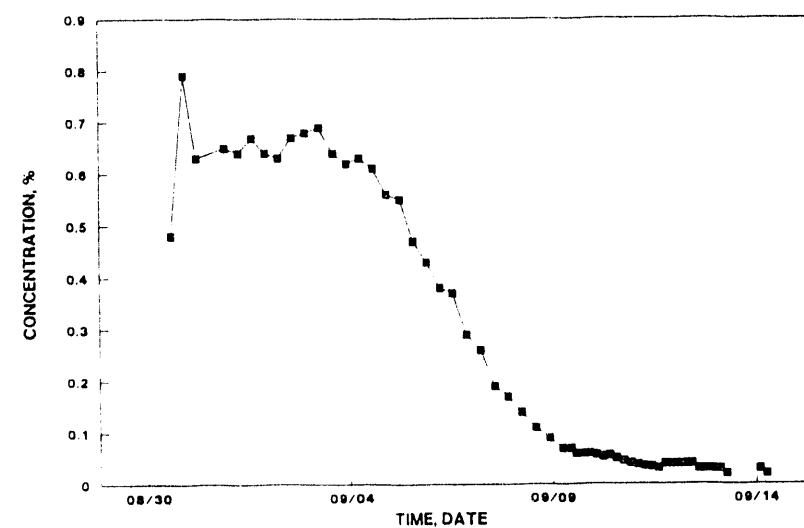
Figure 6. Impurity levels in the aluminum during operation of the pilot cell with two carbon anodes.

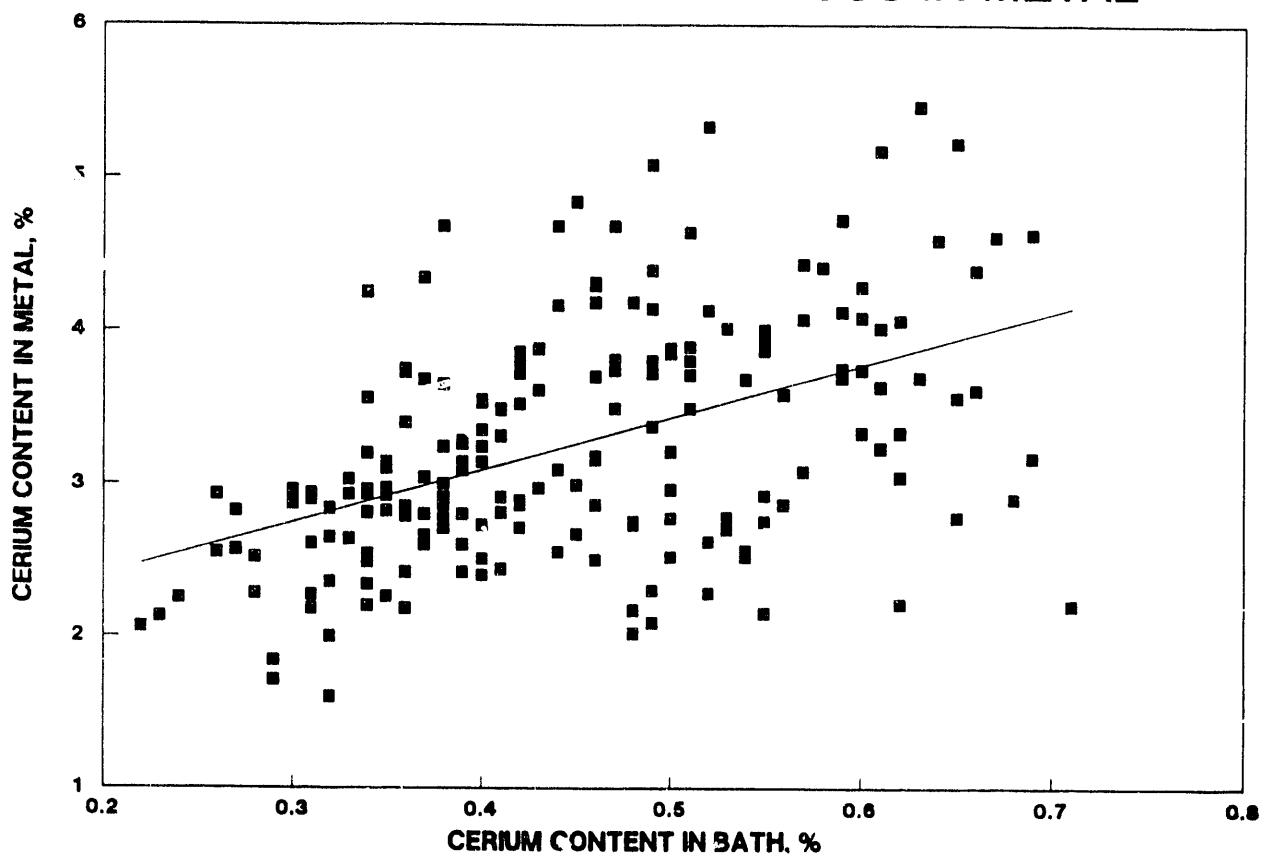
Figure 25.

CERIUM CONTENT IN BATH VERSUS IN METAL

The Ce concentration in the metal followed the same trends as that in the bath. In addition (as the bottom of the cell mucked up) it was suspected that the metal pool became segregated into numerous pools, which caused a lack of equilibrium between the pools. As with the Ce bath concentration, the Ce in the metal was much more erratic and higher than was expected, particularly for the second half of the test.

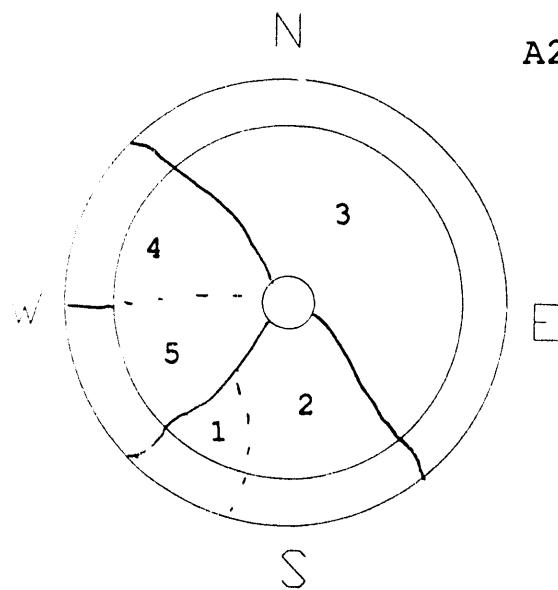
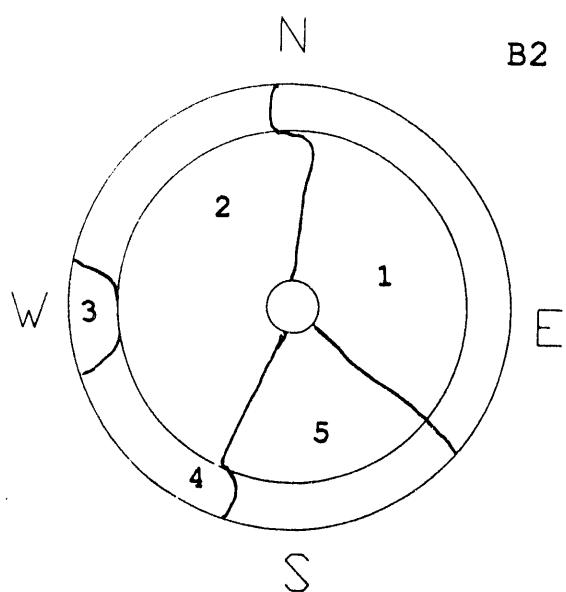
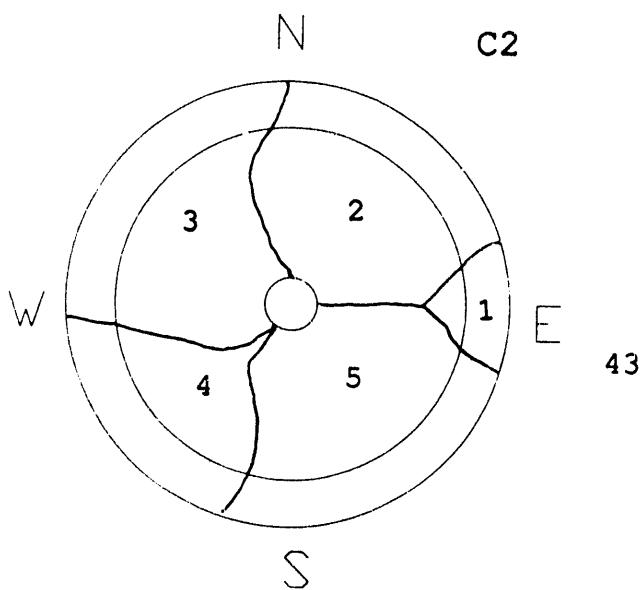
..... Cut Edge
 ——— Crack
 - - - - - Partially Cracked

Sketches of each tested anode showing the orientation of cracks. Cracked pieces were numbered for identification.

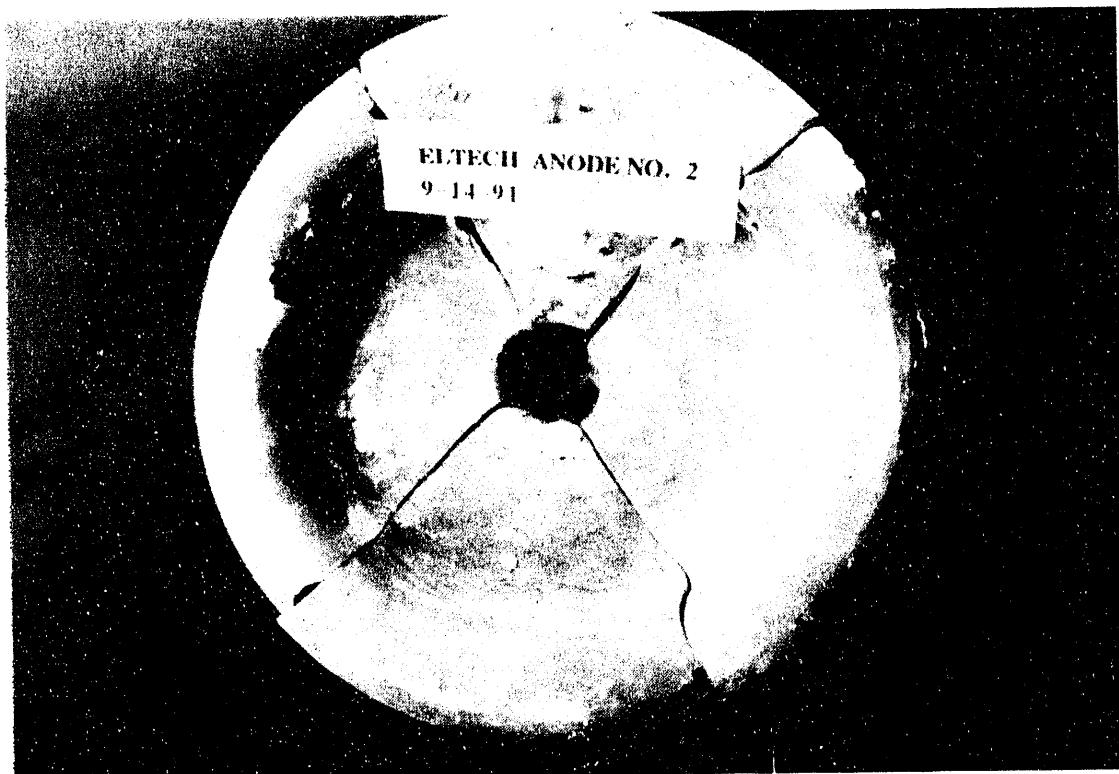
Figure 42. Anode B1 after removal from the test cell. Cracks radiate from the center.

Upon introduction to the bath, it was observed that anode 2 in position B (Anode B1) was cracked and incapable of carrying any significant amount of current. This anode was removed from the cell after ~1 hour.

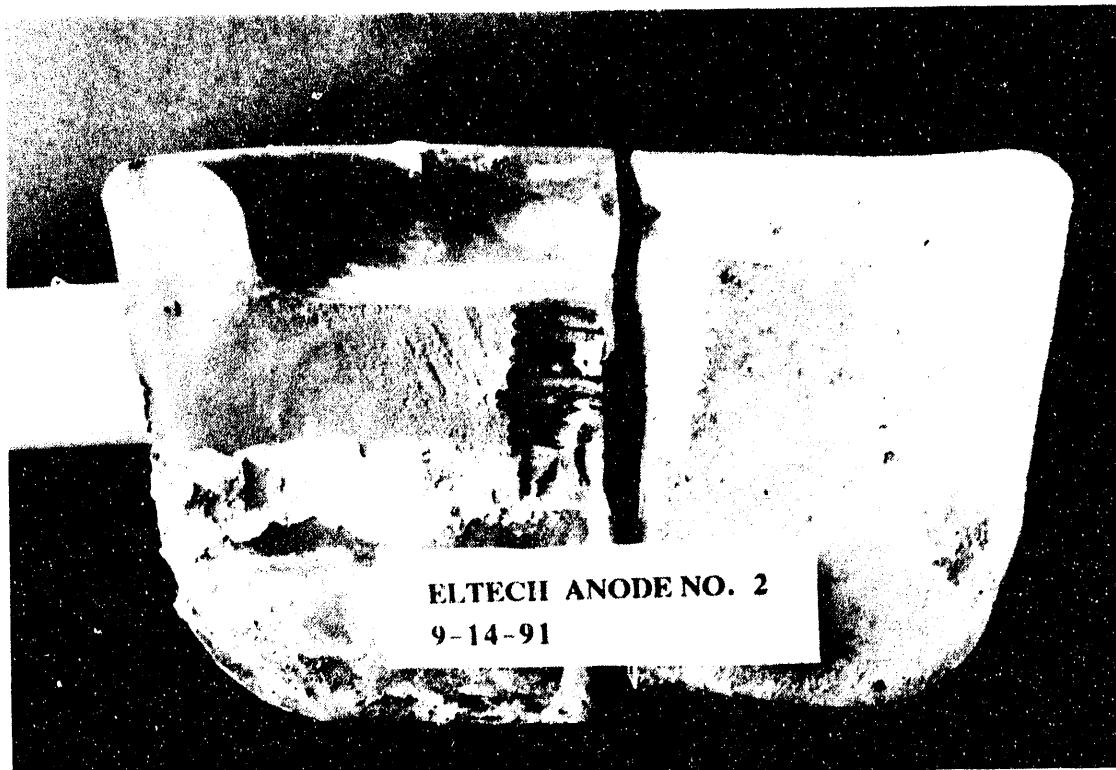
Figure 43. Cross-section of Anode B1 along a crack surface.

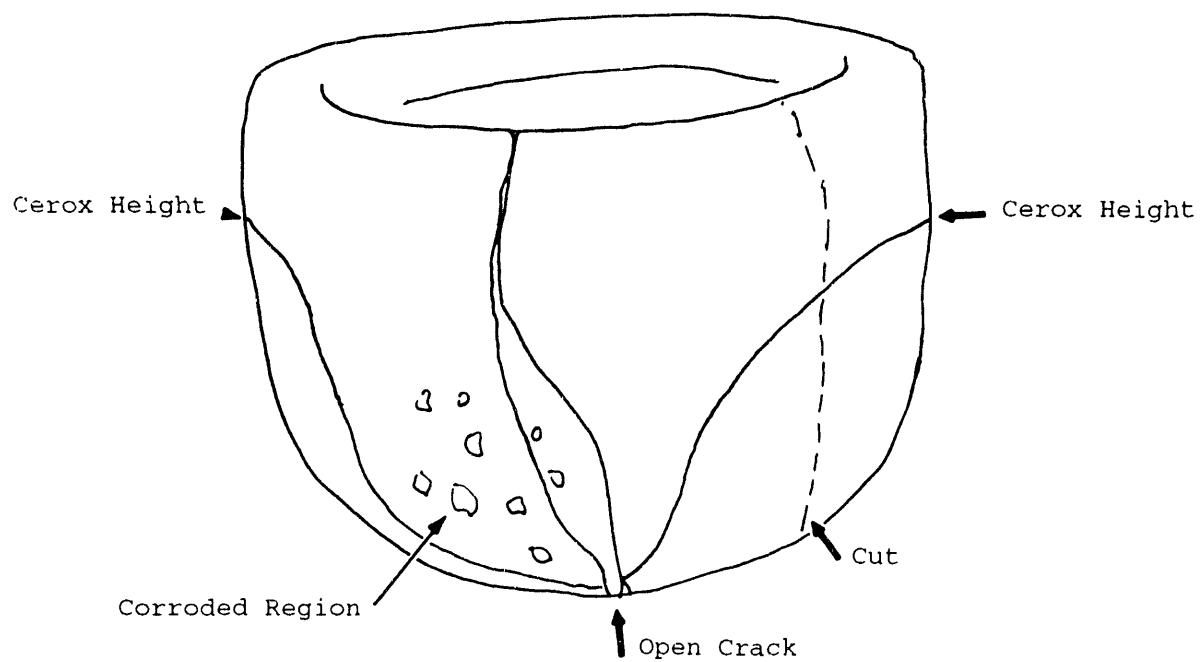
Figure 44. The west side of Anode A1 (which was next to the Carbon Anode) shows a dip in the Cerox coating height and also has a pitted corroded region on that side.

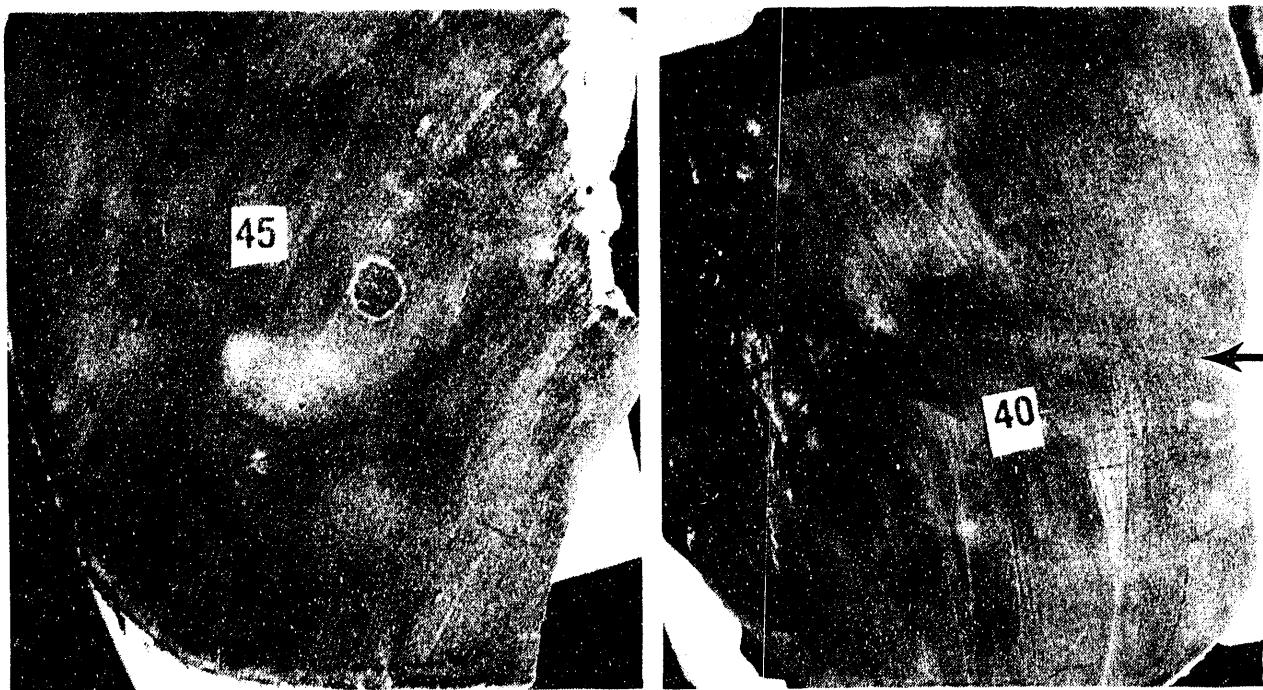
Figure 46. A cross-section of the southeast part of Anode A1 (left) is compared to the west side (right) to show the extent of the indentation (arrow) on the west side facing the carbon anode.

When the anode was cross sectioned a darker gray area (less Cu colored) was found on the bottom surface of the anode and a short distance up the sides. This region appeared devoid of Cu metal and was up to 0.5 mm thick on the side of the anode but up to 7 mm on the bottom of the anode.

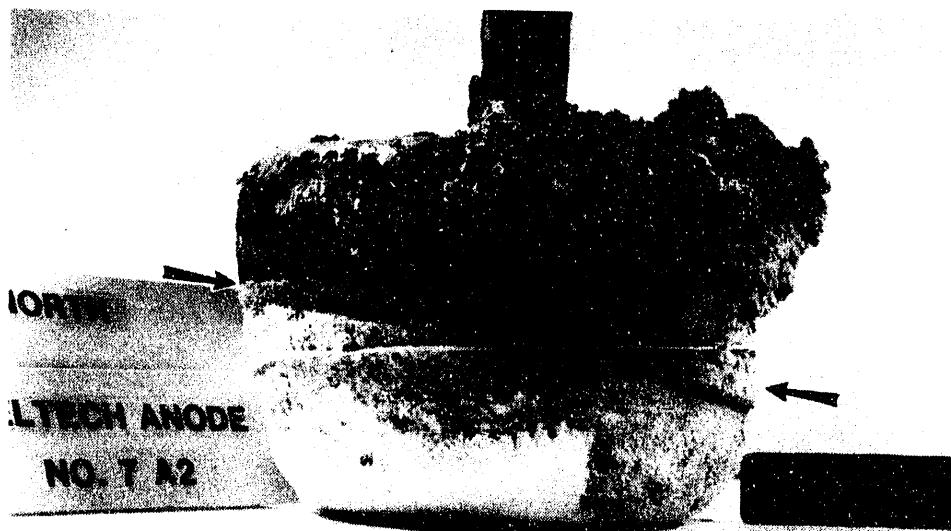
Figure 48. The Cerox coating and Cryolite crust are at an angle on Anode A2, indicating the Anode was hanging at an angle during testing.

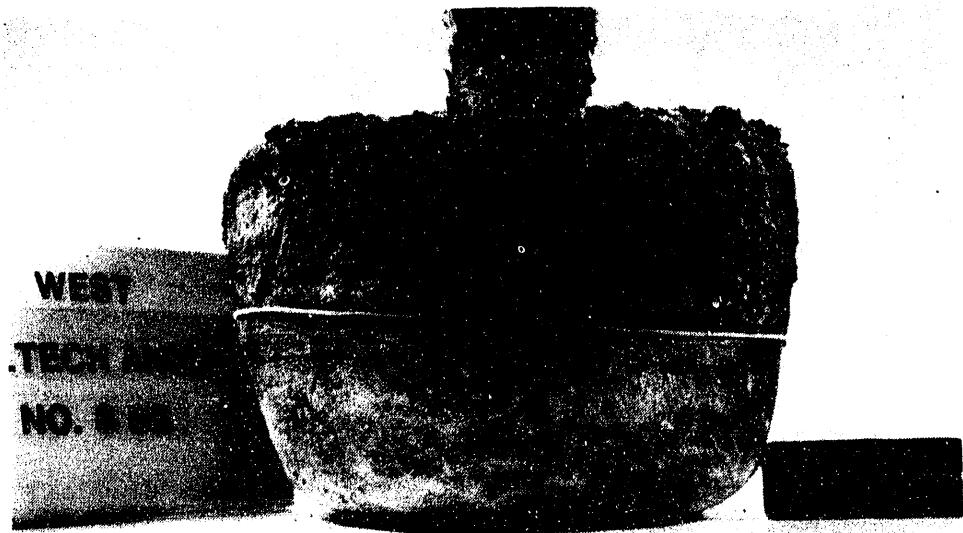
Figure 51. The west side of Anode B2 had a thin Cerox coating. A crack is evident on that side.

indentation was found as shown in Figure 51. The CEROX coating on the bottom of the anode was ~1 mm thick. Anode B2 had one main crack running north to south in the anode; the CEROX coating grew to a depth of 1.2 cm into this crack as shown in Figure 52. Along the crack surface, Cu metal could be found.

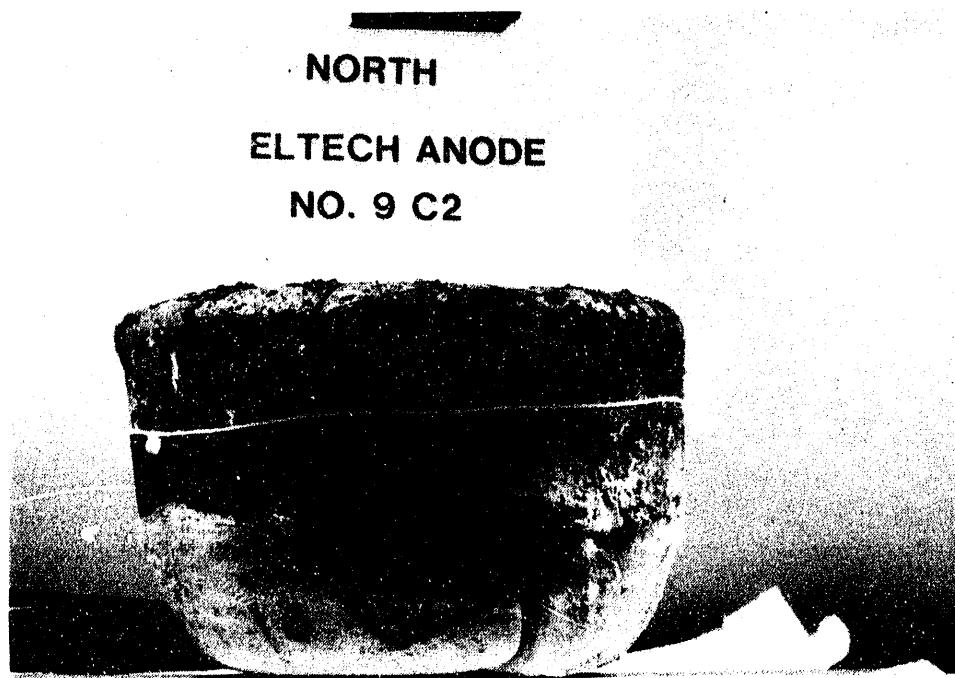
Figure 53. Anode C2 is cracked into multiple pieces. The Cerox coating is present on all sides.

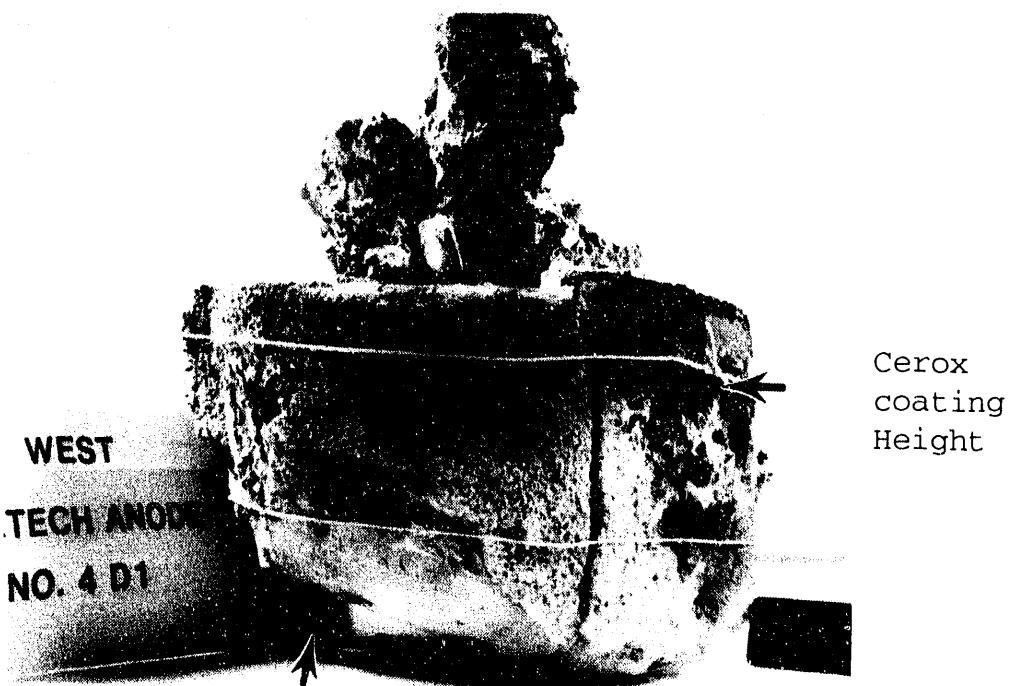
Figure 54. In Anode D1 the north and east sides and part of the bottom of the Anode is missing.

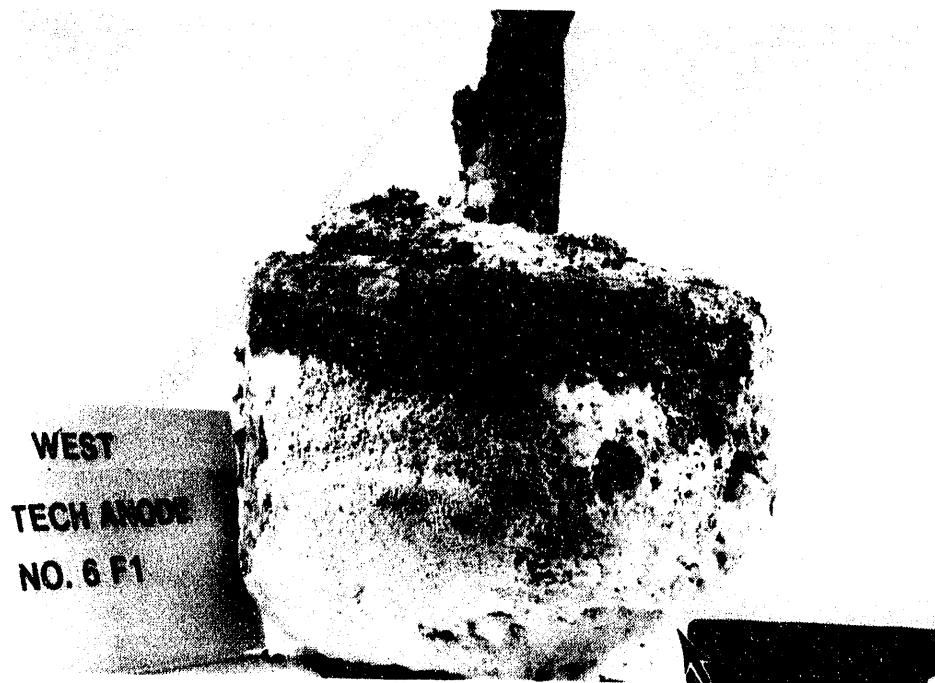
Figure 55. Anode F1. East side bottom of Anode is missing.

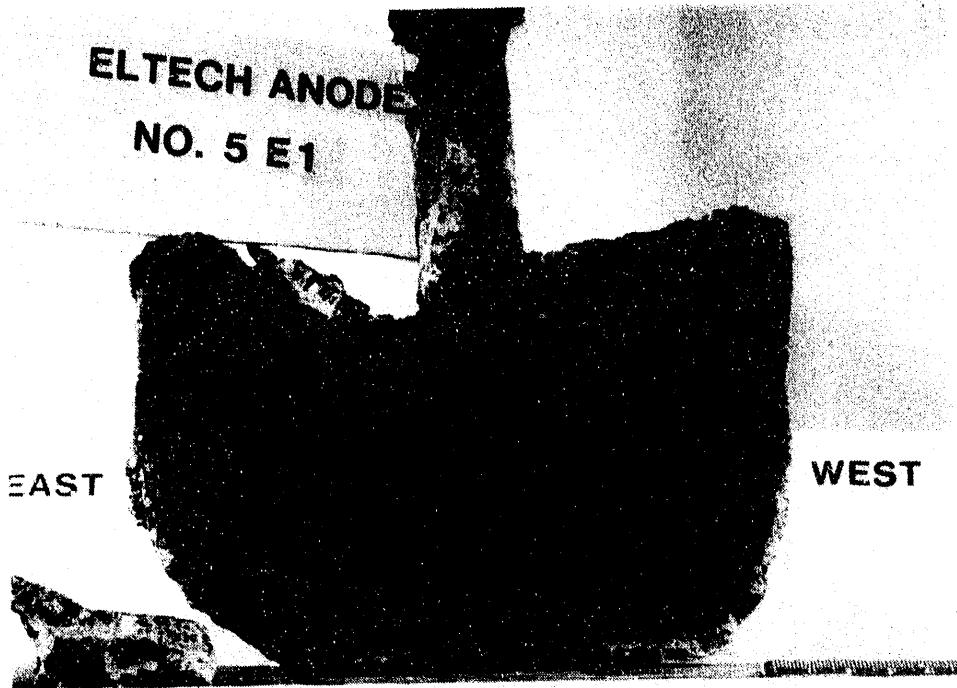
Figure 56. Cross-section of Anode E1 along a crack surface. On the east (left) side, a chunk of the thick Cerox and Cryolite has fallen off.

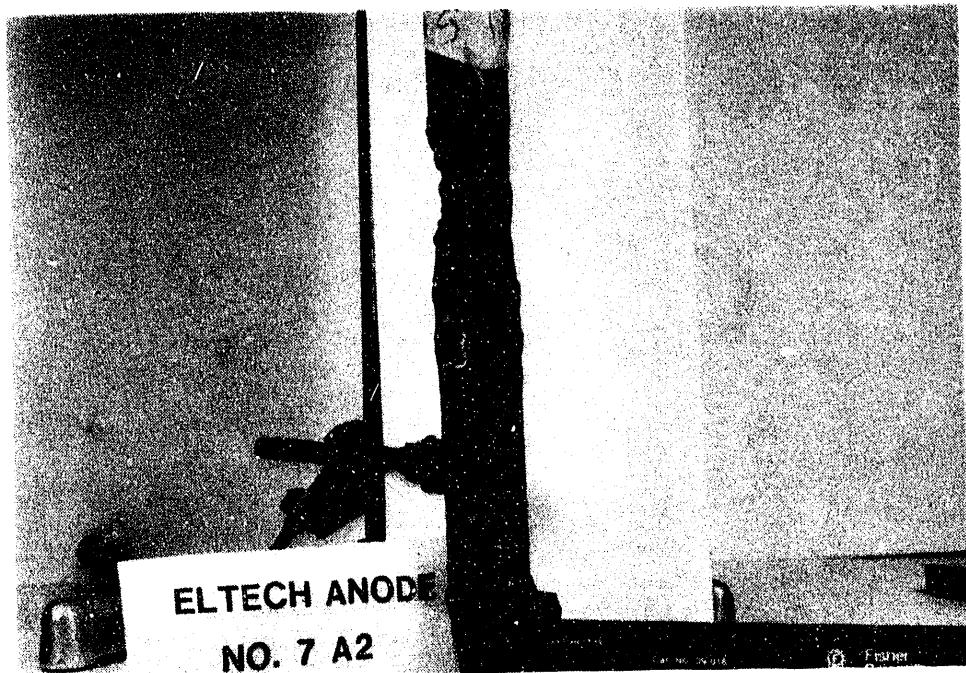
Figure 57. Typical Inconel 601 Anode connector rod after testing for 312 h.

A typical Inconel 601 connector rod is shown in Figure 57. The rods maintained their integrity during the testing, but often had

an indentation in the rod at ~4 in. above the anode: where the alumina sleeve and alumina cement ended. In some cases there was ~25% reduction in the diameter of the rod at this point. The microstructure of the rods will be described in Subsection 4.3.

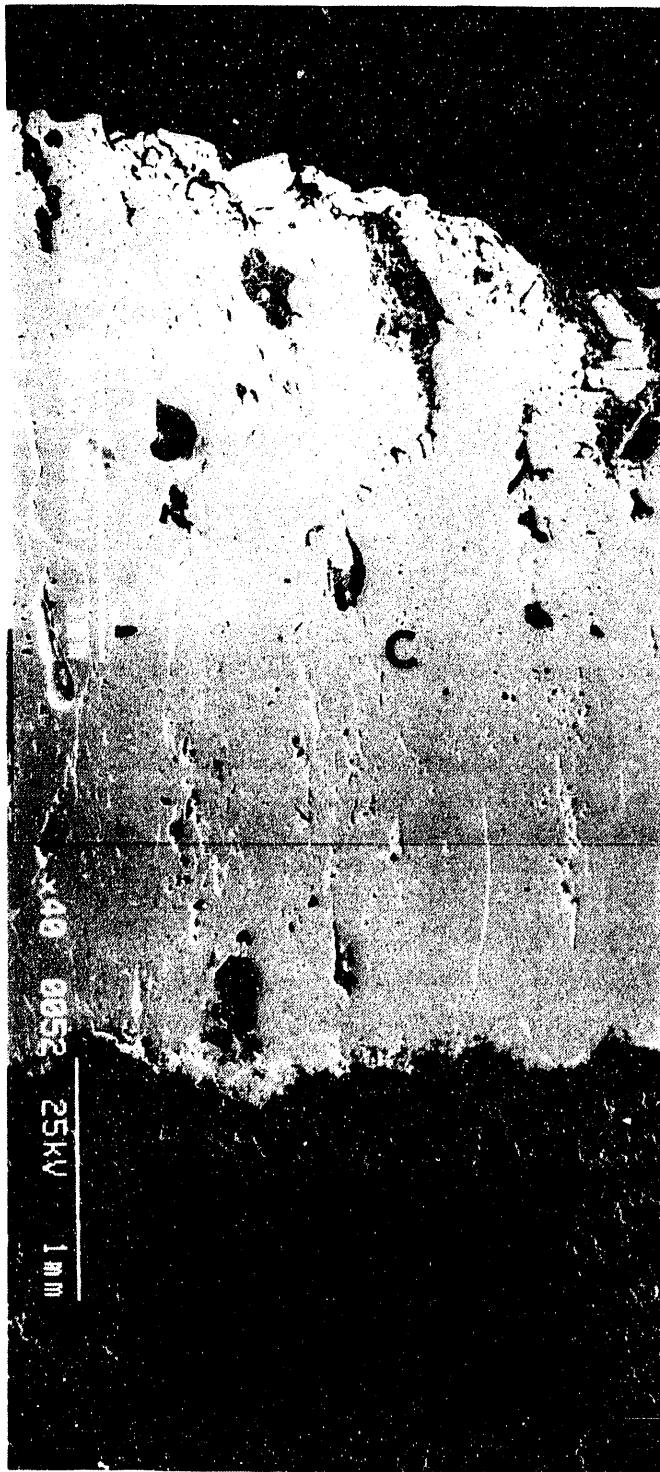
Figure 59. Cerox coating on the northeast side of anode A1.

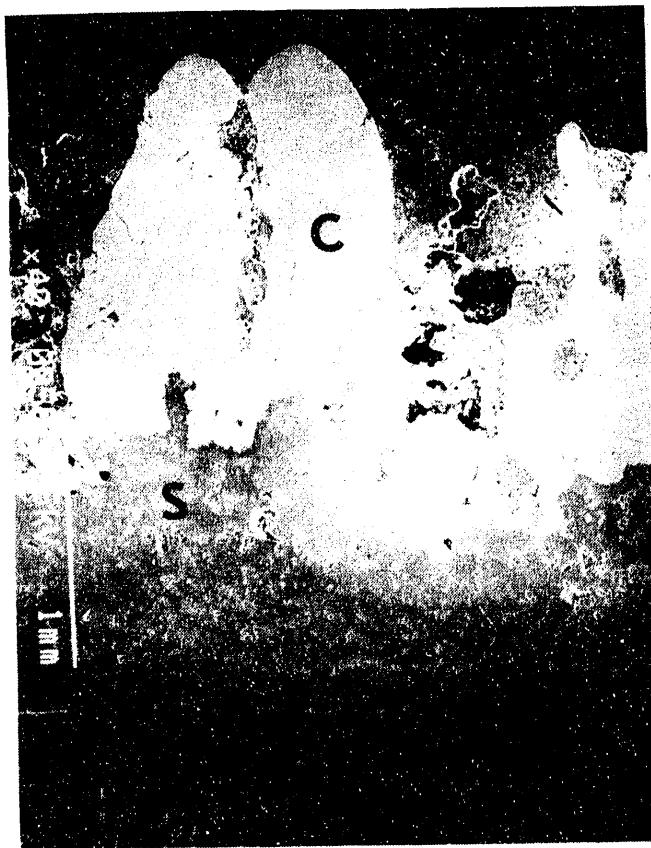
Figure 60. The bottom corner of Anode A1 has a thinner coating than the sides. The coating is also of a more irregular thickness.

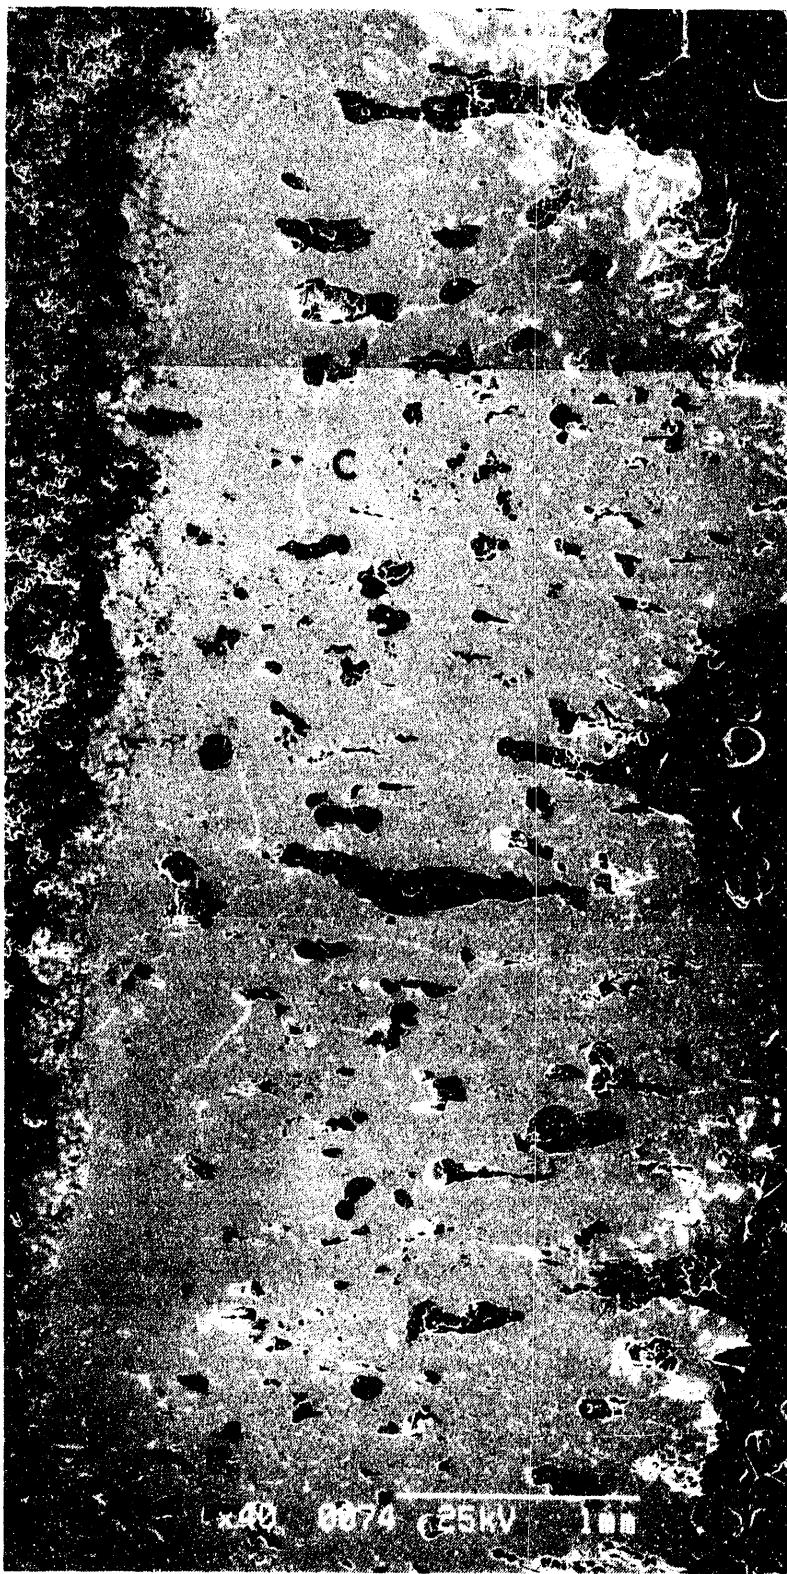
Figure 61. The Cerox coating on the bottom of Anode C1 is thick and continuous.

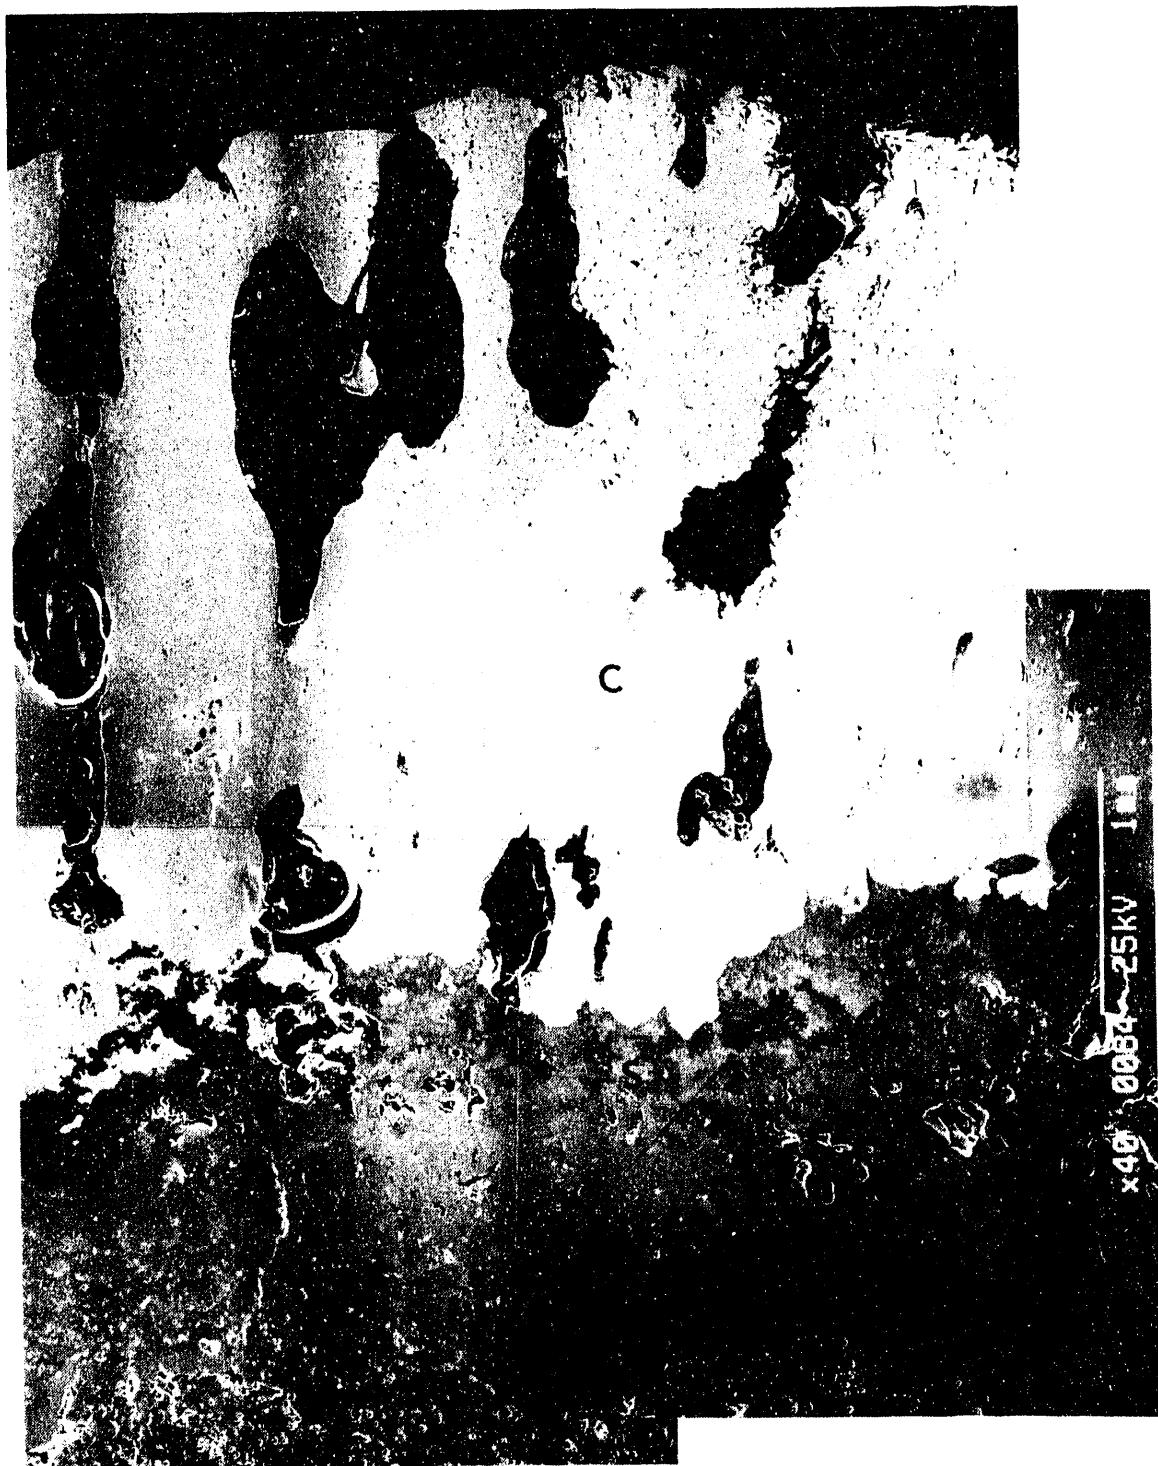
Another region of the CEROX coating on anode C1 (from the northeast bottom corner) is shown in Figure 63. In that region the CEROX coating is also ~3 mm thick, but contains some larger pores in the exterior half of the coating. These pores do not appear to penetrate to the substrate. Again, some of the pores contain cryolite.

Figure 63. Bottom corner of the northeast side of Anode C1. The Cerox coating is thick but contains some pores.
