PILOT DEMONSTRATION OF CERIUM OXIDE COATED ANODES

**Final Report for the Period
April 1990 to October 1992**

**Prepared by
ELTECH Research Corporation
Fairport Harbor, OH**

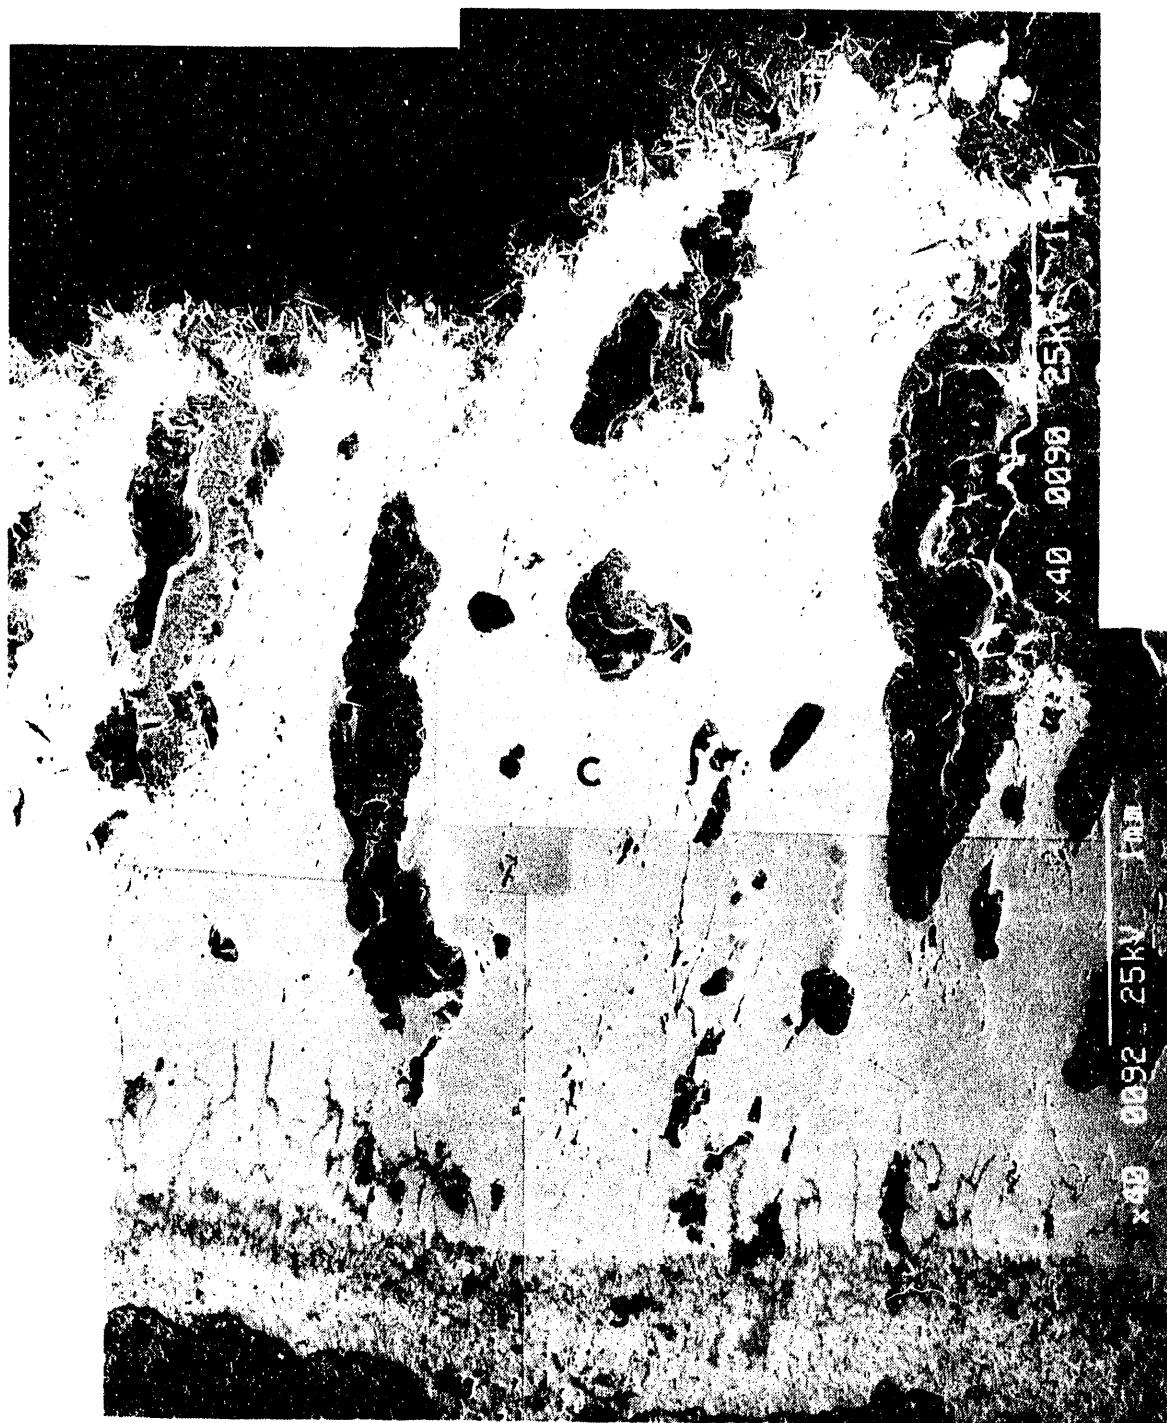
As described in Subsection 4.2.1, anode E1 experienced different conditions on the east and west sides of the anode. On the west side (~3 cm up from the bottom), where it appeared that current was still flowing at the end of the test period, the CEROX coating (Figure 64) appears similar to that in Figure 63 (anode C1). The coating is 3 to 3.75 mm in thickness, with some elongated cryolite-filled pores, particularly in the exterior half of the coating.

Figure 64. The Cerox coating on the west side of Anode E1 is 3 to 4 mm in thickness and porous.

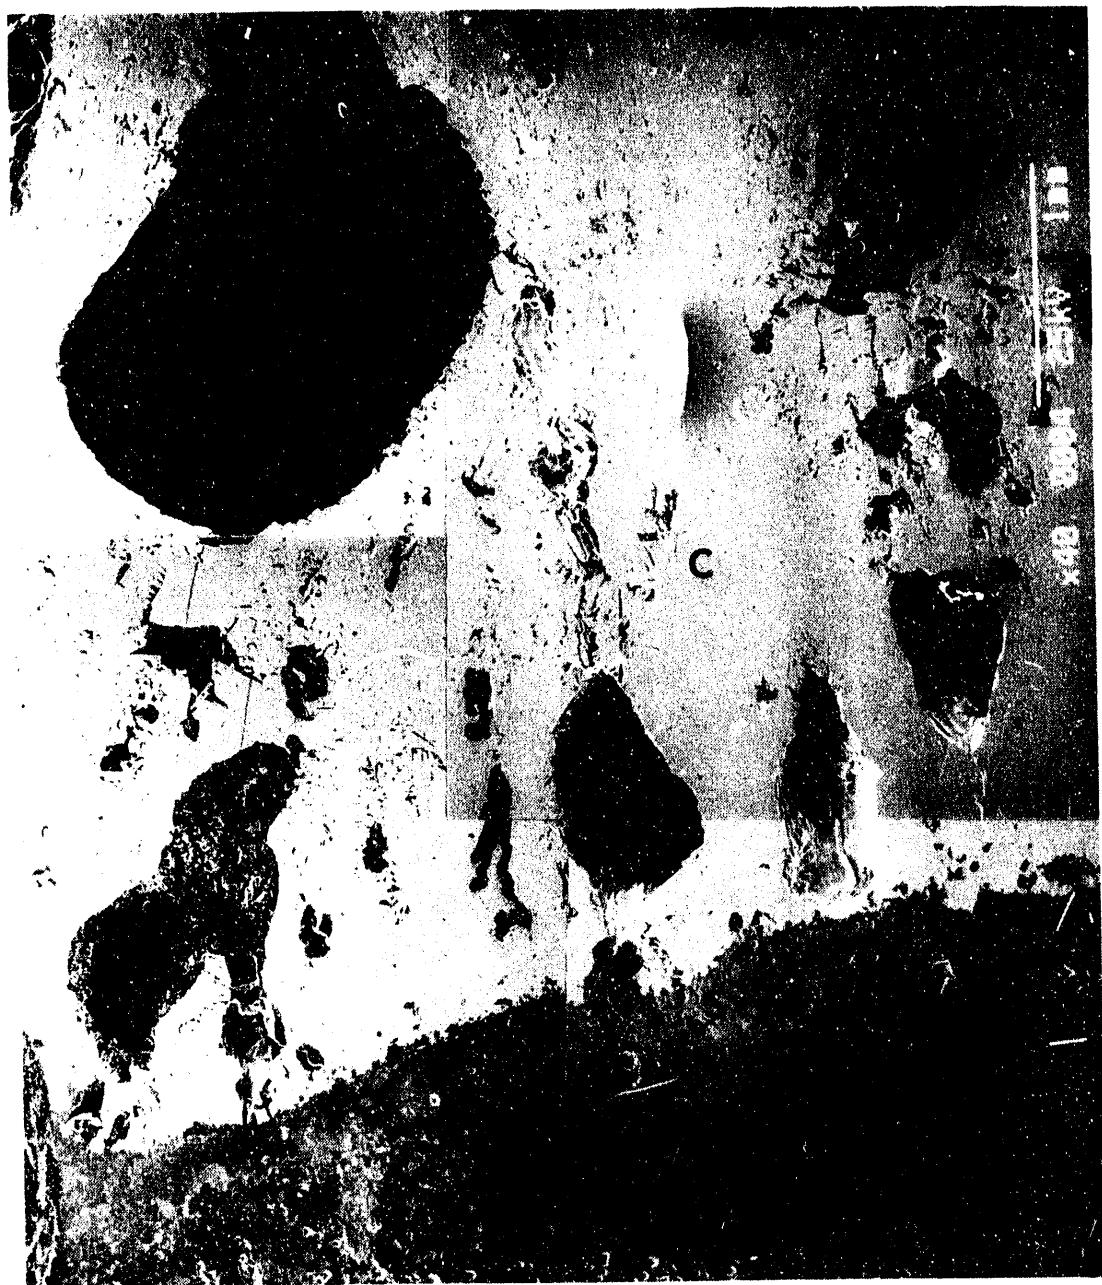
On the east side of the anode (where the anode was frozen into the cryolite) the character of the CEROX coating is completely different. The CEROX coating is so thick (~8.5 mm), that it is shown in Figures 65 (a) and (b). The inner half of the coating [Figure 65 (a)] shows a good, fairly pore-free interface between the CEROX coating and the substrate. The CEROX coating itself has large, roundish pores within it. In the exterior part of the coating [Figure 65 (b)], the coating appears less dense, and many "sawtooth" patterns appear to be present. In addition, numerous small pores occur, which appear to outline $\text{Ce}(\text{O},\text{F})_2$ grains within the coating. It is not known if this pattern is from the growth of the coating or from the dissolution of the CEROX coating at some time after it had been deposited.

Figure 65a. The inner Cerox coating, next to the substrate, on the east side of Anode E1.

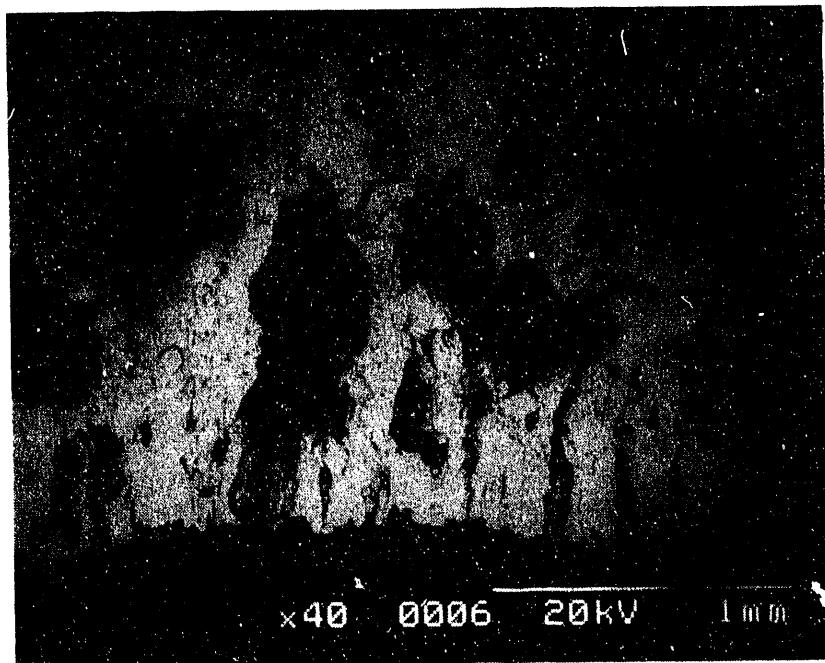
Figure 66. The Cerox coating on the bottom of Anode A2 is irregular and less continuous than on the other Anodes.

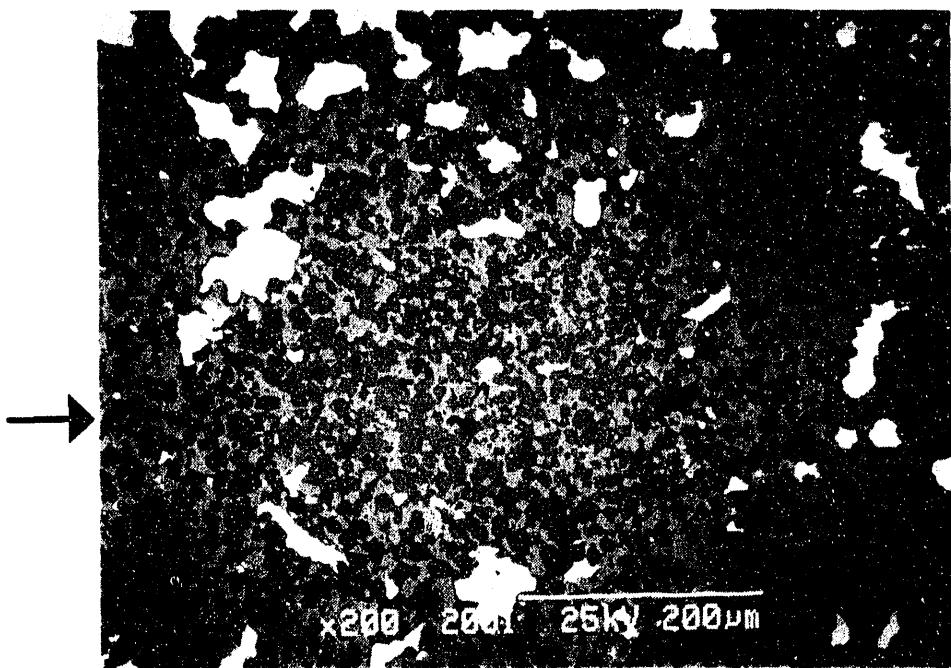
Figure 73. A copper depletion seam is shown within the untested cermet (arrow).

Cu depletion seams are found in the cermets (Figure 73) and tend to run parallel to the bottom surface of the anode. These seams can be observed in Figure 68 and are often easily visible

macroscopically. Figure 73 shows a seam that is $\sim 200\mu\text{m}$ wide; they have been observed to be up to several cm long.

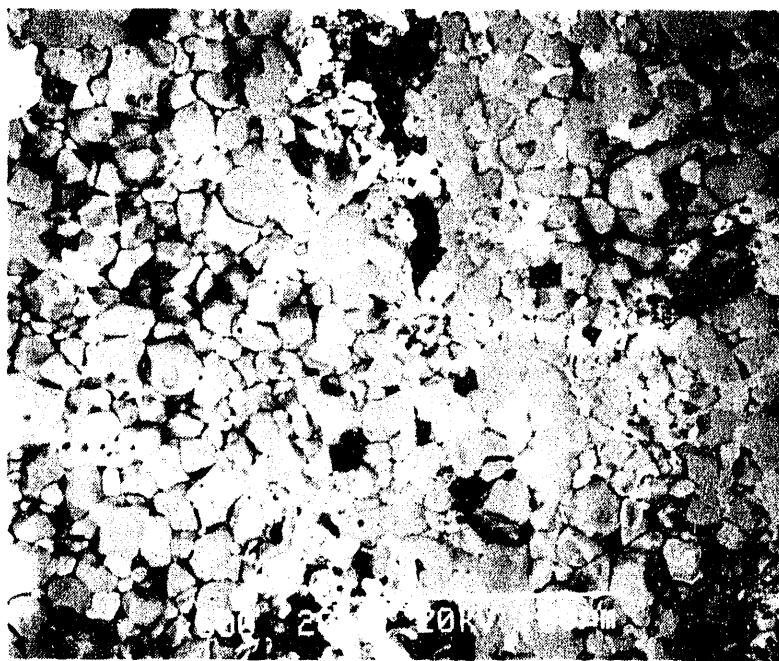
Figure 76b. BEI of the same area as 76a. The bright light grains are Cu-rich phases.

the inner boundary of this reaction layer. The bright features in Layer B are a Cu alloy phase and these are obviously missing in the reaction layer (Layer C). Electron probe microanalysis (EPMA) was performed at 500X in Layer C to estimate a bulk composition of the cermet, and it was found that this region was Cu depleted, containing 8.3 mol% Cu as compared to the starting bulk cermet with 19.9% Cu, 42.8% Ni and 37.4% Fe (all compositions are given in mol%). The Ni/Fe ratio was 1.133, which is very close to the batched ratio of 1.142. Thus, Cu is preferentially removed in this region. Most of the grain boundaries and triple grain junctions are rounded from corrosion with the cryolite and porosity is increased compared to the untested material. EPMA spot analysis on the ferrite grains showed that their composition is changed and they are now nearly stoichiometric NiFe_2O_4 . Thus, Fe was removed from the ferrite grains.

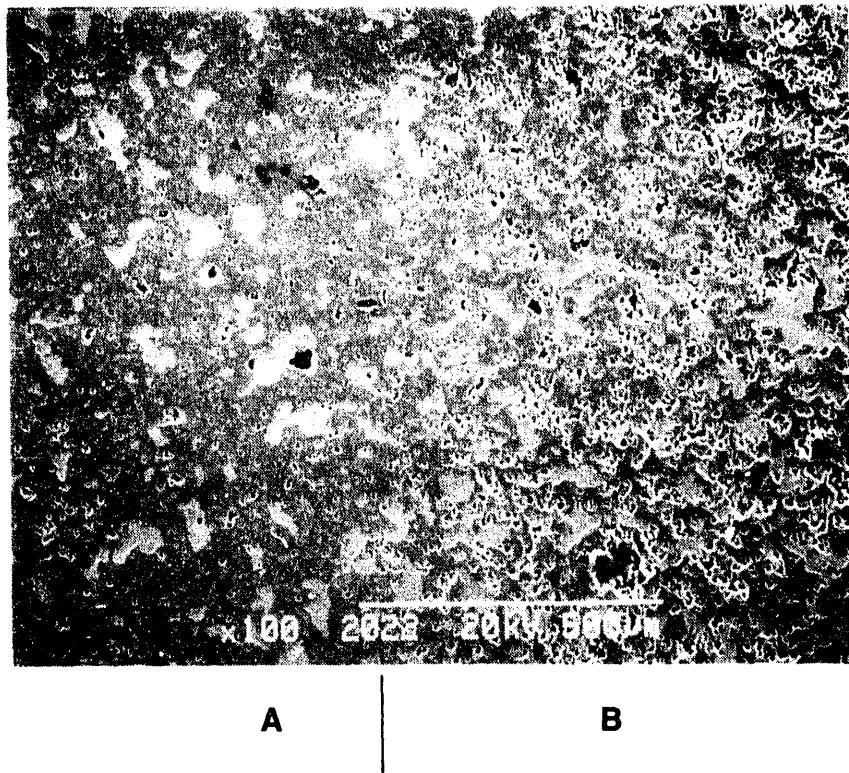
Figure 77. Anode B1, showing the boundary between the porous zone (B) and the dense zone (A) is ~4.2 mm into the sample.

Because the porous zone was ~4.2 mm in from the outer edge of the sample, and because the anode operated for only 1 h, the average penetration velocity of this front was 1.2×10^{-4} cm/s. The diffusion coefficient, D, of the penetrating species was estimated using the equation $x^2 = Dt$ and to give a value of $D = 5 \times 10^{-5}$ cm²/s. This value is over 2 orders of magnitude greater than the diffusion coefficient of Cu in Cu₂O and six orders magnitude greater than the diffusion coefficient of Ni in NiO¹⁵ so it is very doubtful that solid state diffusion is responsible for this microstructure. A more likely explanation would be the penetration of liquid cryolite along any existing open pores and along grain boundaries. The presence of this porous zone emphasizes the need to fabricate completely dense anodes to prevent or slow the rapid penetration and weakening of the cermet by cryolite. If the anode was immersed in molten cryolite for longer than an hour (during the heat-up period), more time might have been available for diffusion into

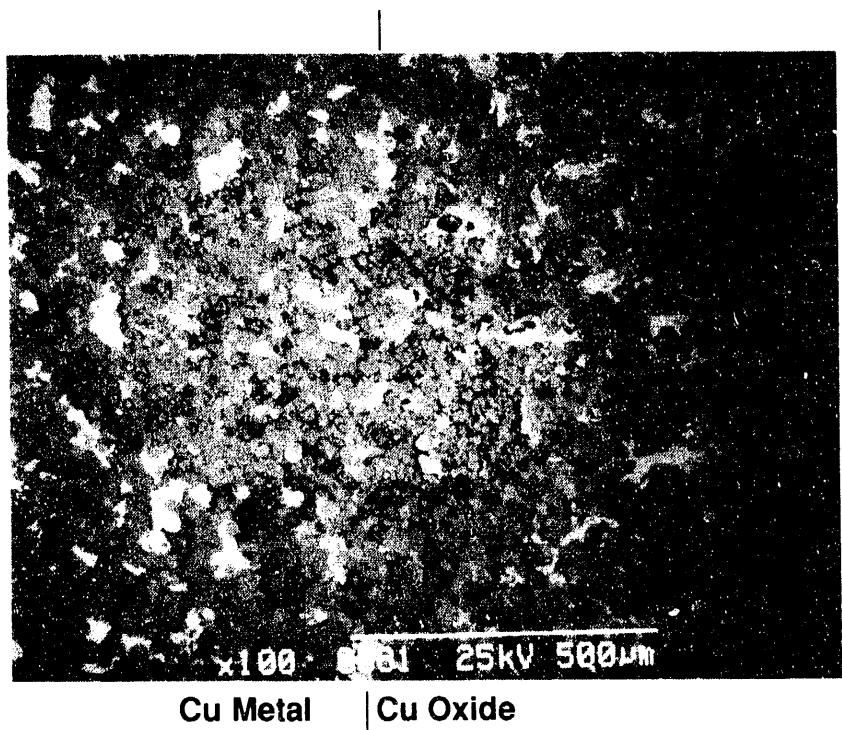
Figure 85. Anode C1, section 40. Boundary between Cu metal and Cu-O zones.

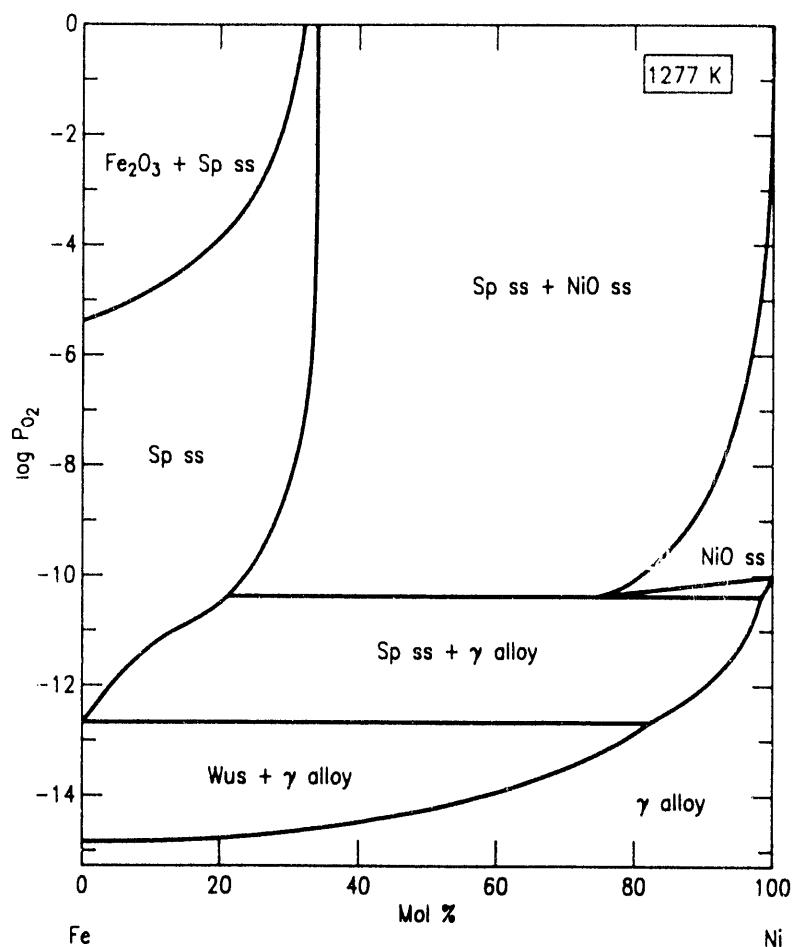
Figure 86. Fe-Ni-O phase diagram at 1277 K.

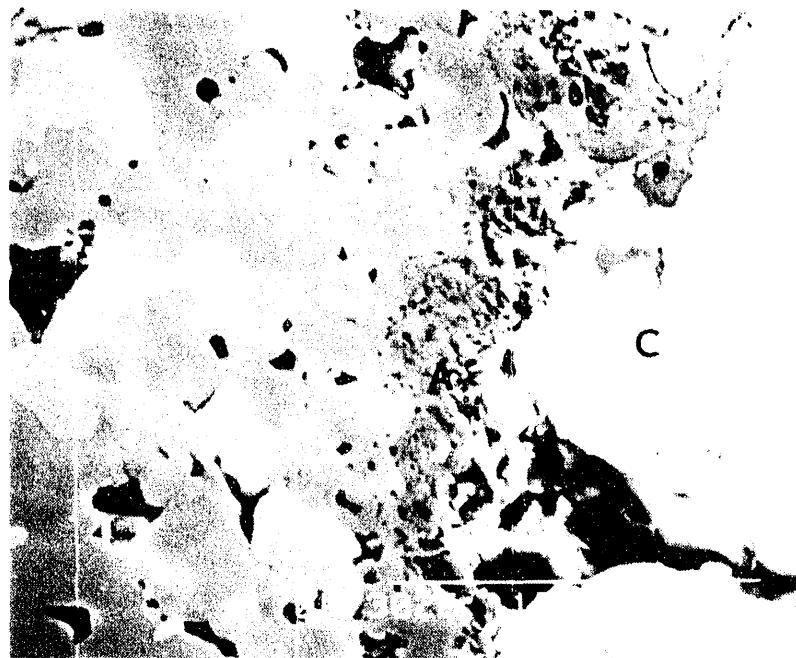
Figure 89. A porous $10 \mu\text{m}$ thick aluminate layer (A) is between the Cerox (C) and the substrate.

A 10 μm thick reaction layer exists between the dense region and the CEROX coating. A BEI of this layer is presented in Figure 89,

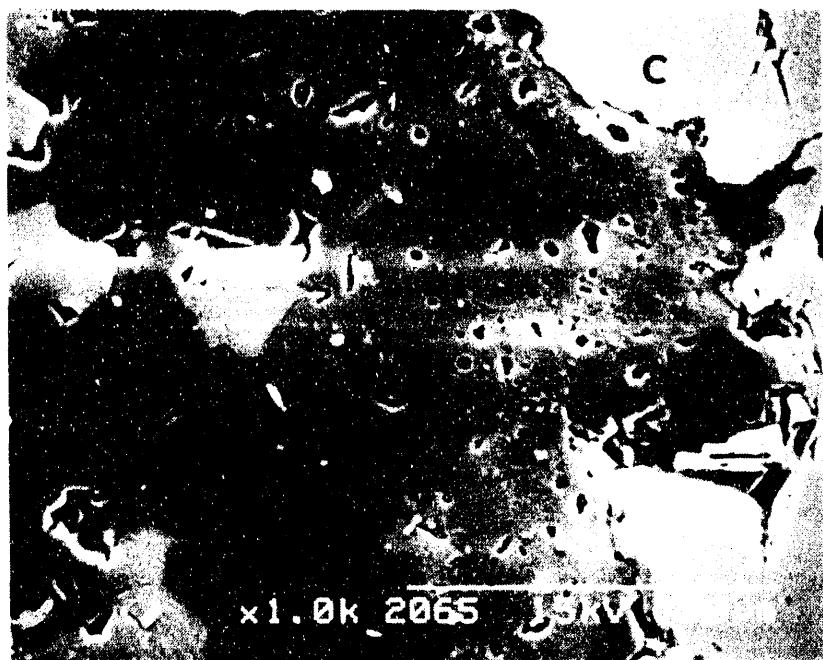
Figure 91. Anode A1, section 43, at the Cerox-substrate interface.

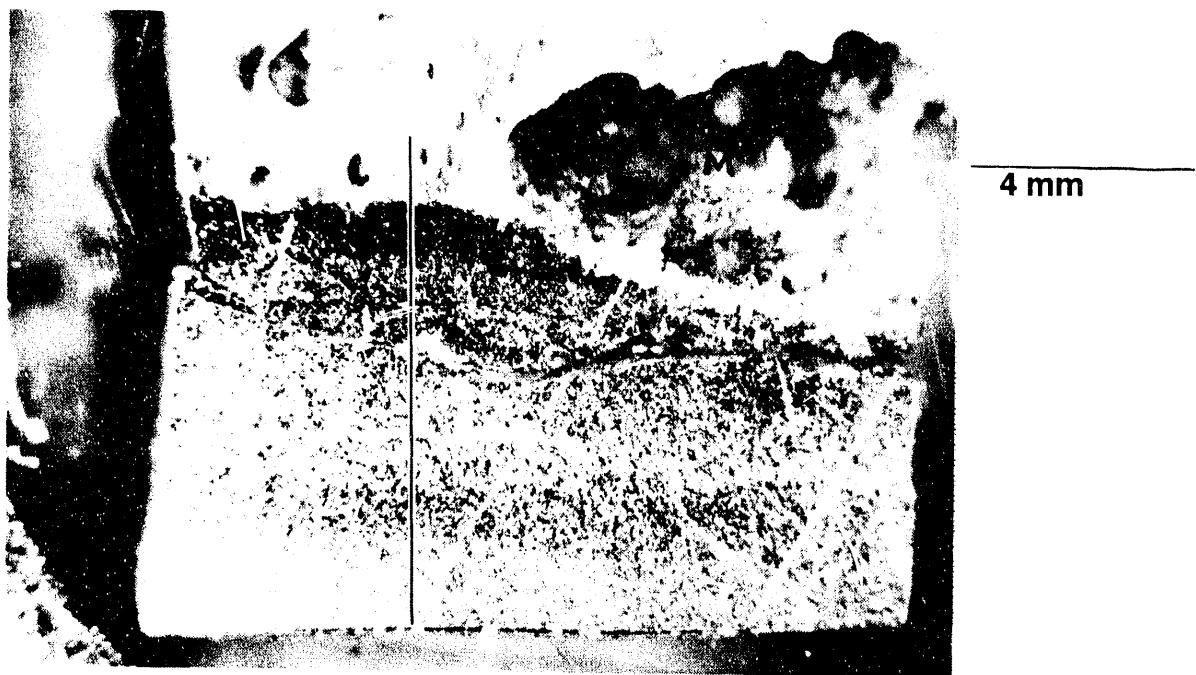
A macroscopic photograph of the polished cross section near the CEROX/substrate surface of anode E1 is shown in Figure 94. The macroscopic color differences were helpful in distinguishing the different zones in the anode. The CEROX coating located at the top of the photo is 8 mm thick. A large pore in the right side of the CEROX is filled with the polymer mounting medium (M). The vertical line in Figure 94 shows the path along which the microstructure was evaluated with the SEM/EDX. A crack exists in the anode ~2 to 2.5 mm from the surface. The top part of this crack is red (macroscopically) and red specks are observed in a zone below it.

Figure 94. Macroscopic section of Anode E1 from the northeast side.

Figure 94 shows that a crack exists 2 to 2.5 mm into the substrate. Figures 97 and 98 are BEI micrographs of both sides of the crack. Figure 97 shows the region to the right (exterior) of the crack, including the Cu depletion zone (N). The isolated bright spots present in the Cu depletion zone are a Ce fluoride. Minor amounts (<3 mol%) of the Ce fluoride (with some Ca) are present throughout the anode.

The large light colored band next to the crack in Figure 97 corresponds to the red zone that was macroscopically observed in Figure 94. EDS analysis shows that this feature is a Cu oxide (97 mol% Cu with 3 mol% of Fe + Ni). Because Cu_2O often has a red color, which is caused by internal reflections within its structure²⁰, the red phase on both sides of the crack is probably Cu_2O instead of CuO .

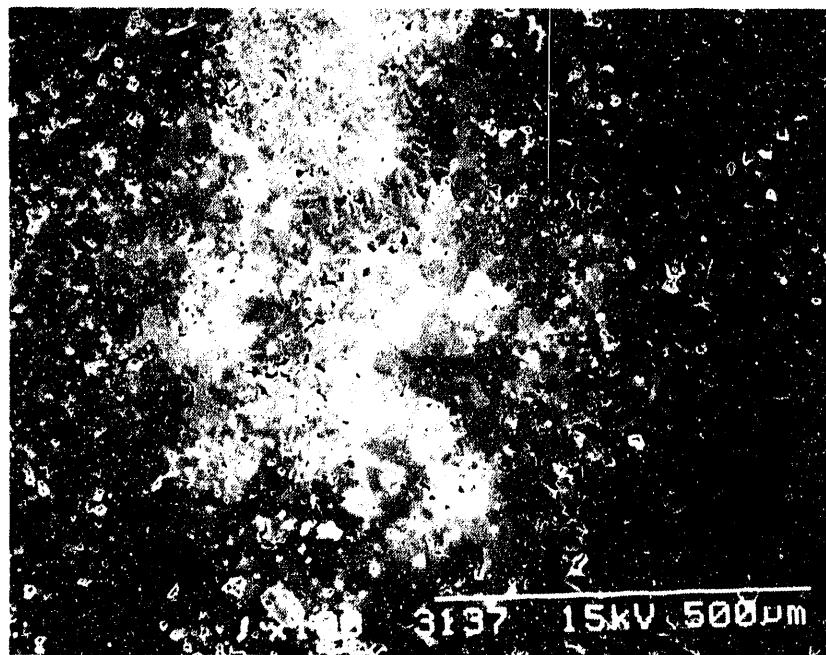
Figure 96. Porous zone between Cu depletion zone (D) and the Cu-O region further into the interior of E1.

Like the other anodes examined, this anode also has a copper depletion zone ~1 mm into the substrate (Figure 96, layer D). The composition of the NiO phase in the copper depletion zone is the

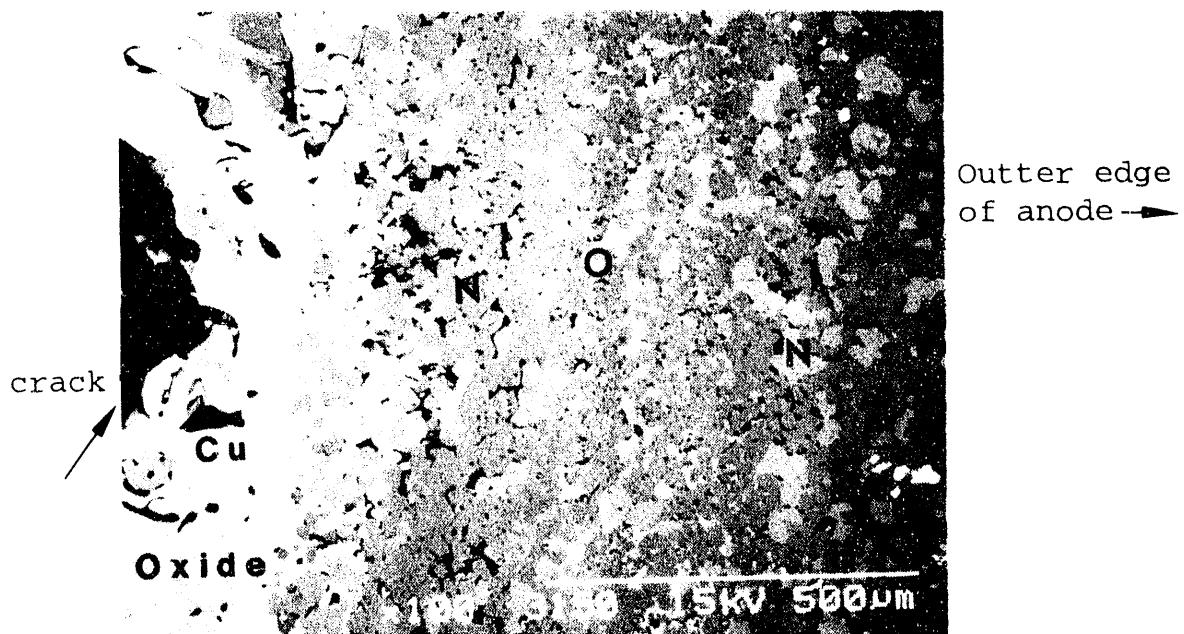
Figure 97. Anode E1 next to a crack. Alternating layers of Cu depleted zones (N) and oxidized zones (O) are present. Cu oxide occurs along the crack.

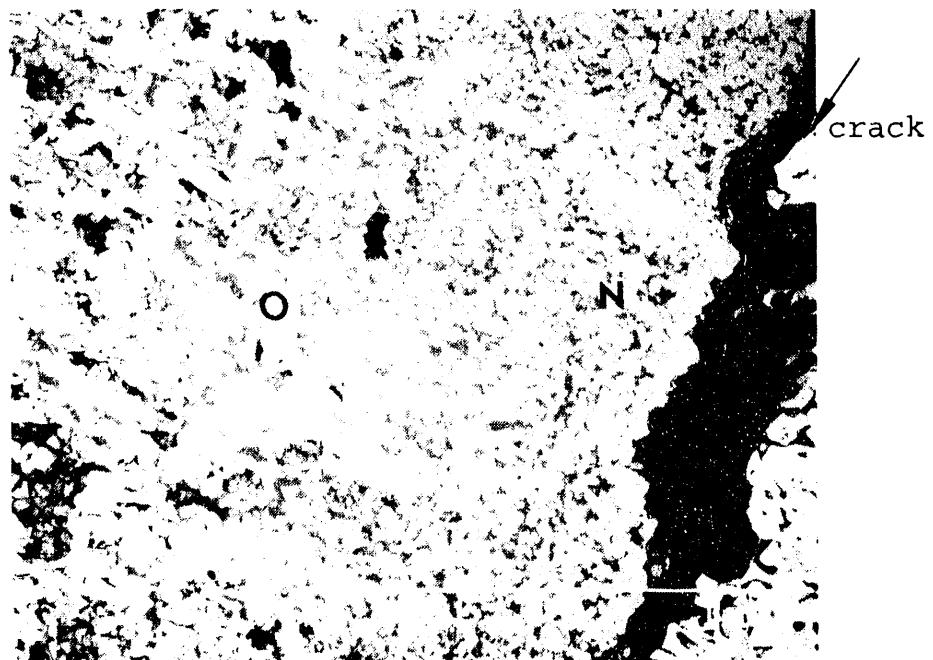
Figure 98. Anode E1, on the left (interior) side of the crack in Figure 97. A Cu depleted zone (N) occurs next to the crack while further into the interior Cu oxide (O) is present with NiO and NiFe_2O_4 .

The dark gray regions between the individual grains in Figures 98, 99, and 100 is a two-phase mixture of frozen cryolite and a solid solution of nickel and aluminum fluoride. EPMA was performed on two spots of the frozen fluoride feature where the spots were separated by a distance of only 15 μm . The cation composition of the cryolite phase was 43.4 mol% Al, 52.8 mol% Na, 1.5 mol% Ca and <1 mol% each of Fe, Ni, and Cu. Converting these to weight

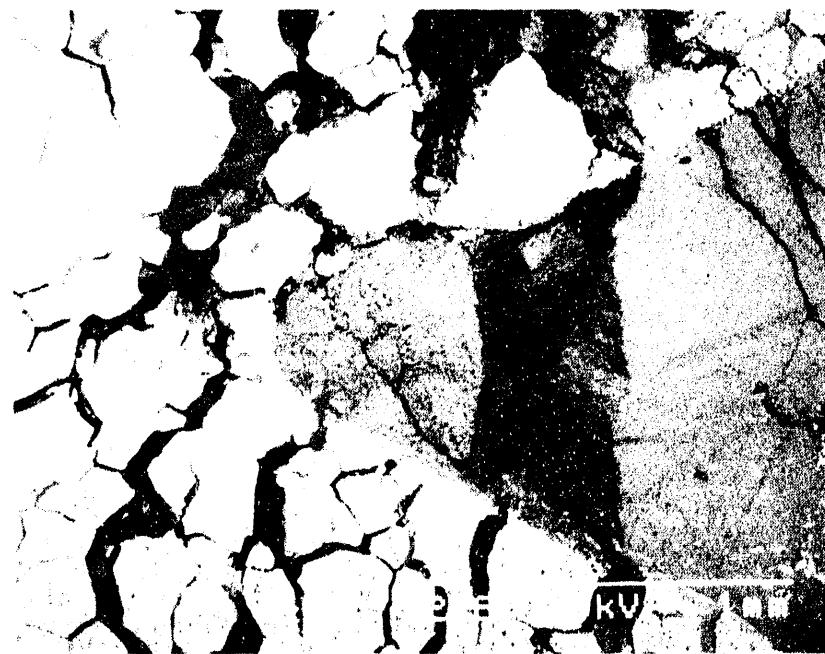
The electrical connection between the rod and anode was made by simply screwing the rod into the anode. The rods were 18 in. long, 1 in. in diameter, and they were tapped with male 1-8 threads. The microstructure of the threaded region is presented in Figures 108 and 109, where Figure 108 represents the region near the tip of the thread and Figure 109 represents the base of the thread. The rod is the brighter feature that lies to the left side of the images. The figures clearly show that the rod was severely attacked and corroded by the local environment. Specifically, the rod underwent pronounced corrosion at the grain boundaries suggesting an enhanced stress corrosion cracking mechanism. A detailed discussion of the corrosion behavior of the rod will be presented, starting at the center of the rod and moving toward the outer surface.

Figure 109. Base of one of the Inconel 601 threads within the Cu cermet.

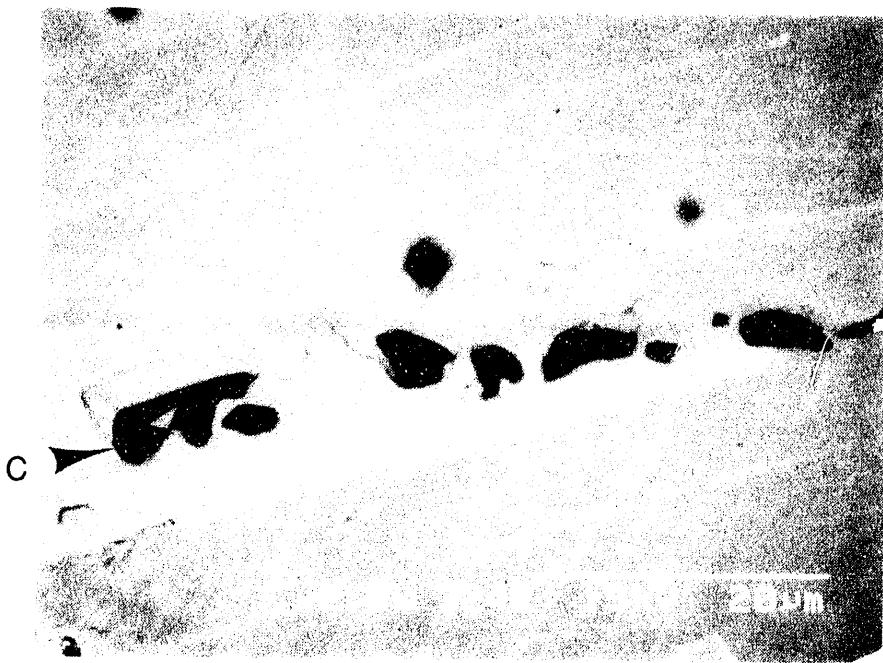
Figure 111. Close-up of the Cr-rich grain boundary inclusions in Figure 110.

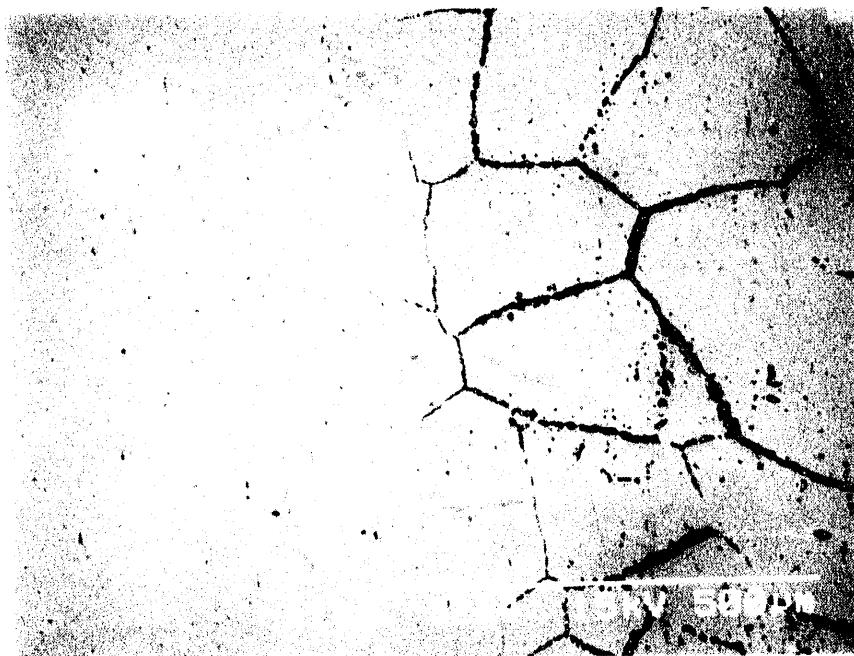
Figure 112. Edge of the reaction zone within the Inconel rod, 6 mm into the rod.

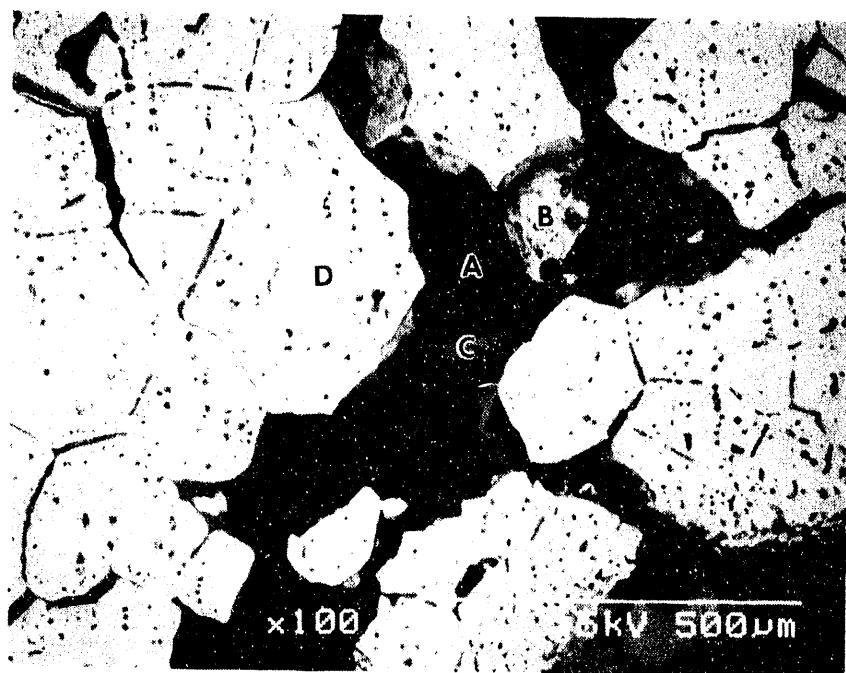
Figure 114. Region of corroded Inconel showing the AlF₃ grain boundary phase (A).

A mechanism for the formation of these Al and Cr rich phases can be formulated from the above discussions. It is clearly demonstrated that AlF_3 preferentially attacks the Cr in the alloy by corroding Cr rich inclusions at the grain boundaries and dissolving Cr from the bulk of the lattice. The dissolved Cr is then transported to the surface of the rod through the liquid AlF_3 grain boundary phase. Locations E, F, and G of Figure 115 are evidence that the amount of Cr that was removed from the alloy and the transport rate of Cr through the molten AlF_3 grain boundary phase is large enough to form Cr rich phases elsewhere in the microstructure.

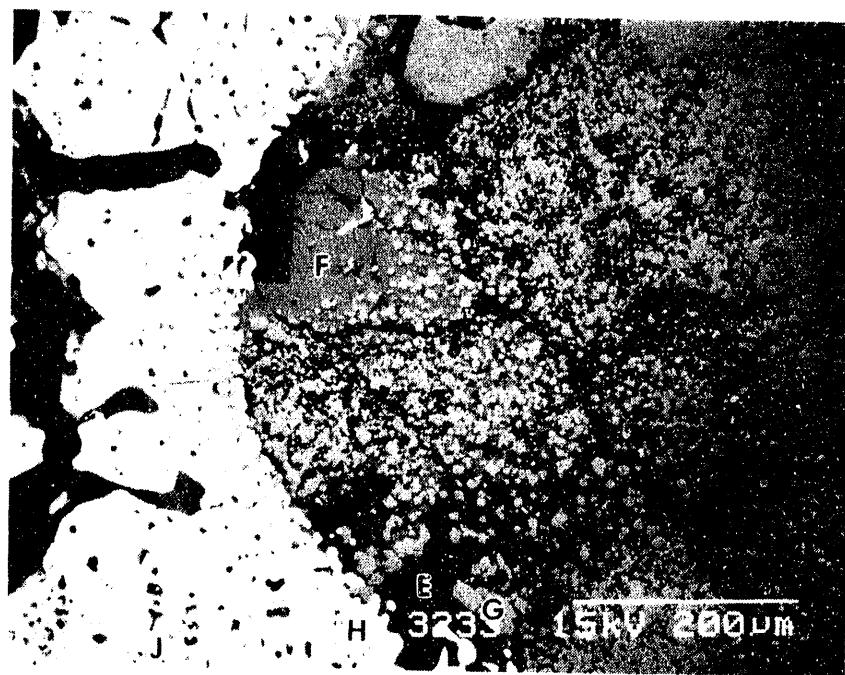
Figure 115. Edge of the Inconel rod at the base of the thread.

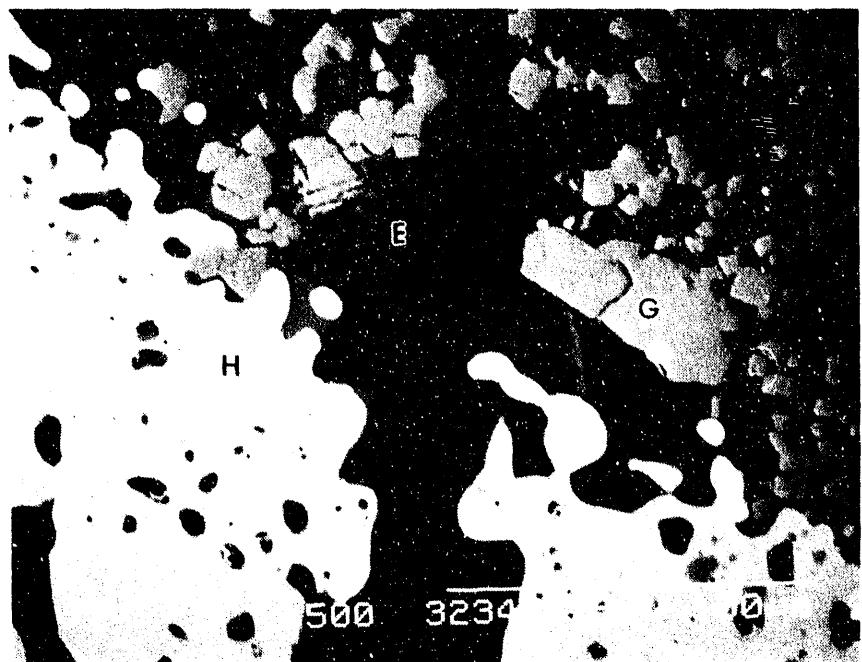
Figure 116. Higher magnification of Figure 115.

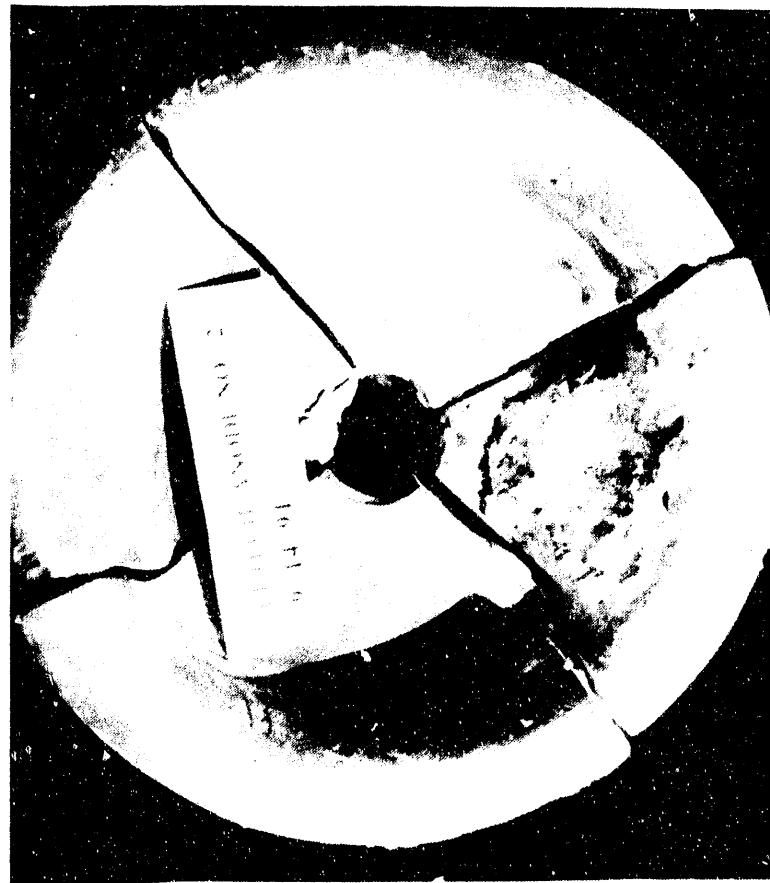
Figure 35. Cermet Anode No.2.
Position B - Sept. 14.

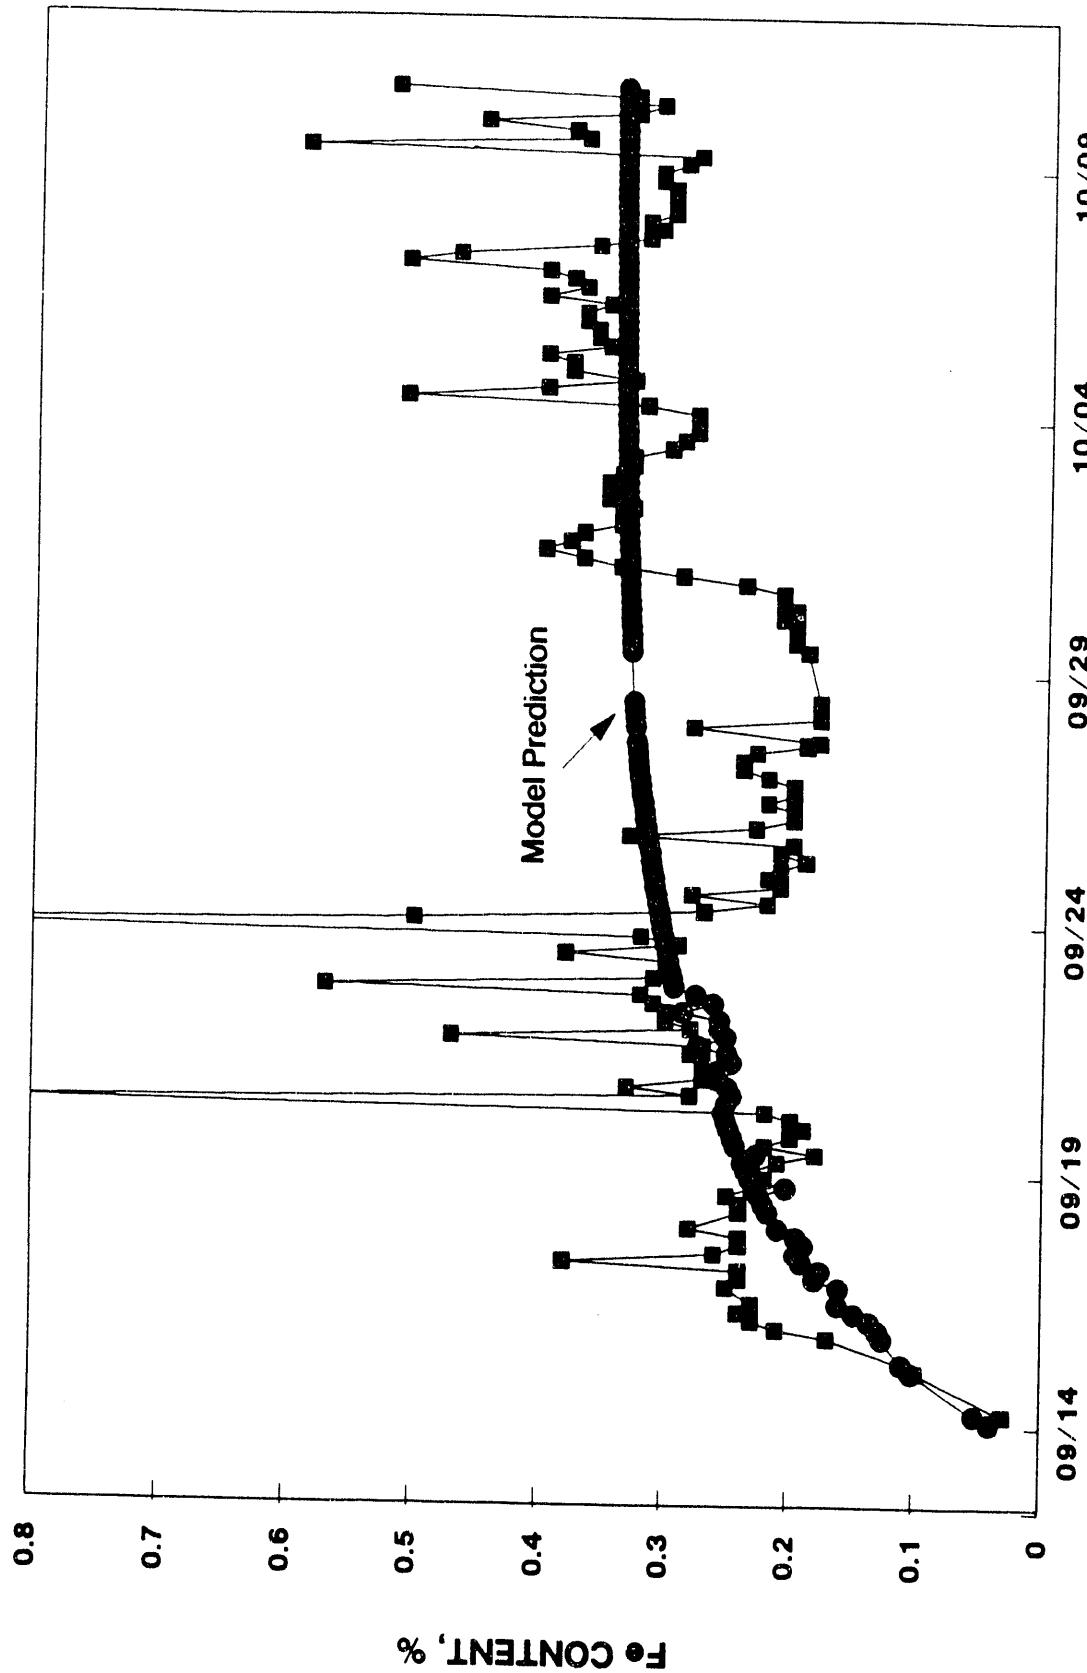
Figure 42

Ni CONTENT IN THE METAL

The primary indicator of the corrosion rate of the cermet anodes was the rate of increase of nickel, copper, and iron impurity content in the aluminum metal during cell

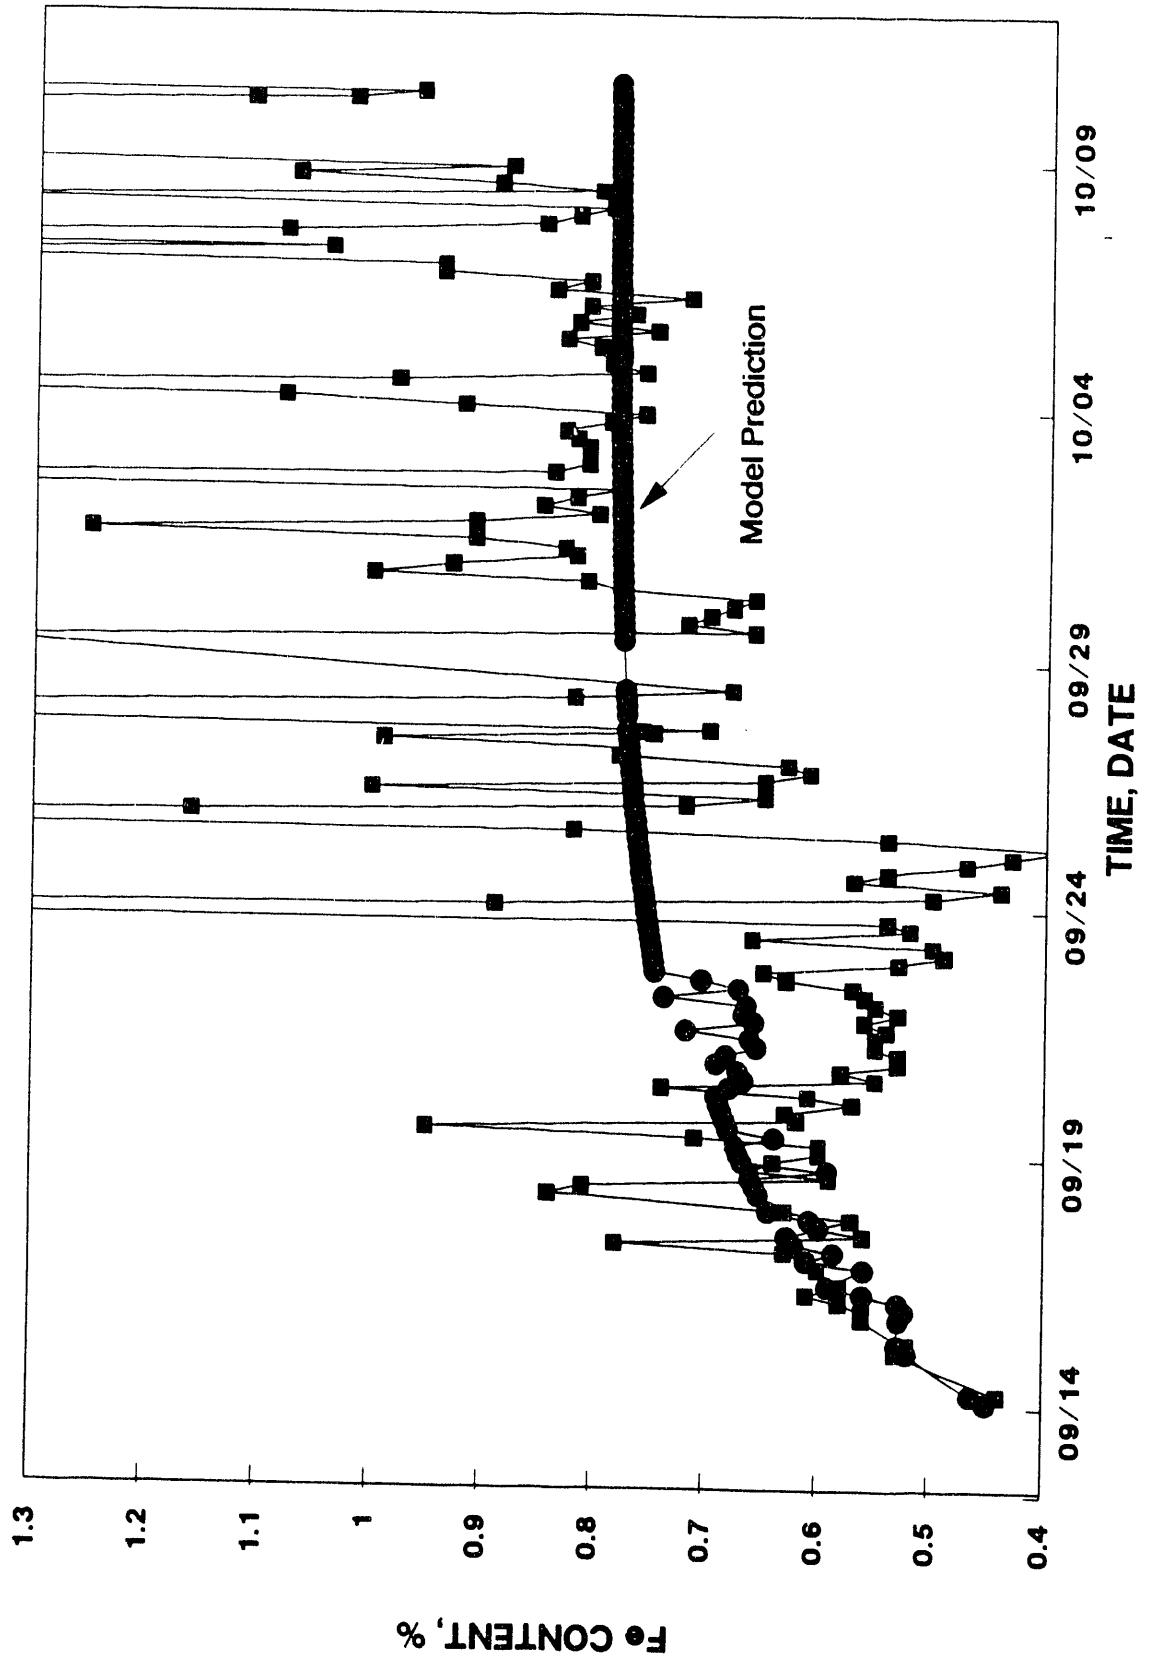
Figure 44

Fe CONTENT IN THE METAL
