## HELIUM BUBBLE DISTRIBUTIONS IN REACTOR TANK REPAIR SPECIMENS - PART I. (U)

WSRC-TR--91-141

**Keywords:**  
Electron Microscopy  
Reactor Vessel  
Stainless Steel  
Helium  
Bubbles  
Welding

**PROJECT:** Reactor Repair Program

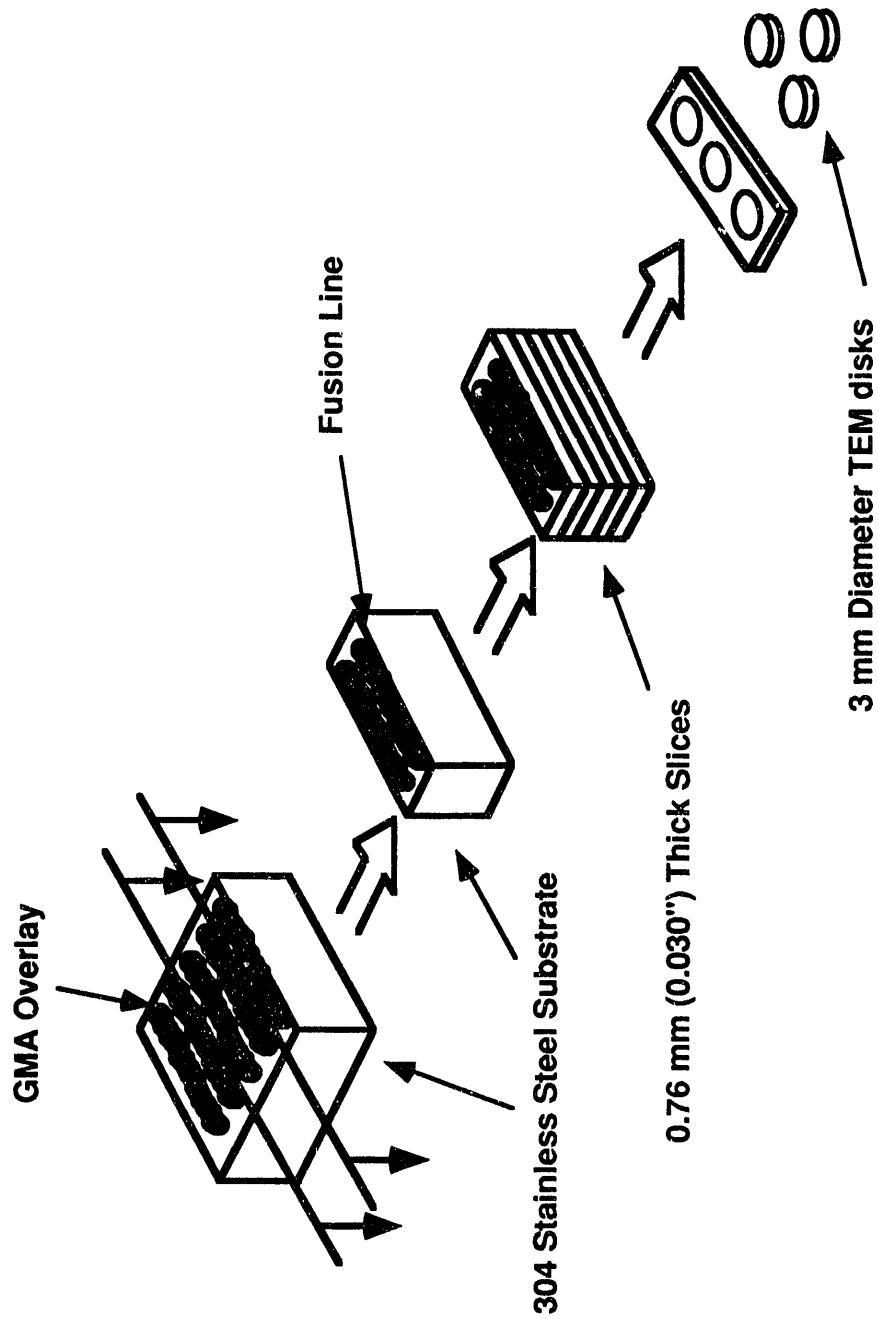
Figure 1. A diagram that illustrates the steps required to prepare 3 mm diameter TEM disks from the substrate material. The base plate containing a weld was sliced parallel to the fusion line, thinned to ~0.1 mm and punched into 3 mm diameter disks.

In the present study, TEM was used to examine as-received plate, as-received plate with a GMA overlay, 147 appm  ${}^3\text{He}$  plate (no weld), and 147 appm  ${}^3\text{He}$  plate with a GMA overlay. (The heat input for the GMA weld overlays was approximately 25.6 kJ/in.<sup>2</sup>) Specimens for TEM were 3 mm (0.12 in.) disks punched from thin slices of the substrate material. Slices from the welded plates were made parallel to the fusion line at selected locations below the weld overlays (Figure 1). TEM specimens from the as-received plate (no weld) and 147 appm  ${}^3\text{He}$  (no weld) plate were taken at random orientations from the bulk material.

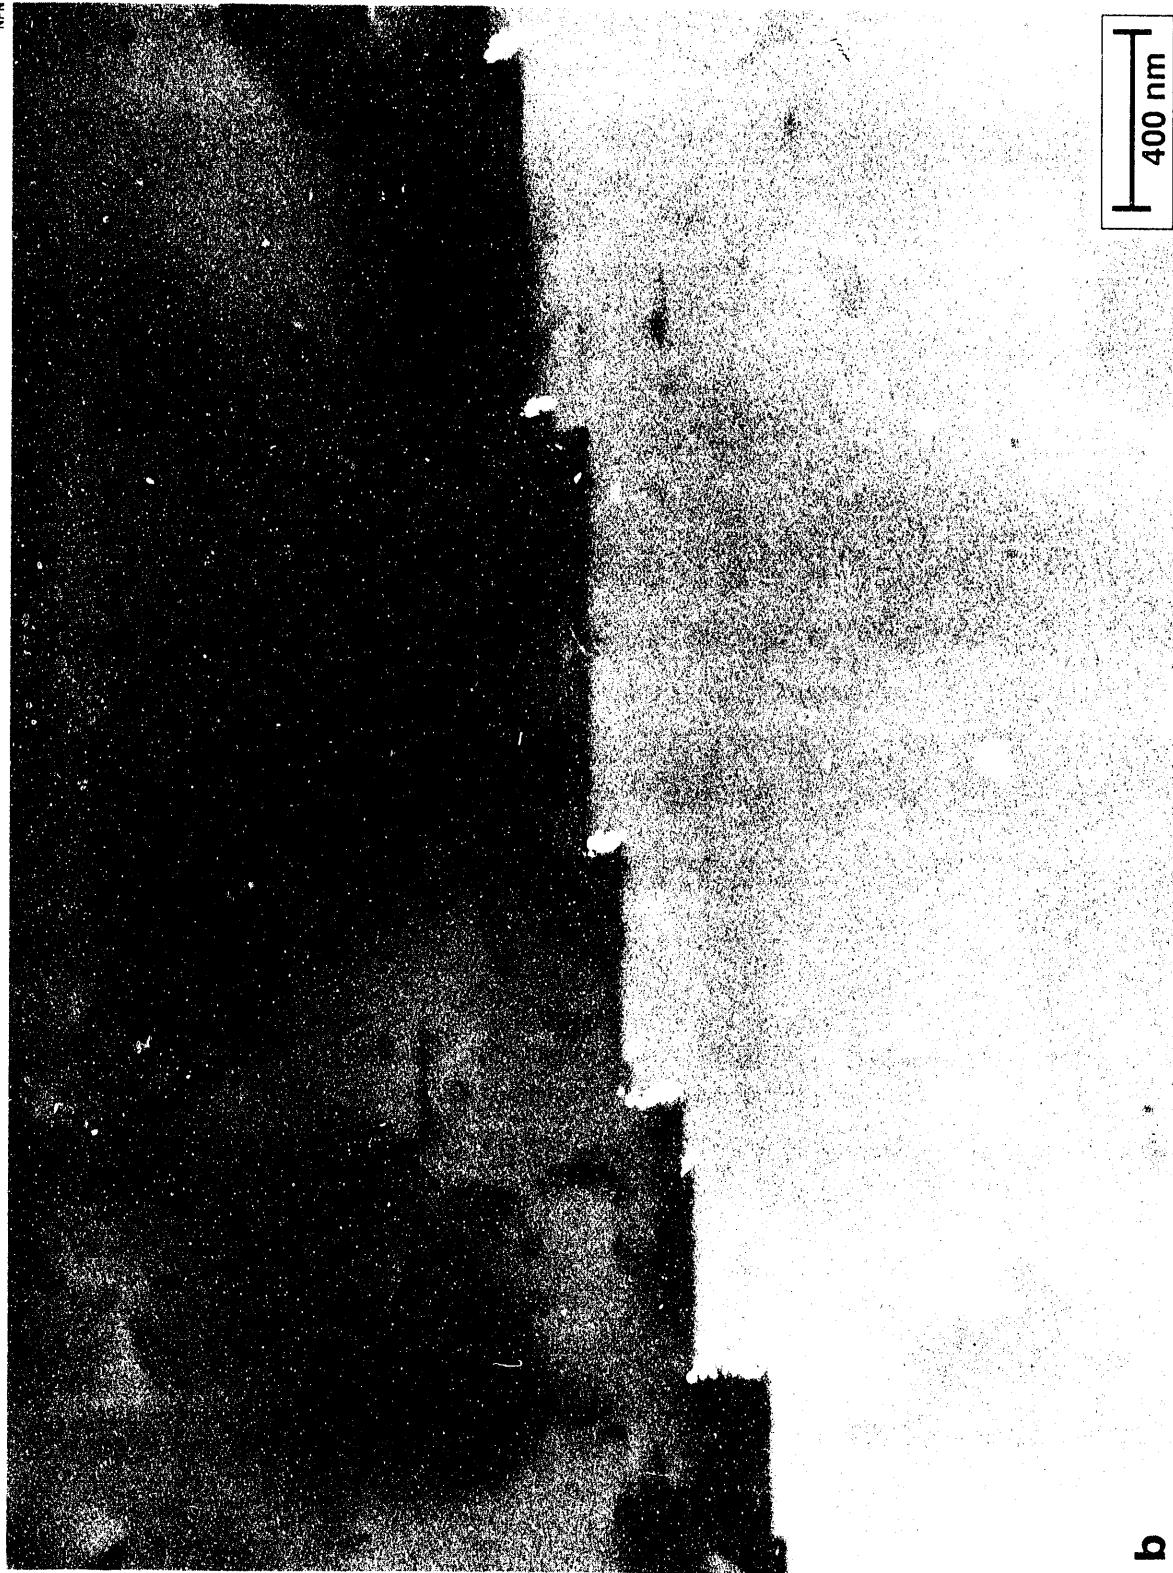
Figure 2b. As-received material (no weld). Centered-dark field image of carbides on the incoherent steps shown in Figure 2a.

Carbides ( $M_{23}C_6$ ) were present throughout the material on the grain boundaries as well as on incoherent twin boundaries. The latter observation is illustrated in Figures 2a and b. Figure 2a is a bright field micrograph of a region containing an annealing twin boundary. The long, straight portions of this boundary are the coherent boundary segments and the small "steps" are the incoherent segments. Incoherent twin boundaries are preferential sites for carbide precipitation and, although not particularly obvious in this micrograph, each one of the "steps" was decorated with carbides. This observation is better evidenced in Figure 2b, a centered-dark field image from the same region as 2a. In this micrograph only electrons diffracted from the lattice planes of the carbides have contributed to the image. Analysis of higher magnification images from this area indicated that the carbides were approximately 10 nm in diameter.

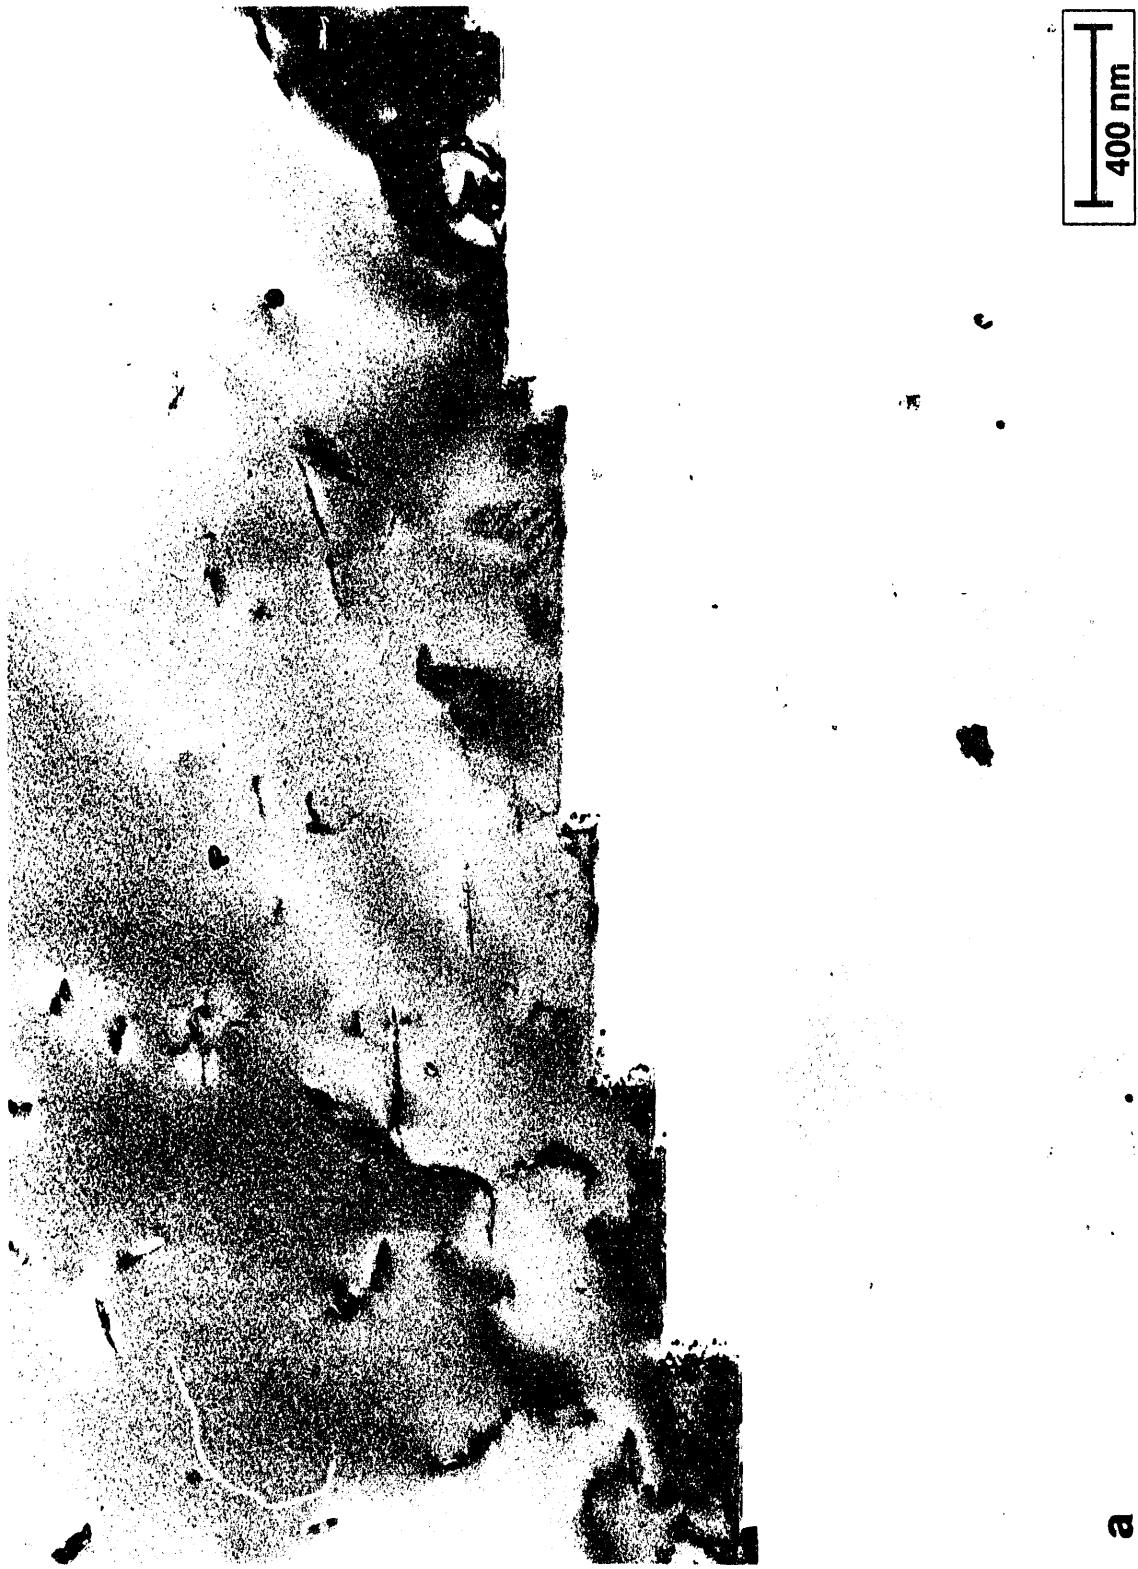
Figure 2a. As-received material (no weld). Bright field micrograph of incoherent twin boundary steps.

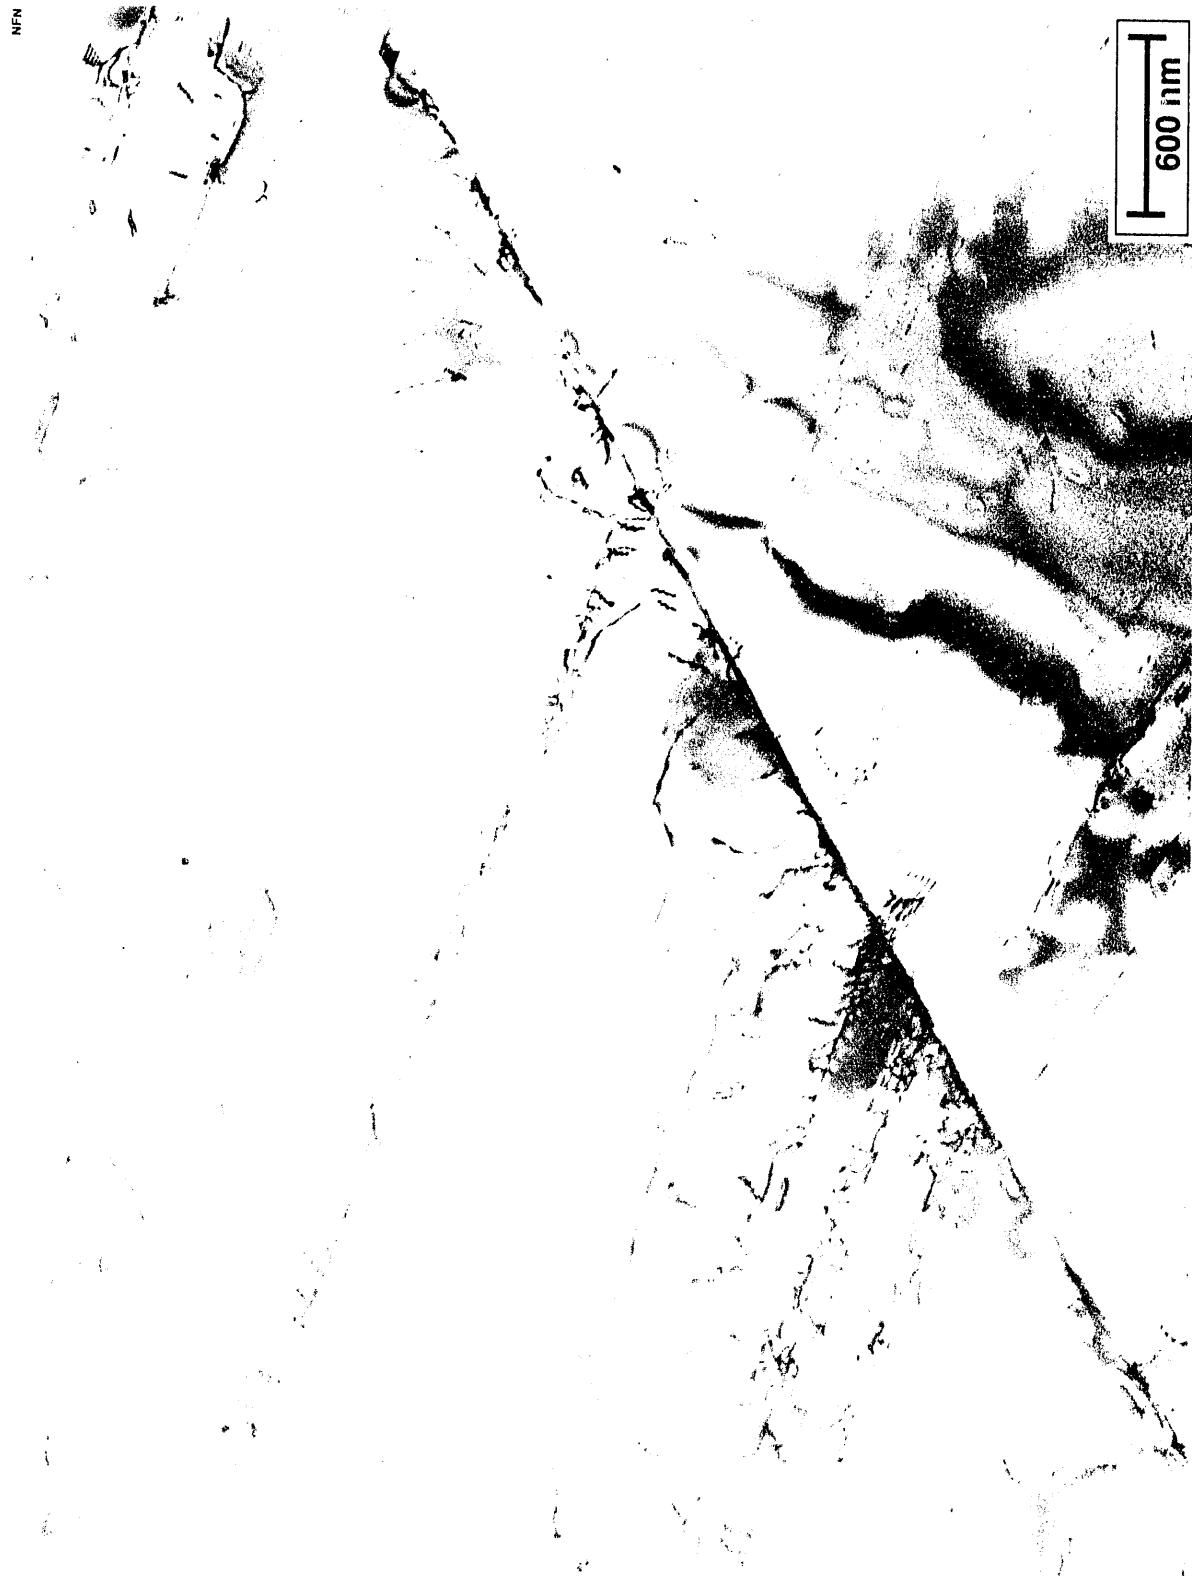
Figure 4. As-received plate with weld overlay. Dislocation pile-ups intersecting a coherent twin boundary ~3 mm below the weld.

The as-received plate with a weld overlay was sectioned to reveal the microstructure at 1 and 3 mm below the weld. The microstructure 3 mm below the overlay was characterized by planar dislocation arrays (Figure 3) and pile-ups at the grain boundaries (Figure 4). The dislocation density at this distance from the weld was very low and was representative of material having experienced very limited plastic strain. The microstructure at 1 mm below the weld (Figures 5 and 6) showed an increase in dislocation density over that observed at 3 mm. The amount of plastic strain in this region was estimated to be 2-3%. In general, dislocations were restricted to planar arrays but, infrequently, areas of dislocation tangles were observed (Figure 6). The higher temperatures experienced at this distance from the weld most probably led to dislocation climb and the subsequent loss of the planar arrays in some areas. It should also be mentioned that carbides were not observed in the regions examined at either 1 or 3 mm from the weld.

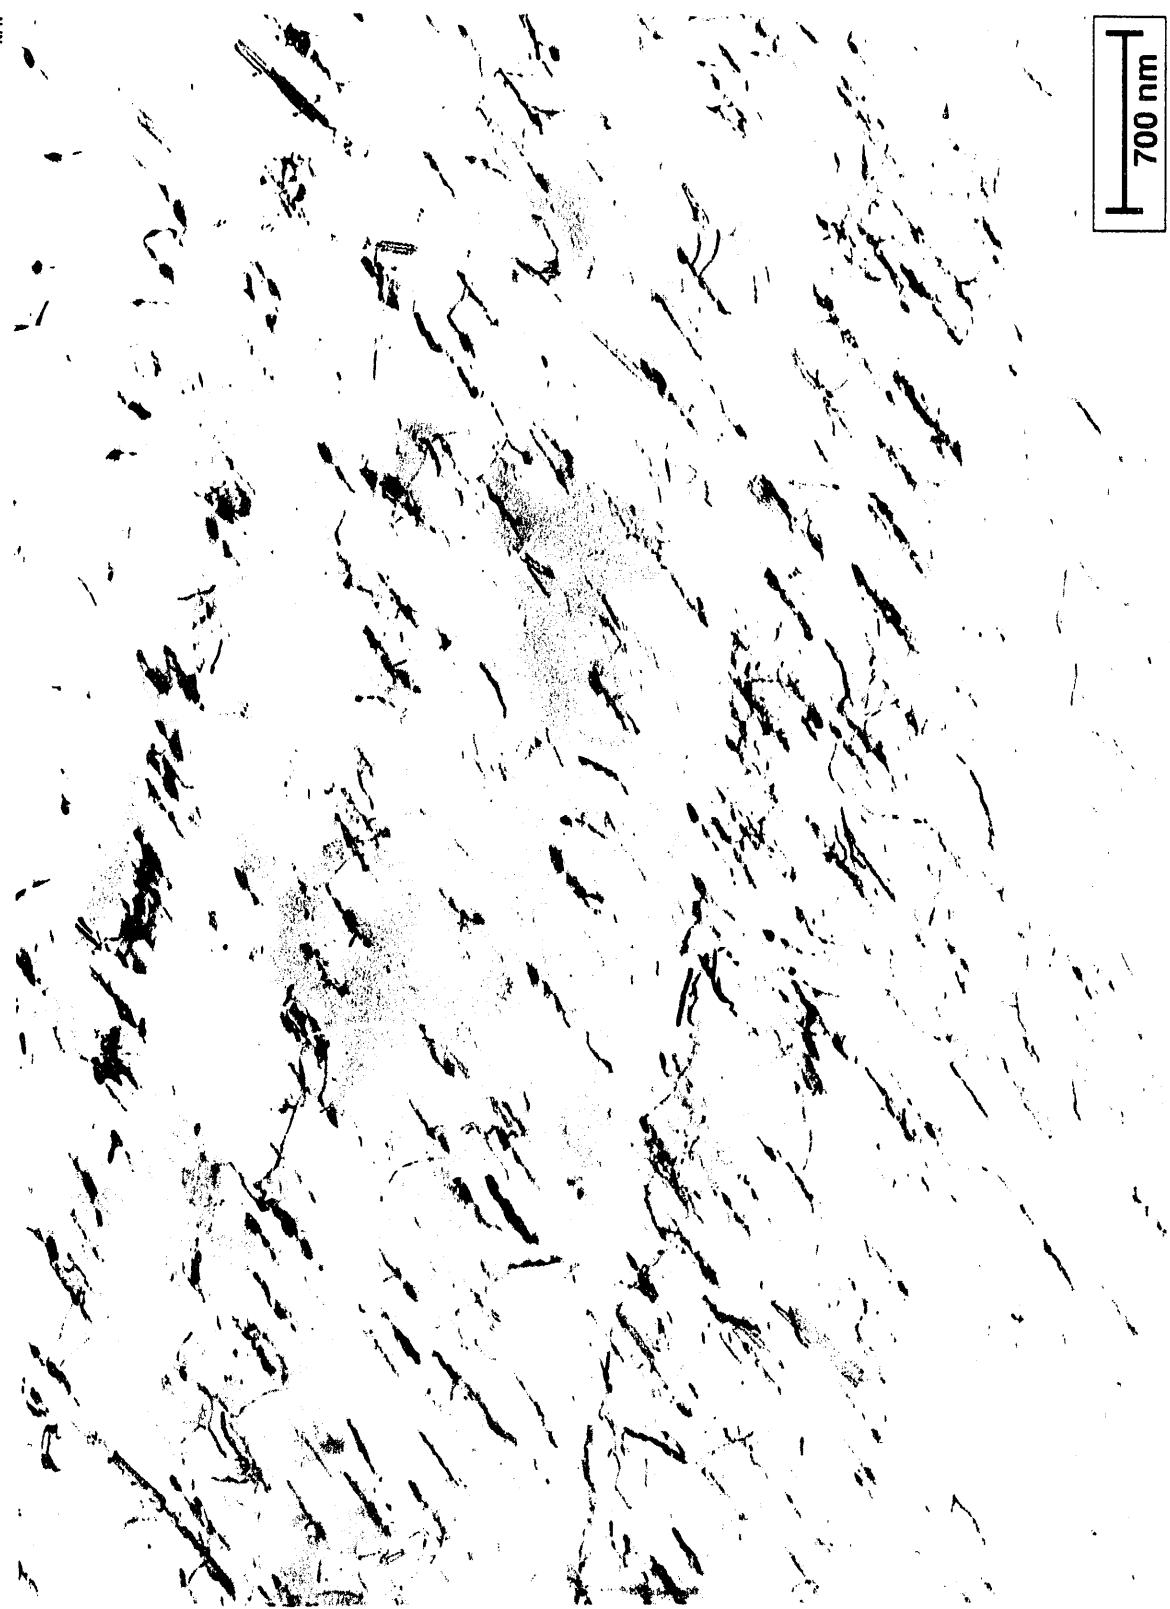
Figure 3. As-received plate with weld overlay. Planar dislocation arrays at 3 mm below the weld.

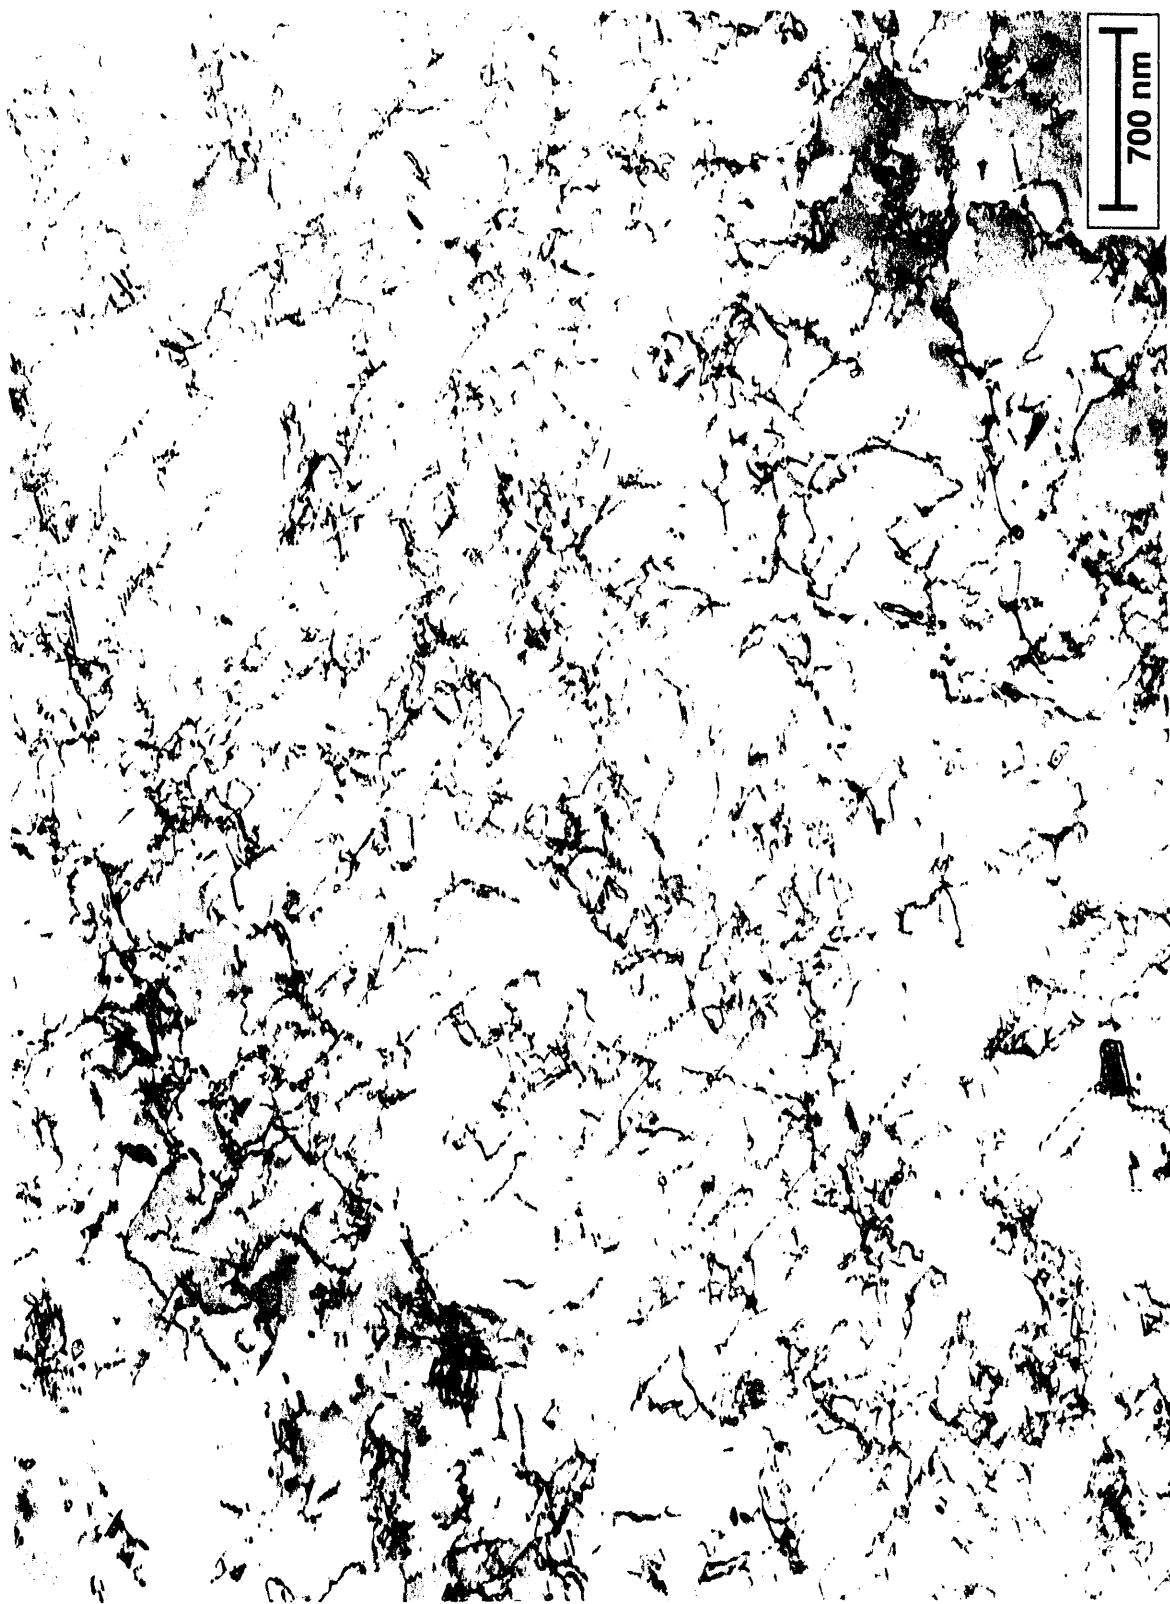
Figure 6. As-received material with a weld overlay. Dislocation substructure observed at ~1 mm below the weld. Note the absence of planar dislocation arrays in this area.

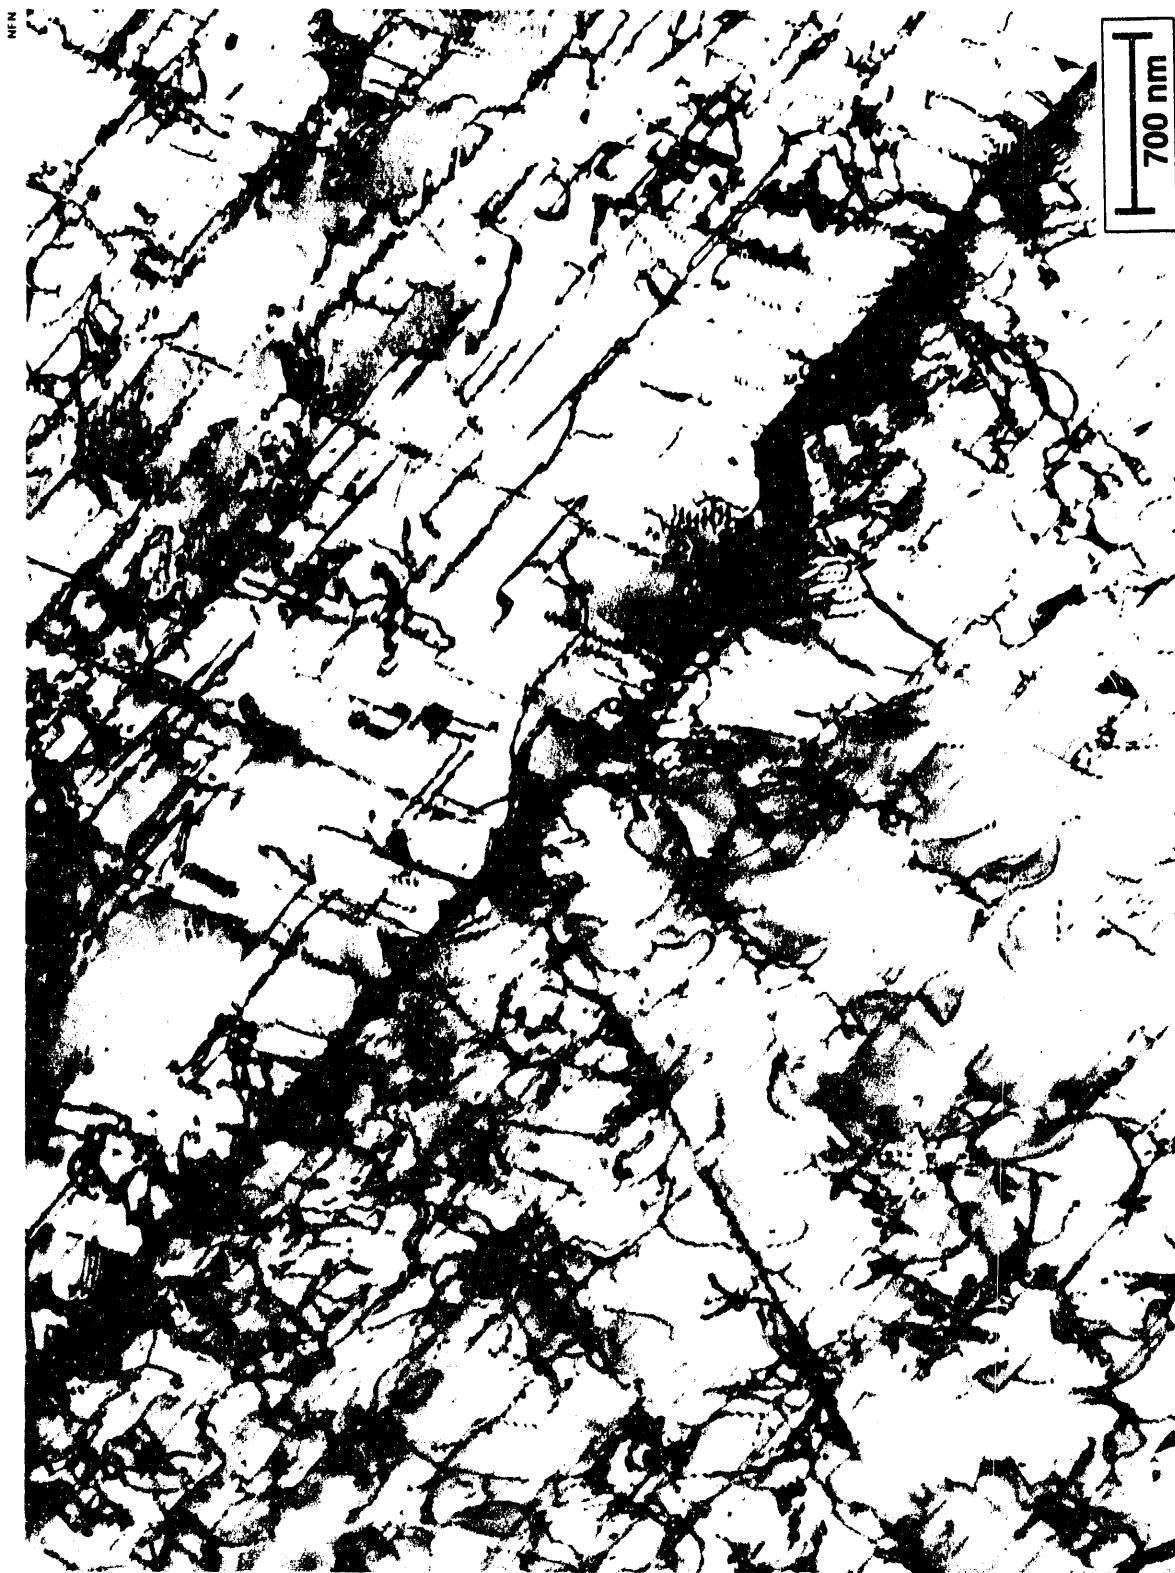
Figure 5. As-received plate with weld overlay. Increased dislocation density in the vicinity of a coherent twin boundary at  $\sim 1$  mm below an overlay.

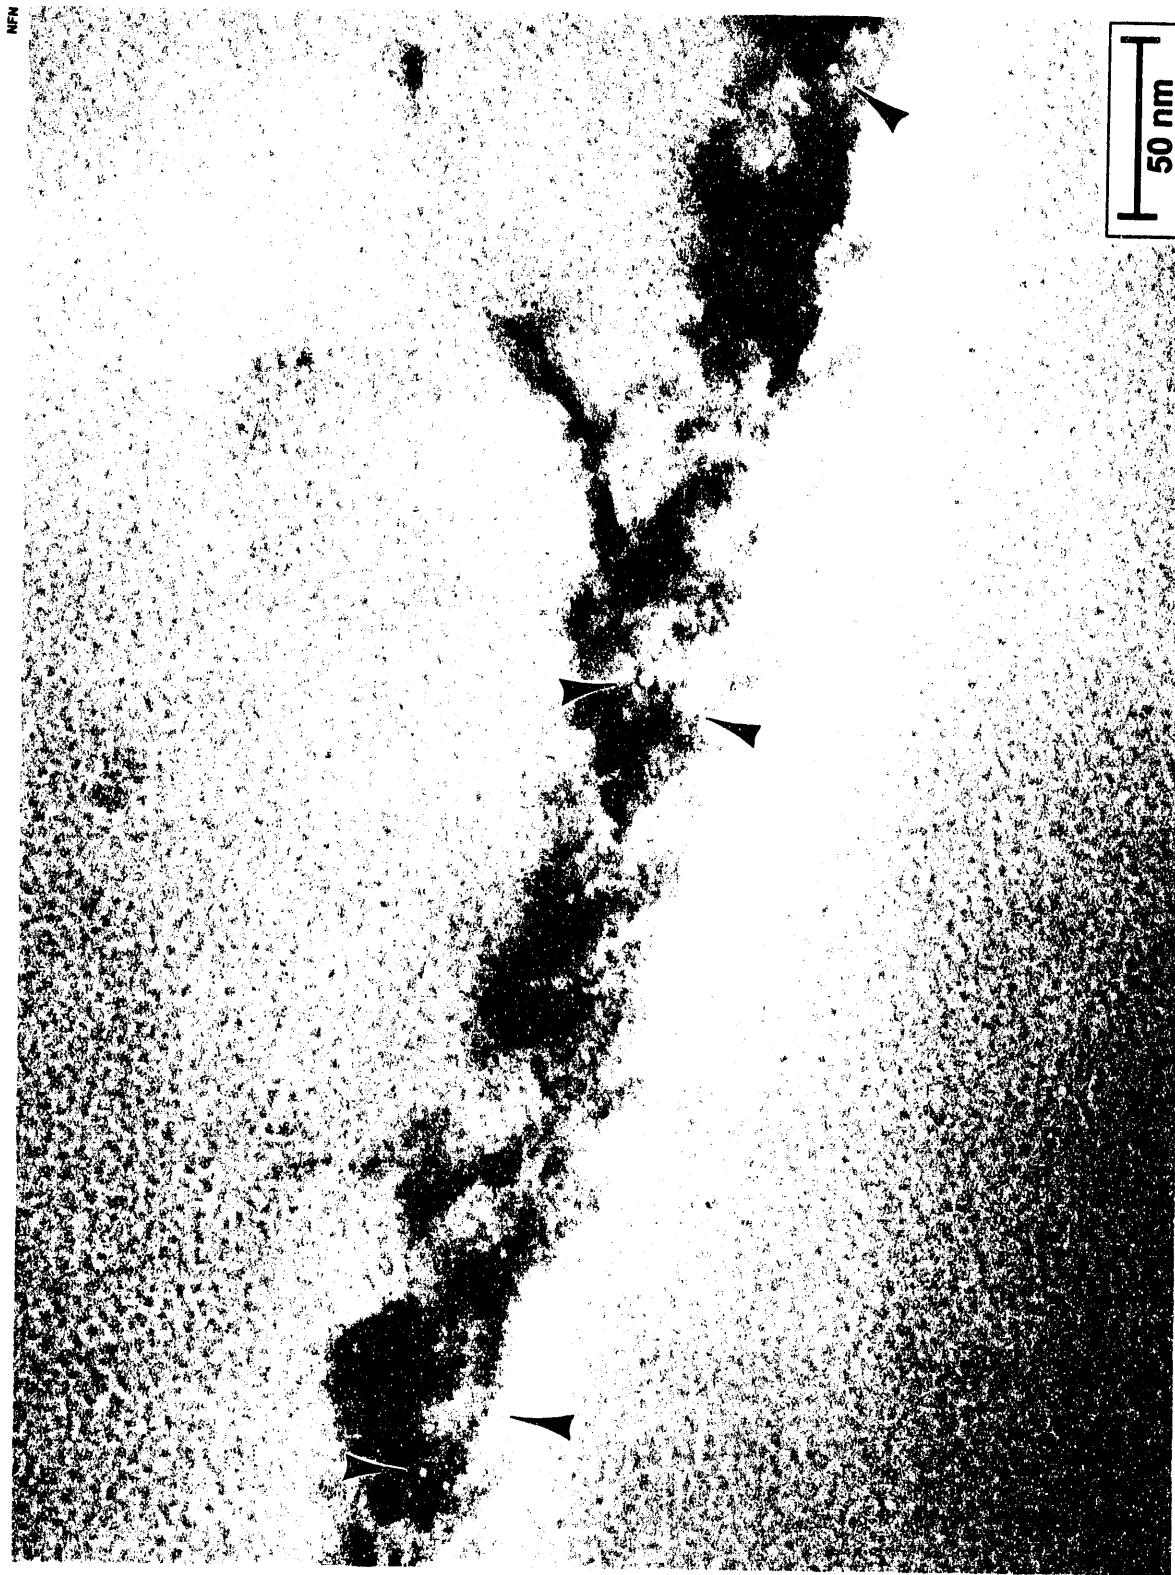
Figure 8. Helium-bearing plate (3.5 mm below weld overlay). Helium bubble distribution on an incoherent twin boundary. Several He bubbles have been arrowed. The dark contrast on the boundary is caused by the presence of a large number of small carbides.

As mentioned above, helium bubbles also nucleated on the incoherent twin boundaries. The bubble size and spacing on the boundary segment shown in Figure 8 were approximately 2 nm and 20 nm, respectively. (This boundary was inclined to the electron beam and, as such, the bubble spacing measurement is slightly more accurate than that measured in Figure 7.) The dark contrast along this boundary was caused by the presence of 15 nm diameter carbides that had nucleated on the boundary. A centered-dark field micrograph from this same area (Figure 9) better illustrates the carbide distribution.

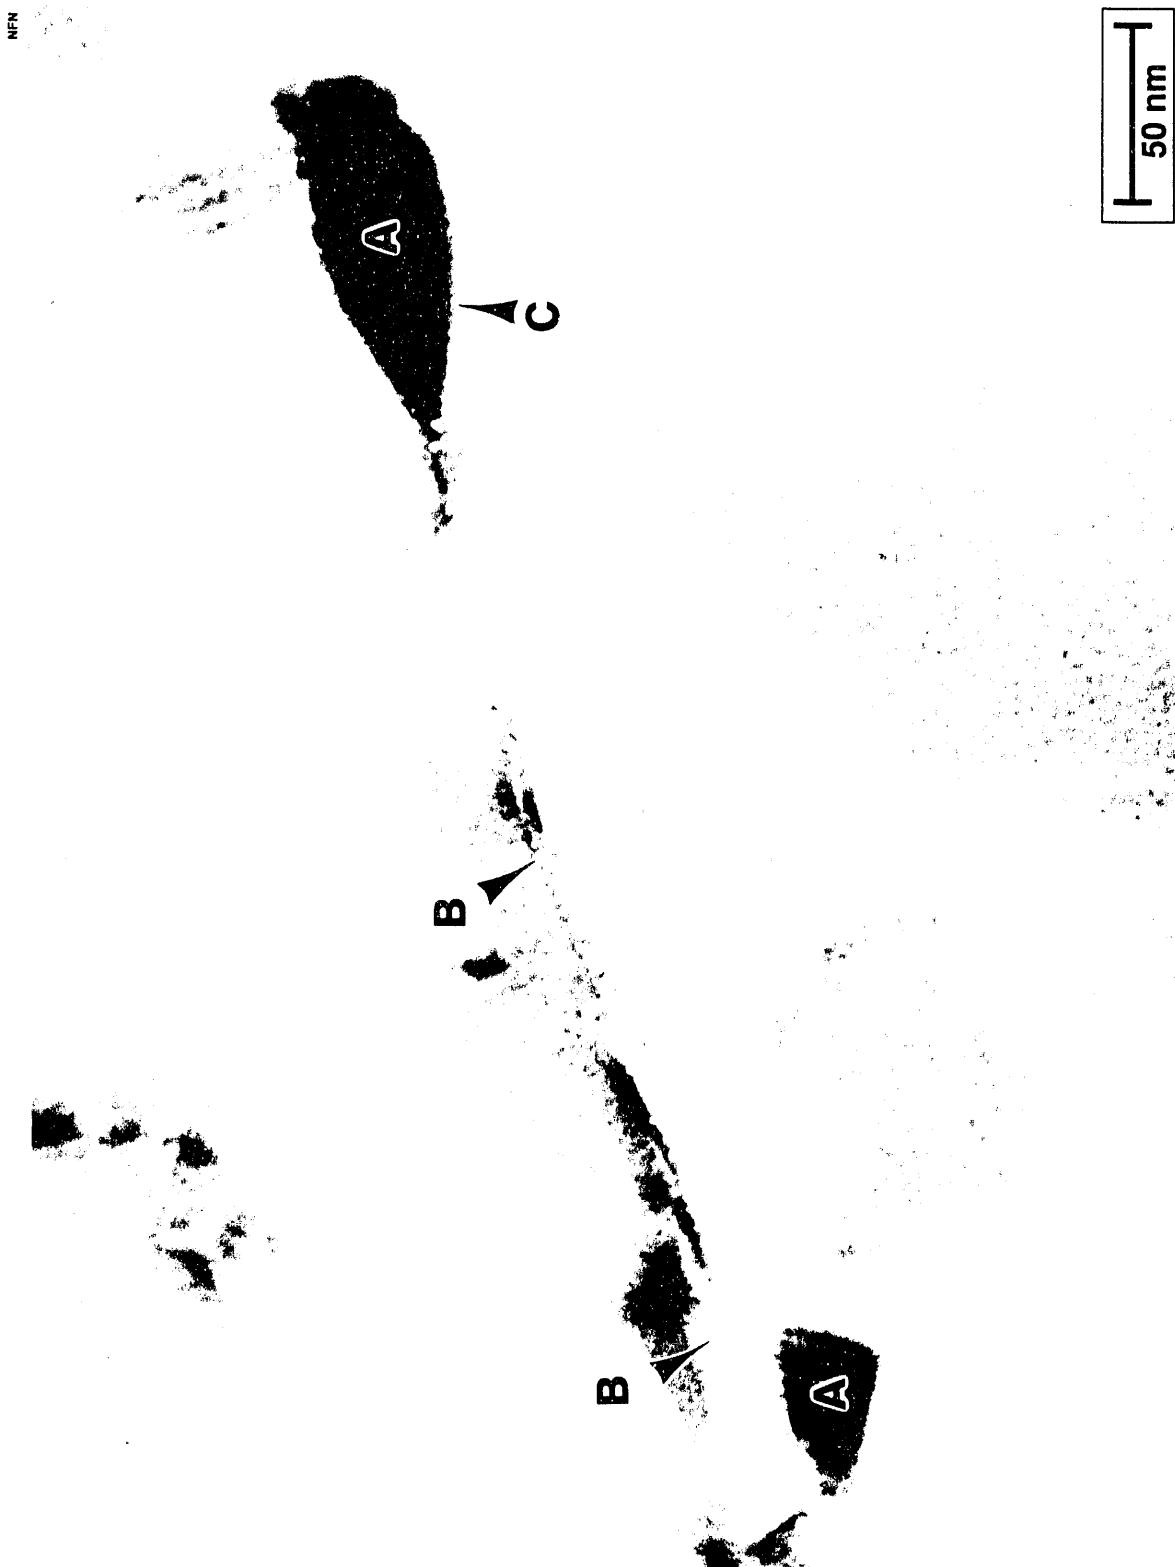
Figure 7. Helium-bearing plate (3.5 mm below weld overlay). Carbide particles (at A) and helium bubbles (e.g., at B) on a grain boundary. Bubbles are not observed at the carbide/matrix interface (at C).

Close examination revealed that helium bubbles had nucleated on the grain boundaries and the incoherent twin boundaries. The first of these observations is illustrated in Figure 7, a bright field micrograph showing a small section of a grain boundary. As can be seen in this micrograph, the boundary has served as a nucleation site for both carbides (arrowed A) and helium bubbles (e.g., arrowed B). The bubbles in this region averaged ~2.5 nm in diameter and were spaced ~14 nm apart\*. It is also interesting to note that helium bubble nucleation was restricted to the boundary plane and the incoherent carbide/matrix interface (carbide interface adjacent to the boundary plane) and not at the coherent or semi-coherent carbide/matrix interface (e.g., arrowed at C). Both the carbide and bubble distributions illustrated in Figure 7 were typical of other grain boundaries at 3.5 mm from the overlay.

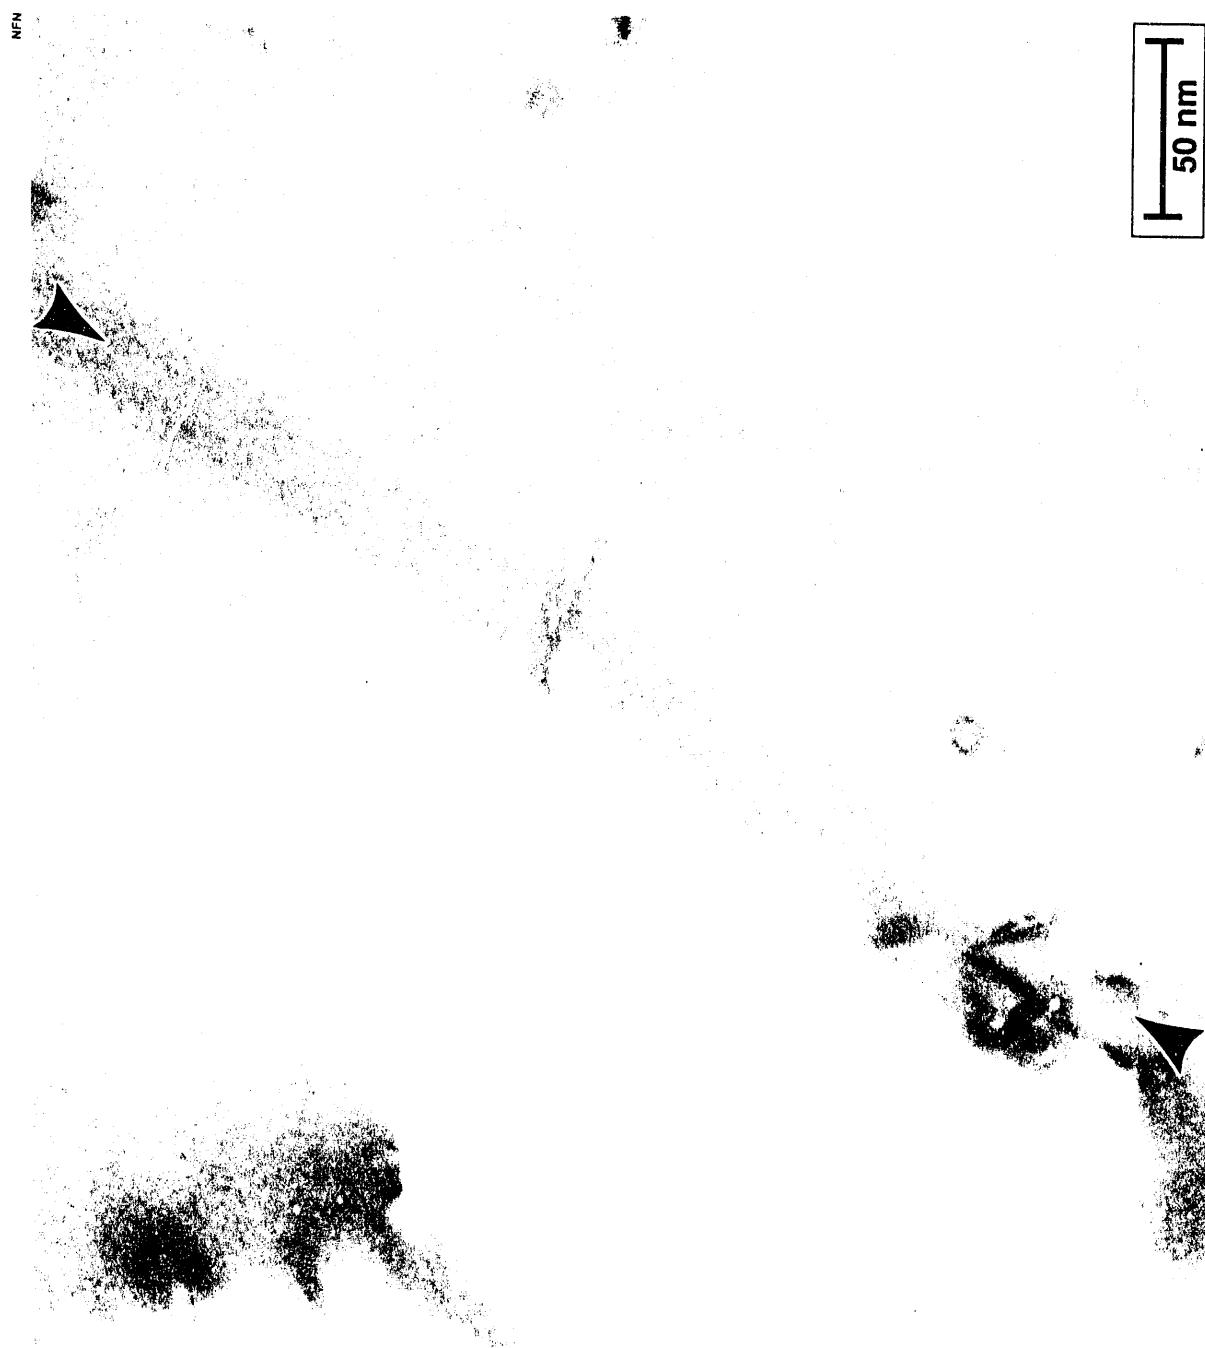
Figure 10. Helium-bearing plate (3.5 mm below weld overlay). Coherent twin boundary (arrowed) is inclined to the electron beam. Bubbles visible in this micrograph are associated with matrix dislocations.

Coherent twin boundaries were observed throughout this specimen material. Bubbles were not observed on this boundary type. This observation is illustrated in Figure 10, a micrograph of a coherent twin boundary. In this image, the boundary (marked with an arrow) is tilted with respect to the electron beam. Several bubbles are visible in this micrograph and appear to be associated with the boundary. Tilting experiments, however, showed that these bubbles had actually nucleated on dislocations located adjacent to the boundary plane.

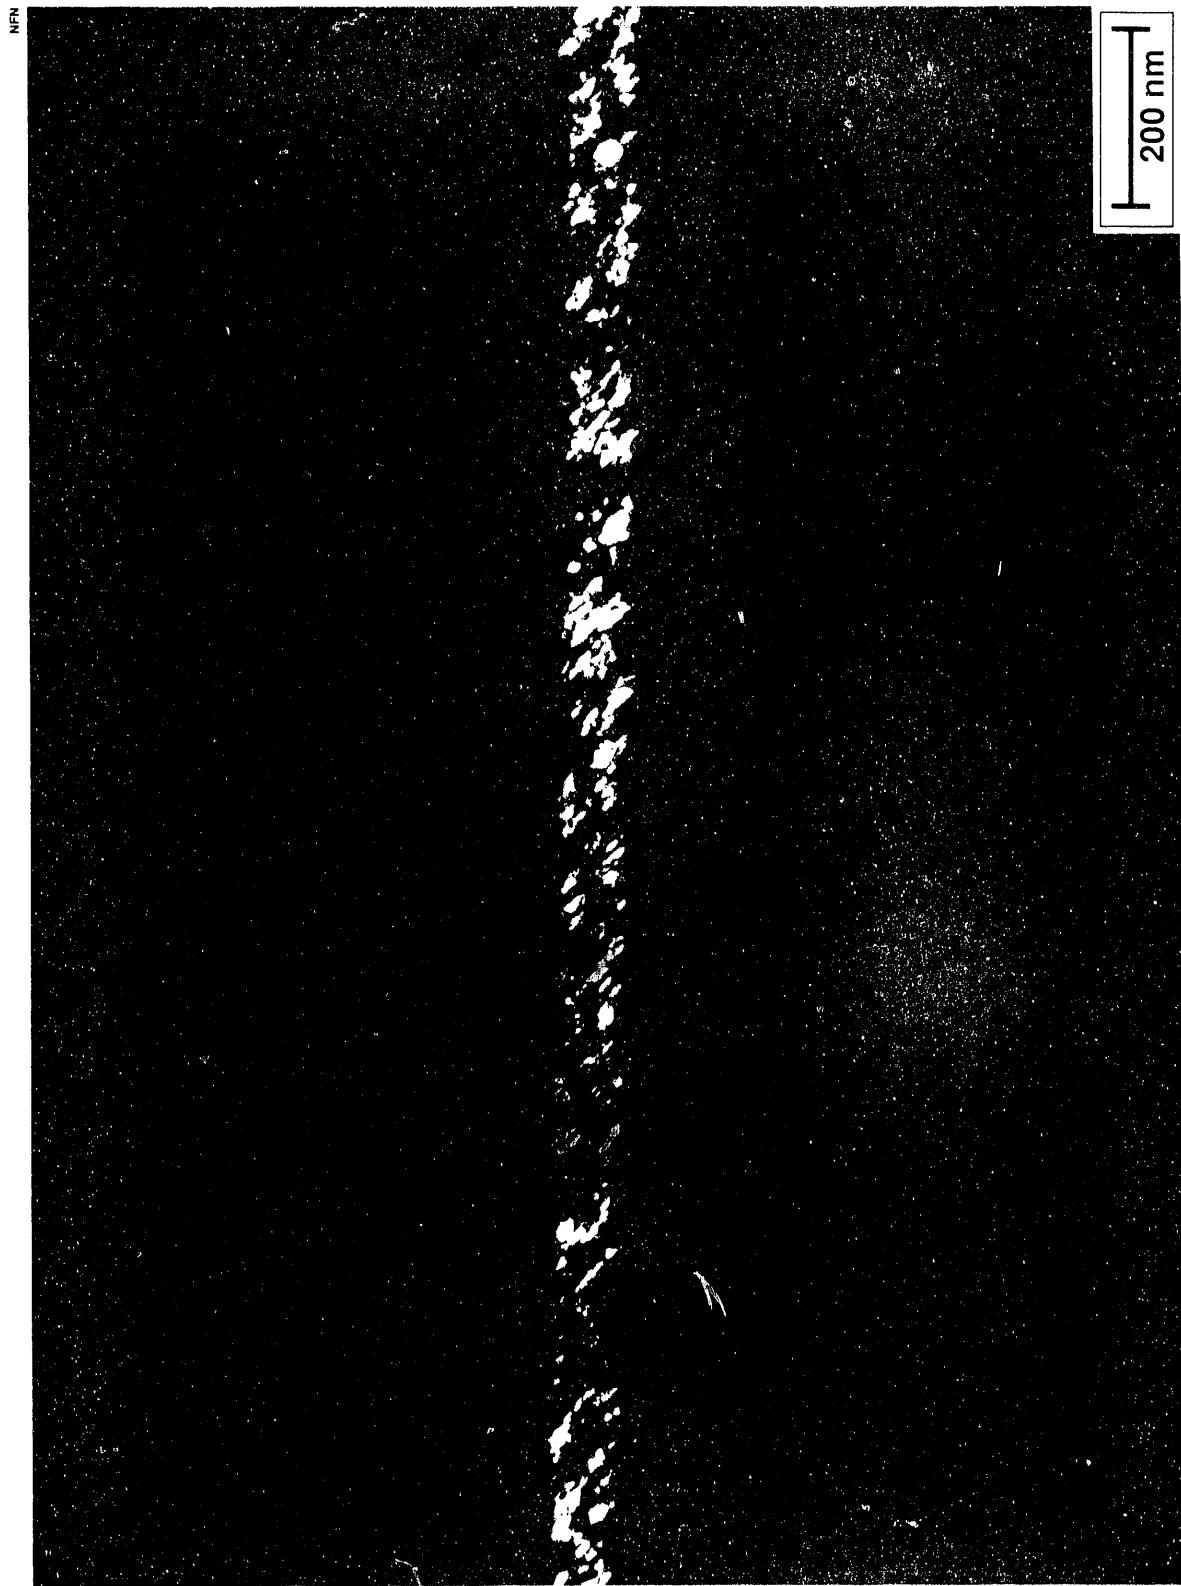
Figure 9. Helium-bearing plate (3.5 mm below weld overlay). Centered-dark field micrograph of carbides on the boundary shown in Figure 8.
