## HELIUM BUBBLE DISTRIBUTIONS IN REACTOR TANK REPAIR SPECIMENS - PART I. (U)

WSRC-TR--91-141

**Keywords:**  
Electron Microscopy  
Reactor Vessel  
Stainless Steel  
Helium  
Bubbles  
Welding

**PROJECT:** Reactor Repair Program

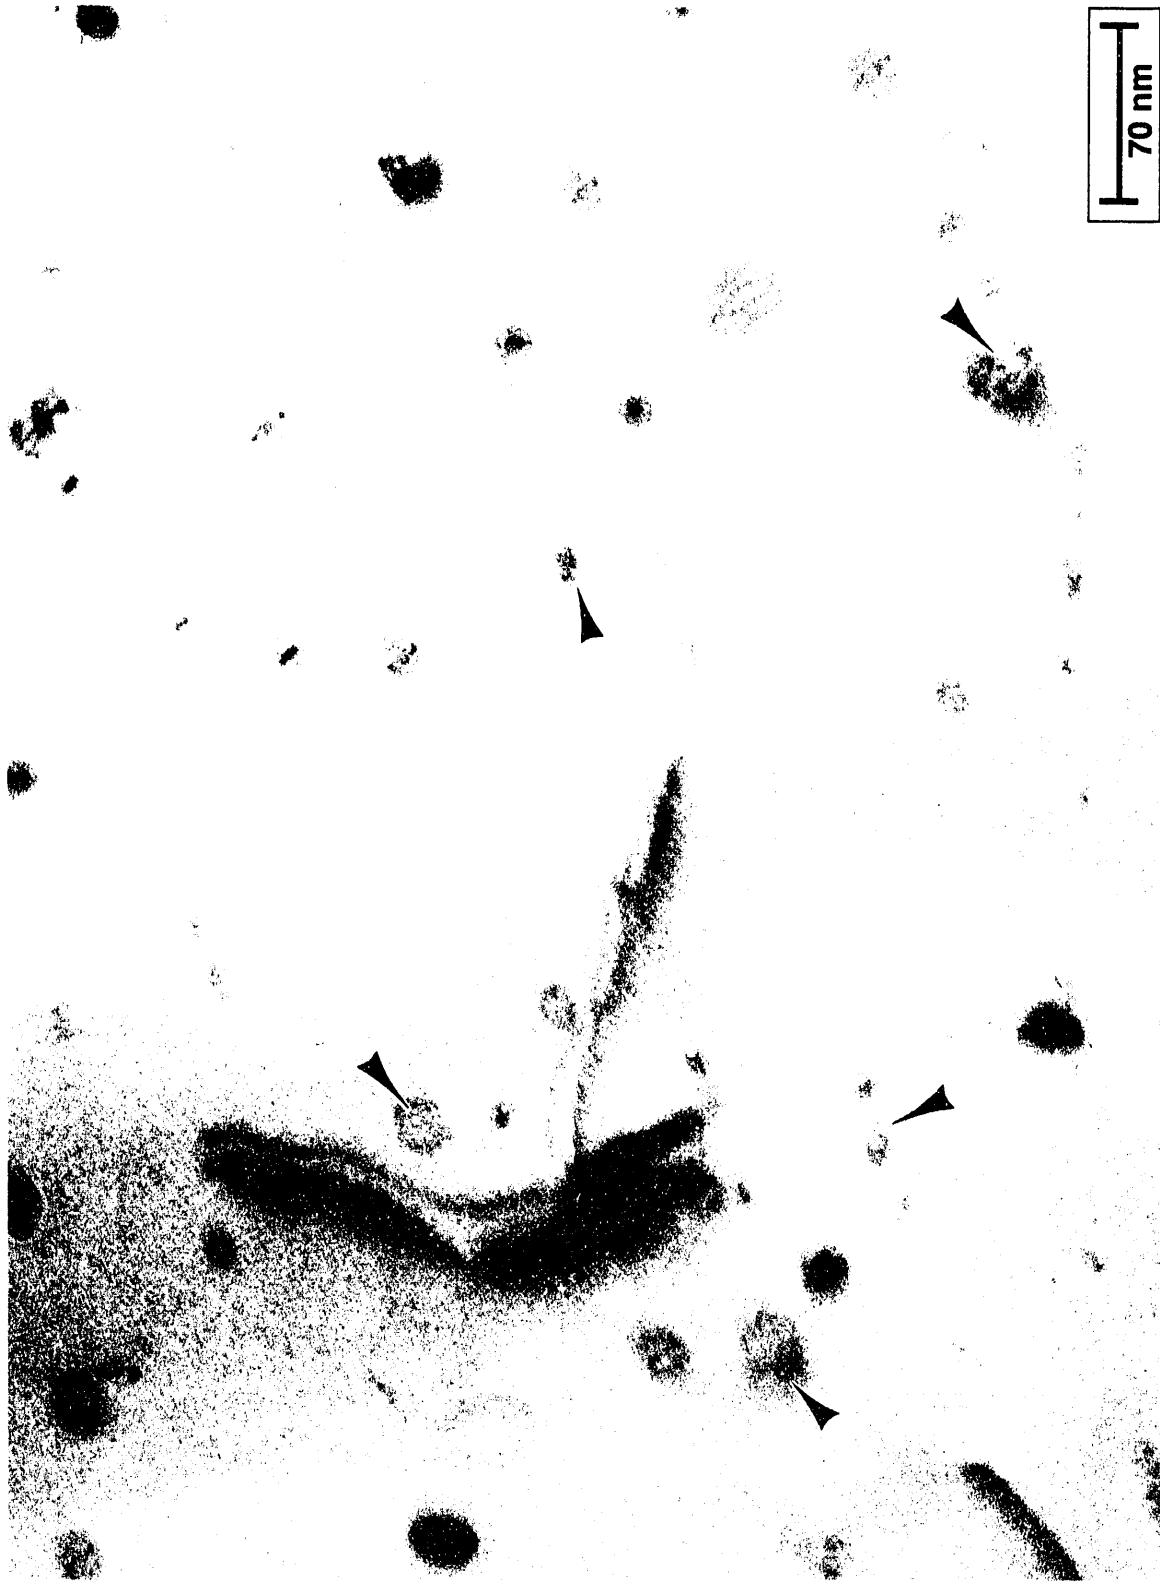
Figure 12. Helium-bearing plate (3.5 mm below weld overlay). Helium bubbles (at arrows) associated with dislocation loops.

Evidence for helium bubbles on, or in close proximity to, dislocation loops can be seen in Figure 12. In this image several helium bubbles, measuring 1-2 nm in diameter, have been arrowed. Rarely were helium bubbles found within the matrix that were not associated with dislocation loops or dislocations. This observation suggests that either the bubbles nucleated on pre-existing loops or the loops were formed as the bubbles grew in size. Although heterogeneous nucleation of bubbles on the loops cannot be completely ruled out, given that dislocation loops were not visible in the as-received material, before or after welding; and given that only one bubble was ever seen on or near a loop, strongly suggests that the loops were "punched-out" by the growth of helium bubbles. The formation of interstitial dislocation loops by the growth of helium bubbles has been observed by, e.g., Thomas [5] in ion-implanted gold and by Evans et al. [6] in molybdenum and has been treated theoretically by Greenwood et al. [7], Evans [8,9] and most recently by Wolfer [10]. An increase in bubble volume is believed to cause plastic deformation of the adjacent lattice and the subsequent formation of an interstitial dislocation loop.

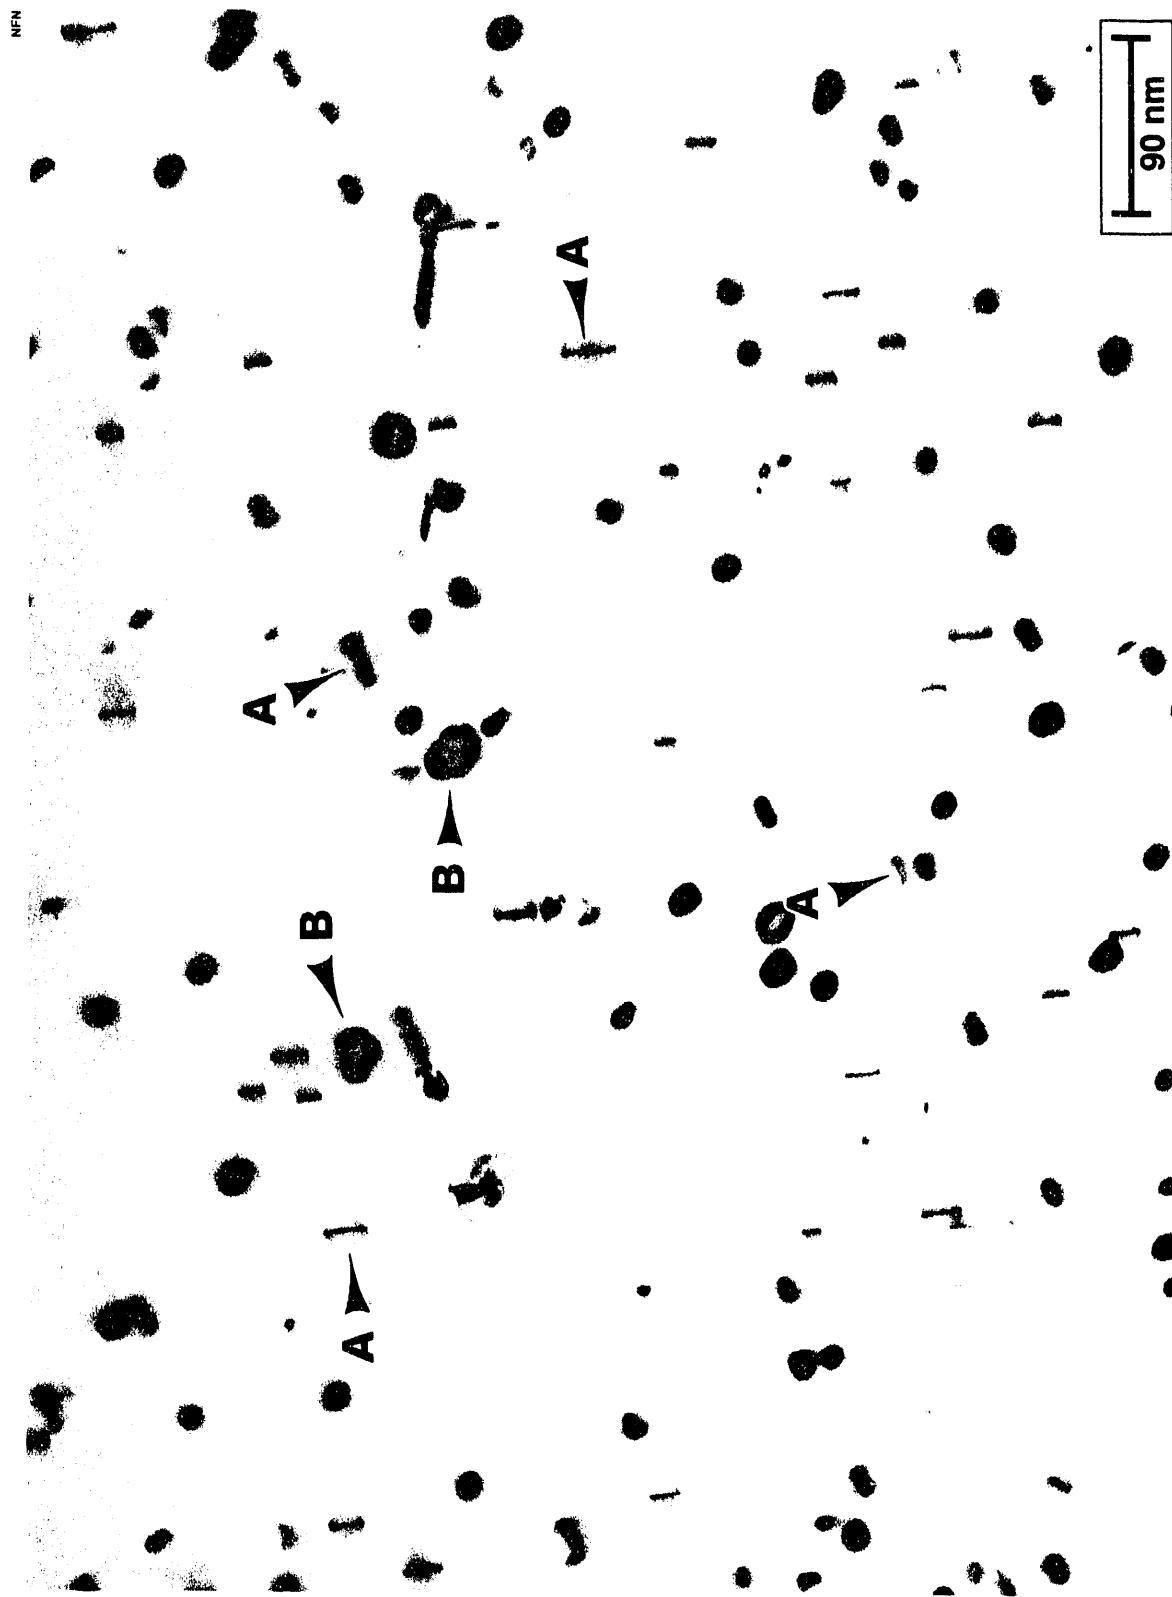
Figure 11. Helium-bearing plate (3.5 mm below weld overlay). Typical dislocation loop distribution found within the grain interiors.

formed on the {111} austenite planes. Figure 11 illustrates a typical dislocation loop distribution. In this micrograph, the matrix beam direction is ~[110] and, as such, two sets of {111} planes are upright in the foil. As a result, two variants of the dislocation loops are viewed edge-on in this foil orientation. Several of these loops have been arrowed, A, in this image. The remainder of the loops lie on the other two sets of {111} planes inclined at ~35° to the electron beam. Close examination of Figure 11 also shows that many of the loops are faulted, as is indicated by the stacking fault fringes visible in the larger loops (arrowed B) in this image. A Burgers vector analysis ( $\mathbf{g} \cdot \mathbf{b} = 0^*$ ) performed on the loops has shown them to be Frank partial dislocation loops with  $\mathbf{b} = 1/3 <111>$ .

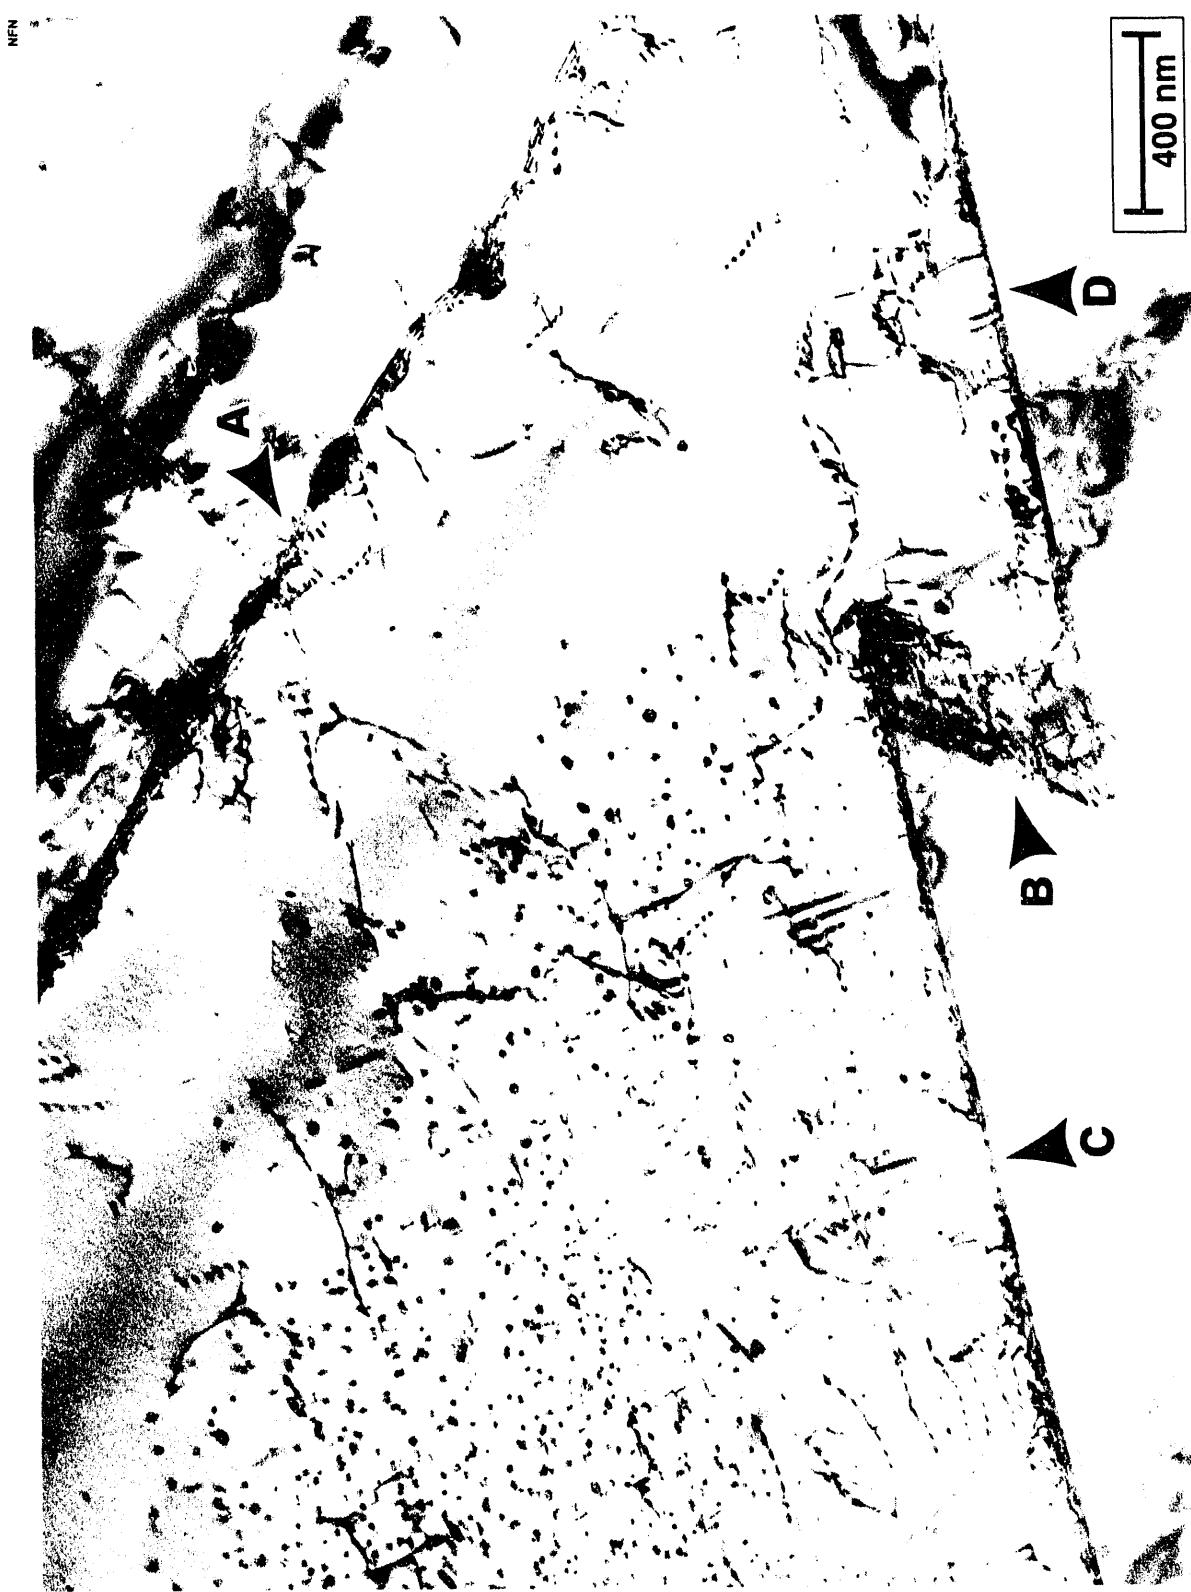
Figure 14. Helium-bearing plate (3.5 mm below weld overlay). Bubble-free zones adjacent to a grain boundary (at A) and an incoherent twin boundary step (at B). Coherent twin boundary segments are labeled C and D.

Additional examples of BFZs are shown in Figure 14. This bright field micrograph was taken from a region of a foil containing a grain boundary (arrowed A) an incoherent twin boundary step (arrowed B) and two coherent twin boundary segments (arrowed C and D). This micrograph shows that BFZs exist at both the grain boundary and the incoherent twin step. In contrast, there is not a BFZ adjacent to the coherent twin boundary segment, C. (A BFZ exists at the coherent segment D but only because of the overlapping BFZs associated with the grain boundary and incoherent twin step.) A closer examination of the image in Figure 14 reveals that, although a BFZ does not exist at boundary segment C, the bubble (loop) density does decrease in the near boundary region. This observation was characteristic of the bubble distribution at many of the coherent twin boundaries in this material.

The existence of BFZs at the coherent twin boundaries in the unwelded material and the absence thereof in material containing a weld (compare Figure 22 to Figure 14 - segment, C) implies that welding can "heal" the denuded regions. This may occur because the increased vacancy concentration at the welding temperatures could allow for the nucleation of additional helium bubbles and the subsequent formation of dislocation loops in these regions. Also, the movement or annihilation of dislocations that had initially served as nucleation sites for helium bubbles could give rise to bubbles within the BFZ.

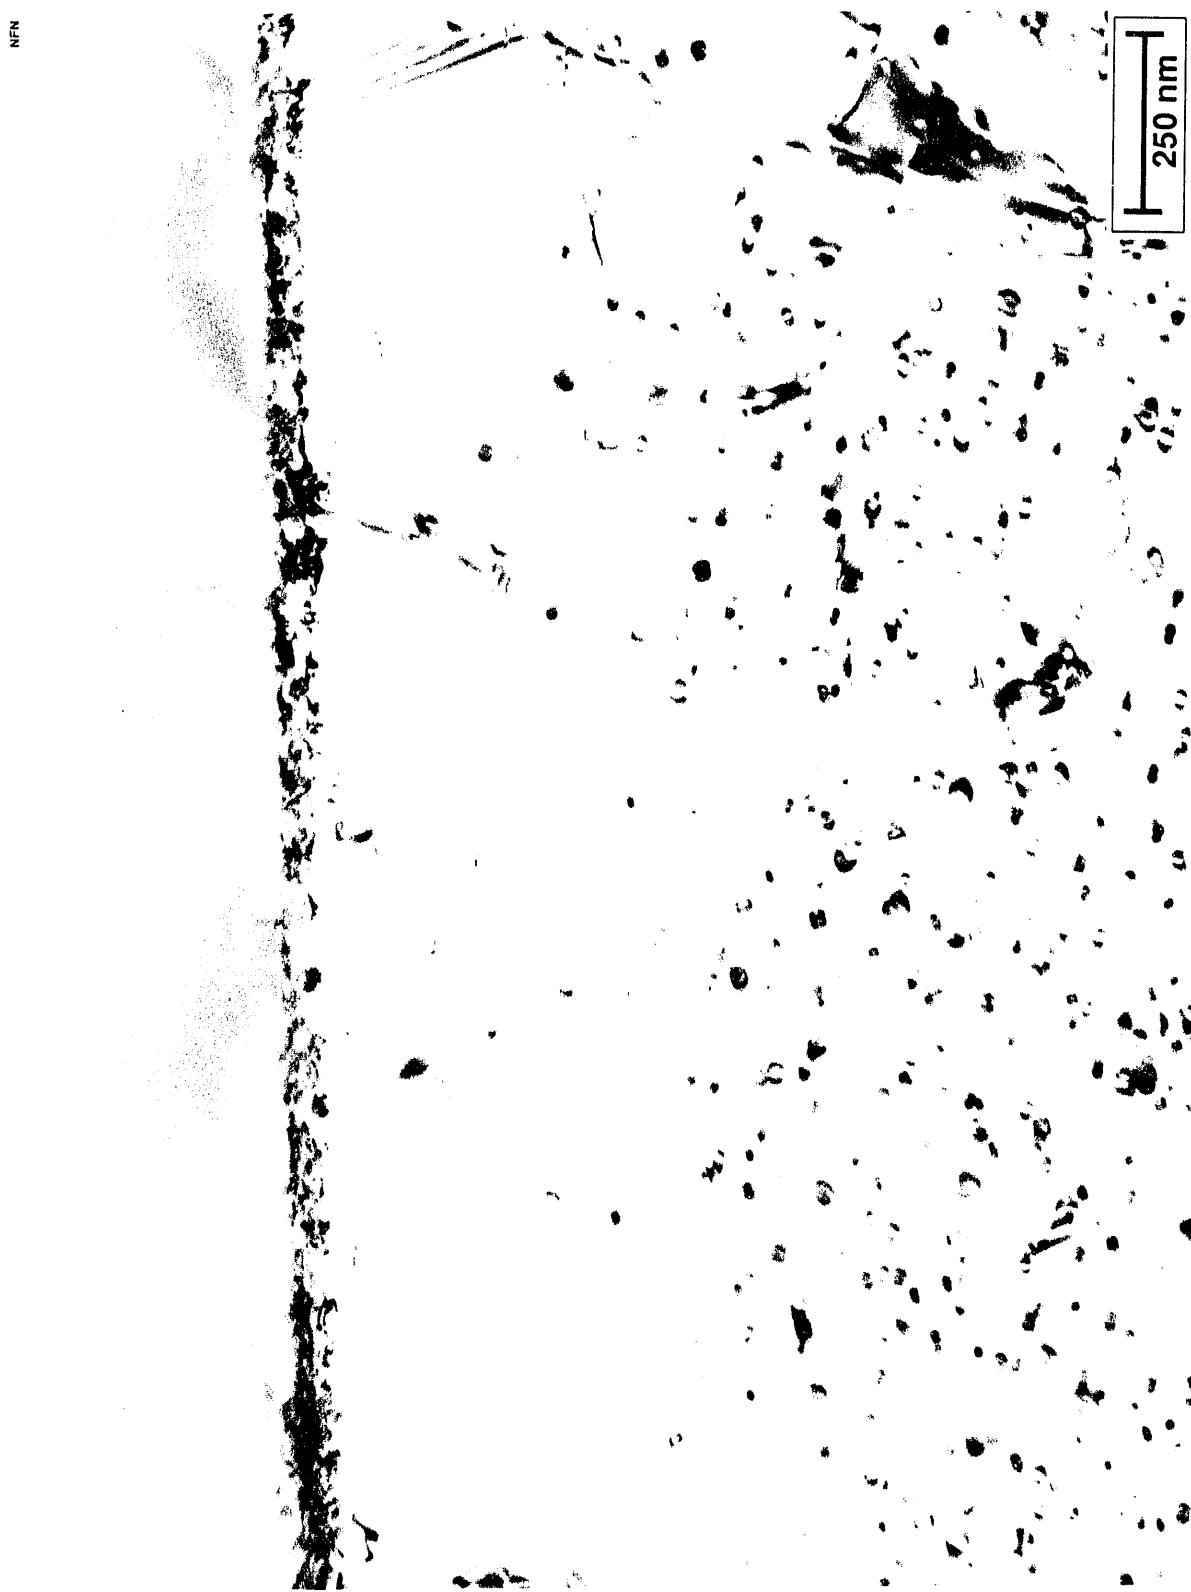
Figure 13. Helium-bearing plate (3.5 mm below weld overlay). Bubble-free zone adjacent to an incoherent twin boundary.

A random distribution of dislocation loops occurred throughout the grain volumes except in the immediate vicinity of the grain boundaries. A denuded zone, free of dislocation loops and essentially free of visible helium bubbles, existed at all grain boundaries and incoherent twin boundaries. These denuded regions have been termed bubble-free zones (BFZs). Figure 13 is an image taken of a region adjacent to an incoherent twin boundary. Only a few dislocation loops have formed within the  $\sim 0.6 \mu\text{m}$  zone nearest to the boundary. Closer examination also revealed this region to be free of additional helium bubbles except for a small number of bubbles that had nucleated on dislocations lying within the denuded region. It should be noted that bubbles smaller than those imaged may have been present in the BFZs but were not visible due to the limitations of the imaging technique.

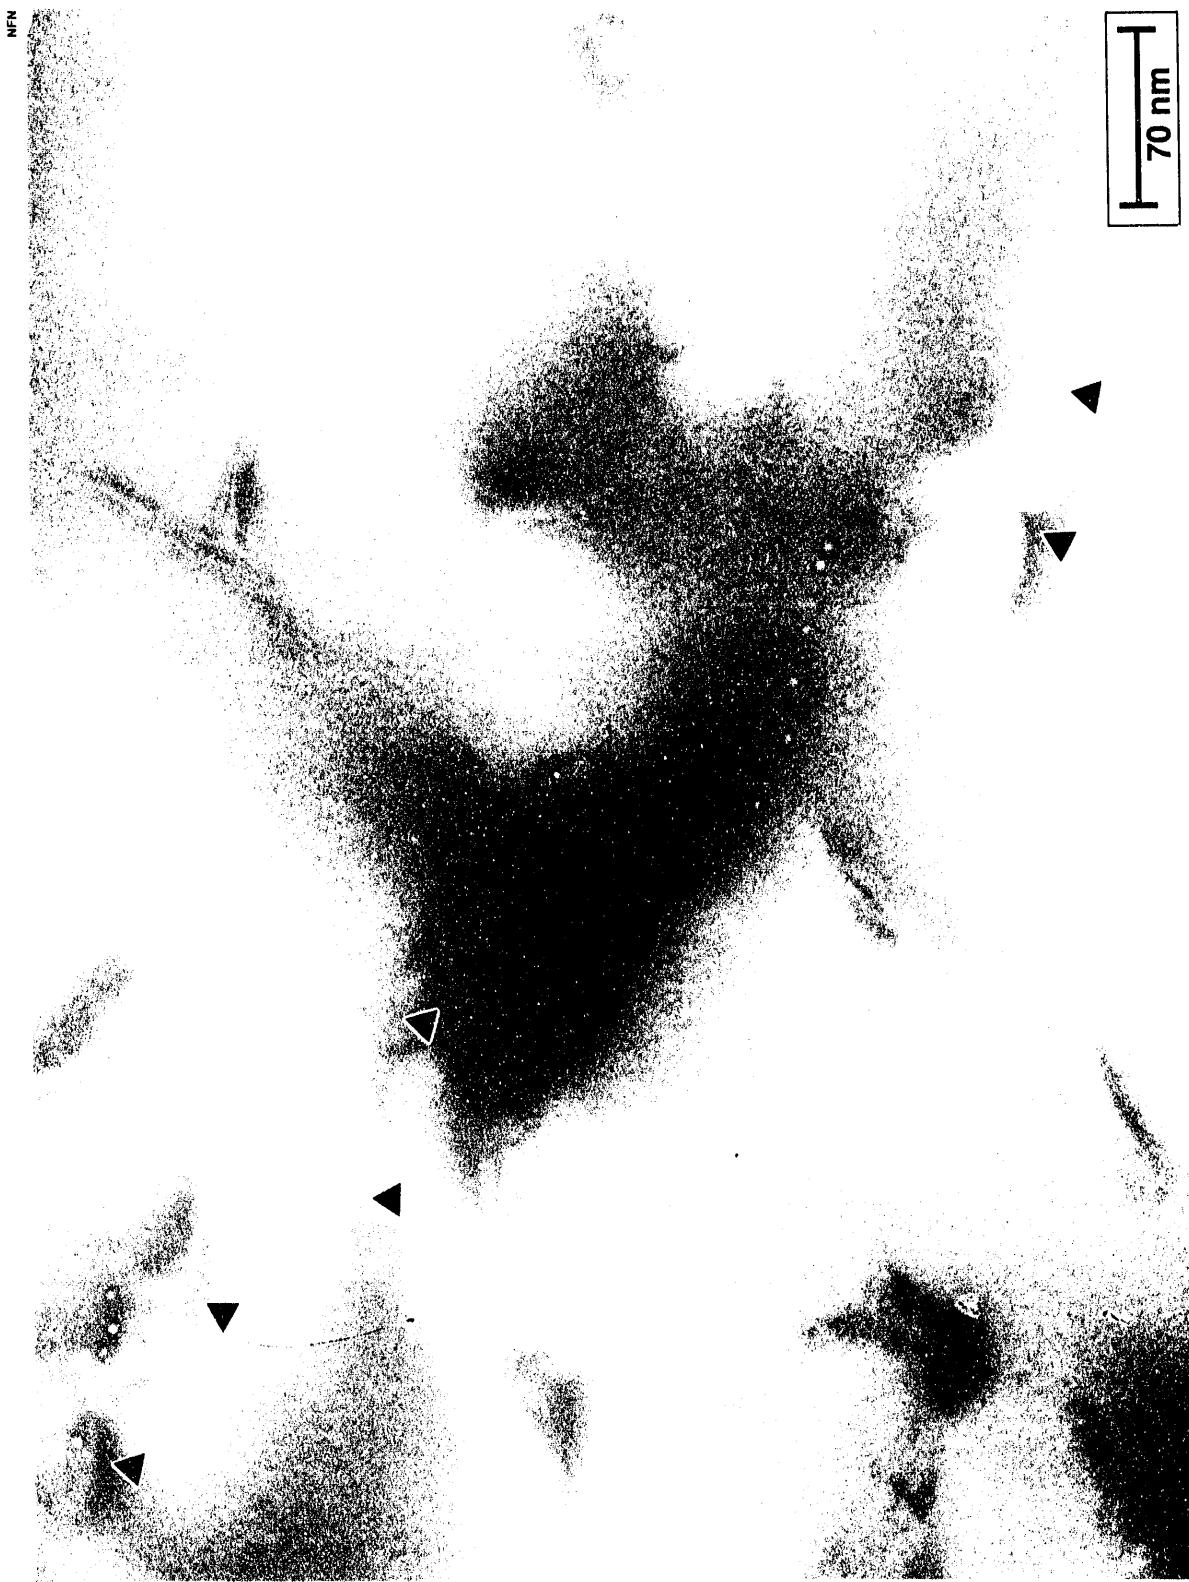
Figure 16. Helium-bearing plate (3.5 mm below weld overlay). Helium bubbles associated with dislocations within a bubble-free zone. Dislocations (at arrows) appear to have moved away from the line of helium bubbles.

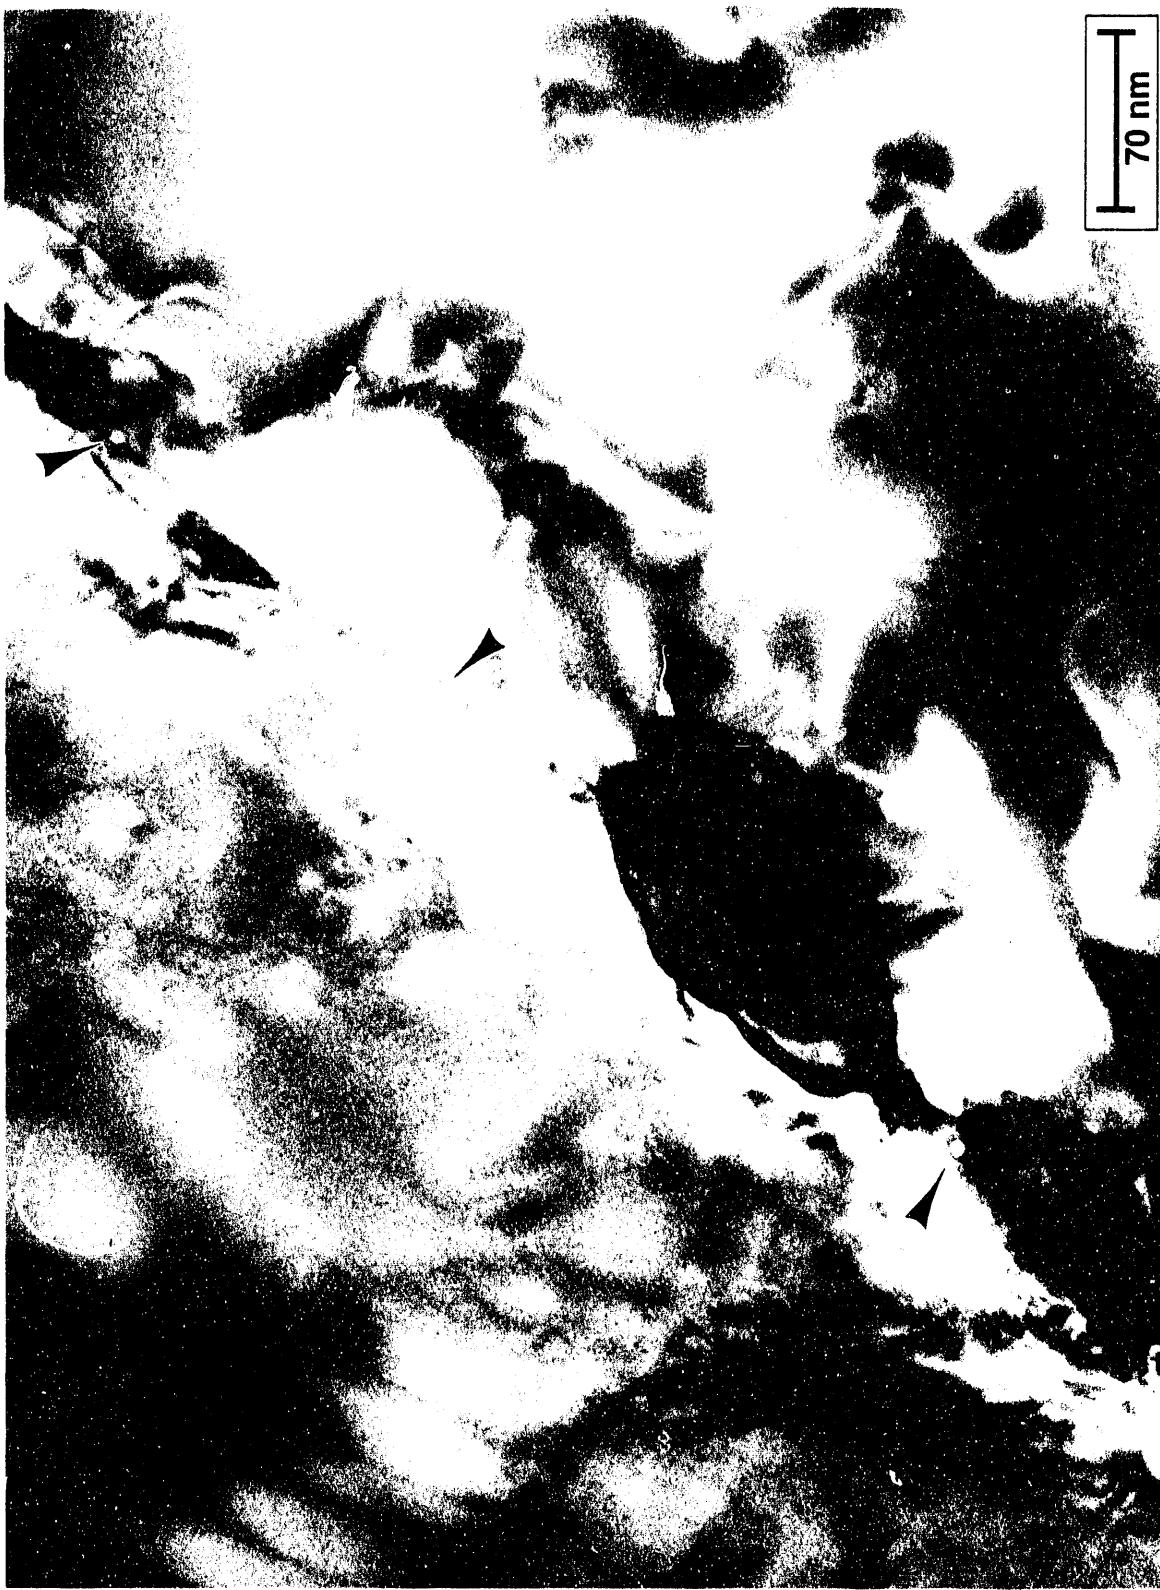
Figure 17. Helium-bearing plate (2.3 mm below weld overlay). Helium bubble distribution on a grain boundary. Several large bubbles have been arrowed. The dark particles on the boundary are carbide precipitates.

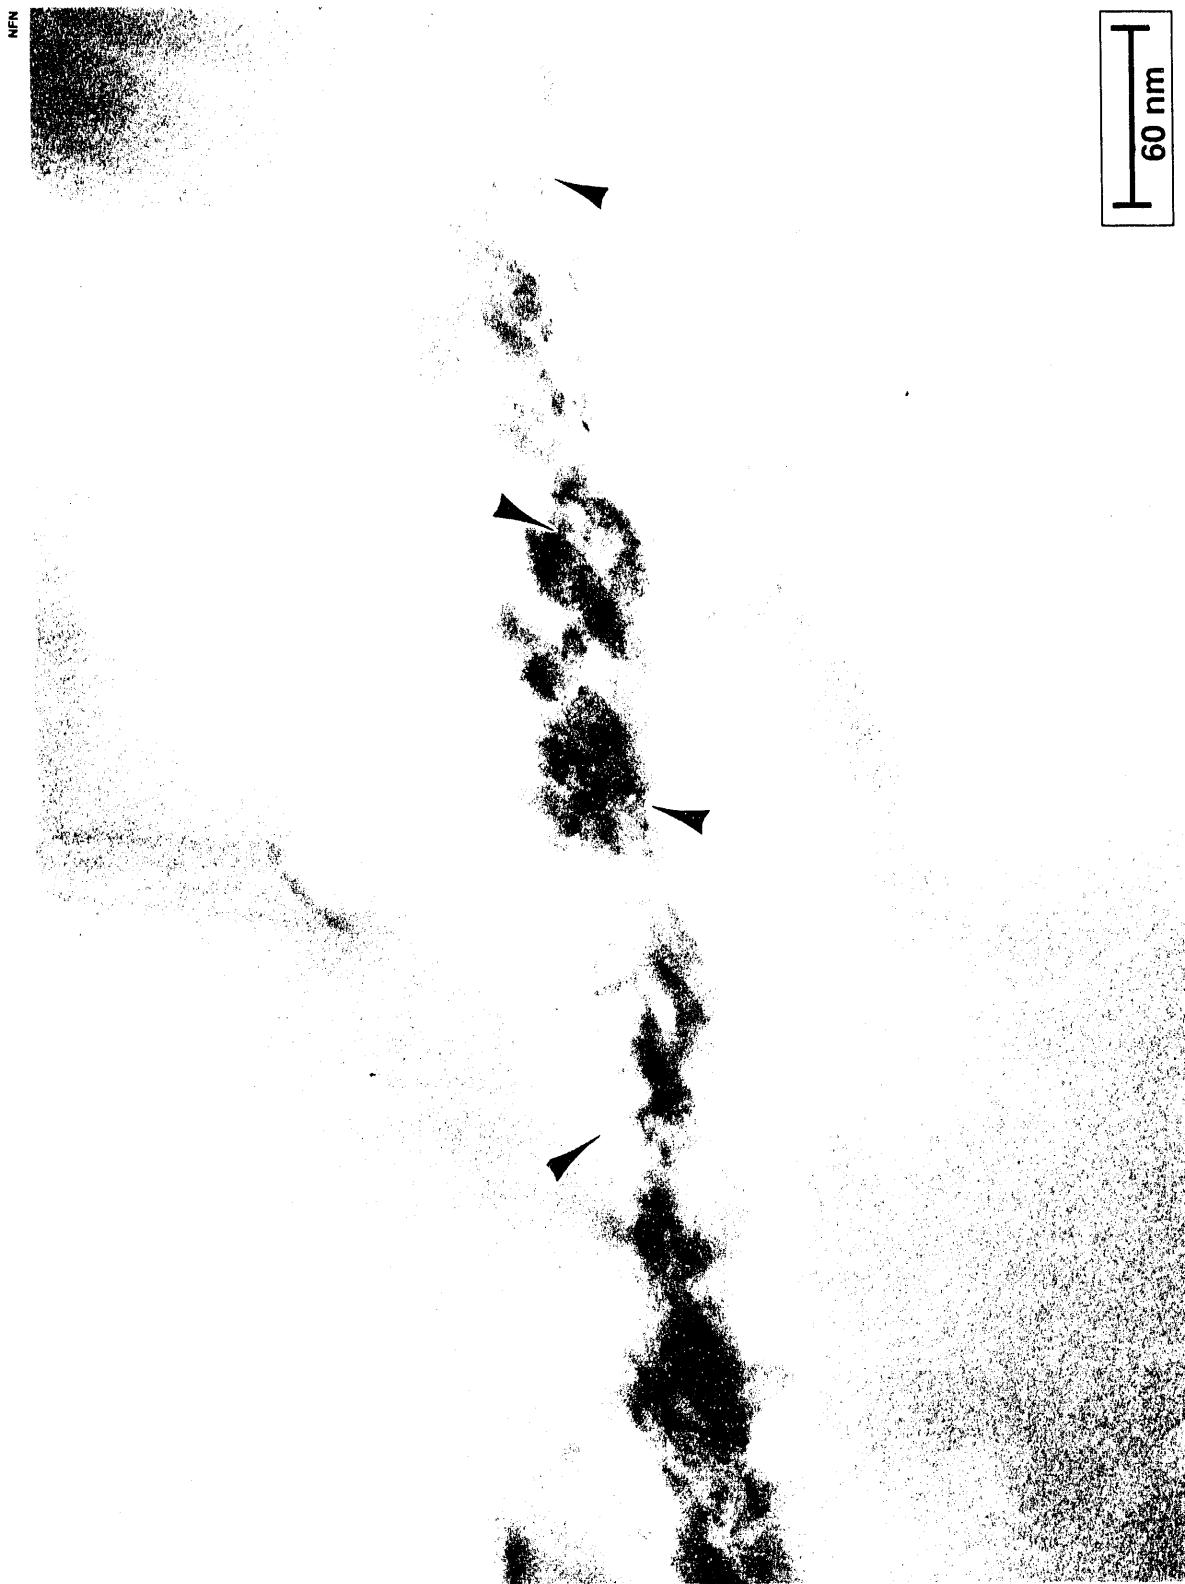
Figure 20. Helium-bearing plate (no weld overlay). Typical helium bubble distribution on an incoherent twin boundary. Several helium bubbles have been arrowed.

grain boundaries. Bubbles on this boundary segment measured ~3 nm in diameter and were spaced, on average, 16 nm apart. The bubble distribution on an incoherent twin boundary is illustrated in Figure 20 and the bubble distribution within the interior of the austenite grains is shown in Figure 21.

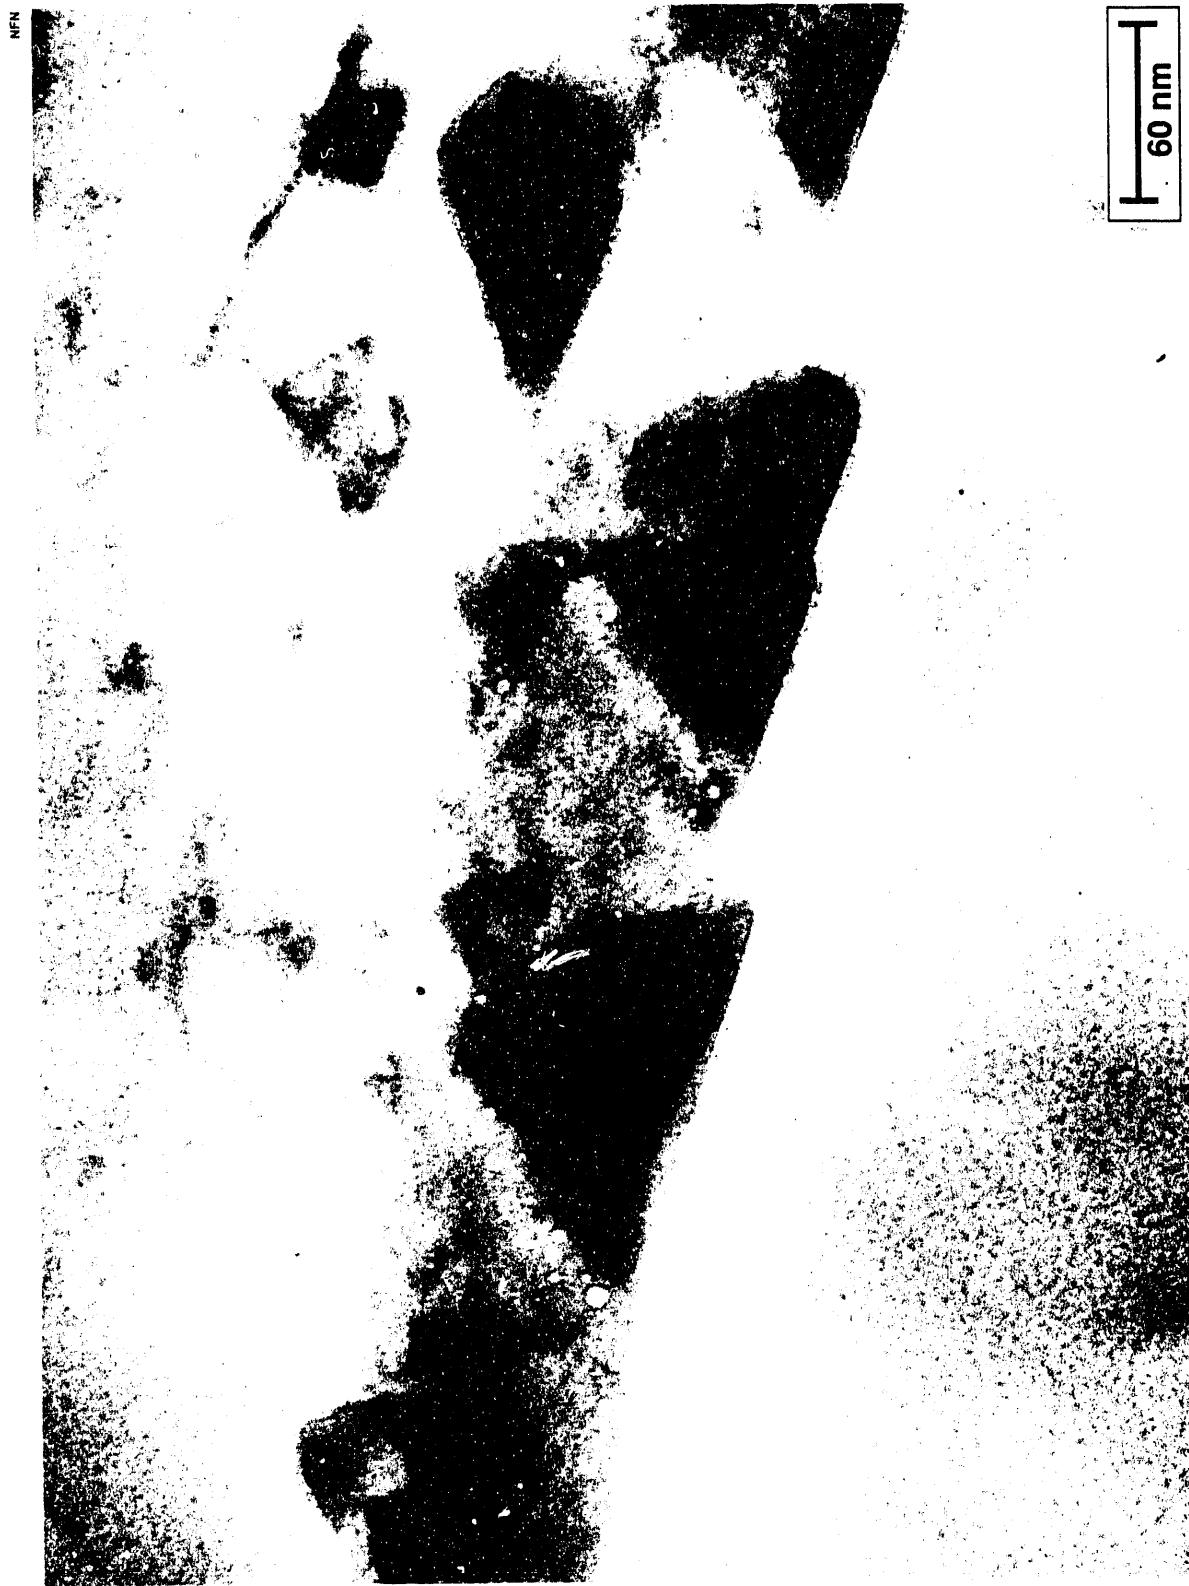
Figure 19. Helium-bearing plate (no weld overlay). Helium bubble distribution on a grain boundary. Several carbides are also located on this boundary.

The base microstructure of this specimen material was consistent with that observed for other 147 appm  $^3\text{He}$  specimens described above. Observations also showed that a well-developed bubble microstructure did exist in this material. The bubble distribution is evident in representative images (Figures 19 - 21) from this material. Figure 19 illustrates the helium bubble distribution at the

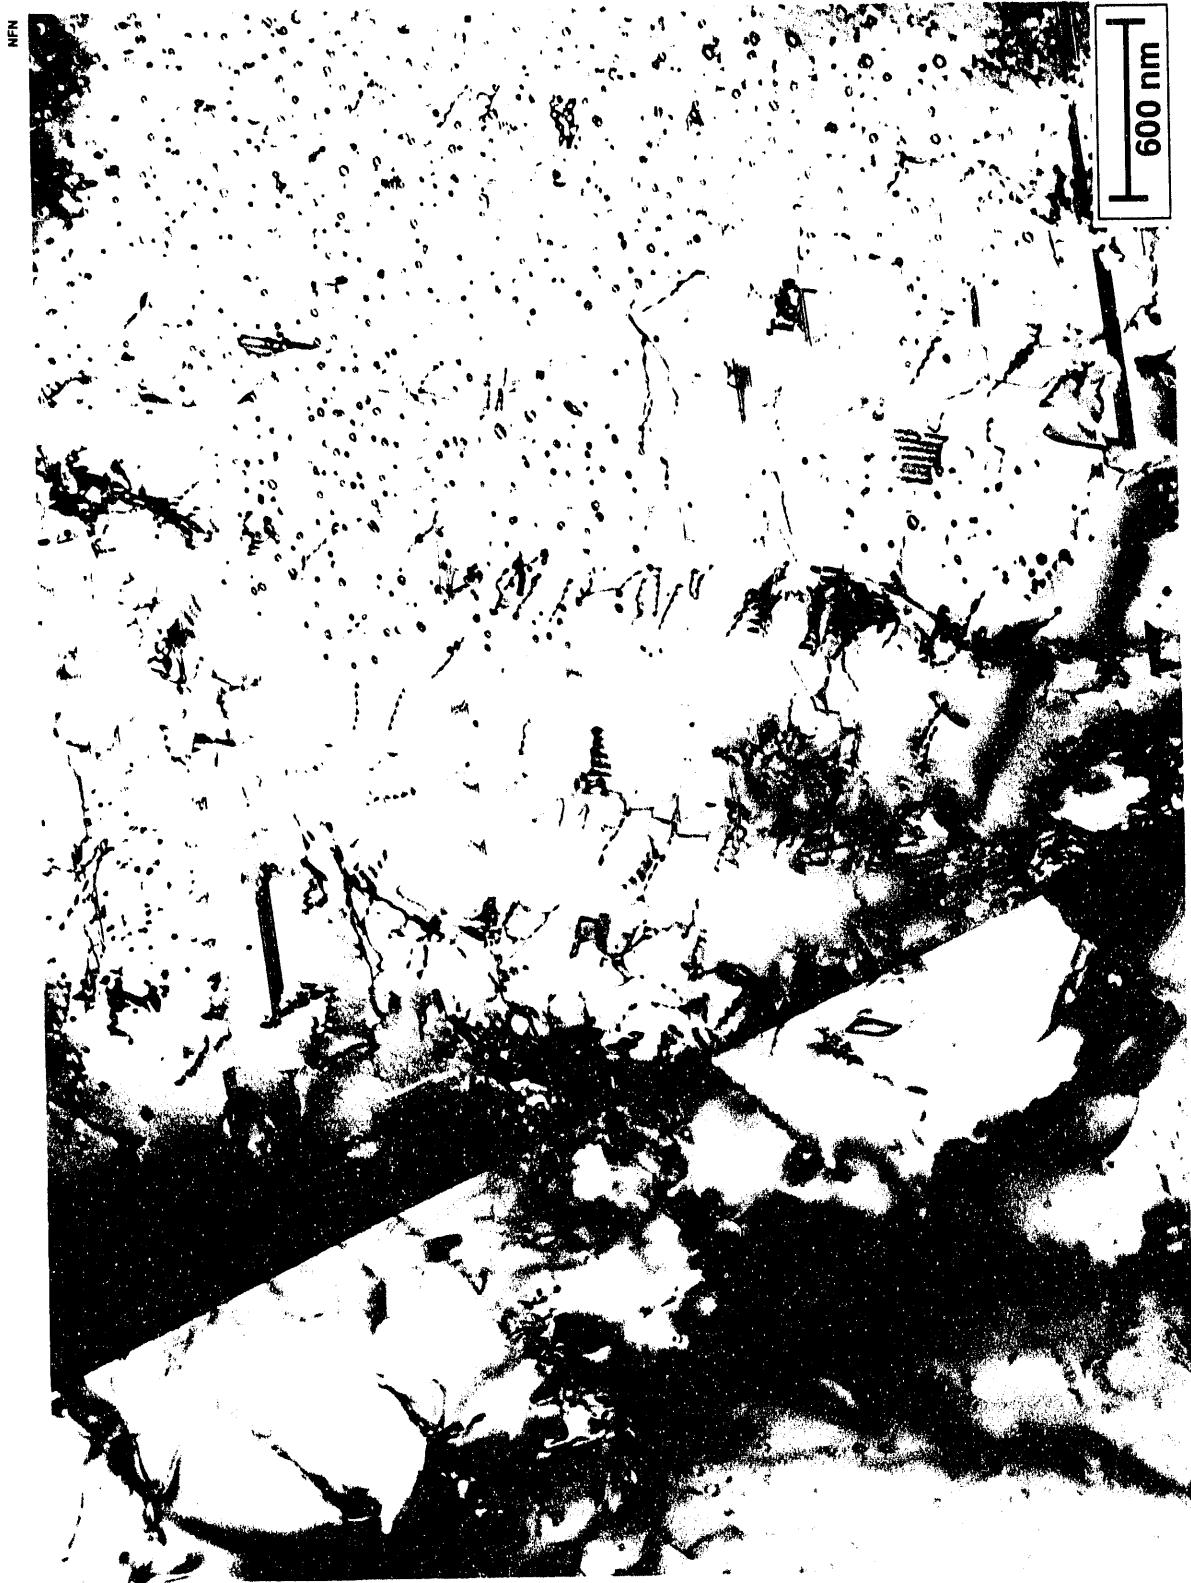
Figure 22. Helium-bearing plate (no weld overlay). Bubble-free zone adjacent to a coherent twin boundary.

A bright field image of a coherent twin boundary is shown in Figure 22. As can be seen, there is a significant BFZ adjacent to this boundary. This phenomenon was observed at all coherent twin boundaries (in addition to the grain boundaries and incoherent twin boundaries) in the unwelded 147 appm  $^3\text{He}$  material and was the only noticeable difference in bubble distribution between this material and that which contained a weld. In this image, the shape of the BFZ appears to be dictated by the dislocation distribution and density in the near-boundary region. Also, in areas where the dislocation density is low there are more loops (i.e., bubbles). Conversely, in areas where the dislocation density is high few loops are observed. Further evidence of dislocation/dislocation loop relationship is shown in Figure 23 where a BFZ is observed immediately adjacent to a coherent twin boundary and a dislocation pile-up. These observations may again indicate that dislocations served as vacancy sinks that prevented helium bubbles from nucleating "homogeneously" in the near-boundary regions.

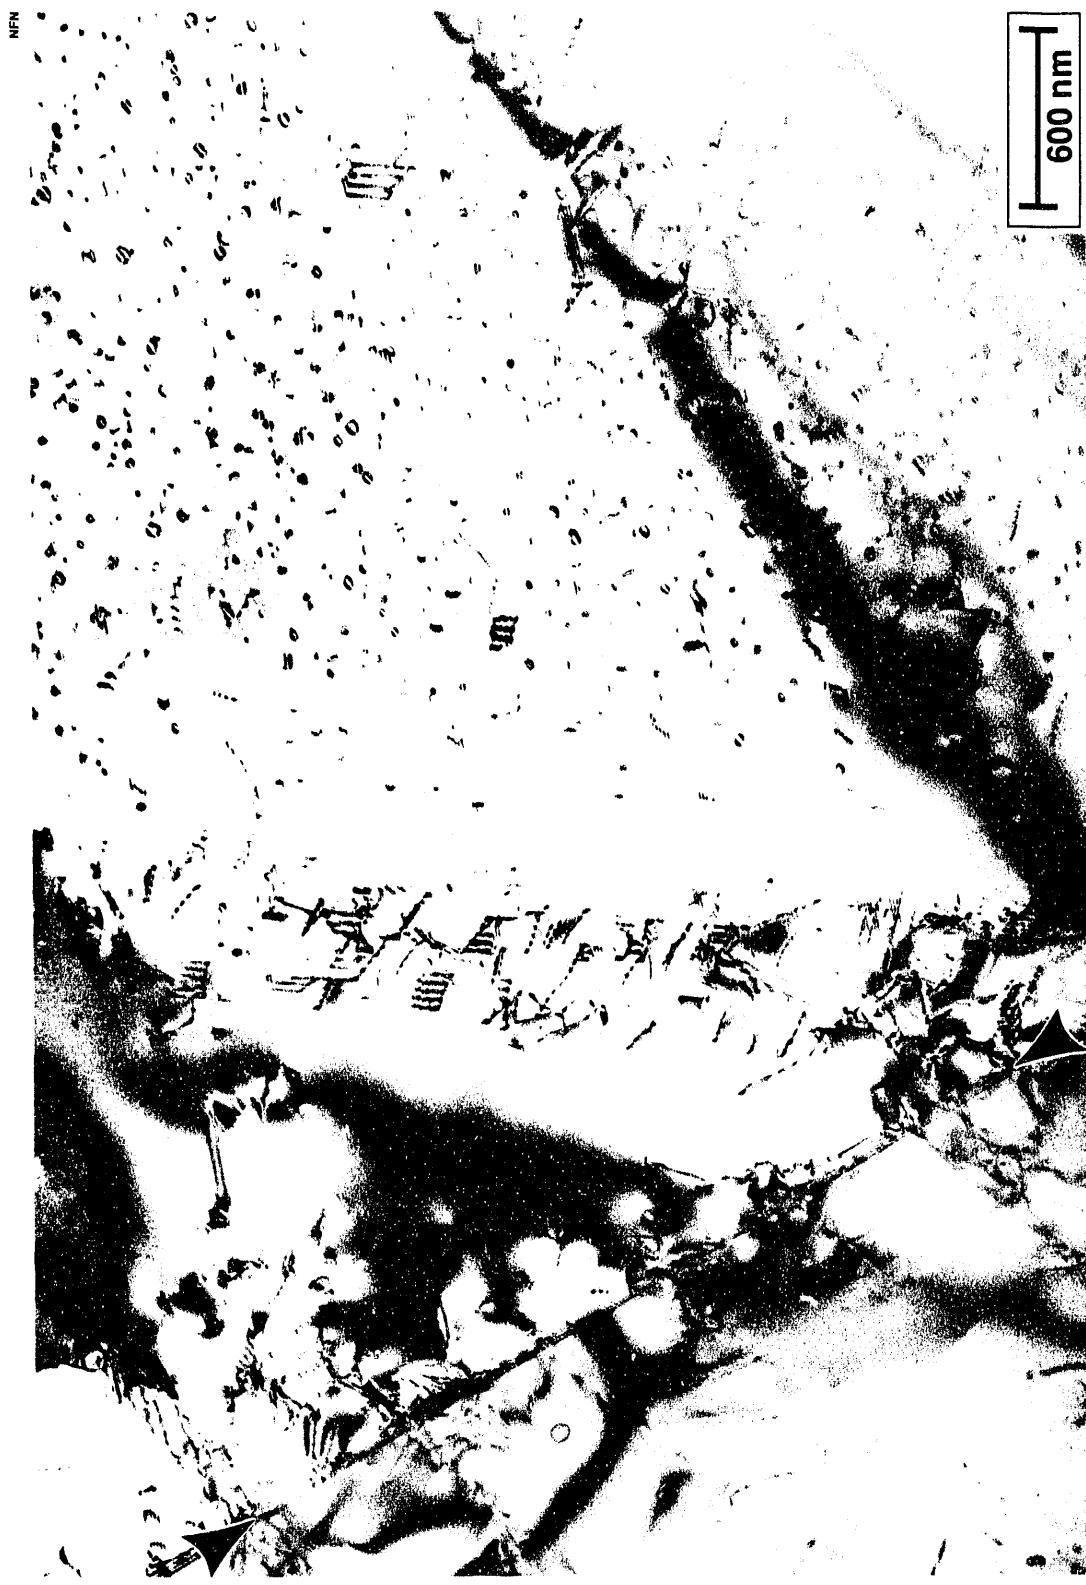
Figure 23. Helium-bearing plate (no weld overlay). Bubble-free zone at a coherent twin boundary (arrowed) and a dislocation pile-up.
