Cast Coil Transformer Fire Susceptibility and Reliability Study

CAST COIL TRANSFORMER FIRE SUSCEPTIBILITY AND RELIABILITY STUDY

S. A. McBride

**EG&G Idaho, Inc.
Idaho Falls, Idaho 83415**

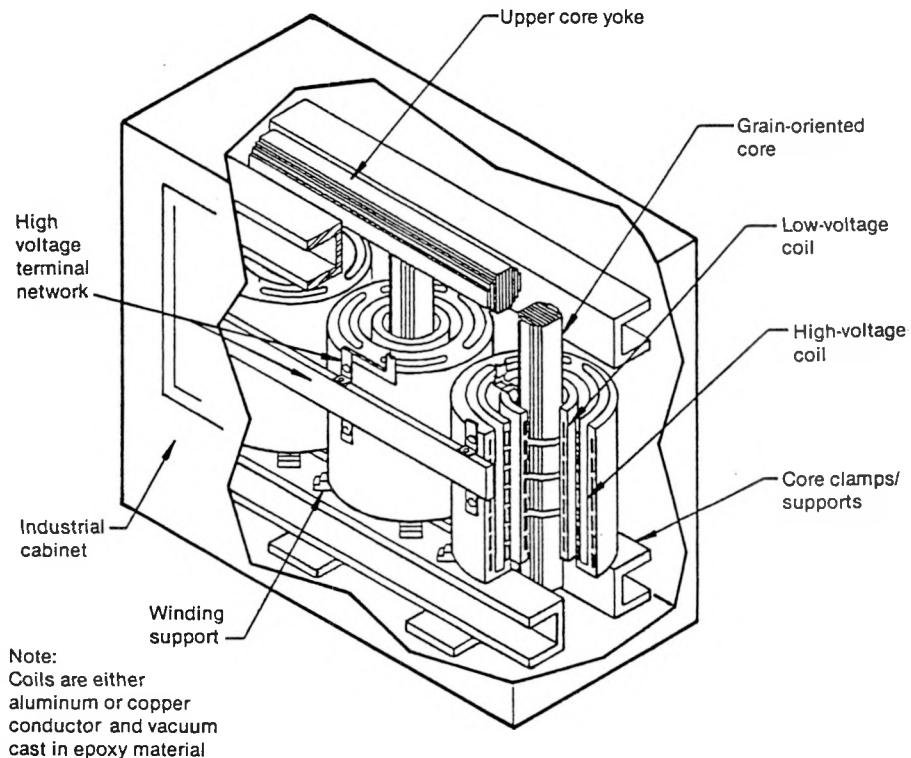
Figure 1. Typical construction of the cast coil transformer.

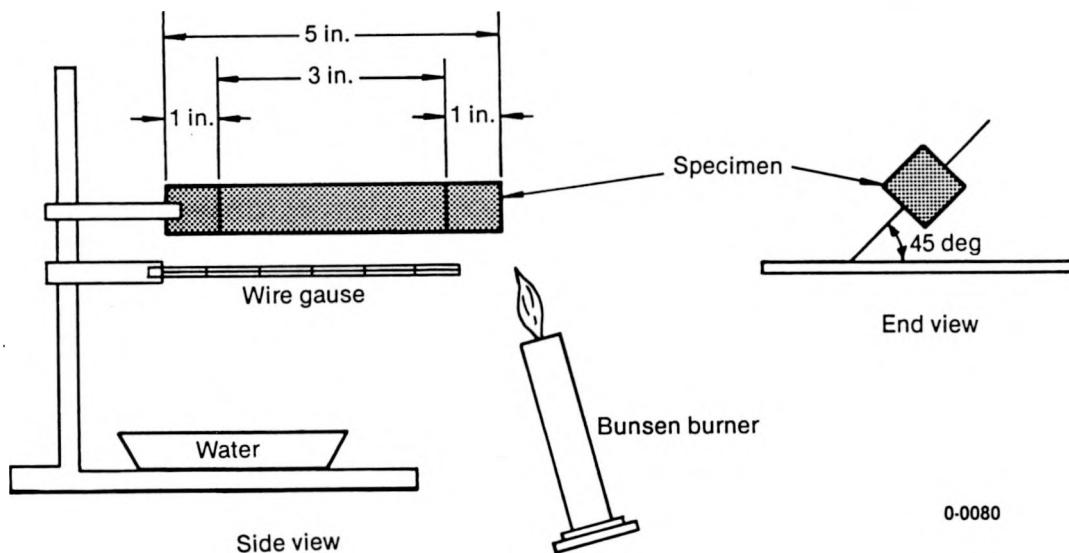
Figure 2. Apparatus for the epoxy material flammability tests performed by the INEL.

Twenty samples of the material, each 5 x 1/2 x 1/2 in., were tested using the procedure in the standard. Calibration marks were made 1 in. and 4 in. from the unclamped end of each sample. The sample under test was clamped horizontally and the flame of a Bunsen burner applied (Figure 2). If after two attempts, the specimen does not ignite, it is considered "nonburning" by this test. If the specimen continues to burn after the first or second ignition, timing is started when the flame reaches the first mark, 1 in. from the free end,

and stopped when the flame reaches the second mark, 4 in. from the free end. A specimen that burns to the 4 in. mark is considered to be "burning" by this test, and the burning rate is determined by the time it takes to burn the 3 in. between the two marks. If the specimen does not burn to the 4 in. mark, then it is determined to be "self-extinguishing" by this test, with the extent of burning being the measured length burned.

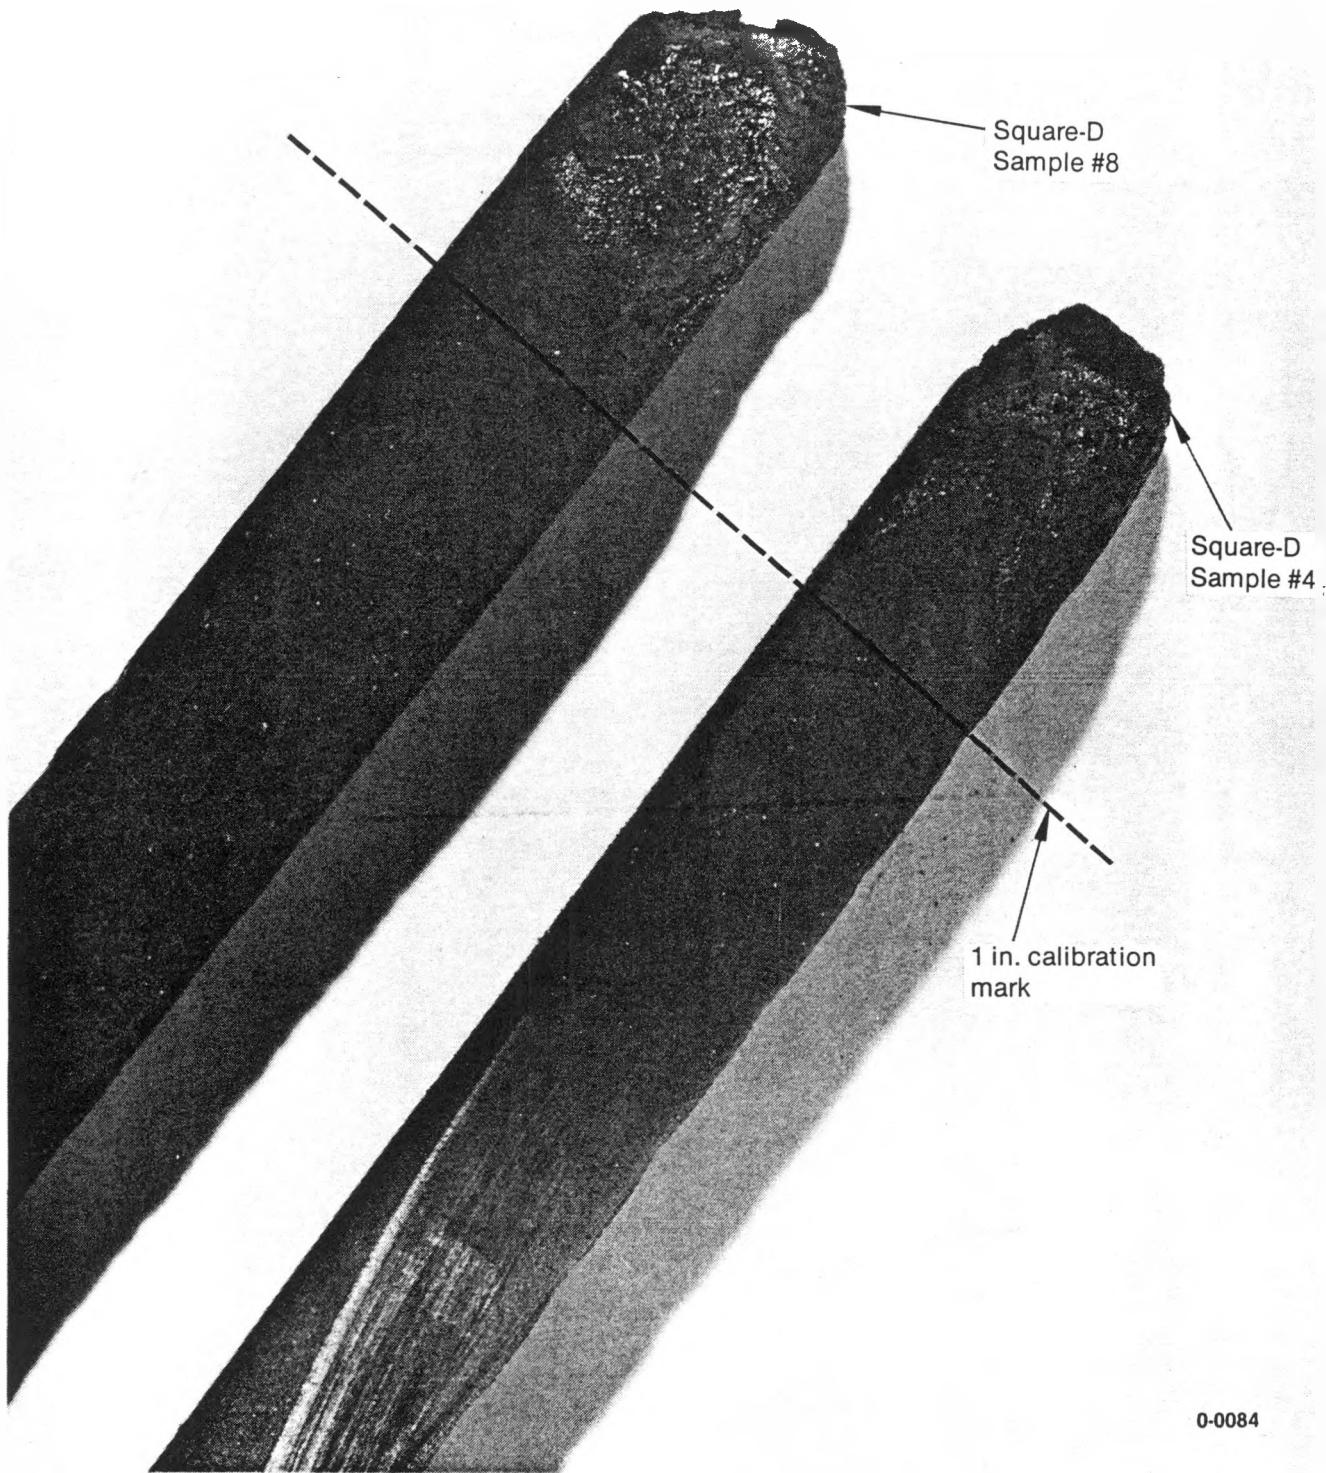
Figure C-1. This photograph is of two unfilled BPA epoxy samples (Square-D) that have been subjected to the burn tests. The flames consumed a small portion of the material, but the degradation did not reach the 1 in. mark. The material proved to be nonburning by the definition of the test procedure.

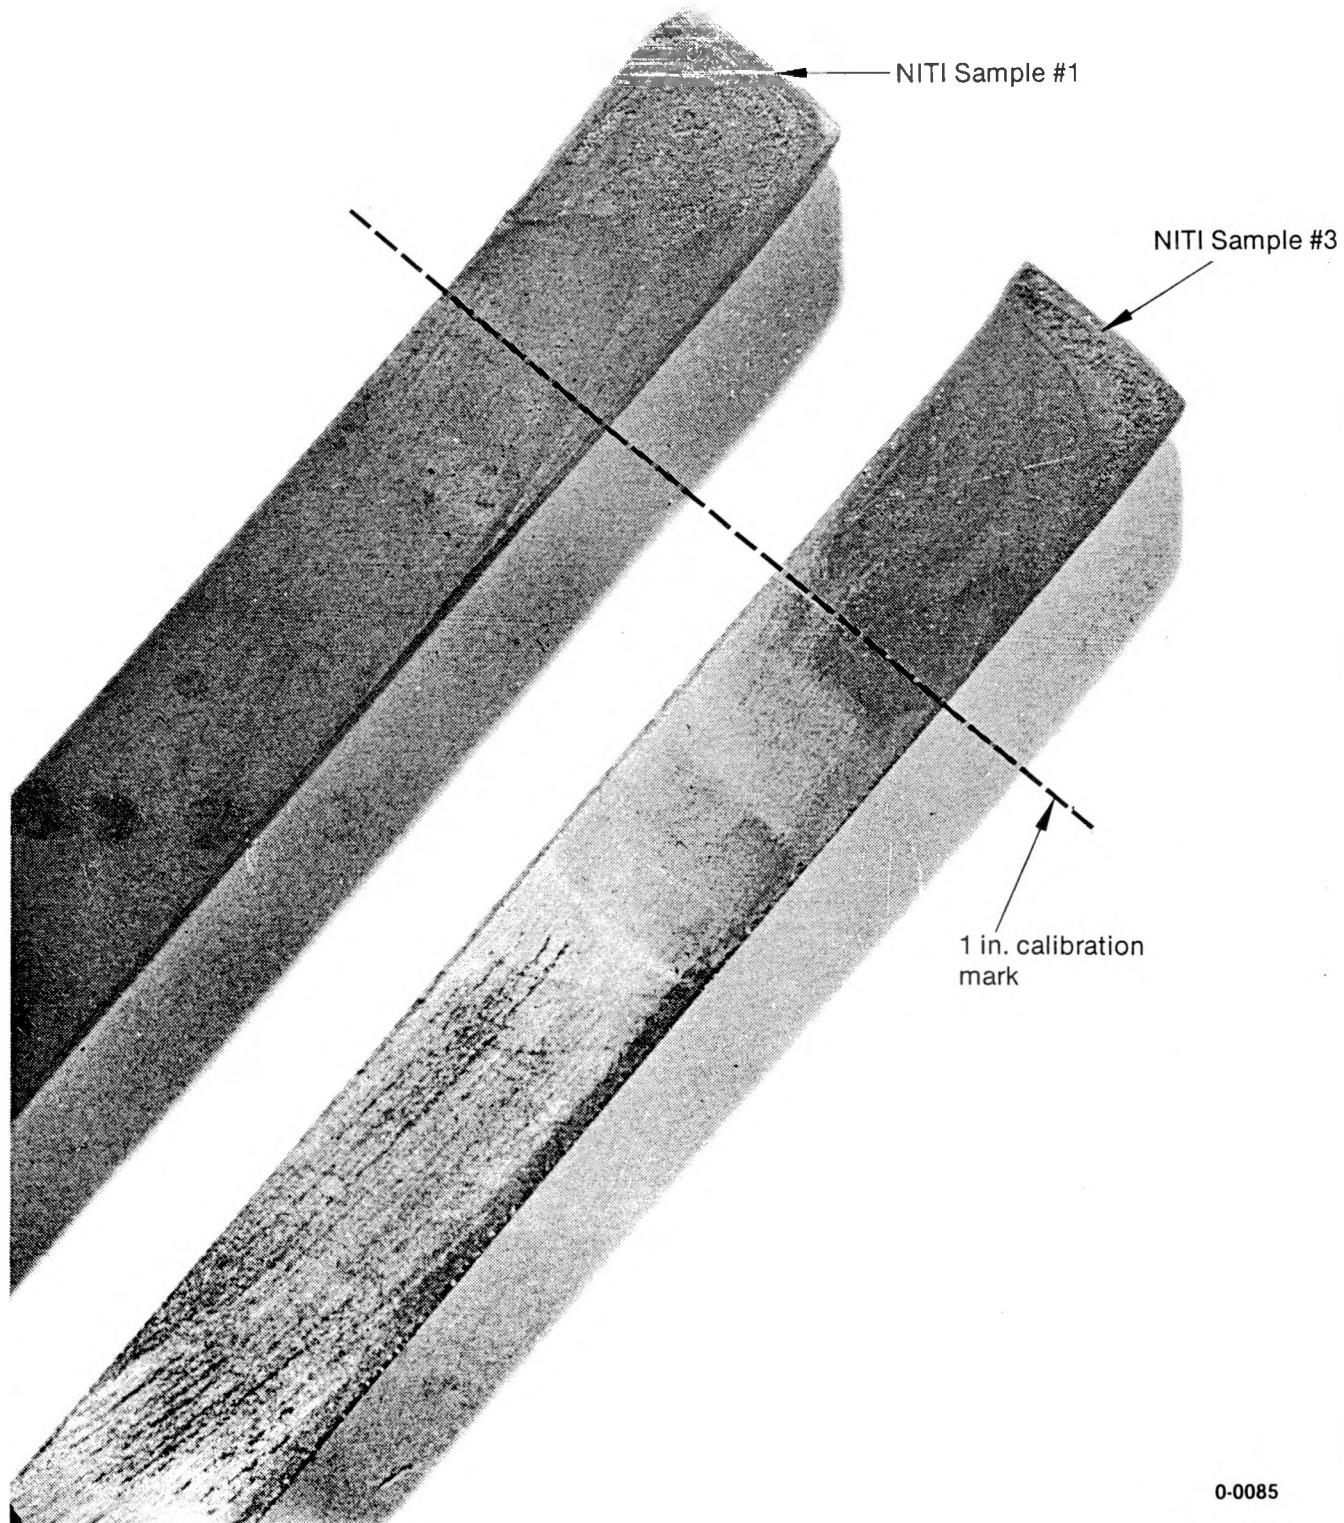
Figure C-2. This photograph is of two silica-filled BPA epoxy samples (National Industri Transformer, Inc.) that have been subjected to the burn tests. The flames caused a minimum amount of degradation of the material. In comparison to Figure C-1 the filled sample was less effected than the unfilled sample. This material also proved to be nonburning by the definition of the test procedure.

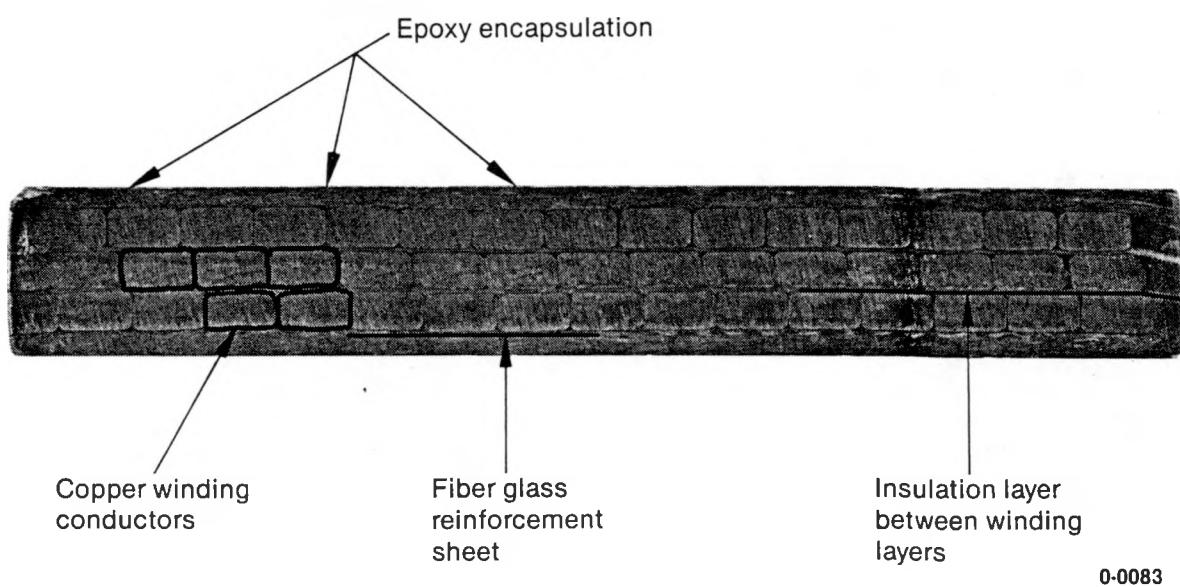
Figure C-3. This photograph shows a cross section of a cast coil taken from an Elma Engineering transformer. The section shows the coil conductors and the insulating sheets that separate the turns as well as the epoxy layer that is used to encapsulate the windings. This particular design also used a layer of fiber glass to provide reinforcement.

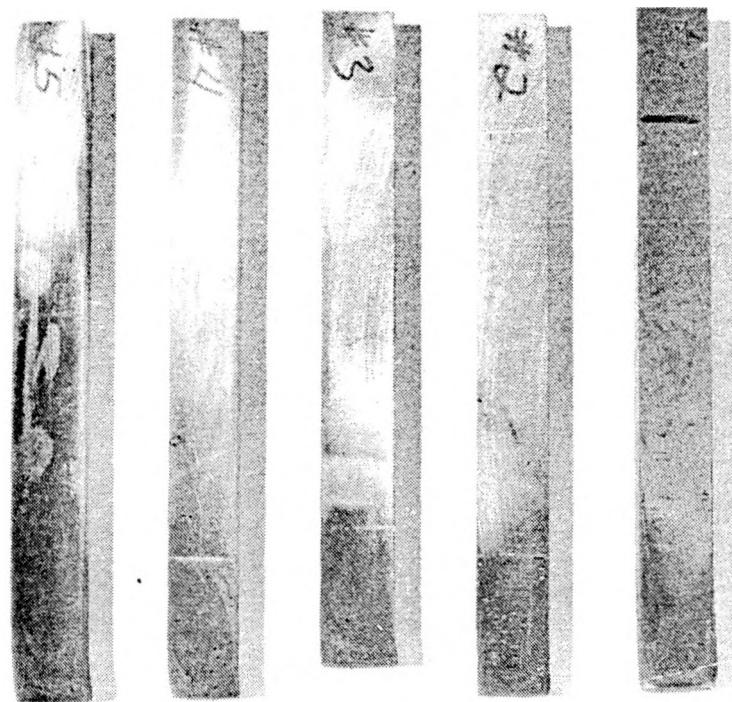
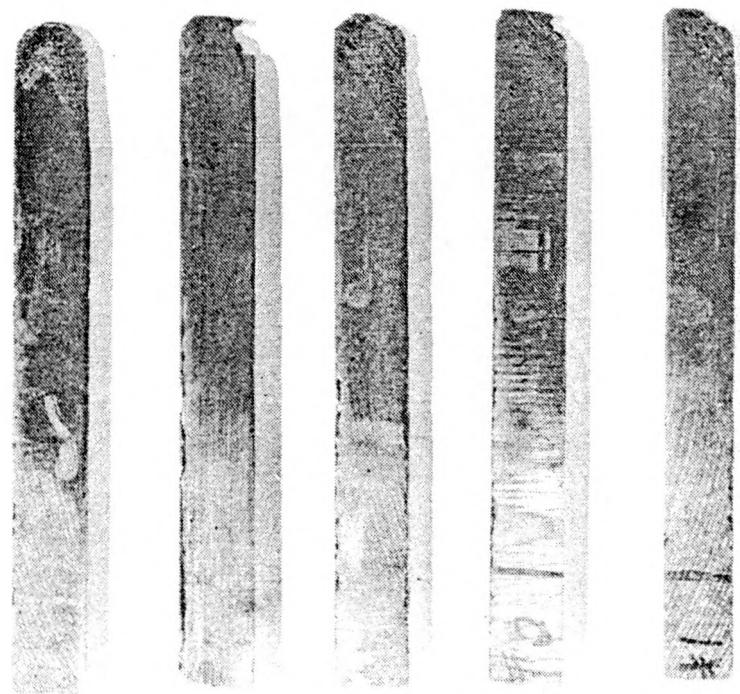
0.0082

Figure C-4. This photograph shows, starting on the top, samples 1 to 5 of the National Industri epoxy material and on the bottom, samples 1 to 5 of the Square-D epoxy.

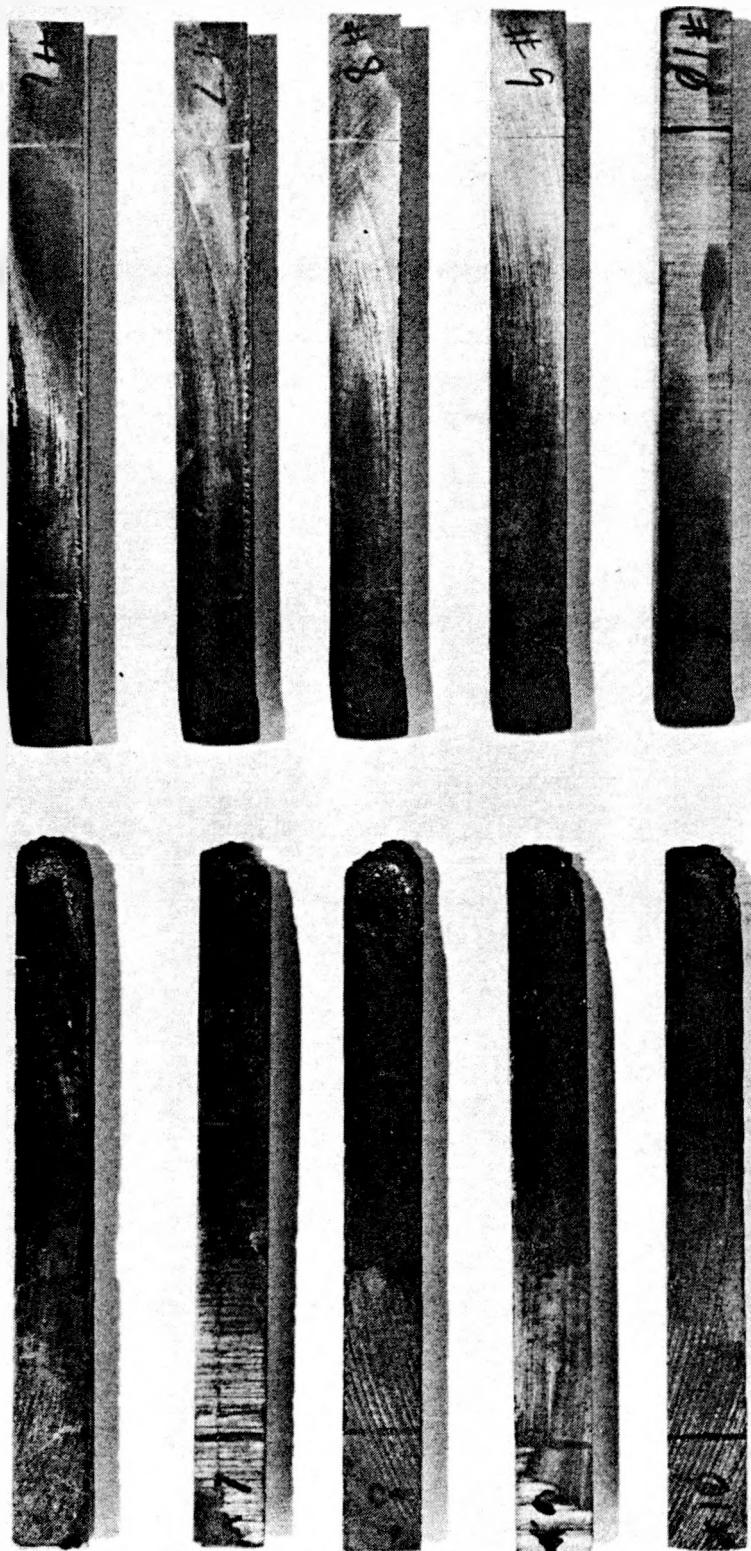
0-0081

Figure C-5. This photograph is very similar to Figure C-4 except that samples 6 to 10 are shown of each type of epoxy.

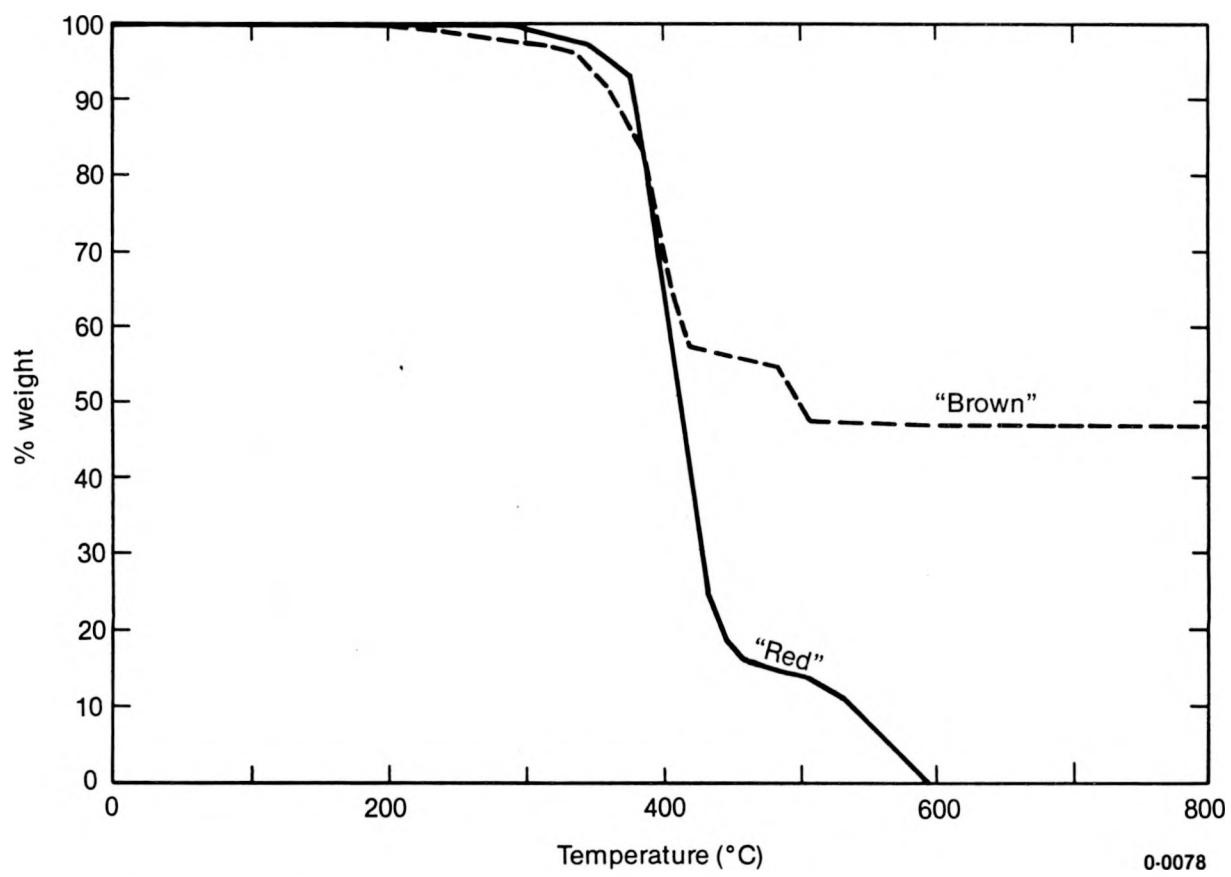
Figure C-6. Thermograms of both the brown and red polymers obtained under an air atmosphere.

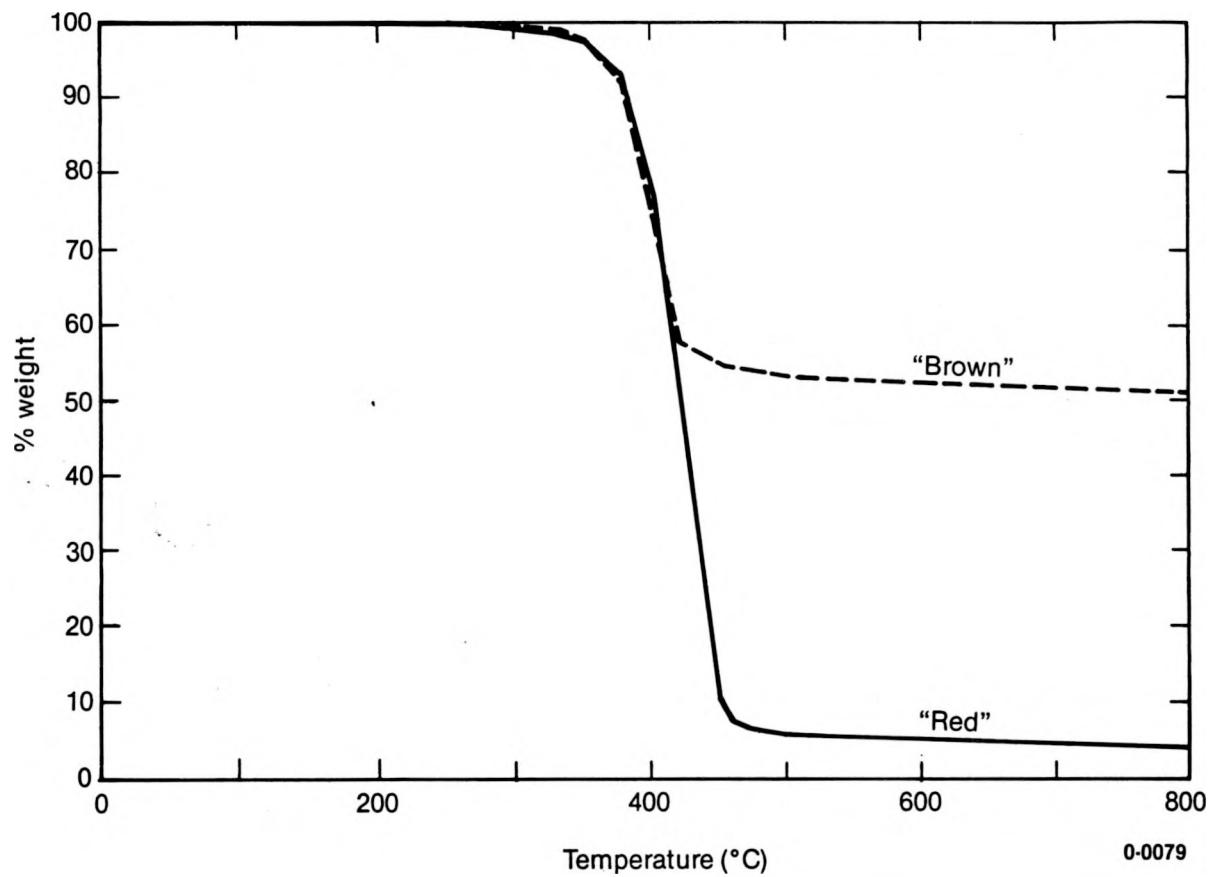
Figure C-7. Thermograms of both the brown and red polymers obtained under a N_2 atmosphere.

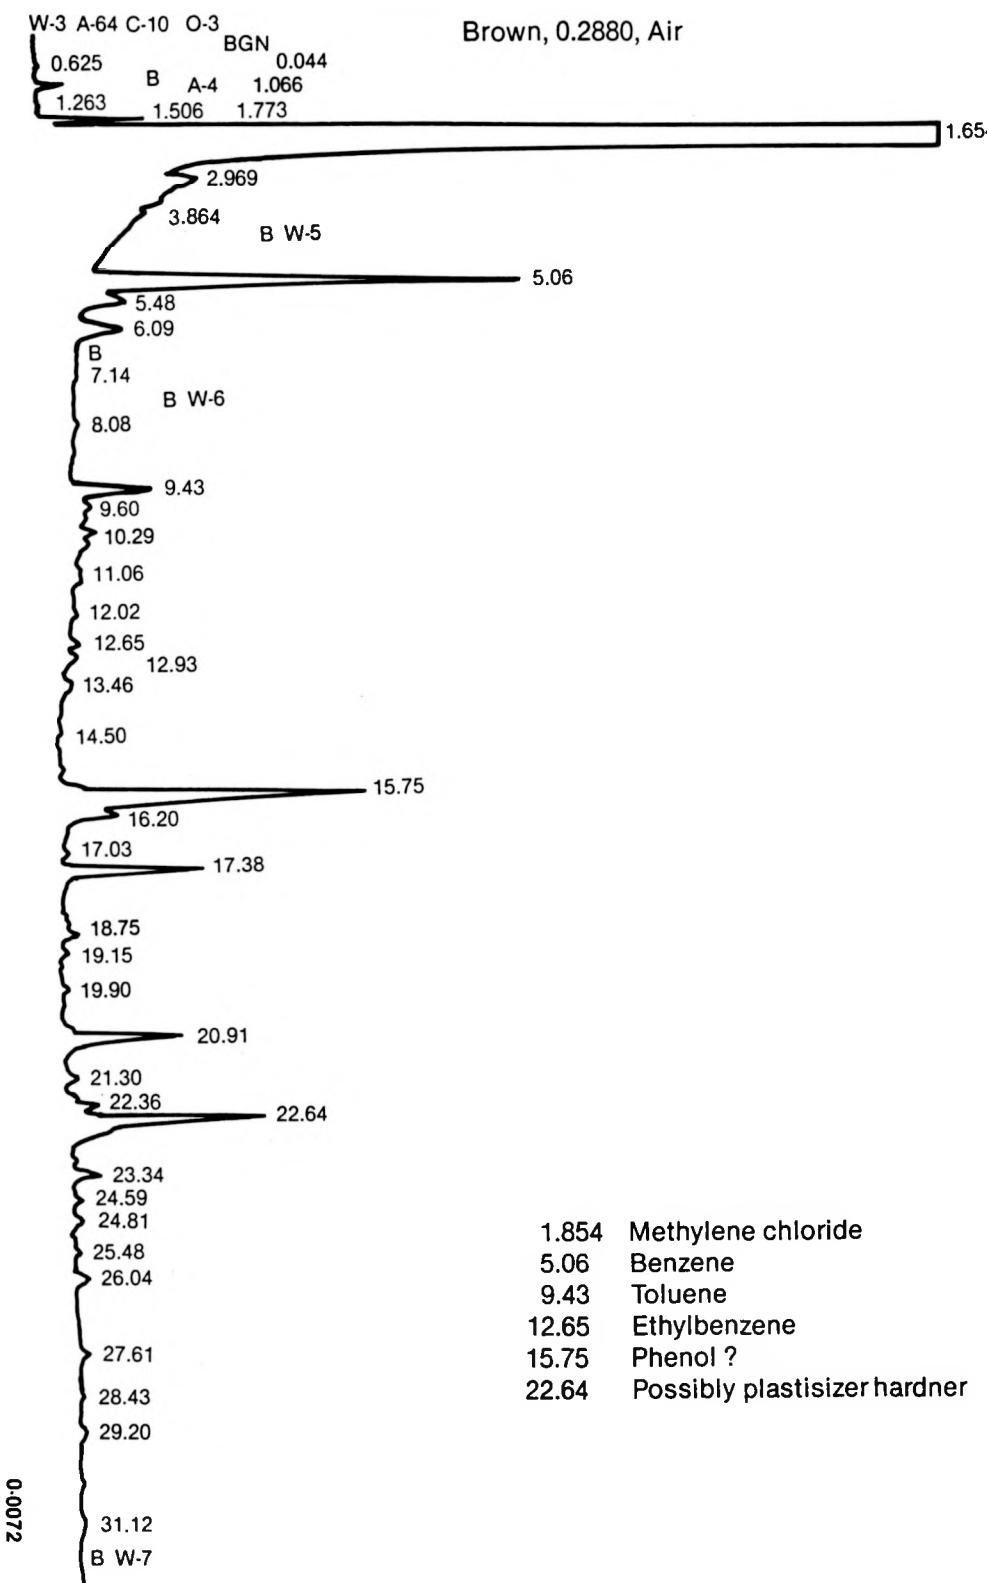
Figure C-8. Pyrolysis products of 0.2880 g of brown under an air atmosphere.

Phase (3). Typical gas chromatograms of the collected gaseous pyrolysis products are shown in Figures C-8 through C-13. The chromatograms of the gases collected in the impinger contained light weight, low boiling hydrocarbons that eluted before the methylene chloride as well as many heavier hydrocarbons. Benzene, toluene, ethylbenzene, and phenol were positively identified in the impinger solutions, and phenol was also identified in the rinsate. The four toxic compounds mentioned were previously identified and quantified from the pyrolysis of BPA. Table C-1 is a brief summary of the quantitative results that were obtained in this study. These results are much higher than those previously reported (Table C-2).

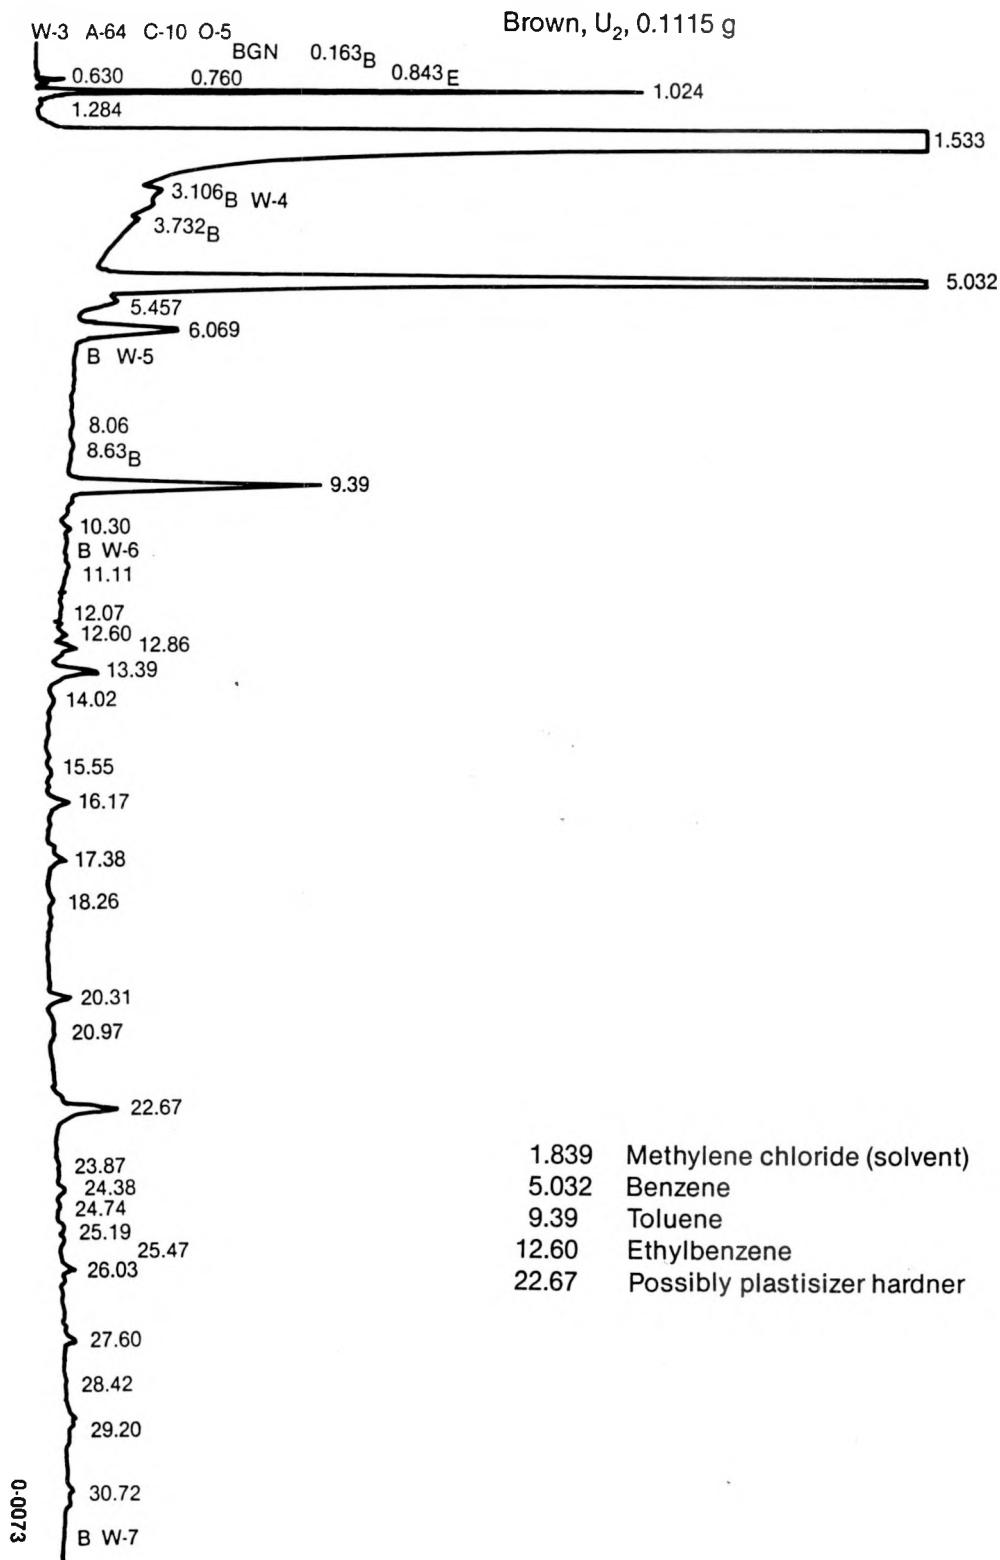
Figure C-9. Chromatogram of the pyrolysis products of 0.1331 g of brown under an N₂ atmosphere.

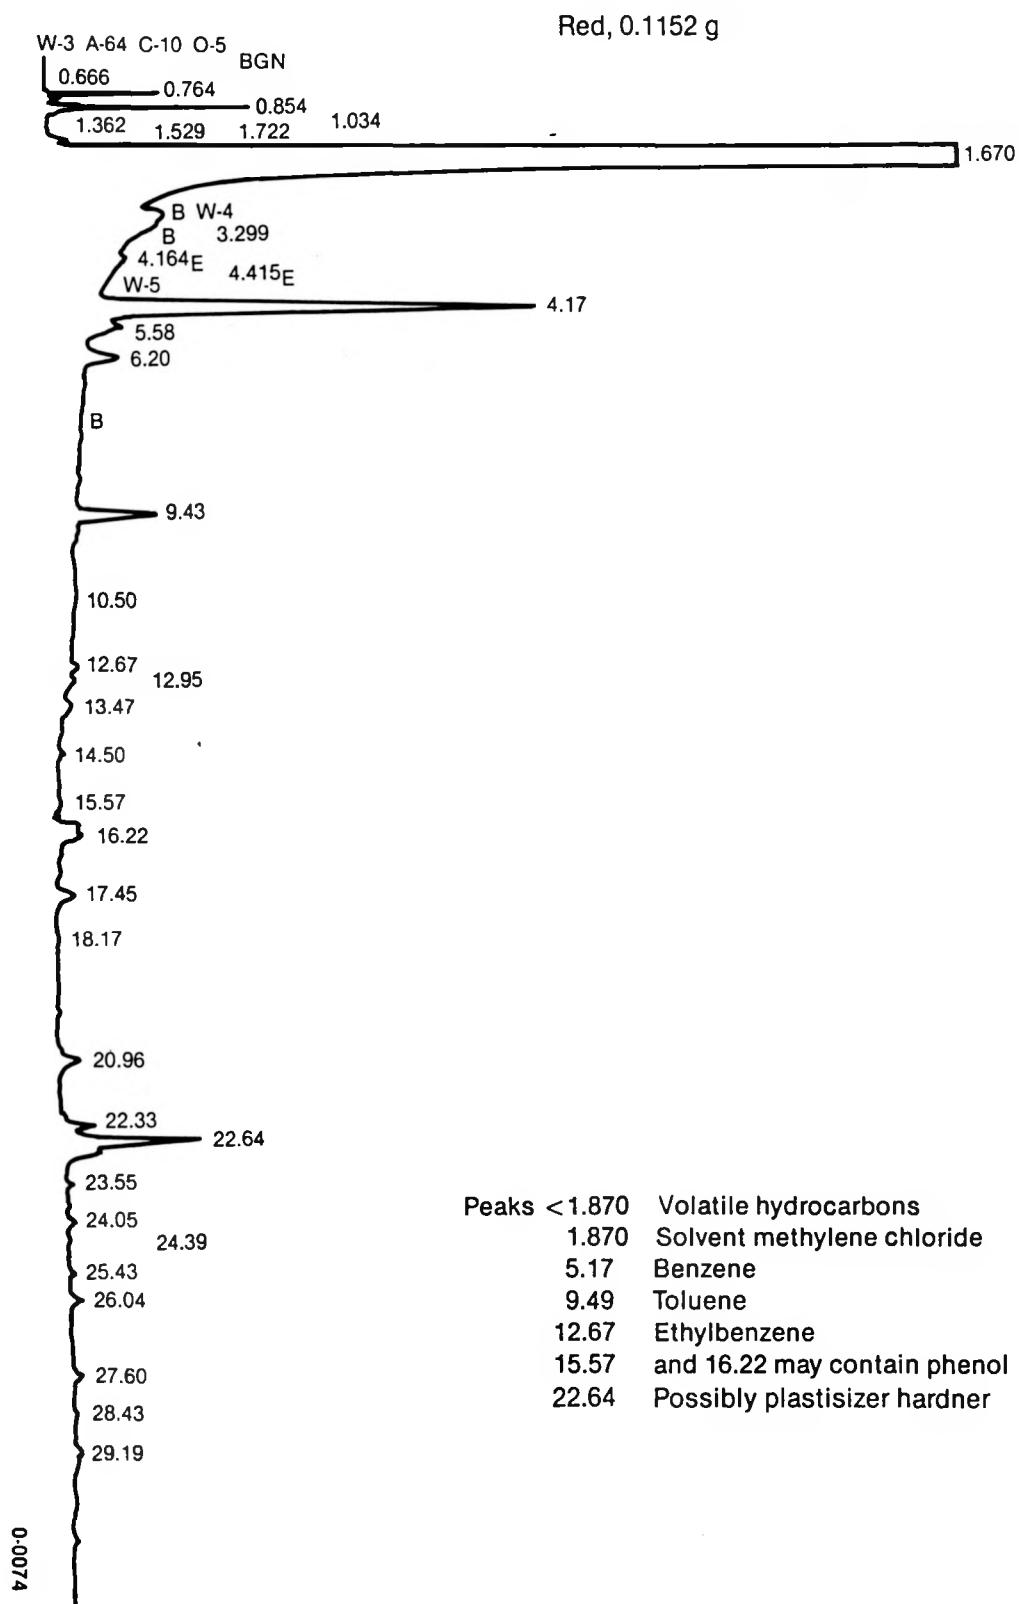
Figure C-10. Pyrolysis products of 0.1152 g of red under an air atmosphere.

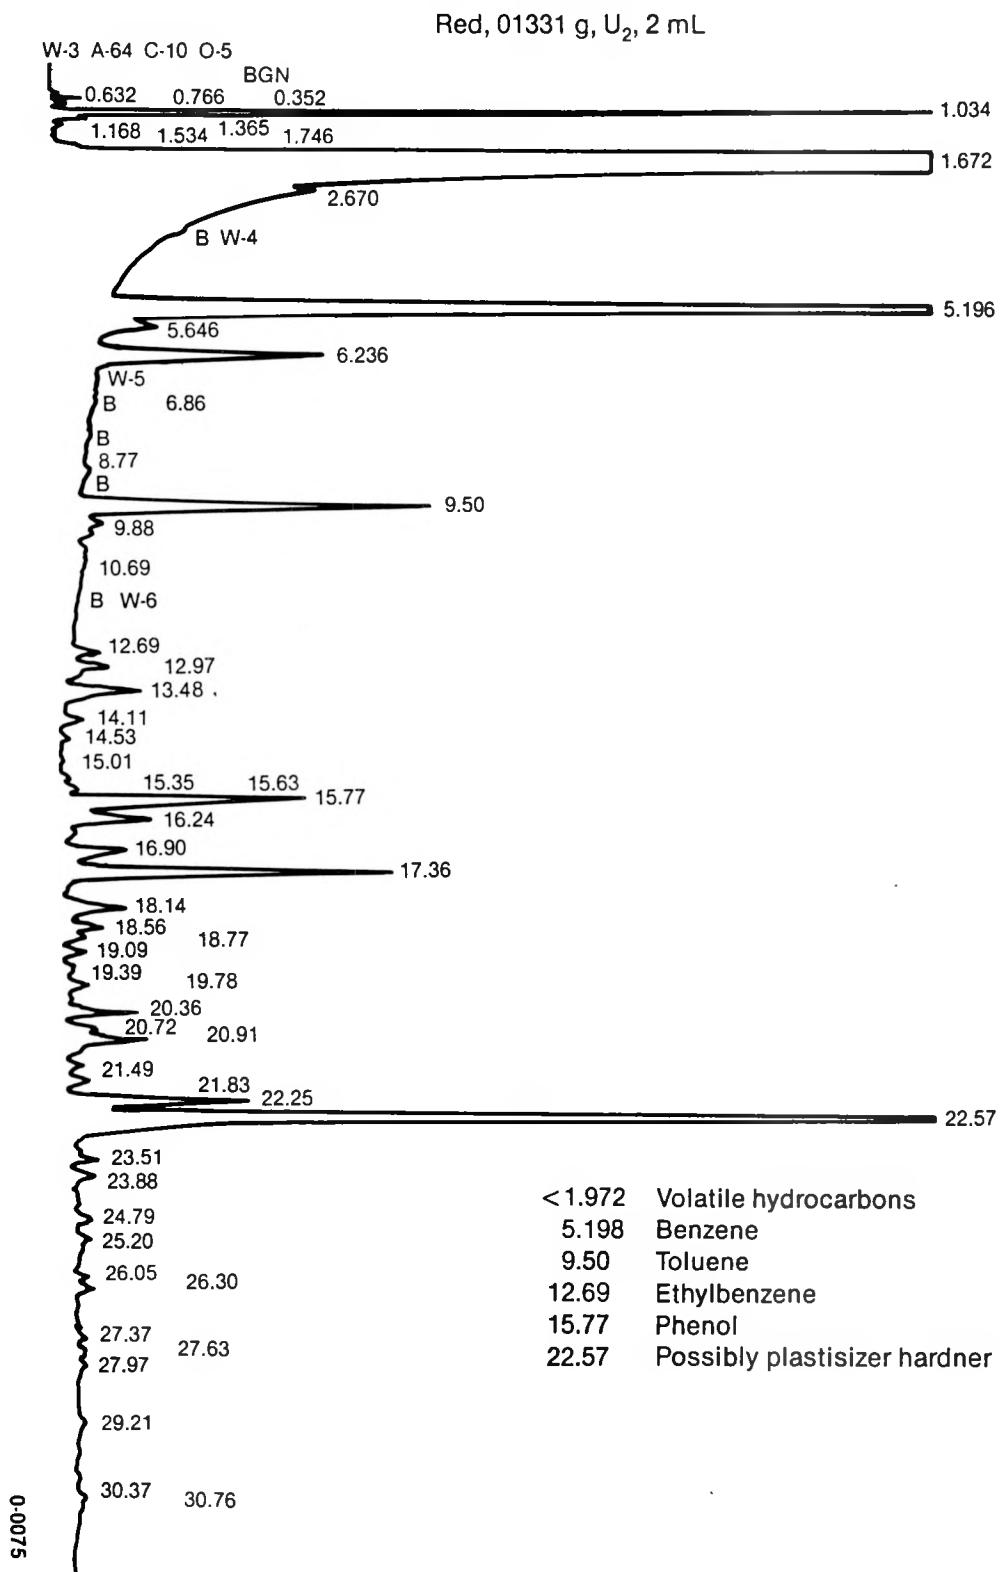
Figure C-11. Chromatogram of products rinsed from furnace tube with methylene chloride after pyrolysis of red under an air atmosphere.

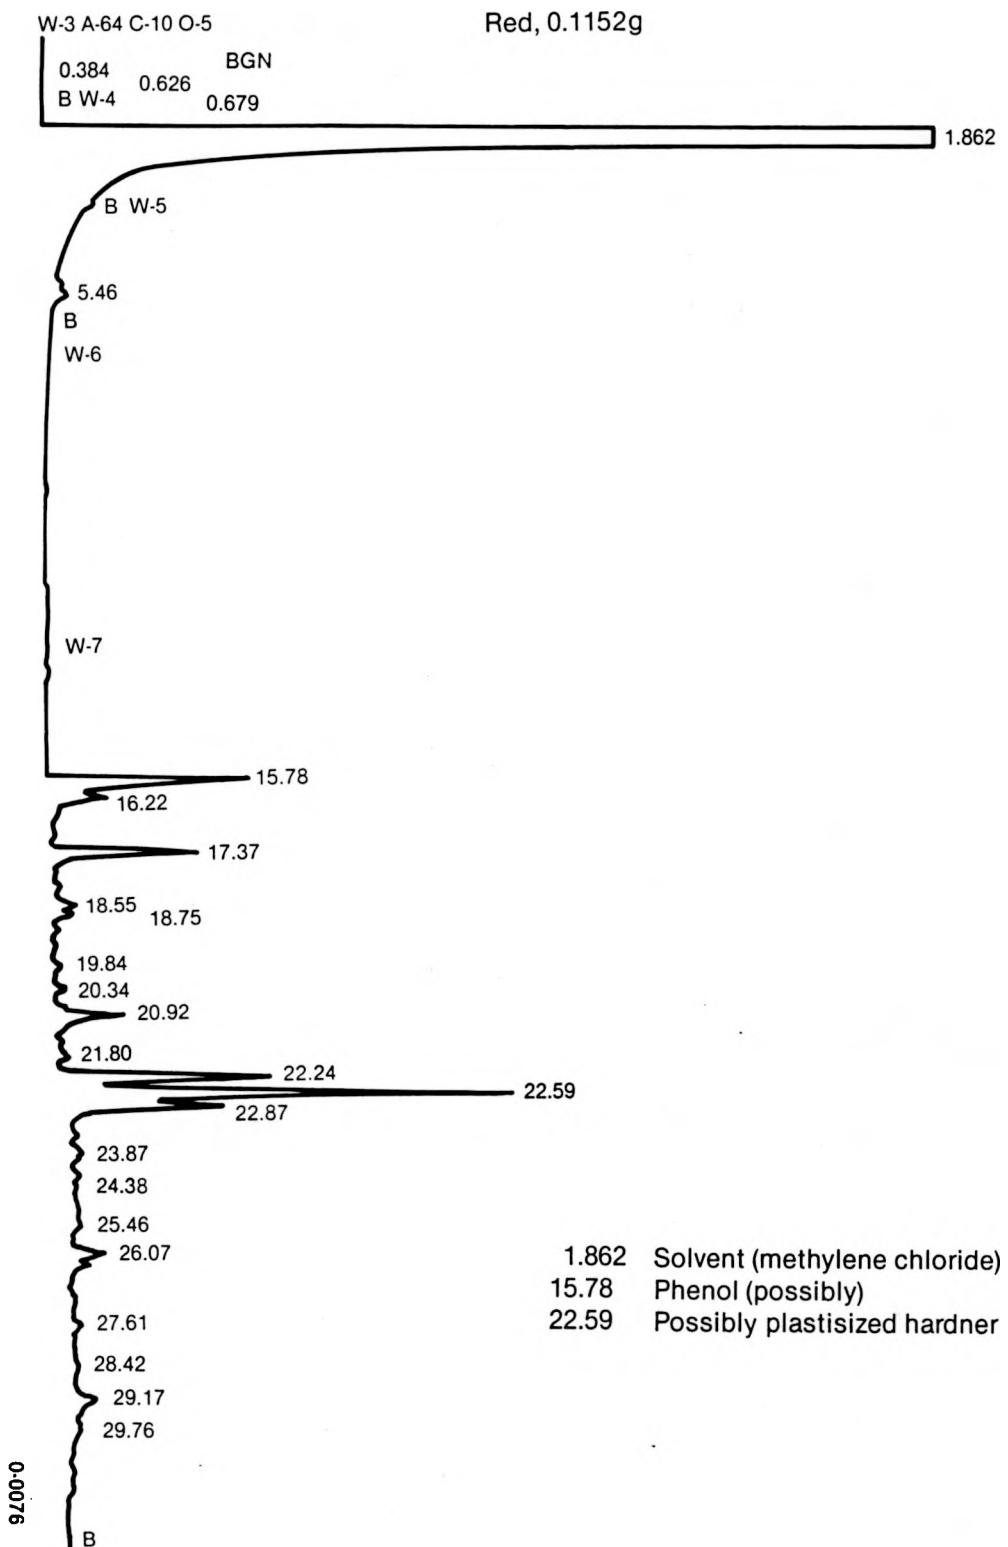
Figure C-12. Chromatogram of the pyrolysis products of 0.1331 g of red under an N₂ atmosphere.

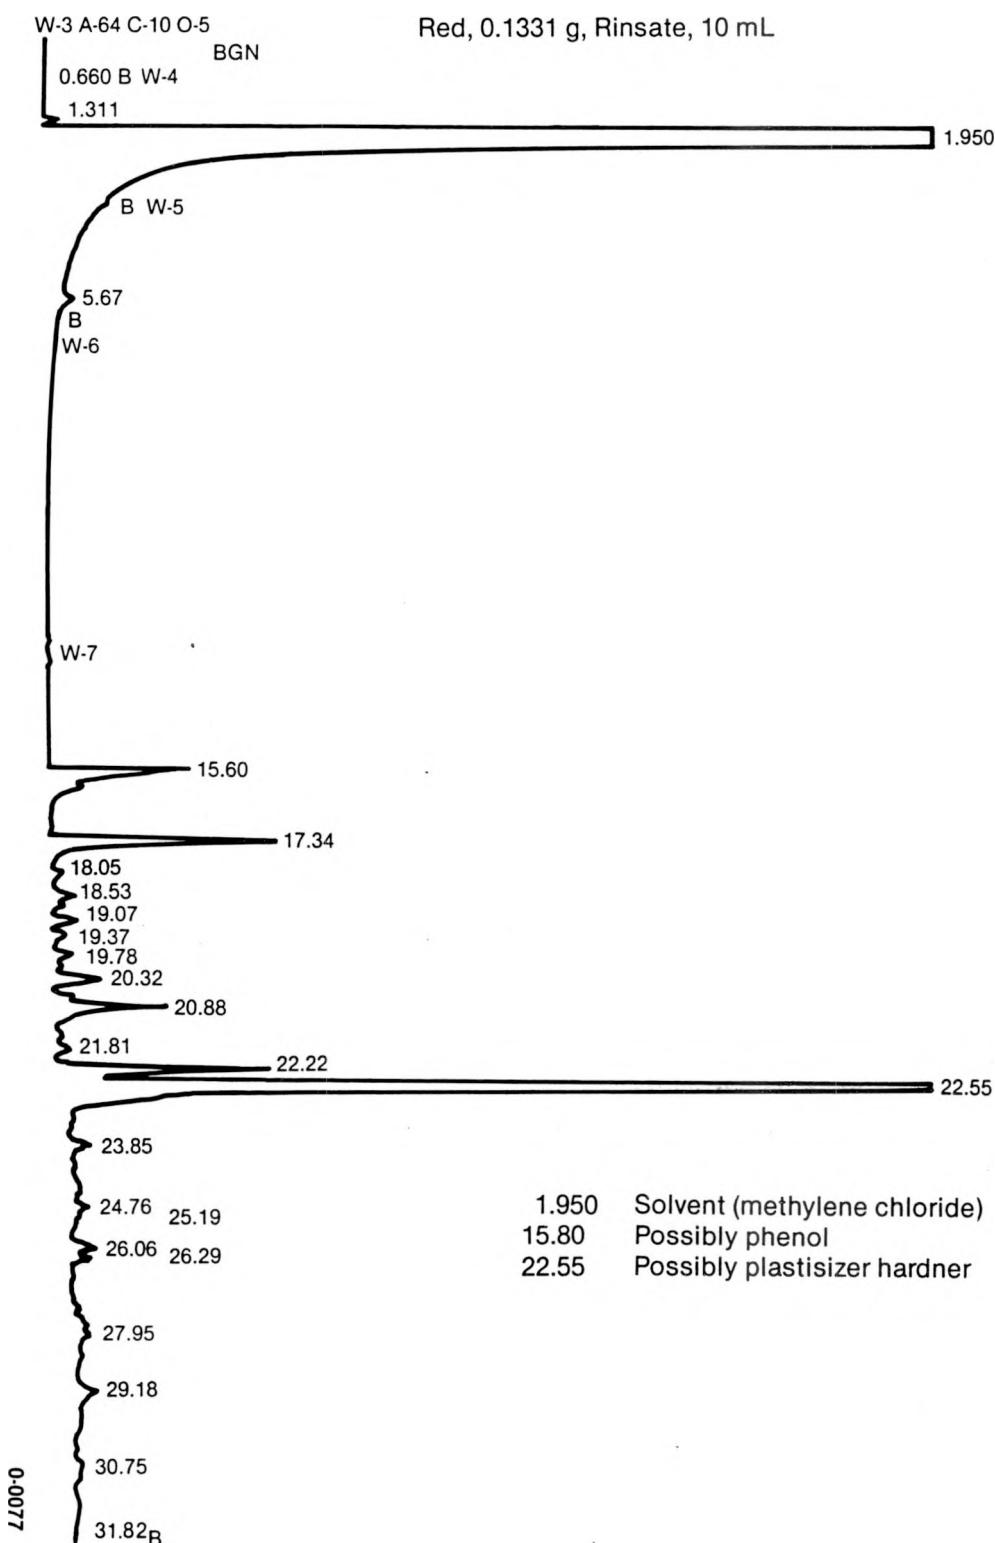
Figure C-13. Chromatogram of products rinsed from furnace tube after pyrolysis of the red under a nitrogen atmosphere.

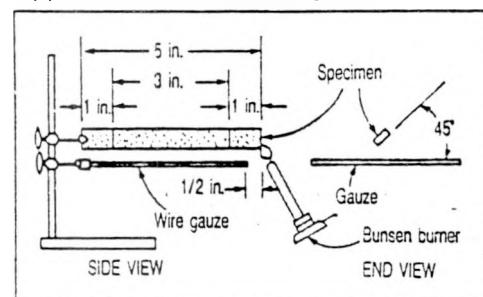
Apparatus for flammability test

It was considered necessary to run two series of tests. One investigated the flammability of the cast epoxy material, whether it would continue to burn, and the time required for the flame to extinguish when the source of ignition was removed. The other determined the types and quantities of products of combustion of the epoxy compound, and the toxicity of these products. While some testing had been done over the years, this was a comprehensive program to obtain complete information.
