Cast Coil Transformer Fire Susceptibility and Reliability Study

CAST COIL TRANSFORMER FIRE SUSCEPTIBILITY AND RELIABILITY STUDY

S. A. McBride

**EG&G Idaho, Inc.
Idaho Falls, Idaho 83415**

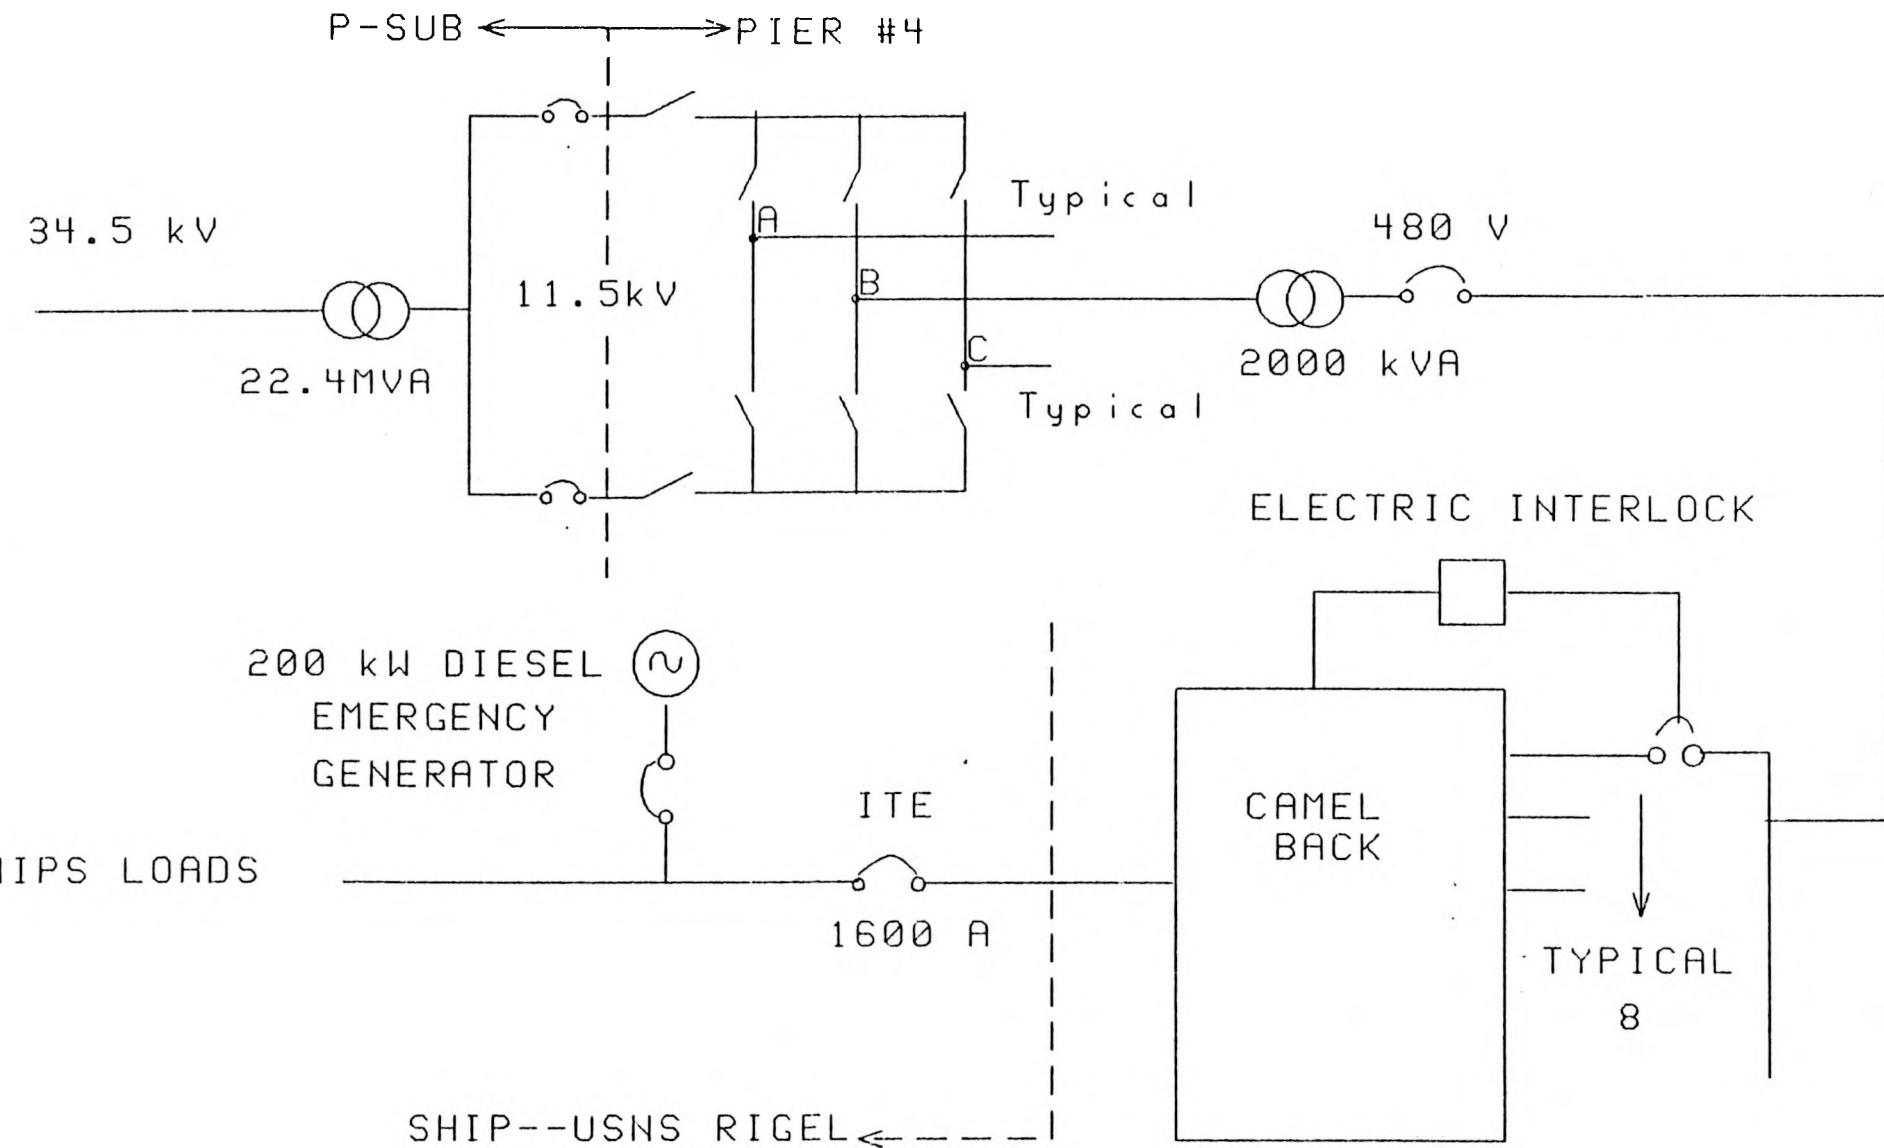
System One-Line Diagram.

After the primary protection cleared the fault, the ship's 200 kW emergency generator was brought on line. Refer to the one-line diagram on the following page. The operator experienced difficulty in getting the voltage to stabilize and eventually the generator's breaker tripped off line. The operator then began to shed unnecessary loads to reduce the load level on the generator. The problem still existed and at that point it was determined that the shore to ship power feed had not been disconnected as is required. It has been estimated that approximately 30 minutes passed before the shore power cables were disconnected from the USNS Rigel. Therefore, the USNS Rigel provided both heat and arcing directly to the fault and sustained the fire for an additional 30 minutes.
