ANL/OTEC-BCM-012

## A STUDY OF THE EFFECTS OF INTERLEAKAGE OF AMMONIA AND SEAWATER ON CORROSION AND SCALING OF CANDIDATE MATERIALS FOR OTEC HEAT EXCHANGERS

Final Report

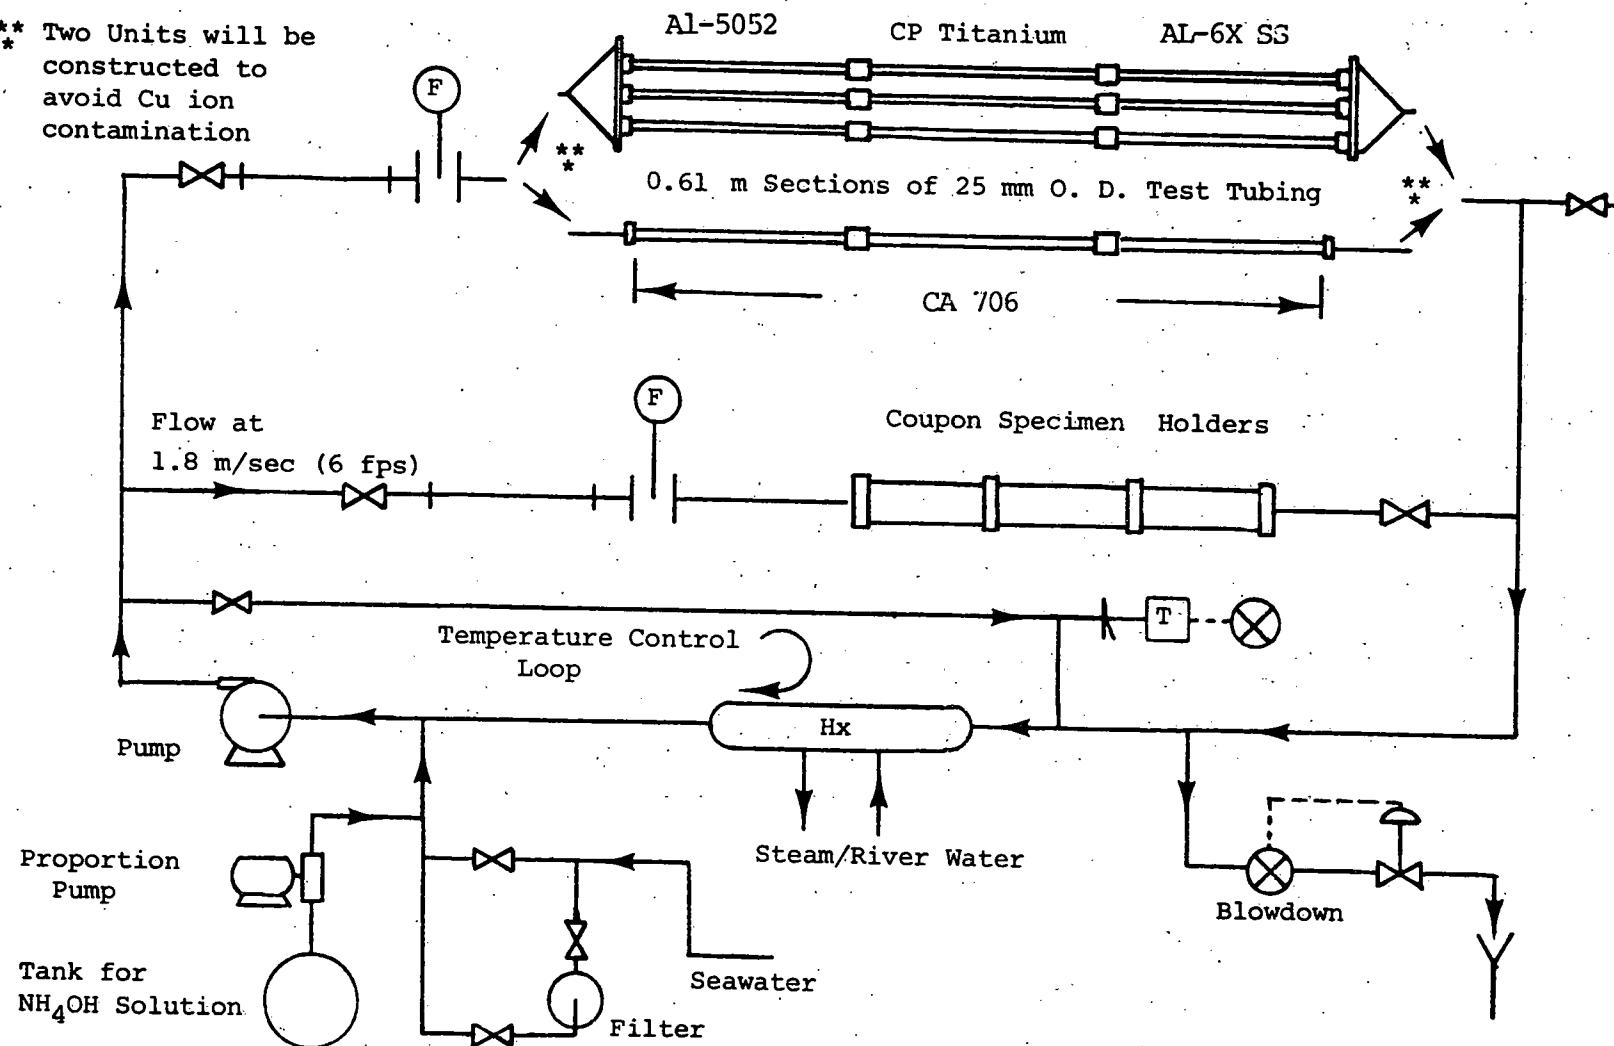
FIGURE III-4  
SIMPLIFIED SCHEMATIC FOR CORROSION TEST UNITS  
TO DETERMINE THE EFFECTS OF SEAWATER PLUS  
LOW CONCENTRATIONS OF AMMONIA

\*\* Two Units will be  
constructed to  
avoid Cu ion  
contamination

Two units were built for exposure of candidate alloys in seawater plus uniform concentrations of ammonia. A schematic of the test unit is presented in Figure III-4, and as photographs in Appendix B, as Figures VIII-3 and VIII-4. Exposure was to 5, 10, and 20 ppm ammonia in 1.8 m/sec (6 fps), 30°C (86°F) seawater. Specimens consisted of 0.61 m (2 ft) long, 25.4 mm (1 in) outside diameter tubes and 150 x 19 x 1.5 mm (6 x 0.75 x 0.06 in) flat coupons. One loop was used specifically for copper alloys. The other loop for all other alloys. Both units contained the instrumentation necessary for automatic control and failsafe shutdown to prevent specimens from experiencing excessive ammonia concentrations.

Aqueous ammonia was injected into the refreshment seawater downstream of the recirculating pump to assure adequate mixing of the test solutions. Concentrations of ammonia in seawater were routinely monitored by analysis of the system blowdown. Solution renewal was provided for by the use of a continuous system blowdown of 15 liter/min (4 gpm), for a total seawater replacement interval of 1.5 minutes for the 22 liter (6 gal) system.

Construction materials consisted of plastic-lined steel (polypropylene, Saran, Teflon, and Kynar®) and Alloy 20 stainless steel. Temperature control was maintained by recirculating seawater through an Alloy 20 heat exchanger coupled to steam and river water inlets. Specimens were mounted using galvanically insulating nylon Swagelok fittings and Teflon plastic coupon holders. Seawater entering the units was filtered of all particles larger than 25  $\mu\text{m}$  (0.001 in). Aqueous ammonia injected into the seawater was technical grade (29%  $\text{NH}_3$ ) ammonia hydroxide.

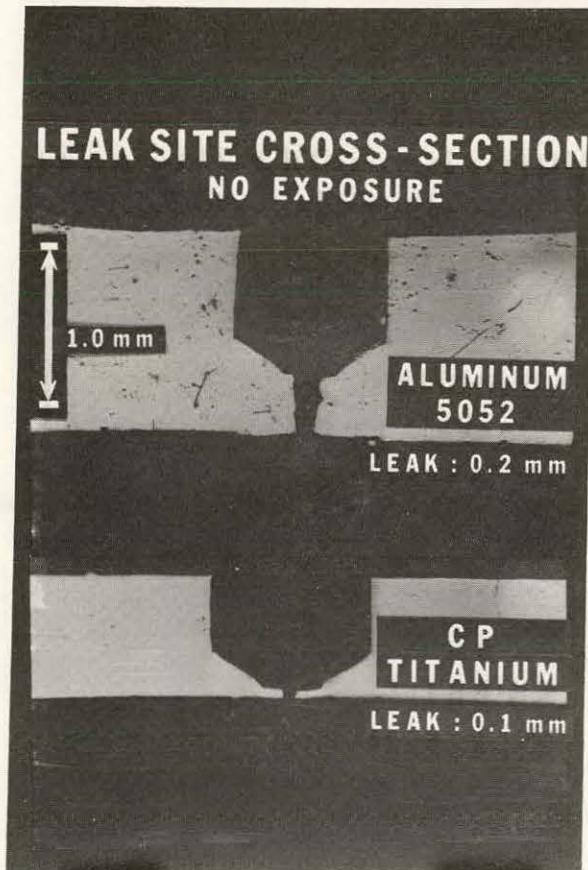
FIGURE III-8

Cross-Section of Artificial Leak Sites  
Before Exposure

Tubes placed on test were first cut to length using a wheel-type pipe cutter. Tubes for test were then prepared by drilling 0.1 mm (0.004 in) and 0.2 mm (0.008 in) "leak" sites in the wall 1.5 m (5 ft) from a tube end. Drilling of the artificial leaks required that a larger drill be used, first because of the short length available with the small sized drills. Examples of the leak site cross-section are presented in Figure III-8. Tubes were then degreased using Chlorothene®NU solvent prior to exposure. The shorter 0.61 m specimens exposed to renewed recirculating seawater plus small concentrations of ammonia were identified on the exterior center using an electric scribe. Longer tube specimens were marked with permanent black ink.

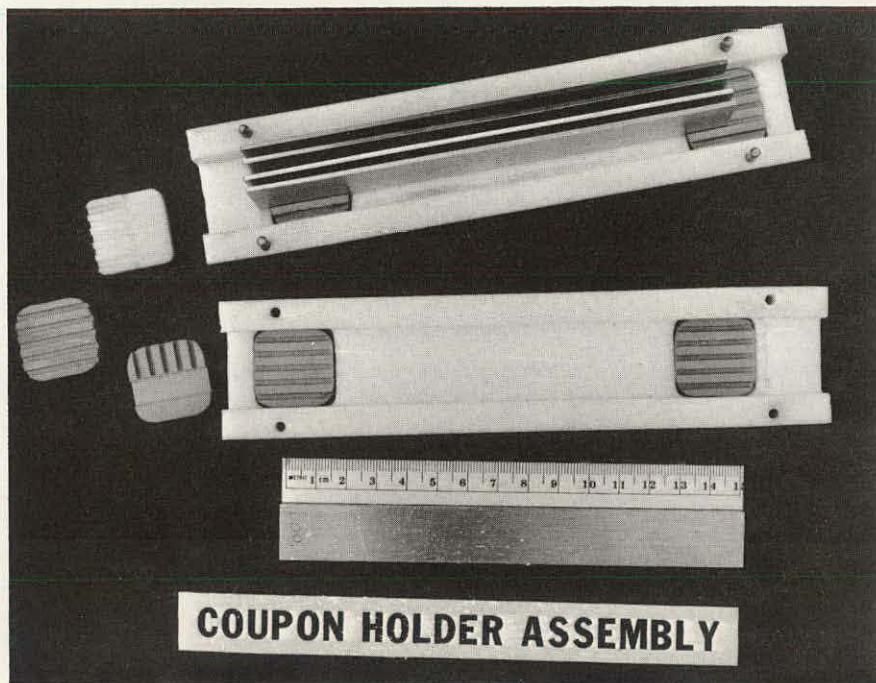
**FIGURE III-9**  
**Teflon Coupon Specimen Holder**  
**(Scale in cm)**

Coupons were also employed in the test program in order to get a second estimate on general corrosion rates in the test environment. The coupons, as prepared by Corrosion Test Supplies Company, all had a buffed surface finish with all edges rounded and free of burrs. For identification, a two-digit number was stamped into one side of the center face of each coupon. All coupons were degreased using Chlorothene NU solvent, dryed, weighed and stored in a desiccator until used. A photograph of the holder used to expose flat metal specimens is shown in Figure III-9.

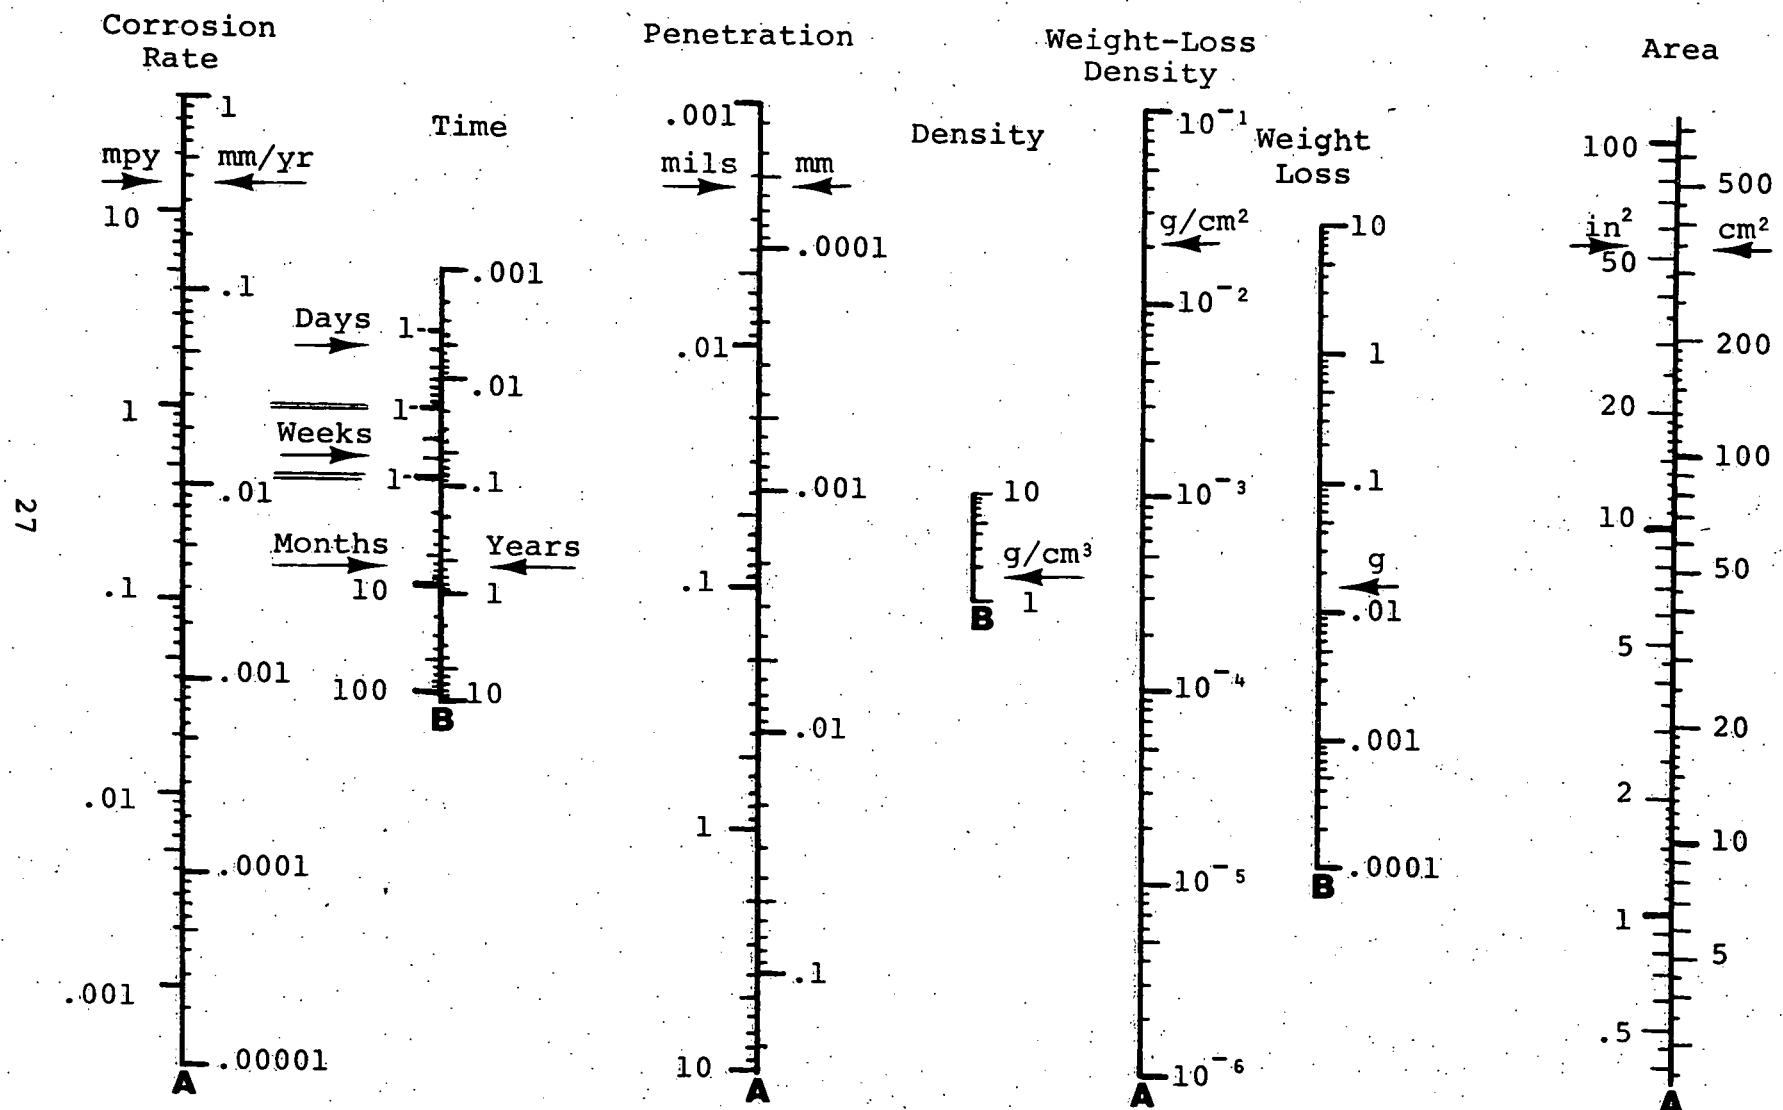
FIGURE III-10  
METRIC/ENGLISH CORROSION NOMOGRAPH

Perform calculations by drawing a straight line through values on adjacent lines A-B-A

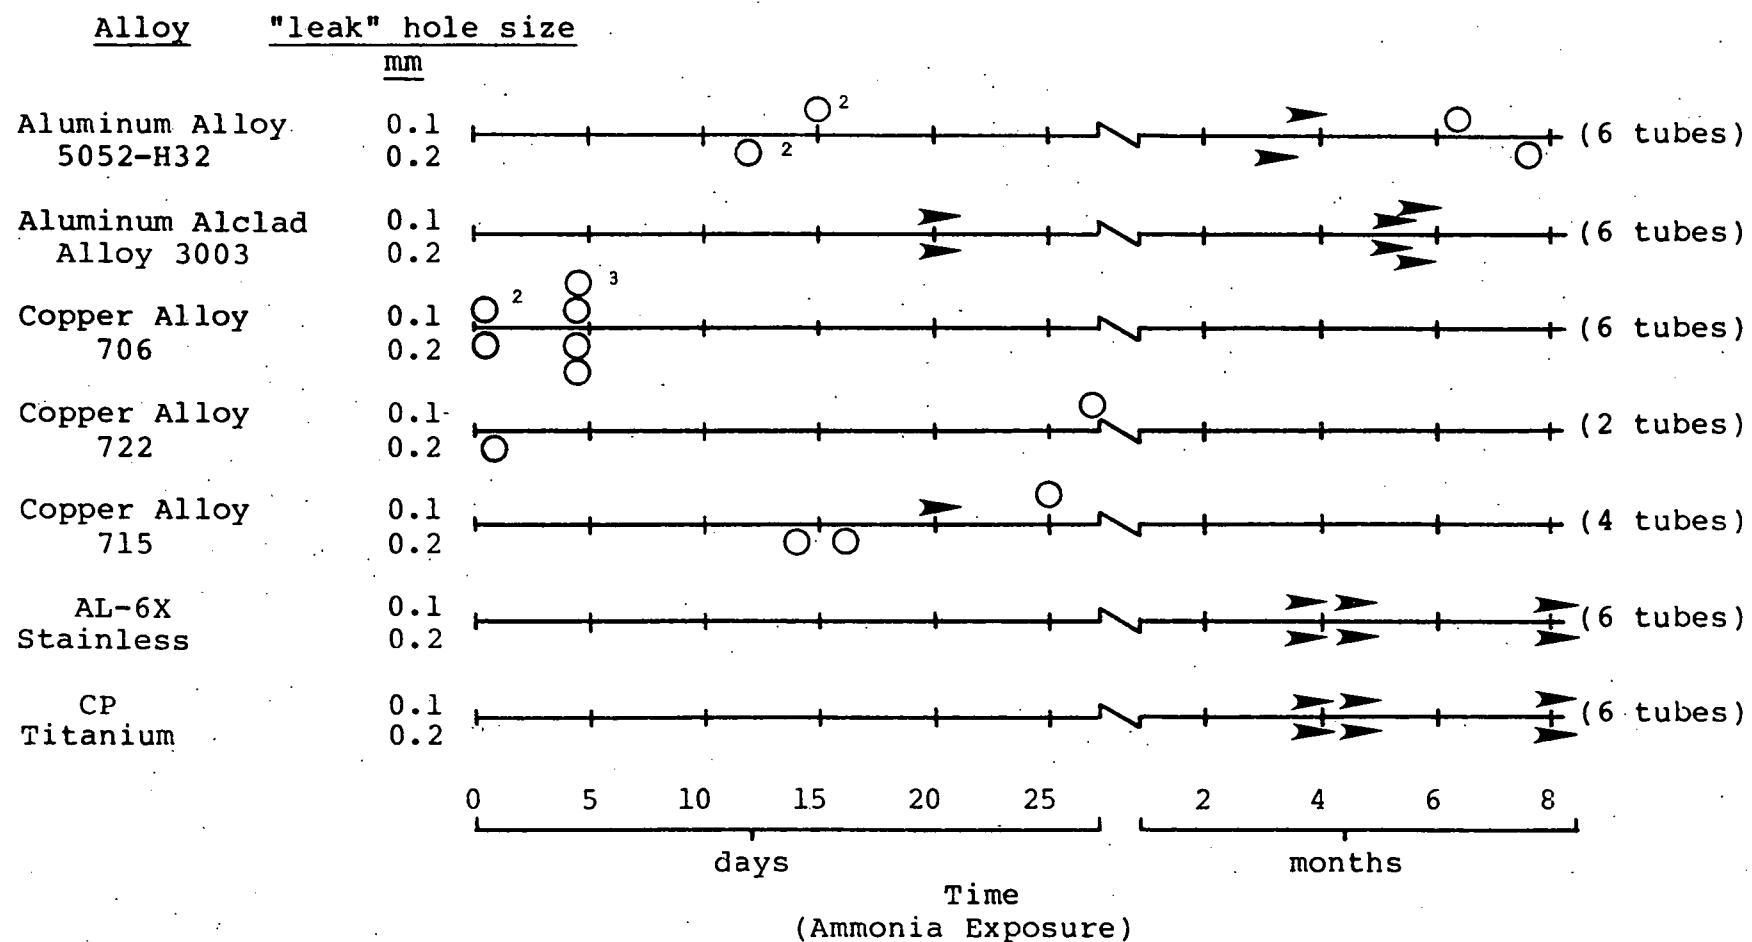
FIGURE IV-1  
TUBE TEST UNIT: TUBE PERFORMANCE<sup>1</sup>

<sup>1</sup> Ammonia pressure was 9.3 kg/cm<sup>2</sup>.  
Average seawater pressure was  
9.1 kg/cm<sup>2</sup> unless otherwise  
stated.

<sup>2</sup> Seawater pressure was 8.4 kg/cm<sup>2</sup>.  
<sup>3</sup> Seawater pressure was 9.5 kg/cm<sup>2</sup>.

→: No failure. Scheduled  
tube removal.

The initial four candidate alloy tubes were exposed to 30°C (86°F) seawater at 1.8 m/sec (6 fps) and a positive nitrogen pressure to permit tube surfaces to receive a seawater contact history. After over three weeks exposure, severe leaks were detected in CA 706 tubes in which the 0.1 and 0.2 mm (0.004 and 0.008 in) diameter holes had enlarged to as much as 3.0 mm (0.12 in) in diameter. These enlarged holes in CA 706 were sealed, and new leak sites were drilled prior to ammonia exposure.

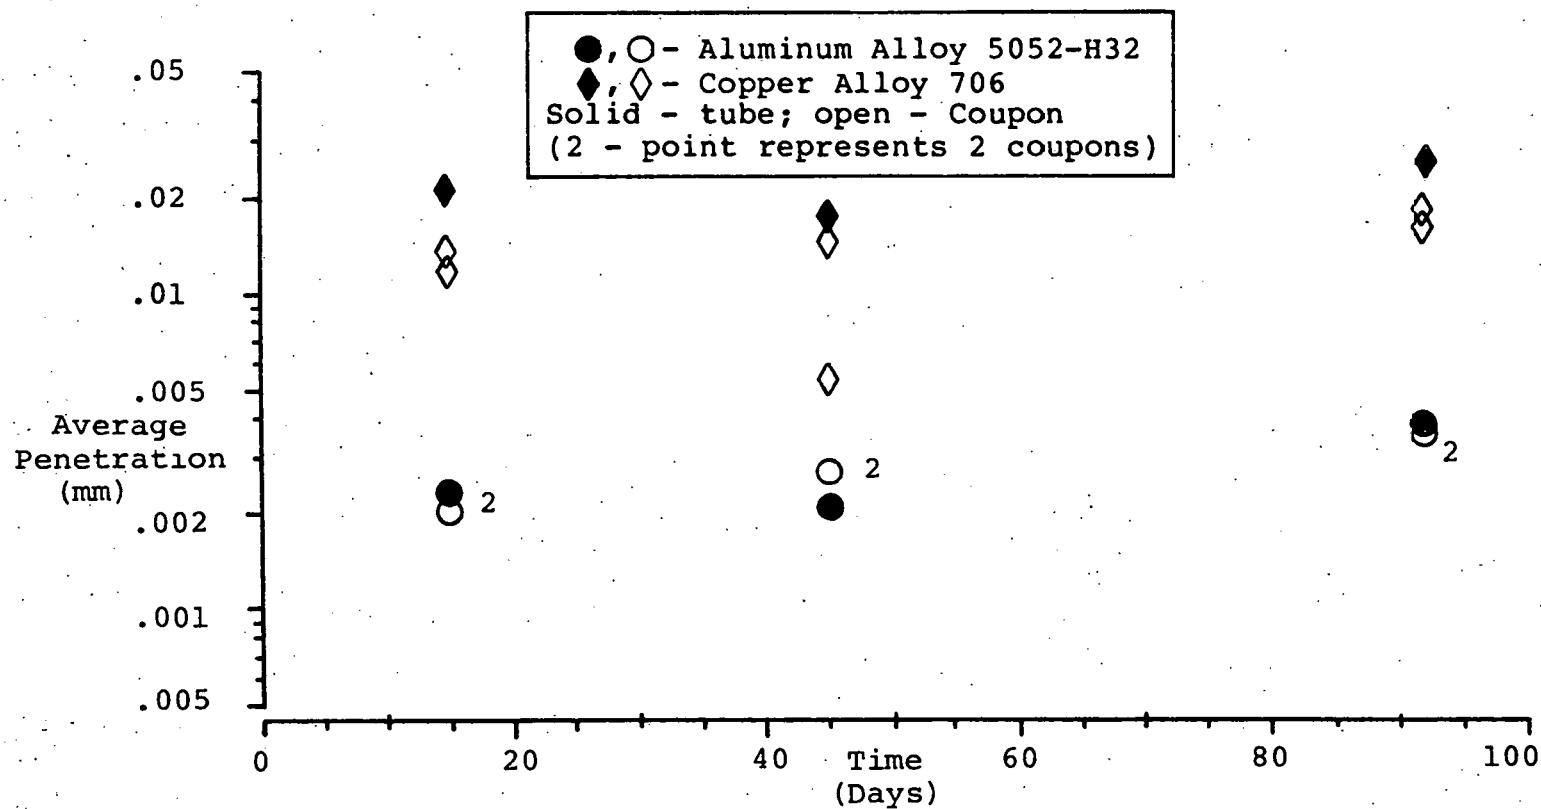
FIGURE IV-2

CORROSION PERFORMANCE OF OTEC CANDIDATE MATERIALS  
EXPOSED TO RECIRCULATING SEAWATER PLUS NOMINAL 5 PPM AMMONIA\*

\* Corrosion penetration for AL-6X stainless steel and CP titanium was less than 0.0005 mm.

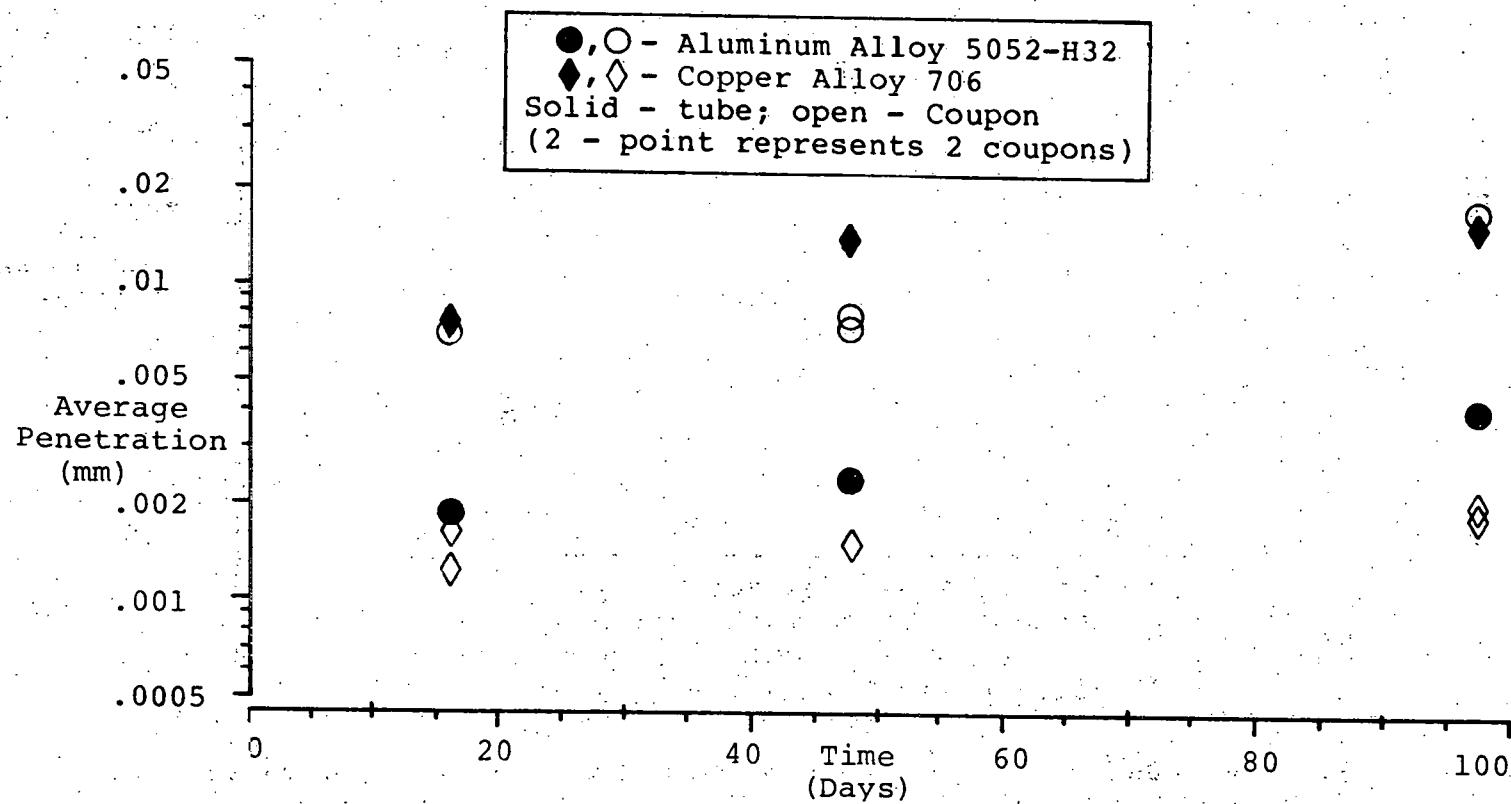
FIGURE IV-3

CORROSION PERFORMANCE OF OTEC CANDIDATE MATERIALS  
EXPOSED TO RECIRCULATING SEAWATER PLUS NOMINAL 10 PPM AMMONIA\*

\* Corrosion penetration for AL-6X stainless steel and CP titanium was less than 0.0005 mm.

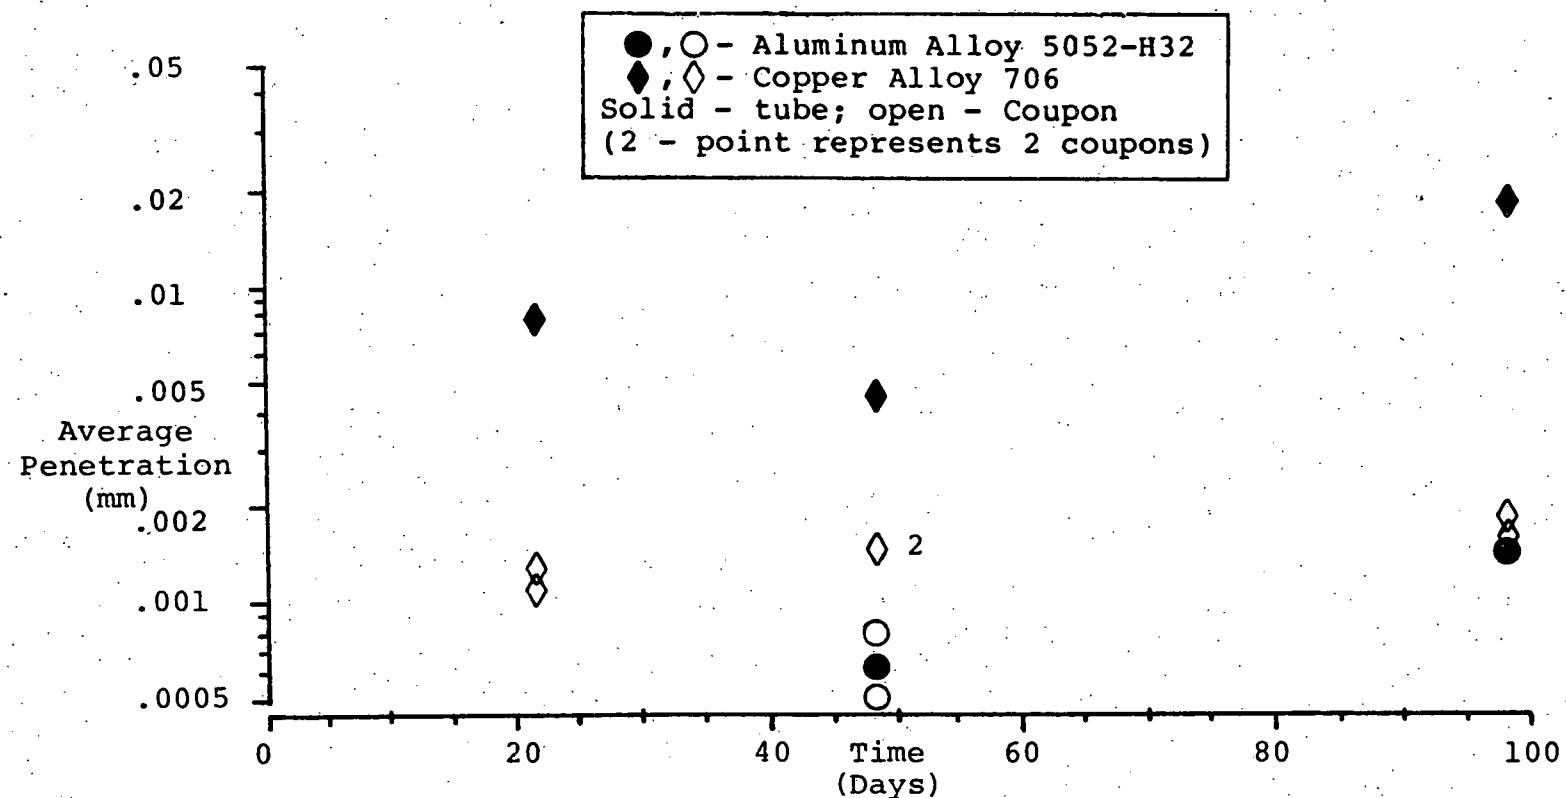
FIGURE IV-4  
CORROSION PERFORMANCE OF OTEC CANDIDATE MATERIALS  
EXPOSED TO RECIRCULATING SEAWATER PLUS NOMINAL 20 PPM AMMONIA\*

\* Corrosion penetration for AL-6X stainless steel and CP titanium was consistently less than 0.0005 mm. Corrosion penetration of Al-5052 was below 0.0005 mm intermittently.

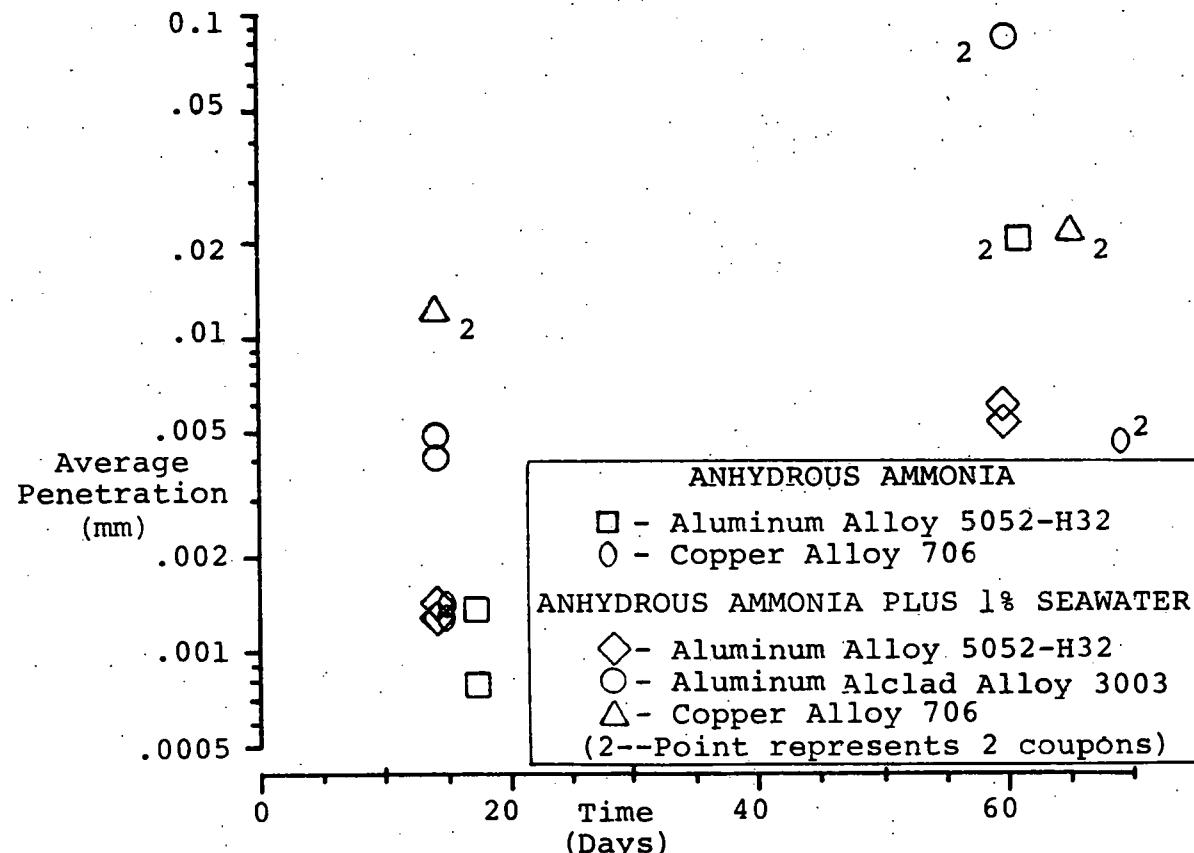
FIGURE IV-5

CORROSION PERFORMANCE OF OTEC CANDIDATE MATERIALS  
EXPOSED TO ANHYDROUS AMMONIA AND ANHYDROUS AMMONIA PLUS 1% SEAWATER\*

\* Corrosion penetration for AL-6X stainless steel and CP titanium was less than 0.0005 mm.

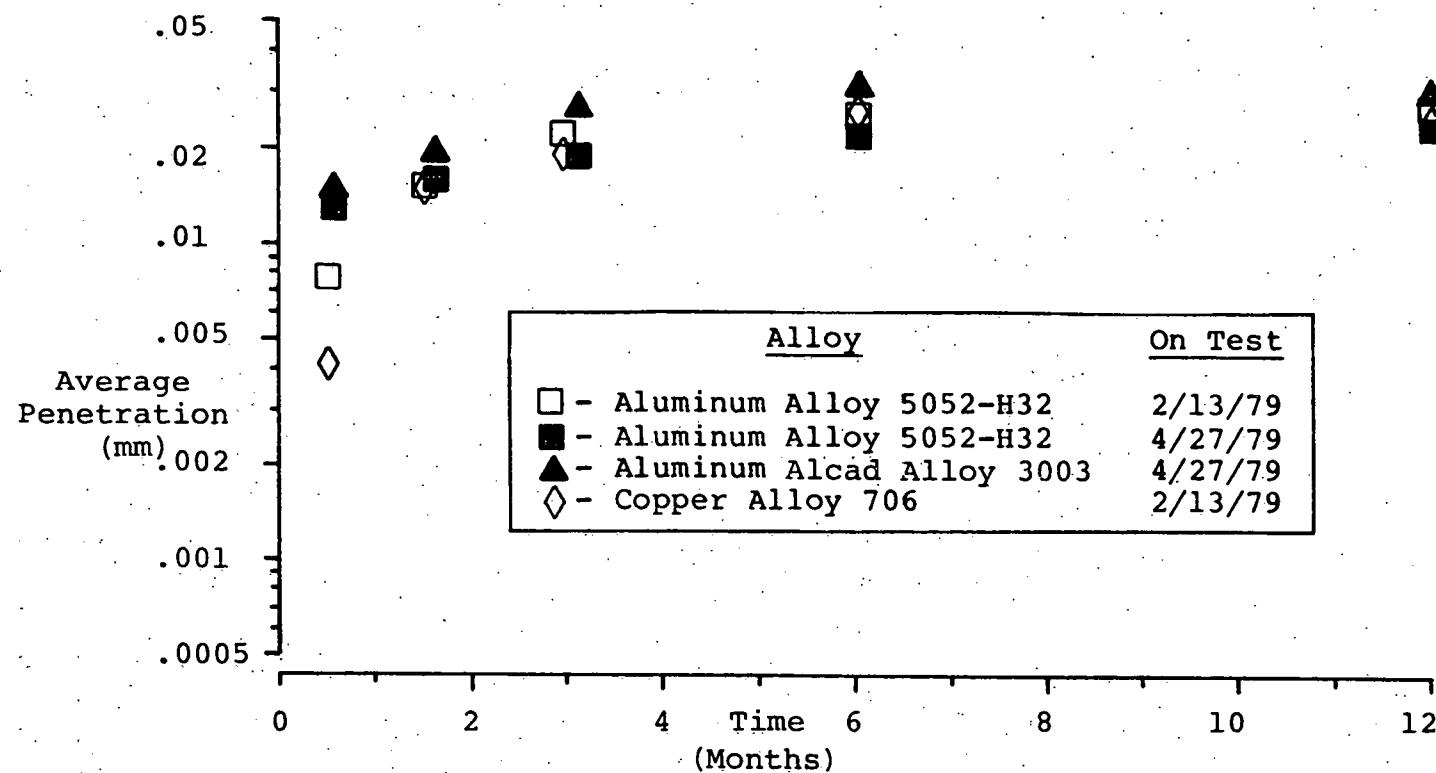
FIGURE IV-6

CORROSION PERFORMANCE OF OTEC CANDIDATE MATERIALS  
EXPOSED AS COUPONS TO AS-RECEIVED SEAWATER\*

\* Corrosion penetration for AL-6X stainless steel and CP titanium was less than 0.005 mm.

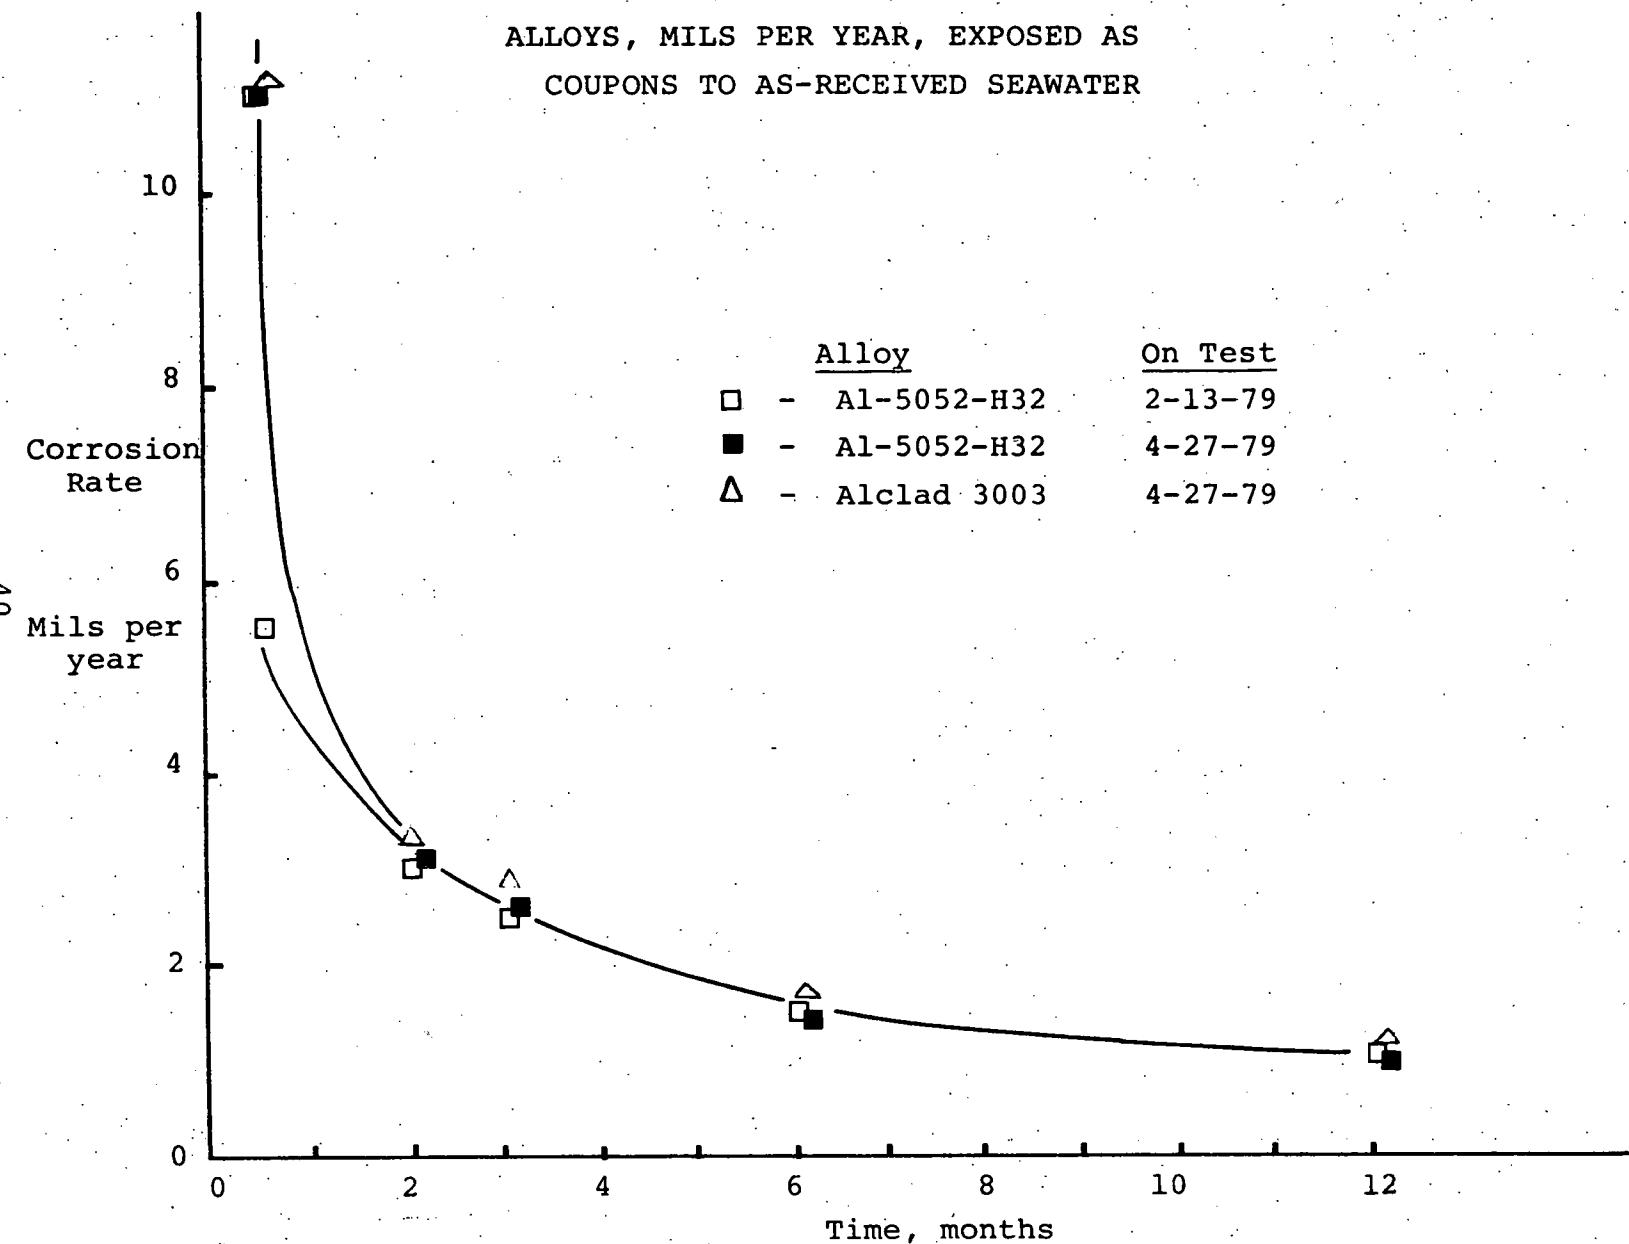
FIGURE IV-7  
CORROSION RATE OF CANDIDATE ALUMINUM  
ALLOYS, MILS PER YEAR, EXPOSED AS  
COUPONS TO AS-RECEIVED SEAWATER

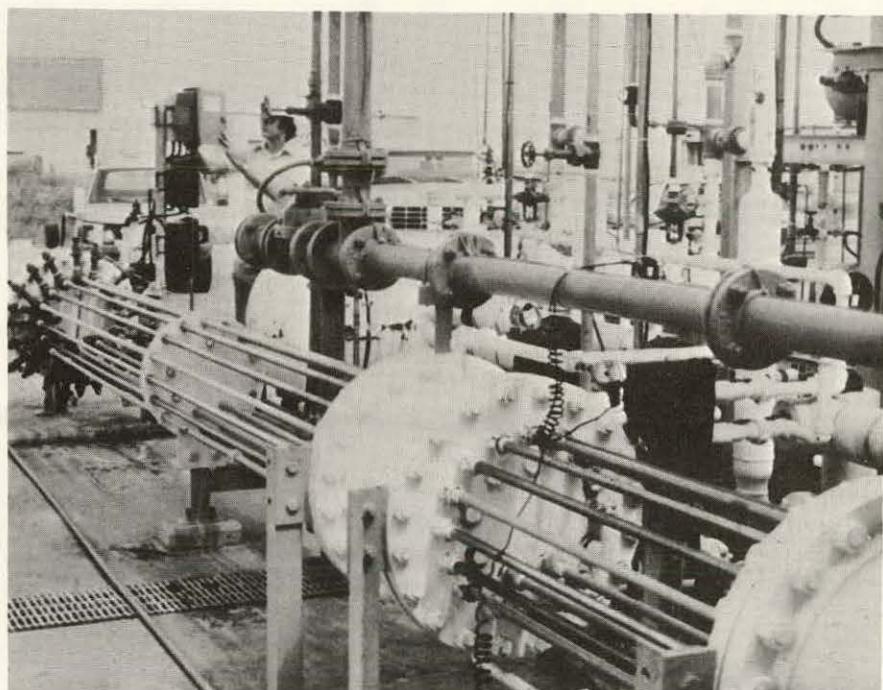
**FIGURE VIII-2**

**Tube Test Unit**

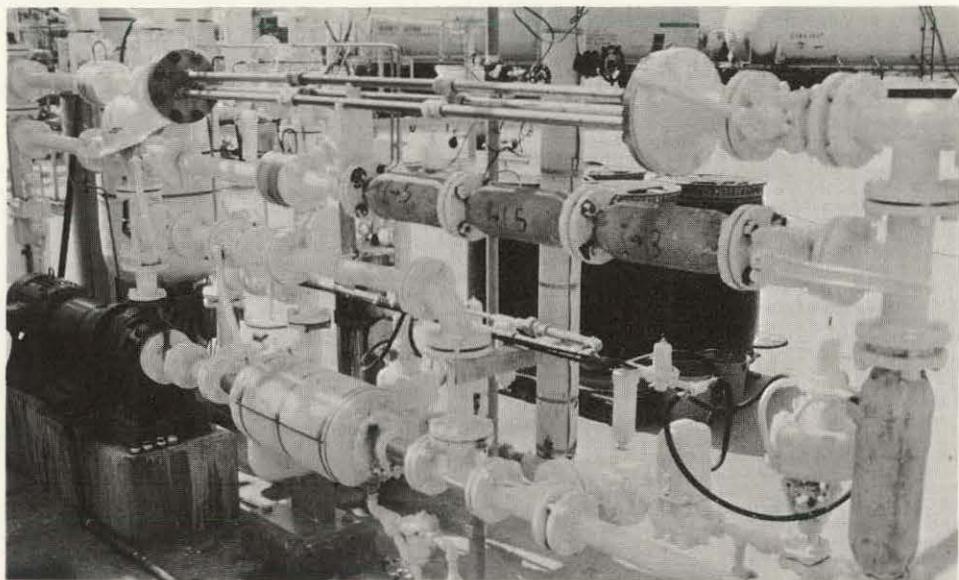
**FIGURE VIII-3**

**Seawater Plus Ammonia Test Loop,  
Non-Copper Alloy Testing**

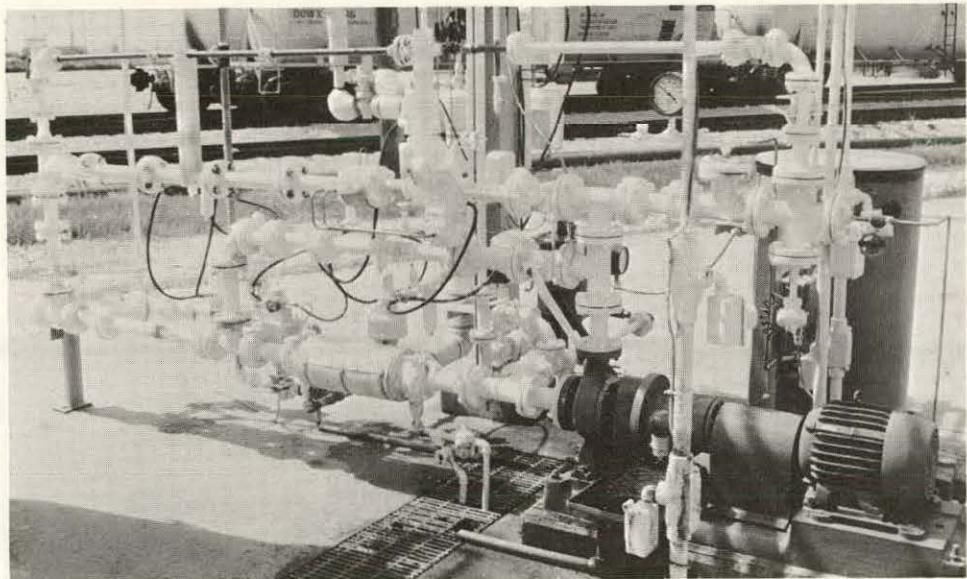
FIGURE VIII-4  
Seawater Plus Ammonia Test Loop  
Copper Alloy Testing

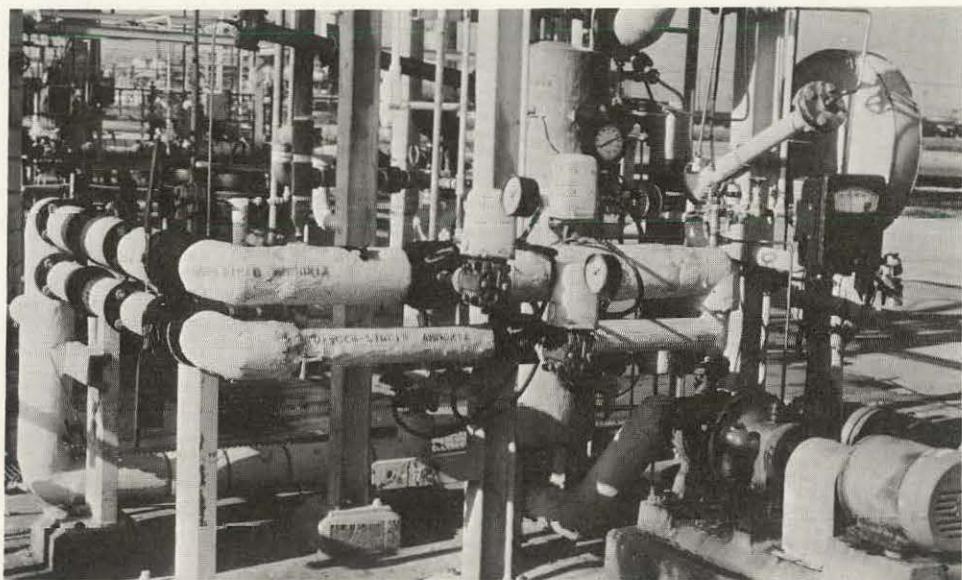
**FIGURE VIII-5**  
**Anhydrous Ammonia Test Unit**

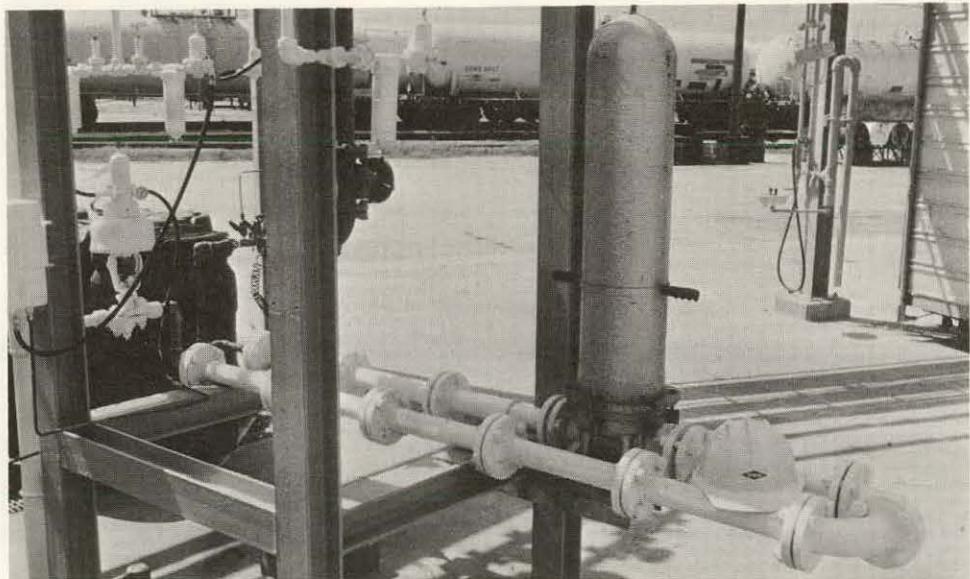
**FIGURE VIII-6**  
**Once-Through Seawater Test Loop**

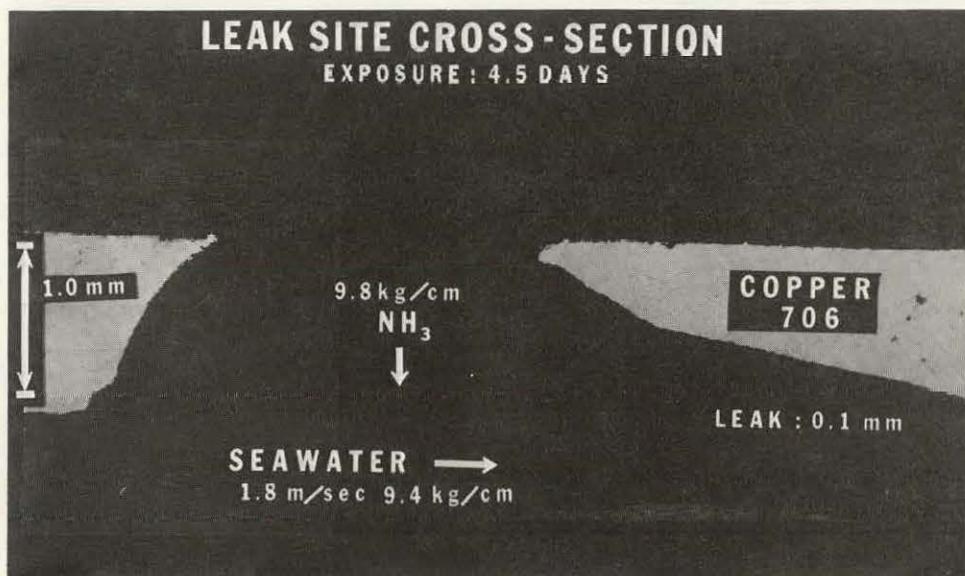
FIGURE VIII-7

Leak Site in Copper Alloy 706 Tube  
Exposed 4.5 Days in the Tube Test Unit  
at a 0.4 kg/cm<sup>2</sup> Ammonia/Seawater  
Pressure Differential

Premature Withdrawal

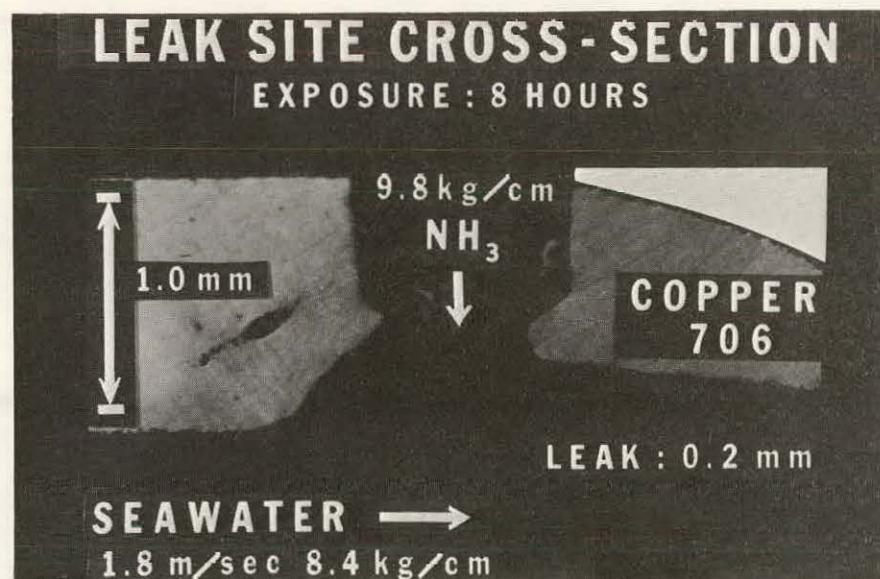
FIGURE VIII-8

Leak Site in Copper Alloy 706 Tube  
Exposed 8 Hours in the Tube Test Unit  
at a  $1.4 \text{ kg/cm}^2$  Ammonia/Seawater  
Pressure Differential

Premature Withdrawal

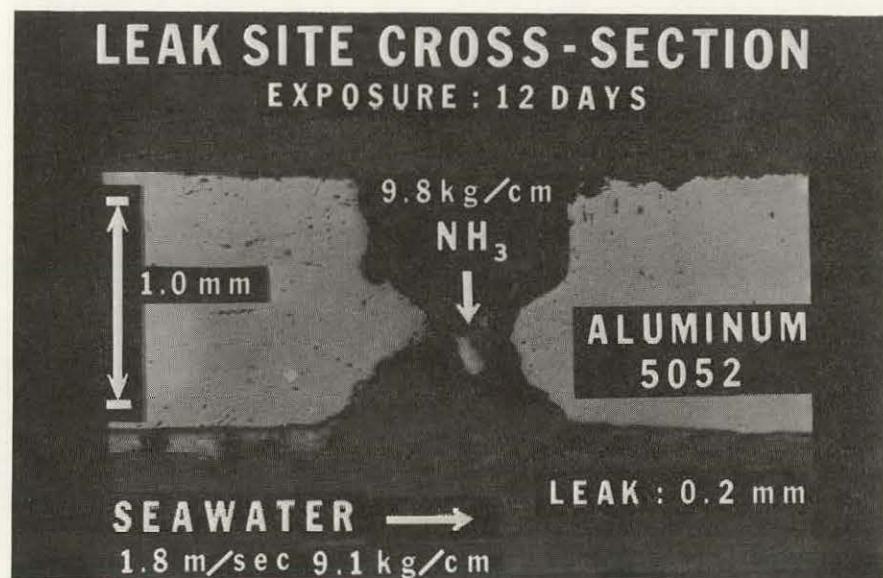
FIGURE VIII-9

Leak Site in Aluminum Alloy 5052 Tube  
Exposed 12 Days in the Tube Test Unit  
at a  $0.7 \text{ kg/cm}^2$  Ammonia/Seawater  
Pressure Differential

Premature Withdrawal

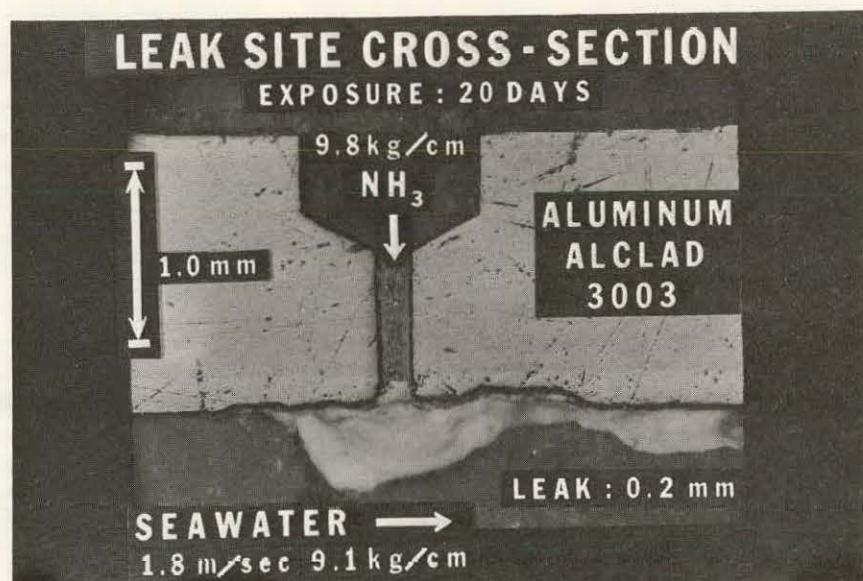
FIGURE VIII-10

Leak Site in Aluminum Alclad Alloy 3003  
Exposed 20 Days in the Tube Test Unit  
at a  $0.7 \text{ kg/cm}^2$  Ammonia/Seawater  
Pressure Differential

Scheduled Withdrawal

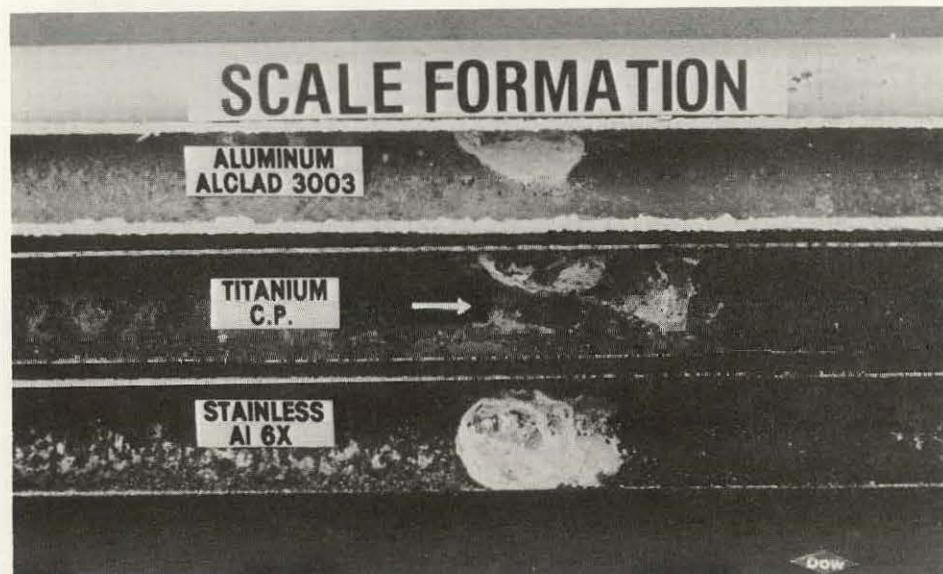
FIGURE VIII-11

Scale Formation at Leak Site  
of Tubes Withdrawn from the Tube Test Unit

7. Tube test unit operation at a  $0.4 \text{ kg/cm}^2$  (5 psi) anhydrous ammonia-seawater pressure differential resulted in plugging and sealing of 100% of the initial artificial leak sites. Operations at a pressure differential of  $0.7 \text{ kg/cm}^2$  (10 psi) were also highly effective at differentials of  $1.4 \text{ kg/cm}^2$  (20 psi), scale formation was observed to plug the artificial leak.

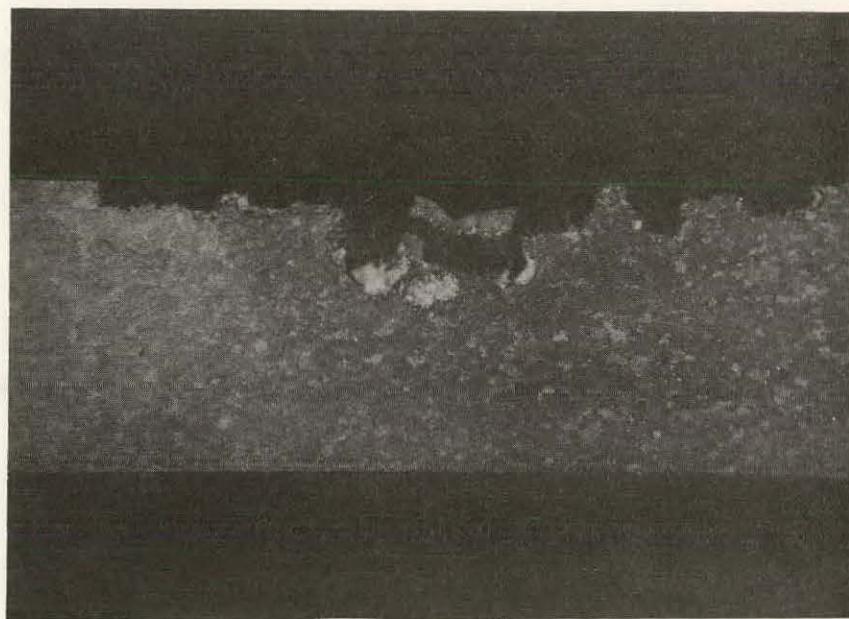
FIGURE VIII-12

Pit Cross-Section of Aluminum Alloy 5052 Tube  
Exposed 0.5 Months to 30°C Seawater  
Plus 5 ppm Ammonia  
(Tube is 1.2 mm, 49 mils thick)

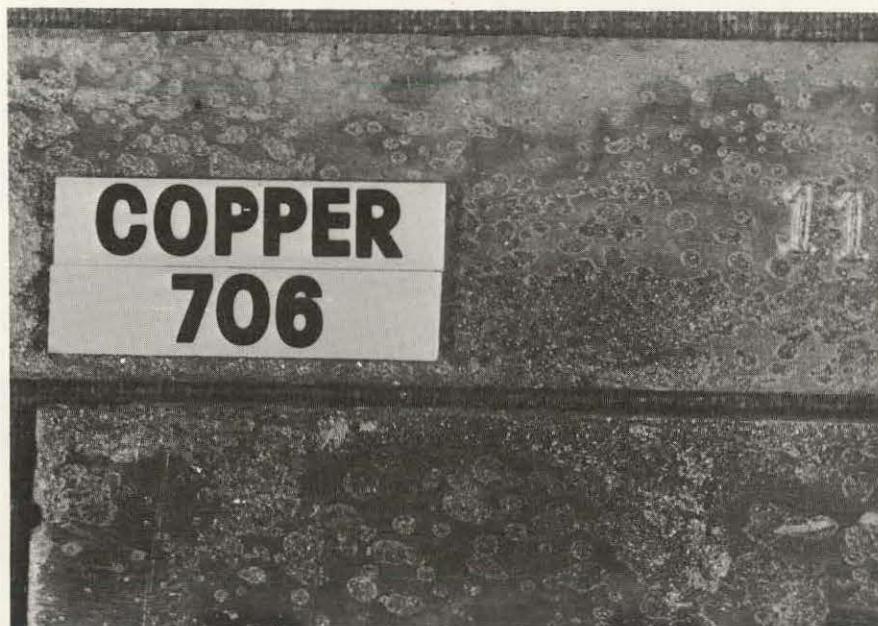
FIGURE VIII-13

Localized Corrosion on Copper Alloy 706 Coupon  
Exposed 0.5 Months to 30°C Seawater  
Plus 5 ppm Ammonia  
(Coupon is 19 mm [0.75 in] wide)
