ANL/OTEC-BCM-012

## A STUDY OF THE EFFECTS OF INTERLEAKAGE OF AMMONIA AND SEAWATER ON CORROSION AND SCALING OF CANDIDATE MATERIALS FOR OTEC HEAT EXCHANGERS

Final Report

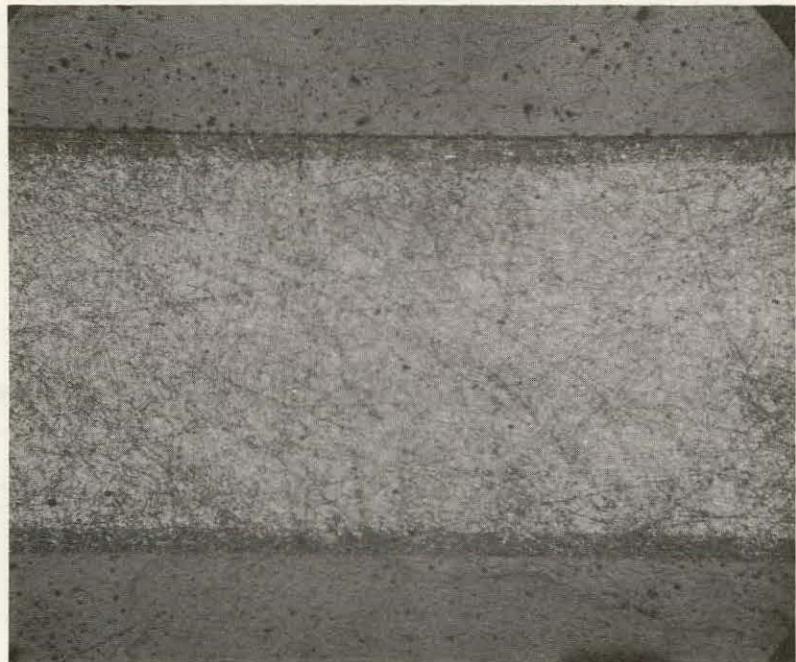
FIGURE VIII-14

Cross-Section of Aluminum Alclad Alloy 3003 Coupon  
No Exposure  
(Coupon is 1.6 mm, 63 mils, thick)
