Inert Electrodes Program

**Results from a Pilot Cell
Test of Cermet Anodes**

August 1992

PNL-8269
UC-313

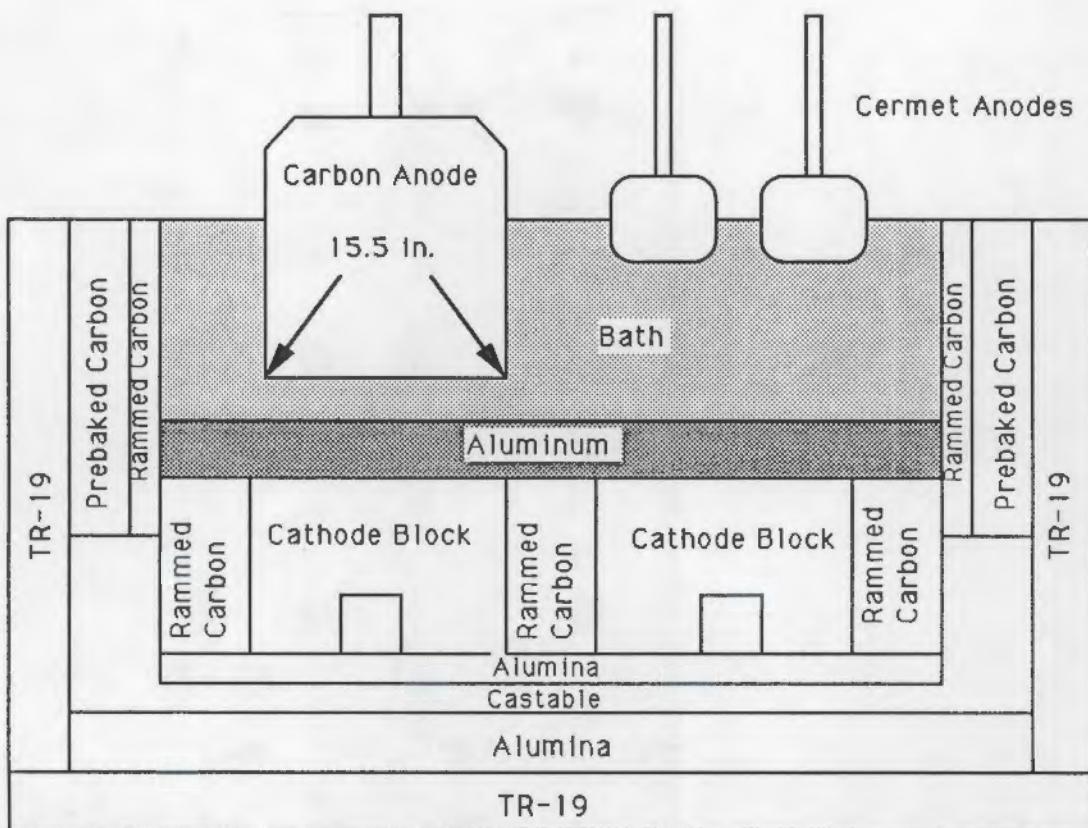
FIGURE 2.3. Diagram of the Pilot Cell (Side View)

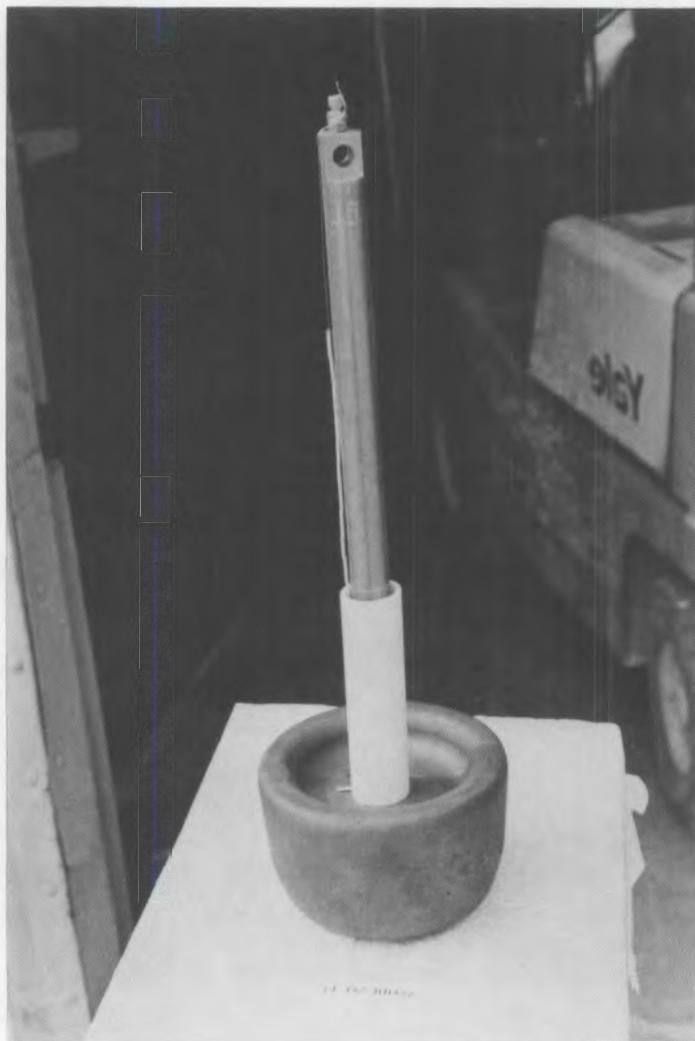
FIGURE 2.6. Photograph of an Assembled Cermet Anode and Connector Rod

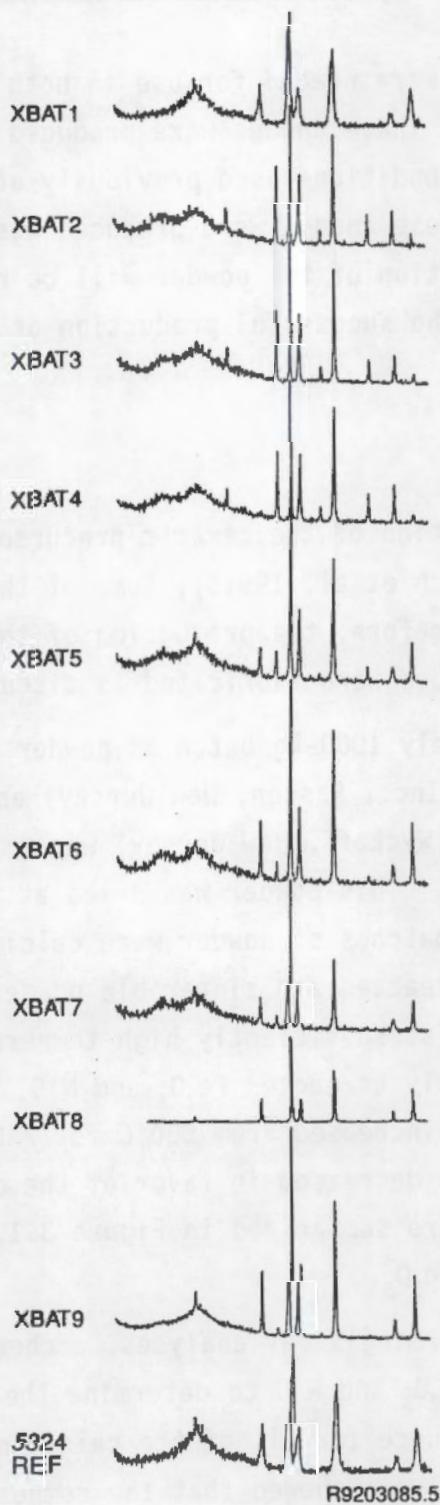
FIGURE 3.1. Results from the X-ray Diffraction Scans of the XBAT Series of Calcined Powders

A large, approximately 1000-kg batch of powder containing hematite (Fe_2O_3 , Pfizer Pigments, Inc., Easton, New Jersey) and high purity, green nickel oxide (NiO, Novamet, Wyckoff, New Jersey) was mixed wet (H_2O) in a steel ball mill for 2 h to 4 h. This powder was dried at room temperature in large flat pans. Eight 50-kg batches of powder were calcined at different conditions to attain a fully reacted and sinterable powder. Initially, the calcining was not performed at sufficiently high temperatures so that the main constituents were basically unreacted Fe_2O_3 and NiO. As the temperature and time at temperature were increased from 800°C for 2 h to 980°C for 6 h, the amount of these materials decreased in favor of the desired compounds, NiFe_2O_4 and NiO. These results are summarized in Figure 3.1. Batch eight (XBAT-8) contained no detectable Fe_2O_3 .

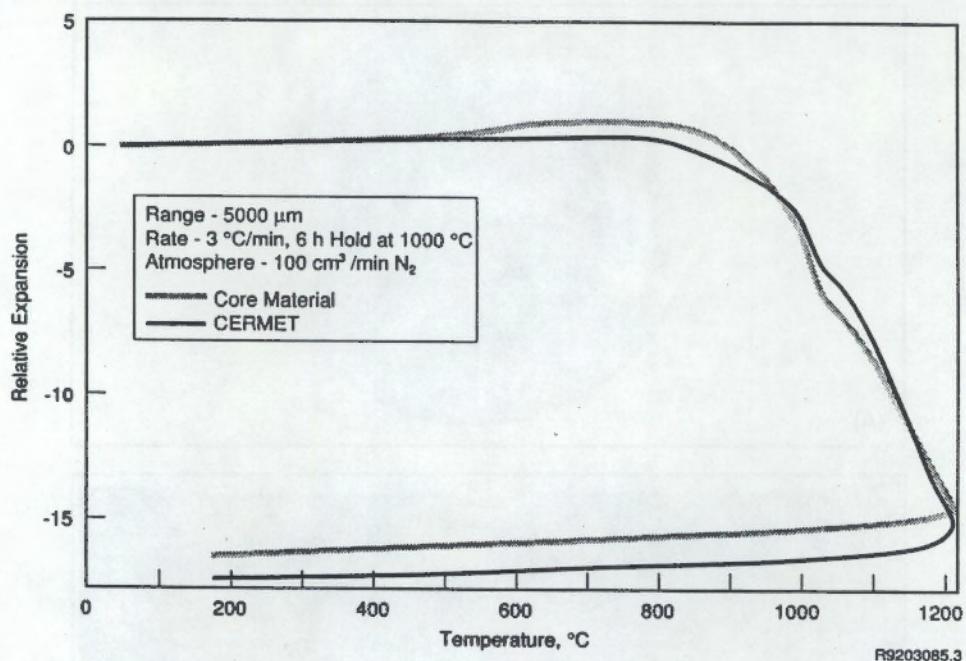
FIGURE 3.3. Results from Dilatometer Measurements on a Pressed, Green Ferrite Sample

In an attempt to understand this cracking phenomenon, the dilatometric properties were measured. The results from this measurement are summarized in Figure 3.3. Although the two materials consolidate at different rates, this is not expected to cause severe stresses in the material. Even if stresses were induced from this behavior, the stresses would have been annealed during the heat treatment at about 1250°C. However, the slope of the curves shown in Figure 3.3 indicate that on cooling the core material shrinks about 1% faster than the cermet material.

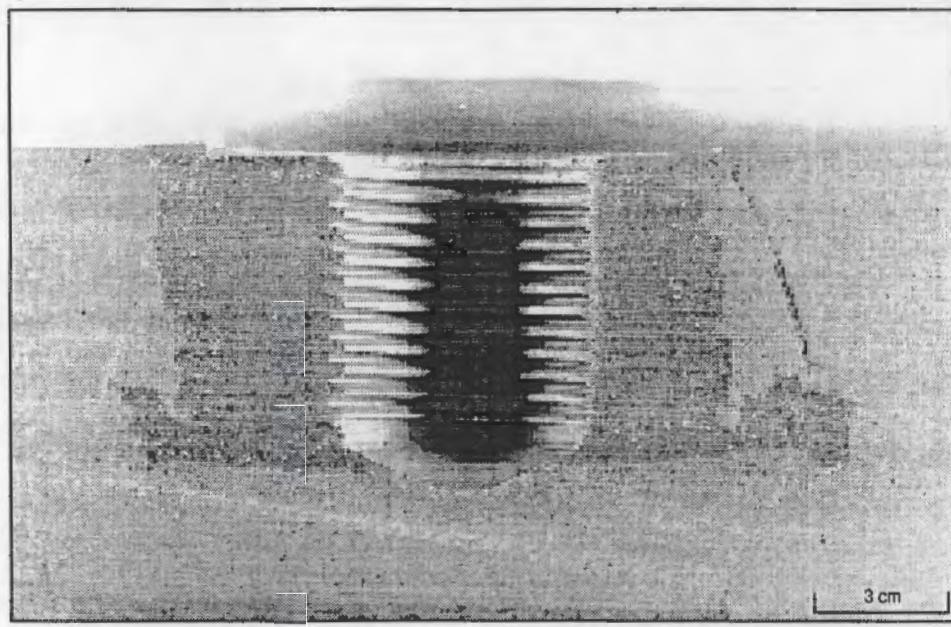
FIGURE 3.4. Close-up View of a Cross Section of a Pilot Cell Anode Showing the Excellent Bonding

This was done to prevent the anode from dropping from the core material during use if a crack developed between the core and the cermet anode material. From the shape of the cracks, it was initially thought that the shape of the core may have been, in some way, causing the cracks; even the anodes with the straight cores cracked. More surprising was the fact that the anode constructed with the "5324" powder also cracked. This result suggests that even the prototype anode used in the laboratory cell test (Strachan et al. 1990) was probably also cracked. In all cases, where a core material was used, excellent bonding occurred between the cermet and core materials (Figure 3.4).

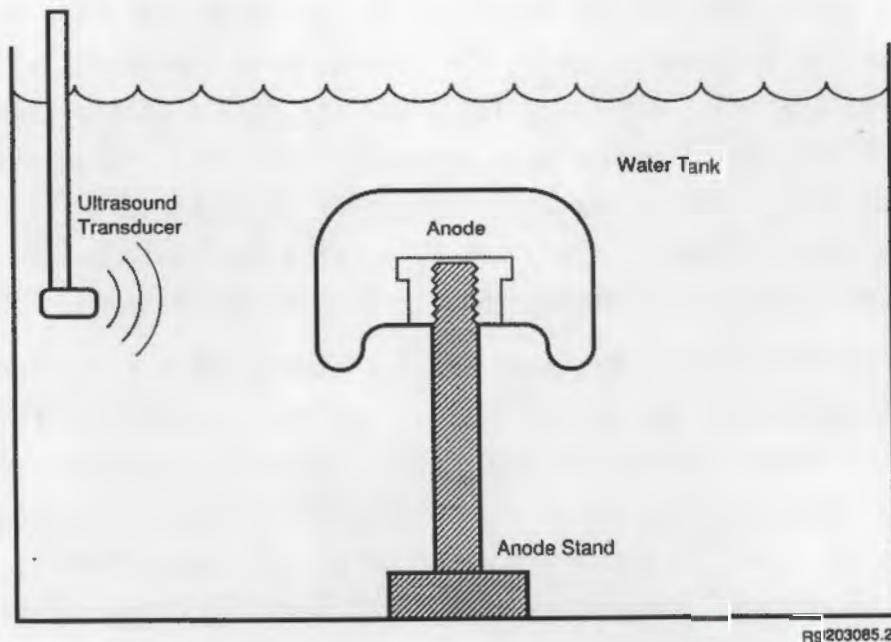
FIGURE 3.5. A Schematic of the Ultrasound Device for Determining the Presence of Cracks in Pilot Cell Anodes

crack or defect exists in the material, the sound is not reflected until it reaches the other side of the anode. The sound will not penetrate beyond a crack, so the intensity of the reflected sound is more intense from a crack. By measuring the time it takes for the sound wave to pass through the water and then into the anode, the depth of the crack from the surface can be measured. For more accuracy, the speed of sound in the cermet material was measured using a solid piece of a sectioned anode of known thickness. An example of the "picture" of the crack in a cracked anode is shown in Figure 3.6. In this figure three views are shown. One view is shown as a cross section. The next view is a circumferential view at the depth of the most intense signal from the crack. In the third view, the crack is viewed from the bottom of a sectioned anode. In these views, the crack is represented by the darkest area. Confirmation of the depth and geometry of the crack was obtained by sectioning the anode and examining the crack.

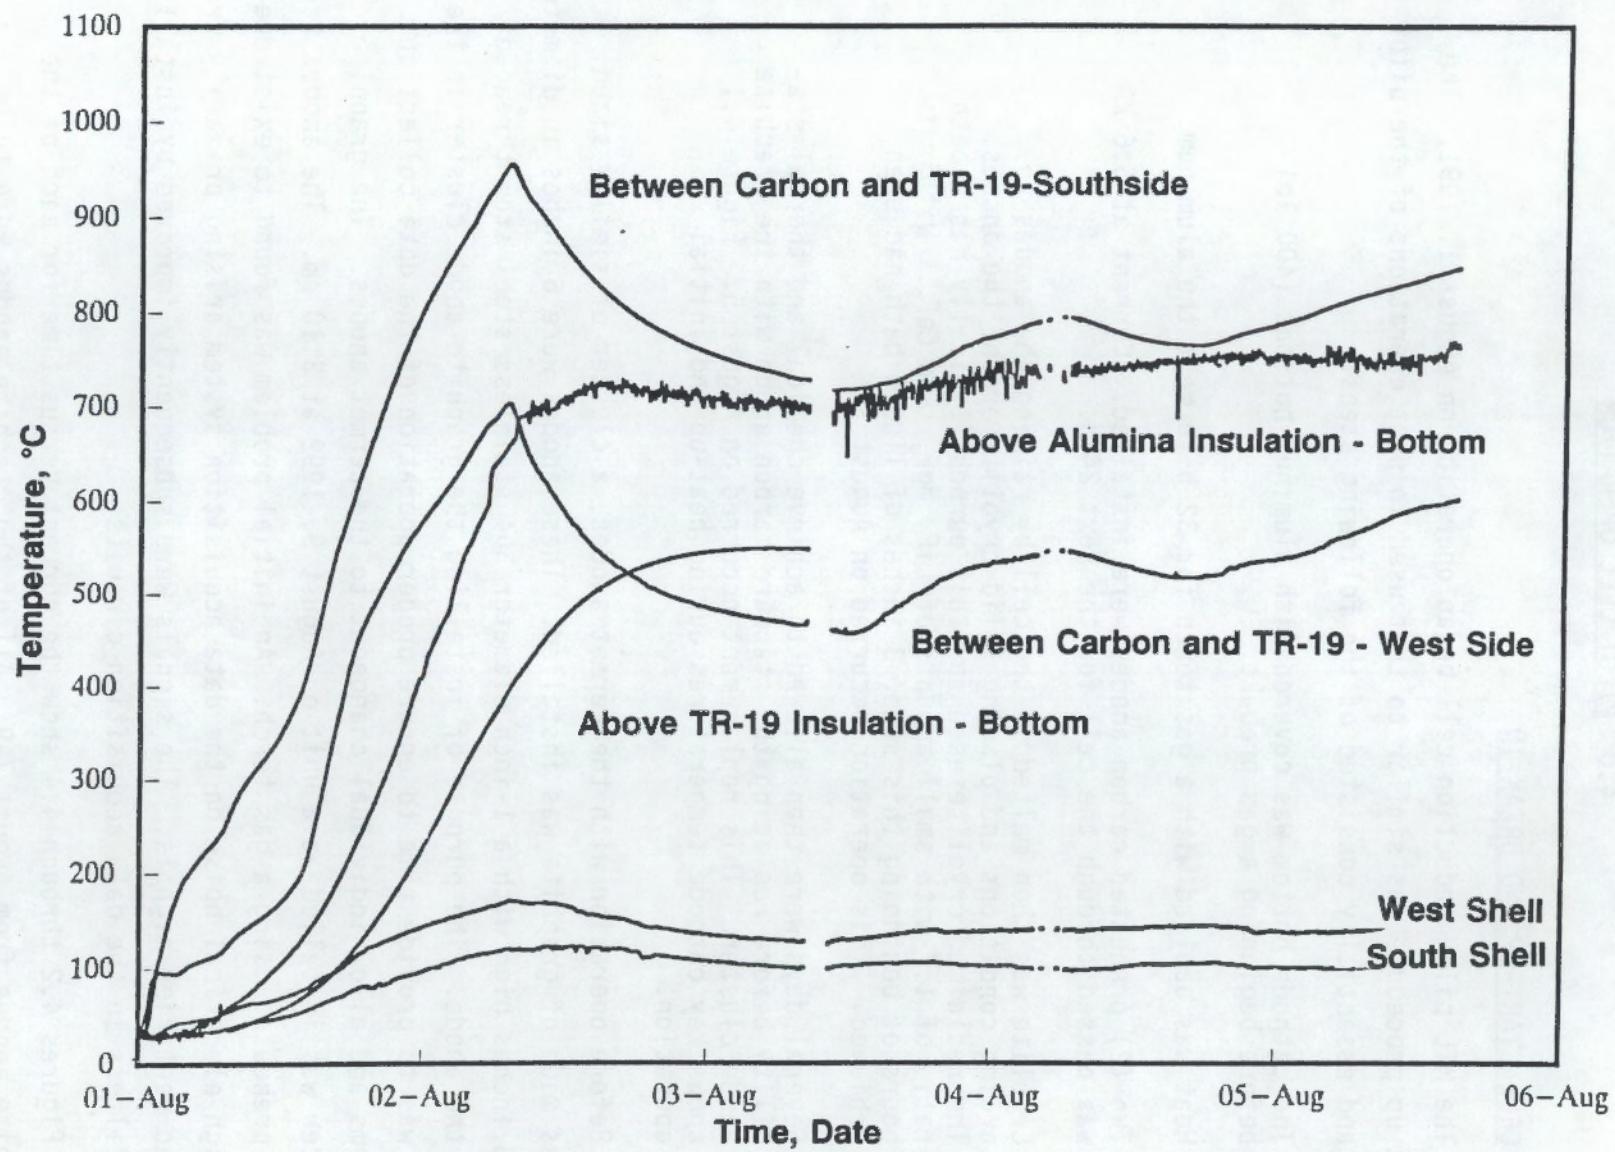
FIGURE 4.1. Cathode Temperature during Heatup

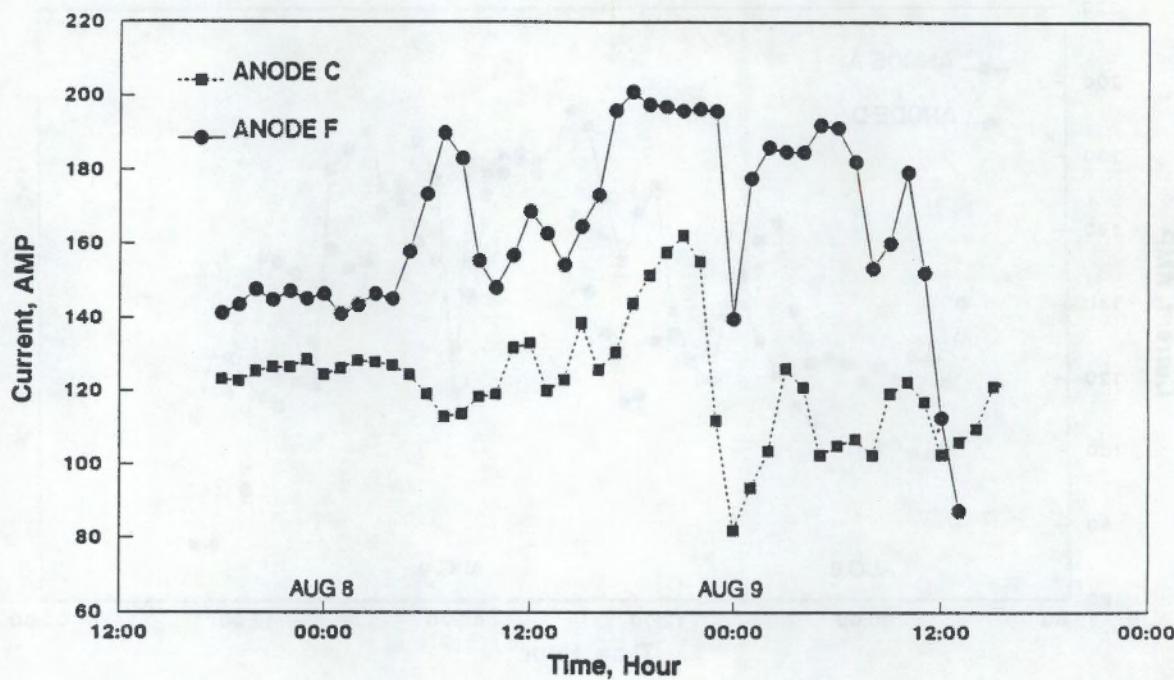
FIGURE 4.4. Current Versus Time for Graphite Anodes in Positions C and F

Figures 4.2 through 4.4 show the current versus time for each of the graphite anodes from August 7-9. All of the graphite anodes were to be

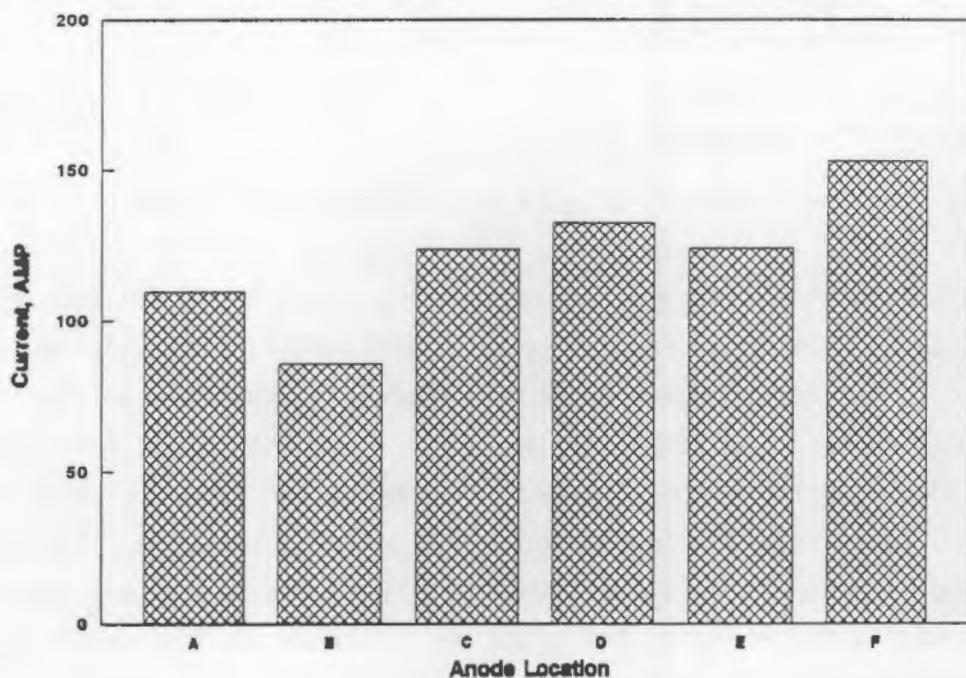
FIGURE 4.5. Current Imbalance on the Carbon Anodes. (Average of readings taken between August 7 at 6:00 am and August 8 at 8:00 am)

Operation with the graphite anode cluster showed a current imbalance among the six anodes as shown in Figure 4.5. Anodes in positions A, B, and C carried about 17% less current than those in positions D, E, and F. Positions A, B, and C were closer to the large carbon anode (west anode) which, as discussed below, perturbed the voltage characteristics of the cell. The

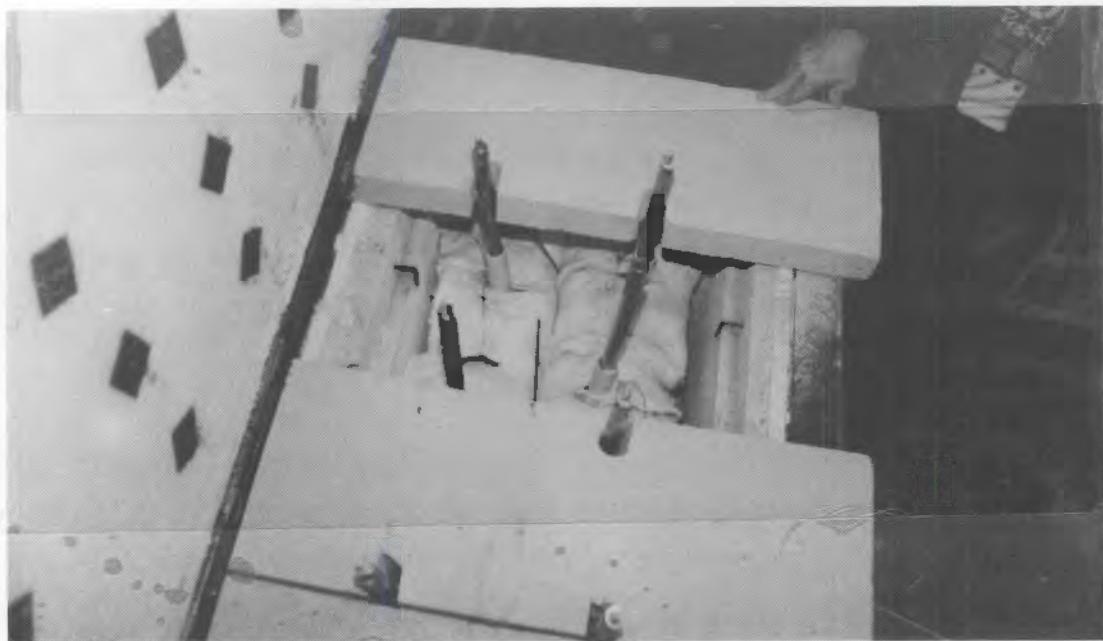
FIGURE 4.6. Photograph of Cermet Anodes in the Preheat Furnace

Figure 4.6 shows the cermet anodes in the preheat furnace. Figure 4.7 shows an anode being transferred to the cell for installation. As indicated in Section 4.1, the first cermet anode transferred in this manner cracked as soon as it was exposed to the open bath. Figure 4.8 shows this first anode, labelled Anode B1, after it had cracked. As shown, the anode cracked radially down a center line including the Ni rod/cermet anode connection. Thermal shock coupled with too large a CTE mismatch between the Ni rod and the cermet anode was probably the cause of the cracking. Further discussion of the thermal shock characteristics of the anode is given in Sections 4.3 and 5.3.

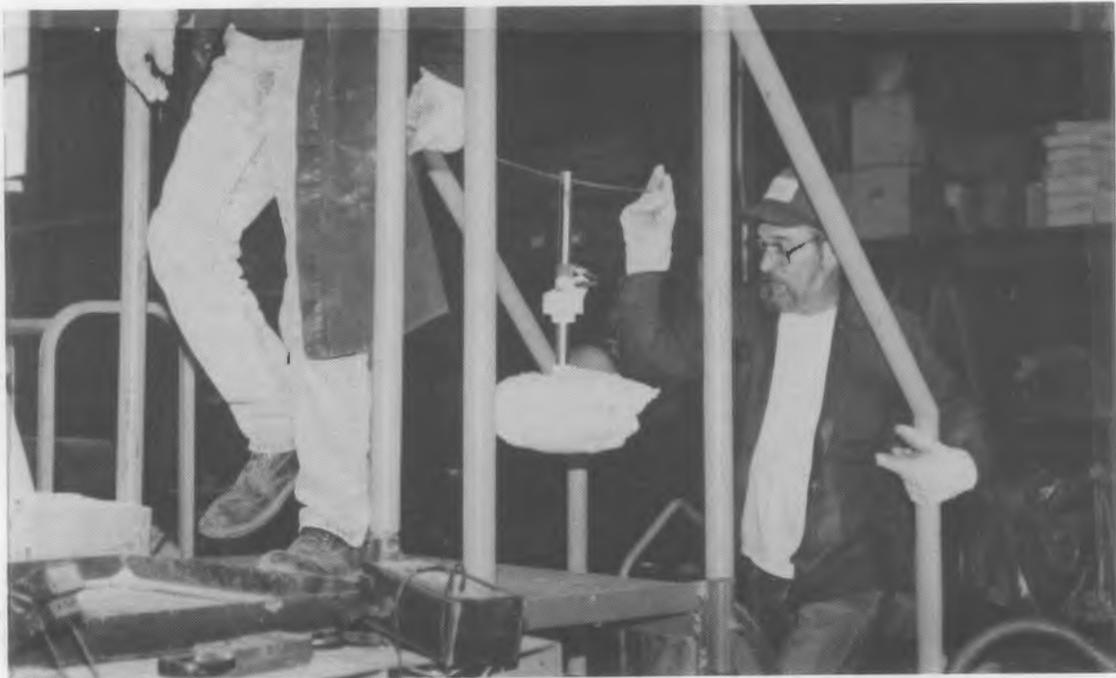
FIGURE 4.7. Transferring a Cermet Anode to the Pilot Cell

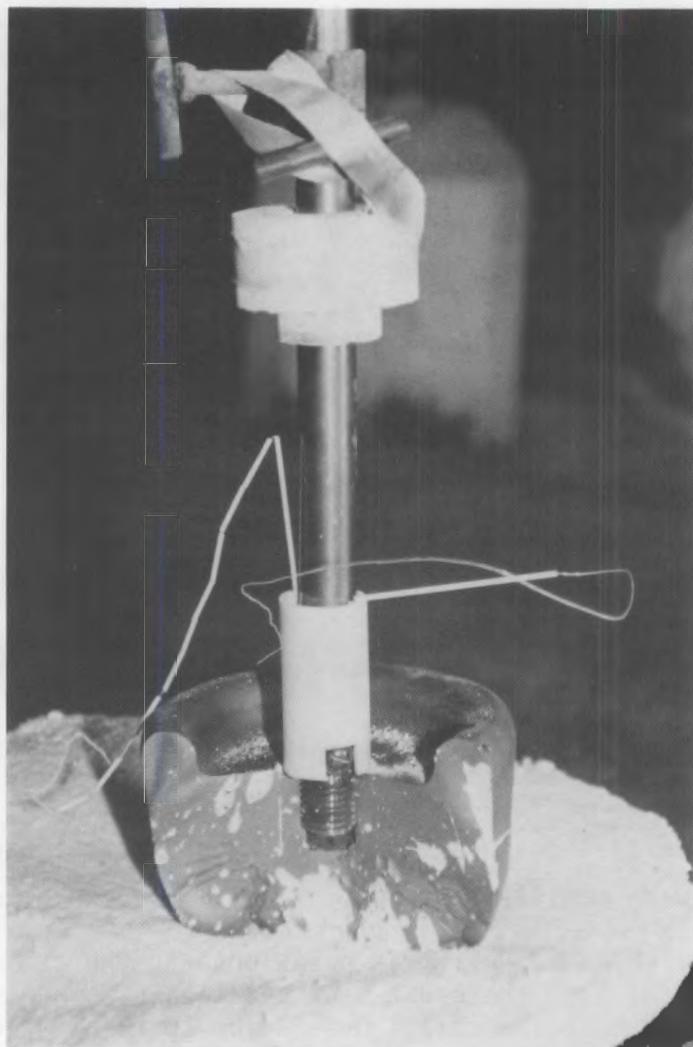
FIGURE 4.8. Anode B1 after It Had Cracked during Transfer to the Pilot Cell

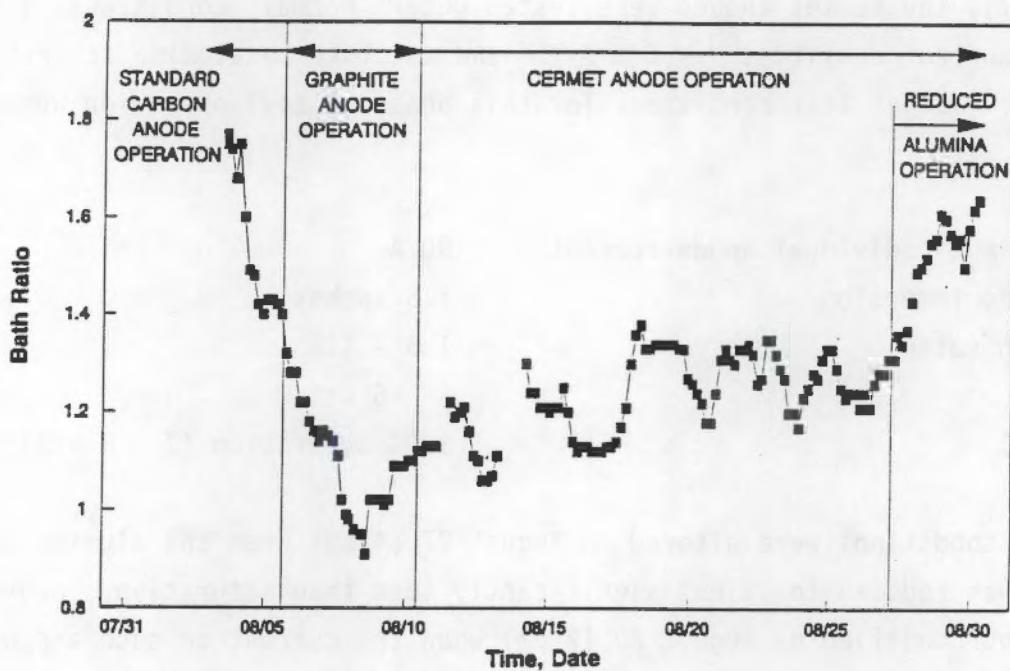
FIGURE 4.9. Bath Ratio Versus Time during the Pilot Cell Test

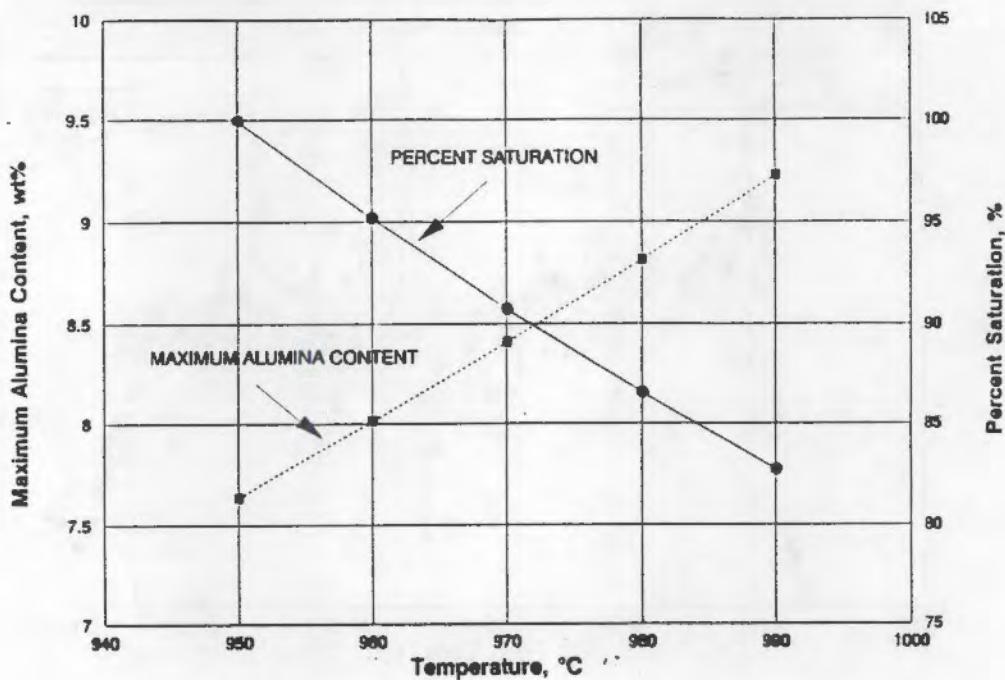
FIGURE 4.15. Effect of Temperature on Alumina Saturation under Pilot Cell Conditions (1.3 Ratio, 5% CaF_2 , 7.6% Al_2O_3)

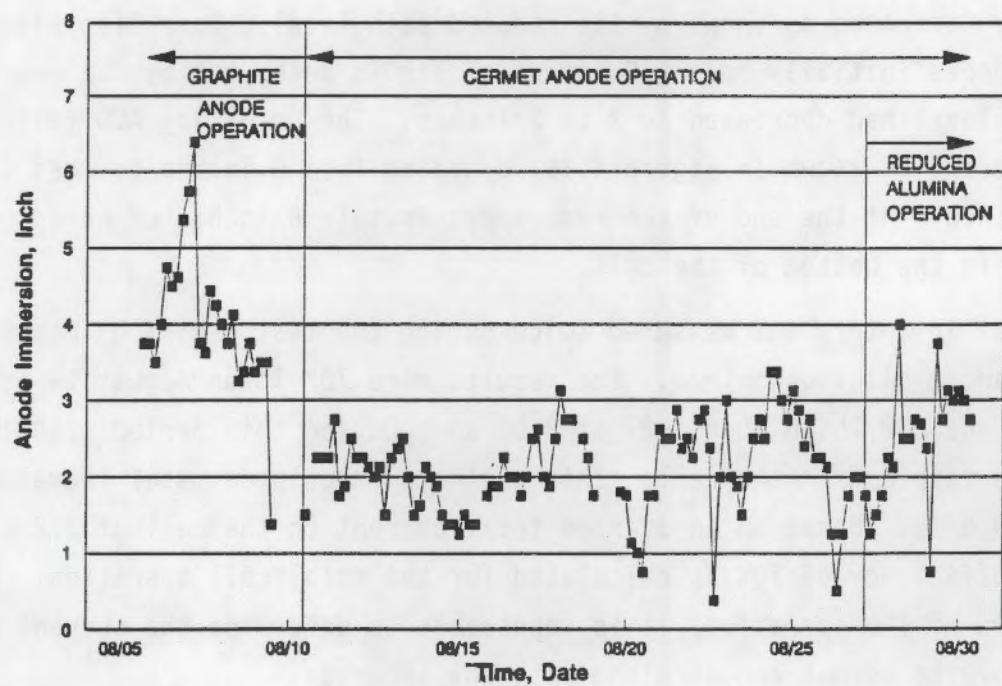
FIGURE 4.16. Anode Immersion Versus Time during the Pilot Cell Test

The target operating conditions included a depth of immersion for the anode equal to 1.5 inches. It was also planned that the ACD would be relatively large. Figure 4.16 shows the anode immersion levels during the test. Generally, all anodes were maintained within 0.5 inches of each other. Typically only anodes in positions B and C were measured for immersion levels. As the plot indicates, the anode immersion varied more than desired, from 1 to 3 inches. This was due to the difficulty in adjusting the anodes as a result of the anode stem problems discussed in Section 4.3.4, as well as the changing bath level. Figure 4.17 shows the bath level throughout the operation. As the run progressed and muck build-up occurred in the cell, the total liquid

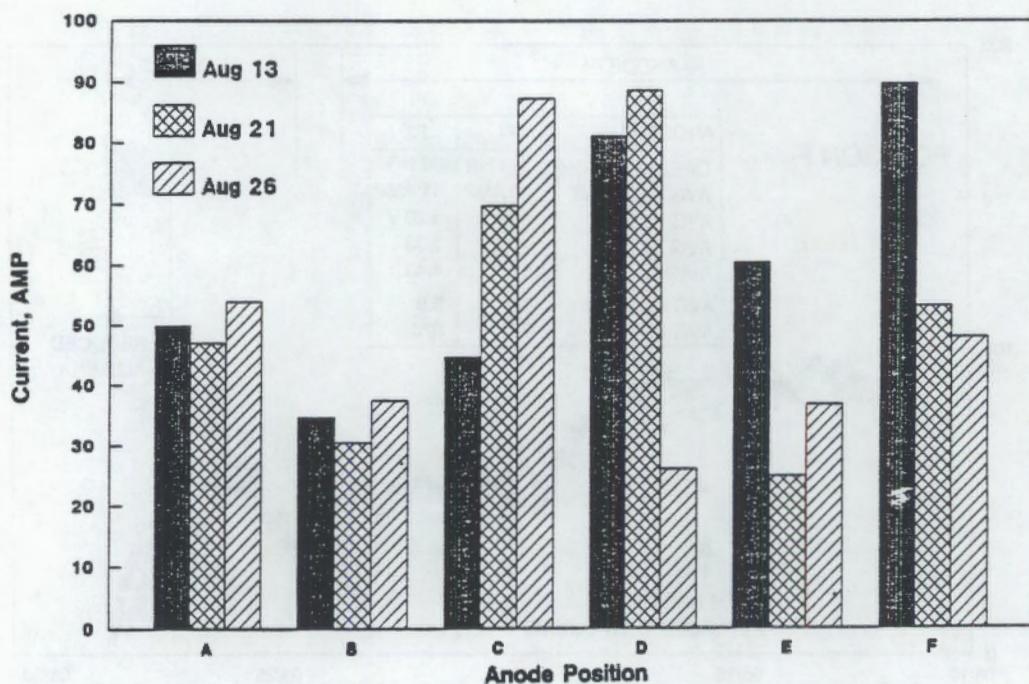
FIGURE 4.26. Current Imbalance on the Cermet Anodes

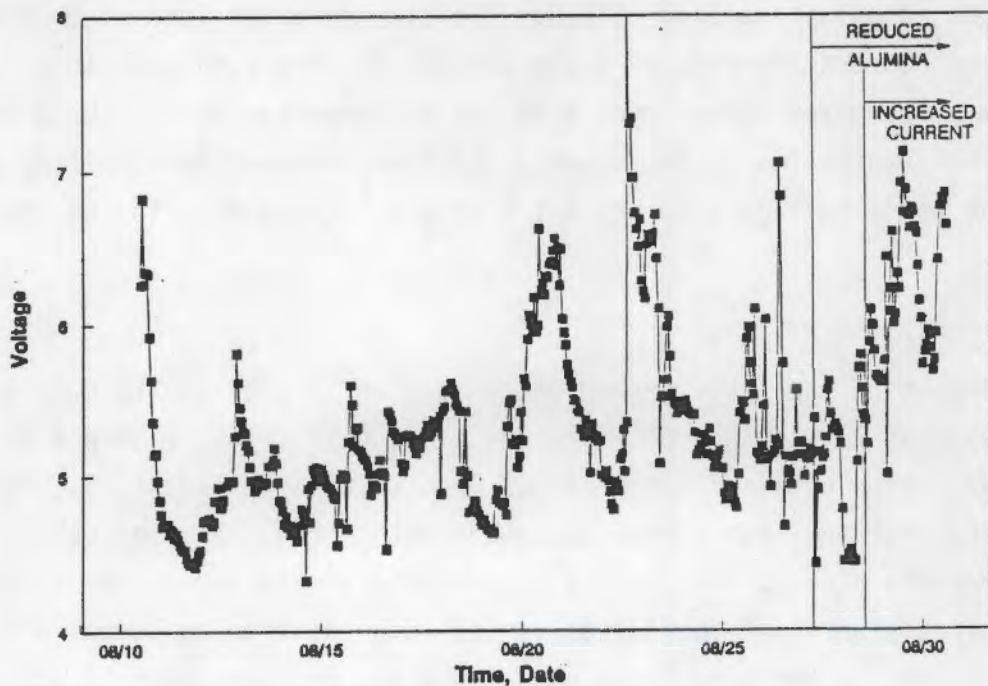
FIGURE 4.27. Variation of Voltage with Time for the Cermet Anodes during the Pilot Cell Test

The voltage of the cermet anodes varied considerably throughout the test as shown in Figure 4.27. This variation was due to a number of variables including cell conditions (muck formation) and carbon anode condition (voltage and current). The average voltage of the cermet anodes was 5.34 V; the total current for the six anodes was 0.32 kA. The cathode drop (voltage from the metal pad to negative metering point) of the cell is shown in Figure 4.28. This measurement reflects the mucky condition of the hearth. As the plot indicates, the cathode drop did increase from 0.65 V to over 1 V (at times) throughout the test, indicating a more resistive cell bottom due to muck buildup. Anode drops (positive metering point to the cermet anode) were measured throughout the run and found to be consistent at 0.19 to 0.22 V. This

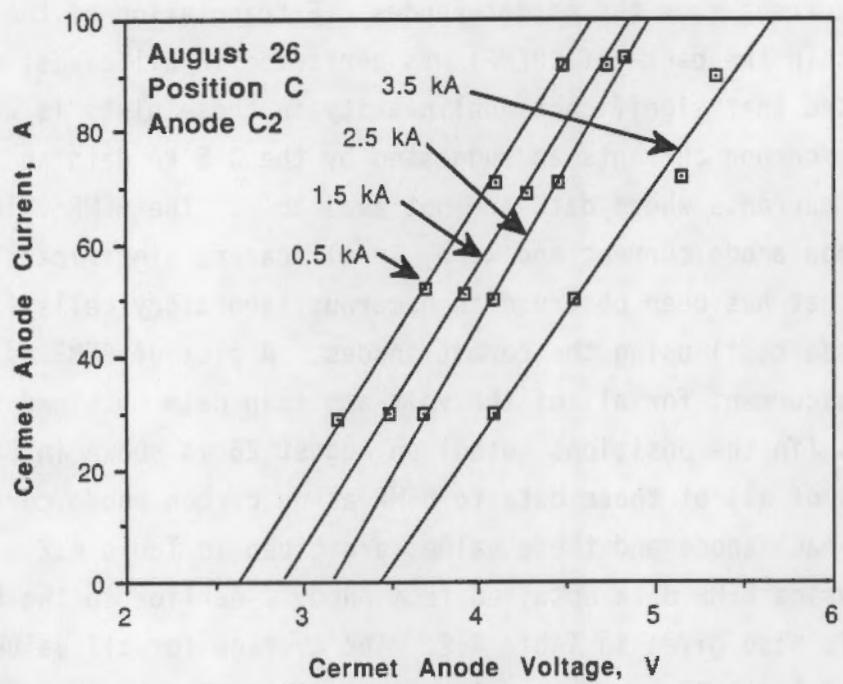
FIGURE 4.29. Current Versus Voltage (iV) Scans for Anode in Position C at Various Carbon Anode Currents

The impact of the large carbon anode is clearly seen in the volt-amp (iv) curves that were obtained during the pilot cell test. Figure 4.29 shows the volt-amp scans obtained for Anode C2 (position C) on August 26. The scans were obtained for the four carbon anode currents shown. Similar behavior was observed for the other cermet anodes in the cell at the same time, although the slope (resistance) of the curves varied with position as shown in Figure 4.30. (This latter effect was expected given the variation of current from anode to anode for the same overall cluster voltage.) Examination of Figure 4.29 indicates that increasing the carbon anode current had the effect

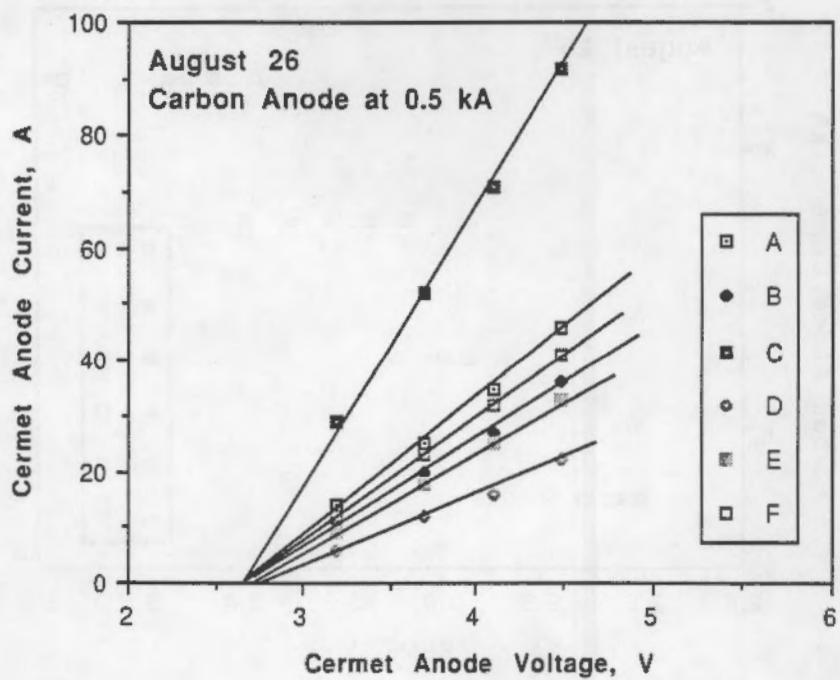
FIGURE 4.30. Current Versus Voltage (iV) Scans for Various Anode Positions with Carbon Anode Current at 0.5 kA

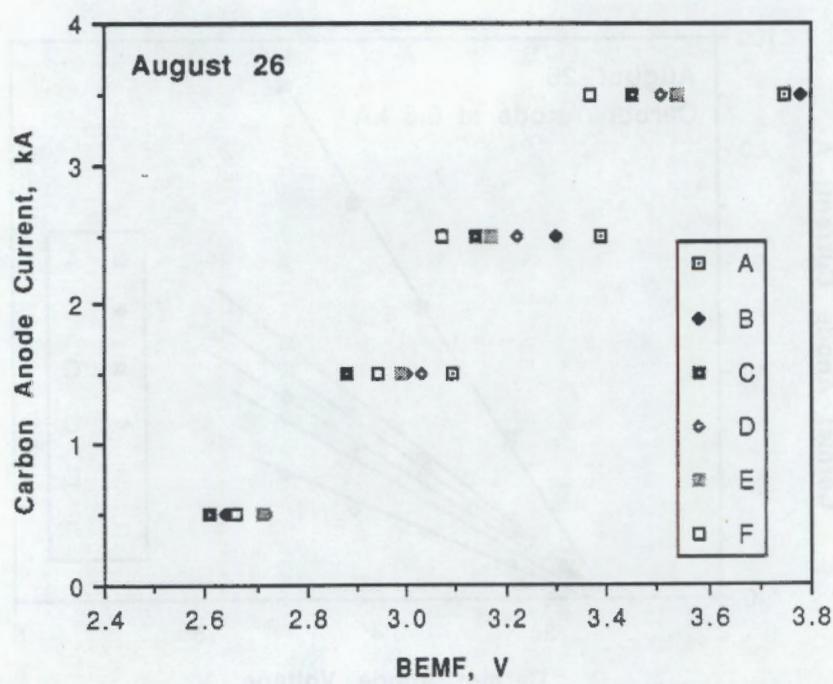
FIGURE 4.31. BEMF as a Function of Current Through the Carbon Anode

of reducing current from the cermet anodes. Extrapolation of the volt-amp curves to obtain the back-emf (BEMF) was performed in all cases, although it should be noted that significant nonlinearity in these plots is probably present at higher carbon currents as suggested by the 3.5 kA data and at very low cermet anode currents where data are not available. The BEMF values increase with the carbon anode current and were, in all cases, significantly above the 2.2 V value that has been observed in numerous laboratory cells (including the prototype anode test) using the cermet anodes. A plot of BEMF as a function of the carbon current for all of the volt-amp scan data obtained from the six cermet anodes (in the positions noted) on August 26 is shown in Figure 4.31. Extrapolation of all of these data to BEMF at no carbon anode current was performed on each anode and these values are given in Table 4.2. The extrapolated value using BEMF data obtained from Anode C earlier in the test (August 14) is also given in Table 4.2. The average for all values on August 26 is 2.52 ± 0.07 V. This value is significantly higher than the expected 2.2 V and probably reflects significant nonlinearity in the volt-amp

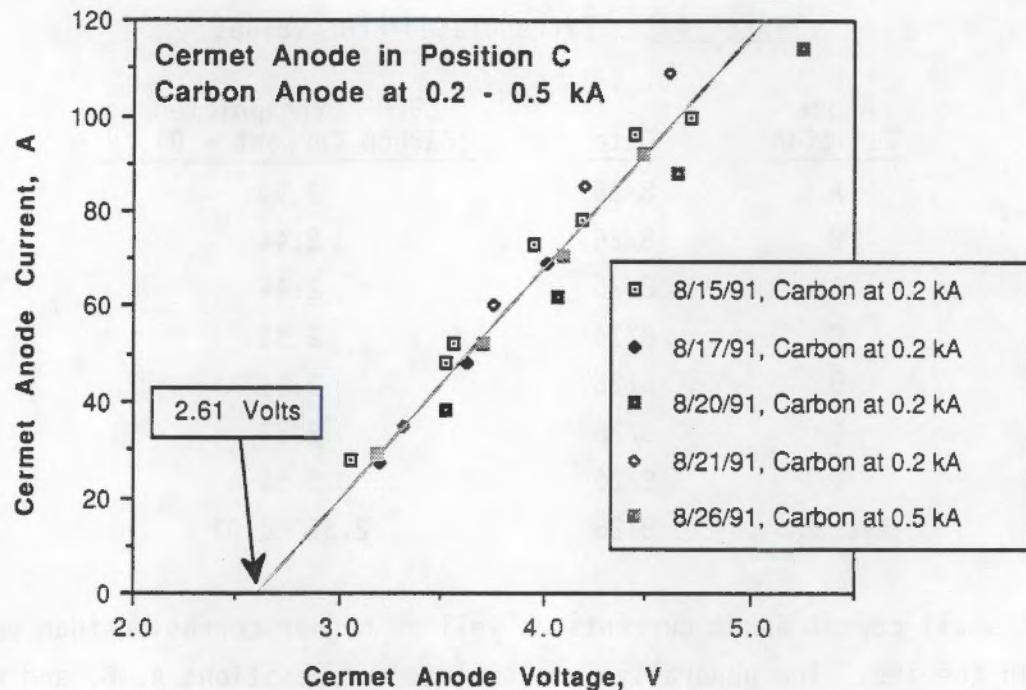
FIGURE 4.32. Plot Showing Negligible Variation of BEMF with Time during the Pilot Cell Test. (Data are for anodes in position C with carbon anode current between 0.2 and 0.5 kA.)

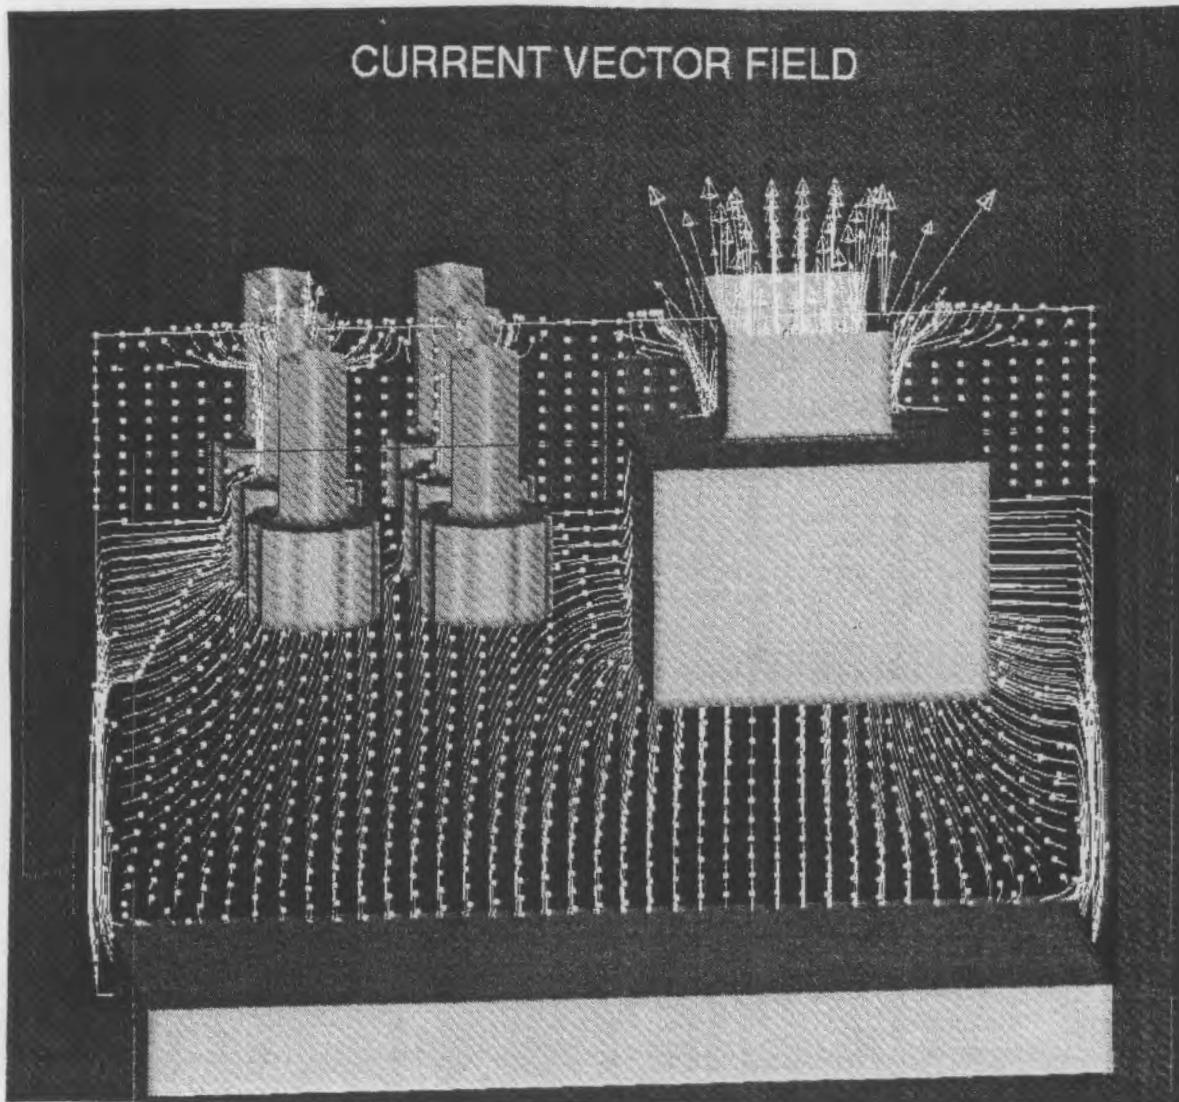
FIGURE 4.38. Three-Dimensional Current Vector Field Calculated with PNL Model

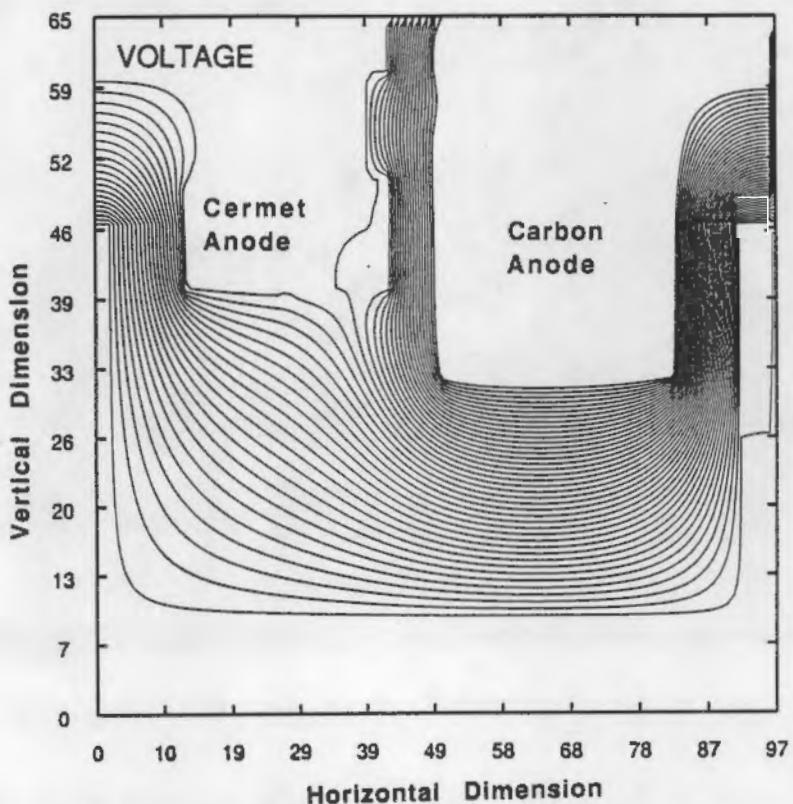
FIGURE 4.39. Cross-Section of the Pilot Cell with Isopotential Lines

The model exhibited the same sensitivity to the relative anode voltages as did the pilot cell. As shown in Figure 4.39, a cross-section of the pilot cell with isopotential lines makes the reason clear: the larger size and smaller ACD of the carbon anode relative to the cermet anodes gives it an

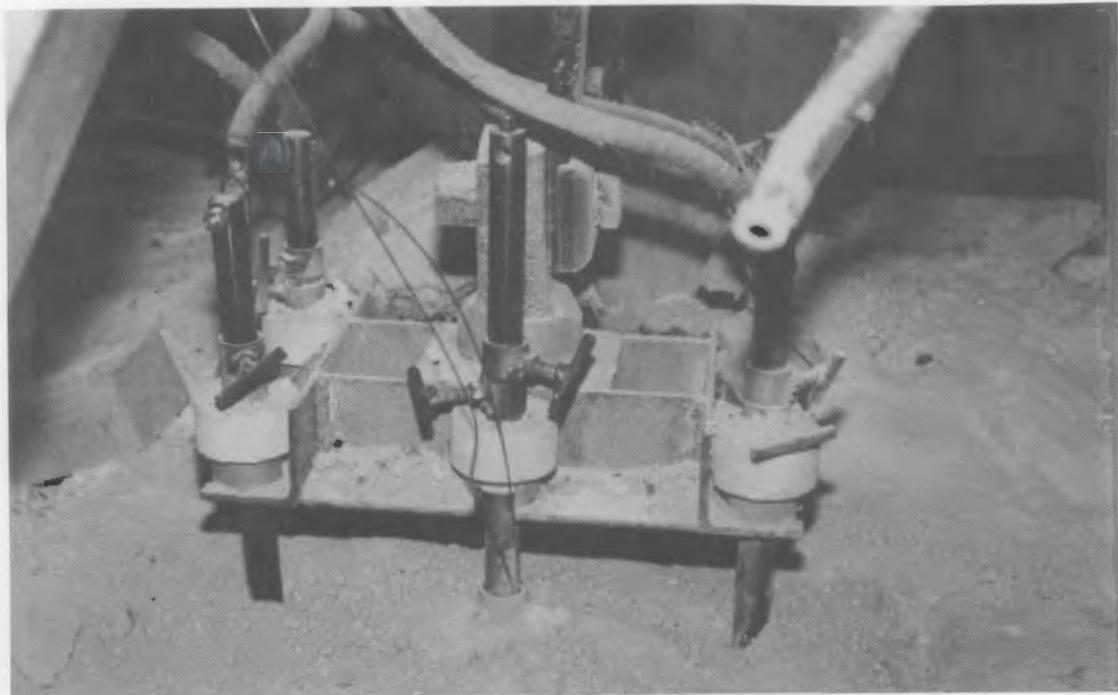
FIGURE 4.40. Photograph Showing the Cryolite Cover on Top of the Cermet Anodes

As shown in Table 4.4, the stem failures first occurred four days after beginning operation, and only one anode (in position E) did not fail. If sufficient stem remained on the anode, a steel pipe was fitted over the stub and operation of the anode continued. Replacement anodes used 304 SS for the stems, which proved to be satisfactory in combination with packing the alumina sleeve with a "pumpable" castable as shown in Figure 4.41. Examination of the fractured Ni rod surface using SEM/EDS (Appendix C) indicated abnormally large grains/crystals and high S content, suggesting embrittlement of the Ni rod had occurred. The prolonged operation at the elevated temperatures in the presence of the cryolite crust, which contains some S, probably led to rapid

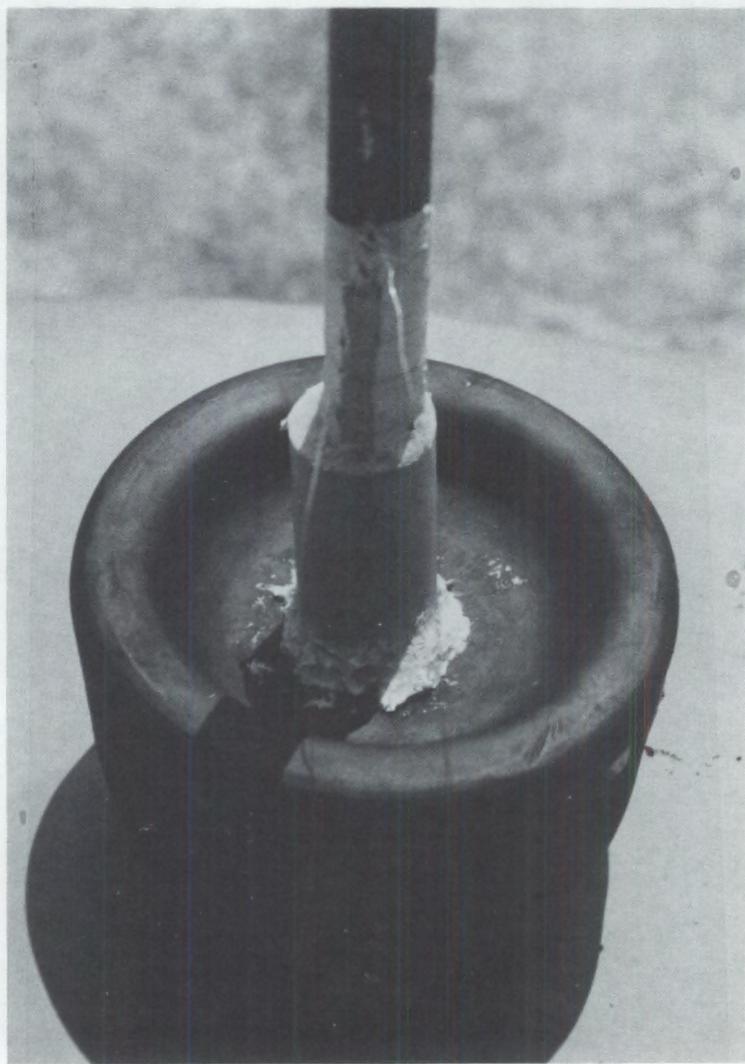
FIGURE 4.41. Photograph Showing the "Packed" Alumina Sleeve

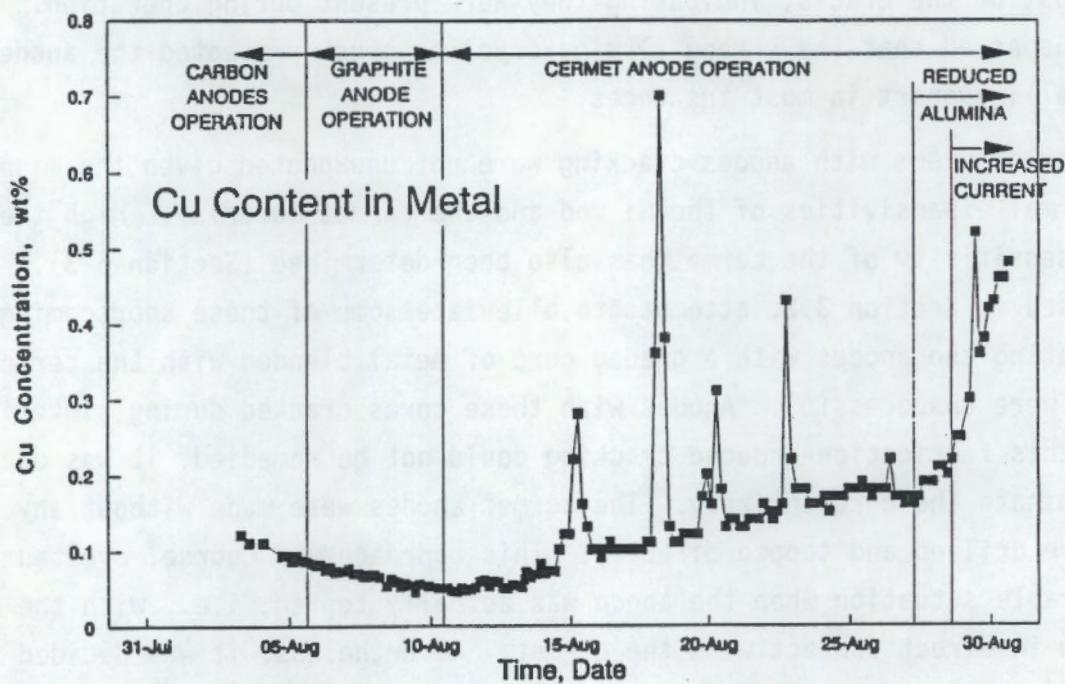
FIGURE 4.42. Concentration of Cu in the Metal as a Function of Time during the Pilot Cell Test
