Inert Electrodes Program

**Results from a Pilot Cell
Test of Cermet Anodes**

August 1992

PNL-8269
UC-313

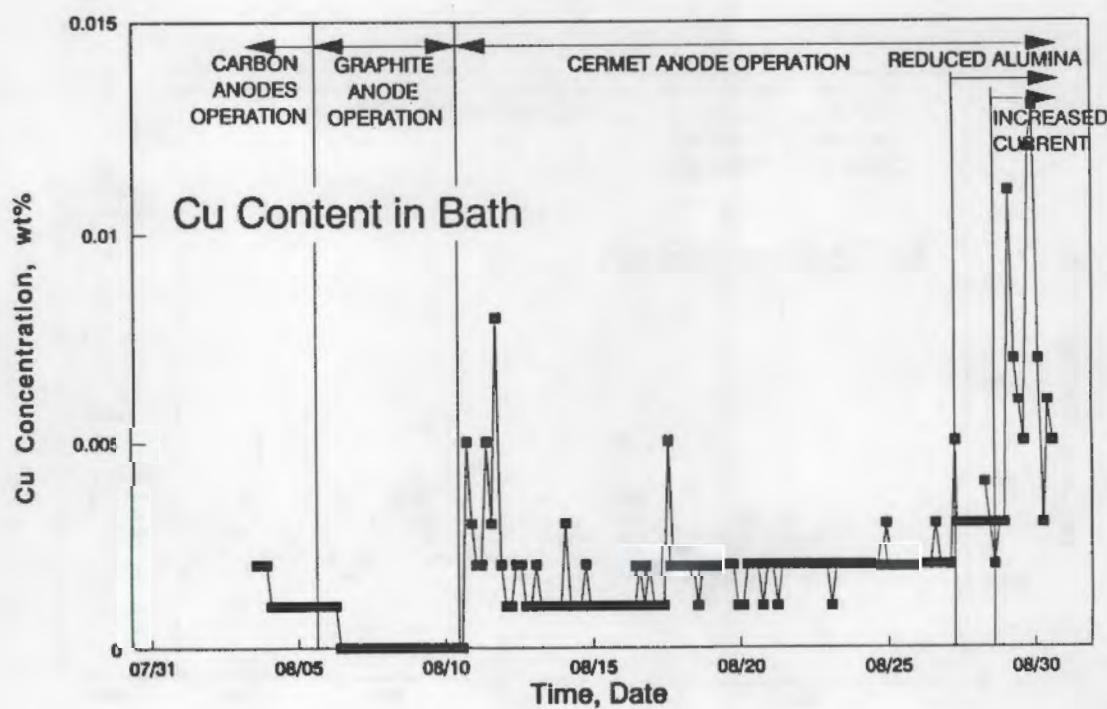
FIGURE 4.45. Concentration of Cu in the Bath as a Function of Time during the Pilot Cell Test

The Fe, Ni, and Cu levels were also monitored in the bath throughout the operation. These values are given in Appendix E and plotted in Figures 4.45 through 4.47. As shown in these plots, little change occurred in the levels of the impurities in the bath throughout the test despite increased levels in

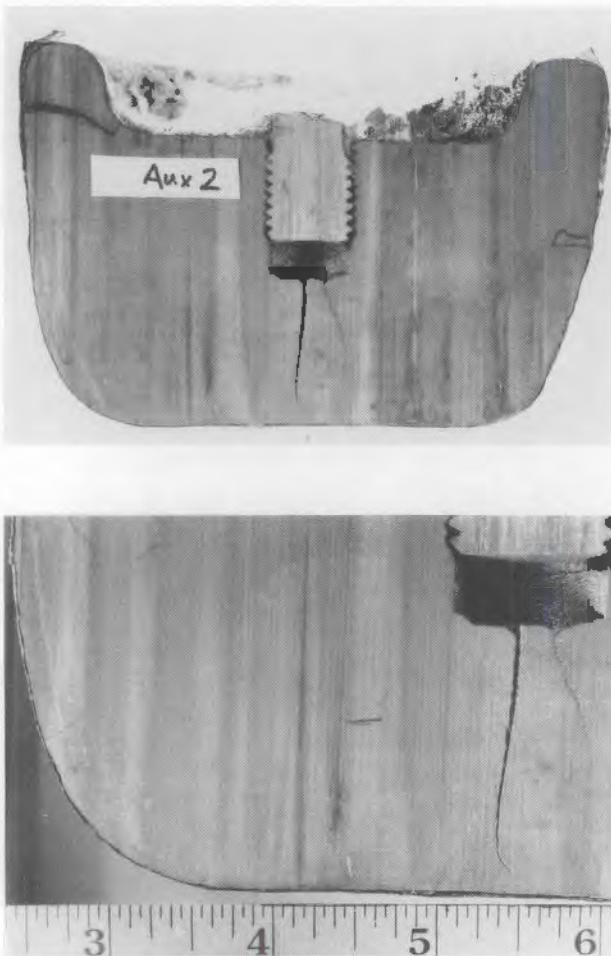
FIGURE 5.3. Photographs of Exterior and Interior of Anode Aux2 after Testing in the Pilot Cell

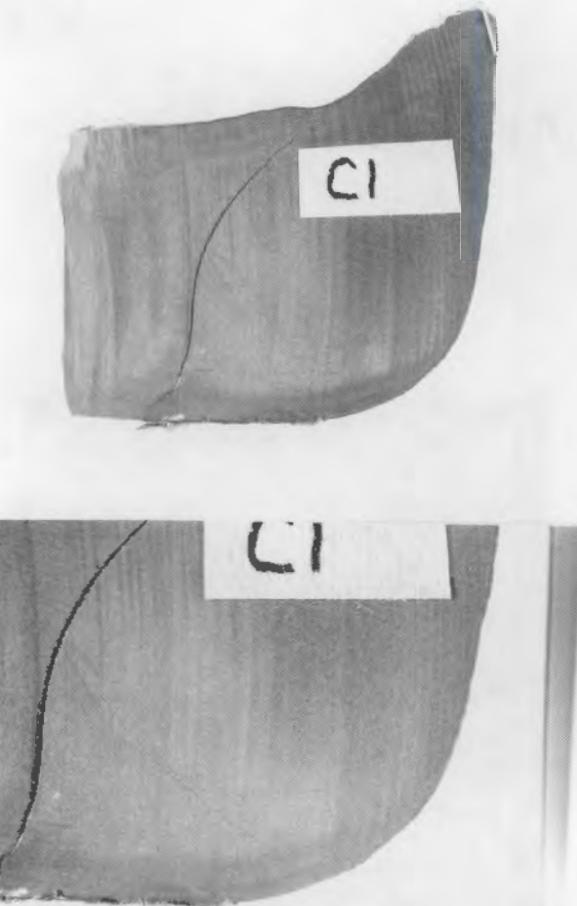
FIGURE 5.5. Photographs of Exterior and Interior of Anode C1 after Testing in the Pilot Cell

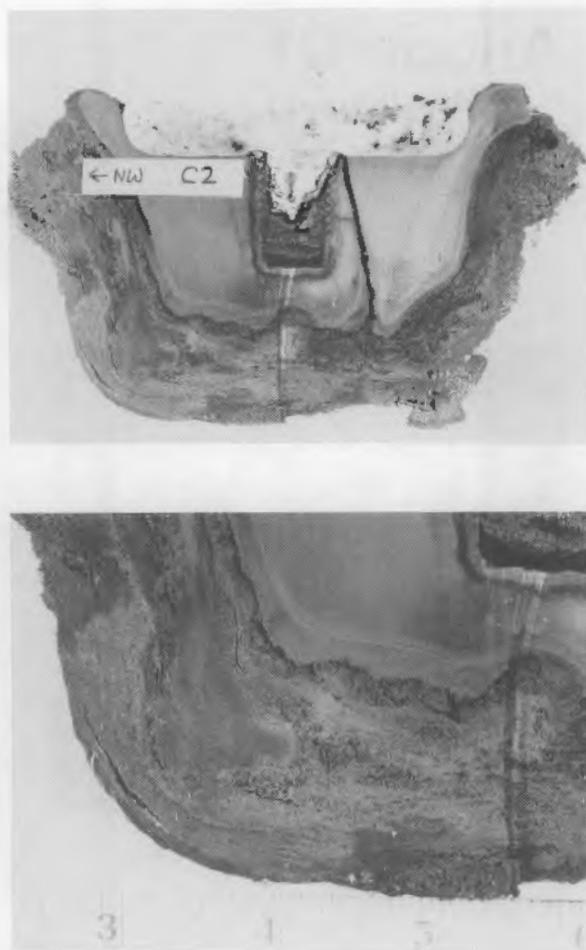
FIGURE 5.6. Photographs of Exterior and Interior of Anode C2 after Testing in the Pilot Cell

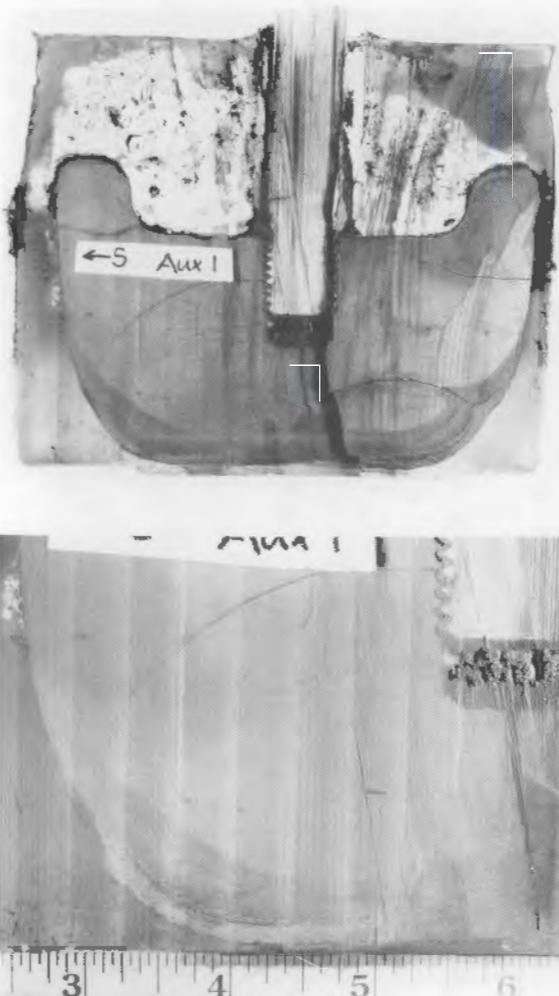
FIGURE 5.9. Photographs of Exterior and Interior of Anode Aux1 after Testing in the Pilot Cell

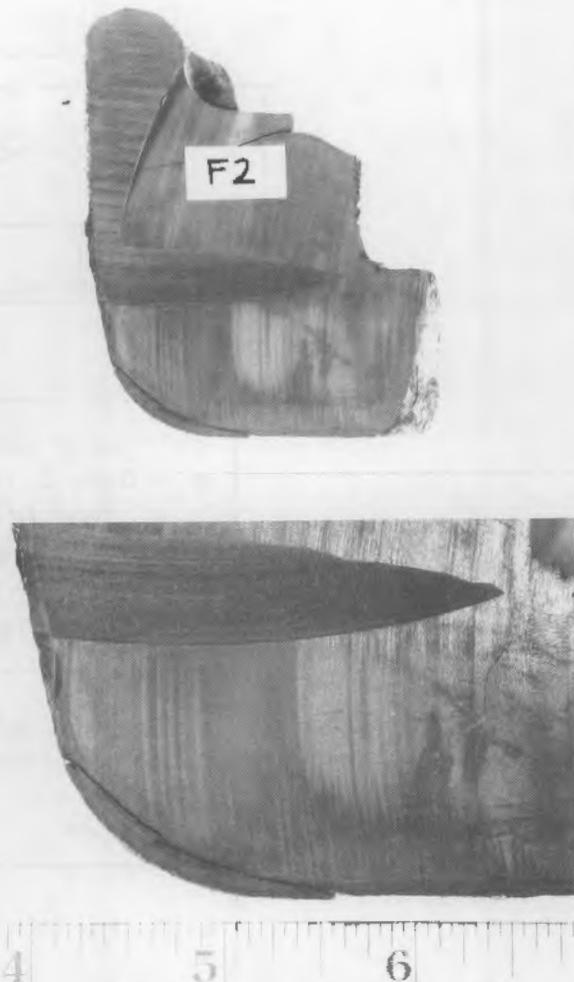
FIGURE 5.12. Photographs of Exterior and Interior of Anode F2 after Testing in the Pilot Cell

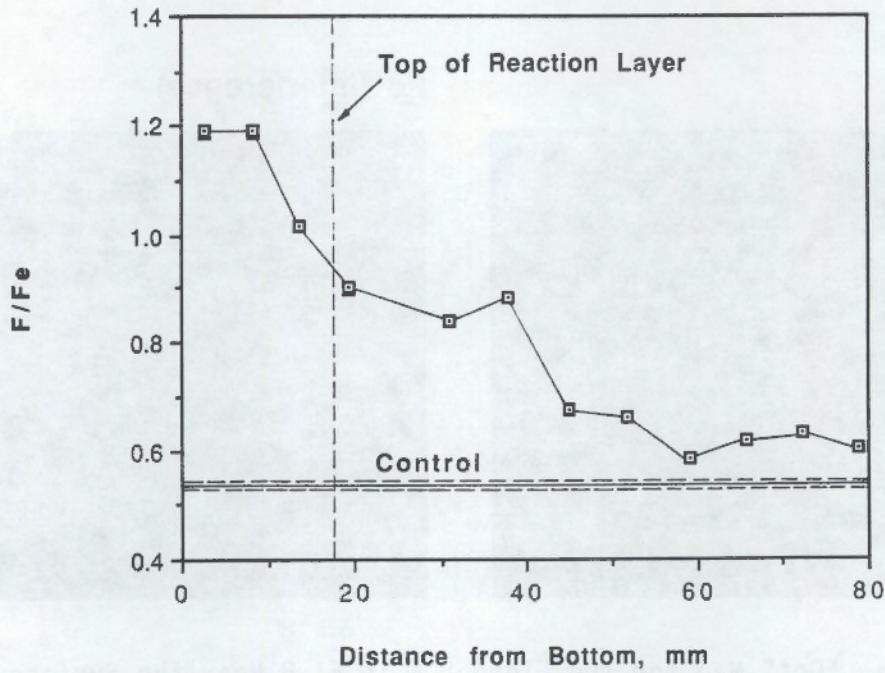
FIGURE 5.28. Variation of F/Fe Intensity Ratio as a Function of Distance from the Bottom of Anode F1

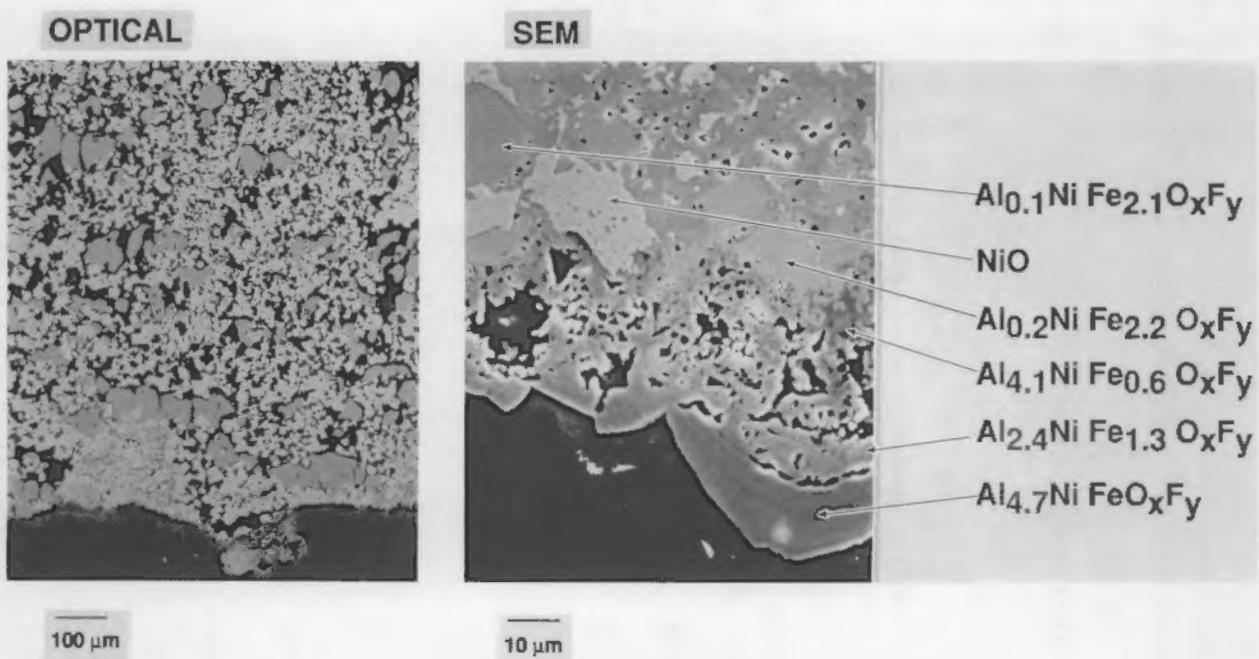
FIGURE 5.29. Micrographs of Region F1-B1

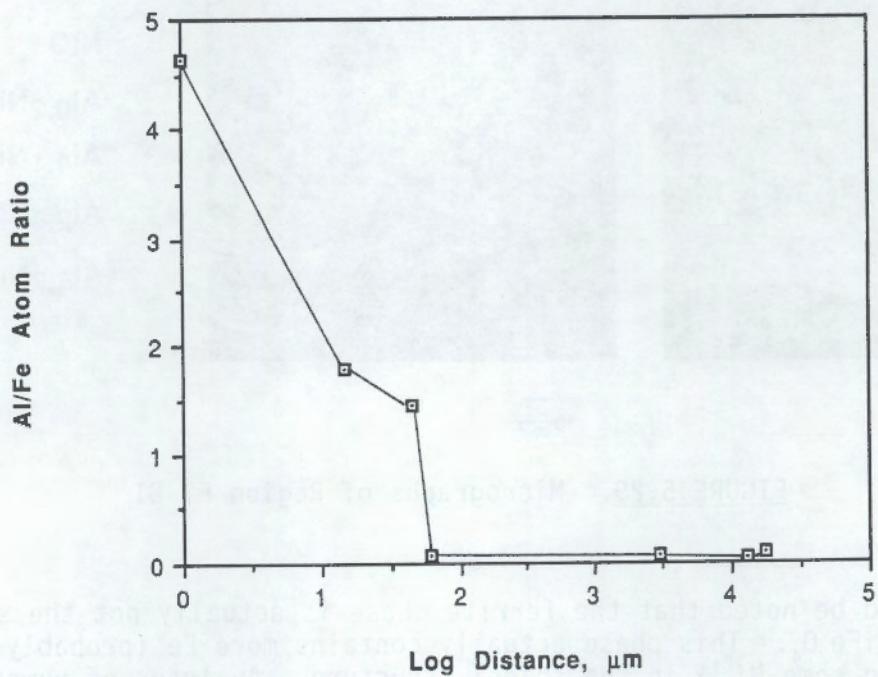
FIGURE 5.30. Variation of Al/Fe Ratio for the Ferrite Phase as a Function of Distance (Log Scale) from the Bottom of Anode F1

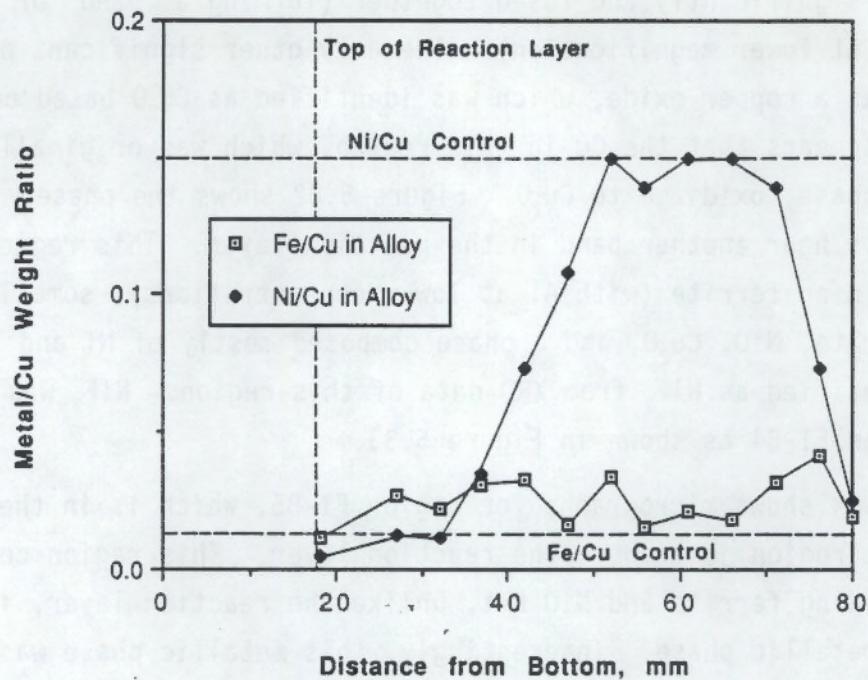
FIGURE 5.35. Composition of Alloy Phase as a Function of Distance from the Bottom of Anode F1

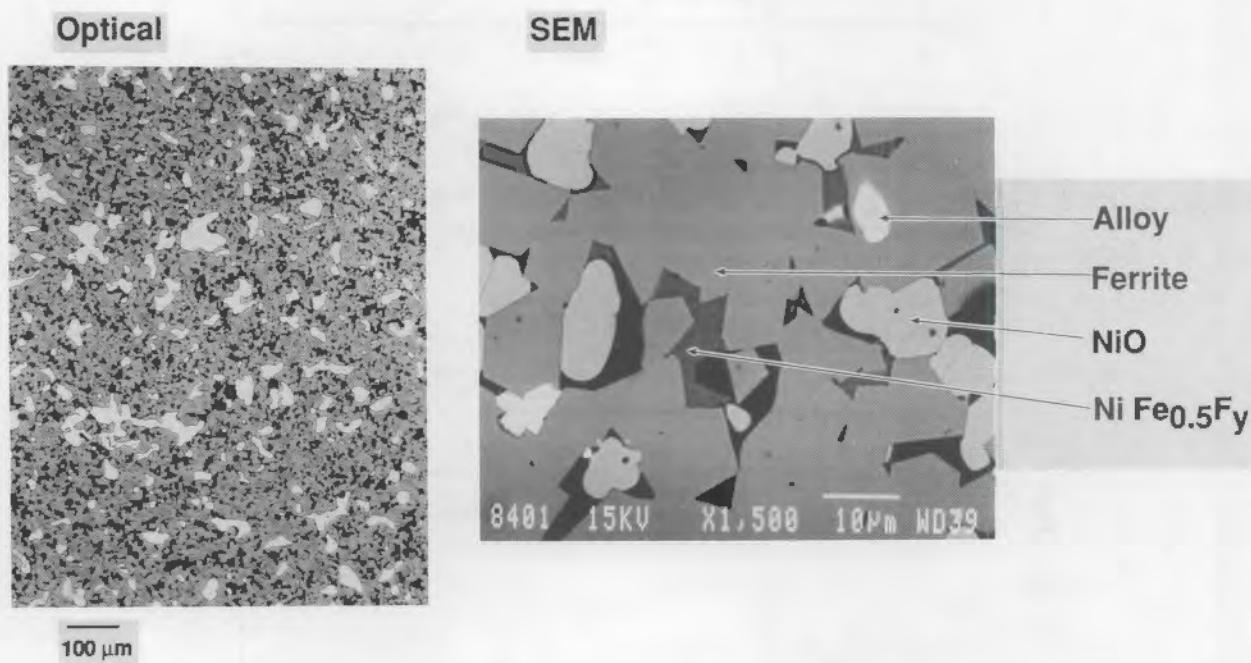
FIGURE 5.38. Micrographs of Region F1-M1

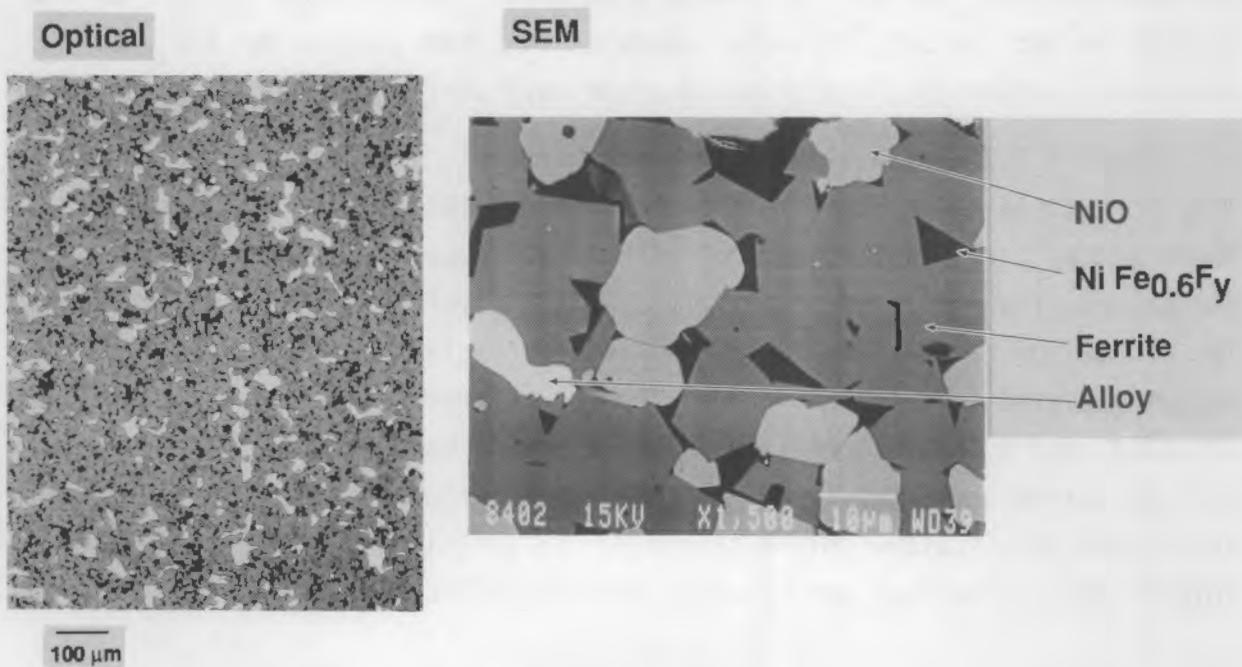
FIGURE 5.39. Micrographs of Region F1-T1

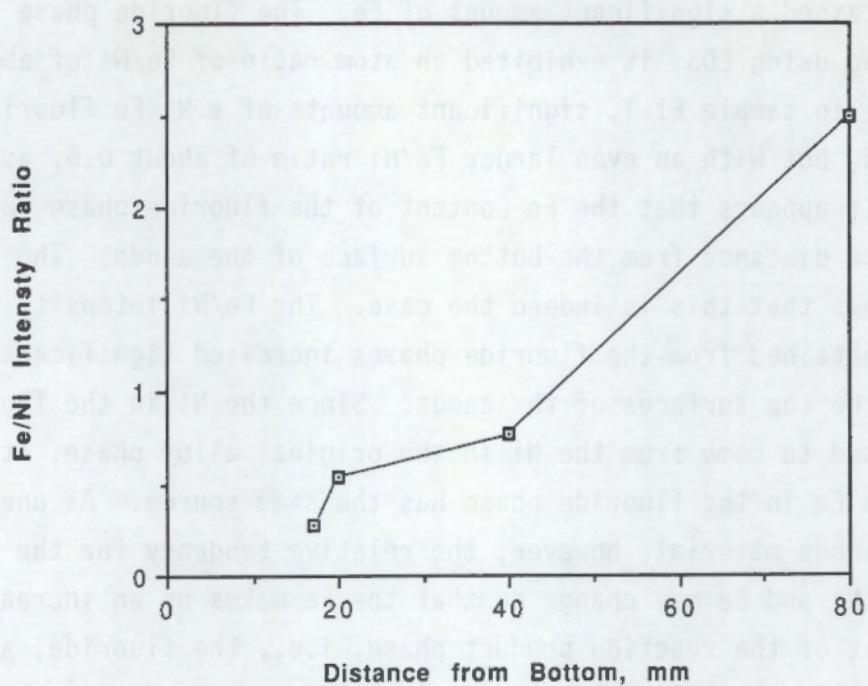
FIGURE 5.40. Composition of the NiF_2 as a Function of Distance from the Bottom of Anode F1

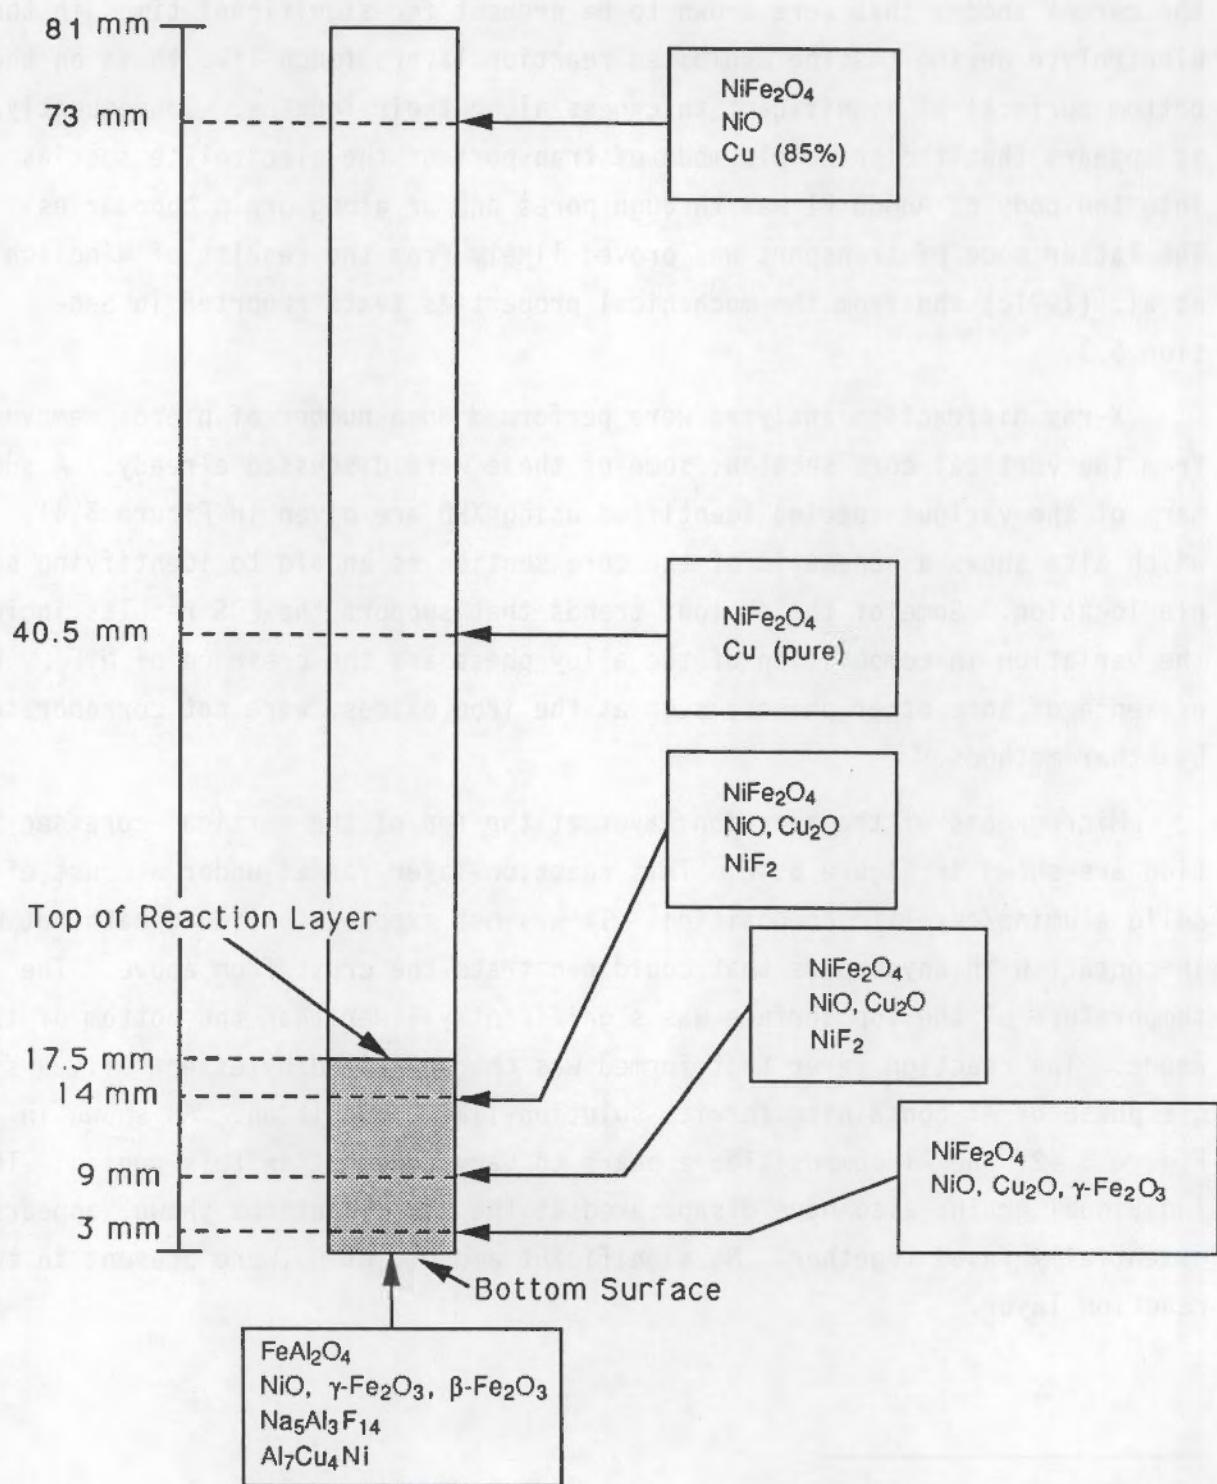
FIGURE 5.41. Schematic Showing Summary of XRD Results on Vertical Core Section from Anode F1

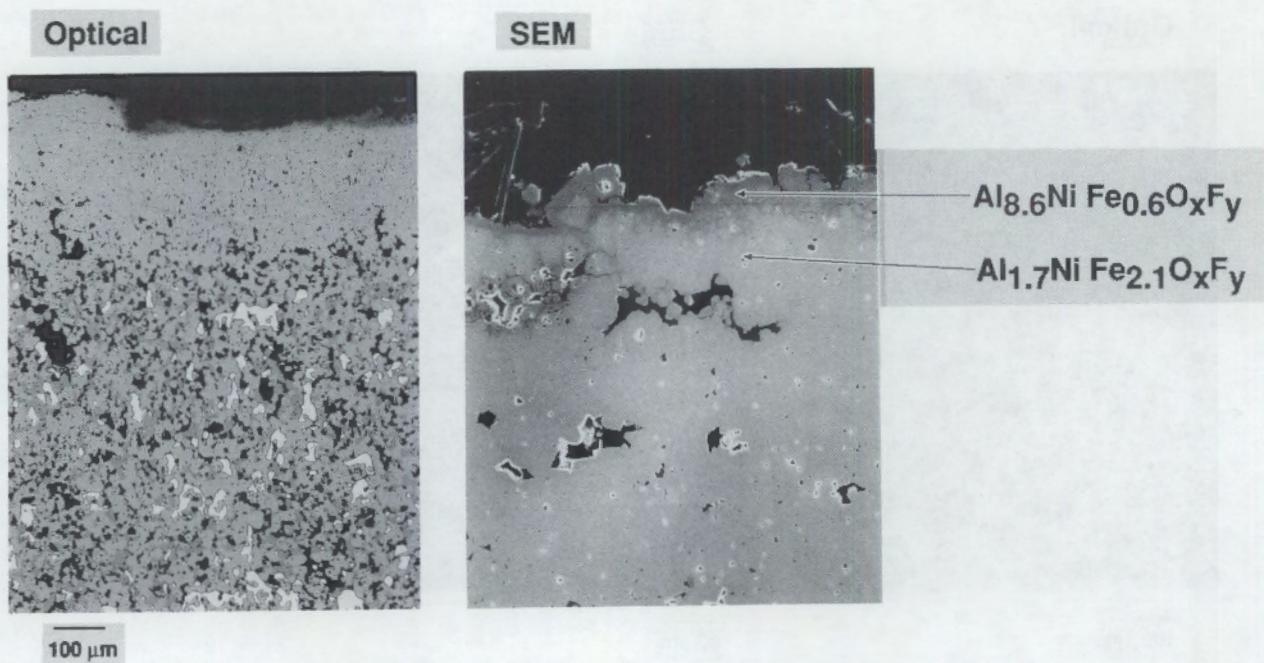
FIGURE 5.43. Micrographs of Region F1-W1 ("Outside")

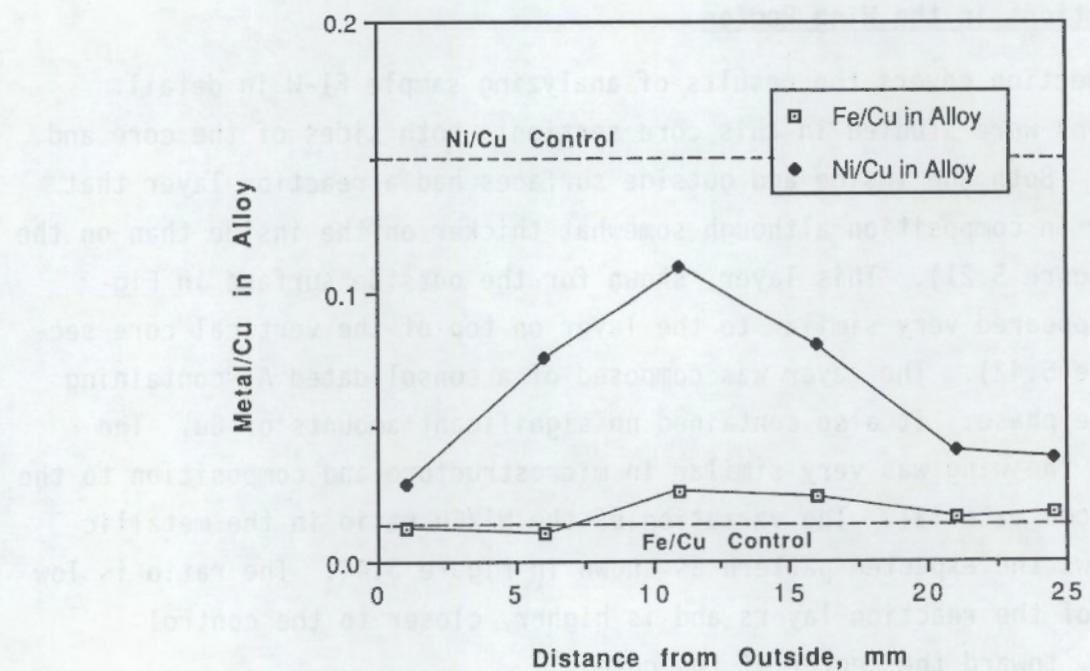
FIGURE 5.44. Composition of Alloy Phase as a Function of Position in the Wing Region

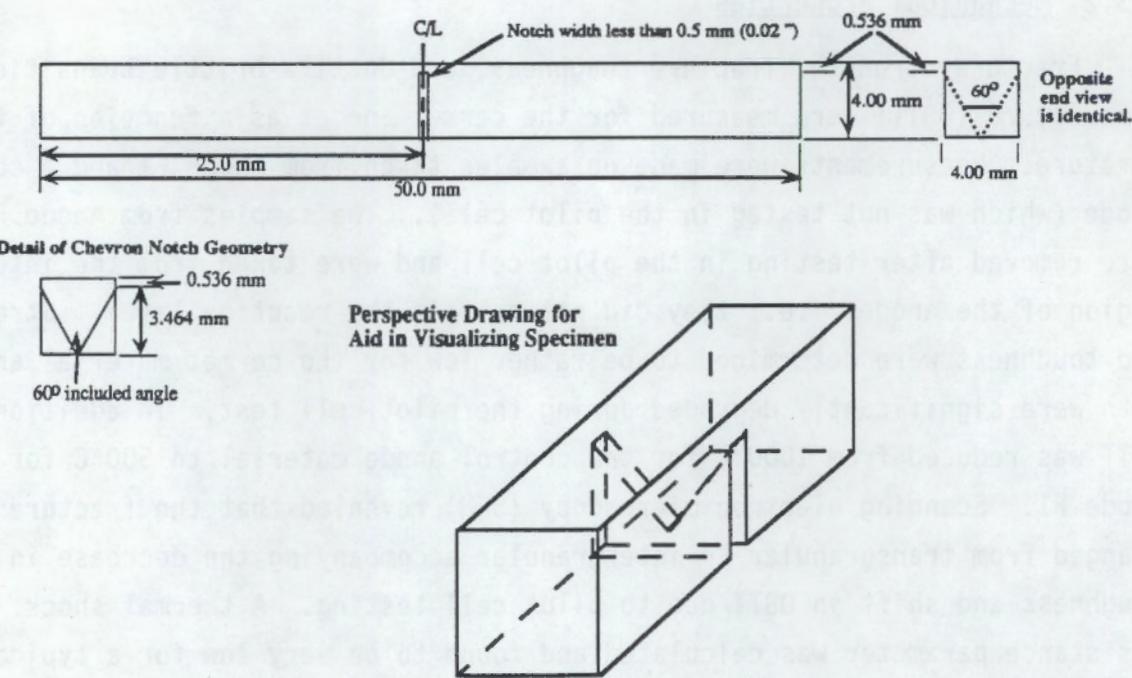
FIGURE 5.48. Chevron-Notch Bars

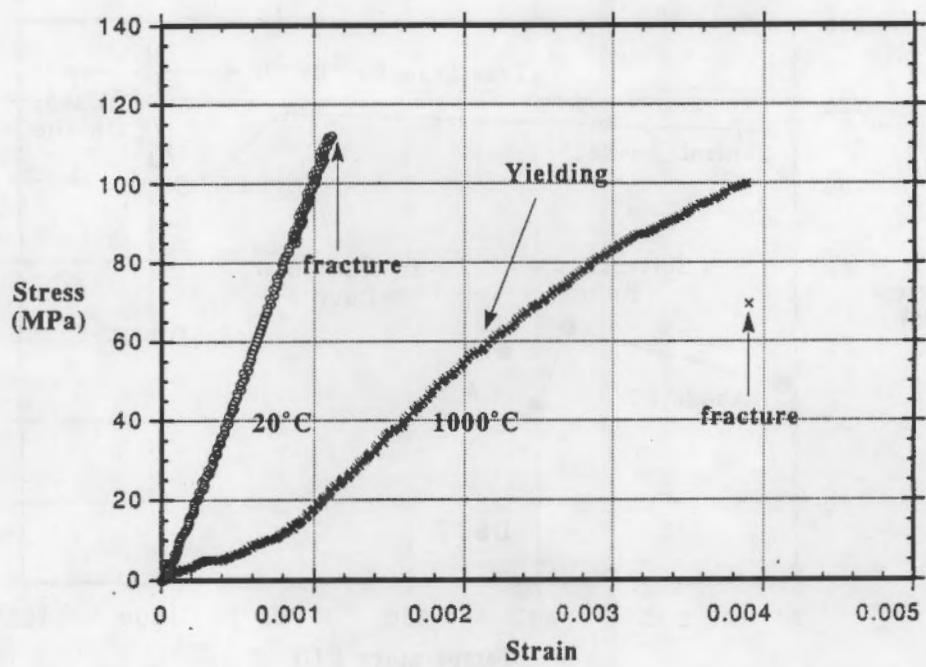
(a) Stress-Strain Curve for Control Anode

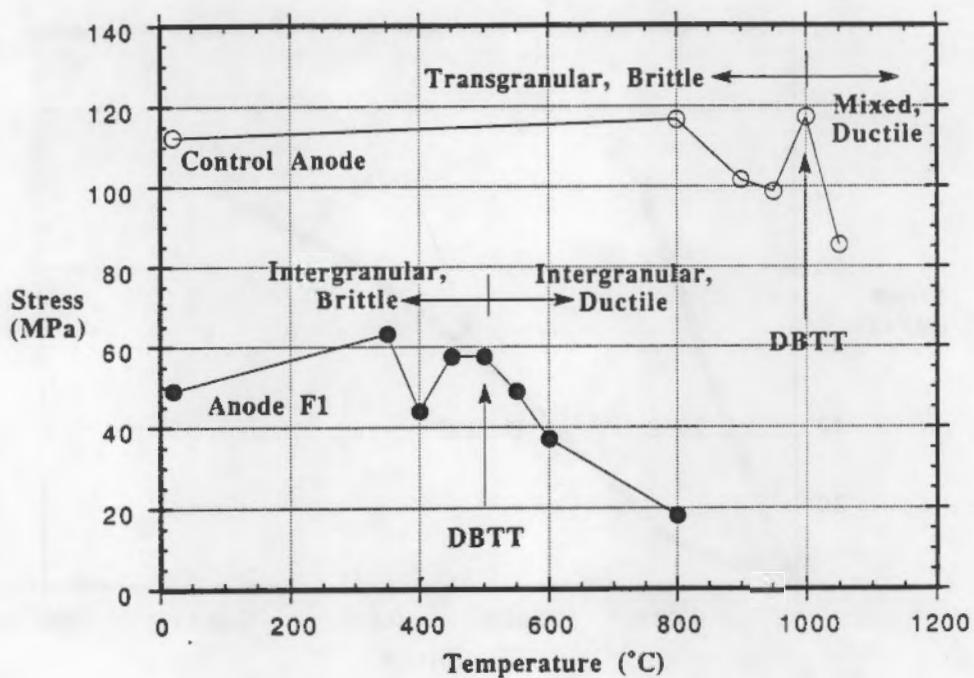
FIGURE 5.50. Variation of Fracture Stress as a Function of Temperature

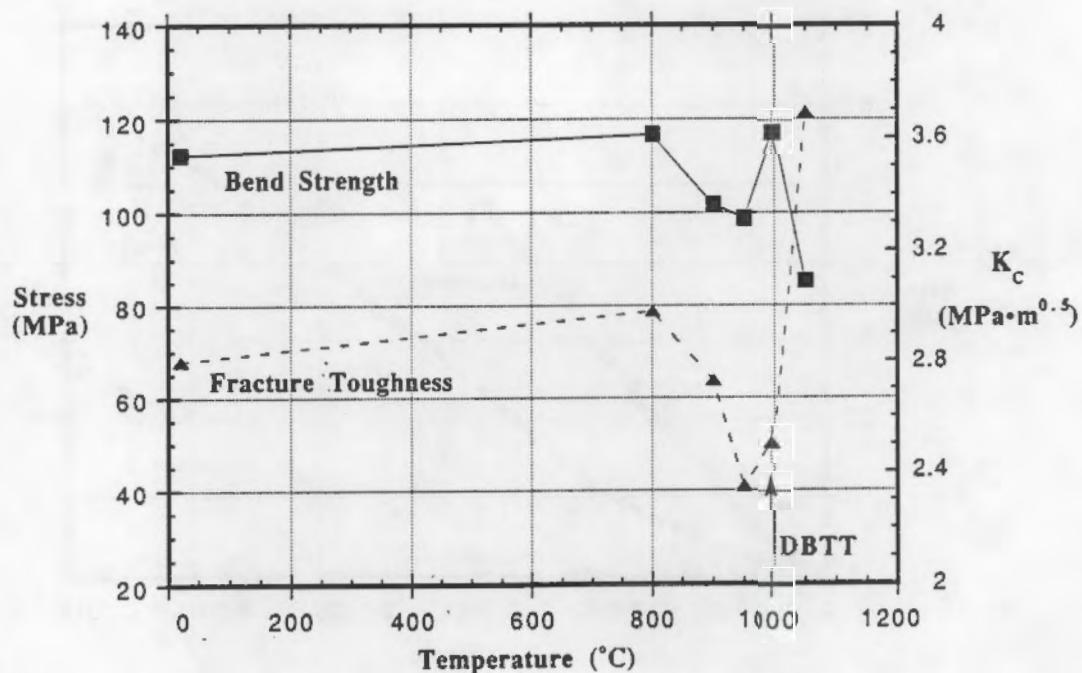
FIGURE 5.51. Toughness and Strength for Control Anode as a Function of Temperature

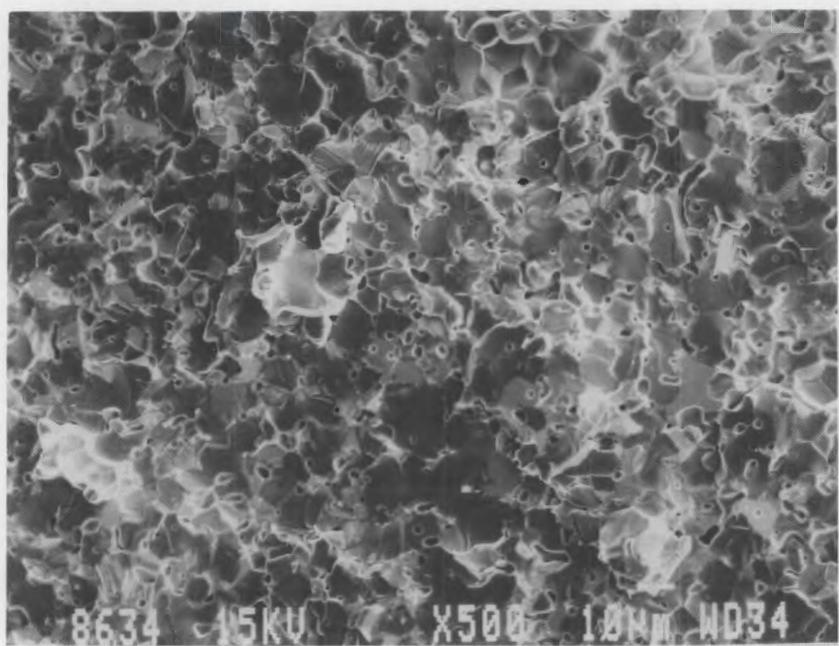
(a) Control Anode Showing Transgranular Fracture

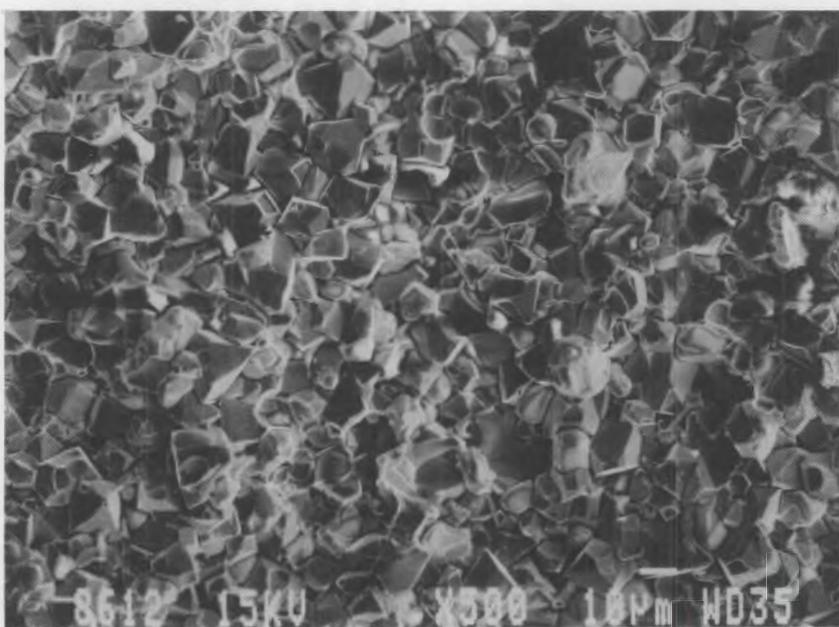
(b) Anode F1 Showing Intergranular Fracture

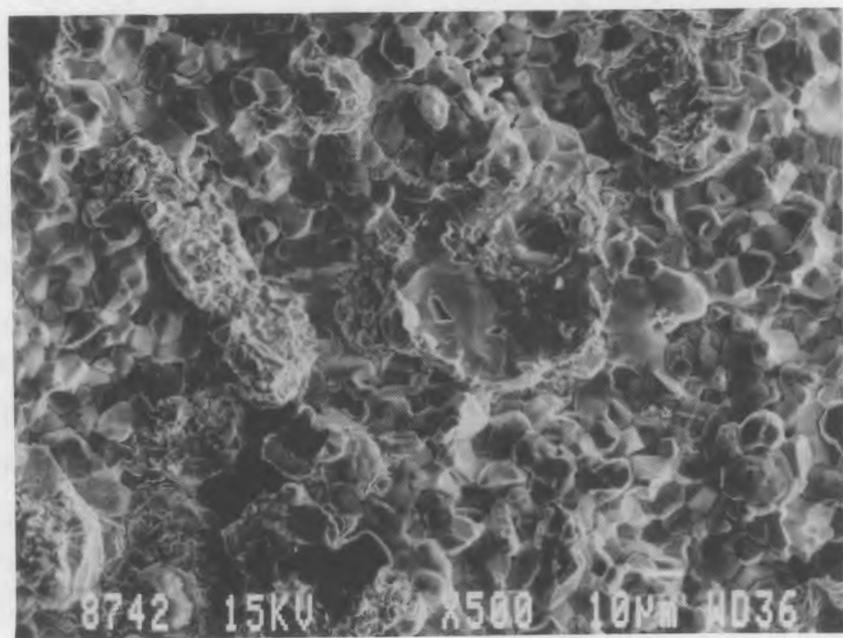
(a) Control Anode at 1000°C Showing Mixed Transgranular-Intergranular Fracture

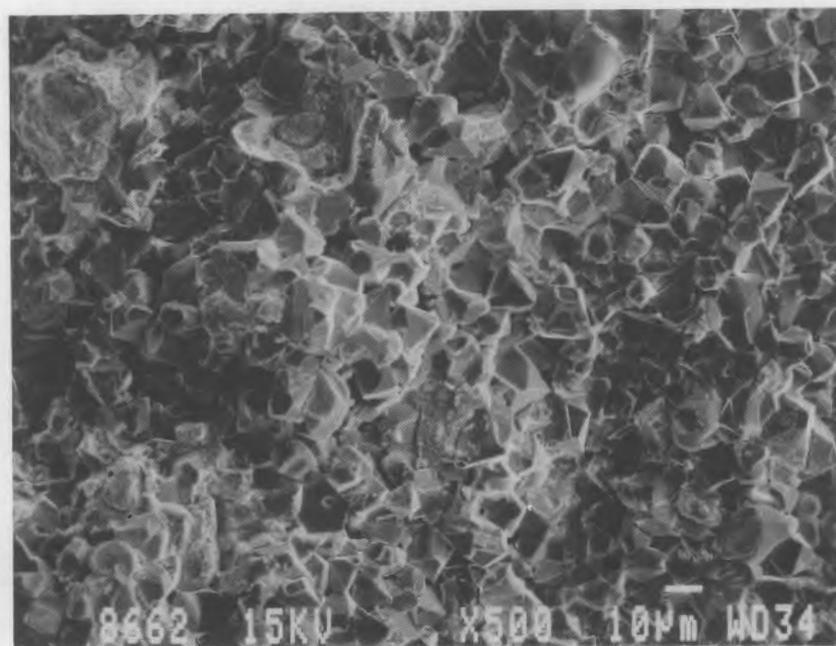
(b) Anode F1 at 500°C Showing Intergranular Fracture

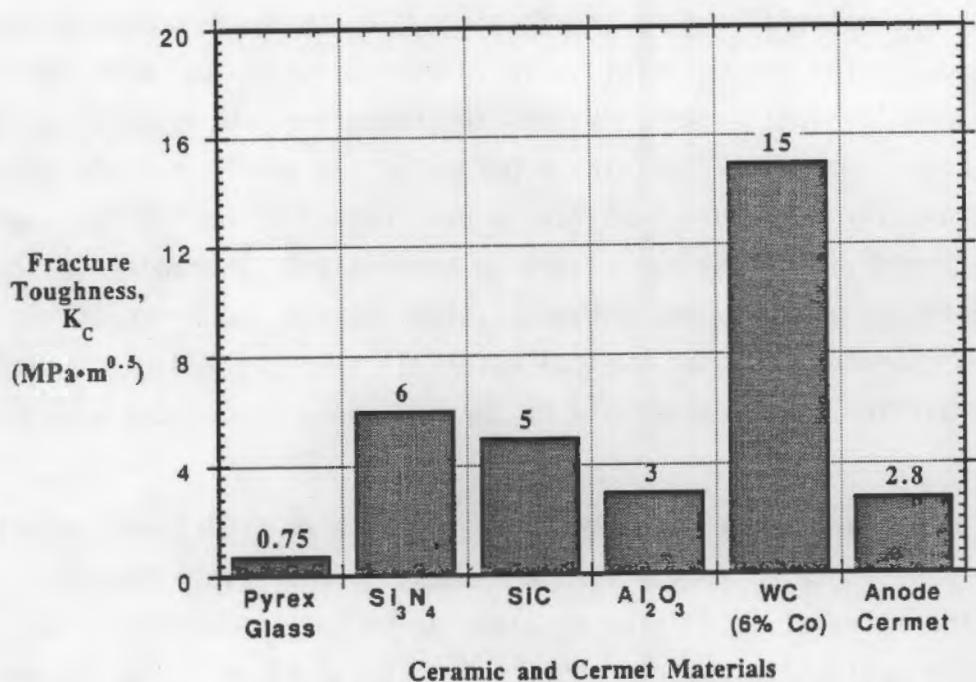
FIGURE 5.55. Comparison of Fraction Toughness Values

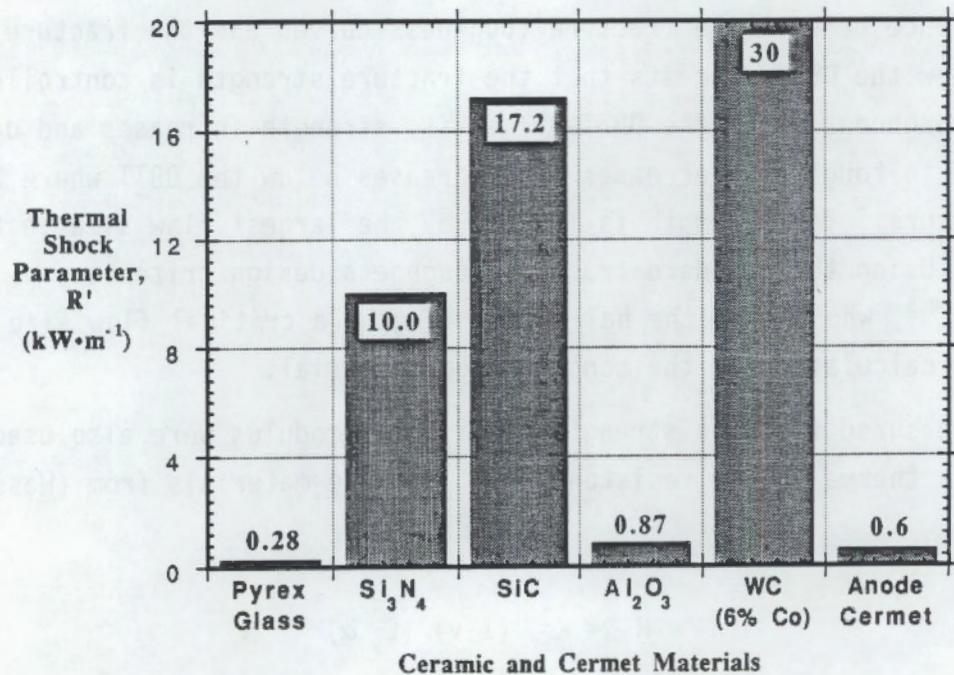
FIGURE 5.56. Comparison of Thermal Shock Values

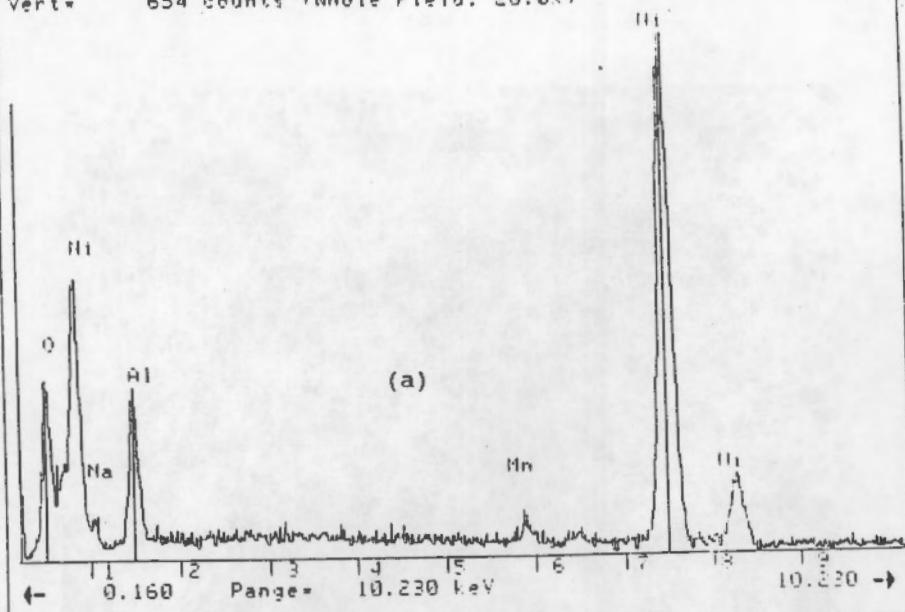
Hi Pod Failed Above Inert Anode (Bright Area)
Vert= 4996 counts (Whole Field, 170X)

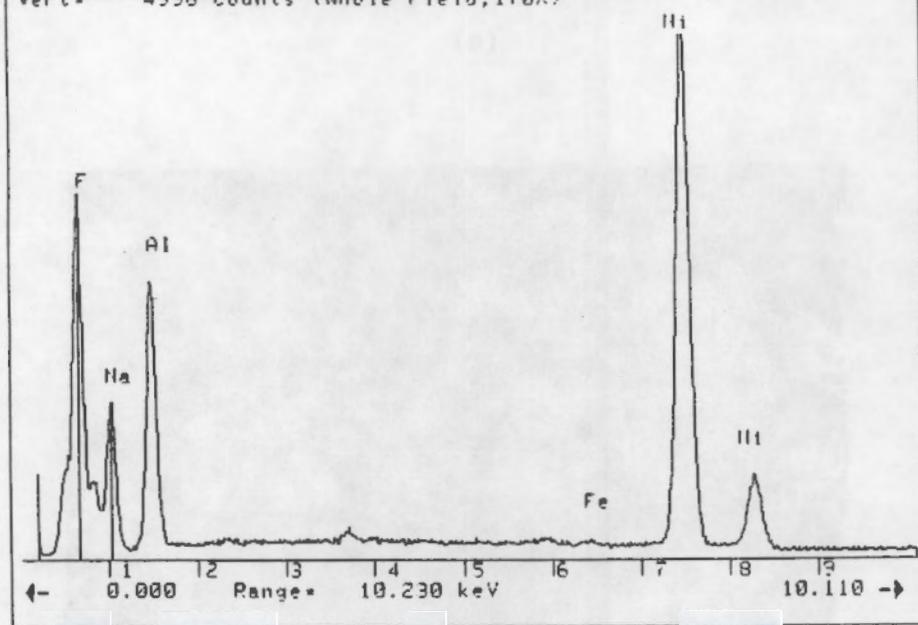
Figure 2 EDS obtained for (a) the whole field of failed surface in Figure 1 (a), and (b) the whole field of the surface in Figure 1 (b).

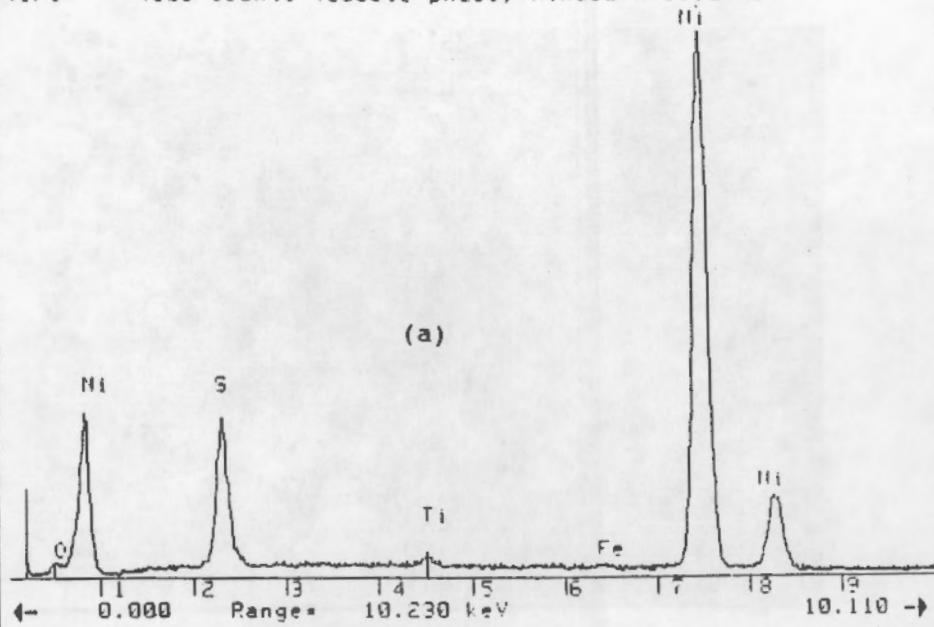
Ni Rod, Opposite side from Failure Site
Vert= 2859 counts (Smooth Phase, Window Area, 2440x)

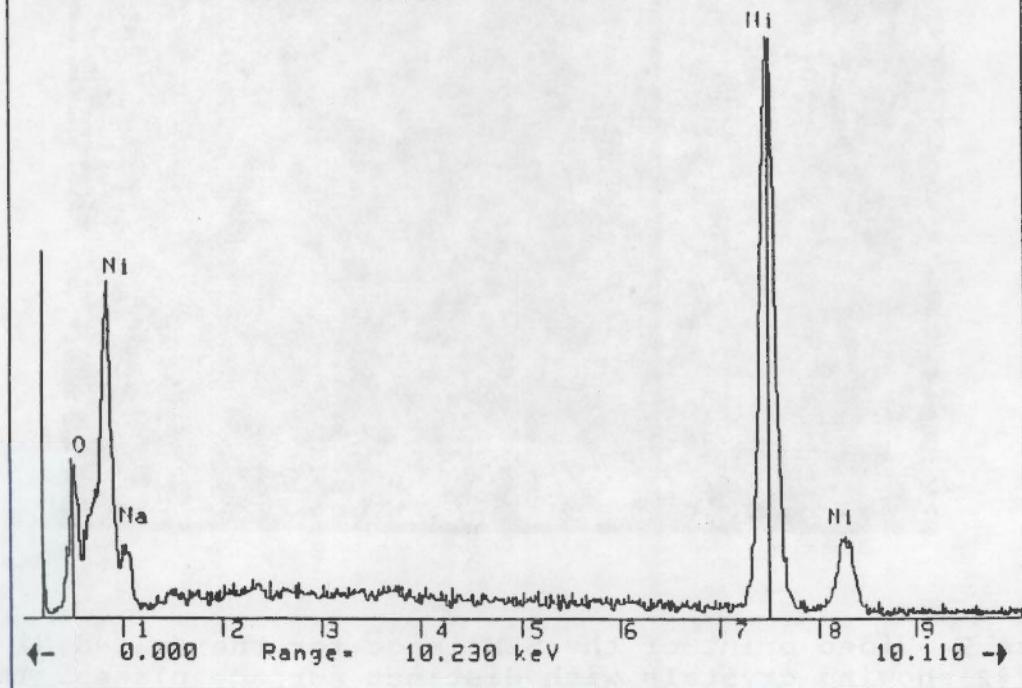
Figure 8 EDS obtained for the green layer zone shown in Figure 7 (a).
