LA-10126-PR
Progress Report

Space Nuclear Safety Program

November 1983

This technical monthly report covers studies related to the use of $^{238}\text{PuO}_2$ in radioisotope power systems carried out for the Office of Special Nuclear Projects of the US Department of Energy by Los Alamos National Laboratory. Most of the studies discussed here are ongoing. Results and conclusions described may change as the work continues.

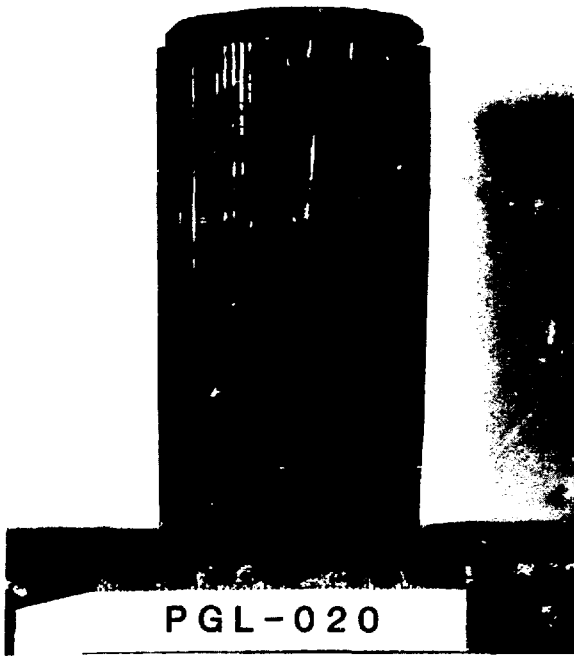
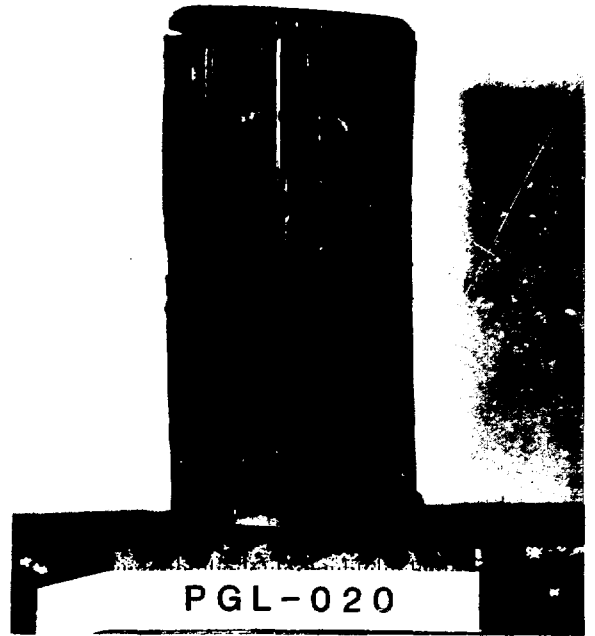
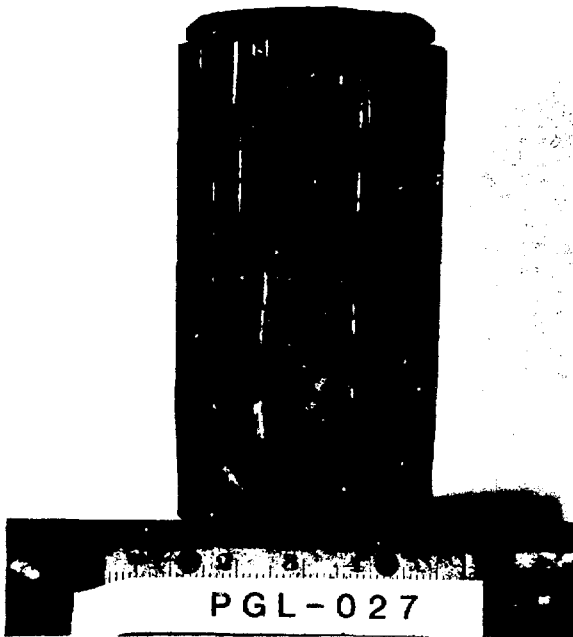
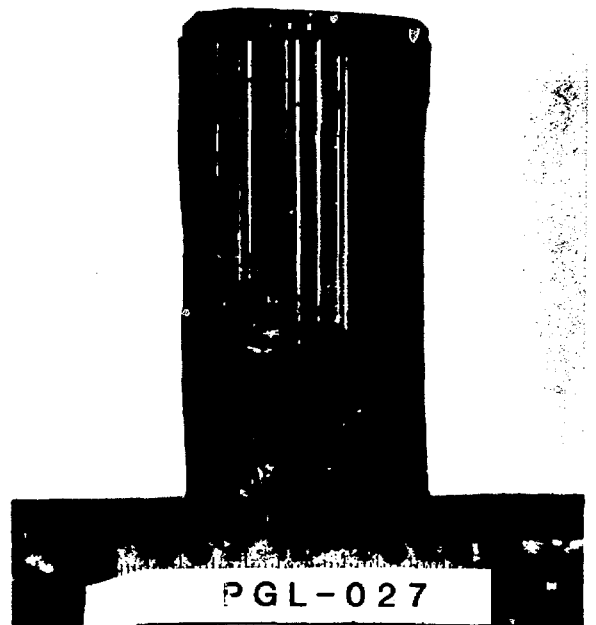
Fig. 3. Graphite impact shells from test SVT-3 showed longitudinal cracks on the impact face and bowed profiles after the test: (a) PGL-020 impact face; (b) PGL-020 side; (c) PGL-027 impact face; (d) PGL-027 side (0.95X).

The photographs in Fig. 2 illustrate the post-impact condition of the aeroshell. There were no cracks on either the impact face or the sides of the aeroshell, but a partial diagonal crack was present on the back side. Both GISs had longitudinal impact-face cracks and typical bowed profiles (Fig. 3).

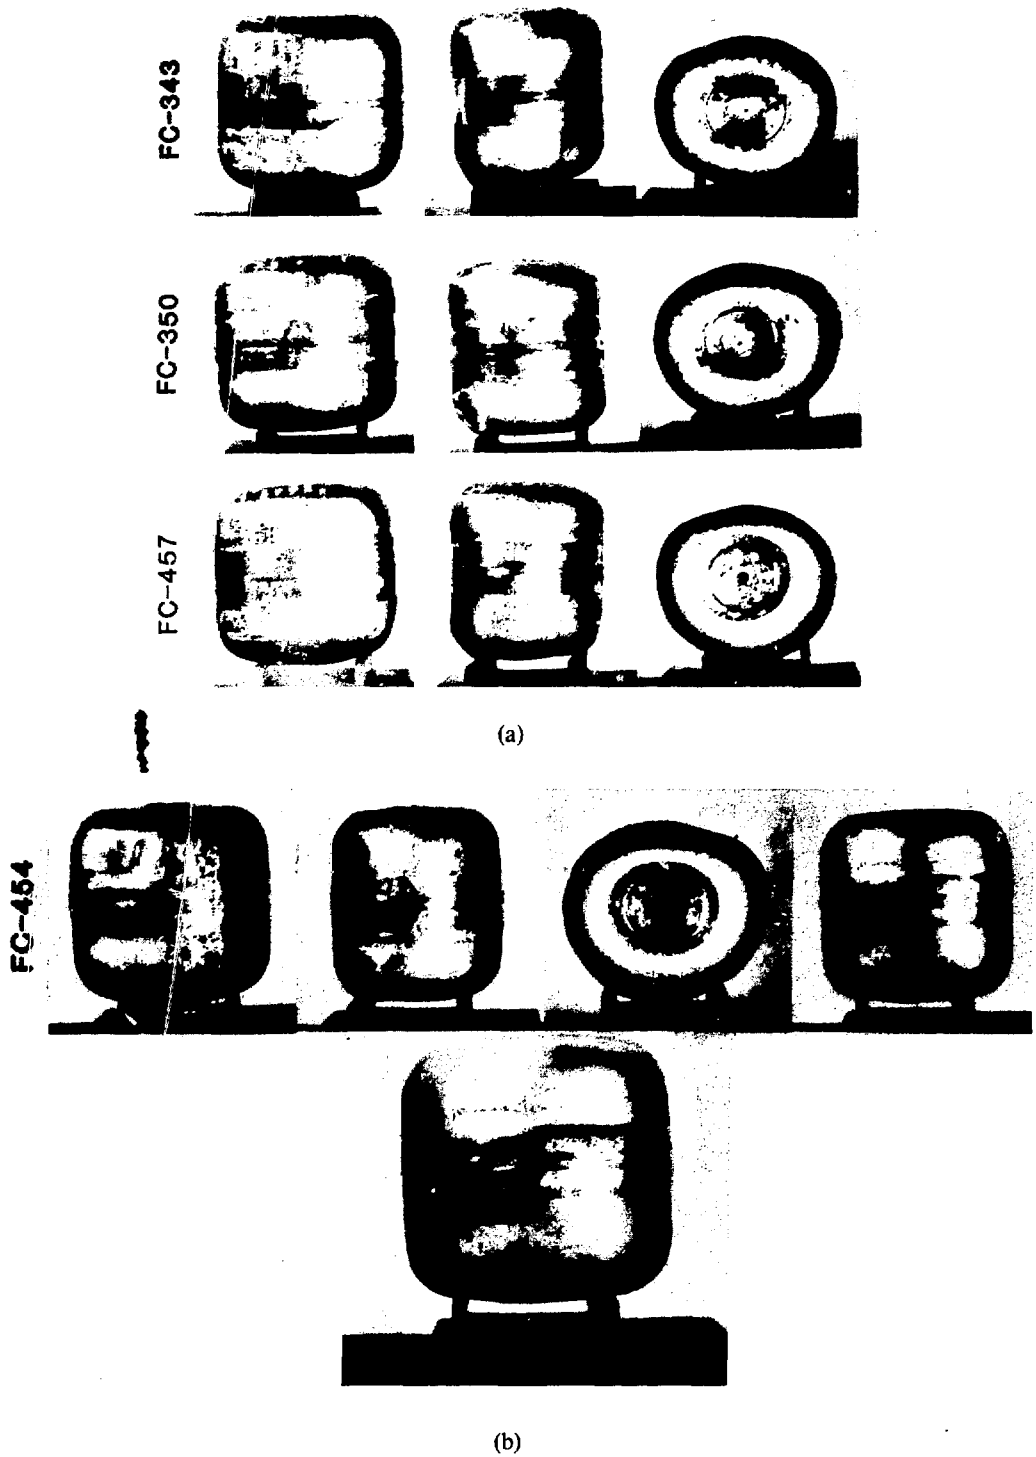
Fig. 4. Deformation of the impacted clads of test SVT-3: (a) fueled clads FC-343, -350, and -457 showing (l to r) impact face, side profile, and end profile (1X); (b) fueled clad FC-454 showing (top, l to r) impact face, side profile, end profile, and back side (1X) and (bottom) enlarged view of the back side with small crack in the shield cup (1.5X).

The fueled clads (HF-343 and HF-350) in the prime impact assembly failed; only moderate localized deformation of the iridium was observed. A minor fracture occurred on the center of the back side of the HF-454 shield cup, but there were no failures of the iridium clad of HF-457. Photographs are shown in Fig. 4. Overall deformation of the fueled clads are listed in Table VI, along with the estimated area of the fracture.

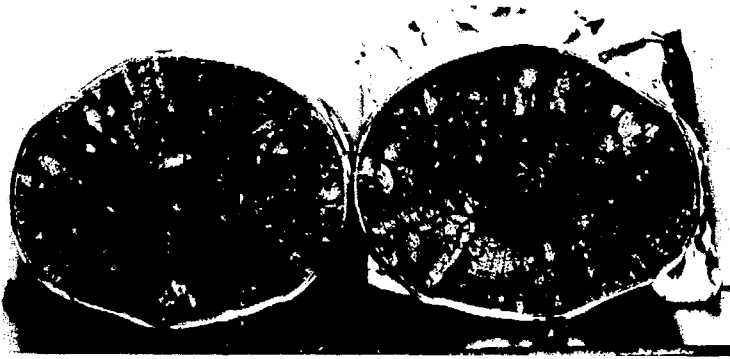
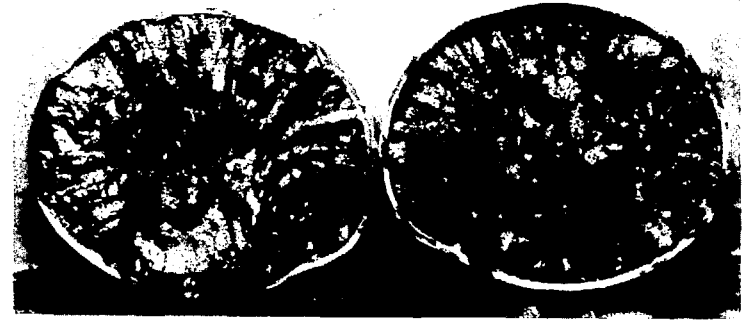
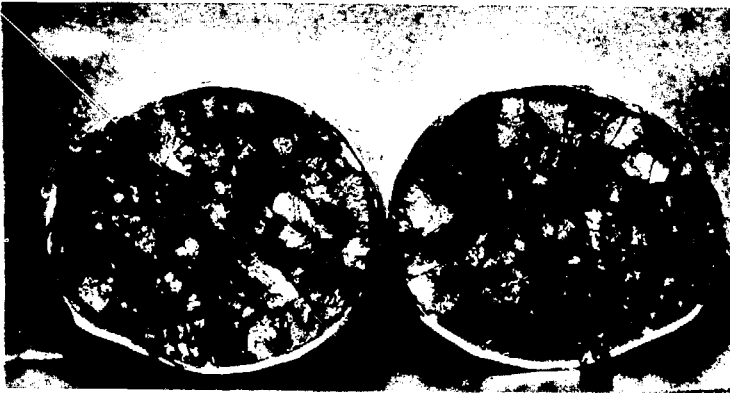
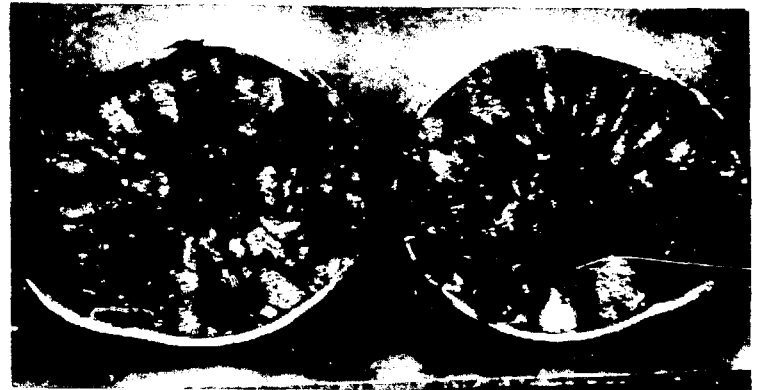
Fig. 5. Fracture patterns of the plutonia pellets of test SVT-3: (a) HF-343; (b) HF-350; (c) HF-454; (d) HF-457 (1.5X).

The fracture patterns of the plutonia are shown in Fig. 5. Pellets HF-343 and HF-350 were similar, consisting of radial, columnar fragments and nearly symmetrical overall deformation. The fracture pattern of HF-454 shows randomly oriented fragments, more nearly equiaxed and generally larger than those of HF-343 or HF-350. The overall deformation is only slightly asymmetric, and there appears to be no significant fuel fragment displacement at the location of the failure in the shield cup. Radial, columnar fragments are also observed in HF-457, but the fragments are larger than those in HF-343 and HF-350. Unsymmetrical overall deformation, with a mild reverse bend in the clad at the impact face, can be seen.

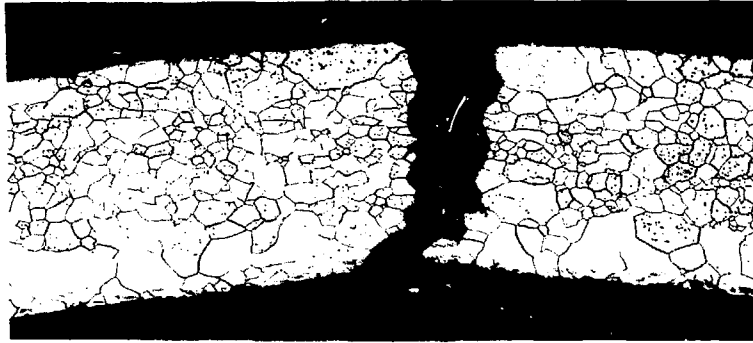
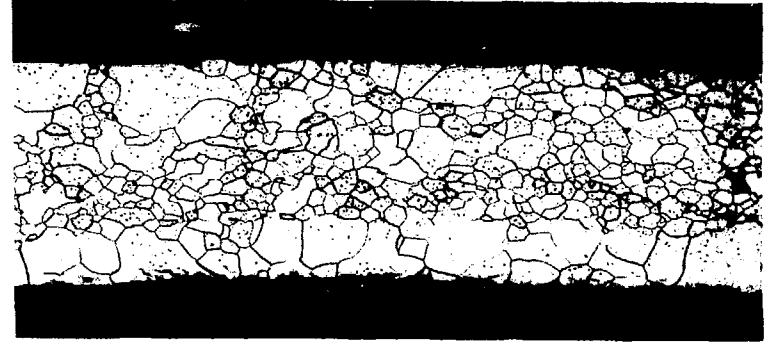
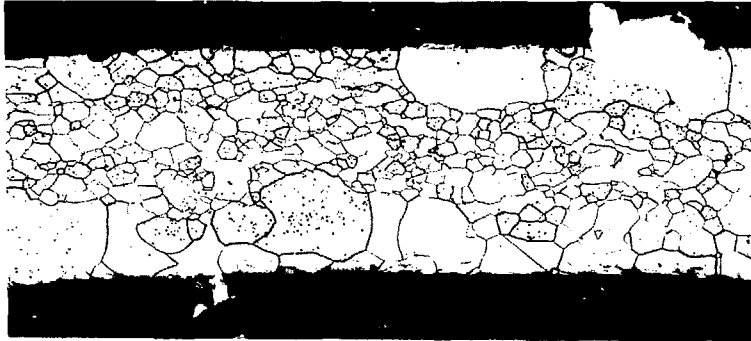
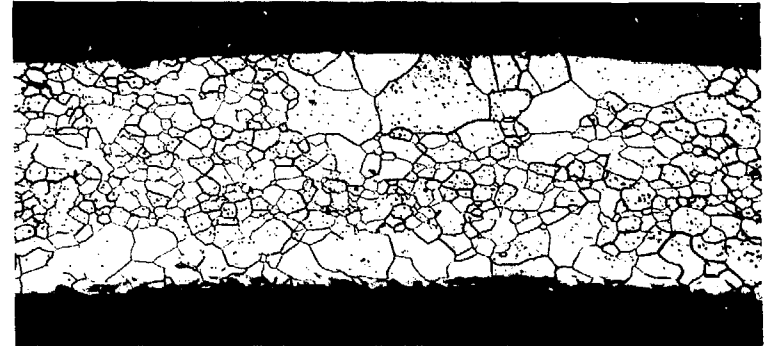
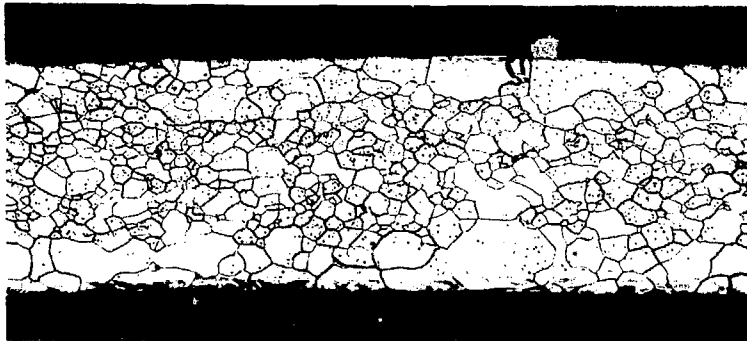
Fig. 6. Iridium microstructure of the shield cup of FC-454 (50X).

Metallographic examination of a transverse cross section through the fracture in the shield cup of HF-454 revealed a variable microstructure (Fig. 6). Large grains occupying 20-25% of the thickness, occurred on the interior of the shell throughout the section examined and at random locations on the exterior. The fracture mode was intergranular. A small reduction in thickness (about 4%) near the fracture indicated limited ductility.

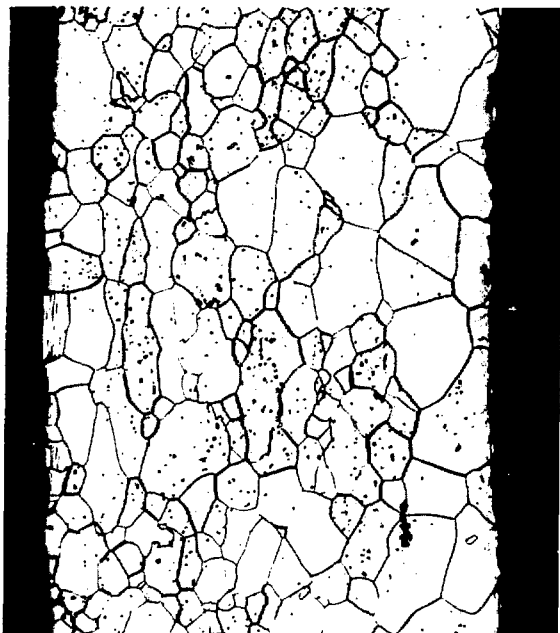
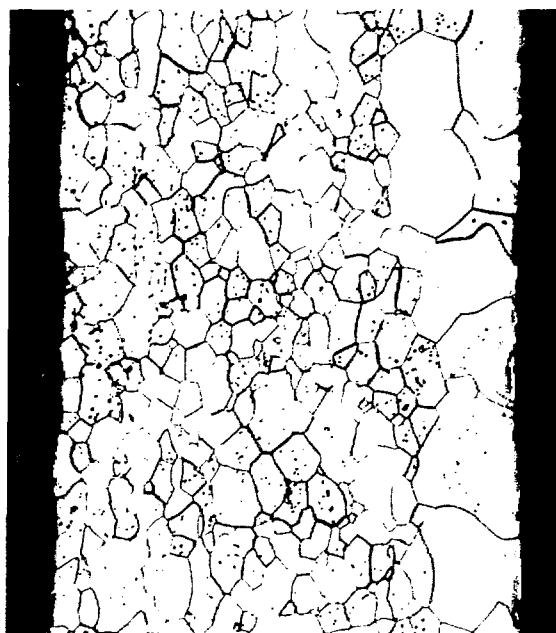
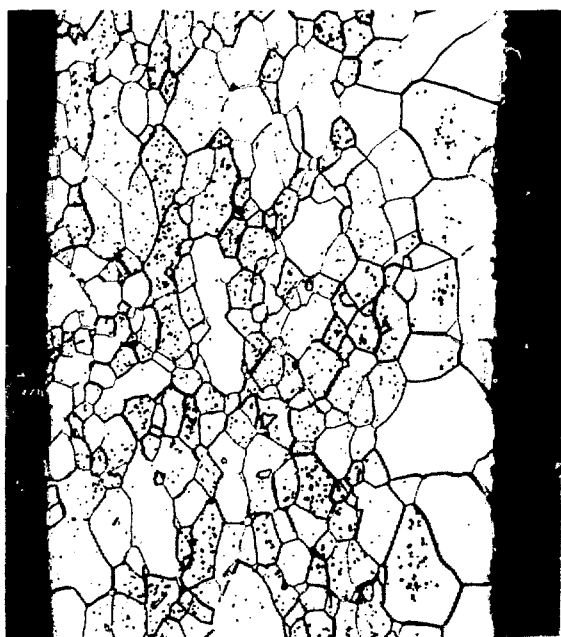
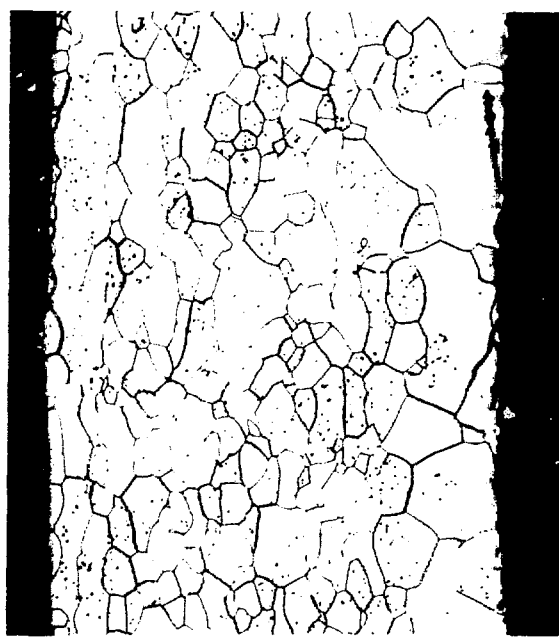
Fig. 7. Typical microstructures of the iridium of HF-343 and HF-350: (a) HF-343 vent cup; (b) HF-343 shield cup; (c) HF-350 vent cup; (d) HF-350 shield cup (100X).

Typical microstructures of transverse sections of the iridium cups of the prime fueled clads HF-343 and HF-350 are shown in Fig. 7. All four samples had nonuniform microstructures, with large grains on the interior. Typically, 20-25% of the thickness consisted of one or two grains. The average grain sizes are listed in Table I. The shield cup of HF-343 had a larger grain size than the other iridium cups in SVT-3, but all are considerably finer grained than the seven to eight grains across the wall predicted from previous observations.

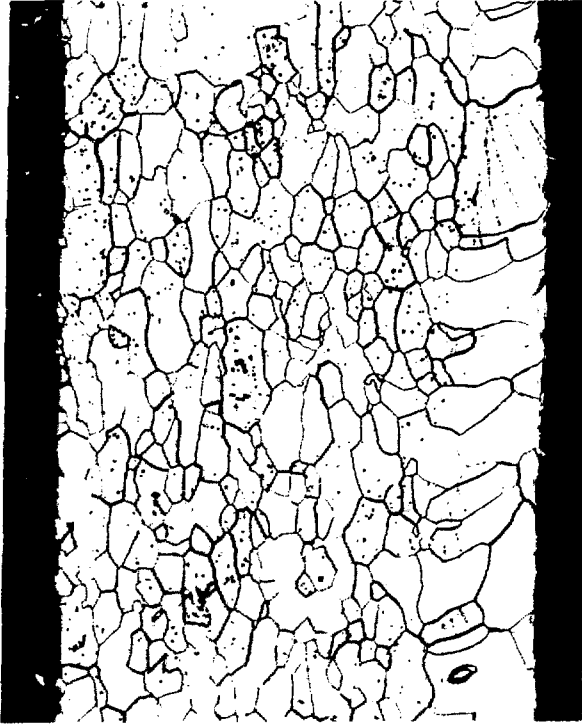
Fig. 8. Abnormal microstructure observed in transverse cross section of the shield cup of HF-350 (100X).

A region of the shield-cup cross section of HF-350 exhibiting a columnar microstructure with some grains showing a substructure similar to that seen in weld metal is shown in Fig. 8. This structure is similar to that observed at the fracture site of the shield cup of HF-261 in the SVT-1 test. The appearance of the weld metal substructure and the columnar grains normal to the thickness direction of the clad wall identify this region as that of the laser weld used to attach the weld shield tab. This microstructure is not characteristic of a large fraction of the cup, but is a structure susceptible to cracking if subjected to bending with the tensile stress on the interior.

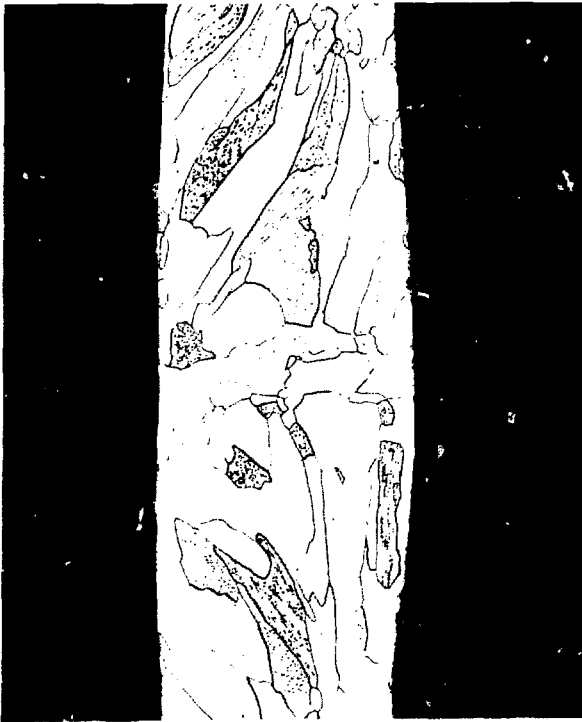
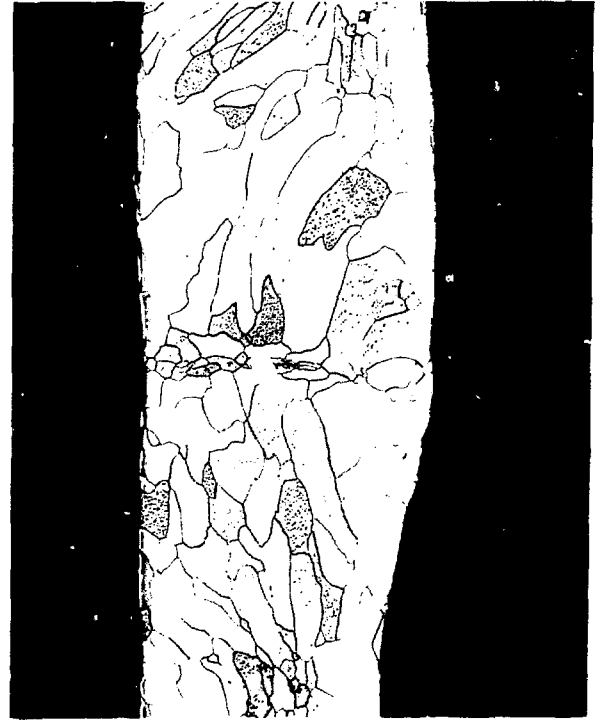
Fig. 9. Microstructure of the weld bead of fueled clads of the prime impact assembly of test SVT-3: (a) HF-343; (b) HF-350 (50X).

The weld cross sections of both prime fueled clads indicated full penetration welds with no porosity and desirable microstructures. Metallographic cross sections are shown in Fig. 9.

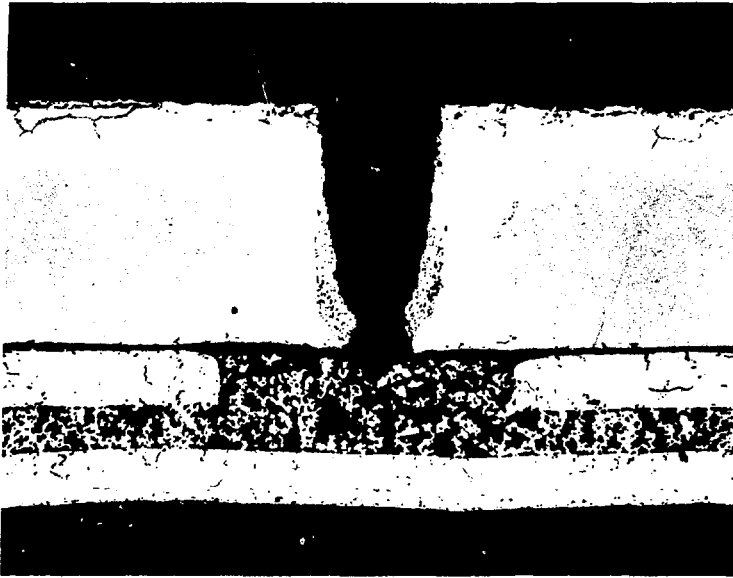
Fig. 10. As-polished cross section of the vent of HF-454 (50X).

Because of the appearance of vent effusate on HF-454, the vent assembly of this secondary fueled clad was sectioned and examined. There were nonmetallic deposits in the filter element (principally at the entrance to the vent assembly), porous vapor-transported iridium-tungsten alloy on the wall of the vent orifice (Fig. 10), and intermetallic reaction products on the exterior of the clad surrounding the vent orifice, as shown in Fig. 11. Electron microprobe analysis indicated the phases at the vent entrance contained iron, silicon, calcium, plutonium, titanium, tungsten, manganese, and oxygen. Deposits at the interior of the vent orifice consisted of phases containing silicon, aluminum, and oxygen; calcium, silicon, and oxygen; silicon, calcium, titanium, iron, aluminum, magnesium, and oxygen; and plutonium, silicon, calcium, titanium, aluminum, chromium, iron, and oxygen. Four phases, identified in the intermetallic reaction product on the exterior of the clad, consisted of (a) iridium, tungsten, and iron; (b) iridium, plutonium, and titanium; (c) iridium and plutonium; and (d) iridium and iron. Although the vent-assembly and decontamination-cover welds were sound, extremely large grains were present in the welds.

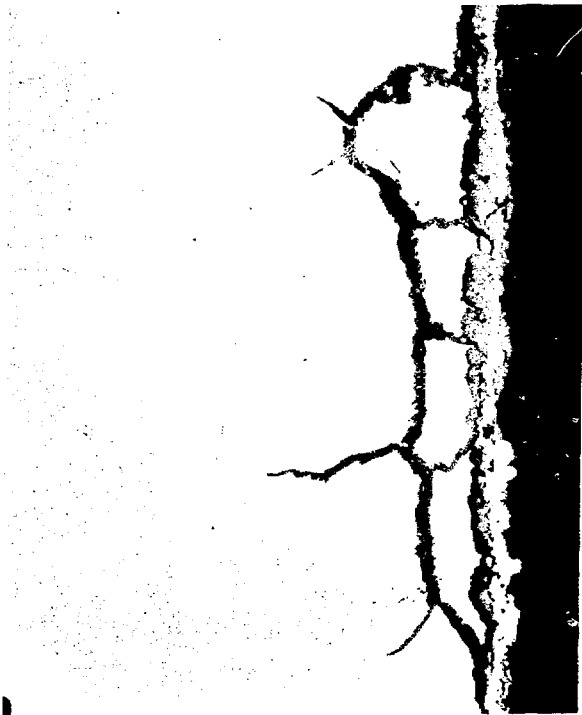
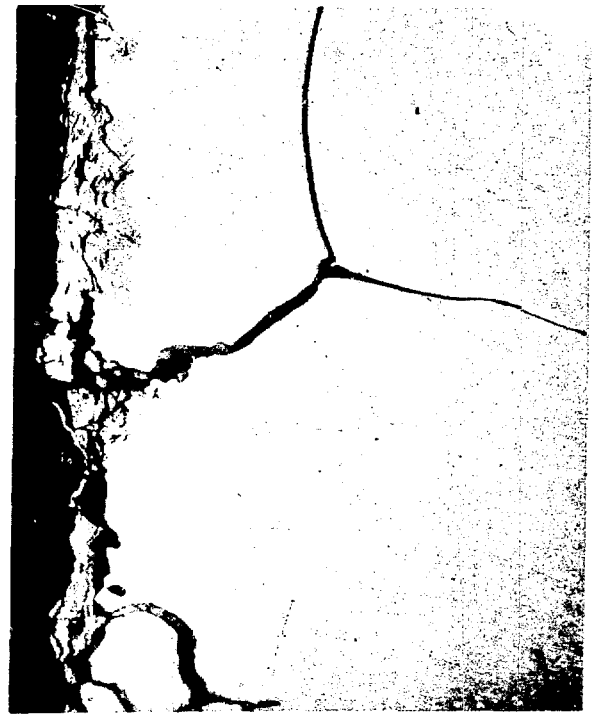
Fig. 11. Intermetallic reaction products on the exterior of the clad of HF-454 (250X).

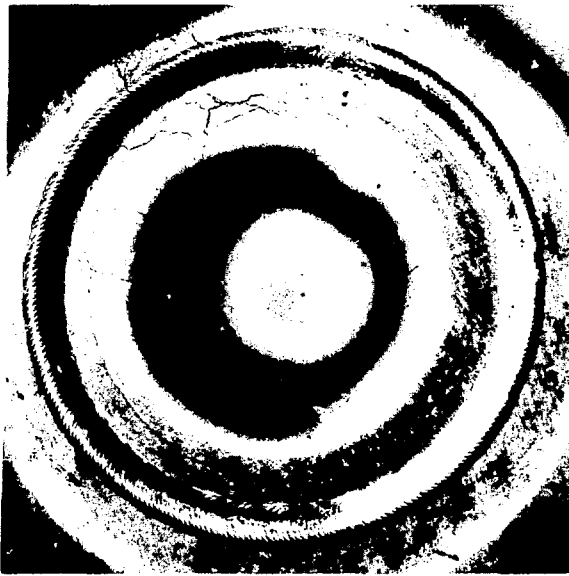
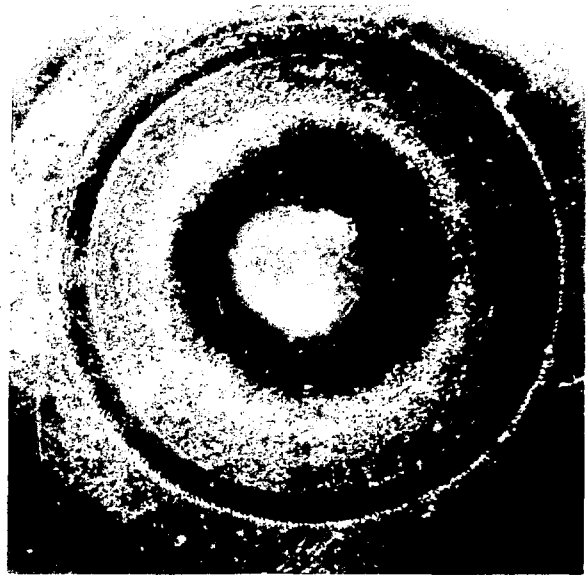
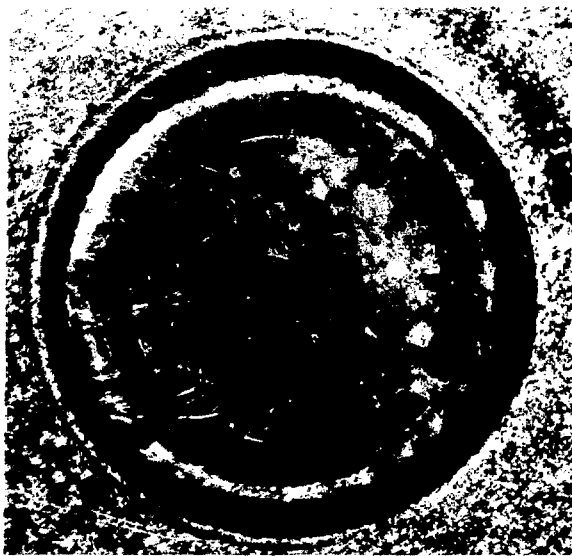
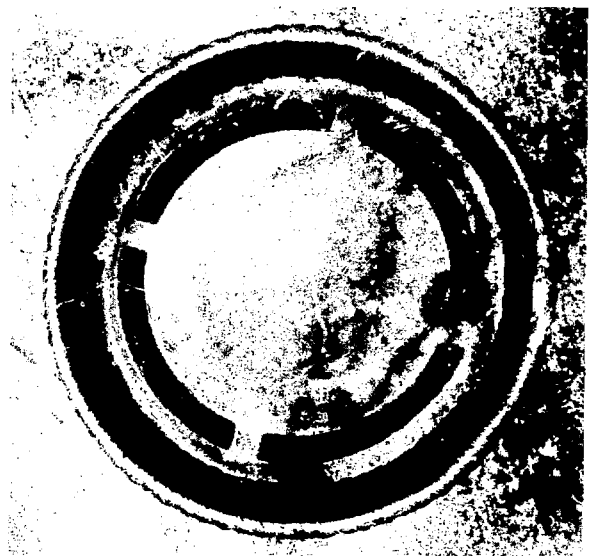
Fig. 13. There were cracks in the decontamination-cover welds of the two leaky capsules, but the interior structures were normal: (a) HF-104 with weld crack at 10 o'clock; (b) HF-219 with weld crack at 10 o'clock; (c) HF-104 interior vent structure; (d) HF-219 interior vent structure.(6:5X).

The external surfaces of the vent assemblies are shown in Fig. 13. A crack at the inner edge of the decontamination-cover weld of HF-104 is visible at 10 o'clock (Fig. 13a). A similar crack is barely visible in the same region of HF-219 (Fig. 13b). The reverse sides of the vents appeared normal (Figs. 13c and 13d).

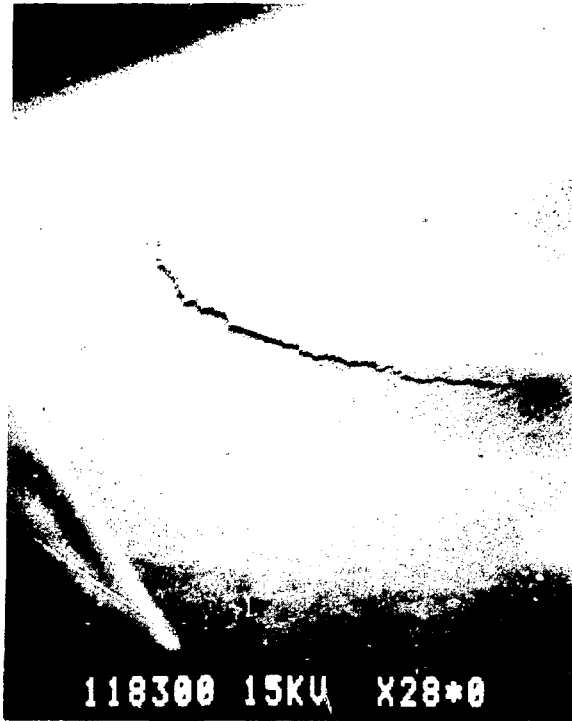
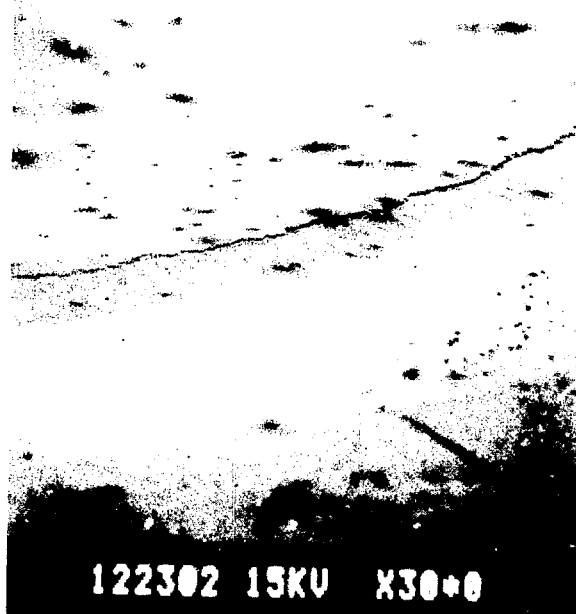
Fig. 14. The cracks in the leaky clads were near the inner circumferences of the decontamination-cover welds: (a) HF-104 (28X); (b) HF-219 (30X).

At higher magnification and with the greater depth of field inherent in the SEM, the cracks were clearly visible on the inner circumference of the decontamination-cover weld (Fig. 14). About 20% of the circumference was cracked on HF-104, and about 15% was cracked on HF-219.

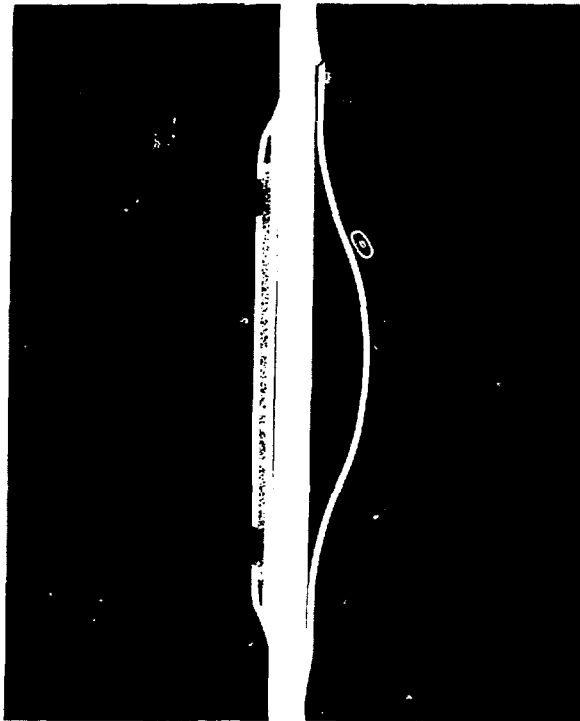
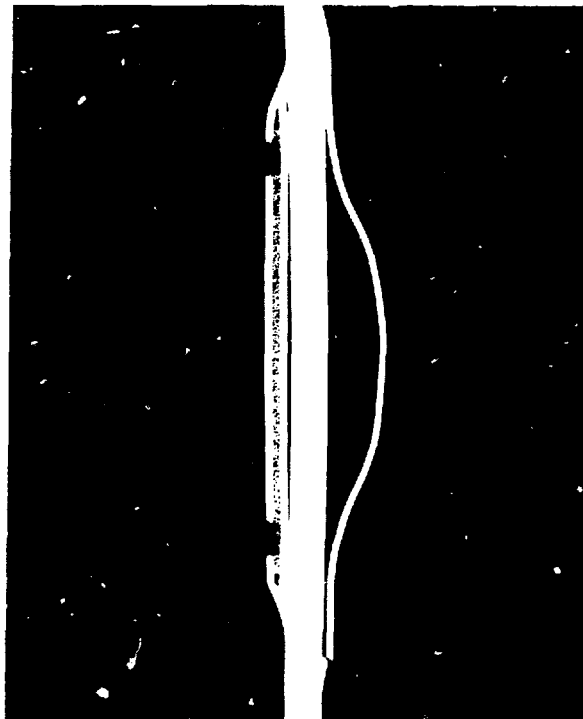
Fig. 15. The cracks penetrated both decontamination covers: (a) HF-104; (b) HF-219 (8X).

After the SEM examination, the vents were sectioned diametrically through the cracks and prepared metallographically. These sections confirmed that the cracks breached the decontamination covers of both vents (Fig. 15) and were the cause of the leaks. Barely visible in HF-104 is a nonbreaching weld crack opposed to the breach. At higher magnification (Fig. 16), we see that each of the cracks occurred in the same relative region, slightly away from the fillet of the weld.

Neither decontamination cover showed external damage, and both were displaced outward suggesting that internal pressure caused the failures.

Although the exact internal pressure cannot be calculated without a detailed knowledge of the temperature history of the fueled clads from the time of the final closure of the assembly weld, it seems unlikely that a pressure differential of much more than 1 atm could have been reached. An internal differential pressure of 1 atm would produce a radial stress at the crack location of 138 MPa (20 000 psi), well below the yield stress of normal polycrystalline iridium. The columnar weld grains cause a local departure from polycrystallinity that results in a straight grain-boundary path through the decontamination cover. Any source of additional stress, such as the residual stress in the decontamination cover, together with the inherent stress raiser at the surface-tension groove where the grain boundary intersects the surface could lead to the start of the crack.

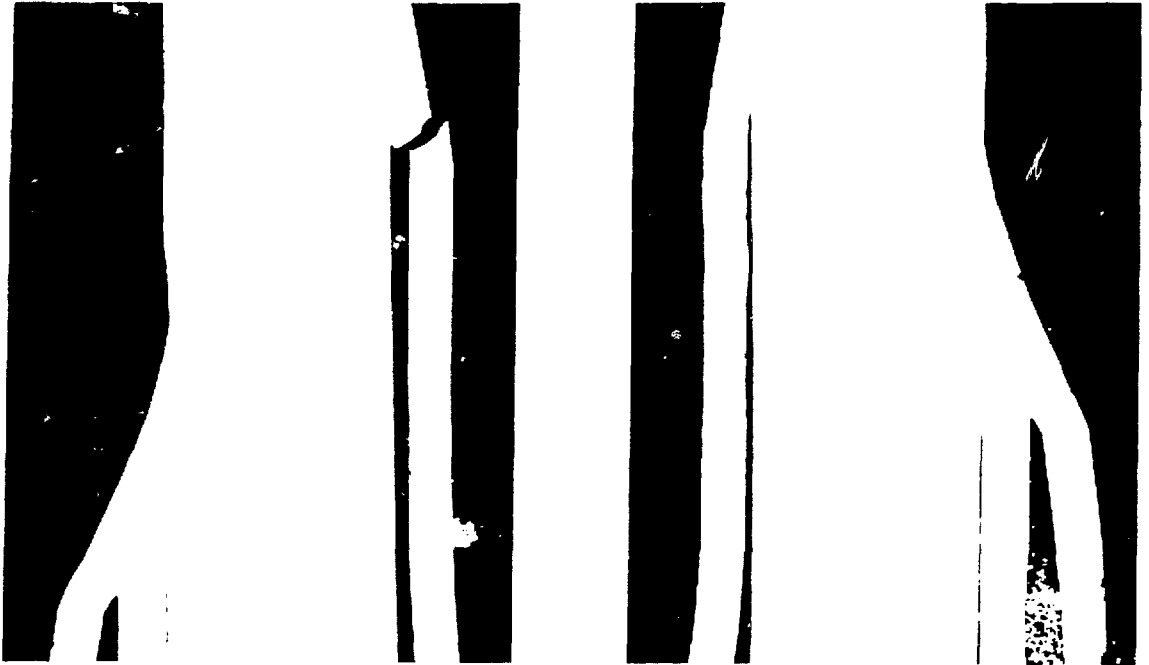
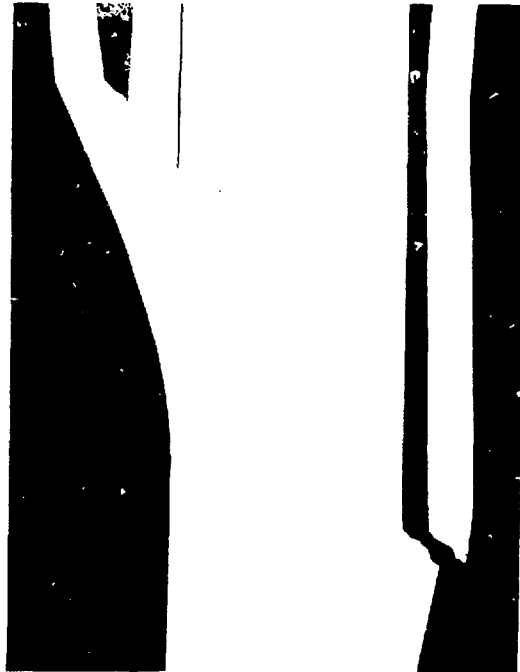
Fig. 16. All the cracks were close to the fillet of the decontamination-cover weld: (a) HF-104 breach; (b) HF-104 opposing crack; (c) HF-219 breach (50X).

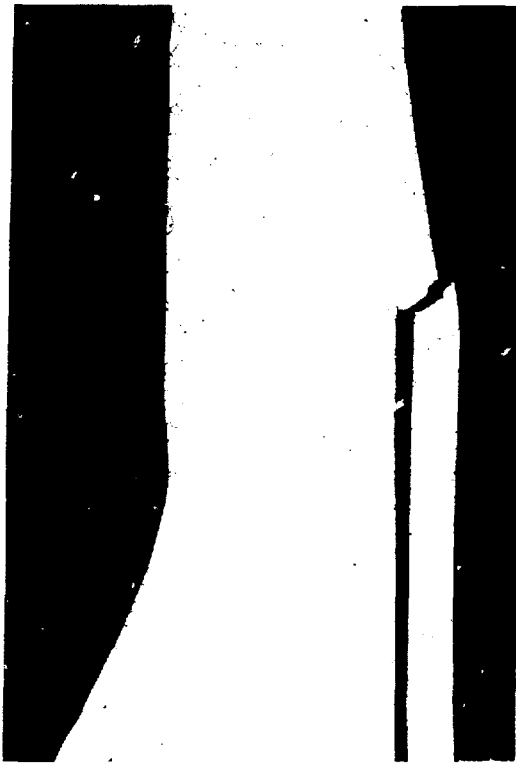
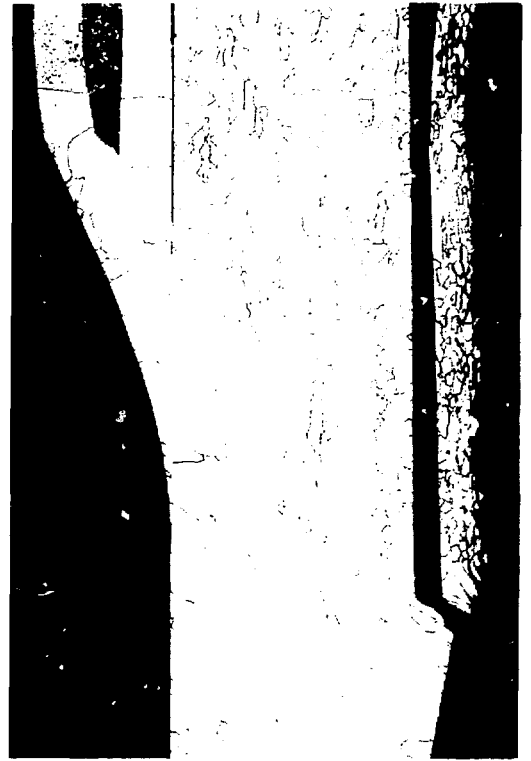
Fig. 17. The cracks occurred in the columnar-grained weld metal: (a) HF-104; (b) HF-219 (50X).

As expected, etching revealed that the cracks were intergranular (Fig. 17). They occurred in the columnar grains that resulted from the directional solidification of the weld-fused metal.

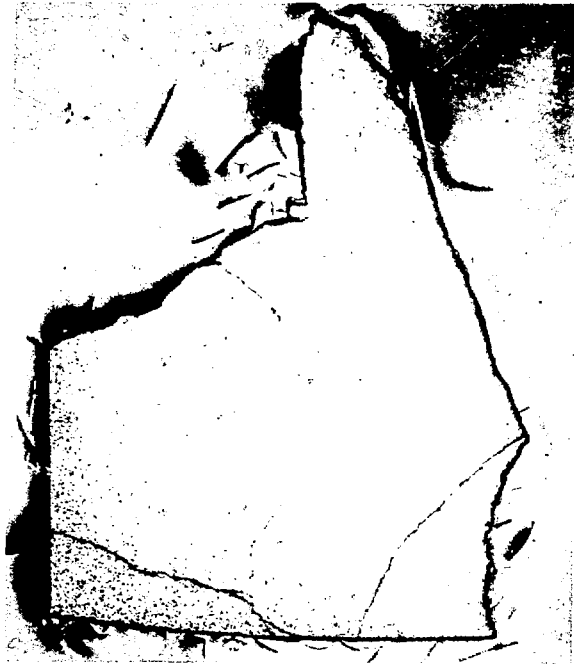
Fig. 18. Pellet ET 2-6 after 943 days in simulated seawater at 35°C, as polished (100X).

Fig. 19. Pellet ET 2-6 after 943 days in simulated seawater at 35°C, as polished (7X).

Fig. 20. Pellet ET 2-6 after 943 days in simulated seawater at 35°C, etched (100X).

Fig. 21. Pellet ET 2-6 after 943 days in simulated seawater at 35°C, etched (50X).

Pellet ET 2-6 was immersed in simulated seawater for 943 days at 35°C. We saw no evidence of erosion or corrosion of the pellet in the as-polished condition (Fig. 18), but the highly porous areas at the end and circumference of the pellet (Fig. 19) were attacked preferentially by the etchant (Fig. 20) to a depth of $\sim 300\ \mu\text{m}$. This effect was not observed along a freshly broken edge (Fig. 21) where the density was greater.

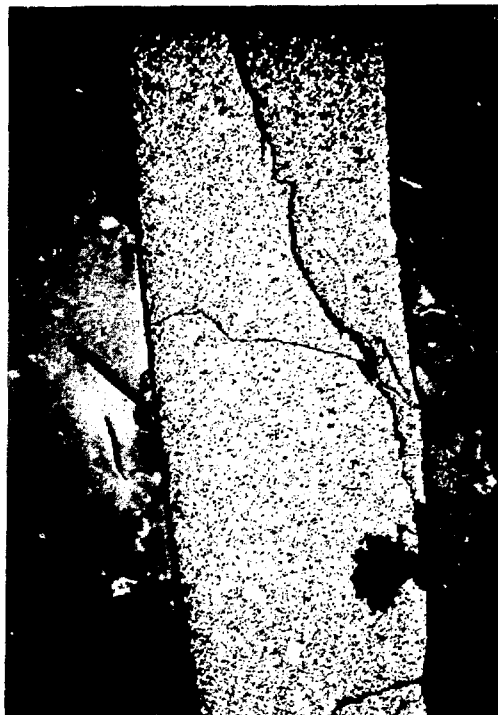
Fig. 22. Pellet ET 1-5 after 943 days in simulated seawater at 10°C, as polished (50X).

Fig. 23. Pellet ET 1-5 after 943 days in simulated seawater at 10°C, etched (50X).

Fig. 24. Pellet ET 1-5 after 943 days in simulated seawater at 10°C, as polished (7X).

Pellet ET 1-5 was immersed in simulated seawater for 943 days at 10°C. There was no evidence of reaction between the seawater and the pellet in the as-polished condition (Fig. 22), but etched, the surface exposed to the seawater was ragged (Fig. 23). The depth of damage was $< 50\ \mu\text{m}$. The porosity along the edge was less than that in the 35°C seawater test pellet (Fig. 24).

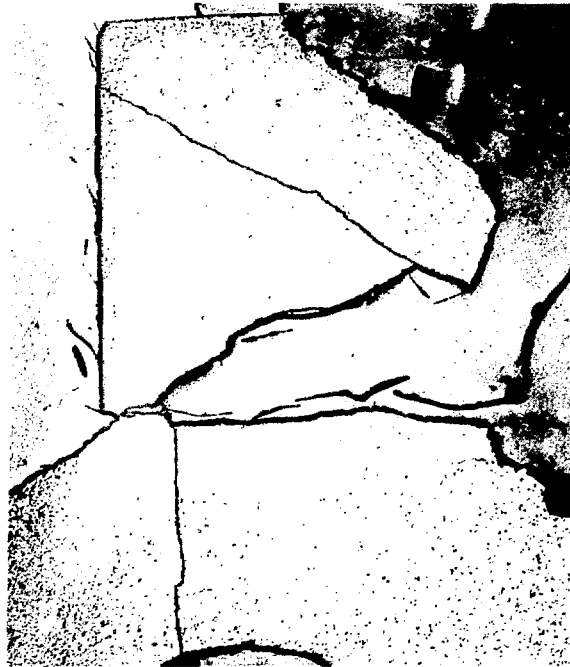
Fig. 29. Pellet ET 2-4 after 943 days in fresh water at 35°C, as polished (7X).

Fig. 30. Pellet ET 2-4 after 943 days in fresh water at 35°C, as polished (100X).

Fig. 31. Pellet ET 2-4 after 943 days in fresh water at 35°C, etched (100X).

Pellet ET 2-4 was immersed in fresh water for 943 days at 35°C. There was a high density band along the end of the pellet and a low density band along the side, as shown in Fig. 29. There was no evidence of a reaction having occurred along the side of the pellet when it was in the as-polished condition (Fig. 30), but etched, the surface showed void enhancement along the edge (Fig. 31).

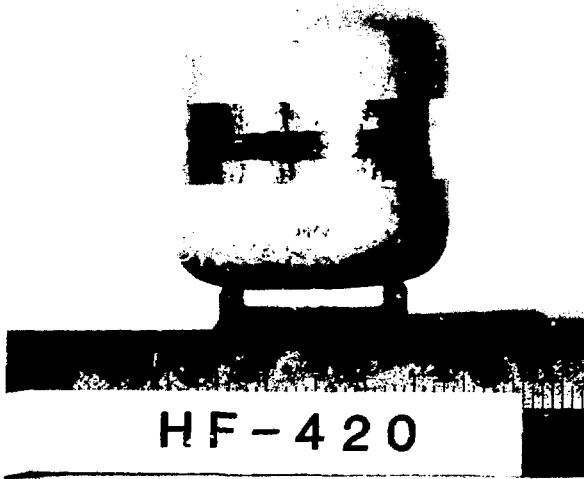
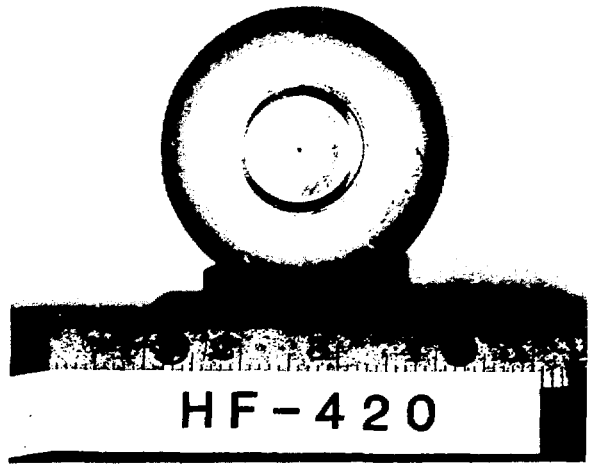
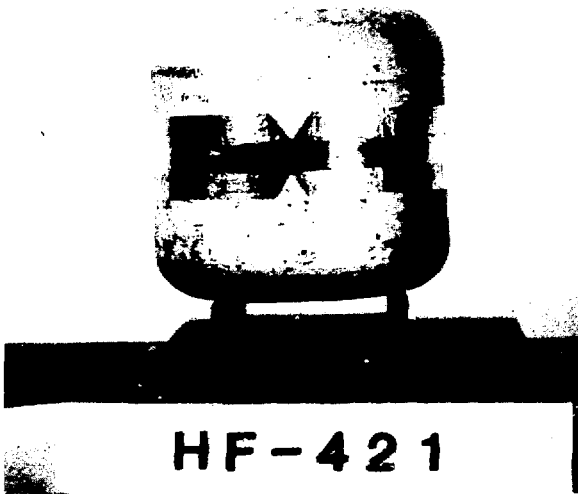
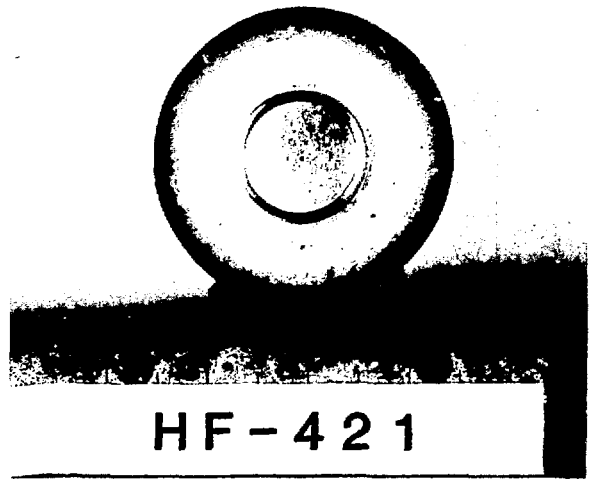
Fig. 35. Fueled clads of the 5-W RTG heat source after impact (~1.5X).

No significant damage to the GIS occurred and only minor deformation of the fueled clads was visible, principally on the impact end of the lead fueled clad, HF-421. Fig. 34 shows a photograph of the impacted test assembly and Fig. 35 shows the fueled clads. Dimensions of the fueled clads are tabulated in Table VIII.

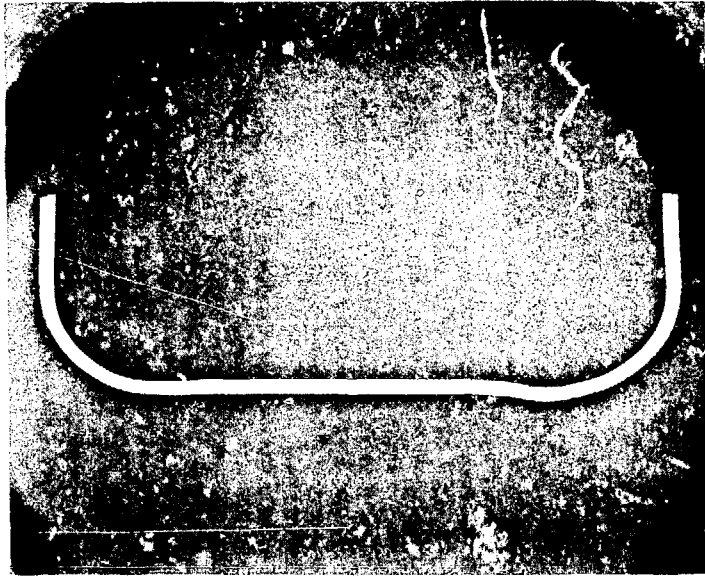
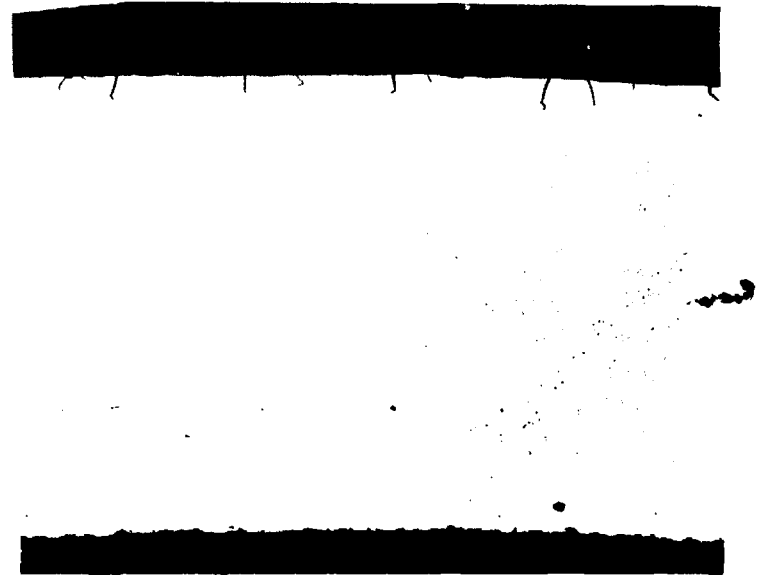
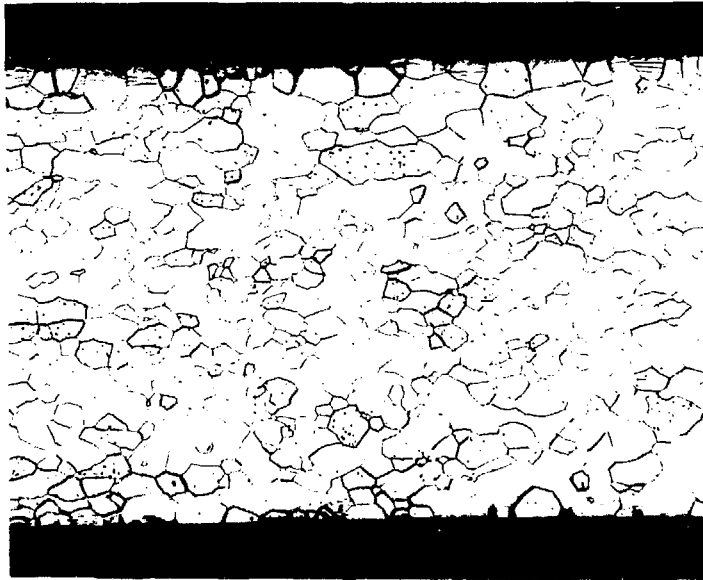
Fig. 36. Metallographic cross section of the impacted end of FC-421: (a) photomicrograph (3X); (b) as-polished photomicrograph (100X); (c) etched photomicrograph (100X).

an as-polished photomicrograph of the impact end of the cladding and reveals several small cracks on the interior surface. In general, the cracks are limited to a depth of one grain, as shown in Fig. 36c.
