ORNL-5899

## Elevated-Temperature Tensile and Creep-Rupture Behavior of Alloy 800H/ERNiCr-3 Weld Metal/2 1/4 Cr-1 Mo Steel Dissimilar-Metal Weldments

Date Published - November 1982

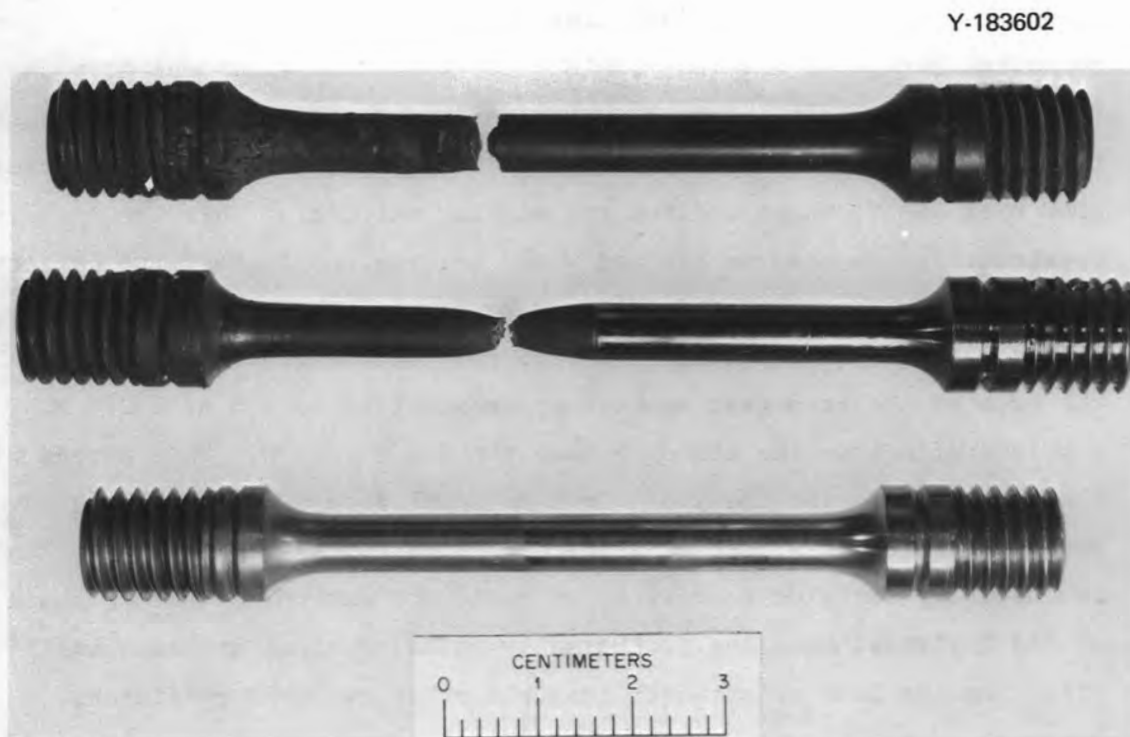
Fig. 10. Different fracture modes. Bottom specimen is untested, middle one is a high-ductility fracture in the 2 1/4 Cr-1 Mo steel base metal, and the top is a low-ductility failure near the fusion line.

Visual inspection of the fractured specimens indicated that all but the three long-time rupture tests failed essentially midway in the 2 1/4 Cr-1 Mo steel portion of the gage section, between the ERNiCr-3 weld metal and the specimen shoulder (Fig. 10). The fractures were ductile

The three long-time tests, on the other hand, failed with a flat fracture, and the failure was very near the fusion line (Fig. 10). We could not determine visually how near the failure was to the fusion line. Examination of the fracture surface with a low-magnification stereo microscope ( $<10\times$ ) revealed that in places the weld bead structure was visible, thus indicating a proximity to the fusion line.

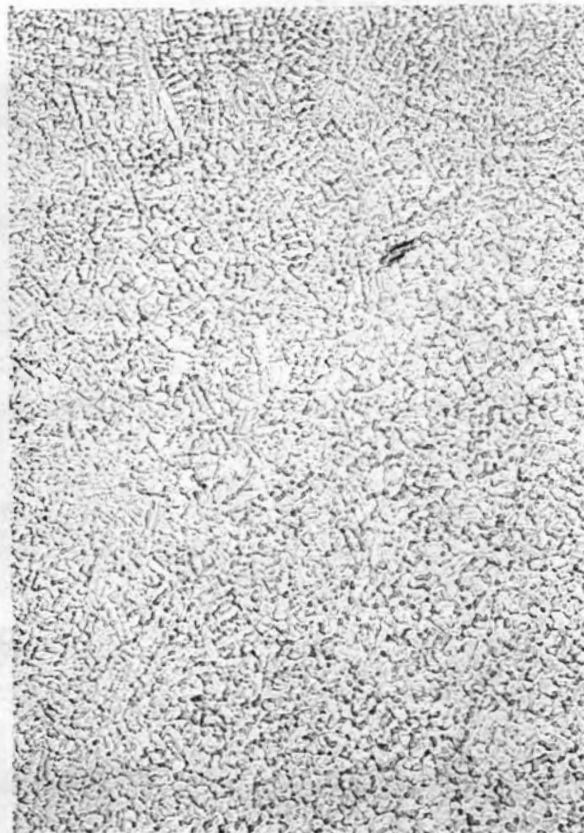
Fig. 14. Microstructure of (a) alloy 800H base metal and (b) ERNiCr-3 weld metal of the composite weldment.

The alloy 800H base metal and the ERNiCr-3 weld metal were typical for these alloys (Fig. 14). Because these materials were not involved in the fracture, they will not be further discussed. The isothermally annealed 2 1/4 Cr-1 Mo steel base metal well back from the fusion line was a polygonal ferrite-bainite microstructure, which is typical for this heat-treated condition [Fig. 15(a)].

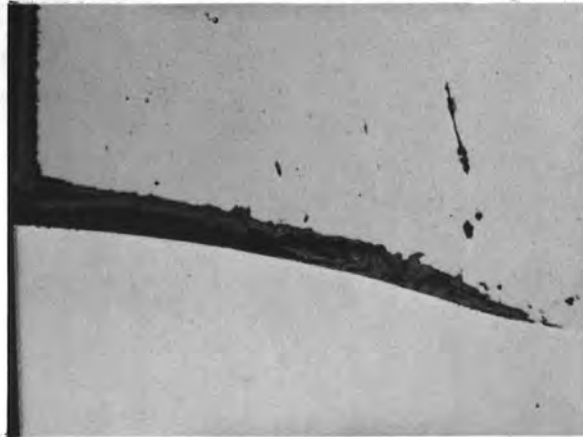
Fig. 17. Examples of oxide-filled cracks and relation to the fusion line on stress-rupture specimens tested at 510°C. Top: rupture life 1508.4 h. Bottom: rupture life 809.2 h.

observation. The fractures were typical of those for 2 1/4 Cr-1 Mo steel base metal tested under similar conditions.<sup>16</sup> Although the fracture for these specimens occurred well away from the fusion line, the microstructure at the fusion line was affected, the effect changing with stress (or time of exposure at elevated temperature). For the specimens examined, an oxide-filled notch or crack was inevitably present in the 2 1/4 Cr-1 Mo steel very near the fusion line (Figs. 16-18). In some instances, quite a small oxide notch was observed [Fig. 16(a)], whereas other specimens contained an oxide-filled crack of considerable length [Fig. 16(b)]. The extent of the crack or notch depended somewhat on stress (or time in test), although a notch was present after even the shortest creep-rupture times [Fig. 16(a)]. We noted in the previous section that the evidence of a crack could be detected visually on one of the lowest stress test specimens that failed transgranularly. The cracks were always filled with oxide that formed from the 2 1/4 Cr-1 Mo steel. The relationship of the oxide to the 2 1/4 Cr-1 Mo steel and the ERNiCr-3 weld metal is shown in Fig. 17.

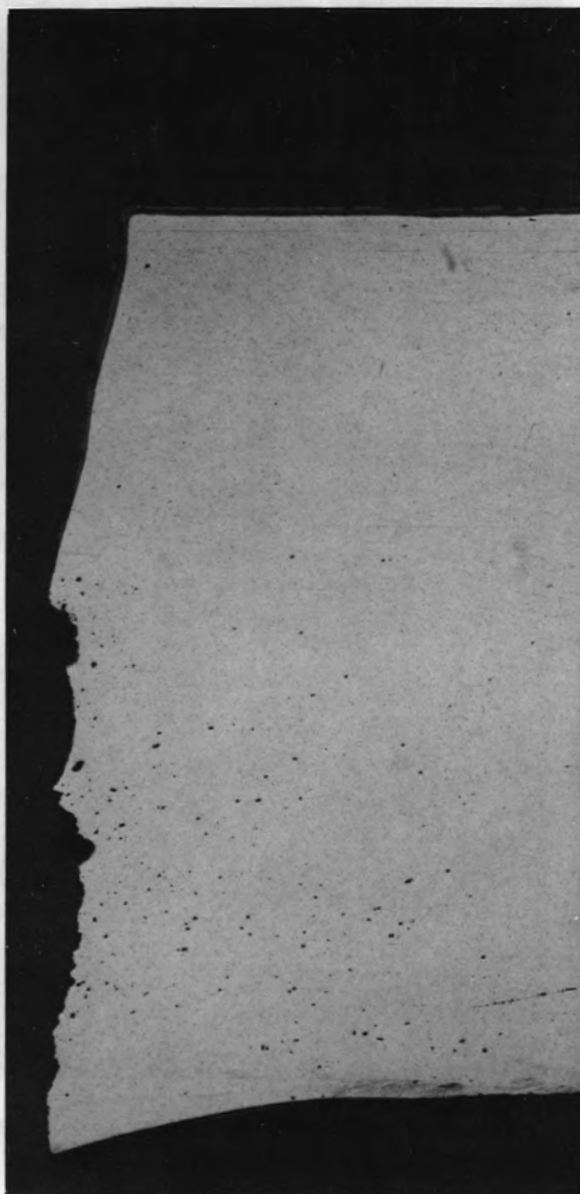
Fig. 20. Morphology of the interface fracture of the composite specimen postweld heat treated 1 h at 732°C, aged 1000 h at 510°C, and tested at 131 MPa at 510°C (rupture life 8768.4 h). Unetched. (a) 2 1/4 Cr-1 Mo steel. (b) ERNiCR-3 with adhering 2 1/4 Cr-1 Mo steel.

For the three long-time rupture tests at 510°C, which failed with very little deformation, failure occurred very near the fusion line (Fig. 20). These fractures obviously occurred by propagation of the interface notch or crack observed on the specimens that failed transgranularly (Figs. 16-18). Similar observations were made on the specimens tested at 593°C at 83 and 69 MPa (Fig. 21). These specimens also failed with limited amounts of deformation (Table 7).

below, this is an intergranular fracture. Further into the specimen the fracture deviates from the fusion line and appears to be quite ductile (Figs. 20 and 21). The fracture apparently started as a notch at the external surface, then developed into a crack and propagated along grain boundaries toward the center of the specimen. After the grain boundary crack has propagated some distance into the specimen, the loss in load-bearing cross section causes the true stress to increase until the fracture begins to propagate in a ductile-transgranular mode (similar to the high-stress tests). Note the holes in the center of the 2 1/4 Cr-1 Mo steel portion of the fractured specimens [Figs. 20(a) and 21(a)]. These are typical of a ductile-transgranular fracture.

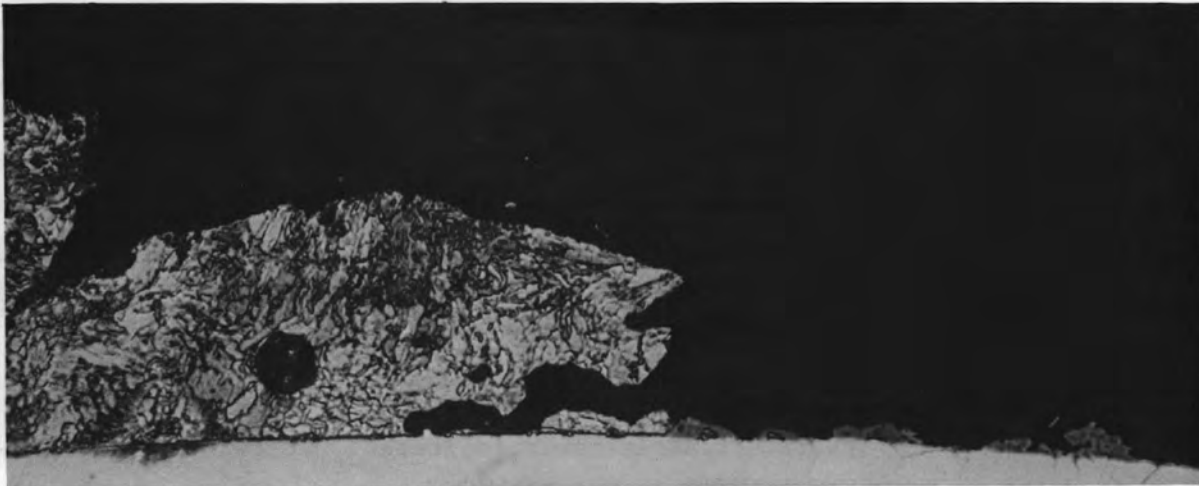
Fig. 23. Microstructure near the region where the fracture mode changes from brittle to ductile, illustrating how the brittle fracture proceeds along grain boundaries approximately one small grain into the 2 1/4 Cr-1 Mo steel. In some cases these small grains have been subsequently consumed by oxide. Specimen is the same as Fig. 22.
