# Final Report on the Power Production Phase of the 10 MWe Solar Thermal Central Receiver Pilot Plant

SAND87-8022  
Unlimited Release  
Printed March 1988

## FINAL REPORT ON THE POWER PRODUCTION PHASE OF THE 10 MW<sub>e</sub> SOLAR THERMAL CENTRAL RECEIVER PILOT PLANT

L. G. Radosevich  
Project Engineering Division III  
Sandia National Laboratories Livermore

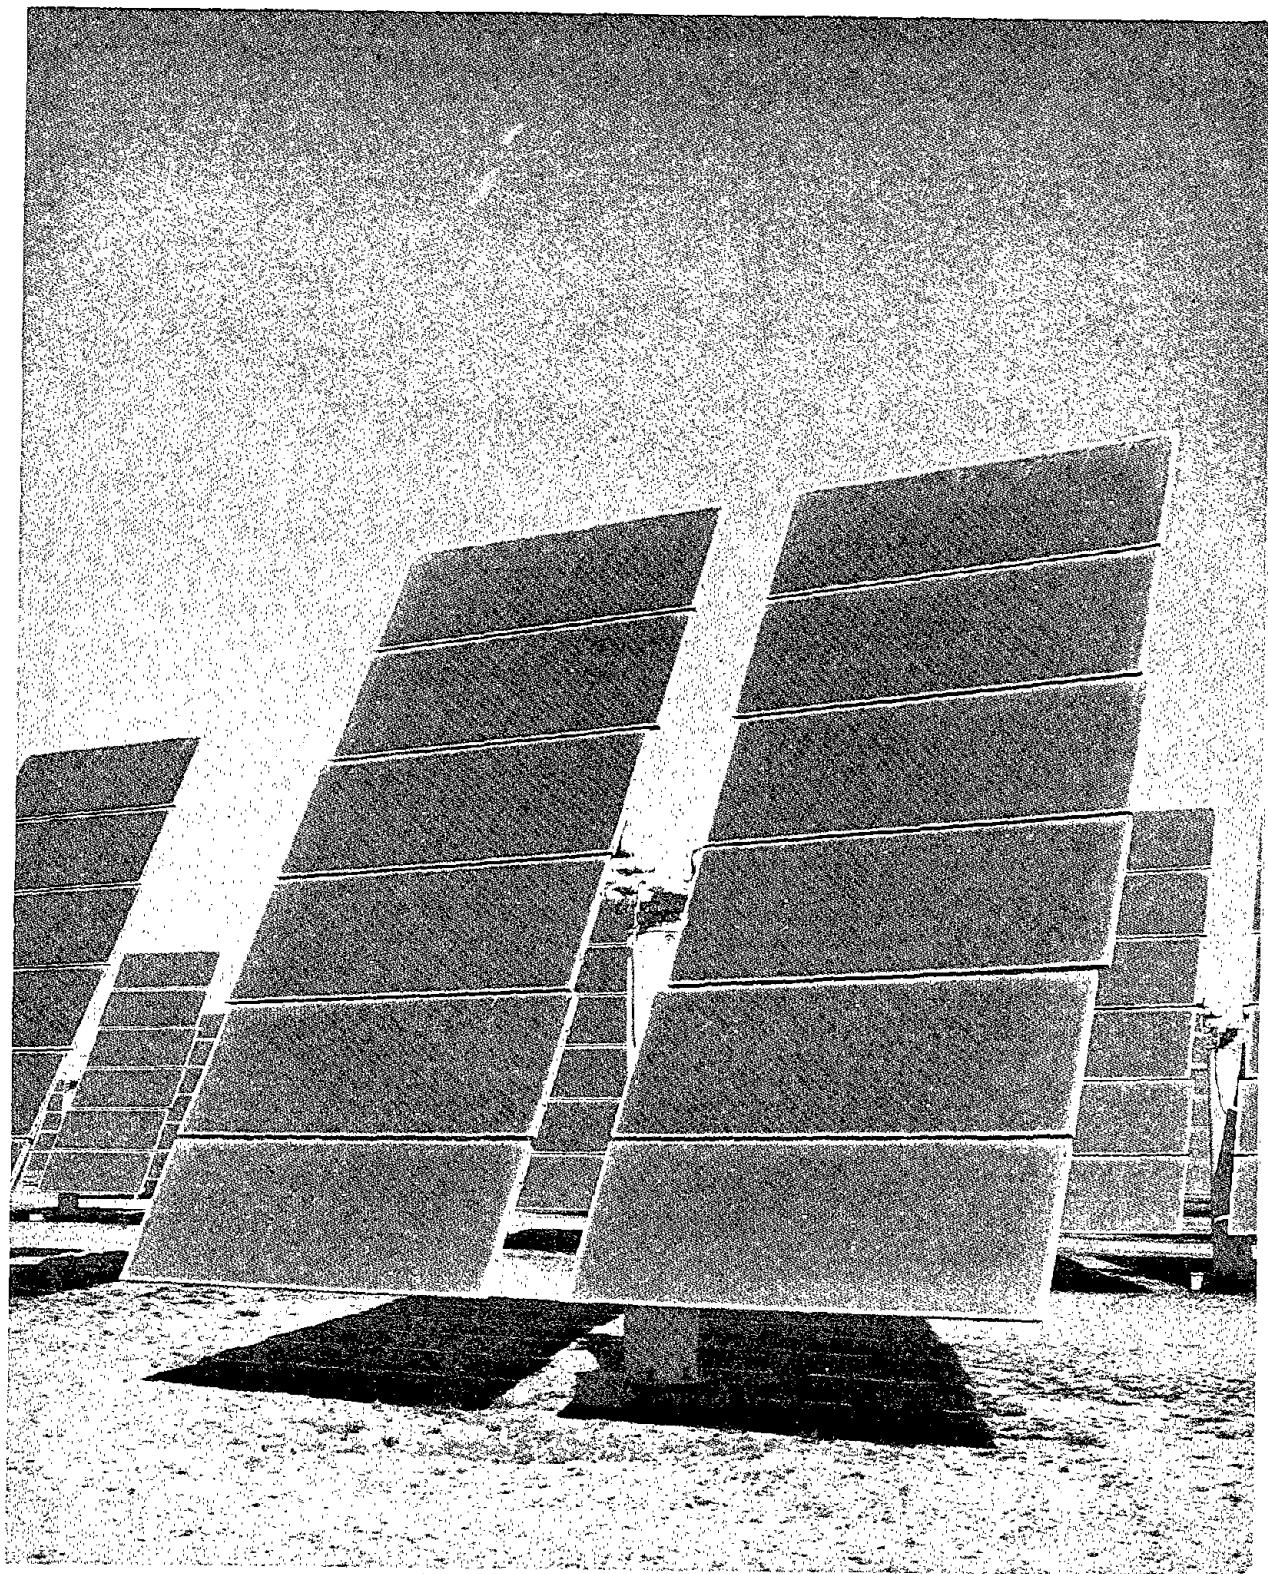
Figure 2-1. Pilot Plant Heliostat

Each heliostat has twelve slightly concave mirror panels totaling 421 ft<sup>2</sup> (39.13 m<sup>2</sup>) of reflective surface. The mirrors have an average clean reflectance of 0.903; this average is area-weighted for the mixture of low- and high-iron glass used in the field. Each mirror assembly attaches to a geared drive unit for azimuth and elevation control. The drive unit is mounted on a fixed pedestal. The total weight of each heliostat is 4,132 lb. (1,875 kg), including the reflective assembly, drive unit, pedestal, and electronics but excluding the poured-in-place concrete pile foundation.

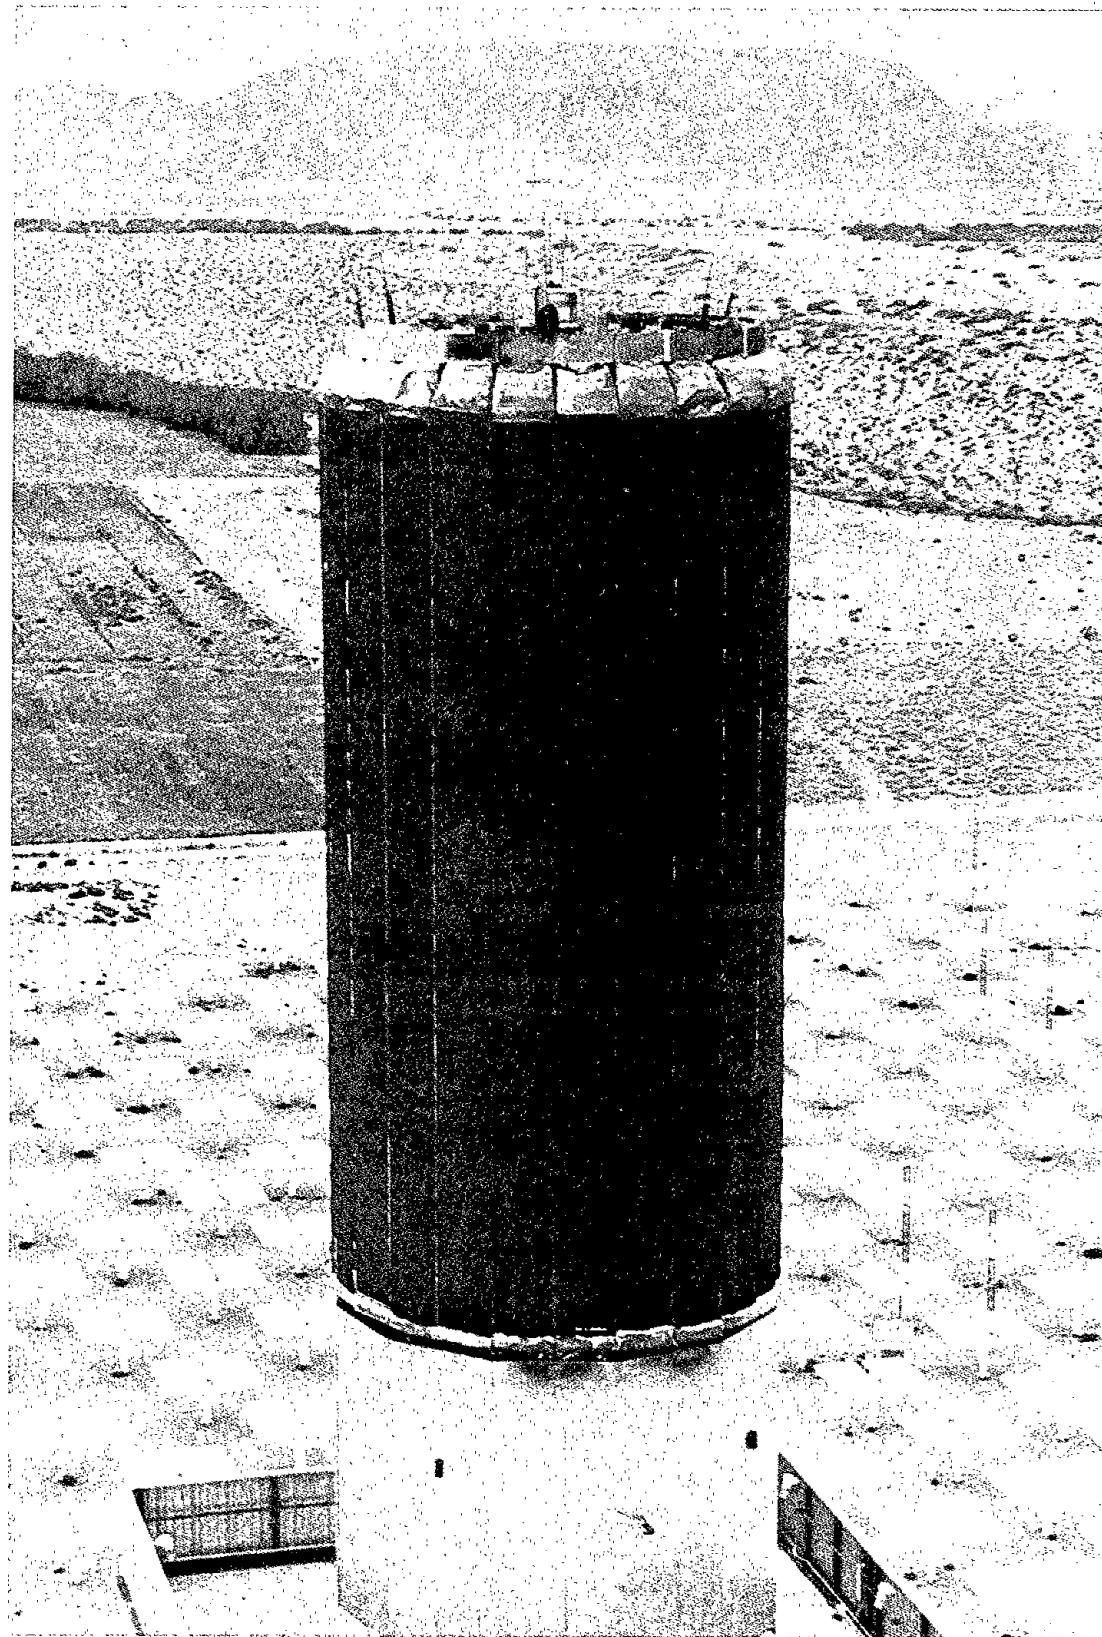
Figure 2-2. Receiver Panels with Boiler Tubes

Each panel consists of seventy tubes (0.5 in or 1.27 cm OD, 0.27 in or 0.69 cm ID) through which the feedwater is pumped and, in the boiler panels, converted to steam. These thick-wall tubes are made of Incoloy 800, an alloy which can withstand the effects of daily heat cycling as well as cloud transients. Within each panel the tubes are welded to each other over their full length and the panel is coated with a special black paint (Pyromark) to increase thermal energy absorption. The back surface of each panel is heavily insulated and sealed against light leaks.

The receiver is designed to produce 112,000 lb/hr of steam at 960°F (516°C) and 1,465 psia (10.1 MPa). The receiver tubes are designed for a peak external surface temperature of approximately 1,150°F (620°C) under normal operating conditions.

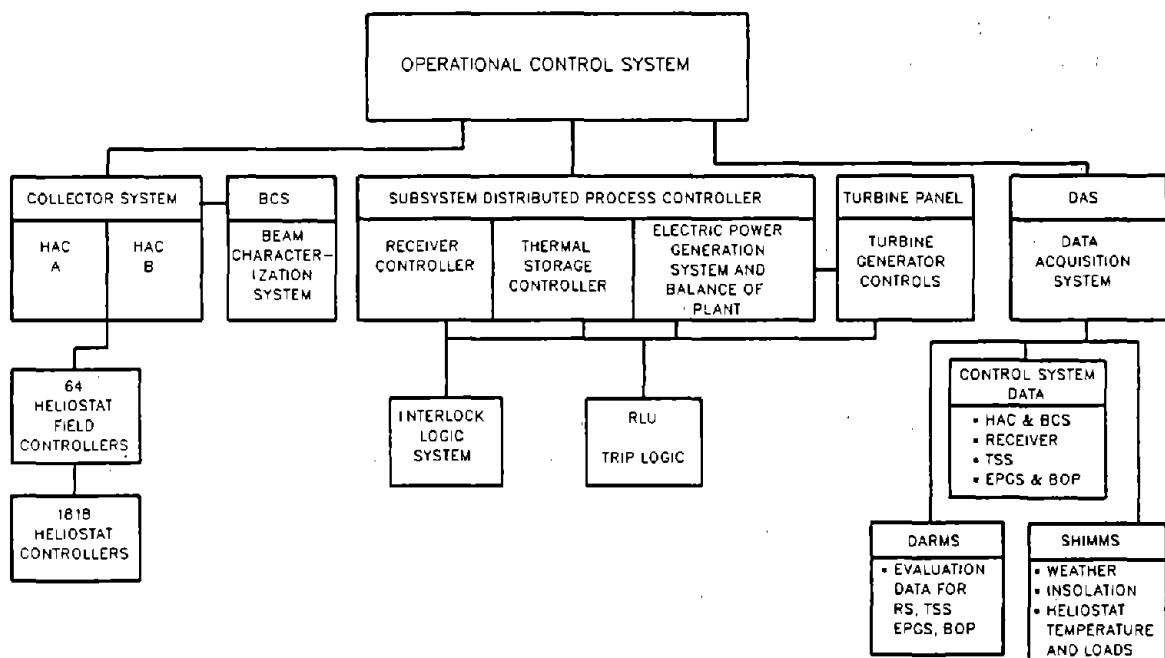
Figure 2-6. Plant Control System Elements

Figure 2-6 is a schematic of the principal elements of the plant control system and its interfaces with other plant elements.

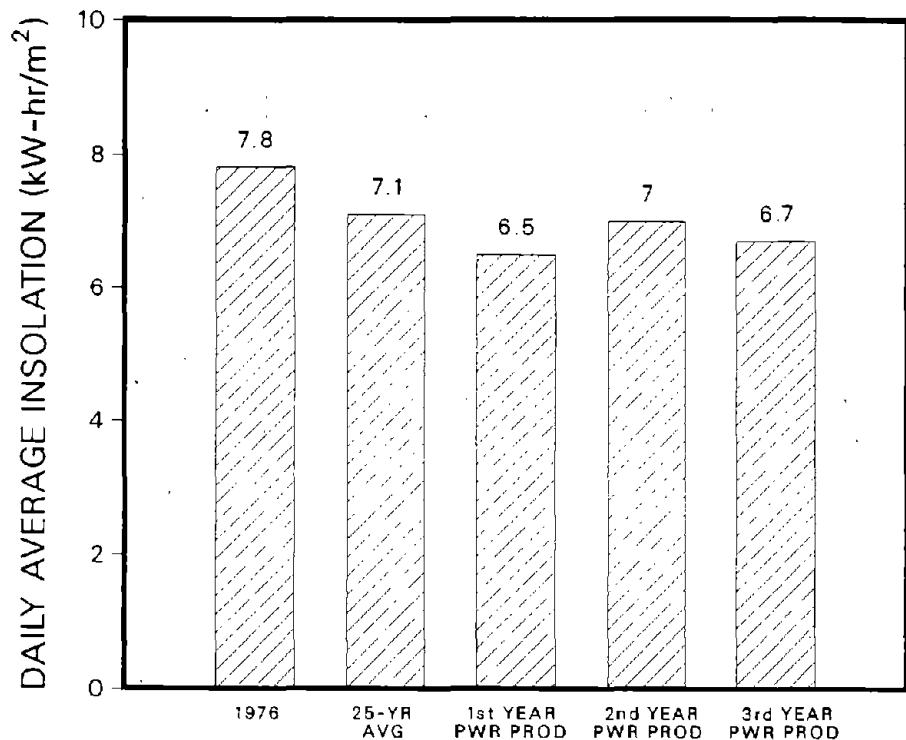
Figure 3-1. Daily Average Direct Normal Insolation

The data in Table 3-1 were combined to derive daily average values for the first, second, and third years of power production operation. The daily average insolation was 6.55, 6.97, and 6.72 kW-hr/m<sup>2</sup> for the first, second, and third years of power production operation, respectively. Figure 3-1 shows these data along with the values for 1976 and the 25-year average. The insolation values for the second and third years of power production operation were greater than the first year value but remained below both the 1976 design and 25-year average values. The insolation values recorded during the first, second, and third years of power production operation are 16, 10, and 14%, respectively, less than the 1976 insolation value.

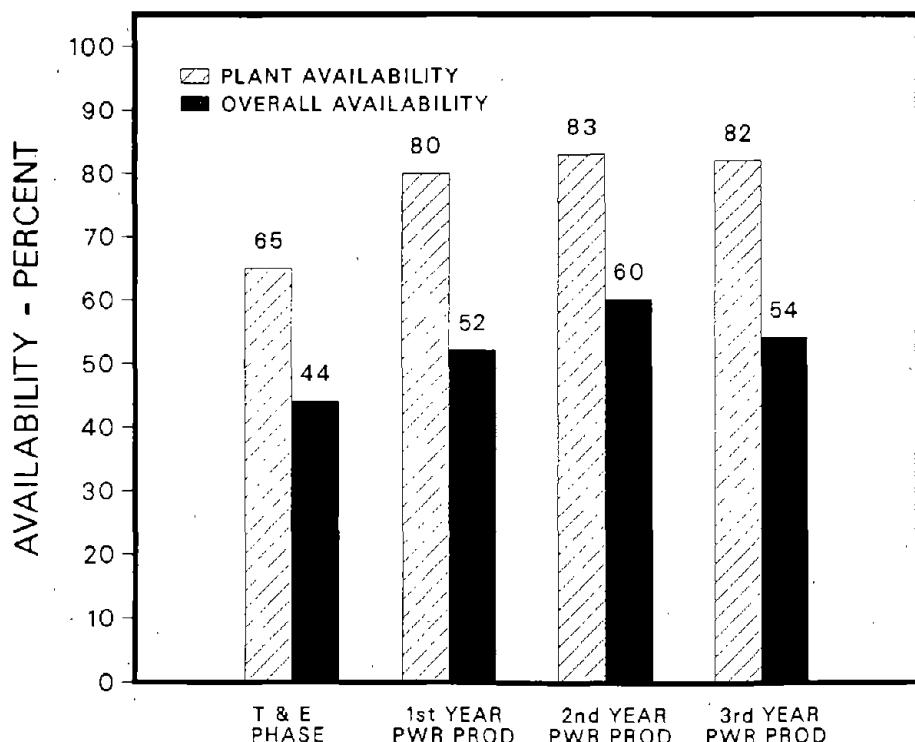
Figure 3-2. Pilot Plant Availability With and Without the Effects of Weather

Figure 3-2 shows the overall and plant availabilities for the Experimental Test and Evaluation Phase and the first, second, and third years of power production operation. The overall availabilities averaged 44, 52, 60, and 54%, respectively. The combined effects of bad weather and equipment outages were evident for the winter months, the months generally with the lowest overall availabilities. The

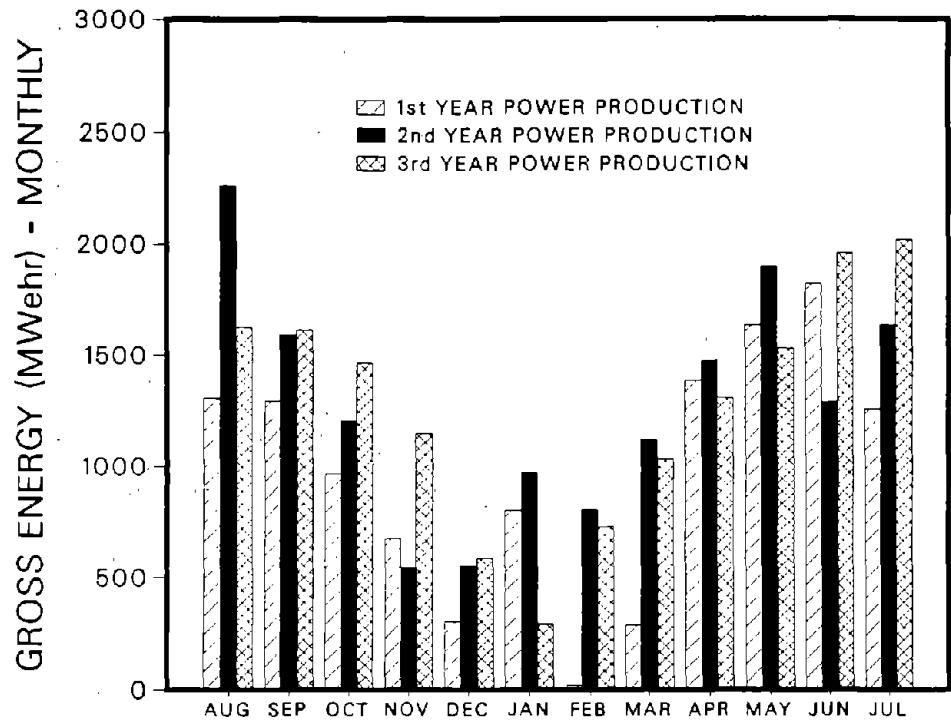
Figure 3-3. Pilot Plant Monthly Gross Energy Production

The cumulative gross energy productions for the first, second, and third years of power production operation were 11,754, 15,345, and 15,305  $MW_e$ -hr, respectively. Generally, the best months for production were April to September due to favorable weather conditions and long operating days. A peak monthly output of 2,262  $MW_e$ -hr was achieved during August 1985. Energy output for February 1985 was nearly zero due to a scheduled maintenance outage. Energy output was low in June 1986, a good weather month, due to an unscheduled maintenance outage for receiver tube leak repairs.

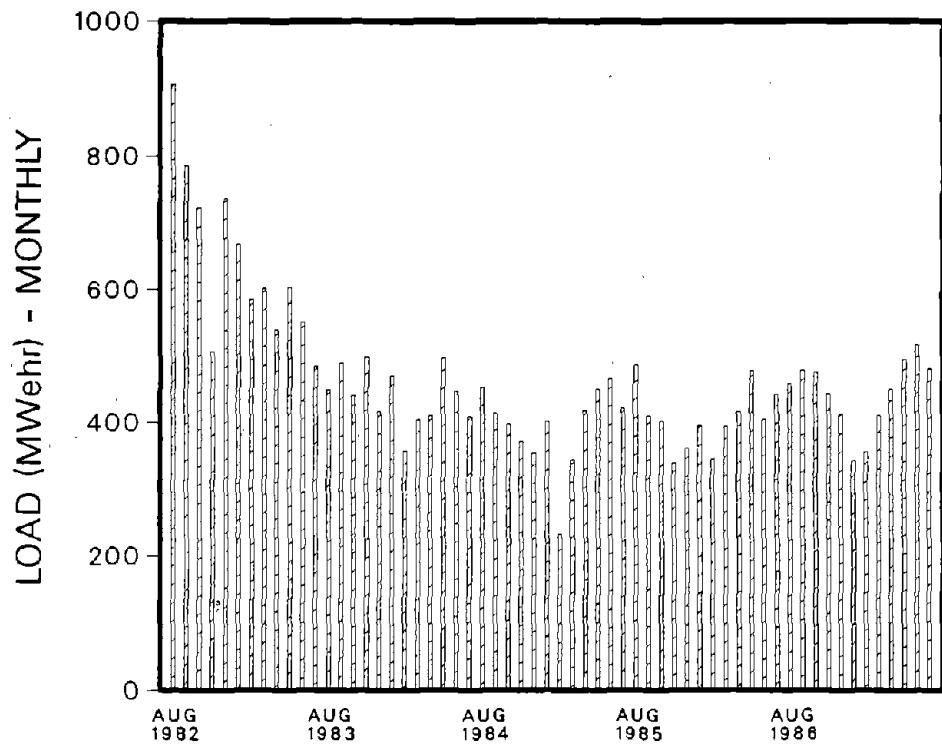
Figure 3-7. Pilot Plant Monthly 24-Hour Load

The cumulative 24-hour plant loads for the first, second, and third years of power production operation were 4,731, 4,880, and 5,323  $MW_e$ -hr, respectively. The monthly plant load averaged 541  $MW_e$ -hr during the Experimental Test and Evaluation Phase and 394, 407, and 444  $MW_e$ -hr during the first, second, and third years, respectively, of the Power Production Phase. Plant load remained relatively constant during the first two years of power production operation even though the plant's gross output increased significantly. The plant load increased about 10% during the third year because an electric boiler rather than the thermal storage system was used to generate auxiliary steam. Overall, the plant load has decreased since Pilot Plant testing began, reflecting successful efforts by SCE to reduce the plant's parasitic power requirements.

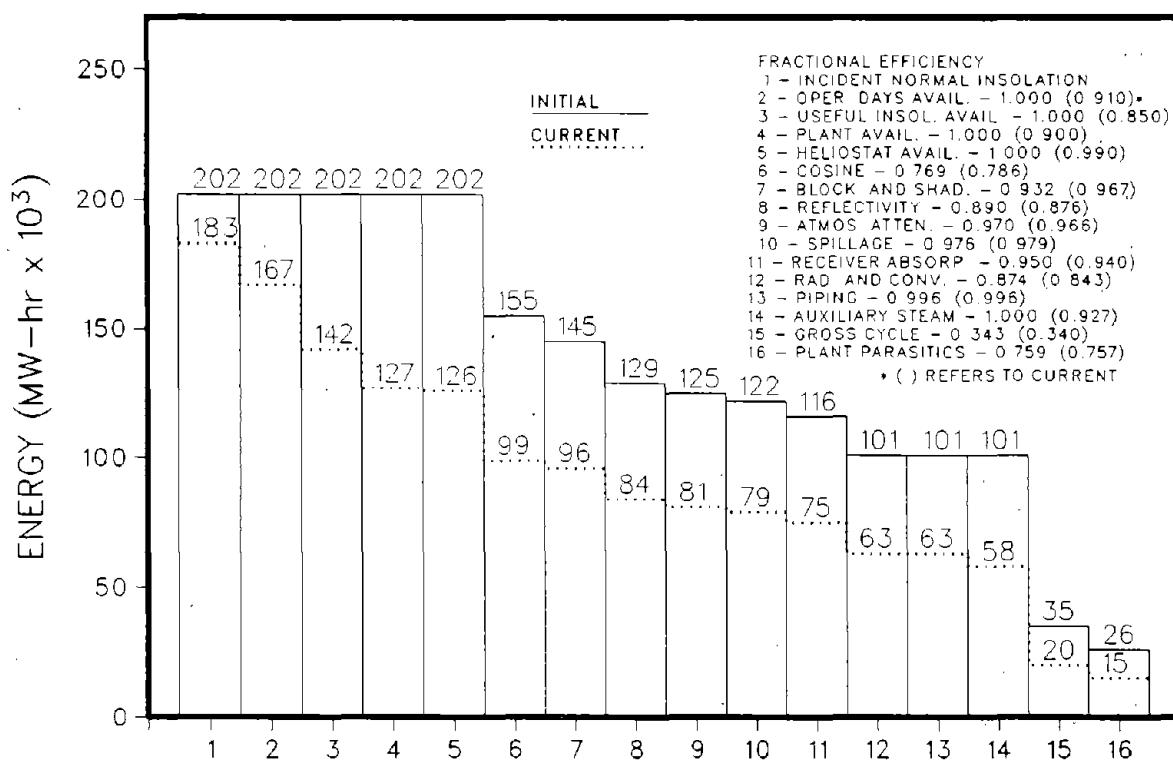
Figure 4-1. Comparison of Initial and Current Pilot Plant System Efficiency and Annual Energy Predictions

Recent predictions of the two performance factors have been made using more realistic plant conditions (Reference 4–3). The substitution of these plant conditions for the values used in the early predictions lowers the capacity factor and system efficiency considerably. The current predictions for the Pilot Plant are a capacity factor of 17% (corresponding to an energy production of 15,000 MW<sub>e</sub>–hr net) and a system efficiency of 8.2%. A comparison of the initial and current predictions for these performance factors is described below.

**Incident Normal Insolation**—The initial annual energy value of  $202 \times 10^3$  MW-hr is based on insolation data collected in Barstow during 1976. The current value of  $183 \times 10^3$  MW-hr is based on a 25-year average value. The 25-year value, which is 9.4% less than the 1976 insolation value, was selected to derive the current prediction because it is more representative of a typical operating year.

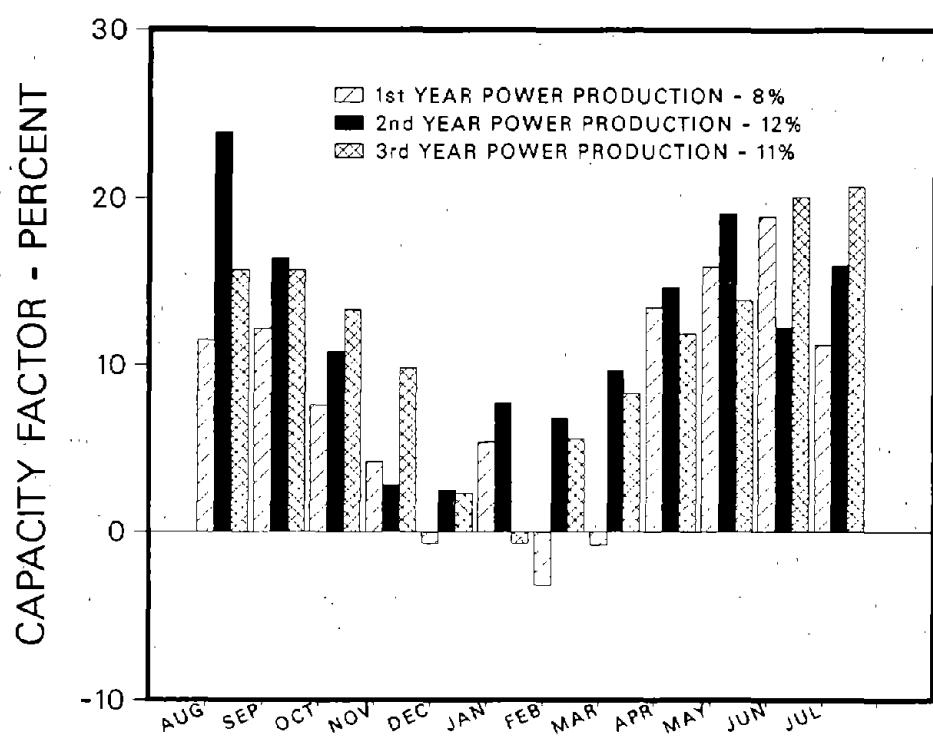
Figure 4-2. Pilot Plant Monthly Capacity Factor

The Pilot Plant's capacity factor averaged 8, 12, and 11% during the first, second, and third years of power production operation, respectively. A considerable improvement in capacity factor was observed during the second and third years of power production operation as a result of better weather conditions and improved operating and maintenance procedures. Better insolation permitted more hours of operation at or near full load. Improved operating and maintenance procedures resulted in increased plant availability, heliostat availability, heliostat cleanliness, receiver absorptance, and reduced start-up times. These factors all contributed to an increased steam flow to the turbine and more hours of full-load operation.

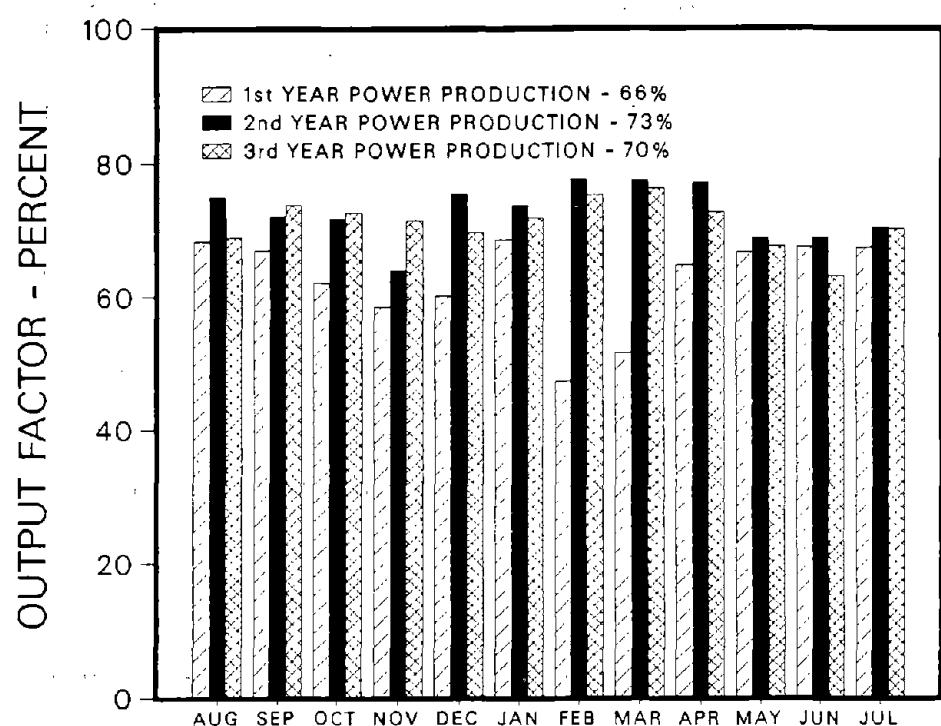
Figure 4-4. Pilot Plant Monthly Output Factor

**Output Factor**—Monthly and annual values for a third performance factor, called the output factor, were also obtained during power production operation. Output factor is the plant's actual net electrical output divided by its rated net output while on line. The output factor is an indicator of the plant's average power output when it is connected to the grid. A low output factor indicates that the plant is operating under off-design plant conditions most of the time and is thus experiencing a reduction in performance.

The Pilot Plant has experienced an increase in output factor since testing began in 1982: the plant's output factor averaged 52% during the Experimental Test and Evaluation Phase and 66, 73, and 70% during the first, second, and third years of the Power Production Phase, respectively. During the Experimental Test and Evaluation Phase the plant was sometimes operated under part-load conditions to test and evaluate the operating characteristics of the plant. Part-load operation resulted in a reduced turbine efficiency and contributed to a reduced output factor. During the Power Production Phase no part-load testing was performed. In addition, improved maintenance procedures, which resulted in improved heliostat availability, cleanliness, etc., increased the steam flow to the turbine and contributed to increased operation at or near full-load conditions. The

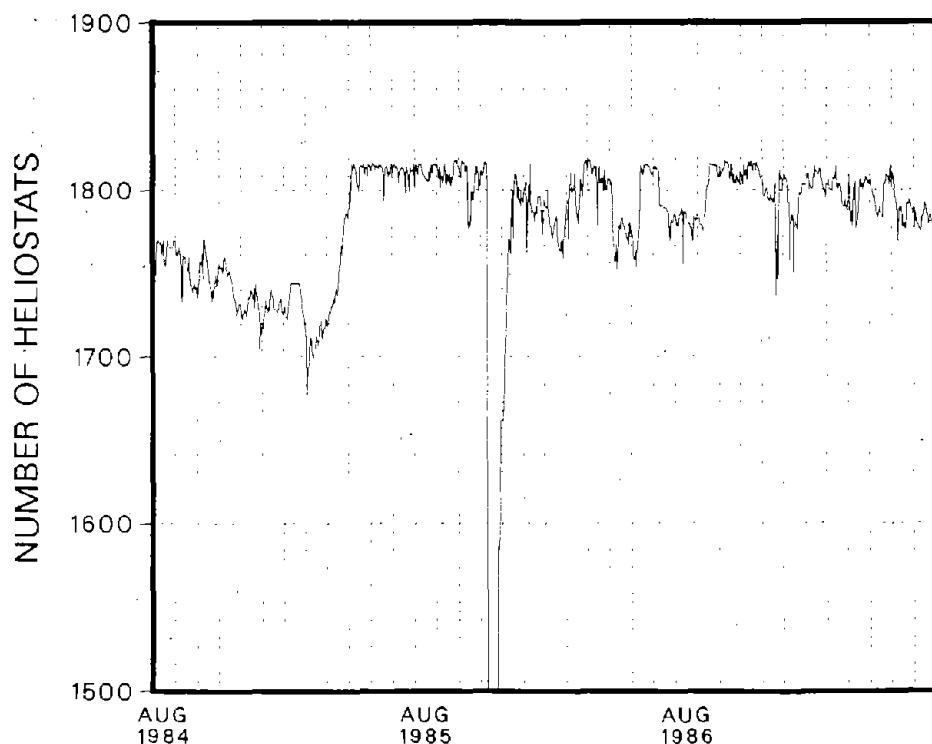
Figure 5-1. Pilot Plant Heliostat Availability

Figure 5-1 shows the heliostat availabilities for power production operation. The monthly values ranged from a high of 99.7% in June 1985 (6 heliostats out of service) to a low of 66.7% in November 1985 (606 heliostats out of service). The average availabilities over the first, second, and third years of power production operation were 96.7, 96.0, and 98.8% (60, 72, and 22 heliostats out of service), respectively.

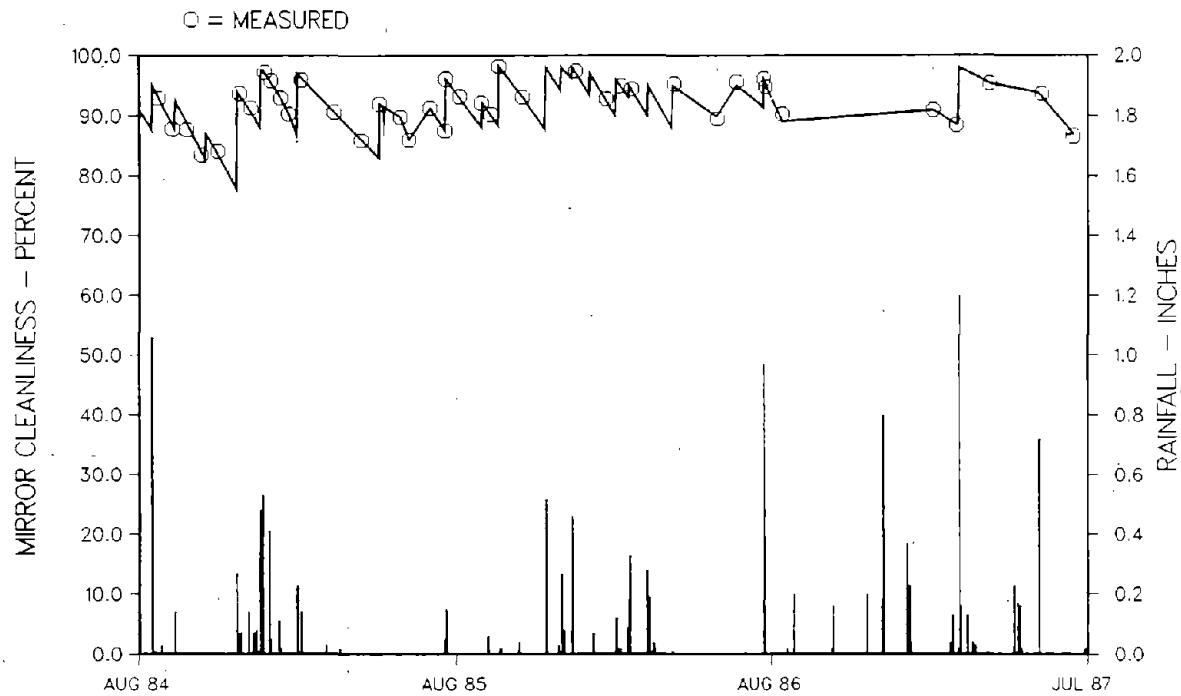
Figure 5-2. Pilot Plant Mirror Cleanliness and Rainfall

Figure 5-2 shows the Pilot Plant mirror cleanliness and rainfall for the years of power production operation. The rainfall values in the figure are from the Daggett, California, airport, about 2.5 miles (4 km) from the Pilot Plant site. The occurrence of reasonable amounts of rainfall, as recorded at the airport, is almost always accompanied by an improvement in mirror cleanliness. This result was the basis for drawing the cleanliness lines through the data points in the figure. The

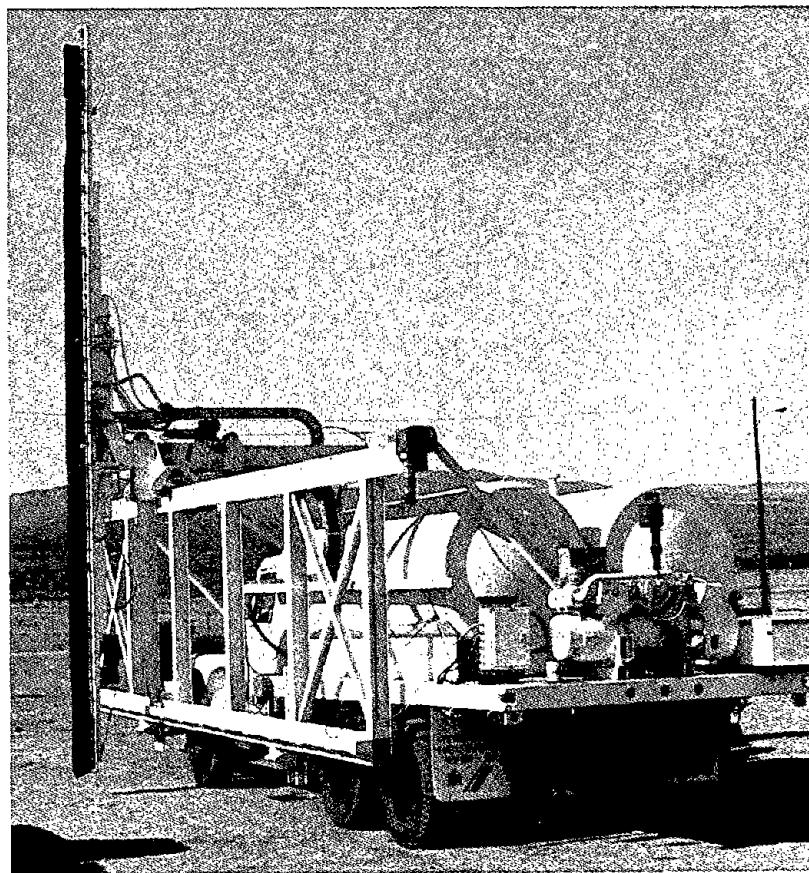
Figure 5—3. Photograph of Water-Spray-With-Brush Wash Truck

The bi-weekly washings needed to achieve an average cleanliness of 97% were not performed during power production operation because of breakdowns of the heliostat wash truck and assignment of personnel to higher priority maintenance activities. The wash truck was an experimental piece of equipment which was sent to the Pilot Plant for evaluation after it had been designed and fabricated under a Sandia contract with Foster-Miller Associates. Modifications to the truck and its washing equipment were made at various times, but the equipment continued to experience breakdowns during power production testing.

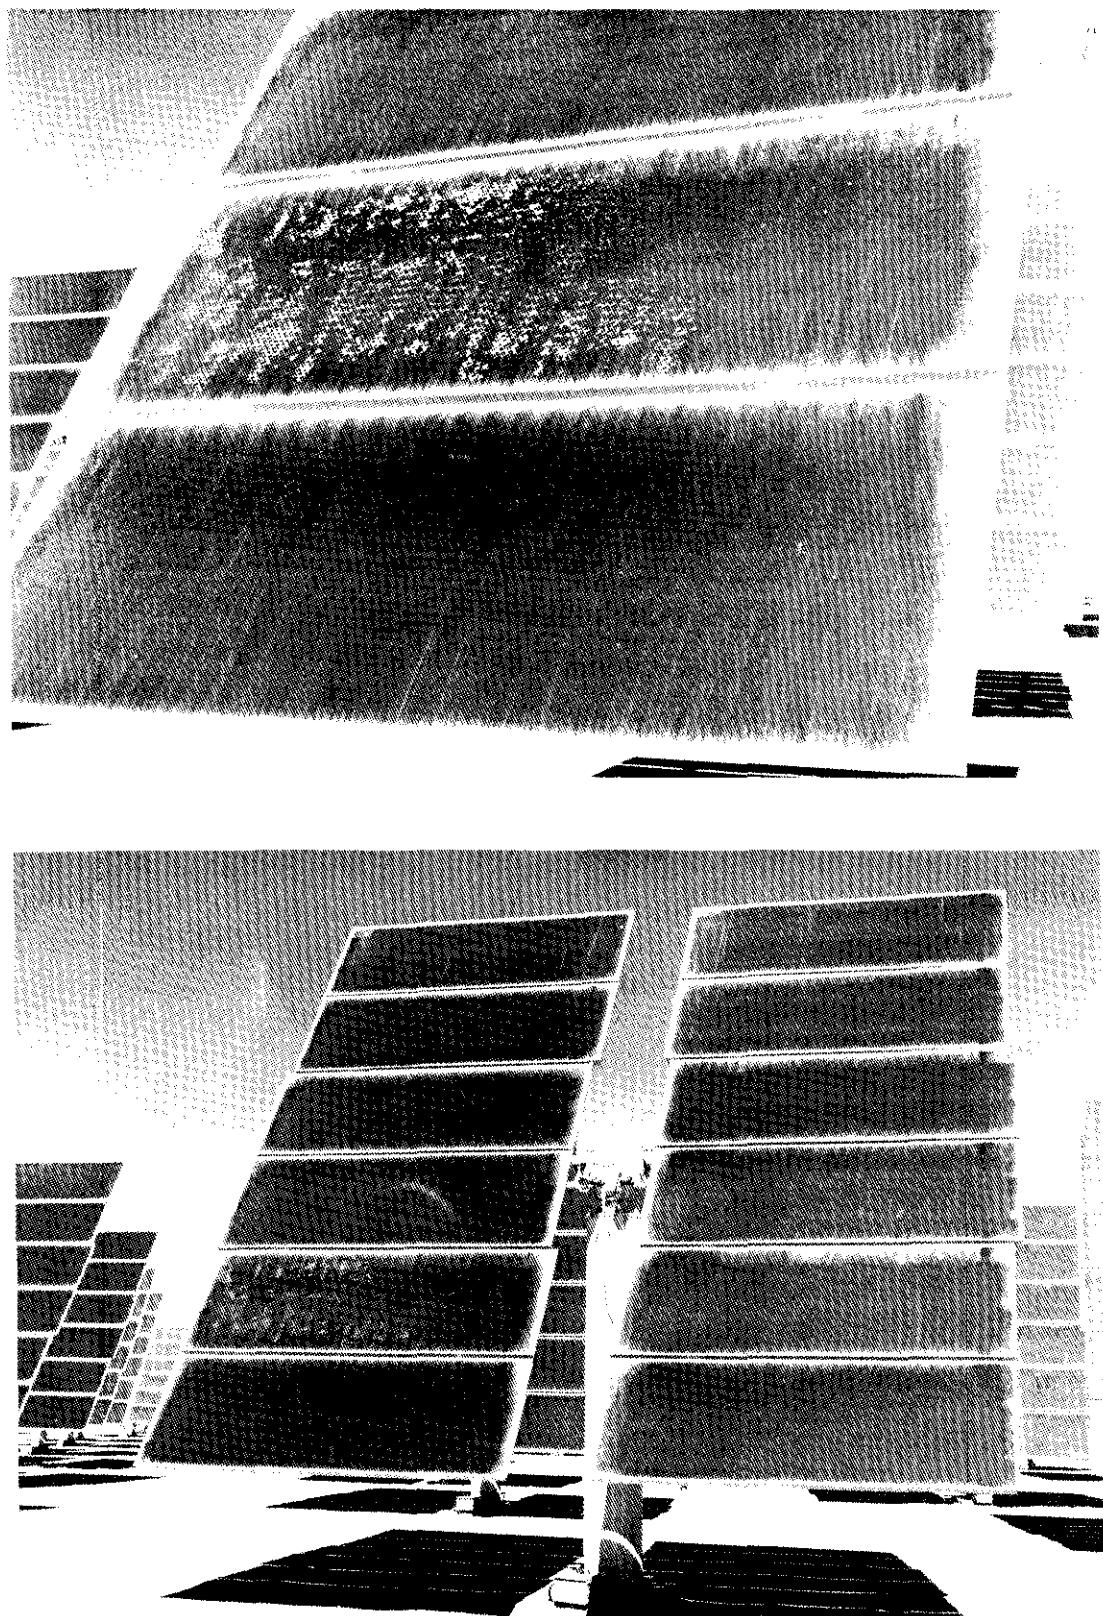
Figure 5-4. Photographs of a Corroded Mirror Module

When the corrosion was detected, several randomly selected mirror modules were first analyzed and then monitored for changes in the amount of corrosion. Beginning in 1983 this monitoring was expanded to include the entire collector field. Corrosion surveys of all 1,818 heliostats were performed during the summers of 1983, 1984, and 1985. The purpose of the surveys, which were performed by SCE, was to inspect all 21,816 mirror modules in the collector field, to document their condition, and to identify trends and/or patterns in the corrosion so that steps could be taken to halt the growth rate.

Silver corrosion has occurred on the Pilot Plant mirrors. The corrosion is caused by water inside the mirror modules that penetrates through the protective paint layers and dissolves the copper; water and oxygen then corrode the silver.

Corrosion surveys of the entire heliostat field were performed during the summers of 1983, 1984, and 1985. During the summer of 1986 a survey was made of 98 randomly selected heliostats. This limited survey was done instead of a full field survey since it had been determined that these heliostats accurately represented the field. The surveys indicated that only 0.061% of the total reflective surface of the heliostat field had corroded by July 1986. This percentage is equivalent to the surface area of about 1.1 heliostats. Thus, although mirror corrosion had been a concern at the Pilot Plant, to date, the overall impact upon collector performance has been small.

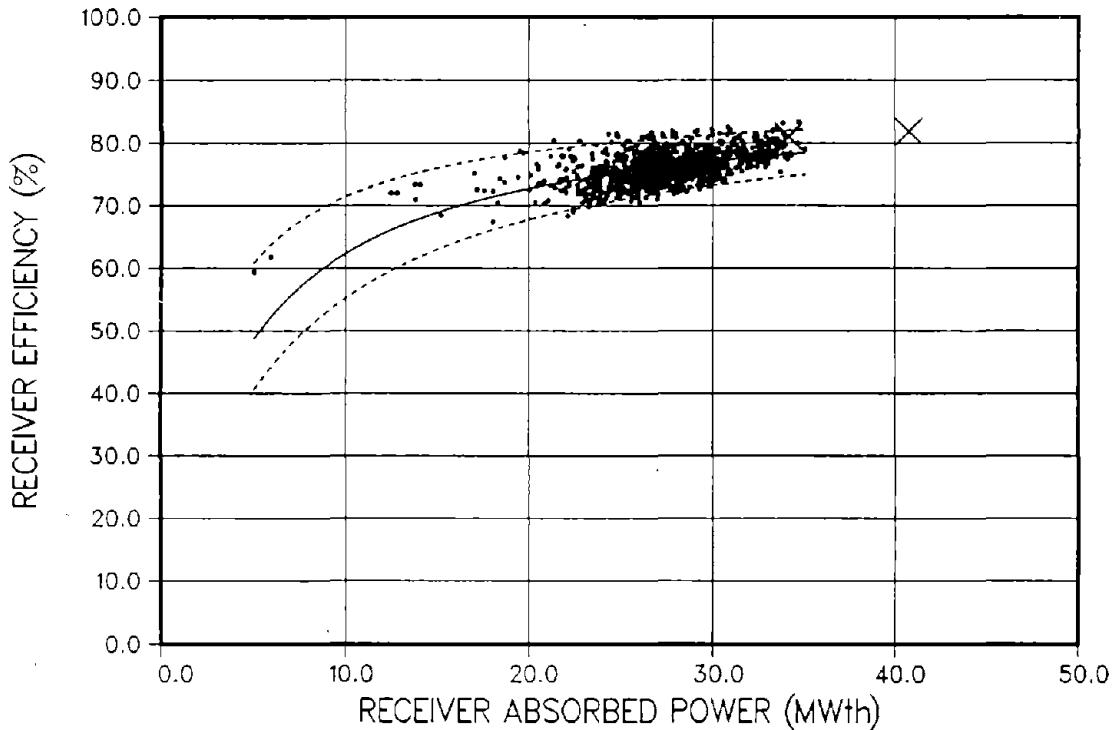
Figure 6-1. Receiver Point-in-time Efficiency Versus Absorbed Power (before Receiver Repainting)

The efficiency as a function of absorbed power is shown in Figure 6-1. This figure displays 898 data points that are based on measured values of the absorbed power and calculated values of the incident power (Method 1). The data were gathered from December 1982 to December 1985, prior to the receiver repainting. The solid line is a least squares fit to the data while the "X"s are design point efficiencies calculated from Reference 6-8. The dashed lines show the 95% prediction interval: for a given value of the absorbed power there is a 0.95 probability that the efficiency will lie between the limits shown.

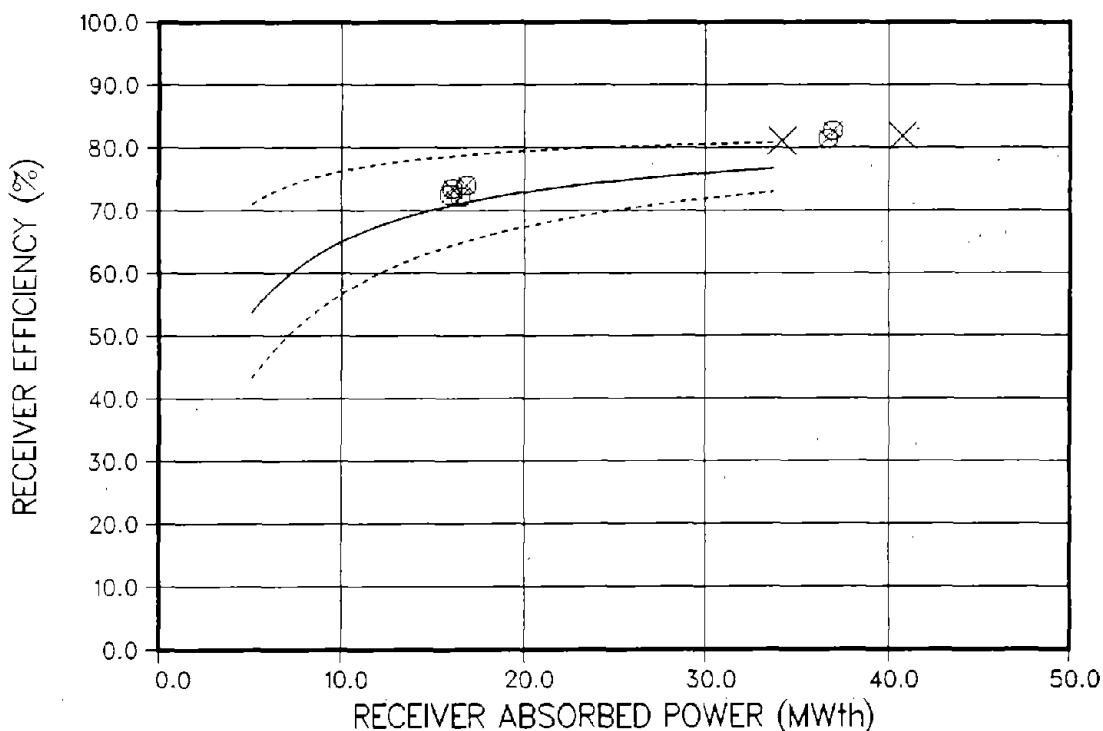
Figure 6-2. Receiver Point-in-time Efficiency Versus Absorbed Power (after Receiver Repainting)

The agreement between the measured and design efficiency values was better after the receiver was repainted. Although the better agreement is encouraging, some caution is required when comparing the results. The "actual" and "design" receivers, on which the values are based, were still different. First, the measured absorptance was 0.97 versus the design value of 0.95. Second, the measured active area of the absorbing surface was 96.2% of the measured exposed area, which in turn differed from the design area. Finally, the measured

The Pilot Plant experience showed that it was possible to successfully repaint the receiver in the field and improve the receiver's thermal performance. The Pilot Plant receiver was completely repainted only once during its five years of operation. For future solar plants, projections should be made regarding the expected rate of degradation in receiver coatings and the economic intervals for repainting.

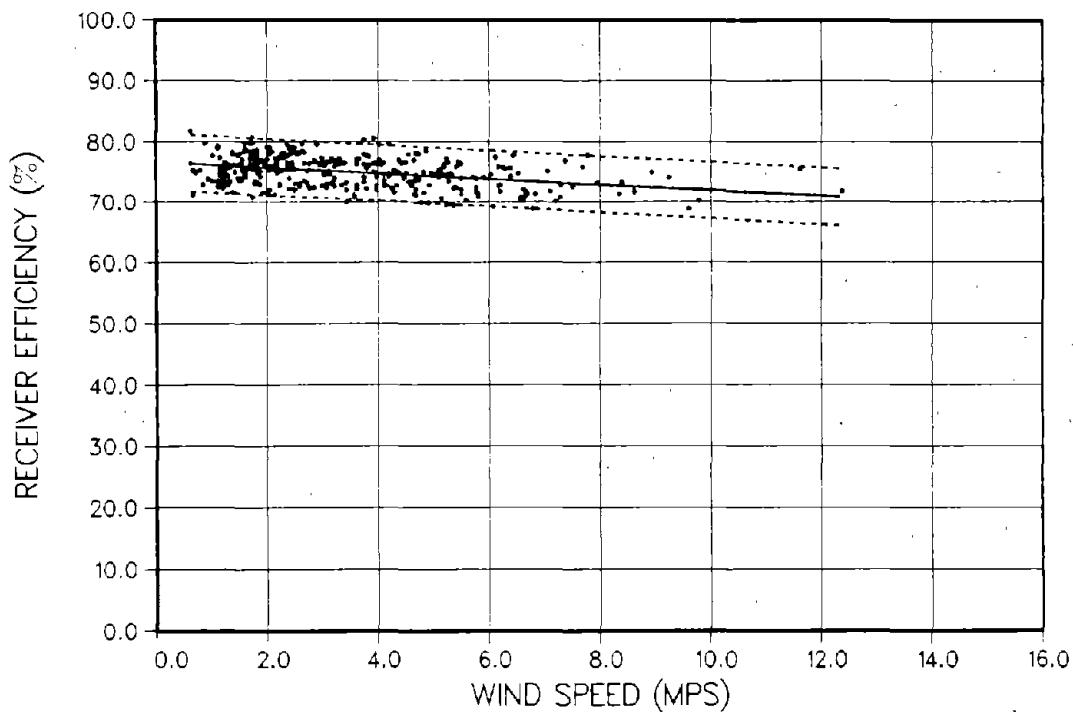
Figure 6-3. Receiver Point-in-time Efficiency Versus Wind Speed

The data show that the expected efficiency is 76.5% at the lowest wind speed and 70.9% at the highest wind speed. Thus, the expected receiver efficiency dropped 5.6 percentage points over the range of wind speeds studied. The results show a slightly stronger dependence on wind speed than the early test results reported in Reference 6-1. The early results, which were based on limited test data, showed that the receiver efficiency decreased about one percentage point as wind speed increased from 0 to 20 mph (0 to 8.9 m/s).

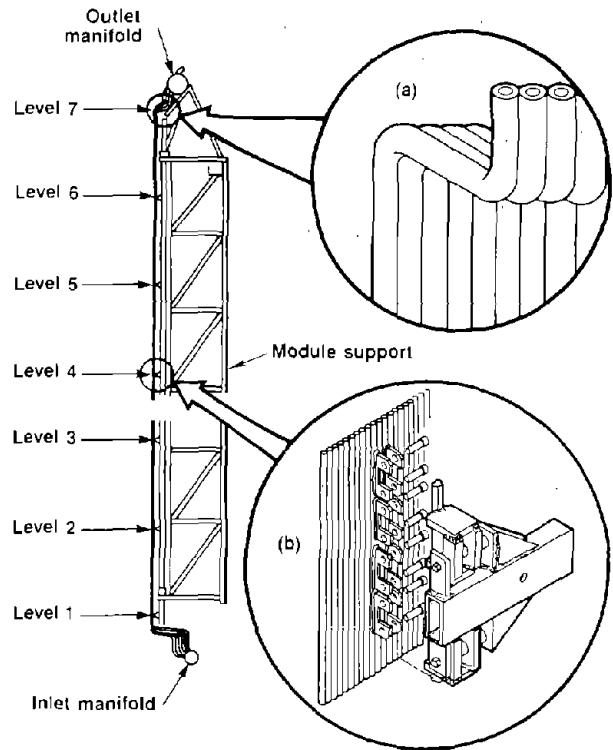
Figure 6-6. Receiver Panel Schematic

A 70-tube receiver panel consists of seven subpanels of ten tubes each. During fabrication the subpanel tubes were first welded together along their entire length, and then the subpanels were welded together. Attachments were welded on the back of the panels to carry the panel loads. Figure 6-6 shows the locations of tube bends and manifolds at the top and bottom of the panels and the panel supports at levels 1-6. The weight of a panel is carried by supports under each subpanel at the top of the panel, level 7.

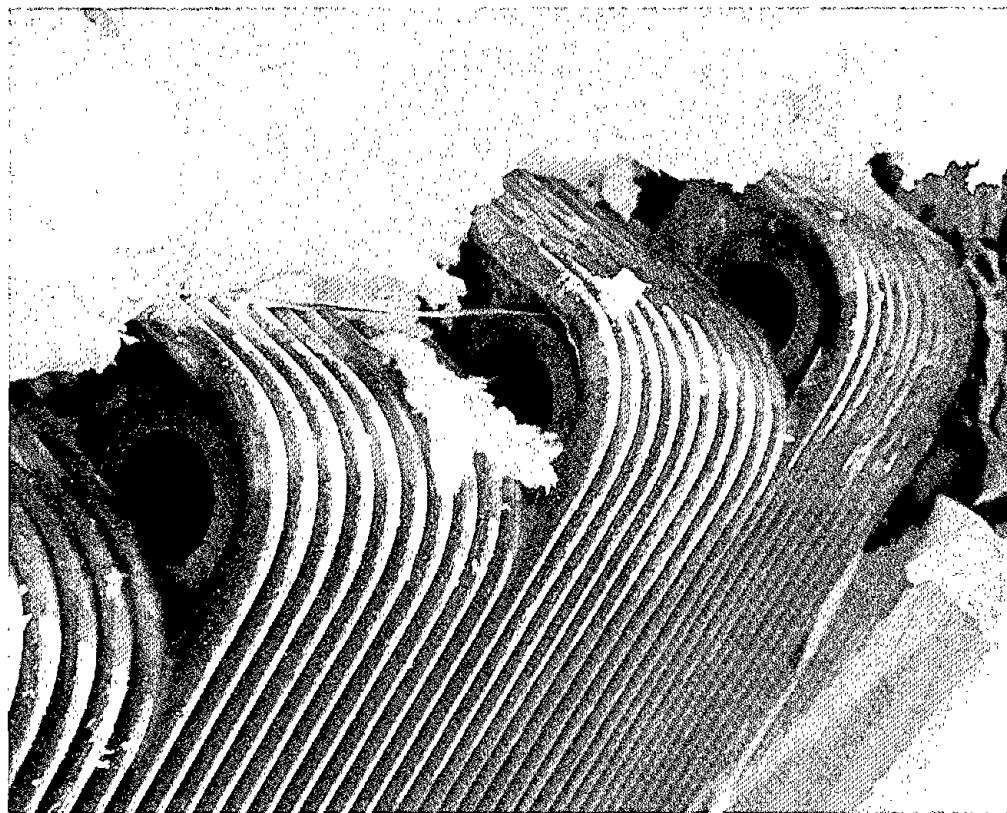
Figure 6-7. Photograph of Top Portion of a Receiver Panel

The welds between the subpanels are referred to as the panel "interstice welds". An interstice weld was terminated at the top and bottom of the panel by extending the weld along the shortest subpanel and wrapping it over about one inch on the front of the panel. A small portion of insulation at the top and bottom of the panel covers the interstice weld termination. Figure 6-7, a photograph of the top portion of a panel, shows the subpanels, supports under the subpanel first  $90^{\circ}$  bend, and interstice welds on the front of the panel. The insulation at the top of the panel has been removed to expose this area of the panel. The wires across the top of the subpanels are used to hold the insulation material above the subpanels in place.

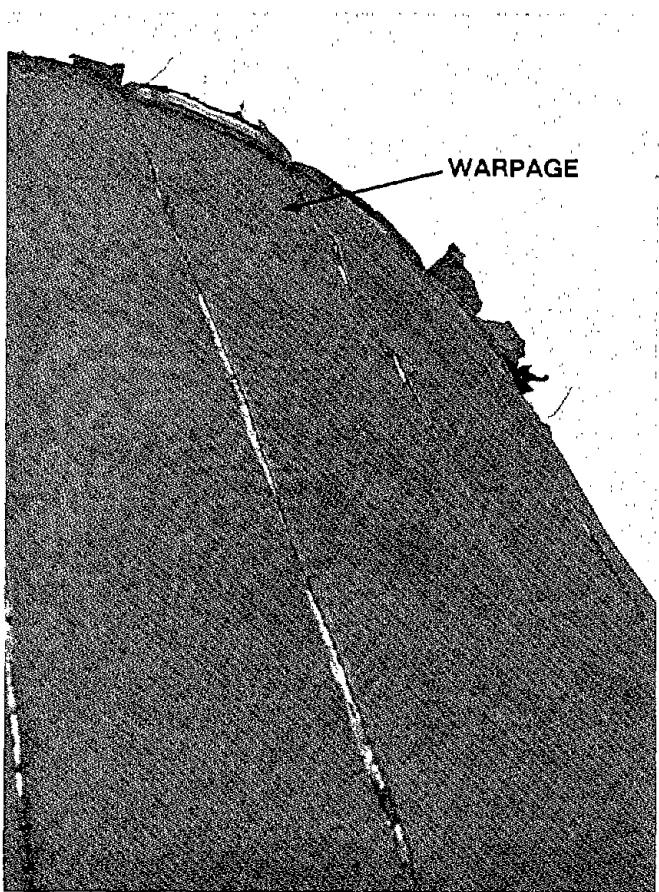
Figure 6—8. Photograph of Early Panel Warpage

A slight panel warpage was observed on several receiver panels in March 1982, two months after the receiver began operation. Figure 6-8 shows the top
