# Final Report on the Power Production Phase of the 10 MWe Solar Thermal Central Receiver Pilot Plant

SAND87-8022  
Unlimited Release  
Printed March 1988

## FINAL REPORT ON THE POWER PRODUCTION PHASE OF THE 10 MW<sub>e</sub> SOLAR THERMAL CENTRAL RECEIVER PILOT PLANT

L. G. Radosevich  
Project Engineering Division III  
Sandia National Laboratories Livermore

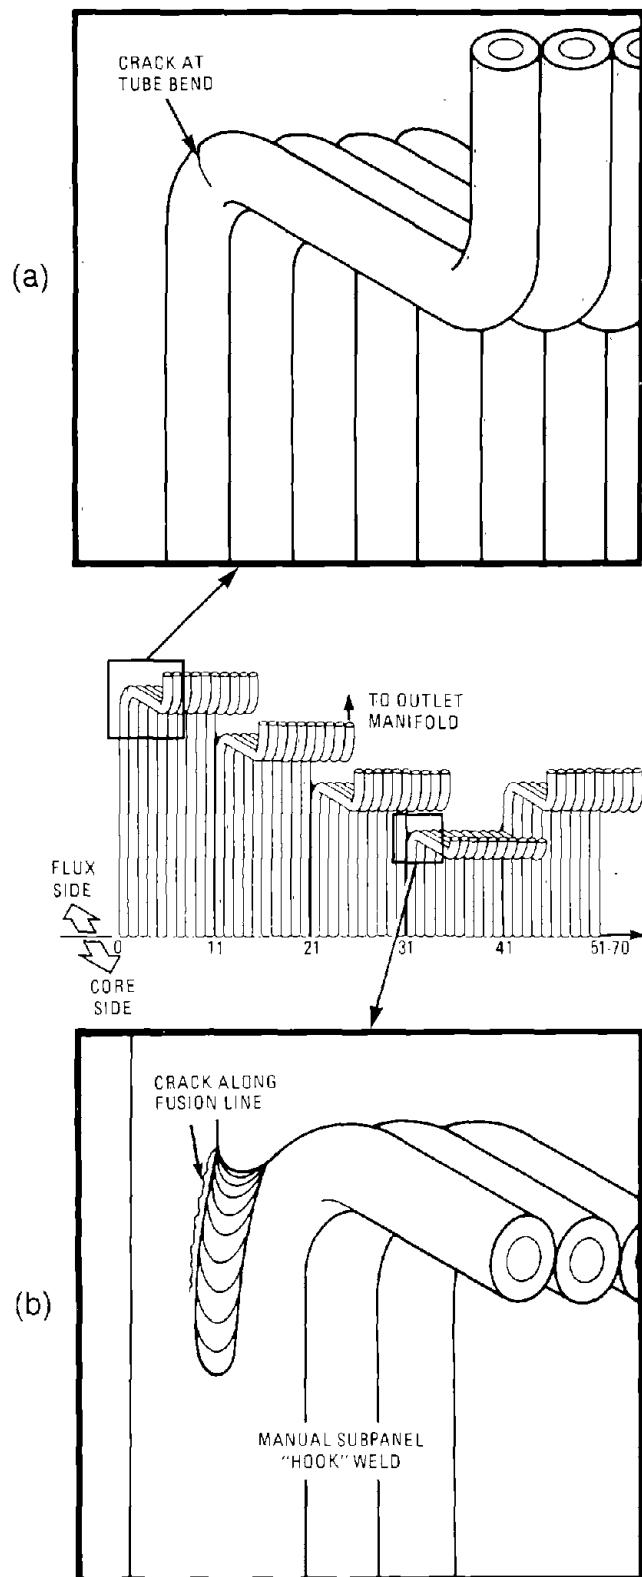
Figure 6-9. Locations of (a) Edge Tube Leaks (Type II) and (b) Subpanel Interstice Weld Leaks (Type I)

During plant operations, tube leaks occurred on several of the receiver boiler panels. The leaks were associated with cracks at two distinct locations on the panels. After eighteen months of service, the leaks occurred at the top of the panels at the interstice weld between subpanels (Type I cracks) and on the edge tube bend (Type II cracks). The second location, which first occurred in July 1985, was on the back of the panels at the panel support assembly (Type III cracks).

Several studies were performed to determine the cause of the two types of leaks and find a way to eliminate their occurrence. The studies were both analytical and experimental in nature. Until the cause of the leaks was understood, the maximum receiver steam outlet temperature was reduced from the design value of 960°F (516°C) to about 770°F (410°C). At first it was hoped that the leaks were exceptions and that there was not a generic problem with the receiver. After several receiver inspections, using dye penetrant and ultrasonics over a period of months, more interstice weld and tube bend cracks and leaks were found. The inspection data showed a tube leak problem affecting several receiver panels.

Panel structural modifications at the top of the panels and changes in the receiver operating conditions eliminated the Type I and II cracks. Start-up procedures were revised to control temperature during start-up and shutdown, and repairs of the receiver tube leaks were carried out successfully.

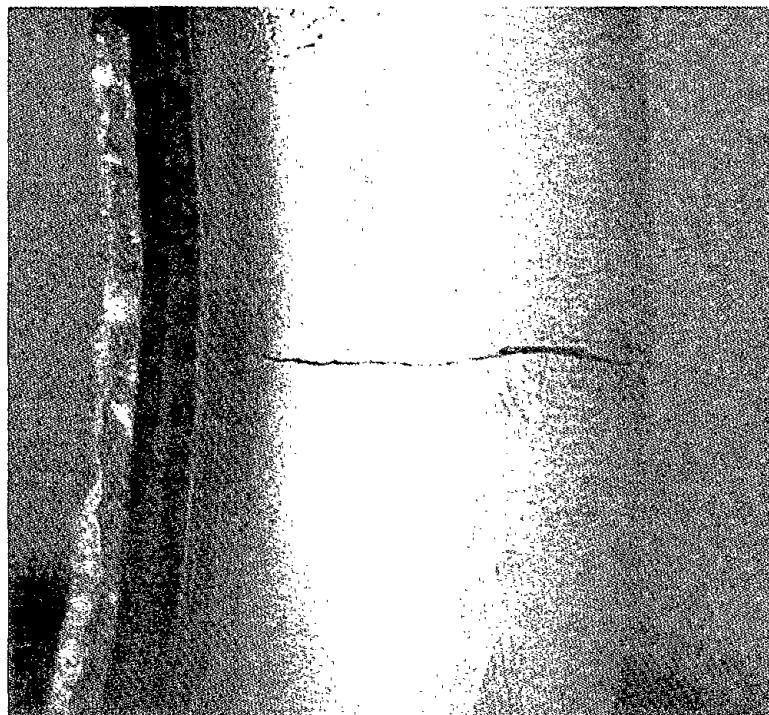
Figure 6-11. Photograph of a Crack in the Edge Tube Bend Section Removed from a Panel

**Edge Tube Leaks**—In August 1983 the leaking edge tube bend was removed and replaced with a new tube bend. The removed tube section extended from below the first 90° tube bend leak location to above the second 90° tube bend, shown in Figure 6-9. Figure 6-11 is a photograph of the Type II crack in the edge tube bend section removed from the panel. The crack is circumferential in direction, around the tube. The crack is located on the extrados, or outer curve, of the bend and wrapped around approximately 150° of the tube (see Figure 6-9 (a)).

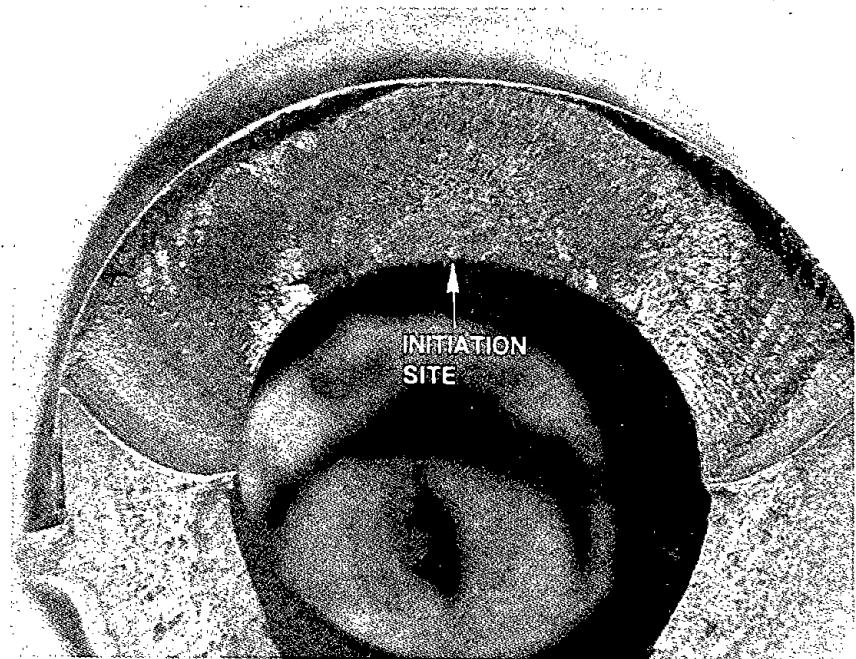
Figure 6-12. Photograph of the Cross-section of a Cracked Edge Tube Bend Section Removed from a Panel

The new tube section, which replaced a section of the first leaking edge tube, showed an ultrasonic indication of a tube bend crack within six months of being installed. The new tube section had a different mechanical environment than the old section since it was not welded to the adjacent tube. Yet, it still cracked. The appearance of cracks in the new tube section again suggests that thermal shock of the high temperature panel edge tubes is the cause of this type of crack.

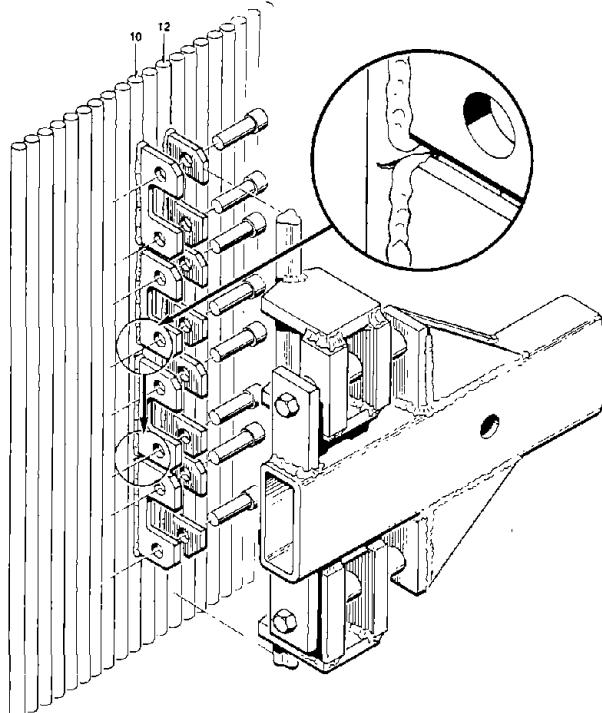
Figure 6-14. Location of Panel Clip Weld Leaks (Type III)

Another possible cause could be the loads that are placed on the panel clips restraining the panels from bowing. With the panel front surface temperature higher than the back surface temperature, the panels will try to bow due to thermal expansion. The panel supports at levels 1 to 6 restrain the panels from bowing. The temperature difference between the front and back surfaces is greatest

Analyses indicated that the Type III cracks were caused by thermal stresses due to temperature gradients through the panel tubes and the panel support clips welded to the back of the tubes. The panel supports were modified to relieve the thermal stresses, but the modifications did not eliminate the occurrence of the Type III cracks. The receiver experience concerning tube leaks has shown that designs need to be improved to account for thermal cycling, and manufacturing techniques need to be changed to eliminate the amount of welding required on the receivers. Almost all tube leaks, except Type II, were associated with welds on the tubes. Simpler manufacturing techniques with less welding should be used in the future receiver designs.

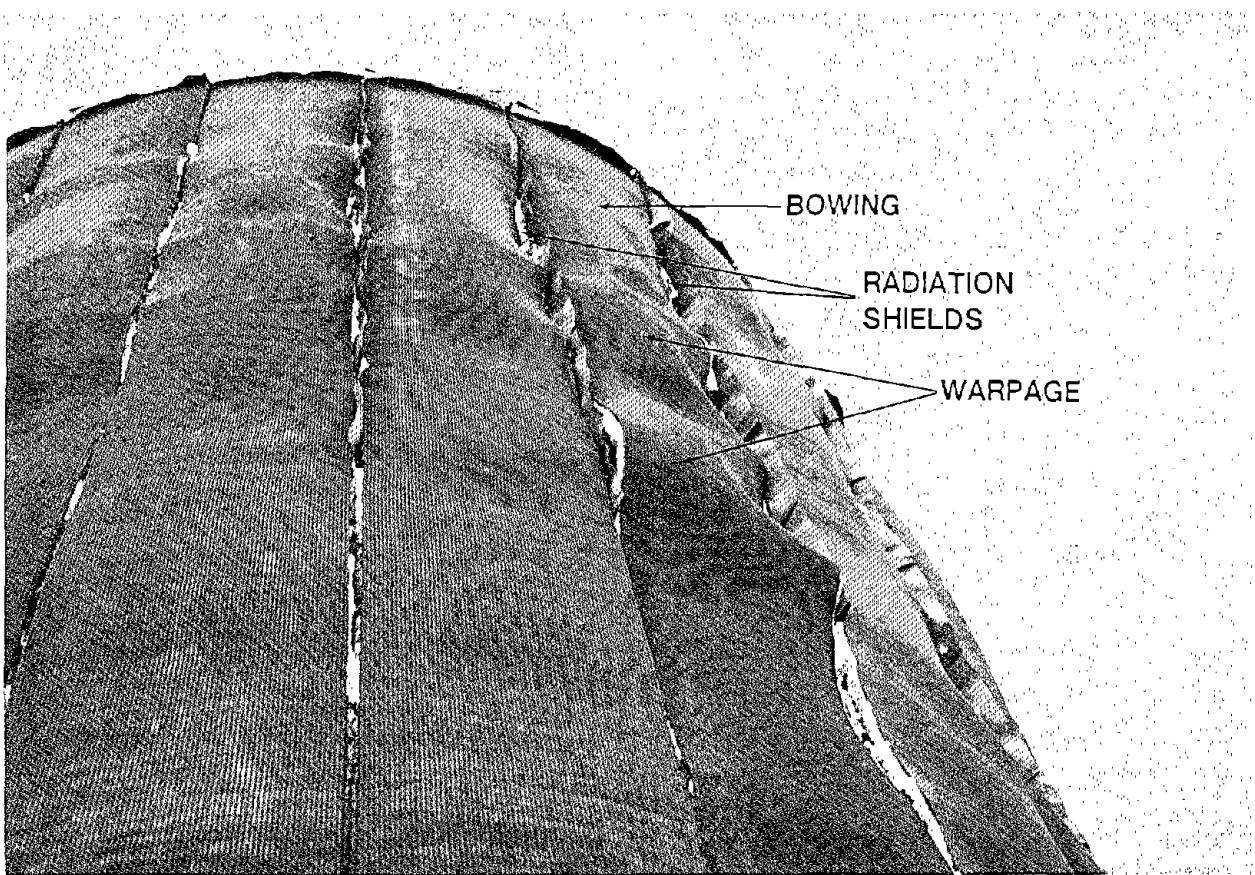
Figure 6-15. Photograph of Current Panel Warpage and Bowing

After more than seventy months of receiver operation, many things about receiver life have been learned. Most tube leaks have been associated with some type of weld on the panels. One need is to reduce the number of welds and be concerned with the relative size of materials welded to the tubes. Over constraining the panel thermal expansion can lead to high thermal stresses in the panel tubes. The severe thermal environment and exposure to weather can cause corrosion on the panel supports and restrict their movement. Temperature gradients due to lateral incident solar flux gradients and panel front-to-back surface temperatures during start-up, cloud transients, and shutdown can cause thermal creep-fatigue leading to panel warpage and bowing. Having the panel tubes welded together along their length when the panel has a lateral temperature gradient can lead to panel deformation. Overall, the Pilot Plant operation has provided valuable receiver life data for the designers of future receivers.

The main problem with the receiver operation resulted from the diurnal and cloud-induced thermal cycling. Cracks appeared in the receiver tubes after eighteen months of service, and several panels warped as a result of thermal expansion constraints (described below under Receiver Life). These led to frequent outages so repairs could be made. All the repairs of the receiver tube leaks were successfully carried out in the field. The repairs were made without removing the receiver panels from the tower.

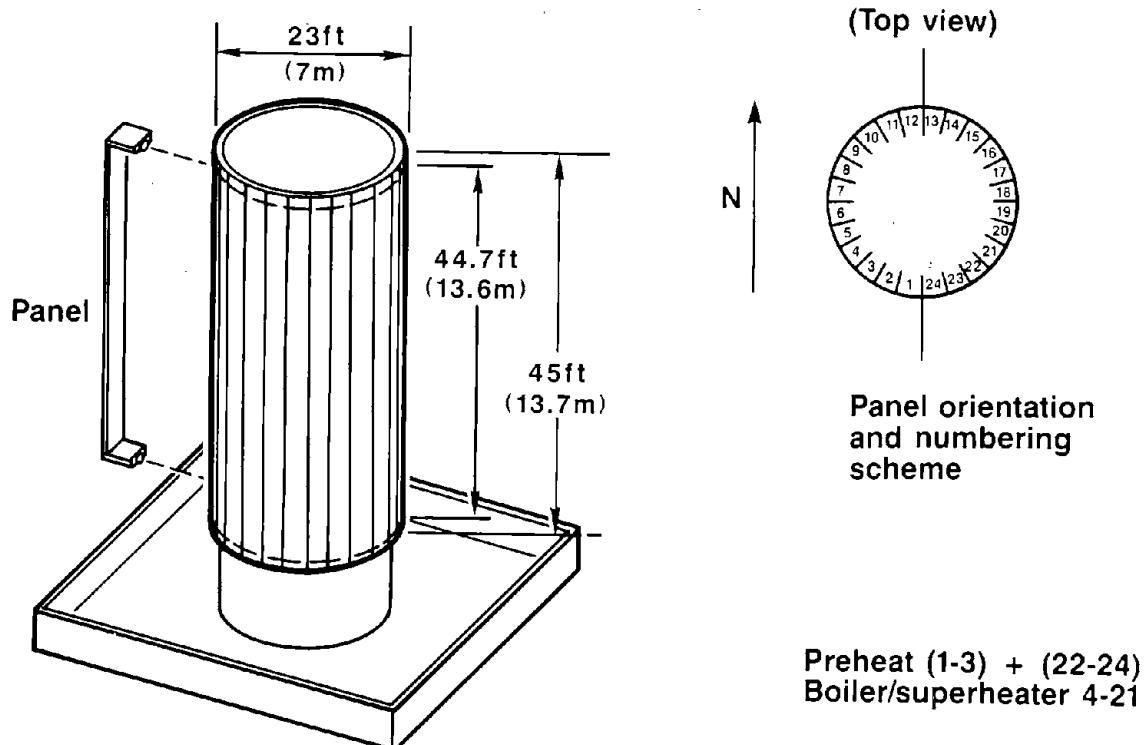
Figure 6-16. Receiver Panel Numbering System

North panels receive the highest incident solar fluxes and south panels receive the lowest. Peak incident flux ranges from a low of 100 kW/m<sup>2</sup> on Panels 1 and 24 to a high of about 300 kW/m<sup>2</sup> on Panels 12 and 13. The incident flux distribution is nearly the same on all panels, and only the peak values change.
