PFBC HGCU Test Facility
Technical Progress Report

Fourth Quarter, CY 1994

American Electric Power Service Corporation
Columbus, Ohio 43215

This is the twenty-first Technical Progress Report submitted to the Department of Energy (DOE) in connection with the cooperative agreement between the DOE and Ohio Power Company for the Tidd PFBC Hot Gas Clean Up Test Facility. This report covers the work completed during the Fourth Quarter of CY 1994.

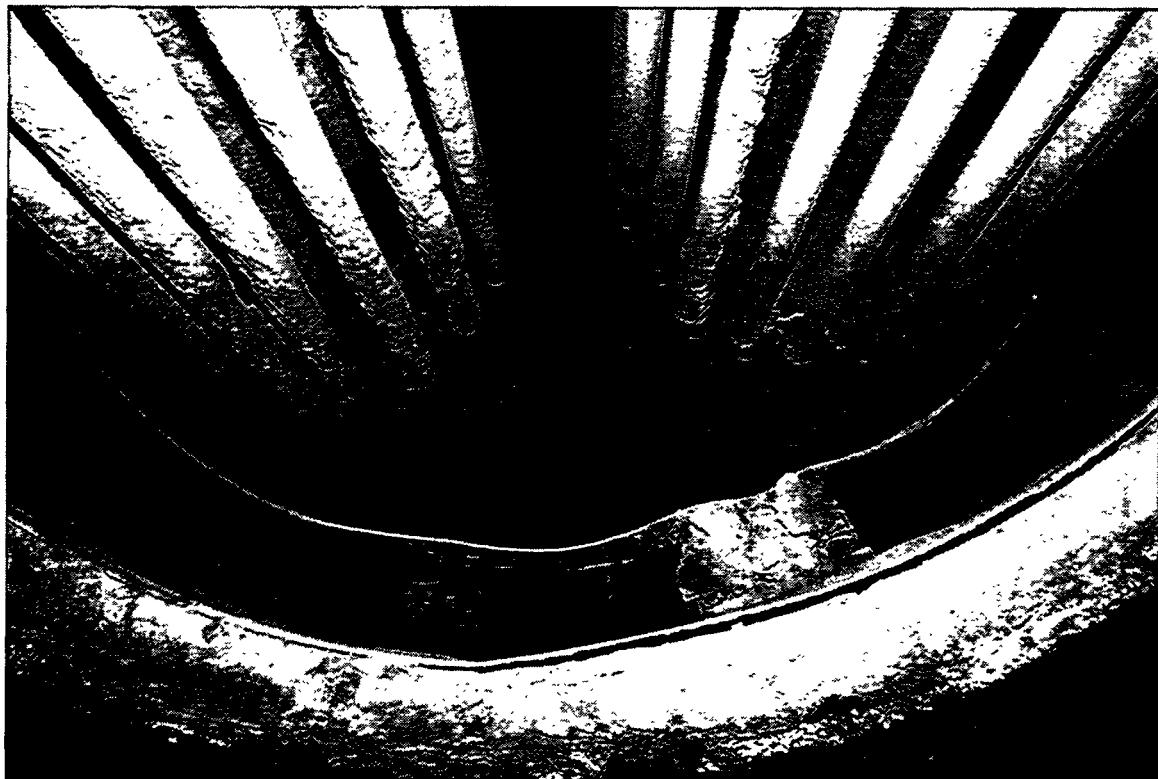
Figure 5 — Ash Bridging Along The Middle Plenum Filter Arrays

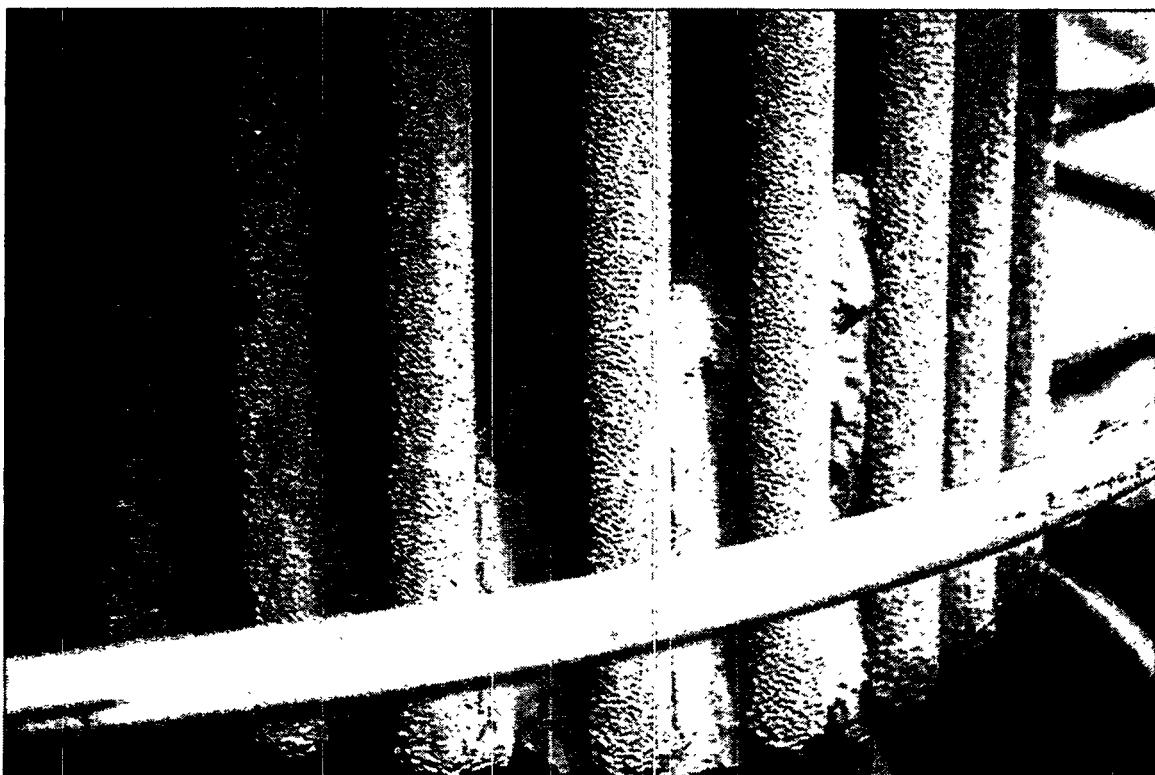
Figure 6 – Ash Bridging At The Bottom Of The Coors P-100A-1 Alumina/Mullite Candle Filters

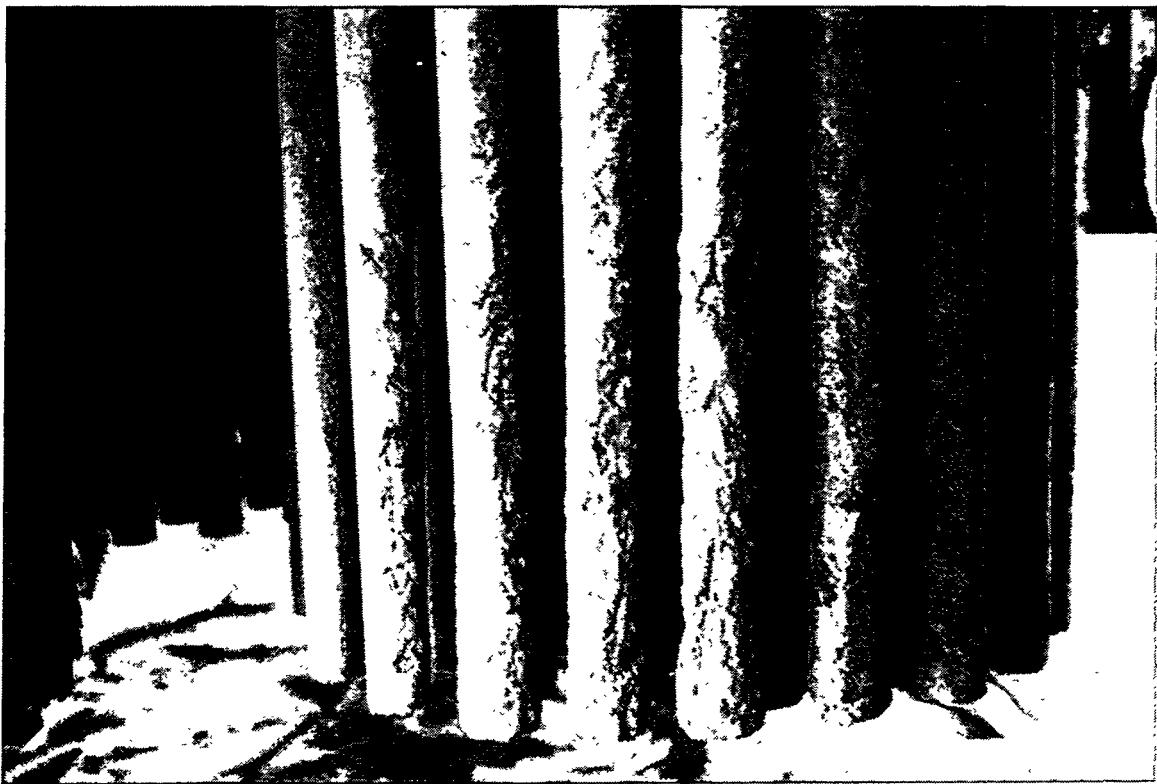
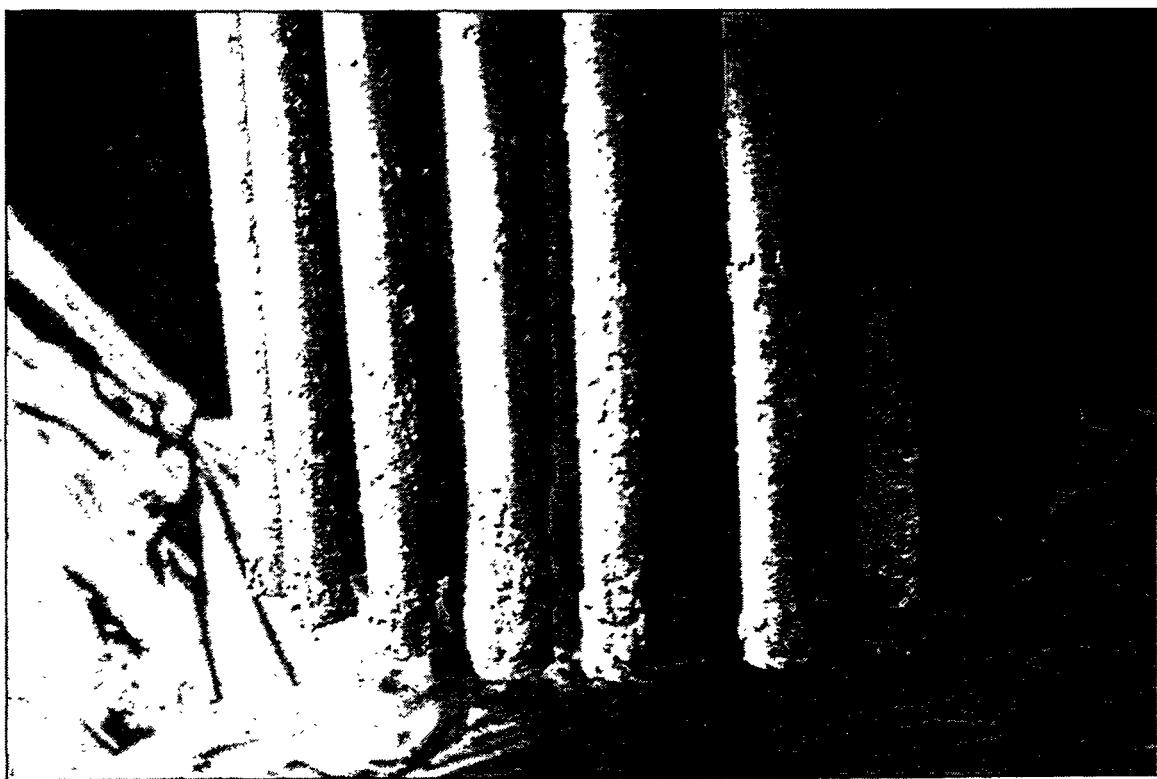
Figure 11 — Ash Cake Formations Along The Schumacher Dia Schumalith F40 Candle Filters In The Bottom Arrays In The W-APF System (October 1994)

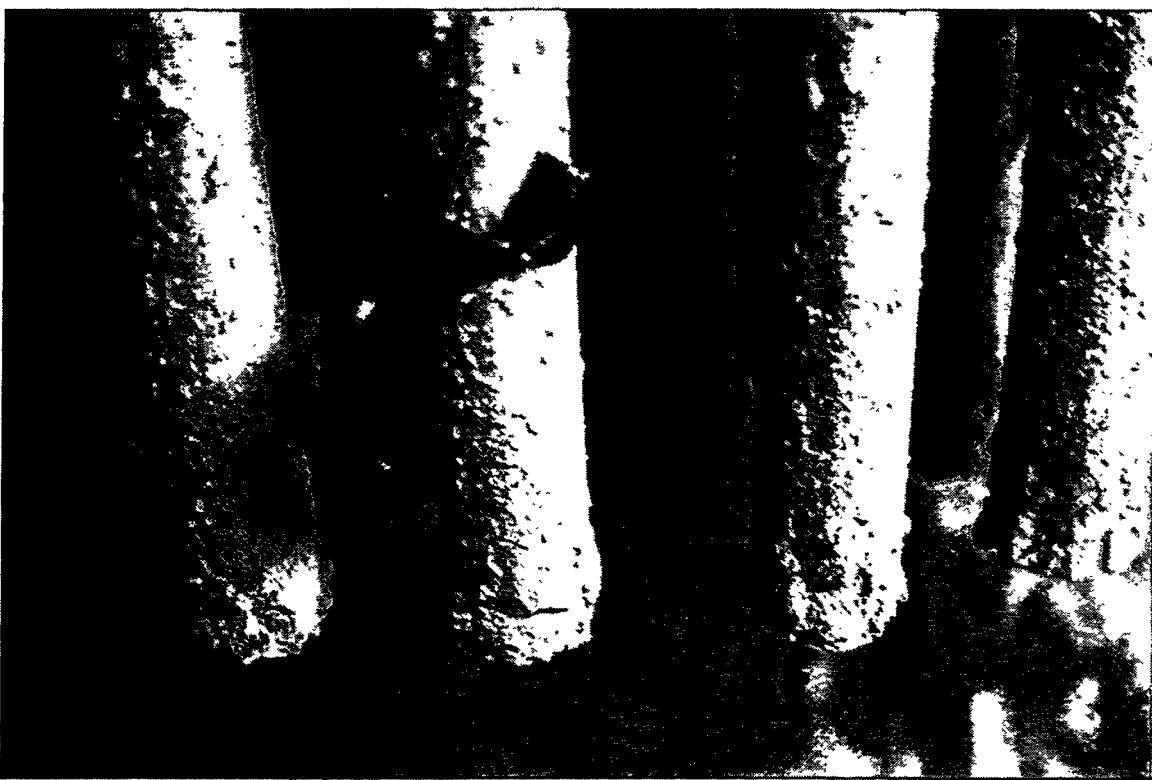
Figure 13 — Ash Cake Formations Along The Schumacher Dia Schumalith F40 Candle Filters In The Bottom Arrays In The W-APF System (October 1994)

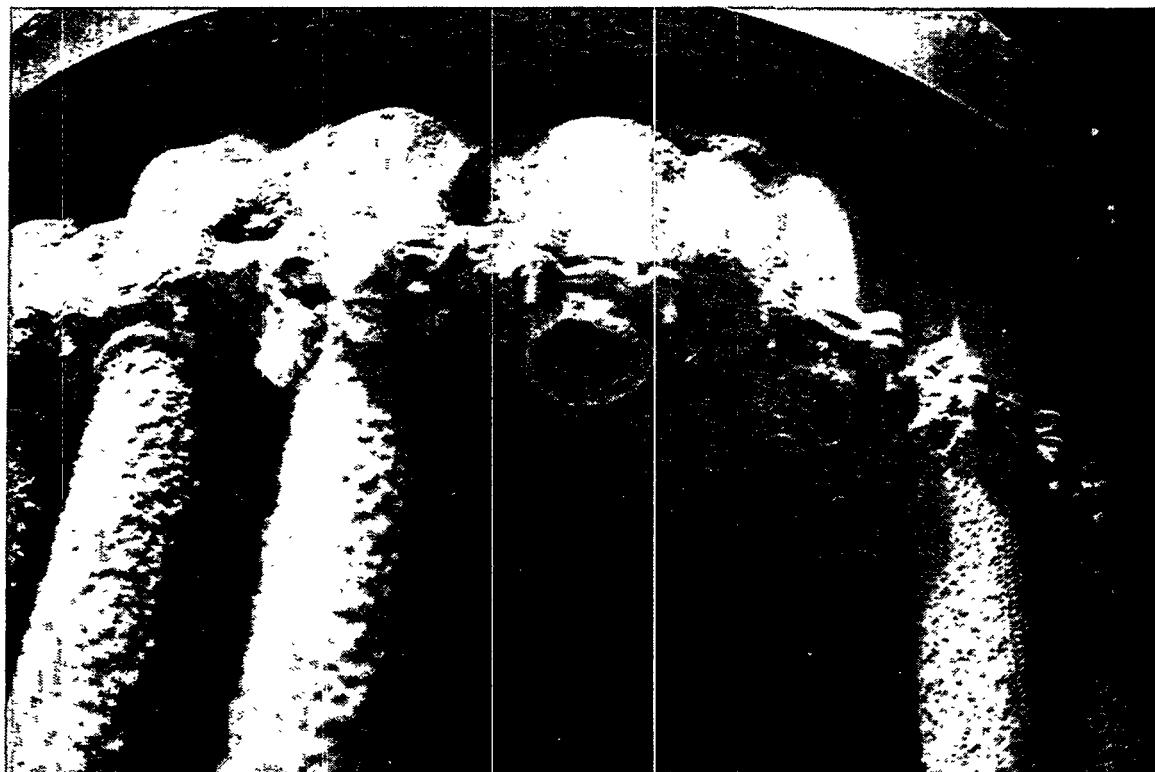
Figure 18 — Filter Holder Mounts Which Originally Housed The 3M CVI-SiC Composite Filters

As shown in Figure 18, two of the three 3M CVI-SiC composite filters had failed below the flange during the last 690.5 hours of test operation in Test Run 24 at Tidd. Although bridged ash was evident between the filter holder mounts, evidence of ash was not apparent between the gasket sleeve and the sections of the 3M filter elements which remained in the filter holder mounts. Fail-safe/regenerators had been included above all filter elements in the B/M array. After failure of the 3M CVI-SiC composite candle filters had occurred, the fail-safe/regenerators above the failed filter elements effectively plugged (Figure 19).

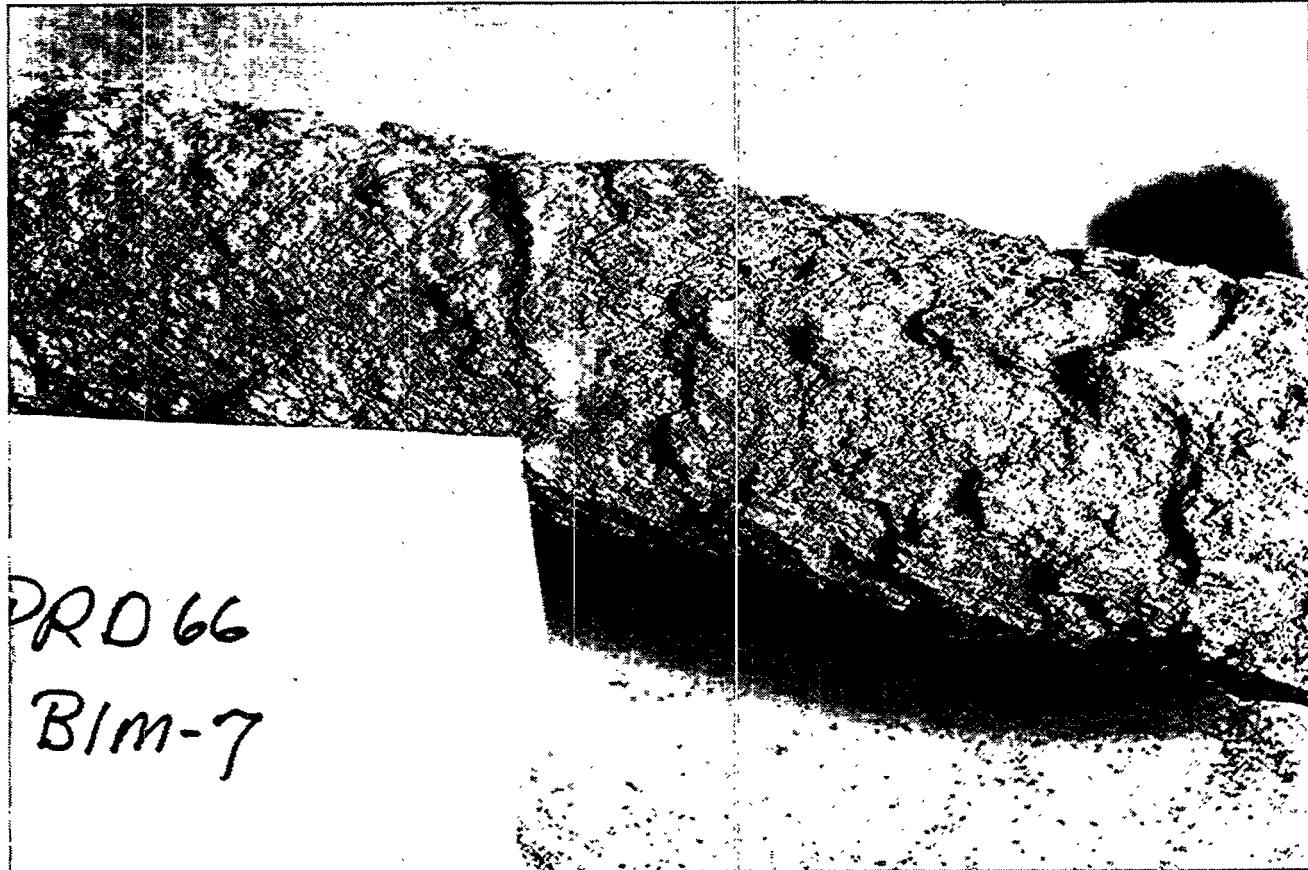
Figure 21a – Thick Ash Cake Formations Along The Surface Of The DuPont PRD-66
Candle Filter Which Filled With Ash Along Its ID Bore

resulted from misalignment of the top gasket which permitted dust to enter and fill the inside of the filter element. During removal of the DuPont PRD-66 candle filter from its holder, the candle fractured at the base of its flange. The fail-safe/regenerator unit that was positioned above the B/M-7 PRD-66 candle filter was seen to be entirely plugged with ash fines after 1705 hours of hot gas filtration in the PFBC gas environment (Figure 22).

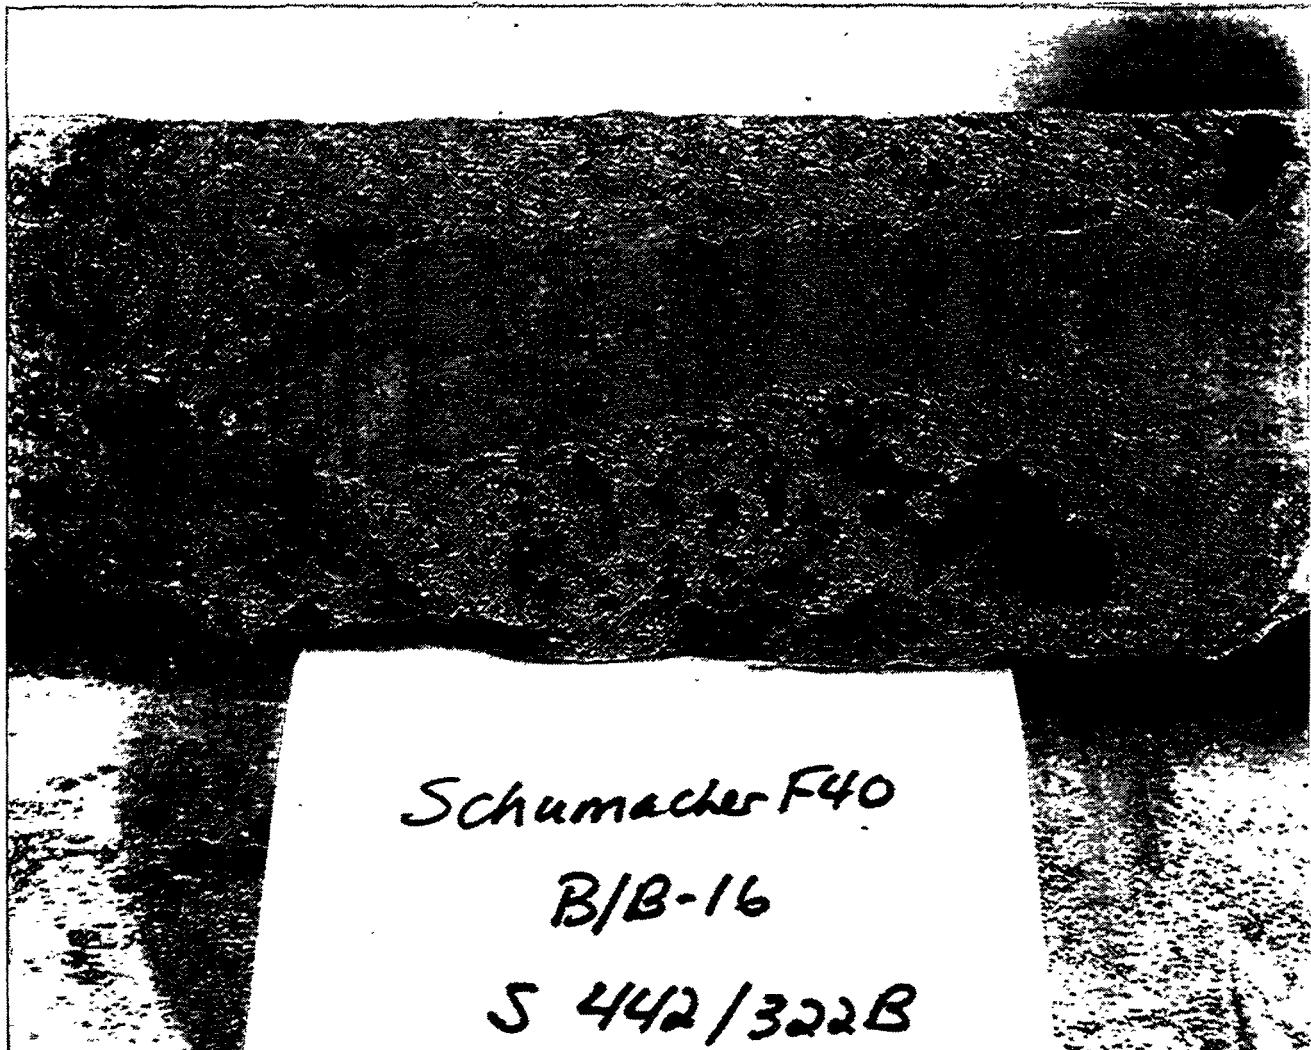
Figure 24b – Ash Cake Formations Along The Outer Surface Of The Schumacher Dia Schumalith F40 Candle Filters After 1705 Hours Of Hot Gas Filtration In The PFBC Gas Environment

were observed along the three Schumacher Dia Schumalith F40 candle filters which had been removed for material characterization. As shown in Figure 24, the morphology of the thick residual dust cake layer varied and was rather nondescript in many areas along the surface of the Schumacher Dia Schumalith F40 filter elements.

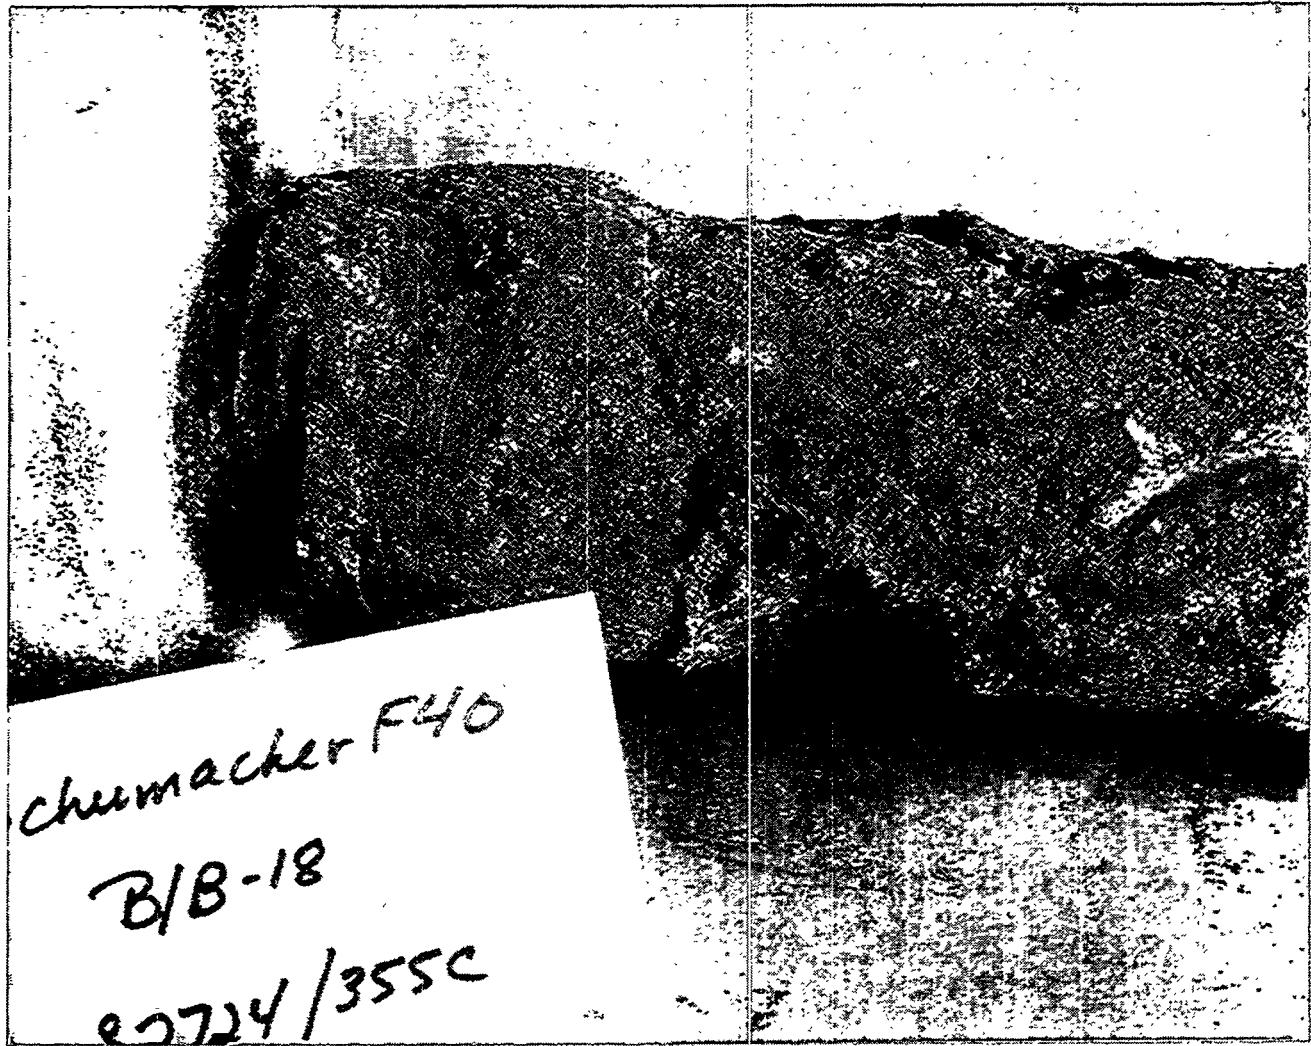
Figure 24e – Ash Cake Formations Along The Outer Surface Of The Schumacher Dia Schumalith F40 Candle Filters After 1705 Hours Of Hot Gas Filtration In The PFBC Gas Environment

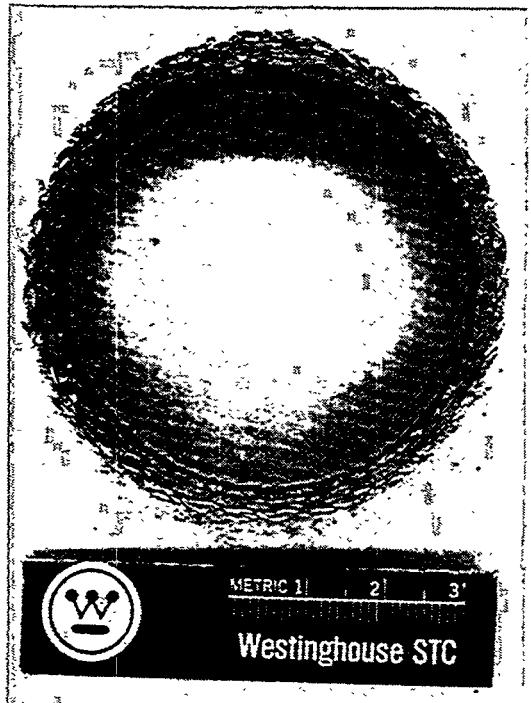
Figure 1 — Construction Of The 3M CVI-SiC Composite Filter Matrix

Elemental microprobe analyses (EMA) were conducted on the fibers that were present in the as-manufactured outer confinement layers of the 3M CVI-SiC composite filter matrix (Figure 3). Fiber pull-out during sample preparation is evident in the micrographs shown in Figure 3. EMA indicates the presence of aluminum, silicon and oxygen within the NextelTM 312 fibers (i.e., an aluminosilicate), with silicon and carbon

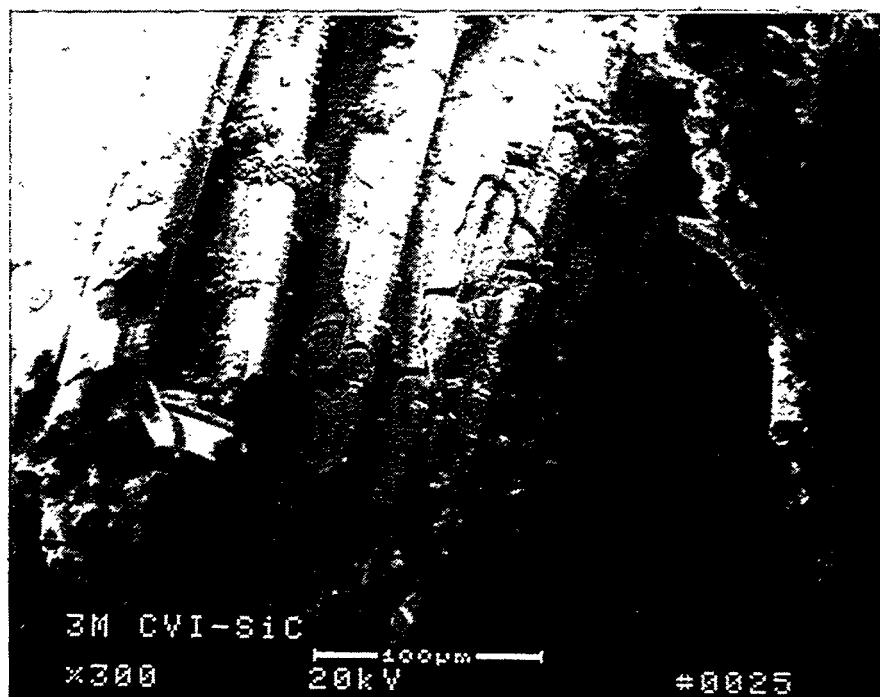
Figure 2c – Cracking Of The CVI-SiC Coating During Sample Preparation

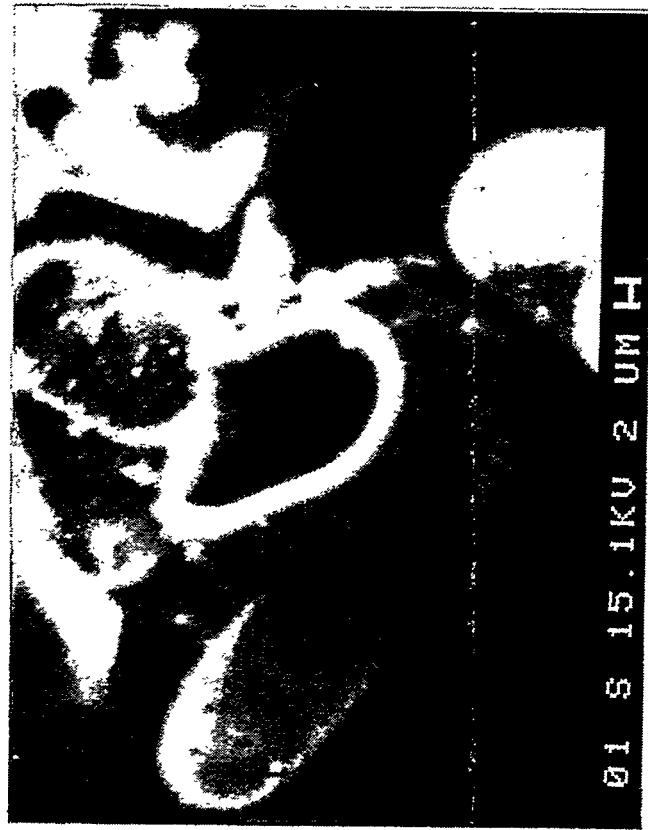
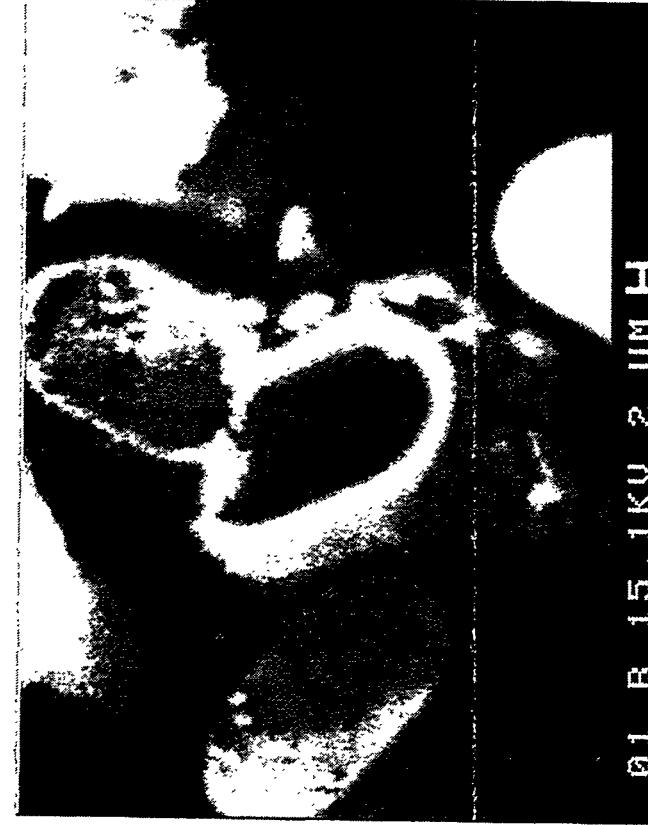
Figure 3a – Elemental Microprobe Analyses Of The Fibers Present In The As-Manufactured Confinement Layer Of The 3M CVI-SiC Composite Filter Matrix

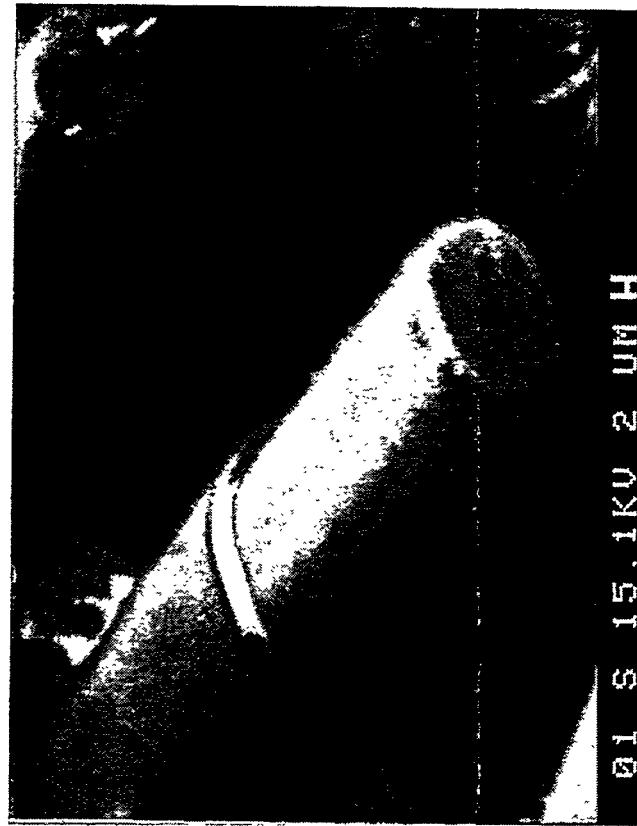
Figure 3b – Elemental Microprobe Analysis Illustrating Fiber Pull-Out During Sample Preparation

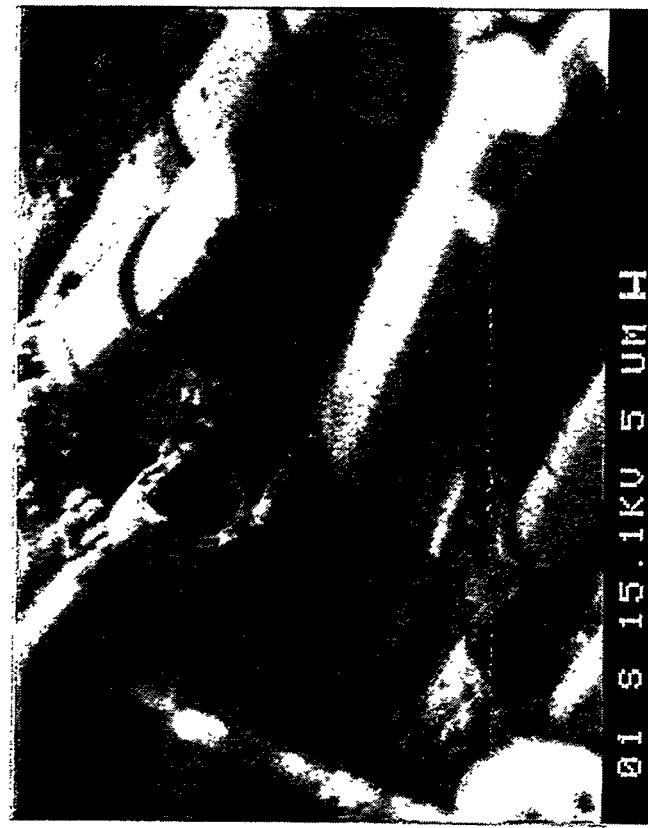
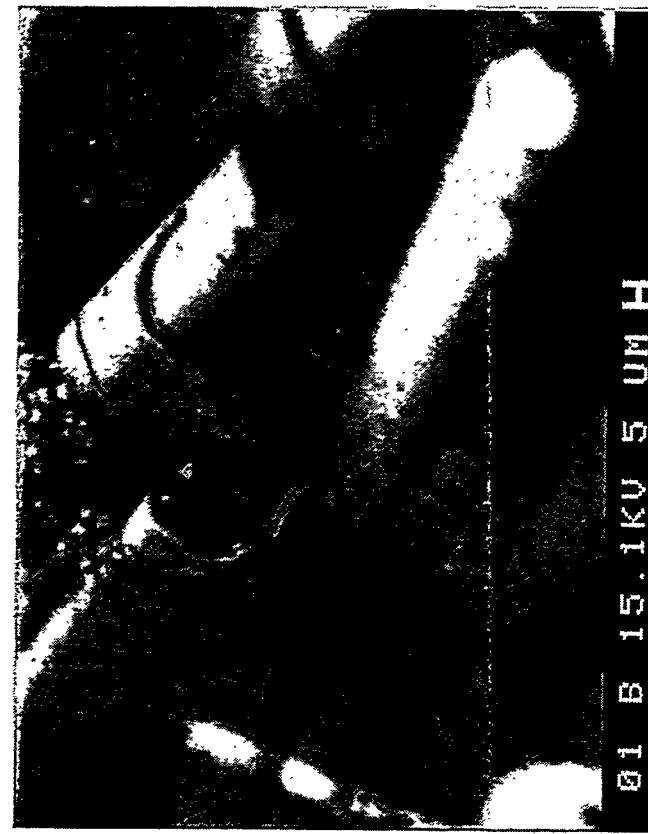
Figure 3c – Additional Elemental Microprobe Analyses Of The Nextel™ 312 Fibers In
The Confinement Layer Of The As-Manufactured 3M CVI-SiC Composite
Filter Matrix

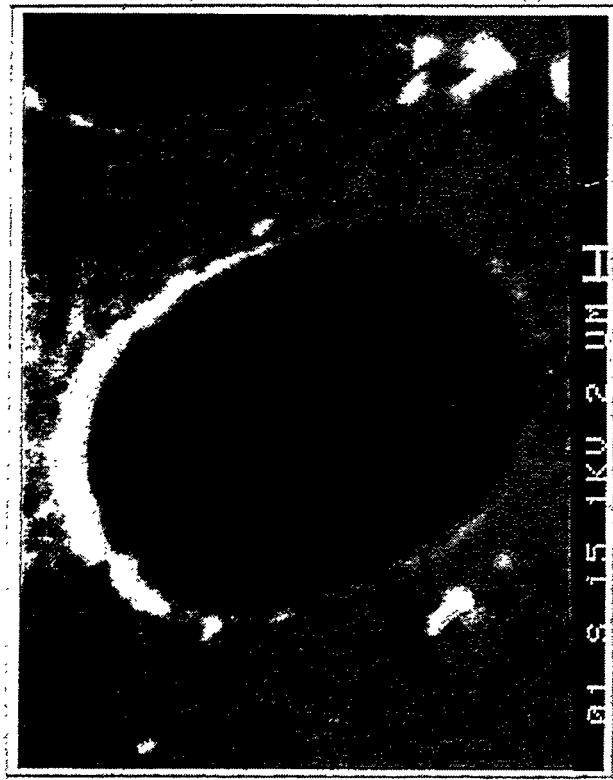
Figure 4a – Polished Cross-Section Of The Confinement Fibers In The As-Manufactured
3M Composite Filter Matrix

In an attempt to demonstrate whether the interface layer between the SiC coating and the Nextel™ 312 fibers could be identified, several of the as-manufactured confinement layer fibers were flashed with silver and nickel plated, mounted, and a polished cross-section was prepared for EMA. As shown in Figure 4, definitive separation between the outer SiC coating and the Nextel™ 312 fibers could not be identified. Elemental mapping at 10,000x (i.e., elemental line traces) may be capable of discerning the presence (i.e., composition) of the interface layer which is expected to exist between the SiC coating and the surface of the Nextel™ 312 fibers in the as-manufactured composite.

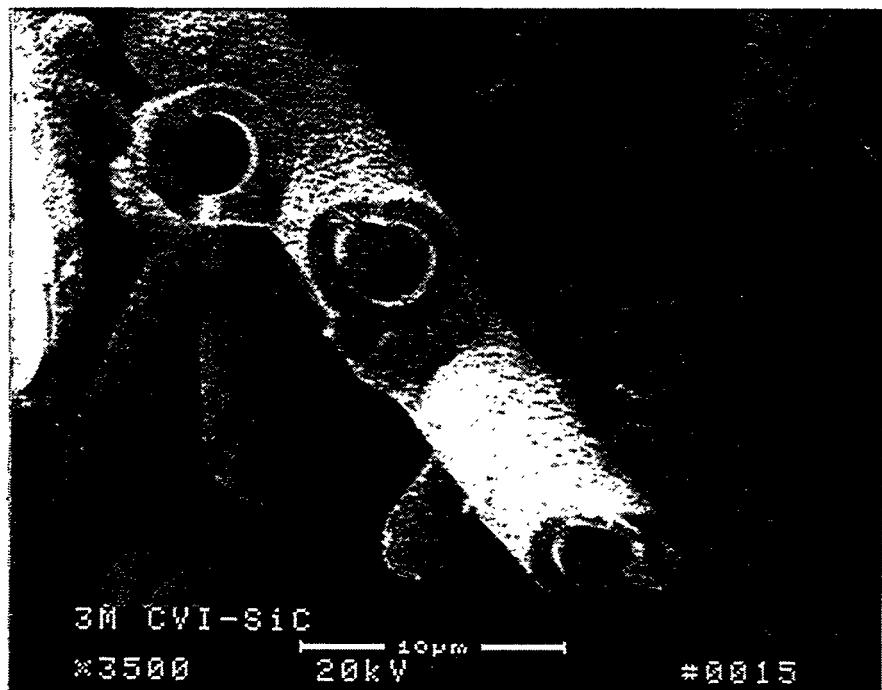
Figure 5c — Additional Micrographs Illustrating The Morphology Of The Filtration Mat Fibers

As shown in Figure 5, numerous fibers are present in the ~1 mm thick filtration mat layer which is present between the outer confinement layer and the triaxial support braid in the 3M CVI-SiC composite filter matrix. In contrast to the elliptical Nextel™ 312 fibers, the fibers which are present in the filtration mat are generally ~2-5 μm in diameter. An ~1 μm SiC layer coats the filtration mat fibers. Frequently several of the filtration mat fibers are adjacent to each other, and during the CVI-SiC deposition process are "twinned" together into what appears to be a "bundle-like" structure. An irregular or mottled surface texture is apparent along the outer surface of the CVI-SiC coating. Similarly a granular appearance is evident along the fractured fiber surface.

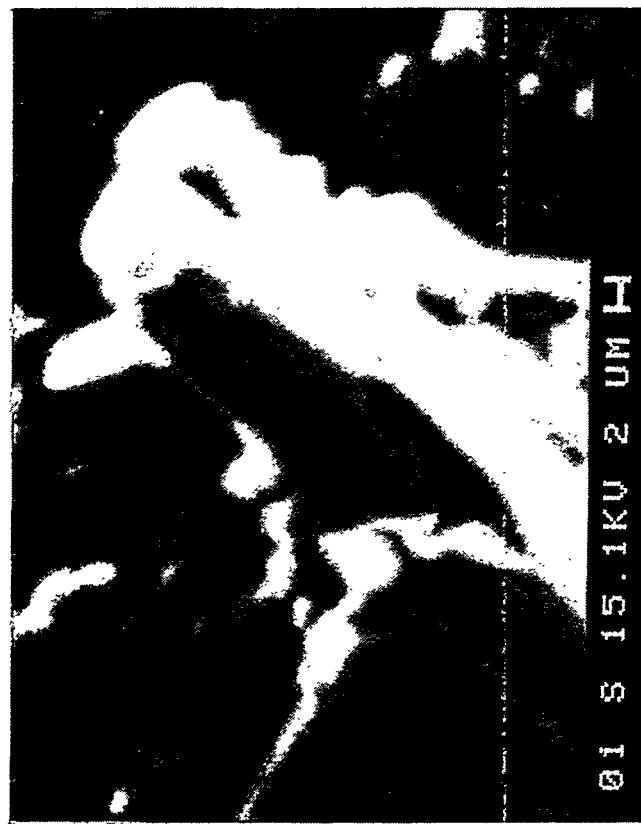
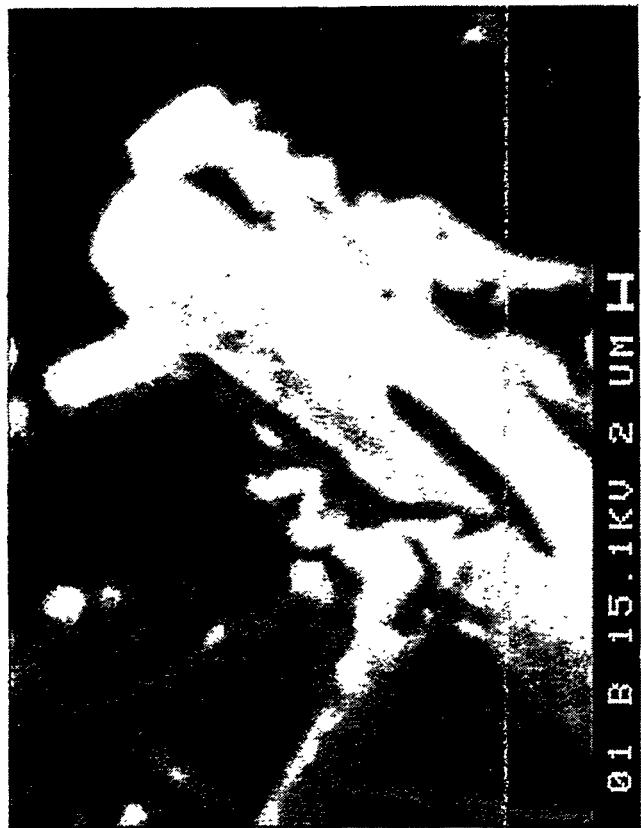
Figure 6f – Additional Scanning Electron Micrographs Illustrating The Morphology Of The CVI-SiC Coated NextelTM 312 Fibers In The Triaxial Braid Support Matrix

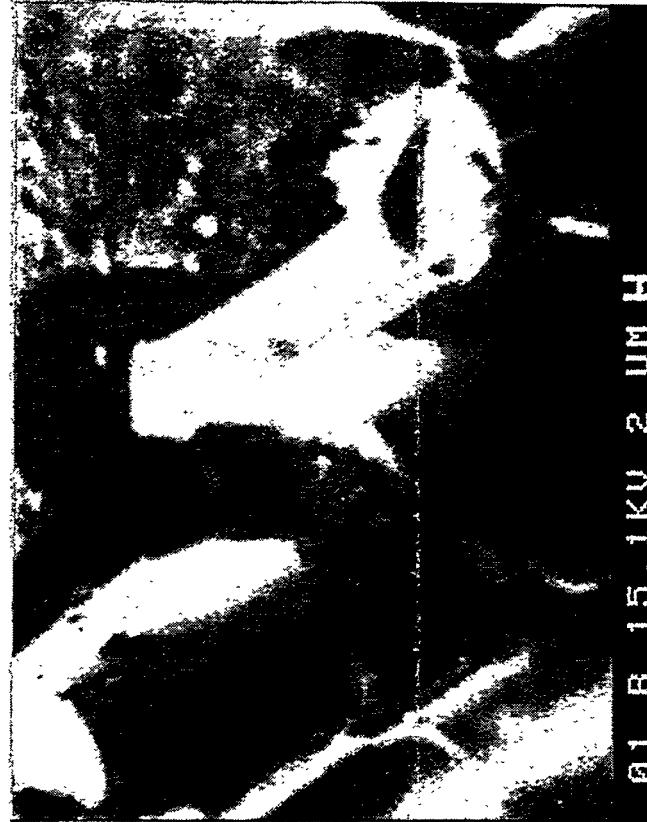
Figure 7b – Elemental Microprobe Analyses Of The CVI-SiC Coated Fibers In The As-Manufactured Triaxial Braid Support Matrix In The 3M Composite Filter

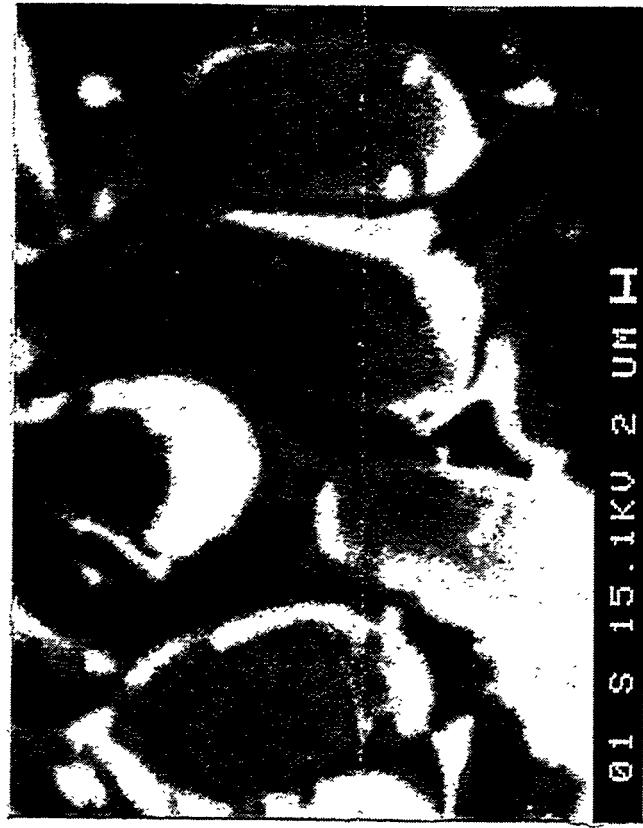
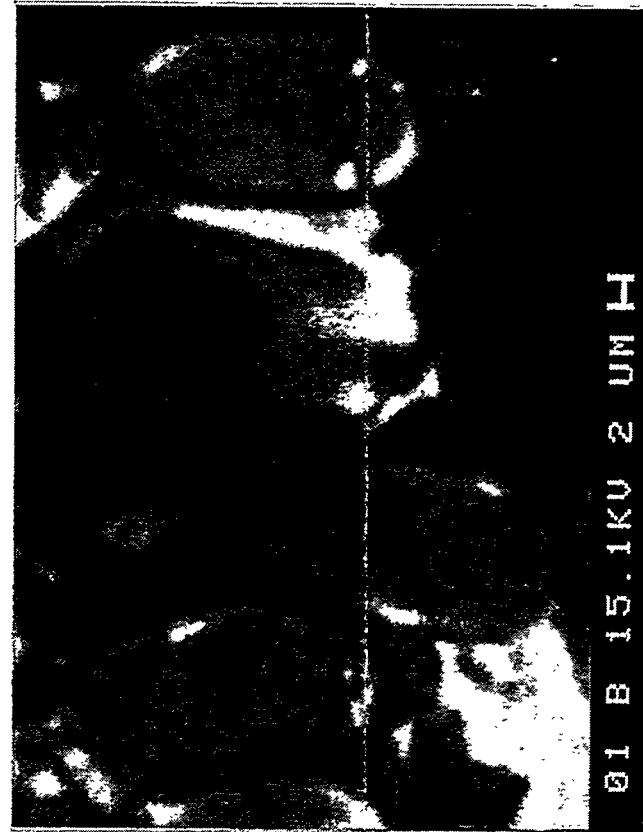
Figure 7c – Elemental Microprobe Analyses Of The CVI-SiC Coated Fibers In The As-
Manufactured Triaxial Braid Support Matrix In The 3M Composite Filter

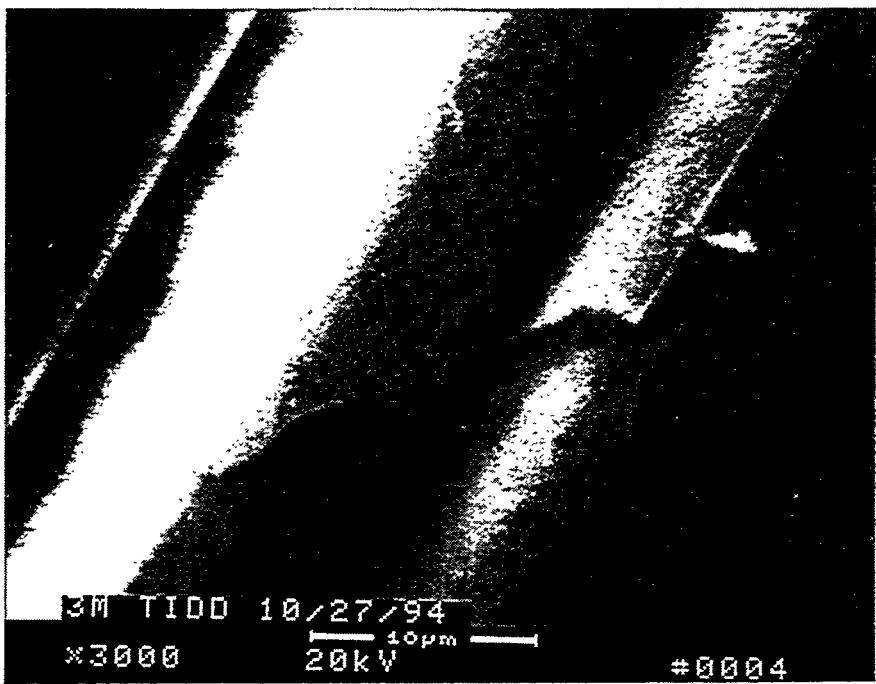
Figure 14b – Higher Magnification Micrographs Of The Confinement Layer Fibers

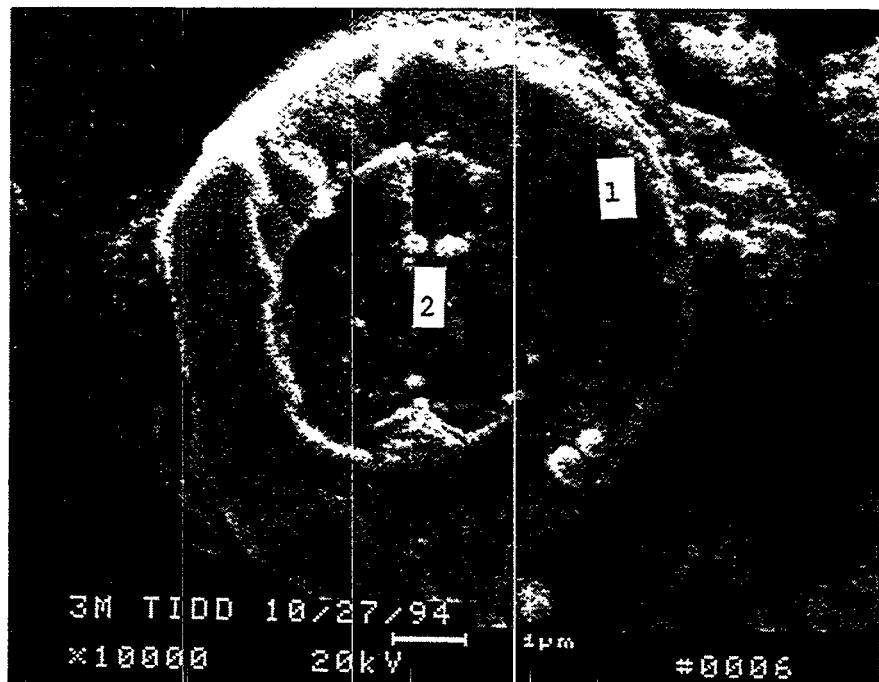
Figure 15c – Higher Magnification Micrographs Illustrating The Morphology Of A Cross-Sectioned Filtration Mat Fiber After 1705 Hours Of Exposure To The PFBC Gas Environment

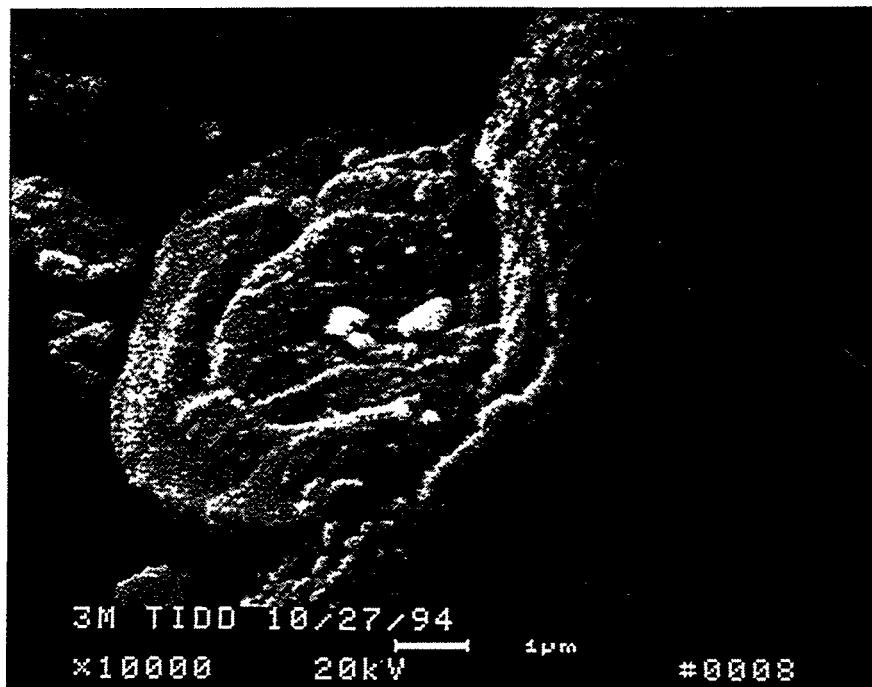
Figure 15d – Additional Higher Magnification Micrographs Illustrating The Morphology Of A Cross-Sectioned Filtration Mat Fiber After 1705 Hours Of Exposure To The PFBC Gas Environment

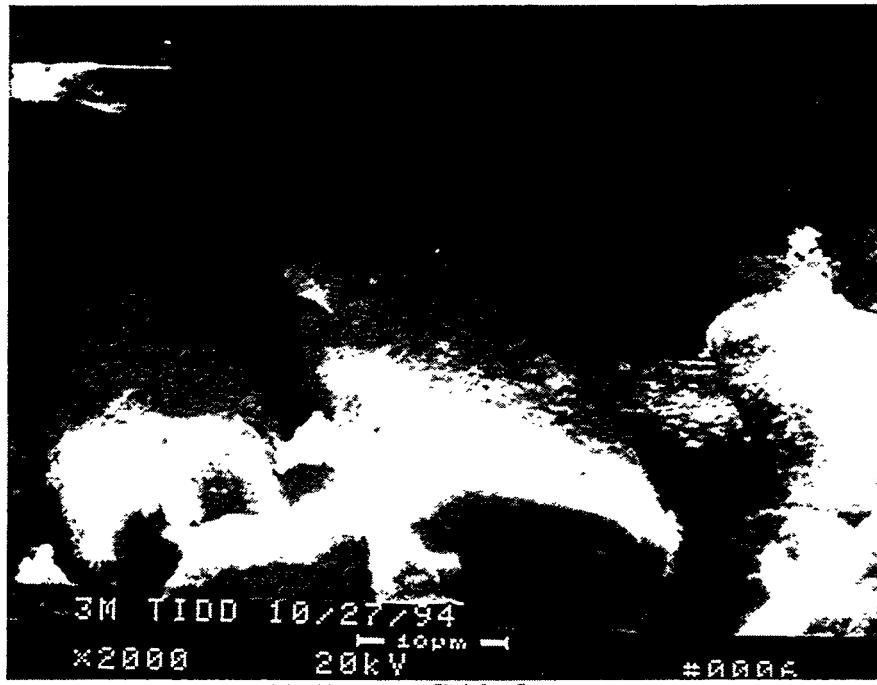
Figure 16d – Higher Magnification Micrograph Illustrating The Tight Bond Between The CVI-SiC Coating That Encapsulates The Individual NextelTM 312 Fibers In The Triaxial Support Braid, As Well As A Micrographs Which Illustrates Fracturing Of The CVI-SiC Coating Along The Surface Of The NextelTM 312 Fiber

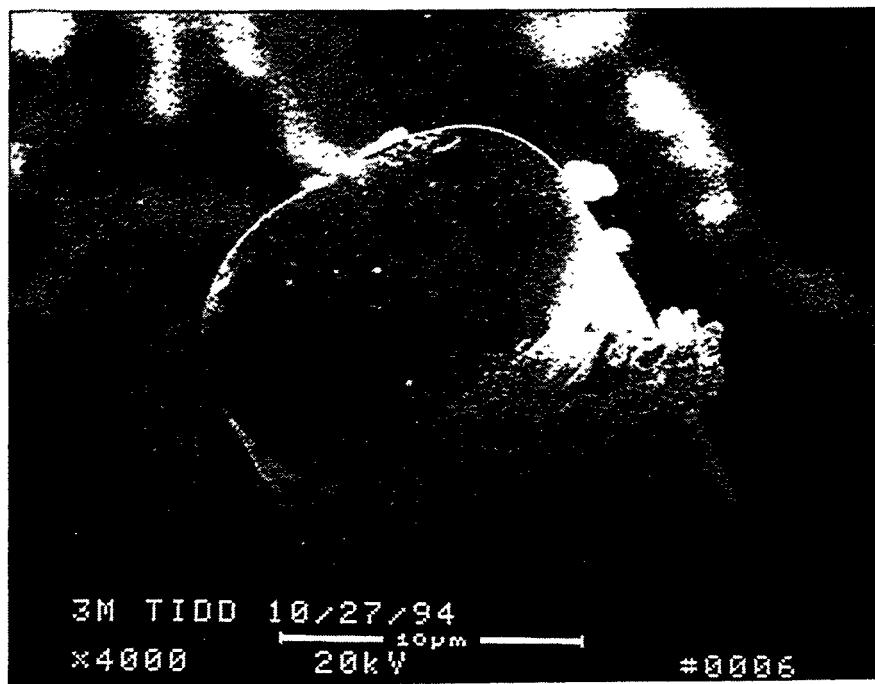
Figure 18c – Higher Magnification Micrographs Illustrating The Surface Features Of The NextelTM 312 Fiber In The Confinement Layer After 1705 Hours Of Exposure To The PFBC Gas Environment

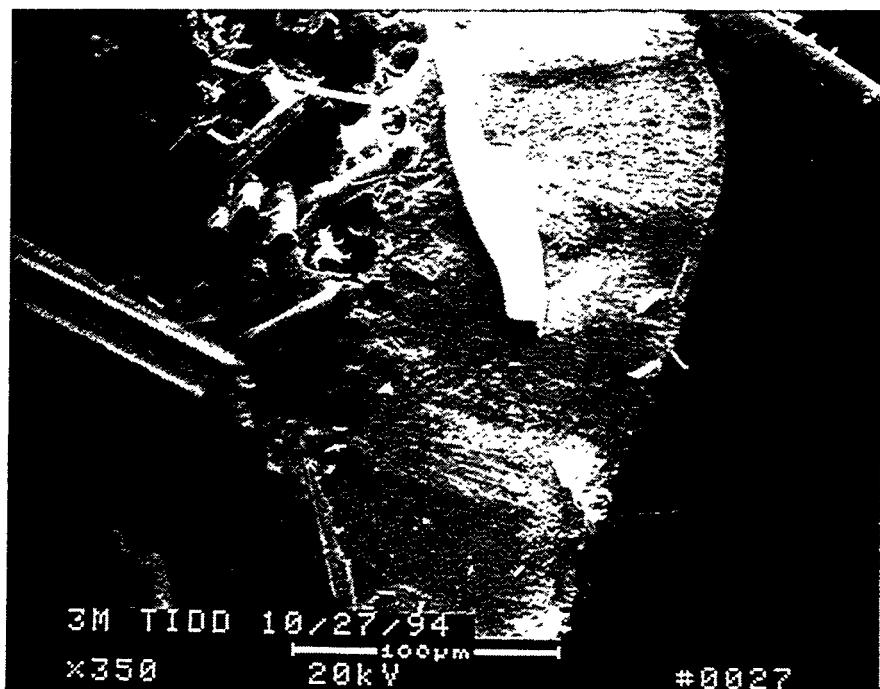
Figure 20e — Micrographs Illustrating The Thick SiC Coating Which Encapsulates The Triaxial Braid, As Well As Fibers Which Were In Direct Contact With The Thick CVI-SiC Layer

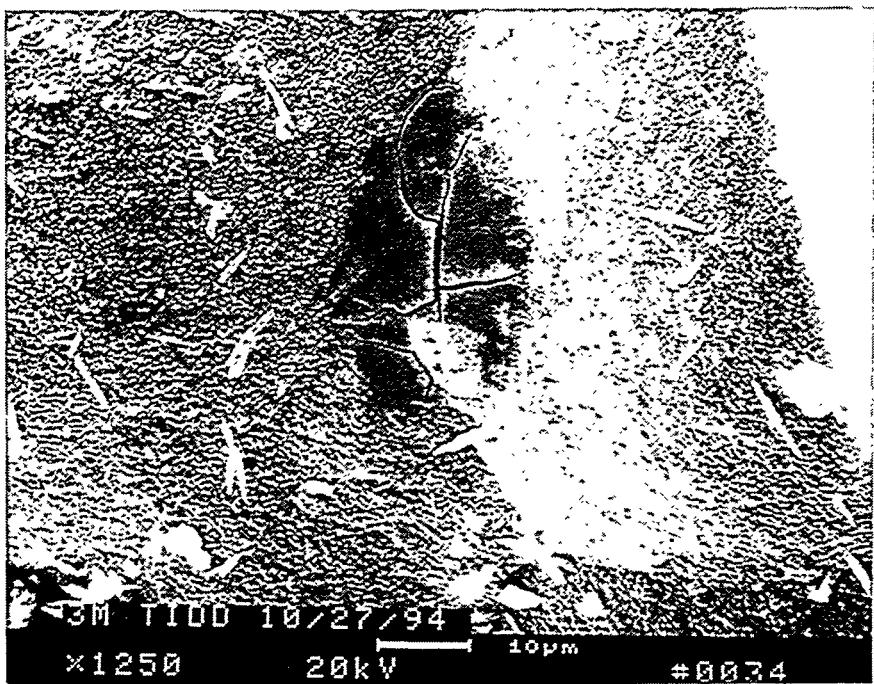
Figure 20i – High Magnification Micrographs Of The Columnar CVI-SiC Surface Which Encapsulates The Triaxial Braid

The outer surface of the CVI-SiC coating which encapsulates the triaxial braid is shown in Figure 20h. Columnar growth of the CVI-SiC matrix is evident. Frequently in the valleys or crevices of the CVI-SiC matrix are areas which appear to contain "melt-like", mud crack areas (Figure 20i).
