LOCA Simulation in the National Research Universal Reactor Program

Postirradiation Examination Results for
the Third Materials Experiment (MT-3)

Prepared by W. N. Rausch

Pacific Northwest Laboratory
Operated by
Battelle Memorial Institute

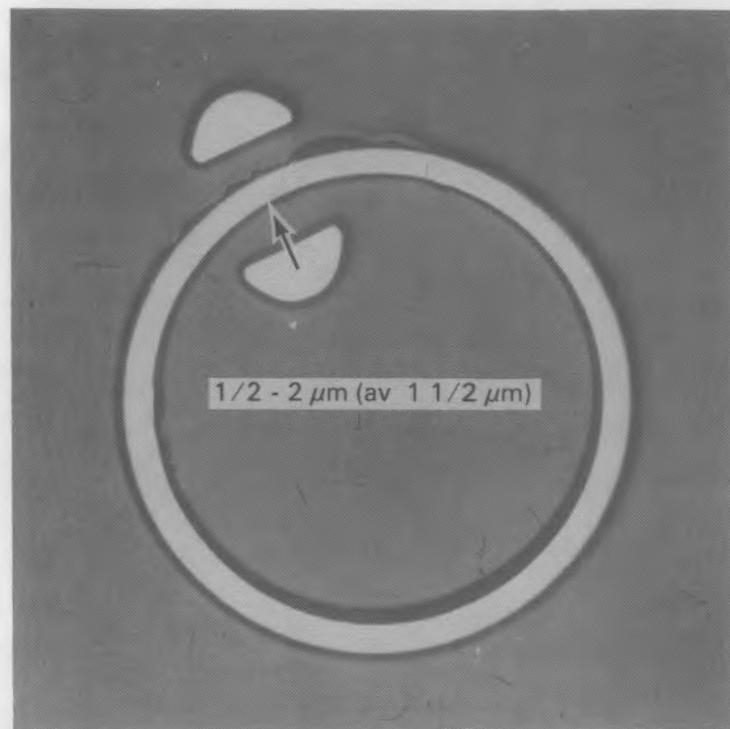
2 1/2 - 5 μm (av 4 μm)
A FEW PATCHES UP TO 8 μm

FIGURE 30. Rod Section 5C5-3, ZrO_2 Thickness (μm) on Inner and Outer Cladding Surfaces are as Shown. (Arrow indicates the reference point for wall thickness measurements.)

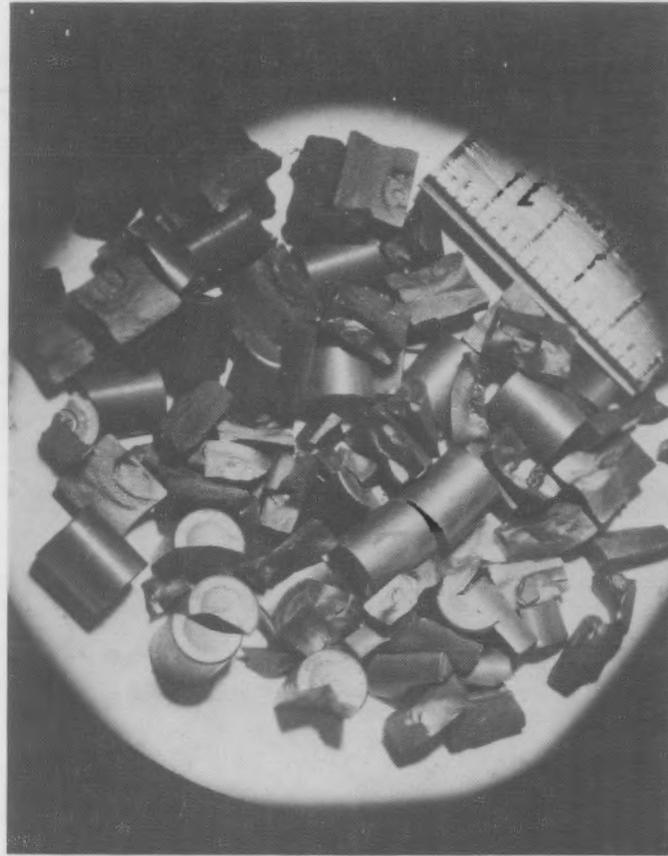
FIGURE 41. Fuel Fragments from Rod Section 3B5A Before Sieve Shaking

The results of the fuel particle size analysis are presented in Table 16, which gives the percentage of the sample weight retained on each size screen. Photographs were taken before and after the size analysis; Figures 40 through 48 show the results from 3B5A. The ballooned and ruptured rod is shown in Figure 40; and the fuel fragments, before sieve shaking, are shown in Figure 41. Figures 42 through 48 show the fuel fragments recovered from each of the six screens and the receiver pan. Only two pellets were still intact after the analysis; both were from rod section 3B5B.

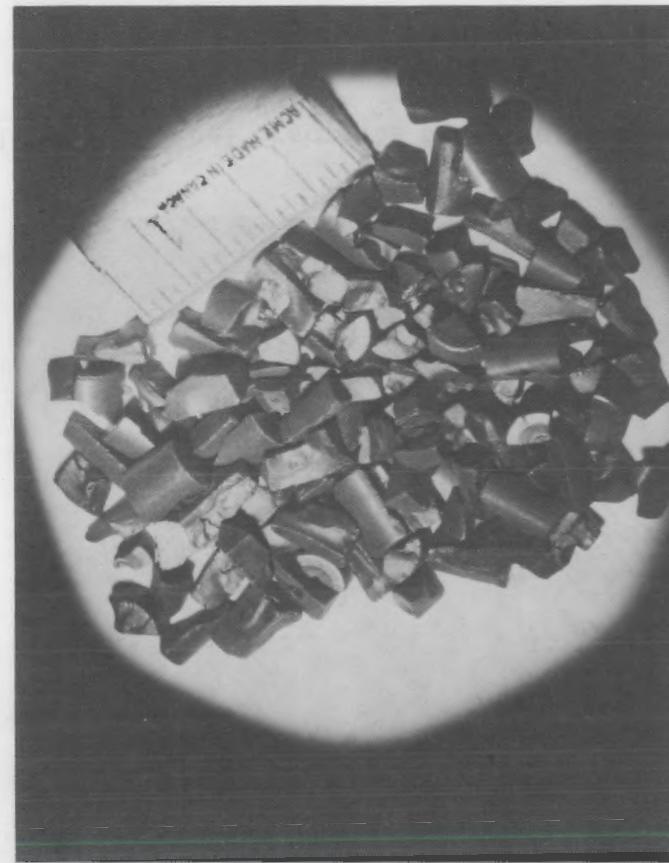
FIGURE 43. Rod Section 3B5A Fuel Fragments from Screen 2 (0.157 in., 4.0 mm)
