# Steam Generator Group Project

Annual Report - 1982

Prepared by R. A. Clark, M. Lewis

**Pacific Northwest Laboratory**  
Operated by  
Battelle Memorial Institute

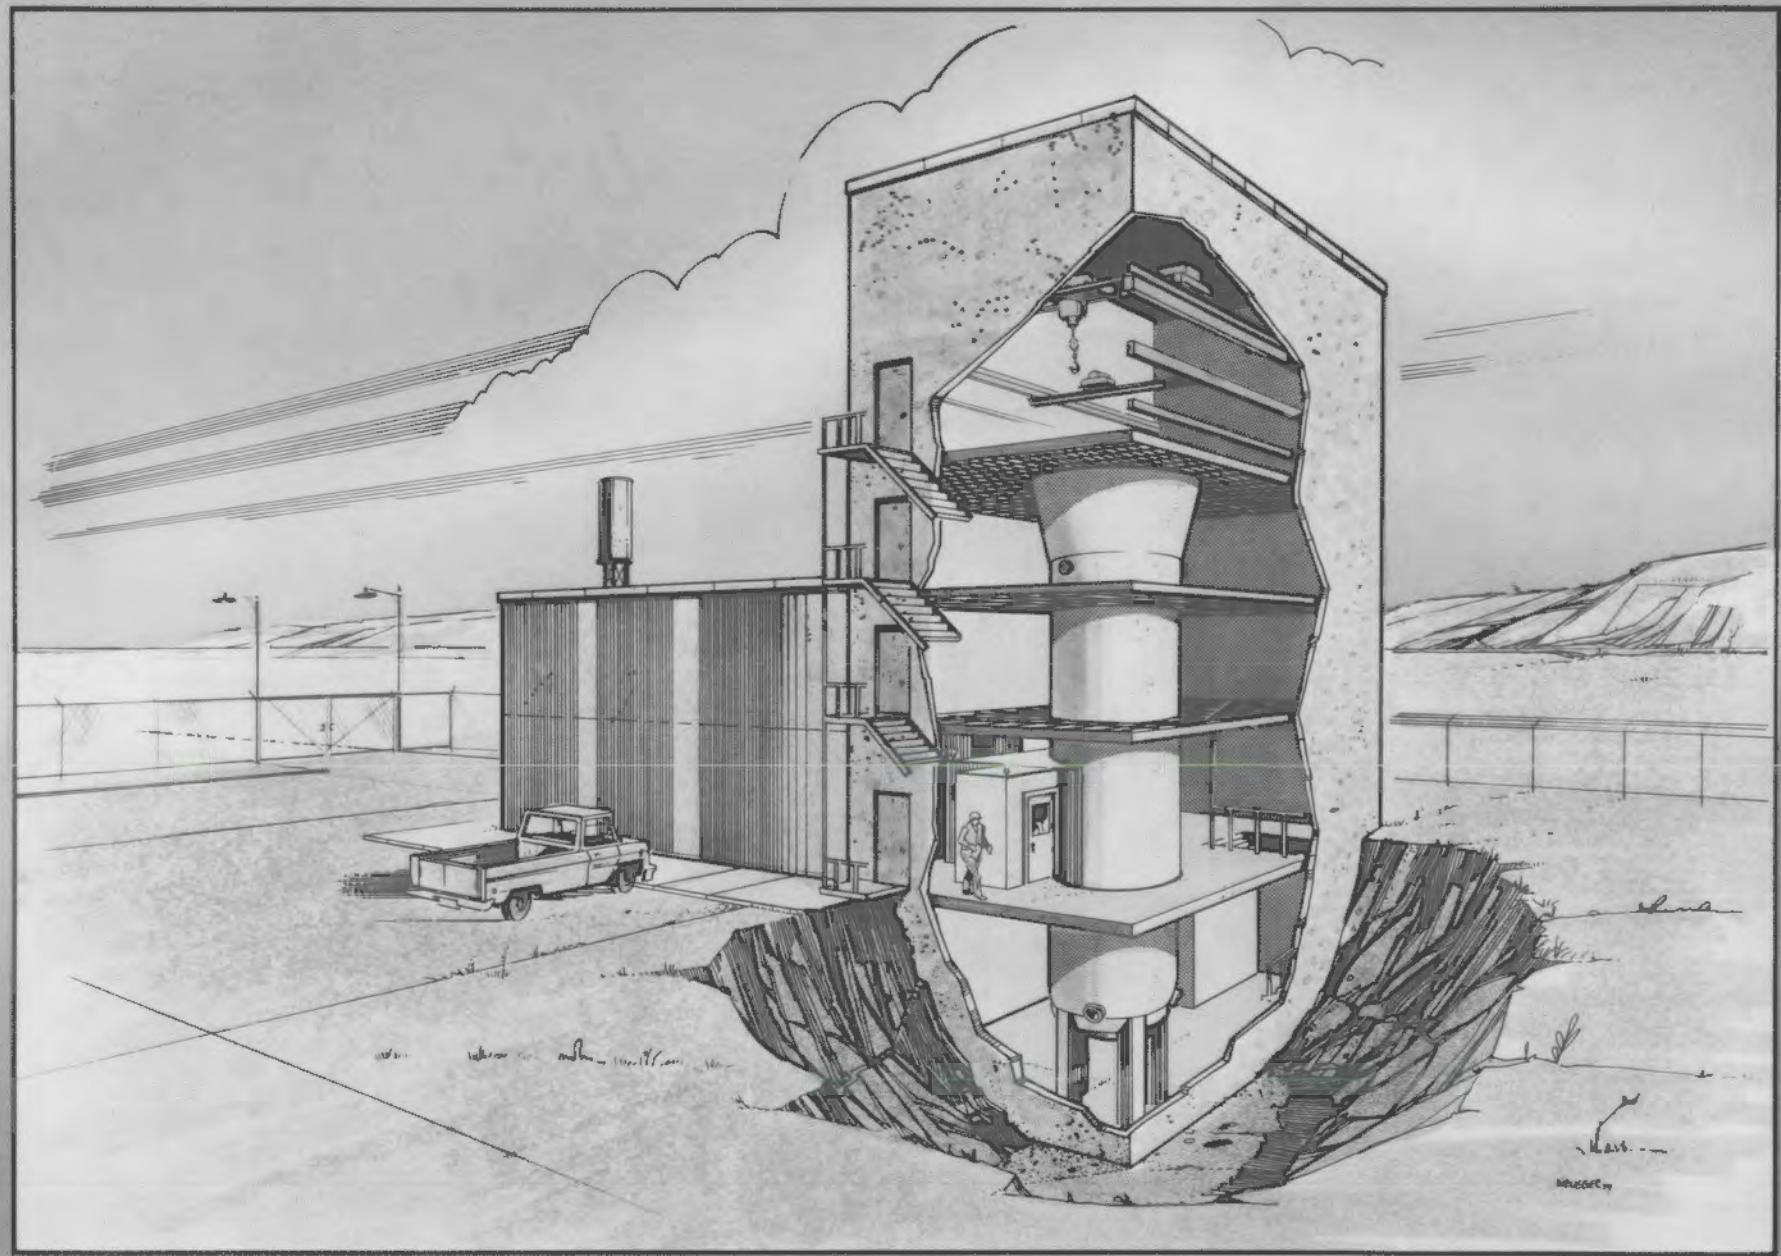
FIGURE 8. Cut-Away of SGEF Showing Position of Steam Generator

- Figure 8 shows an artist's cut-away rendition of the SGEF with the research generator in place. The generator is in its operating position allowing nondestructive examinations, decontamination experiments, etc., to be performed under normal orientation conditions. The SGEF has a four story high bay, or tower, portion which is the generator containment. Each above-ground floor has an emergency exit leading to an exterior steel safety staircase. Owing to its massive size, to match the shielding of the concrete, the main floor emergency door has a power assist. Connected to the tower is a two story support area. The upper story of this area contains HVAC equipment, HEPA (high efficiency particle acceptor) filters, the breathing air system, and other building control and support equipment. The main floor is comprised of air locks, change rooms, a cask handling facility/loading dock, and a small laboratory with triple HEPA filtered hoods. A control room for remote monitoring of tower operations is also located here. Figure 9 is a plan drawing of the main floor. The tower portion of the SGEF has both a bridge crane and a gantry crane to assist in removal of generator sections. Tower services include electric power at 110V, 220V and 440V, 90 psig compressed air, bottled nitrogen and argon, vacuum for air samples, breathing air, and cold water. Intermediate floors utilize removable gratings to ease positioning of equipment at different heights. The gratings also permit free flow of building air. A portable rigid greenhouse is provided to contain contamination produced during cutting and grinding operations. The portable greenhouse may be positioned at any point in about a 180° arc around the steam generator. It may be easily moved between the first and second floors. Another rigid greenhouse, not portable, was constructed on the third floor. The

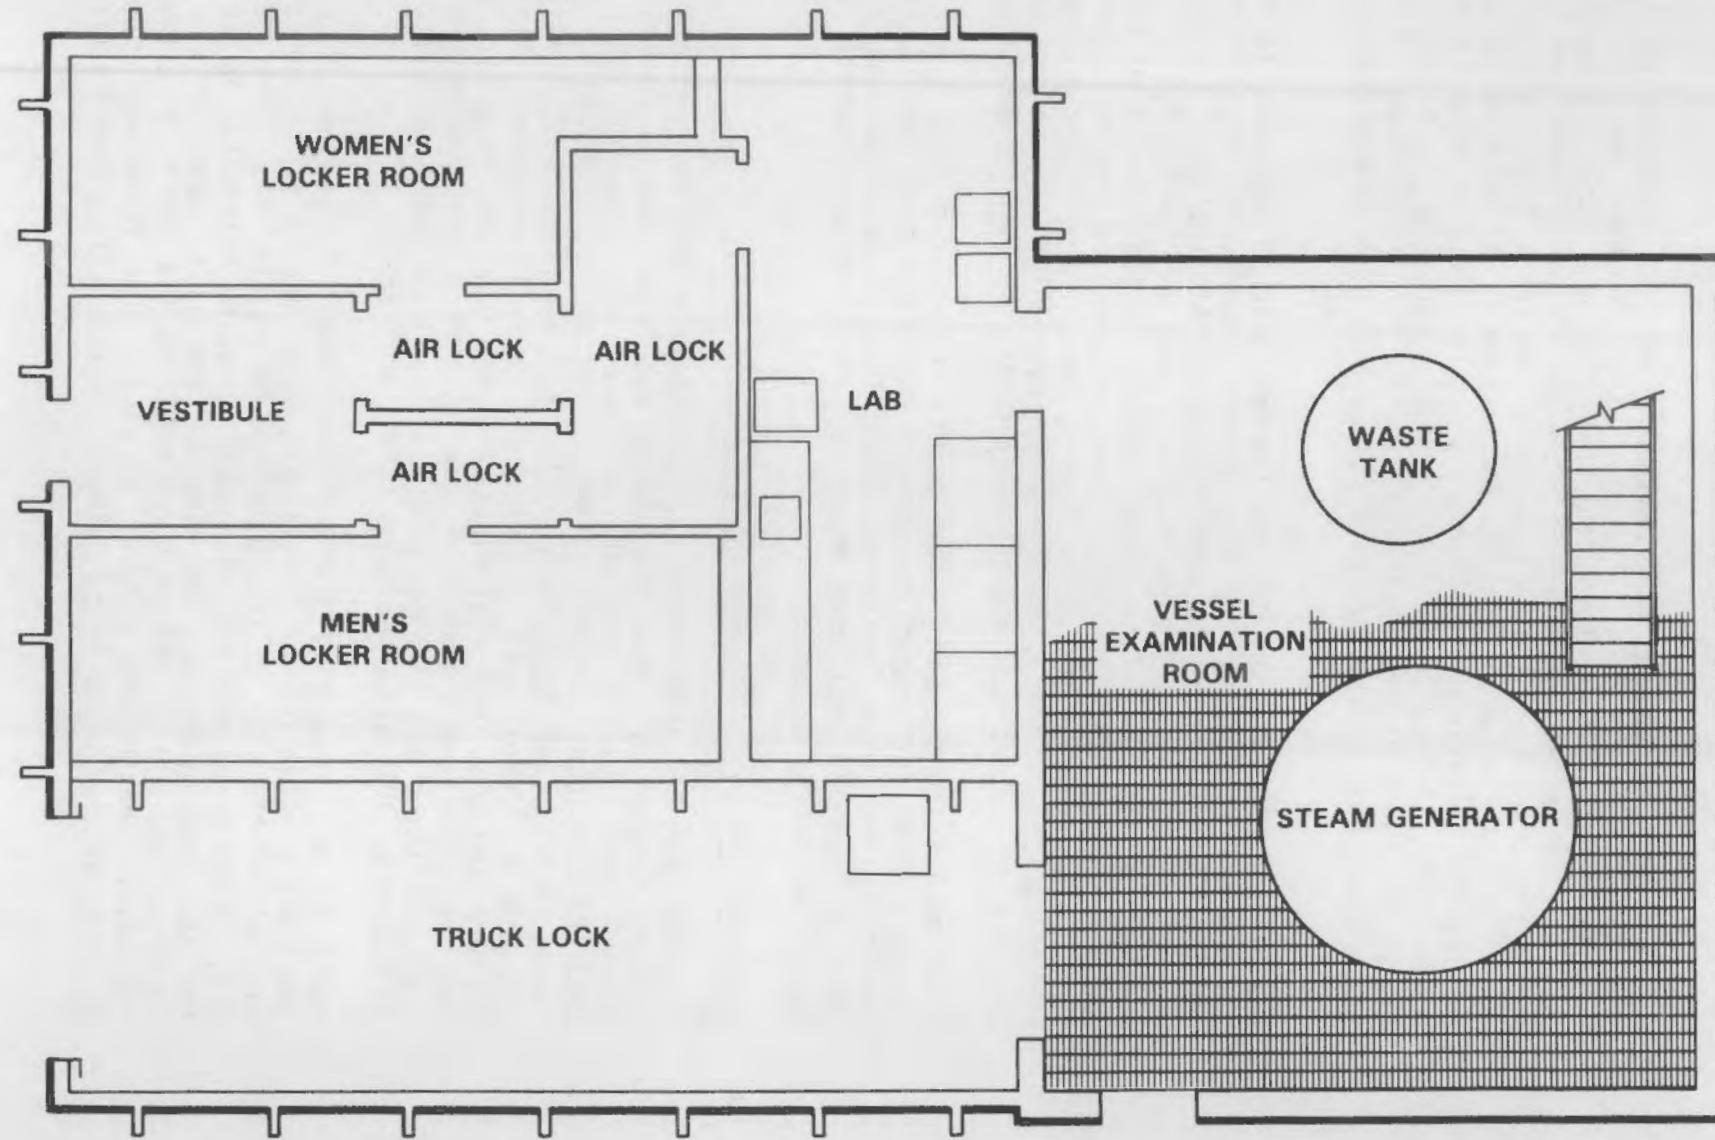
FIGURE 9. Plan Drawing of SGEF Main Floor

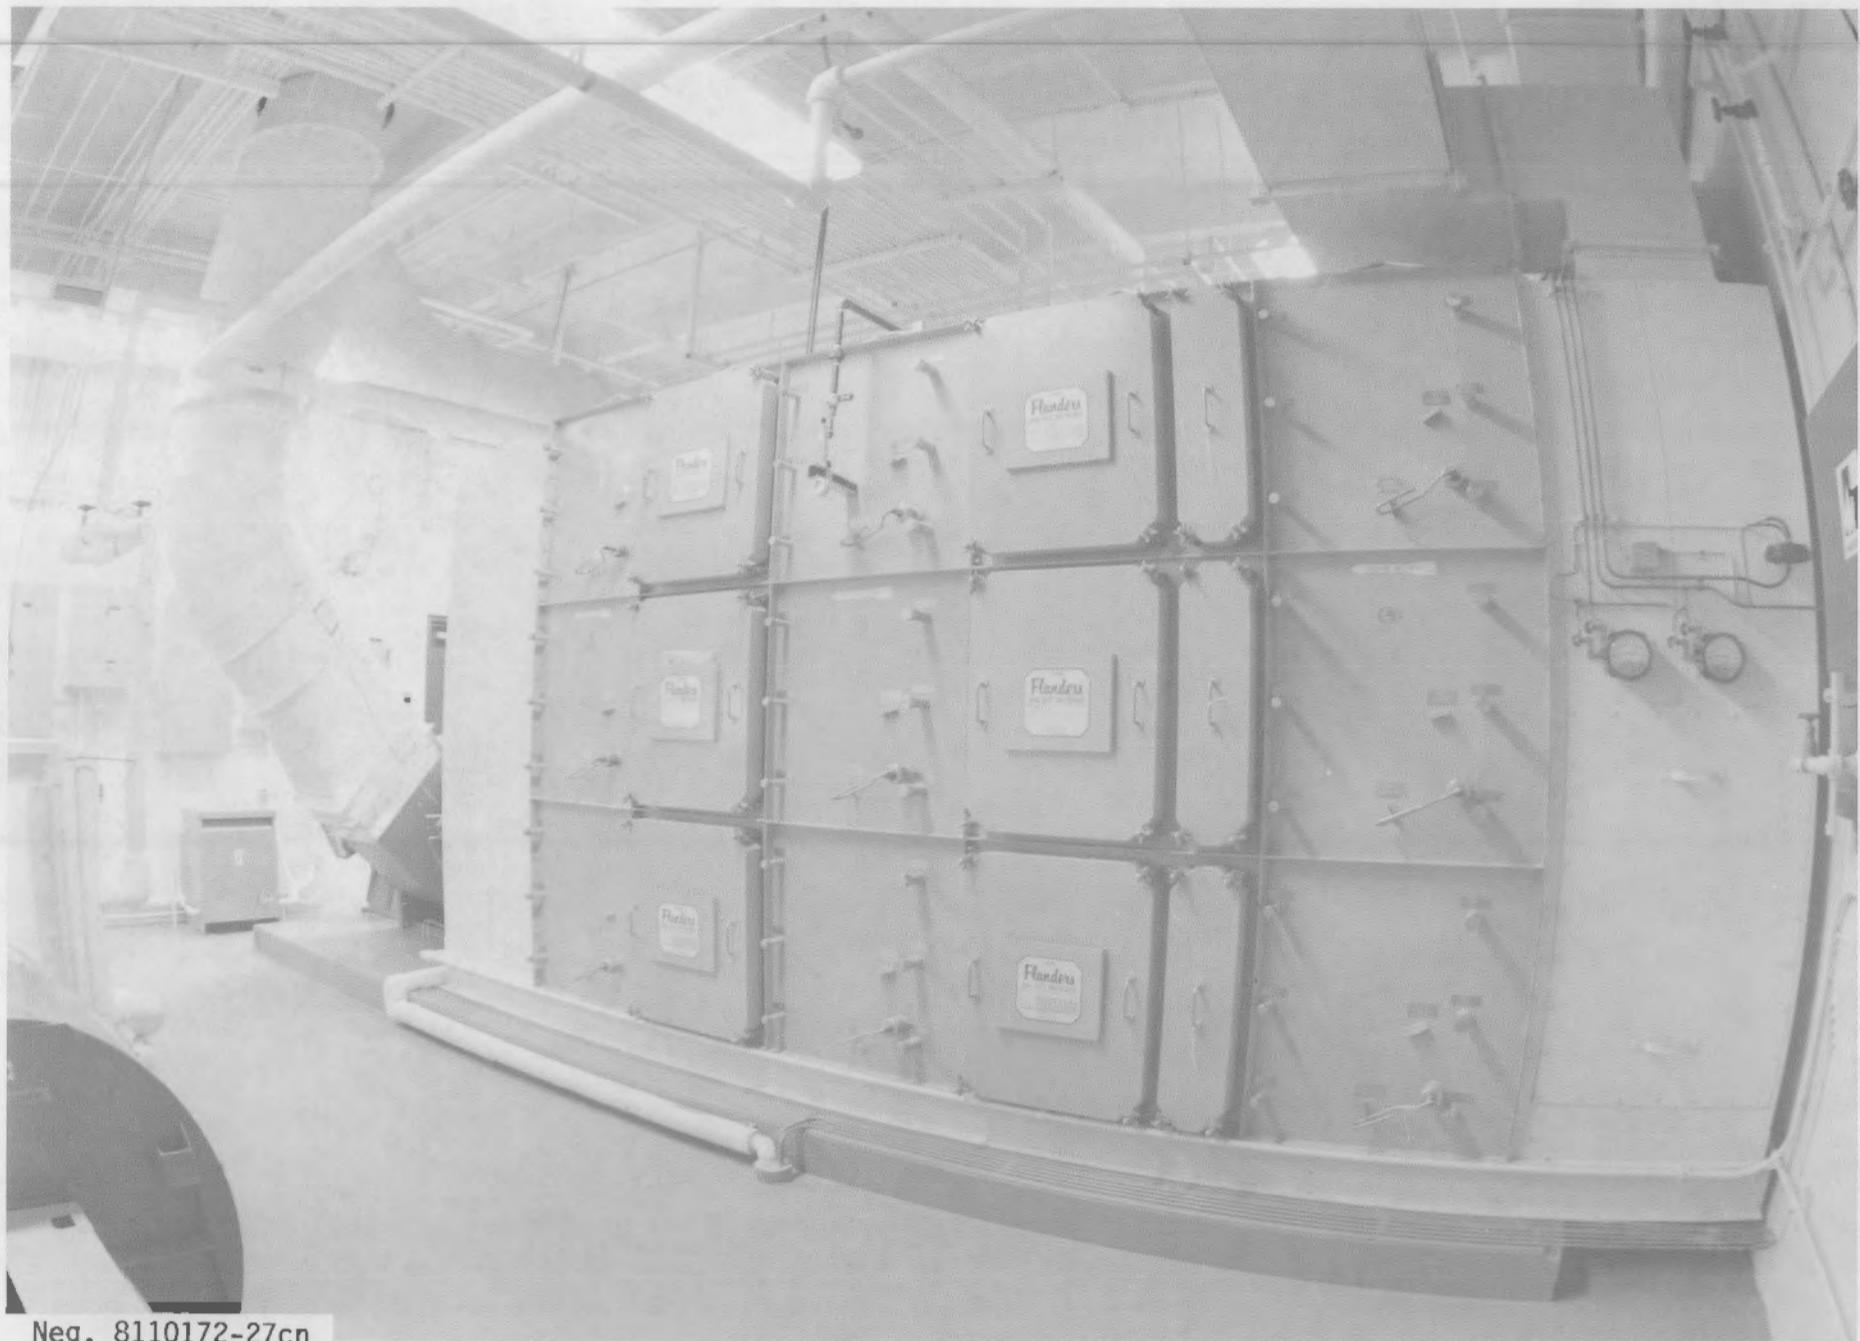
FIGURE 12. HEPA Filter Bank in Equipment Room

entire tower is double HEPA filtered and the greenhouses are independently triple HEPA filtered. In the basement of the tower is a 2000 gallon fiberglass tank for storing liquid radioactive waste. Also in the basement, is a 50 gpm stainless steel pump and piping for transferring liquid waste to the truck lock. Figure 10 shows the SGEF tower including the cranes. The roof panel for placing the generator is visible. Figure 11 is a view of the triple HEPA filtered hoods in the support laboratory. Figures 12 and 13 are views in the Equipment Room on the second floor of the Support Building showing the HEPA filter bank and the breathing air system.

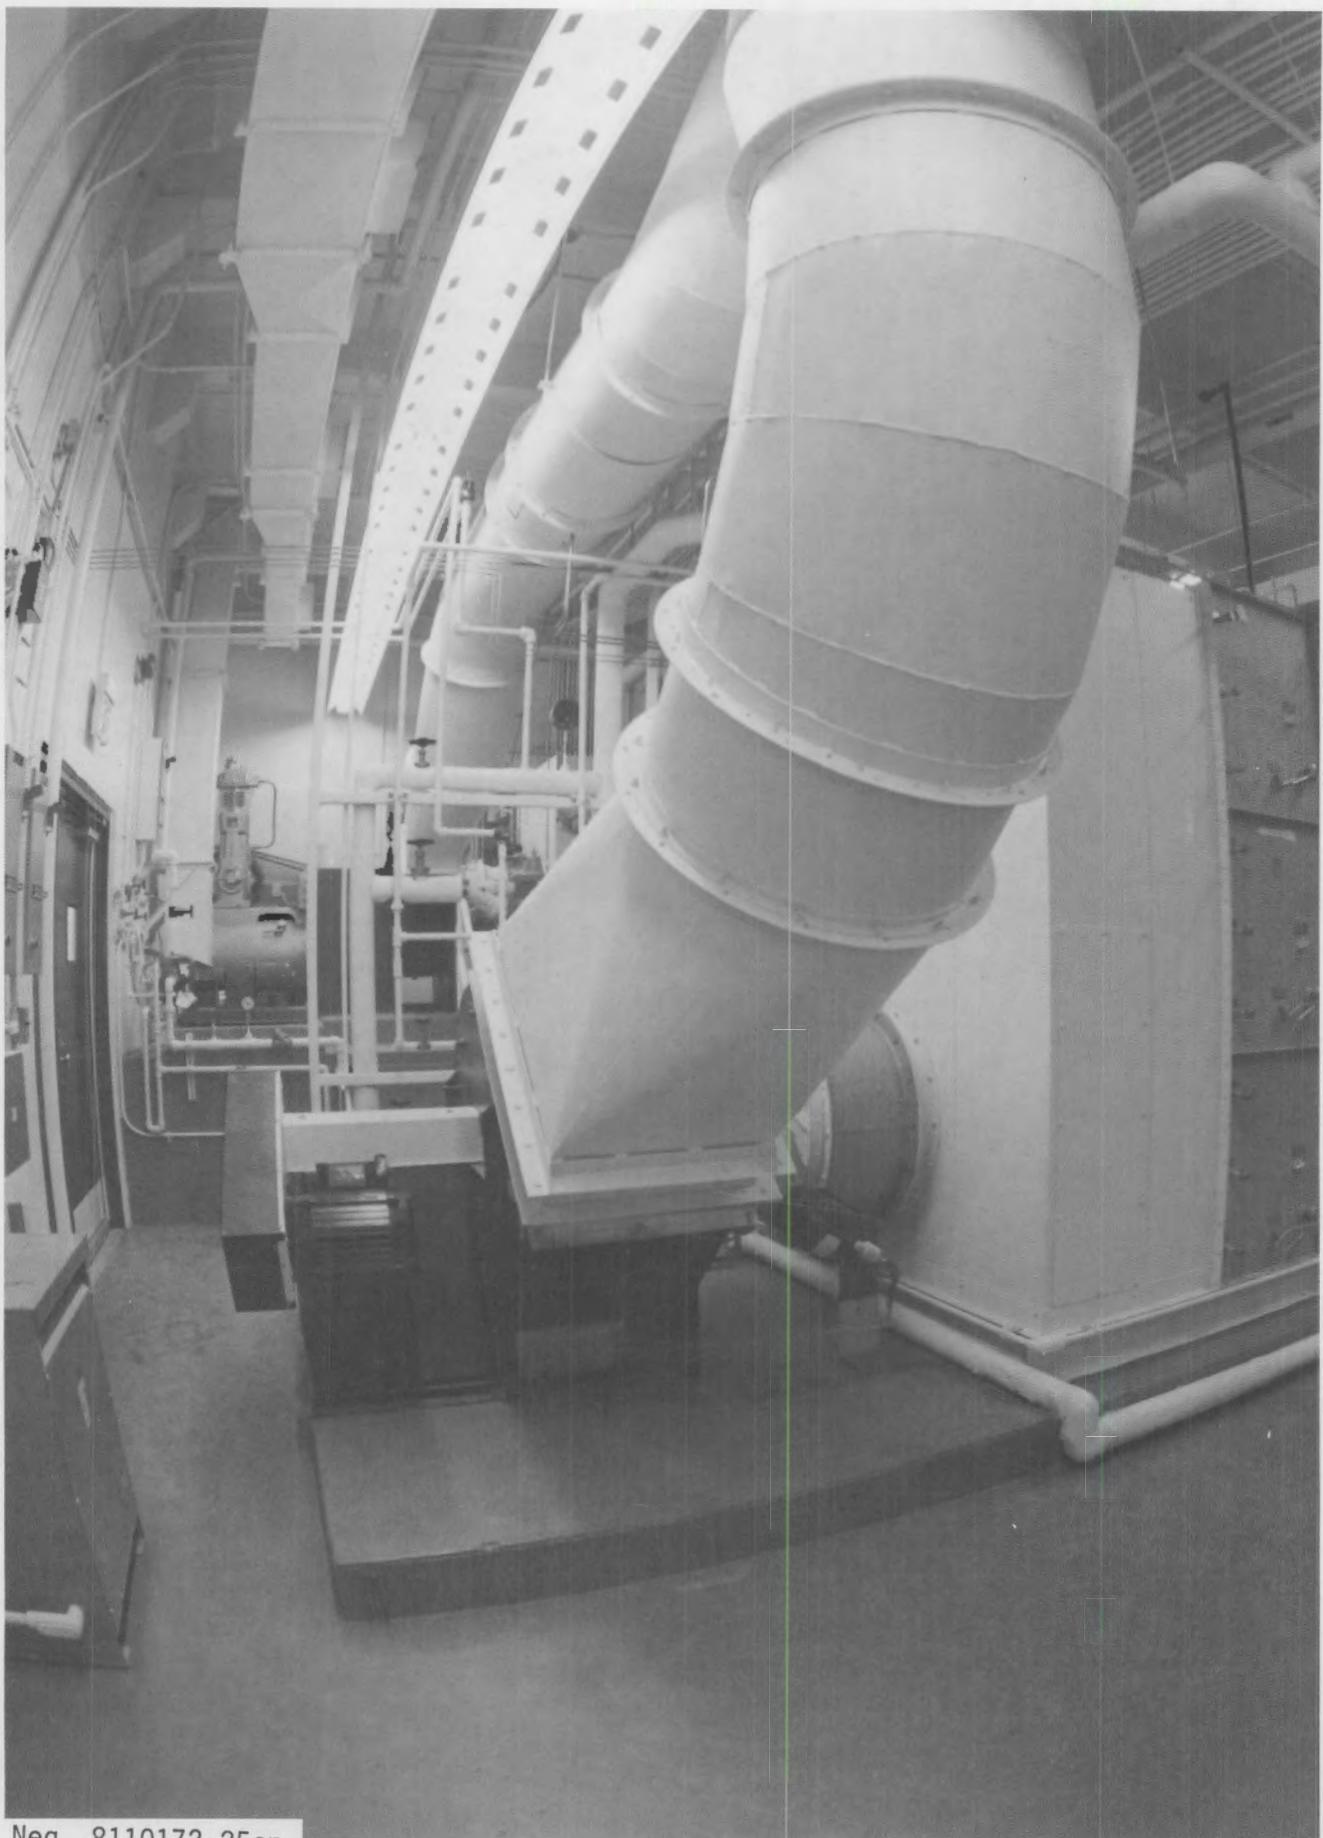
FIGURE 13. Breathing Air System in Equipment Room

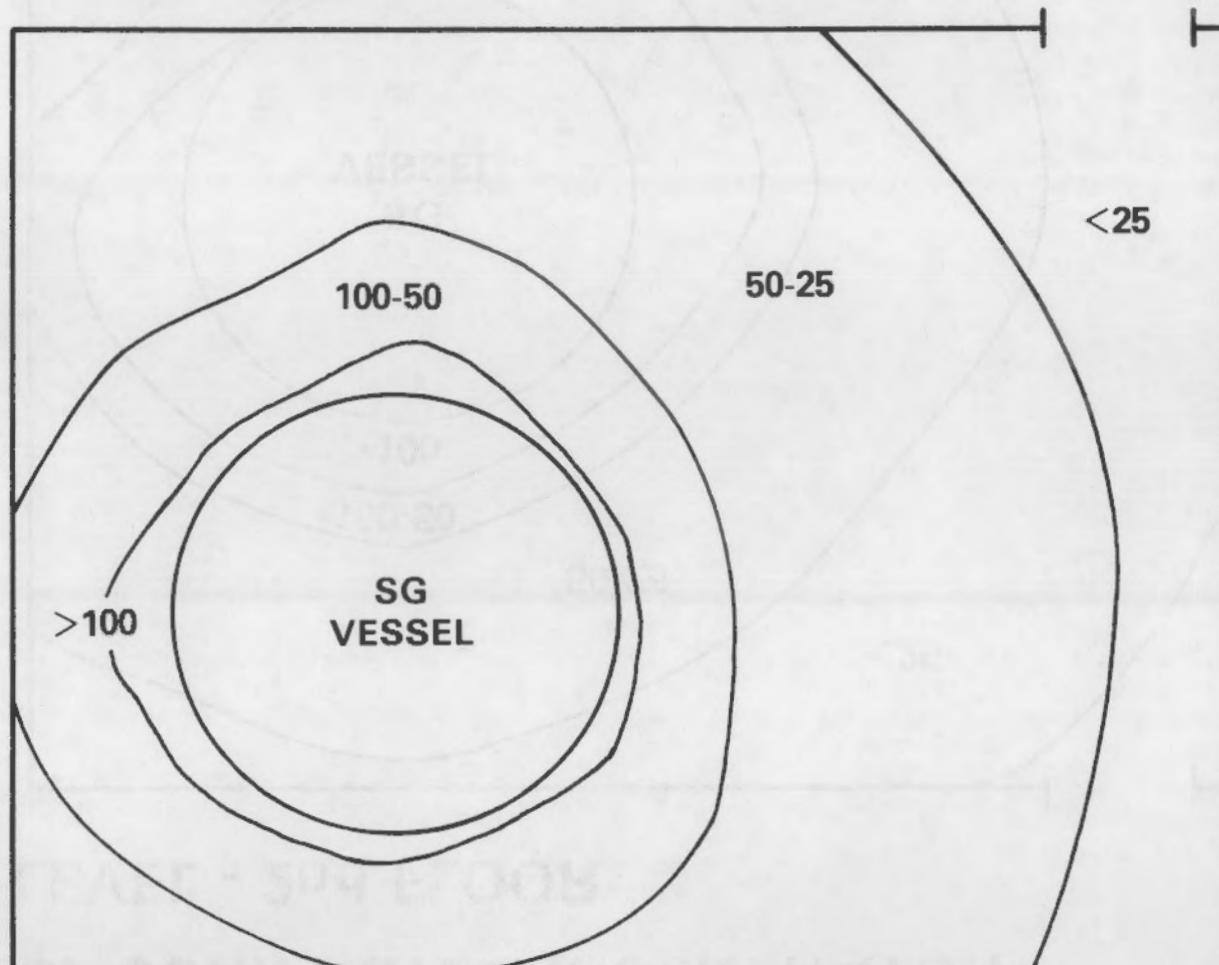
\*DOSE RATES ARE IN mR/hr

FIGURE 24. Radiological Map - 1st Floor Level

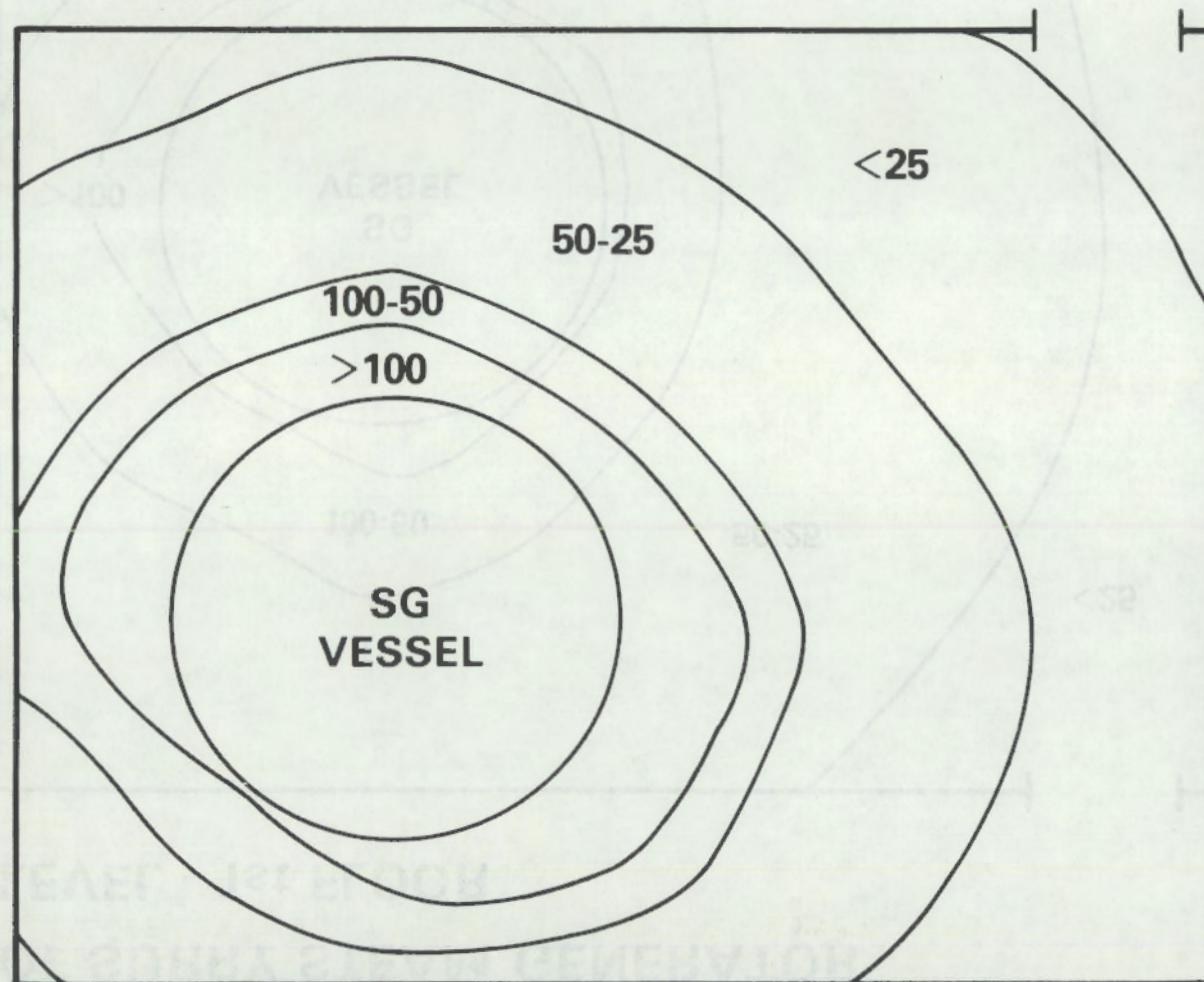
\*DOSE RATES ARE IN mR/hr

FIGURE 25. Radiological Map - 2nd Floor Level

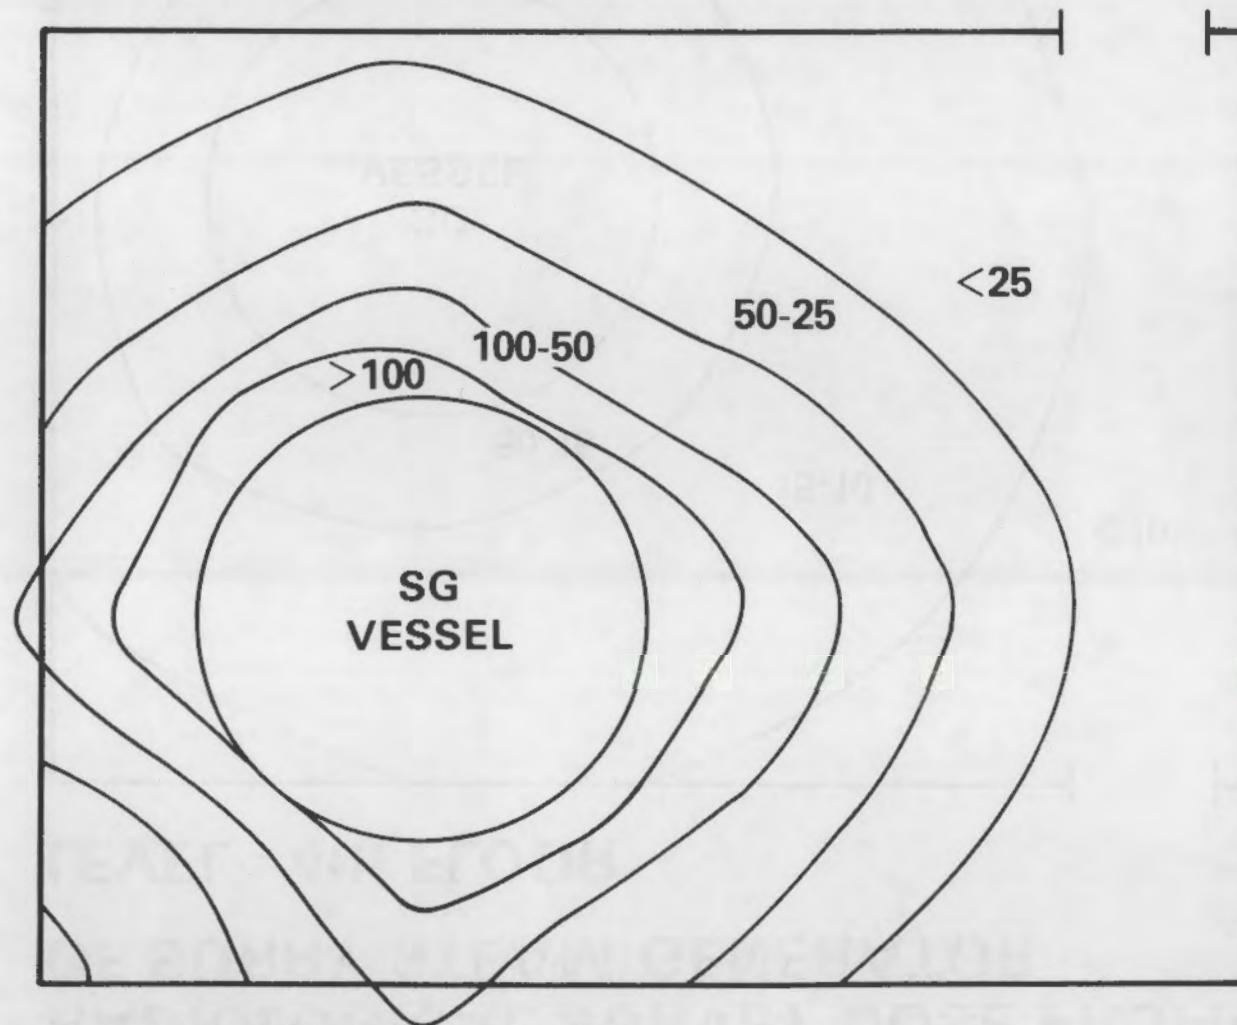
**\*DOSE RATES ARE IN mR/hr**

FIGURE 26. Radiological Map - 3rd Floor Level

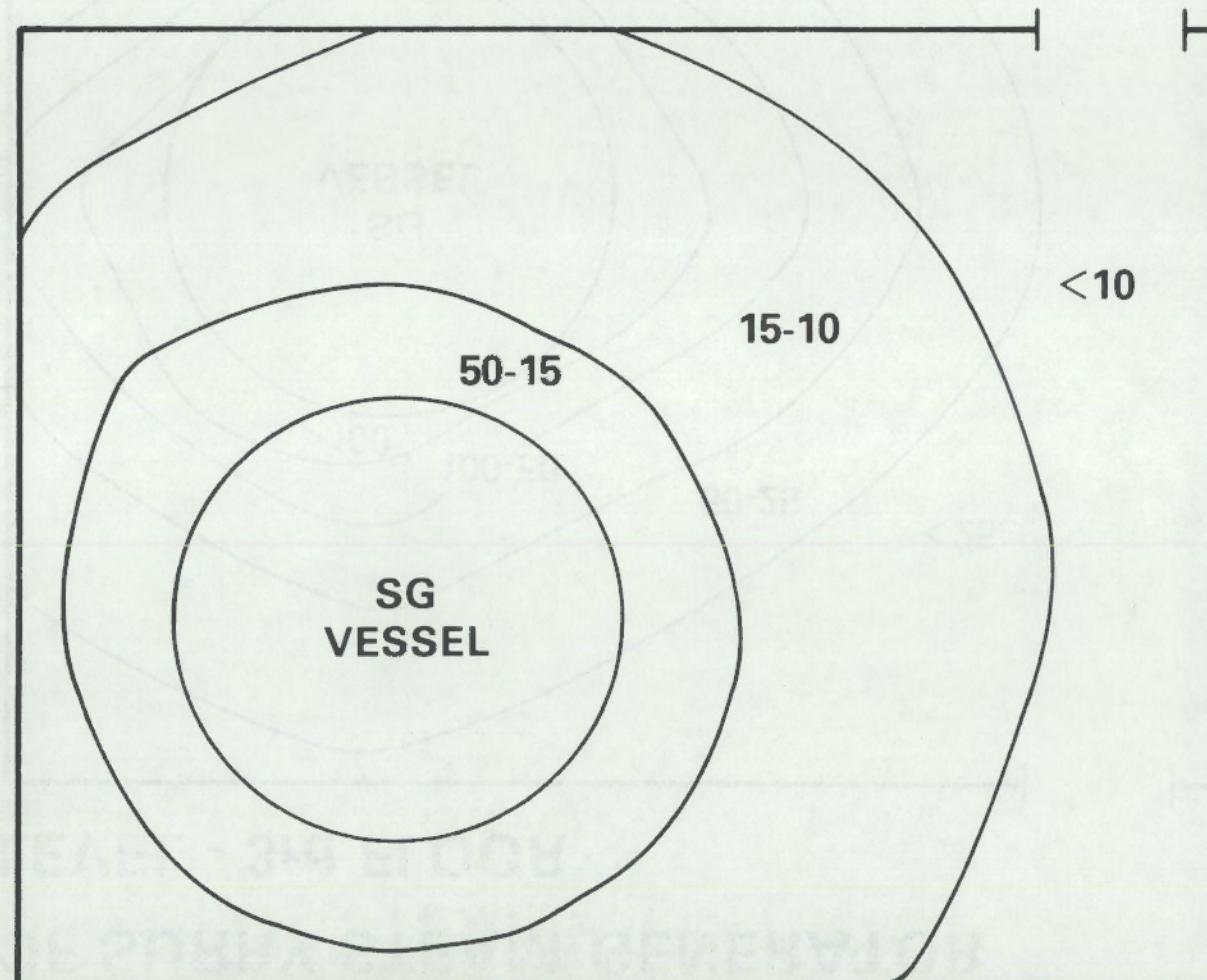
\*DOSE RATES ARE IN mR/hr

FIGURE 27. Radiological Map - 4th Floor Level

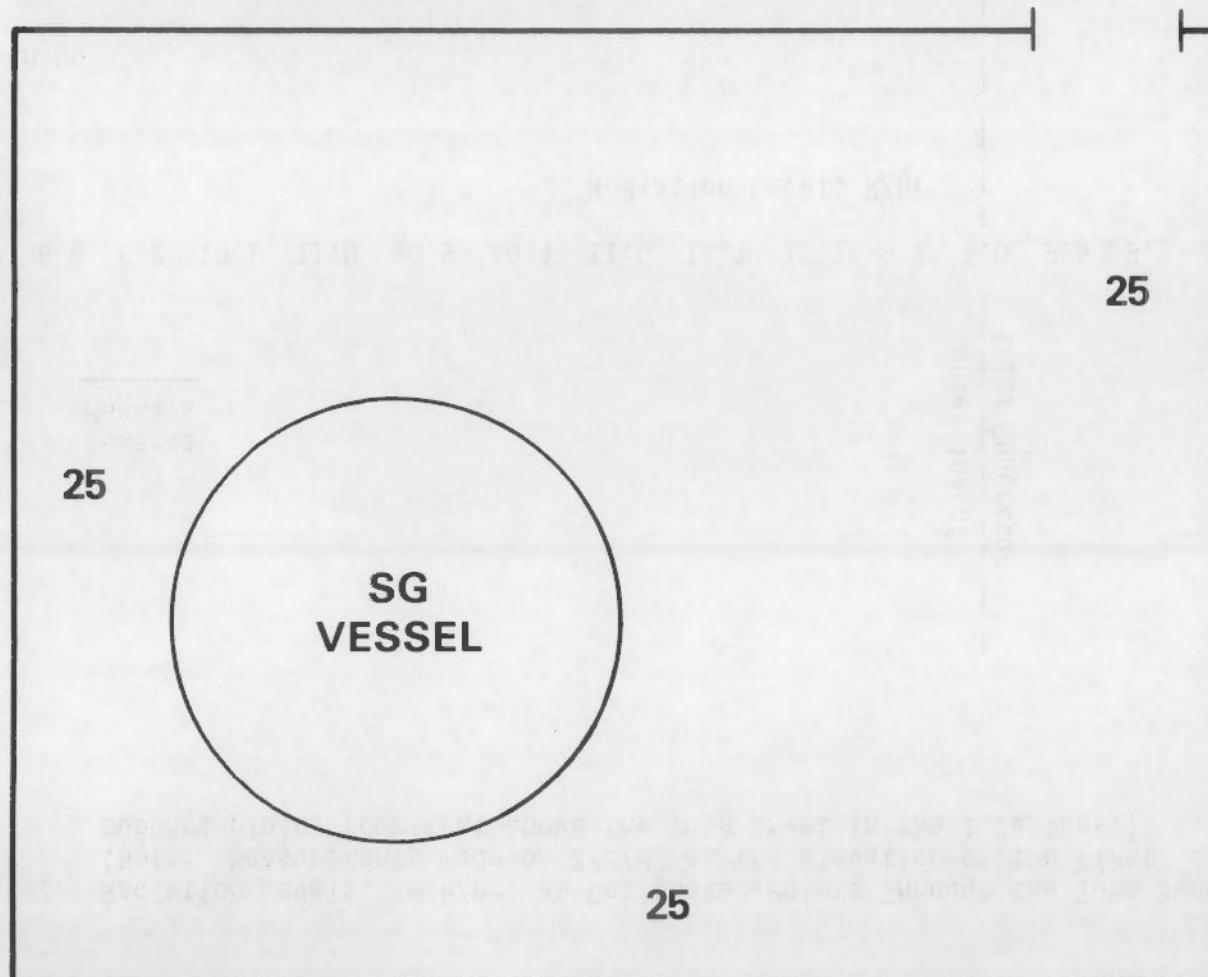
**\*DOSE RATES ARE IN mR/hr**

FIGURE 28. Radiological Map - Basement Level

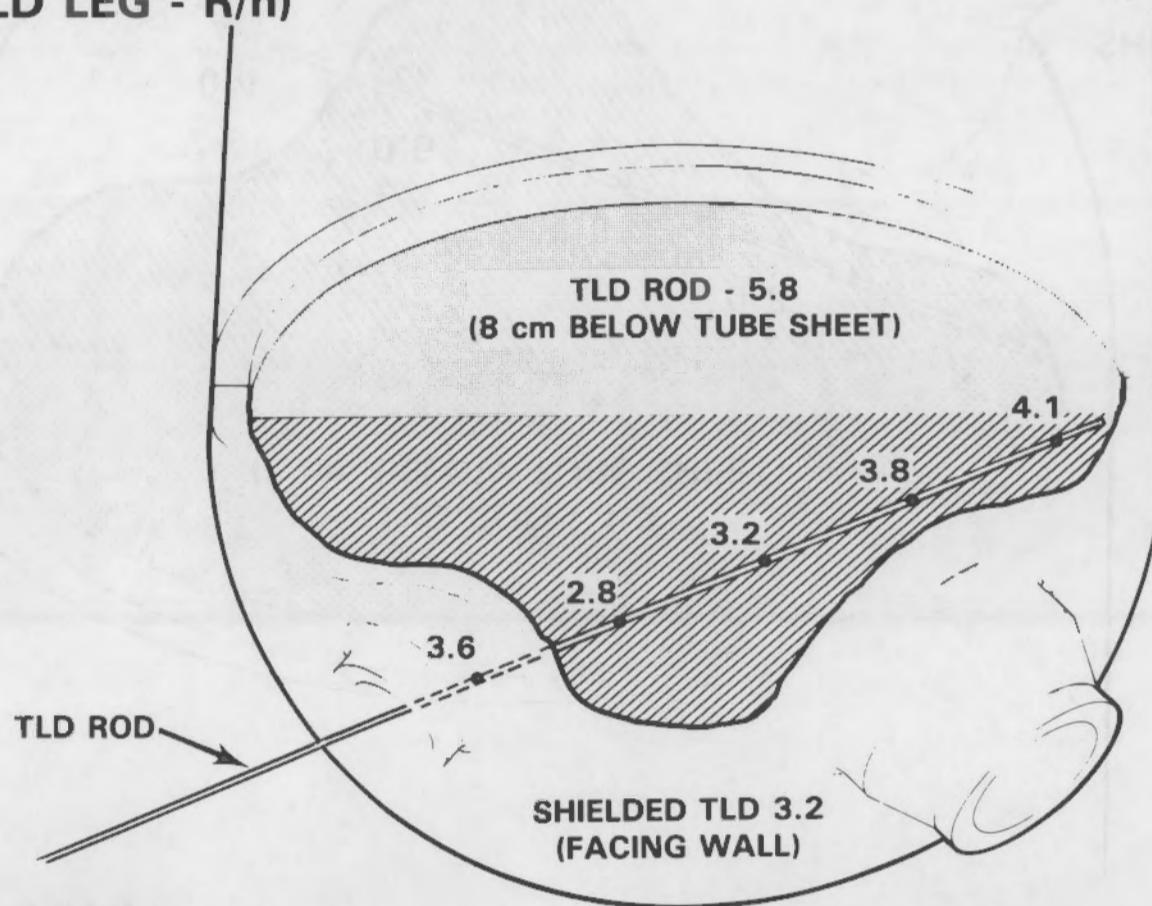
FIGURE 30.

INITIAL RADIATION READINGS  
(COLD LEG - R/h)

Both subcontractors performed well. The results of their operations are considered to be satisfactory as shown by the measurements recorded in Figures 30 through 35, earlier in this report. From analysis of the wastes, it is estimated that 2.1 curies of Co-60 were removed from the cold leg side, and 1.3 curies from the hot leg side. At least a part of the difference may be attributed to radioactive material being loosened and flushed from the tubes overhead by an excursion of decontaminating solution into the tube sheet portion of the tubes during the cold leg operation. On both sides, water evaporated from the process solutions up into the tubes where it was condensed.

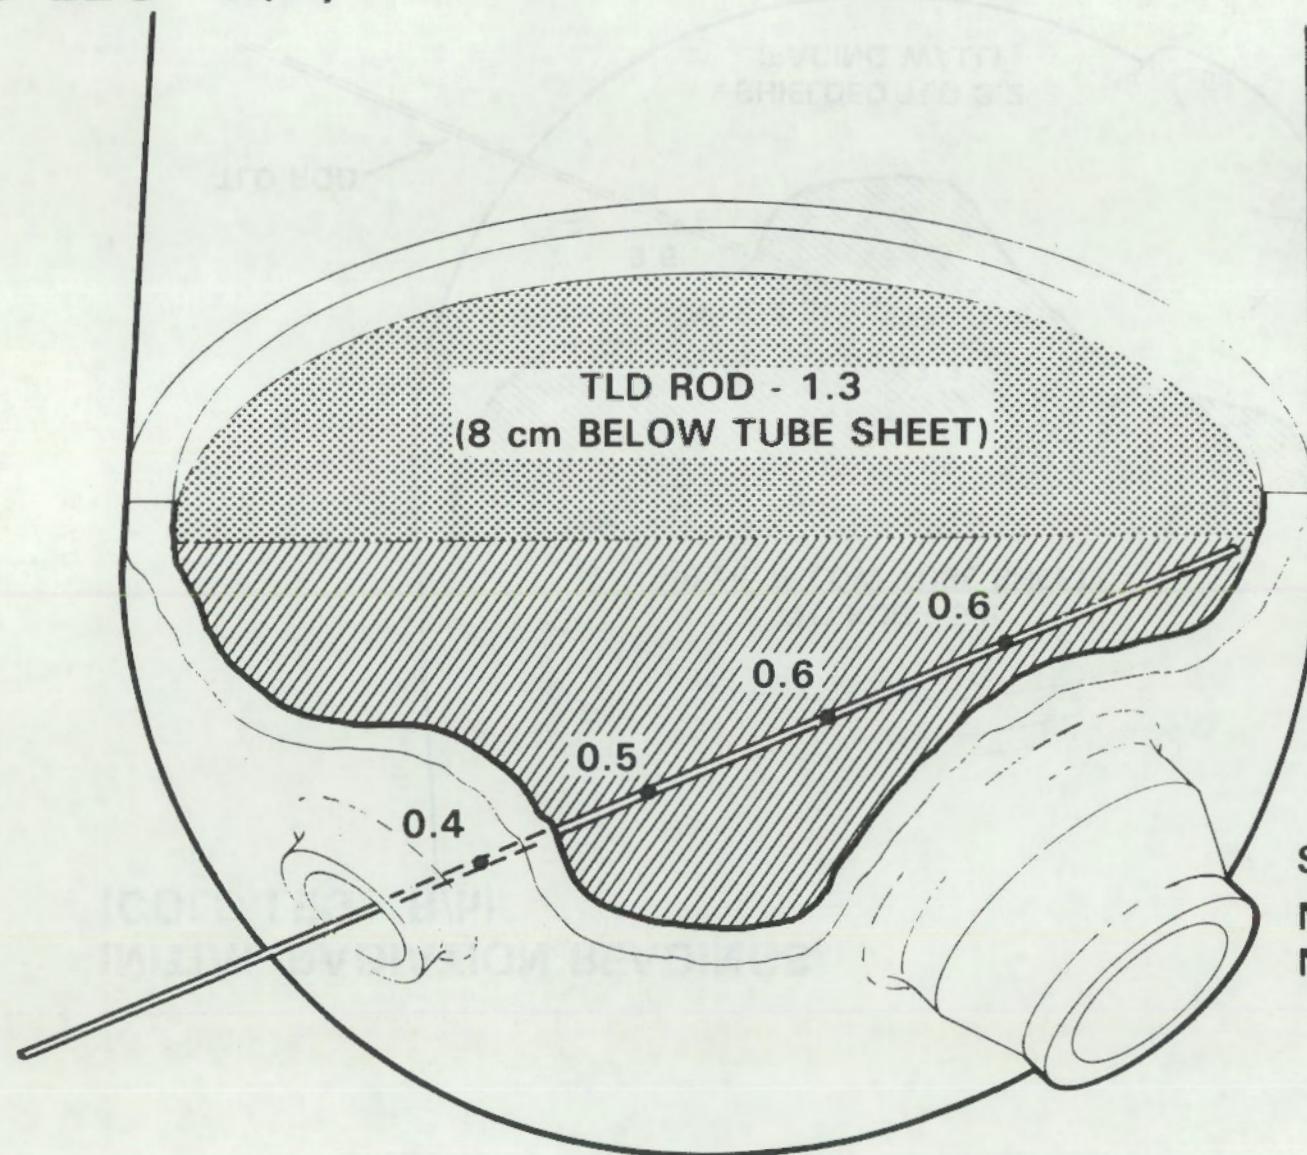
FIGURE 31.

## FINAL RADIATION READINGS COLD LEG - R/h)

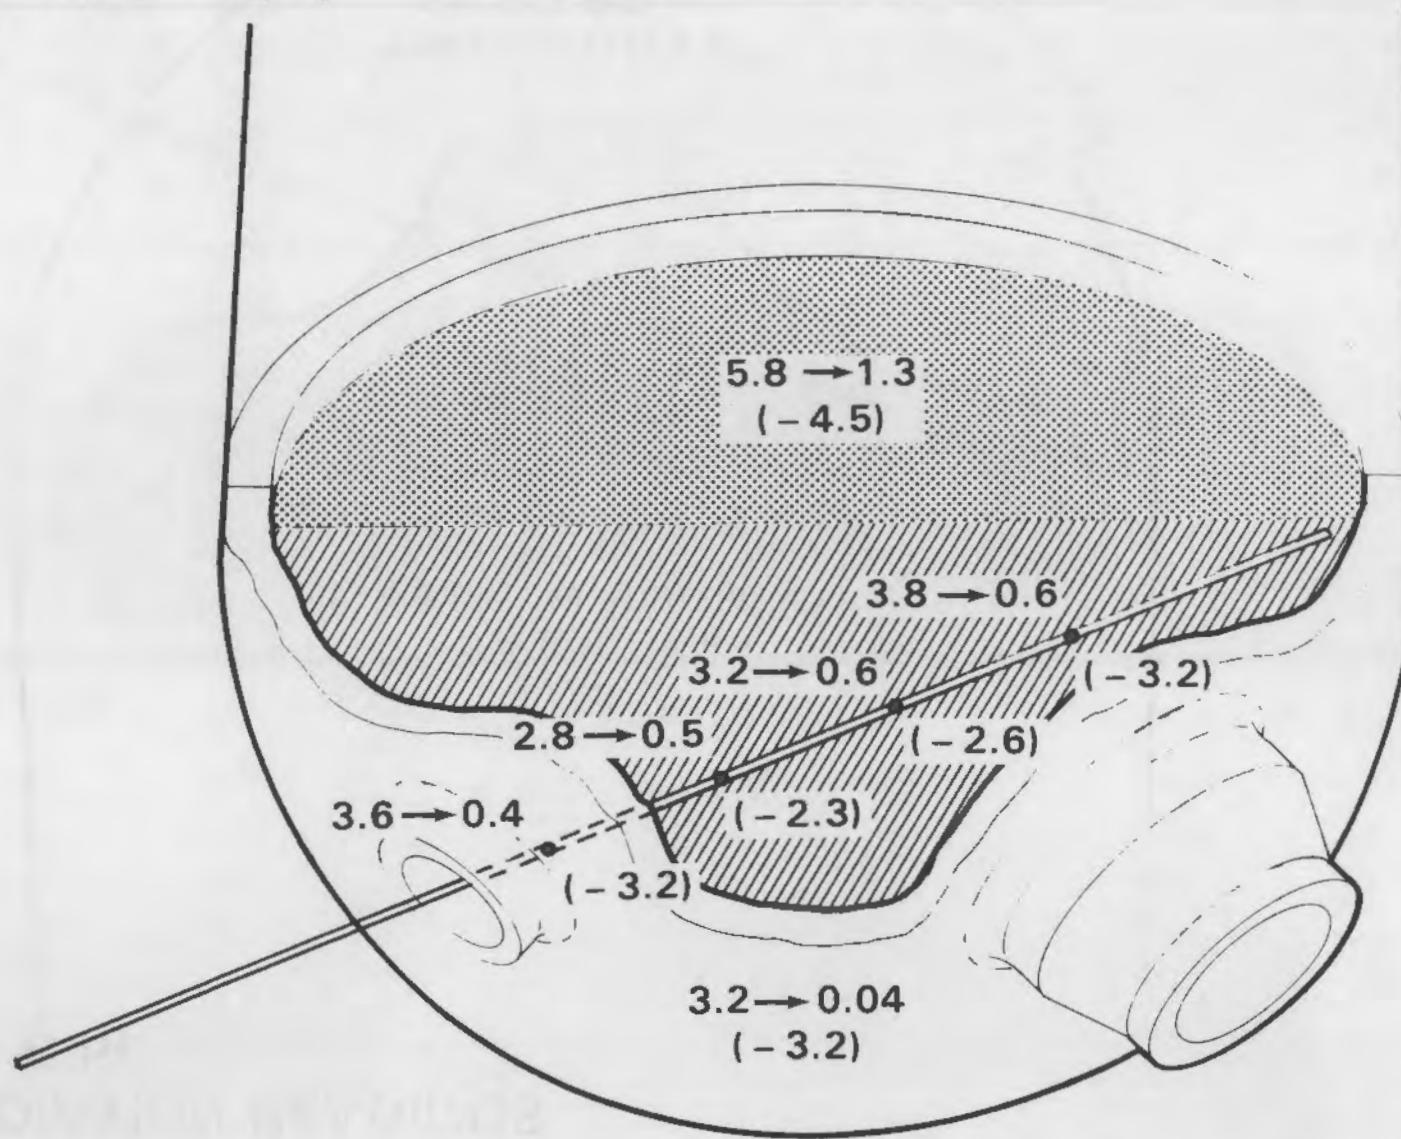
FIGURE 32.

## RADIATION READING CHANGE (COLD LEG - R/h)

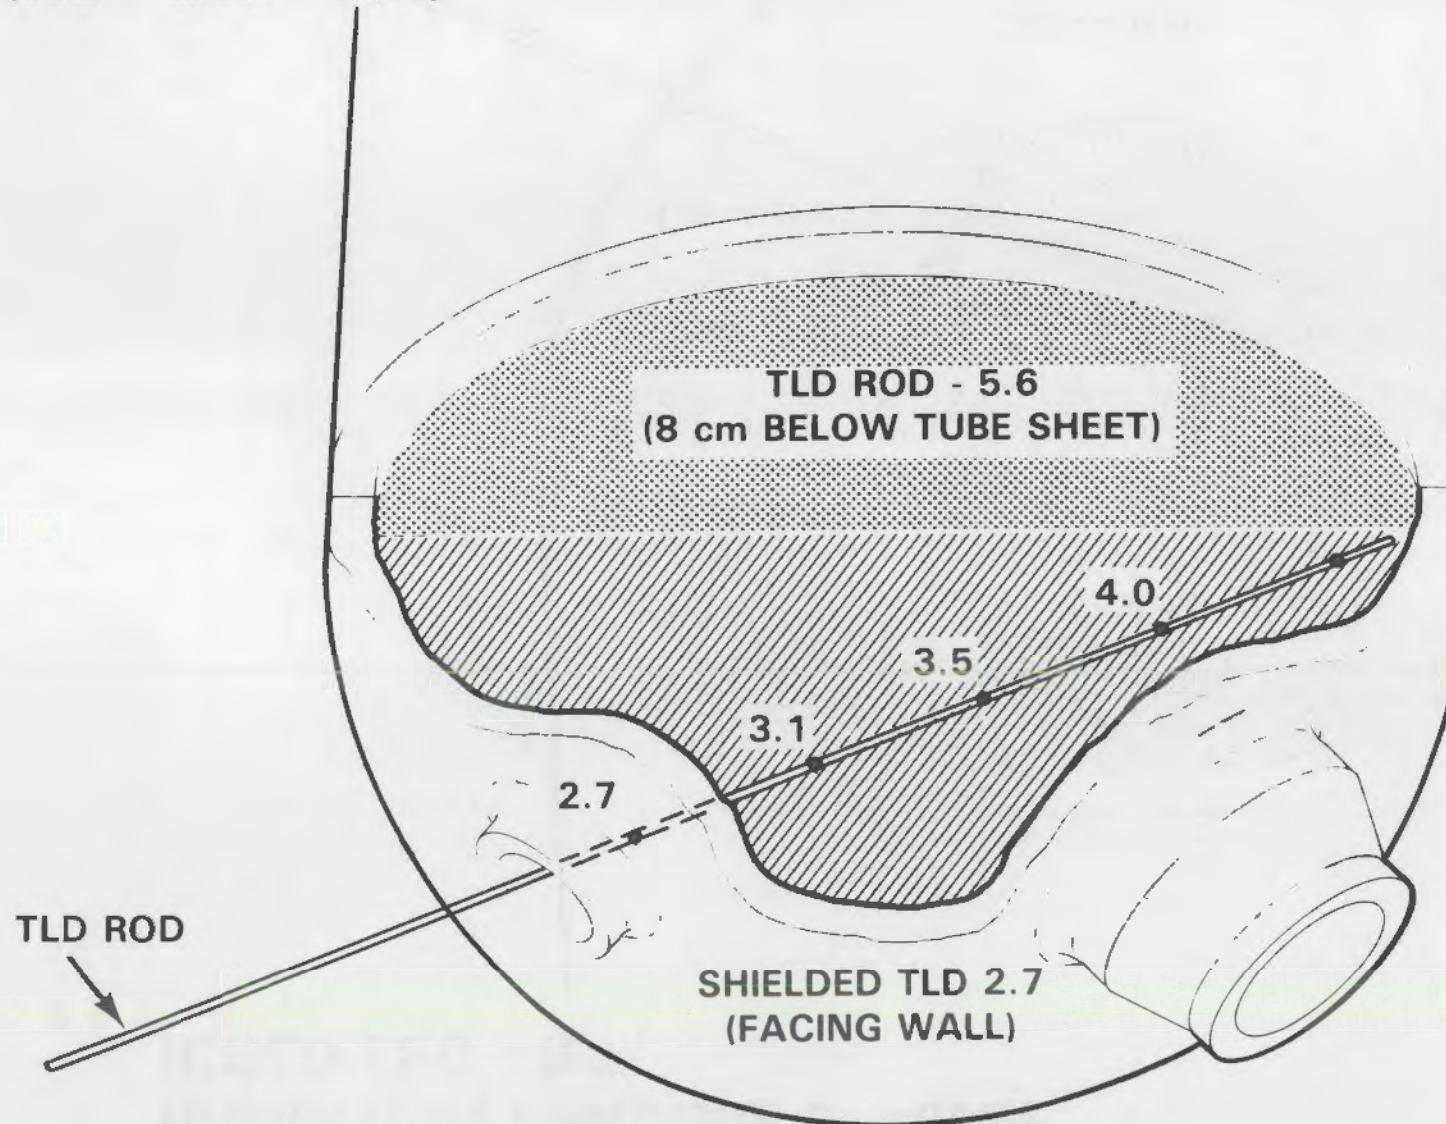
FIGURE 33.

## INITIAL RADIATION READINGS (HOT LEG - R/h)
