# Steam Generator Group Project

Annual Report - 1982

Prepared by R. A. Clark, M. Lewis

**Pacific Northwest Laboratory**  
Operated by  
Battelle Memorial Institute

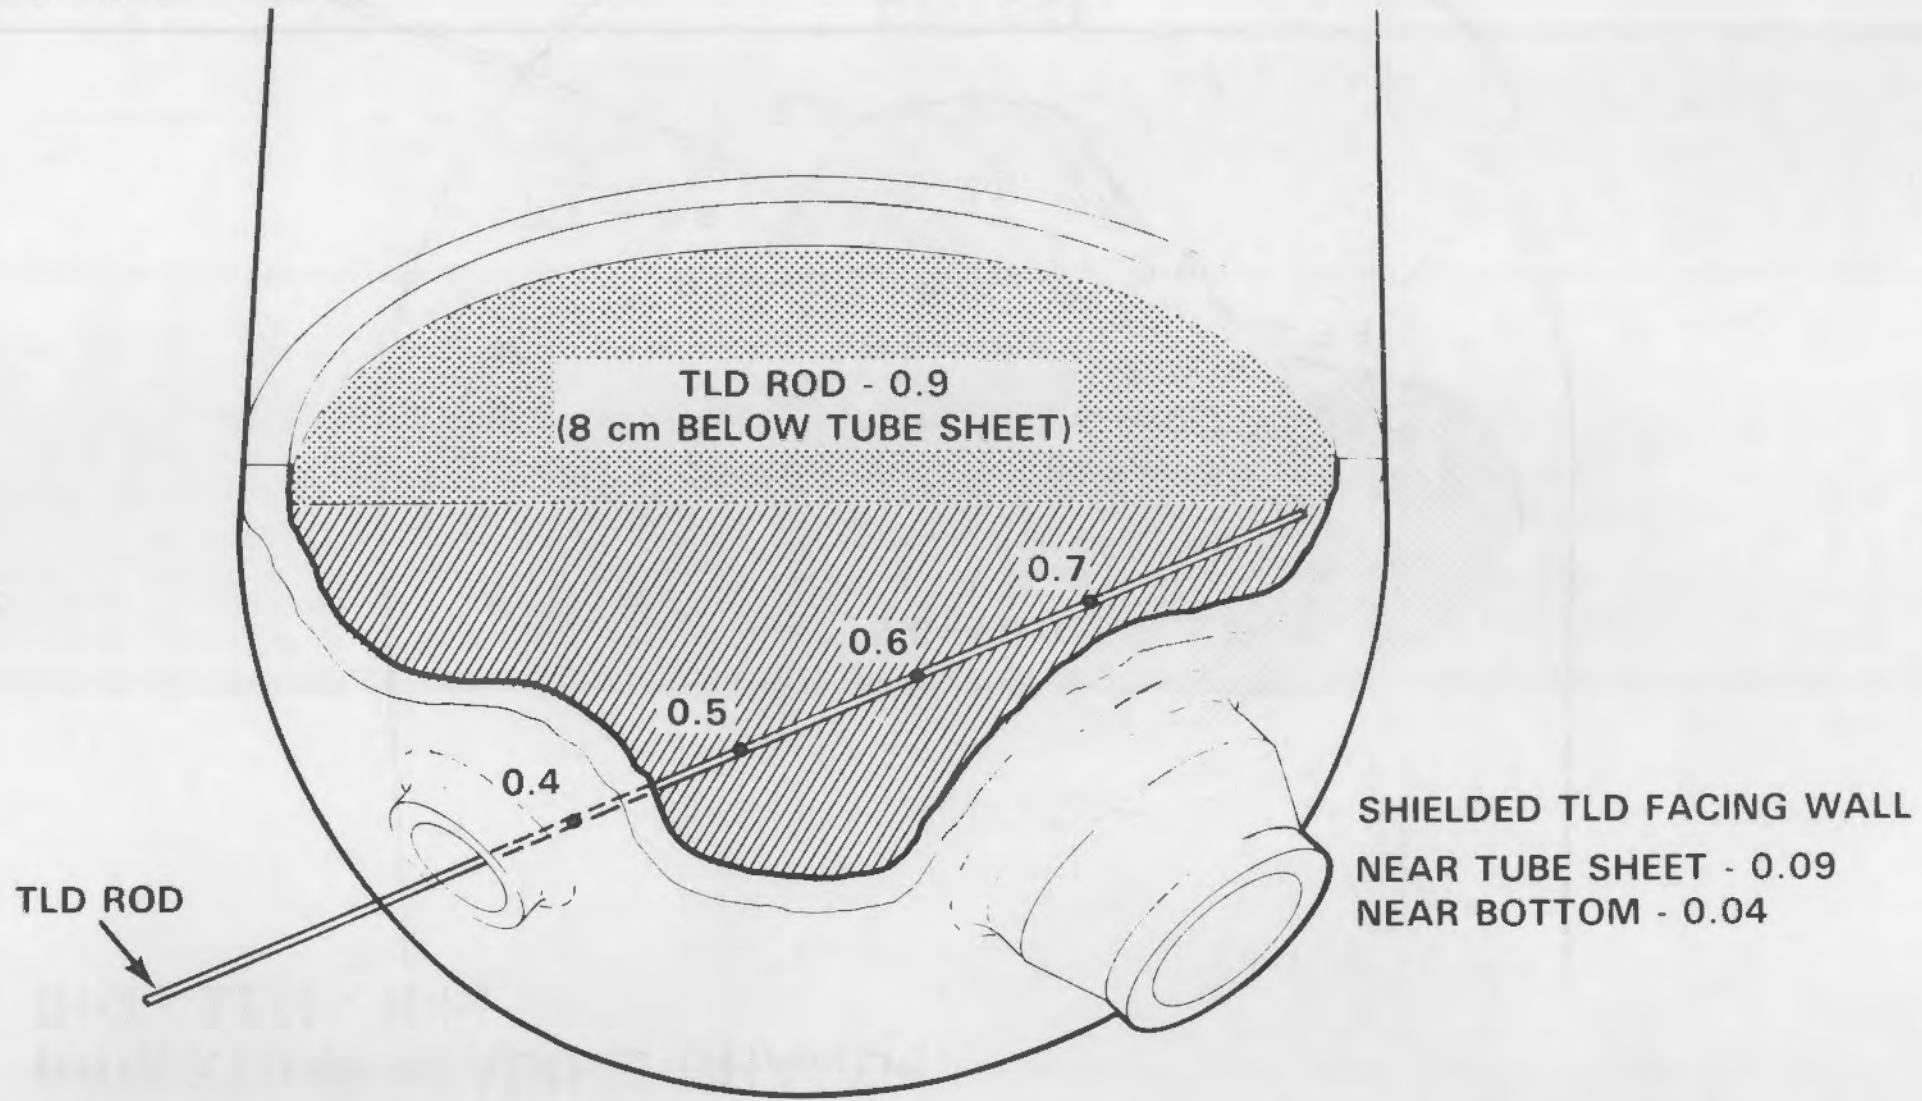
FIGURE 34.

## FINAL RADIATION READINGS (HOT LEG - R/h)

Both subcontractors performed well. The results of their operations are considered to be satisfactory as shown by the measurements recorded in Figures 30 through 35, earlier in this report. From analysis of the wastes, it is estimated that 2.1 curies of Co-60 were removed from the cold leg side, and 1.3 curies from the hot leg side. At least a part of the difference may be attributed to radioactive material being loosened and flushed from the tubes overhead by an excursion of decontaminating solution into the tube sheet portion of the tubes during the cold leg operation. On both sides, water evaporated from the process solutions up into the tubes where it was condensed.

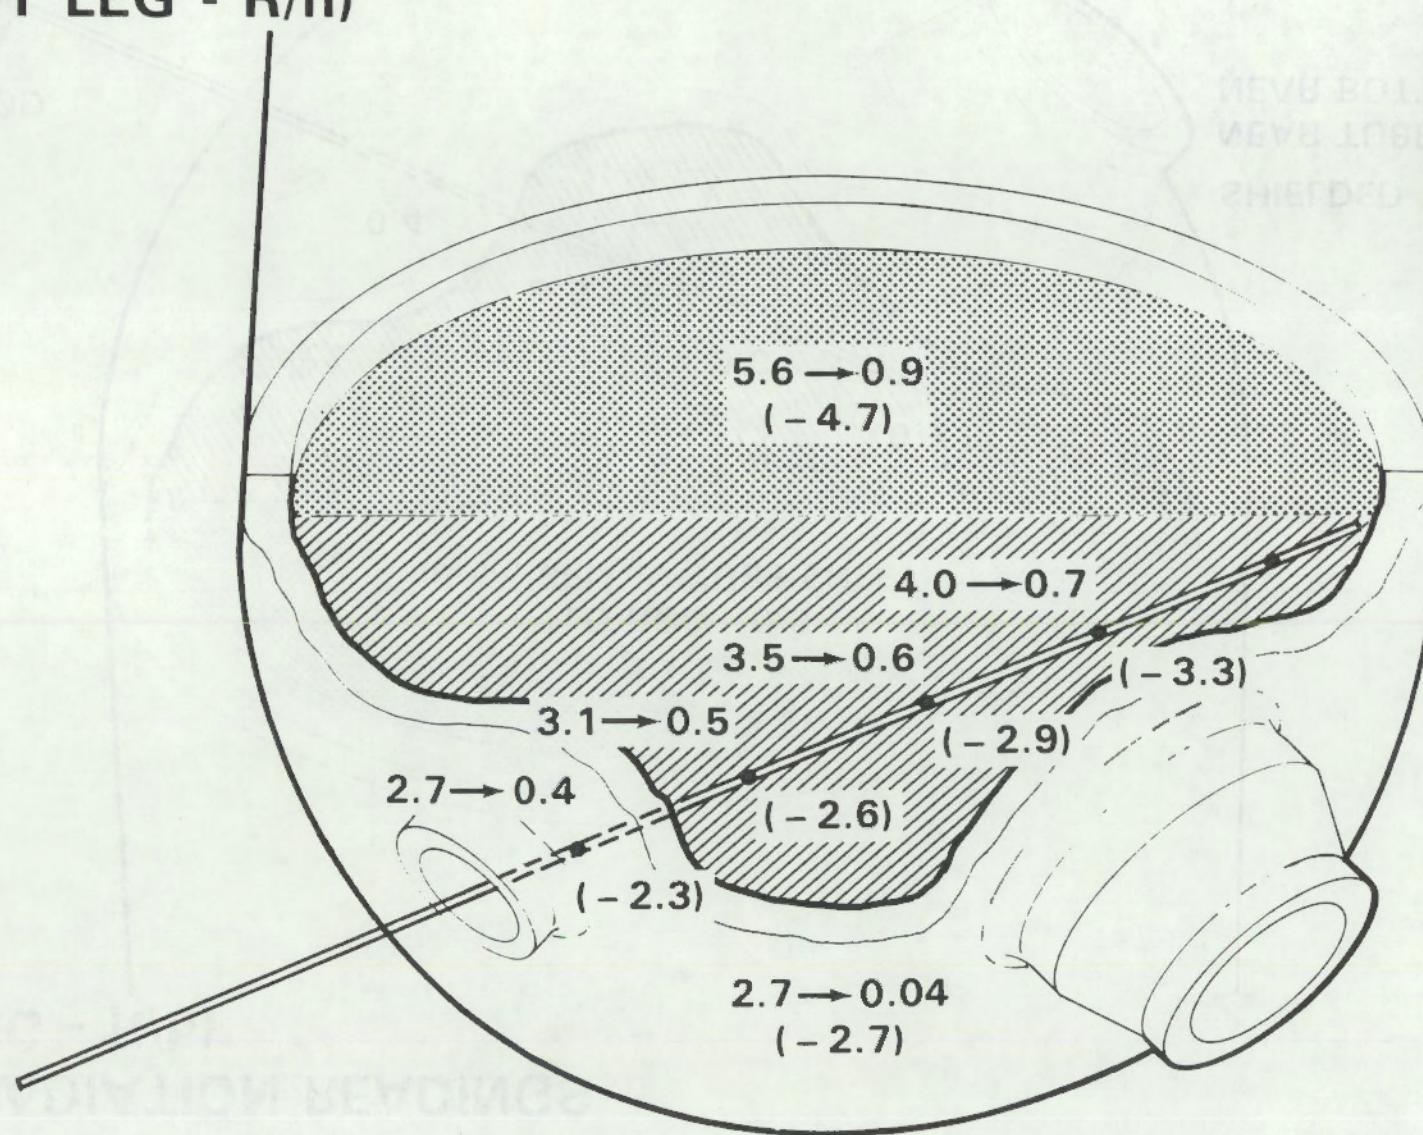
FIGURE 35.

## RADIATION READING CHANGE (HOT LEG - R/h)

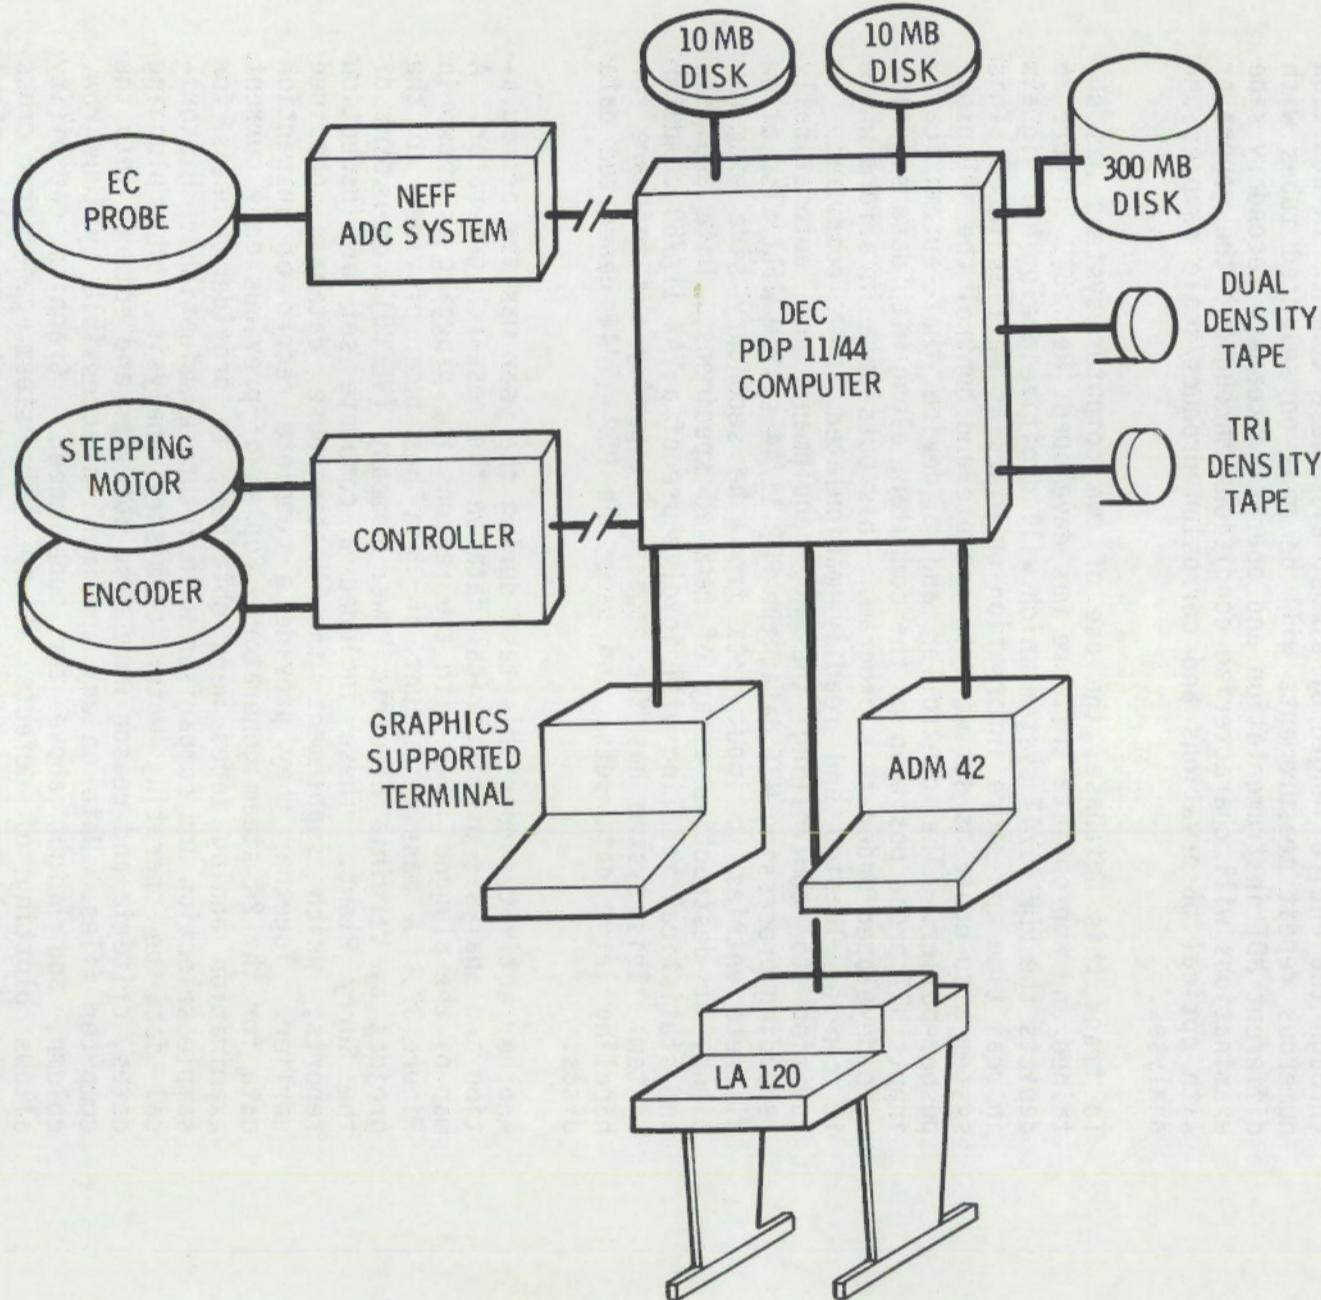
FIGURE 36. Computer System for NDT Probe Control and Data Aquisition/Digitization

To track this database, the use of two computer systems was obtained and appropriate software was developed (Ref. 3). Figure 36 depicts the PDP 11/44 system which will digitize analog NDT signals in real time and store information on discs as well as tape. This system also contains software to operate and control the NDT probe pusher-puller. The controller and a device that automatically inputs NDT probe position to the computer, along with data signals, were developed under this program. This puts data in a form where it can be located and readily manipulated in a computer. In addition to controlling the NDT equipment and automatically recording/processing NDT data, the PDP 11/44 system will also allow discrete entries to input data from the secondary side examinations, or destructive assay of removed specimens. Data analysis and statistical modeling will involve use of a VAX 11/780 computer system. This system has the necessary capacity and software for handling large data sets, and uses the PDP 11/44 generated data discs.

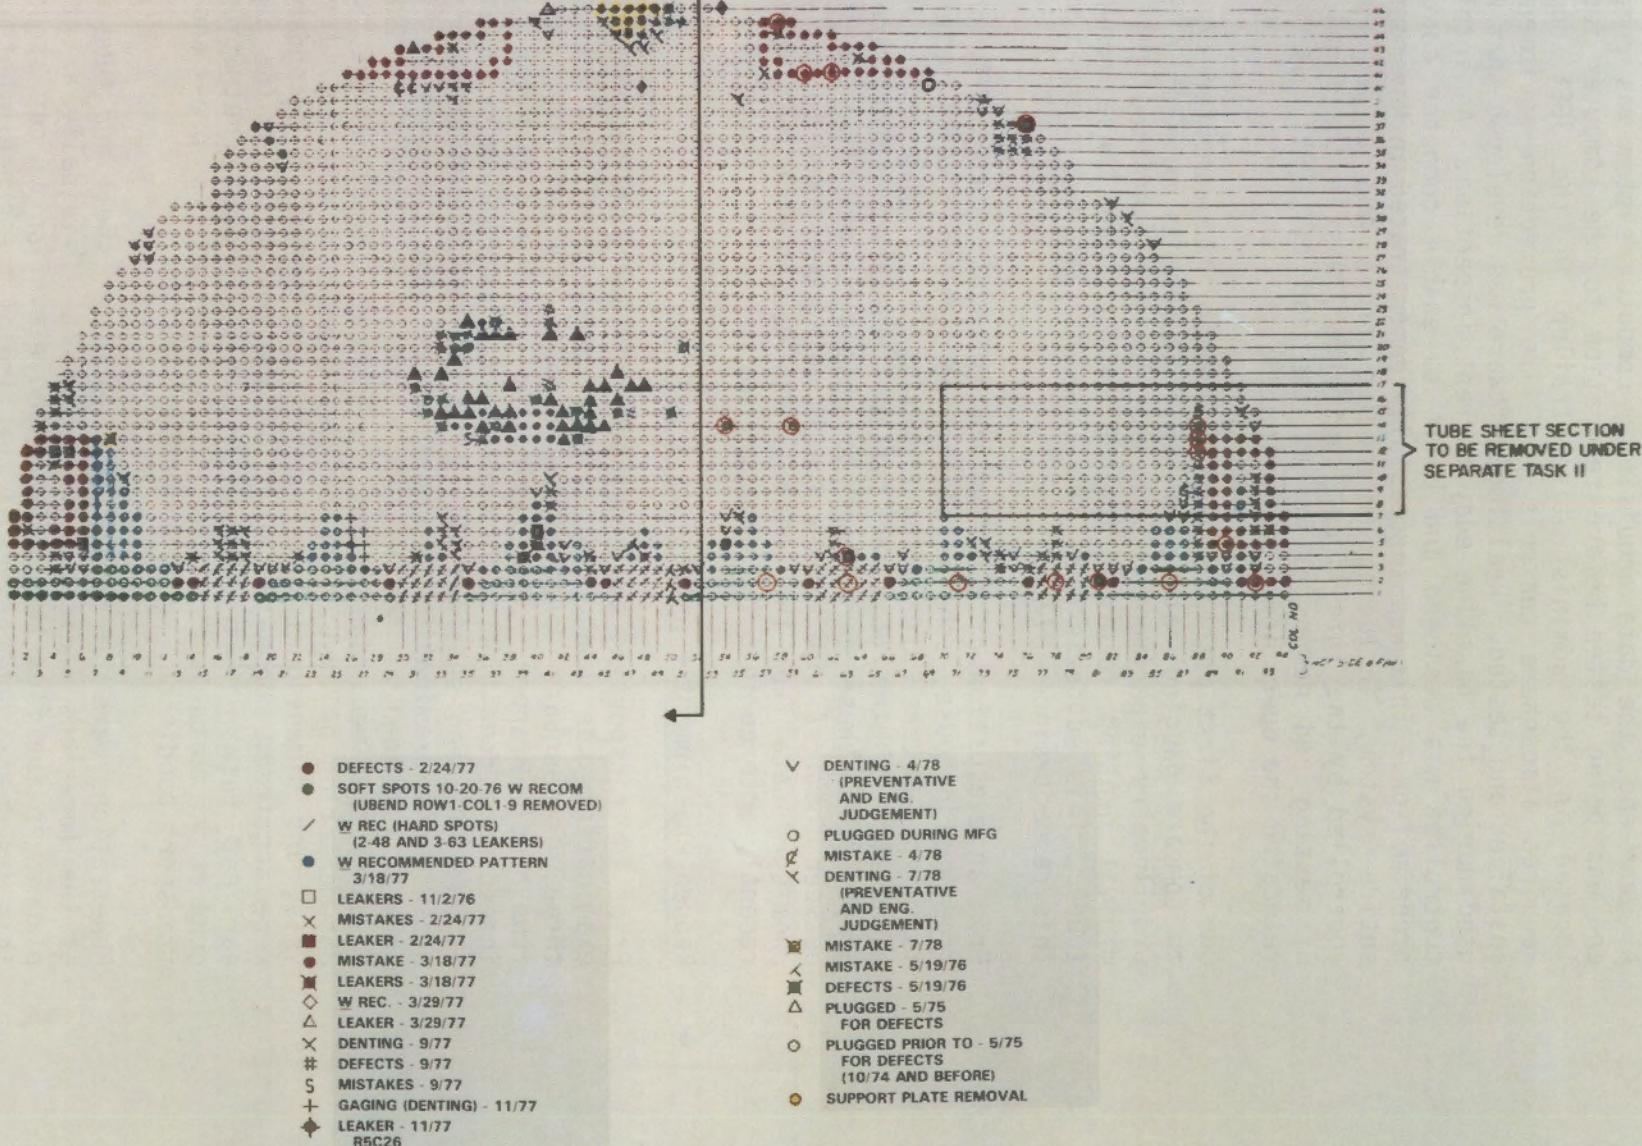
FIGURE 37.

**SURRY 2A STEAM GENERATOR  
TUBE PLUGGING MAP AS OF 8/8/78**

**ALL PLUGS REMOVED**

Another activity under this task during the year was the accumulation and analysis of historical data on the research generator. A map of the plugged tubes with the reasons for plugging is shown in Figure 37. A massive amount of data has been provided to the project by Virginia Electric Power Company (VEPCO), operators of the Surry Plant. These included a complete set of inspection reports, which supplement the Westinghouse database obtained earlier. Together they provide a complete record of inspection data for the 2A steam generator. Copies of previous eddy current examination analog tapes were obtained, to provide a basis for sample selection and comparison with future examinations. Historical data on operating water chemistry analysis, tube plugging dates, criteria and reason were also obtained and entered into the computer files. Data on any specimen is accessible by tube row, column, and height above the tube sheet. Graphics capability allows plotting of defects at specific steam generator cross sections as well as maps of a specific defect occurrence throughout the generator.

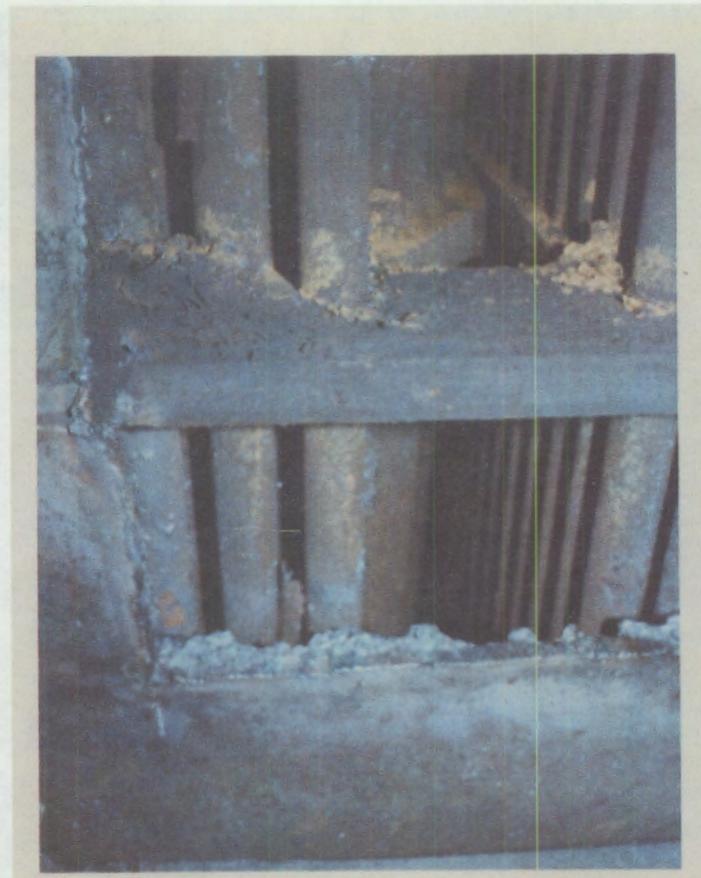
FIGURE 42. Condition of First Support Plate at Penetration 1 Before Shipment

Figures 42 and 43 were taken through penetration 1, at the first support plate. These pictures represent the identical region taken at Surry and in the SGEF. Severe deformation in the support plate with almost complete closure of the flow slot is apparent. A crack in the support plate is visible four tube rows in. Note there is little difference in comparison of the preshipment with post-shipment figure, only an expected redistribution of loose scale and corrosion product. Sludge scrapings before and after transit produced identical corrosion product analysis, indicating no penetration of seawater into the generator during transport.

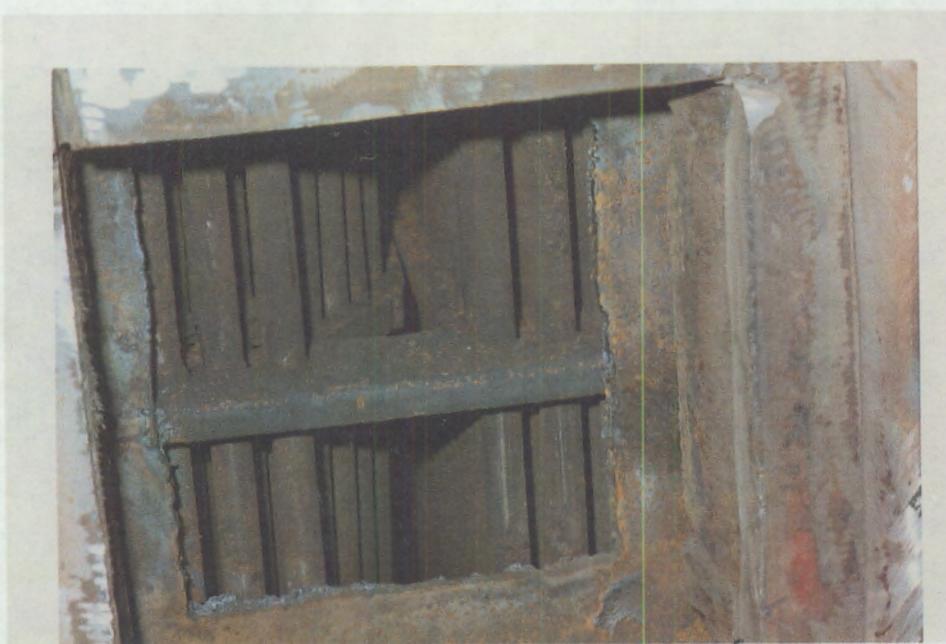
FIGURE 43. Same as Figure 42 After Generator Transport

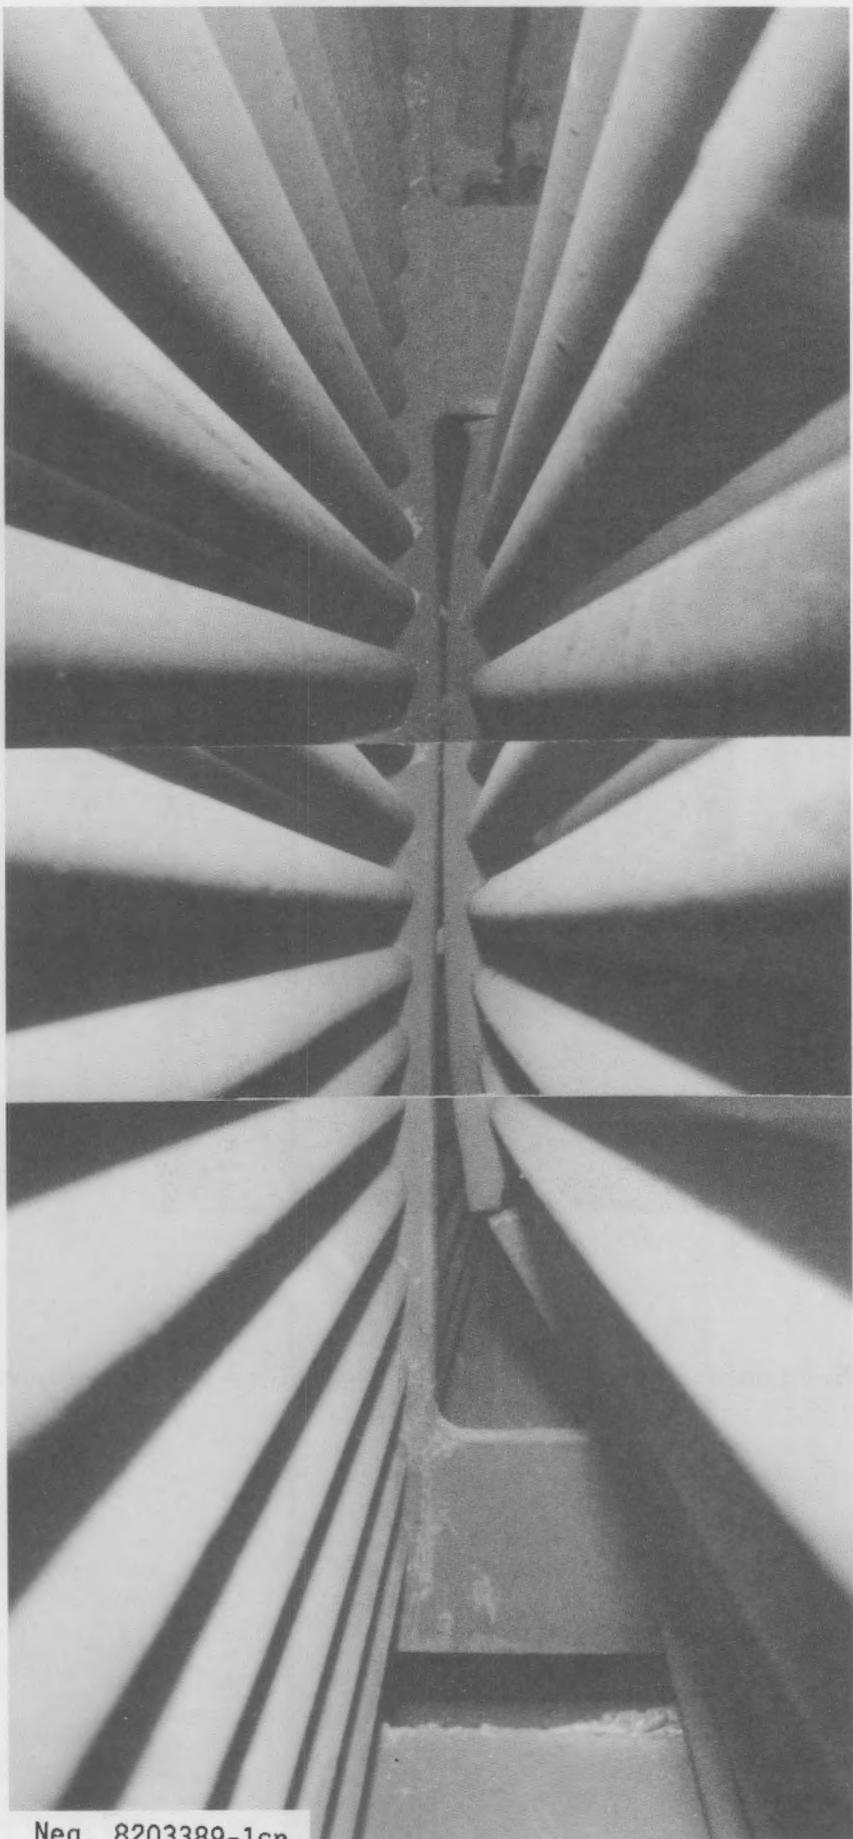
FIGURE 44. Bottom Surface of First Support Plate Viewed Upward from Handhole  
(Composite Photograph)

Figure 44, a photo-composite of three pictures shows a more extensive view of the first support plate flow slot closure seen in Figure 43. It should be observed that all deformation is from the hot leg side. Outside of the uppermost support plate the classical hourglassing of flow slots was not apparent. Also in Figure 44 part of a second flow slot is visible. This flow slot has closed completely through failure at a corner. Of particular interest is the extensive crack in this region and obvious missing piece of tube support plate. Support plate fragments have been found during the preshipment examination (Figure 45) and during the current examination (Figures 46 and 47).

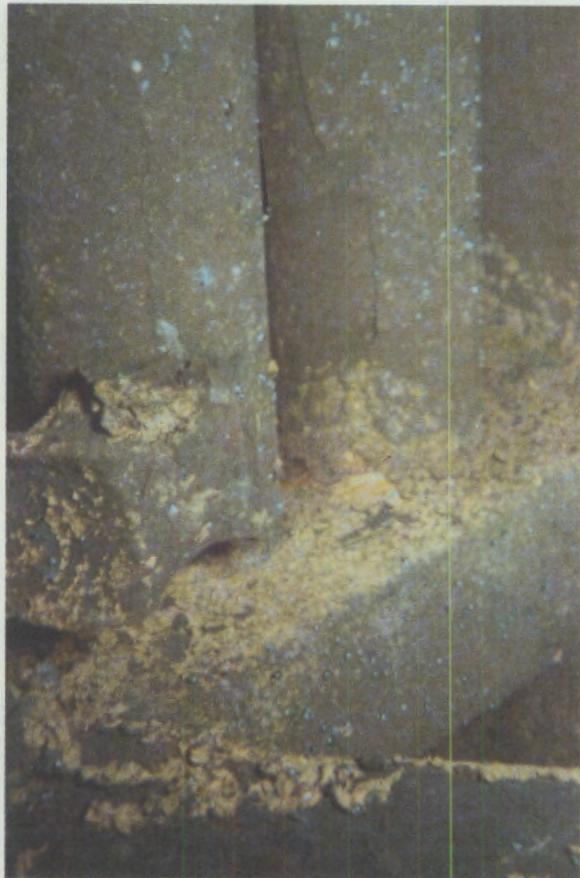
FIGURE 45. Loose Support Plate Piece Near Tube - Tube Support Junction

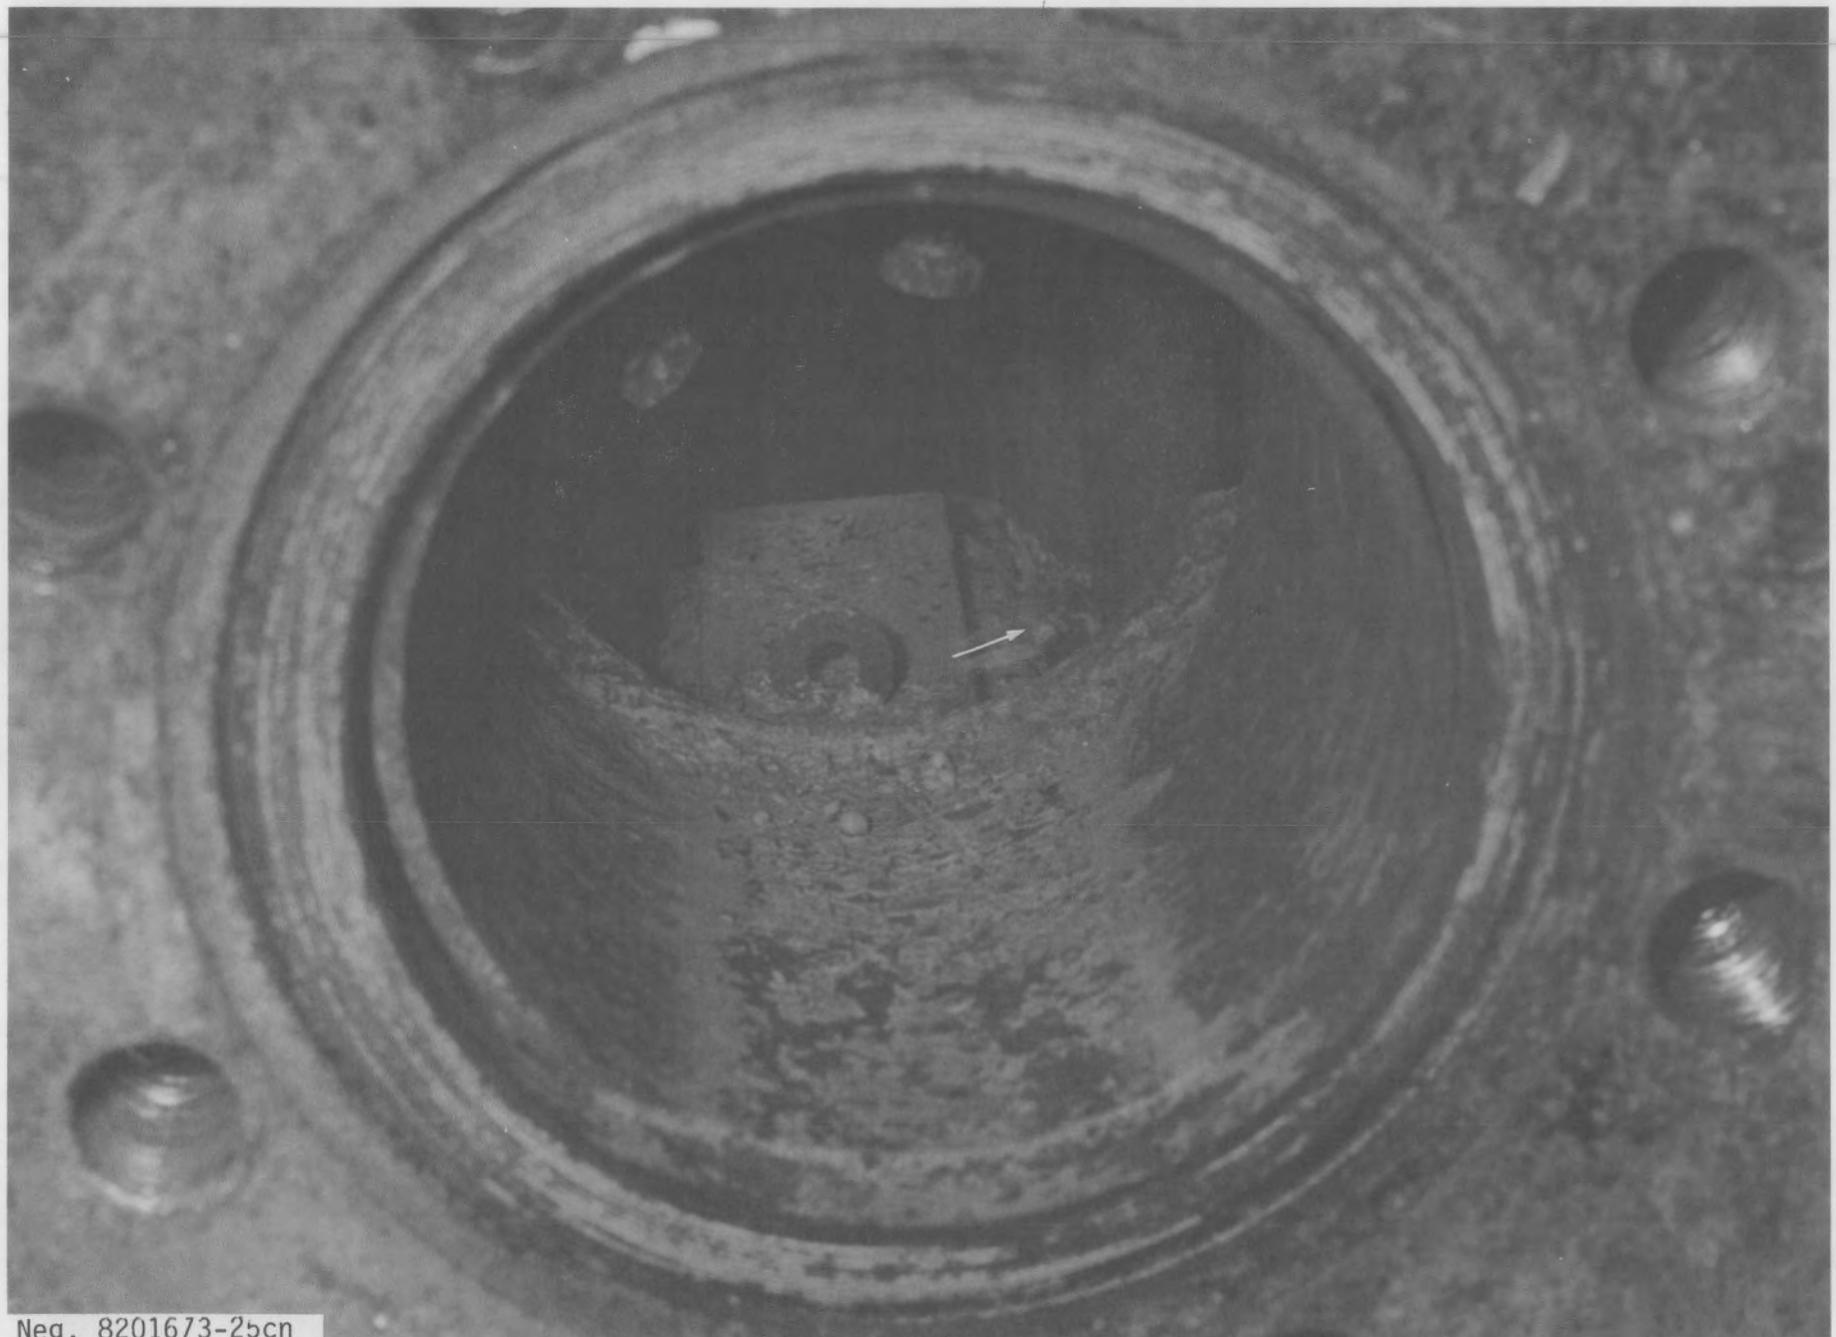
FIGURE 46. Separated Support Plate Piece at Lower Handhole

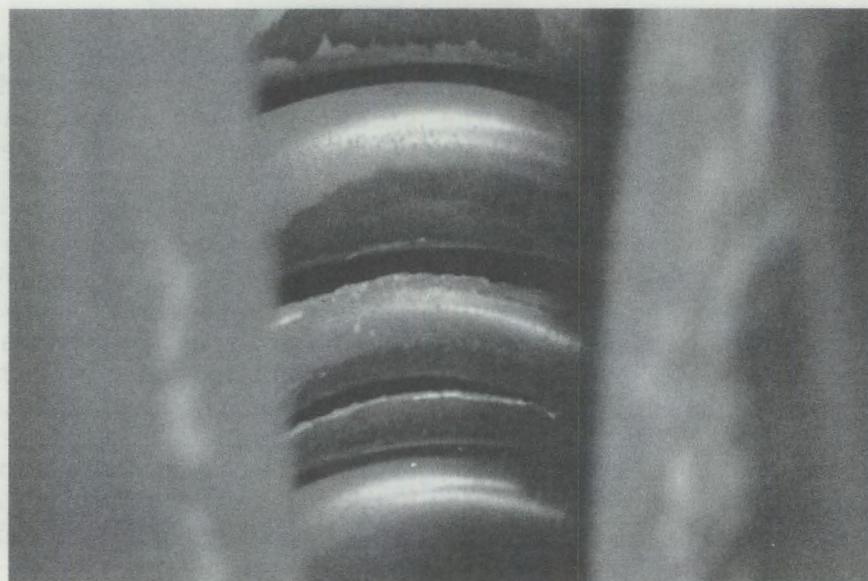
FIGURE 54. Large Longitudinal Failure

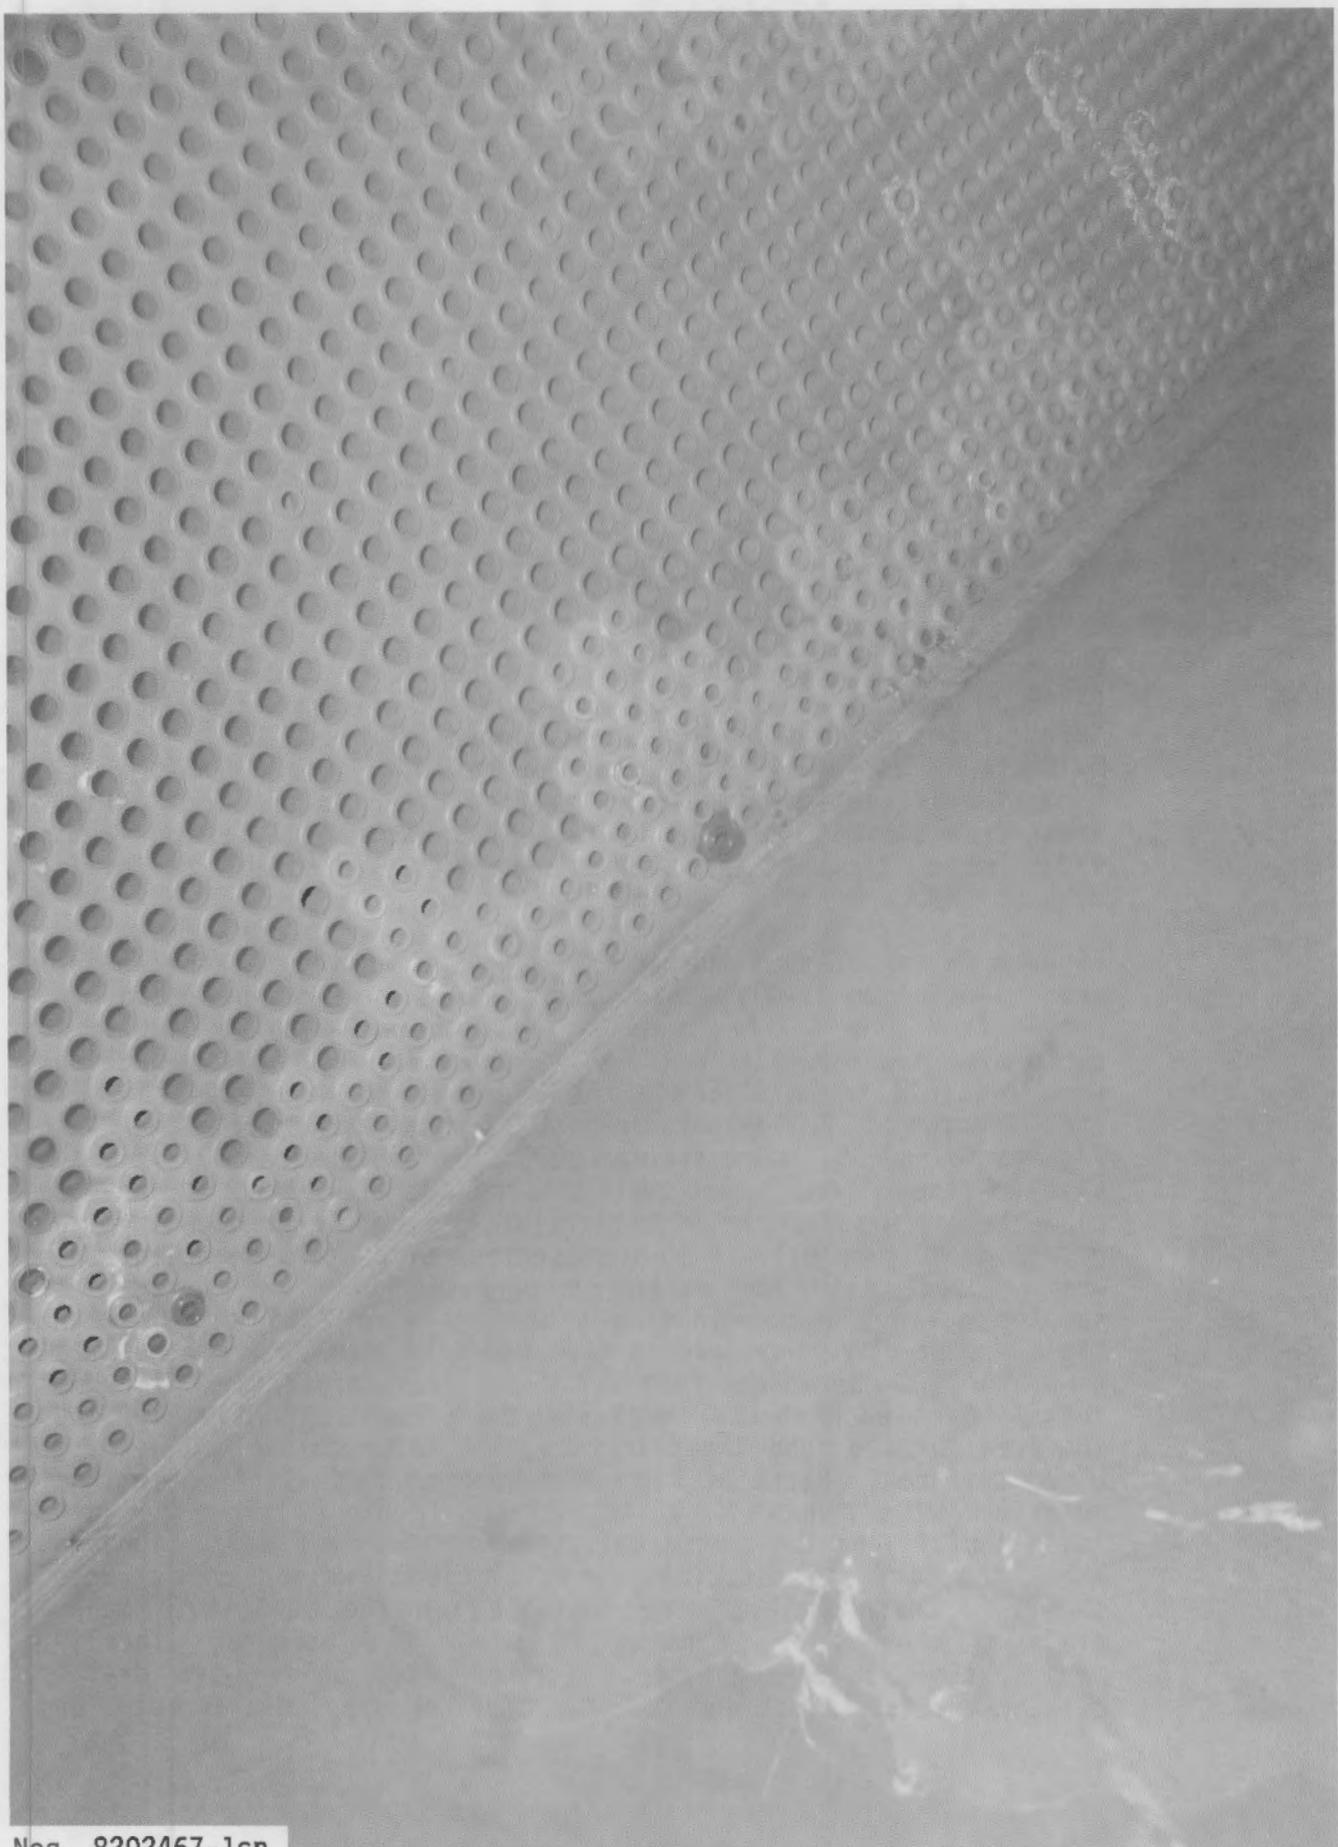
FIGURE 55. Bottom of Tube Sheet

The other region on which we have initiated characterization is the primary side of the tube sheet. Figure 55 shows a portion of the underside of the tube sheet, with a clear visibility of the tube plugging. Also leakage at certain plugs is apparent. Three gallons of liquid were removed from the channel head after placement of the generator into the SGEF. All of this liquid is presumed to have leaked from plugged tubes. Analysis of the liquid showed that it contained 135 ppm chloride ion, thus indicating that its source was not seawater. A complete analysis is shown in Table 5.

1. Corrosion product buildup in the tube-tube sheet annuli.
2. Sludge buildup around the tubes.
3. Tube sheet stresses from tube plugging and unplugging operations.
4. Intergranular corrosion of tubes and the tube sheet from alternate wetting and drying, and chemical deposits, at the mouths of the tube-tube sheet crevices.
5. Stress corrosion cracking at the tube-tube sheet interfaces. The ability of NDT methods to detect defects such as these will be validated.
6. Safety implications of circumferential cracks, if found, in tubes above the tube sheet.
7. Denting of tubes inside the tube sheet from annular corrosion product deposition.
8. Damage or corrosion to tube plugs that result in leakage or potential loss of plug integrity. (Note evidence of leaking plugs in Figure 55).

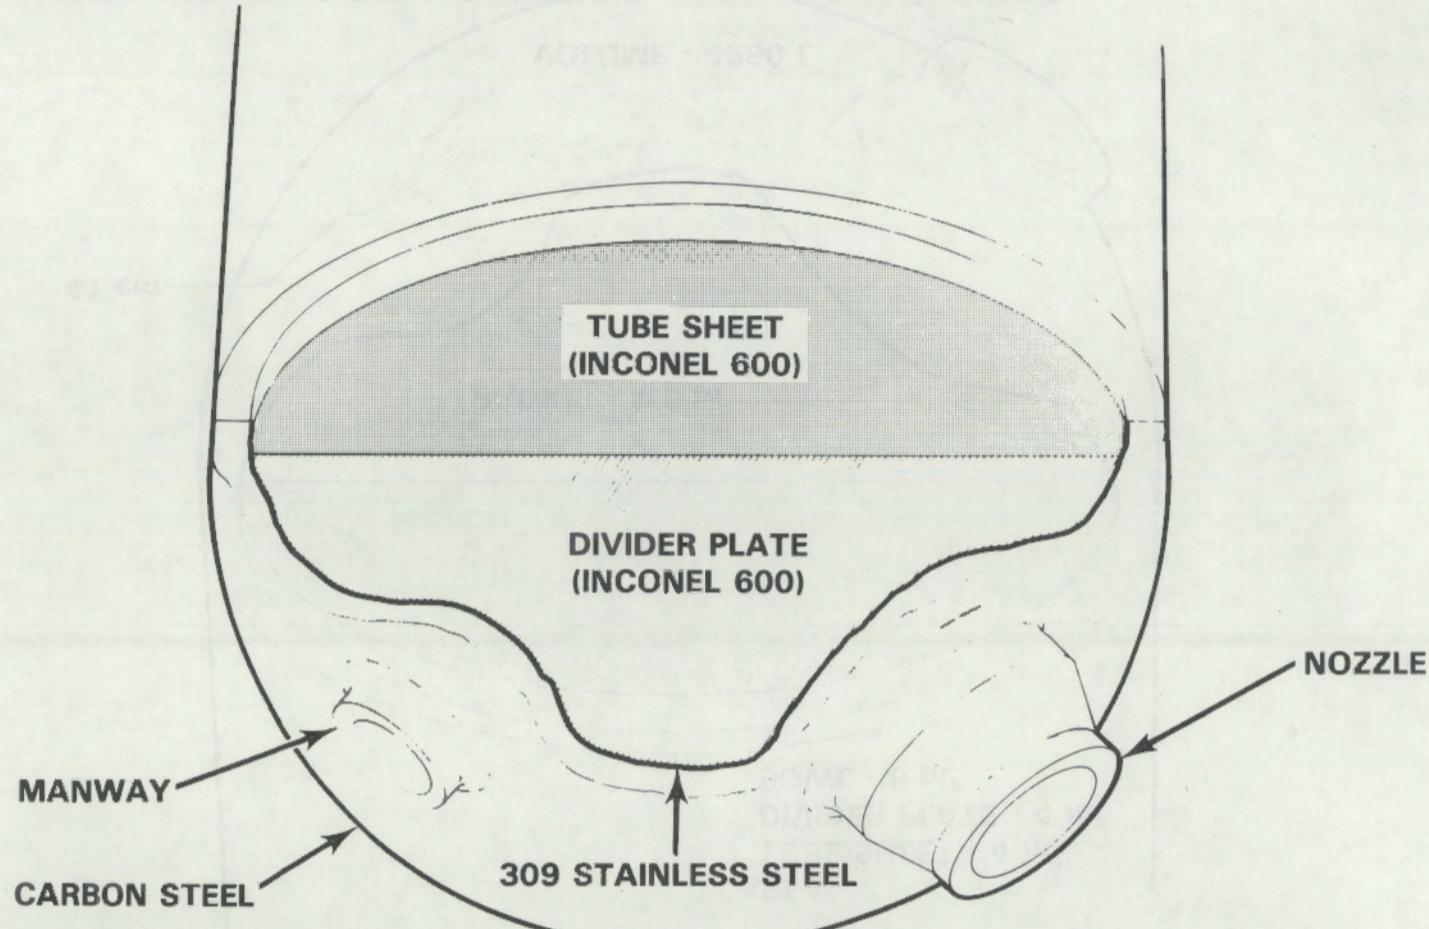
FIGURE 56.  
Neg. 8206911-9

## CHANNEL HEAD COMPONENTS AND MATERIALS

Figures 56 and 57 show the materials and dimensions of the channel head. Radiation levels inside each half of the channel head bowl ranged from 3 to 6 R/hr, as shown in Figures 30 and 33. Prior to performing the decontamination, a number of preparatory actions were required in addition to the radiation measurements shown in the figures. Pre-decontamination photographs are shown in Figures 58 and 59. Core samples were drilled (Figure 60) from each side of the channel head wall that contained about a one-inch diameter circular sample of the stainless steel inner cladding from each side (Figure 61). A 10-inch section of a steam generator tube was removed, also for reference purposes and for use as test samples during decontamination. Samples were also cut from the stainless steel manway inserts that had been removed from the steam generator. A one-square-foot stainless steel protective plate was installed on each channel head side to prevent decontamination of two areas of the tube sheet surface, for later comparison with the clean surfaces. Racks of corrosion specimens of all the pertinent materials were prepared and installed. Figure 62 shows the protective plate and the corrosion specimen racks in place. Figure 63 shows the corrosion specimens which included welded and stressed samples. Corrosometers were installed in the substitute manway plates (Figure 64). A number of minor but necessary facility modifications were completed. For example, holes were drilled between the truck lock and the tower for hoses to deliver solutions

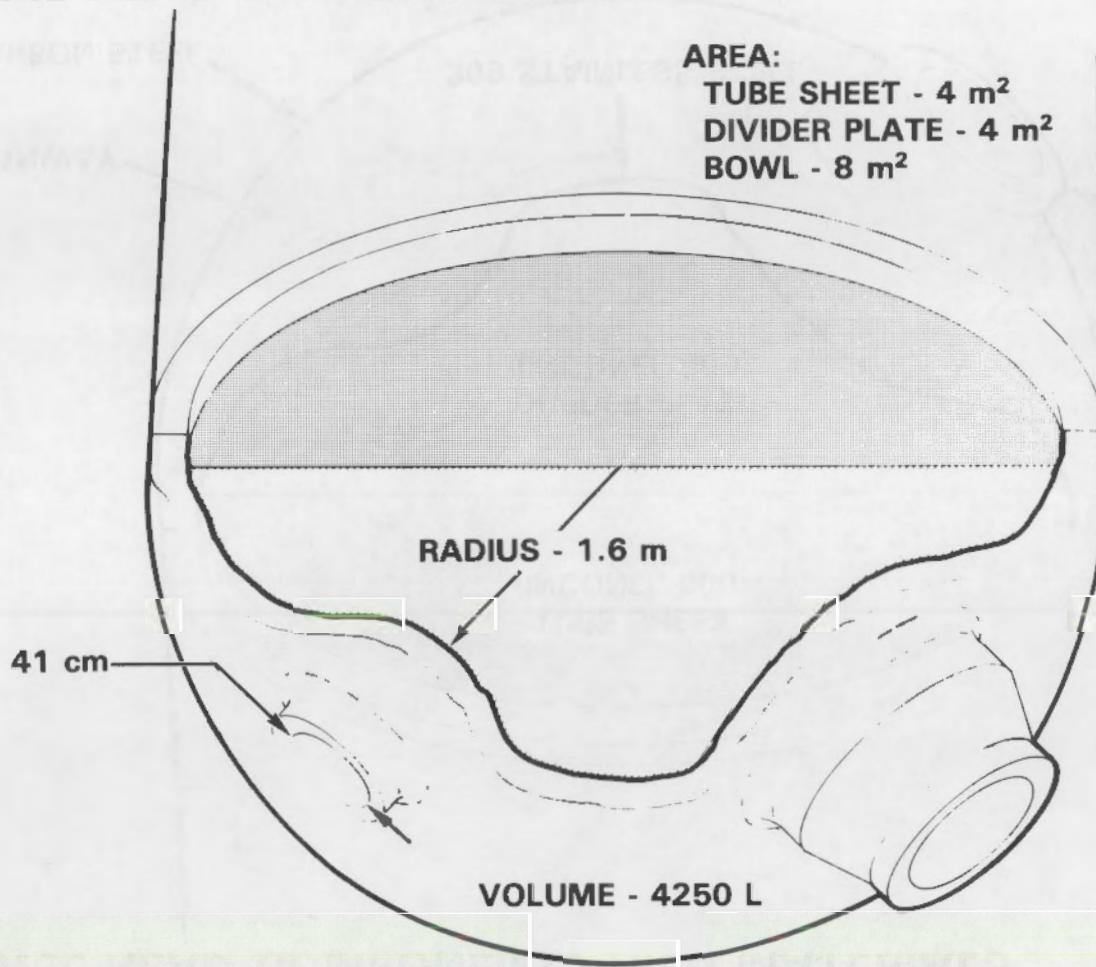
FIGURE 57.  
Nov. 2006011-2

## CHANNEL HEAD MEASUREMENTS

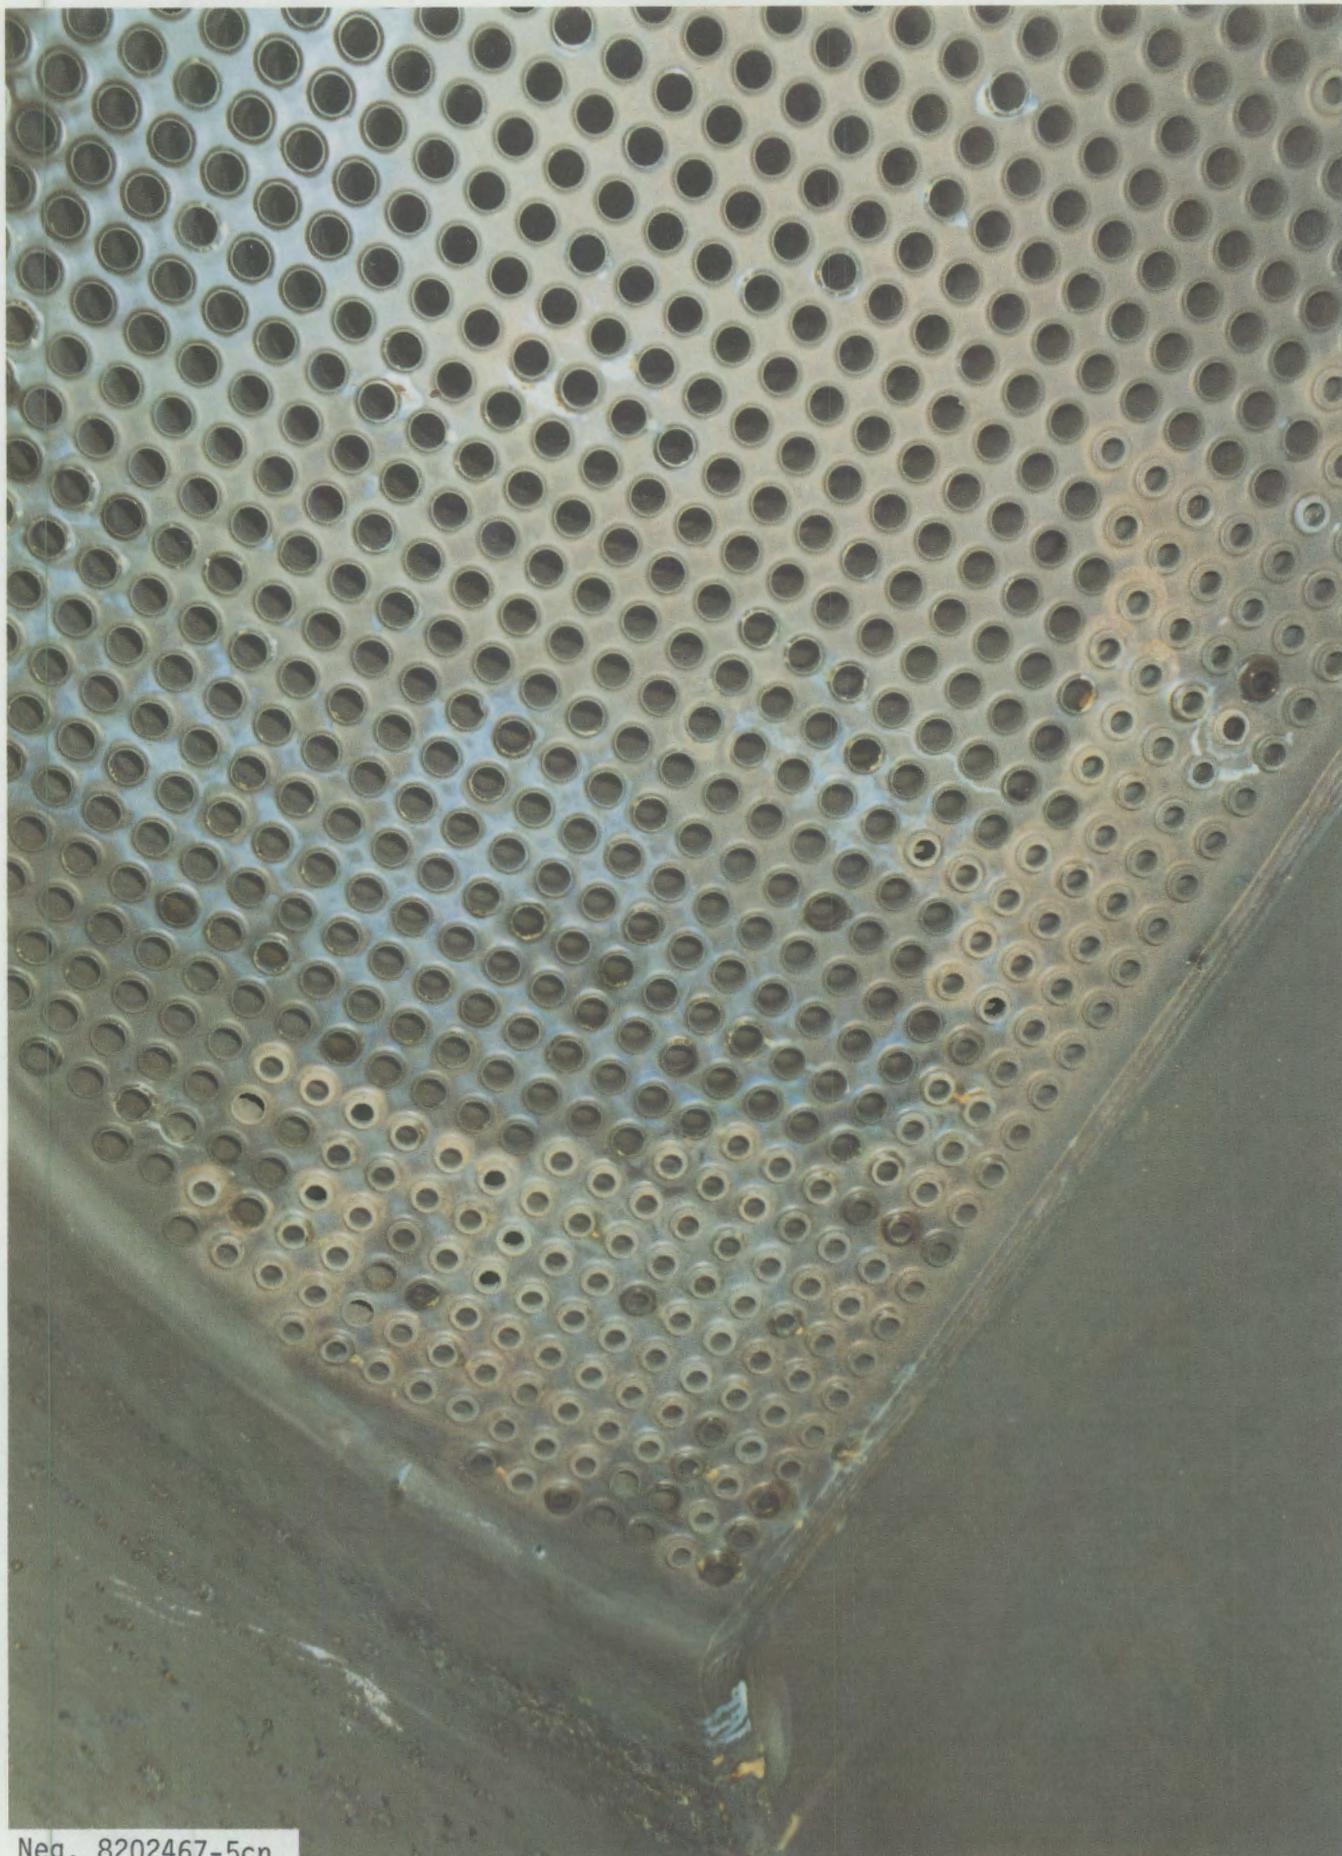
FIGURE 58. Initial Condition of Channel Head Surfaces - Cold Leg Side
