# Steam Generator Group Project

Annual Report - 1982

Prepared by R. A. Clark, M. Lewis

**Pacific Northwest Laboratory**  
Operated by  
Battelle Memorial Institute

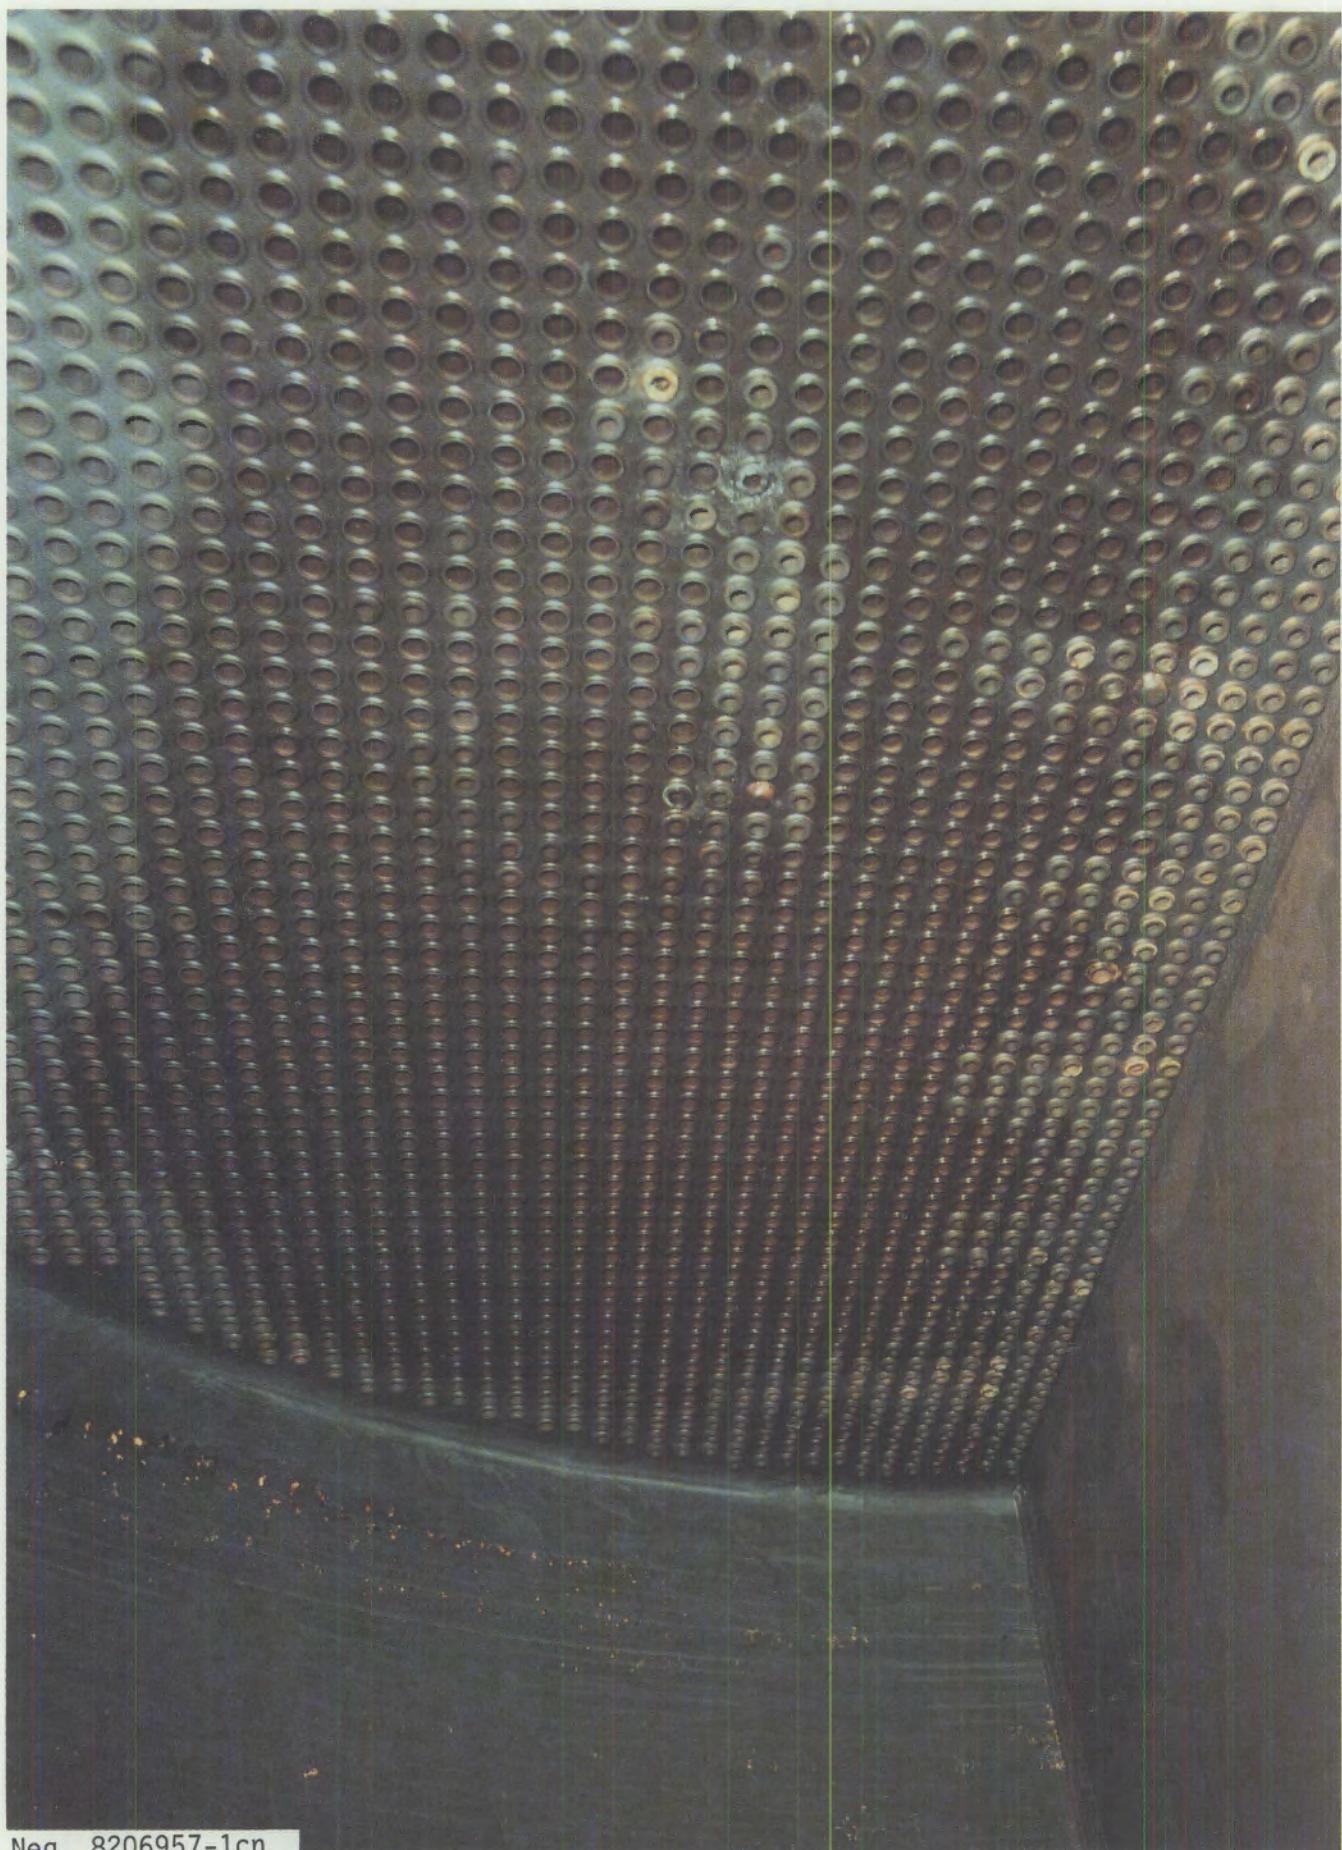
FIGURE 59. Initial Condition of Channel Head Surfaces - Hot Leg Side

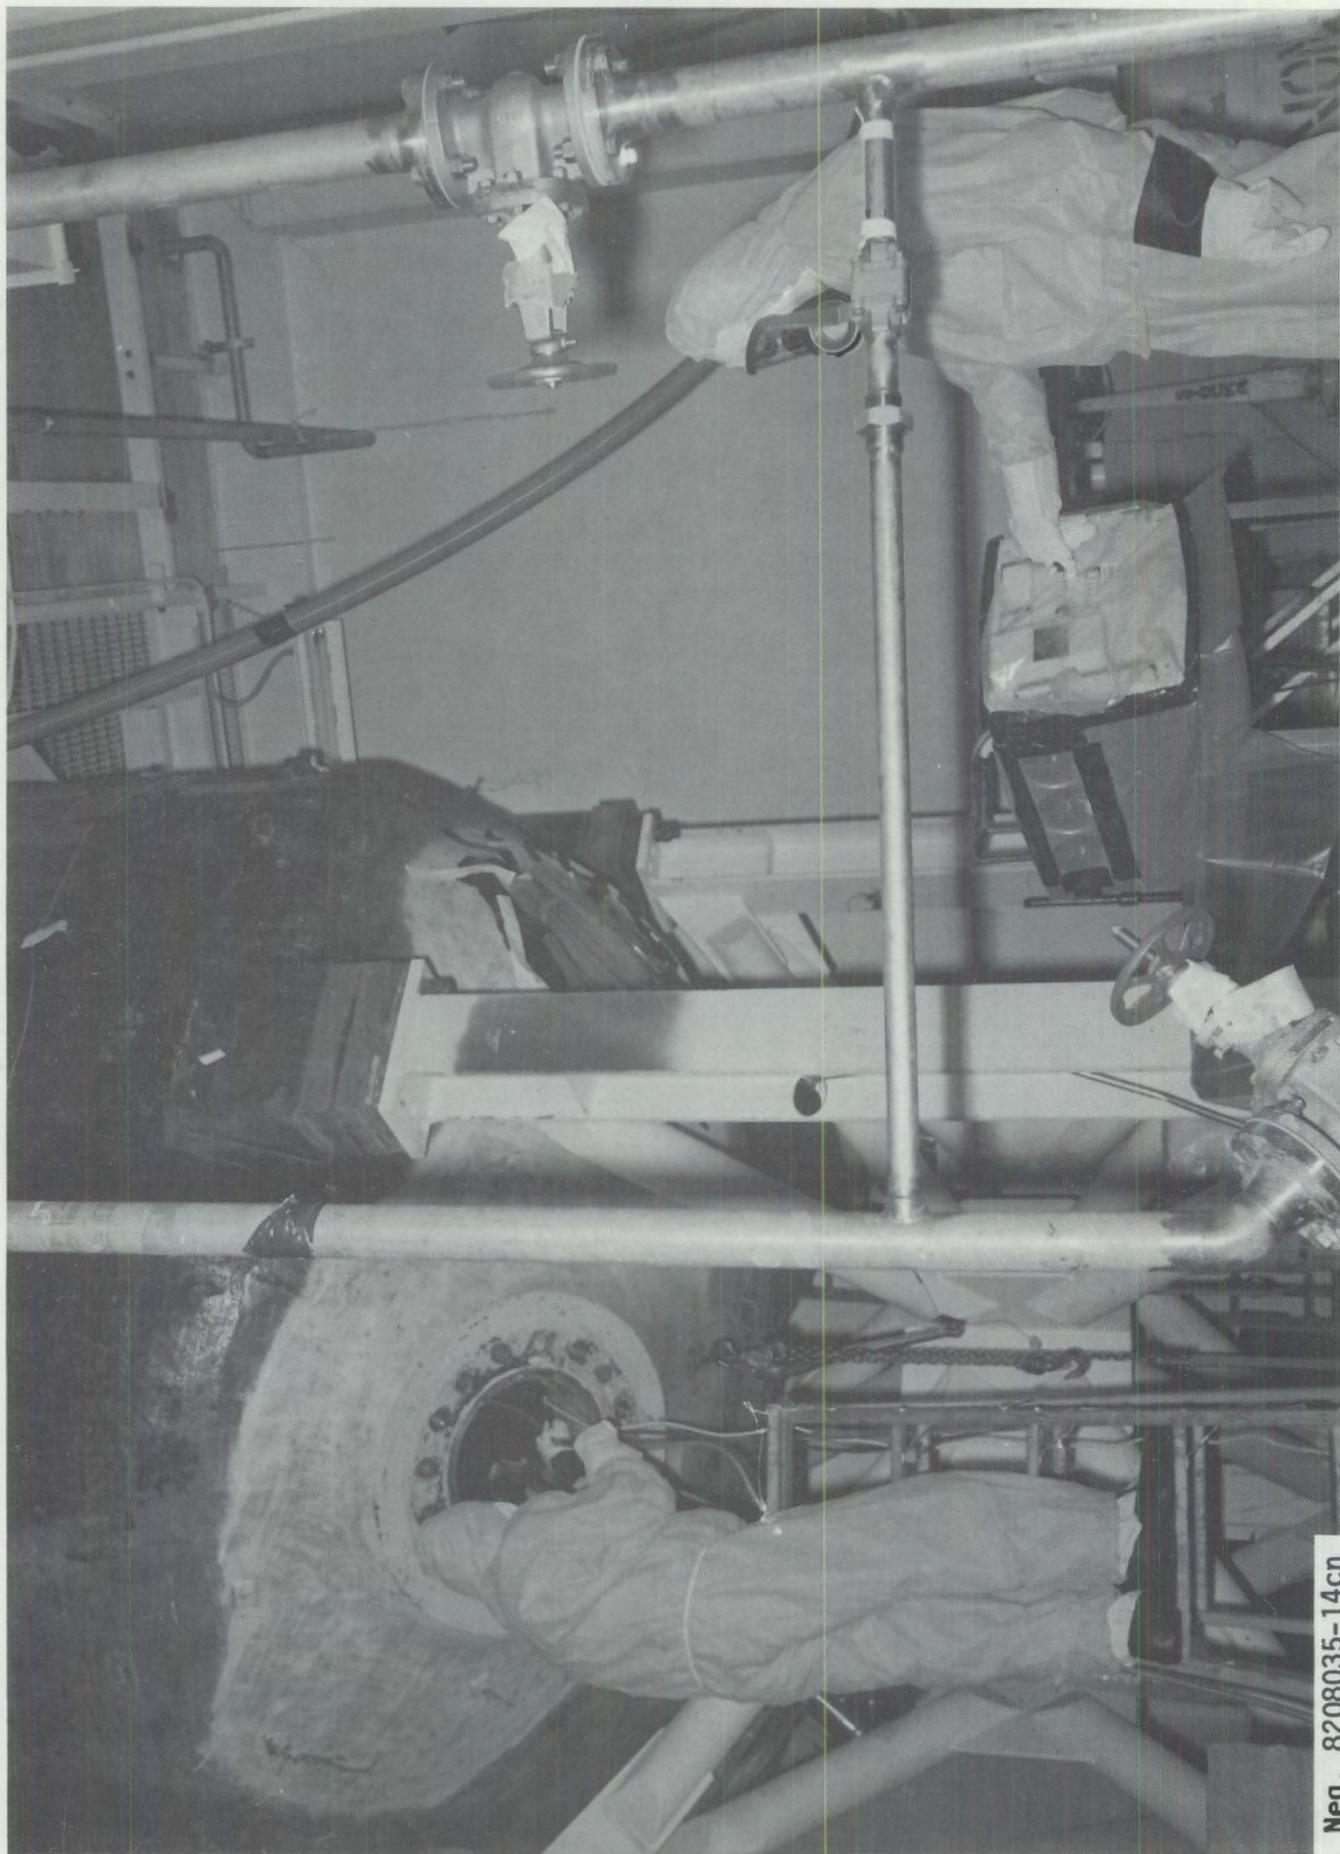
FIGURE 73. Electropolishing Operation

Electropolishing (Figure 73) was demonstrated to be an effective "touch-up" method after the Quadrex operation. It was used to clean each of the manway areas to a shiny metal state so that personnel contamination was greatly reduced during subsequent entries to the channel head.

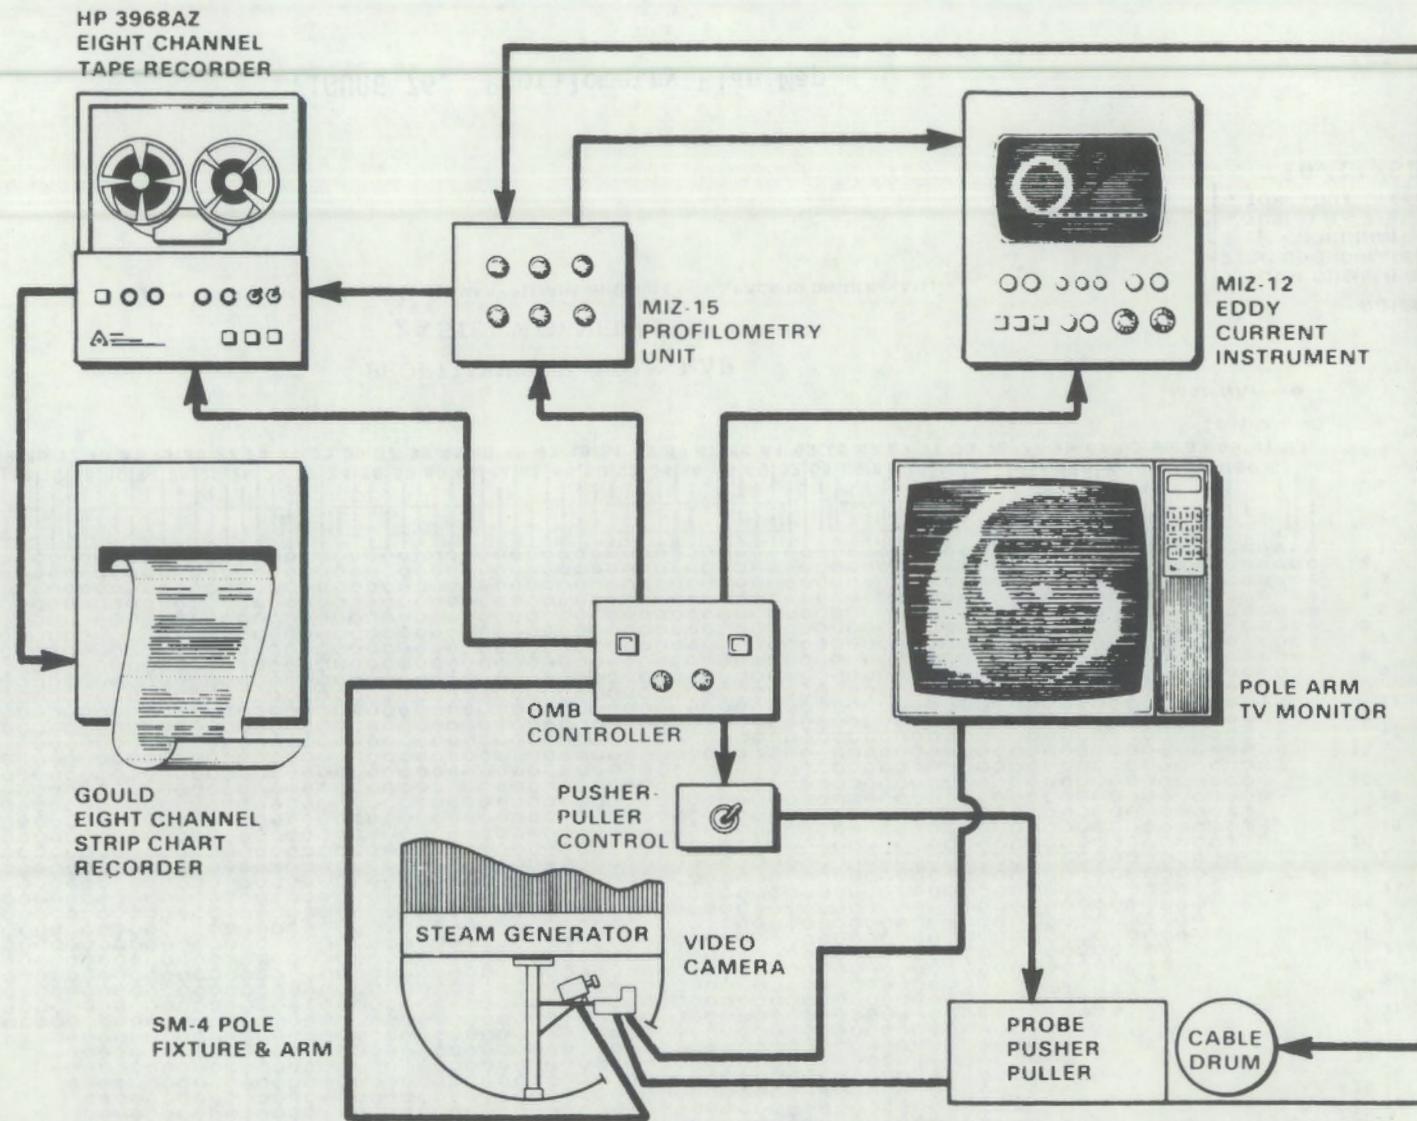
FIGURE 75. Equipment for the Baseline Eddy Current ISI

Equipment purchased for the baseline study is shown in Figure 75, including the pusher/puller, video monitor, remote control system, communication system, cables, and encoder assembly pieces. Probes will be purchased on the basis of the results from a profilometry test described below. Personnel training, testing of defect models, and equipment calibration have proceeded. Owing to schedule slippage in the tube unplugging task (see Task 8), the baseline study will probably not begin until May, 1983. An RFP to select an NDE subcontractor is ready for distribution to potential bidders.

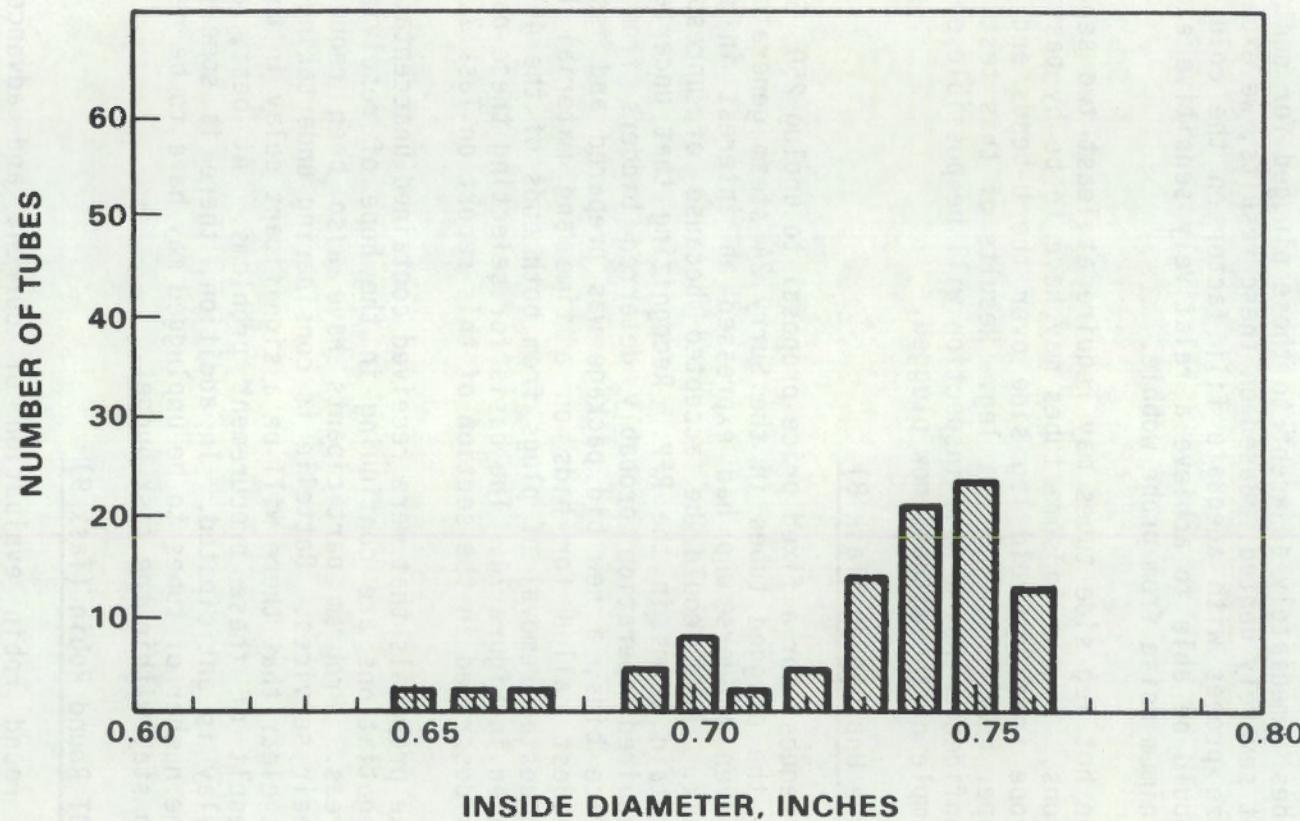
## OCCURENCE OF MAXIMUM DENTING PER TUBE HOT LEG SURRY 2A STEAM GENERATOR

FIGURE 77. Occurrence of Maximum Denting Per Unplugged Tube - Hot Leg

Most denting was detected on the hot leg, or inlet side. Three tubes would not pass the probe at all. Eleven readings were obtained below 0.700" (minimum was 0.65"). Only two hot leg tubes

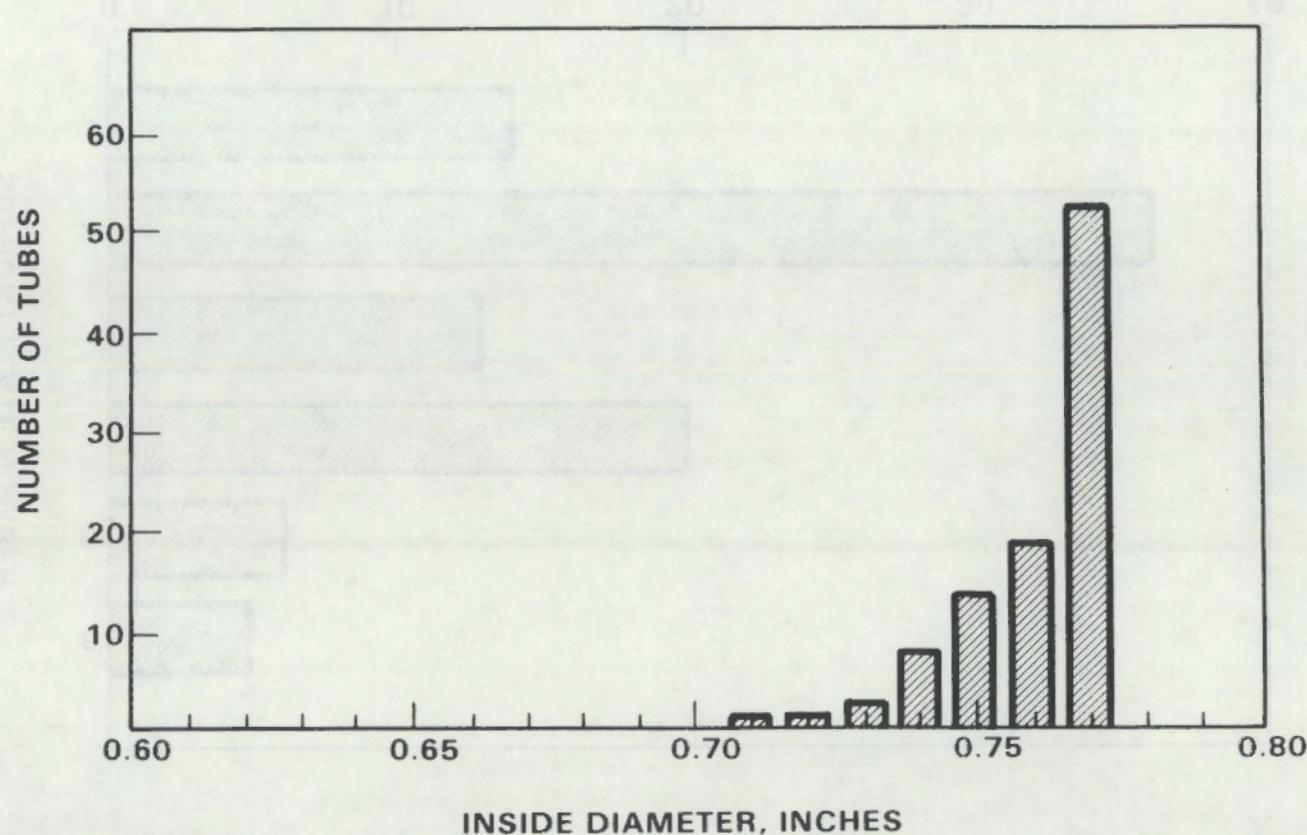
FIGURE 78. Occurrence of Maximum Denting Per Unplugged Tube - Cold Leg

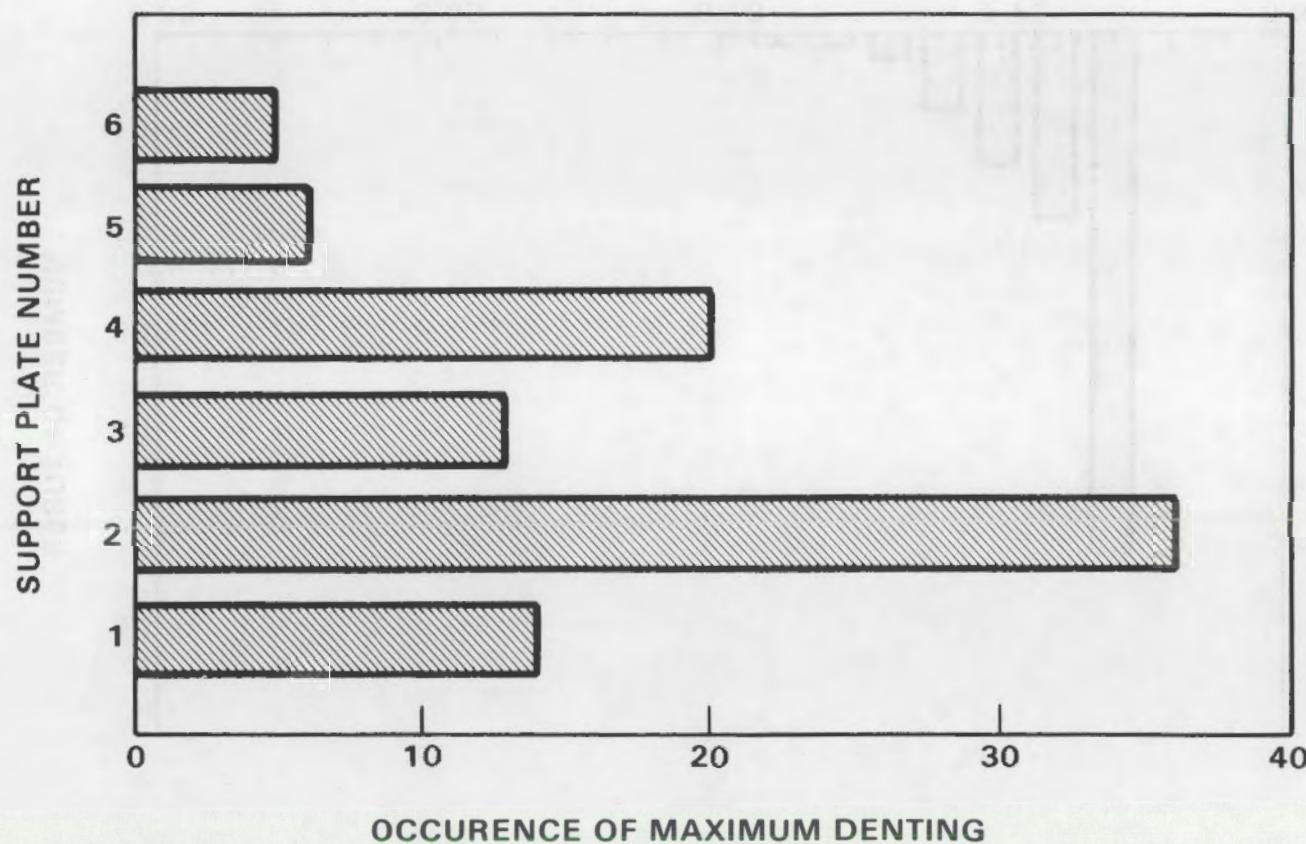
**LOCATION OF MAXIMUM DENTING**  
**HOT LEG**  
**SURRY 2A STEAM GENERATOR**

FIGURE 79. Distribution of Denting in Unplugged Tubes - Hot Leg

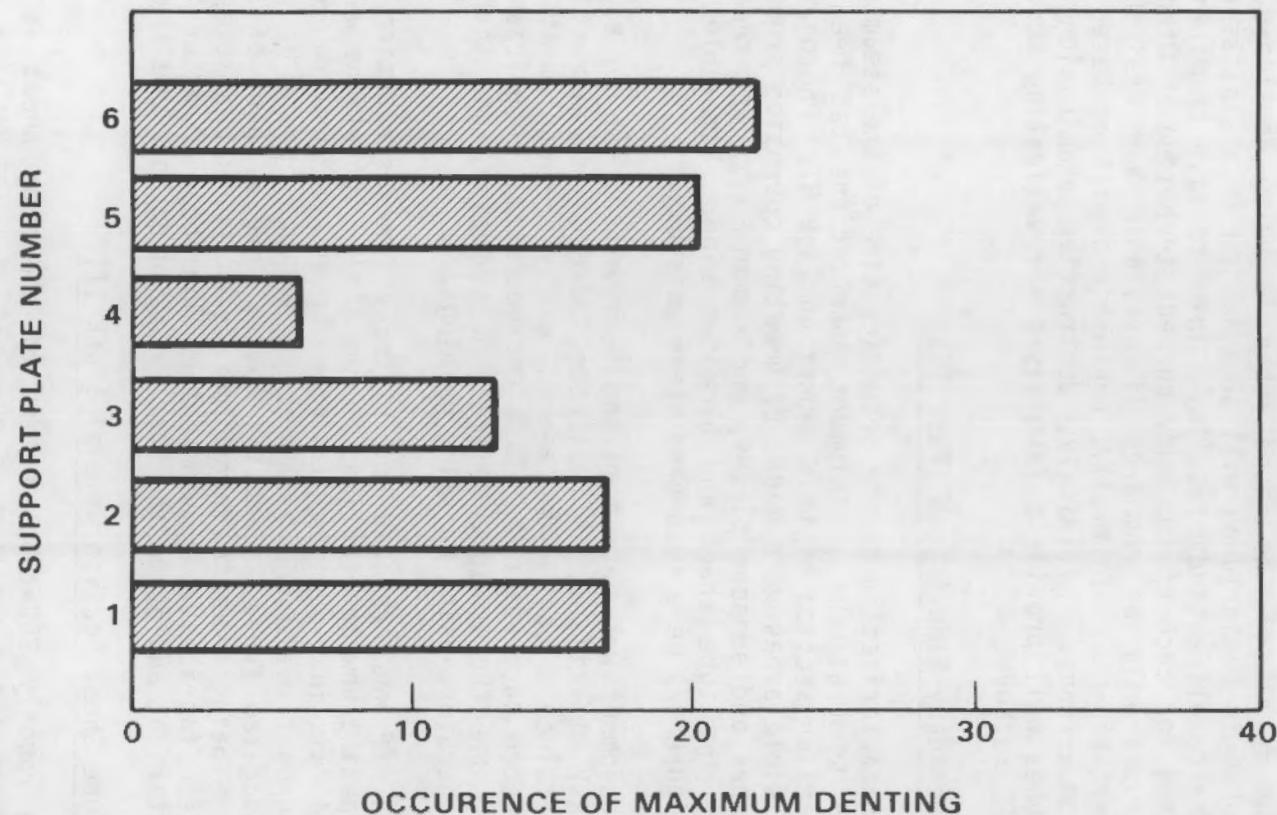
LOCATION OF MAXIMUM DENTING  
COLD LEG  
SURRY 2A STEAM GENERATOR

FIGURE 80. Distribution of Denting in Unplugged Tubes - Cold Leg
