# Fuel/Cladding Compatibility in Low-Burnup U-26Pu-10Zr/HR9 Fuel at Elevated Temperatures

## IFR Technical Memorandum

September 1991

IFR TECHNICAL MEMORANDUM NO. 152

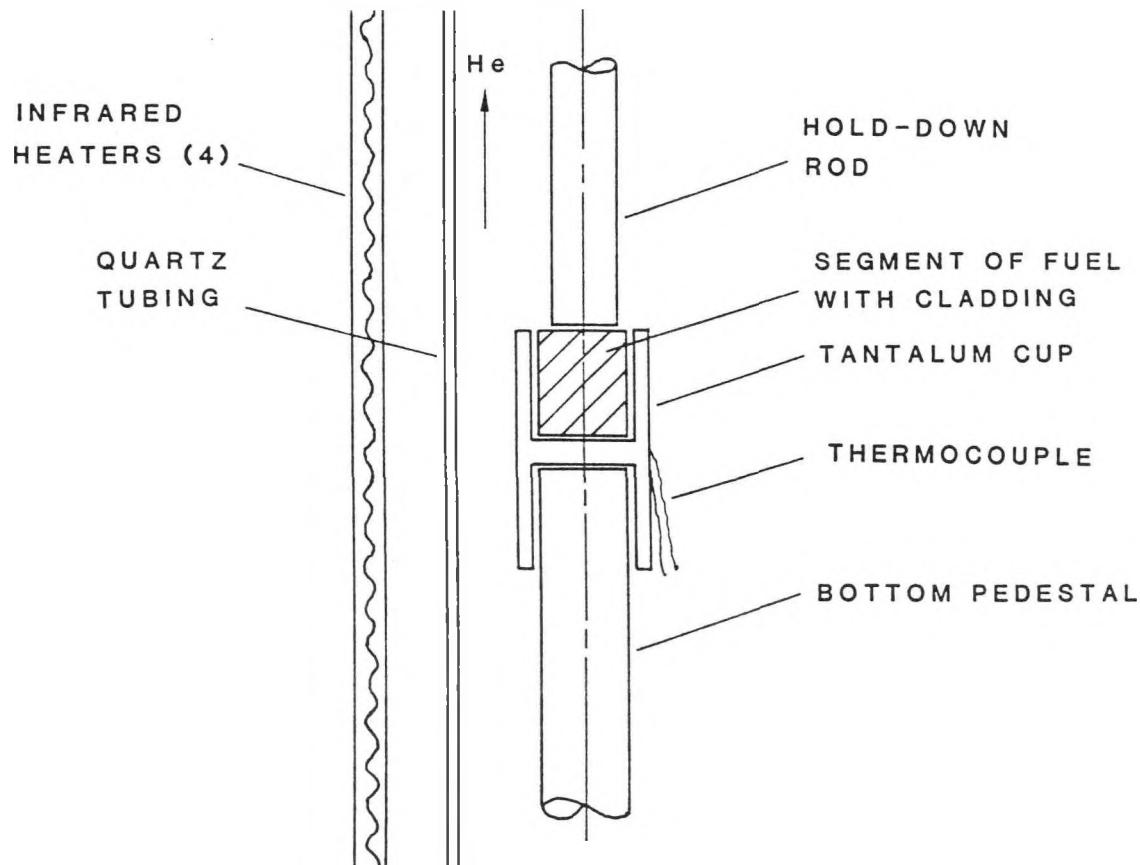
Fig. 1. Schematic Diagram of the Fuel Behavior Test Apparatus

A schematic diagram showing the specimen and the radiant furnace is given in Fig. 1. A detailed description of the FBTA can be found in Ref. 6.

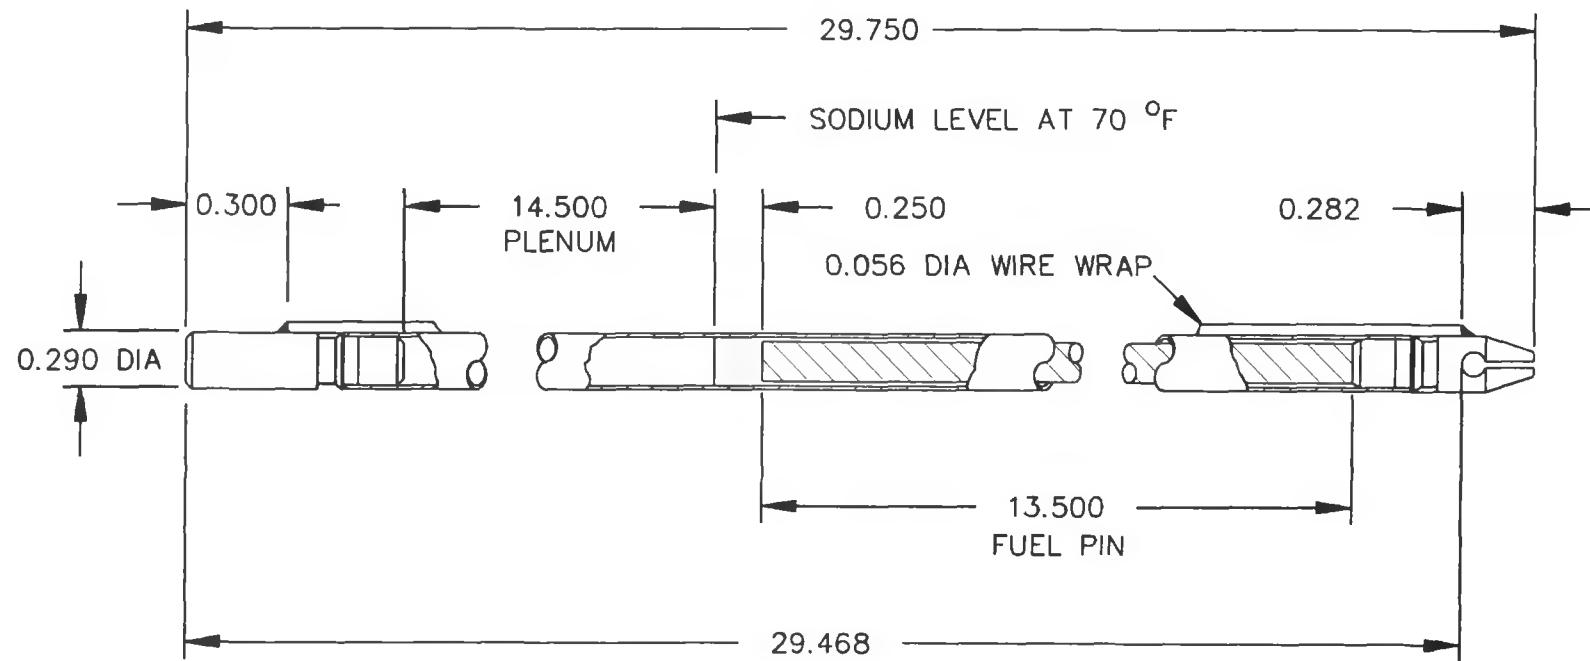
Pin Diameter	0.290 in. (7.37 mm)
Cladding Material	HT9
Cladding Thickness	0.0165 in. (0.42 mm)
Fuel Material	U-26wt.%Pu-10wt.%Zr
$^{235}\text{U}$ Enrichment ( $^{235}\text{U}$ /Total U)	15.5 wt.%
Fuel Slug Diameter	0.223 in. (5.67 mm)
Fuel Slug Density	15.8 g/ml (100% TD)
Fuel/cladding Diametral Gap	0.034 in. (0.86 mm)
Planar Fuel Smear Density	75%
Fuel Column Height	13.5 in. (343 mm)
Fuel Column Weight	139 g
Upper or Lower Blanket	None
Fuel/Cladding Bond	Sodium
Nominal Bond (BOL, at room temp.)	0.25 in. above fuel
Plenum Length (BOL, at room temp.)	14.5 in. (373 mm)
Plenum/Fuel Volume Ratio (BOL)	1.5
Plenum Gas	75% He + 25% Ar
Gas Tag	Yes
TED's	No
Fuel Hold-down Spring	No
Overall Pin Length	29.75 in. (749 mm)
End Plug Material	HT9
Spacer Wire Diameter	0.056 in. (1.067 mm)
Wire Material	HT9
Pitch-to-diameter Ratio	1.28
Axial Wire-wrap Pitch	6 in. (152 mm)
Wire Tension	6.0 lb
Pitch Orientation	Clockwise

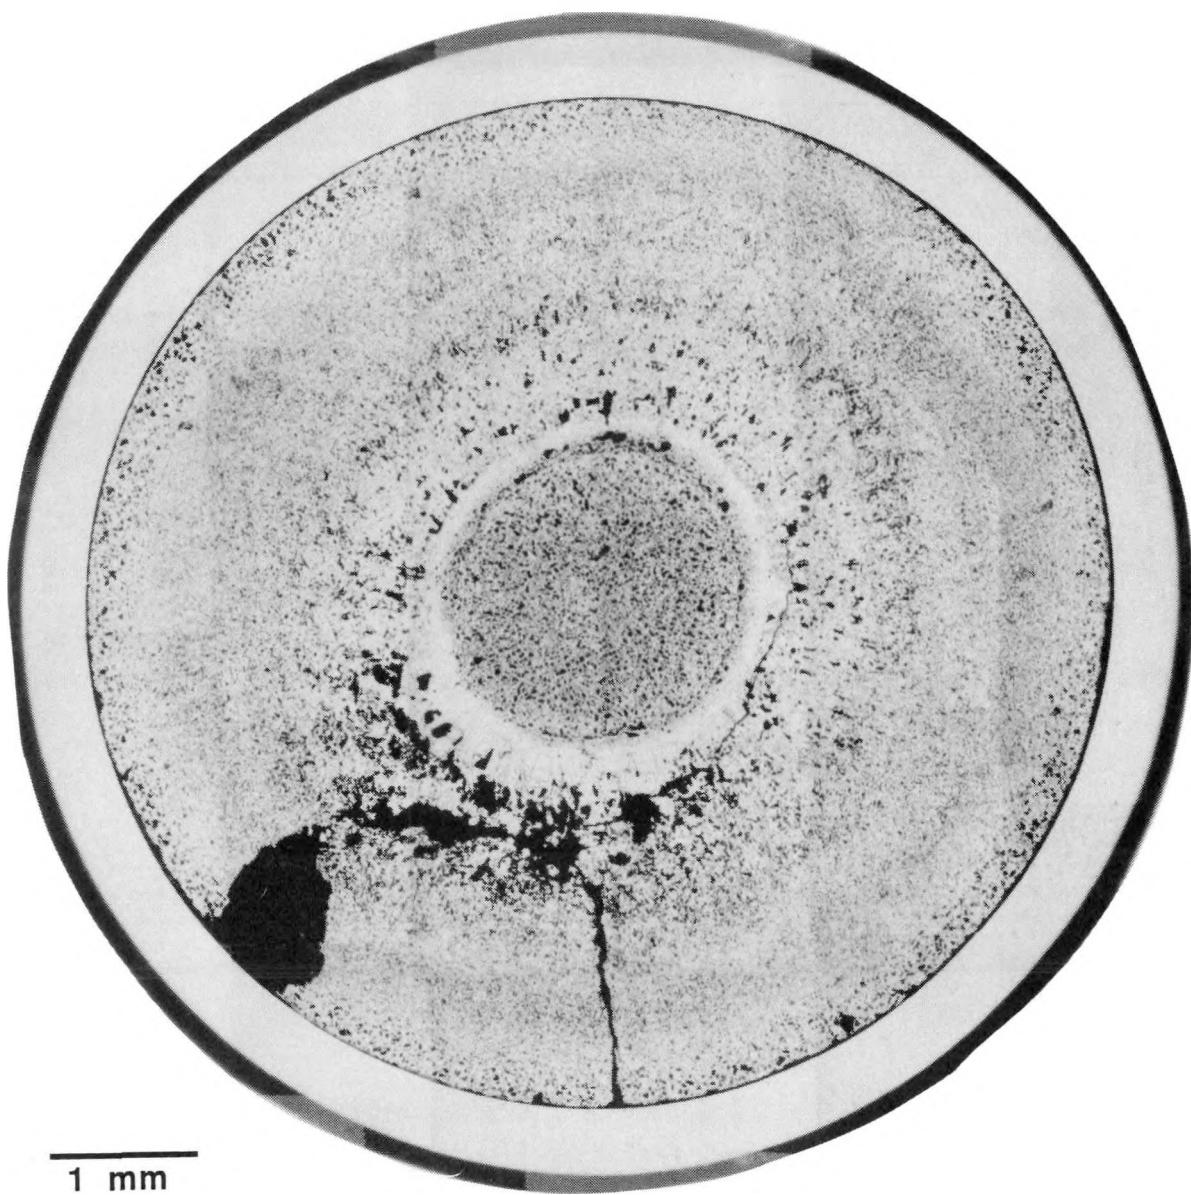
Fig. 3. Transverse Section of Pin T678 at  $X/L = 0.77$  after Steady-state Irradiation  
(As-polished, MCT 277592)

the fuel pin was found to be in excellent condition. Fuel/cladding inter-diffusion during the steady-state irradiation was apparently minor because little sign of interaction could be detected on the cladding ID. The results of the metallographical examination of the steady-state samples are given in the Appendix. With the  $X/L = 0.77$  section, shown in Fig. 3, used as an example, the key features noted in the examination were (1) closed fuel/cladding gap, (2) distinct zone formation in the fuel due to the redistribution of U and Zr, (3) a wedge-shaped crack in the fuel periphery from the anisotropic swelling of the fuel early-in-life, and (4) little noticeable solid fission-product accumulation on or near the fuel surface. All of these features were expected.

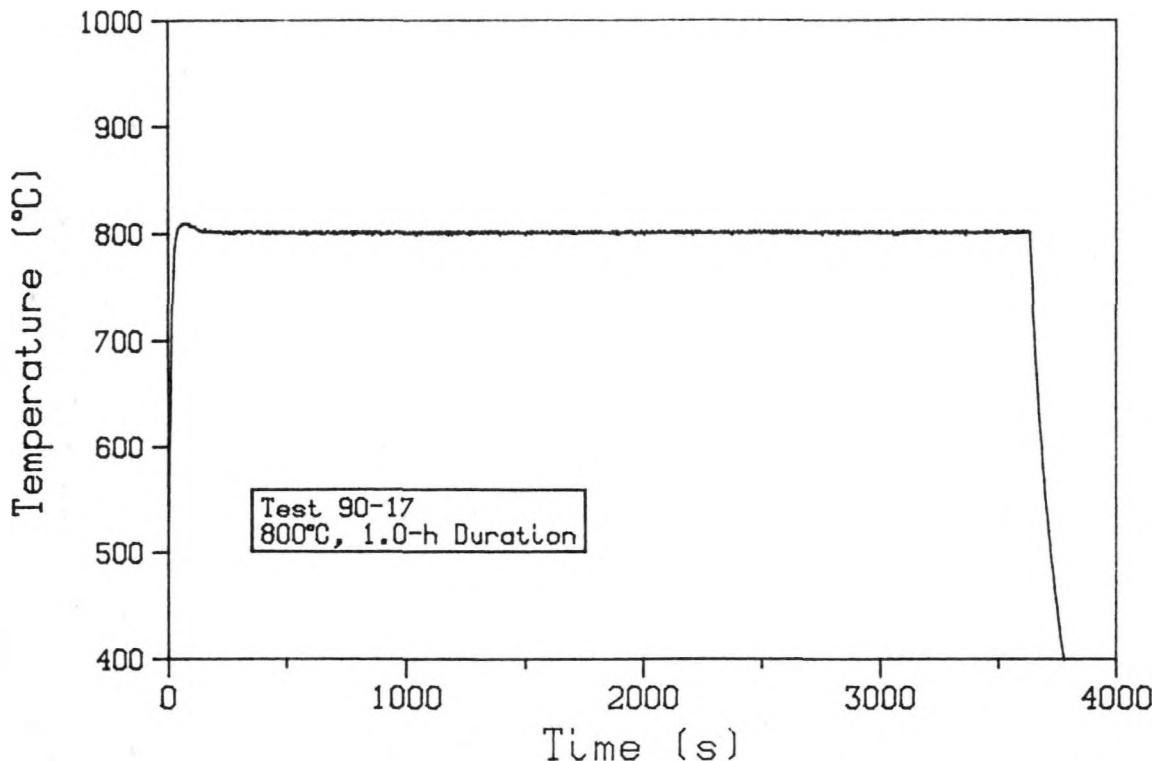
Fig. 4. Example of Temperature Control Capability of FBTA. This was actual test condition for Test 90-17 in this series.

After the specimen was loaded in the FBTA, the helium gas flow was turned on for several minutes to purge the test chamber. The furnace was then powered up by executing the temperature/power control program. Following the shutdown, the specimen was allowed to cool by radiant and convective heat losses. Figure 4 illustrates the attained temperature history of a typical test.

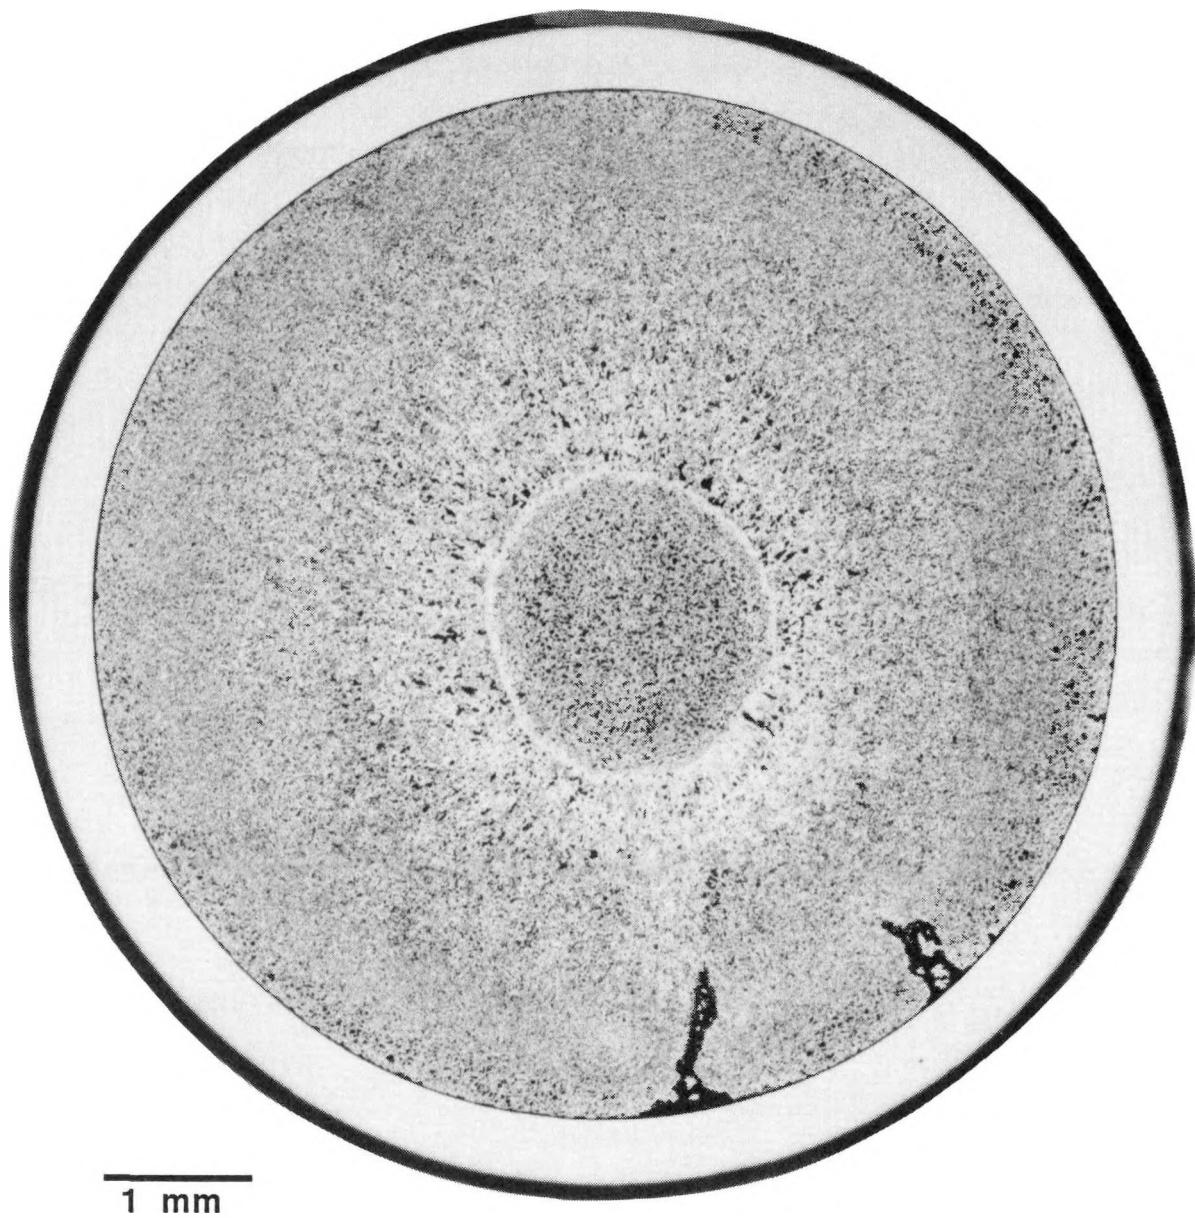
Fig. 5. Transverse Section of 90-18 Test Specimen after 1 h at 750°C. There are noticeable changes in fuel structure (cf. Fig. 3) due to the test, but no signs of fuel/cladding interaction.  
(As-polished, MCT 277872).

This temperature for the U-26Pu-10Zr/HT9 test fuel was bracketed in the 90-17 and 90-18 tests. In the 750°C 90-18 test, the specimen incurred no noticeable fuel liquefaction or liquid-phase cladding attack, as shown in Fig. 5. On the other hand, the 800°C 90-17 test specimen clearly showed fuel liquefaction and liquid-phase cladding penetration (Fig. 6). The temperature for the onset of liquid-phase-formation was thus determined to be between 750 and 800°C. This temperature is slightly better than the 725-750°C found previously for the other metallic fuel systems.<sup>8</sup>

In the 750°C 90-18 test, even though there was no liquid-phase fuel/cladding interaction, substantial fuel restructuring occurred due to the heat treatment. Most of the changes (see Fig. 3 and the Appendix) occurred in the outer regions of the fuel where the prior irradiation temperature was substantially lower than the FBTA test temperature (by  $\approx 100^\circ\text{C}$ ).

The irregularly shaped pores in the anisotropic  $\alpha$ -phase structure on the fuel periphery have disappeared. An isotropic,  $\gamma$ -phase structure with smaller pores now prevails. The wedge-shaped crack on the fuel periphery is essentially filled with expanded fuel. The thickness of the high-density middle ring appears to have diminished and the large pores in the band just outboard of the high-density middle ring have also disappeared. The higher-temperature feature, i.e., the porous core, on the other hand, remains largely unchanged due to the similarity between the irradiation and test temperatures.

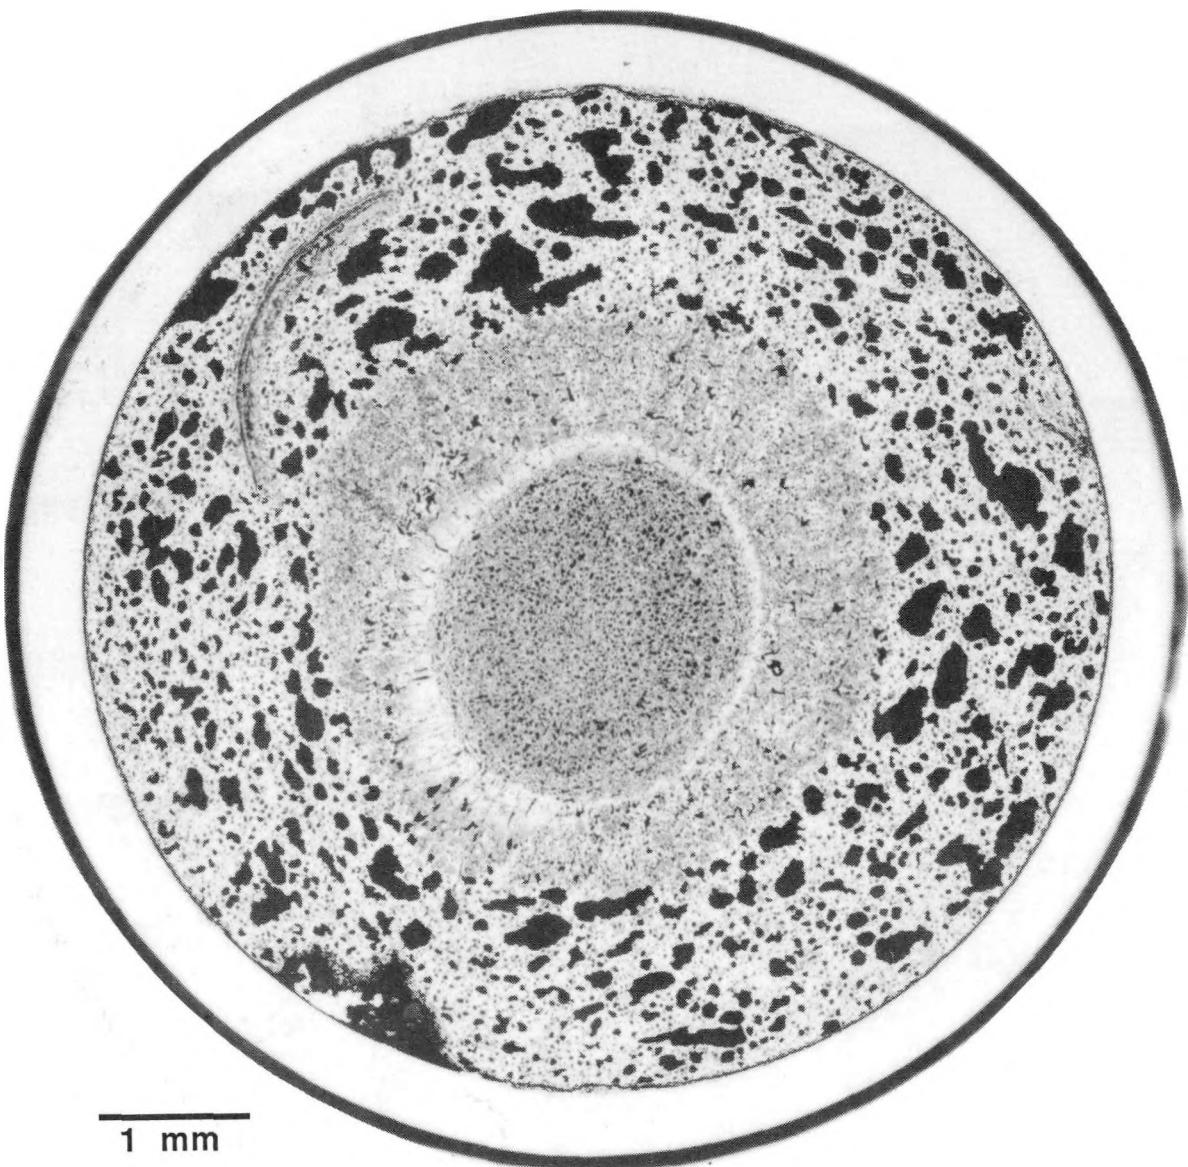
Fig. 6. Transverse Section of 90-17 Test Specimen after 1 h at 800°C. Fuel liquefaction extended to approximately mid-radius. Arc-shaped structure in ten-o'clock direction is probably an artifact from casting. (As-polished, MCT 277871)

When fuel/cladding interaction occurs at higher temperatures, as in the 90-17 specimen (Fig. 6), the cladding constituents that diffuse into the fuel cause the fuel to liquefy, forming a solid/liquid two-phase mixture. This phenomenon has been seen in all previous compatibility tests conducted above the temperature for "onset of melting." In the case of 90-17, fuel liquefaction extended from the fuel/cladding interface to approximately mid-radius of the fuel, for an areal fraction of  $\approx 70\%$ . The region where fuel liquefaction occurred is characterized by large pores formed from the coalescence of smaller fission-gas bubbles in the fluid solid/liquid mixture. The solidified structure of the once-liquefied fuel is shown in Fig. 7. In previous tests with U-10Zr/HT9 and U-19Pu-10Zr/HT9 systems, fuel liquefaction was found to be the direct result of diffusion of the cladding components (chiefly Fe) into the fuel and lowering the fuel solidus temperature. In those tests, the liquefaction boundary was found to coincide with the Fe diffusion boundary.<sup>8,10-11</sup> This was confirmed also in this test series (see Section III, D). In the center of the 90-17 specimen, where Fe was absent, the condition of the fuel was essentially unchanged.

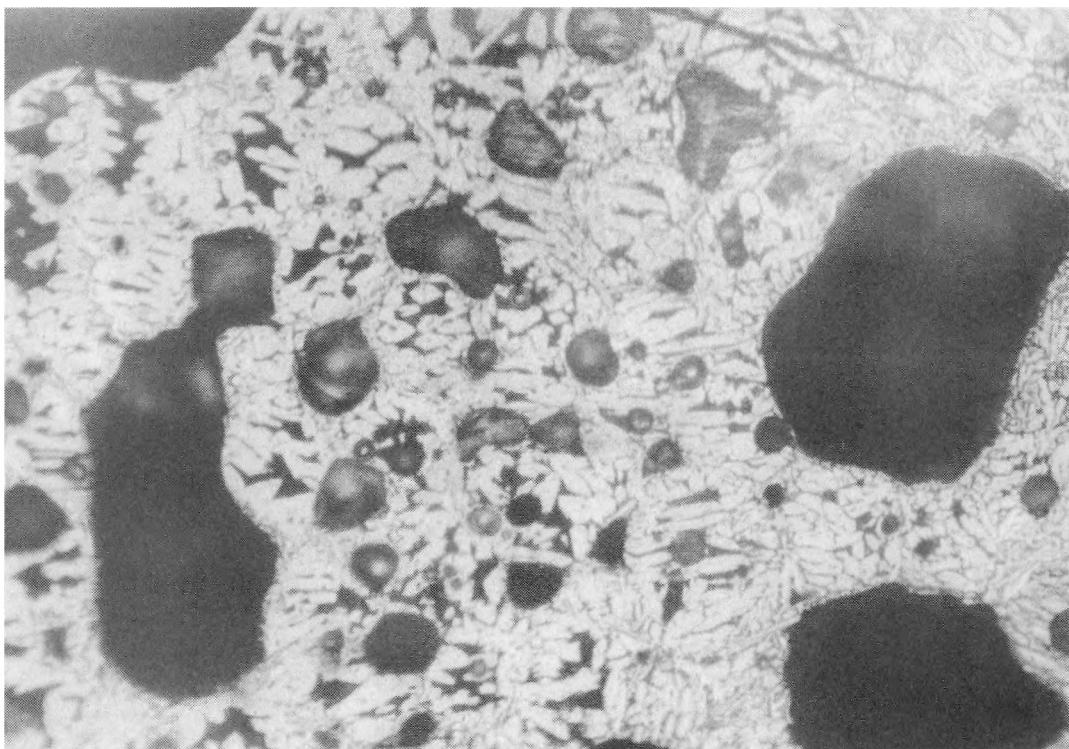
Fig. 7. Solidified Structure of Once-liquefied Fuel  
(500X, Etched, MCT 279082)

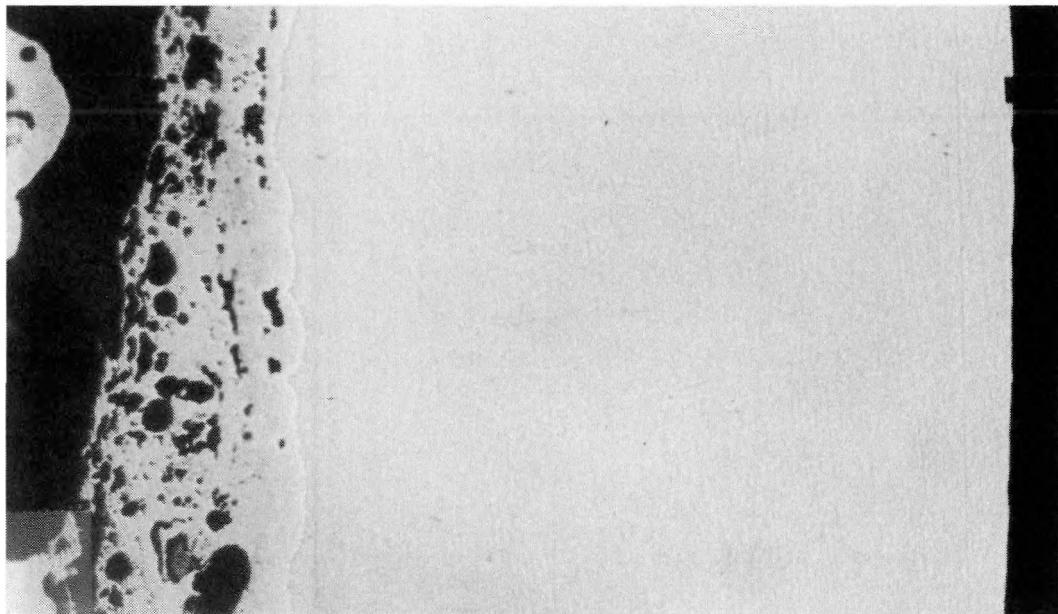
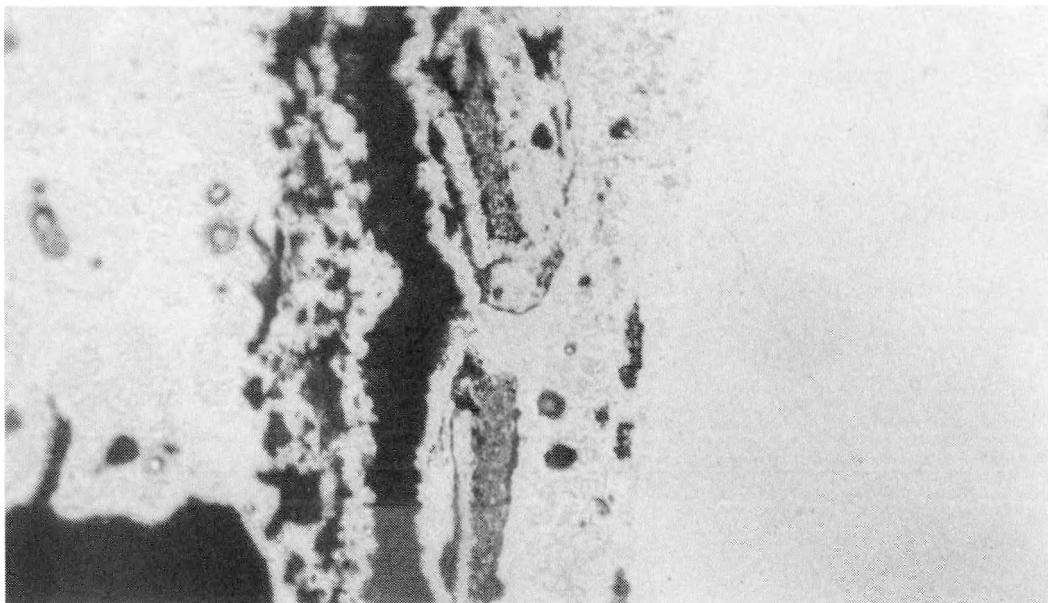
(a) 250X (As-polished, MCT 27778)

(b) 500X (As-polished, MCT 277782)

Fig. 8. Liquid-phase-fuel/Cladding Interaction in 90-17 Specimen.  
Unreacted cladding is at right.

The condition of the liquid-phase-fuel/cladding interaction zone in the 90-17 specimen is illustrated in higher-magnification photomicrographs in Fig. 8. The reaction appeared to be liquid-phase (i.e., molten fuel/cladding alloy) dissolution of the cladding. On the optical photomicrographs up to 500X, the boundary separating the reacted and the unaffected cladding appeared to be smooth and well-defined. The reaction boundary had, for the most part, rounded fronts into the cladding that met in sharp

ridges. There were no intergranular or intragranular cladding cracks ahead of the visible reaction boundary. The reacted cladding immediately adjacent to the reaction boundary had a dendritic two-phase appearance, indicating it was once molten. All of these features are similar to those seen in the earlier tests with U-10Zr/HT9 or U-19Pu-10Zr/HT9 fuels.<sup>10-11</sup>

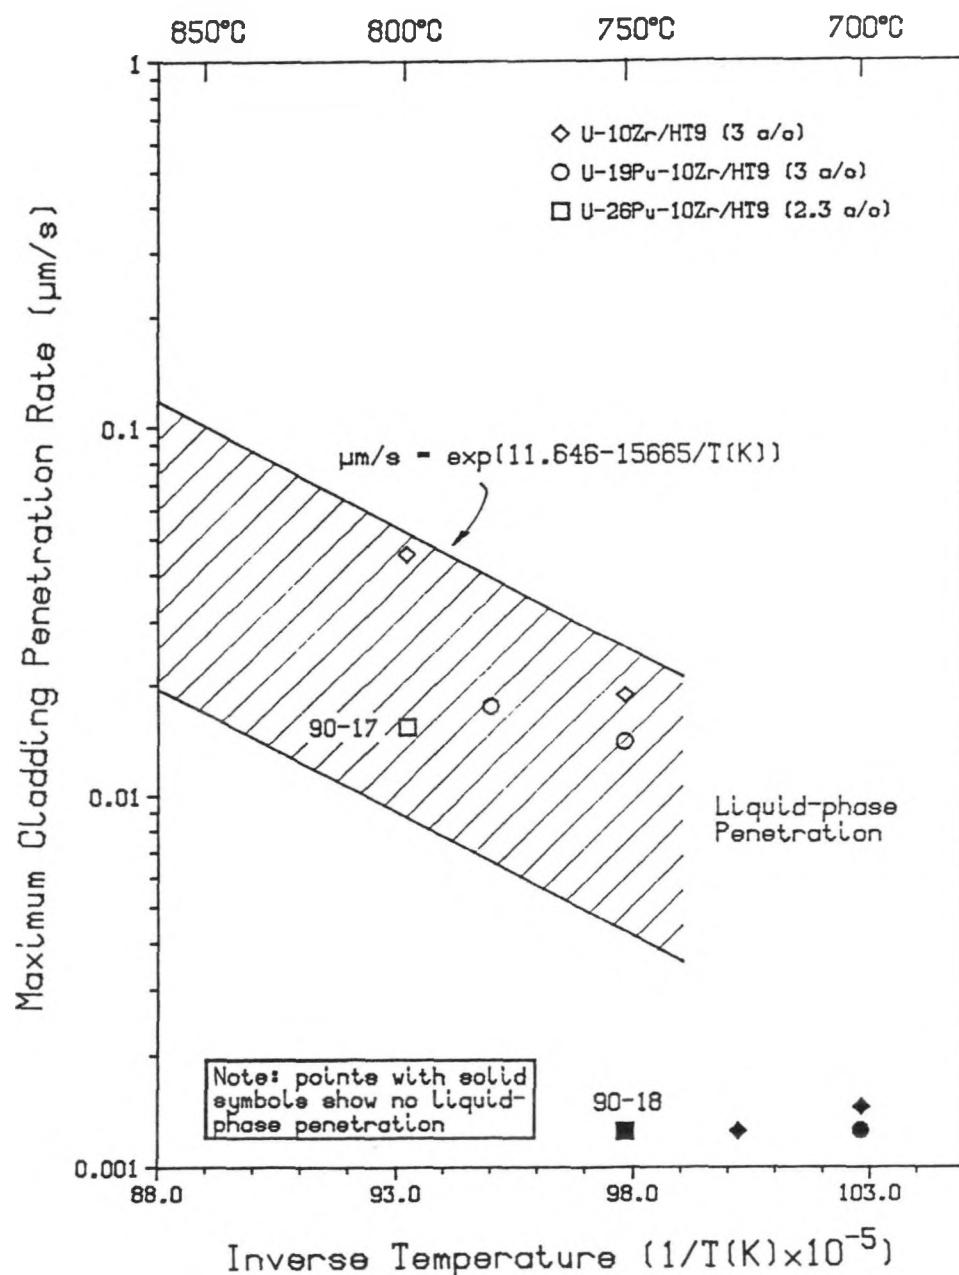
Fig. 9. Effective Cladding Penetration Rates for Specimens Tested for 1.0 h. Shaded band represents the entire FBTA data base. Specific data points for low-burnup, HT9-cladding tests are shown for comparison.

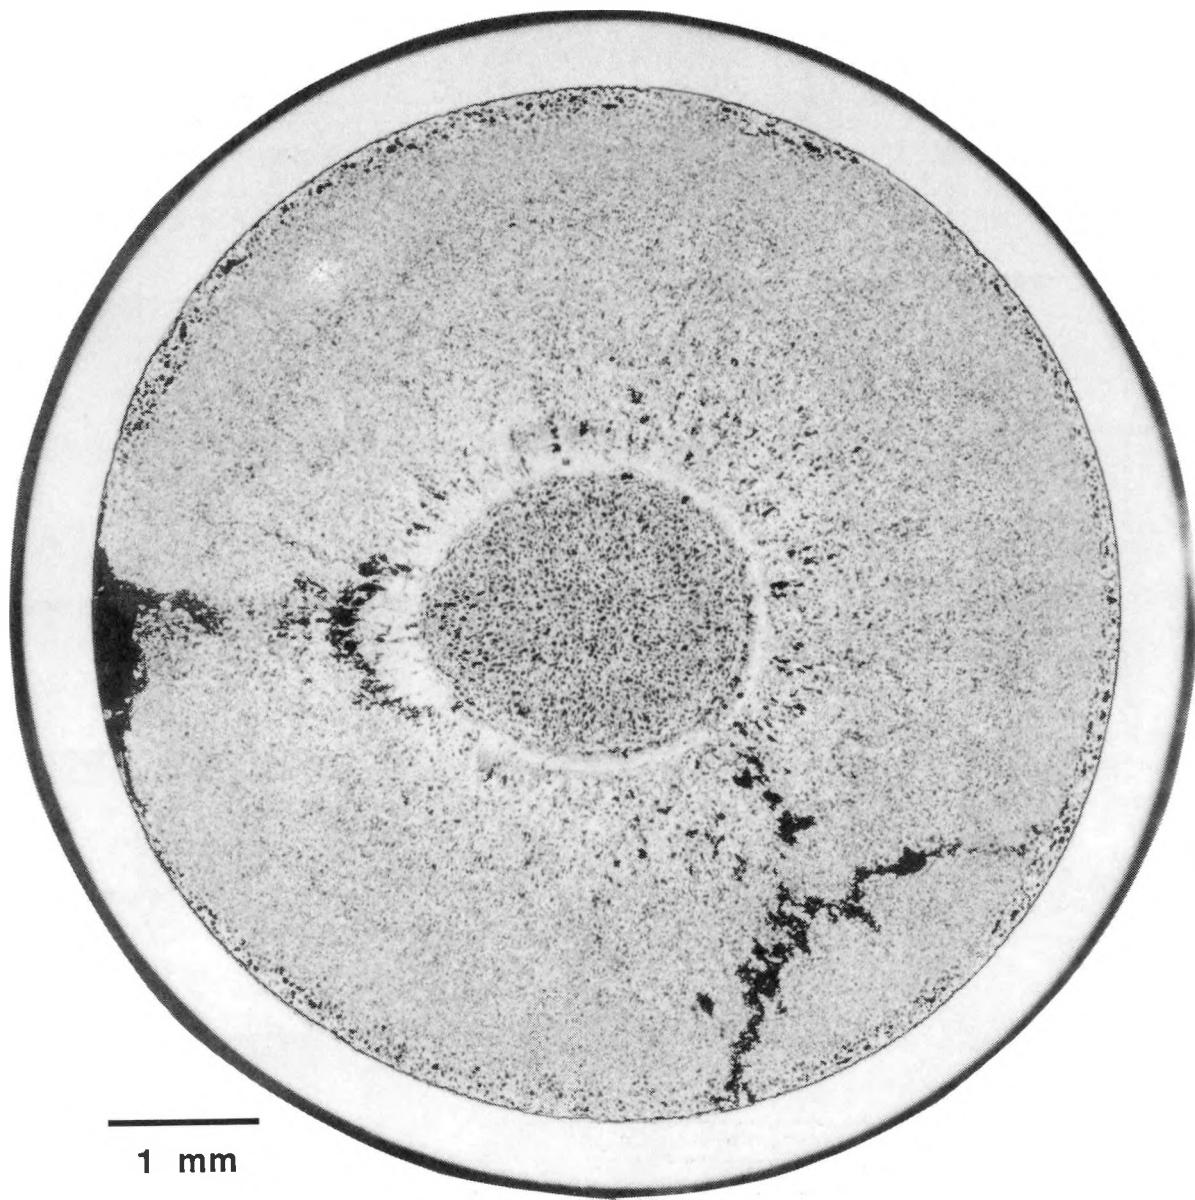
Fig. 10. Transverse Section of 90-19 Test Specimen after 5 min at 800°C.  
Fuel surface liquefaction was shallow. (As-polished, MCT 277873)

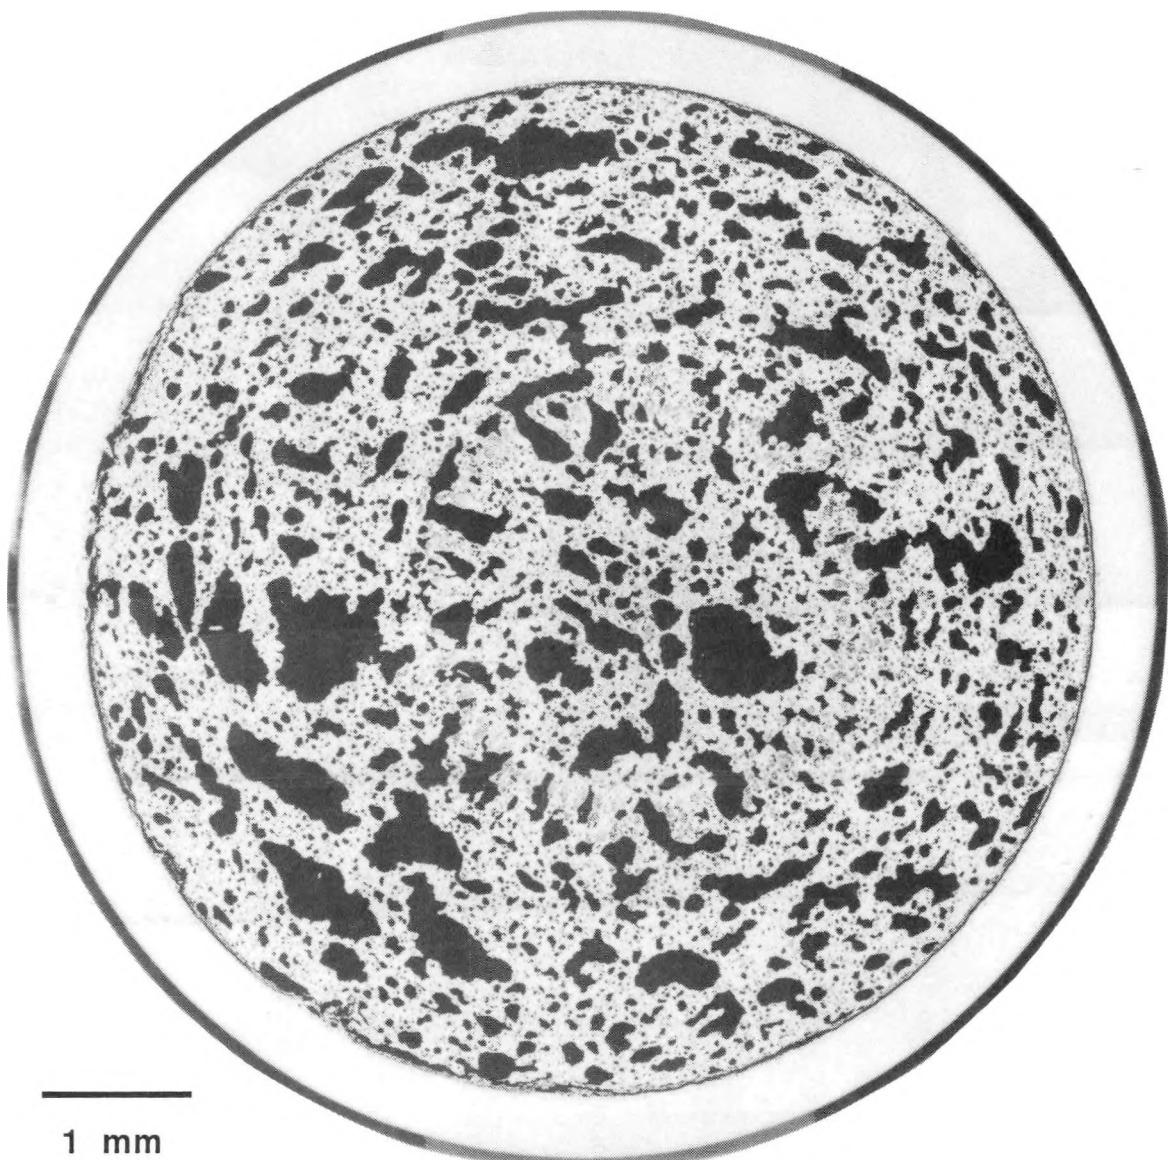
Fig. 11. Transverse Section of 90-21 Test Specimen after 2 h at 800°C.  
Fuel liquefaction was extended to centerline.  
(As-polished, MCT 277870)

In the 2.0-h 90-21 test, with extended time for Fe diffusion into the fuel, the entire fuel cross section was affected. The transverse section of the fuel is shown in Fig. 11 and a typical section of the

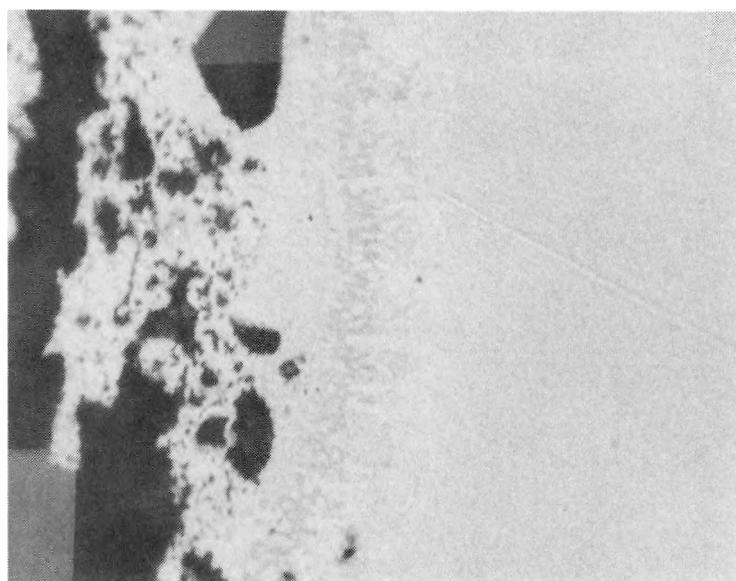
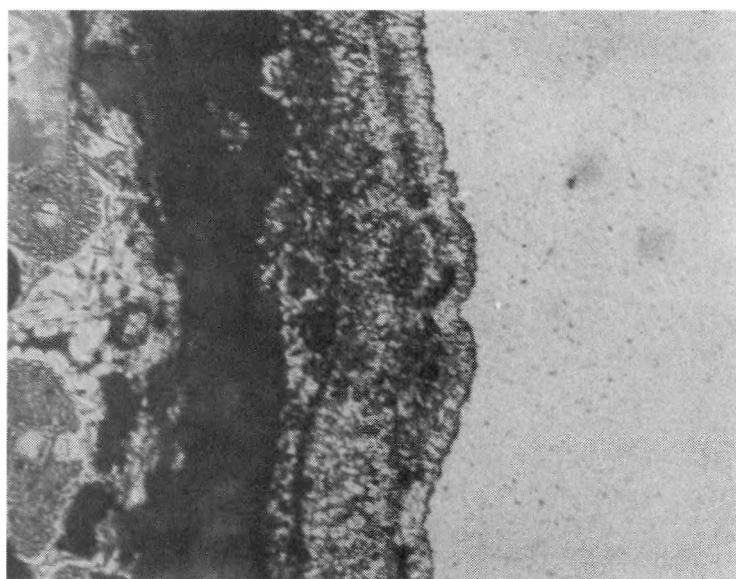
Fig. 12. Typical Fuel/Cladding Interaction Zones in 90-21 Specimen.  
Unreacted cladding is at right.

fuel/cladding interface is shown in Fig. 12. In spite of extended exposure to the liquefied fuel, cladding integrity was maintained. The maximum cladding penetration in the specimen was only 65.0  $\mu\text{m}$ , or  $\approx 15\%$  of the original cladding thickness.

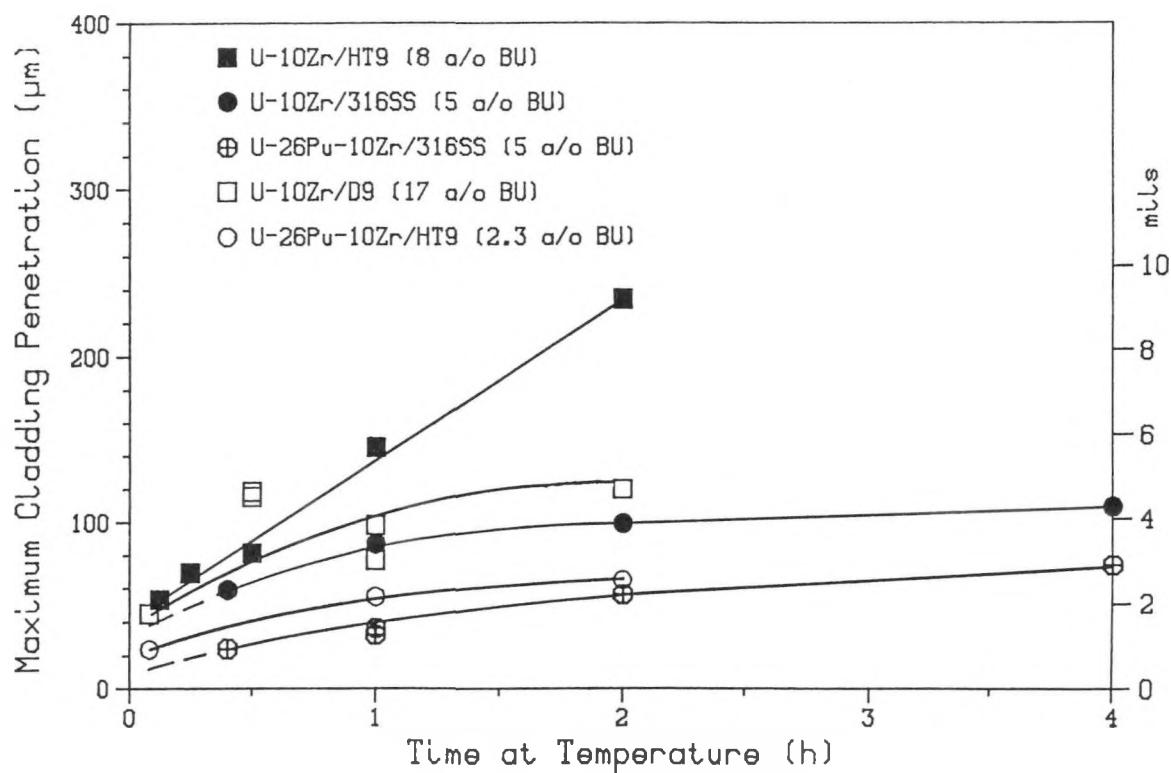
Fig. 13. Time-dependent Cladding Penetration at 800°C

The maximum depths of cladding penetration from the 90-17, -19, and -21 tests are plotted in Fig. 13 as a function of time. The "instantaneous" penetration of  $\approx 20 \mu\text{m}$  at the onset of the heating cycle is likely related to the rapid melting of an interdiffusion layer formed during the steady-state irradiation, even though none was obvious (Fig. 3). After this initial rapid interaction, the rate of cladding penetration leveled off with time. This decrease in penetration rate is indicative that the reaction kinetics were probably controlled by diffusional processes across the thickening reaction layers. In Fig. 13, the behavior of the U-26Pu-10Zr/HT9 system is compared with that of the other fuel systems tested in the FBTA. In terms of cladding penetration, the behavior of the specimens in this test series is comparable to that of U-26Pu-10Zr/316SS and superior to that of U-10Zr with 316SS, D9, or HT9 cladding.

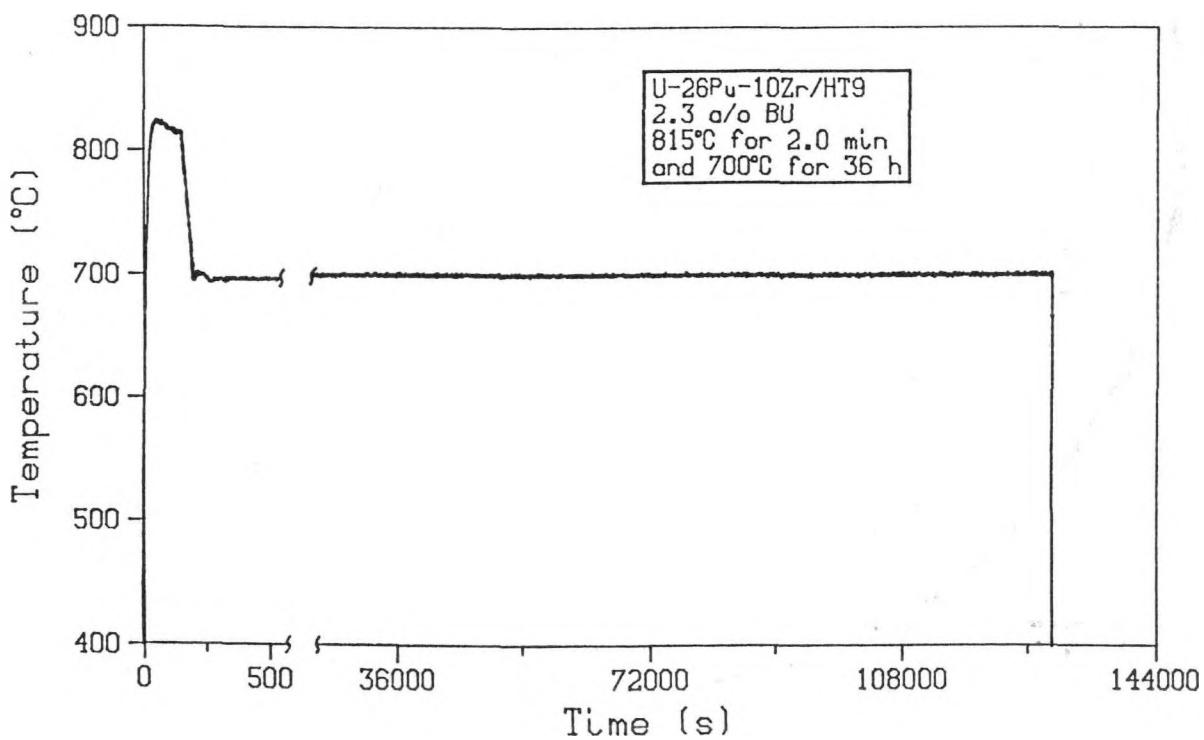
Fig. 14. Thermal History of 90-24 Test Simulating NRC Bounding Event 1B

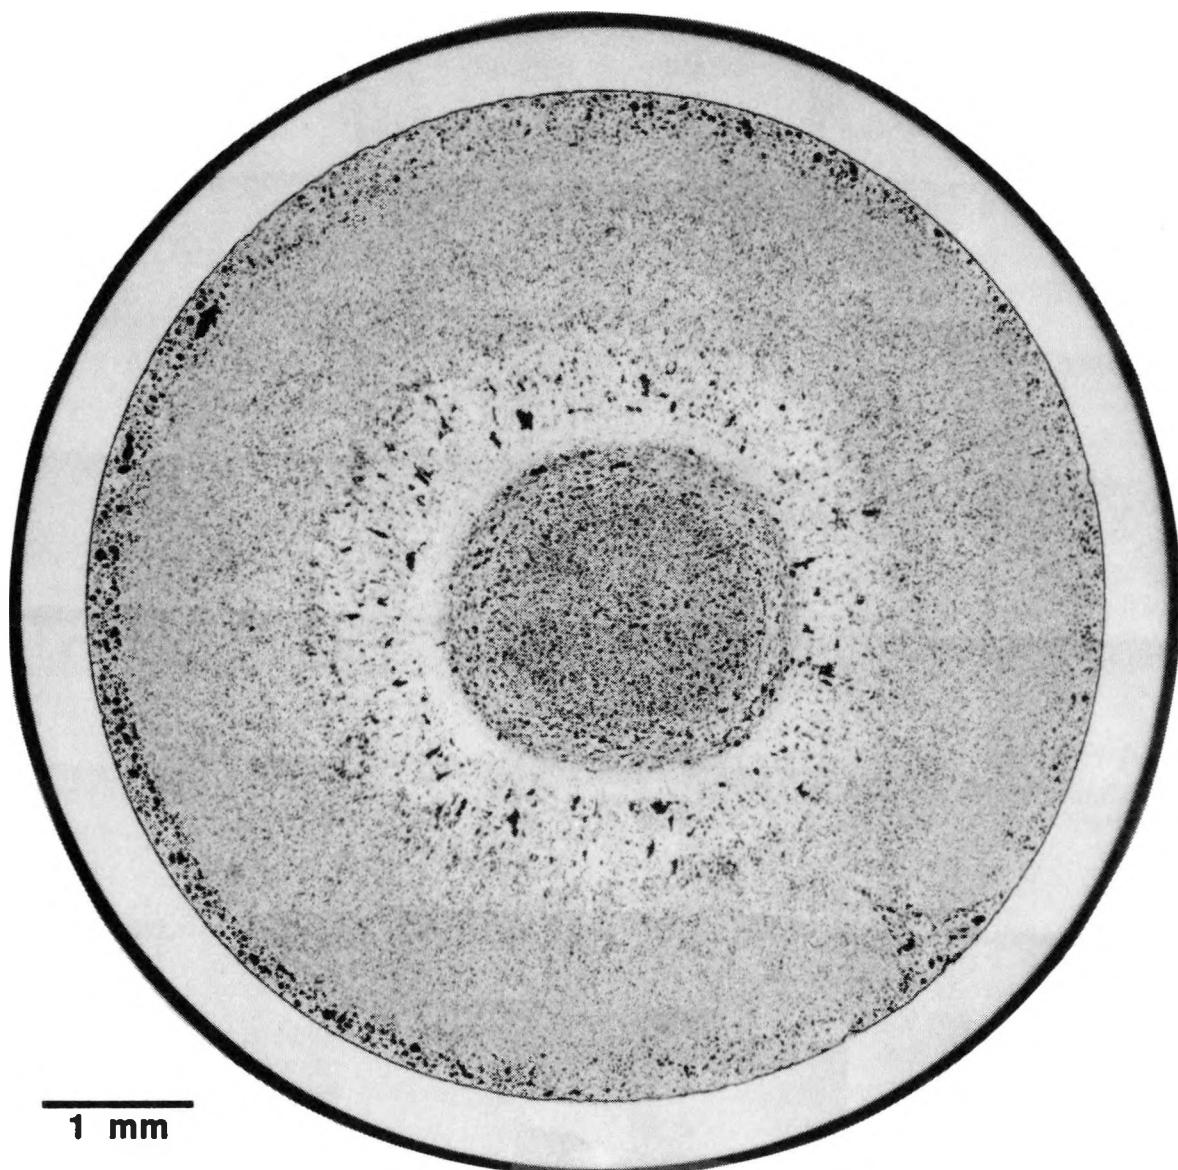
Fig. 15. Transverse Section of 90-22 Specimen after Simulated 0.40\$ UTOP Event (2 min at 815°C)  
(As-polished, MCT 277875)

In the 90-22 test, even with the brief duration (2 min), fuel surface liquefaction and cladding interaction occurred, as shown in Fig. 15 (see also Fig. 19a). The extent of fuel surface liquefaction, however, was shallow and nonuniform around the circumference. The liquefied fuel/cladding reaction product apparently filled the wedged-shaped crack on the fuel periphery (about 5 o'clock in Fig. 15). Inward from the surface, the fuel microstructure was unaffected by the short test. The depth of maximum cladding penetration was  $\approx$ 19  $\mu\text{m}$ , which is comparable to the "instantaneous" penetration shown in Fig. 13.

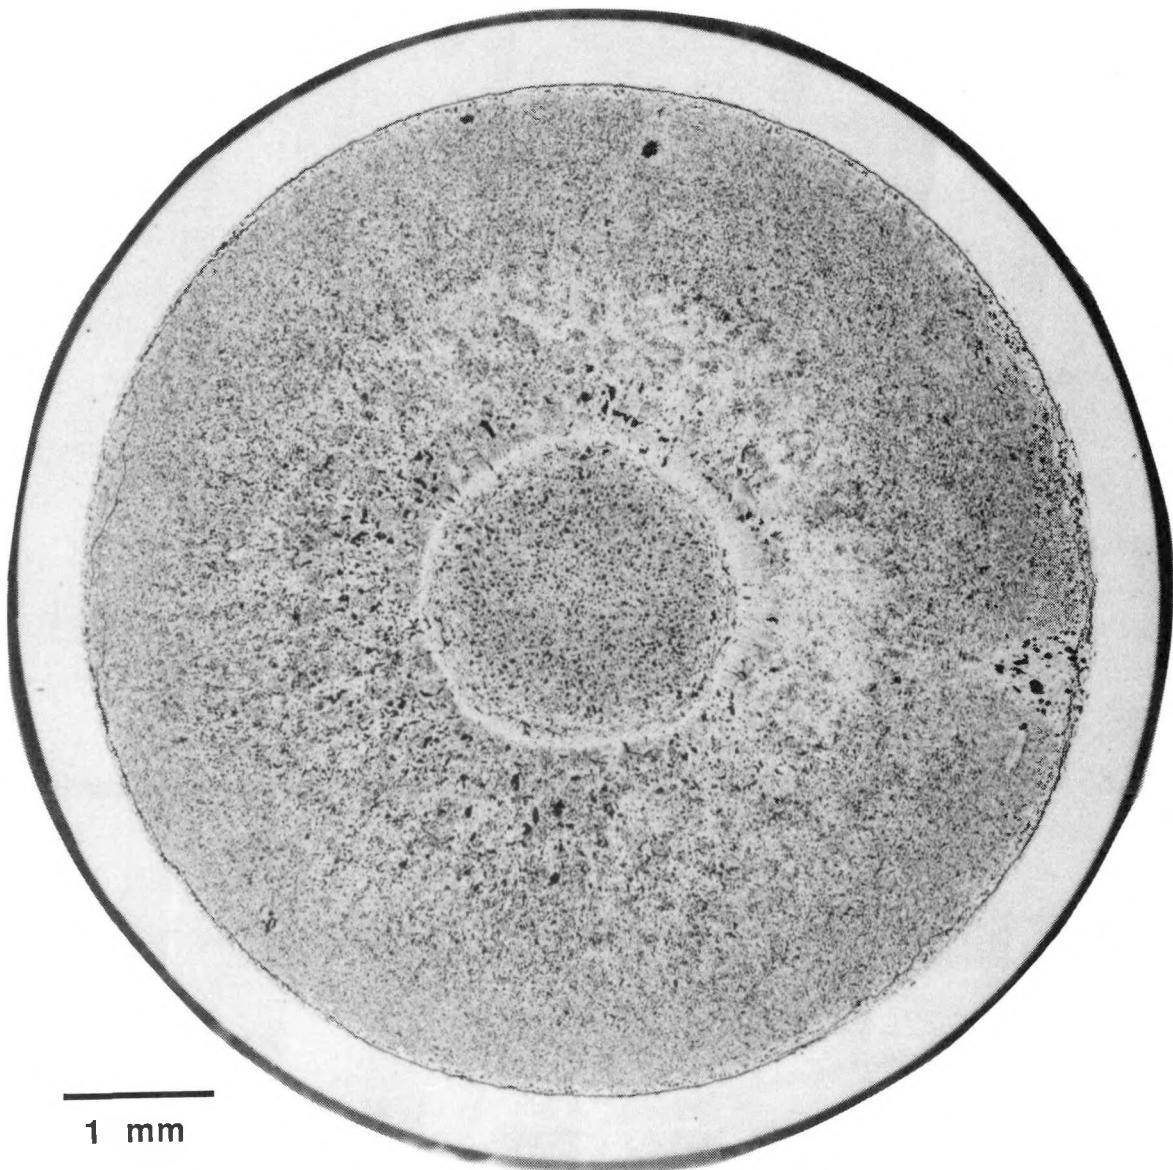
Fig. 16. Transverse Section of 90-20 Specimen after Simulated 0.40\$ UTOP  
and 9.3-h Hold at 700°C  
(As-polished, MCT 277874)

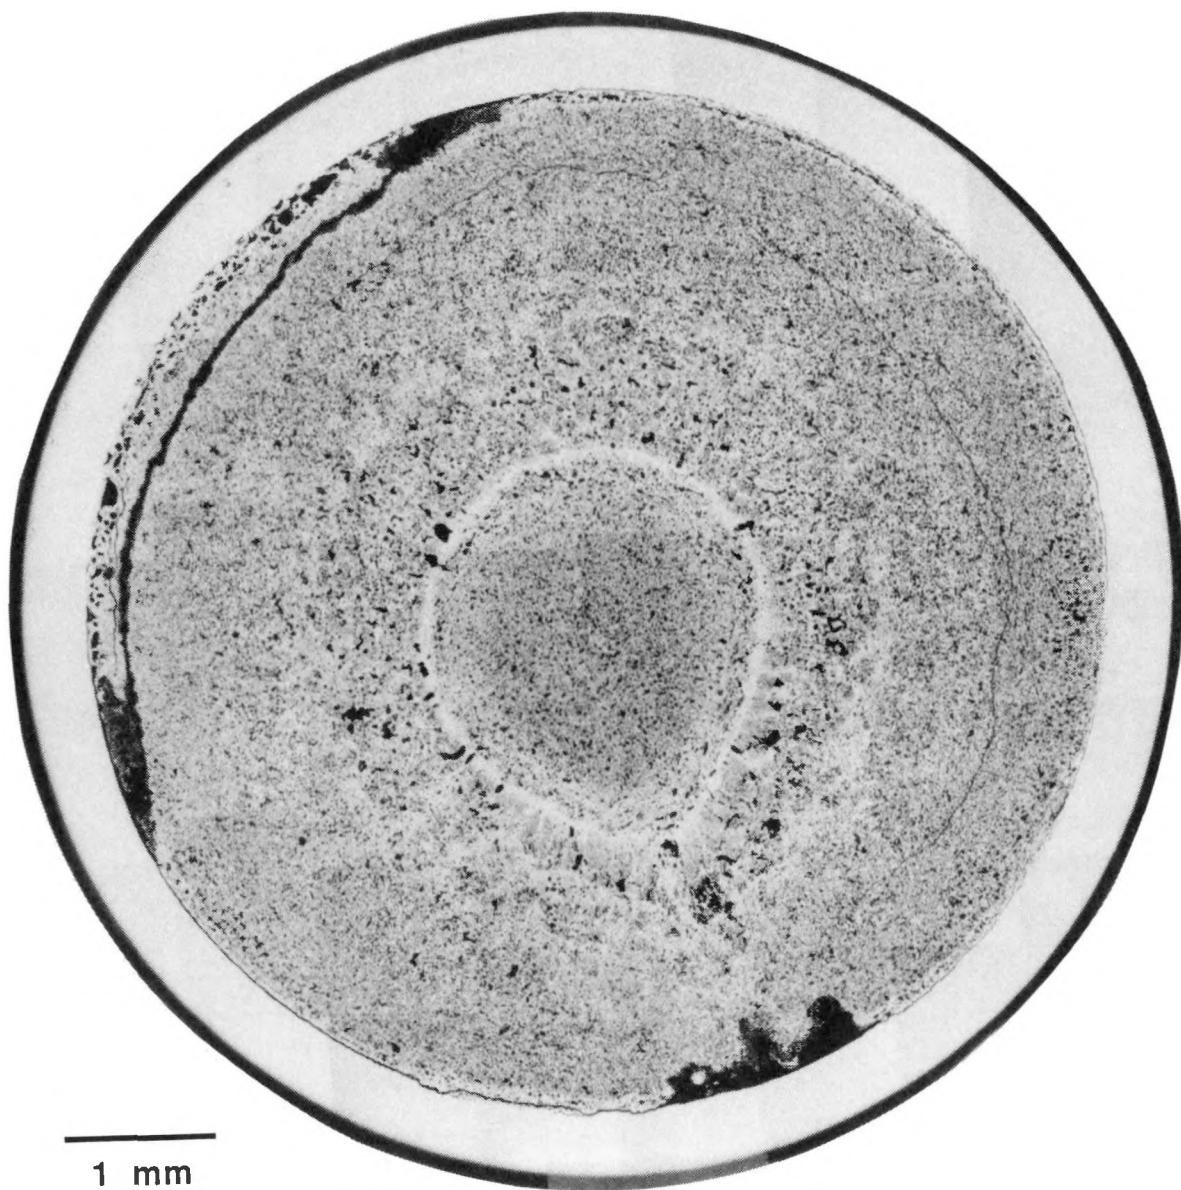
Fig. 17. Transverse Section of 90-23 Specimen after Simulated 0.40\$ UTOP  
and 16.6-h Hold at 700°C  
(As-polished, MCT 277995)
