# Fuel/Cladding Compatibility in Low-Burnup U-26Pu-10Zr/HR9 Fuel at Elevated Temperatures

## IFR Technical Memorandum

September 1991

IFR TECHNICAL MEMORANDUM NO. 152

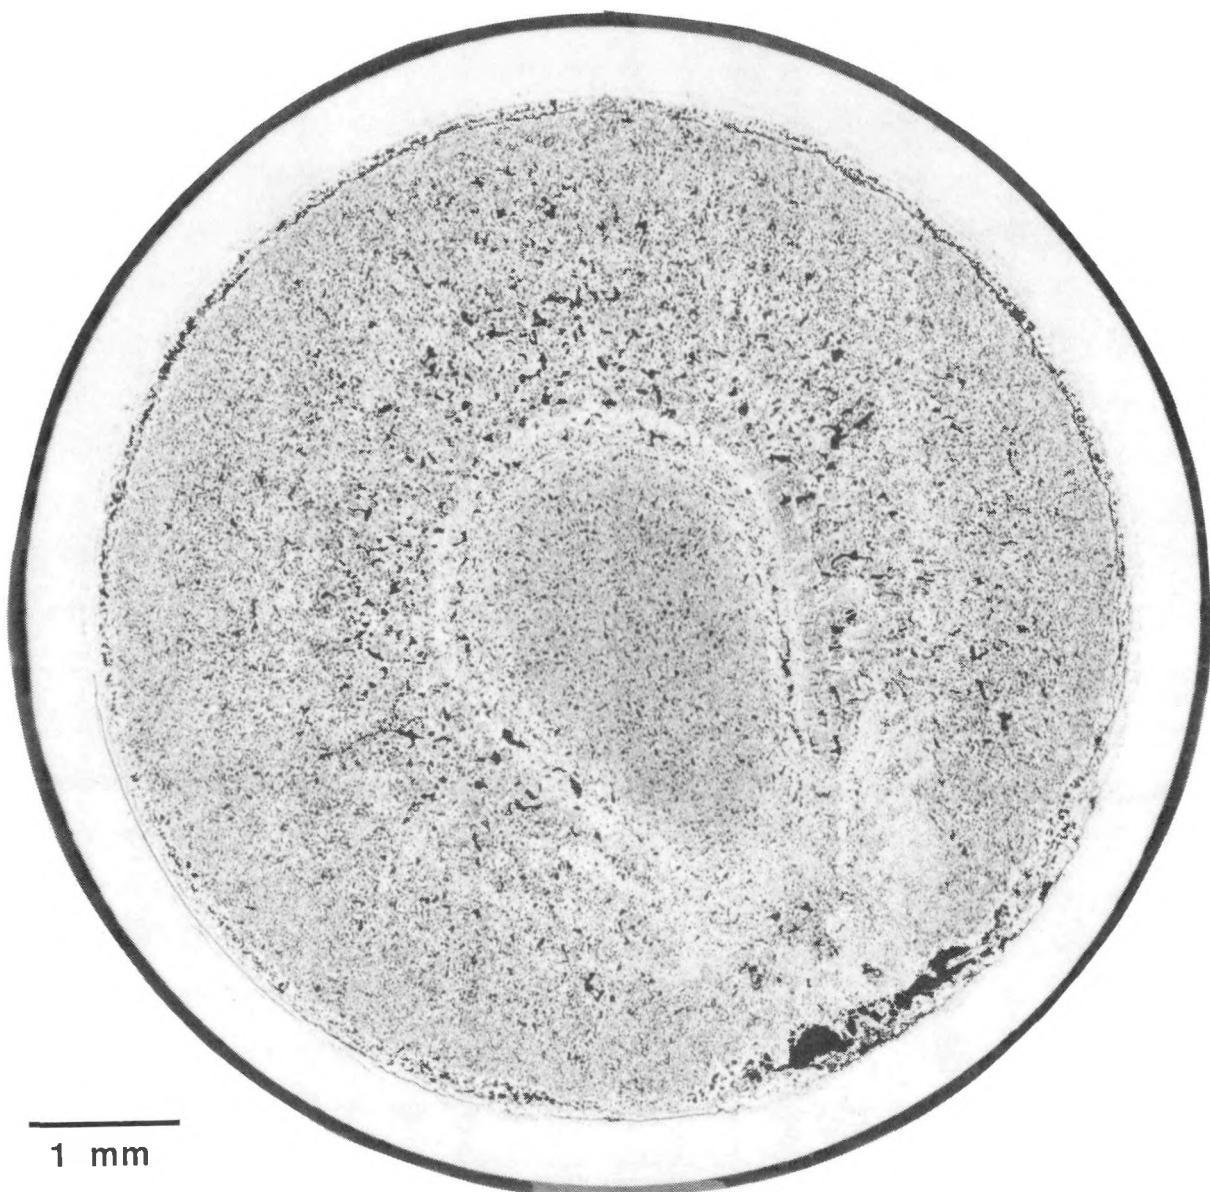
Fig. 18. Transverse Section of 90-24 Specimen after Simulated 0.40% UTOP  
and 36-h Hold at 700°C (As-polished, MCT 278116)

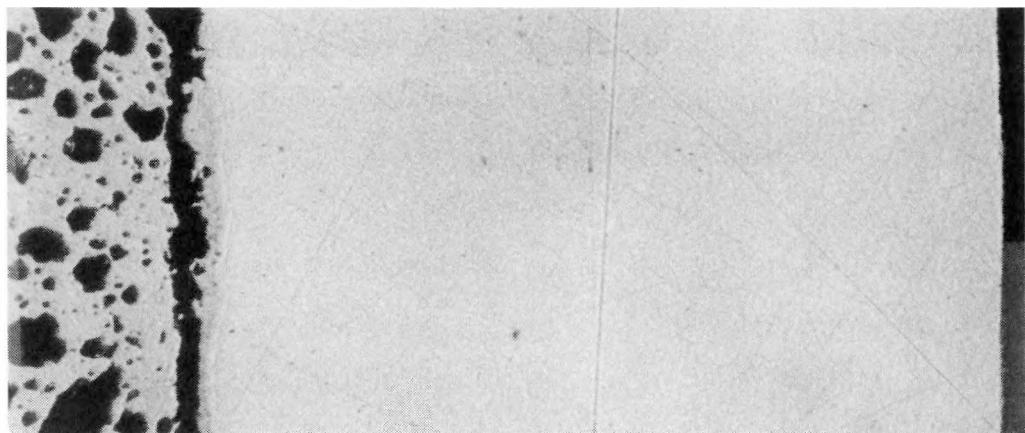
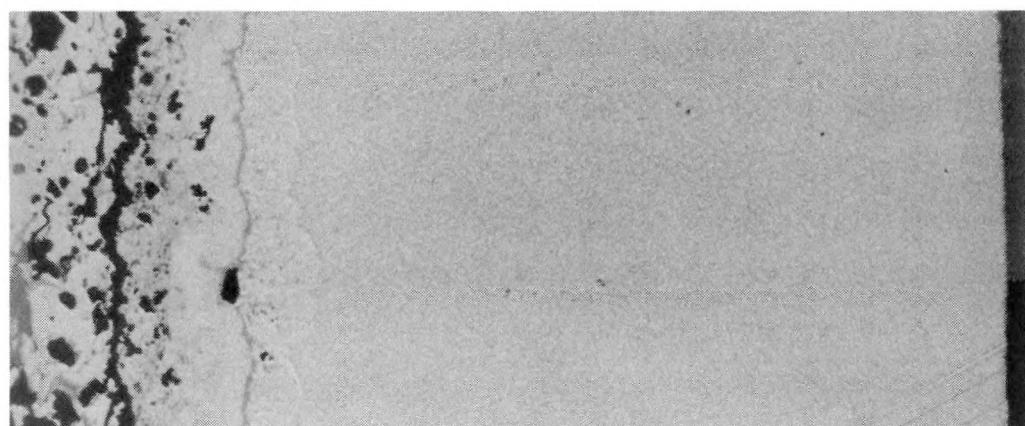
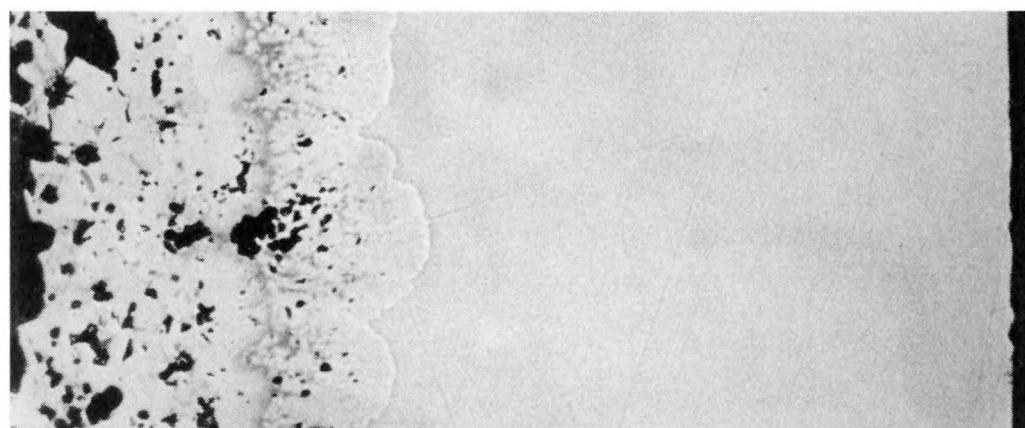
(a) UTOP only (no hold at 700°C)

(b) UTOP and 9.3-h hold at 700°C

(c) UTOP and 36-h hold at 700°C

Fig. 19. Comparison of Fuel/Cladding Interaction in Test Specimens  
(a) 90-22, (b) 90-20, and (c) 90-24 (As-polished, 250X)

In the 90-22 test, even with the brief duration (2 min), fuel surface liquefaction and cladding interaction occurred, as shown in Fig. 15 (see also Fig. 19a). The extent of fuel surface liquefaction, however, was shallow and nonuniform around the circumference. The liquefied fuel/cladding reaction product apparently filled the wedged-shaped crack on the fuel periphery (about 5 o'clock in Fig. 15). Inward from the surface, the fuel microstructure was unaffected by the short test. The depth of maximum cladding penetration was  $\approx$ 19  $\mu\text{m}$ , which is comparable to the "instantaneous" penetration shown in Fig. 13.

While the reaction boundary appears to have the same features as in the 800°C tests, the presence of a gray phase in the middle of the reaction zone suggests a different overall reaction mechanism than that at 800°C. The morphology of this gray-phase structure is delineated in high-magnification photographs in Fig. 21. The accumulation is predominantly along a cusp-shaped boundary; root-like stringers on the fuel side and precipitated phases on the other side are also noted.

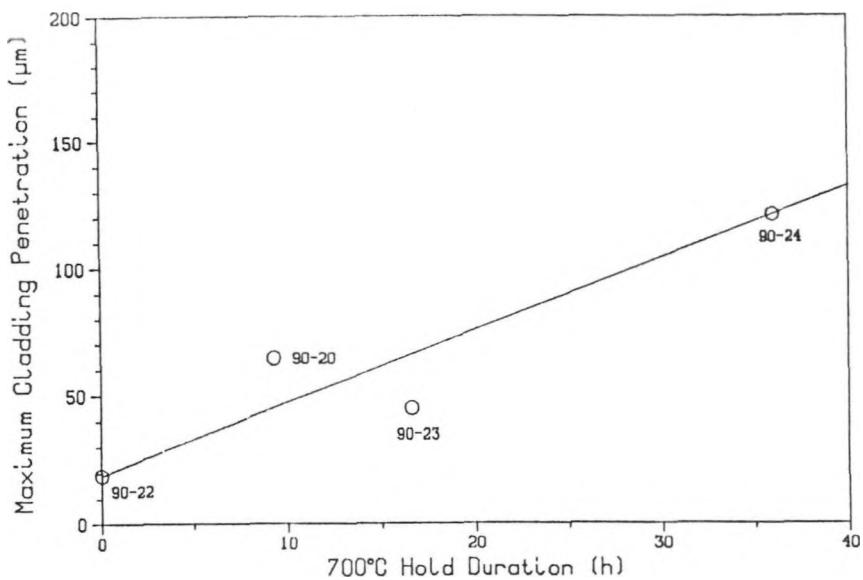
Fig. 20. Cladding Penetration during Simulated NRC Bounding Event 1B.  
(815°C for 2 min, followed by 700°C hold)

cladding penetration in the four tests. The penetration rate, assuming a linear correlation, is  $\approx 7.9 \times 10^{-4} \text{ } \mu\text{m/s}$ , or  $\approx 3 \text{ } \mu\text{m/h}$ .

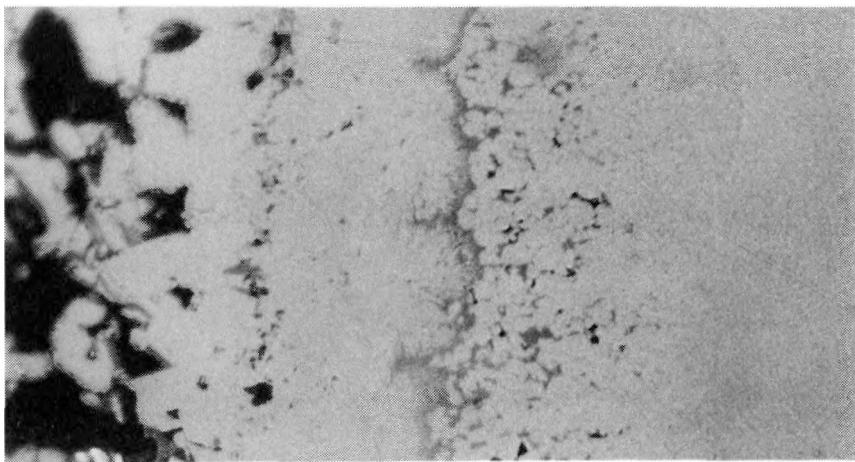
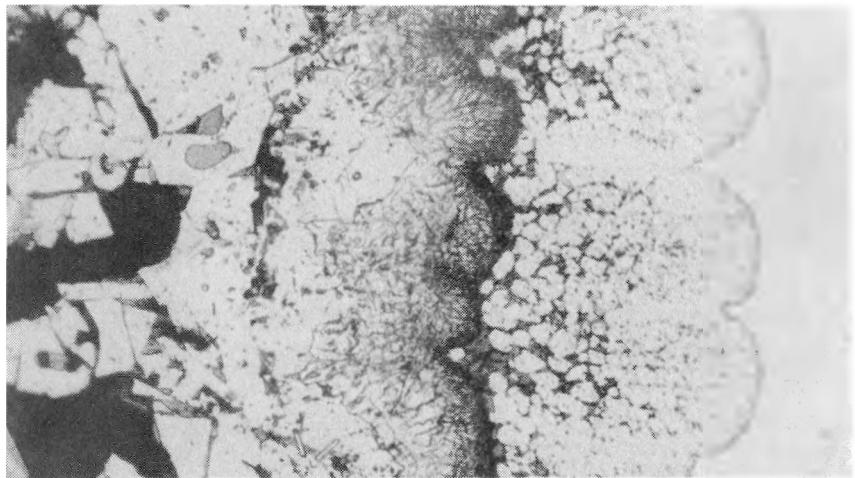
Fig. 21. Fuel/Cladding Interaction Zone in 90-24 Test Specimen. Unreacted cladding is at right.

From Fig. 23, the following major structures were identified (from right): (A) the unreacted cladding, (B) a light gray (high-Z) band with a duplex structure, (C) the cusp-shaped band with fine stringers, (D) a dark gray (low-Z) band, (E) a medium gray band with large blocky grains, (F) reacted fuel band, and (G) unreacted fuel. The compositions of these structures, from the SEM/EDX analyses, are shown in Table III. All of these phases can be readily identified on the corresponding optical micrographs (e.g., Fig. 21).

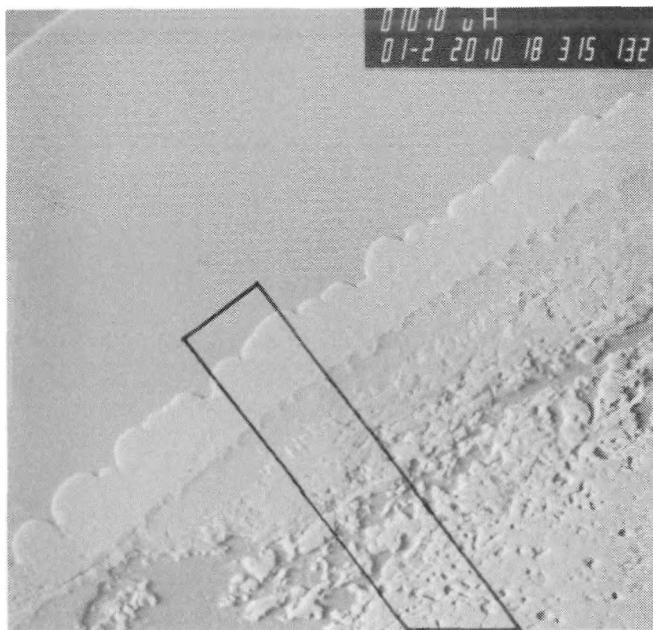
Fig. 22. Outline of Area Examined with Scanning Electron Microscope. Cladding OD can be seen at upper left.  
MCT 315132

To investigate the reaction zone in a greater detail, a thin slice of the 90-24 test specimen was examined with a scanning electron microscope. The examined area is outlined in Fig. 22. An enlargement of this area, in backscattered electron (BSE) image, is shown in Fig. 23. [In BSE images, phases with high average atomic numbers (Z) are light, and phases with low average atomic numbers are relatively dark]. Energy-dispersive X-ray (EDX) analyses were conducted to determine the approximate compositions of the various phases. Because of the finite effective X-ray diameter ( $\approx 2\text{-}\mu\text{m}$ ), the results of EDX analysis of structures whose sizes were comparable to or smaller than that of the beam tend to be less accurate due to the boundary effects from the surrounding dissimilar phases.

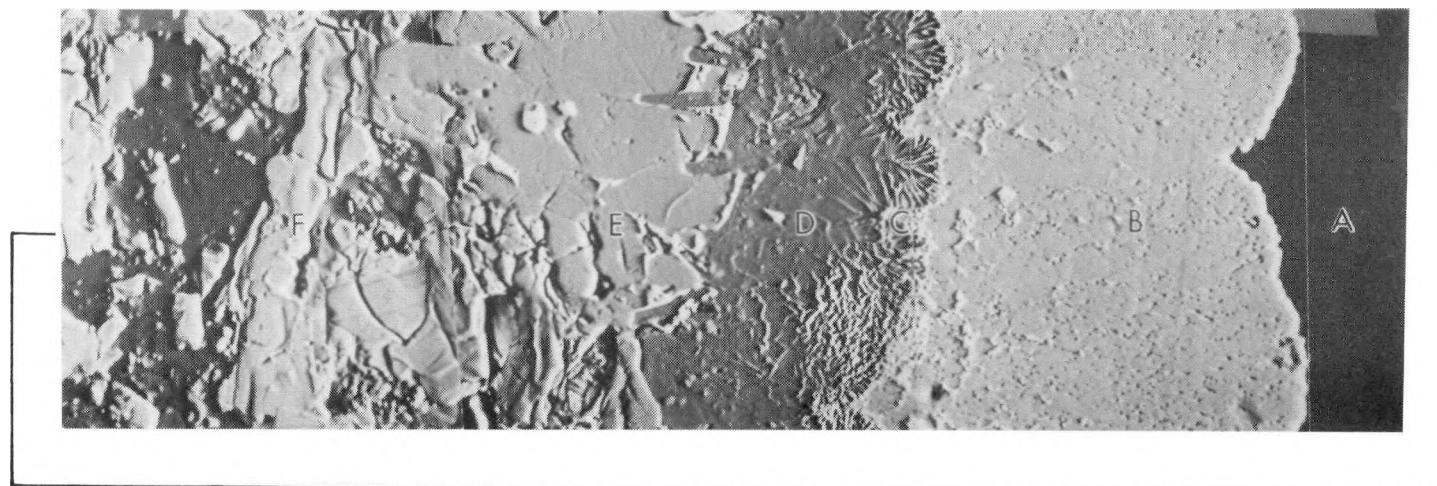
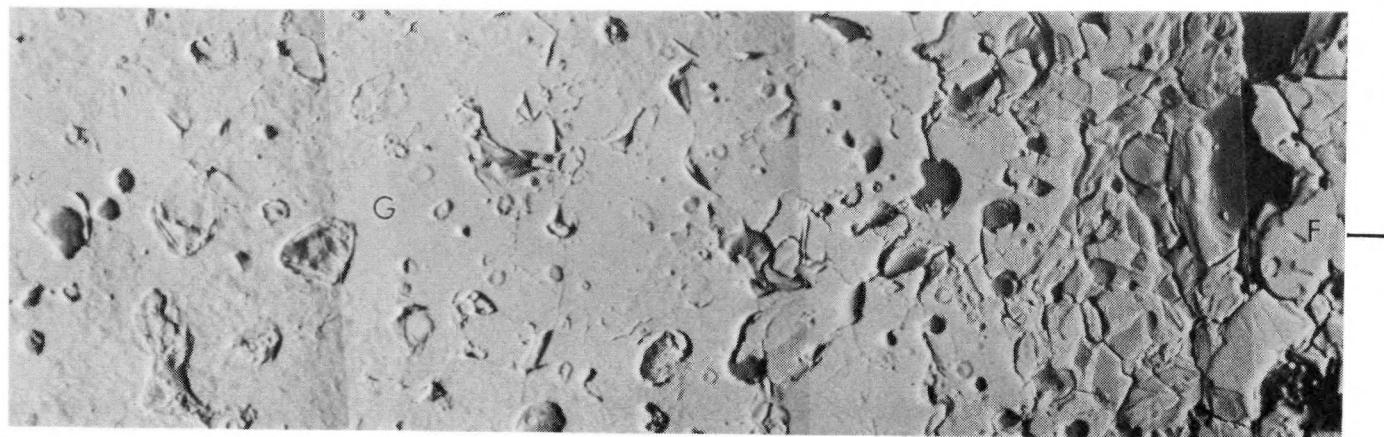
Fig. 23. BSE Image of Outlined Area in Fig. 22. From right: (A) the unreacted cladding, (B) a light gray (high-Z) band with a duplex structure, (C) the cusp-shaped band with fine stringers, (D) a dark gray (low-Z) band, (E) a medium gray band with large blocky grains, (F) reacted fuel band, and (G) unreacted fuel.

The stringers (Area C, Fig. 23) on the cladding side of this band appear to be a fuel-rich phase, although the composition could not be accurately determined due to its small particle size. Based on the

Area E in Fig. 23 is also a high-Zr, high-Fe (Cr) phase, but with a substantially greater concentration of (U, Pu) than in Area D (see Table III). It appears to be a different intermetallic compound than that in Area D because the demarcation between the two areas is sharp and distinct. A high-Z (light gray) phase is found on some of the grain or subgrain boundaries in this band.

Further inward was the reacted fuel phase (Area F in Fig. 23); the thickness of the band is  $\approx 100 \mu\text{m}$ . The concentration of Fe, which is responsible for the reaction, is small ( $\approx 3$  at.% max.) and decreases with radial position in this band. Extensive fracturing indicates that the reacted material is brittle. Beyond this band, there is no detectable Fe and the microstructure of the fuel appears to be unchanged from the test.

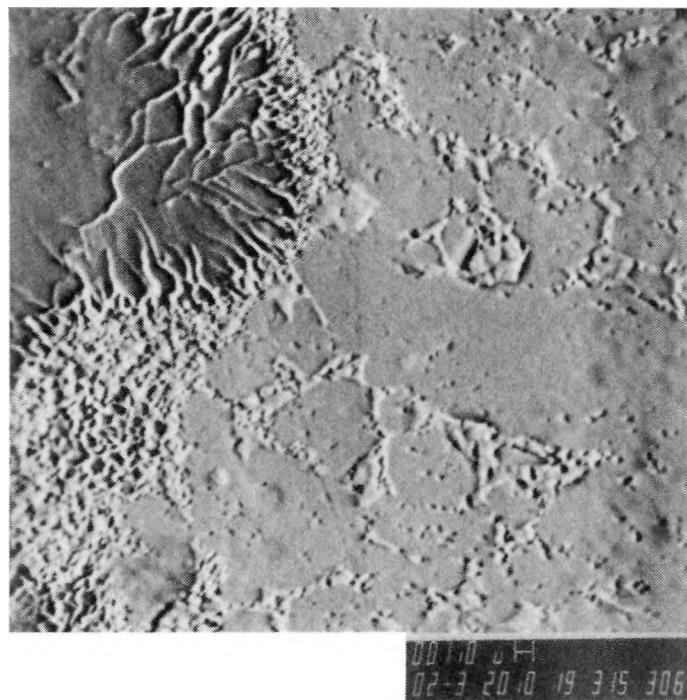
Fig. 24. BSE Image of Interface Region between Areas B and C, Showing Grain-Boundary Structure in Area B and Stringers in Area C. See Fig. 22 for area definition.

grayness on the BSE images (see Fig. 24), the stringers appear to have a composition similar to that of the intergranular phase in band B. Within the cusps, the orientations of the stringers are predominantly perpendicular to the cusps. The stringers are probably a diffusion-induced subgrain structure, along which much of the U and Pu fuel constituents migrated to the reaction front. Similar structures have been noted in an unirradiated U-19Pu-10Zr/HT9 diffusion-couple specimen after 300 h at 725°C.<sup>5</sup> The formation mechanism of the stringers and the cusp-shaped morphology is not known at this time.

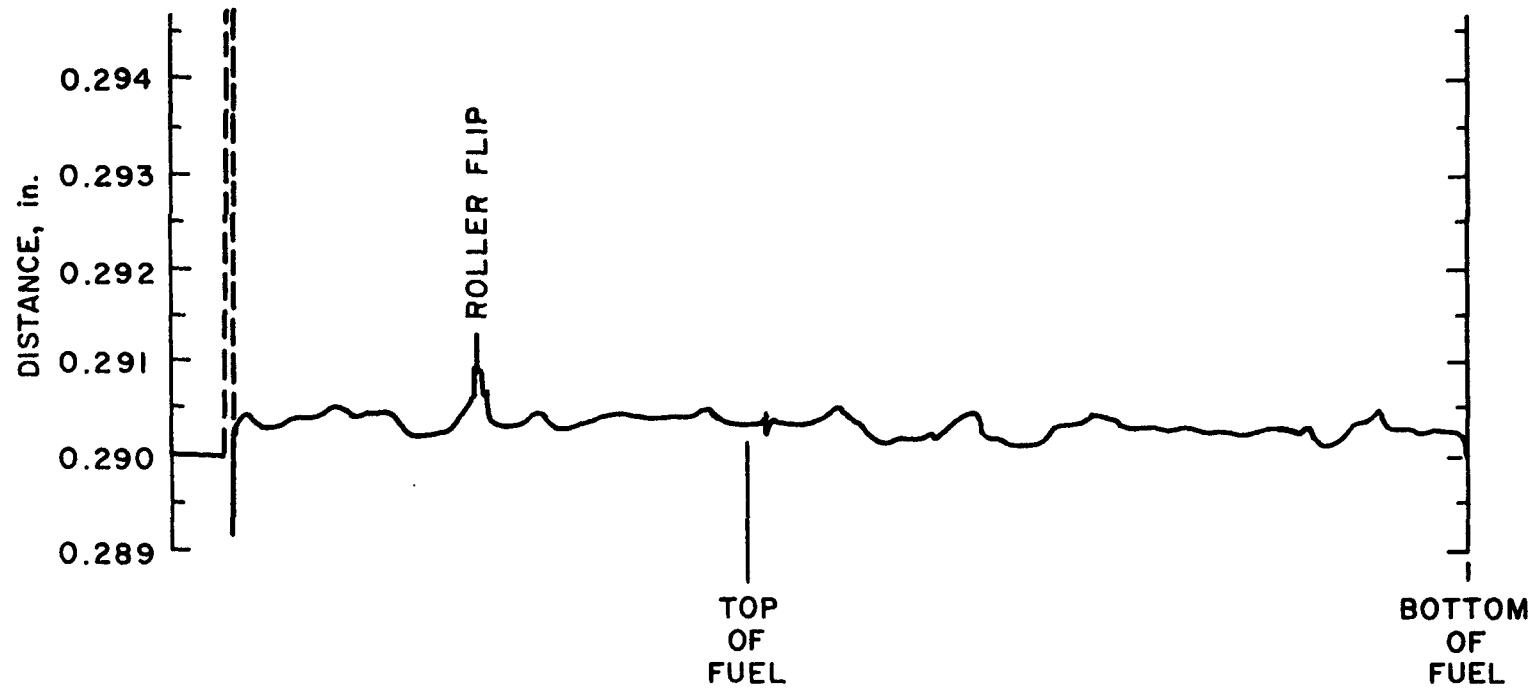
Fig. A2. Contact Profilometry Trace of Pin T678, Showing Negligible Cladding Strain

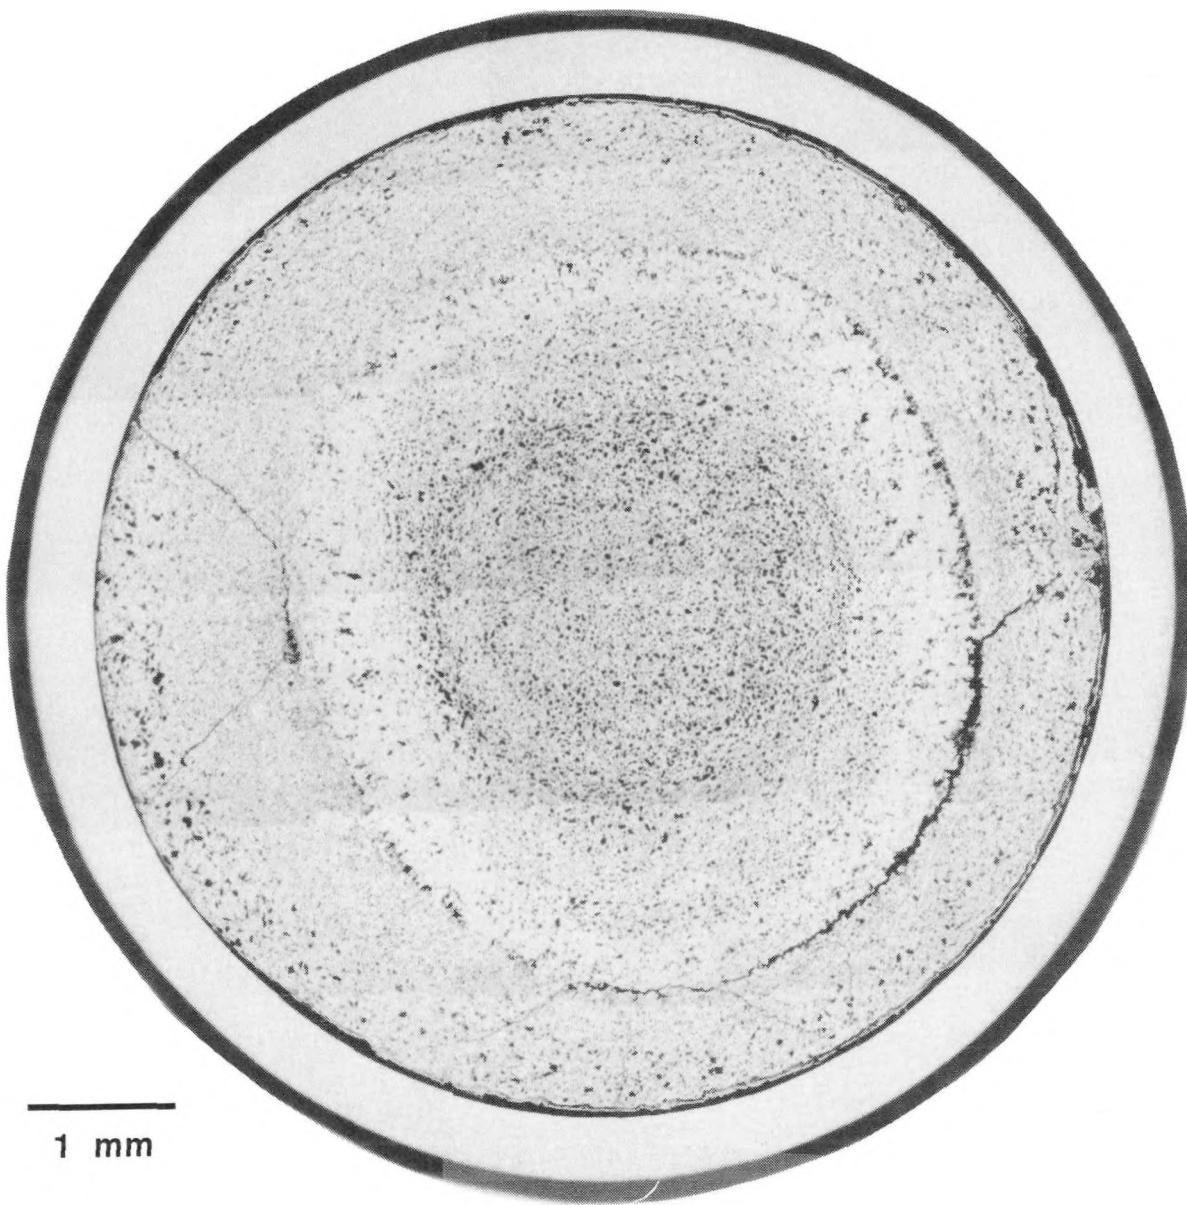
Fig. A3. Transverse Section of Pin T678 at  $X/L = 0.20$  (M1) after Steady-state Irradiation  
(As-polished, MCT 277590)

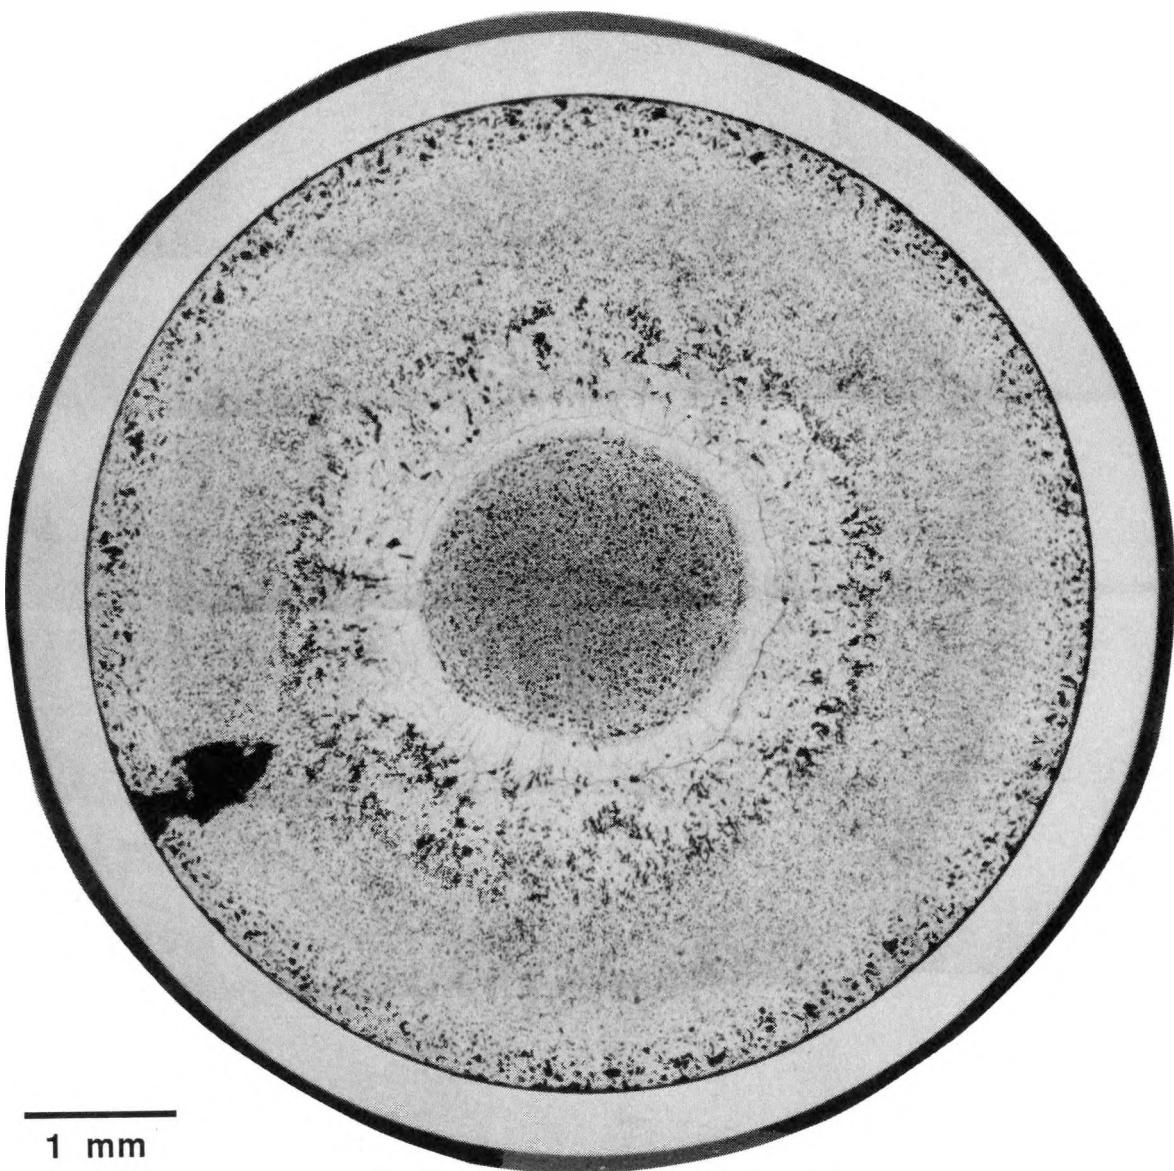
Fig. A4. Transverse Section of Pin T678 at  $X/L = 0.49$  (M2) after Steady-state Irradiation  
(As-polished, MCT 277591)

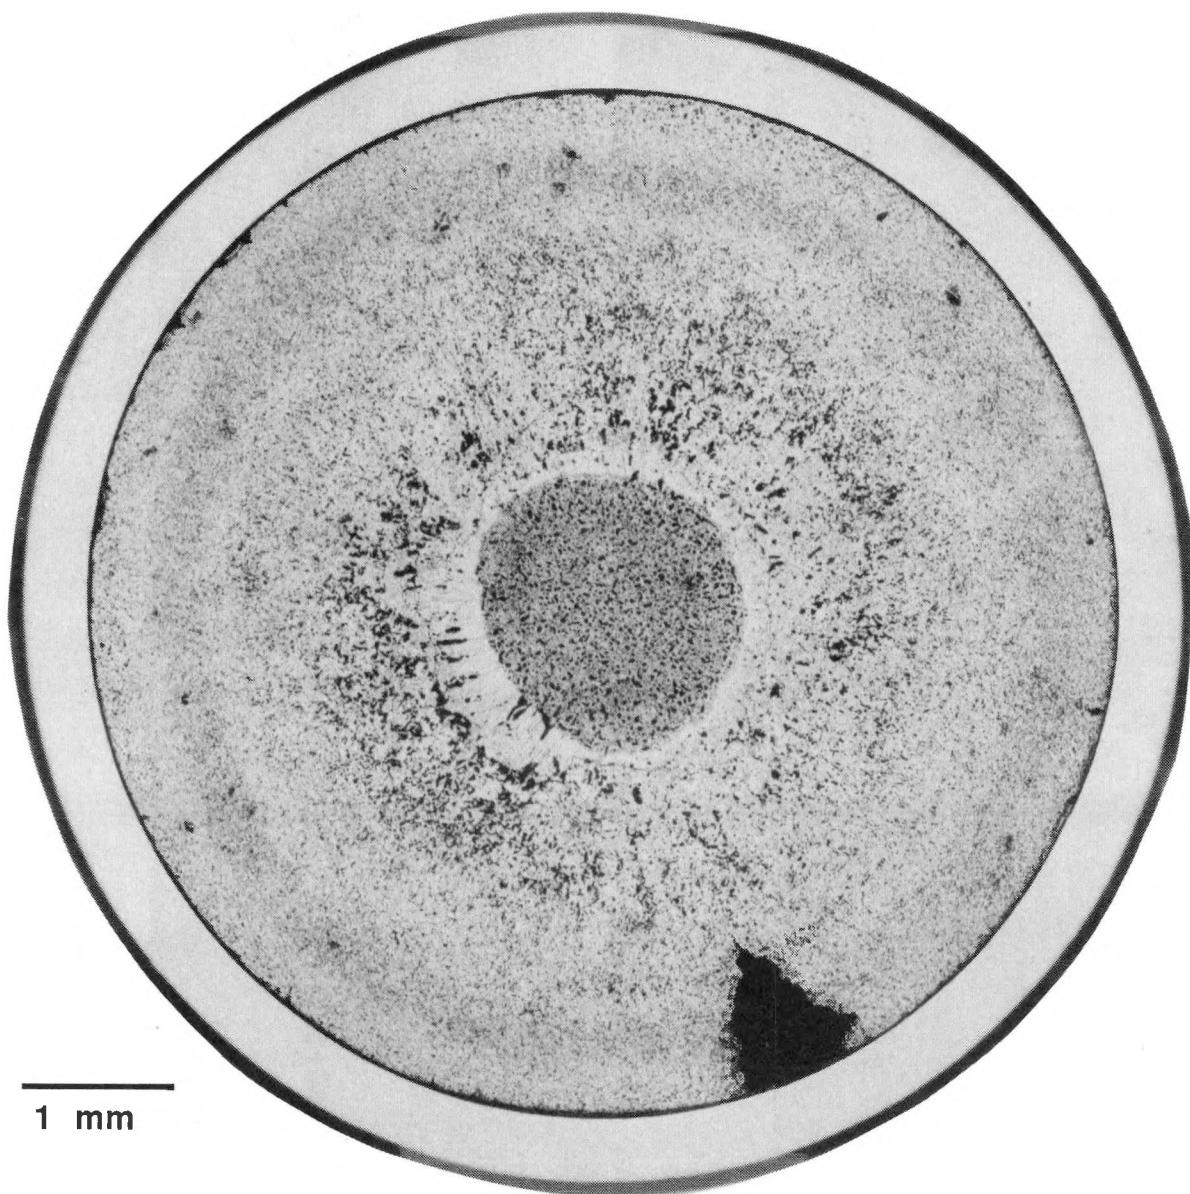
Fig. A5. Transverse Section of Pin T678 at  $X/L = 0.91$  (M4) after Steady-state Irradiation  
(As-polished, MCT 277593)

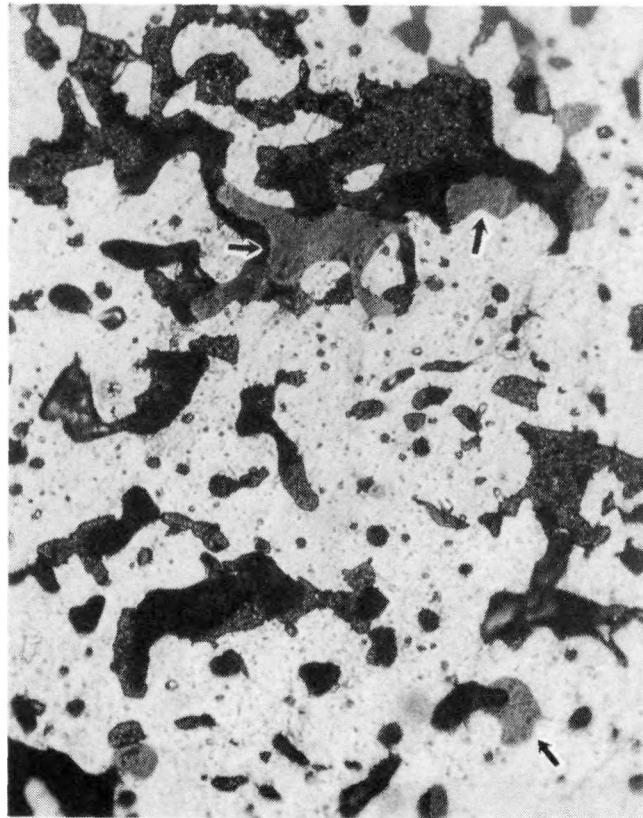
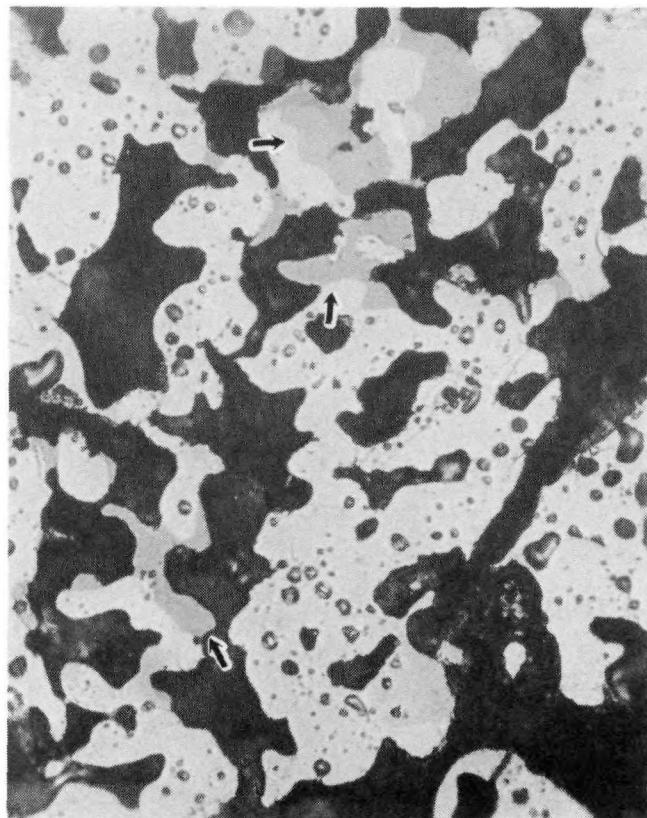
Section M2  
(MCT 277726, 500X, AP)

Section M3  
(MCT 277668, 500X, AP)

Fig. A6. Fission-product Accumulations in As-irradiated Fuel

In spite of the relatively low burnup, deposits of solid fission products were noted in the fuel, mostly in the fuel zone immediately inward of the porous fuel periphery, at an  $r/R$  of  $\approx 0.6-0.7$ . Figure A6 shows some of the typical deposits found in sections M2 and M3. Based on past experience, these deposits consist mainly of lanthanide fission products.

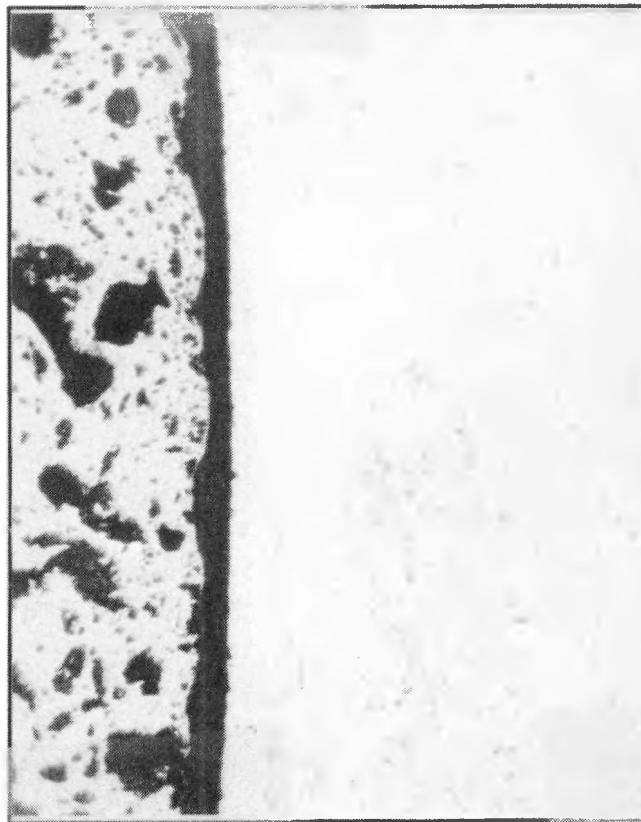
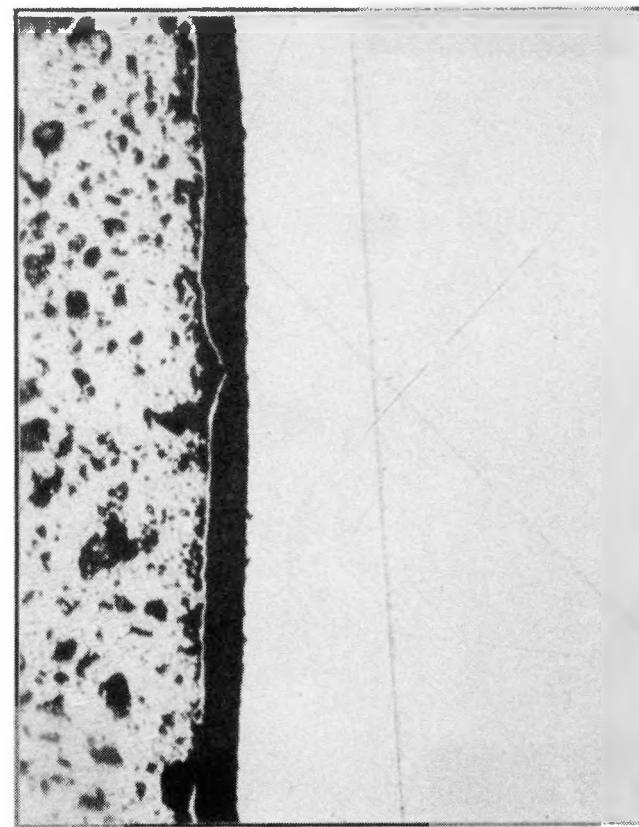
Section M3, X/L = 0.77  
(MCT 277760, 250X, AP)

Section M4, X/L = 0.91  
(MCT 277695, 250X, AP)

Fig. A7. As-irradiated Pin T678 Cladding, Showing No Obvious Fuel/Cladding Interaction

The condition of the HT9 cladding at all four elevations appeared to be excellent. There were no obvious indications of fuel/cladding chemical interaction as a result of the steady-state irradiation. Figure A7 shows typical fuel/cladding interface areas from sections M3 and M4. The slight gap ( $\approx 15 \mu\text{m}$  average) between the fuel and cladding at room temperature was apparently from reactor shutdown, i.e., due to the fuel/cladding differential thermal contraction. At irradiation temperature, the gap was probably closed.
