POSTIRRADIATION EXAMINATION RESULTS FROM THE LP-FP-2 CENTER FUEL MODULE

Steven M. Jensen and Douglas W. Akers
Idaho National Engineering Laboratory
EG&G Idaho
Idaho Falls, Idaho, United States

The LP-FP-2 experiment was conducted on July 9, 1985 in the Loss of Fluid Test (LOFT) facility located at the Idaho National Engineering Laboratory (INEL). The primary purpose of this experiment was to provide information on the release, transport, and deposition of fission products and aerosols during a severe core damage event performed in a large scale nuclear reactor facility. Postirradiation nondestructive and destructive examinations of the fuel bundle provided information to assist in achieving this objective, as well as providing information on the material behavior and interactions that occurred within the fuel bundle during this severe core damage experiment. This was a large-scale integral test, incorporating an 11 X 11 array of fuel rods, control rods, and instrumentation tubes, with an active core length of 1.68 m. Peak temperatures in the fuel bundle exceeded 2100 K for approximately 4.5 min, with localized peak temperatures exceeding the melting point of the UO₂ fuel (3120 K)

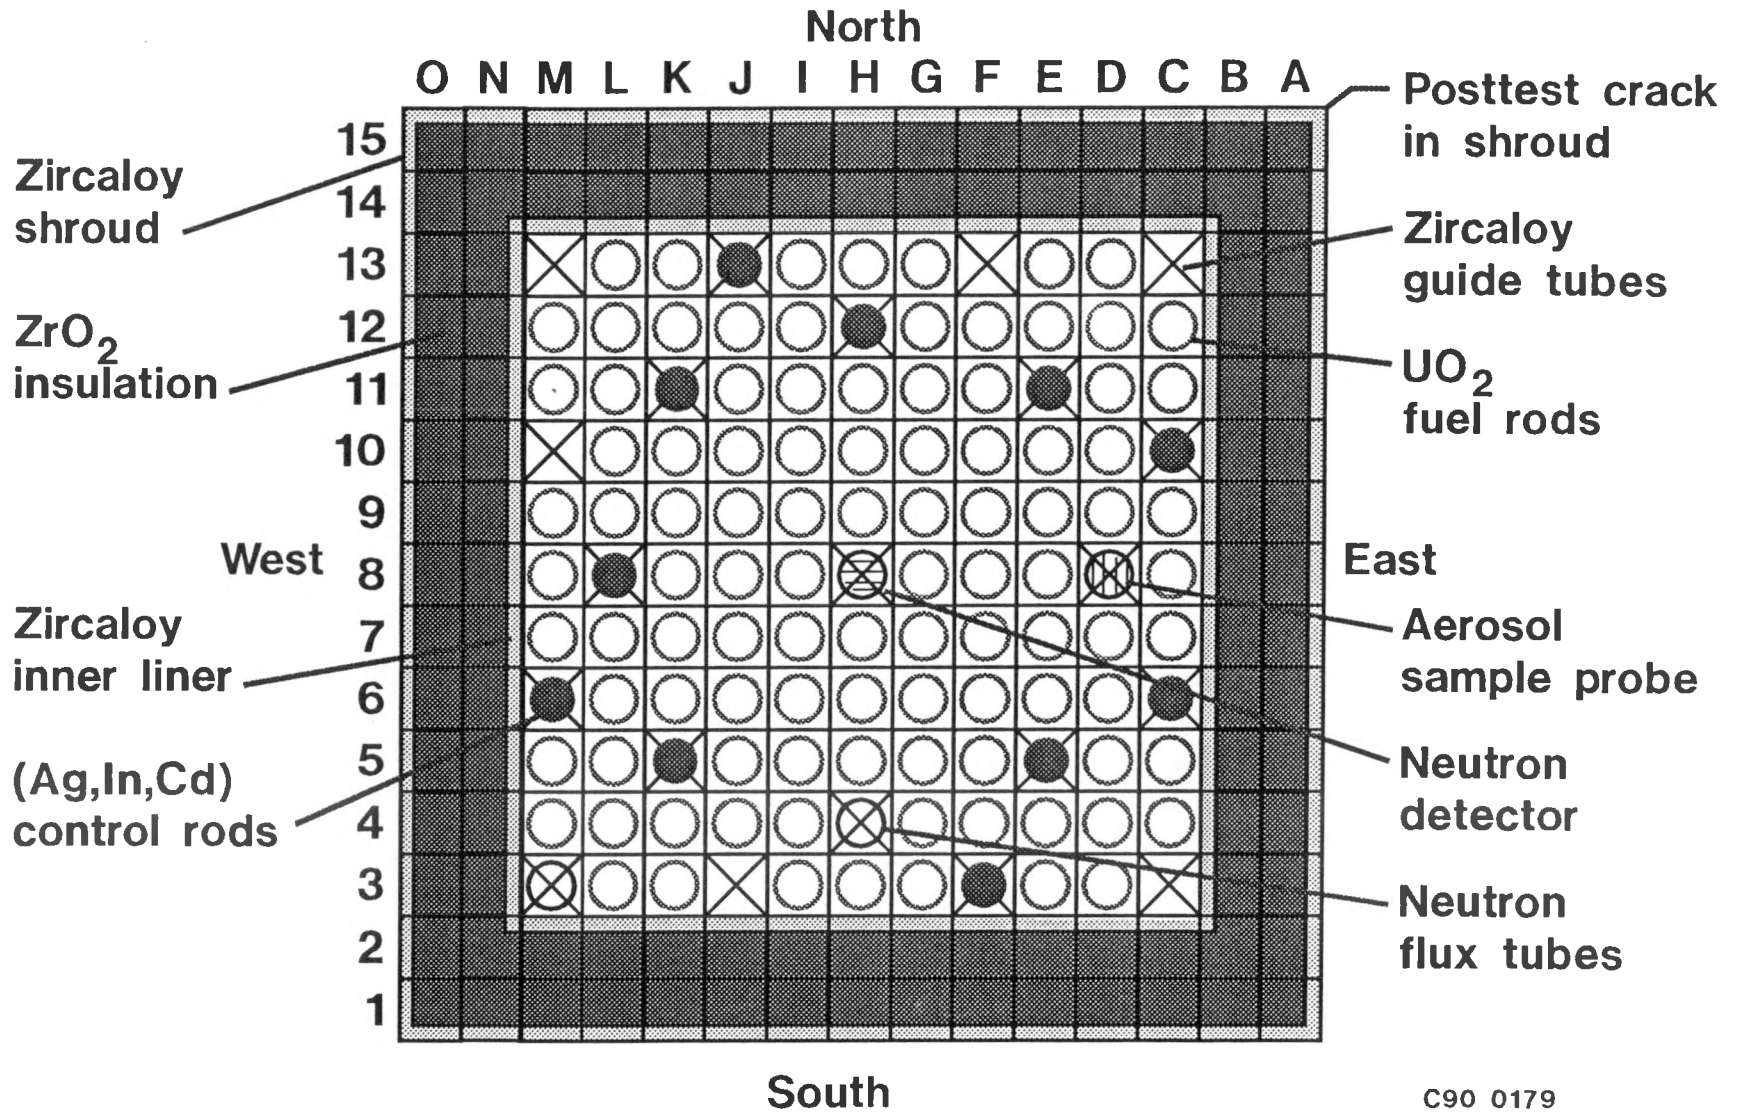
Figure 1. Cross section through LP-FP-2 fuel bundle.

A schematic cross-section through the LP-FP-2 fuel bundle is shown in Figure 1. The fuel assembly consisted of 100 UO_2 fuel rods with zircaloy cladding, eleven (Ag,In,Cd) control rods with stainless steel cladding surrounded by zircaloy guide tubes, six empty zircaloy guide tubes, and various instrumentation tubes. ZrO_2 insulation was sandwiched between a zircaloy inner liner and the zircaloy outer shroud. The fuel was 9.74 wt.% enriched and 94.7% of theoretical density. Additional fabrication details are provided elsewhere [6].

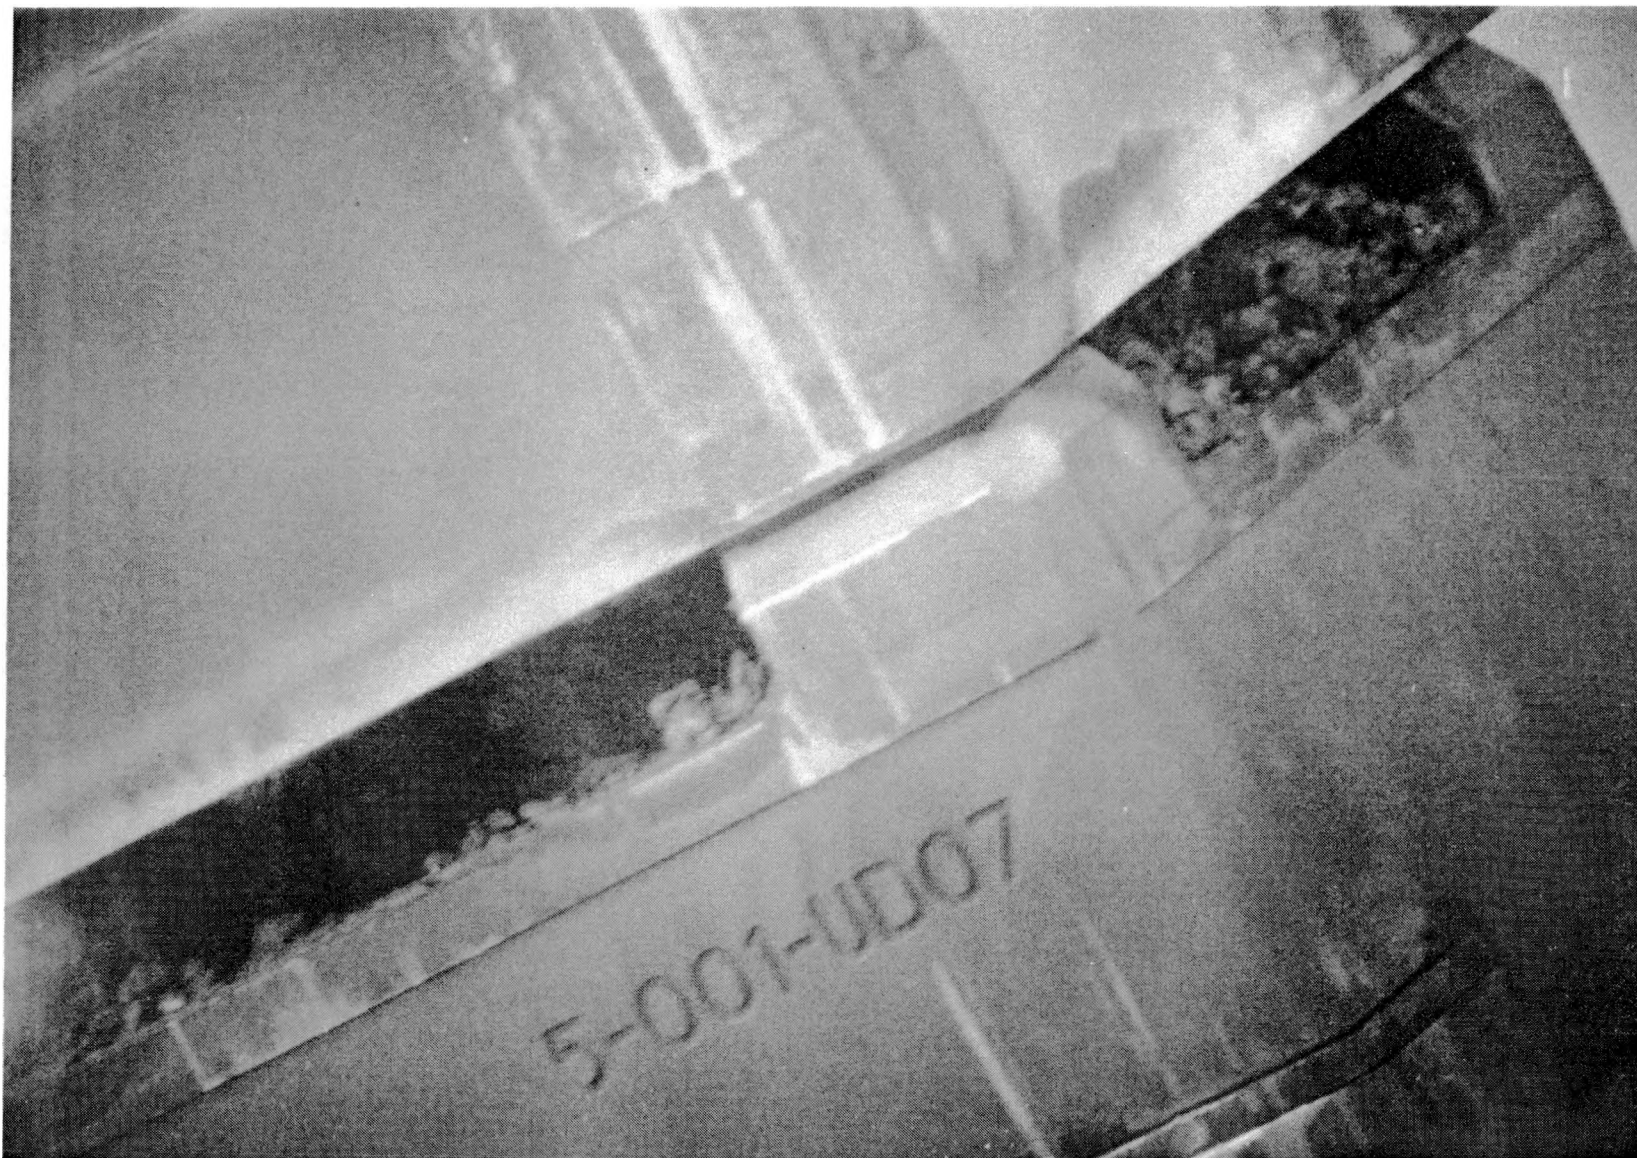
Figure 3. Close-up view of relocated debris in the LP-FP-2 upper end box.

Figure 3 shows ceramic debris which were observed in the upper end box. Subsequent analyses indicated these were fuel and melt particles which were blown upward by the large amount of steam generated during the reflood stage.

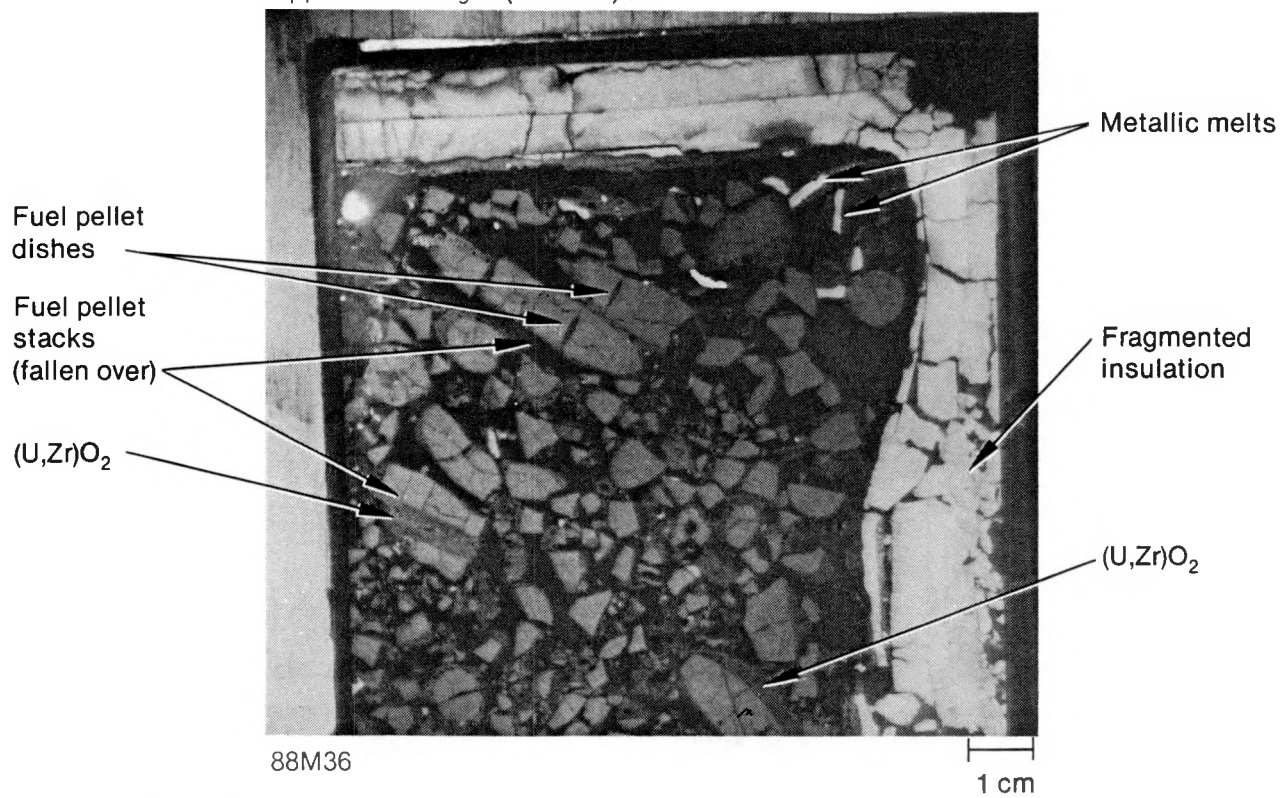
Figure 12. Quarter cross-section through the fuel debris bed (1.2 m).

This region consisted primarily of a rubble bed of fuel pellets without any intact cladding to restrain them. Ceramic melts, from molten zircaloy cladding and the upper tie plate, had flowed down around the fuel debris. A lot of material was missing on the eastern side of the fuel module, including much of the insulation. Some fuel pellet stacks (without any intact cladding) remained intact on the western side of the module. As described in Section 2.2, comparison of the gamma scan results with the observed material distribution indicates that posttest handling did not affect the posttest configuration within the module; the solidified ceramic melt held the fuel debris in place. A representative quarter section through this region is shown in Figure 12.

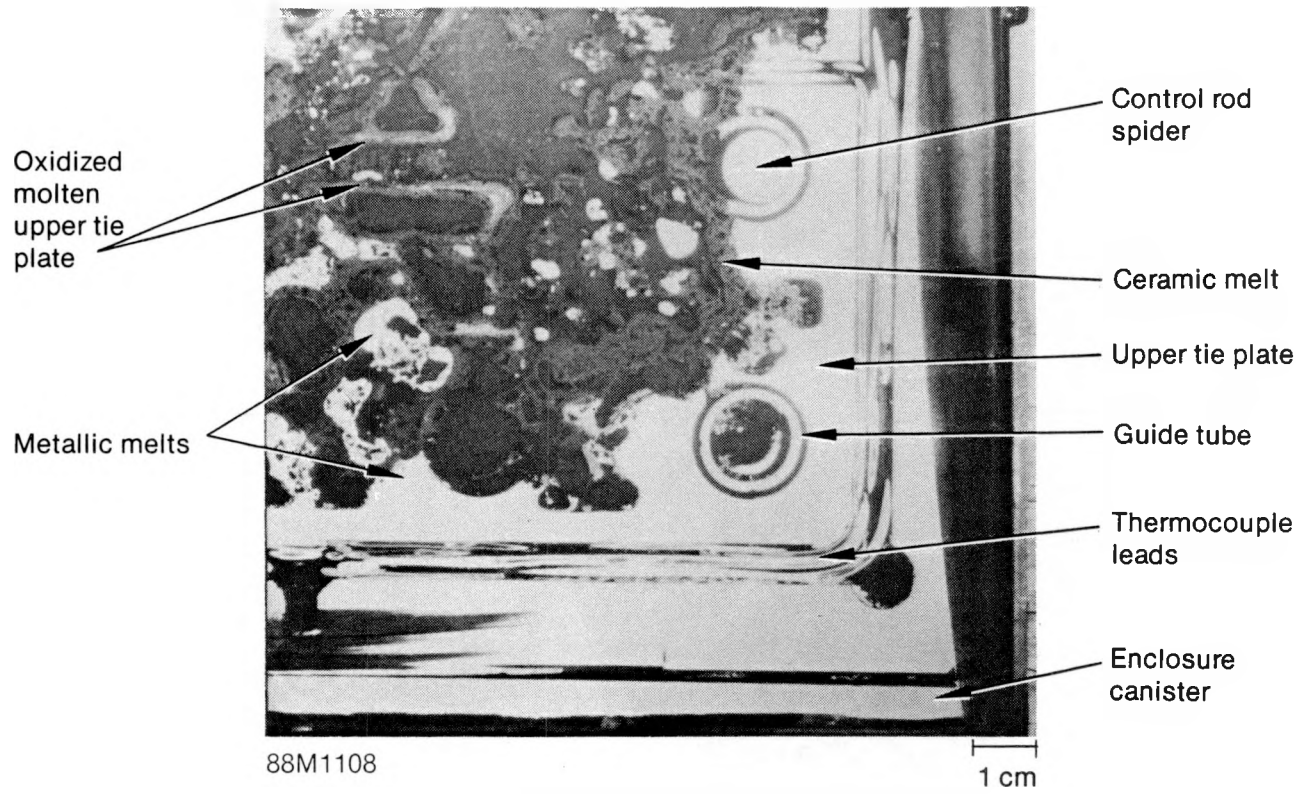
Figure 13. Quarter cross-section through the upper tie plate (1.8 m).

Relocated material was observed in the upper end box during both the visual examinations and in the subsequent neutron radiographs. Figure 13 shows a representative quarter section through the middle of the stainless steel upper tie plate. The upper tie plate was only intact on the periphery of the bundle; in the center it had liquefied and oxidized. Intact fuel pellet fragments were also observed in this area. As described in more detail elsewhere [7,8], the liquefaction and oxidation of the upper tie plate, and the relocation of melt and fuel debris to this region, could only have occurred during the reflood period. During the transient the

temperatures and steam mass flow rates were too low to account for the observed behavior, but during the reflood period both the temperature and steam mass flow rates increased dramatically.

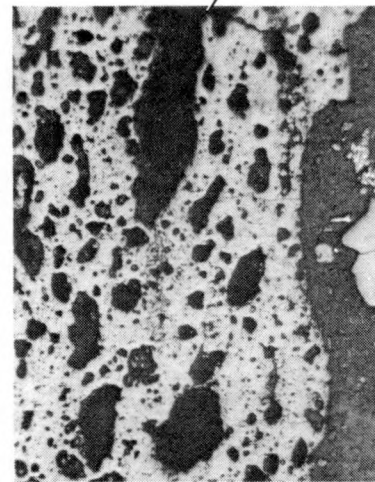
Figure 29. Foamy fuel structure on outer periphery of fuel pellet at 0.77 m.

Areas of fuel with a foamy morphology were observed on the periphery of some fuel pellets in the midcore region and above. An example of this behavior is shown in Figure 29. It shows that on the outer periphery of the foamy fuel region the grain structure was obliterated, whereas farther inward a grain structure was still apparent in the foamy fuel. Elemental dot maps from SEM/WDS examinations of a similar sample indicated the presence of iron, chromium, and nickel in the fuel. Review of U-Fe-O phase diagrams indicates that eutectic interactions can take place between these materials, although the data is very limited, which suggests that the observed foamy fuel morphology may be due to fuel liquefaction by iron-oxides.

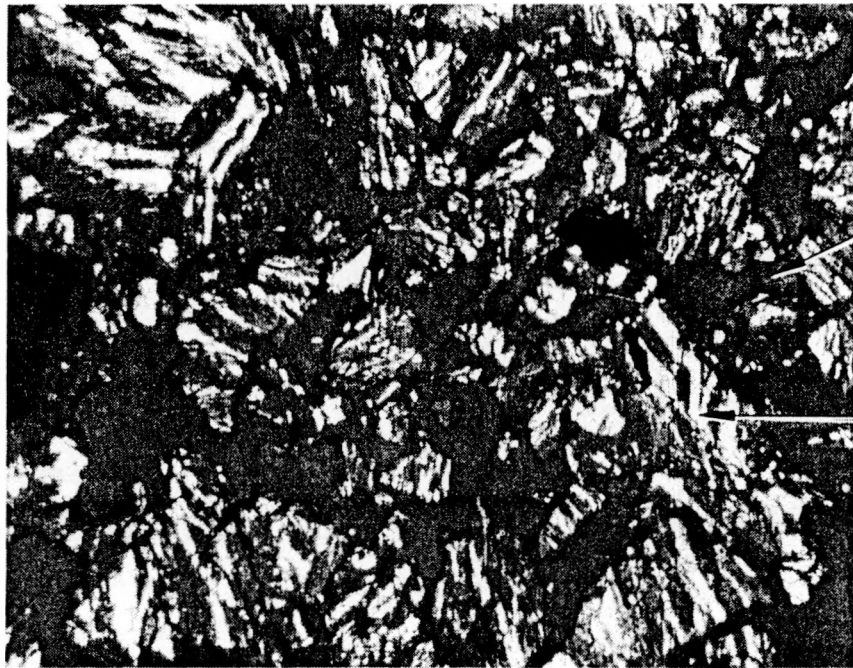
Metallic Eutectic Melts Formed Lower Blockage

Porosity

Eutectic
metallic
melt

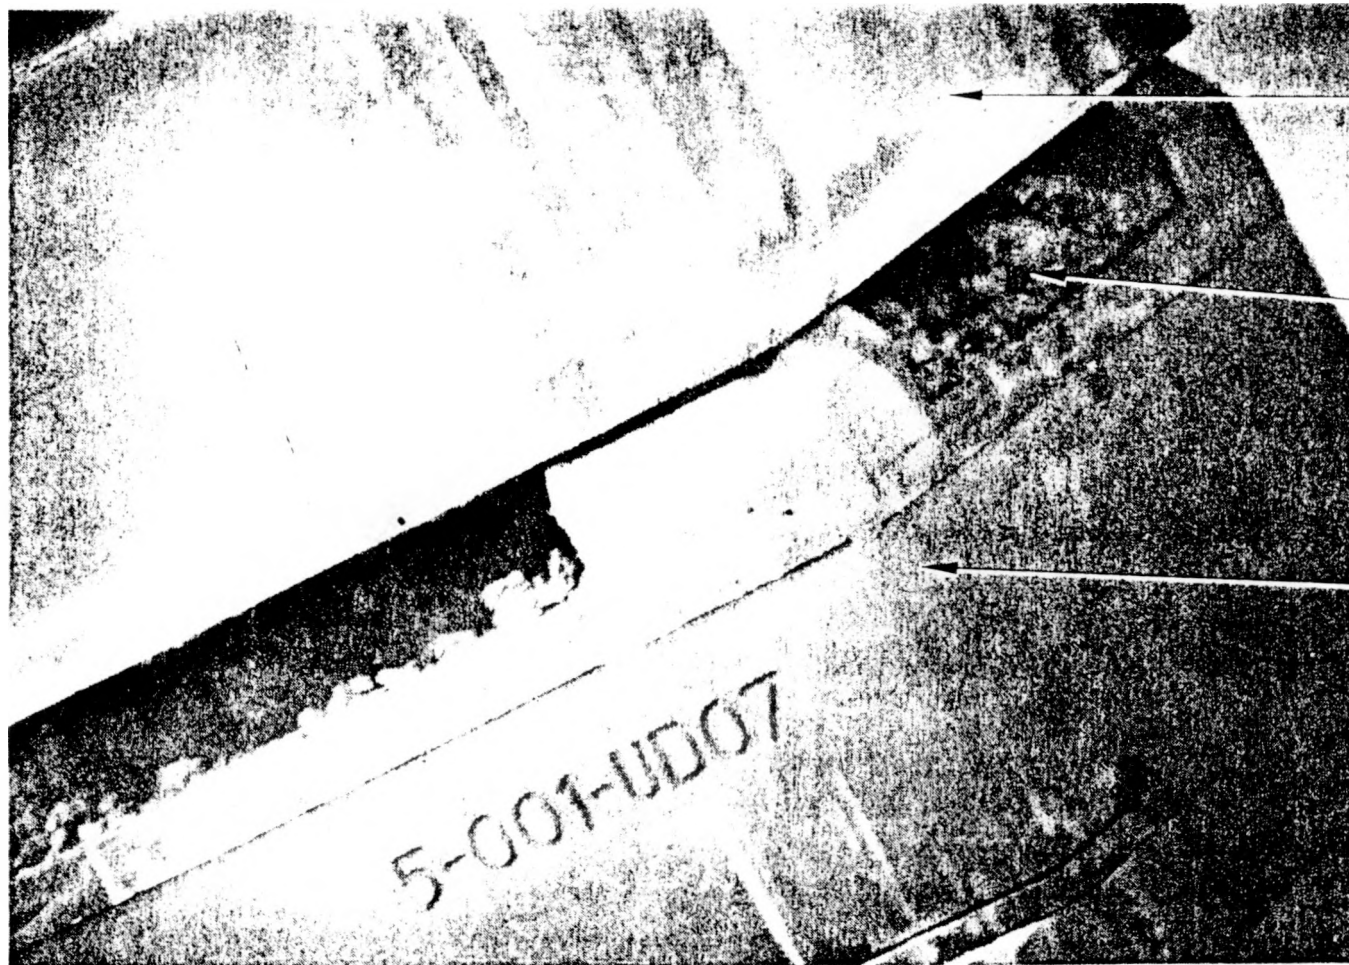
Fuel and Melt Debris Relocated to Upper End Box During Reflood

Upper
support
structure

Relocated
debris

Reflood caused significant damage to upper tie plate.

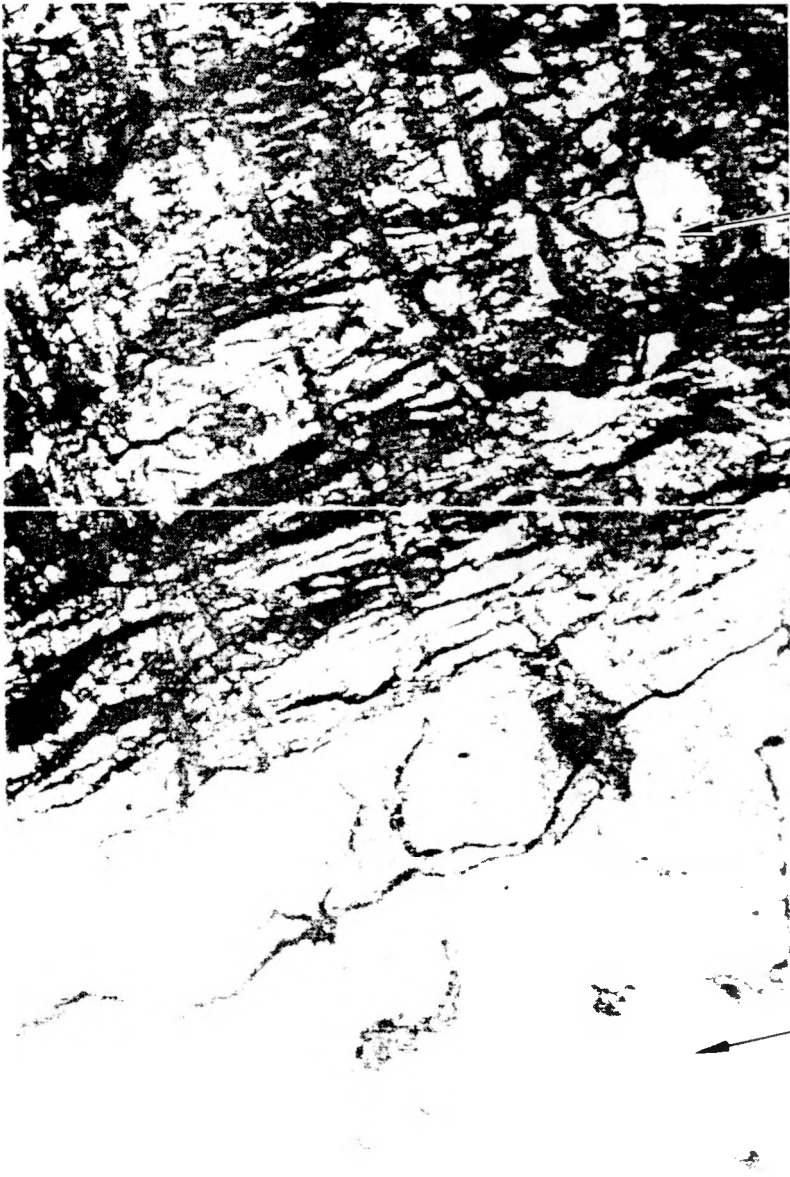
Stainless Steel Liquefaction Contributed to Formation of Lower Blockage

(Fe, Cr, Ni,
Zr, Ag)
multiphase
metallic
structure

Stainless
steel
cladding

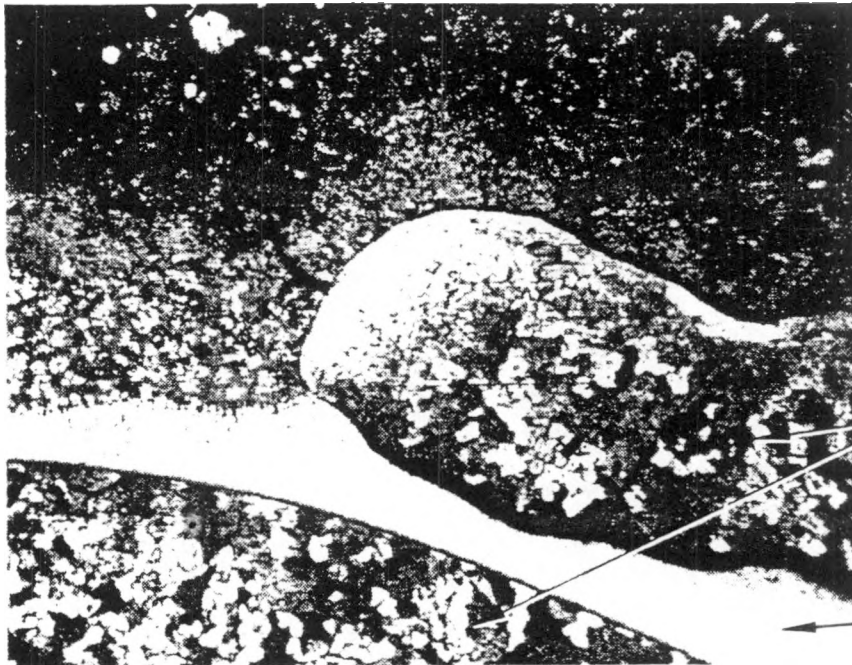
Eutectic Interactions Liquefied Stainless Steel Below Its Melting Point

Stainless
steel
interaction
zone

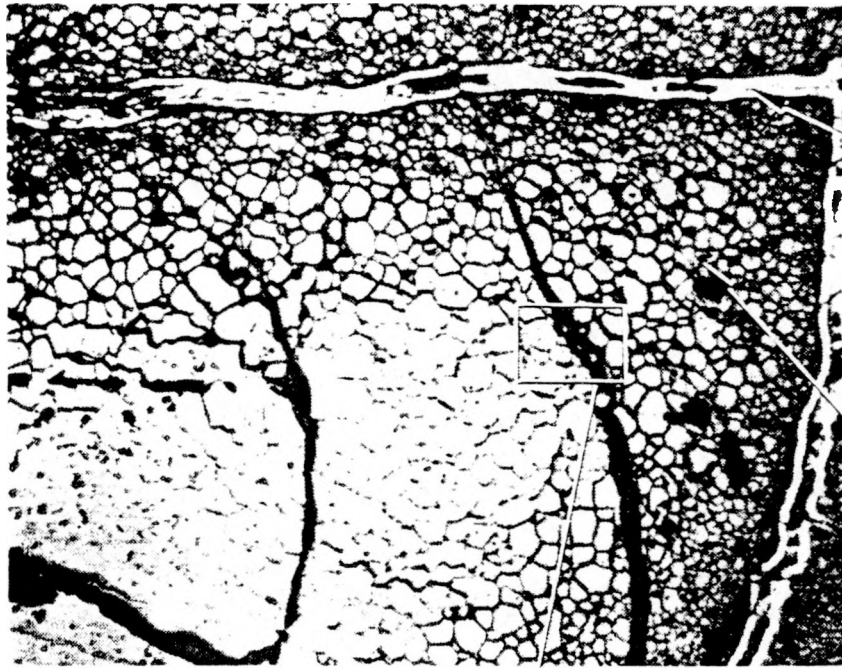
Metallic Melts Caused Grain Boundary Separation

- Metallic melts caused fuel grain boundary separation and fragmentation
- Additional fuel fragmentation probably occurred from thermal shock at reflood

Metallic melt
in fuel crack

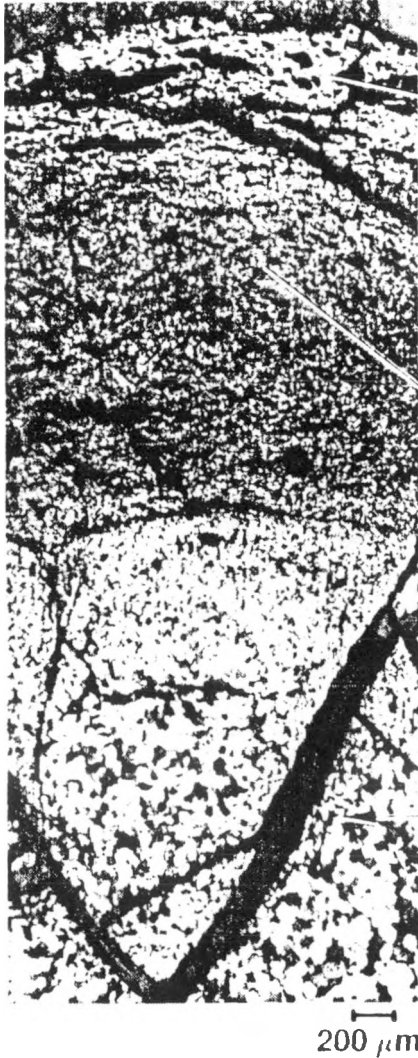
Fe-oxides Caused Fuel Liquefaction

- Some fuel liquefaction occurred as a result of Fe-oxides contacting exposed fuel
- Some fuel melting occurred in center of $(U,Zr)O_2$ upper blockage

Grain growth
