NEDM-14110
MAY 1976

CAUSTIC STRESS CORROSION TESTS FOR THE LLTR

FAST BREEDER REACTOR DEPARTMENT • GENERAL ELECTRIC COMPANY
SUNNYVALE, CALIFORNIA 94086

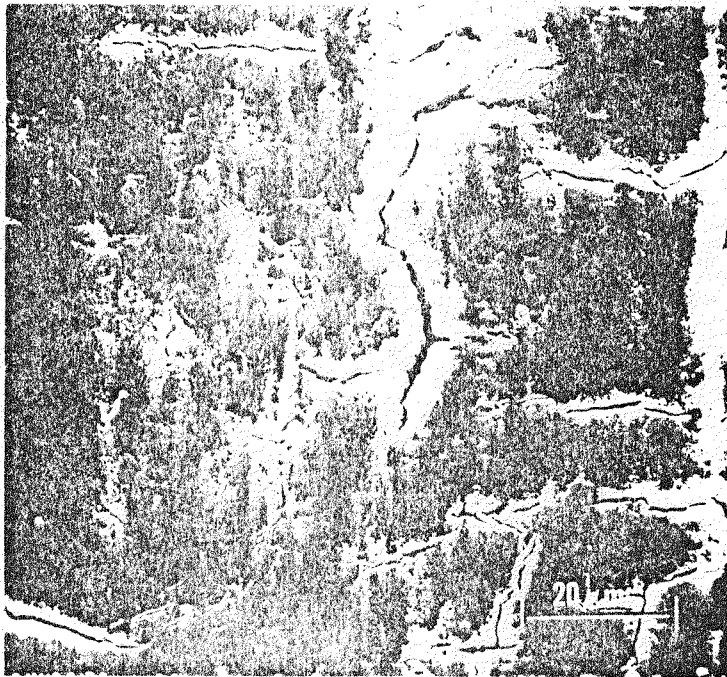
Figure 8. SEM of Cracked Type-304 Stainless Steel (Run D003)

Figure 9. SEM of Cracked Type-304 Stainless Steel (Run D003)

Figure 10. SEM of Cracked Type-304 Stainless Steel (Run D003)

Figures 8, 9 and 10 are scanning electron micrographs of a mill-annealed stainless steel sample from run D003 stressed at 100% of the 300°F yield strength. The edge cracks are clearly intergranular while surface cracks appear to be mixed mode. Some cracks appear to initiate at pits.

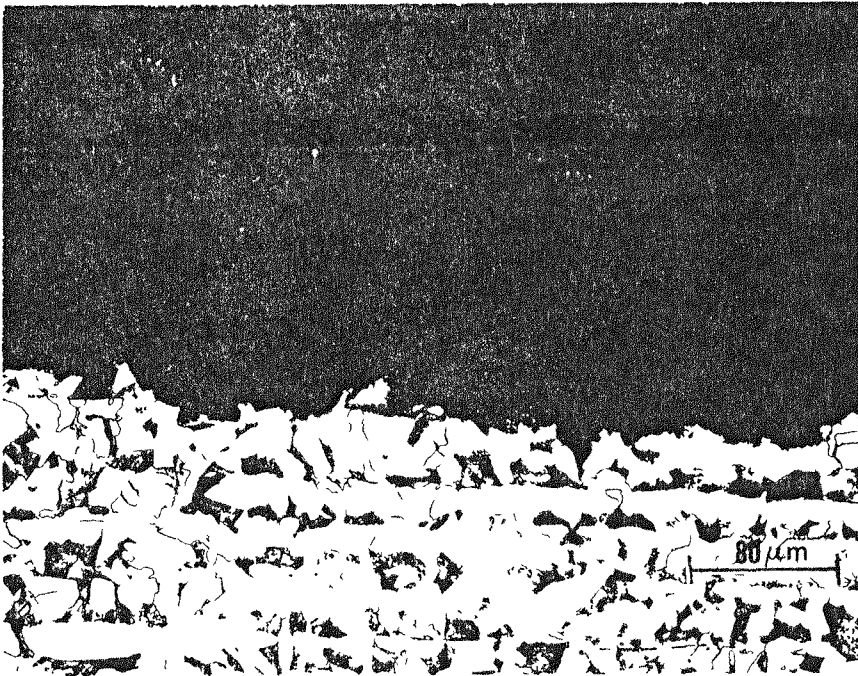
Figure 16. Metallography of Highly Stressed and Corroded 2-1/4Cr-1Mo (Run D003)

*Figure 17. Metallography of Highly Stressed and Corroded Carbon Steel
(Run D006)*

In comparison, the highly stressed 2¹/₄Cr-1Mo and carbon steel samples showed no evidence of stress corrosion. Figures 16 and 17 show the general metallographic sections of the highly stressed samples after exposure to the caustic solution.
