EVALUATION OF FUEL ROD PERFORMANCE IN MAINE YANKEE CORE I

TASK C

**EPRI NP-218
(Research Project 586-1)**

Final Report

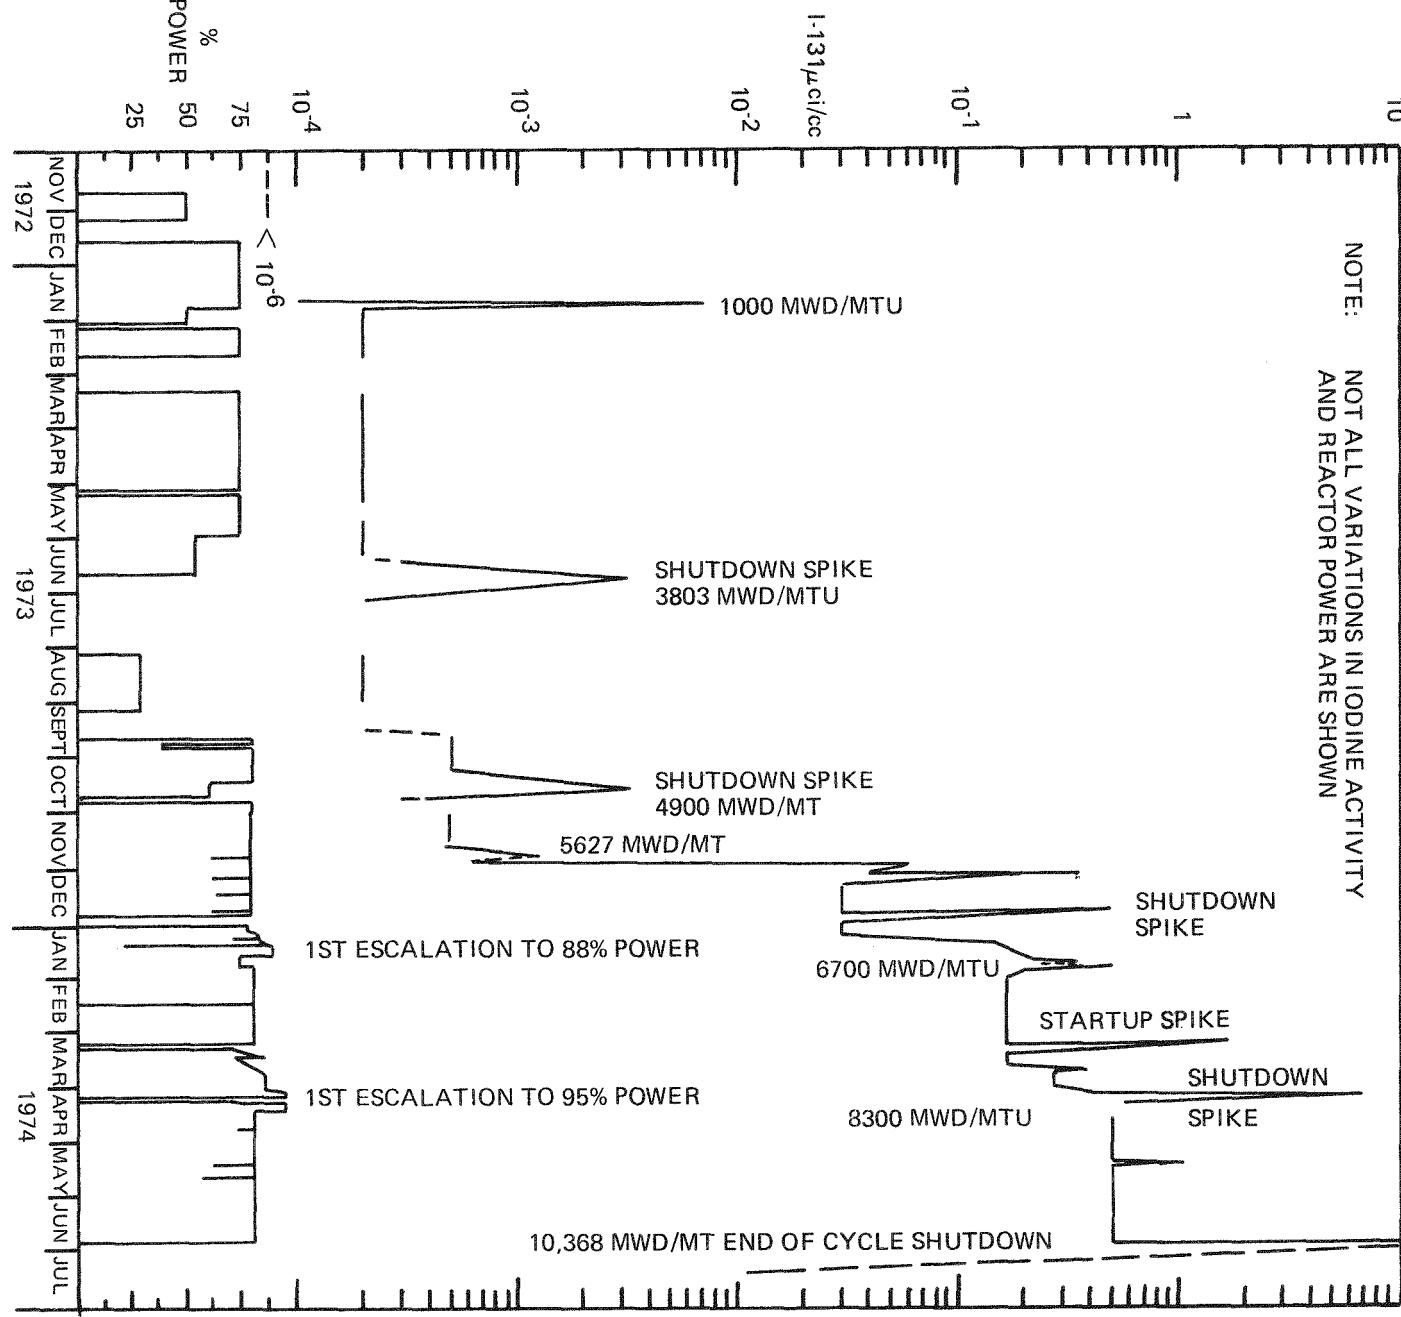
I-131 ACTIVITY IN MAINE YANKEE

The Maine Yankee Core I fuel description and the operating history of the first cycle are summarized in Tables 1-1 and 1-2. The iodine activity history, simplified by presenting the estimated steady state levels (indicative of the number of perforated fuel rods present), as a function of time, is shown in Fig. 1-1. The figure shows that the first significant I-131 activity increase occurred at an average core burnup of 5,627 Mwd/MTU. Later, two major step increases occurred when the core power was escalated for the first time to 88% and 95% of full rating, respectively. It is estimated that the total number of perforated rods, corresponding to the steady state I-131 at the end of Cycle 1, was 225*.

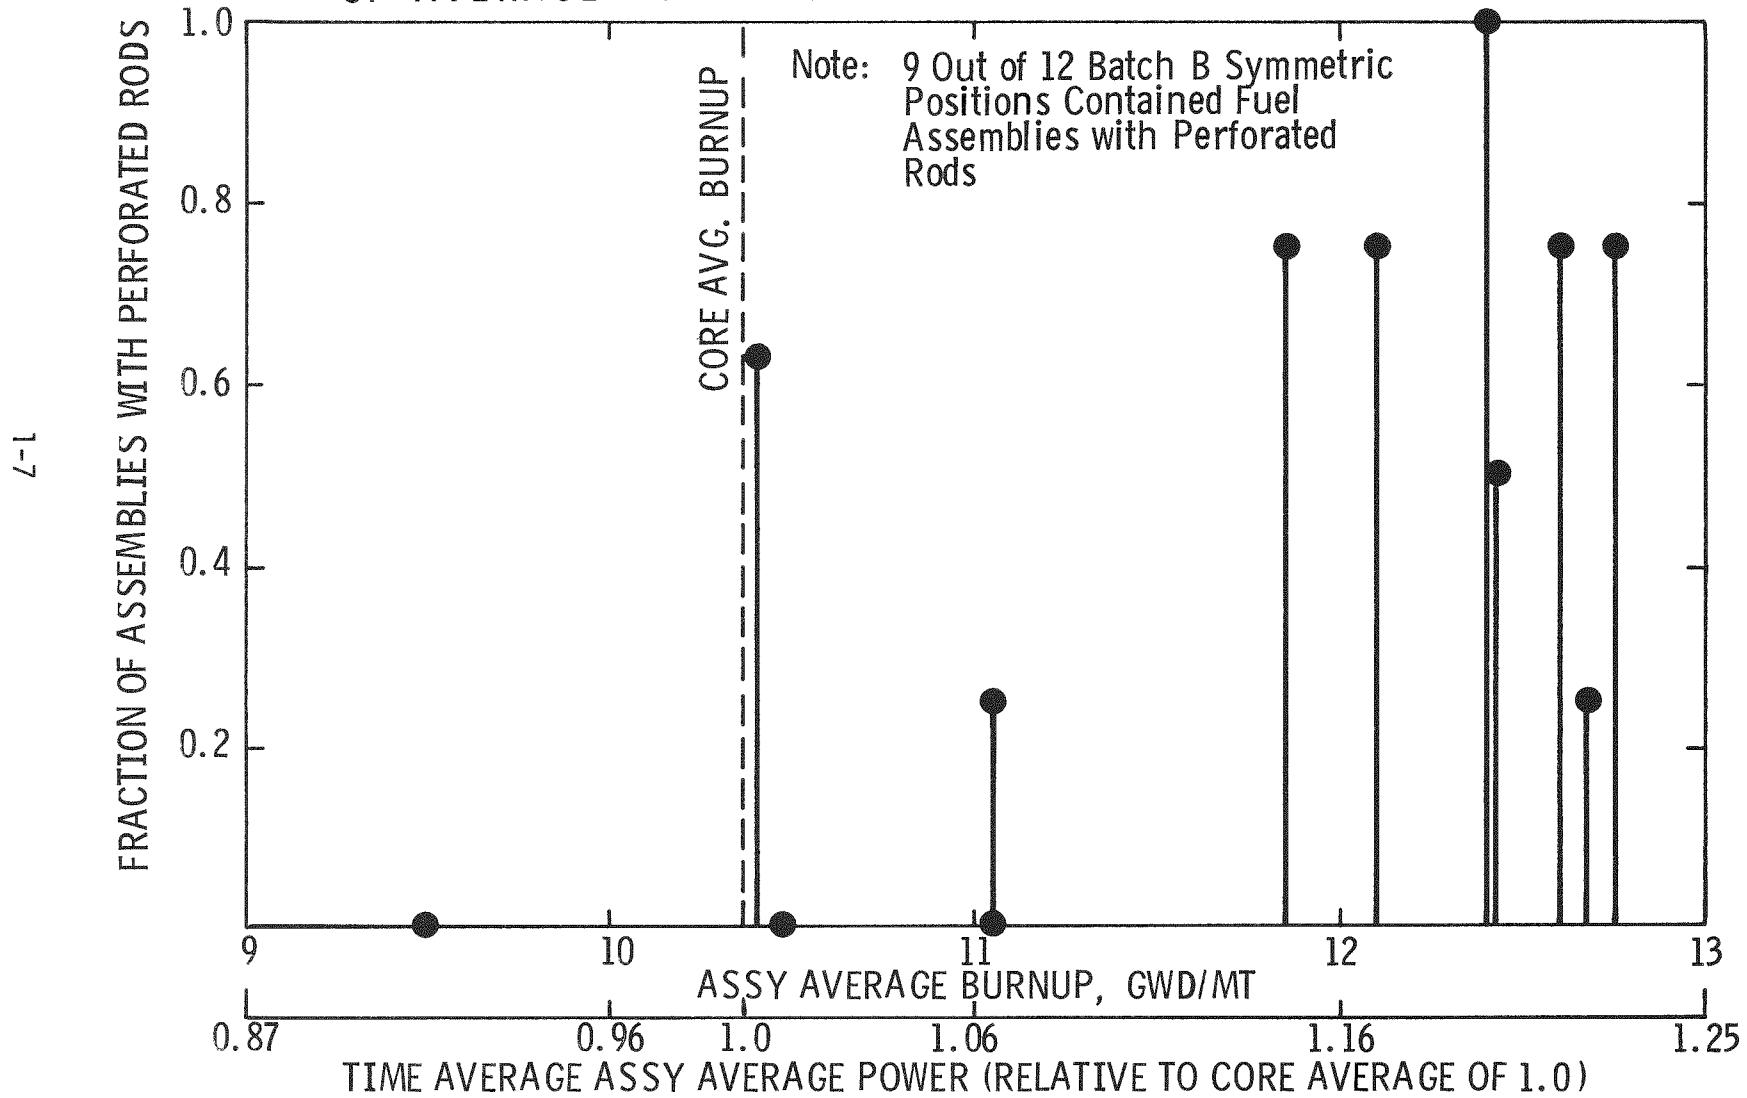
Sipping tests, performed during the first cycle shutdown in July 1974 on all 217 fuel assemblies in the core, identified a total of 43 assemblies with perforated rods; 41 from Batch B and only one each from Batches A and C. The location and identification of these assemblies can be seen in the Fig. 1-2 core map which also shows the positions of the control element assemblies (CEAs) of Banks Nos. 4 and 5. These were used for maneuvering during the first cycle, and it should be noted that they are located only in Batch A and C assemblies. Generally, the Batch B assemblies experienced the highest burnup (also the highest power operation) in the core; and, as shown in Fig. 1-3, the perforated fuel rods were predominantly in the higher power Batch B assemblies.

HISTOGRAM SHOWING THE FRACTION OF BATCH B ASSEMBLIES WITH
PERFORATED RODS IN EACH CORE SYMMETRIC POSITION AS A FUNCTION
OF AVERAGE ASSEMBLY BURNUP FOR EACH POSITION

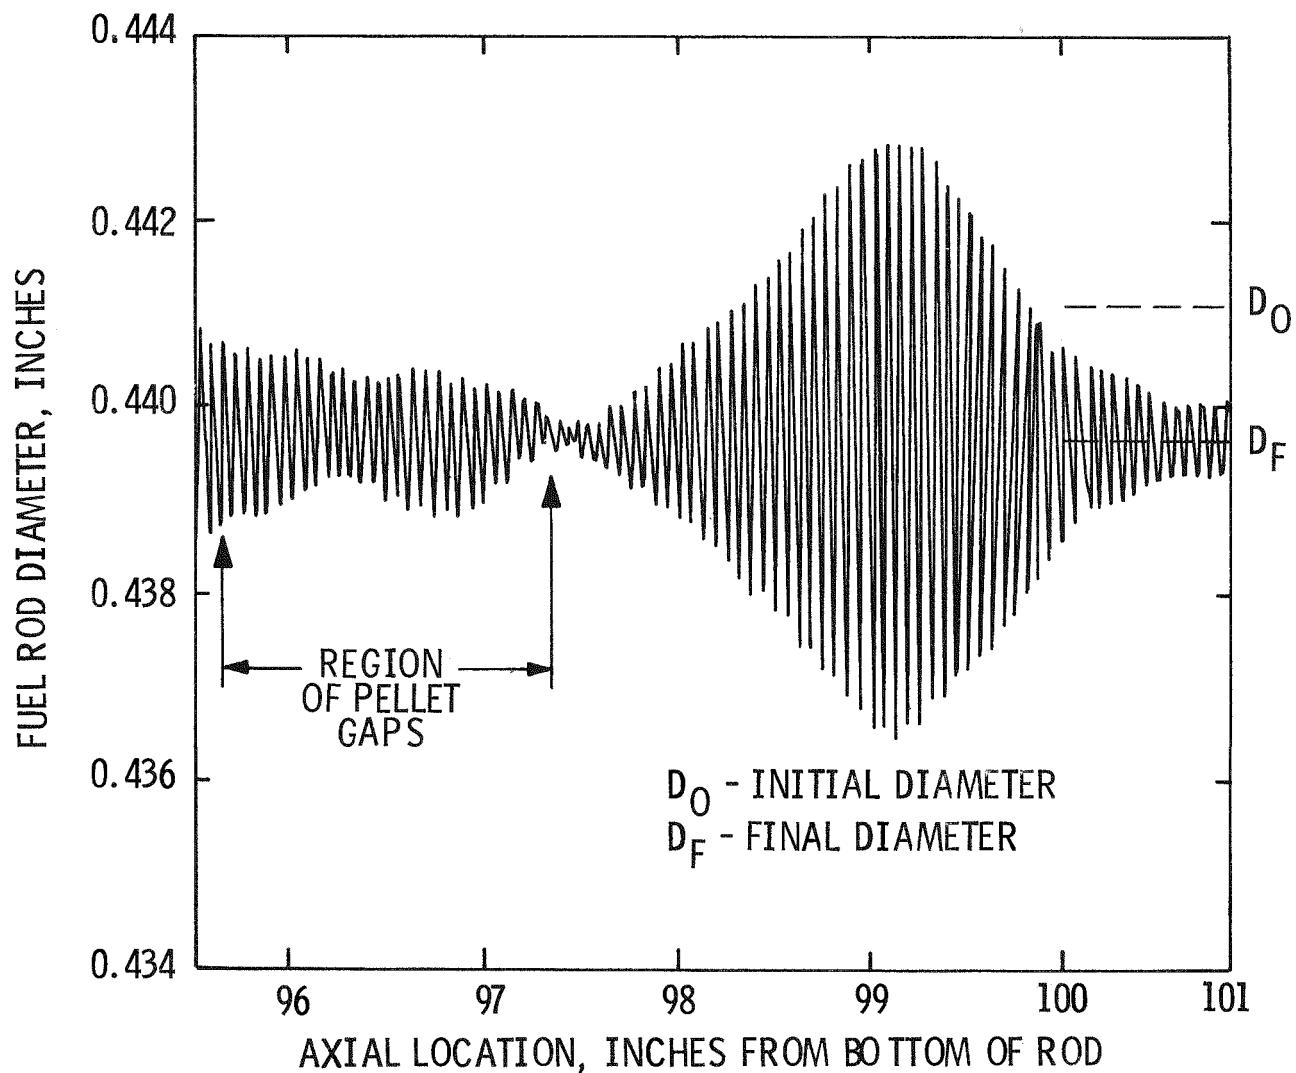
PORTION OF PROFILOMETER TRACE OF JBP-027
SHOWING AREA OF PELLET GAP WITH HIGHEST
OVALITY ON ROD JUST ABOVE THE GAP

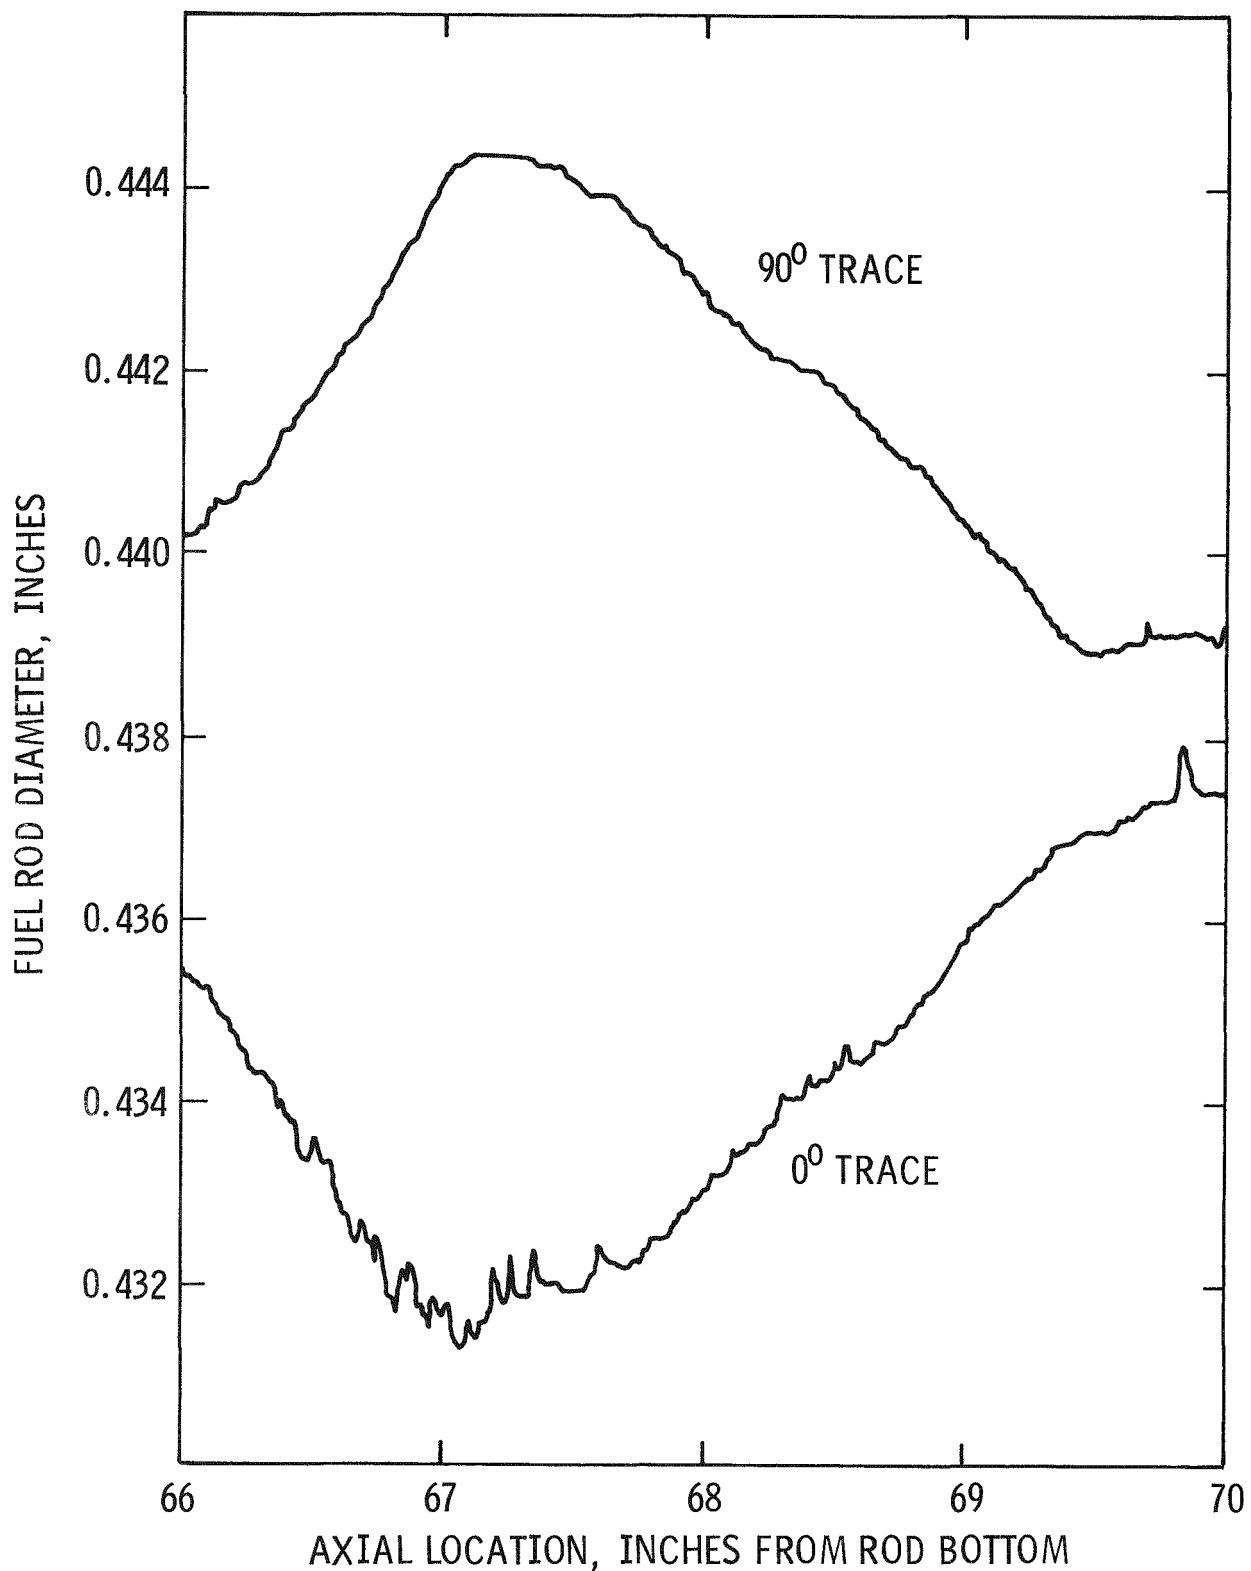
Figure 4-7 SUPERPOSITION OF LINEAR DIAMETER TRACES
AT 0^0 AND 90^0 FROM ROD JBY-097 SHOWING
ROTATION IN FUEL ROD OVALITY

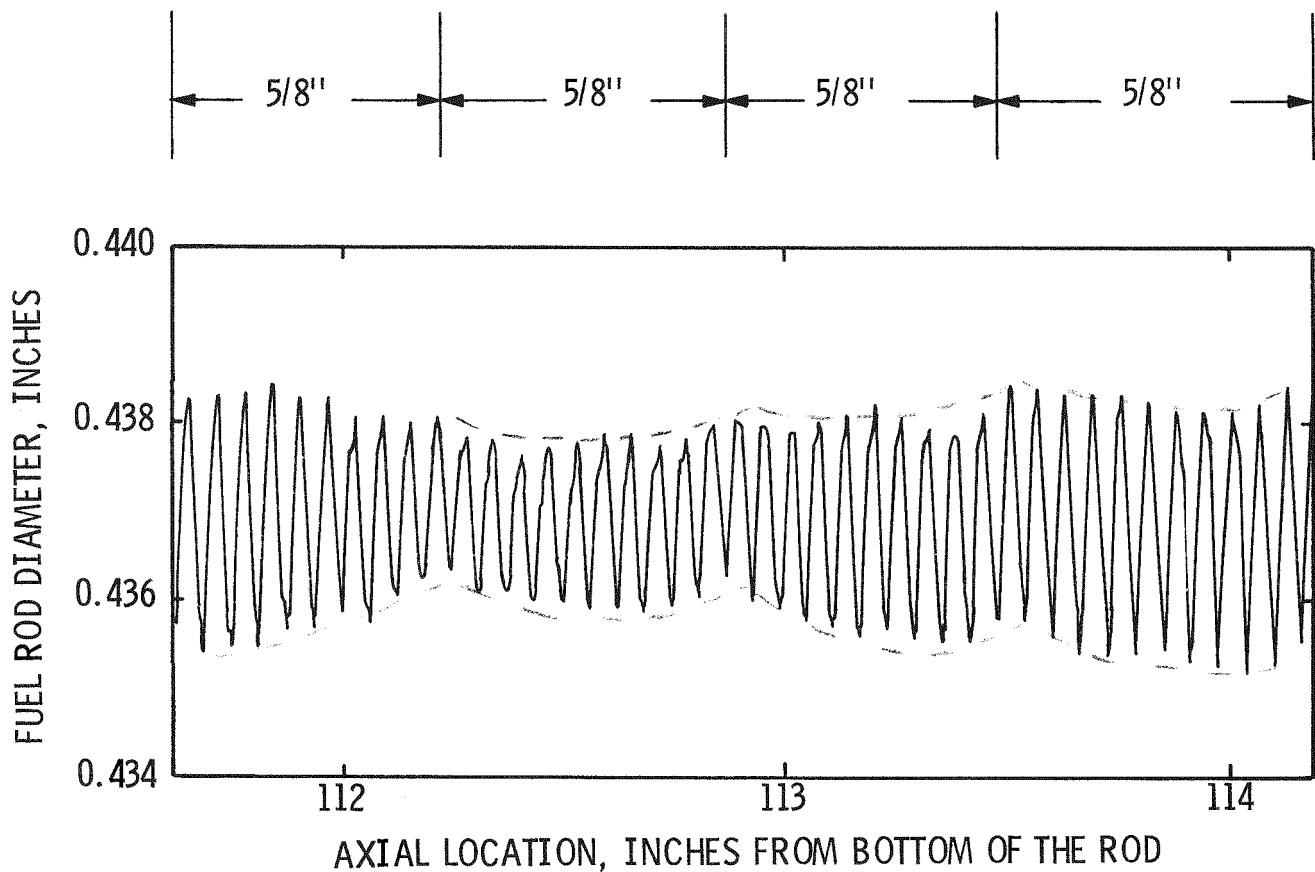
Figure 4-8
PORTION OF PROFILOMETER TRACE OF JBP-005
SHOWING FUEL PELLET RIDGING

APPROXIMATE PELLET LENGTH = 5/8 IN.

Linear diameter traces were obtained on two rods during the second campaign which more clearly showed the presence of clad ridging (ridges of up to 0.4 mils were observed). For example, Fig. 4-9 shows the clad ridging observed at pellet interfaces in Rod JBY-097. Note that additional ridges are seen away from pellet interfaces. These are believed to be related to the transverse pellet cracking pattern seen during longitudinal clad slitting and examination of fuel rods. Another observation of significance is the presence of ridges mostly at the minor axis of clad ovality as seen in Fig. 4-9. The fact that clad ridges are less frequently observed on the major axis of the clad ovality ellipse indicates that the ridges are real (i.e., not caused by crud particles) and are not continuous over the fuel rod circumference.

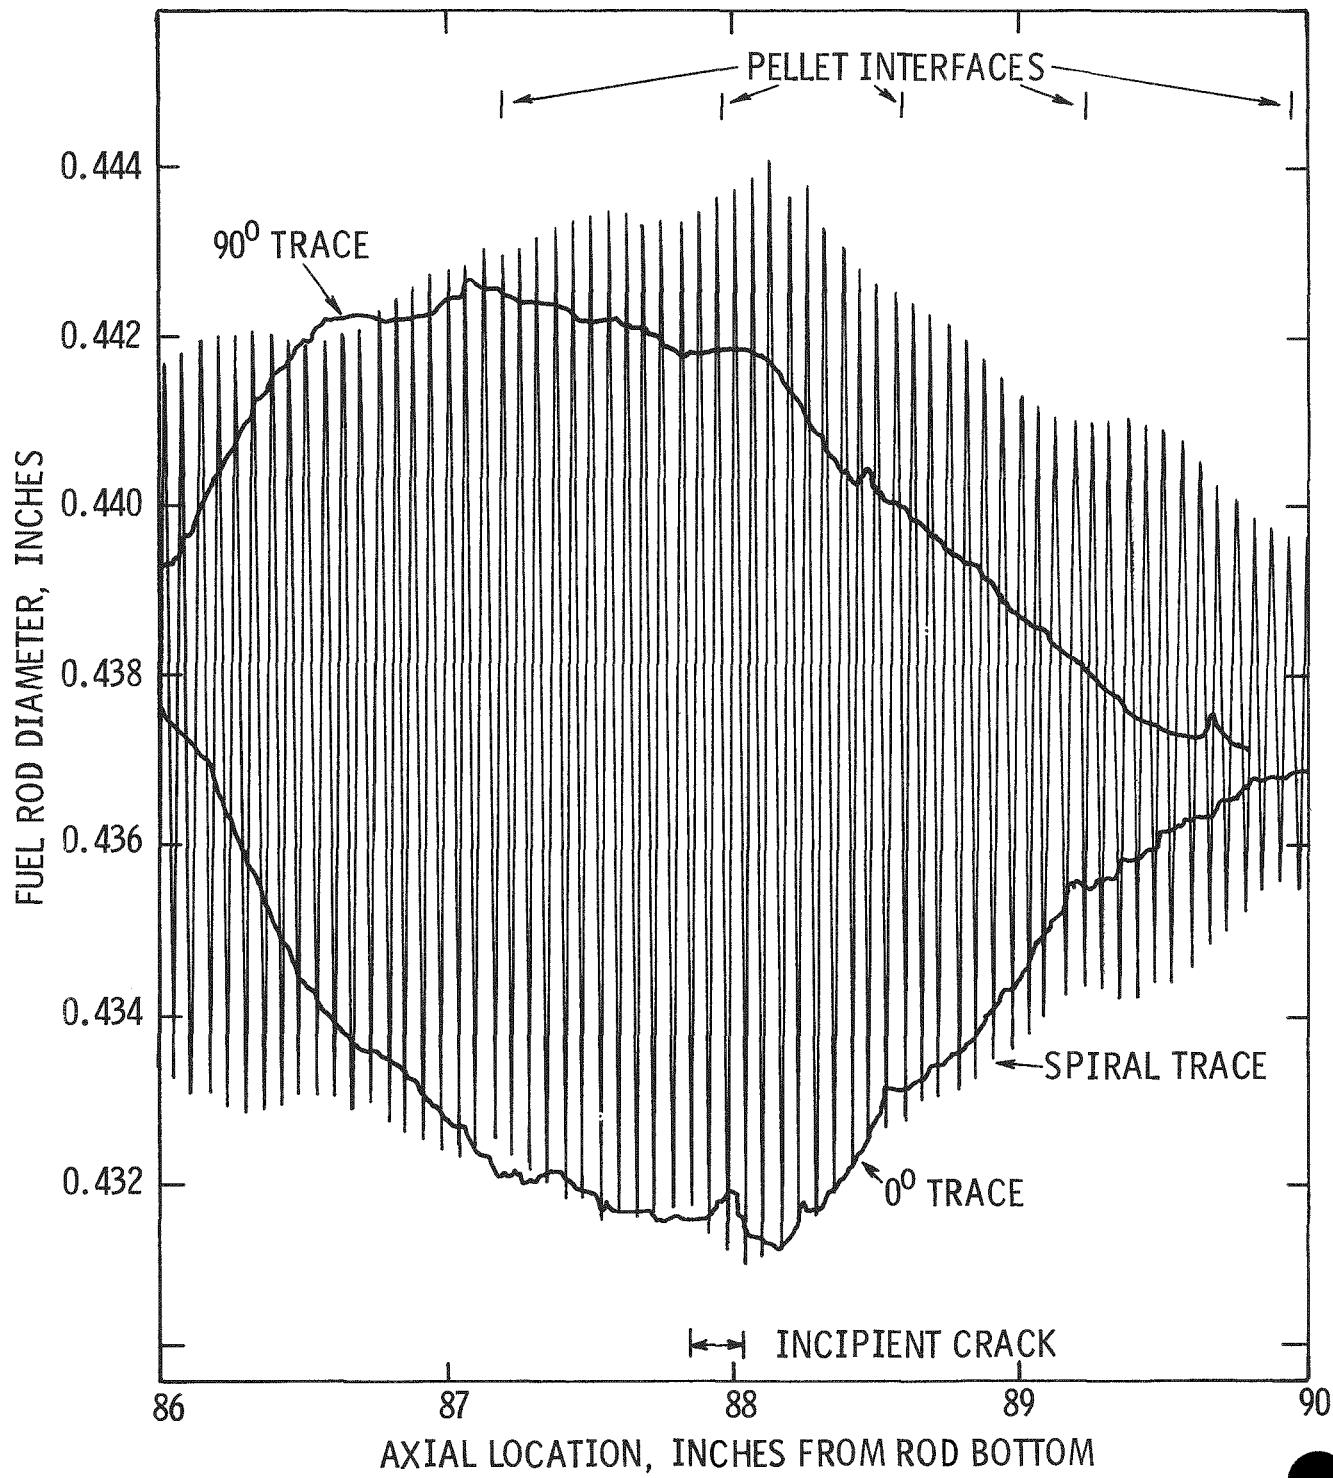
Figure 4-9
SUPERPOSITION OF LINEAR AND SPIRAL DIAMETER TRACES
SHOWING CLAD RIDGING AT PELLET LENGTH INTERVALS
IN ROD JBY-097

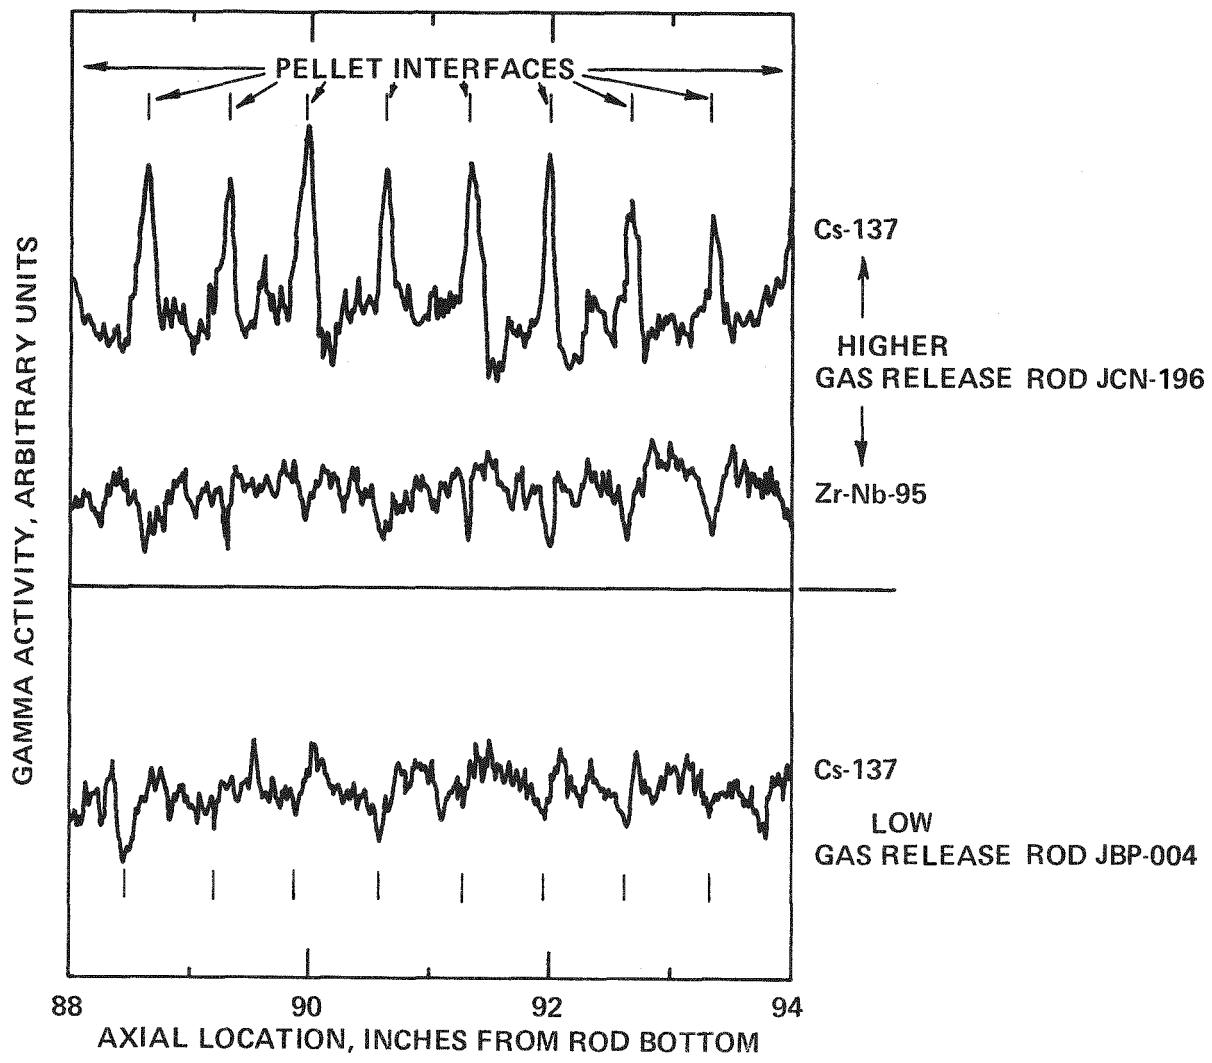
Figure 4-21
 PORTIONS OF Cs-137 SCAN FROM THE PEAK POWER POSITION (88-94 IN)
 OF HIGH AND LOW GAS RELEASE RODS SHOWING THE DIFFERENCE IN
 Cs PEAKING AT PELLET INTERFACES

Only the higher gas release rods exhibited cesium gamma scan peaks at pellet interfaces. Further evidence of fission product redistribution in these rods was observed in visual and scanning electron microscope (SEM) examinations of the internal clad surface. These revealed fuel-clad bonding mainly near pellet interface locations. Chemical characterization by X-ray spectrometry indicated the chemical composition of the fuel-clad bond region to be a mixture of cesium, uranium and zirconium combined with oxygen. Also, redistributed iodine and tellurium were detected on the clad surface. The presence of a Cs-Zr-U-O phase in the fuel-clad bond was confirmed by electron microprobe analysis of metallographic specimens.

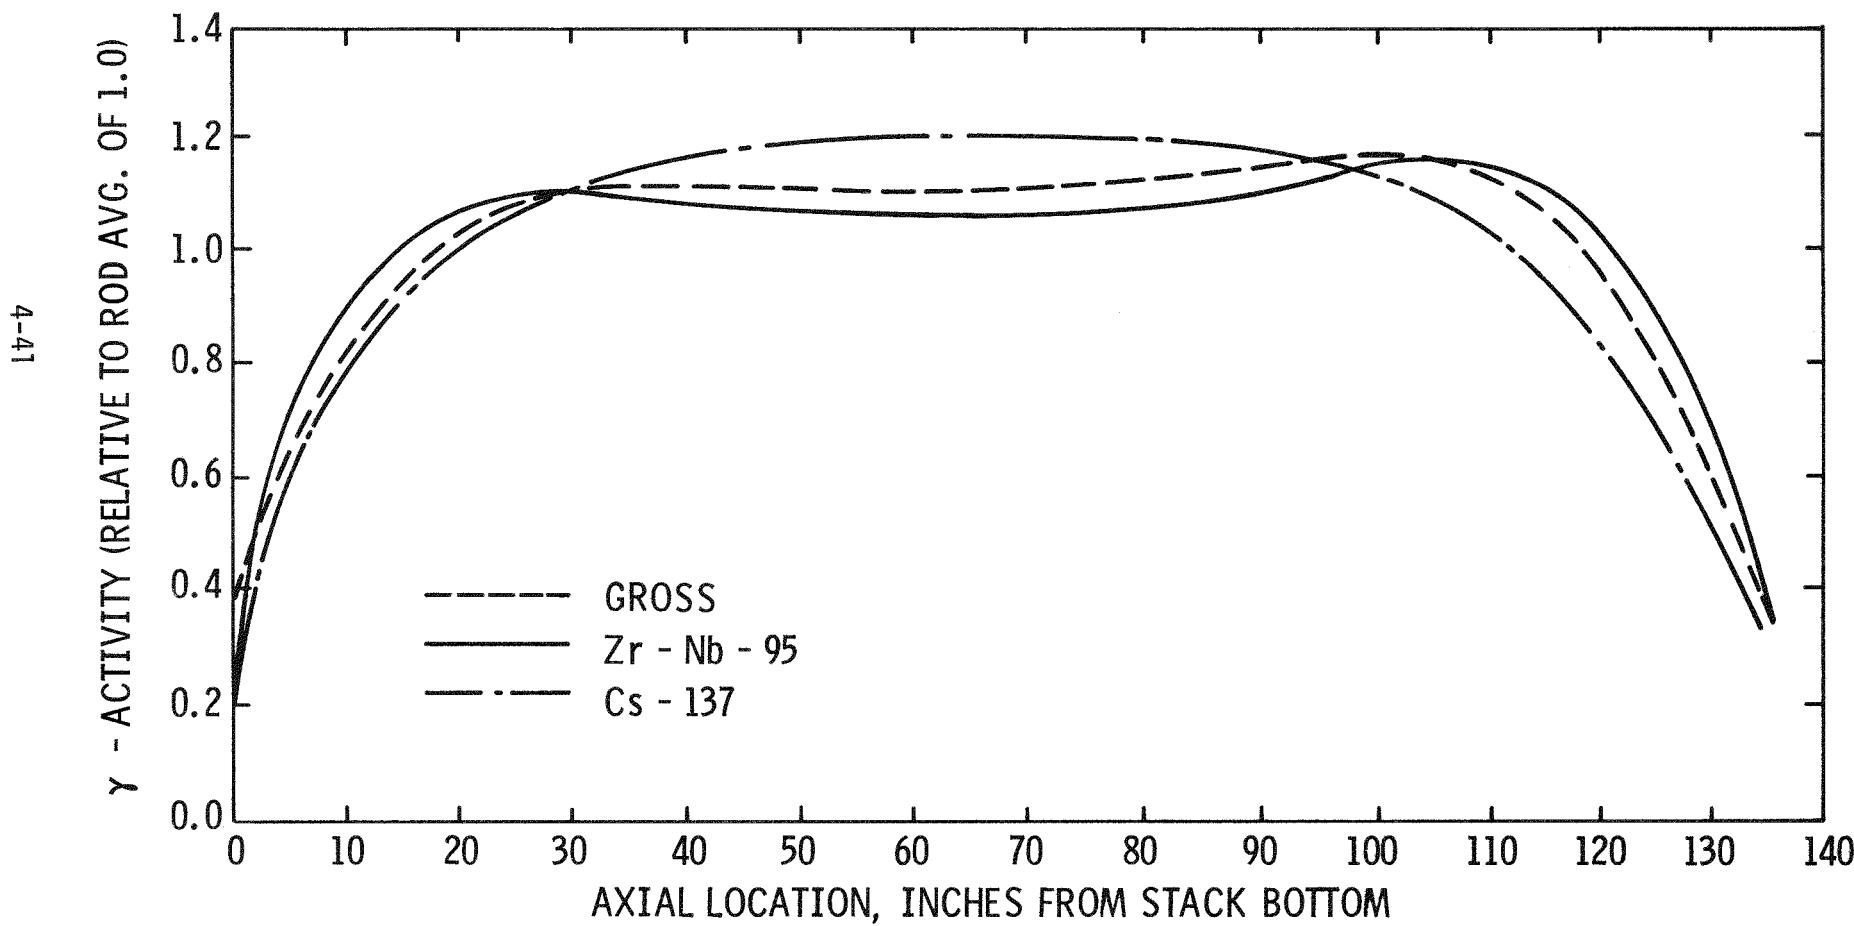
Figure 4-22
COMPARISON OF GROSS GAMMA SCAN PROFILE WITH SPECIFIC ISOTOPE
GAMMA SCANS FOR ROD JCN-196

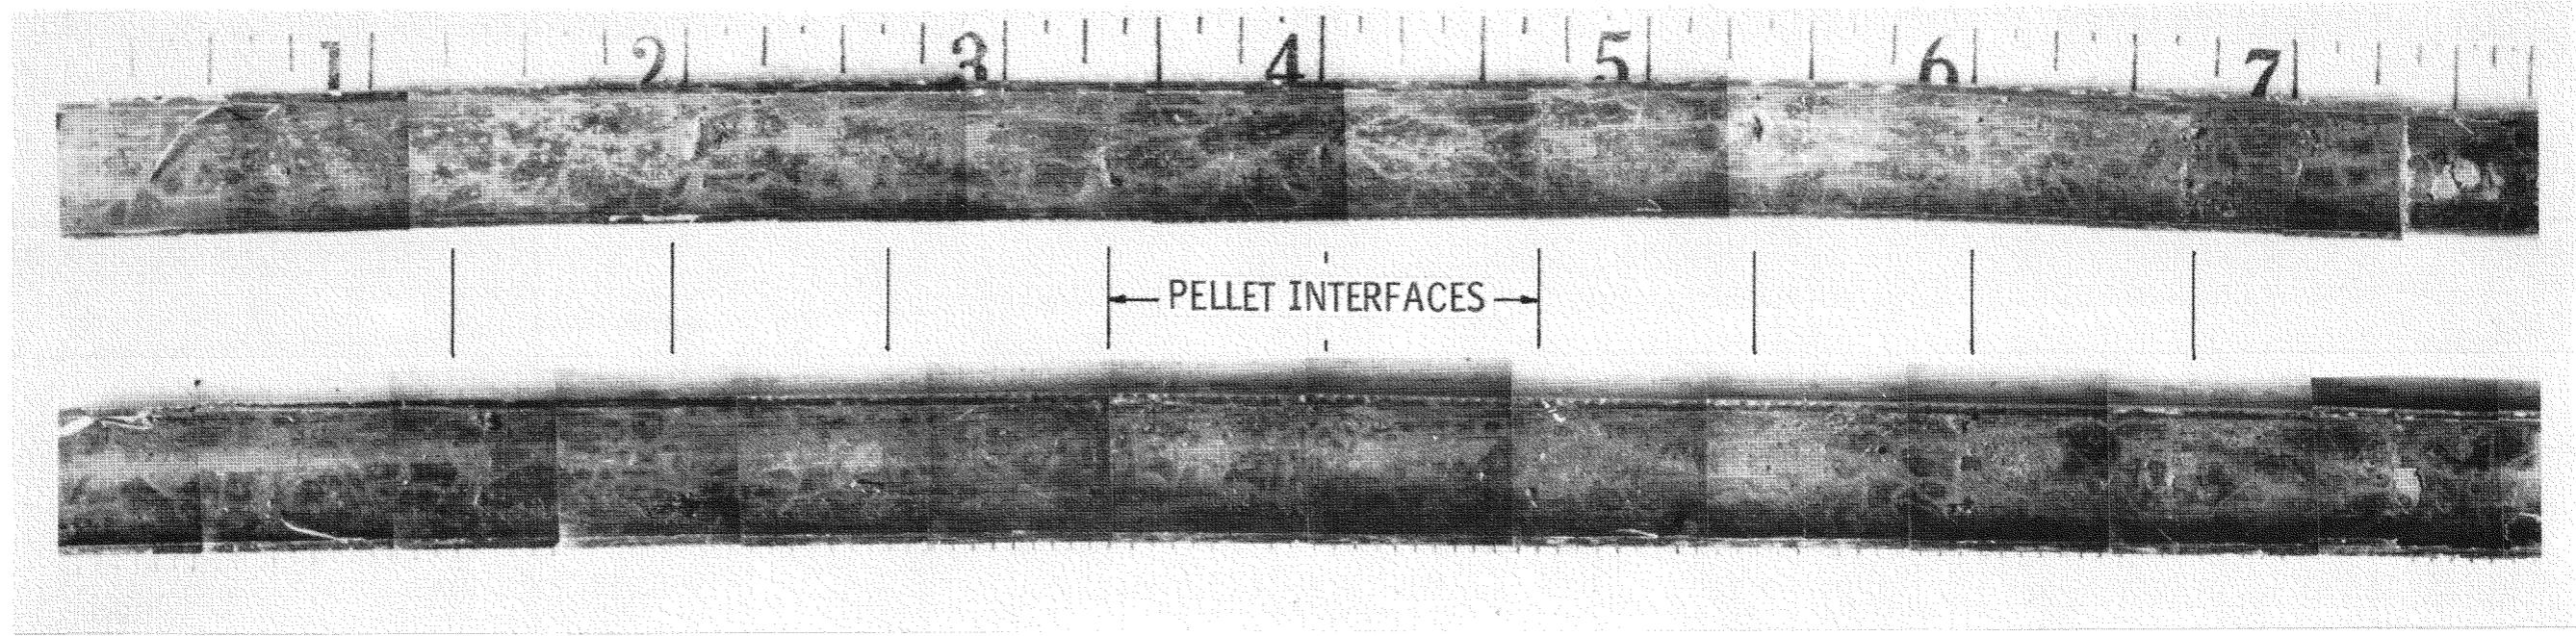
Figure 4-27 MONTAGE OF SLIT CLADDING SECTION FROM JBP-027 SHOWING THE TWO SHELLS WITH FUEL BONDED TO CLADDING AT PELLET INTERFACES.

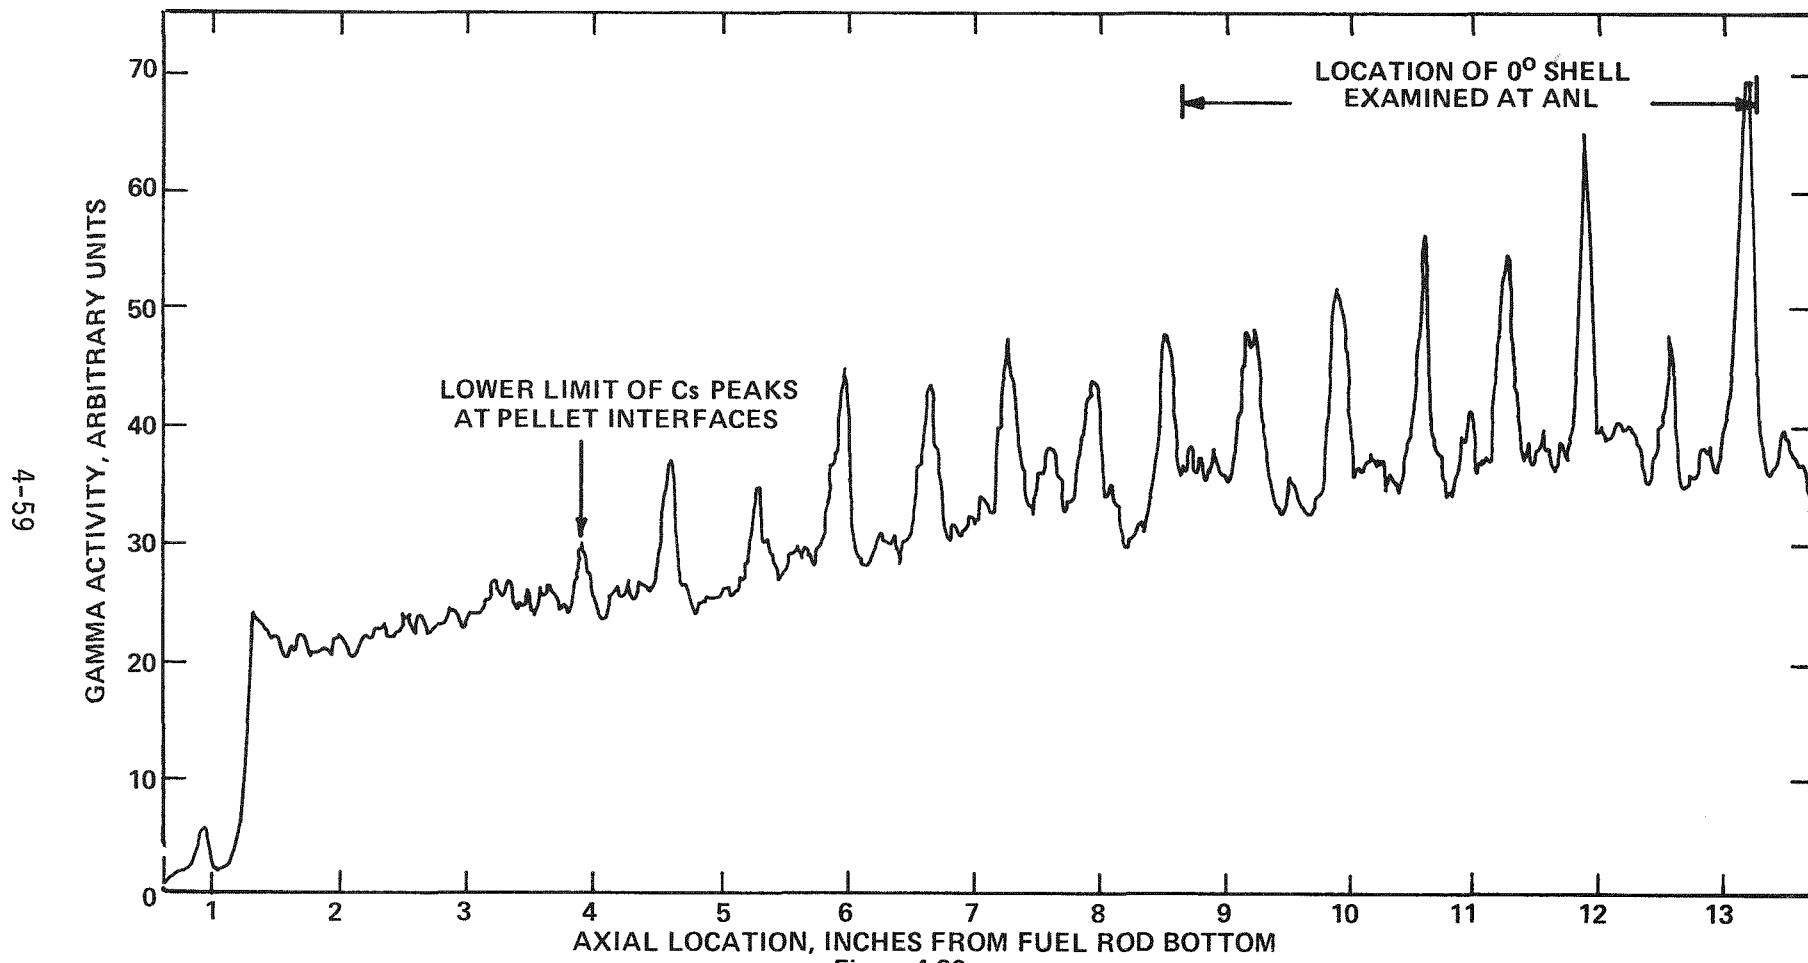
Figure 4-30
WHOLE ROD Cs-137 GAMMA SCAN OF BOTTOM END OF JCN-196 SUBJECT TO CLADDING
INTERNAL SURFACE EXAMINATION

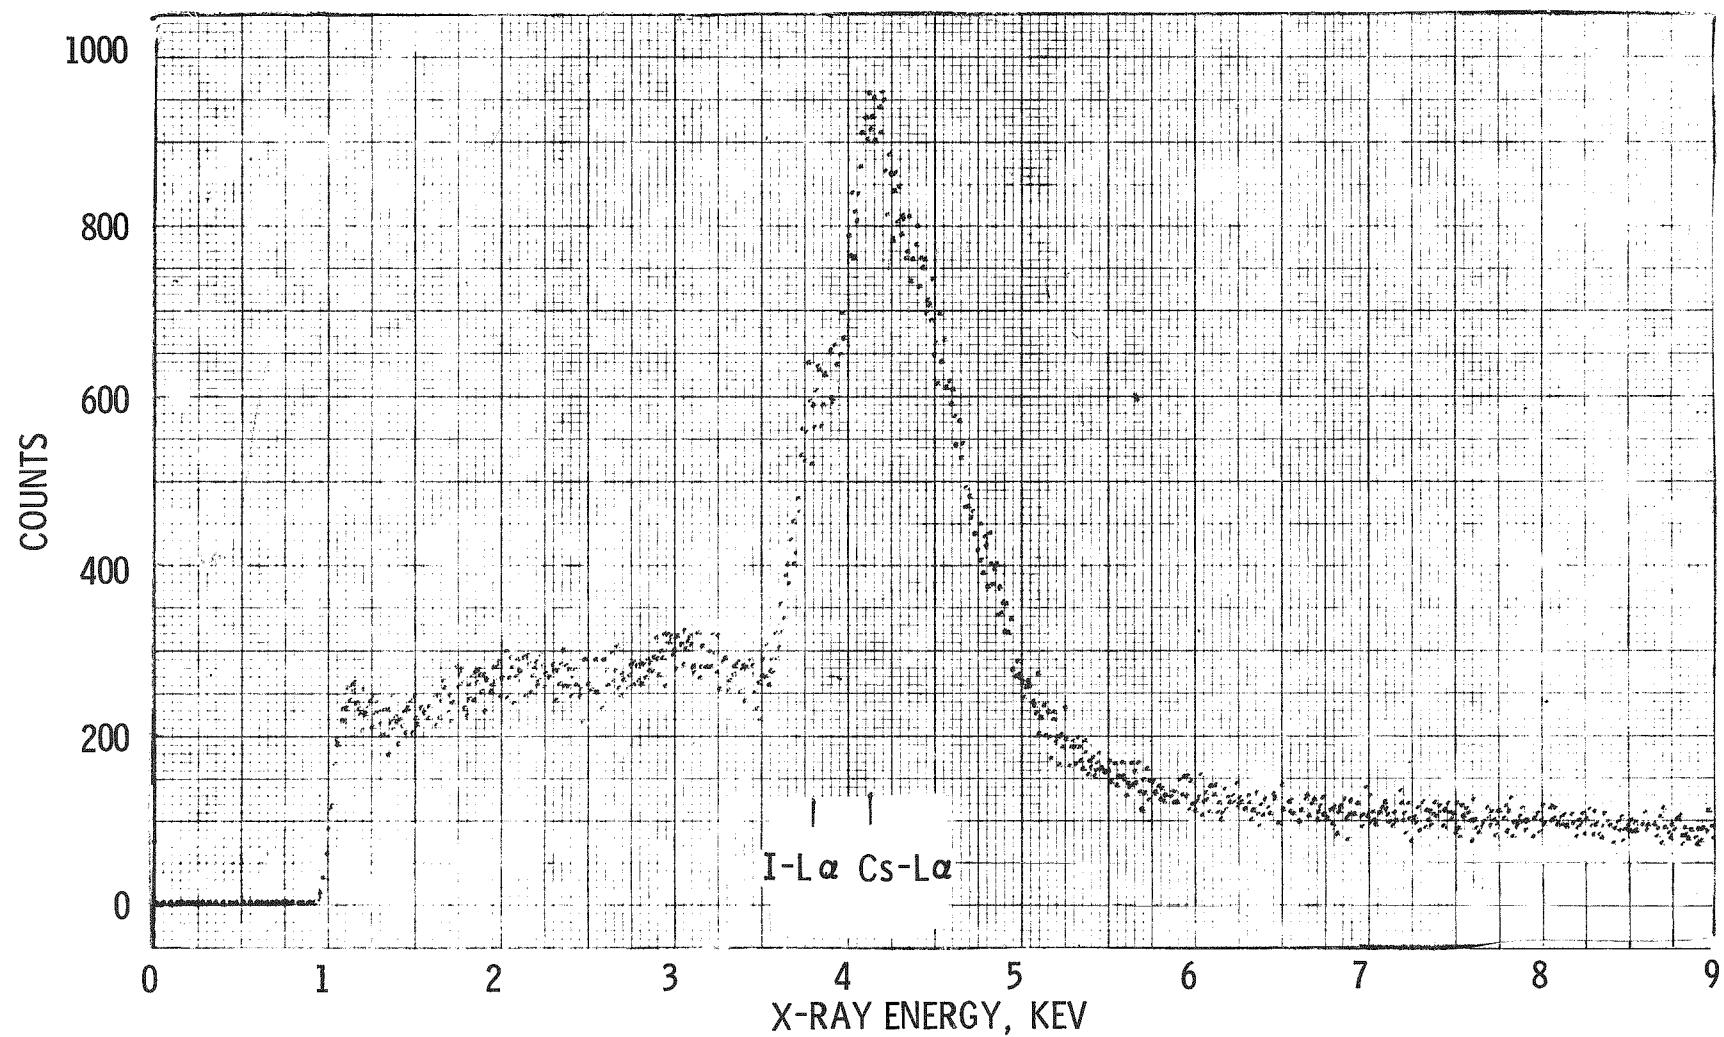
Figure 4-43 X-RAY SPECTRUM OF POINT G IN Figure 4-40 (TOP) SHOWING THE PRESENCE OF Zr, Cs, U AND Te.

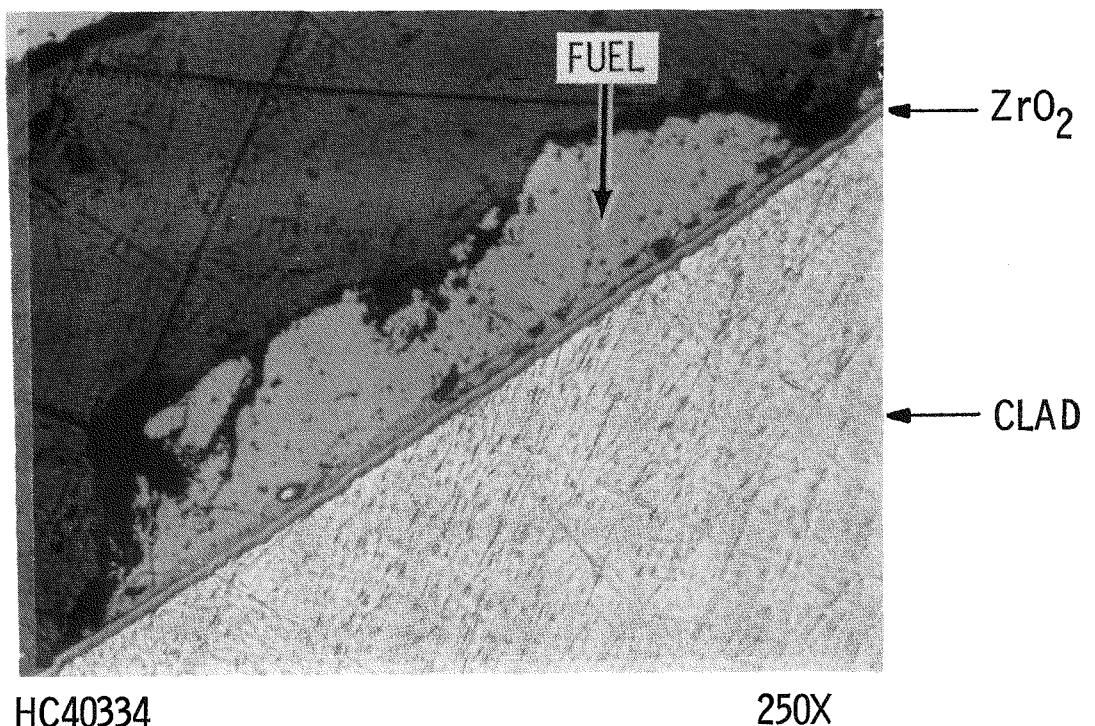
Figure 4-53 FUEL/CLAD BONDING IN ROD JBP-027, 59 1/8 INCH
FROM BOTTOM (AS POLISHED)

In the second hot cell campaign, fuel-clad bonding was again observed in the high gas release rods on a frequent basis. For example, Fig. 4-57 shows typical bonded areas in transverse metallographic specimens. The Fig. 4-58 detail of the longitudinal specimen cross section shows examples of bonding at or near the pellet interfaces.

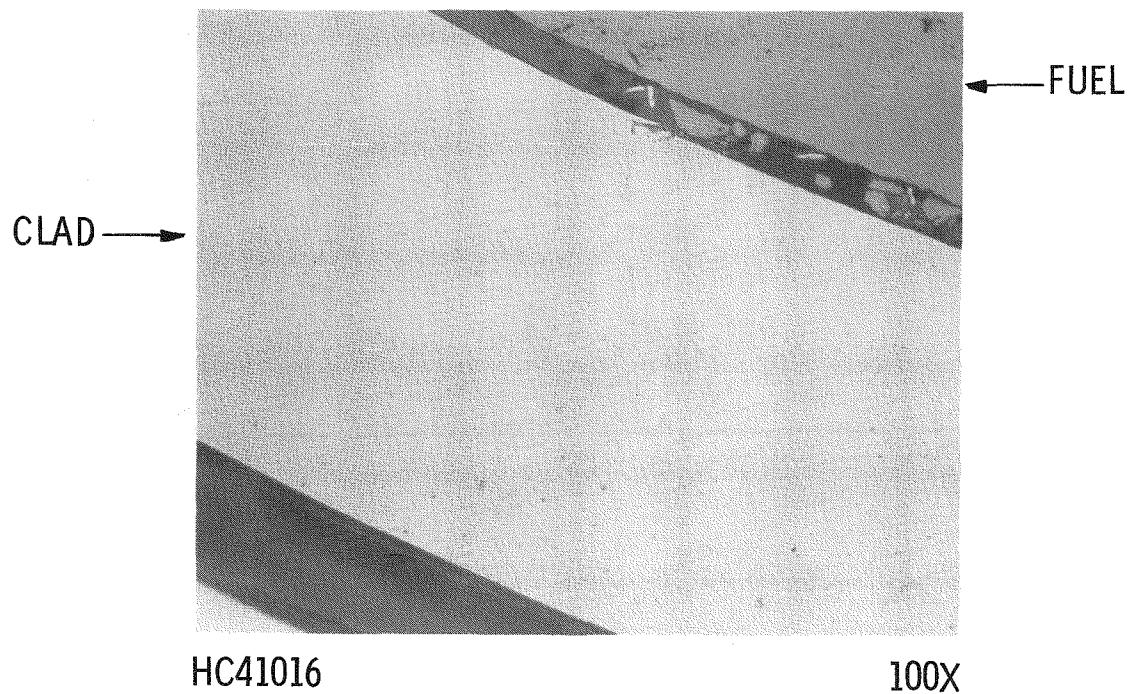
Figure 4-59 DEFECT ON INNER CLADDING SURFACE OF ROD JBY-142
AT 90-11/32 INCHES FROM BOTTOM (AS POLISHED)

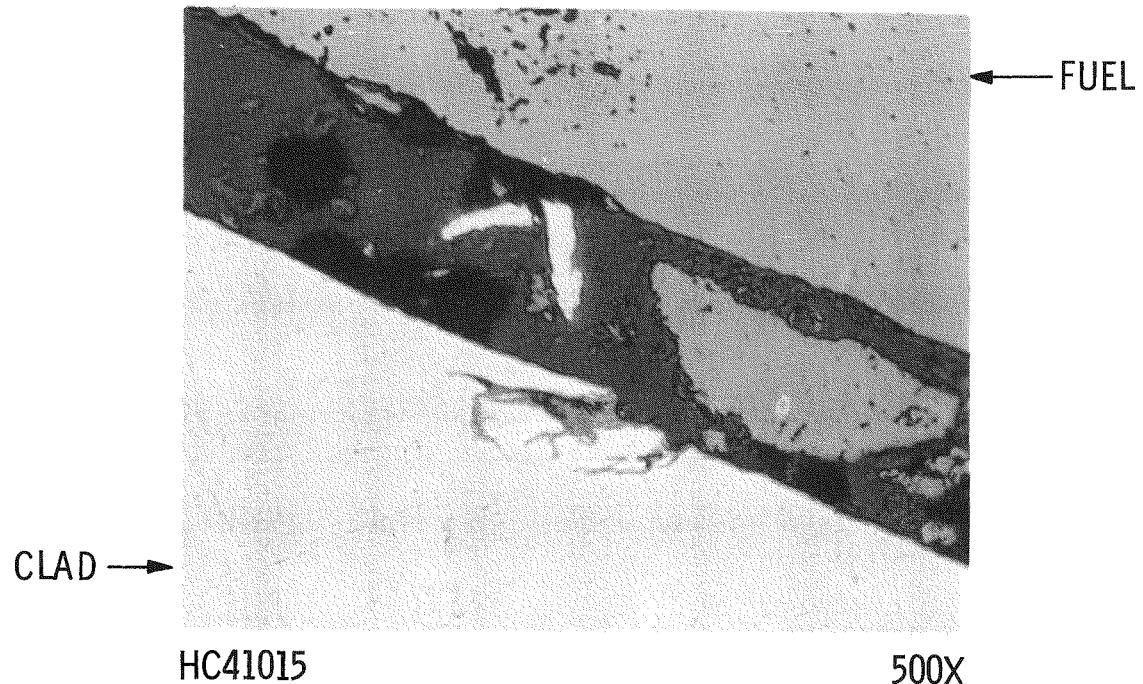
Figure 4-60 DETAIL OF Figure 4-59 CLADDING DEFECT IN ROD
JBY-142 (AS POLISHED)

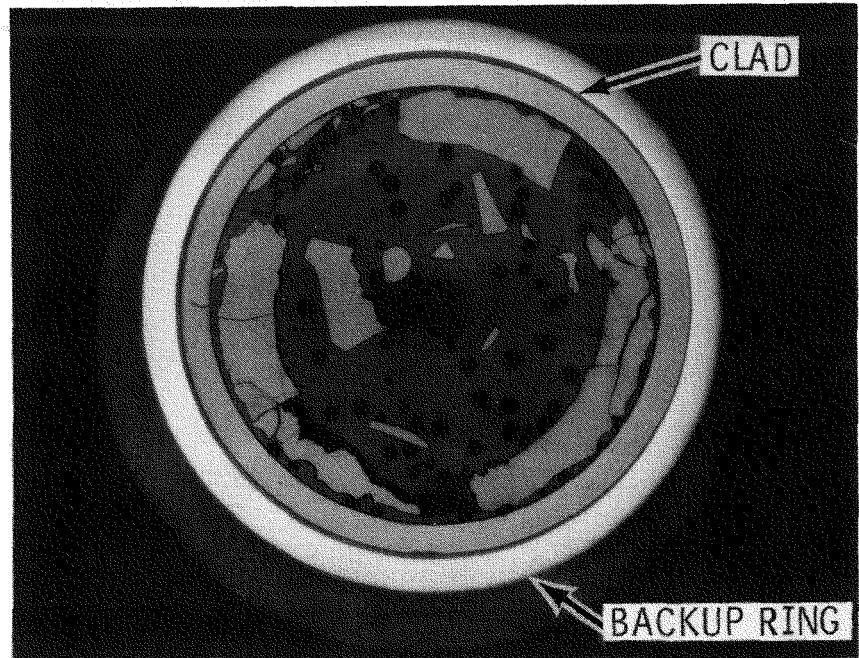
HC41254

Figure 4-61 MACROPHOTOGRAPH OF CRACK AT PELLET-PELLET INTERFACE IN MOUNT X-342 FROM ROD JBP-005 (ABSENCE OF FUEL IS DUE TO PELLET END DISHING).

The other defect, consisting of two internal surface cladding cracks, was found in Mount X-342 from Rod JBP-005 containing the ECI shown in the Fig. 4-25 trace at 94-3/16 inches from the bottom of the rod. (Note that this is in a relatively high burnup position of a high gas release rod.) One of the two cracks was observed immediately on the first surface examined at a pellet-pellet interface as shown in Fig. 4-61 and 4-62. Further metallography of successive surfaces was performed to characterize the crack and establish its axial length. Upon grinding 4 mils to the second surface, the second crack was found adjacent to the first crack. Both cracks were observed on the next five surfaces over a distance of 61 mils. The typical appearance of the cracks is illustrated in the photographs of the sixth surface shown in Fig. 4-63 through 4-66. After grinding a total of 93 mils from the first surface, both cracks disappeared. From a
