EVALUATION OF FUEL ROD PERFORMANCE IN MAINE YANKEE CORE I

TASK C

**EPRI NP-218
(Research Project 586-1)**

Final Report

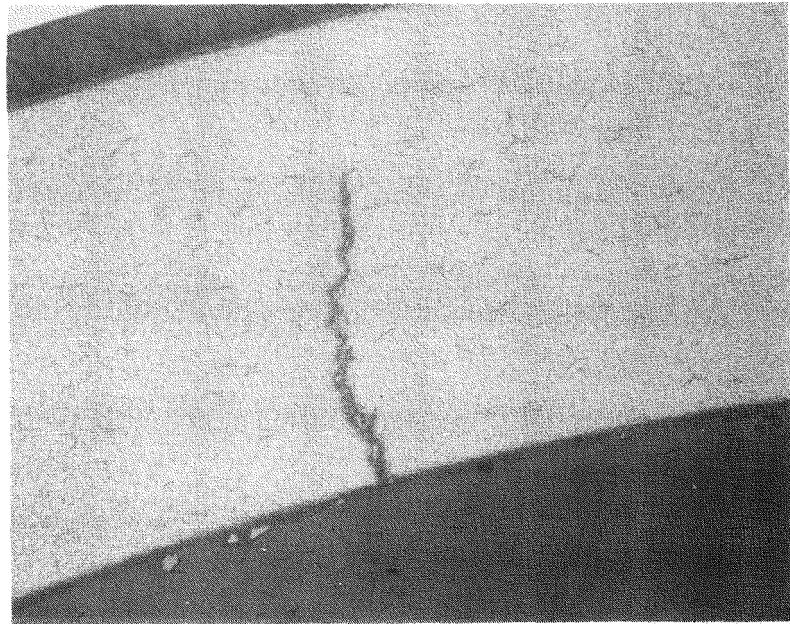
HC41239

Figure 4-62 CRACK AT 75^0 IN MOUNT X-342 FROM ROD JBP-005 AT PELLET INTERFACE 1st SURFACE (ETCHED).

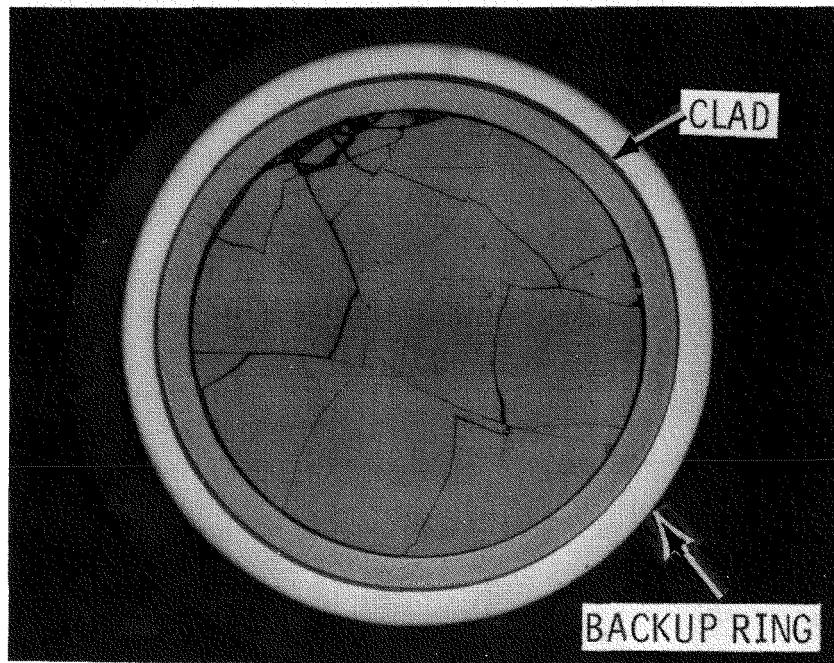
HC41420

Figure 4-63 MACROPHOTOGRAPH OF CRACKS IN MOUNT X-342 FROM ROD JBP-005 - 6th SURFACE (ETCHED)

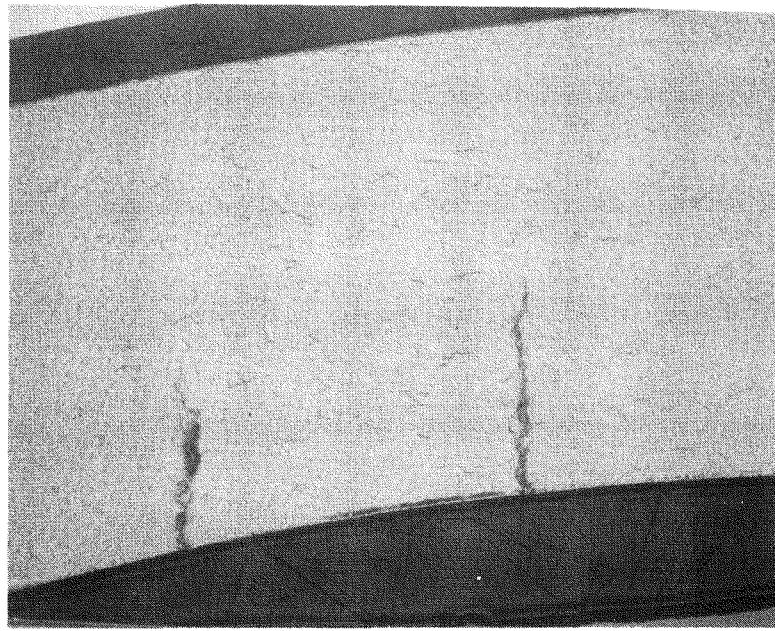
HC41415

Figure 4-64 CRACKS AT 75^0 AND 80^0 IN MOUNT X-342 FROM ROD JBP-005 - 6th SURFACE (ETCHED)

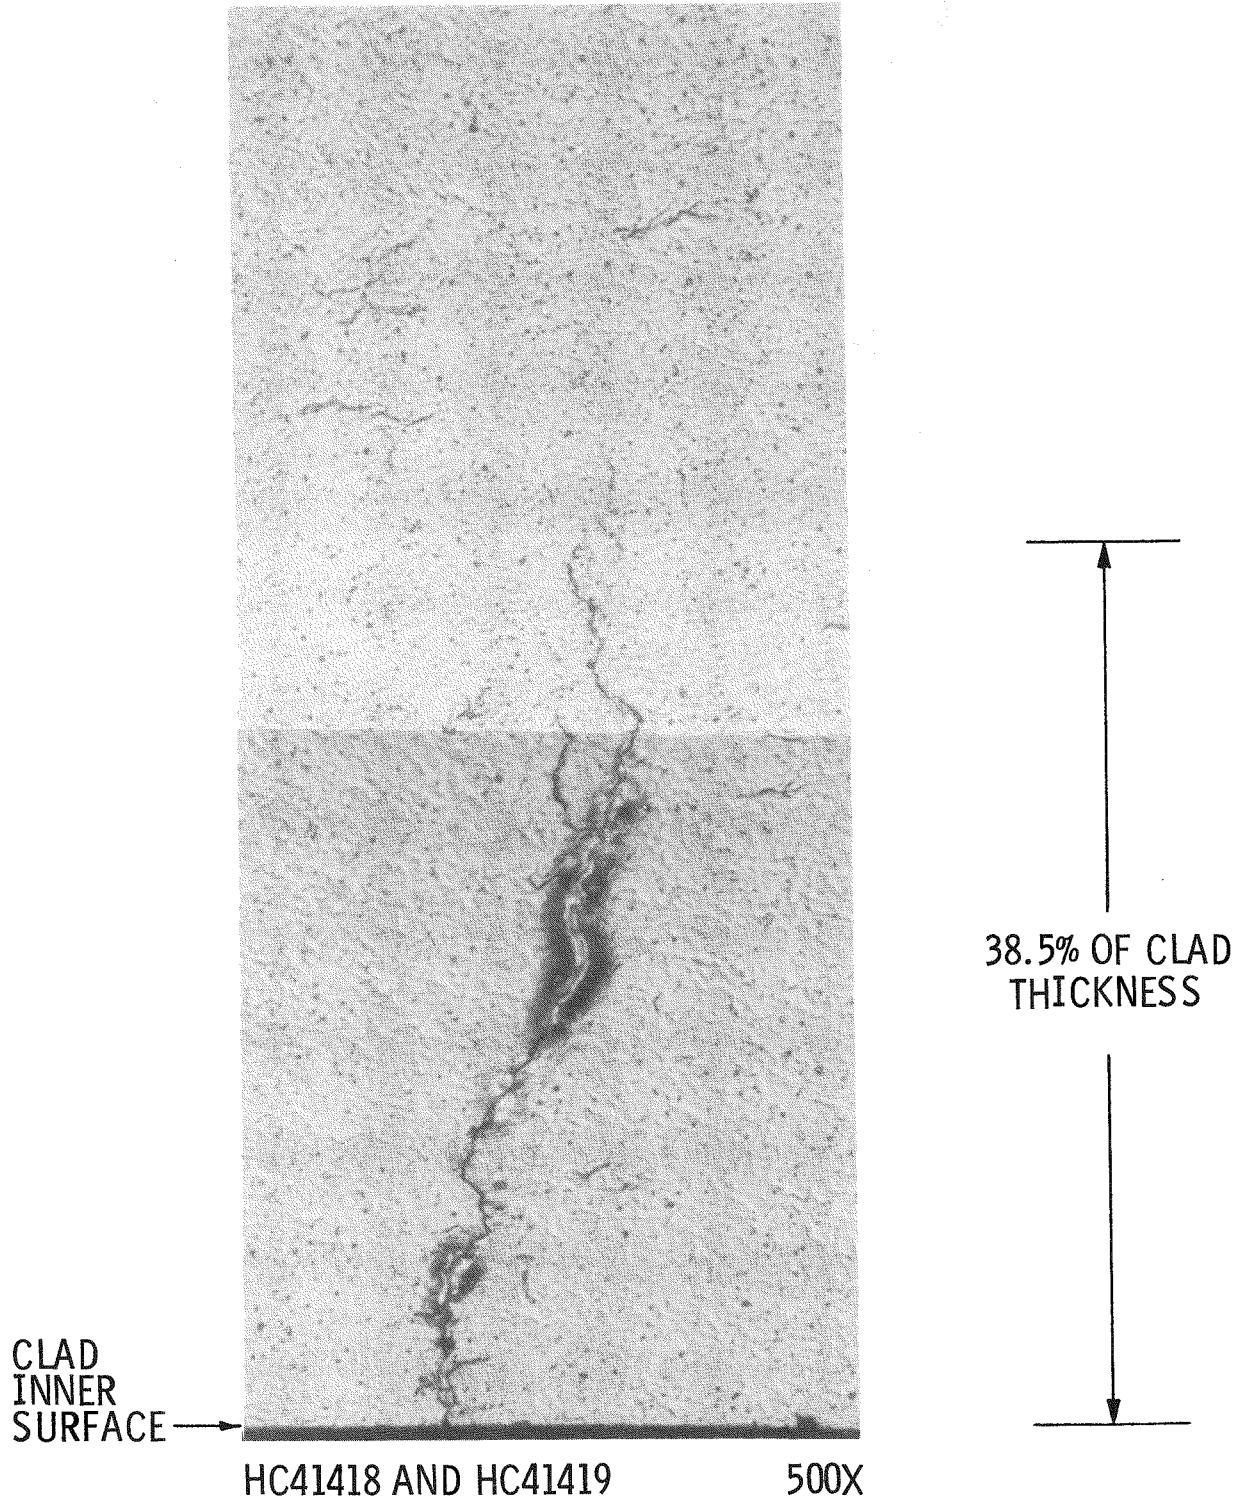
Figure 4-65 CRACK IN MOUNT No. X342 FROM ROD JBP-005
AT 75^0 - 6th SURFACE (ETCHED).

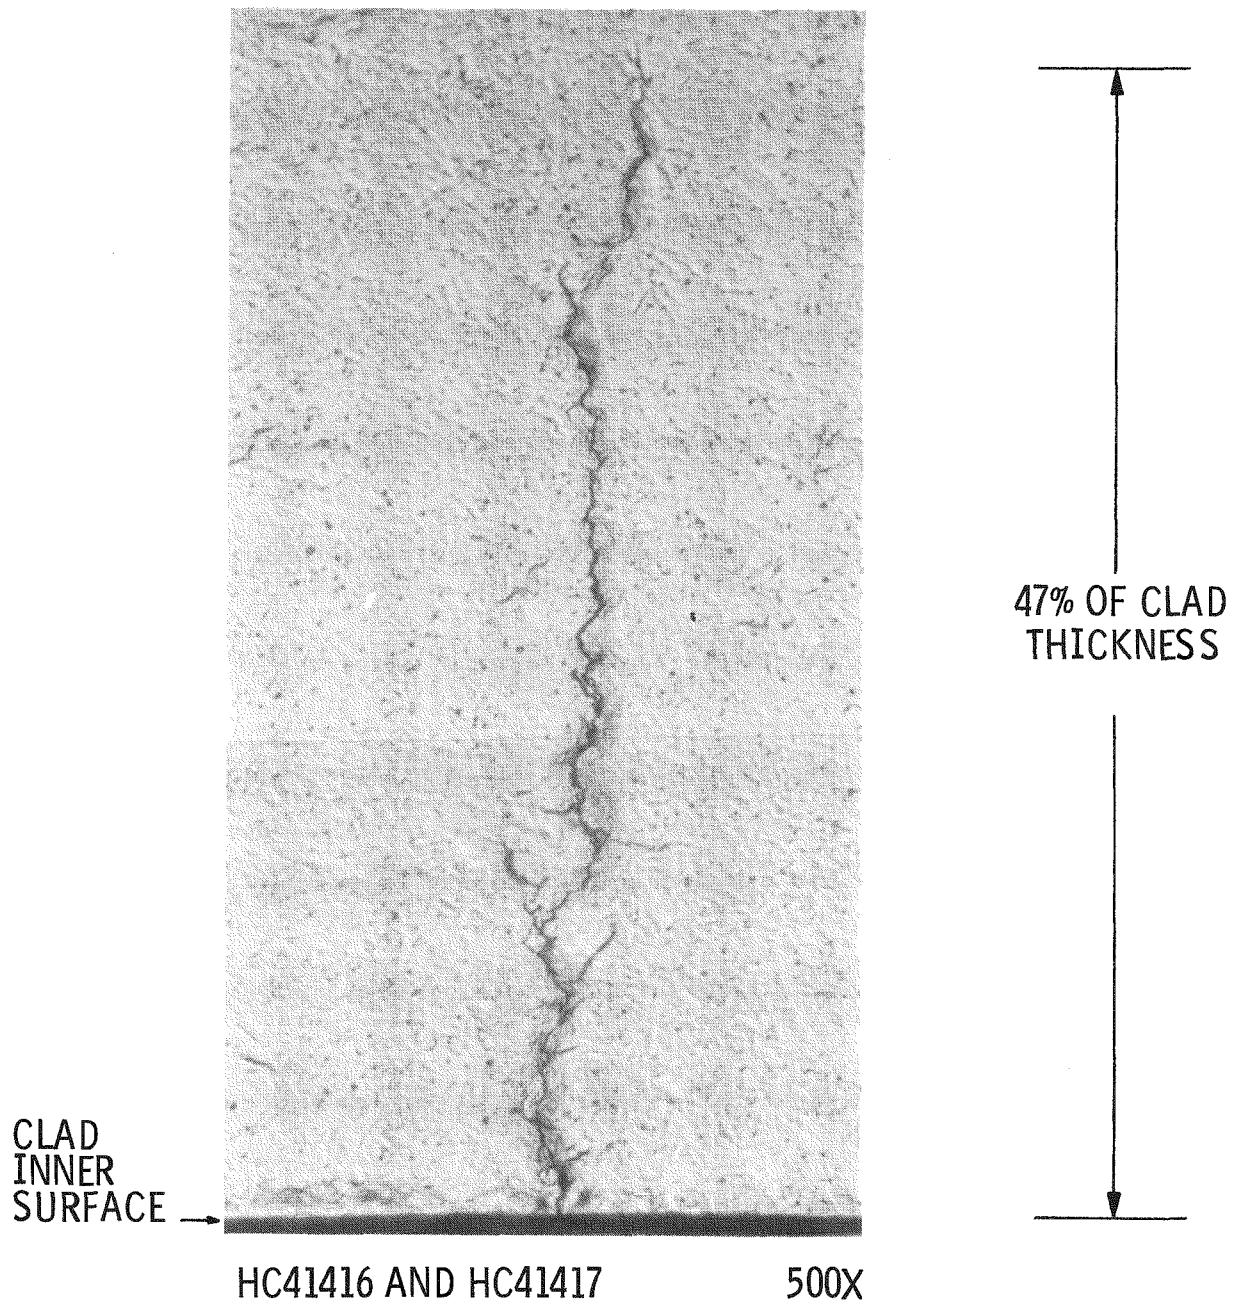
Figure 4-66 CRACK AT 80° IN MOUNT No. X342 FROM ROD
JBP-005 - 6th SURFACE (ETCHED).

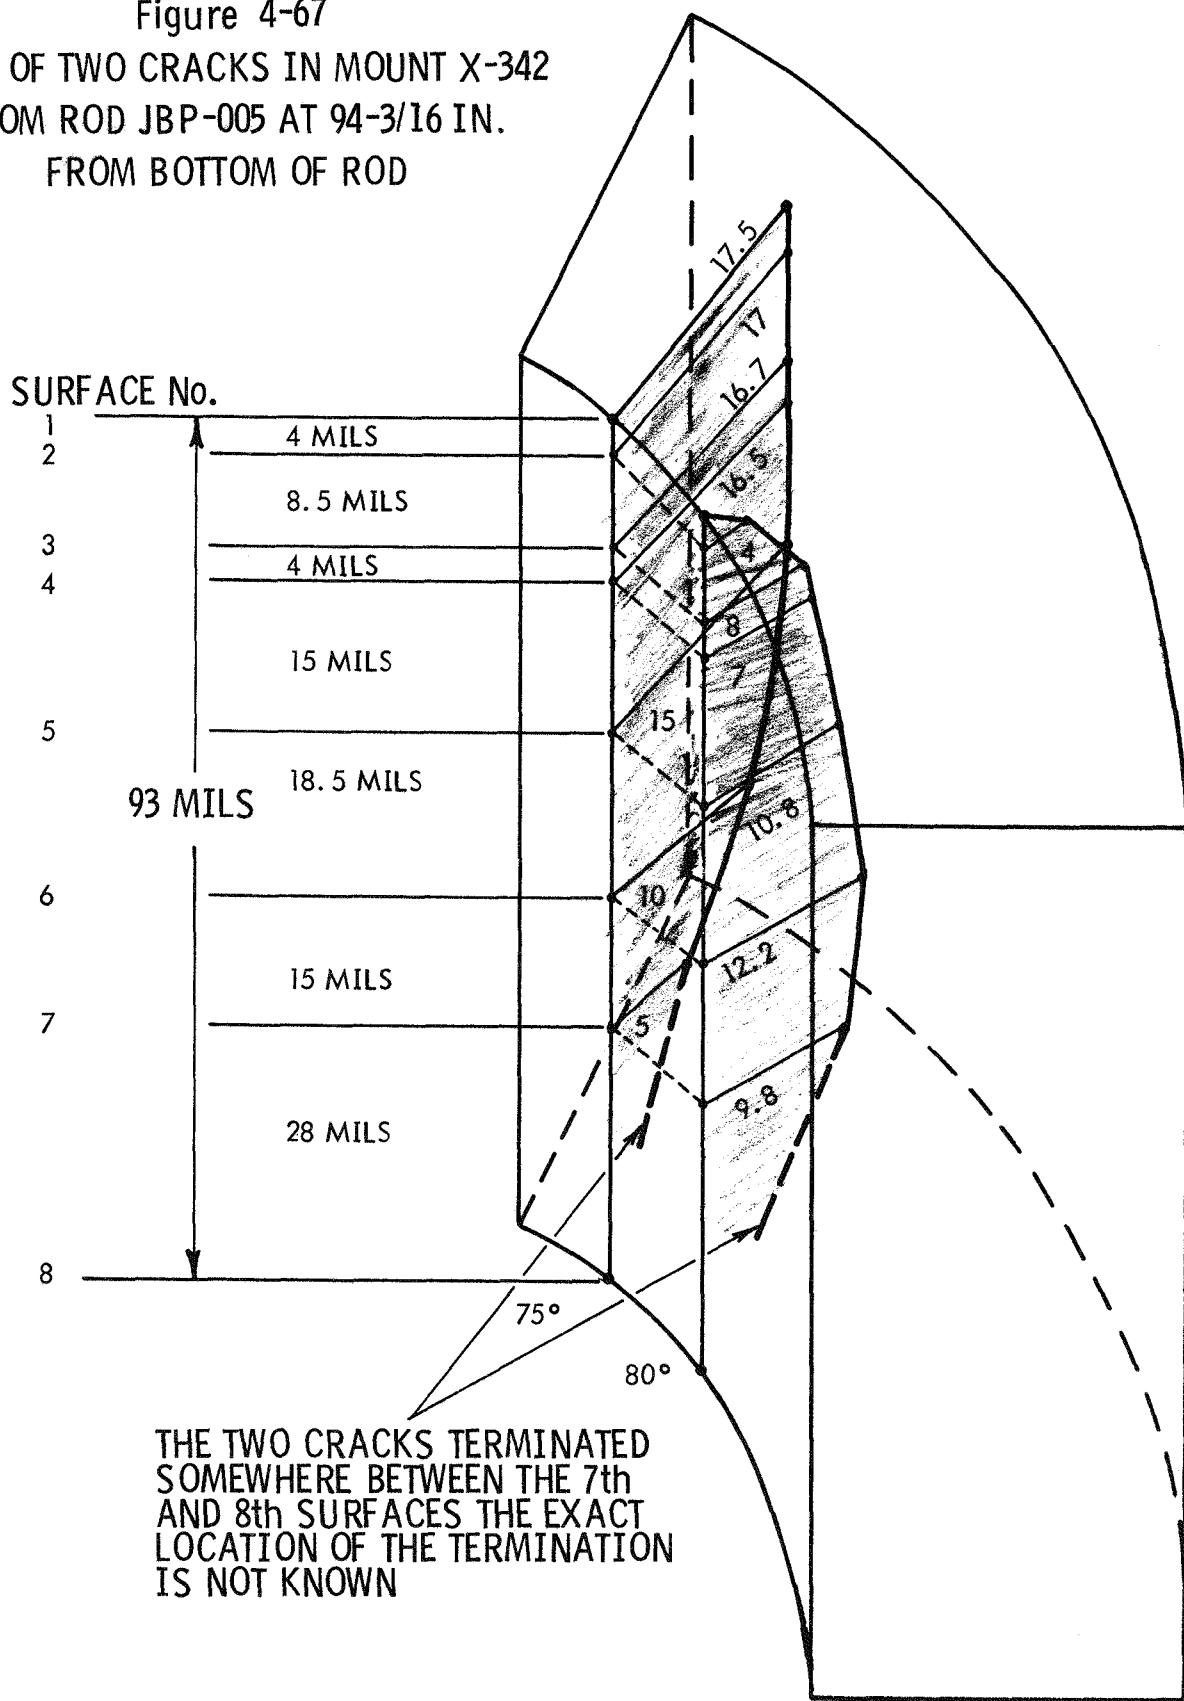
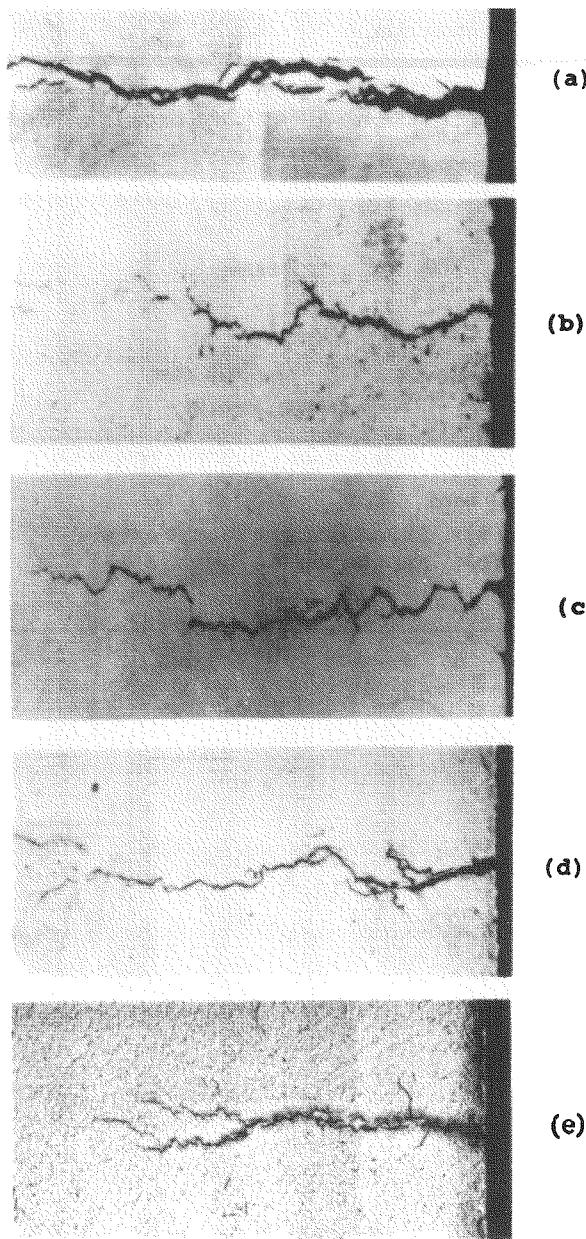
Figure 4-67
MAP OF TWO CRACKS IN MOUNT X-342
FROM ROD JBP-005 AT 94-3/16 IN.
FROM BOTTOM OF ROD

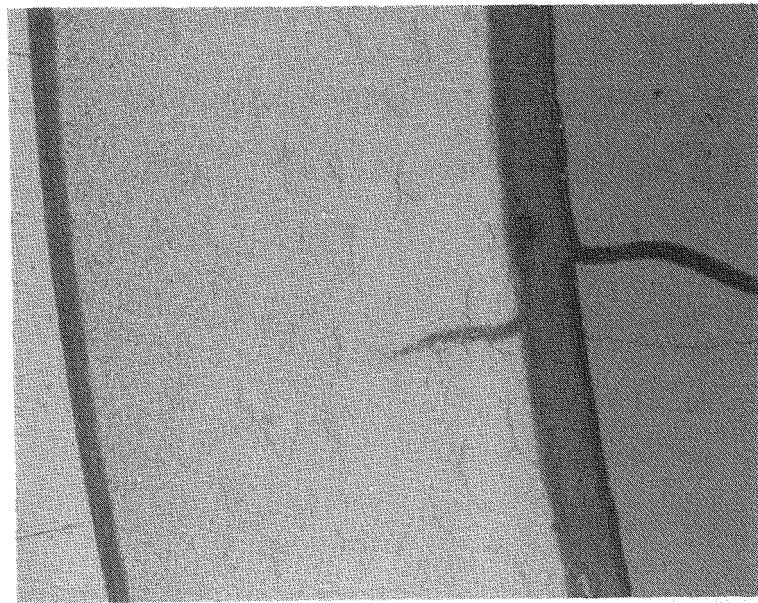
41854

Figure 4-69 PHOTOMICROGRAPH OF INCIPIENT CLADDING CRACK IN ROD
JBY-097 AT 88 3/8 IN. FROM THE BOTTOM (ETCHED)

It is noteworthy that JBP-122 and JBP-005 came from the same quadrant of assembly B-042, and the clad cracks discovered in both rods were at the same elevation (~95 in. from the bottom). Rod JBY-097 had been selected from assembly B-069, and its crack was found at ~88 in. from the bottom which is also a relatively high power position. The crack in Rod JBY-097, which was found first, was subsequently characterized by scanning electron microscopy (see Section 4.9). The crack in Rod JBP-122 was found later as part of a secondary effort to demonstrate a search technique; therefore, it was not characterized beyond optical microscopy. In both cases the cladding surfaces containing the cracks were characterized by polarized light metallography. For this purpose, the specimens were briefly reground, polished, etched with the slower acting etch, and then anodized. Under polarized light and/or sensitized tint illumination, all cracks were found to be transgranular with no evidence of twins or slip in or around the cracks indicating no plastic deformation occurred. This morphology along with the branching characteristics, is consistent with stress corrosion cracking.

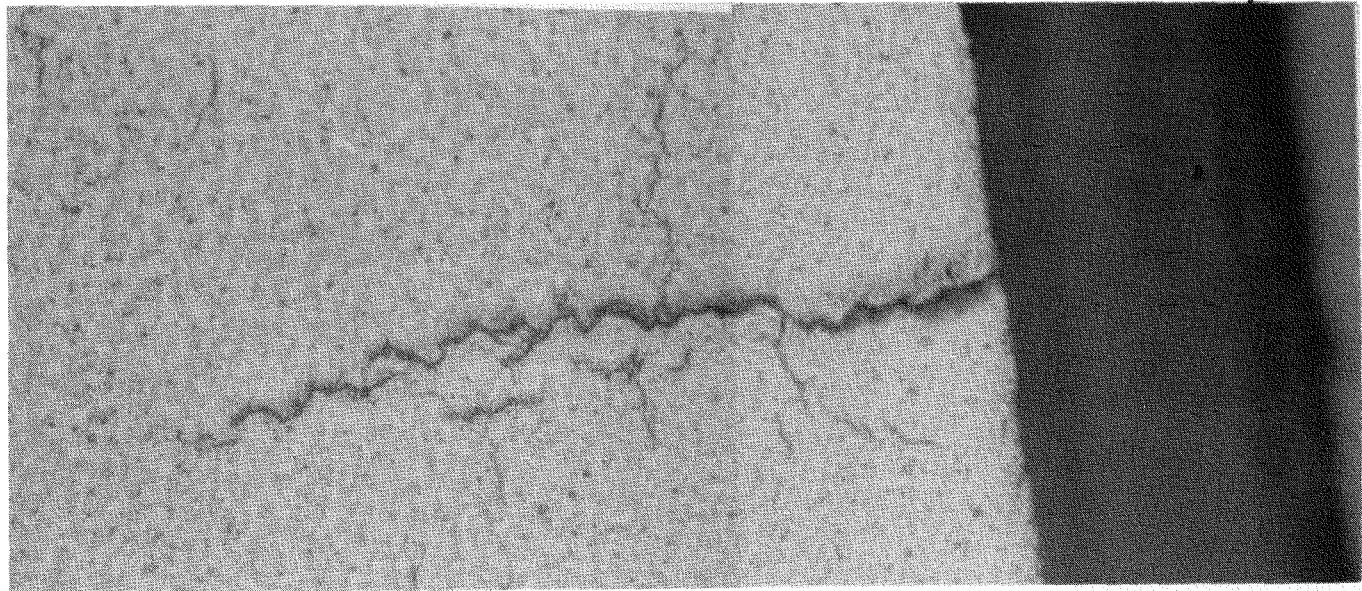
41857 & 41858

Figure 4-70 DETAIL OF INCIPIENT CLADDING CRACK IN ROD JBY-097
SHOWN IN Figure 4-69 (ETCHED)

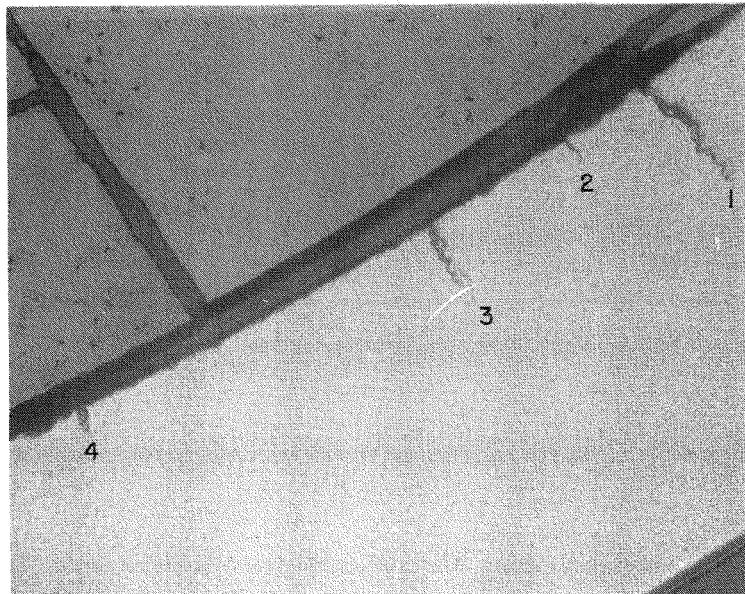
42078

Figure 4-71 PHOTOMICROGRAPH OF INCIPIENT CLADDING CRACKS IN ROD JBP-122 AT 95 IN. FROM THE BOTTOM (ETCHED)

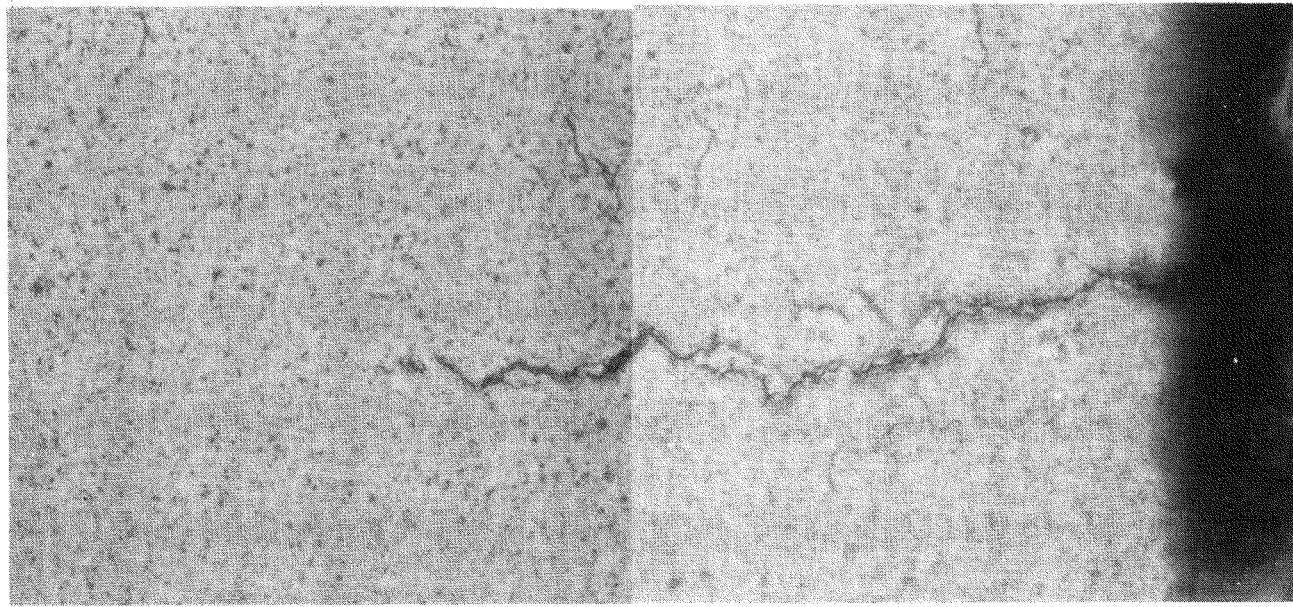
42189 & 42190

Figure 4-72 DETAIL OF INCIPIENT CLADDING CRACK No. 1 IN ROD JBP-122 SHOWN IN Figure 4-71 (ETCHED)

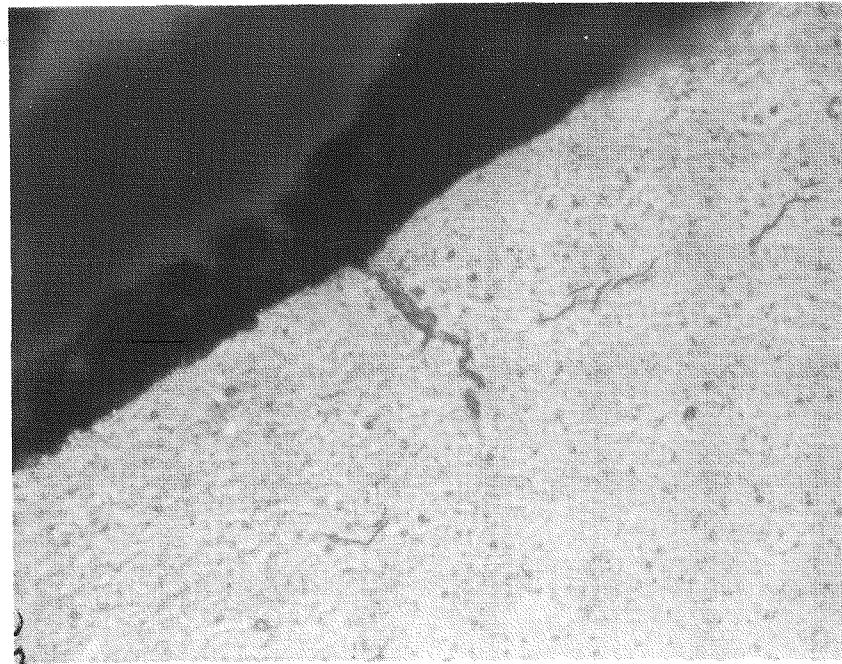
42082

Figure 4-73 DETAIL OF INCIPIENT CLADDING CRACK No. 2 IN ROD
JBP-122 SHOWN IN Figure 4-71 (ETCHED)

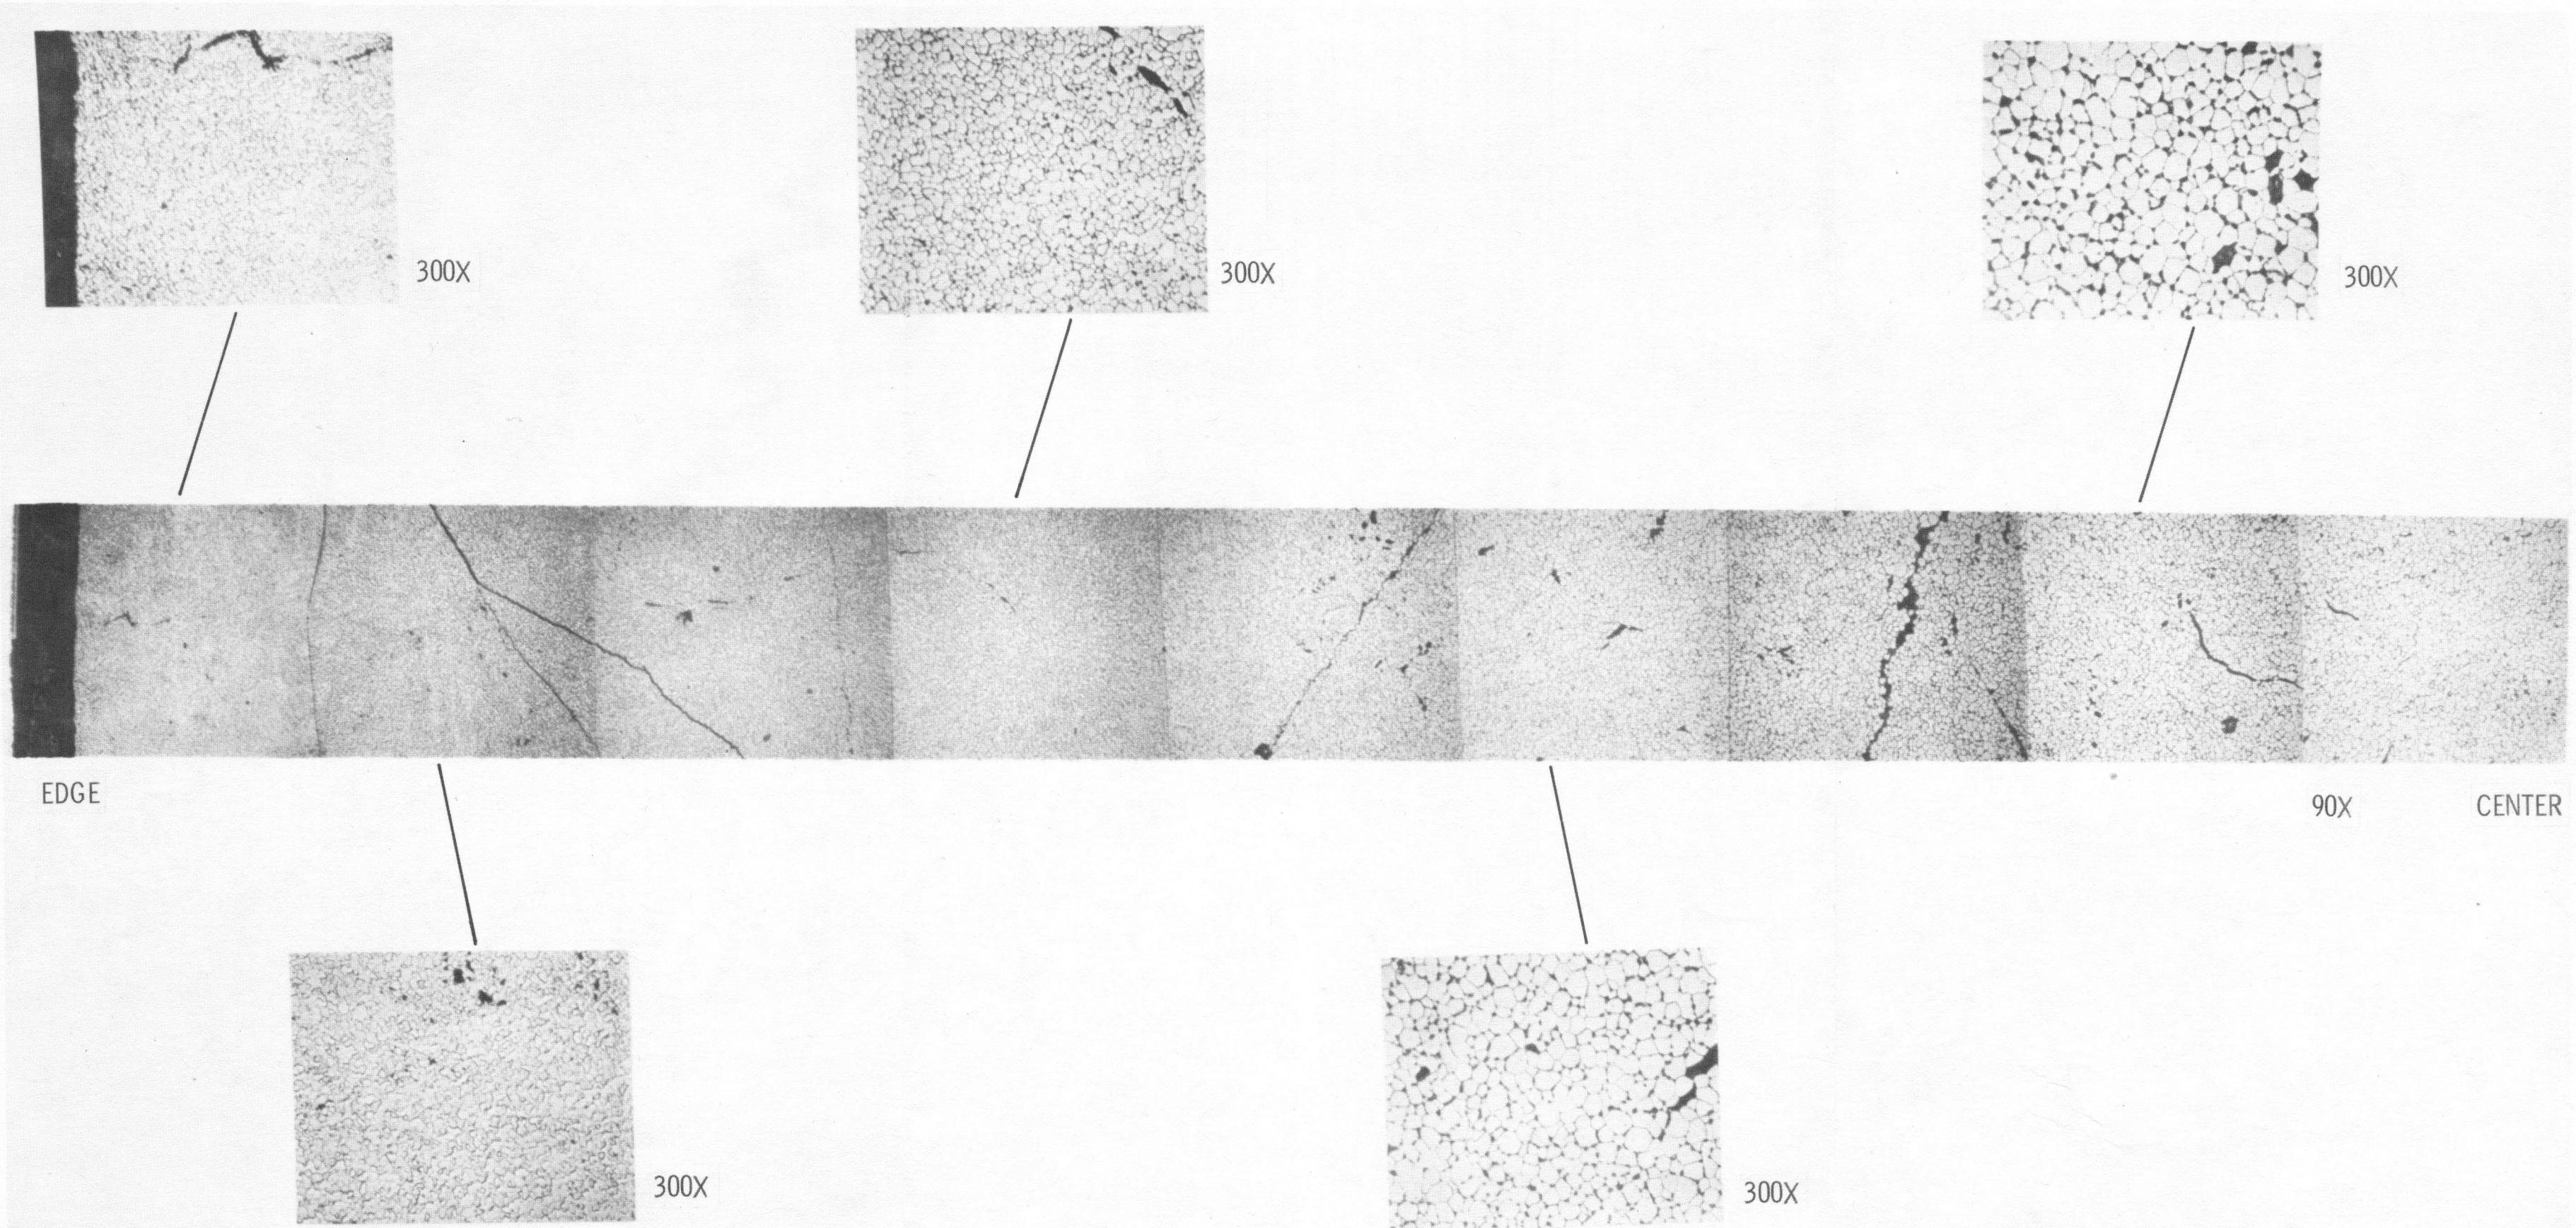
Figure 4-75 UO_2 MICROSTRUCTURE OF ROD JBP-005 AT 94-7/16 INCHES
FROM THE BOTTOM SHOWING EQUIAXED GRAIN GROWTH.

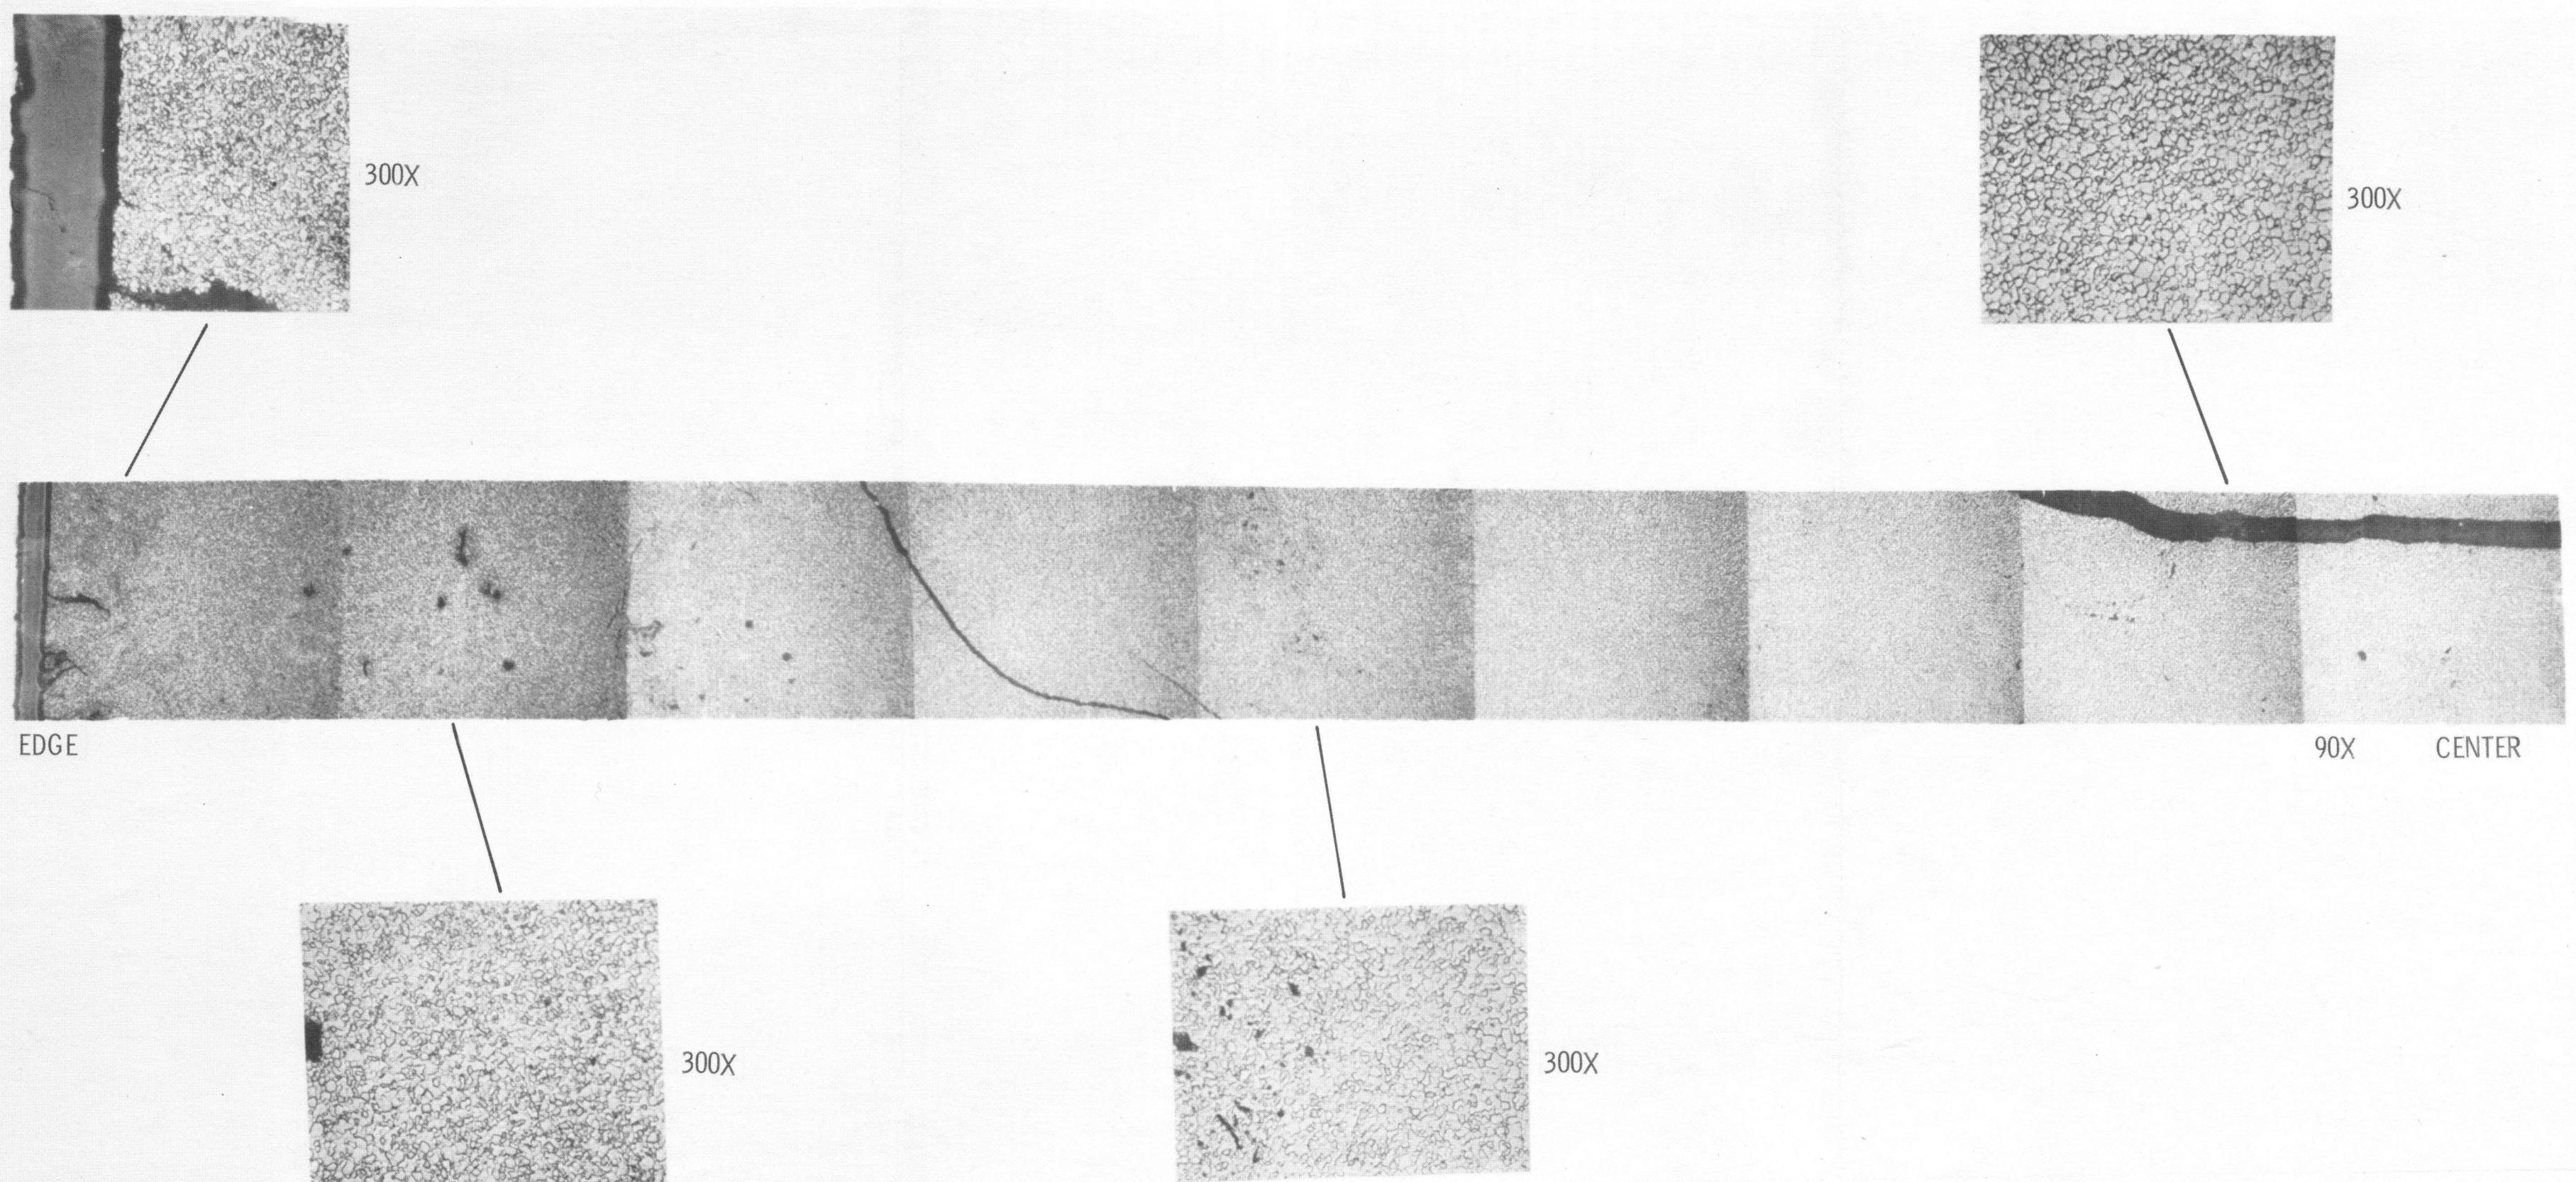
Figure 4-76 UO_2 MICROSTRUCTURE OF ROD JBY-157 AT 96 INCHES
FROM BOTTOM SHOWING NO GRAIN STRUCTURE TRANSITION.

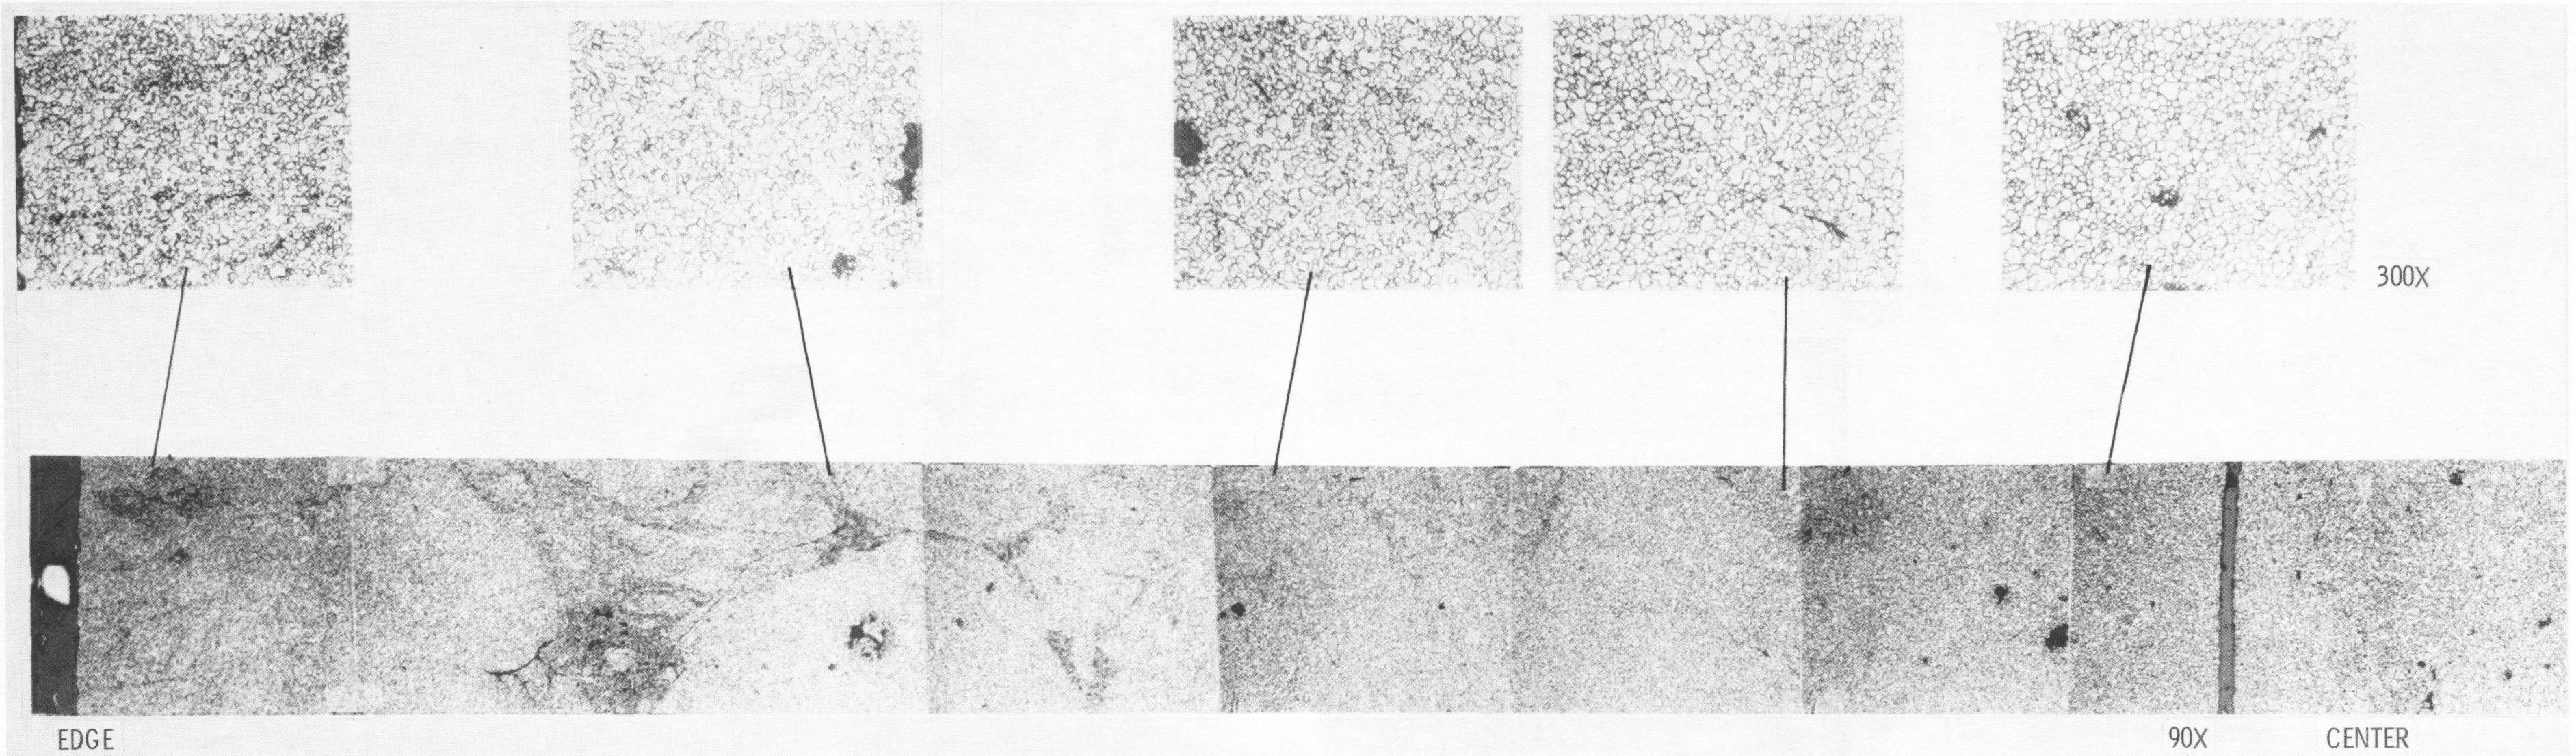
Figure 4-77 UO_2 MICROSTRUCTURE OF ROD JBP-005 AT 6 INCHES FROM THE BOTTOM SHOWING NO TRANSITION TO EQUIAXED GRAIN GROWTH.

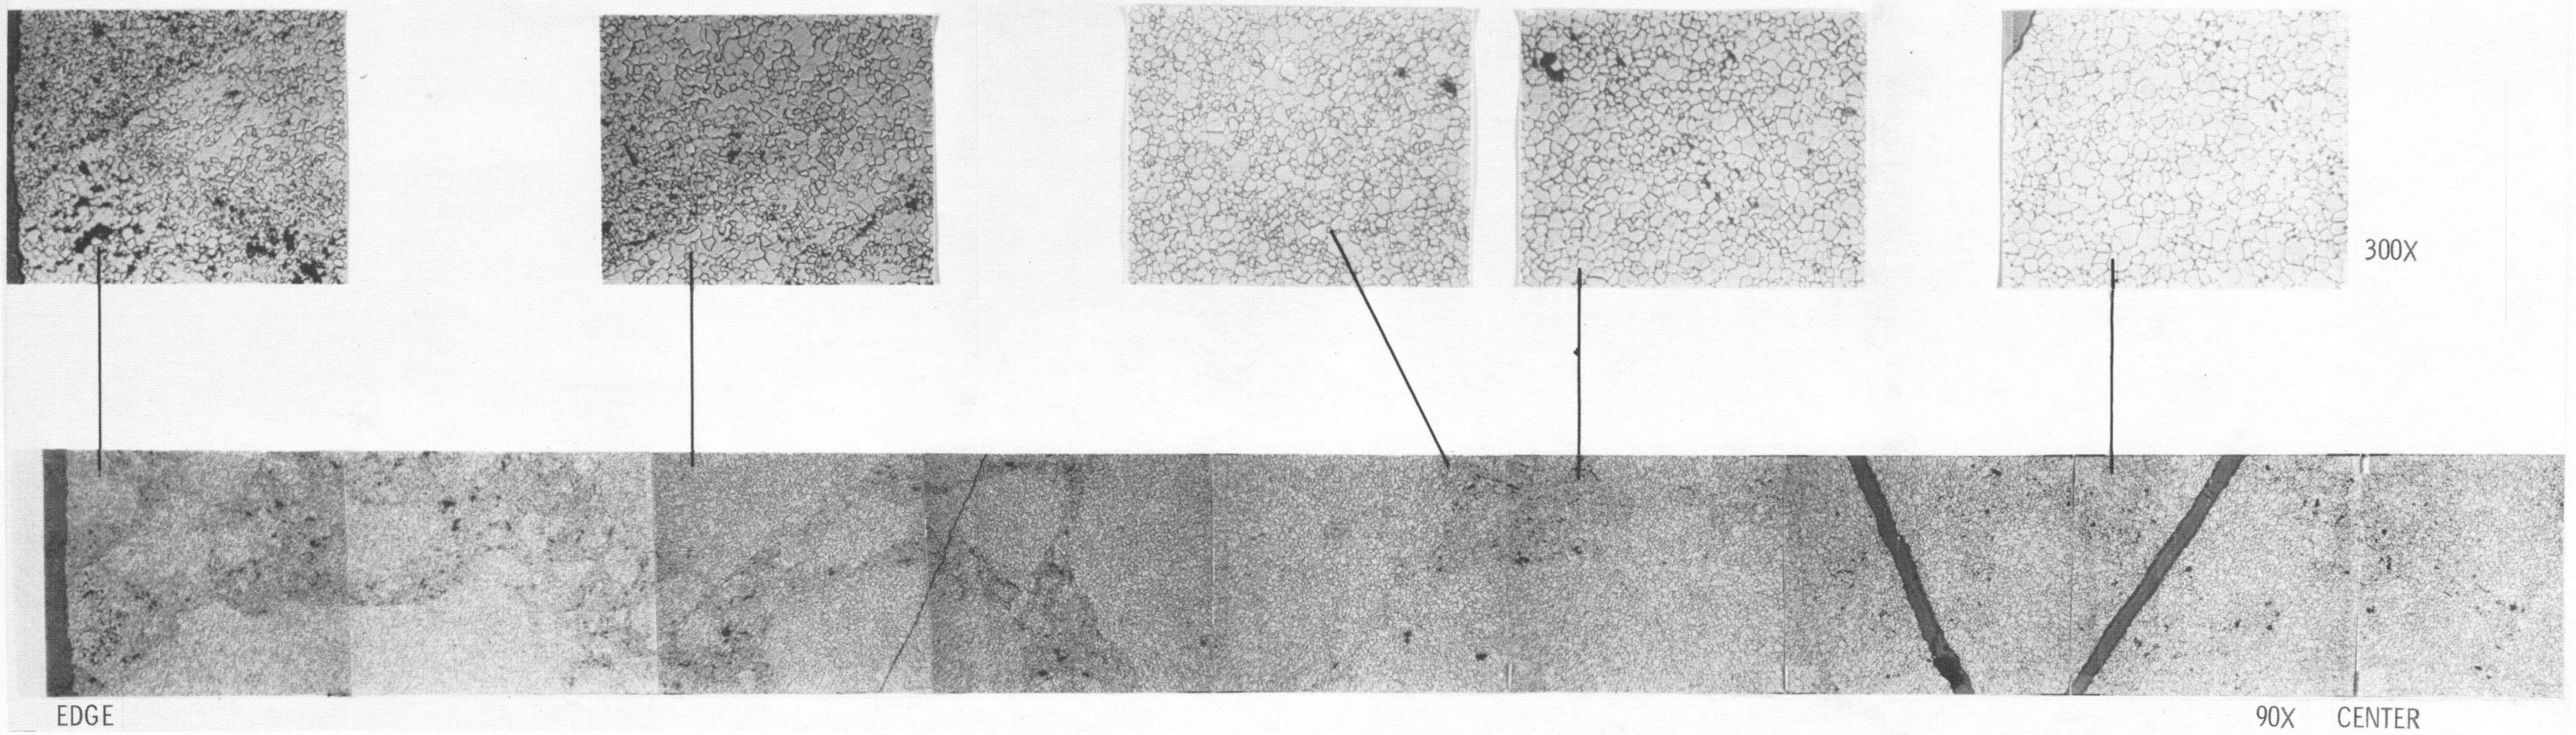
Figure 4-78 UO_2 MICROSTRUCTURE OF ROD JBP-005 AT 128 INCHES
FROM BOTTOM SHOWING EQUIAXED GRAIN GROWTH.
