EVALUATION OF FUEL ROD PERFORMANCE IN MAINE YANKEE CORE I

TASK C

**EPRI NP-218
(Research Project 586-1)**

Final Report

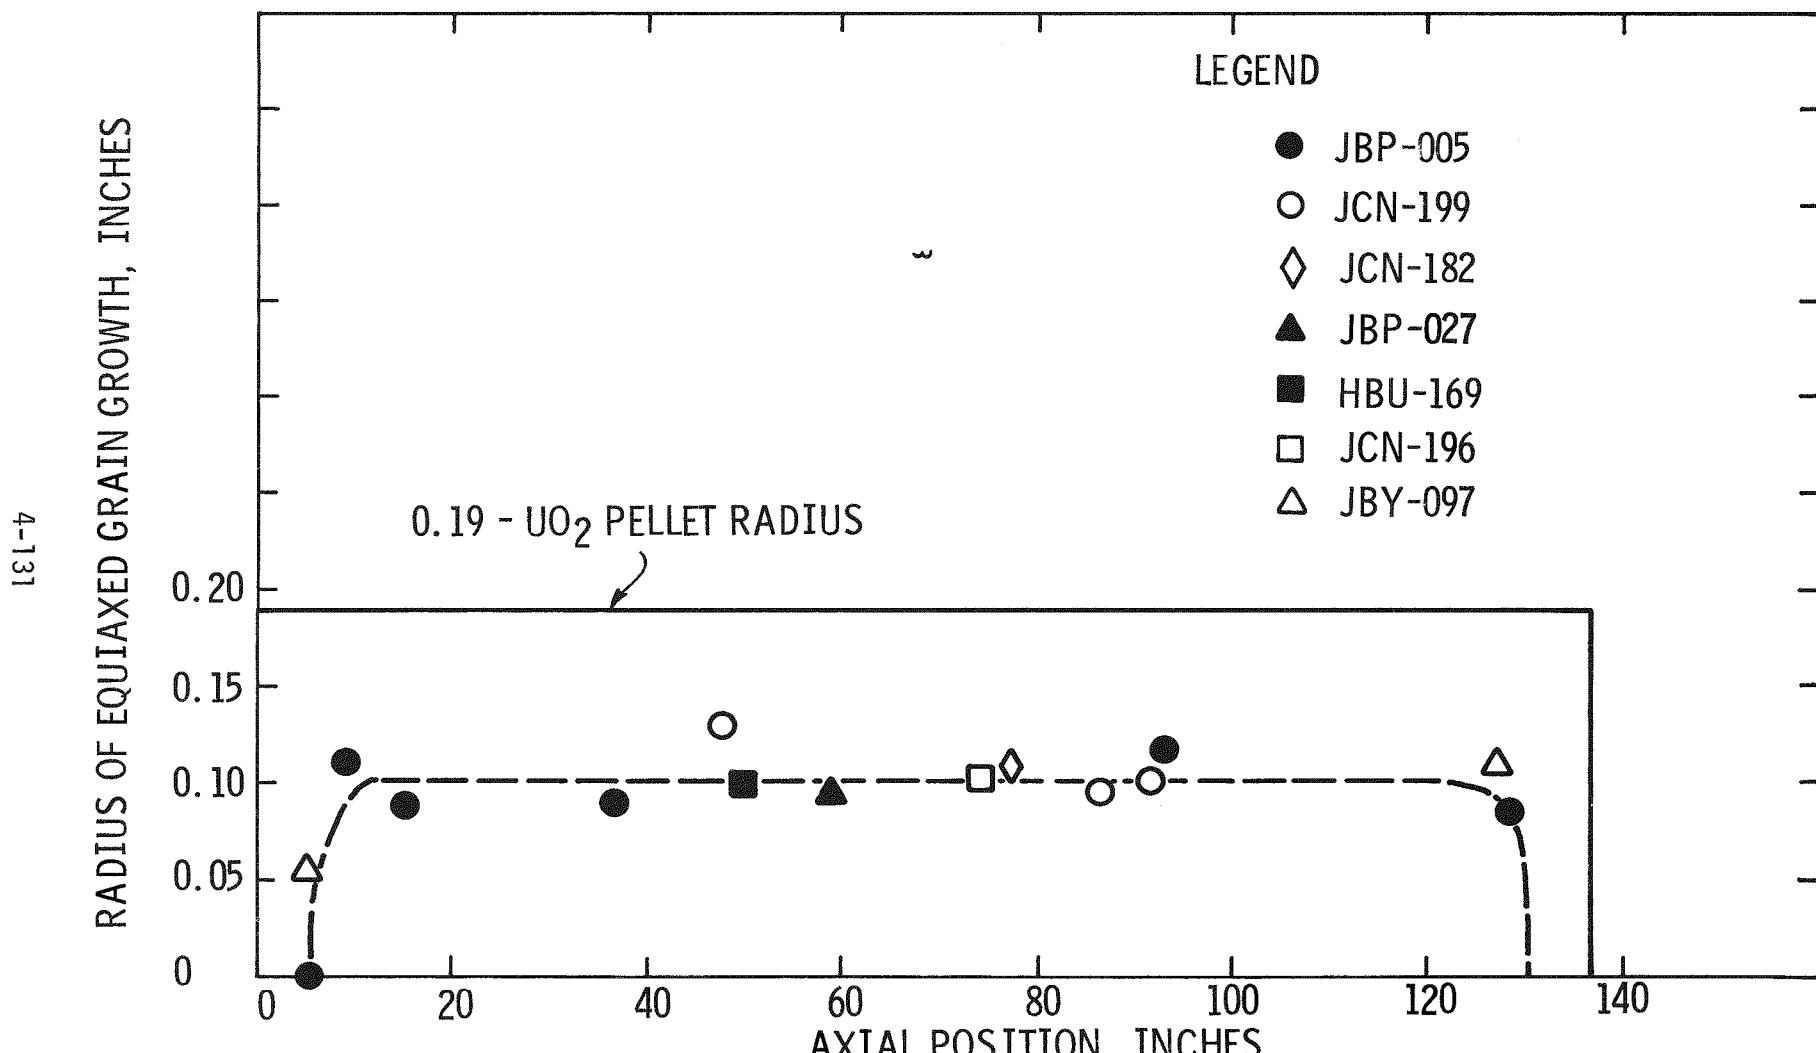
Figure 4-79 EXTENT OF EQUIAXED GRAIN GROWTH
IN HIGHER GAS RELEASE RODS

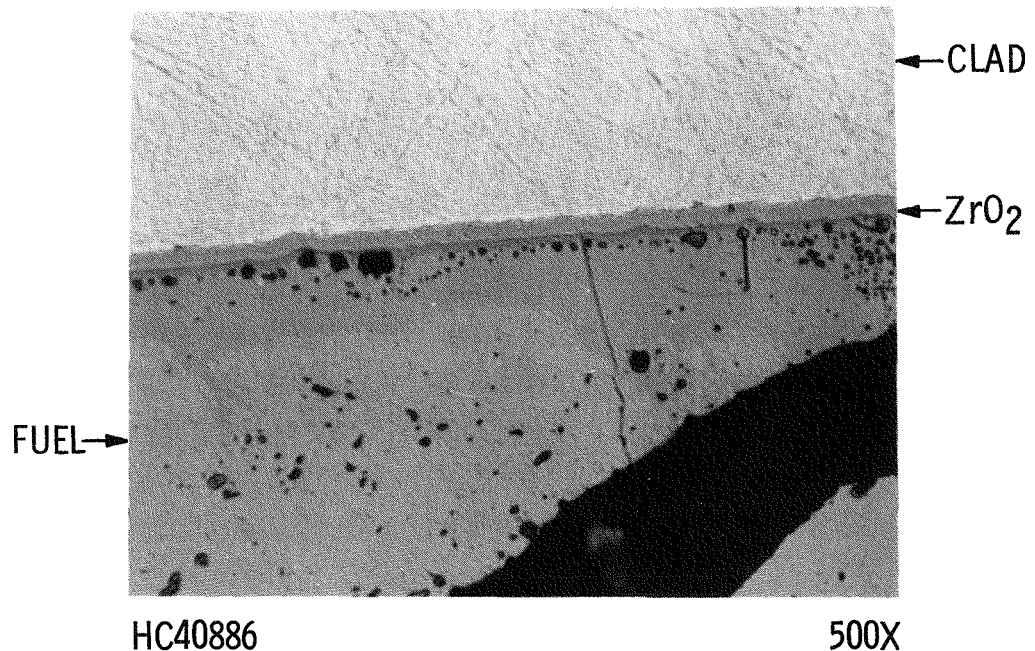
Figure 4-81 APPEARANCE OF ZrO_2 LAYER ON THE INNER SURFACE OF THE CLADDING OF MOUNT X-331 AT THE LOCATION OF FUEL-CLAD BONDING (AS POLISHED)

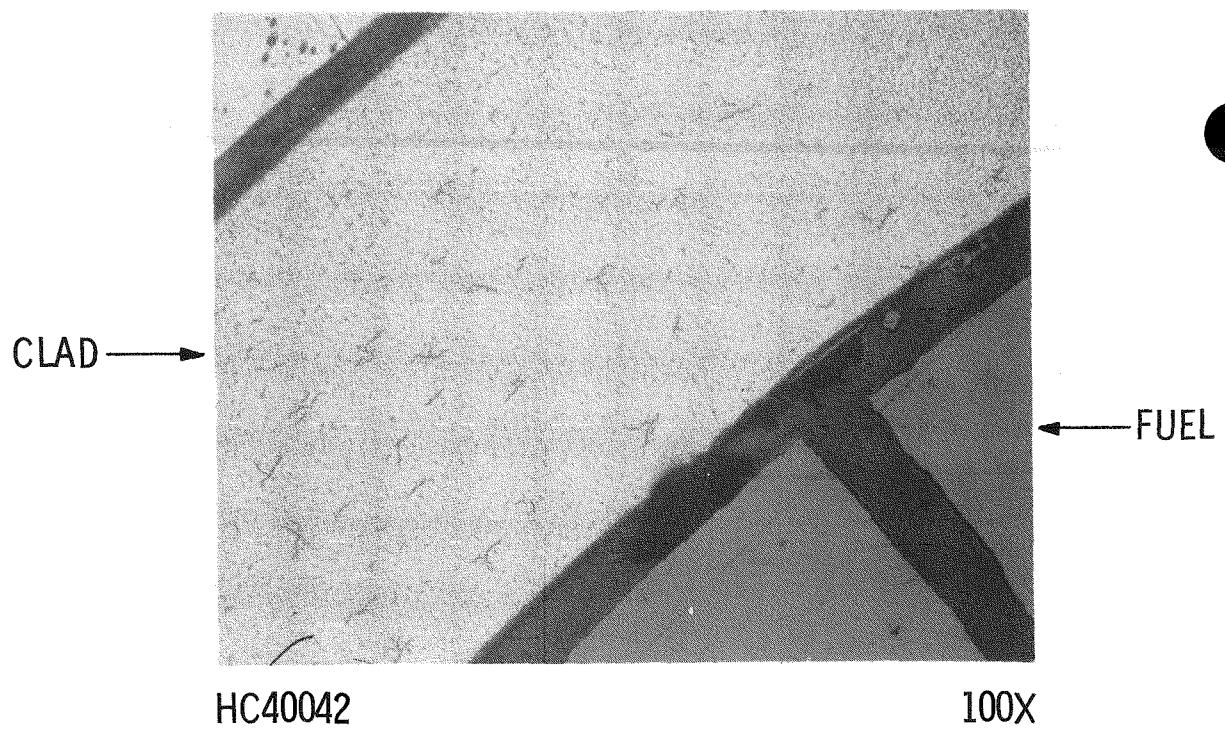
Figure 4-82 TYPICAL APPEARANCE OF HYDRIDE PRECIPITATES IN THE SPECIMEN FROM ROD JBP-027 (ETCHED).

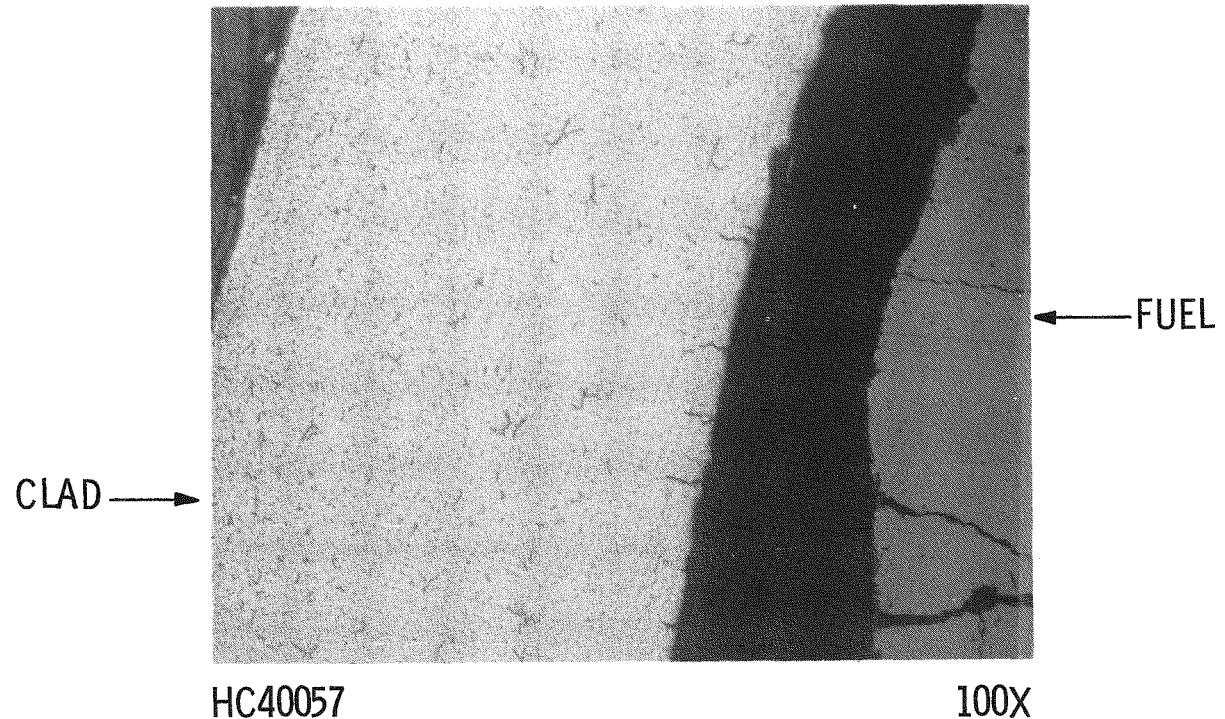
Figure 4-83 APPEARANCE OF RADIALLY ORIENTED HYDRIDES ON THE INNER SURFACE OF THE CLADDING IN THE SPECIMEN FROM ROD JBP-027 (ETCHED).

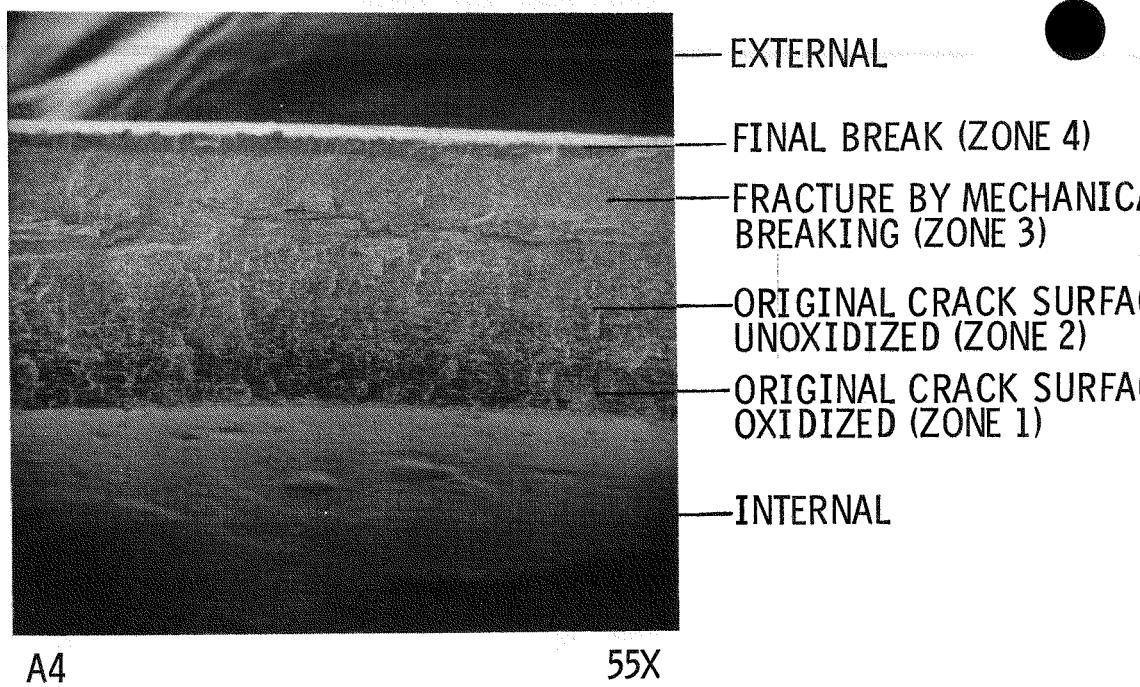
Figure 4-87 LOW MAGNIFICATION SEM-PHOTOGRAPH OF FRACTURE

A SEM fractography examination showed no ductile dimpling on the crack surface, confirming essentially no plastic deformation had occurred. Only flat cleavage planes and river patterns were observed. These are produced in Zircaloy by a stress corrosion cracking mechanism.

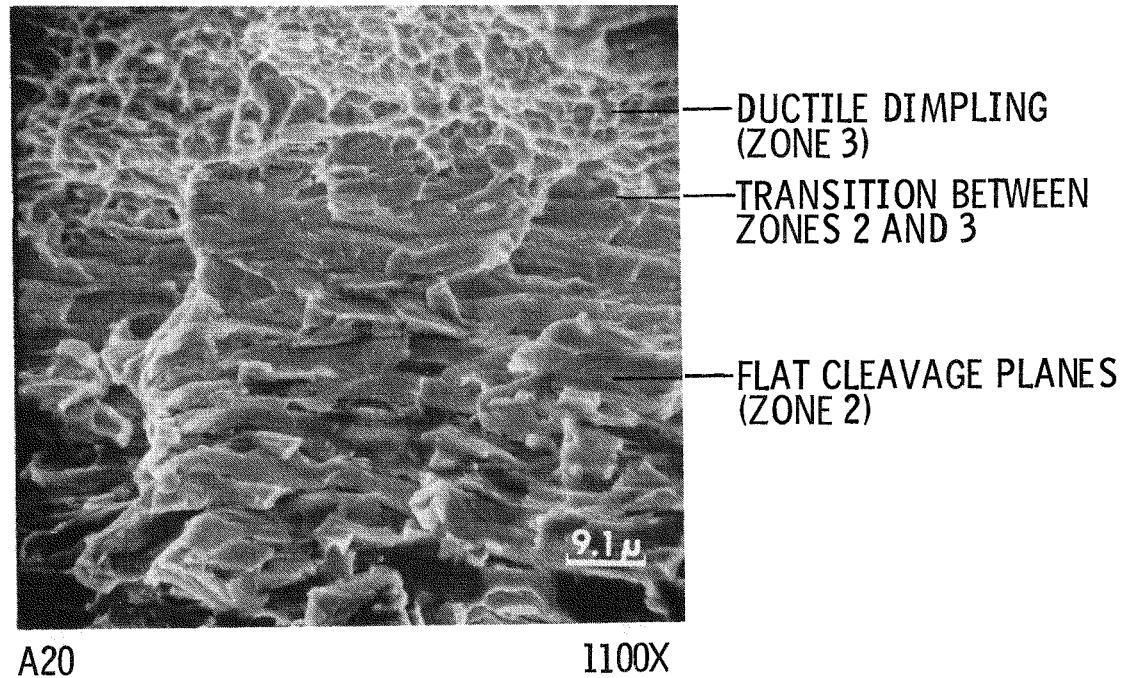
Figure 4-88 FRACTURE SURFACE AT CRACK TIP

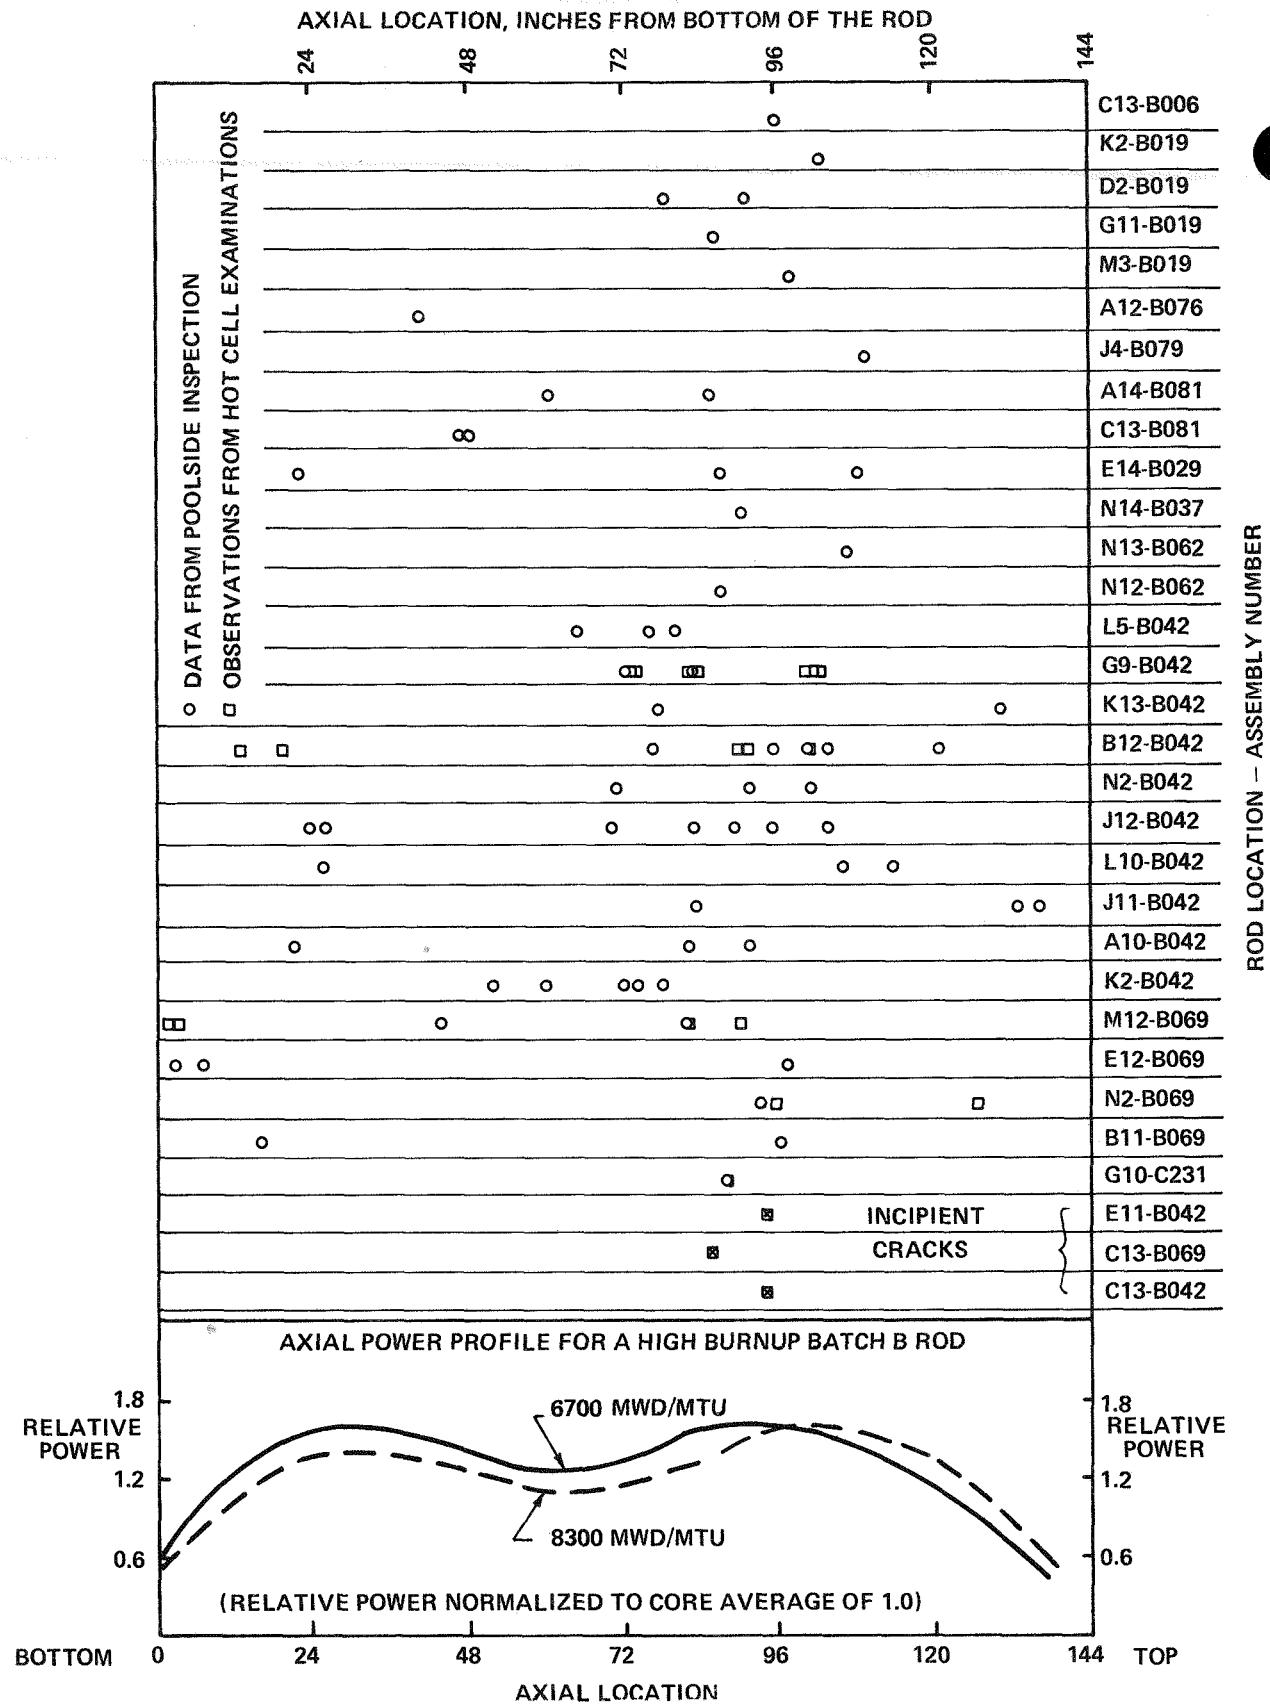
Figure 6-12 AXIAL LOCATION OF ALL BLISTERS OBSERVED DURING MAINE YANKEE POOLSIDE INSPECTION AND HOT CELL EXAMINATION
