ORNL/TM-5613

## Prestressed Concrete Reactor Vessel Thermal Cylinder Model Study

HTGR BASE TECHNOLOGY PROGRAM  
Prestressed Concrete Nuclear Pressure  
Vessel Development (189a. No. 01331)

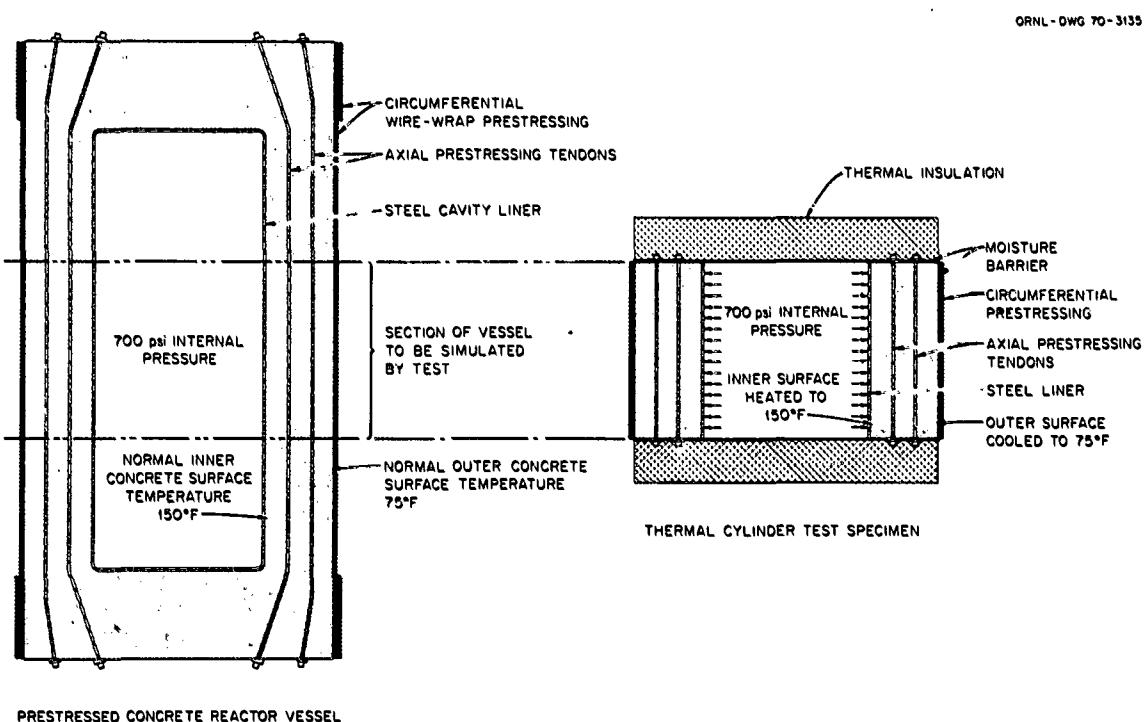
Fig. 1.1. Relationship of thermal cylinder test model to prestressed concrete reactor vessel [1 psi = 6895 Pa; K = 273.15 + 5/9 (°F - 32)].

The thermal cylinder is an approximately 1/6-scale model of the middle, or barrel, section of the cylindrical portion of a prestressed concrete reactor vessel, as shown in Fig. 1.1, which was subjected to the simulated in-service operating conditions shown diagrammatically in Fig. 1.2. The

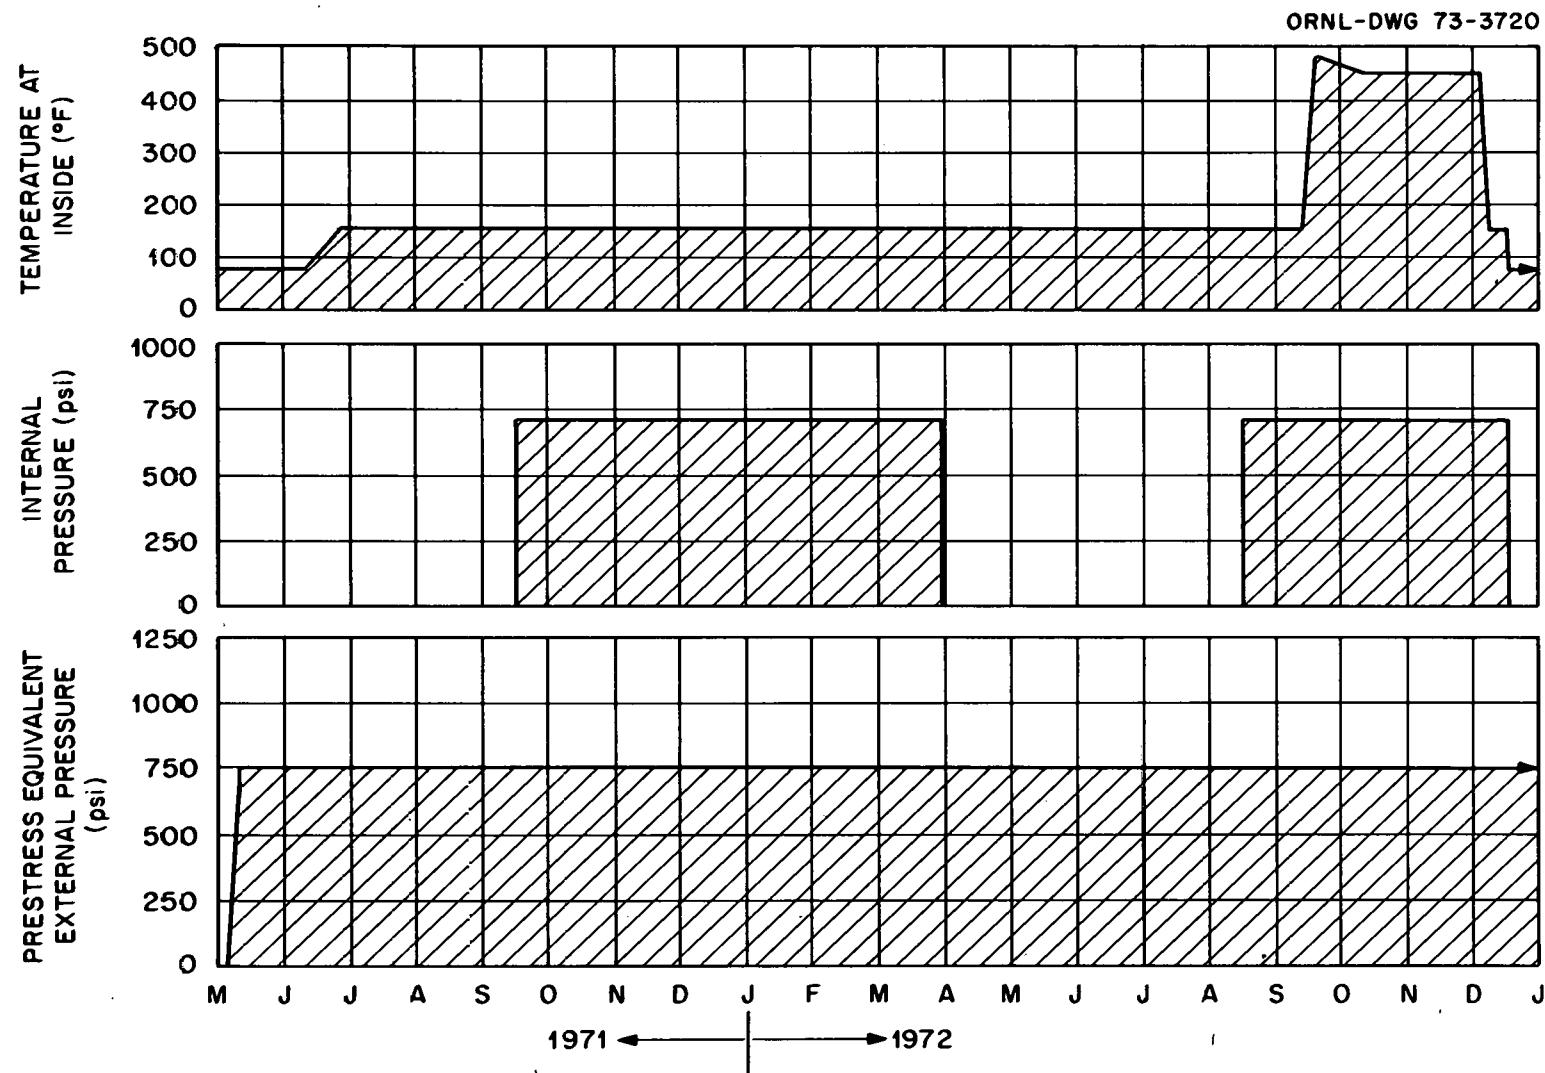
Fig. 1.2. Temperature and loading history of the thermal cylinder  
 [1 psi = 6895 Pa;  $K = 273.15 + 5/9 ({}^{\circ}\text{F} - 32)$ ].

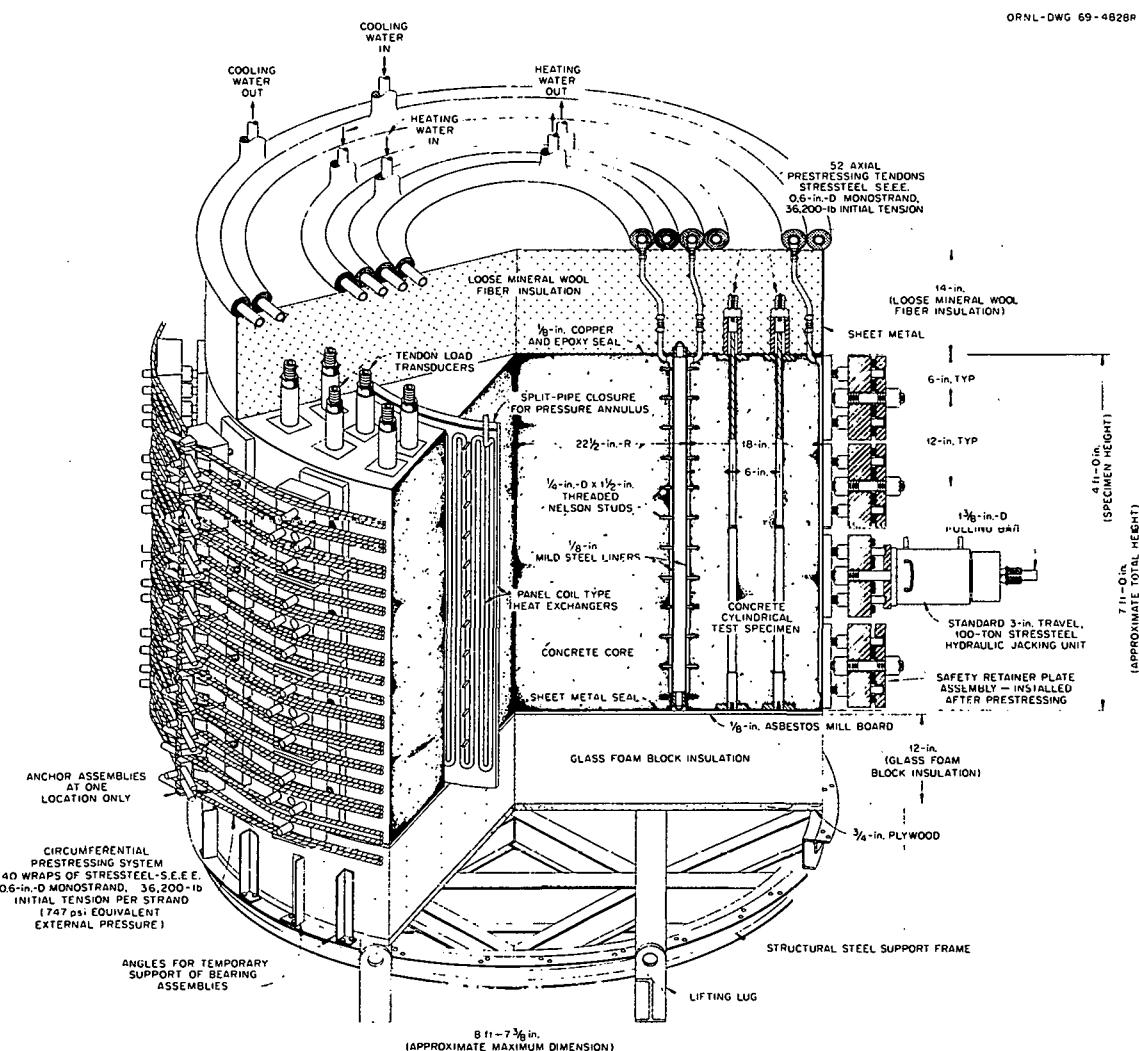
Fig. 1.3. Isometric drawing of the thermal cylinder test structure (1 in. = 25.4 mm; 1 ft = 0.305 m). Initial tension per strand is 0.161 MN (36,200 lb), equivalent to 5.15-MPa (747-psi) external pressure.

The prestressing arrangement is shown in Fig. 1.3. There were 52 axial tendons arranged in two rows of 26 tendons each. The S.E.E.E. anchor system was used with the axial tendons. A unique arrangement was employed for the circumferential prestressing; monostrand tendons were wrapped around the outer surface of the cylinder and posttensioned by jacking them outwardly, as shown in Fig. 1.3. The axial and circumferential tendons

The bottom support and insulating layers of the model were assembled, as shown in Fig. 1.3, to the sheet-metal moisture seal located directly above the asbestos cement board. A temporary support superstructure was then erected on the base support framework.

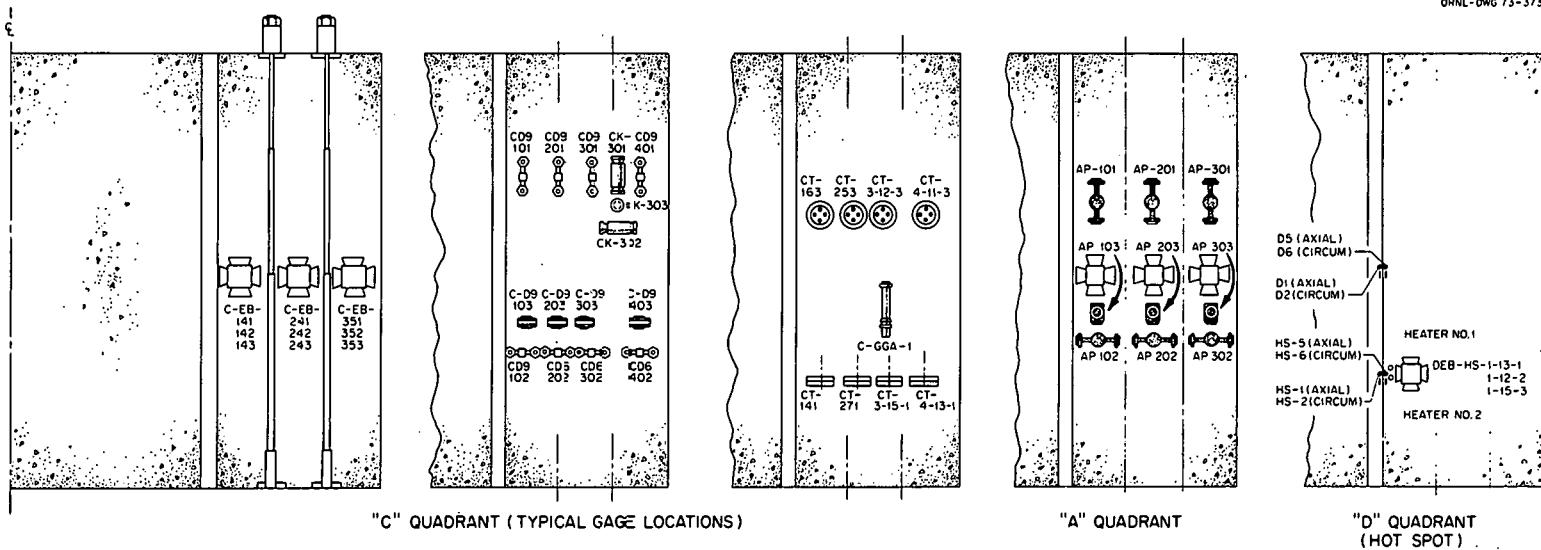
Fig. 2.1. Typical locations of each type of embedment gage.

Average comparisons for the type A vibrating-wire strain gages in radial position 1 (see Fig. 2.1) are shown in Figs. 6.8 to 6.10 for axial, radial, and circumferential directions, respectively. The same general trends discussed for the single-filament-type gages shown in Figs. 6.1 and 6.2 were recorded by this entirely different type of concrete embedment strain gage, which was cast directly into the concrete of the thermal

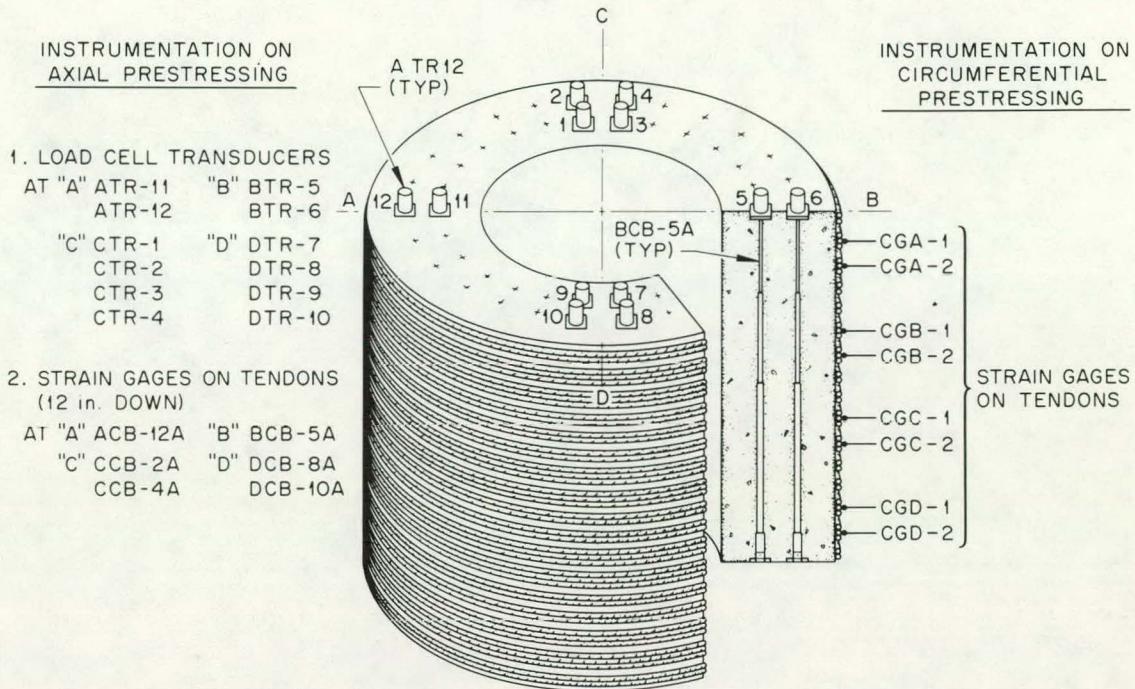
Fig. 2.2. Instrumentation on axial and circumferential prestressing (1 in. = 25.4 mm).

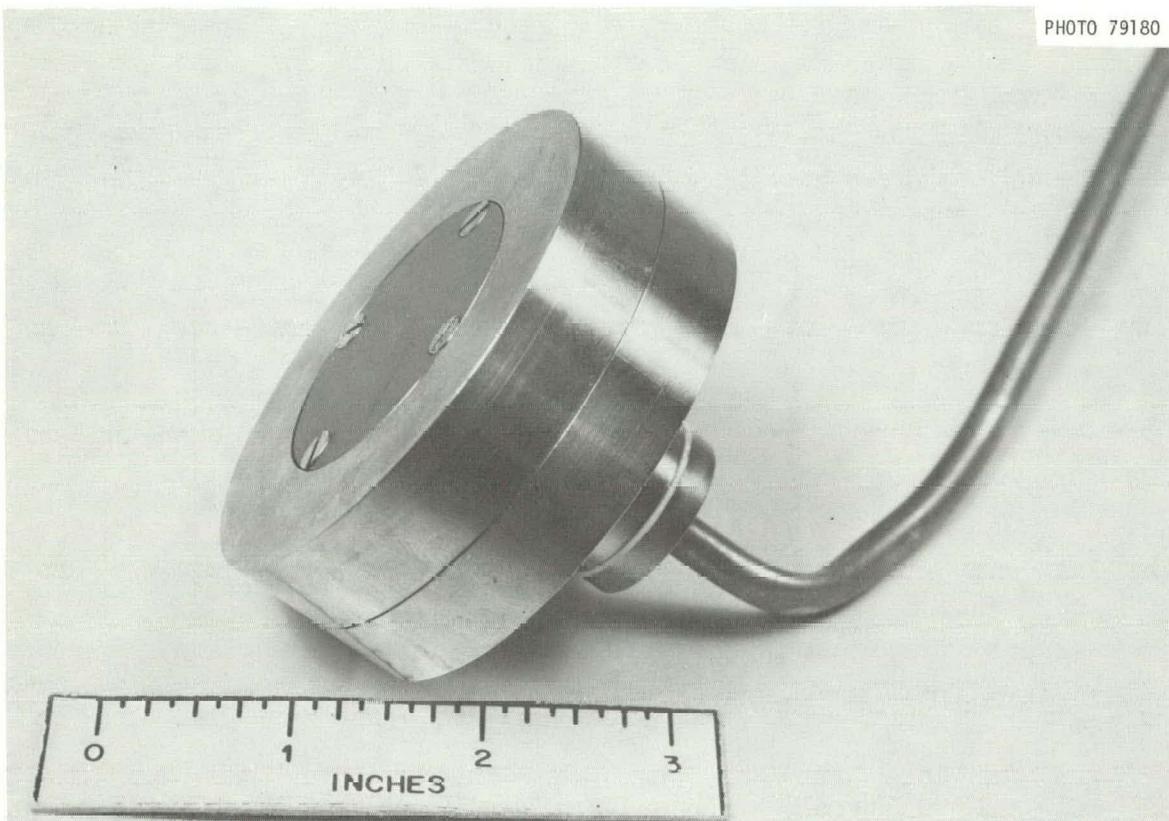
Fig. 2.3. Assembled titanium stress cell (1 in. = 25.4 mm).

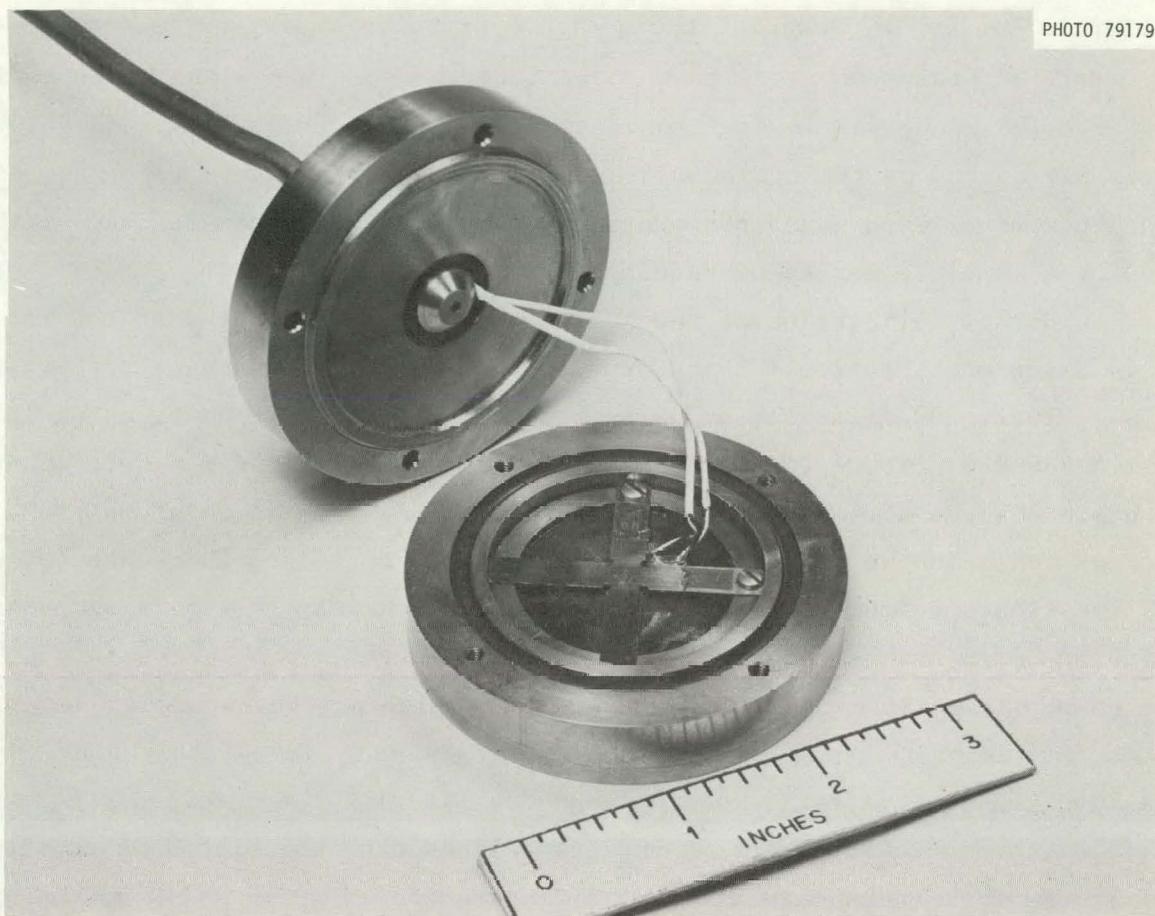
Fig. 2.4. Disassembled titanium stress cell (1 in. = 25.4 mm).

In order to provide a means for measuring possible variations in strain readings unrelated to existing stress conditions, the titanium disk through which the strain gage leads pass (see Fig. 2.4) houses a

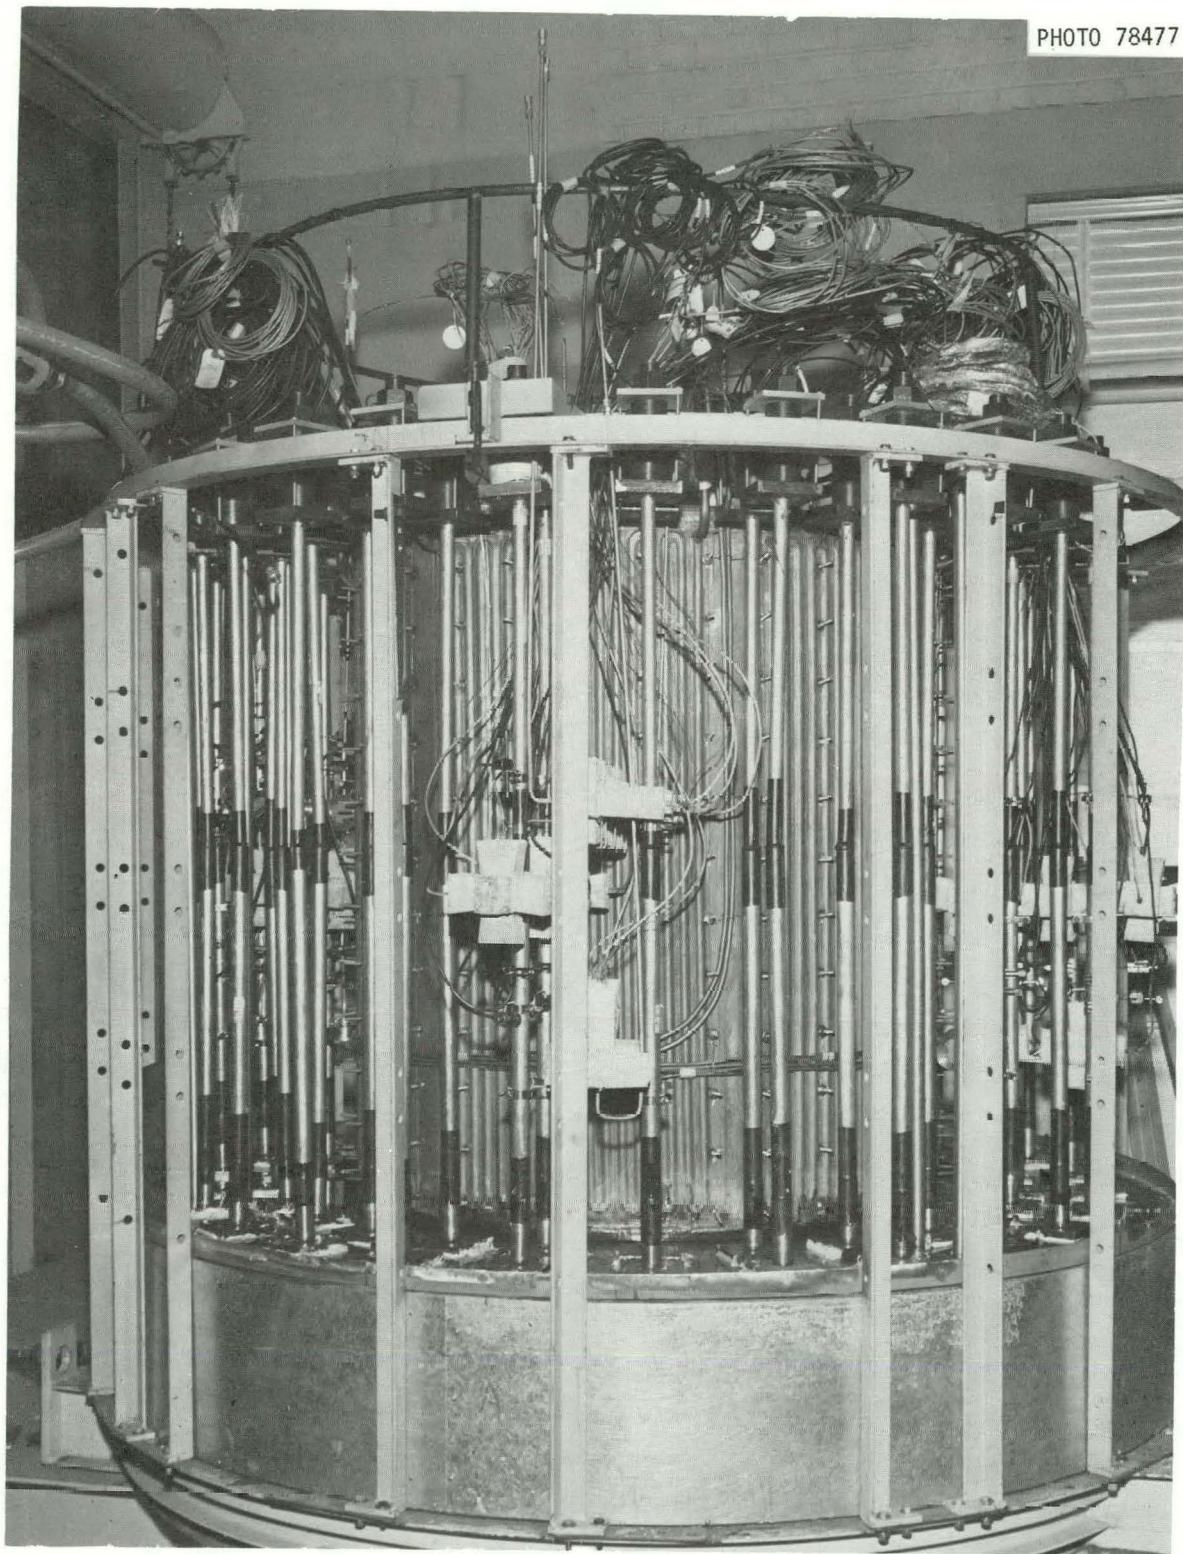
Fig. 3.1. Partially assembled mold with outer heat exchanger removed.

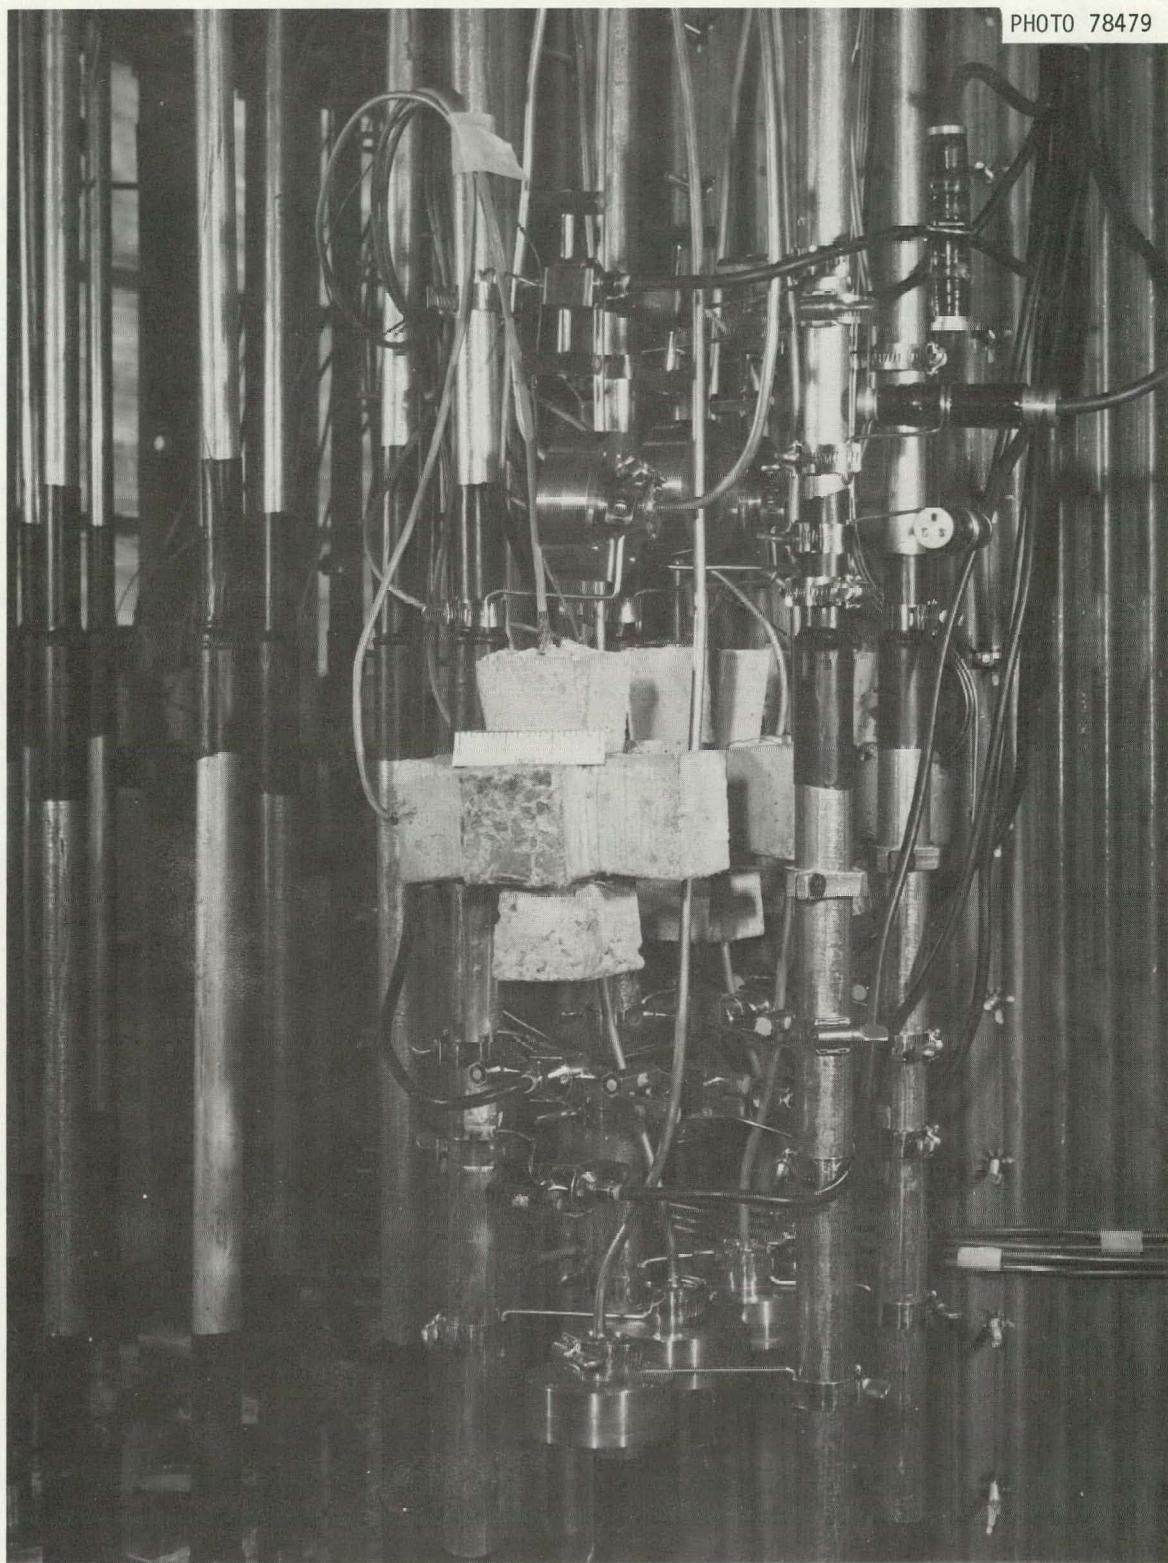
Fig. 3.2. Close-up of instrumentation at one of four gaged sections.

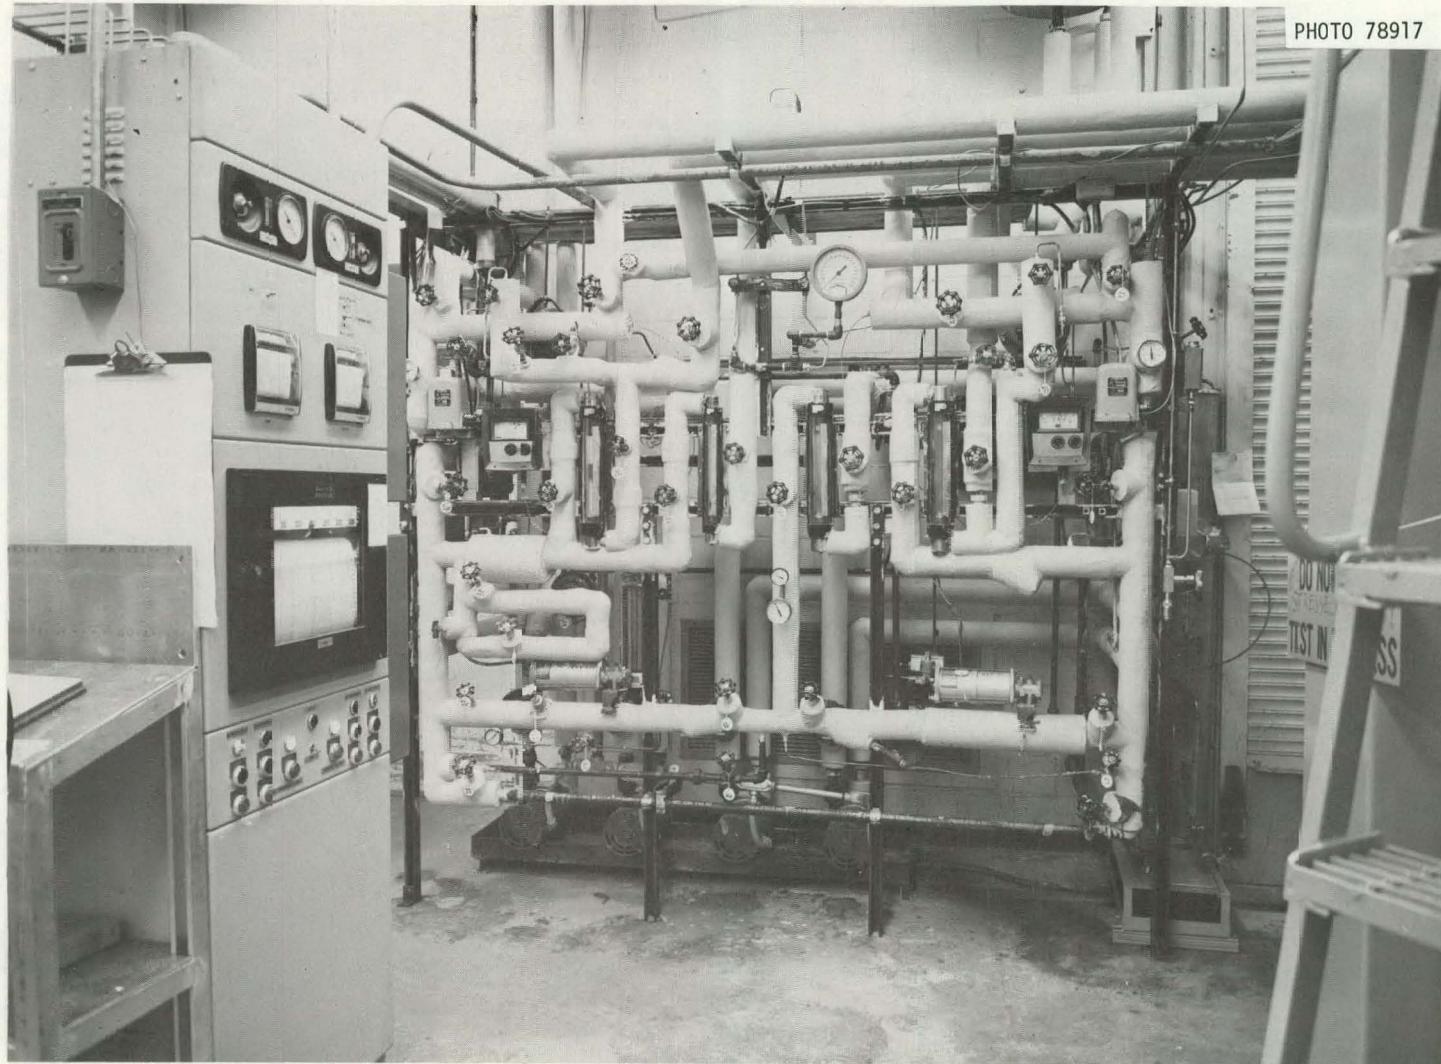
Fig. 3.3. Temperature control system.

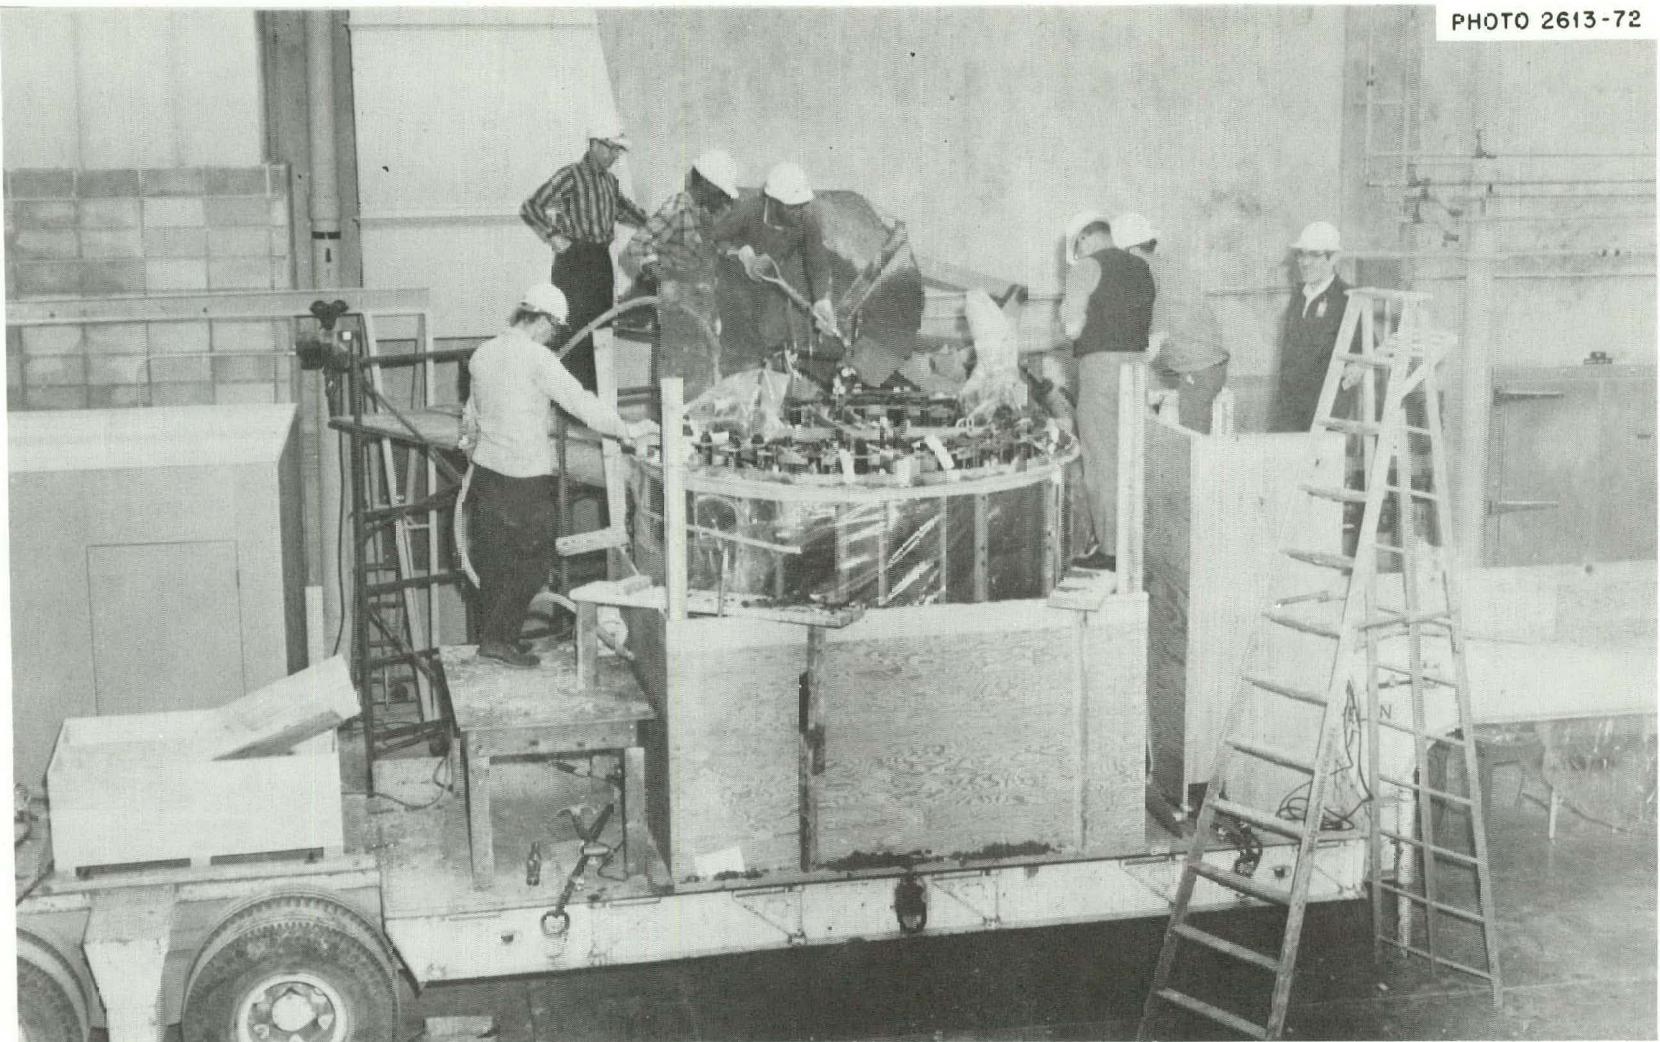
Fig. 3.4. Casting operation, showing placing of concrete into thermal cylinder mold.

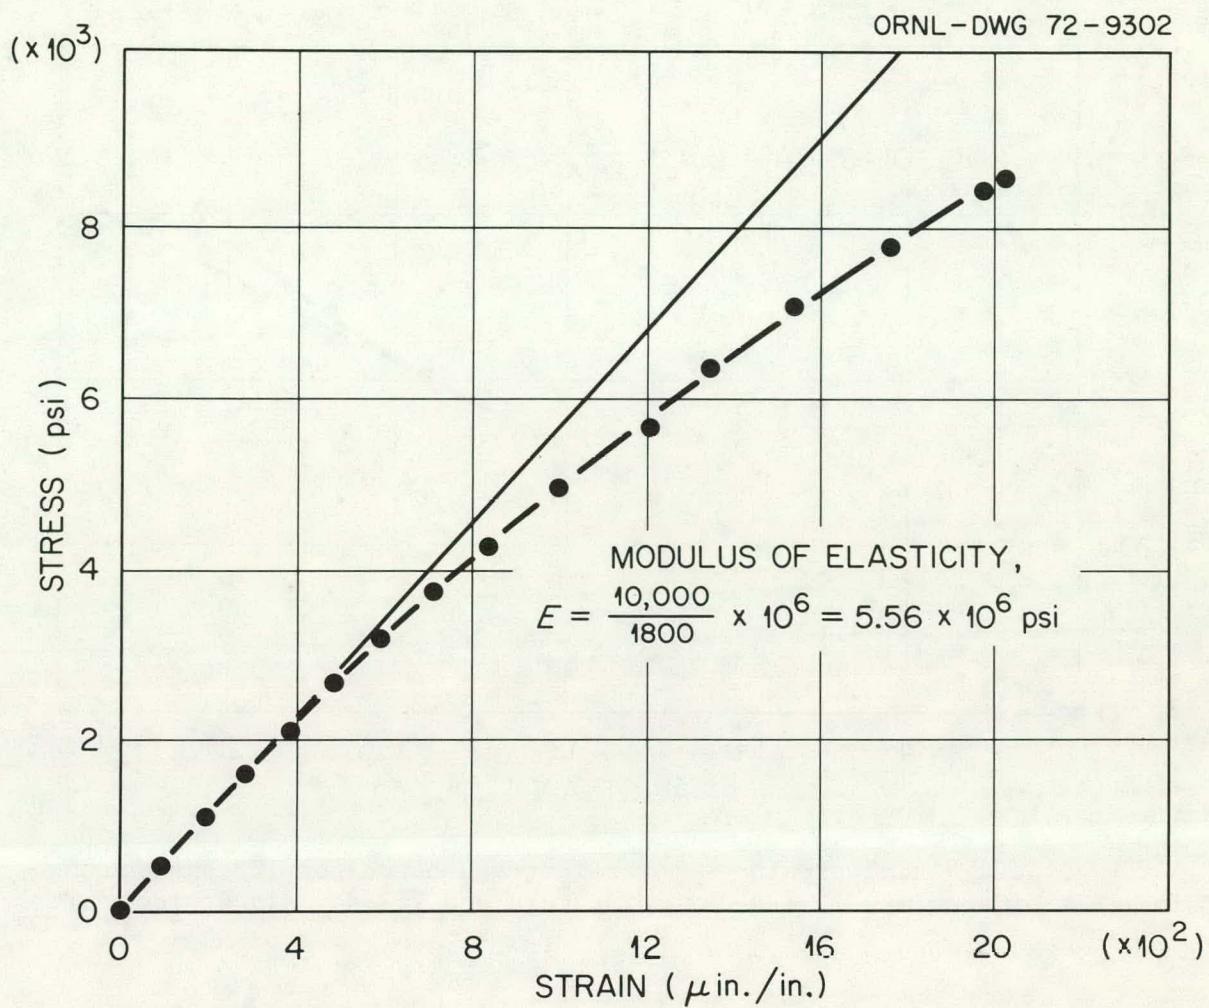
Fig. 4.1. Axial stress-strain curve for 180-day compression test of specimen 13 (28-day moist cure and 152-day air drying). (1 psi = 6895 Pa.)

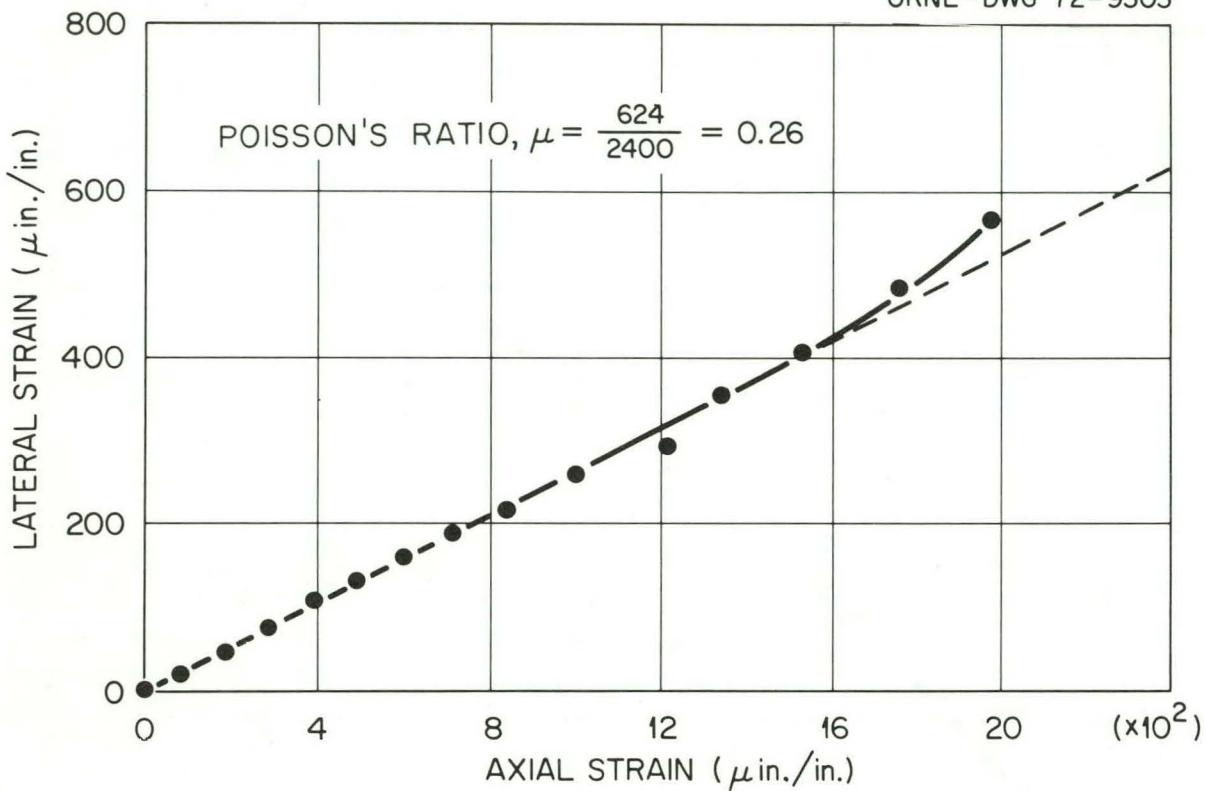
Fig. 4.2. Axial strain vs lateral strain curve for 180-day compression test of specimen 13 (28-day moist cure and 152-day air drying).

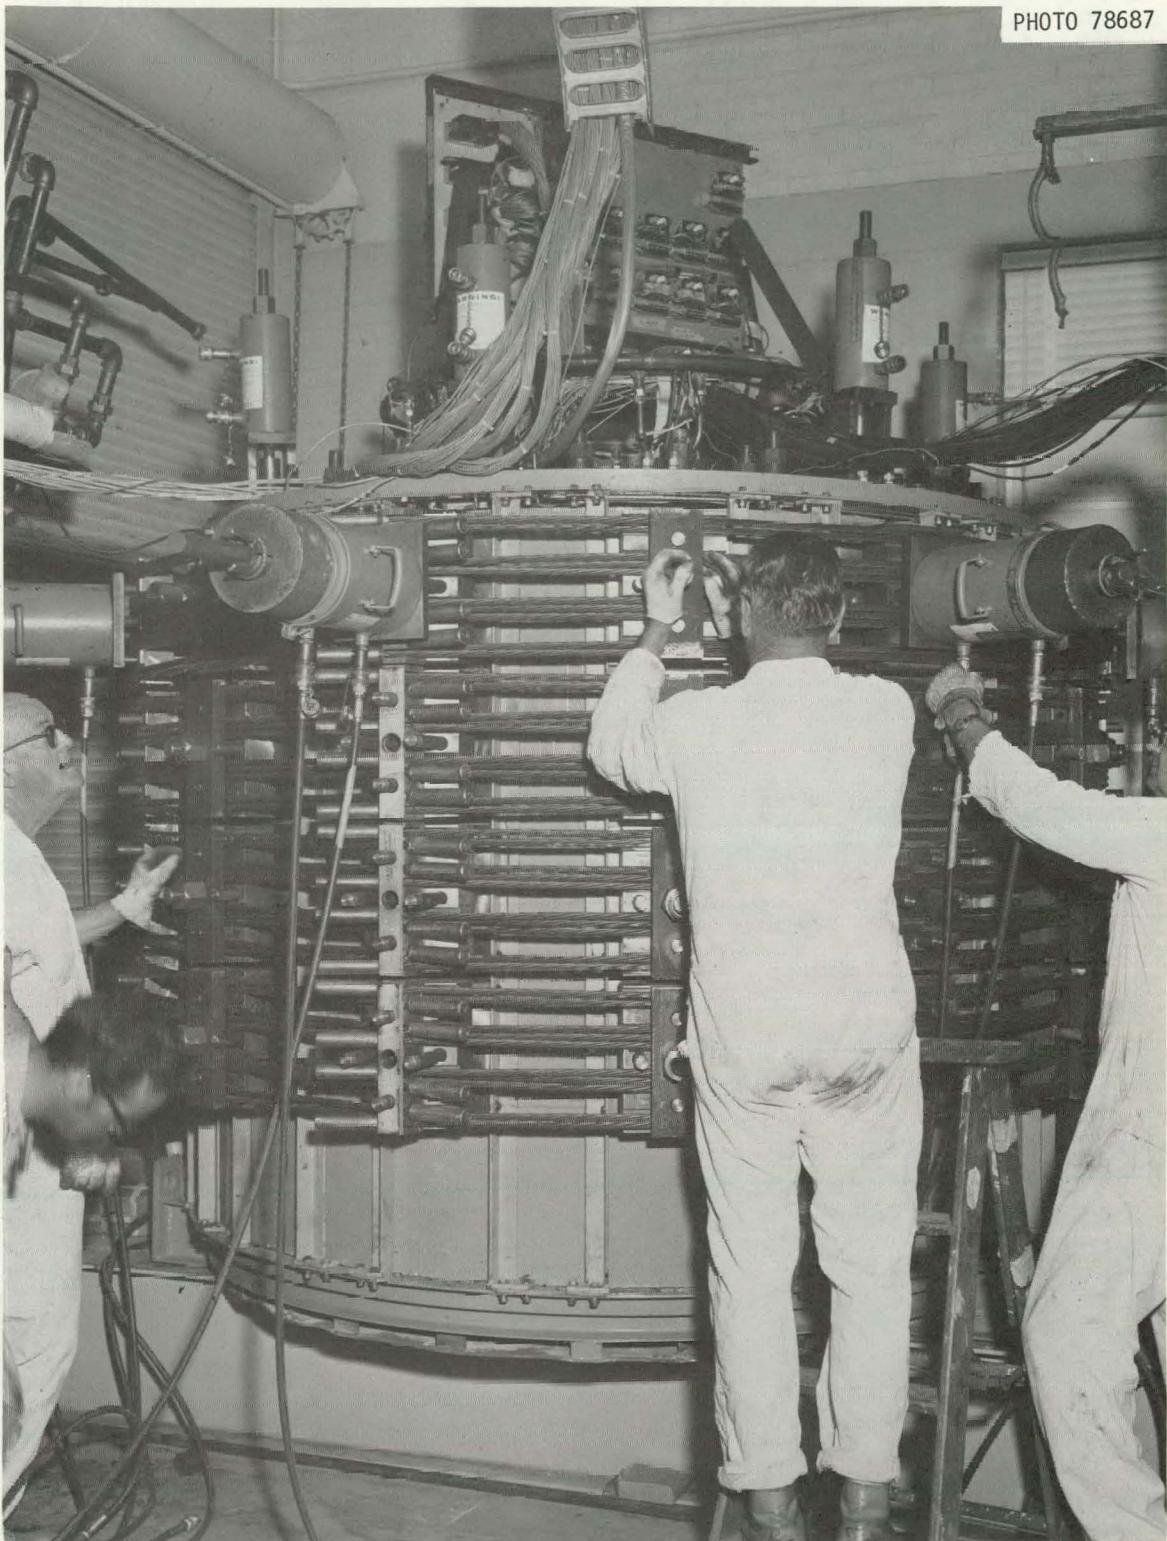
Fig. 4.3. Posttensioning operation, showing longitudinal and circumferential rams in position.

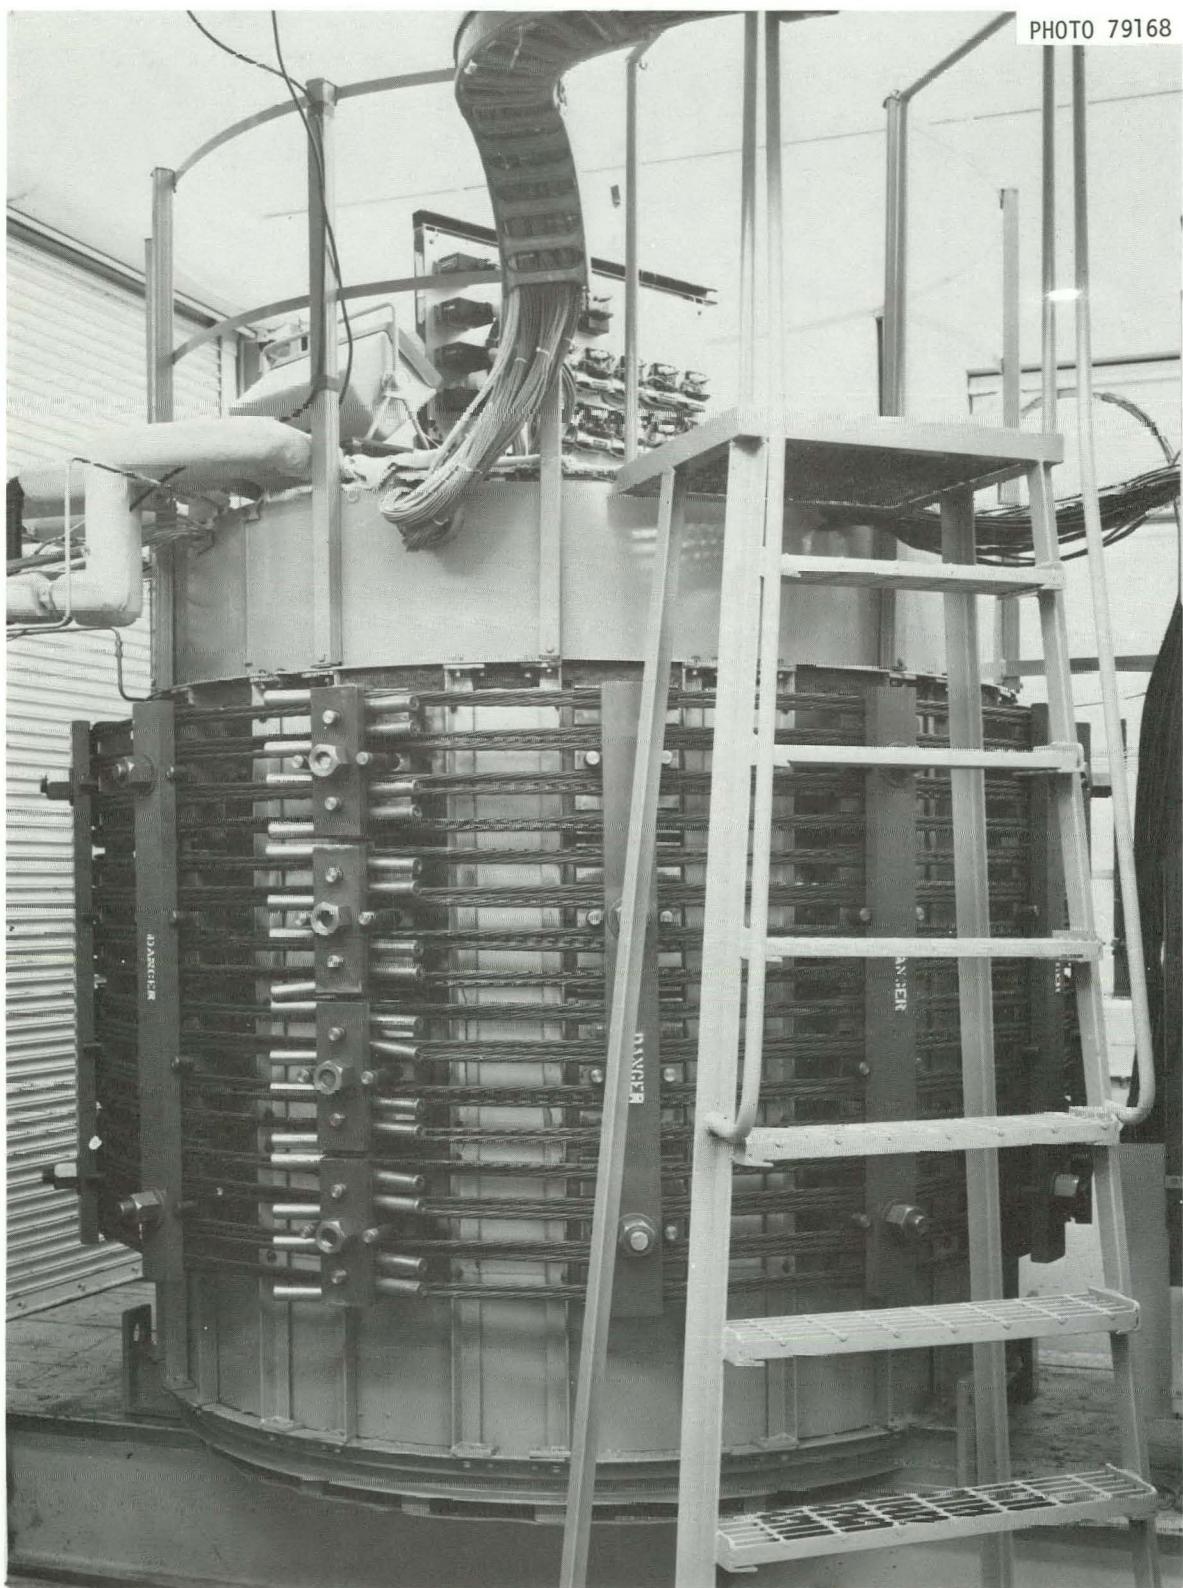
Fig. 4.4. Completed thermal cylinder model.

After posttensioning, the remaining phases of assembly, which consisted of installation of the upper insulation and moisture tube extensions and filling of the pressurizing annulus with hydraulic fluid, were completed. The completed model is shown in Fig. 4.4.

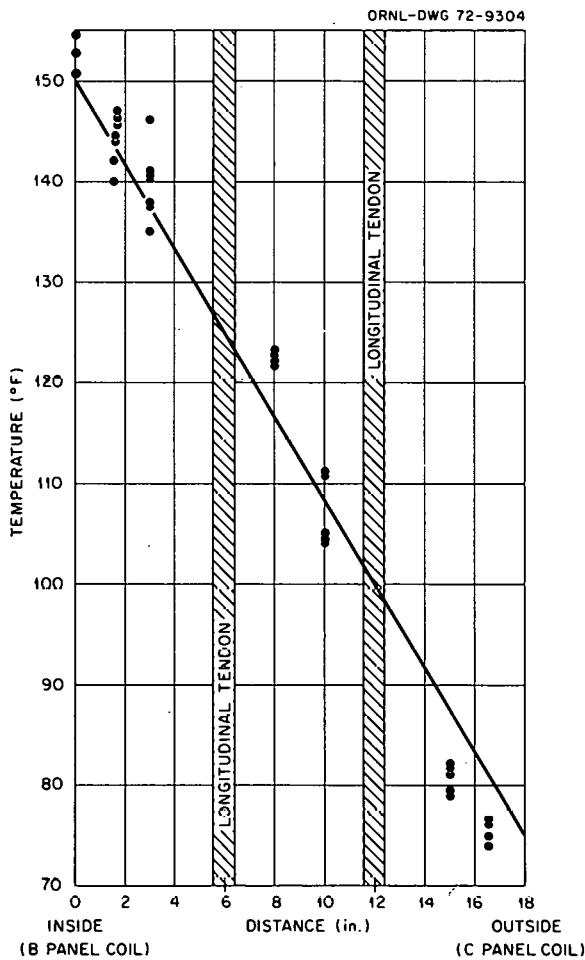
Fig. 4.5. Final thermal cylinder temperature gradient. Points indicate individual temperature readings of thermocouples and precision resistors. [1 in. = 25.4 mm; K =  $273.15 + 5/9 (°F - 32)$ .]
