ORNL/TM-5613

## Prestressed Concrete Reactor Vessel Thermal Cylinder Model Study

HTGR BASE TECHNOLOGY PROGRAM  
Prestressed Concrete Nuclear Pressure  
Vessel Development (189a. No. 01331)

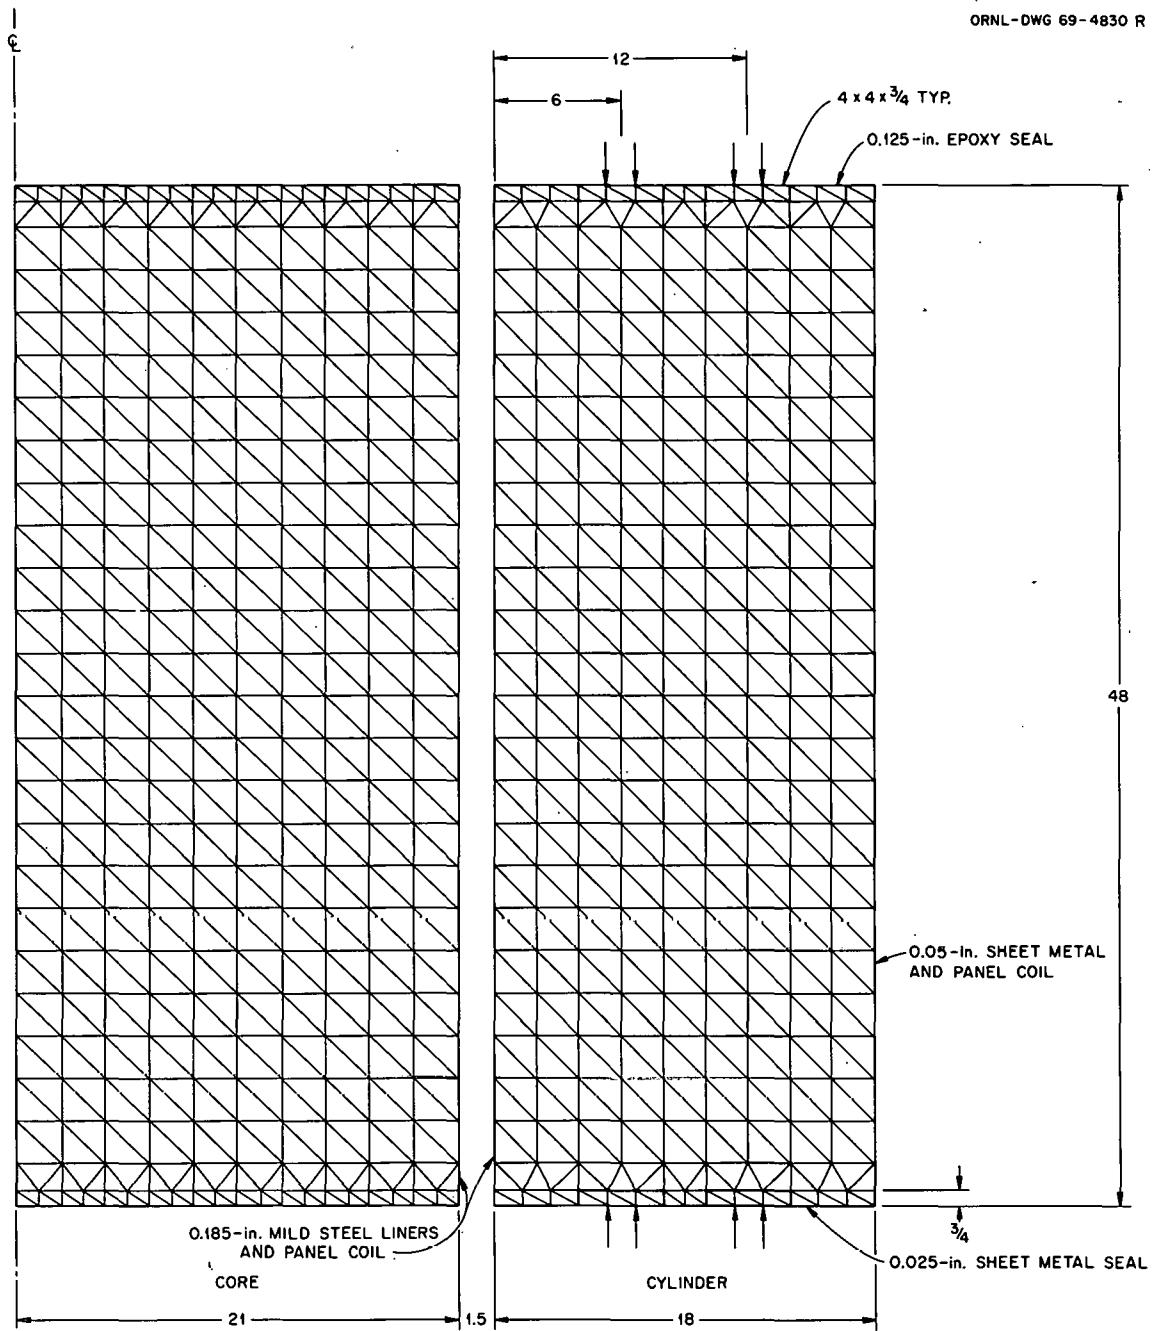
The analytical model is the axisymmetric thick-walled cylinder shown in Fig. 5.1, having the dimensions and geometry of the test model. Both the cylinder and core are included in the finite-element grid. A total of 564 elements are used, with triangular ring elements representing the concrete and membrane shell elements representing the liner or heat exchangers. The circumferential prestressing is represented as uniform pressure applied to the outer barrel section, and the axial prestressing tendons are treated as concentrated nodal loads. Once the specified failure criteria are exceeded, the affected concrete element is allowed to crack, and new stiffness and load matrices are computed in the analysis. The resulting new equilibrium equations are then solved for new displacements.

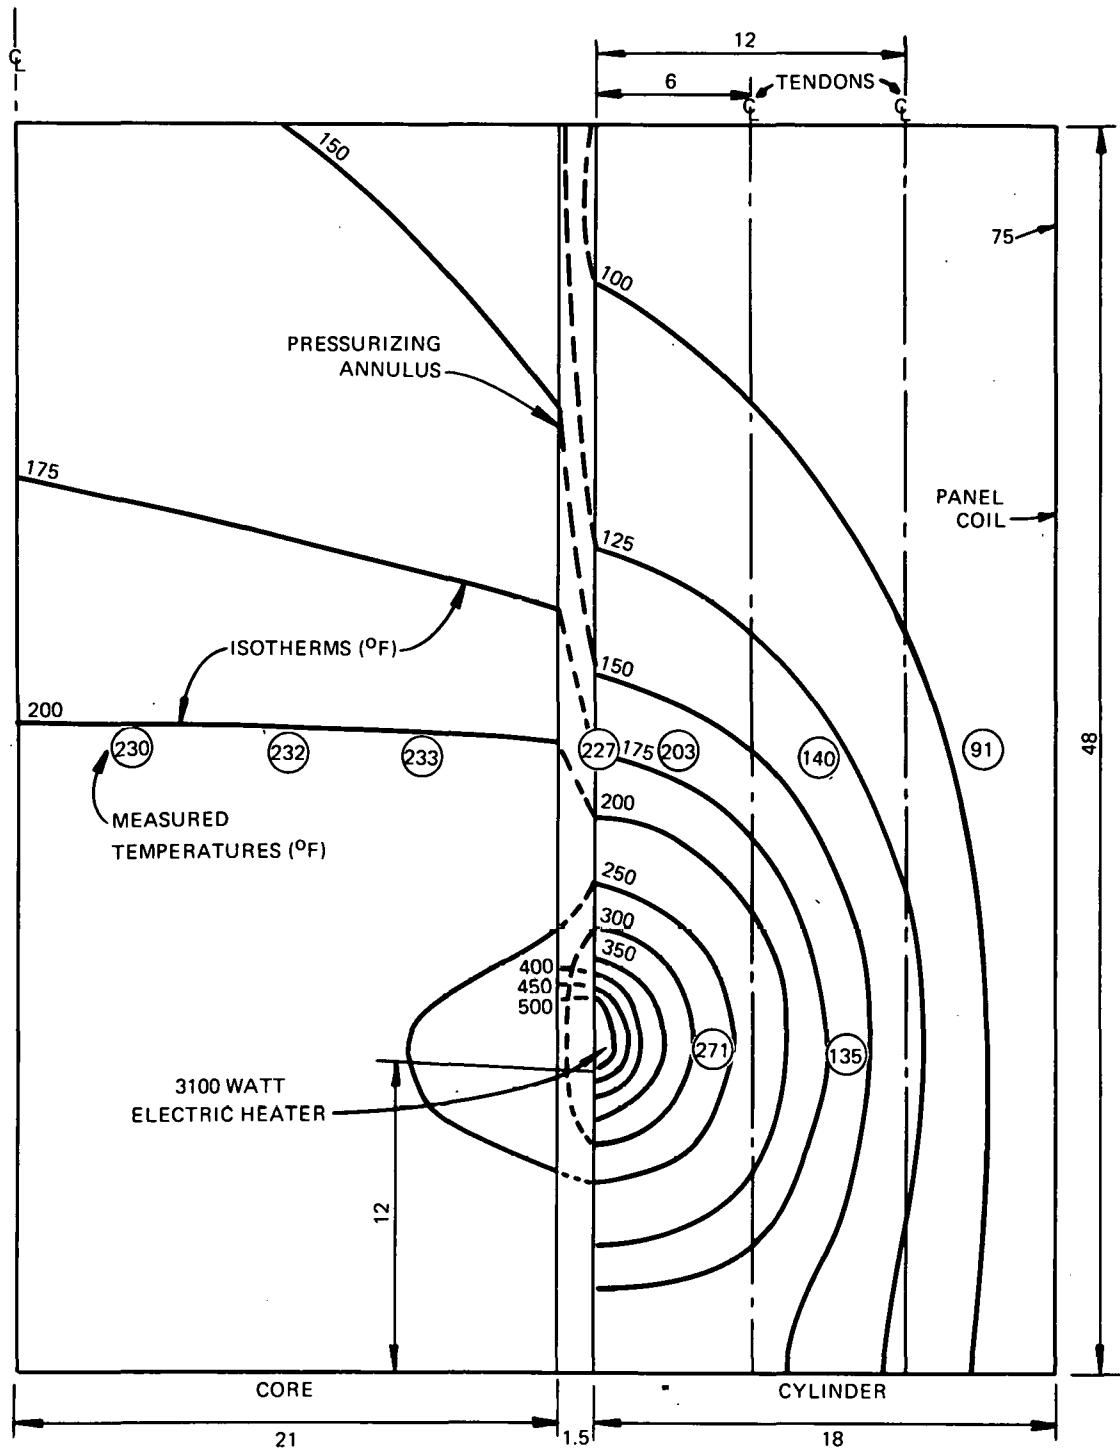
Fig. 5.2. Temperature profiles during thermal cylinder hot-spot test [1 in. = 25.4 mm;  $K = 273.15 + 5/9 (°F - 32)$ ].

A heat transfer analysis was performed for the hot-spot condition to evaluate the temperatures that were measured during this overtemperature event. Internal and external boundary conditions and materials properties were varied to obtain the best fit of measured temperatures in the test specimen section. The material and heat transfer parameters that gave the best fit are listed in Table 5.1, and the recorded and predicted temperatures are shown in Fig. 5.2. The transport of heat by the synthetic fluid

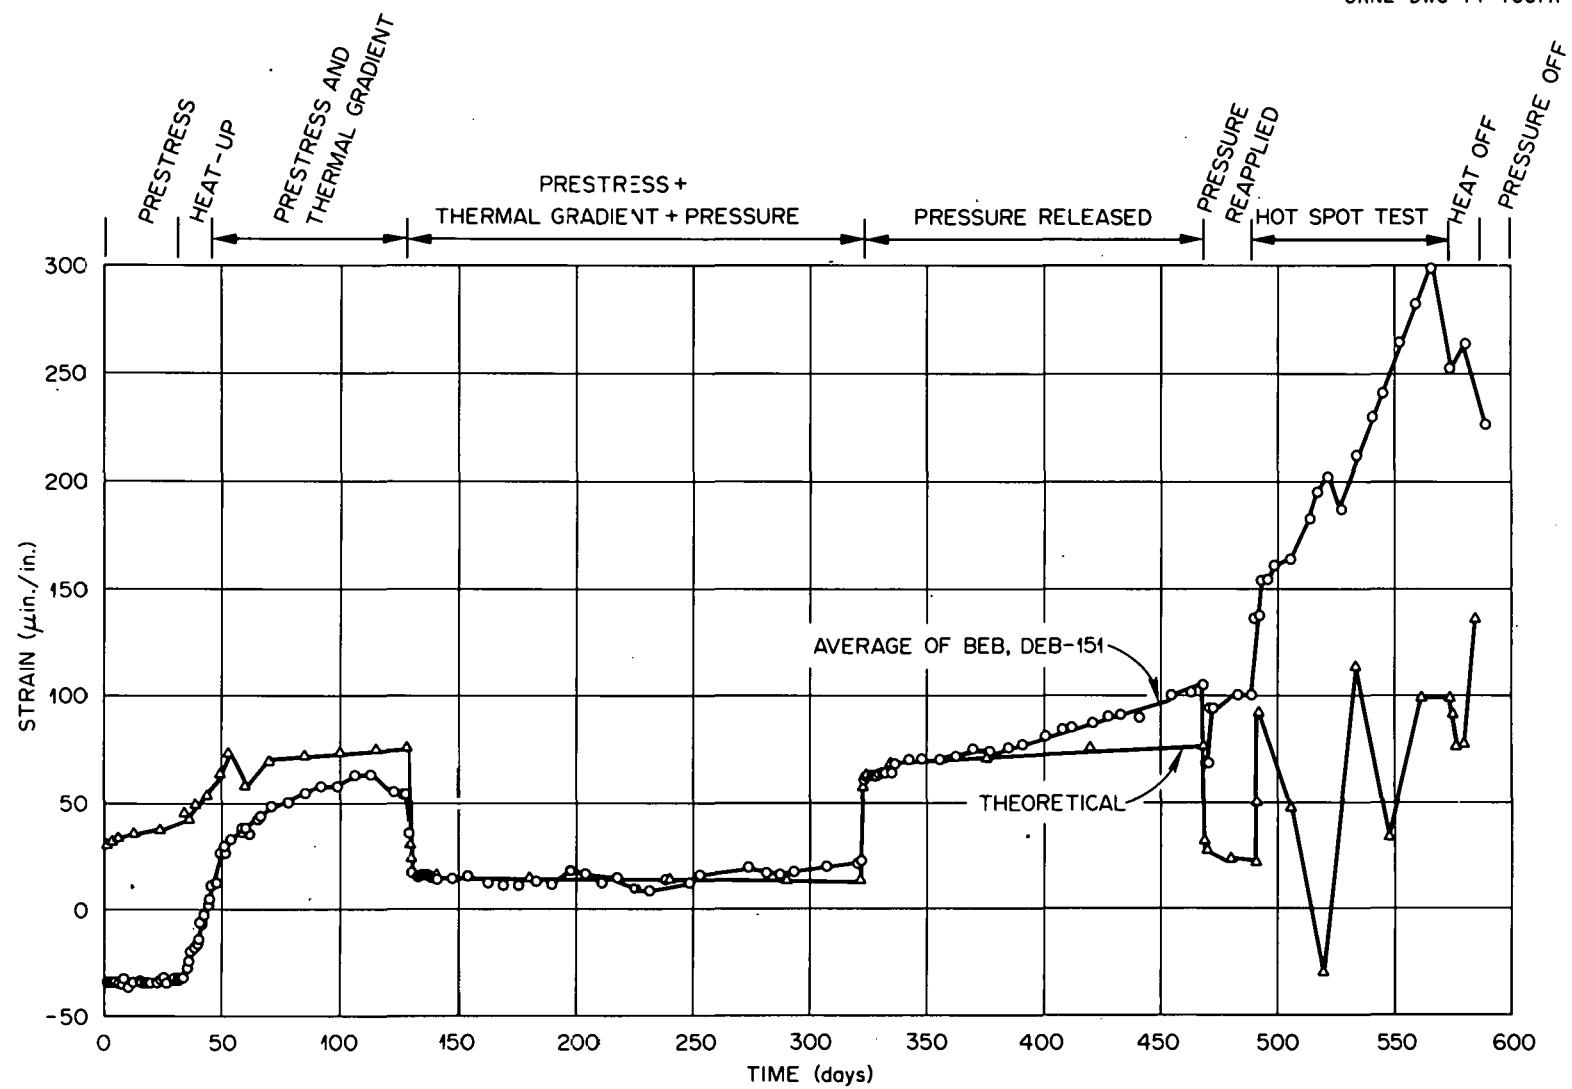
Fig. 6.1. Calculated and experimental results for first-position axial single-filament resistance strain gages.

Comparisons of analytical and experimental results for axially and radially oriented gages located in position 1 are given in Figs. 6.1 and 6.2, respectively. (See Sect. 2.1 for a complete explanation of gage and position designations.) In both cases, the prestressing and pressurization strains were overestimated, while strains produced during heatup were underestimated. The behavior of the axial gages during hot-spot heating appears erratic, since a strain jump was recorded shortly after repressurization. The probable causes of this effect as well as the sharp fluctuations in analytical values are discussed in Chap. 7.

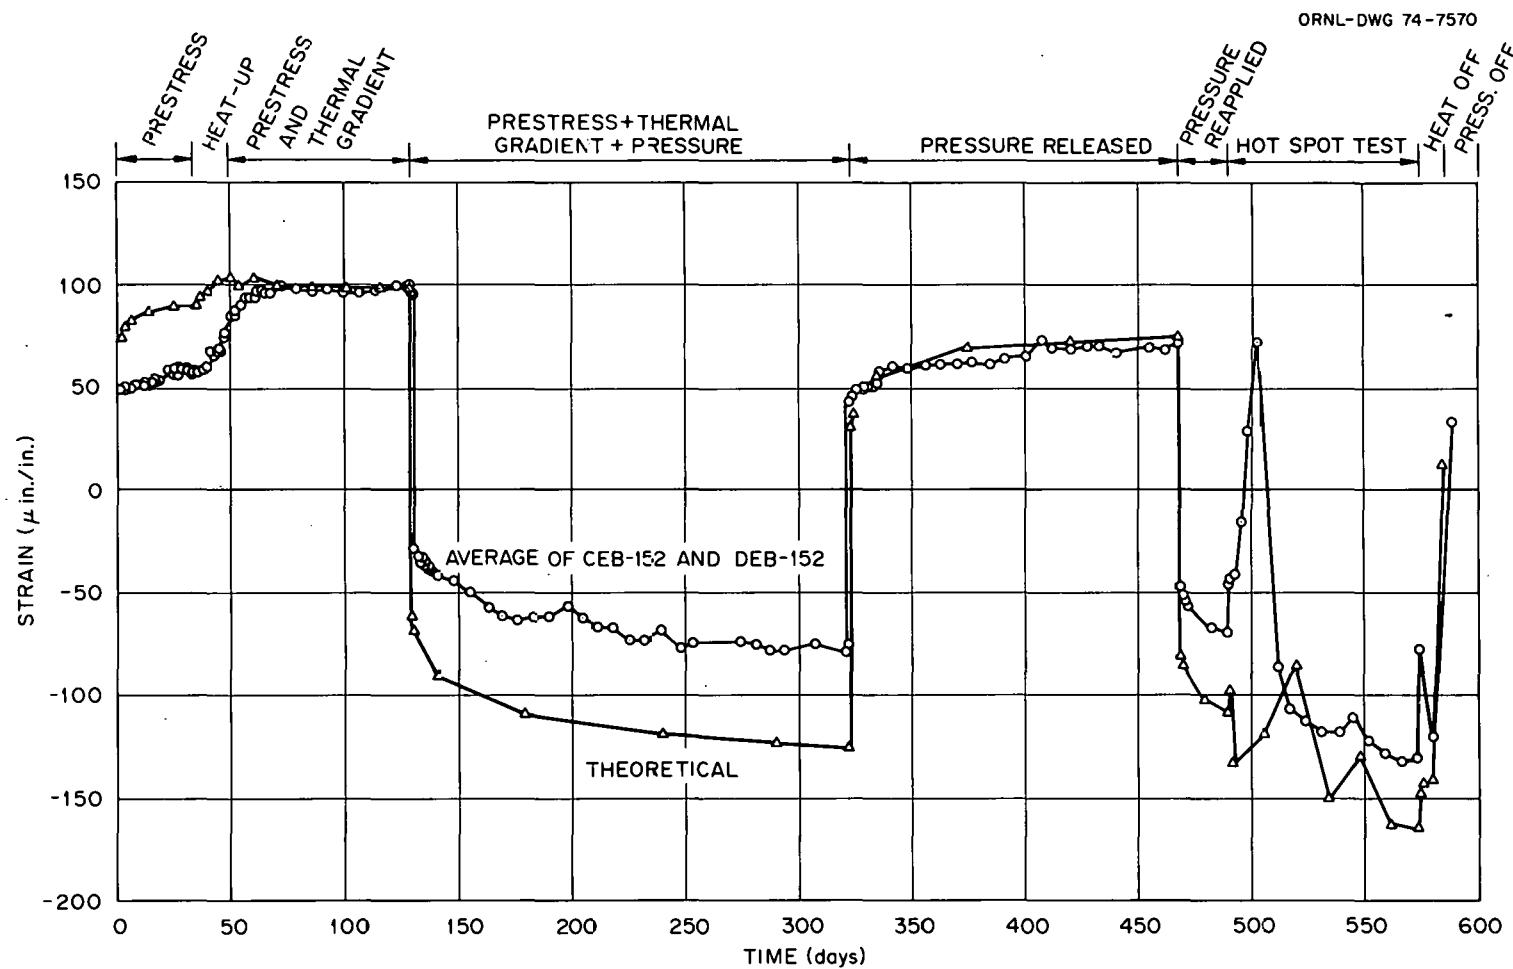
Fig. 6.2. Calculated and experimental results for first-position radial single-filament resistance strain gages.

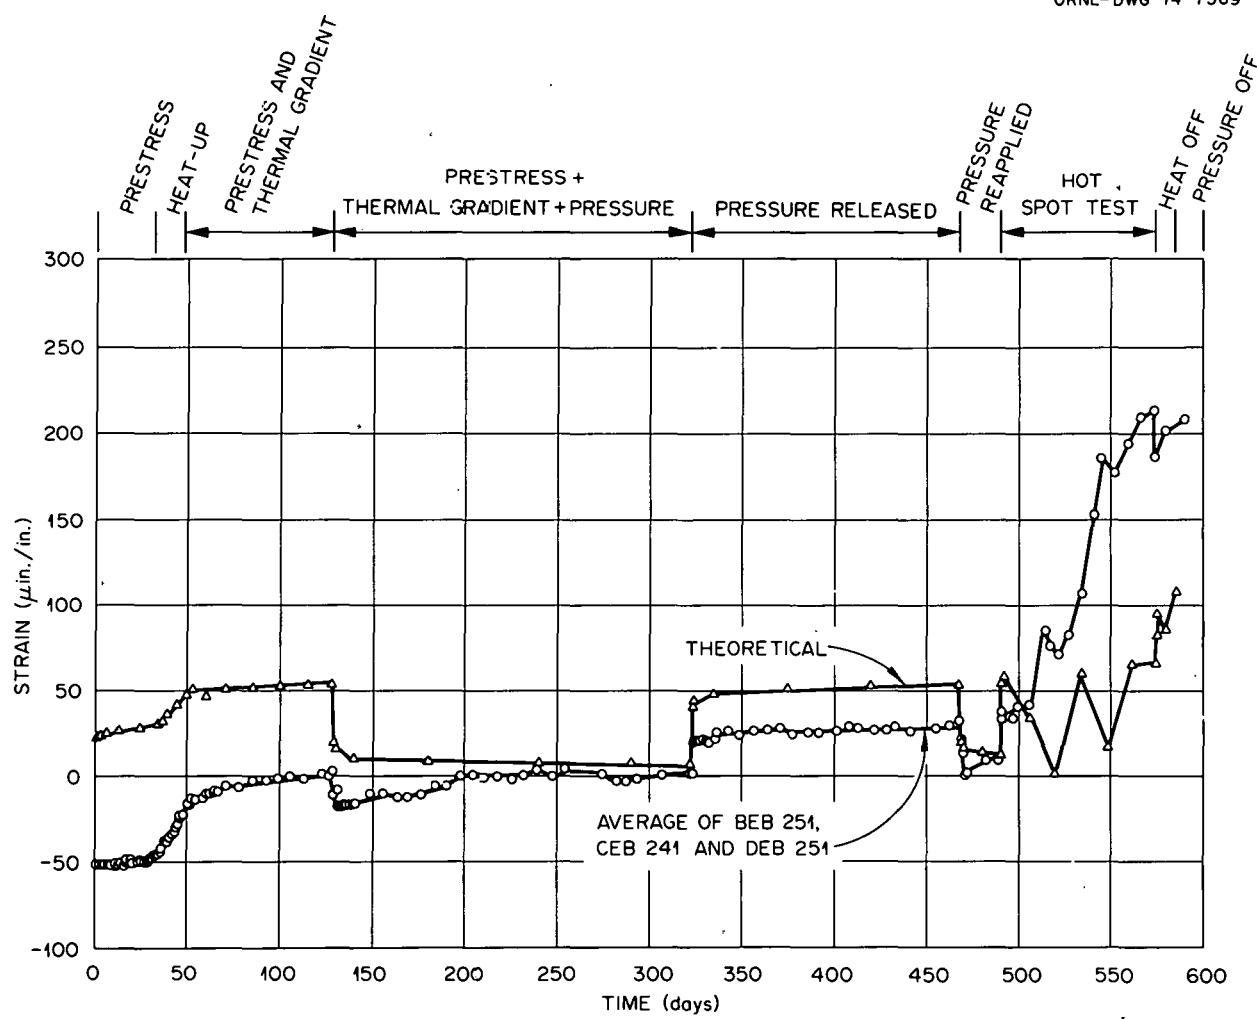
Fig. 6.3. Calculated and experimental results for second-position axial single-filament resistance strain gages.

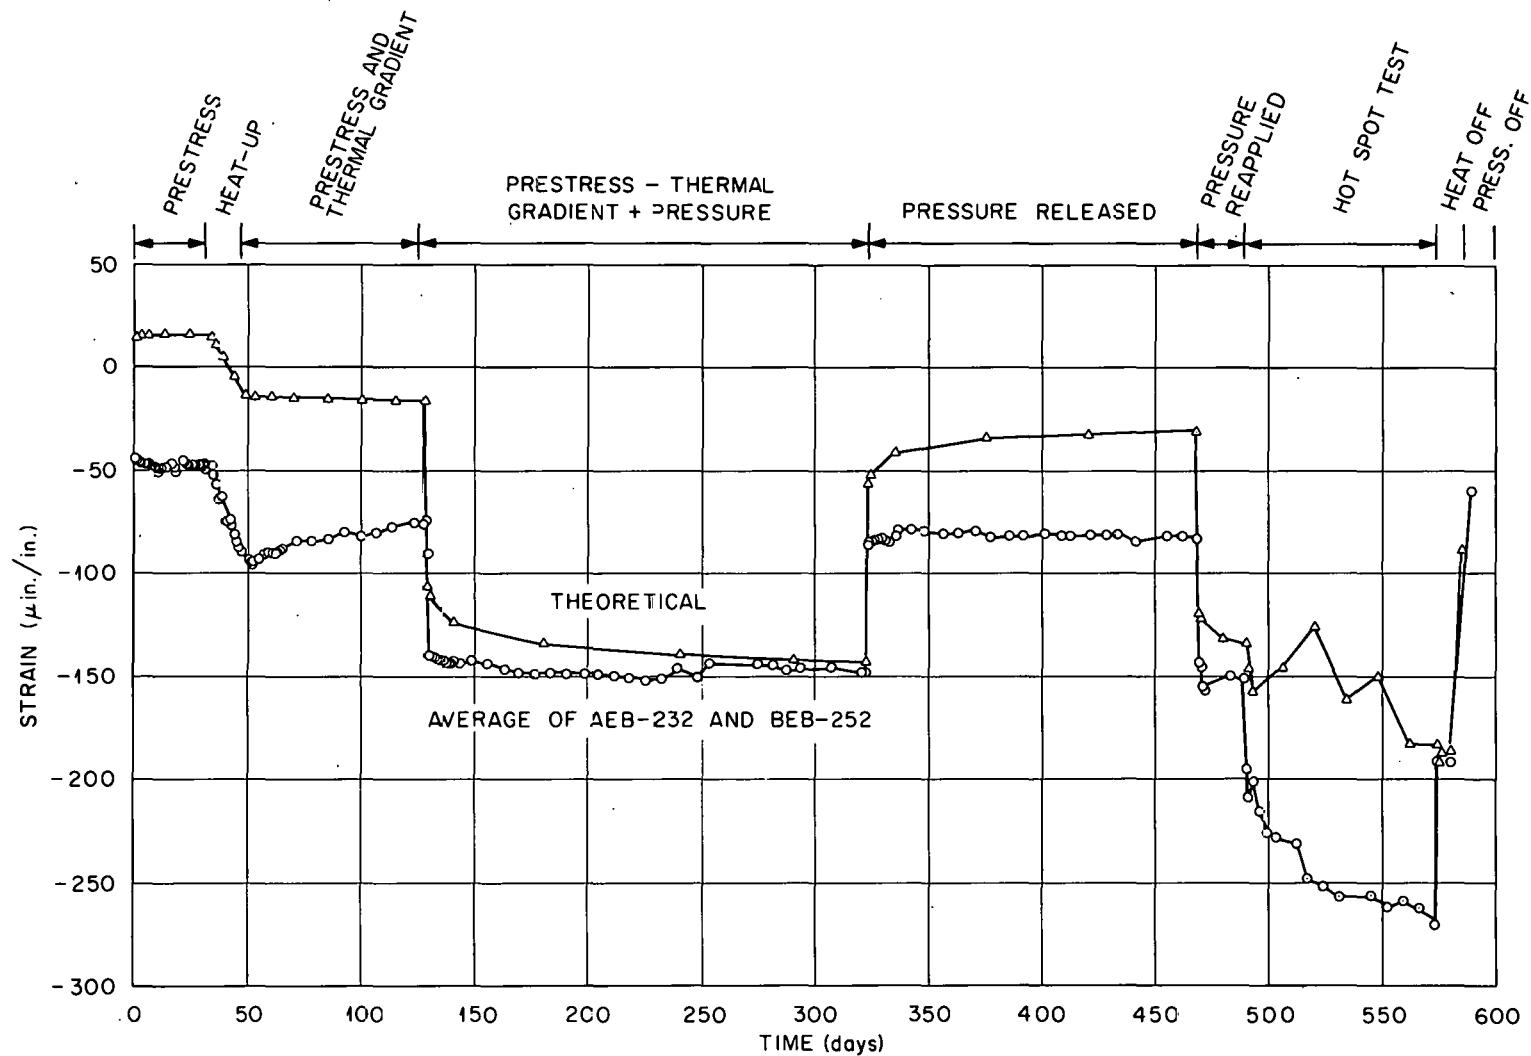
Fig. 6.4. Calculated and experimental results for second-position radial single-filament resistance strain gages.

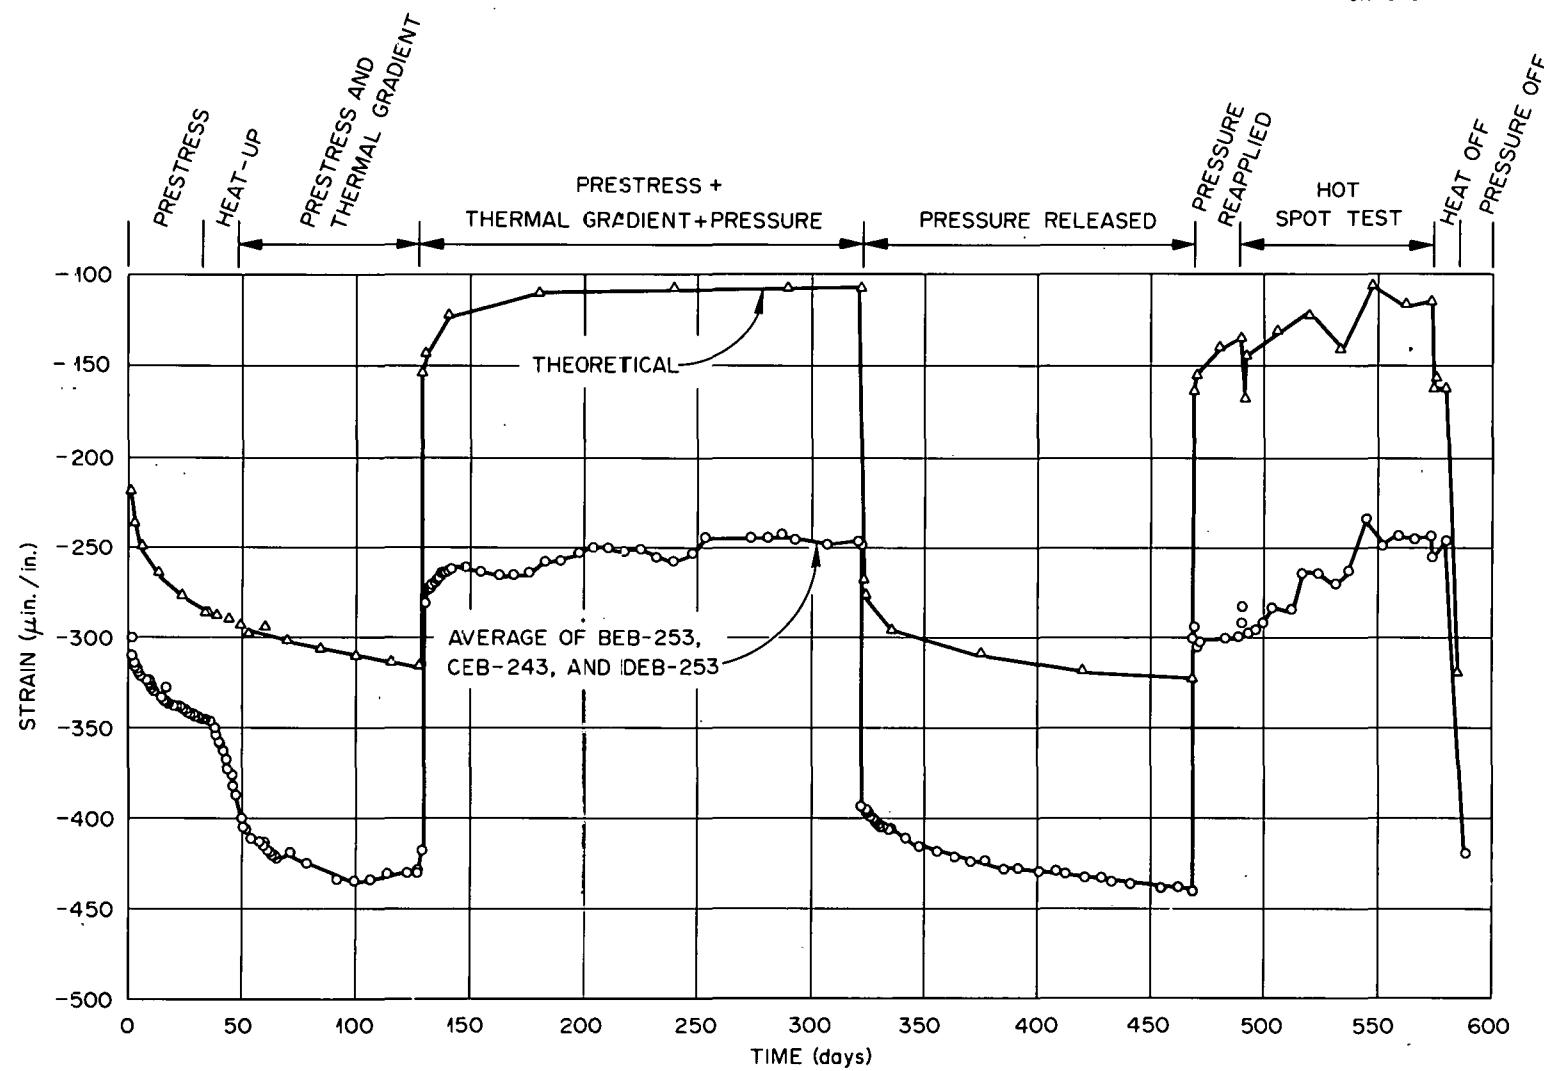
Fig. 6.5. Calculated and experimental results for second-position circumferential single-filament resistance strain gages.

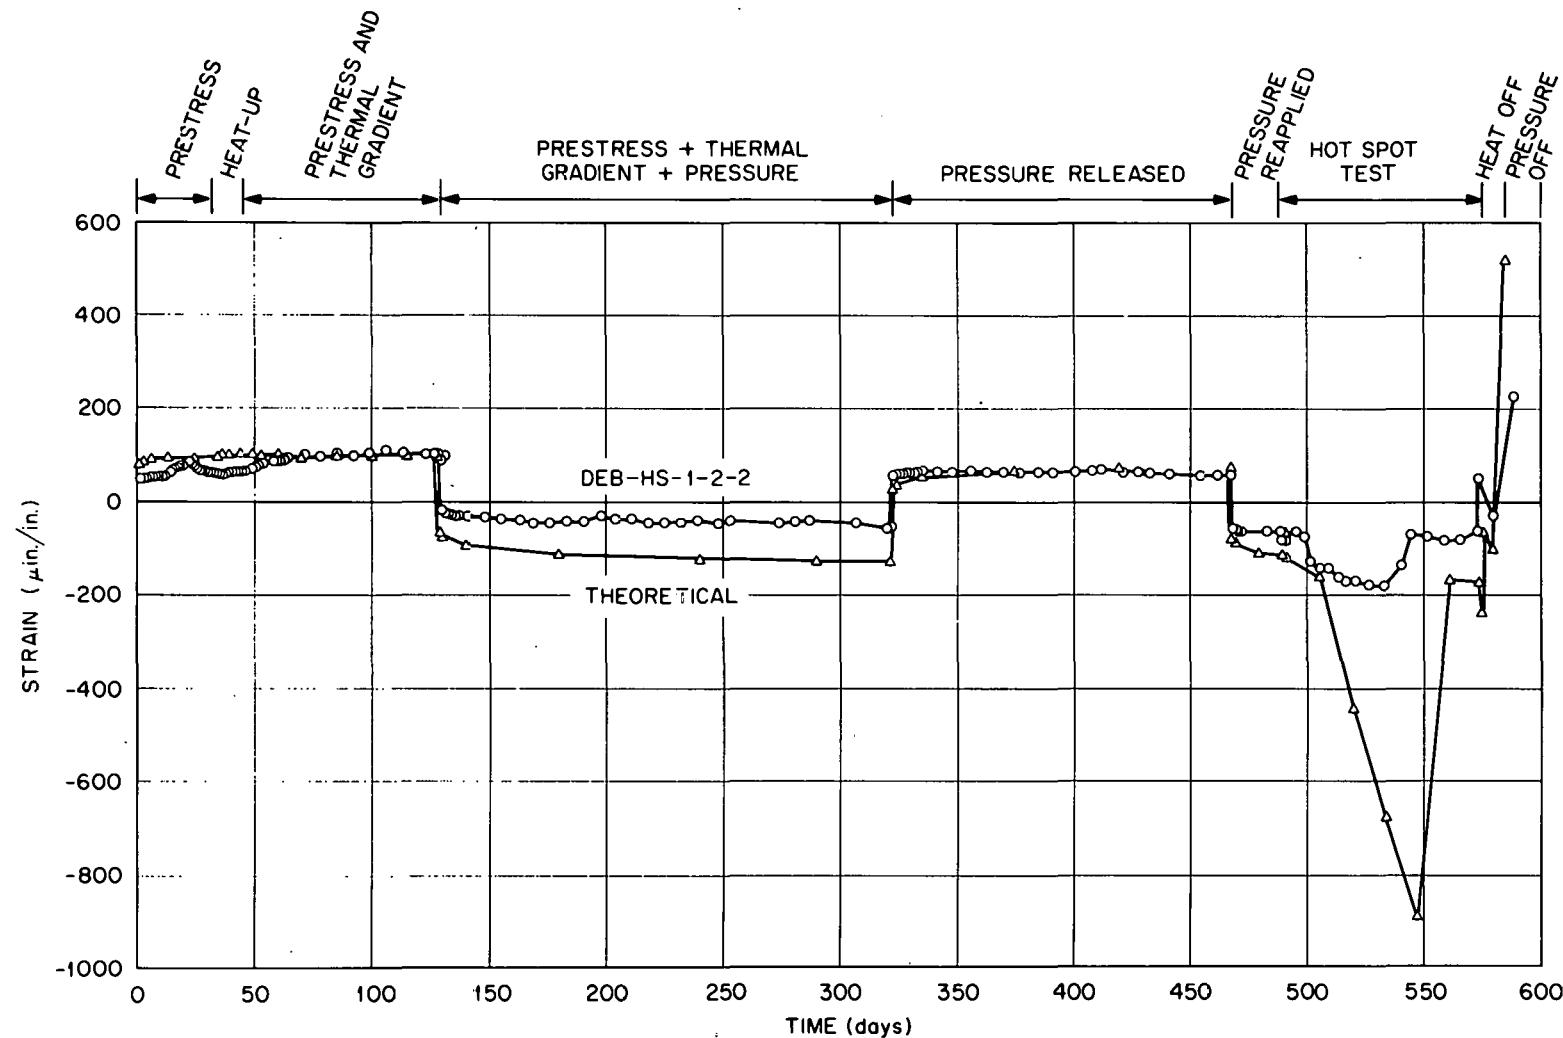
Fig. 6.6. Calculated and experimental results for hot-spot-position radial single-filament resistance strain gage.

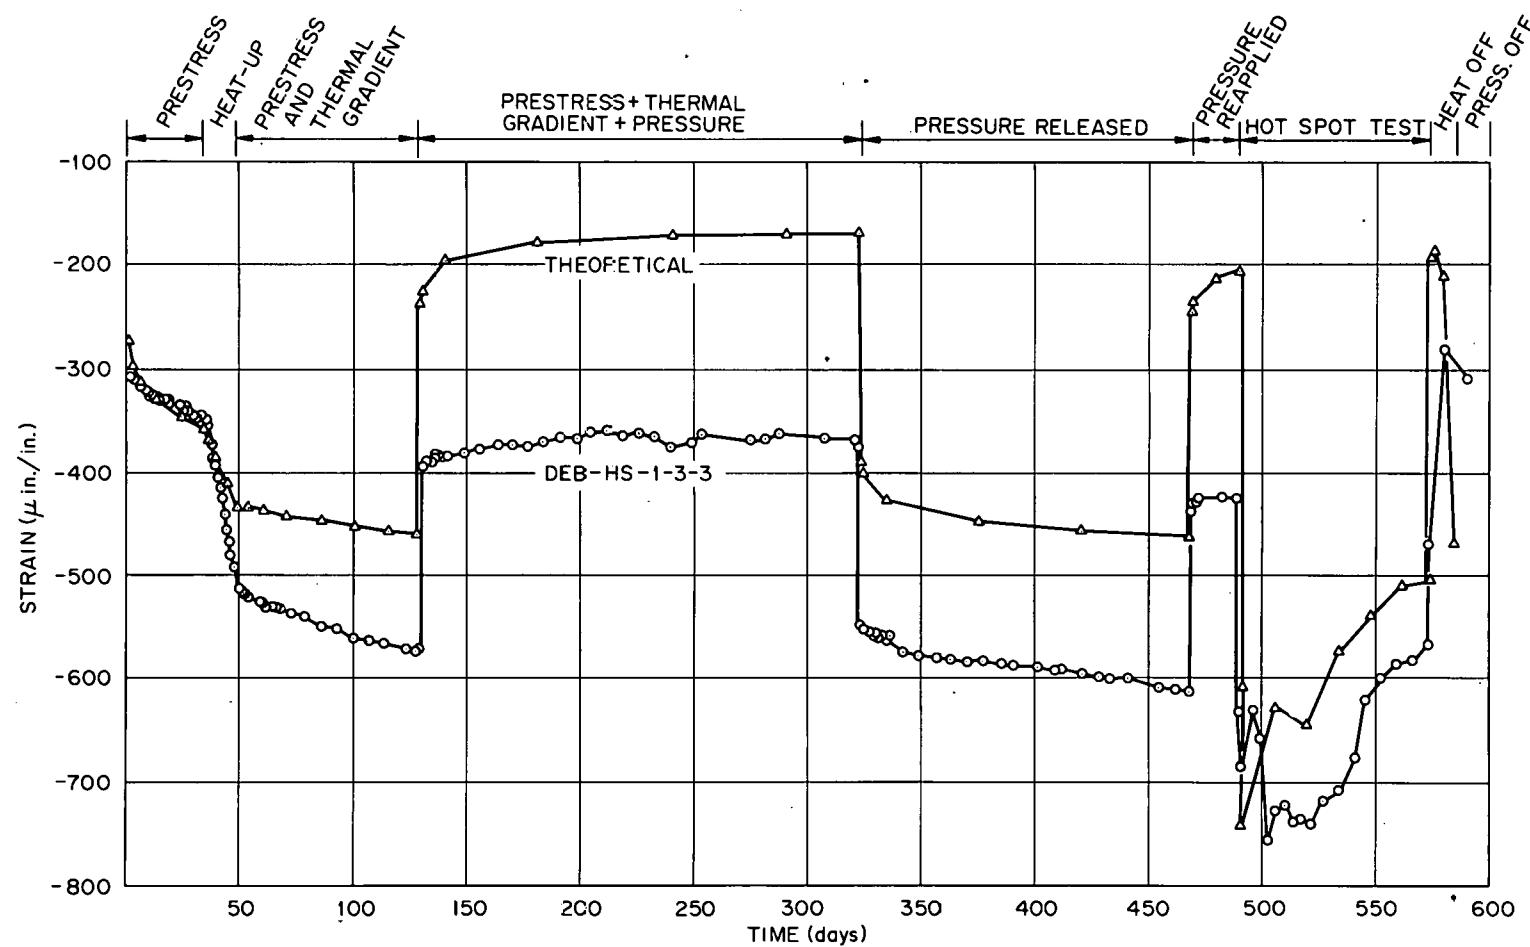
Fig. 6.7. Calculated and experimental results for hot-spot-position circumferential single-filament resistance strain gage.

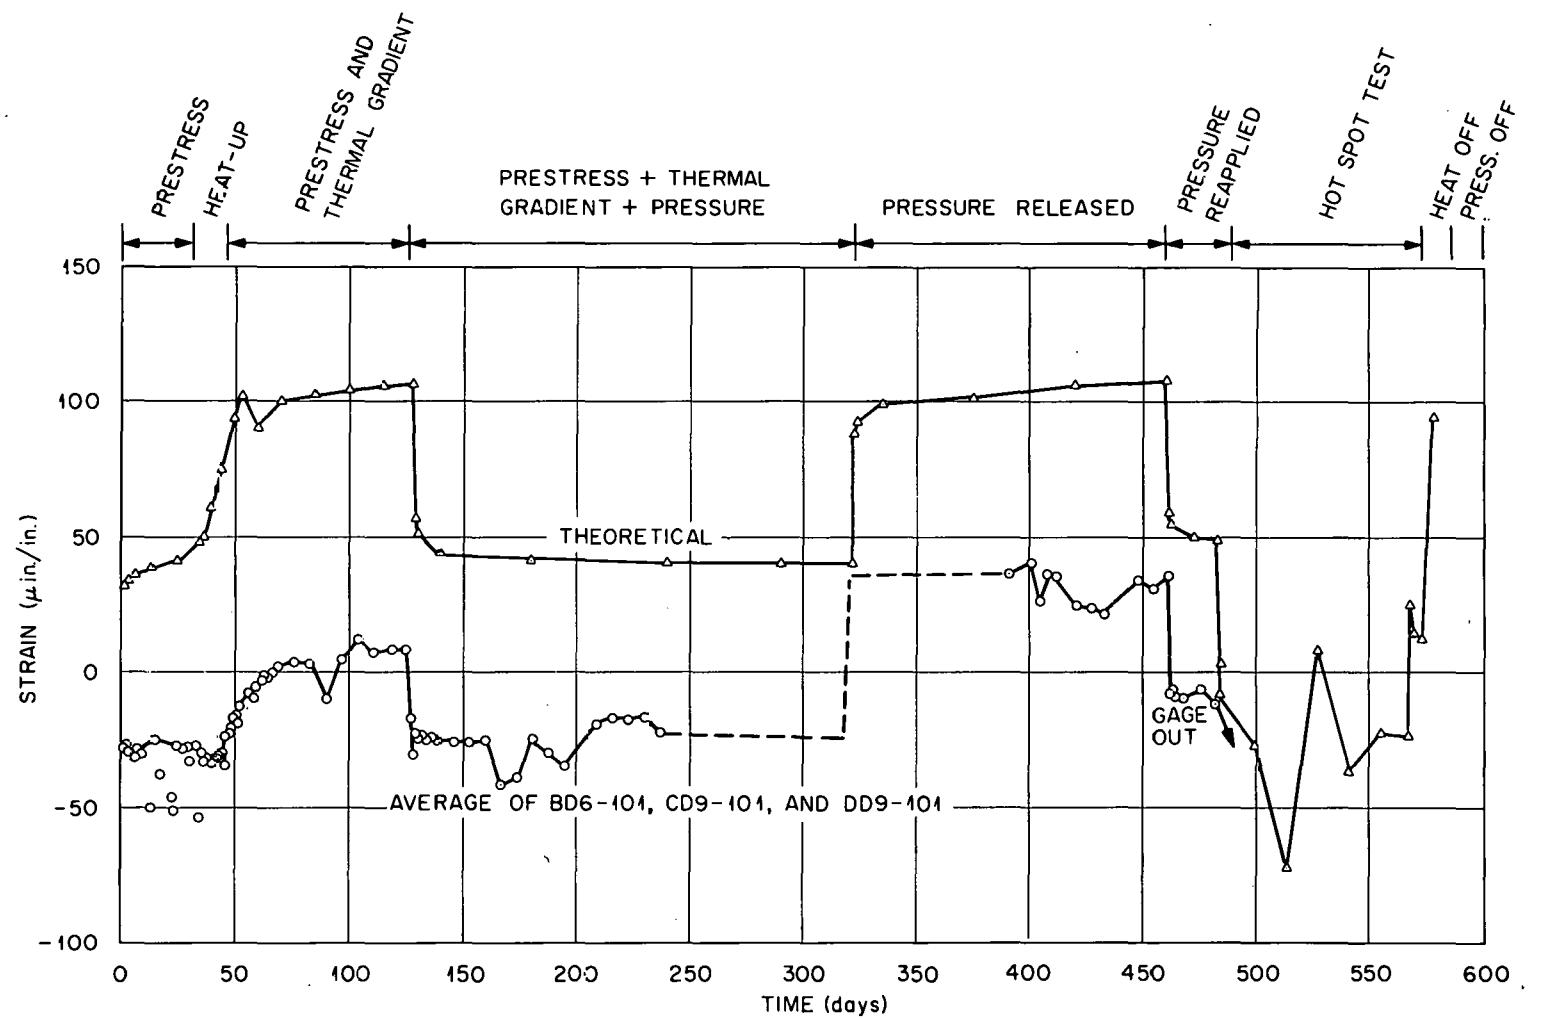
Fig. 6.8. Calculated and experimental results for first-position axial type A vibrating-wire strain gages.

Average comparisons for the type A vibrating-wire strain gages in radial position 1 (see Fig. 2.1) are shown in Figs. 6.8 to 6.10 for axial, radial, and circumferential directions, respectively. The same general trends discussed for the single-filament-type gages shown in Figs. 6.1 and 6.2 were recorded by this entirely different type of concrete embedment strain gage, which was cast directly into the concrete of the thermal

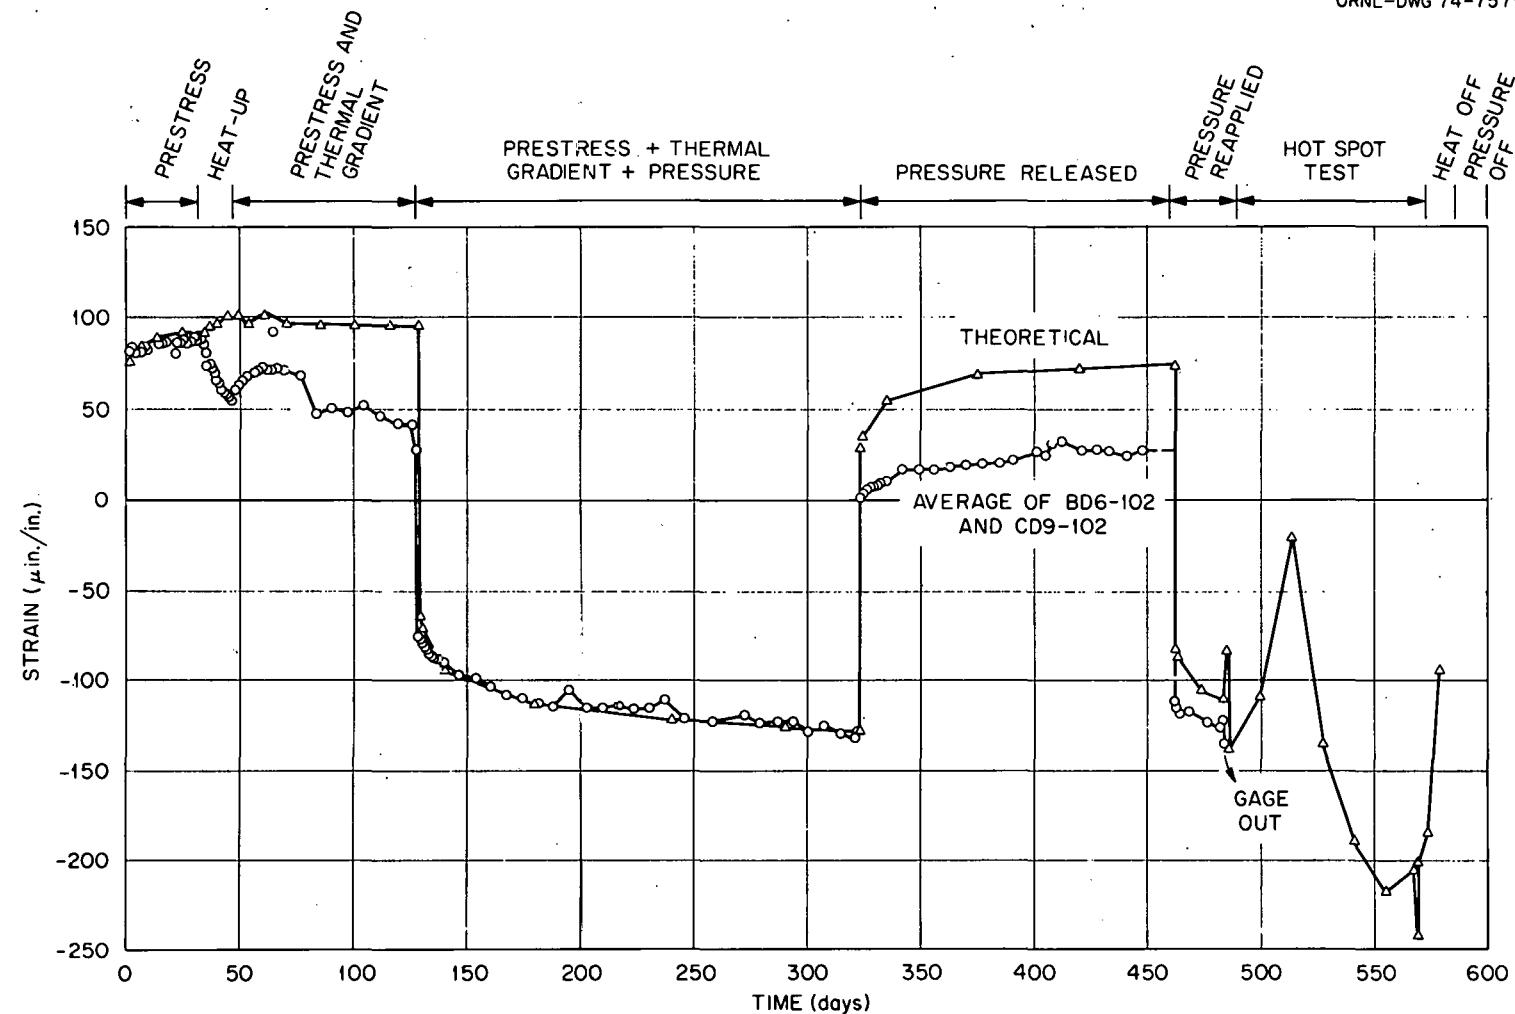
Fig. 6.9. Calculated and experimental results for first-position radial type A vibrating-wire strain gages.

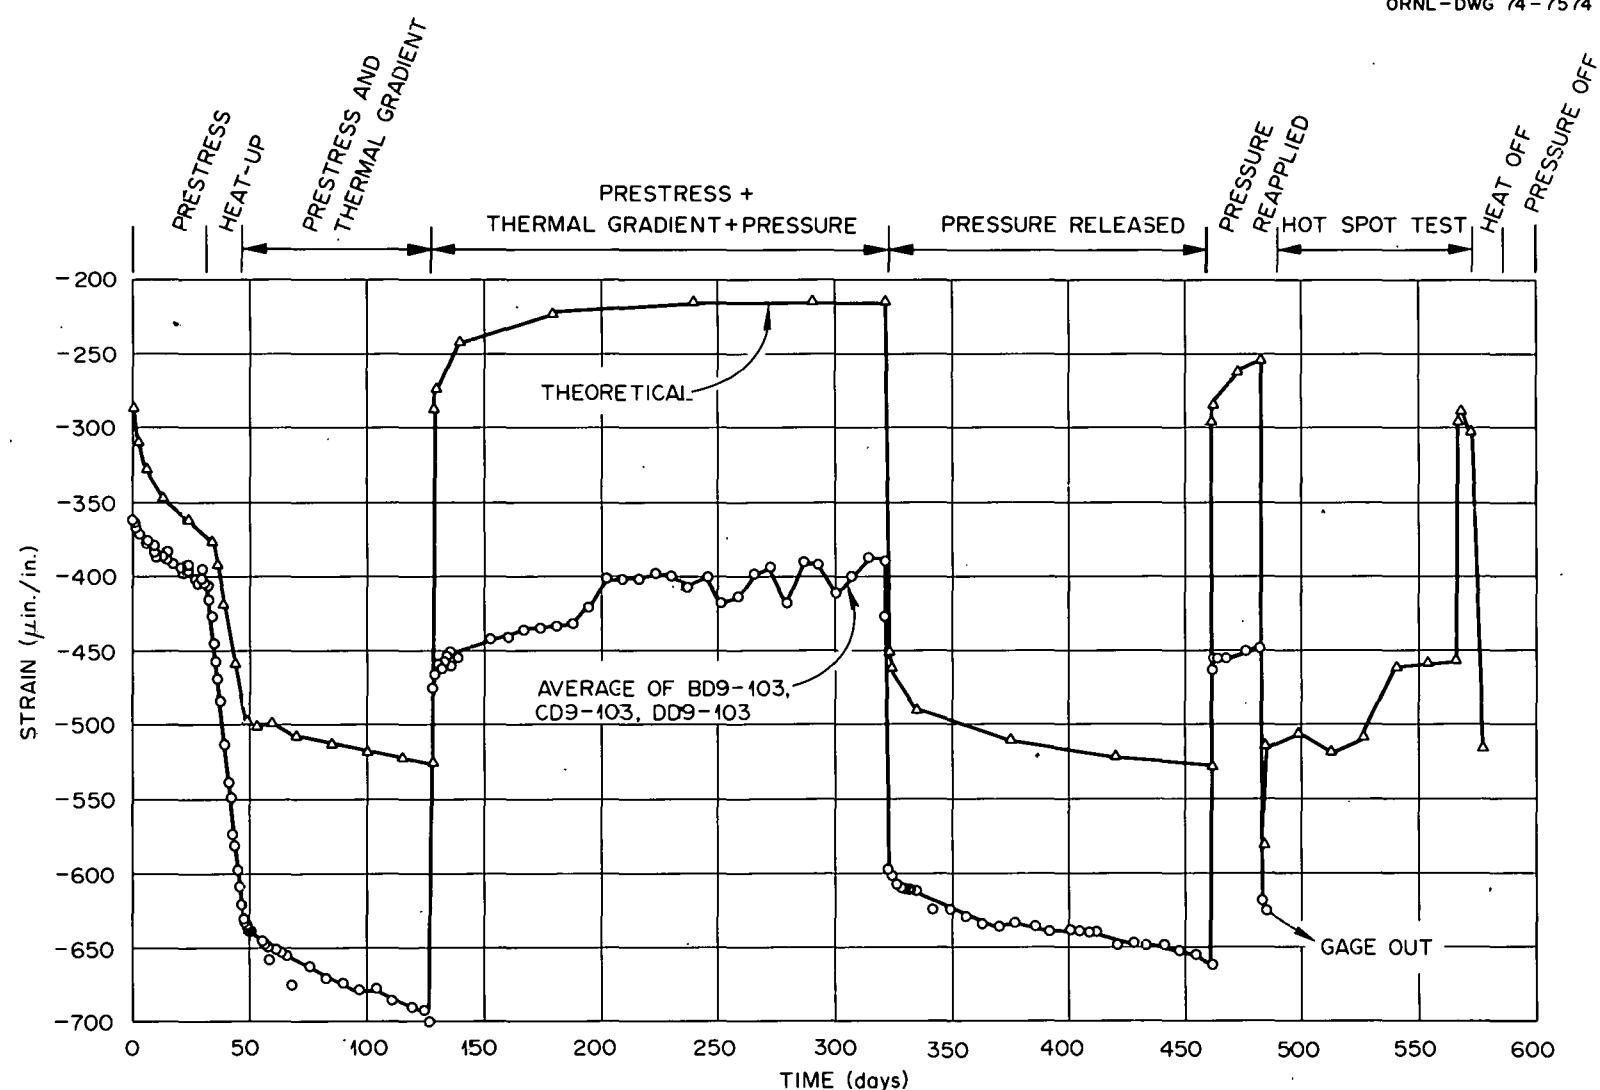
Fig. 6.10. Calculated and experimental results for first-position circumferential type A vibrating-wire strain gages.

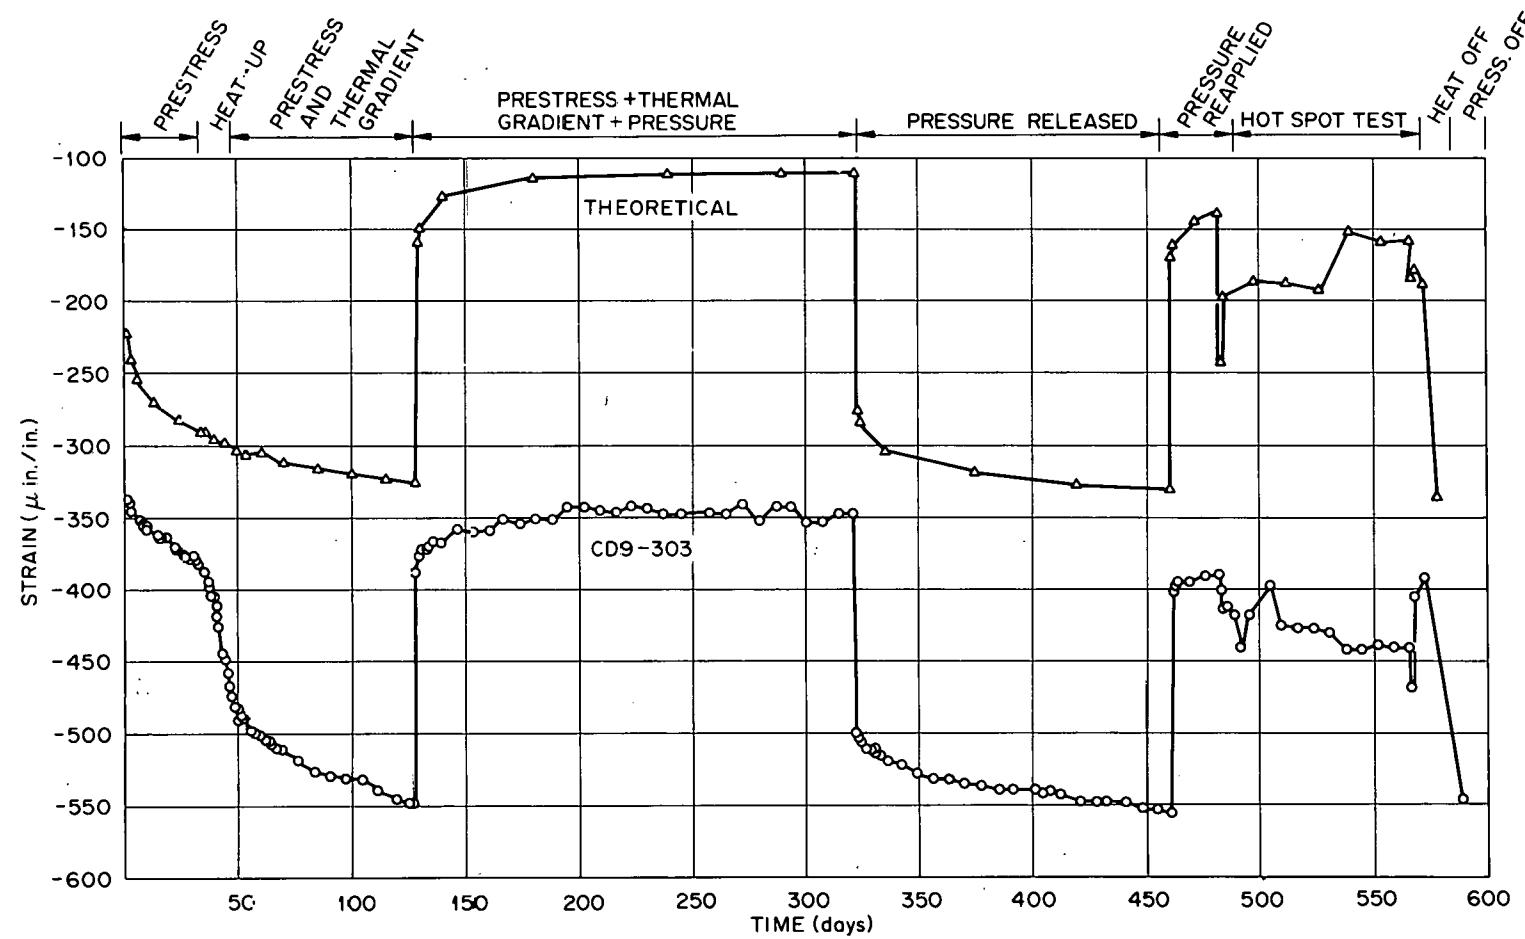
Fig. 6.11. Calculated and experimental results for the third-position circumferential type A vibrating-wire strain gage.

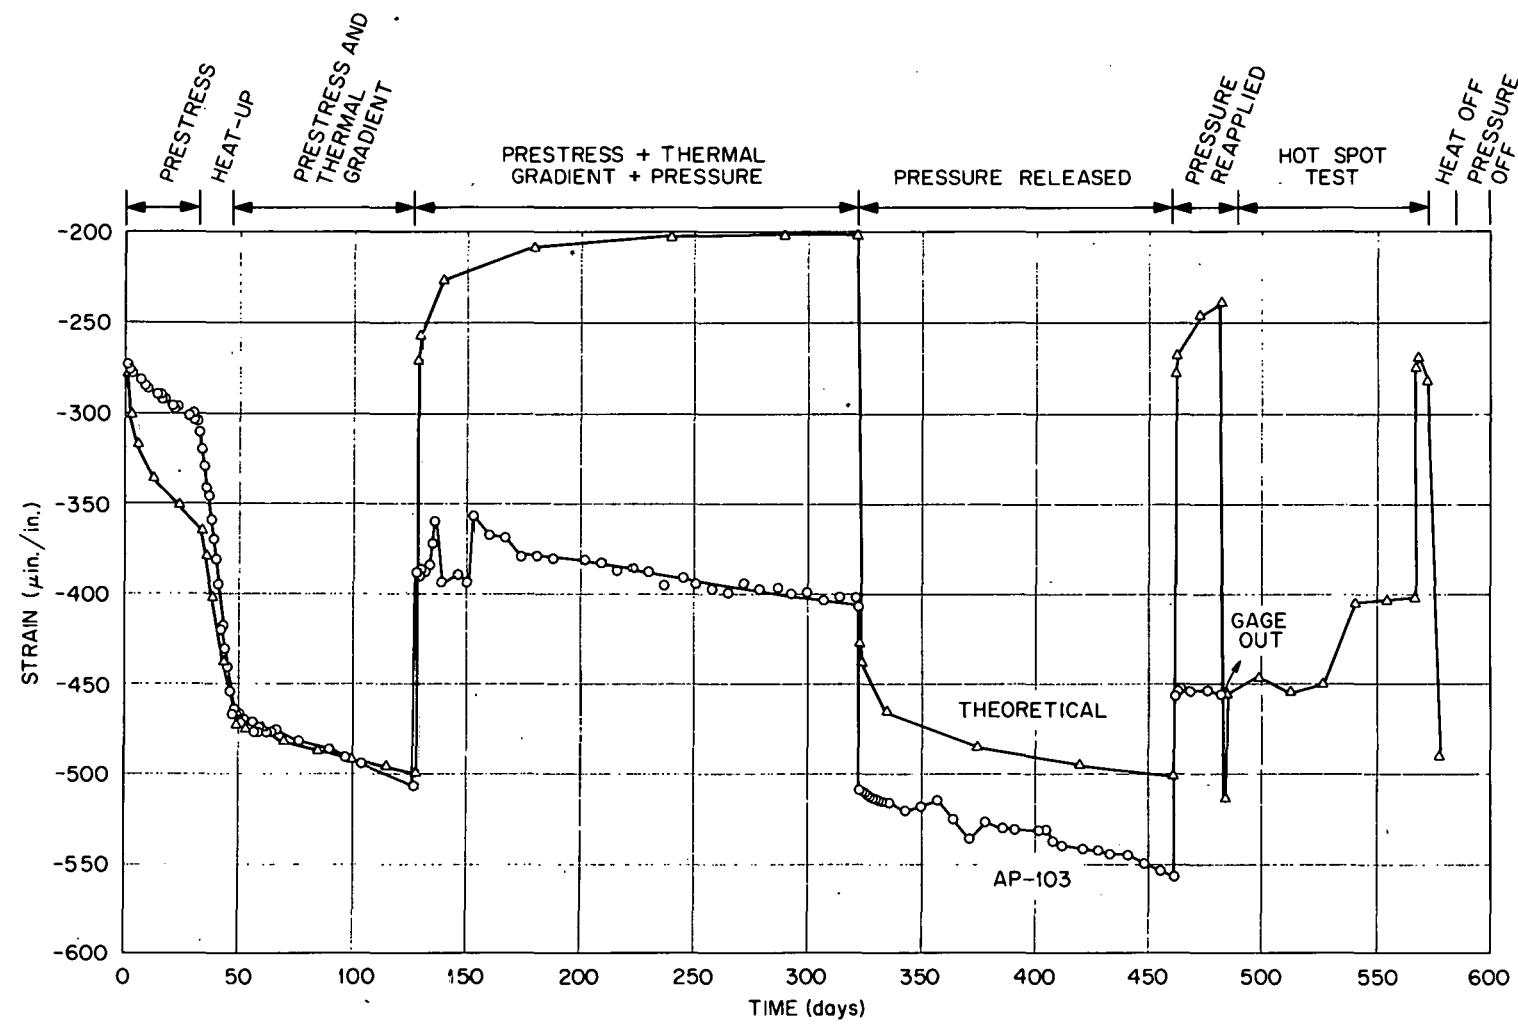
Fig. 6.12. Calculated and experimental results for first-position circumferential type B vibrating-wire strain gage.
