ORNL/TM-5613

## Prestressed Concrete Reactor Vessel Thermal Cylinder Model Study

HTGR BASE TECHNOLOGY PROGRAM  
Prestressed Concrete Nuclear Pressure  
Vessel Development (189a. No. 01331)

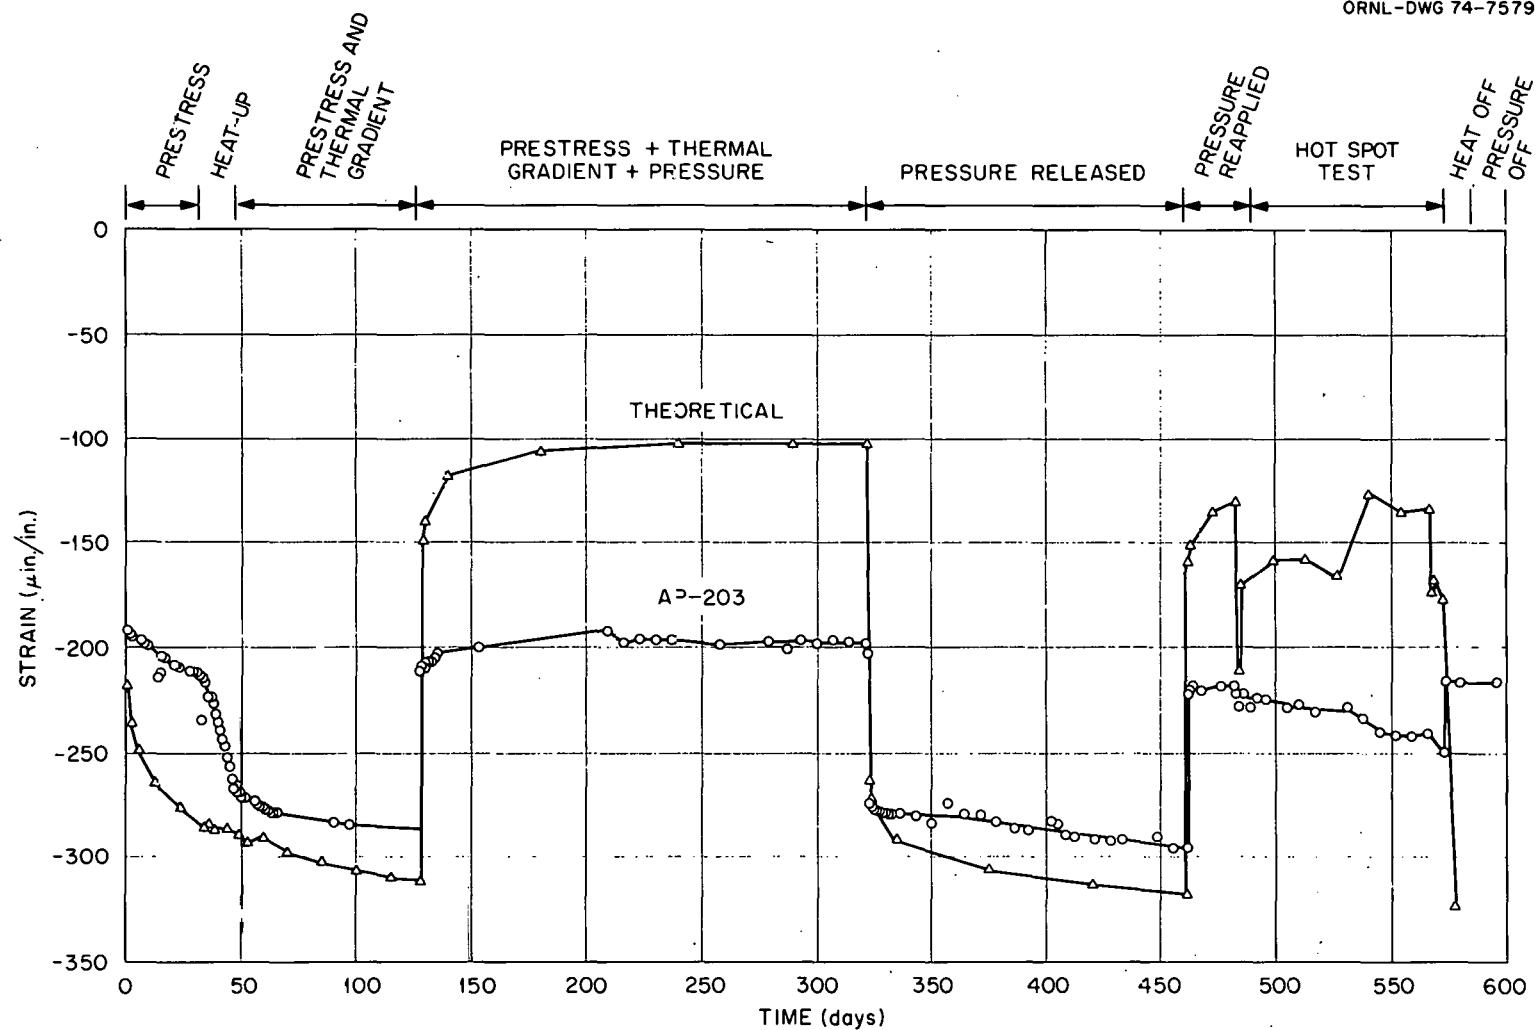
Fig. 6.13. Calculated and experimental results for second-position circumferential type B vibrating-wire strain gage.

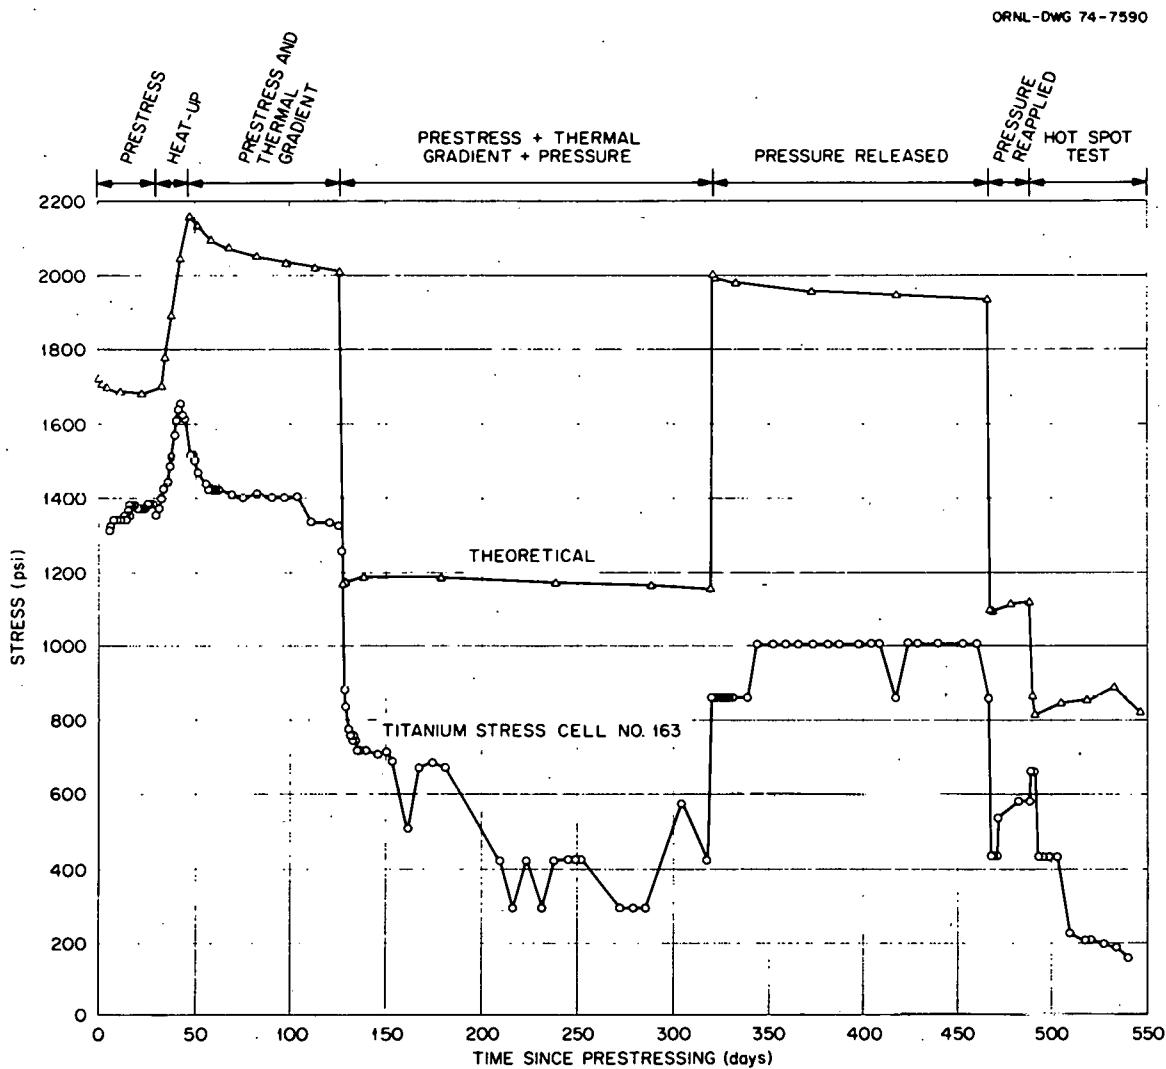
Fig. 6.14. Calculated and experimental results for first-position circumferential titanium stress cell (1 psi = 6895 Pa).

Experimental and calculated stresses for three circumferentially oriented titanium stress cells are shown in Figs. 6.14 to 6.16 for the first, second, and fourth positions of Fig. 2.1, respectively. These cells functioned satisfactorily until after the initial pressurization loading. Cell 253 performed spasmodically from that point until the pressure was released, and cell 4-11-3 monitored an unexplainable stress drop at 360 days. This test was the first attempt to use a stress cell of

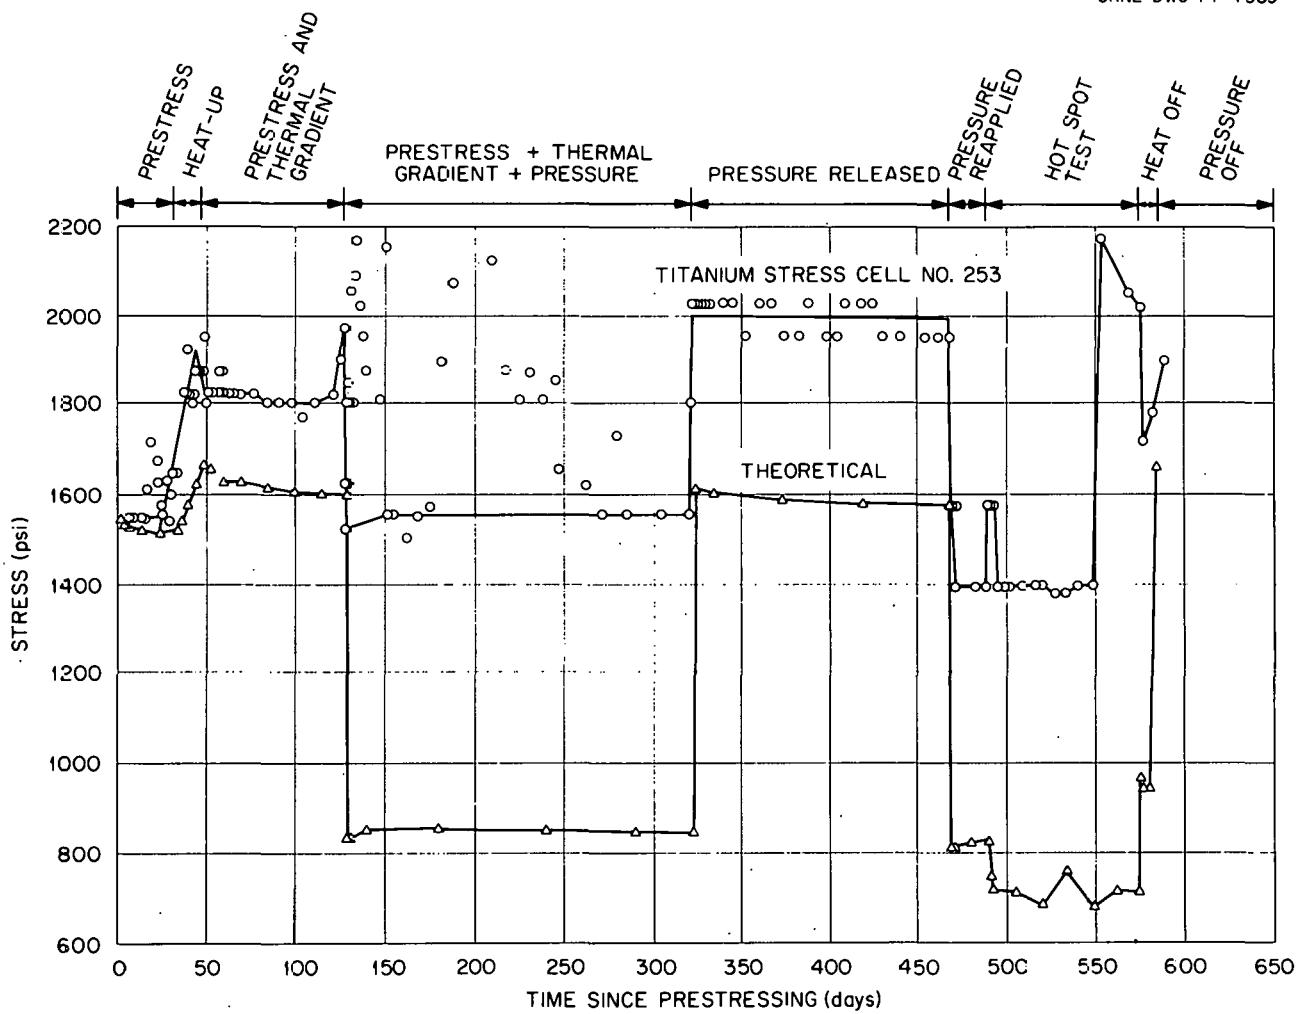
Fig. 6.15. Calculated and experimental results for second-position circumferential titanium stress cell (1 psi = 6895 Pa).

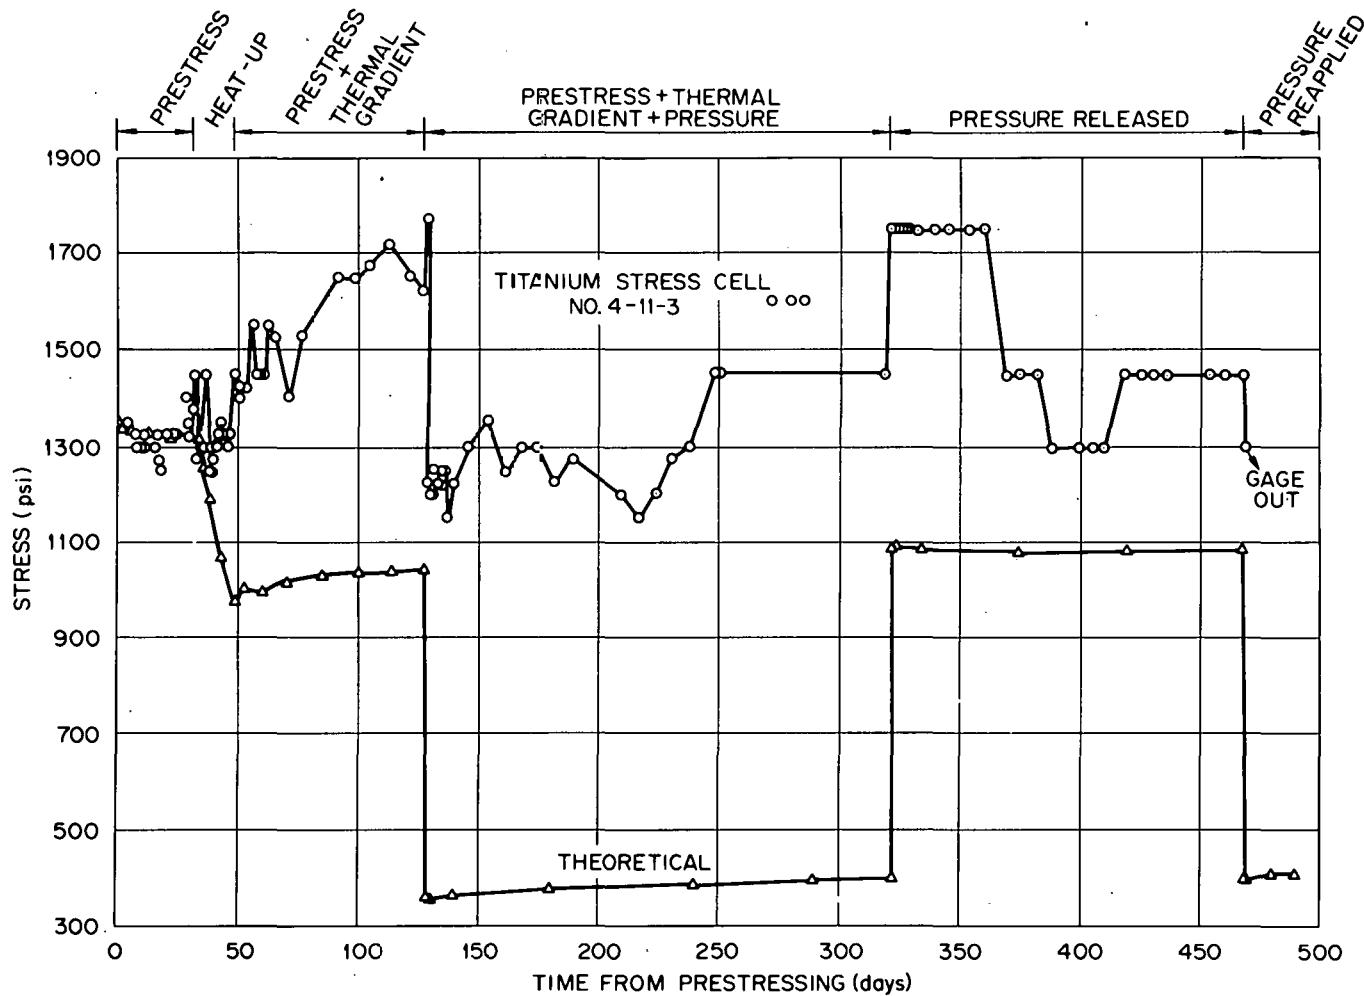
Fig. 6.16. Calculated and experimental results for fourth-position circumferential titanium stress cell (1 psi = 6895 Pa).

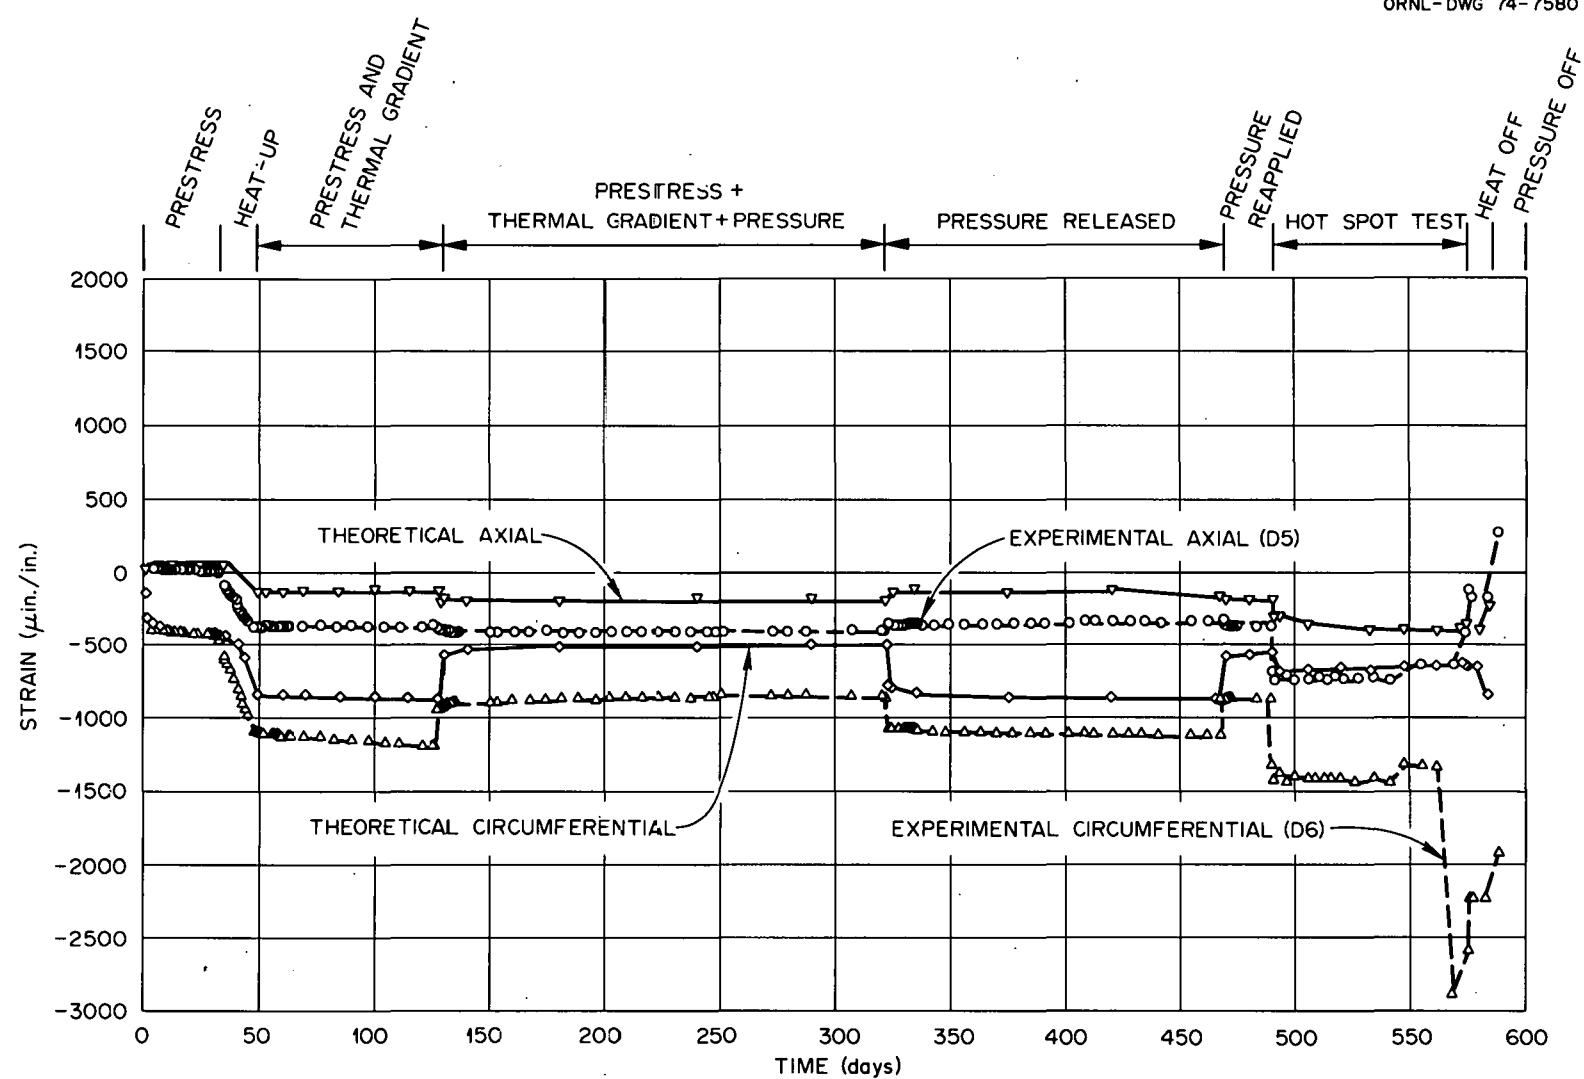
Fig. 6.17. Calculated and experimental results for axial and circumferential weldable strain gages attached to the concrete side of B heat exchanger.

The calculated and experimental strains for axial and circumferential weldable strain gages are shown in Figs. 6.17 and 6.18 for the concrete and annulus sides, respectively, of the inside heat exchanger (heat exchanger B). The same general observation made for the embedment instrumentation also applies to these gages; that is, except for the hot-spot test, the strains produced by mechanical loadings were slightly overestimated by the analysis and those produced during heatup were underestimated. The sharp fluctuations in calculated results noted previously for the embedment gages during hot-spot heating were not seen on the liner, but the greatest disagreement occurred during the hot-spot test. This was especially true in the case of the circumferential gage.

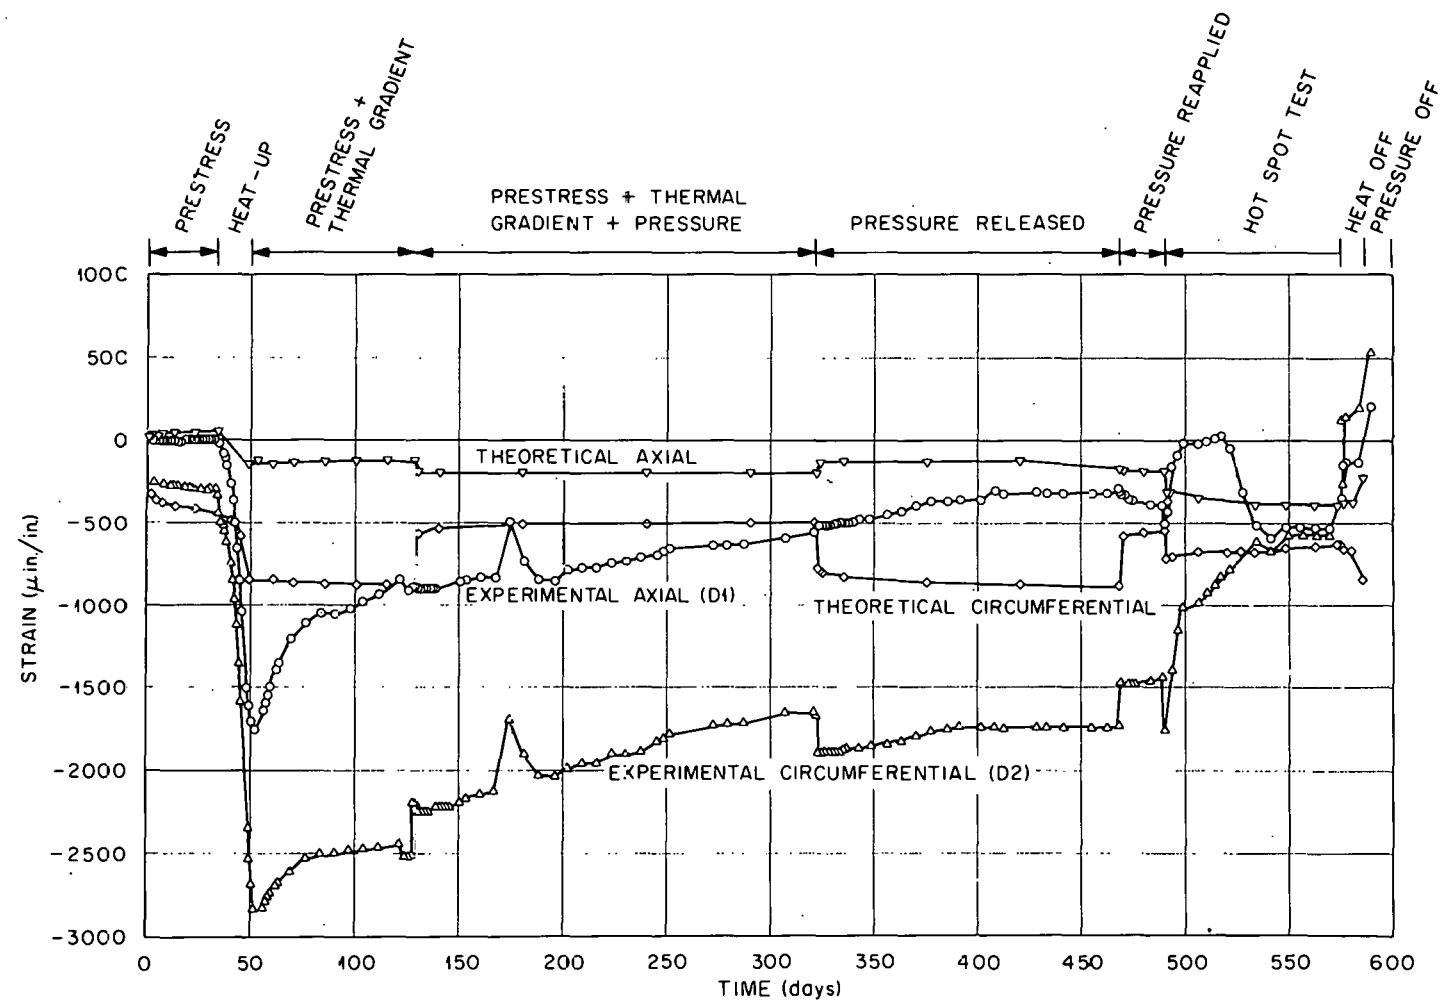
Fig. 6.18. Calculated and experimental results for axial and circumferential weldable strain gages attached to the annulus side of B heat exchanger.

Comparisons for the weldable gages located on the annulus side of the heat exchanger or liner (Fig. 6.18) show considerably greater disagreement. This trend was consistent for all four sets of liner gages. The strains produced by heatup were considerably distorted; however, pressurization strains were consistent with the readings for the concrete side. A final check of the gages on both sides showed that the resistance of the gages on the annulus side, which were not equipped with integral leads, changed during the experiment, whereas the resistance of the gages on the concrete side, which were equipped with integral leads, remained unchanged. It was

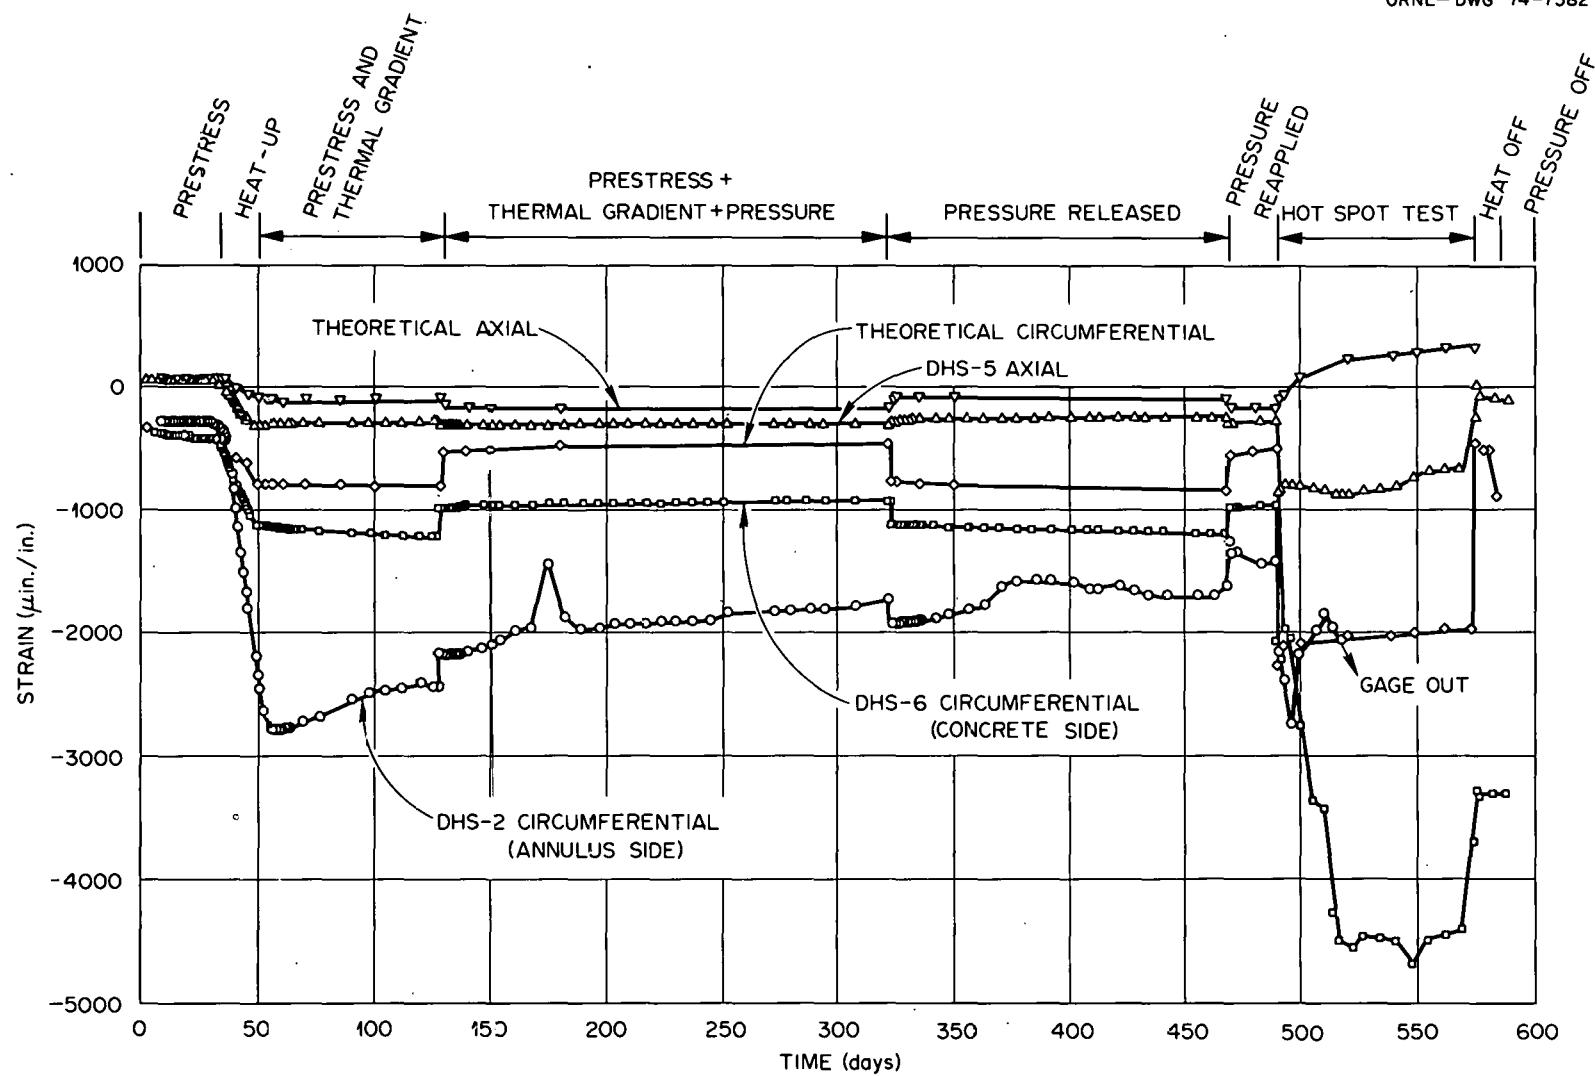
Fig. 6.19. Calculated and experimental results for axial and circumferential weldable strain gages attached to concrete side and for circumferential gage attached to annulus side of B heat exchanger.

The results for weldable gages attached at the level of the hot-spot heaters are shown in Fig. 6.19, along with plots for circumferential gages attached to both sides of the heat exchanger for comparison. Although the strains during hot-spot heating were much greater than those shown in Fig. 6.17, the same general trend is seen; however, in this case, the circumferential gage did not exhibit the previously noted strain jump toward the end of the hot-spot heating period.

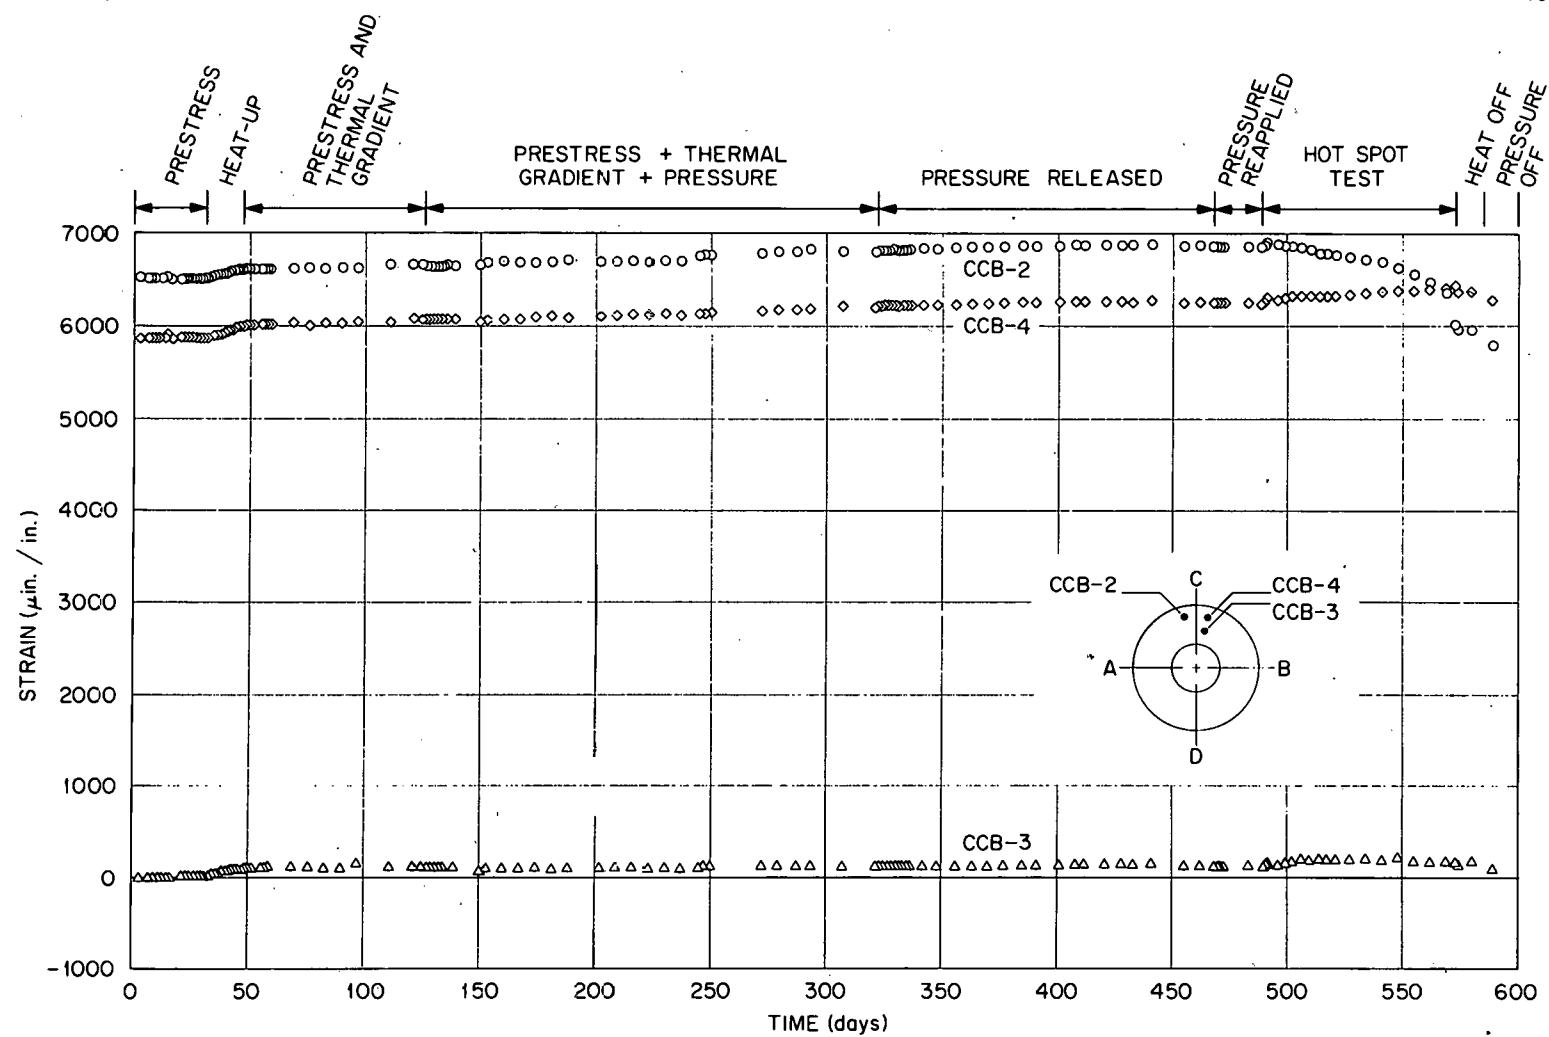
Fig. 6.20. Experimental results for foil-type strain gages attached to axial prestressing tendons.

Individual strands of 12 axial and 8 circumferential prestressing tendons were instrumented with conventional foil-type resistance strain gages, and compression load cells were attached in series with the axial tendons. Results for three axial tendon strain gages are shown in Fig. 6.20. The inner-row tendon gage CCB-3 apparently suffered a bonding failure prior to prestressing and must therefore be discounted. The two outer-row tendon gages, positioned as shown in the small inset of Fig. 6.20, indicated stable conditions until initiation of the hot-spot test. At that time, gage CCB-2 showed a gradual decrease in strain followed by a distinct downward jump. The load-vs-time plot of axial tendon load cell CTR-2 is shown in Fig. 6.21. This transducer, which was attached to the CCB-2 instrumented tendon, indicated a stable loading during the hot-spot heating period. It is therefore doubtful that the strain gage recorded the actual tendon behavior. On the other hand, load transducers CTR-1 and CTR-3, which were coupled to inner-row tendons, measured periodic step-load drops during the experiment. Recent postmortem studies yielded strong evidence that the load changes were produced by progressive corrosion failure of inner-row tendons. The corrosion problem is discussed in Chap. 7.

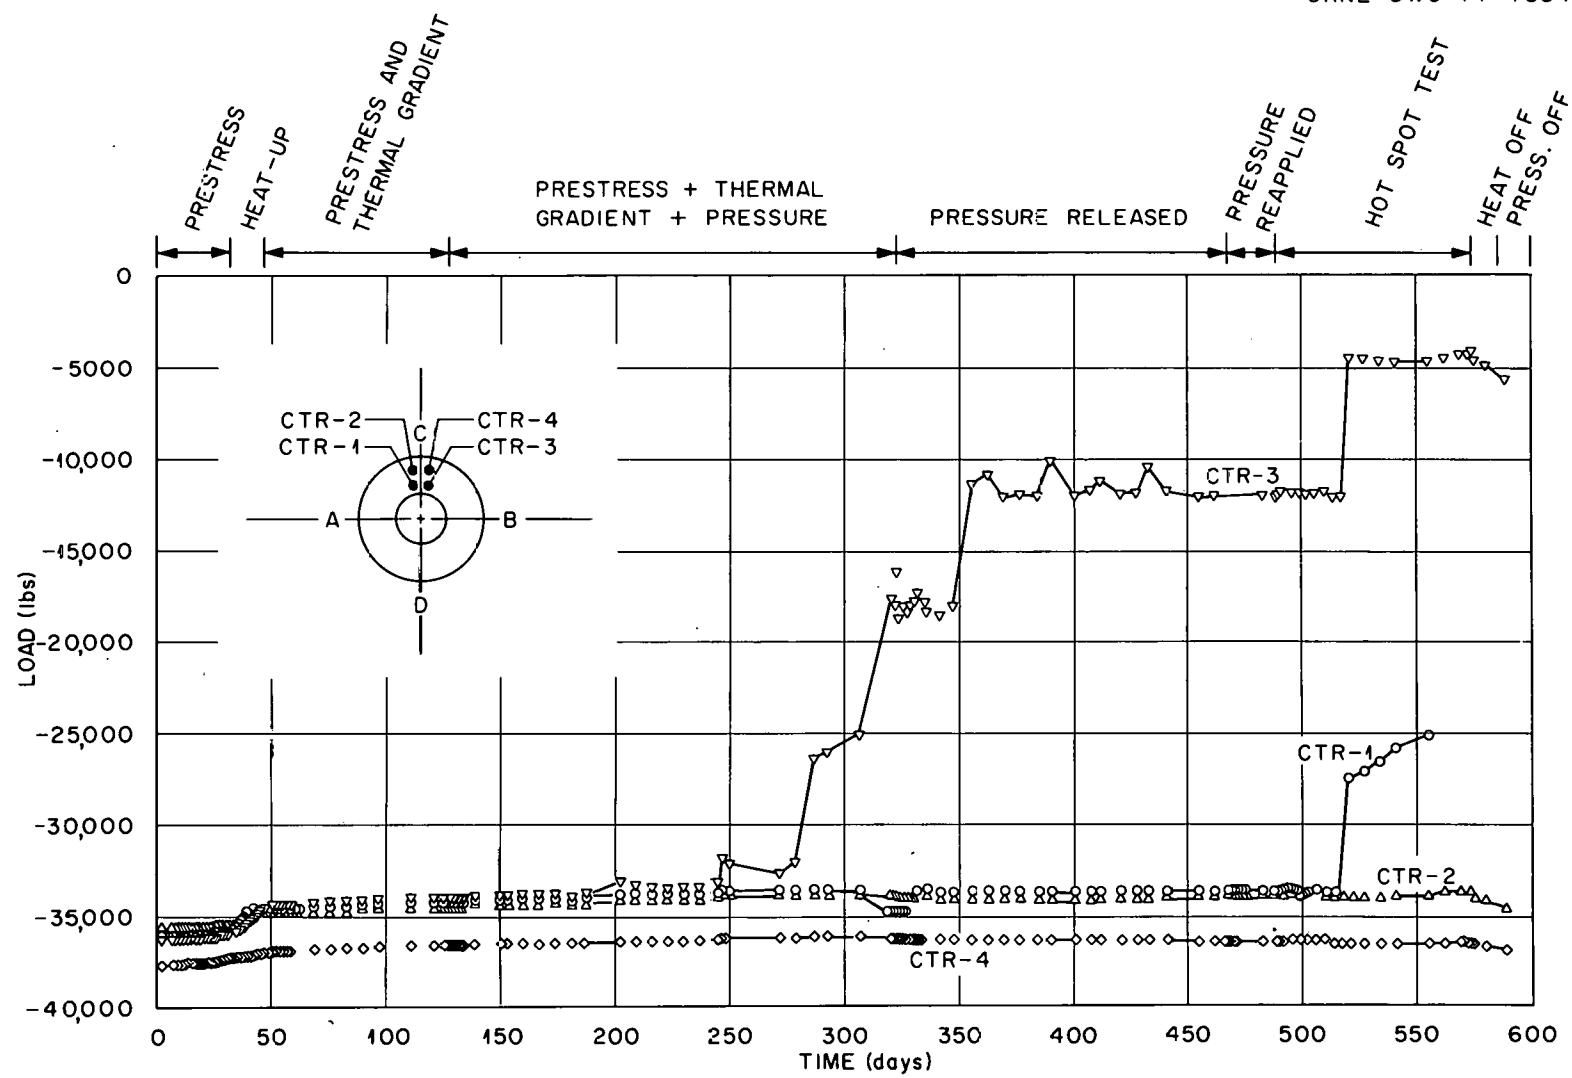
Fig. 6.21. Experimental results for load cells coupled to axial pre-stressing tendons (1 lb = 4.448 N).

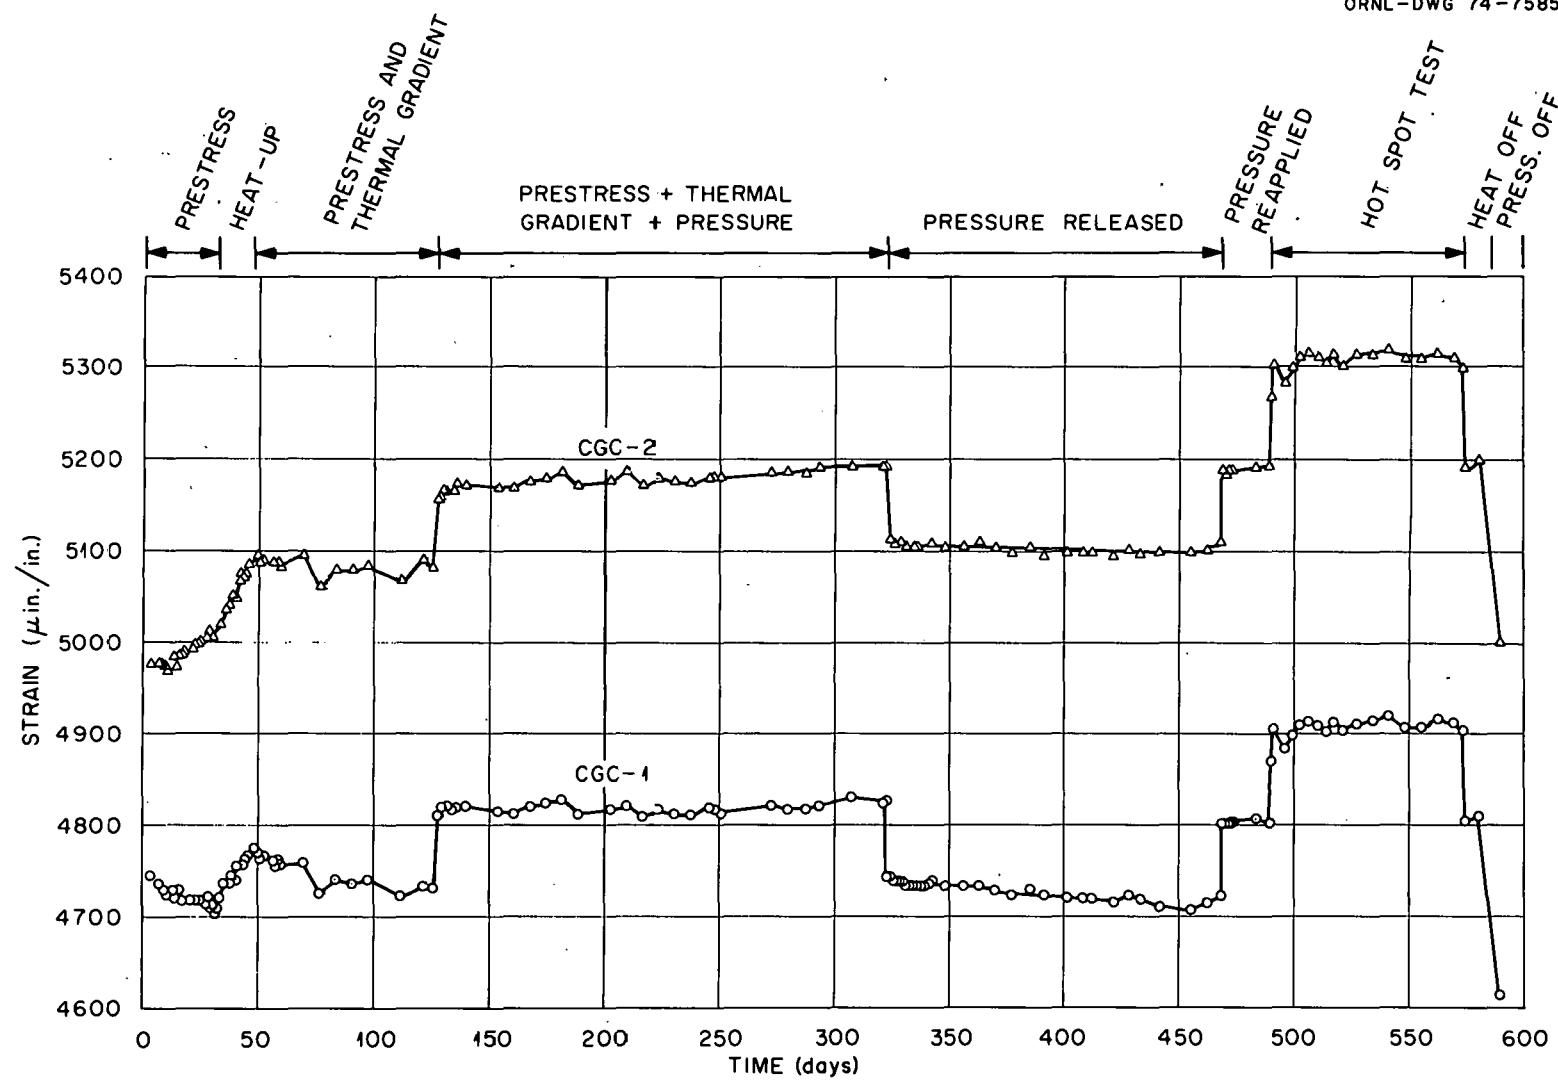
Fig. 6.22. Experimental results for foil-type strain gages attached to circumferential prestressing tendons.

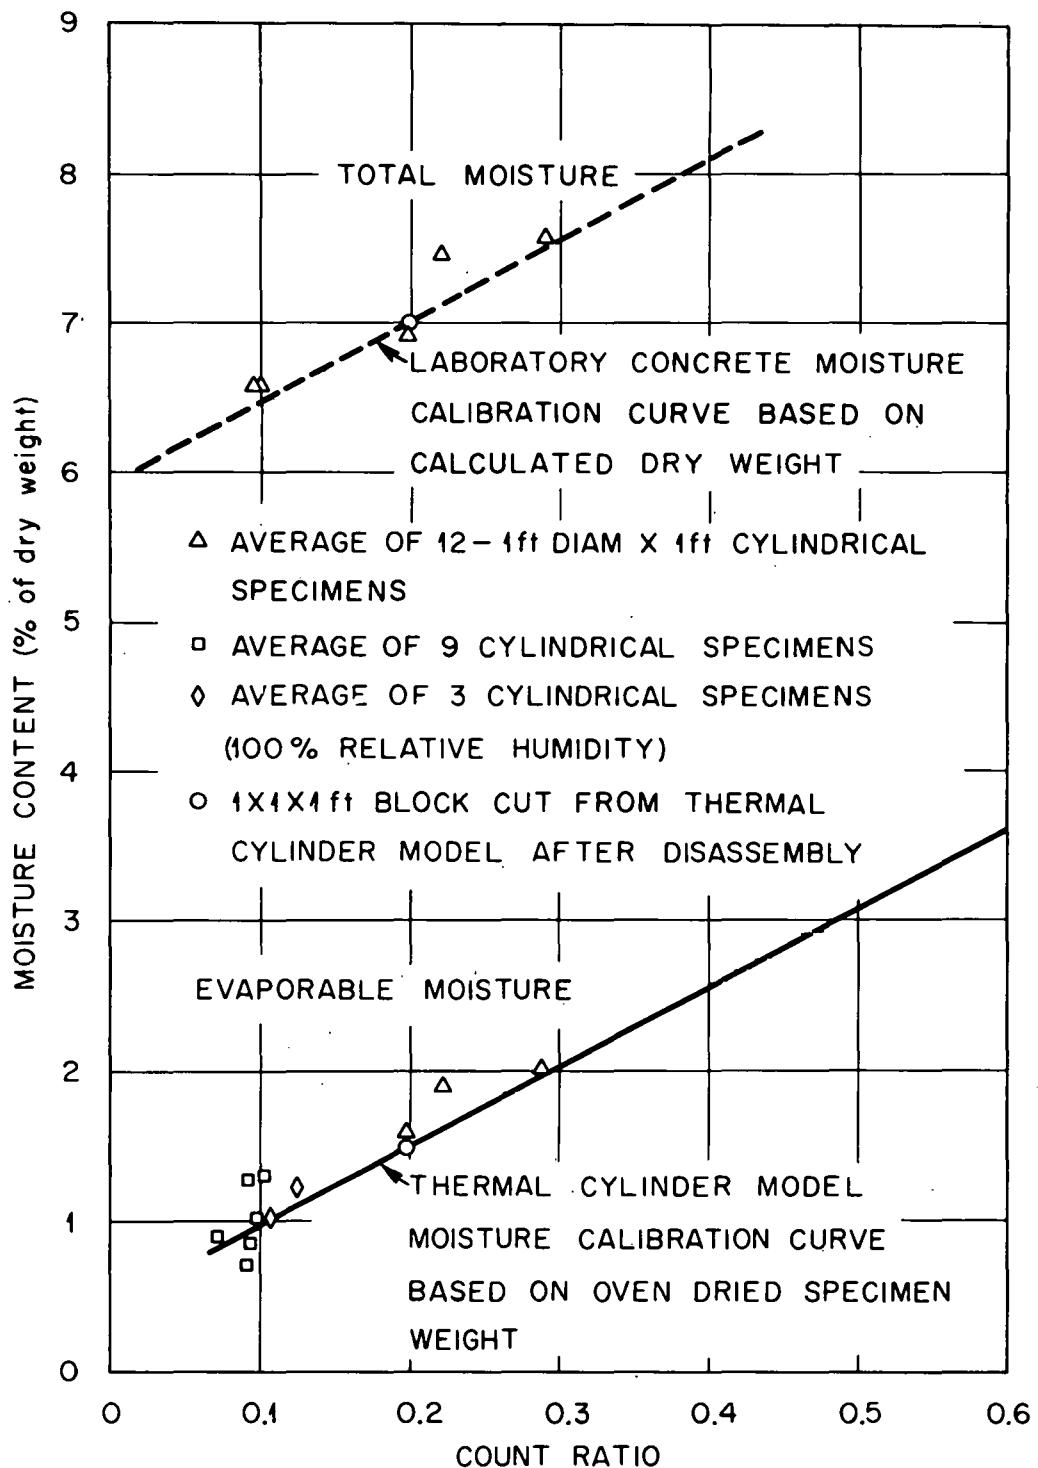
Fig. 6.23. Total and evaporable moisture-content calibration curves for ORNL thermal cylinder concrete having 7.59% as-cast total moisture content (1 ft = 0.3048 m).

The results of the probe-type neutron and gamma-ray backscattering instrument calibration tests are shown in Fig. 6.23. Inconsistencies were found between the recorded weights and the probe readings of the specimens subjected to 100% relative humidity when compared with those from the remaining nine specimens; consequently, only two sets of these readings are shown in the figure. No discernible difference was seen between the rates of moisture loss in the remaining three sets; the average values are shown in Fig. 6.23. Of the two curves shown, the upper curve and data points represent total moisture content (based on calculated dry weight), and the lower curve represents evaporable moisture content (based on oven-dried specimen weight). The circled data points on both curves represent the moisture content measured using a 0.3- by 0.3- by 0.3-m specimen cut from the thermal cylinder model.

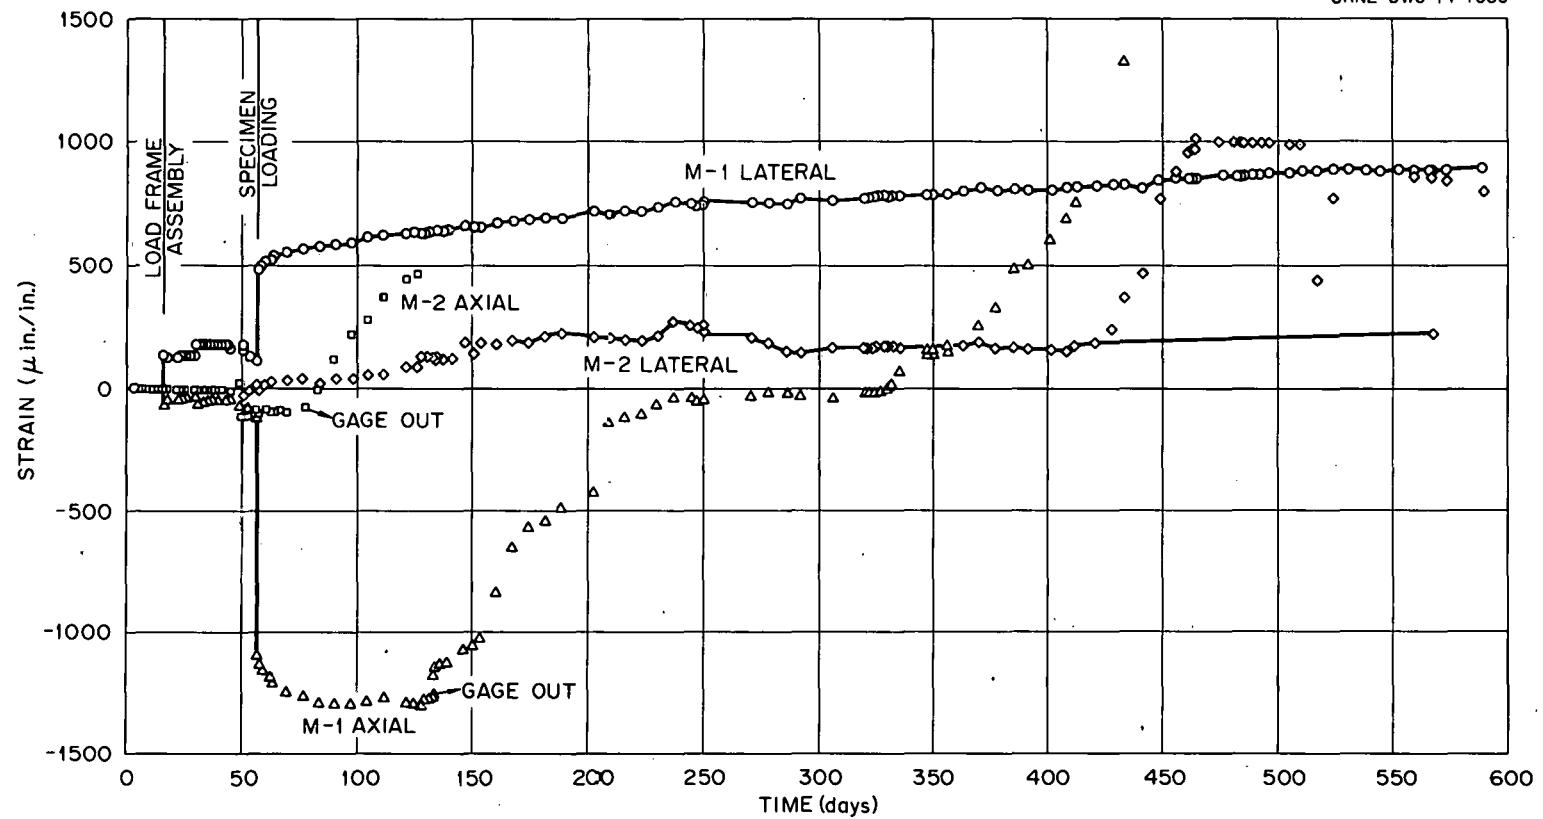
Fig. 6.24. Experimental results for axial and lateral single-filament resistance strain gages of stressed M-1 and unstressed M-2 companion concrete cylinders.

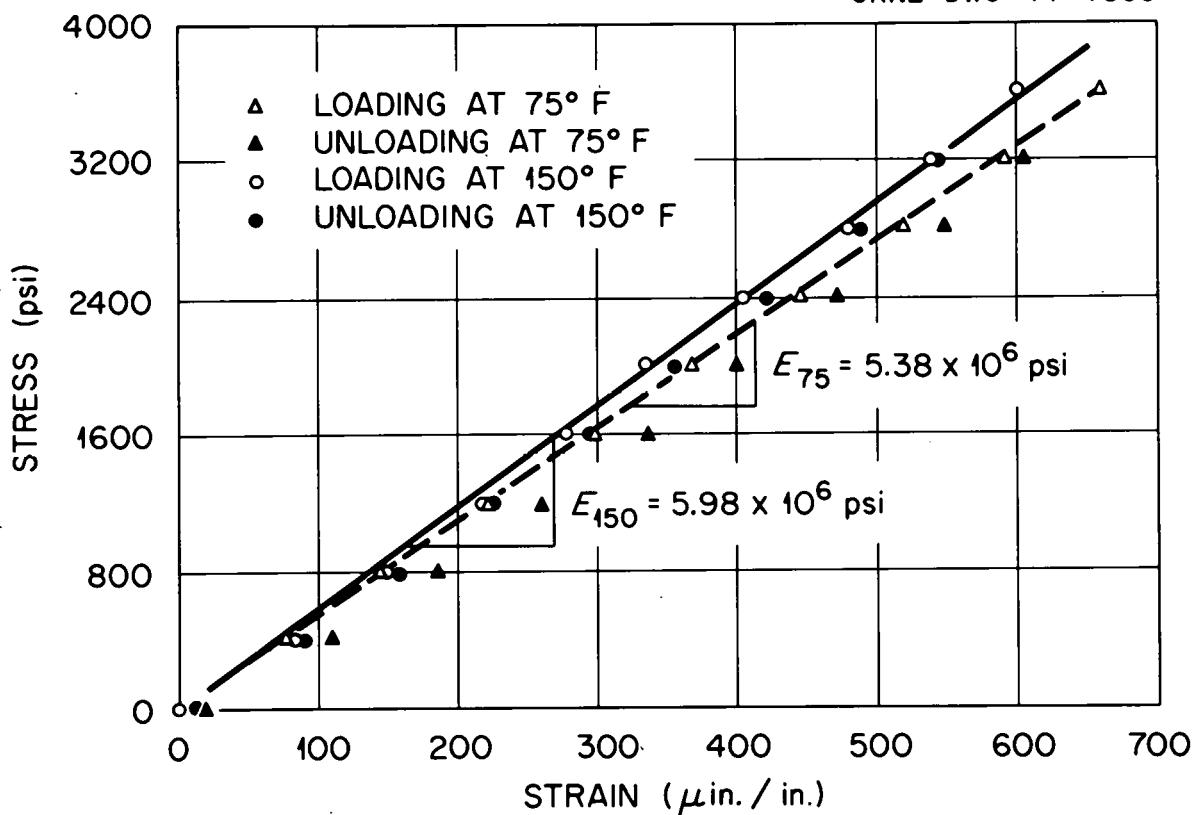
Fig. 6.25. Results of short-time M-1 specimen load test for axial single-filament resistance strain gage [1 psi = 6895 Pa;  $K = 273.15 + 5/9 (^{\circ}\text{F} - 32)$ ].

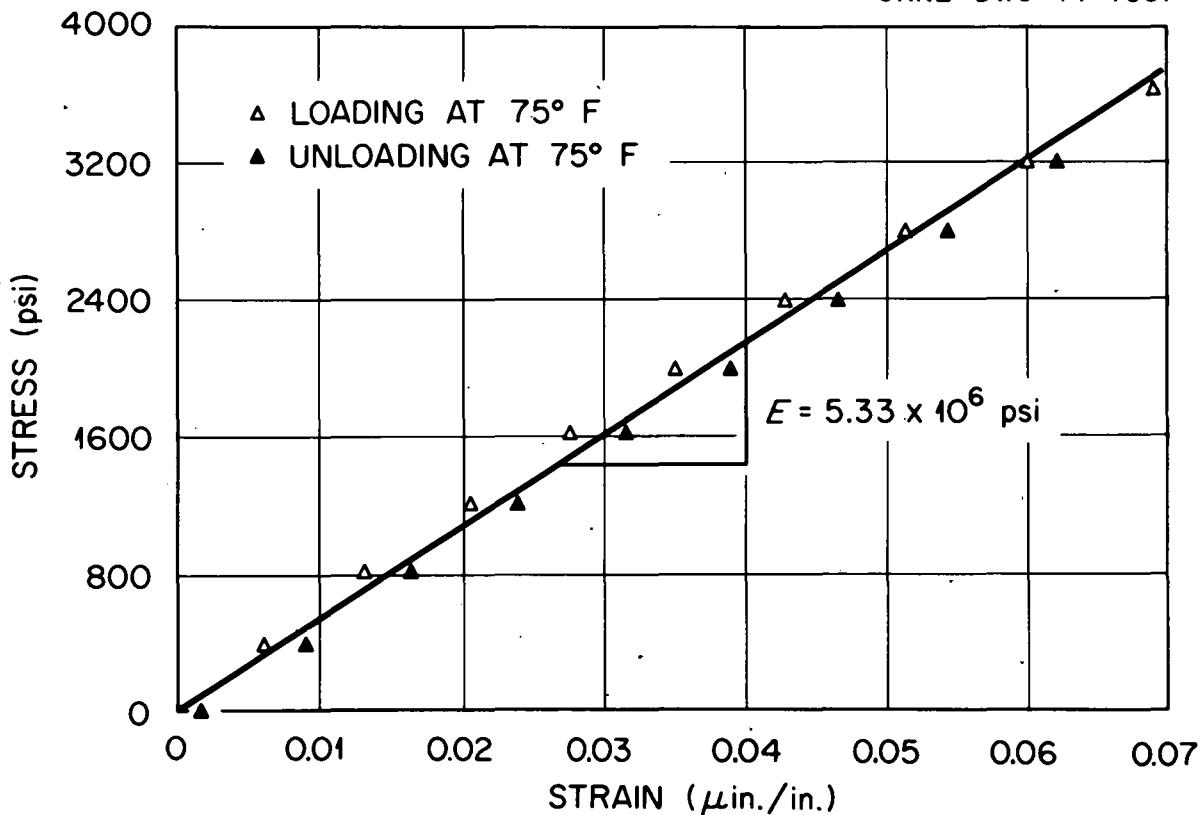
Fig. 6.26. Results of short-time M-2 specimen load test for axial type B vibrating-wire strain gage [1 psi = 6895 Pa;  $K = 273.15 + 5/9$  ( $^{\circ}\text{F} - 32$ )].

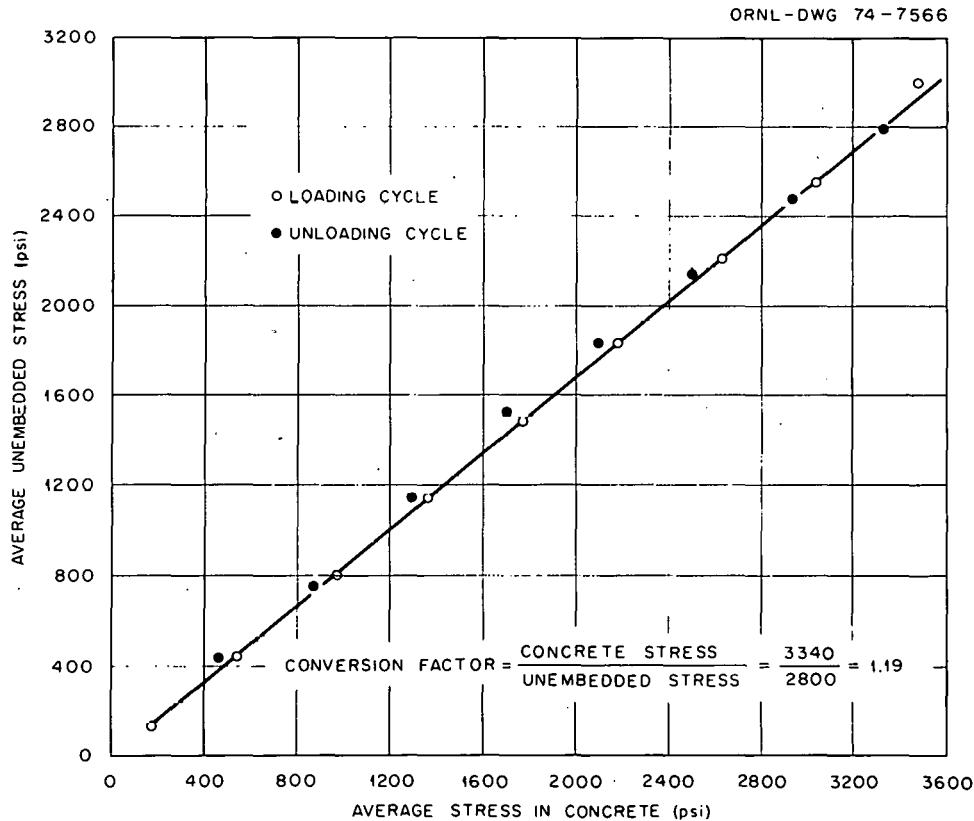
Fig. 6.27. Comparison of laboratory calibration of concrete embedment stress cell for embedded and unembedded conditions (1 psi = 6895 Pa).
