ORNL/TM-5613

## Prestressed Concrete Reactor Vessel Thermal Cylinder Model Study

HTGR BASE TECHNOLOGY PROGRAM  
Prestressed Concrete Nuclear Pressure  
Vessel Development (189a. No. 01331)

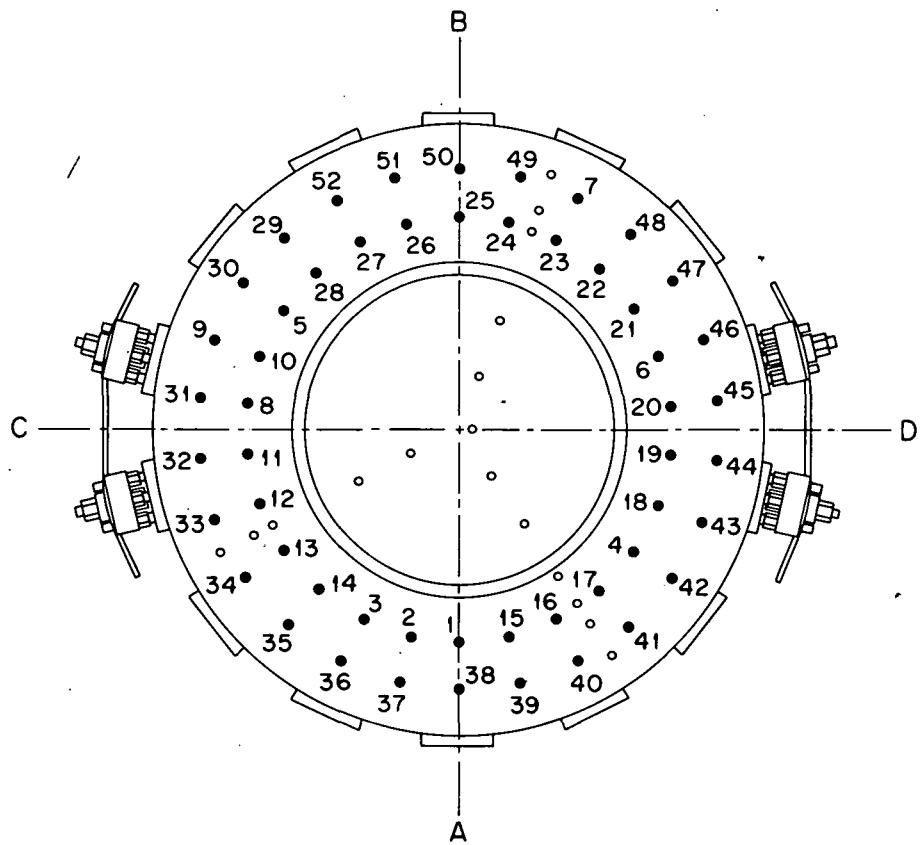
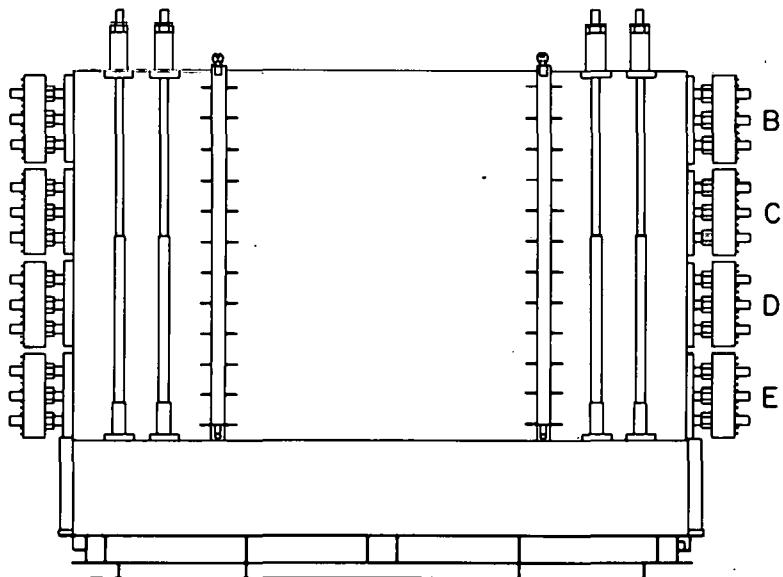
Fig. 7.1. Thermal cylinder prestressing system.

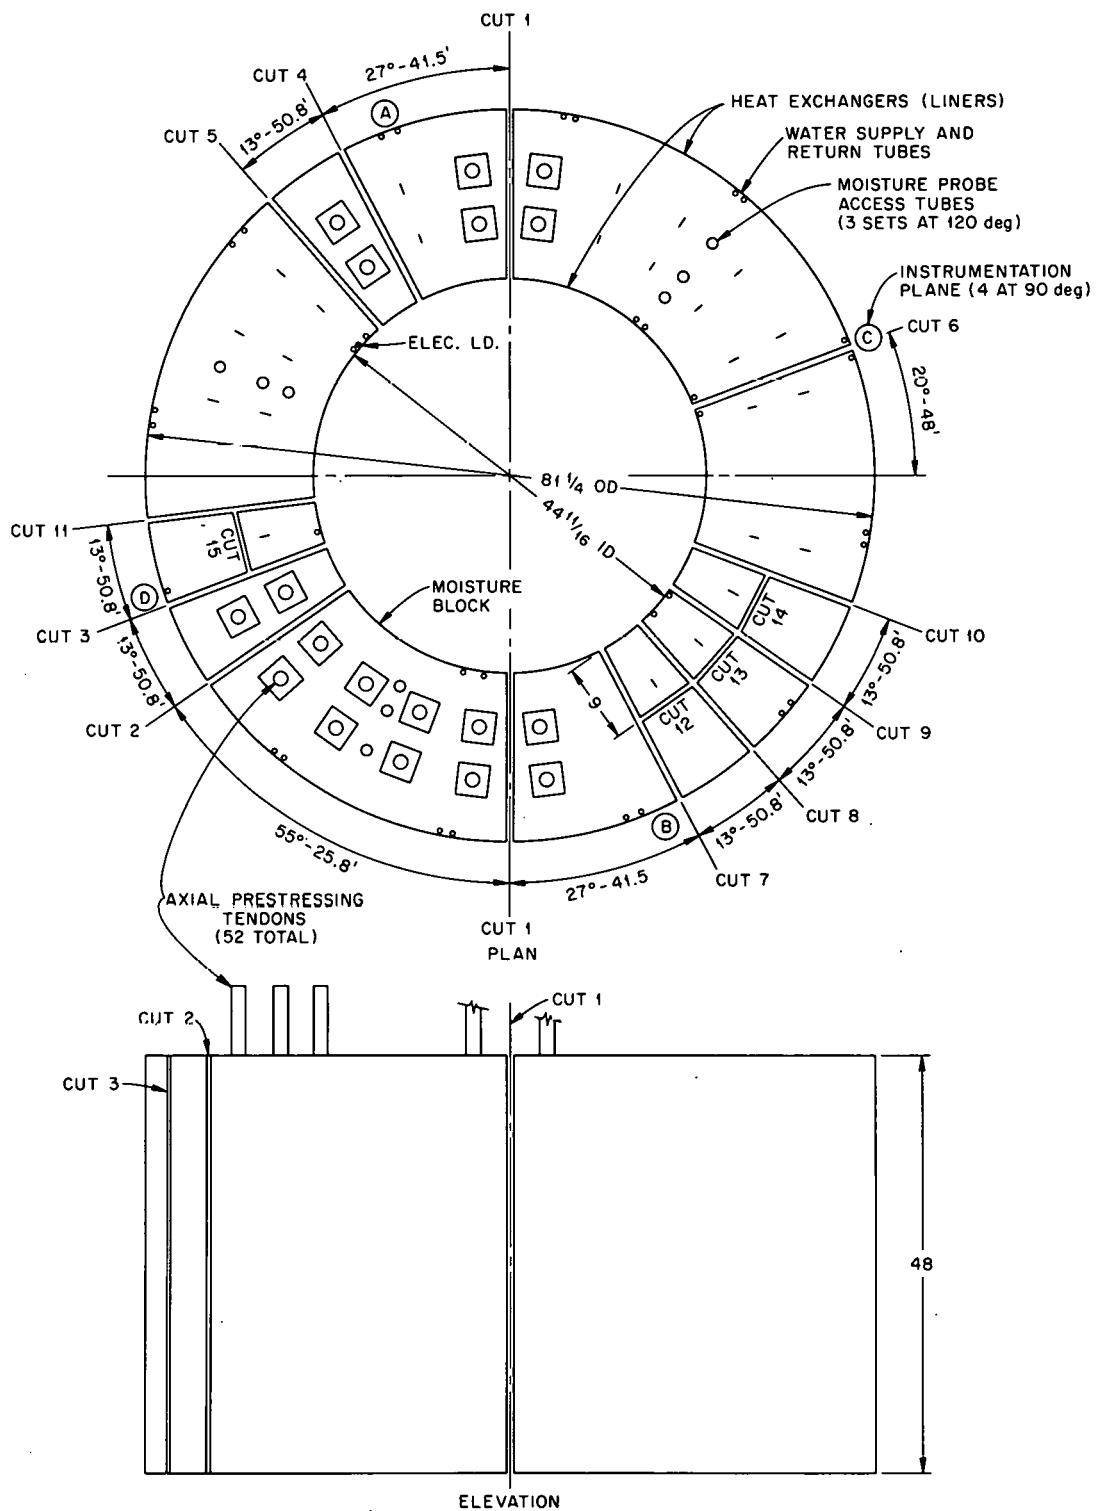
Fig. 7.2. Thermal cylinder model sectioning plan [dimensions not otherwise identified in figure are in inches (1 in. = 25.4 mm)].

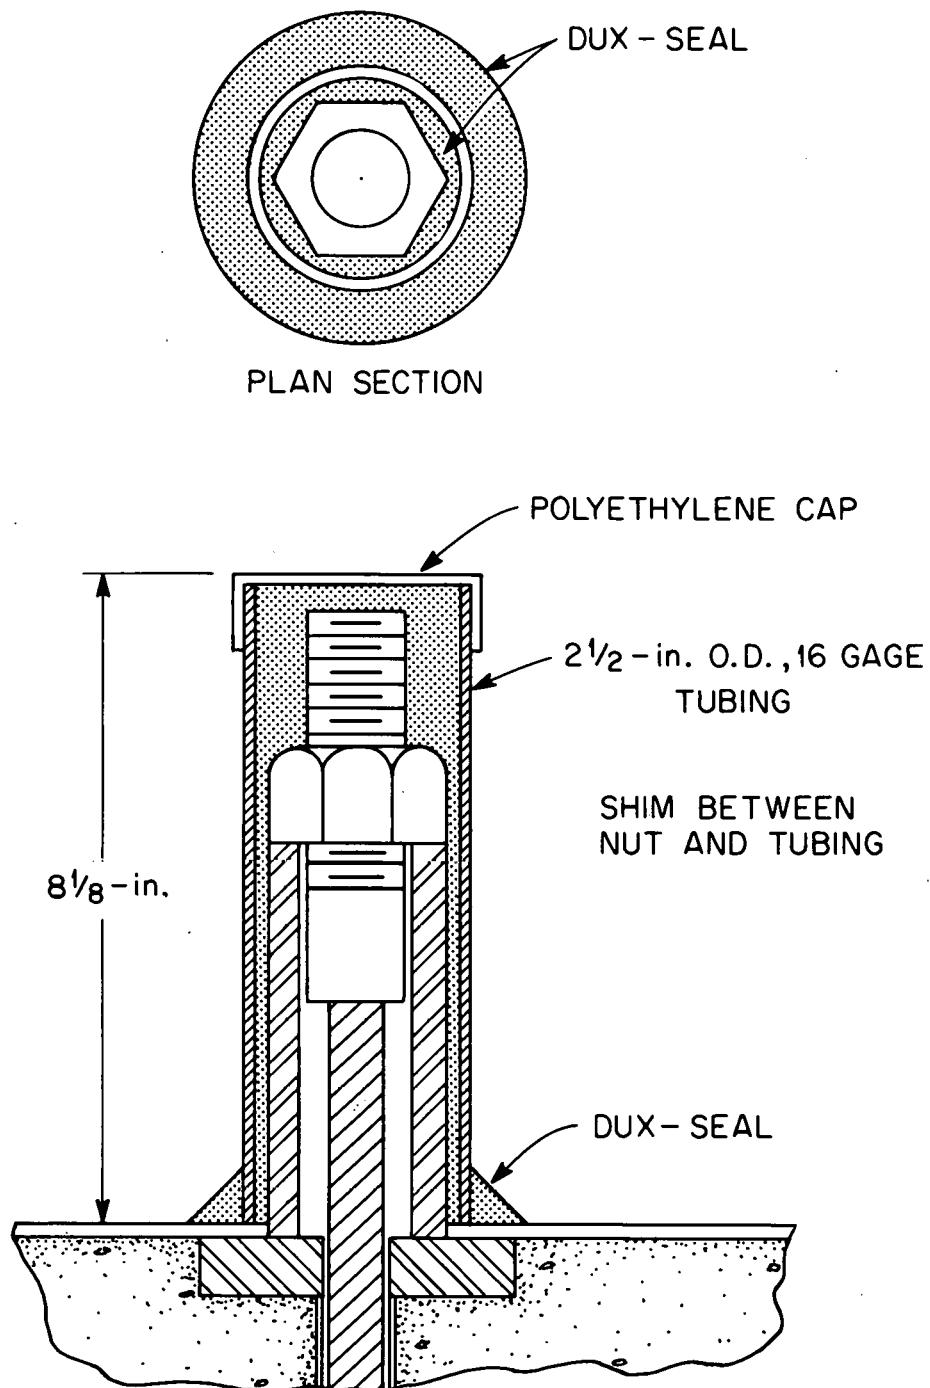
Fig. 7.3. Axial prestressing tendon assembly moisture seal for concrete sectioning (1 in. = 25.4 mm).

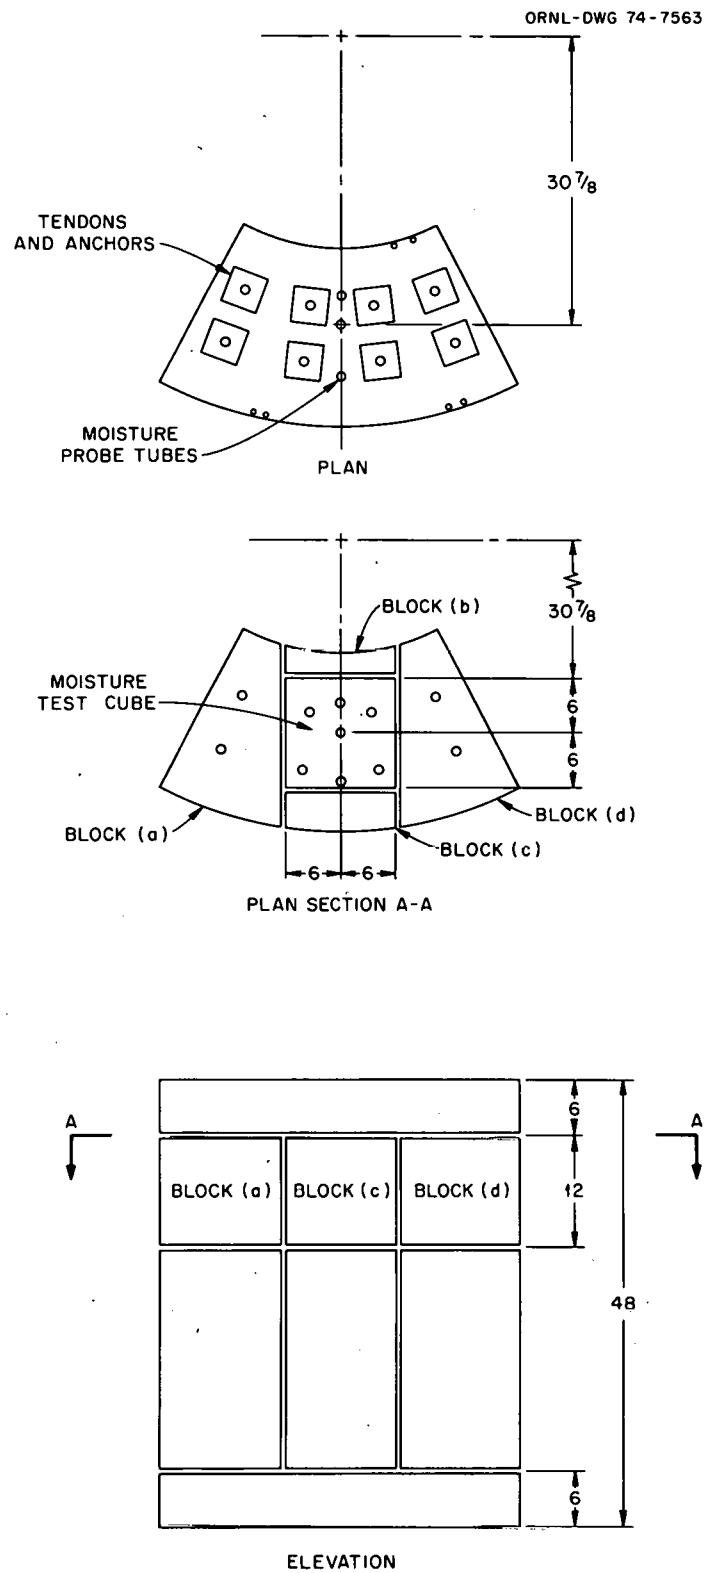
Fig. 7.4. Cutting plan for moisture block section of thermal cylinder model [dimensions in inches (1 in. = 25.4 mm)].

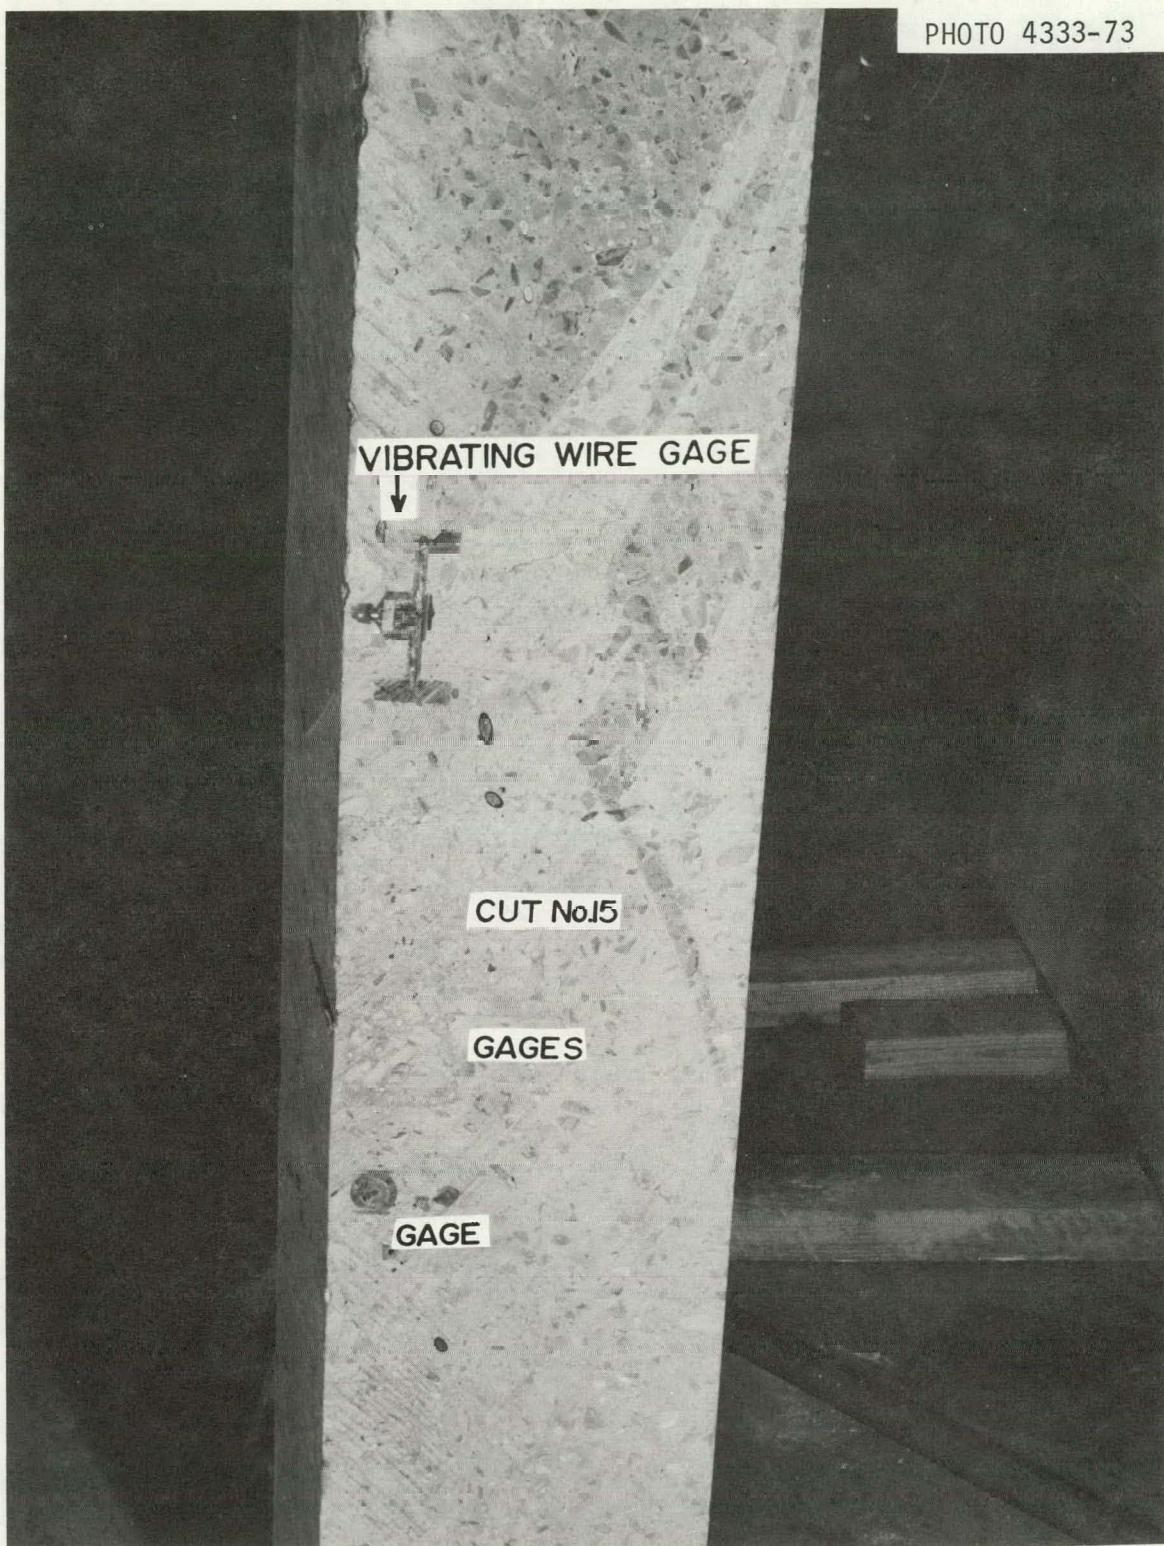
Fig. 7.5. Thermal cylinder model section produced by cut 15.

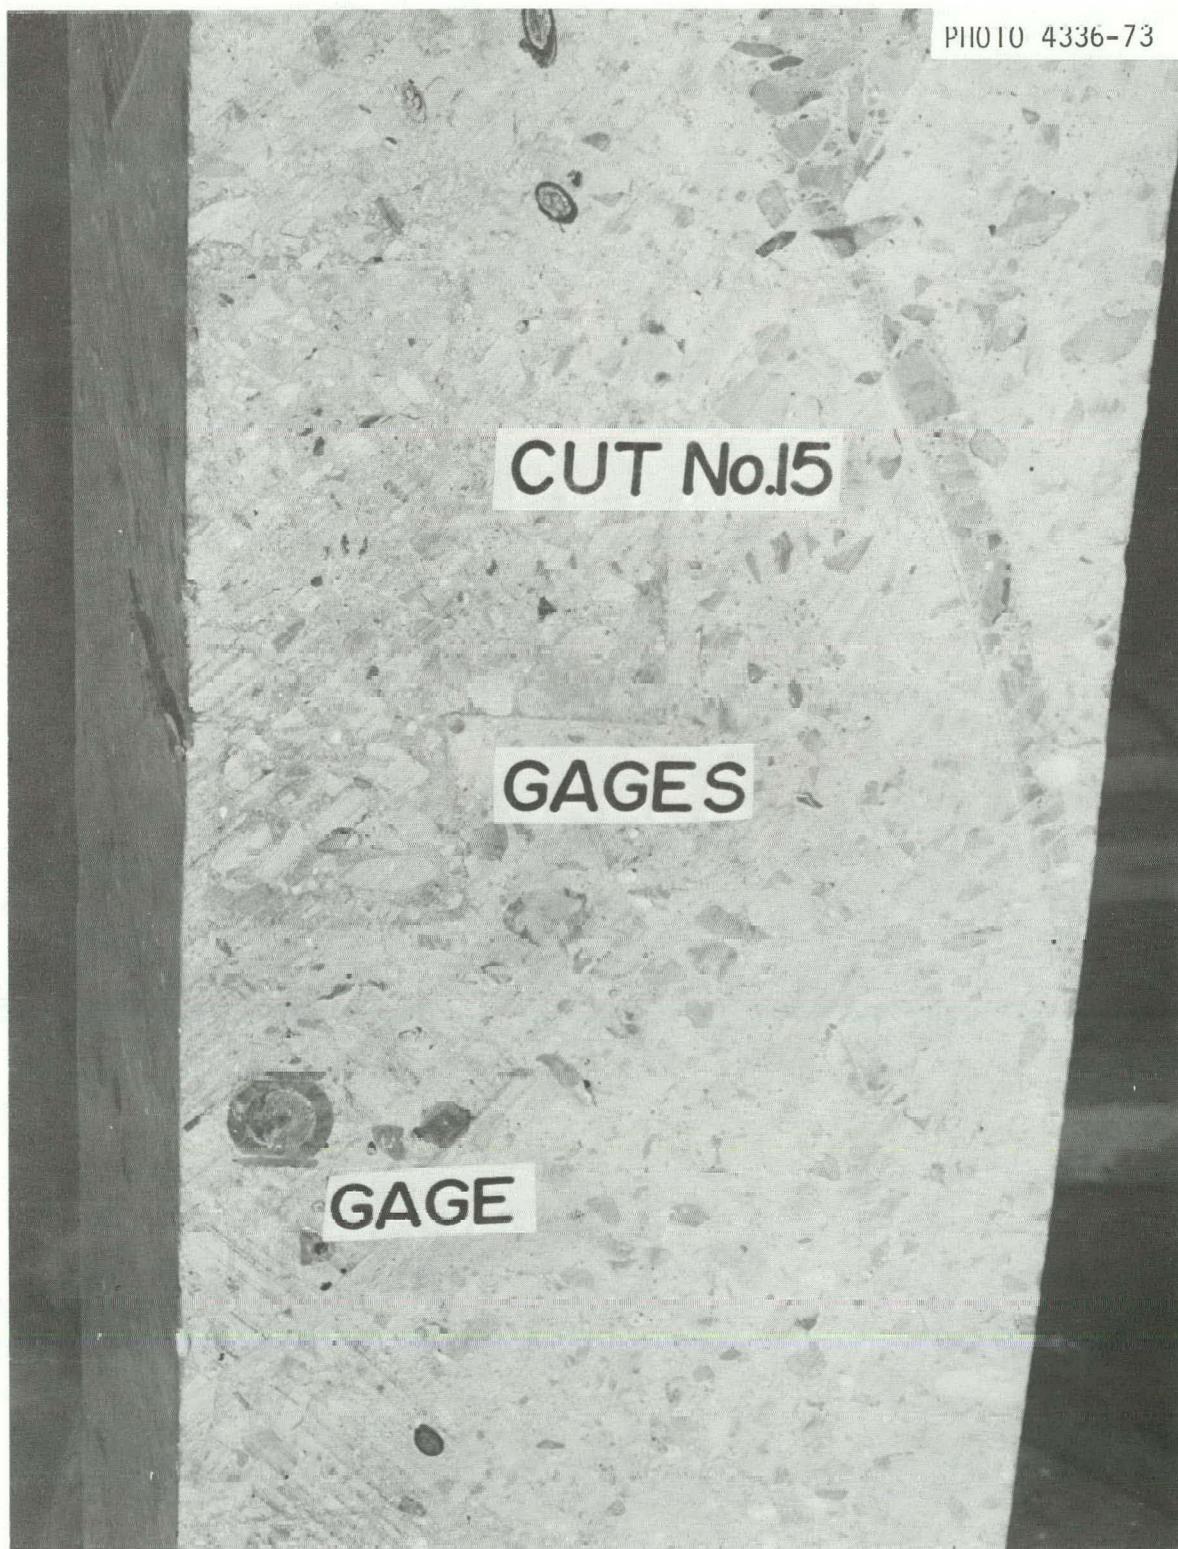
Fig. 7.6. Closeup of cut 15 showing bond between precast single-filament resistance gage rosettes and model concrete.

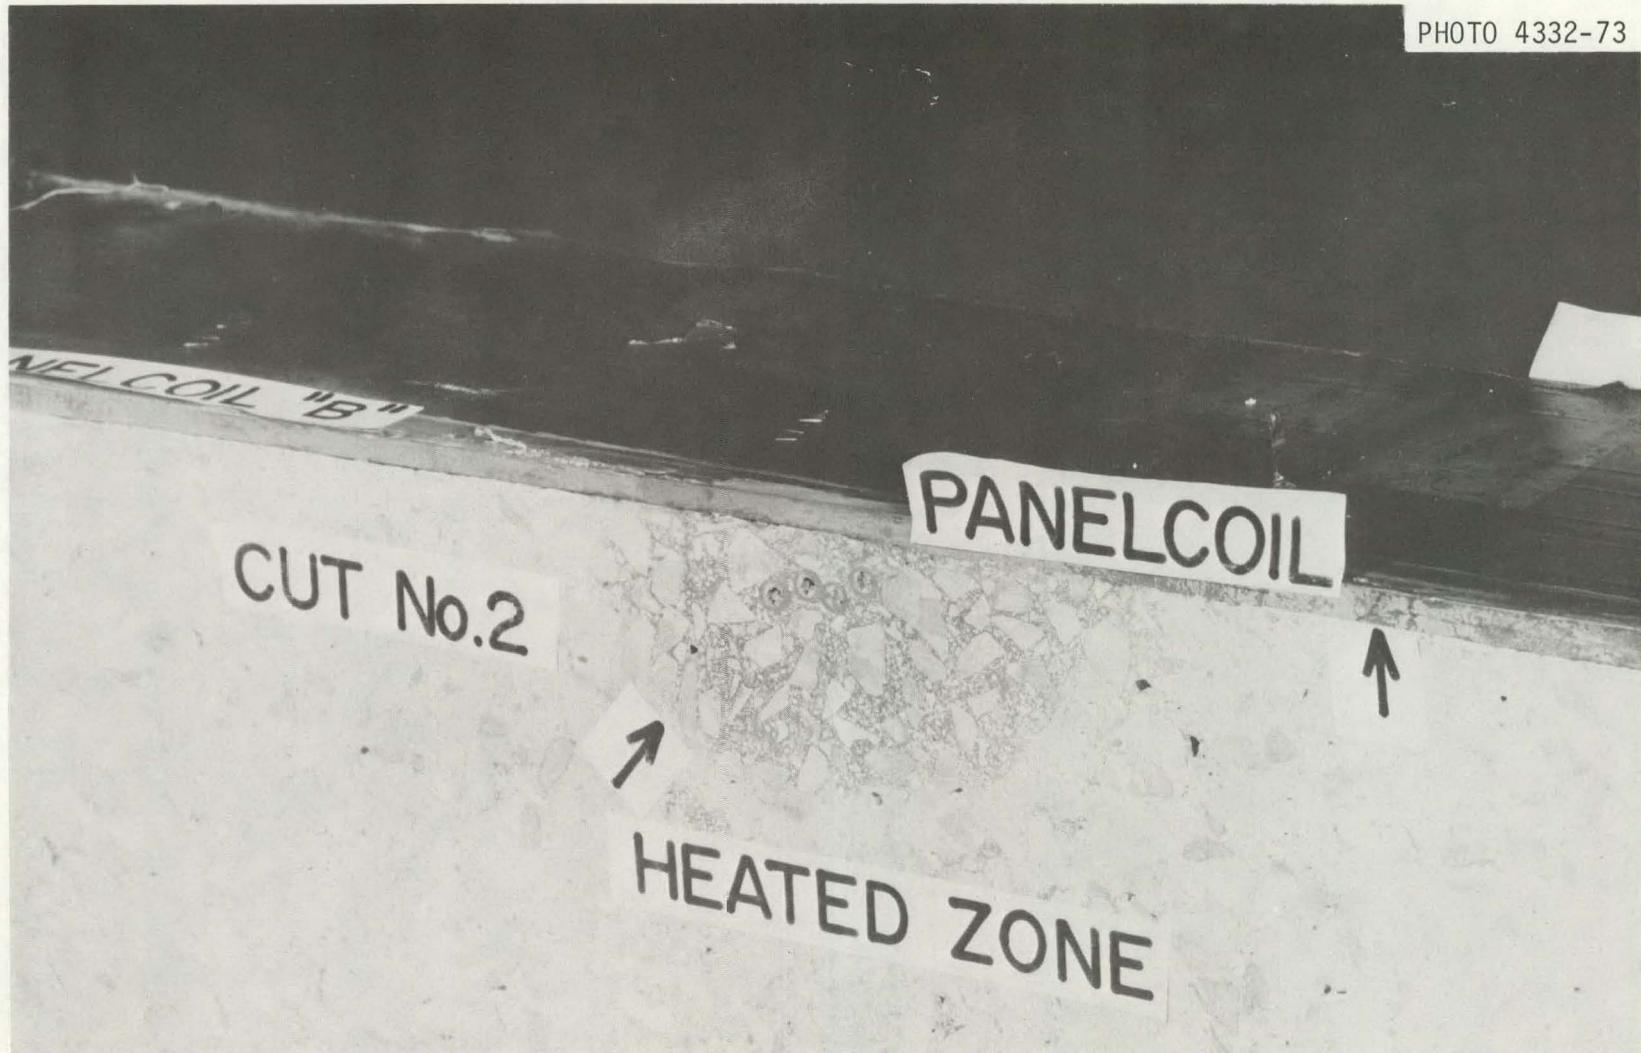
Fig. 7.7. Cross section of cut 2 showing discoloration in the vicinity of the hot-spot heating coils.

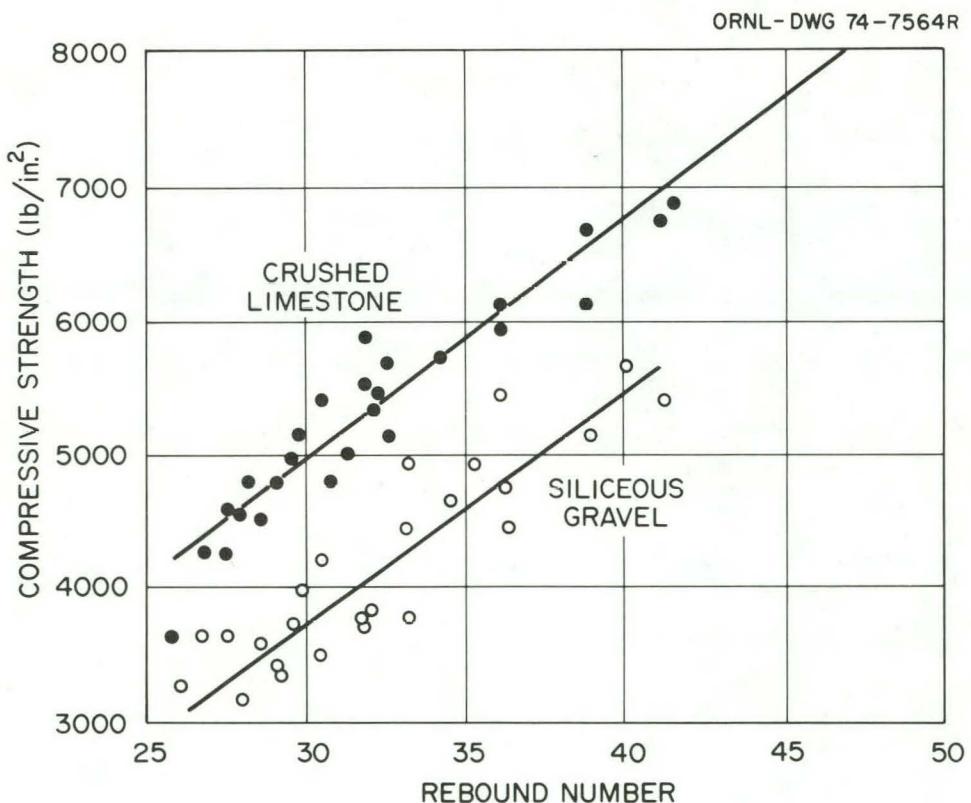
Fig. 7.8. Relationship between compressive strength and rebound number for concrete cylinders made with different aggregates. Readings taken on the side of a cylinder with the hammer horizontal. (1 lb/in.<sup>2</sup> = 6895 Pa.)

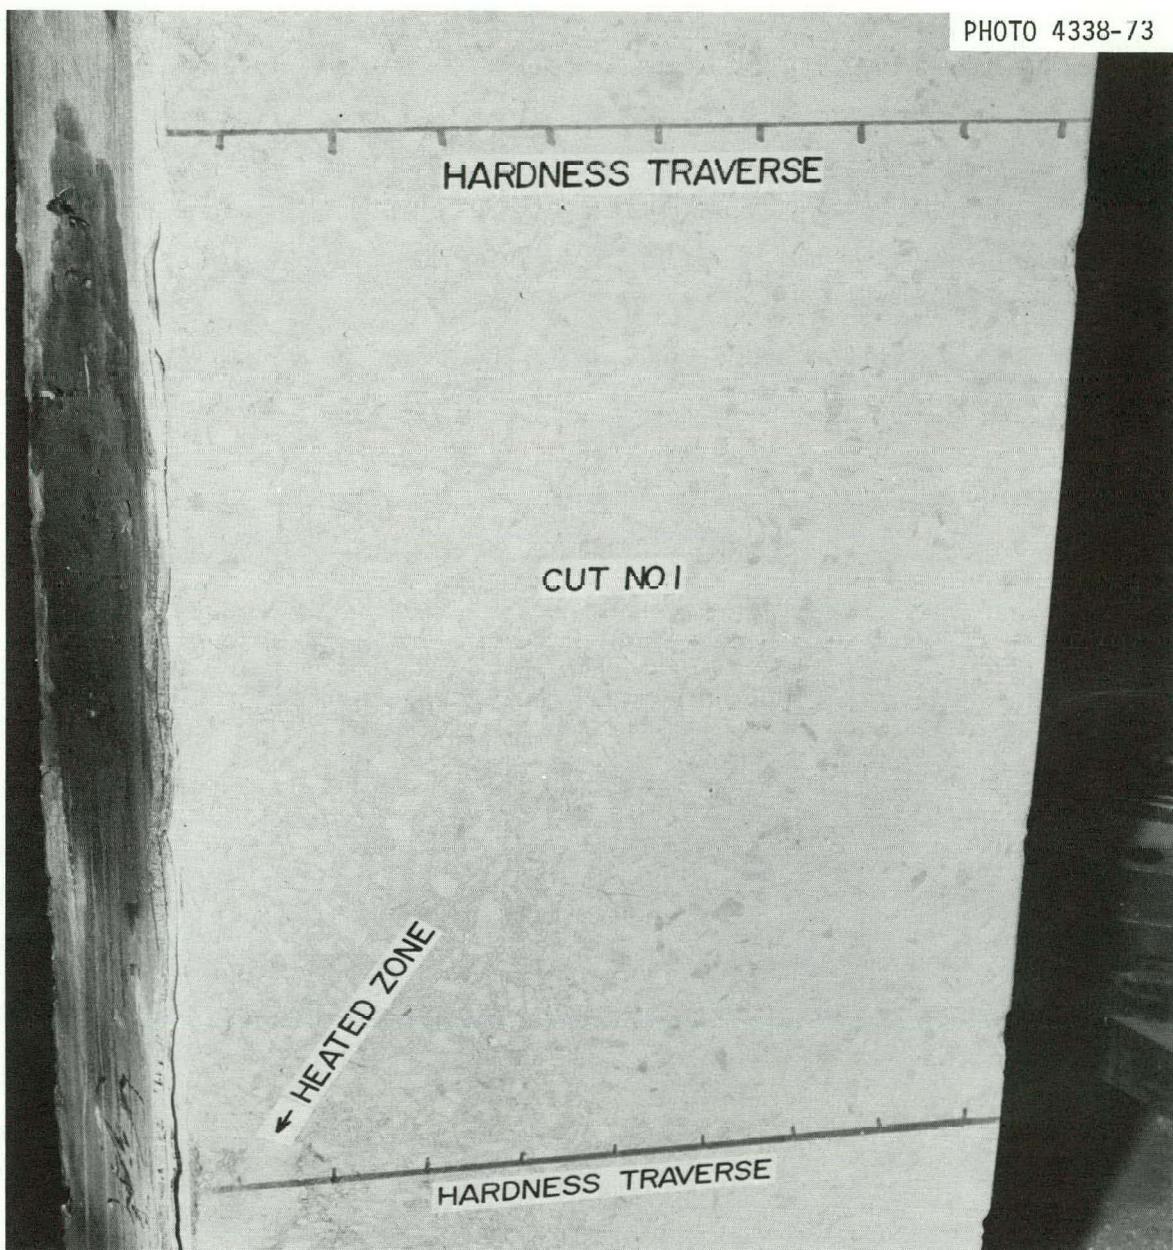
Fig. 7.9. Concrete rebound test traverse lines for concrete section of cut 1.

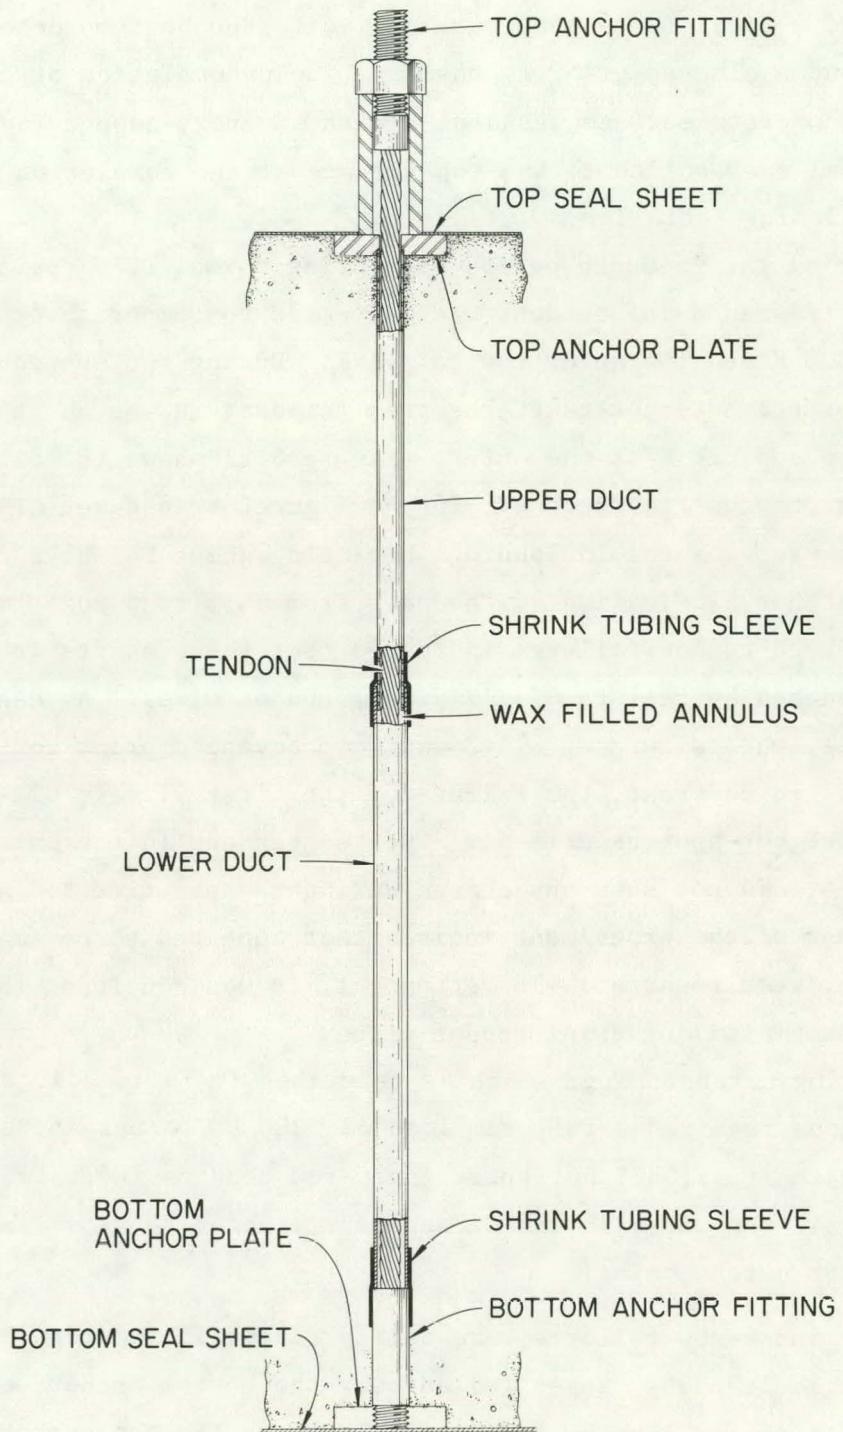
Fig. 7.10. Axial tendon assembly detail.

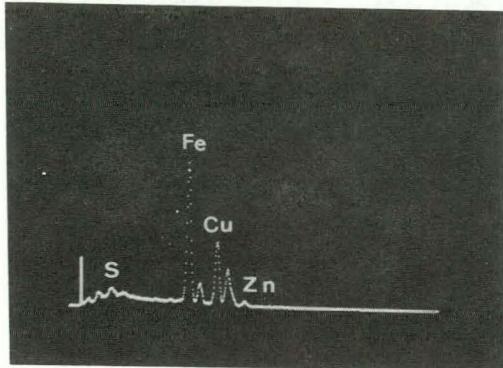
X-RAY ANALYSIS OF FRACTURE SURFACE

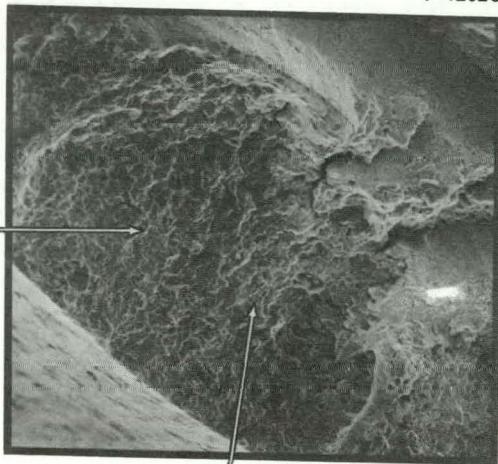
SEM PHOTOGRAPH OF FRACTURE SURFACE

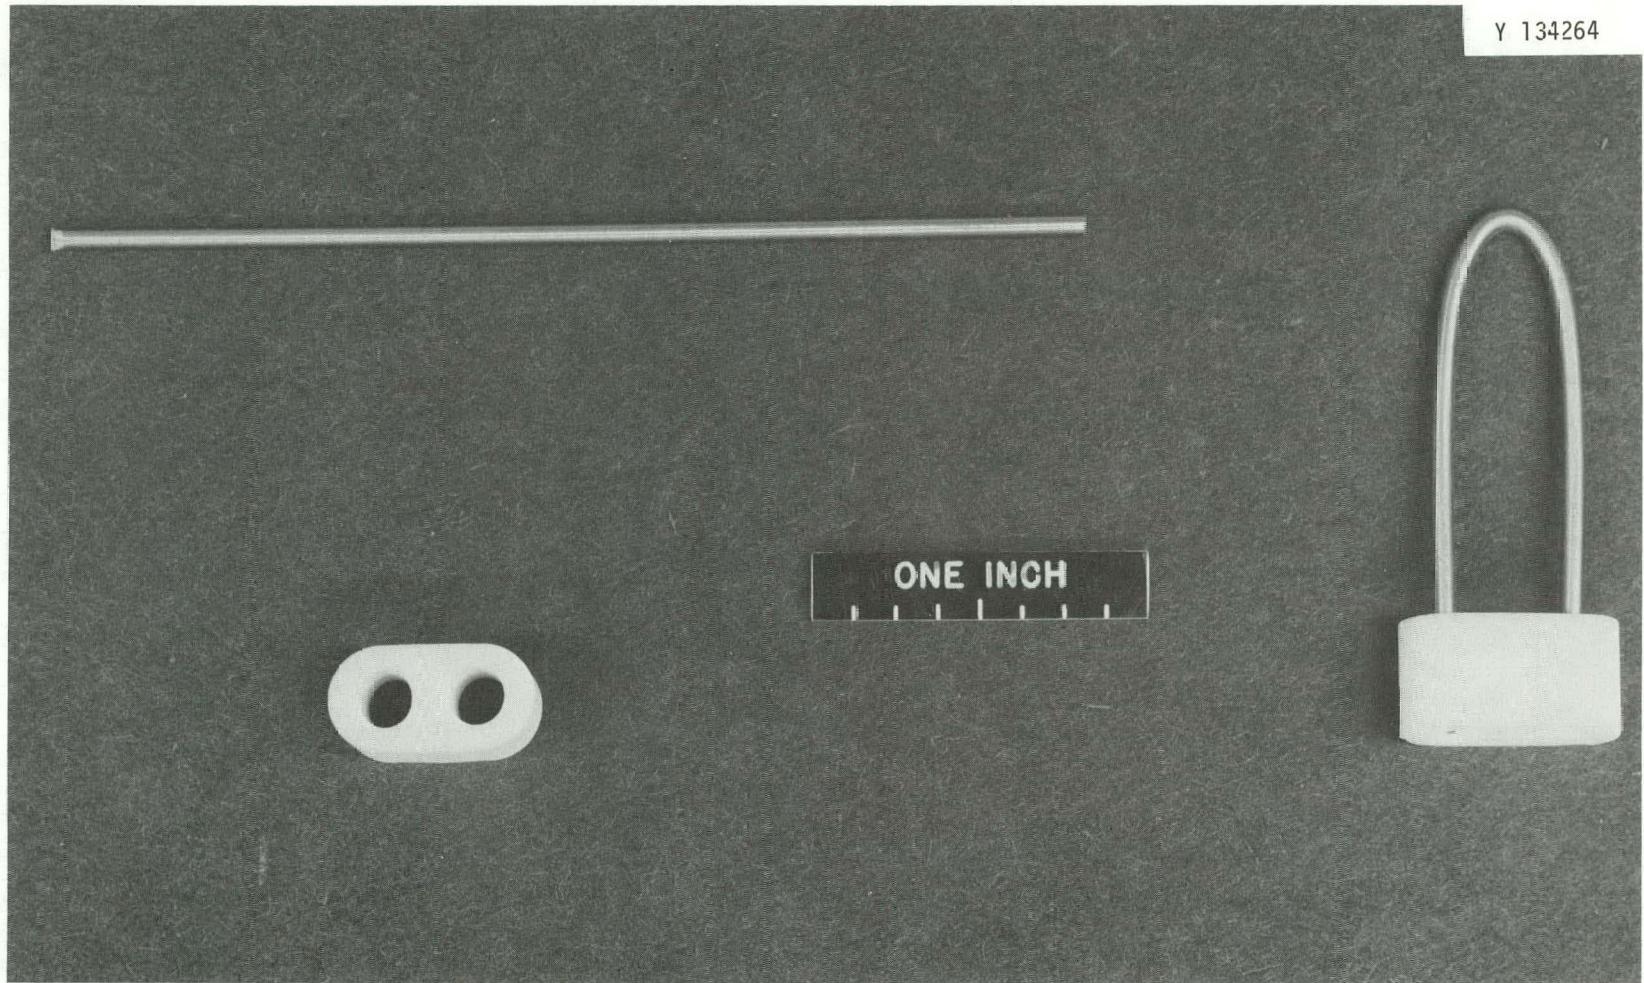
Fig. 7.12. The U-bend specimen used in the stress-corrosion studies. The 1.5-mm-diam steel test section was ground from a sound area of a wire removed from a tendon in which individual wires had failed. The wire is bent into the U configuration, and its ends are placed in the refractory retainer. (1 in. = 25.4 mm.)

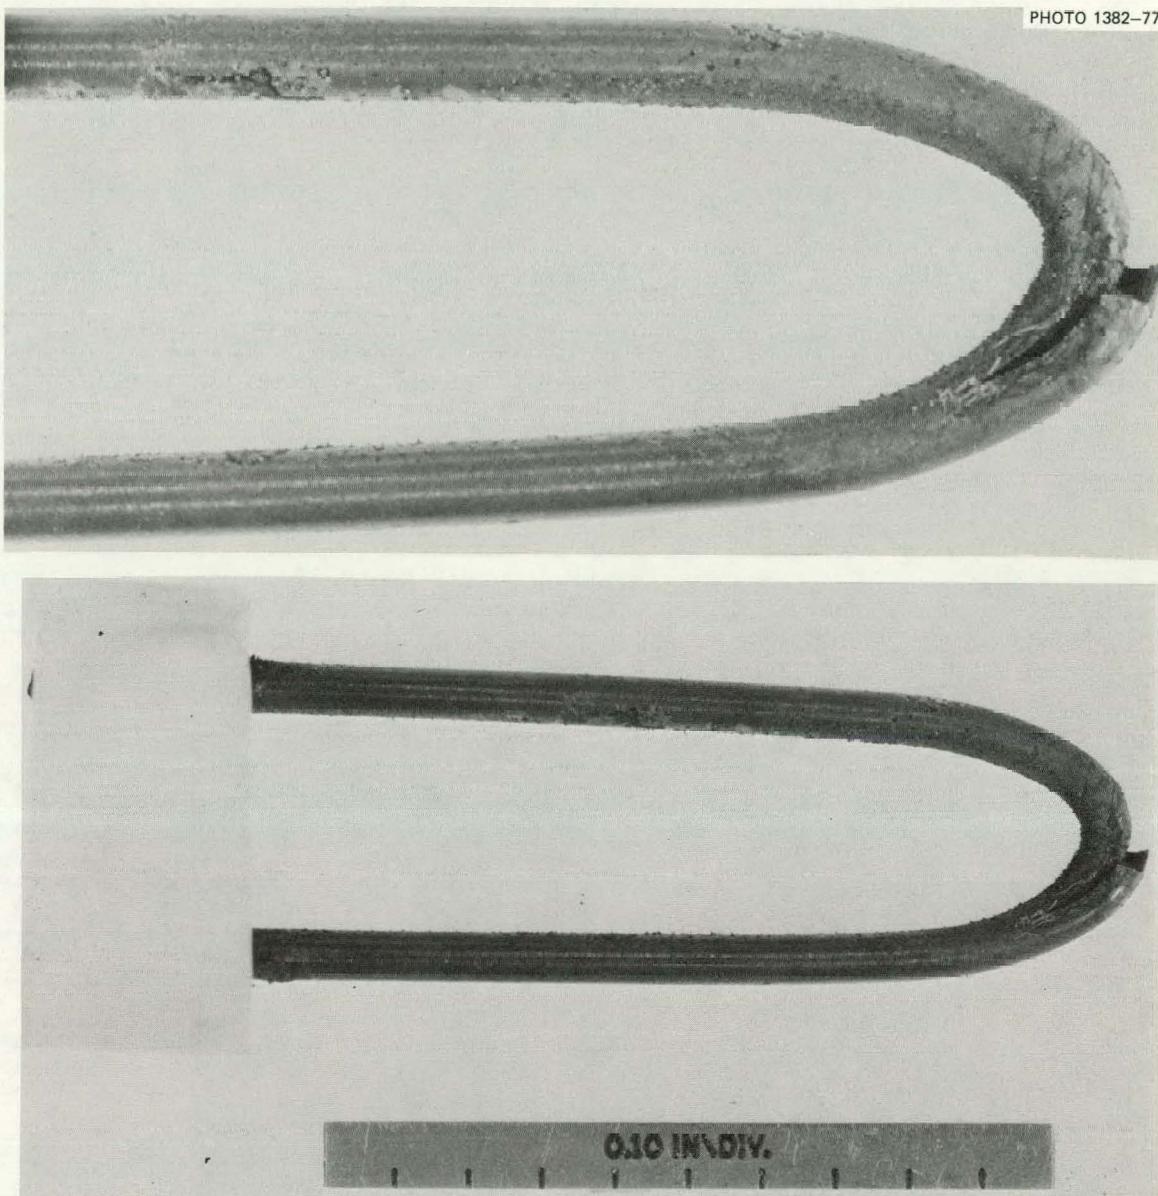
Fig. 7.13. U-bend stress-corrosion specimen that failed in a 0.2-*M* ammonium nitrate solution in 72 hr at 343 K (1 in. = 25.4 mm). (Original reduced 42.5%)

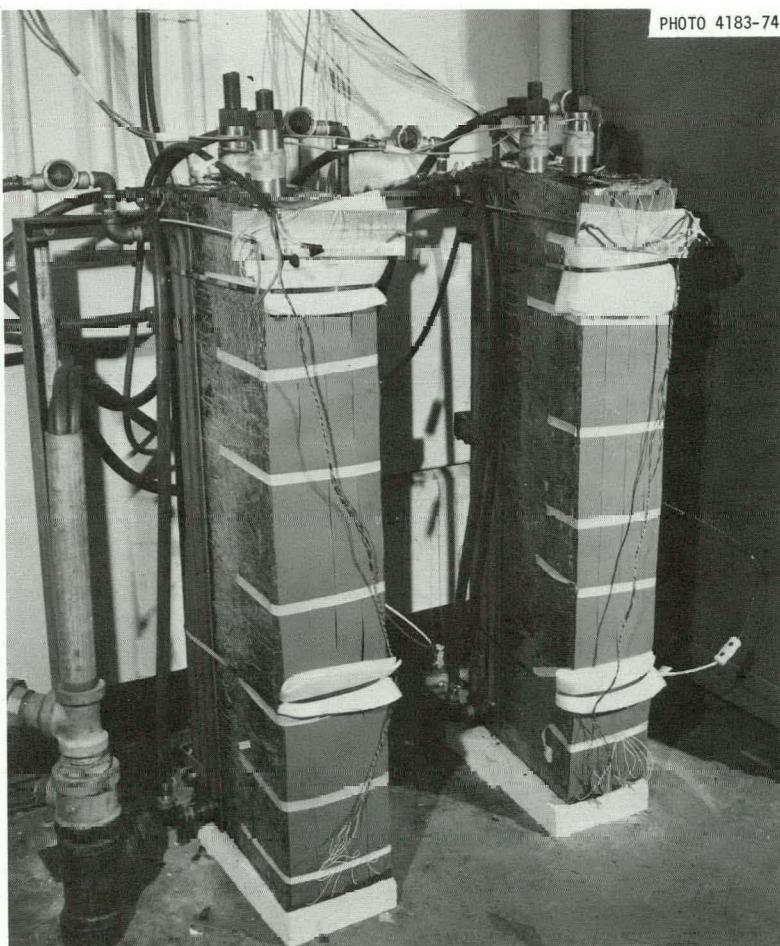
Fig. 7.14. Panelcoils and electric strip heaters installed on segments of thermal cylinder before insulation.

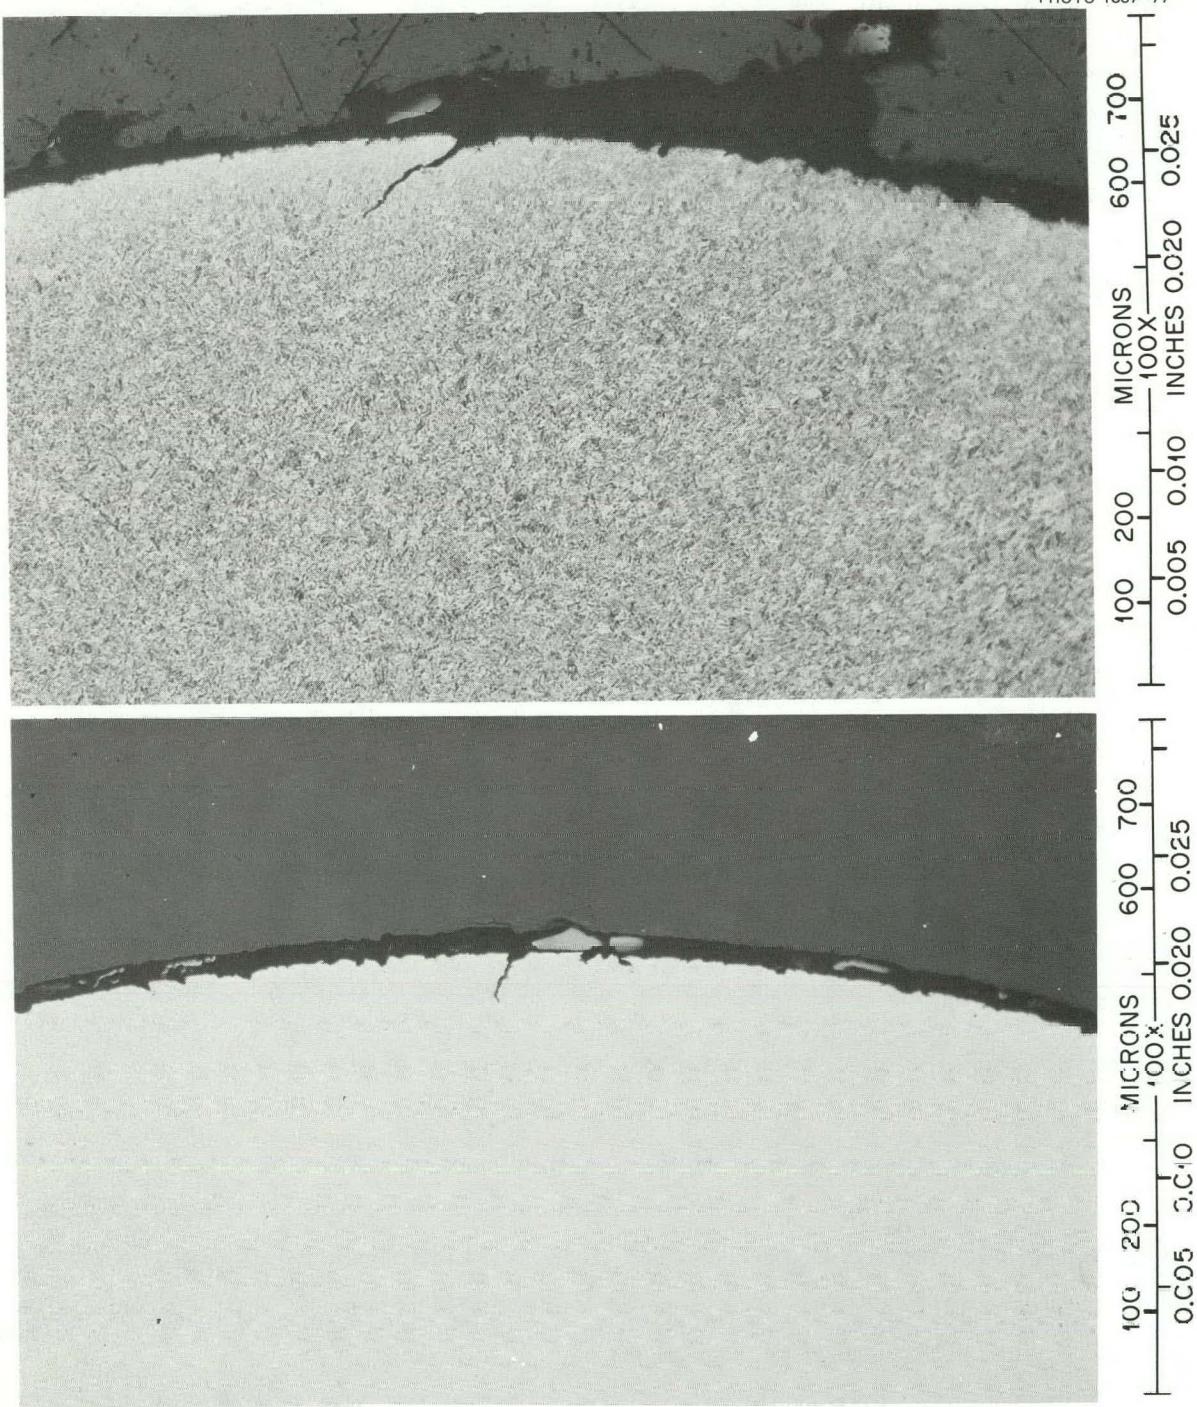
Fig. 7.15. Surface defects in a wire used in the manufacture of tendons (100 $\times$ ). These surface defects could serve as sites for the concentration of contaminants that cause stress-corrosion cracking. (Original reduced 42.5%)

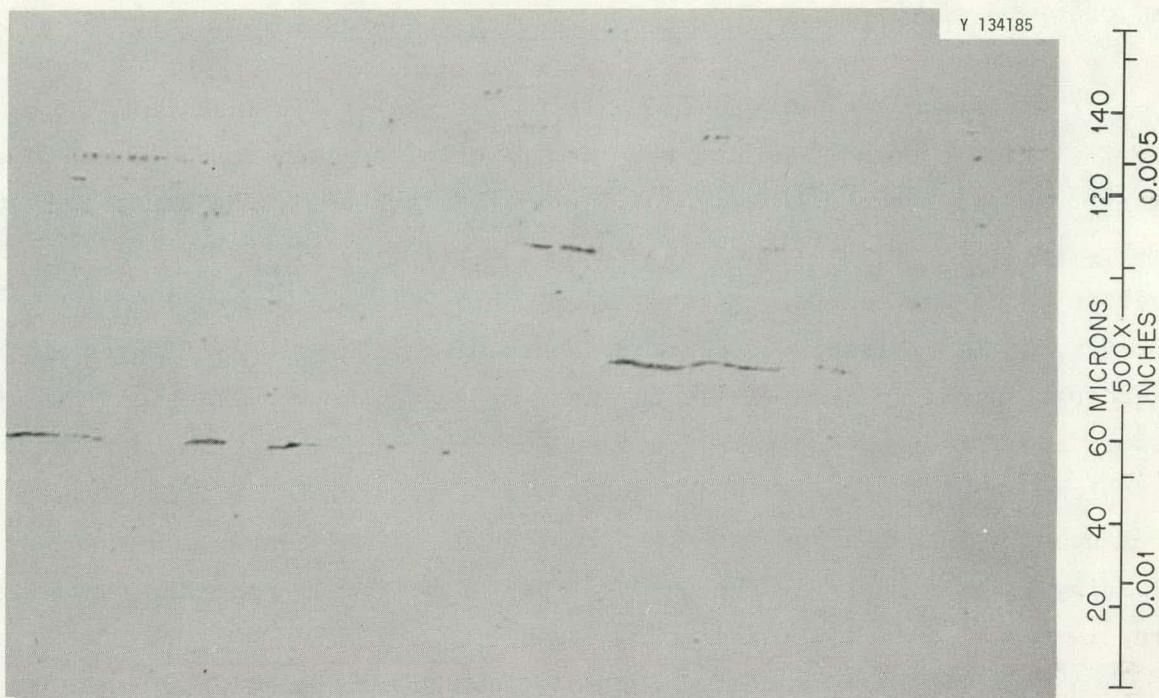
Fig. 7.16. Photomicrograph showing sulfide stringers in the interior of a randomly selected section of circumferential tendons employed in the thermal cylinder test (500 $\times$ ). (Original reduced 43%)

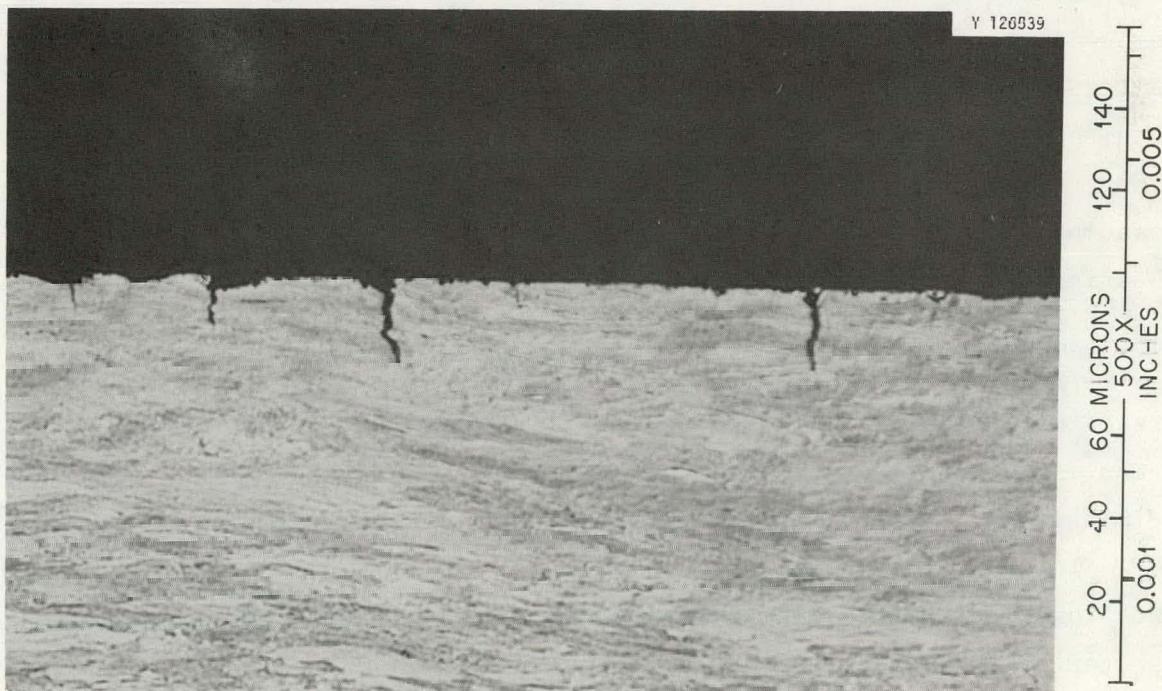
Fig. 7.17. Photomicrograph of a wire that separated during a center-less grinding operation. The cracks, which are perpendicular to the longitudinal axis of the wire, could contribute to premature failure. (Original reduced 43%)

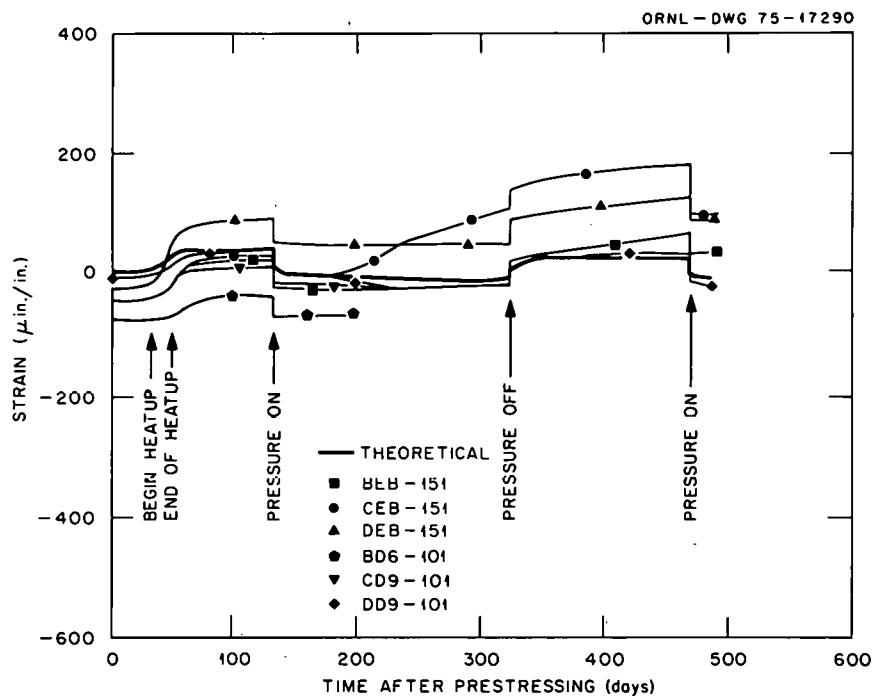
Fig. 7.18. Axial strain 76.2 mm (3 in.) from inside wall.
