ORNL/TM-5613

## Prestressed Concrete Reactor Vessel Thermal Cylinder Model Study

HTGR BASE TECHNOLOGY PROGRAM  
Prestressed Concrete Nuclear Pressure  
Vessel Development (189a. No. 01331)

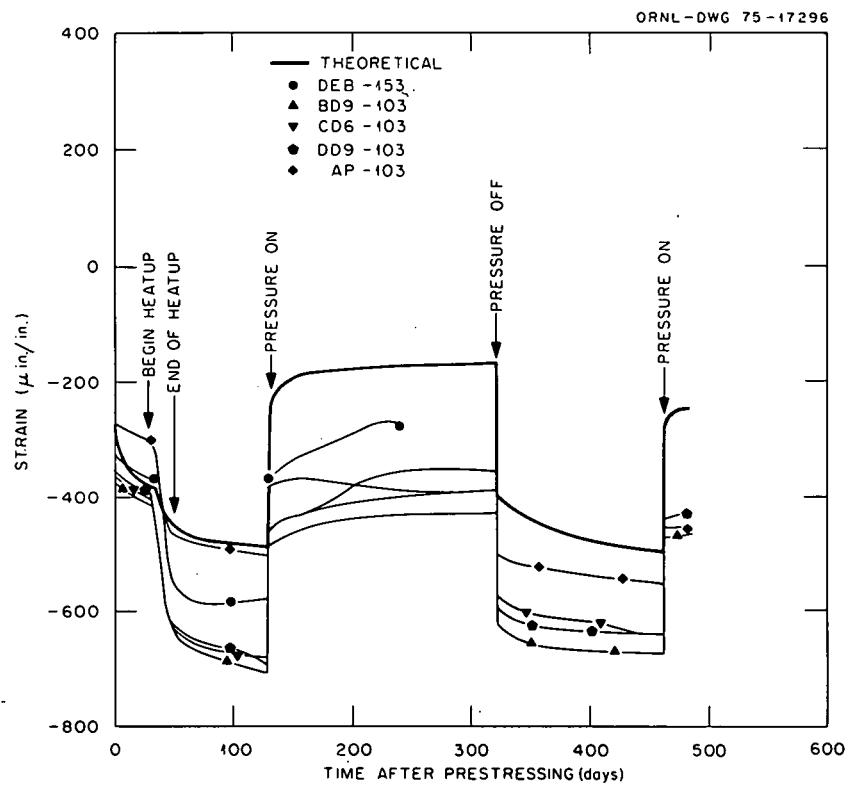
Fig. 7.20. Circumferential strain 76.2 mm (3 in.) from inside wall.

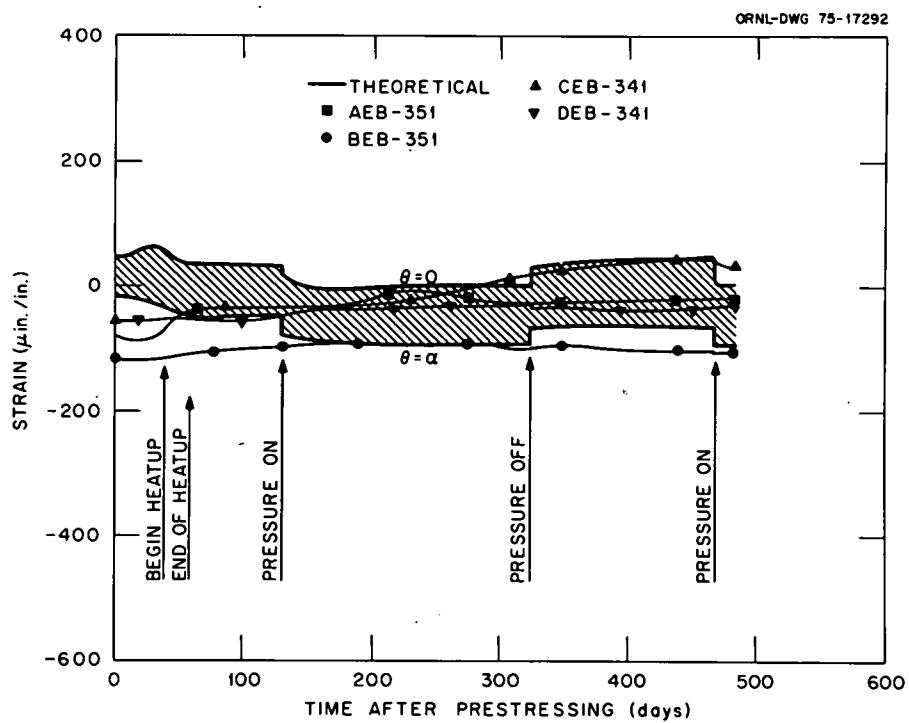
Fig. 7.24. Axial strain 76.2 mm (3 in.) from outside wall.

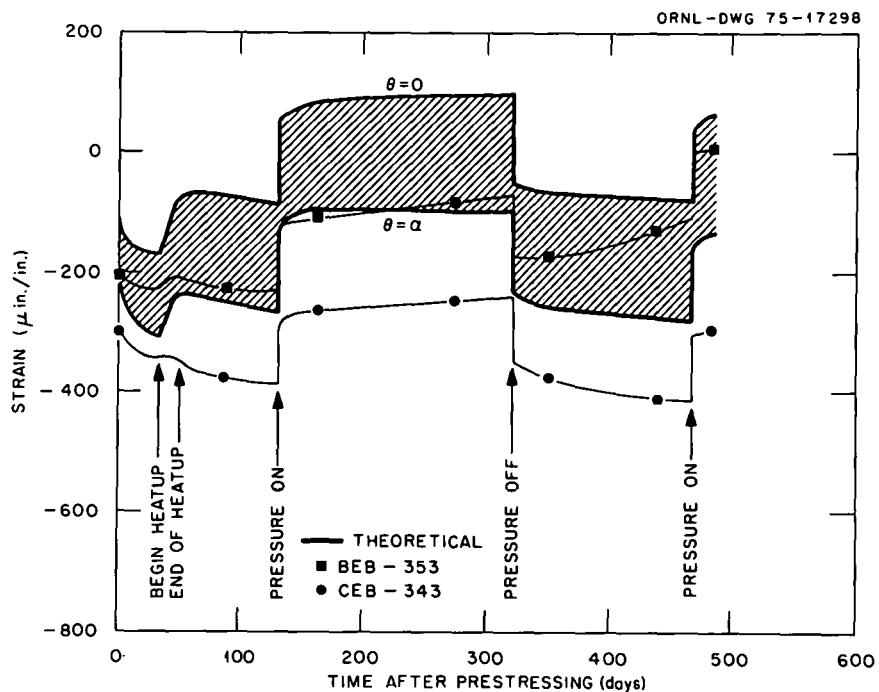
Fig. 7.26. Circumferential strain 76.2 mm (3 in.) from outside wall.

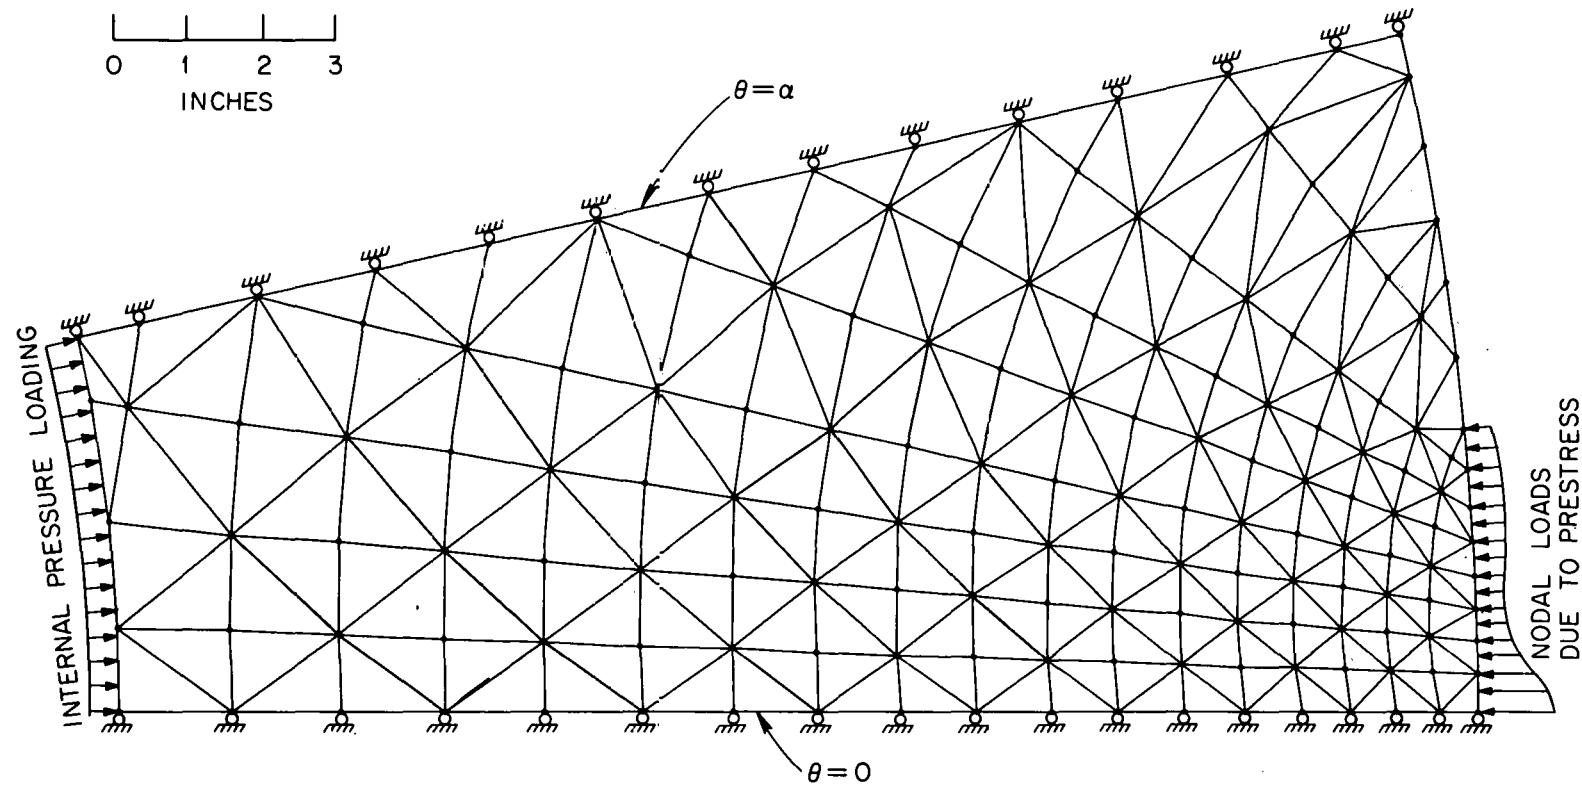
Fig. 7.27. Plane slice at midheight of thermal cylinder (1 in. = 25.4 mm).
