SODIUM REFLUX POOL-BOILER SOLAR RECEIVER ON-SUN TEST RESULTS

Charles E. Andraka
James B. Moreno
Richard B. Diver
Timothy A. Moss
Solar Thermal Electric Technology

Sandia National Laboratories
Albuquerque, New Mexico 87185

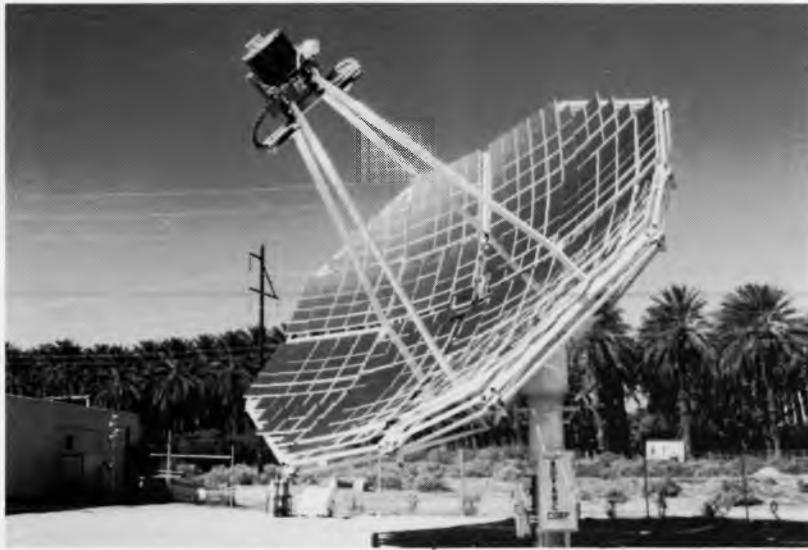
Figure 1. Advanco-Vanguard dish-Stirling module in operation. This module currently holds the world record for sunlight-to-grid-power conversion efficiency at 29.4%.

Dish-Stirling systems have demonstrated the potential to produce economical environmentally acceptable electric power from the sun. In 1984, the Advanco-Vanguard dish-Stirling module (Figure 1) demonstrated a world record sunlight-to-electricity peak net conversion efficiency of 29.4% (Washom, 1984a). McDonnell Douglas Corporation further developed and nearly commercialized a system based on the Advanco module (Coleman and Raetz, 1986). Recently, dish-Stirling system development by the Department of Energy (DOE) and industry has emphasized advanced components to improve system performance, cost, life, and reliability.

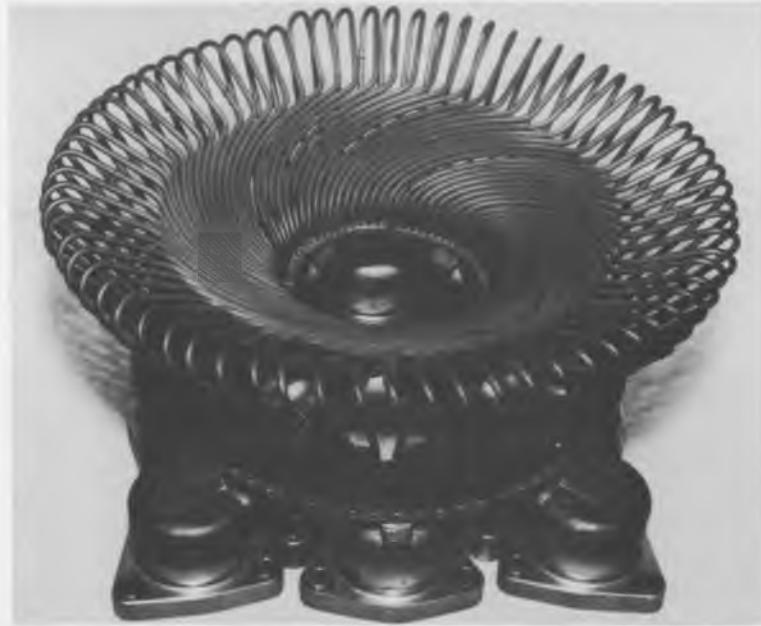
Figure 2. United Stirling of Sweden heater head used on the Advanco dish-Stirling Module. The heater head tubes were expanded to make the solar flux levels lower and more uniform.

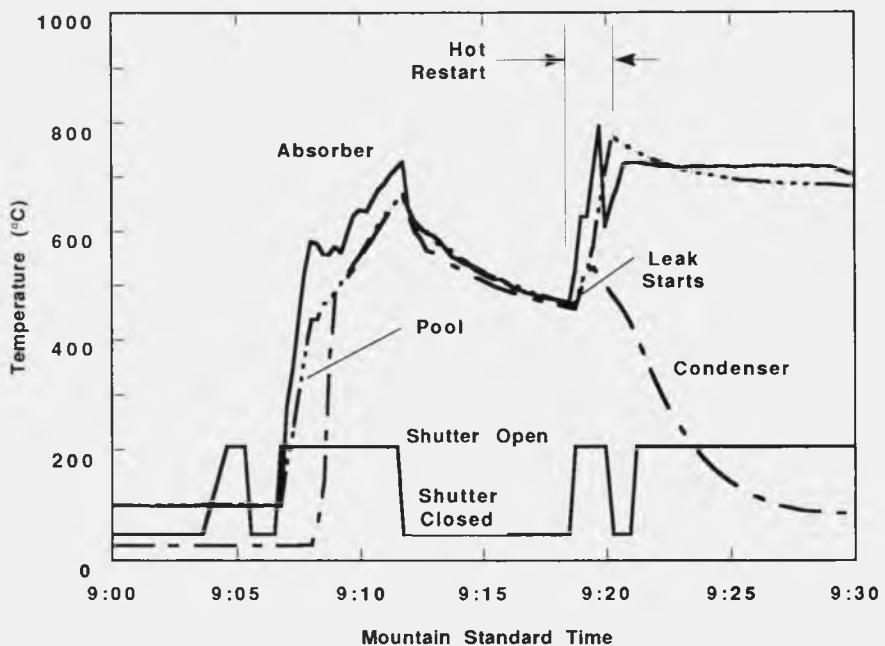
Figure 7. Temperature history during the May 30, 1990 receiver test and subsequent failure. Boiling, as evident by the microphone sounds, occurred during each start-up. No receiver thermocouples experienced an over-temperature indication during the failure.

On May 30, during a hot restart, the receiver absorber developed a leak approximately 1/8 x 1/4 in. Approximately 2.27 kg (5 lb) of the 5.77-kg (12.7-lb) inventory of sodium was consumed during subsequent fire. Figure 7 shows data taken during the test. The start of the leak is believed to coincide with the decrease in slope of the condenser temperature during the hot restart. Indicated temperatures during the fire were not greater than those seen in normal operation, and damage to the receiver was confined to the immediate vicinity of the leak.

The receiver failed during a unique hot restart. The failure was probably due to a loss of coolant (sodium), resulting in the formation of a 1/8 x 1/4 in. melt zone in the stainless steel absorber. Loss of coolant could be due to exceeding the flooding limit or local film boiling.

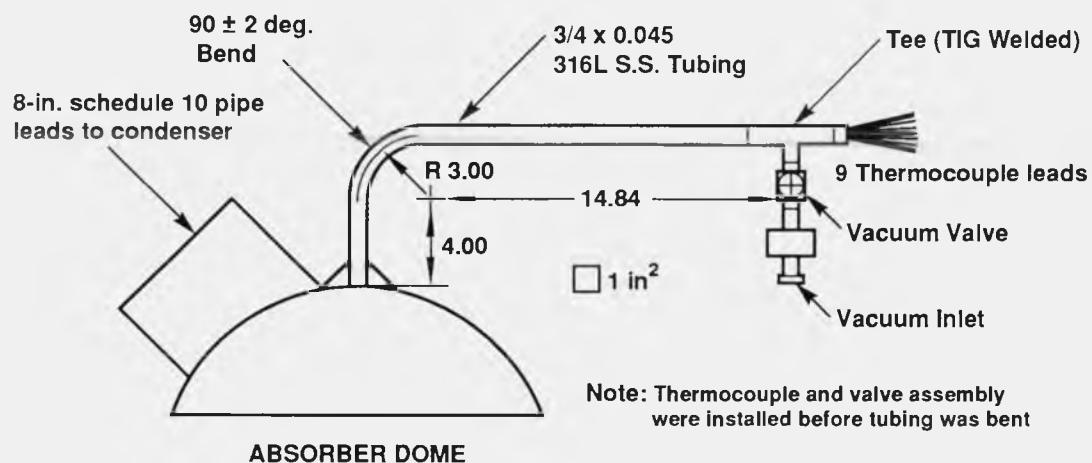
Figure A-3. Details of the aft dome and vacuum pumpout port with thermocouple feedthrough. Nine type-K stainless steel sheathed thermocouples entered through the brazed port and were attached to the absorber dome.

A 3/4-in. stainless steel tube was attached to the aft dome to provide a vacuum pumpout port. This tube also contained a feedthrough for nine 1/16-in.-diameter sheathed type-K thermocouples. The tubing was bent 90 degrees downward after exiting the aft dome to prevent vapor from entering and transferring heat to the valve and feedthrough. Another 3/8-in. tube was attached to the condenser cap, and was used for filling the receiver. This tube contained a feedthrough with five thermocouples, and was similarly bent to provide a liquid pool thermal barrier to the valve. The tube and feedthrough details are shown in Figures A-3 and A-4. The two thermocouple feedthroughs consisted of a stainless steel plug with 1/16-in. diameter holes for each thermocouple. The thermocouples were furnace-brazed into the feedthroughs using BNi-3 brazing alloy. BNi-7 furnace braze alloy was used to attach the thermocouple tips to the inside surfaces. Incurlo-60 braze alloy was used for external thermocouples.

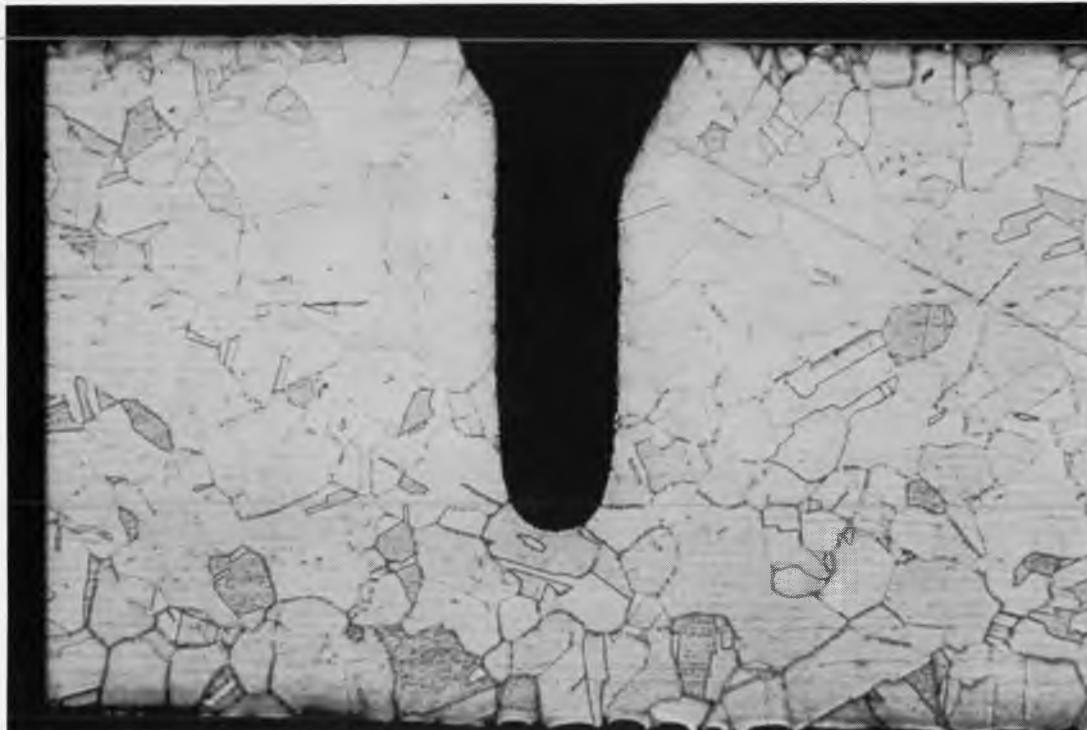
Figure A-6. Polished and etched section of an artificial cavity. This section was taken from the receiver after testing. The conical opening of the cavity is probably due to fatigue caused by bubble departure (see Appendix S of this report).

Based on results from bench-scale pool-boiler testing (Moreno and Andraka, 1989), "artificial" cavities were formed in the absorber dome, spaced approximately four inches apart (Figure A-5). The cavities were formed by electric-discharge machining, and were specified 0.020 in. deep, and 0.006 in. in diameter. Checking 30% of the actual cavities yielded diameters from 0.005 to 0.0095 in. and depths from 0.018 to 0.022 in. Figure A-6 shows a polished and etched cross section of a cavity removed from the dome after testing. These cavities supply stable nucleation sites for bubble formation.

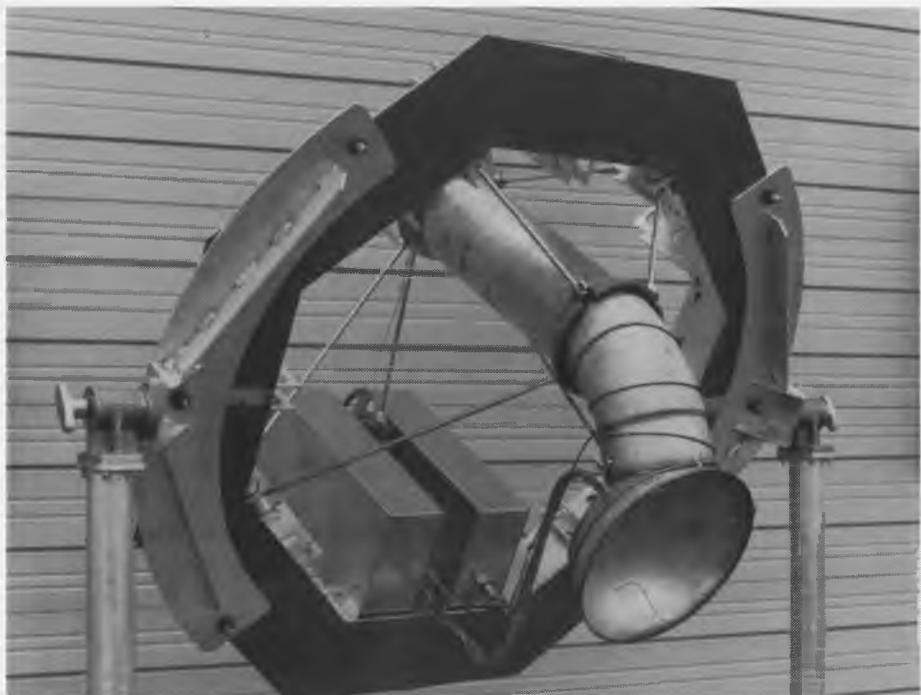
Figure B-5. Photograph of the pool-boiler receiver in the mounting ring.

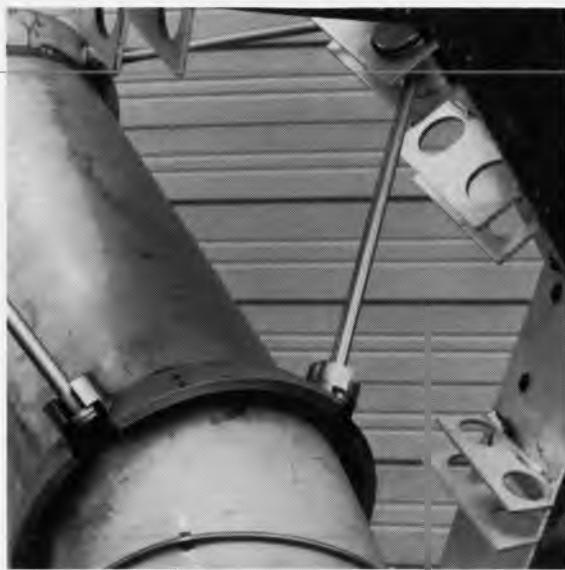
Figure B-6. Photograph showing the spoke attachments to the pool-boiler hub assembly.

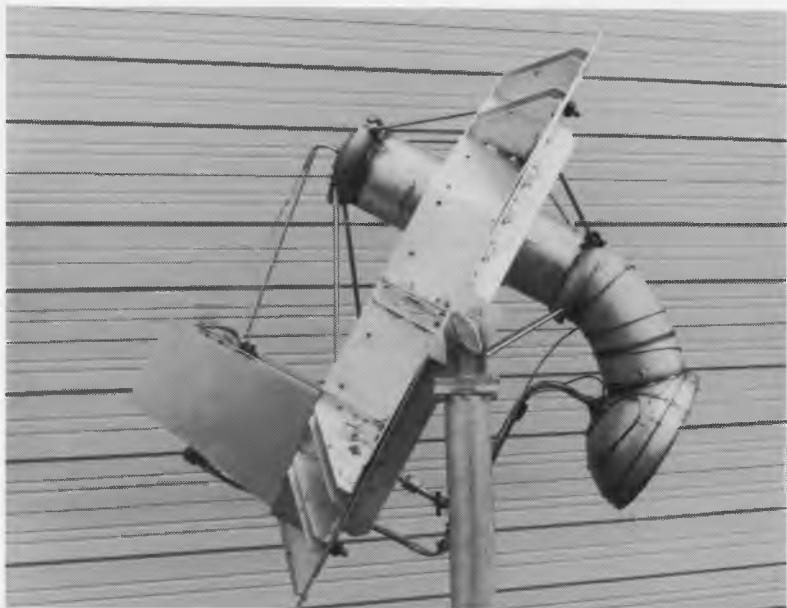
Figure B-9. Photograph showing a side view of the pool-boiler receiver in the mounting ring.

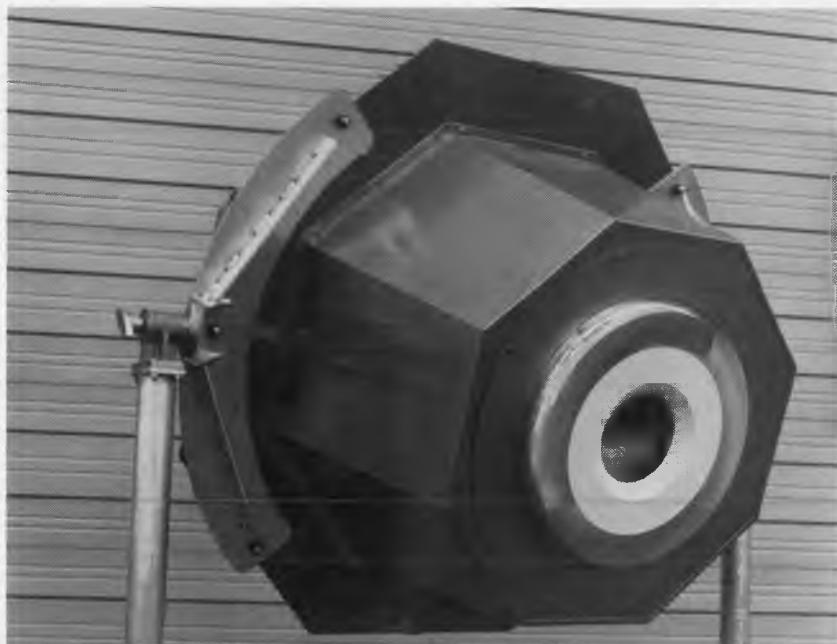
Figure B-10. Photograph of the pool-boiler receiver with the insulation housing.

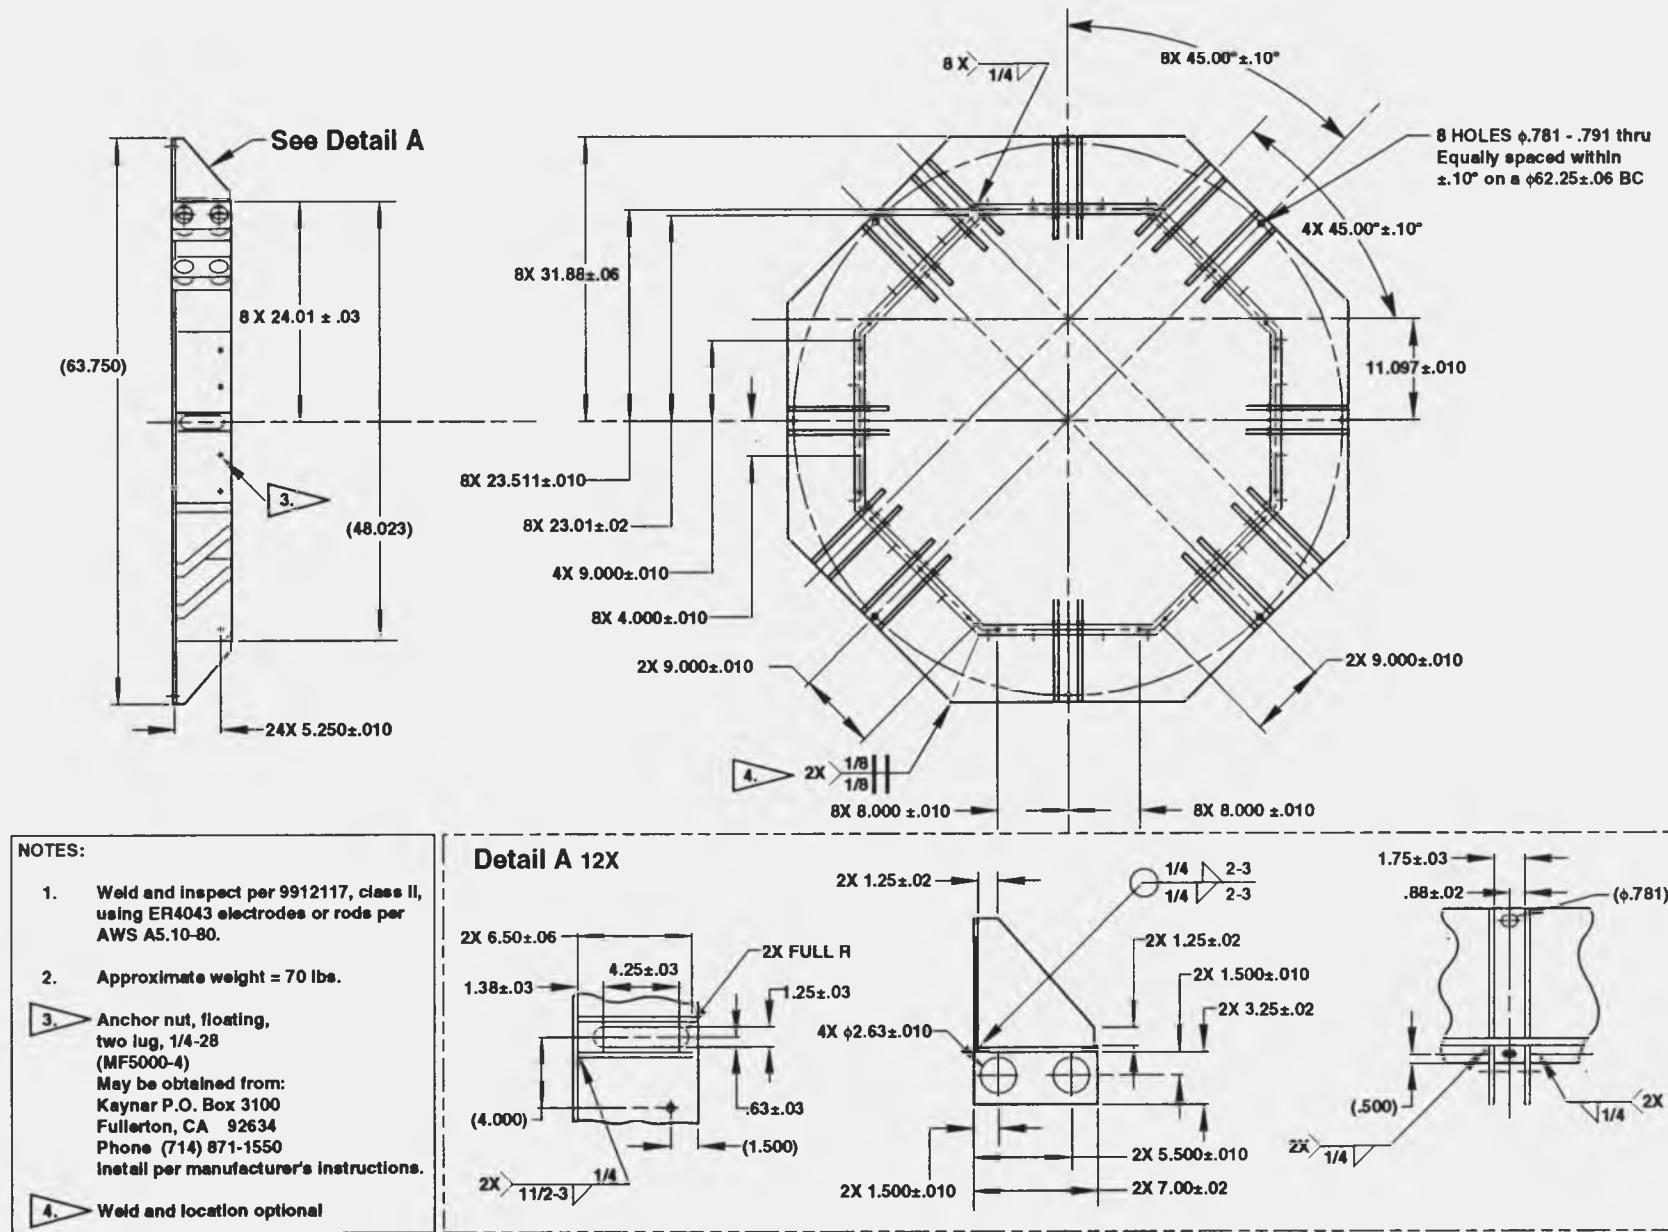
Figure B-11. Engineering drawing of the Sandia reflux receiver octagon support ring.

The receiver was supported by eight 0.5-in. (1.27-cm) diameter stainless steel 316L stainless steel spokes. They were attached to the aluminum octagon support ring through spoke pins that were held in place by retaining rings. Recessed within the spoke pin, a spherical washer set and four Schnorr Disk Springs (Belleville Springs) were secured by a 1/2 in. x 13 thread/in. nut. Approximately one turn of pretension was applied to each nut. The disk spring assembly was designed to allow thermal expansion differences between the spokes and condenser while maintaining approximately 100 to 500 pounds of axial preload force in the spokes. Two support hubs were skip welded to the receiver condenser section to provide attachment pads for the spokes. Spherical washer assemblies (one spherical washer was welded to the spoke end) provided latitude for up to 5 degrees of spoke misalignment to the hubs. The receiver support hubs were machined from 304L stainless steel 10-in. schedule-40 pipe end caps. Following the test, it was observed that all but one or two of the skip welds on each hub had cracked. However, the weld bead interference between the hub and condenser was adequate to maintain position.

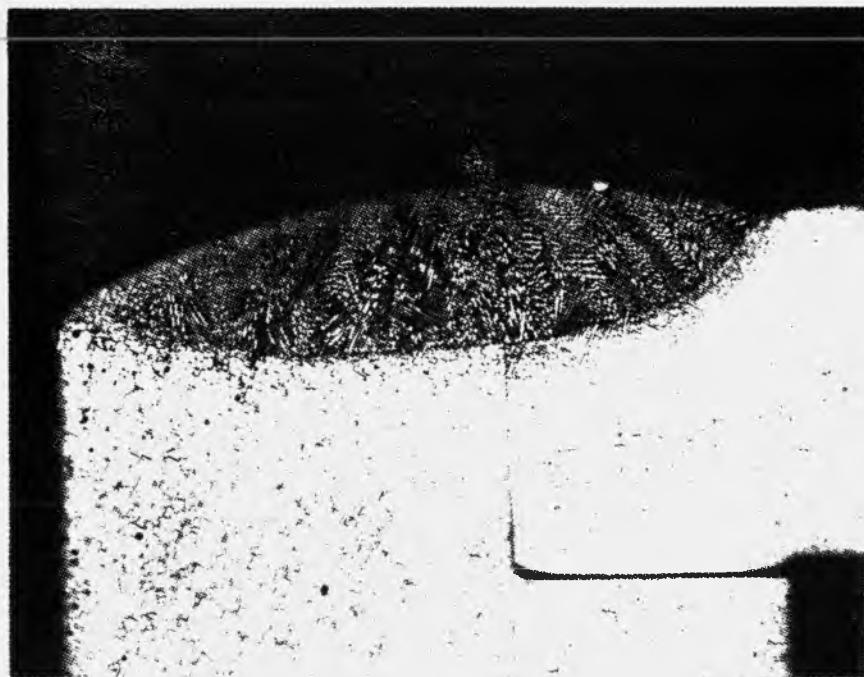
Figure 1. Cross section of autogenous Haynes 230 corner groove weld (no filler metal).
32X magnification.

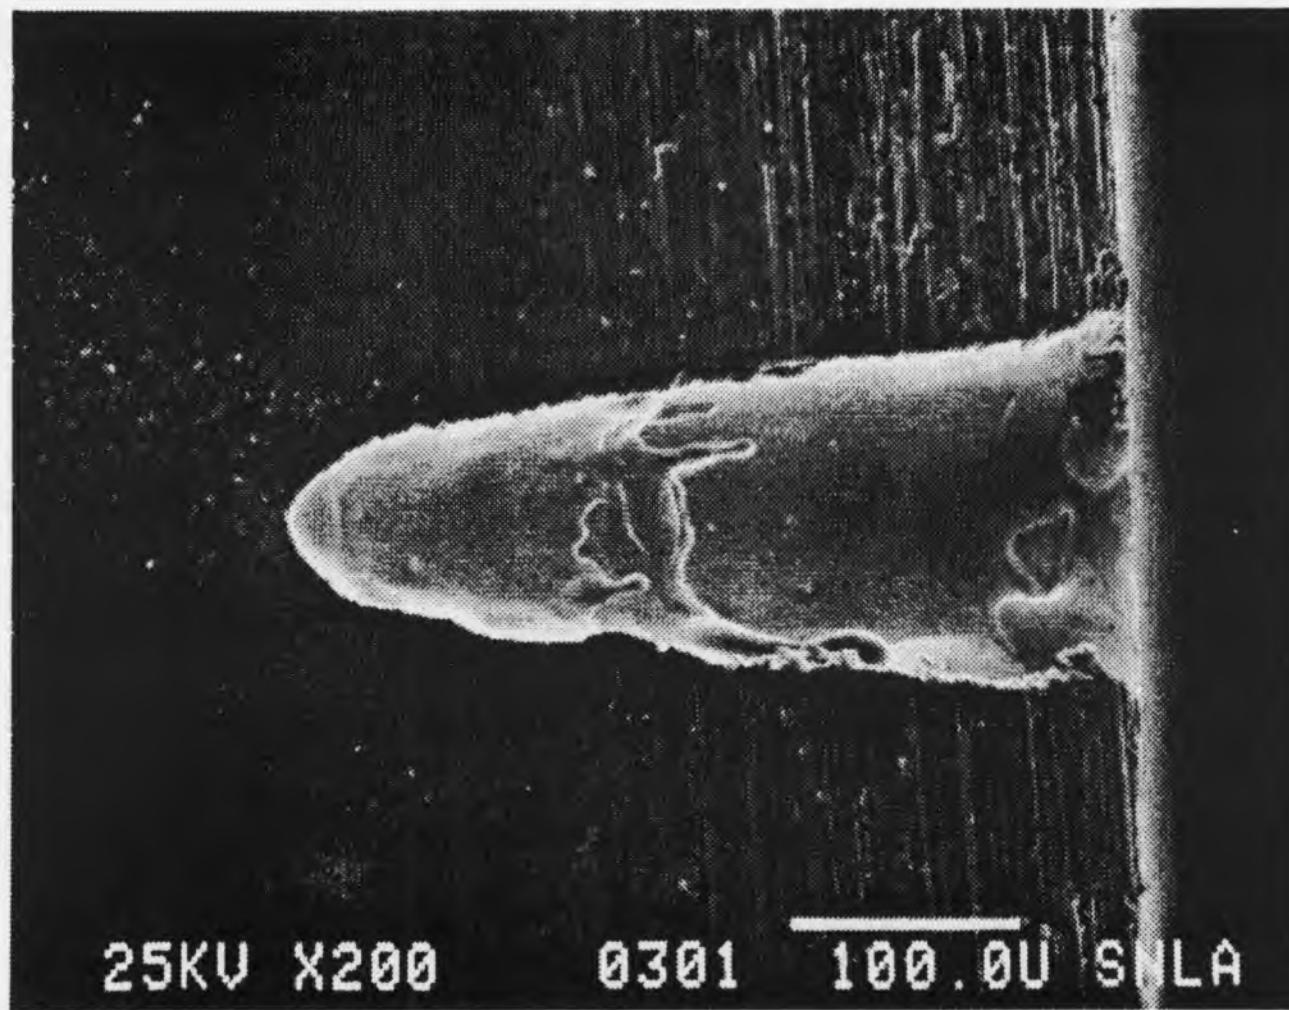
Figure 3. Electron Micrograph of a typical hole cross section. The hole was formed with a single 200 mJ laser pulse.

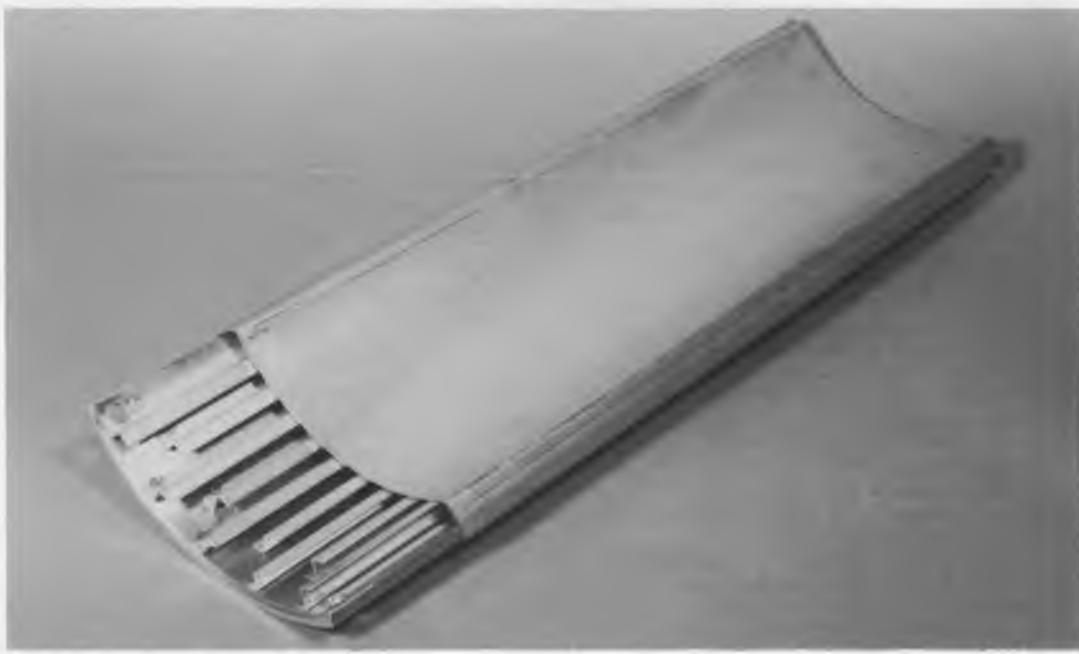
Figure F-2. Photograph of the inner and outer shell of one calorimeter quadrant, with the inner shell slid back to reveal the water-flow baffles.

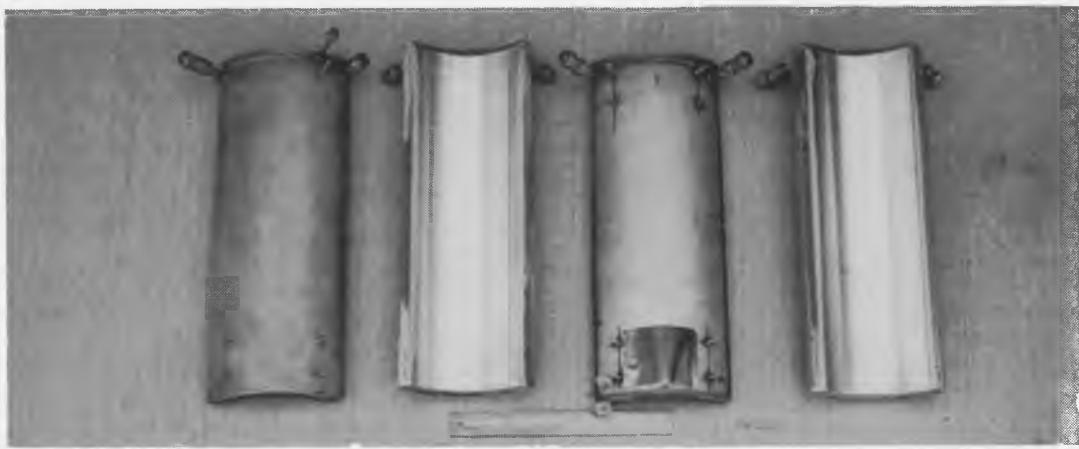
Figure F-3. Photograph of four calorimeter quadrants showing inside and outside surfaces. The quadrant second from the right has two thermocouples brazed in place to sense the heated-surface temperature near the water inlet and outlet. A square shim-stock protector is spot-welded over the area where the thermocouples pass through the outer (unheated) surface.

The calorimeter was designed by J. F. Muir and W. C. Ginn of Sandia, and was built in four quadrants to facilitate both handling and accurate fit to the condenser section. The narrow gap (approximately 0.04 inches [in.]) between the condenser and the quadrants was maintained by spring-loading each quadrant against longitudinal spacer wires welded to the condenser. To distribute the helium-argon gas mixture uniformly over the gas gap, a circumferential plenum was built into one end of each calorimeter quadrant. Once the calorimeter was spring-loaded onto the condenser, the spaces between the quadrants and between the gas plenum and the condenser were sealed with mineral-wool insulation backed by stainless-steel foil. Two quadrants were connected in series for each half section of calorimeter, and the halves were connected in parallel to achieve the required water flow rates. Baffles within each quadrant were arranged to ensure high flow velocities and to prevent stagnation regions, so that boiling would not occur (Figure F-2). Two metal-sheathed thermocouples were brazed into one of the quadrants to sense temperatures on the wet side of the heated surface, near the water inlet and outlet ports. By monitoring these temperatures over time, it was hoped that potentially-damaging mineral scaling of the surfaces could be detected. Photographic views of the quadrants are shown in Figures F-3, F-4, and F-5.

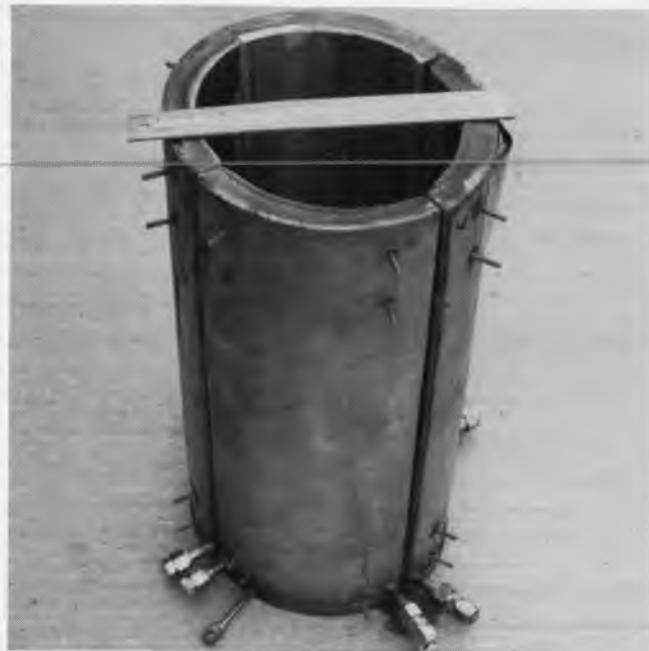
Figure F-4. Photograph of the four calorimeter quadrants grouped as installed on the pool-boiler receiver. The large and small fittings at the bottom are the water and gas ports, respectively.

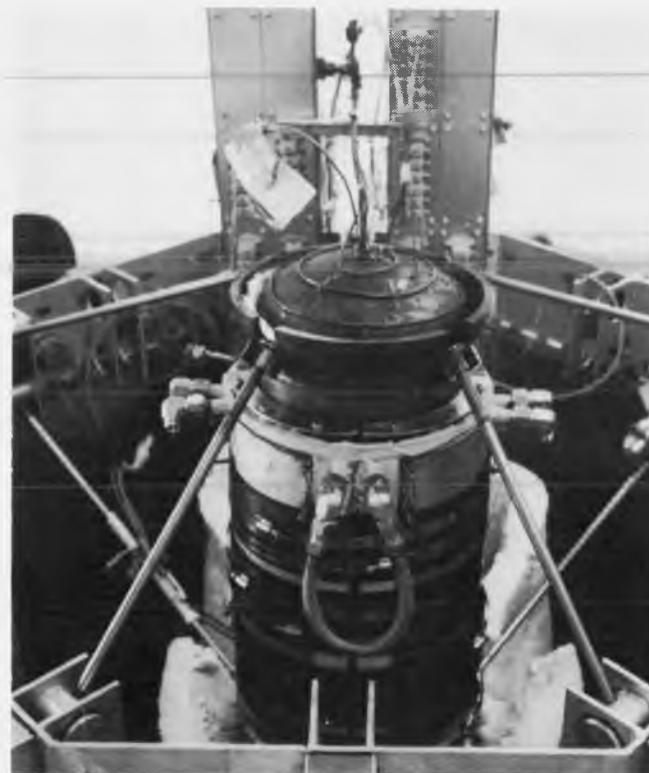
Figure F-5. Photograph of the four calorimeter quadrants installed on the pool-boiler receiver with one water connection between quadrants completed.

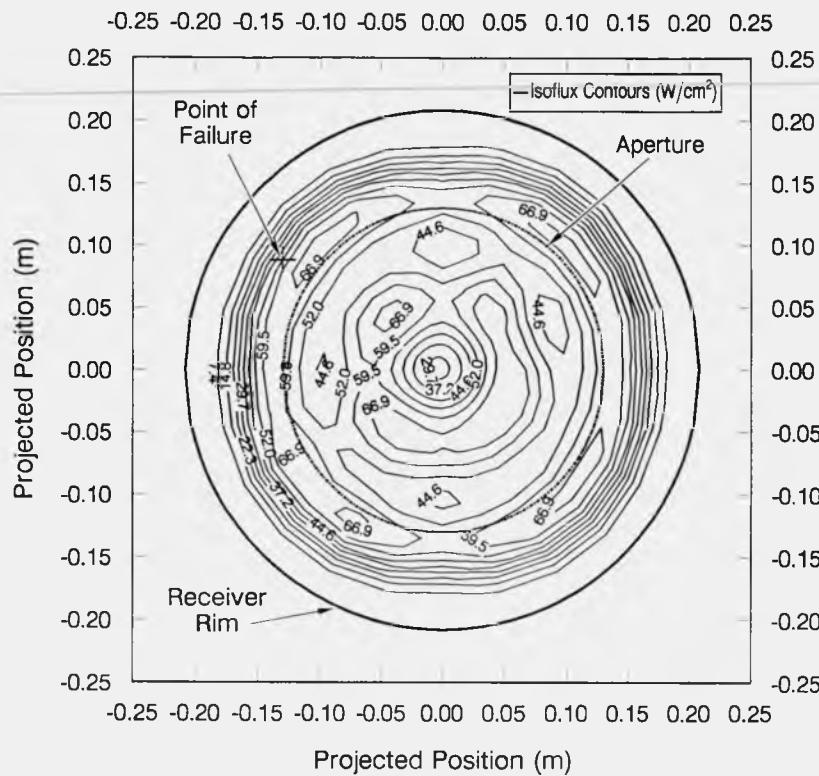
Figure G-3. CIRCE2-predicted incident solar flux for the tested receiver. The integrated solar power of 65.3 kW is approximately equal to calorimeter measurements. Perfect tracking of TBC-1 was assumed. The image is reversed left-to-right (like a mirror image) of what an observer, standing at the concentrator looking at the receiver, sees. The peak flux intensity is 75 W/cm².

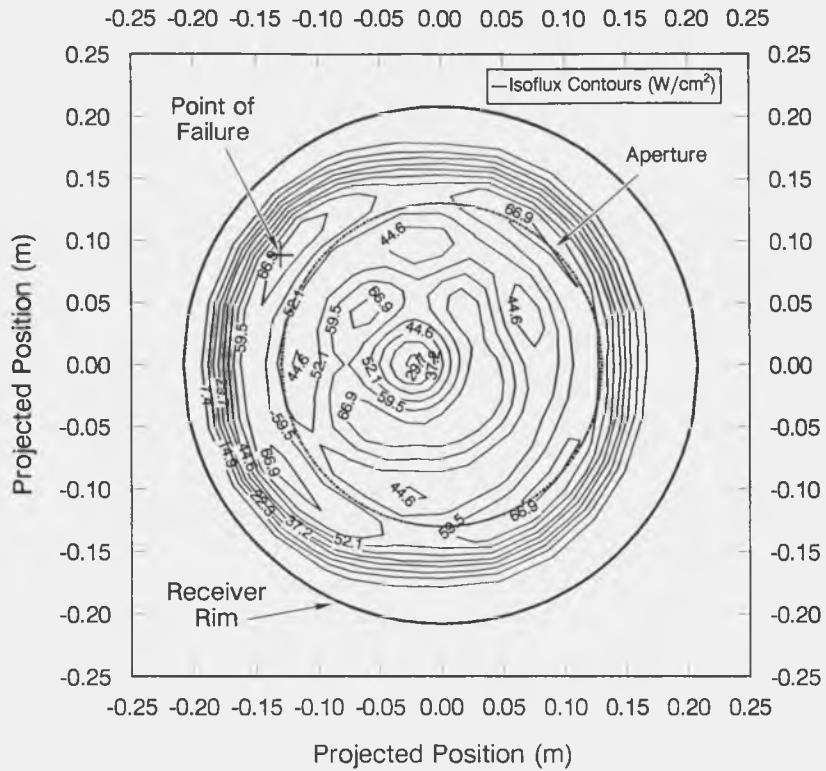
Figure G-4. CIRCE2-predicted incident solar flux for the tested receiver assuming a 3-mrd concentrator mistrack—consistent with observation with the infrared camera. The integrated solar power is 65.0 kW. The image is reversed left-to-right (like a mirror image) of what an observer, standing at the concentrator looking at the receiver, sees. The peak flux intensity is 74 W/cm².

To assess the actual flux intensity, a flux gage was positioned at the point of failure, and the TBC-1 tracking was adjusted while looking for a local “hot spot.” Within the uncertainty of the measurements, the magnitude of the peak flux and the presence of a localized area of high flux was substantiated. However, because tracking offsets are determined visually (using light scattered from the edge of the aperture as a reference) and are input to the automatic tracking system at the beginning of each test, it is impossible to substantiate whether the same tracking error occurred at the time of the failure.

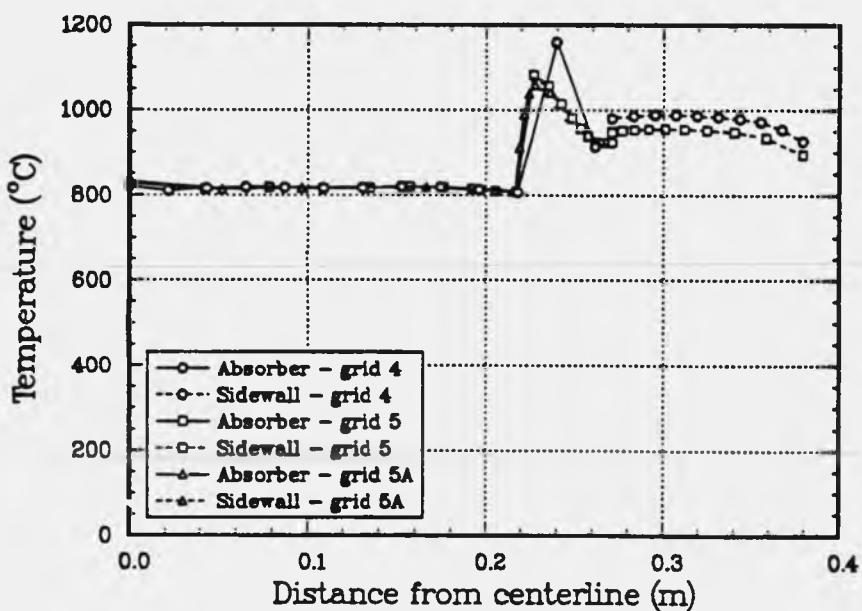
Figure 5. Air-side absorber temperature distribution for computational grids 4, 5, and 5A.

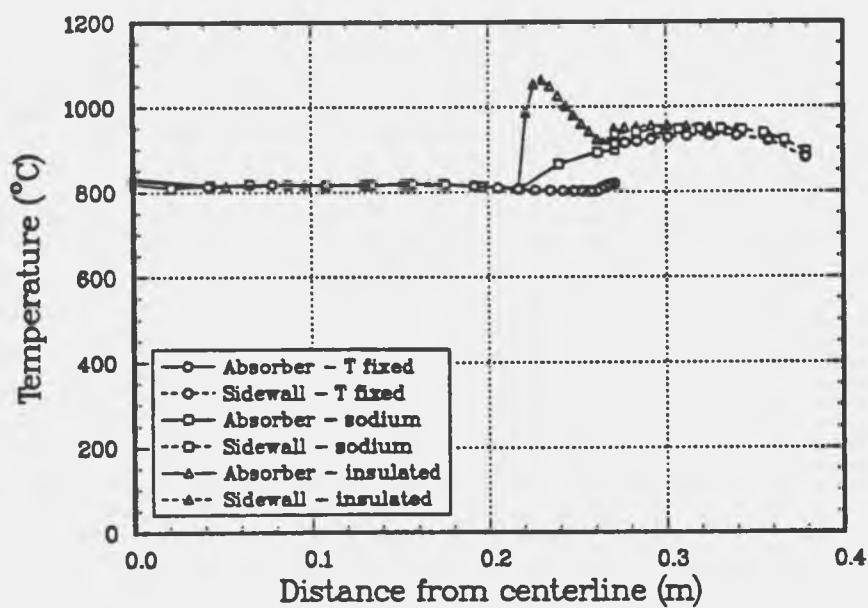
Figure 6. Air-side absorber temperature distribution for the specified temperature, the stationary sodium, and the insulated sodium-side boundary conditions near the weld ($59.2^\circ < \phi < 68.5^\circ$).

Although the insulated boundary on the sodium-side of the absorber is the worst case condition, it is not the most likely. If there is insufficient sodium motion in the region near the absorber and aft-dome weld, then the most likely situation is to have stationary sodium in this region. Figure 6 shows the air-side absorber surface temperature distribution for the specified temperature boundary, the stationary sodium boundary, and the insulated boundary conditions. For the stationary sodium (the most likely condition), the maximum absorber temperature occurs on the air-side and is 899°C and the average weld temperature is 895°C. This temperature is less than the insulated boundary (worst case) but greater than the specified temperature boundary (normal case).

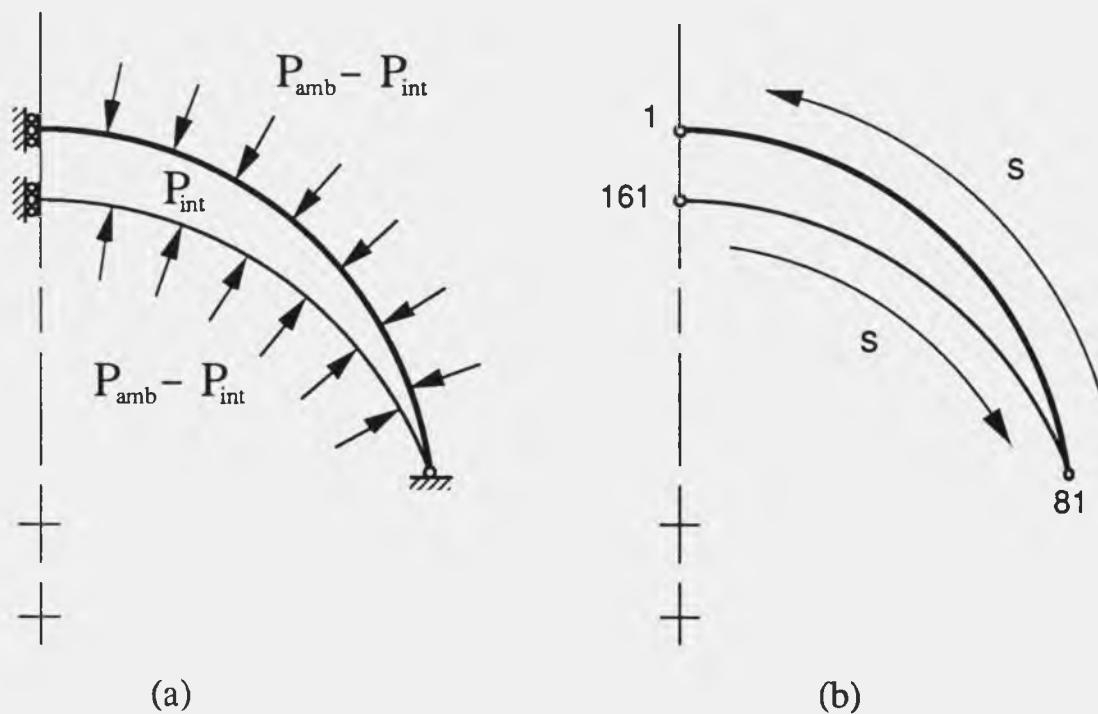
Figure 3. (a) Structural boundary conditions used for the reflux pool-boiler receiver analyses. (b) Definition of the surface position variable, s , used for the presentation of results.

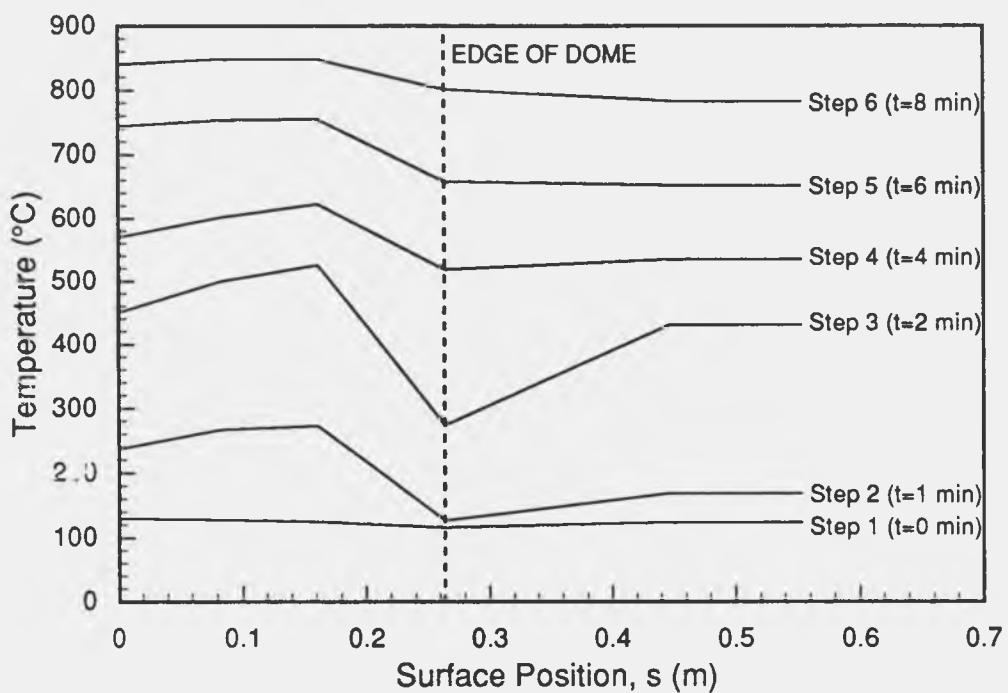
Figure 5. Temporal and spatial temperature distributions assumed for the startup and steady state operating conditions.

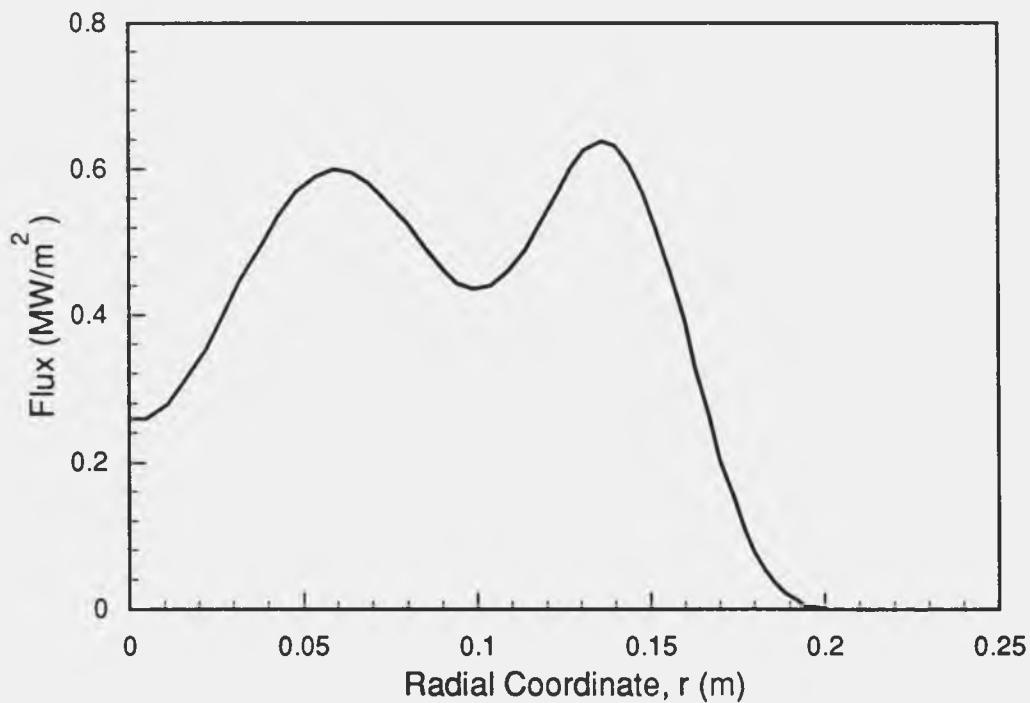
Figure 6. Computed incident solar flux distribution assumed for the startup and steady state operating conditions.

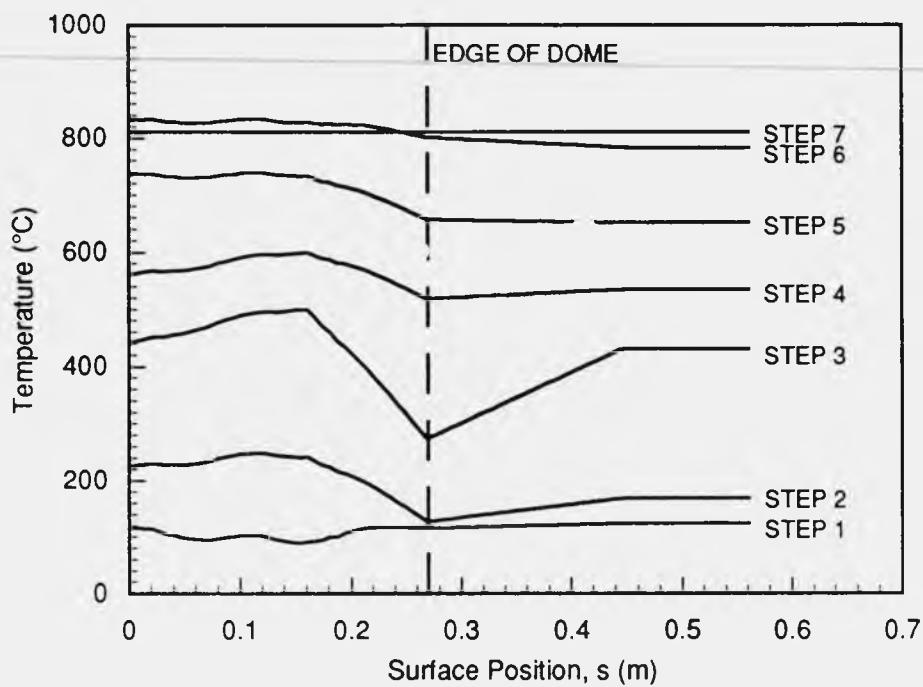
Figure 7. Absorber and aft dome inner surface temperature profiles for startup and steady state operating conditions.

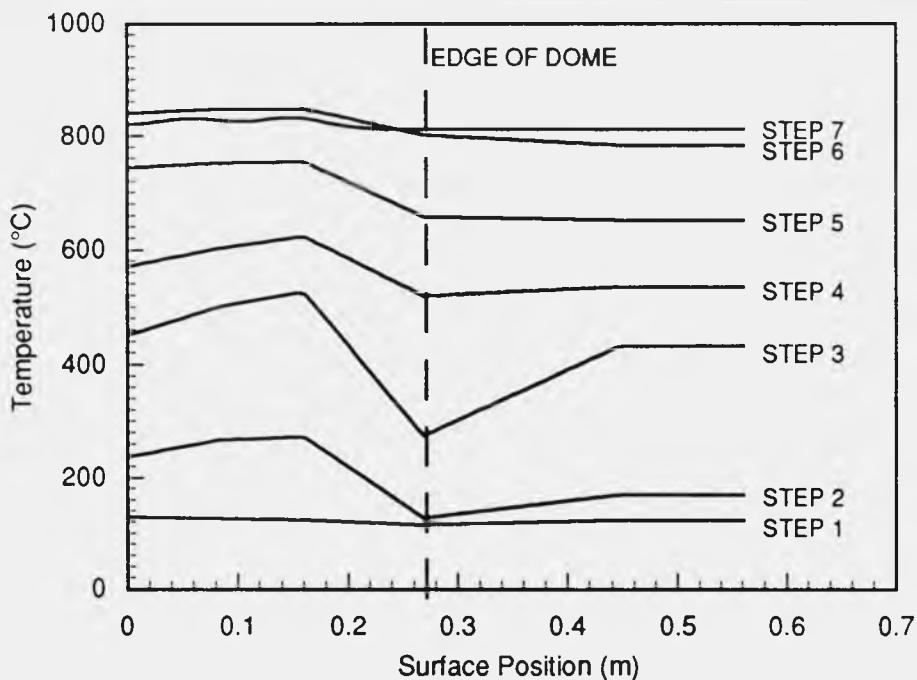
Figure 8. Absorber and aft dome outer surface temperature profiles for startup and steady state operating conditions.

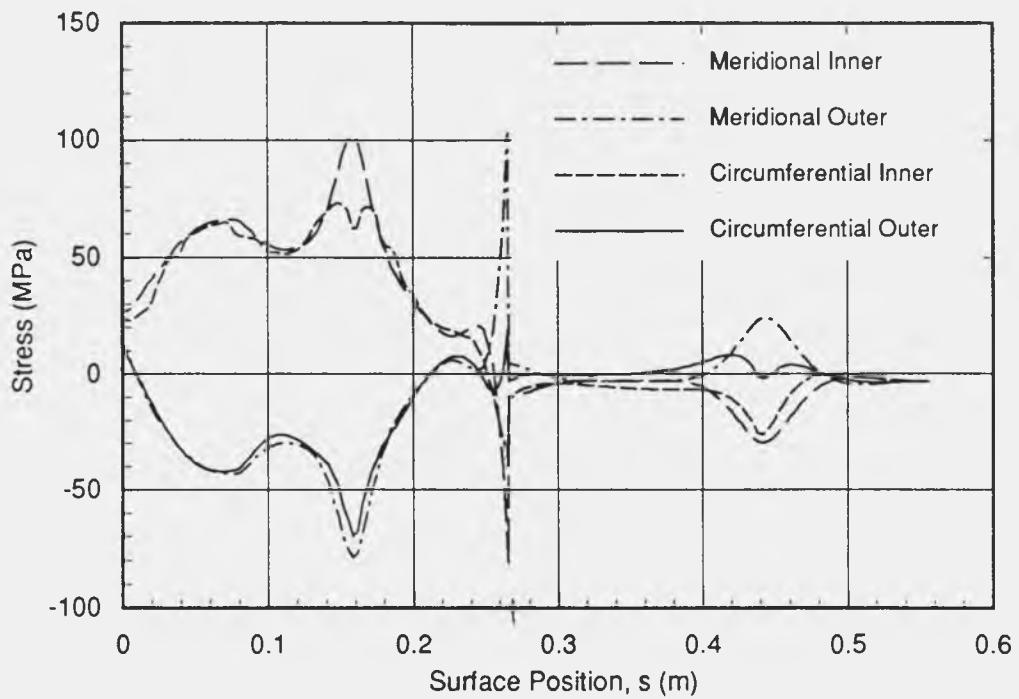
Figure 9. Receiver meridional and circumferential stress profiles during Step 3 of the receiver startup for 316L and a full-thickness (3.18) mm aft dome.

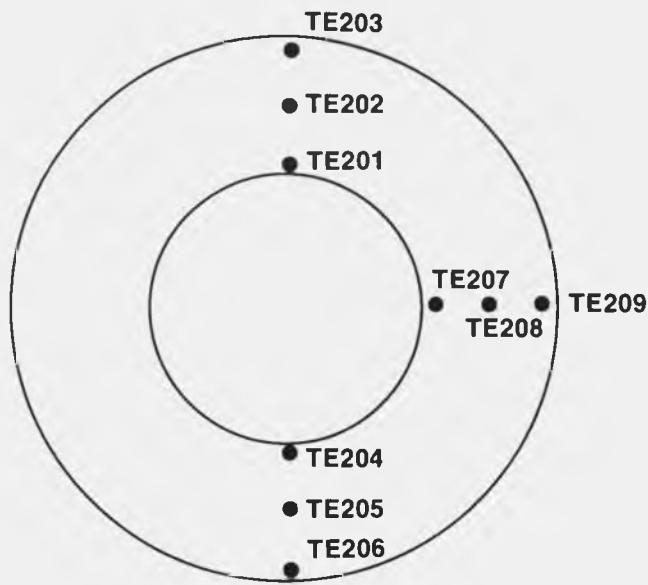
Figure I-1. Thermocouple placement on the conical stainless steel side wall looking toward the concentrator.

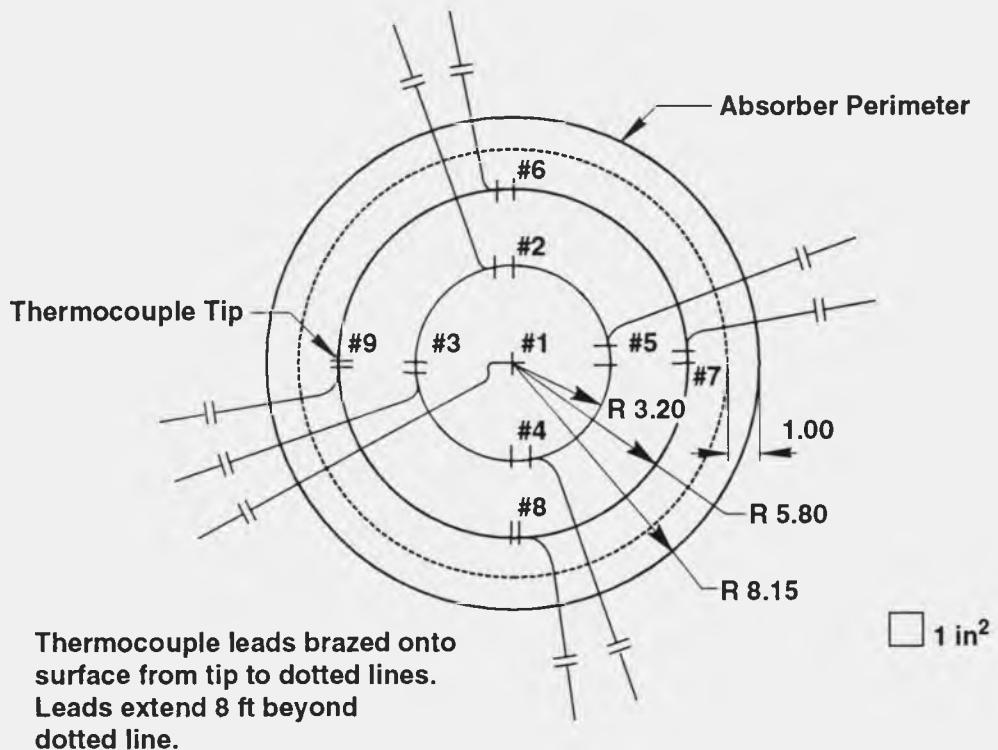
Figure I-2. Thermocouple placement on the air side of the absorber, as viewed from the concentrator. The thermocouples were brazed to the surface with Incuro-60 along their entire length to prevent overheating of the sheath.
