SODIUM REFLUX POOL-BOILER SOLAR RECEIVER ON-SUN TEST RESULTS

Charles E. Andraka
James B. Moreno
Richard B. Diver
Timothy A. Moss
Solar Thermal Electric Technology

Sandia National Laboratories
Albuquerque, New Mexico 87185

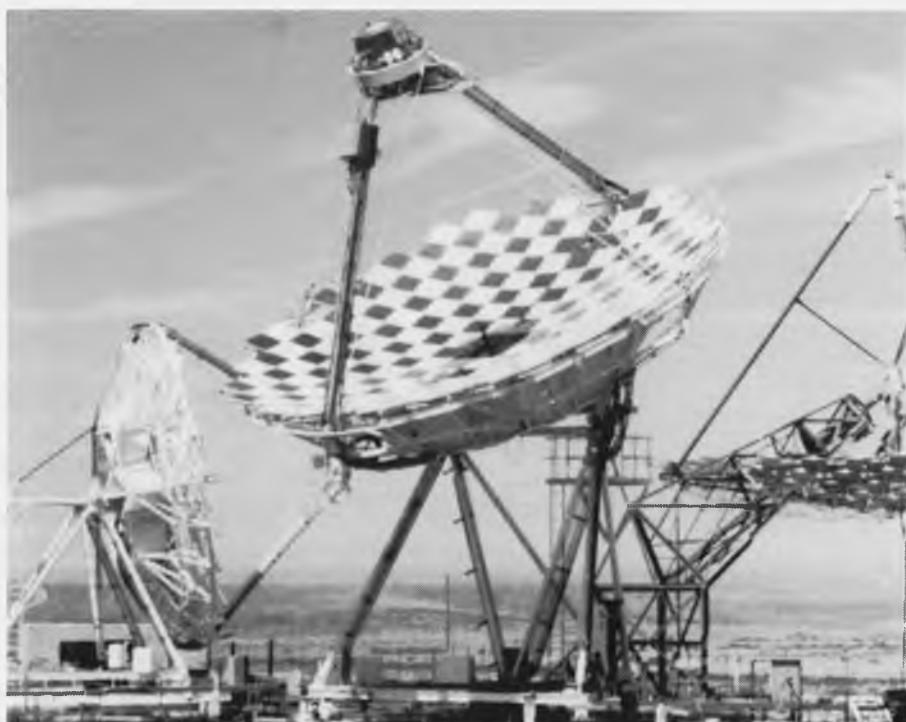
Figure M-1. Mirror coverage on TBC-1 during the 1/2-power test. This mirror coverage provides a reduced power level with a qualitatively similar flux distribution to the full-power testing.

The objective of the first three tests was to demonstrate well-behaved boiling at 1/2, 3/4, and full power. The power was attenuated by covering selected mirror facets on Test Bed Concentrator #1 (TBC-1). Figure M-1 shows the mirror coverage for the 1/2-power test. The mirror coverage patterns are specified in the standardized test plan (Appendix J of this report). Two specific concerns in these initial tests were boiling instabilities and flooding limits (Moreno and Andraka, 1989). Test #1 totaled 96 minutes (min) at 1/2 power, with eight minutes of steady operation at 800°C condenser temperature. In tests #2 and #3, nearly all test time was at 800°C. Time totaled 204 min at three-quarter power and 180 min at full power. Figures M-2 through M-4 show the solar insolation, pool temperature, and power throughput histories for these three tests. Figure M-5 shows extracted power and temperatures measured during a steady-state portion of the full power test. This figure demonstrates the stability of the boiling, with temperature fluctuations on the absorber surface of less than 10°C. Receiver thermal efficiency was about 90% when the input power and sodium temperature were at their maximum tested values. The temperature was quite steady and nearly isothermal within the receiver, indicating that stable nucleate boiling was achieved. The absorber temperature shown was measured with a flattened thermocouple brazed to the air side of the absorber. Because the thermocouple was about as thick as the absorber, this temperature was estimated to be as much as 15° to 20°C higher than at the surface of the absorber, and was considered to be dependent on the local heat flux. Qualitatively similar temperature results were obtained at 1/2 and 3/4 power, and in brief runs at 700° and 750°C at 1/2 and full power.

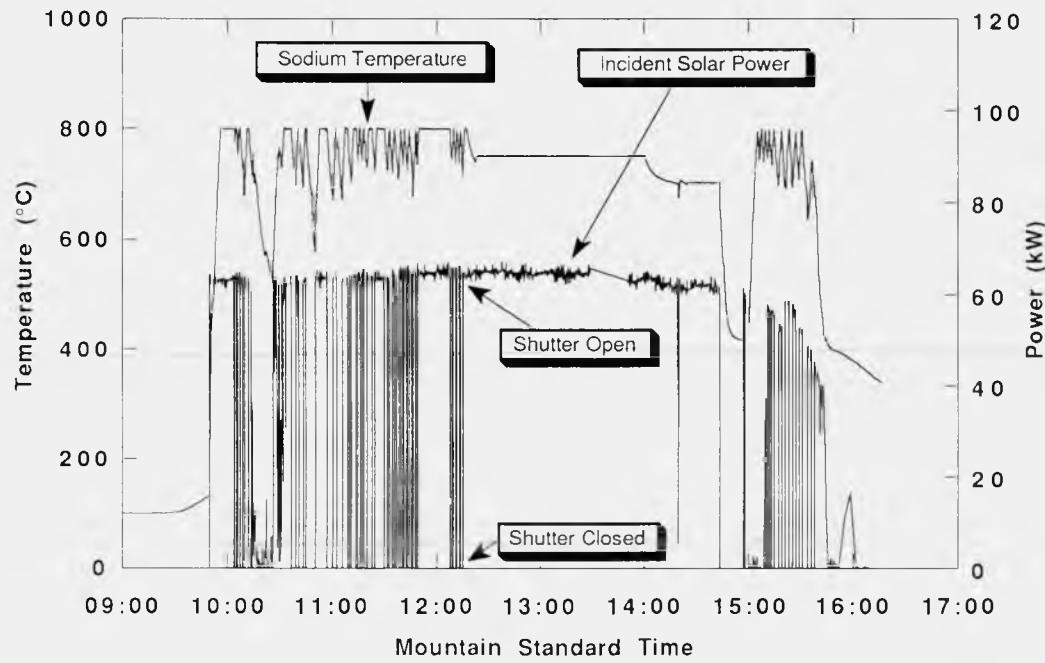
Figure M-9. Sodium pool temperature and incident power during the first hot-restart test series (September 13, 1989). Hot restarts were attempted at many orientations and power levels, and some steady state testing was also performed. Over-temperatures due to failure to restart boiling occurred very rapidly compared to the data rate, and therefore do not appear on this plot.

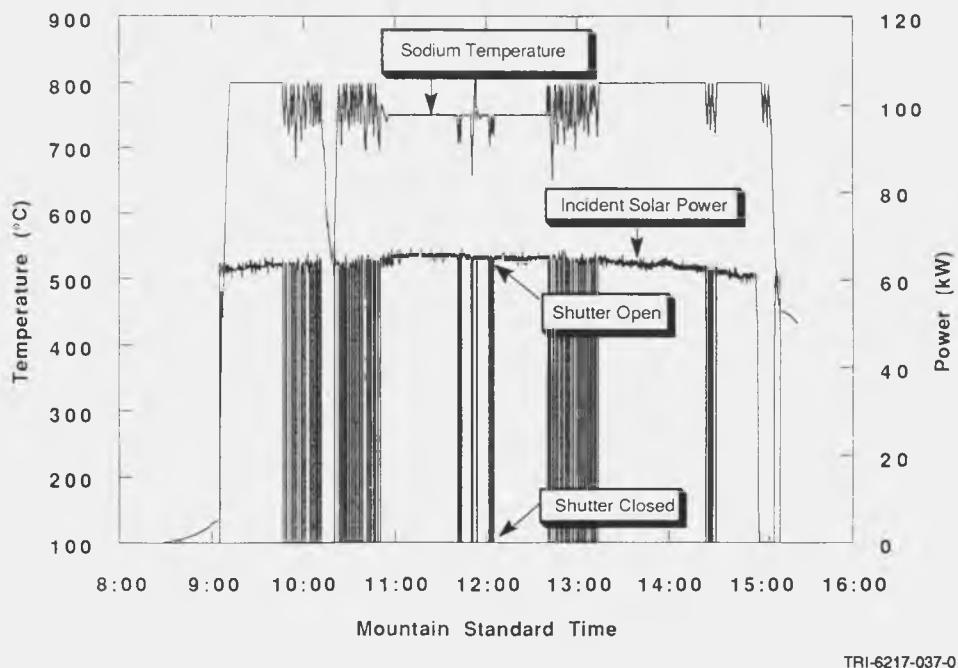
Figure M-10. Sodium pool temperature and incident power during the second day of hot restart characterization (September 14, 1989). Hot restarts were attempted at several operating temperatures, and a repeatable sequence was developed. Active control of the pool-to-condenser temperature difference was attempted during these tests.

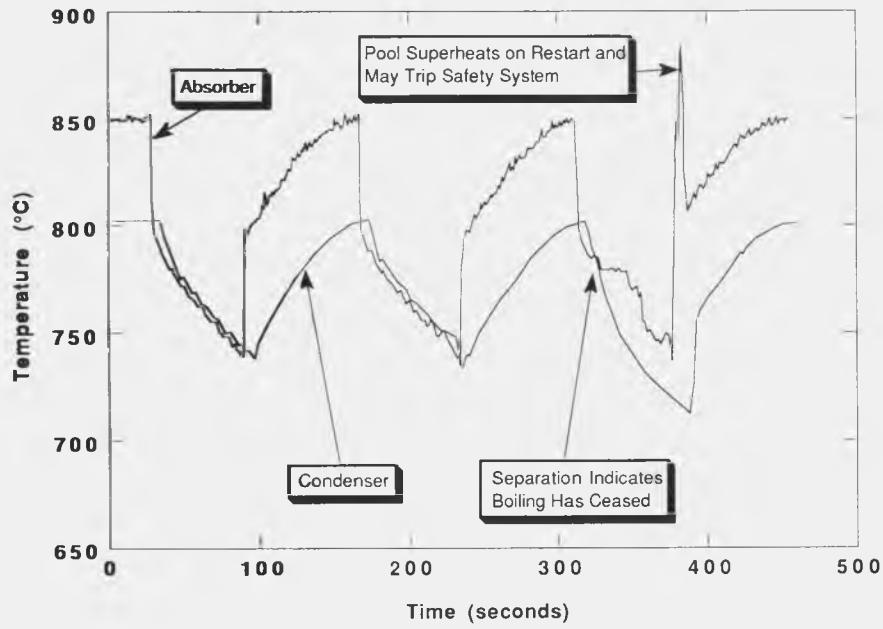
Figure M-11. This stripchart recording of the absorber and condenser temperatures during hot restarts demonstrates the repeatable sequence of three hot restarts that leads to separation upon cool-down and a failure to start boiling upon reapplication of power. The very rapid temperature spike was usually not detected by the data system, but caused automated emergency shutdowns to be initiated.

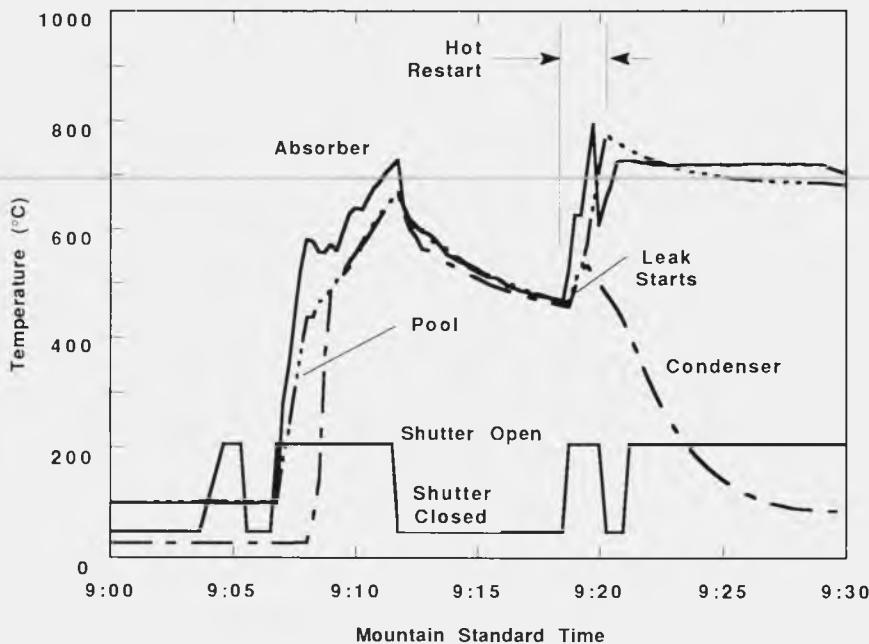
Figure M-16. Temperatures and shutter positions during the May 30, 1990 test leading to the failure of the receiver.

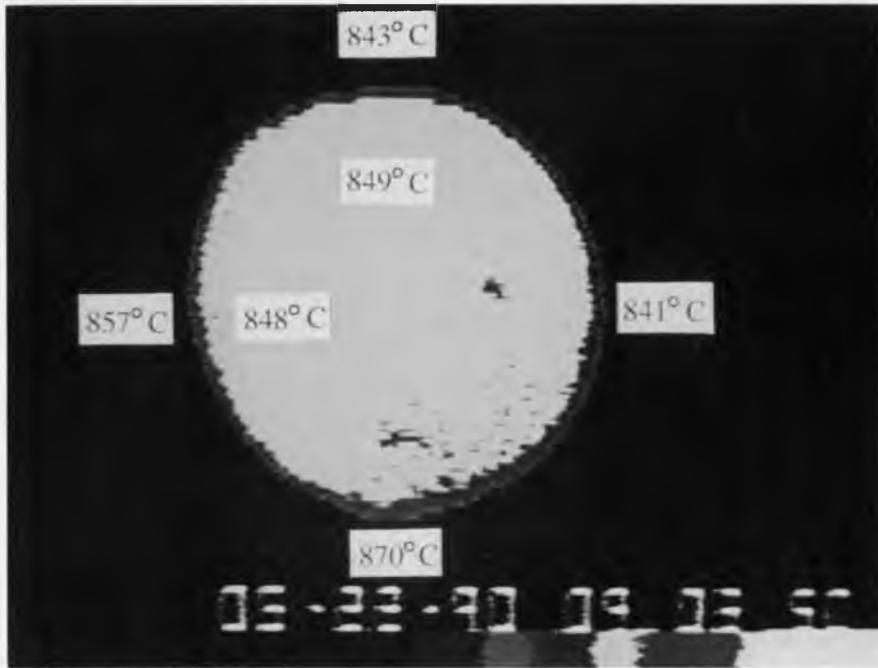
Figure P-1. Typical steady-state infrared video image of the Sandia pool-boiler receiver. The aperture restricted the field-of-view to 10.2 inches. The image is a reversed left-to-right (by the mirror) view of what an observer, standing at the concentrator and looking at the receiver, sees. Functioning absorber thermocouple readings in their approximate locations are shown on the figure. Each change in color represents approximately 50°C.

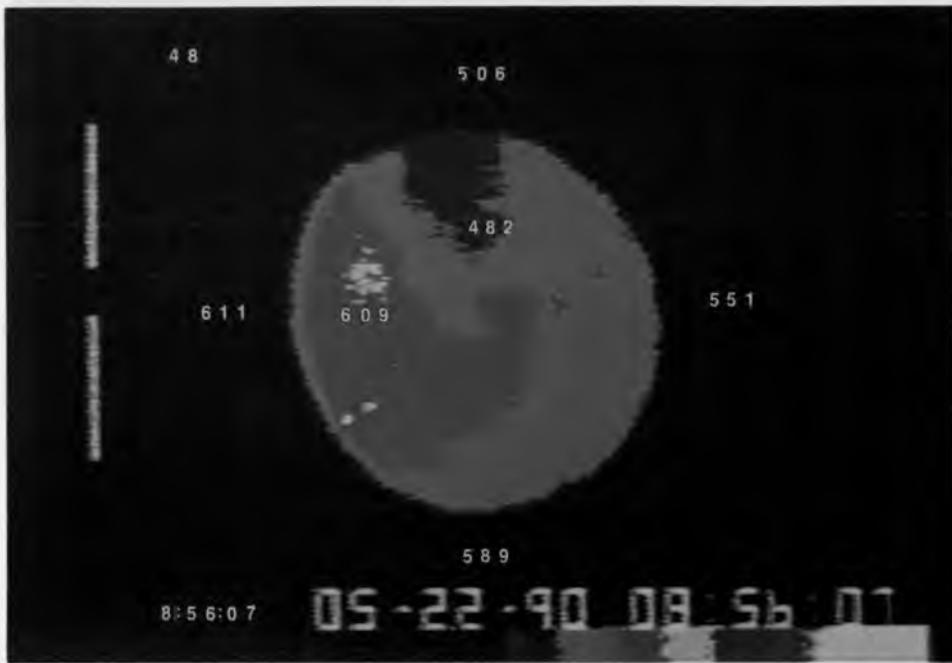
Figure P-3. Infrared video image taken 15 seconds after startup. The high flux inner ring predicted by CIRCE2 appears to be offset to the left indicating a 3 milliradian concentrator mistrack. The image is a reversed left-to-right (by the mirror) view of what an observer, standing at the concentrator and looking at the receiver, sees.

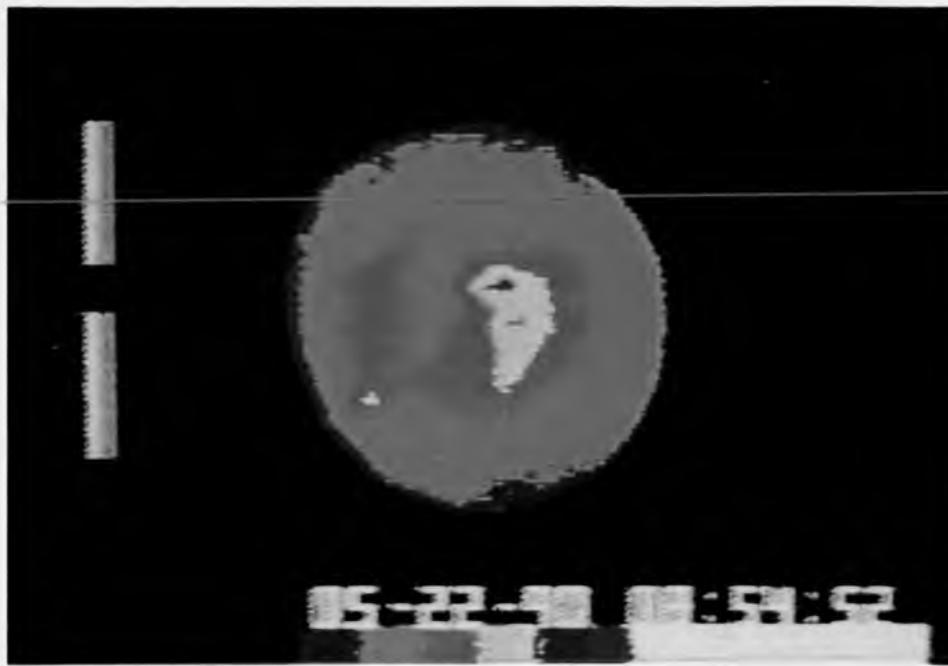
Figure P-4. Infrared video image taken seconds after boiling began. Both a relatively cool salient from the top of the receiver and the temperature shift (the left side of the image is now the hottest) can be seen in the figure. The thermocouple temperature readings in their approximate locations are shown on the figure and are in agreement with the infrared camera.

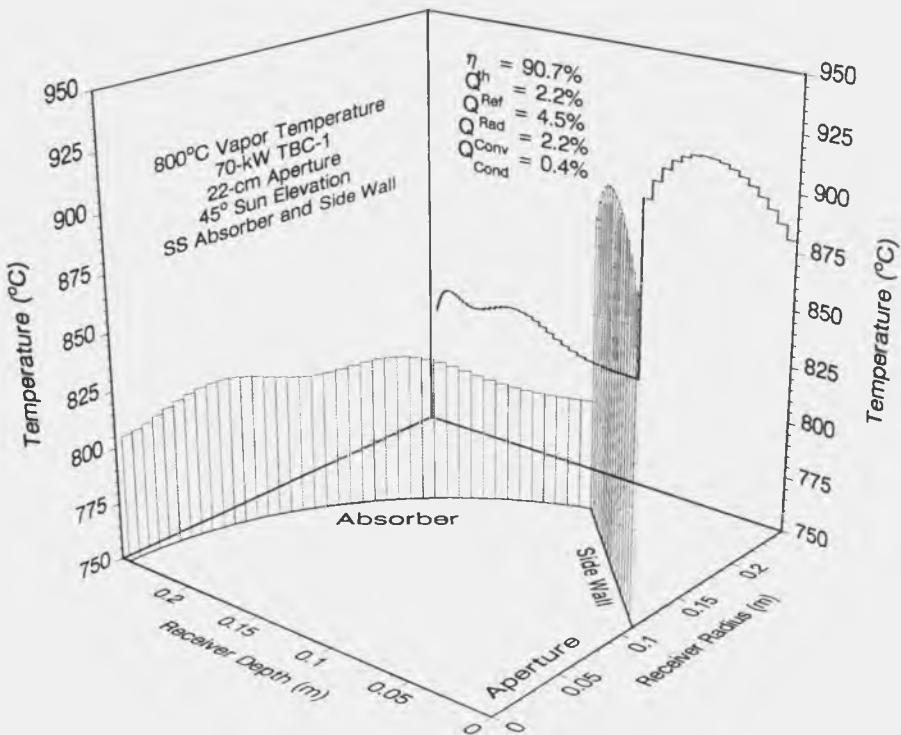
Figure R-1. Sandia pool-boiler receiver design point temperature distribution and performance prediction.

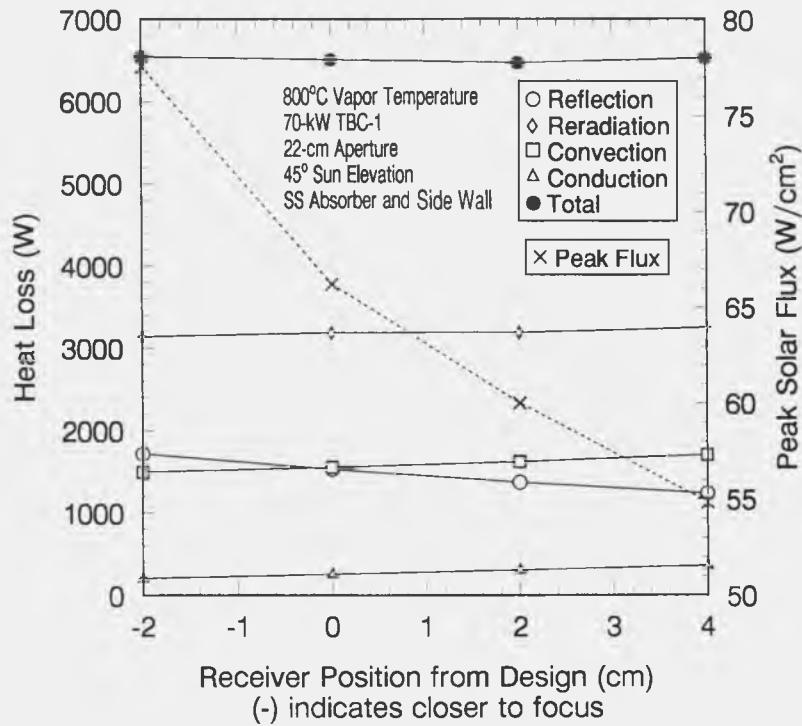
Figure R-2. Receiver heat loss and peak incident solar flux as a function of spherical absorber position.

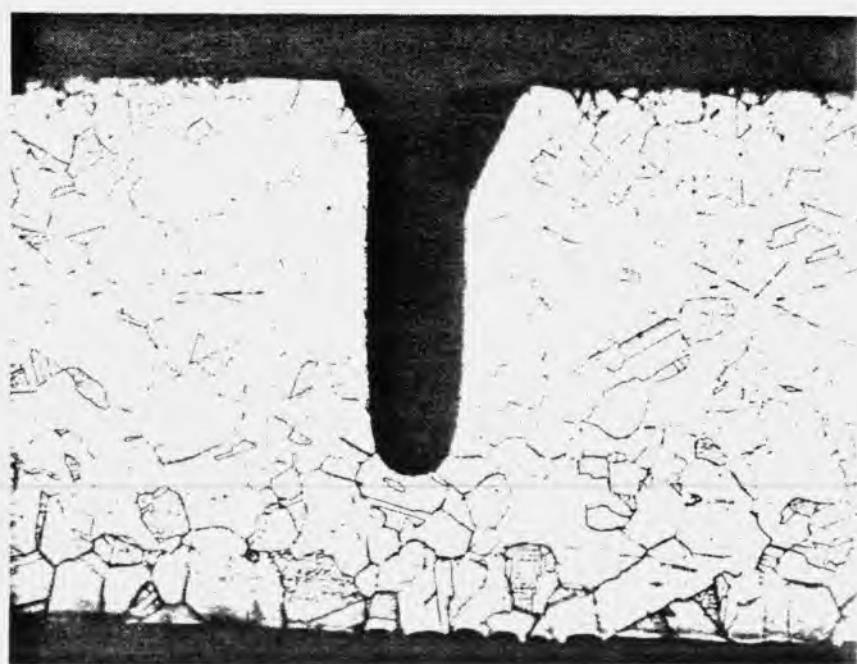
Fig. 7 Polished and etched cross-section through artificial cavity showing damage near top surface, 90X.

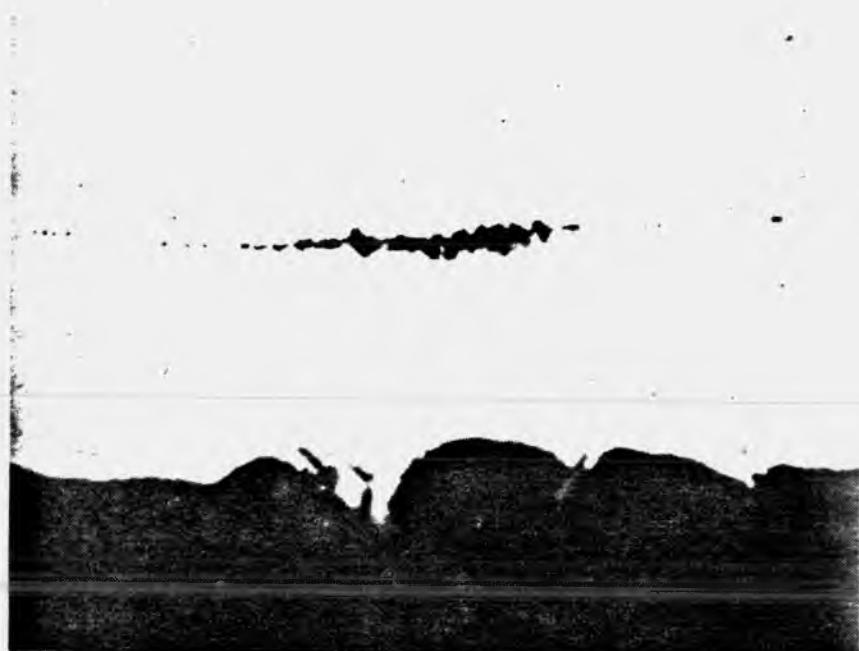
Fig. 9 Oxidation of air-exposed outer wall showing penetration within grains and protrusions at grain boundaries. Dark inclusion stringer noted within wall, 500X.

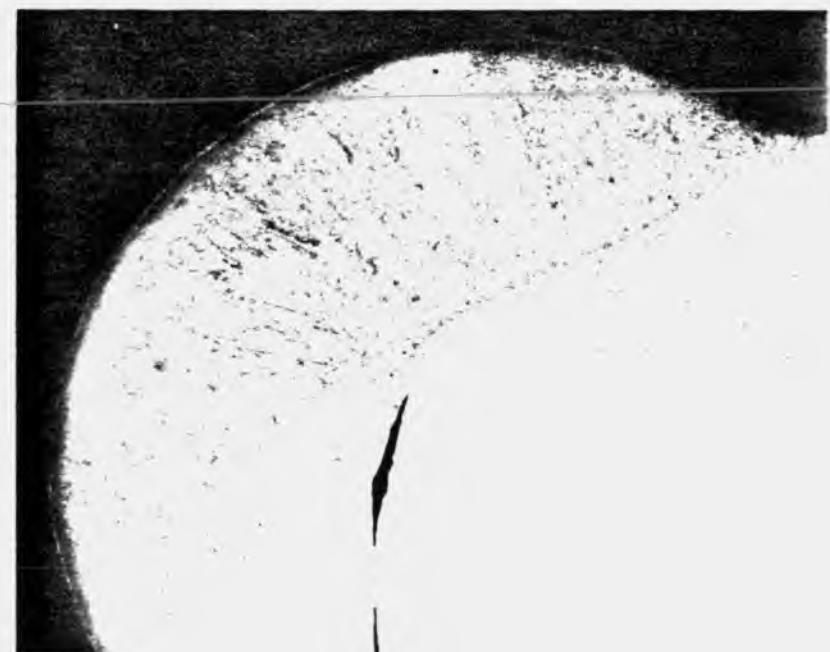
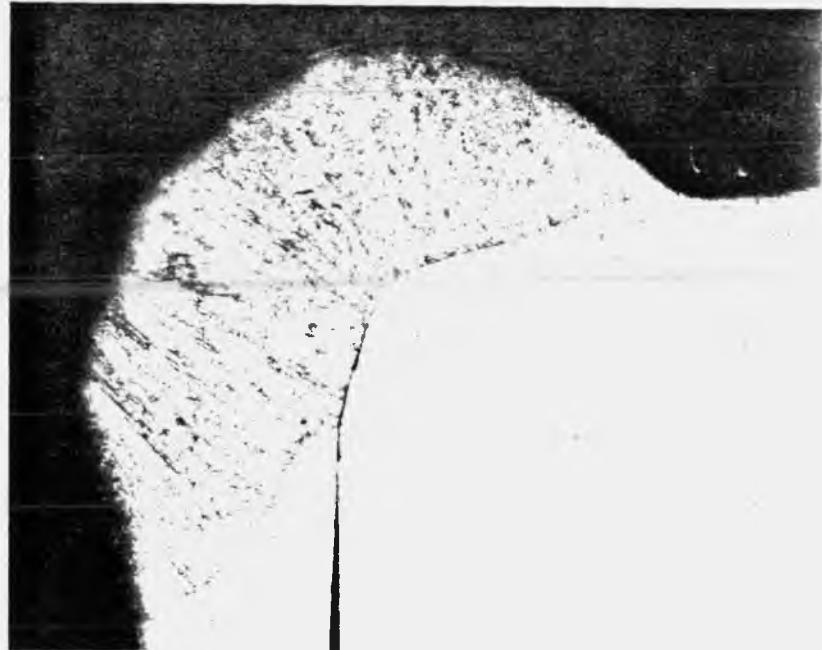
Fig. 11 Metallographic cross-sections of samples taken at 90° intervals around the receiver rim weld; a) 40X; b) 32X;

Manual TIG welding procedures were used to join the fore and aft spherical sections of the receiver. This weld geometry forms a crack-like joint where the two spherical segments join tangentially. A concern is that cyclic thermal stresses could induce fatigue crack growth into the weld fusion zone. Metallographic analyses were performed on four sample sections cut out at 90° intervals around the outer rim. Resulting cross-sections are shown in Figure 11. In these micrographs the thicker section is the receiver rear wall, and the thin section is the front absorber. The dendritic weld fusion zone is darker. There are substantial differences in weld geometries and gap size among there four examples. There is no evidence of extension of the crack-like joints in any of the cross-sections.

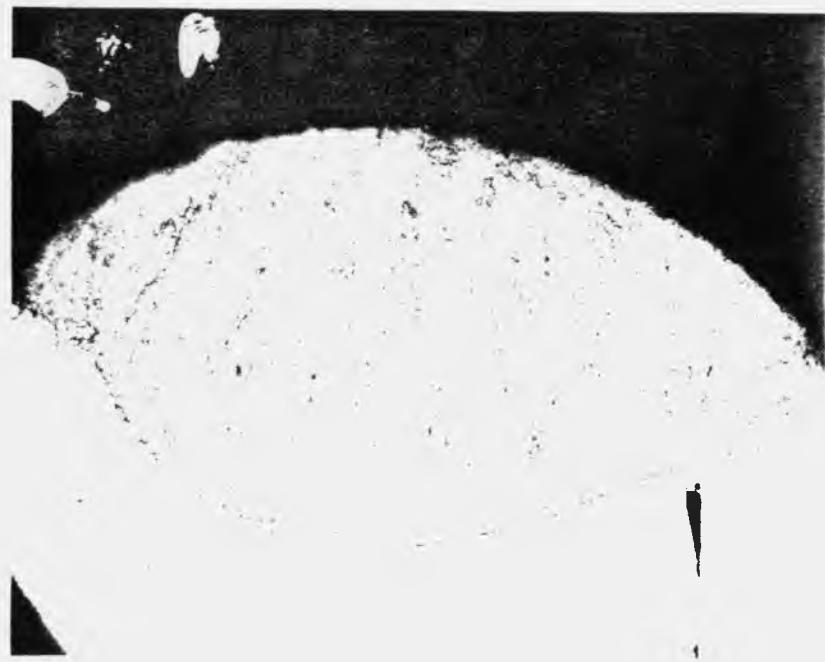
(d)

Fig. 11 Metallographic cross-sections of samples taken at 90° intervals around the
cont. receiver rim weld; c) 40X; d) 32X.
