Advanced On-Site Power Plant Development Technology Program

Final Report

Work Performed Under Contract No.: DE-AC21-82MC24222

By
International Fuel Cells
P.O. Box 739
195 Governors Highway
South Windsor, Connecticut 06074

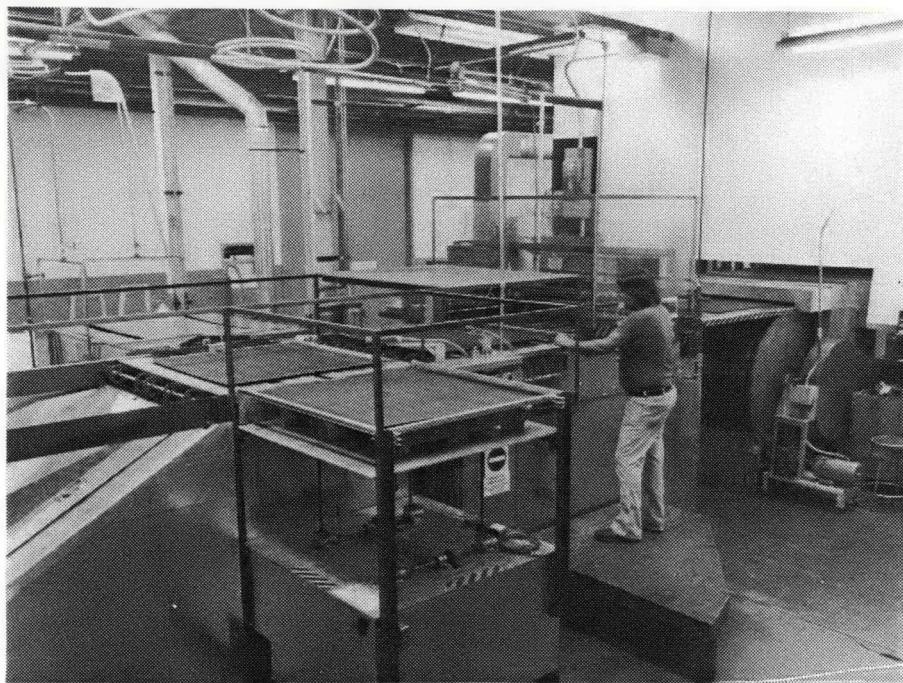
(WCN-13640)

Figure 2.1-5. Forming Substrates with Fiber "D"

The initial full-scale Fiber "D" forming trials were completed using conventional double belt press, substrate forming equipment. Substrates were formed without difficulty and possessed adequate strength, flatness, and thickness uniformity. Heat treating was also completed by standard processes and equipment, and the physical properties were nominally equivalent to the baseline fiber. Flexural strength was marginally lower than baseline substrates and conductivity was better. The substrate forming trial is shown in progress in Figure 2.1-5.

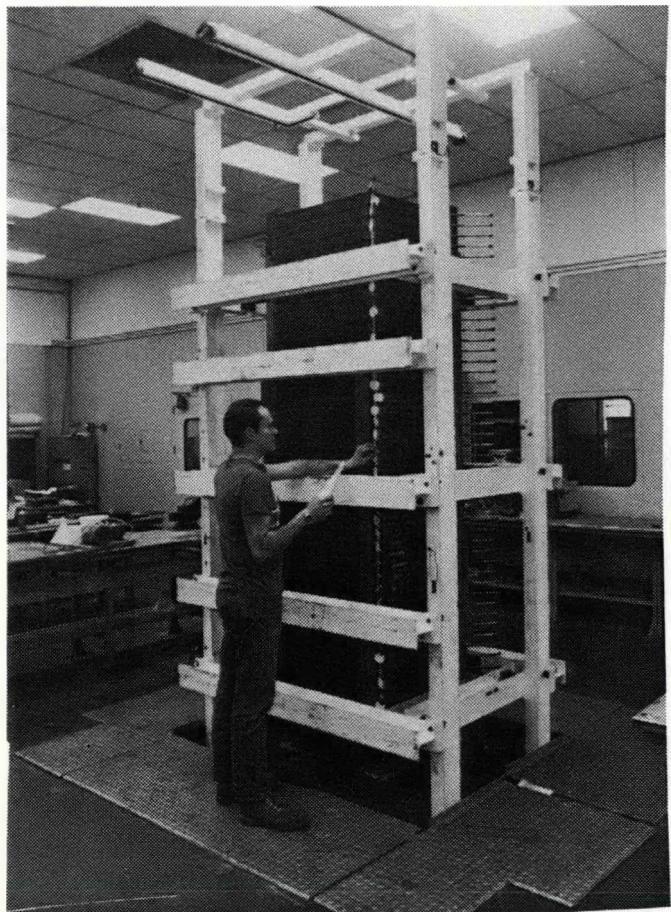
(WCN-14308-11)

Figure 2.4-14. Full-Height Stack During Fabrication

Fabrication and assembly of a full-size 308-cell stack was conducted in 1986. This stack contains the same design features as the third short stack. The full-height stack was mounted on a test cart and delivered for installation and testing in the Verification Test Article under Subtask 7.2. A photograph of the full-height stack is shown in Figure 2.4-14.

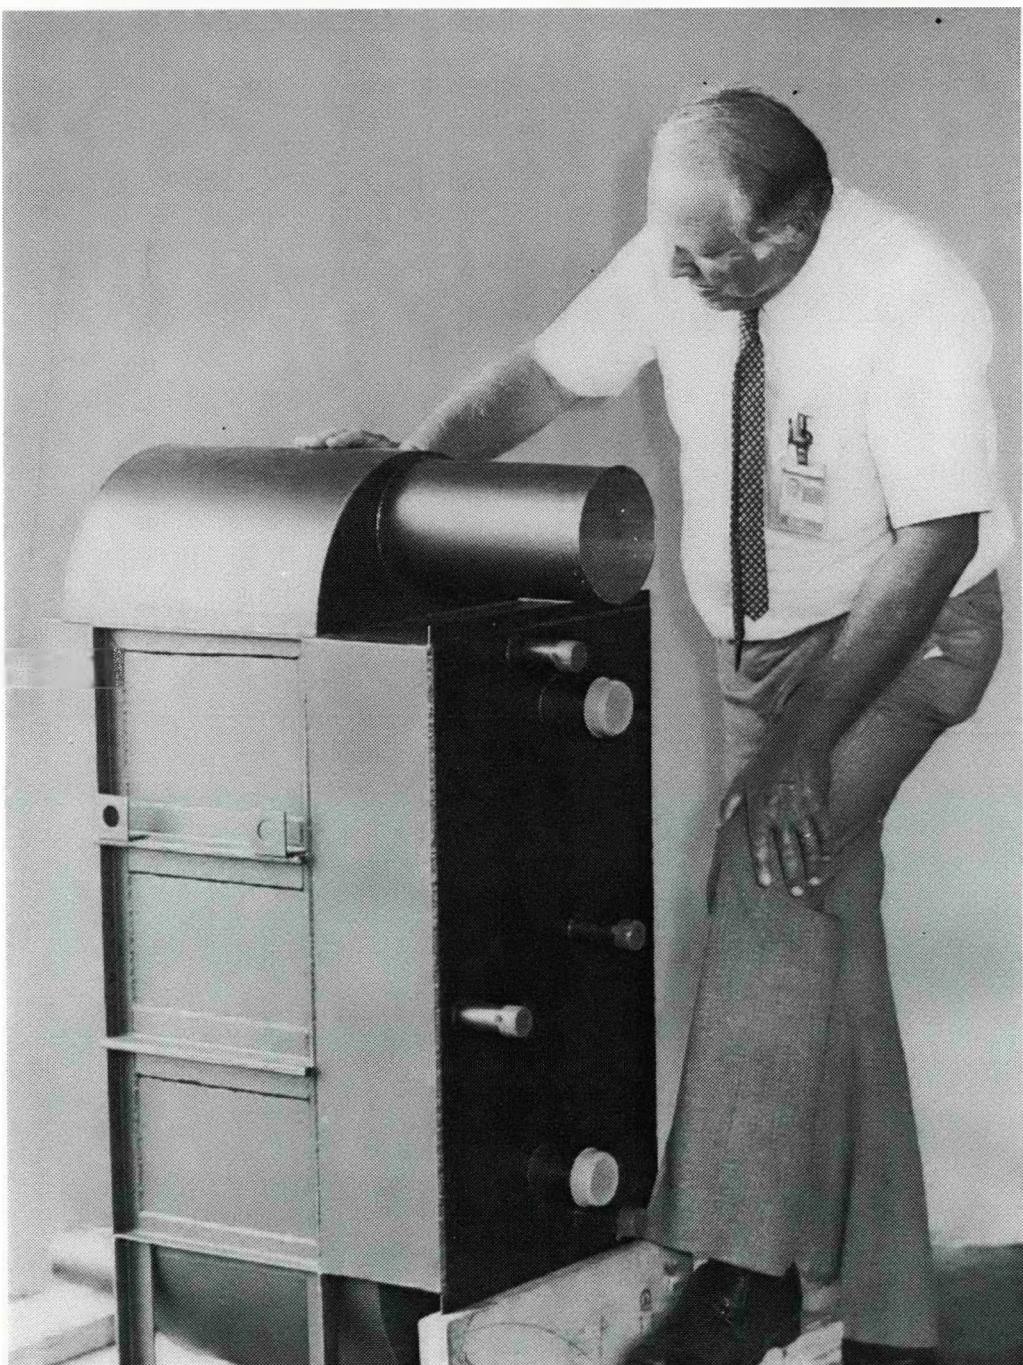
(WCN-13725)

Figure 4-1 shows the Integrated Heat Exchanger received for verification testing. It was assembled and successfully tested with the fuel processor subsystem (subtask 5.4). Unfortunately, the unit was damaged by contaminants in facility water before insertion in the Verification Test Article (VTA). A second integrated heat exchanger was fabricated and successfully used in the VTA without further problems.

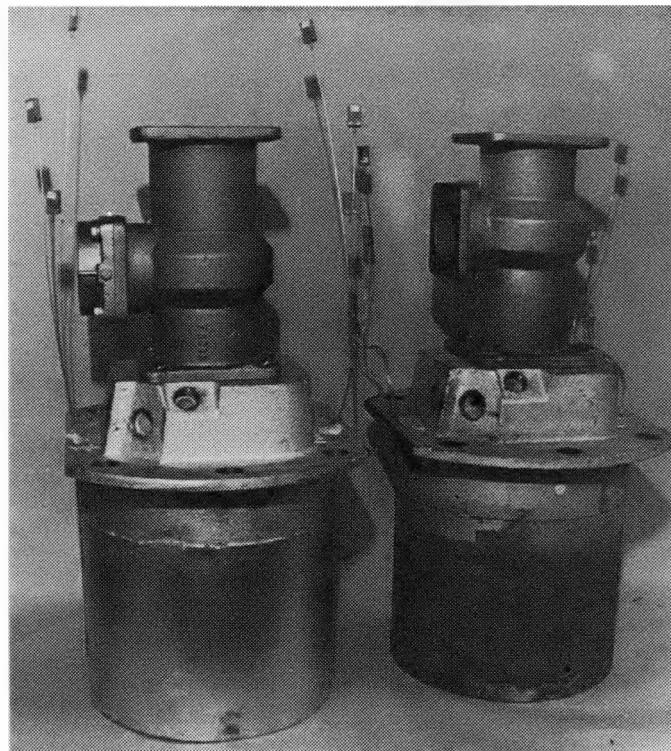
(WCN-13573-18)

Figure 5.3-15. Original and Upgraded Reformer Burners

1. Burner temperatures during startup and steady-state operation exceeded the manufacturer's long-term temperature rating limit of 750°F. A replacement burner rated for long-term operation up to 1000°F was purchased and installed. Both burners are shown in Figure 5.3-15. The burner casting was also changed from 304 to 310 stainless steel to provide long-term corrosion resistance.

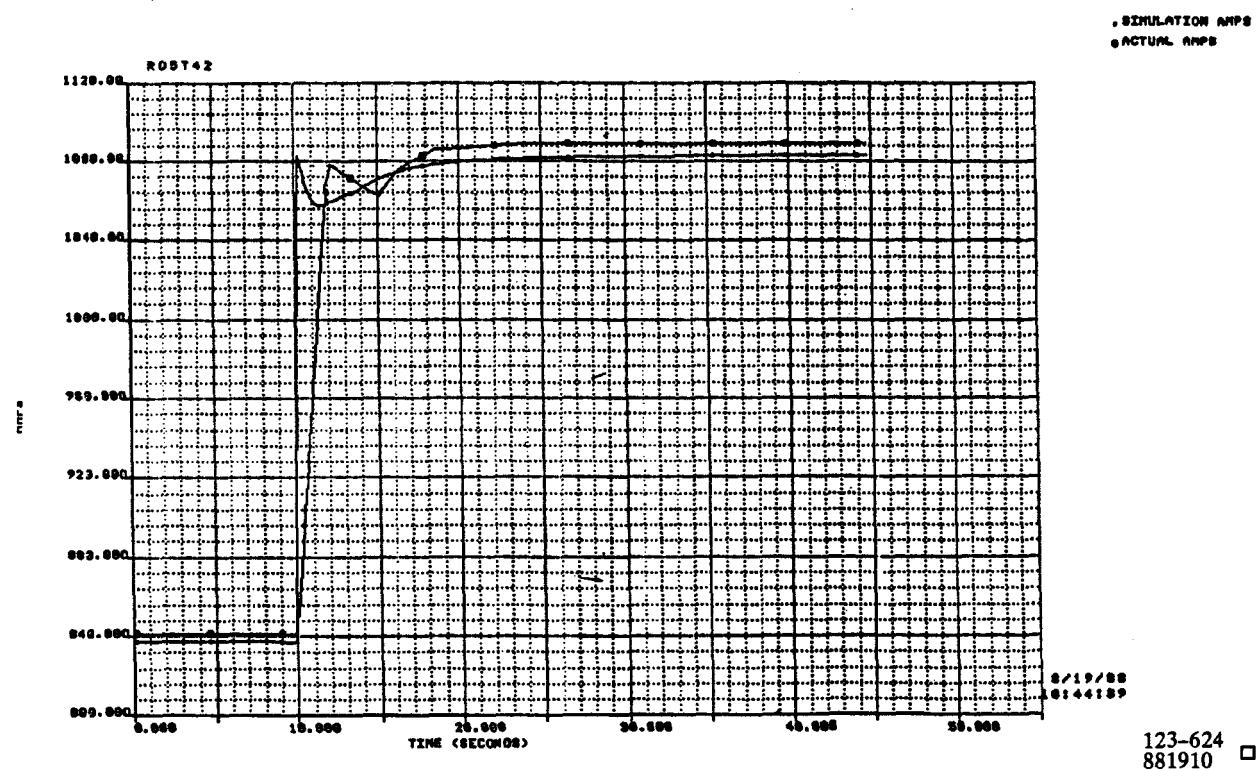
Figure 7.2-28. Comparison of Current Change During VTA Transient to Prediction
