STRUCTURAL RESEARCH SERIES NO. 429

MASTER
SHEAR STRENGTH OF END SLABS
OF PRESTRESSED CONCRETE NUCLEAR
REACTOR VESSELS

A Report on an Investigation Carried Out as Part of the Prestressed Concrete Reactor Vessel Program of the Oak Ridge National Laboratory Operated by the Union Carbide Corporation for the Energy Research and Development Administration

UNIVERSITY OF ILLINOIS
at URBANA-CHAMPAIGN
URBANA, ILLINOIS
JULY 1976

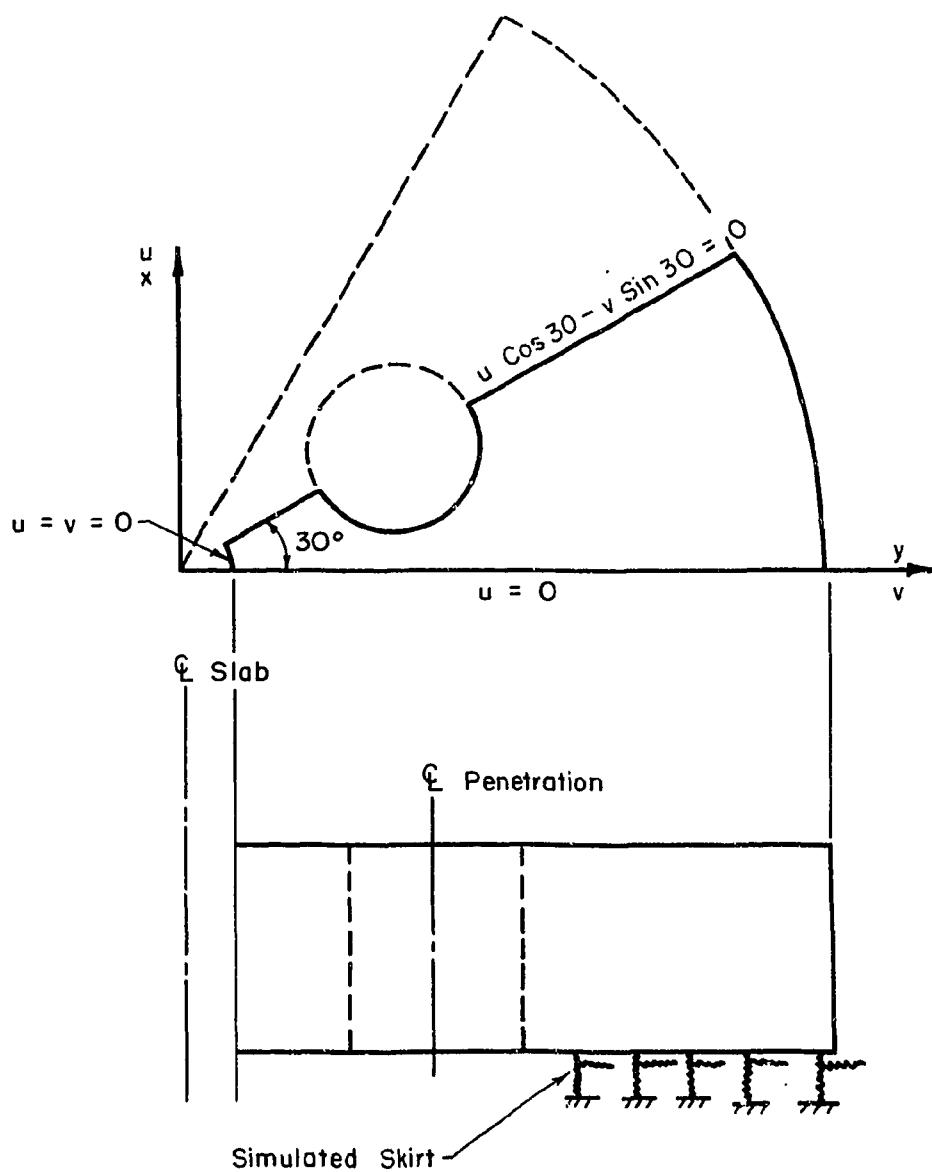
Fig. 3.2 Boundary Conditions Used in Three Dimensional Analysis

Boundary Conditions. Within the context of a displacement or stiffness form of finite element analysis conditions can only be specified on the displacements. The segment of the slab that was analyzed is shown in Fig. 3.2 on which the boundary conditions are also indicated. Symmetry lines of $\theta=0$ and $\theta=30^\circ$ require that the displacements normal to the symmetry surface be specified as zero. However, within the element method no restriction can be placed upon the shear stress on those faces. The inner surface, radius equal one inch has zero radial and circumferential displacements but allows normal (or in other words vertical) displacements. The previous section discussed the interaction problem at the junction of the slab with the cylindrical wall. As noted vertical and radial springs replace the interactive stiffness with the cylinder.

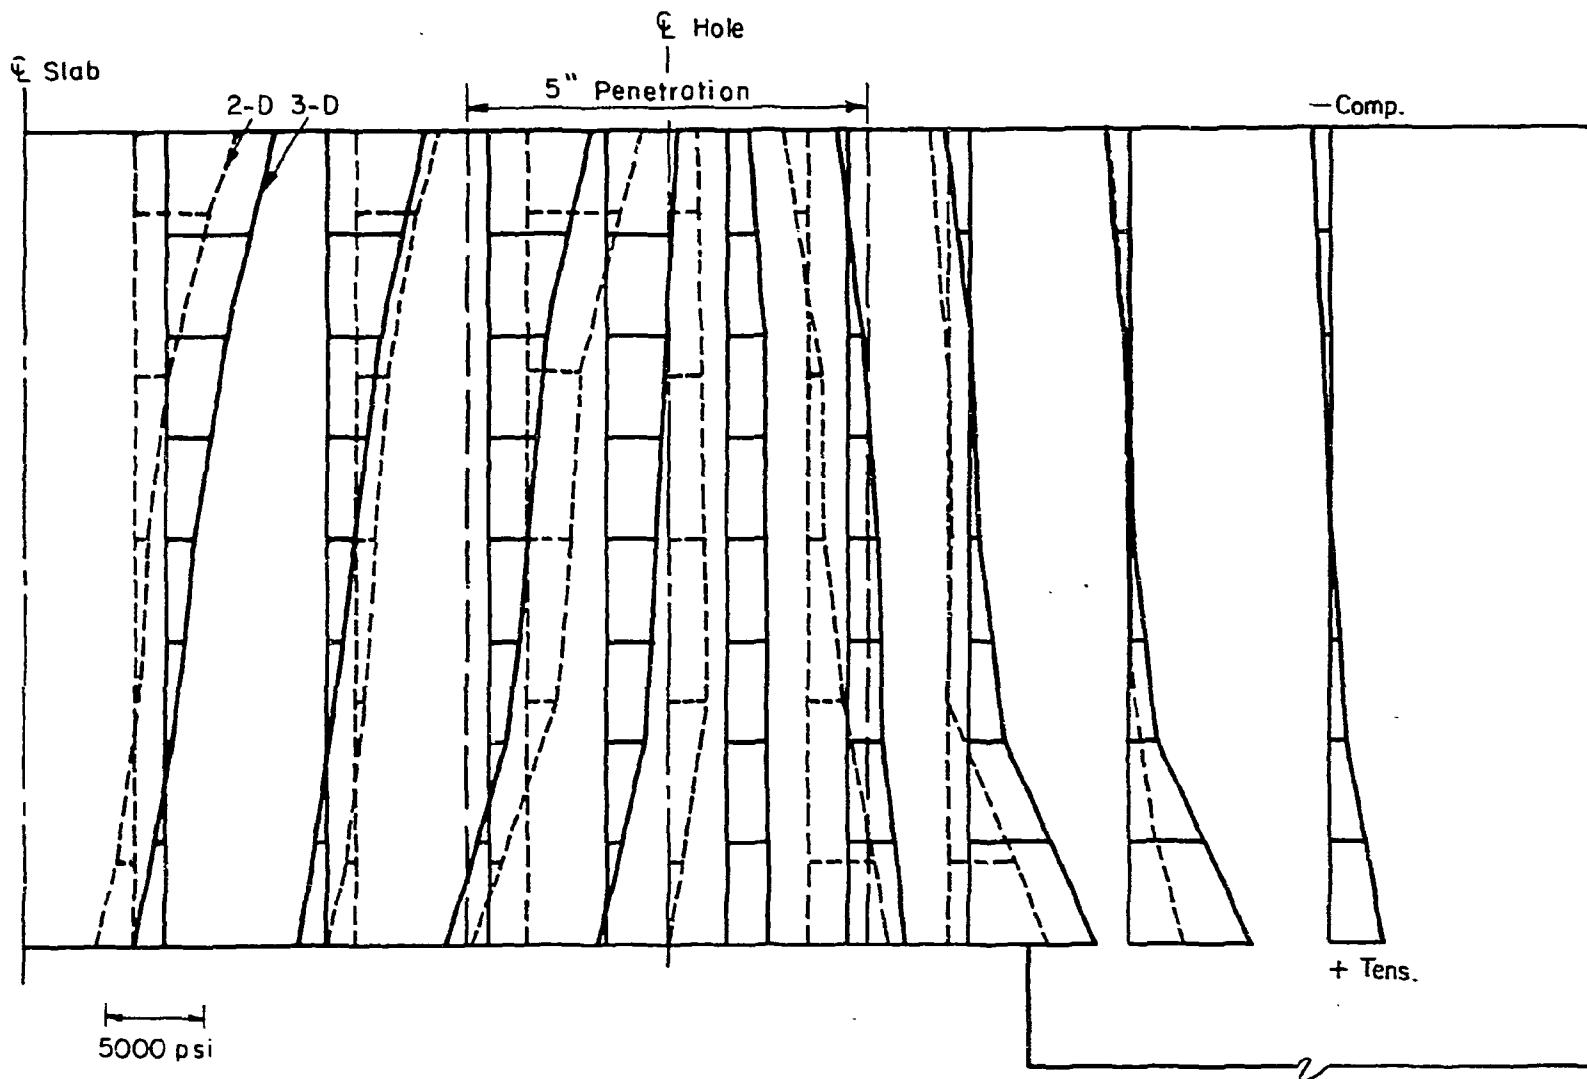
Fig. 3.5a Radial Stress in 10-in. Slab with 5-in. Diameter Penetrations

Figures 3.5 to 3.6 show the stresses as computed from the axisymmetric program and those from the 3D program. The stresses were calculated for an internal pressure of 1000 psi and no prestress. The load condition was selected to represent the test condition of the already prestressed vessel. That is the vessel being subjected to an internal pressure of 1000 psi, the prestressed vessel being the zero or base of reference.

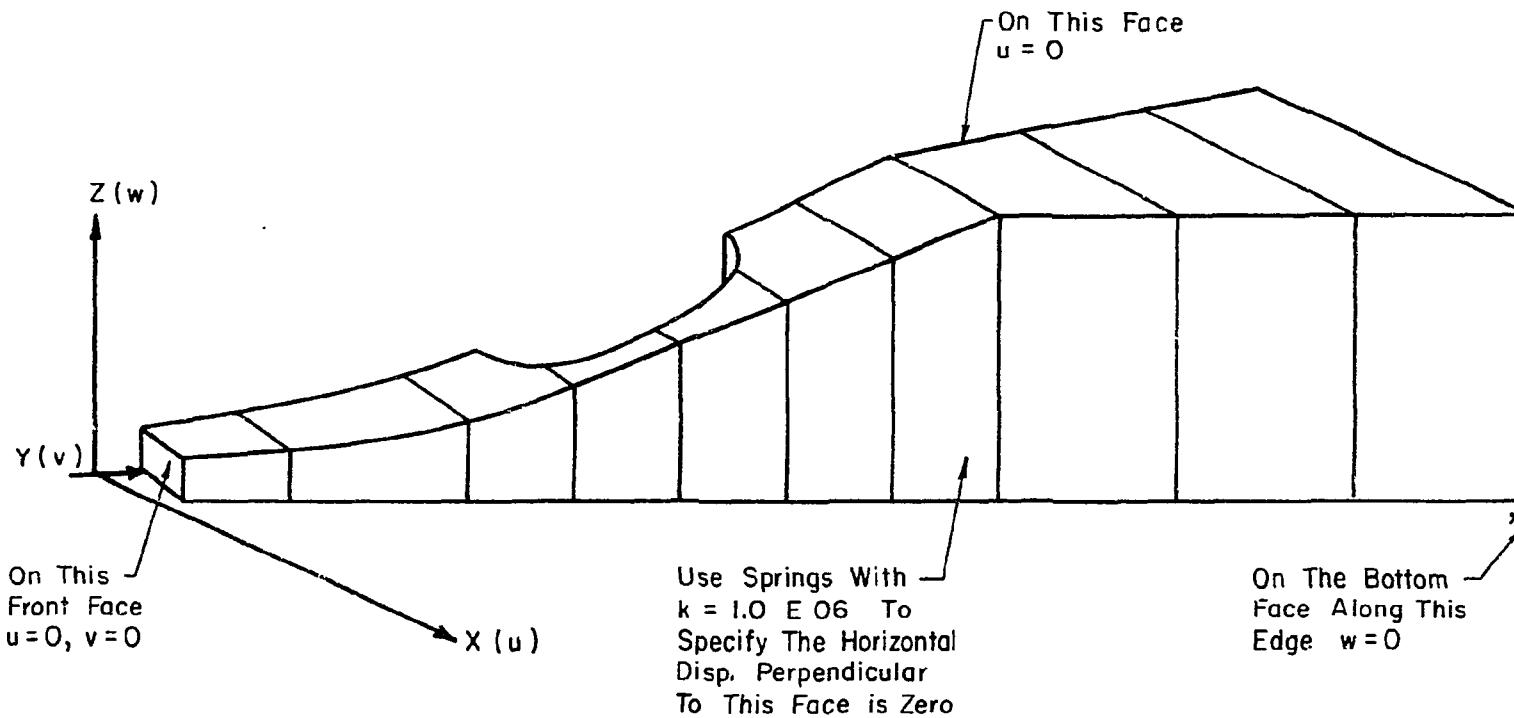
Fig. 3.8 Boundary Conditions Used in Cryptodome Analysis

The shape of the cryptodome and the boundary conditions used are shown in Fig. 3.8. It is assumed that horizontal cracking has progressed through the skirt wall-end slab connection. It is therefore admissible to model only the structure shown in the figure. The vertical movement (rigid body motion) was constrained out of the system by a roller support placed around the outer edge. Vertical forces simulate the longitudinal prestress. The presence of the circular steel seating plate at the base of each penetration was neglected in the solution as was the rigidity of the anchor ring for the longitudinal prestress. Although the FINITE program contains the ability to provide for relative constraints, that is interrelate the displacements at a number of node points, that option was not used because of its severe effect on the bandwidth and consequent sizeable increase in equation solving time.

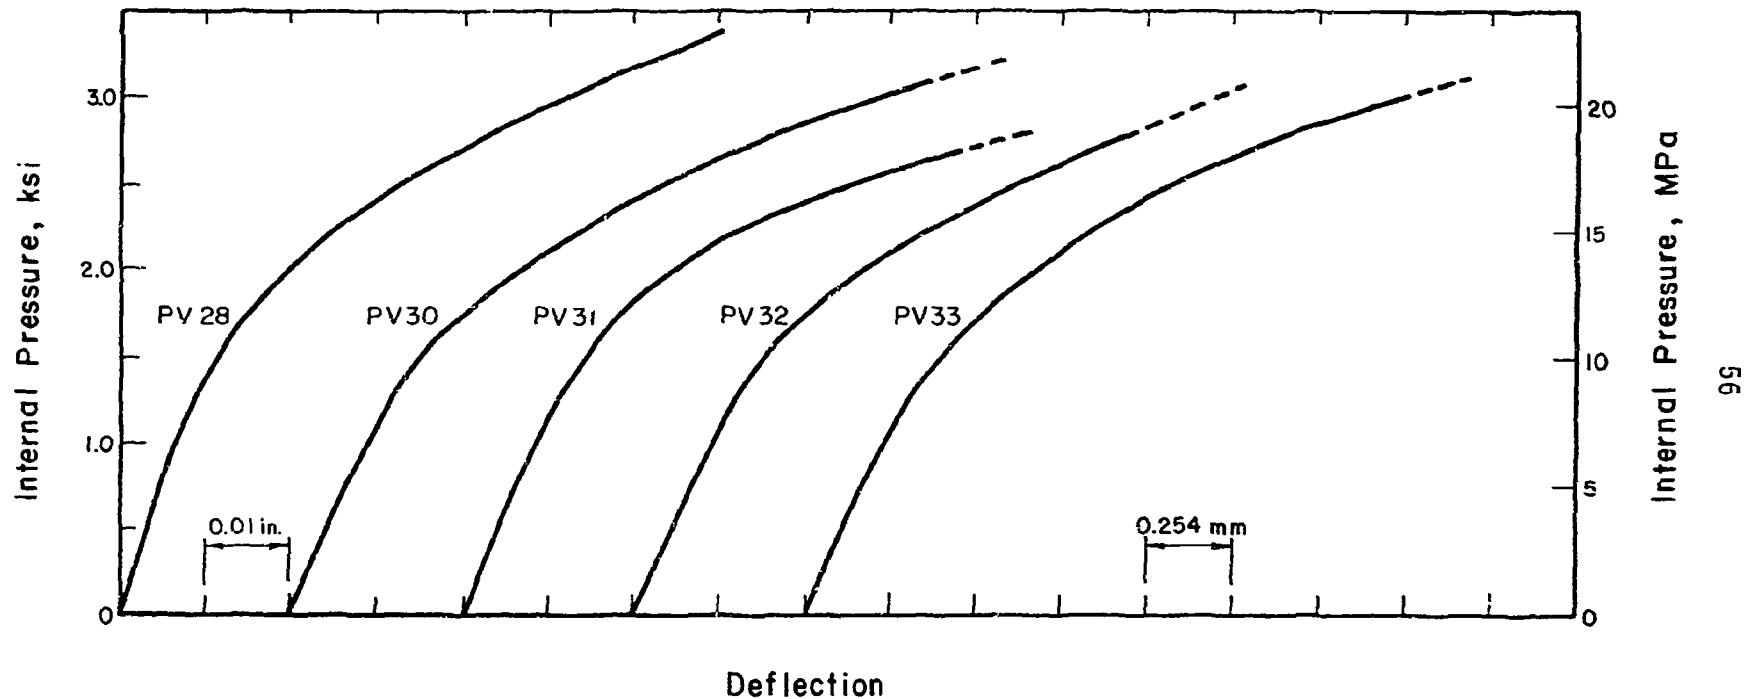
Fig. 4.2 Measured Relationships Between Internal Pressure and Total Deflection at Midspan of End Slab for Test Vessels with 12.5 in. End Slabs

The measured relationships between deflection at center of slab and internal pressure for all eight vessels are shown in Fig. 4.1 and 4.2. The entire set of recorded pressure-deflection relationships are included in Appendix A. The deflections reported are the total deflections with respect to the initial position of the slab and include the small but finite extension of the side wall. In comparing the pressure-deflection curves, it must be considered that these refer to second-loadings for PV26, 28, 31, and 33. As recorded in Appendix B, the liner in some of the vessels leaked during initial pressurization at various levels (PV26, 800 psi; PV28, 3200 psi; PV31, 1200 psi; PV33, 1700 psi). These vessels were relined and reloaded. The curves in Fig. 4.1 and 4.2 refer to the tests in which structural failure was achieved.

All curves show two typical ranges of response: an initial linear and a following nonlinear range. As would be expected, the initial linear range extends to higher pressures for the vessels with the thicker slabs. Although a certain amount of "ductility" may be read into the curves, this is a moot question considering that the maximum deflection at failure was less than 0.4 percent of the clear span or one percent of the slab thickness for all test vessels. It should also be pointed out that, had the only available sensor been the deflection at midspan of the slab, structural distress would have been anticipated simply from comparing the change in measured deflection over a short time with that based on a linear analysis of the structure and that warning would have been registered well in advance of failure in

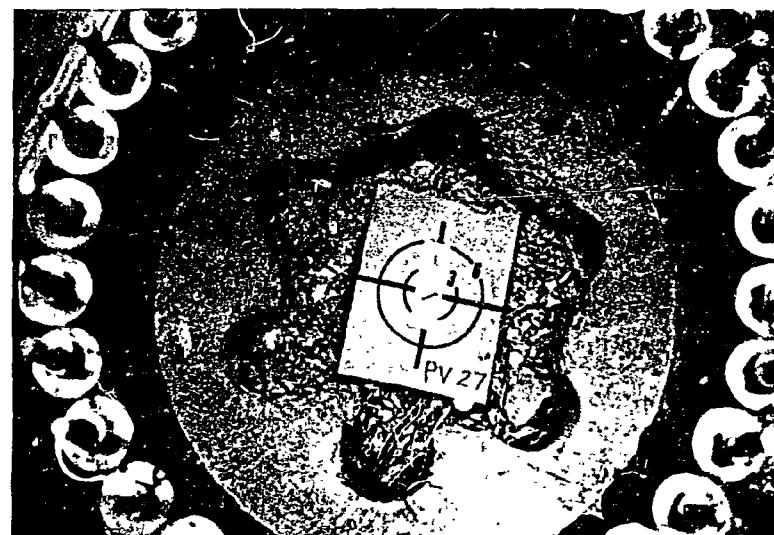
Fig. 4.6 End Slab after Test, PV26

One type of failure is illustrated in Fig. 4.6 and 4.9 which refer to solid slabs. As in the tests reported by Karlsson (1971), a three-dimensional inclined crack carves out from the end slab the kernel shown in the lower photograph leaving behind a "cryptodome" to resist the internal pressure. Collapse occurs as a result of failure of the concrete in the cryptodome near the center of the slab. Viewed in two dimensions (in the vertical plane), this mode of failure has characteristics similar to the shear-compression failure observed in reinforced concrete beams.

All end slabs failed in shear, but in different modes (Fig. 4.6 through 4.13). As listed in Table 4.1, all three vessels with 10-in. (0.25m) slabs and the vessel with a solid 12.5-in. (0.32m) slab failed

after the formation of a "cryptodome", as observed by Karlsson (1971), within the end slab. The location of concrete failure was near the center of the slab and away from the section of maximum shear stress. For this mode of failure, the shear strength of the end slab was insensitive to the presence of the penetrations.

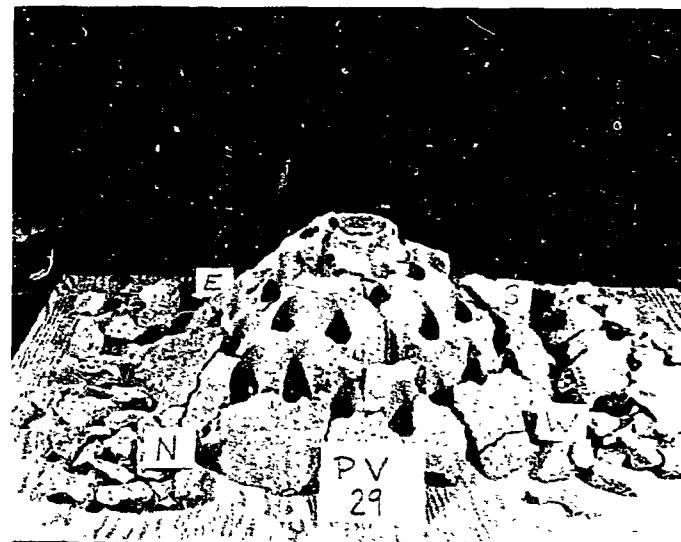
Fig. 4.8 End Slab after Test PV29

as belonging clearly to one category or the other. The failed end slab of vessel PV29 (Fig. 4.8), in addition to a well developed dome had a vertical failure plane through the outermost line of penetrations.

The shear failures of 12.5-in. (0.32m) end slabs having penetrations were characterized by failure of the concrete on an almost vertical plane through the section of maximum shear stress and were designated as "shear-proper" or "punching" failures. In this case, the strength of the end slab was affected by the penetrations. Measured nominal shear stresses are listed in Table 4.2.

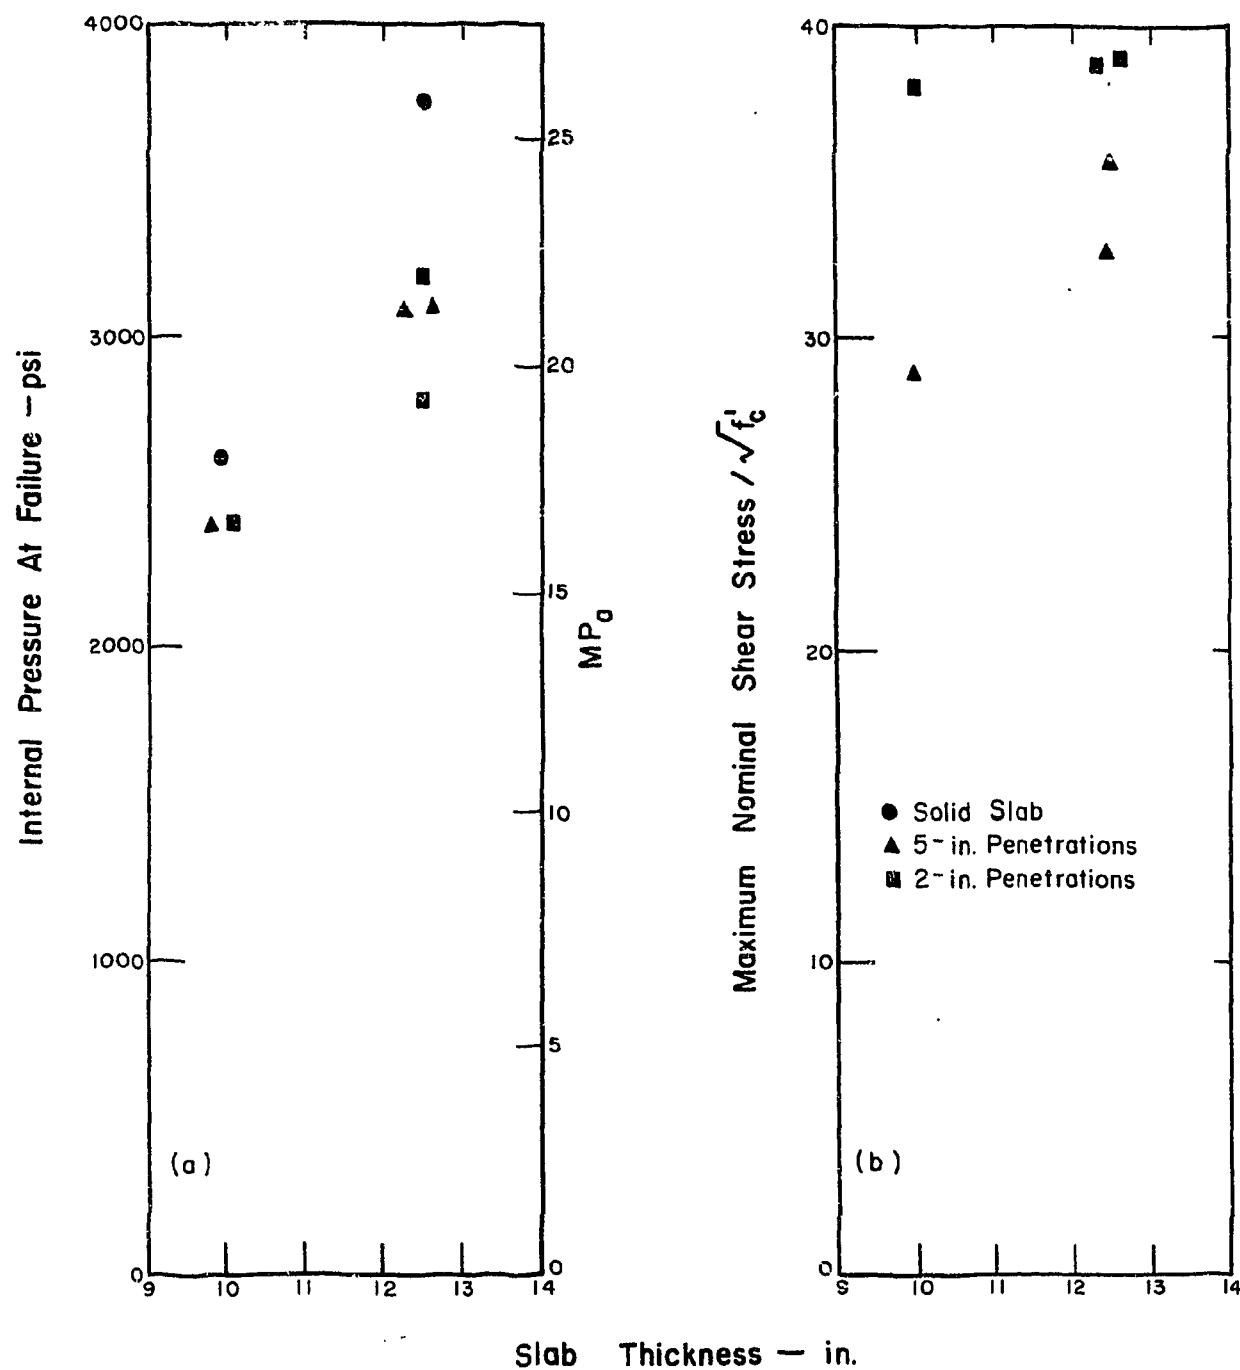
Fig. 4.14 Failure Prestress and Maximum Nominal Shear Stresses

Table 4.2 lists the nominal shear stresses, based on measured dimensions of the end slabs, for all test vessels. Failure pressures and maximum shear stresses normalized with respect to the square root of the compressive strength of concrete (in psi) are plotted against the slab thickness in Fig. 4.14.

Consider Fig. 4.14a which shows the raw test results. As in the series of tests by Karlsson (1971), the difference between the measured strengths of the 10-in. end slabs with and without openings was quite small. The perforated slabs had 92% of the strength of the solid slab. The difference, if considered significant, is plausible. As long as the final collapse is by material failure in the cryptodome near the

For the 12.5-in. slabs, there was a meaningful difference in maximum pressures measured for the solid and the perforated slabs, consistently with the observation that the perforated slabs failed in the section through the openings.

Both modes of failure involve complex internal stress conditions. As hypothesized by Karlsson (1971), maximum pressure for failure in the cryptodome mode is a function of the overall geometry and concrete strength with the influence of the prestressing forces affecting the pressure through their influence on the initiation and trajectory of the three-dimensional inclined crack. The shear-proper failure occurs on a plane through the penetrations and close to the boundary, both of which conditions complicate the stress distribution. Strain measurements discussed in the next chapter imply that failure occurs after appreciable redistribution of internal stresses. To generalize the results of the tests must await the conclusion of the numerical studies some of which are briefly discussed in Chapter 3. However, certain trends discernible in Fig. 4.14 are of interest.

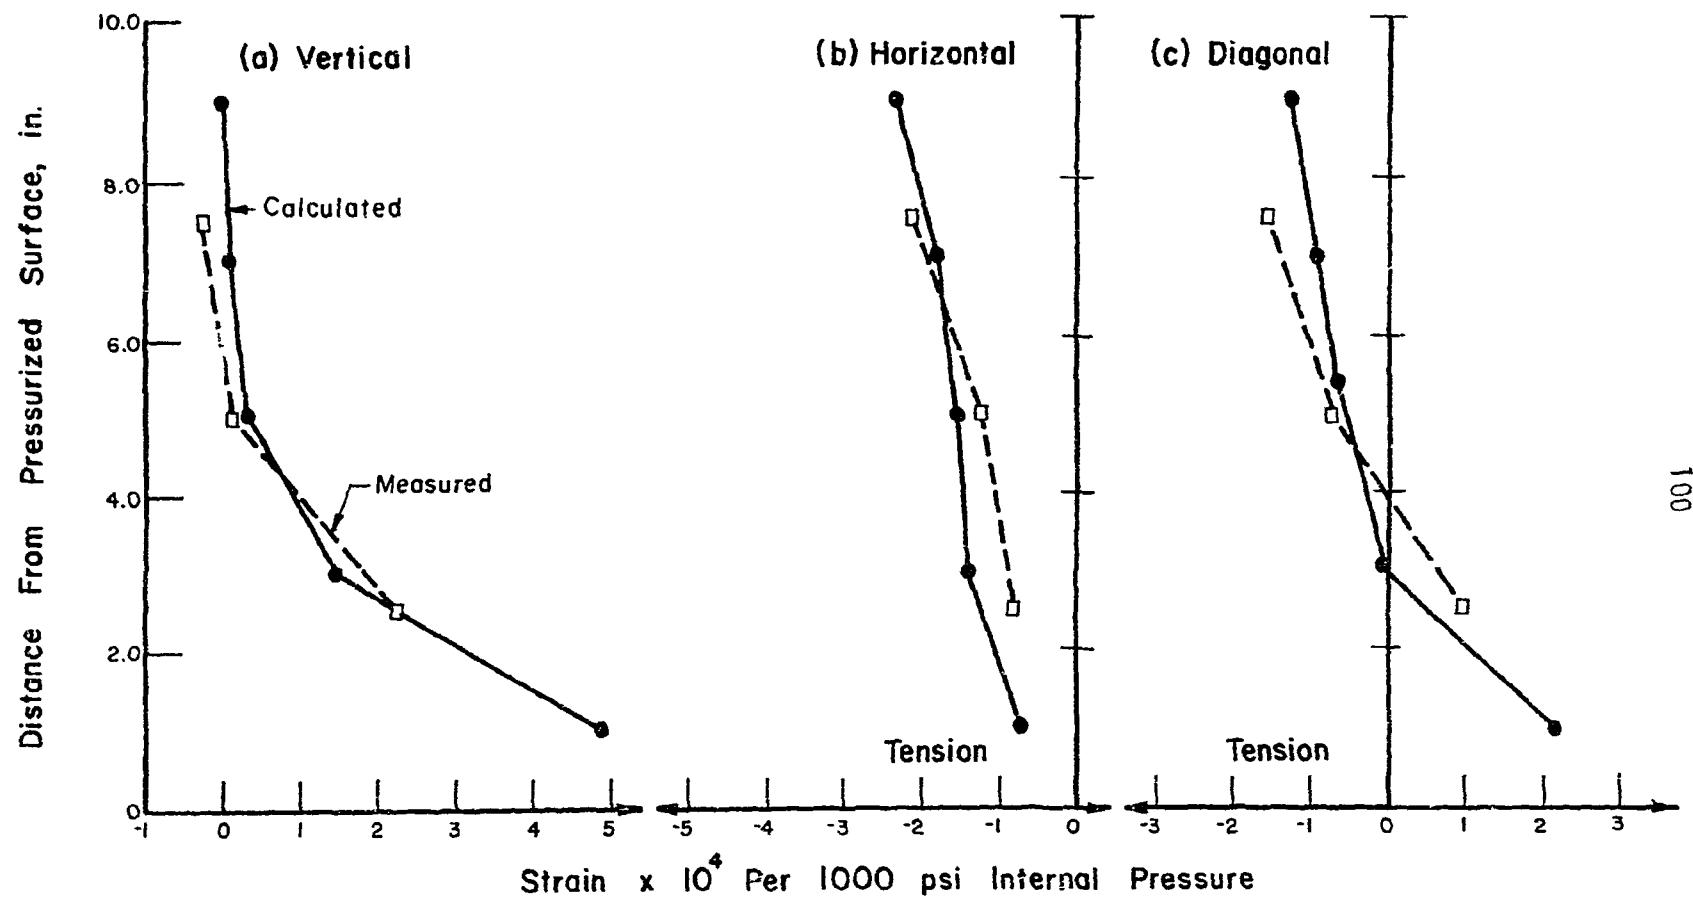
Fig. 5.53 Comparison of Measured and Calculated Strains at an Internal Pressure of 1000-psi for a 10.0-in. End Slab. Strains at 12:00 Position (See Fig. 5.31a)

Measured values represent the mean initial slope of the pressure-strain plots obtained from gages attached to the walls of the penetrations. Each datum point represents the average of all available data for that location. The scatter range was as large as 60% for mean values less than 1×10^{-4} and less than 20% for mean values equal to or greater than 1×10^{-4} . Readings from initial and second loadings of test vessels which had to be loaded twice because of leakage in the first test were treated as independent values.

Strains were calculated using the linear axisymmetric models described in Chapter 3 with modifications to represent the effect of the penetrations. It should be noted that the calculated strains refer

The comparisons are, in general, favorable indicating that the axisymmetric model may be used to investigate strain conditions around the penetrations in the linear range of response.

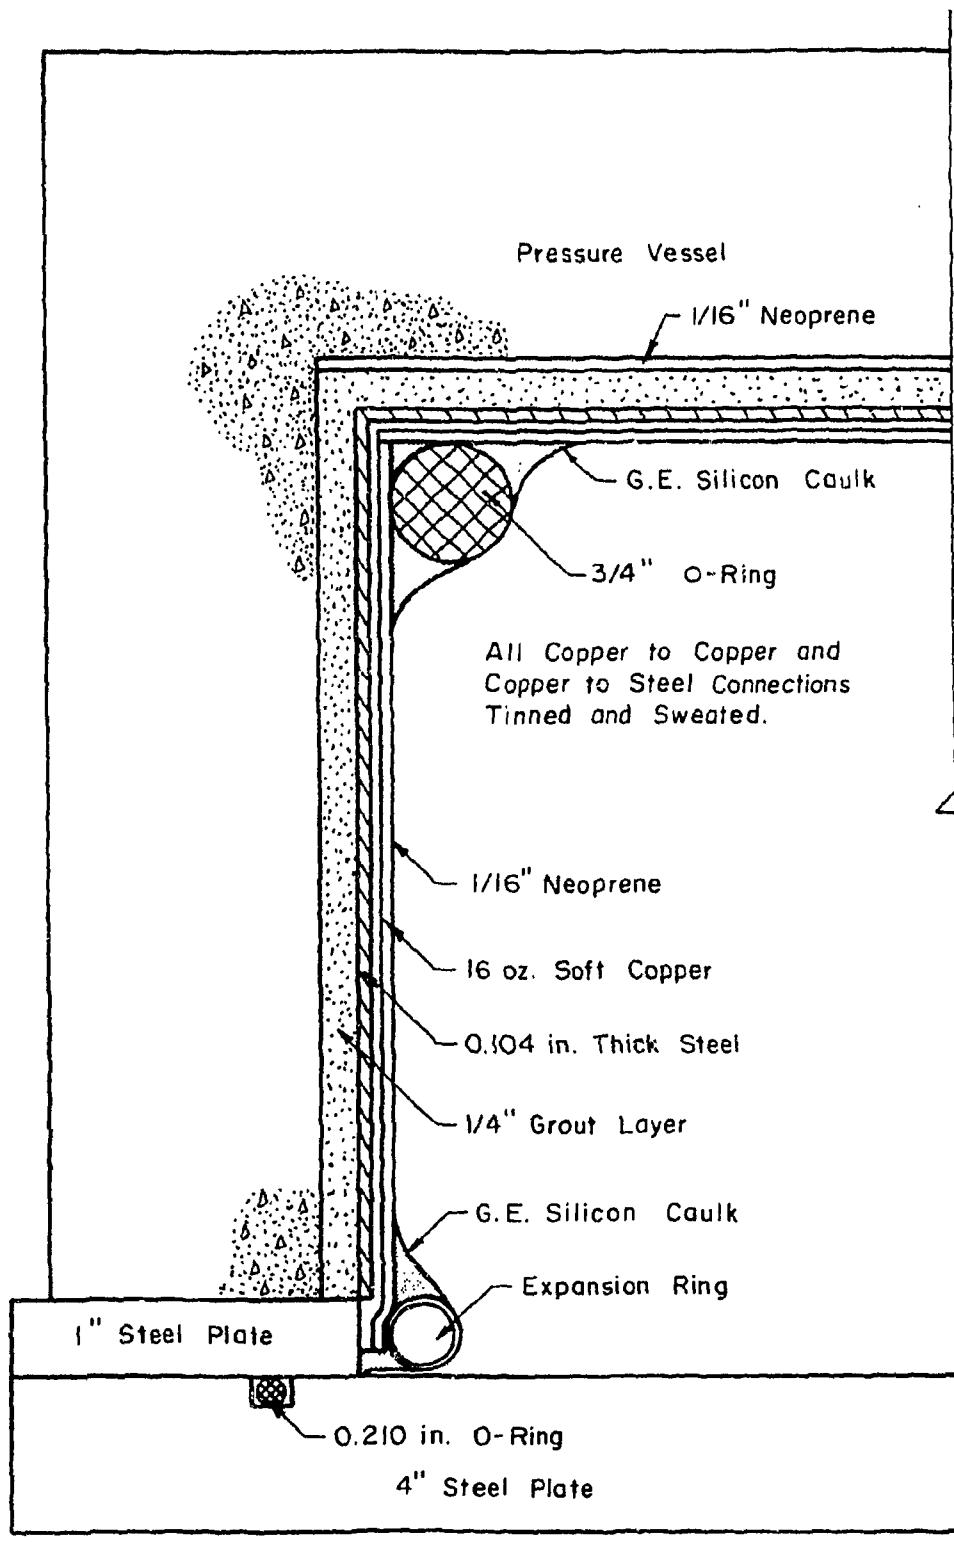
Fig. A.6 Typical Liner Details (not to scale)

The liner for the internal cavity comprised sheets of steel, copper, and Neoprene. Each vessel was pressurized hydraulically to failure over a period of approximately three hours. Maximum pressures ranged from 2400 psi (16.6 MPa) to 3765 psi (26.0 MPa). Despite the use of fluid as the loading medium, the structural failures were violent.
