CORRELATION OF SUBSTRUCTURE WITH MECHANICAL PROPERTIES
OF PLASTICALLY DEFORMED REACTOR STRUCTURAL MATERIALS

Progress Report
for Period January 1, 1976 - June 30, 1977

J. Motteff

Materials Science and Metallurgical Engineering
University of Cincinnati
Cincinnati, Ohio 45221

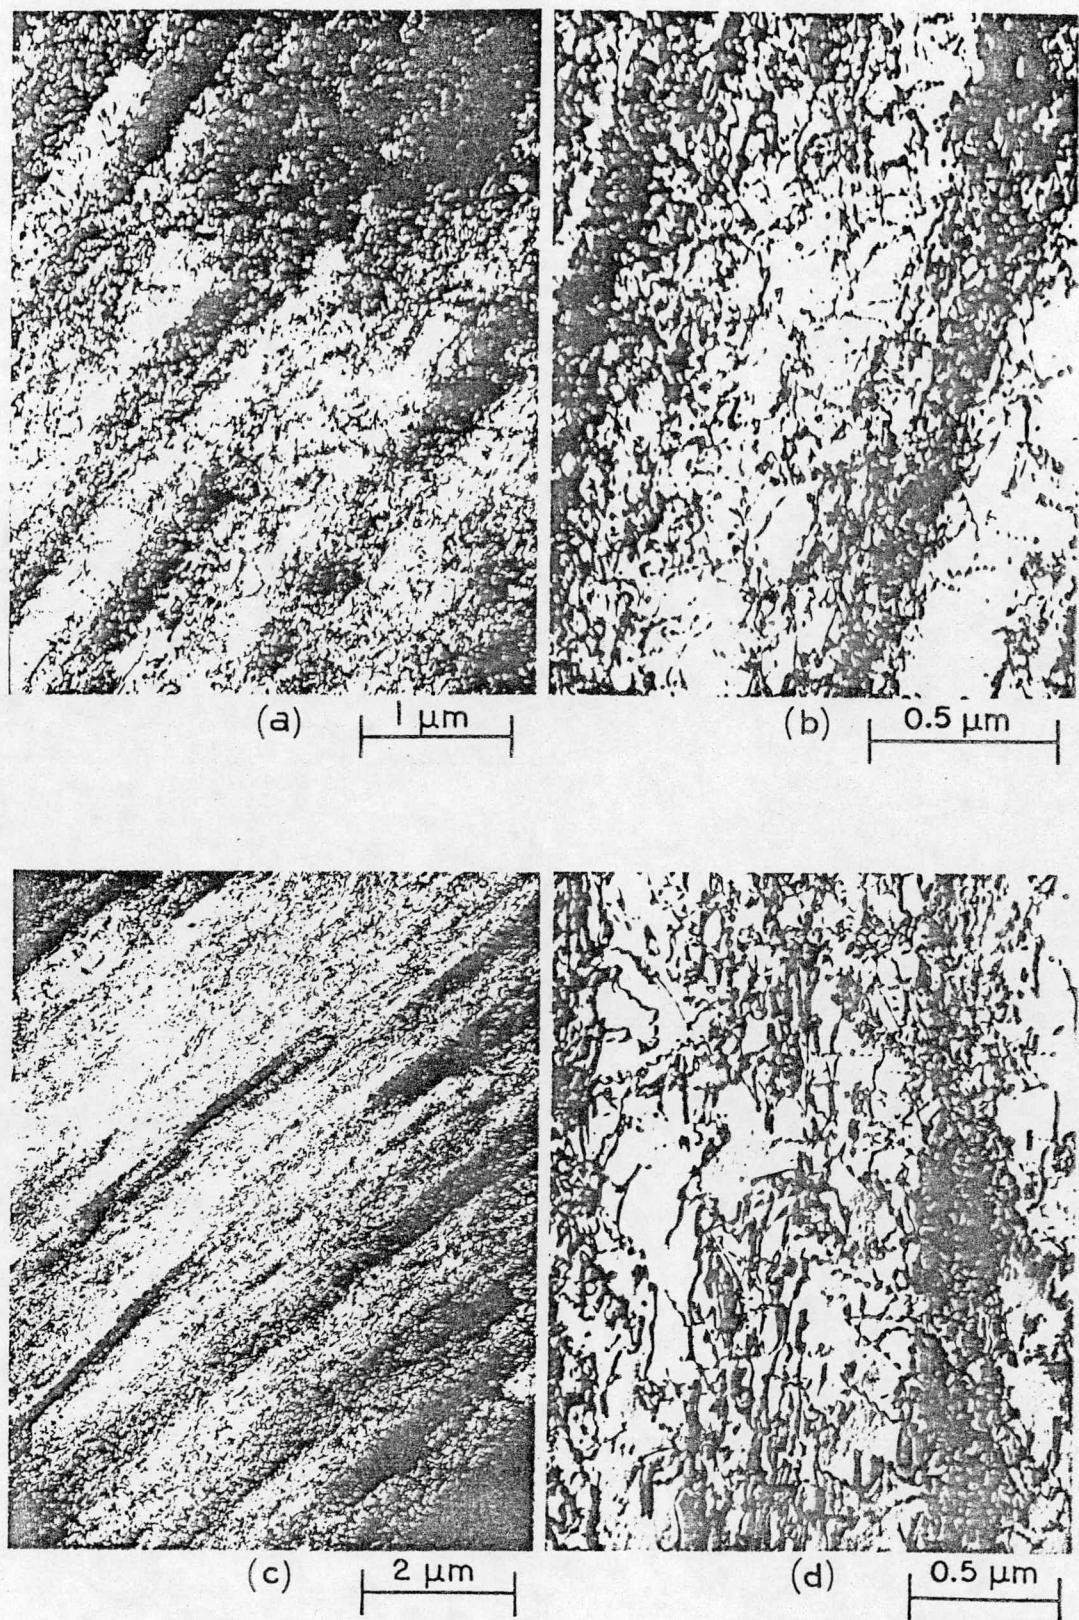
Fig. 2. Fatigue Substructure of Incoloy 800 at 538°C;
(a) Specimen 2H8; (b) Specimen 2H8;
(c) Specimen 2I9; (d) Specimen 2I9.

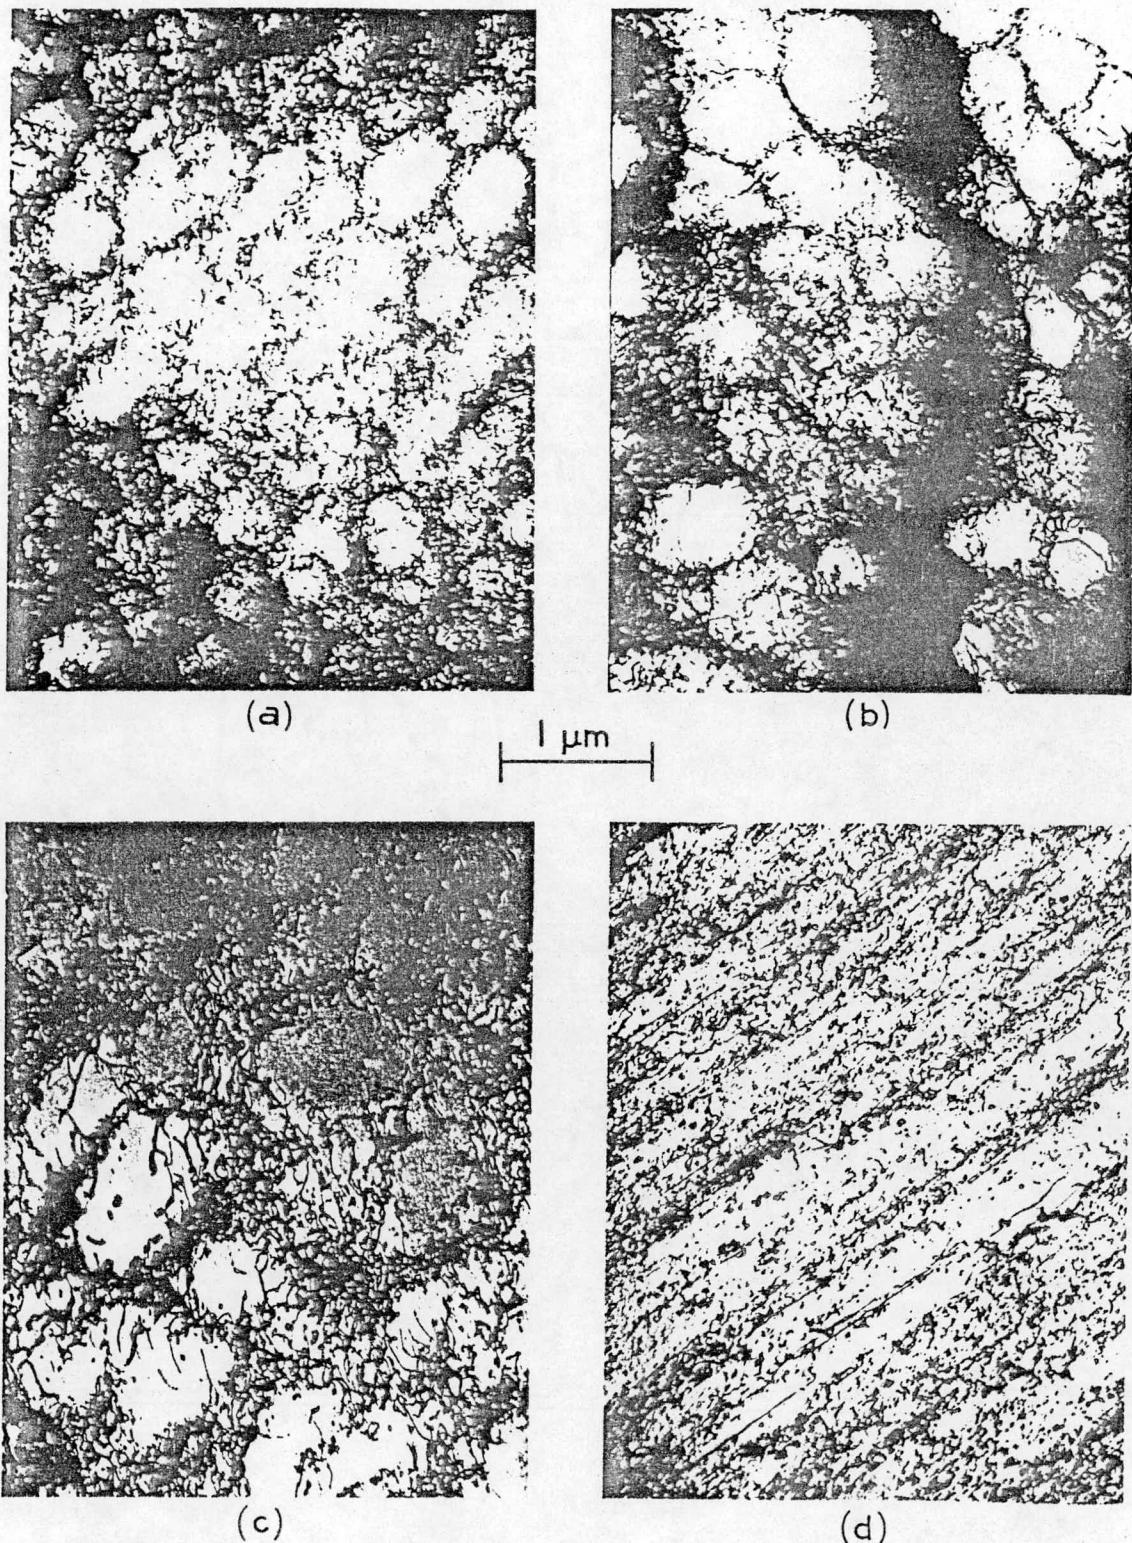
Fig. 3 Fatigue Substructure of Incoloy 800 at 649°C;
(a) Specimen 2E53; (b) Specimen 2A73;
(c) Specimen 2Q40; (d) Specimen 2F54;
(e) Specimen 2N14; (f) Specimen 2M13;
(g) Specimen 2N62.

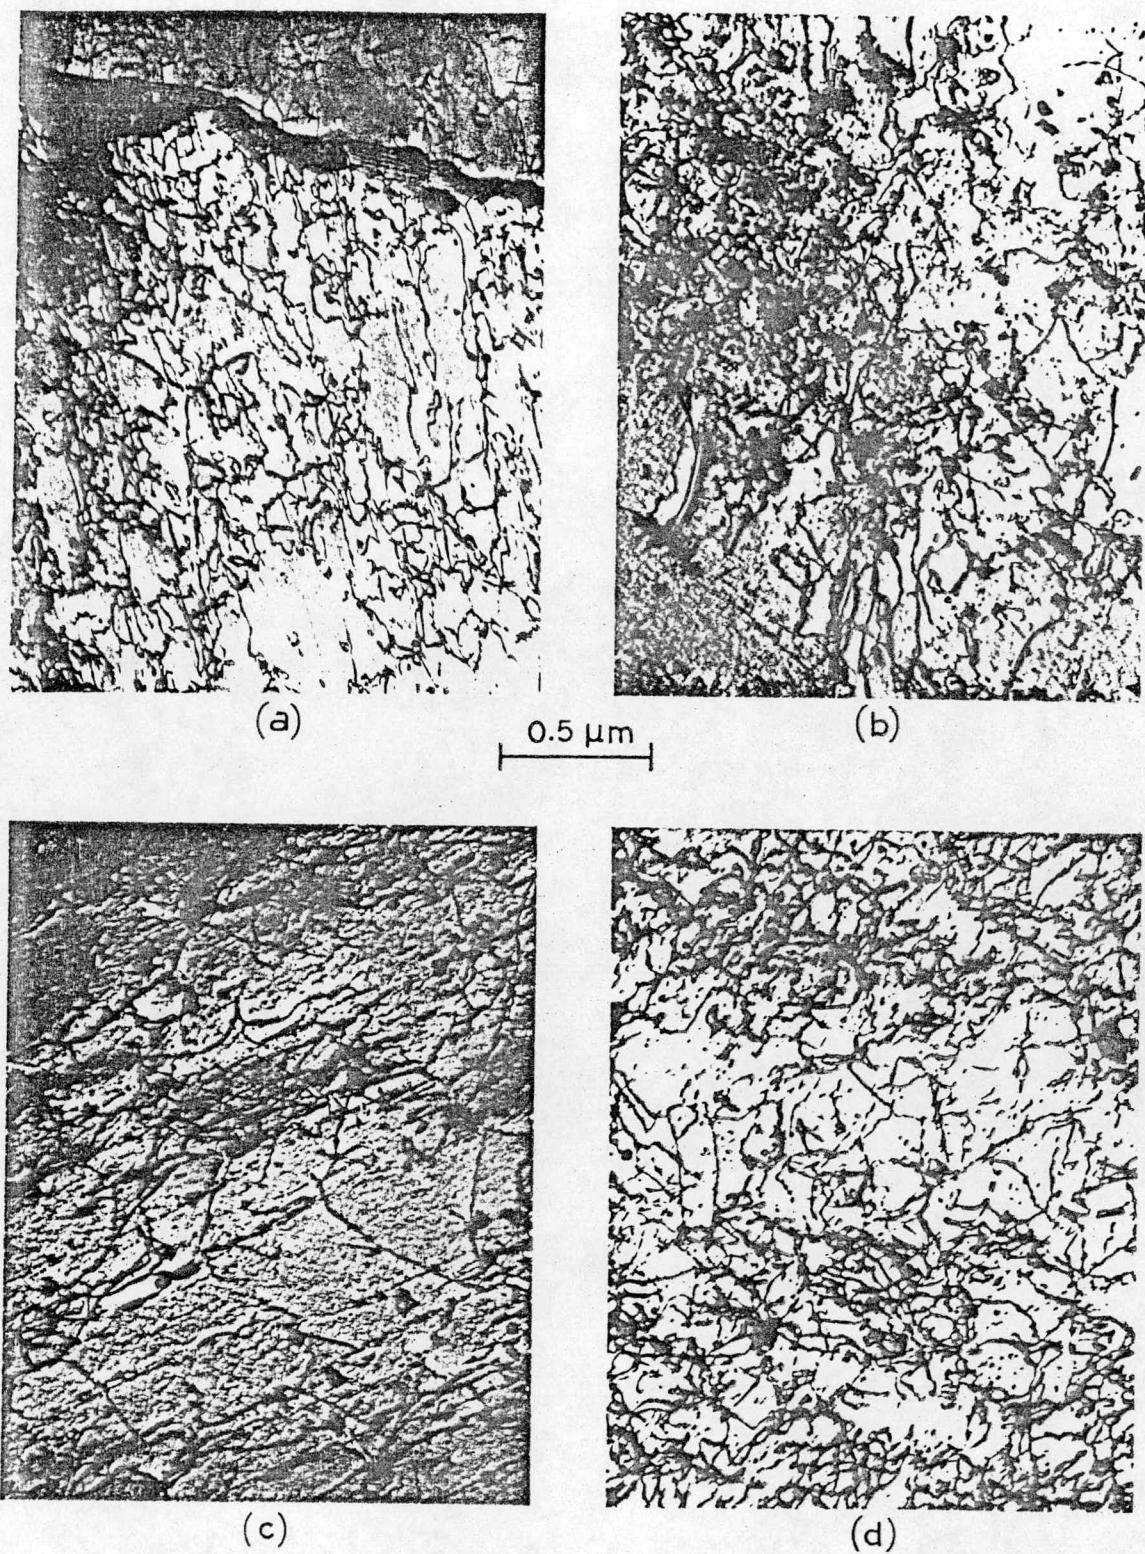
Fig. 4 Fatigue Substructure of Incoloy 800 at 649°C ;
(a) Specimen 2Q40; (b) Specimen 2F54;
(c) Specimen 2N14; (d) Specimen 2M13.

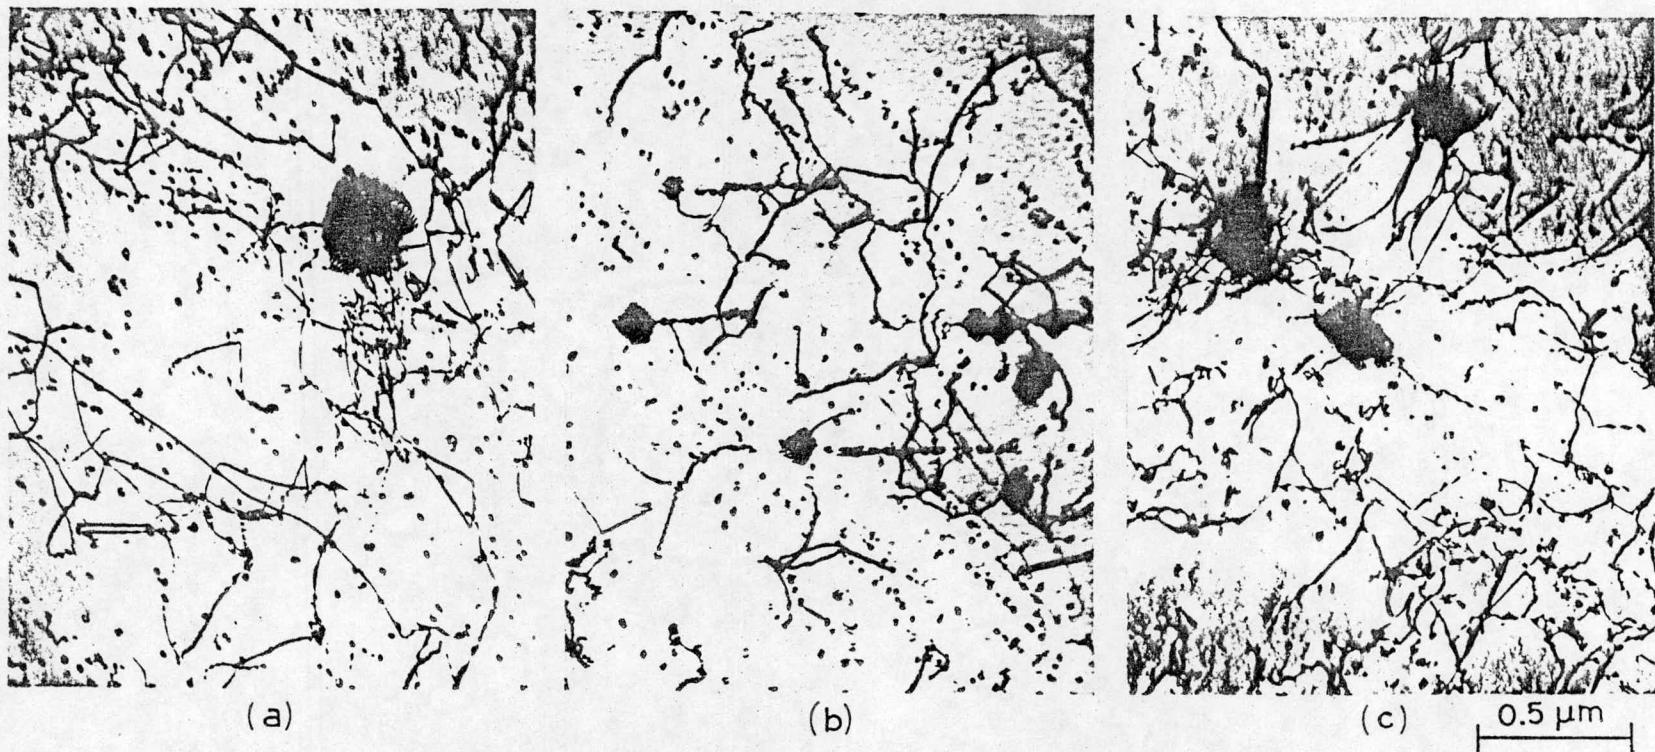
Fig. 7 Fatigue Substructure of Incoloy 800 at 760°C; (a) Specimen 2F6; (b) Specimen 2D28; (c) Specimen 2K35.

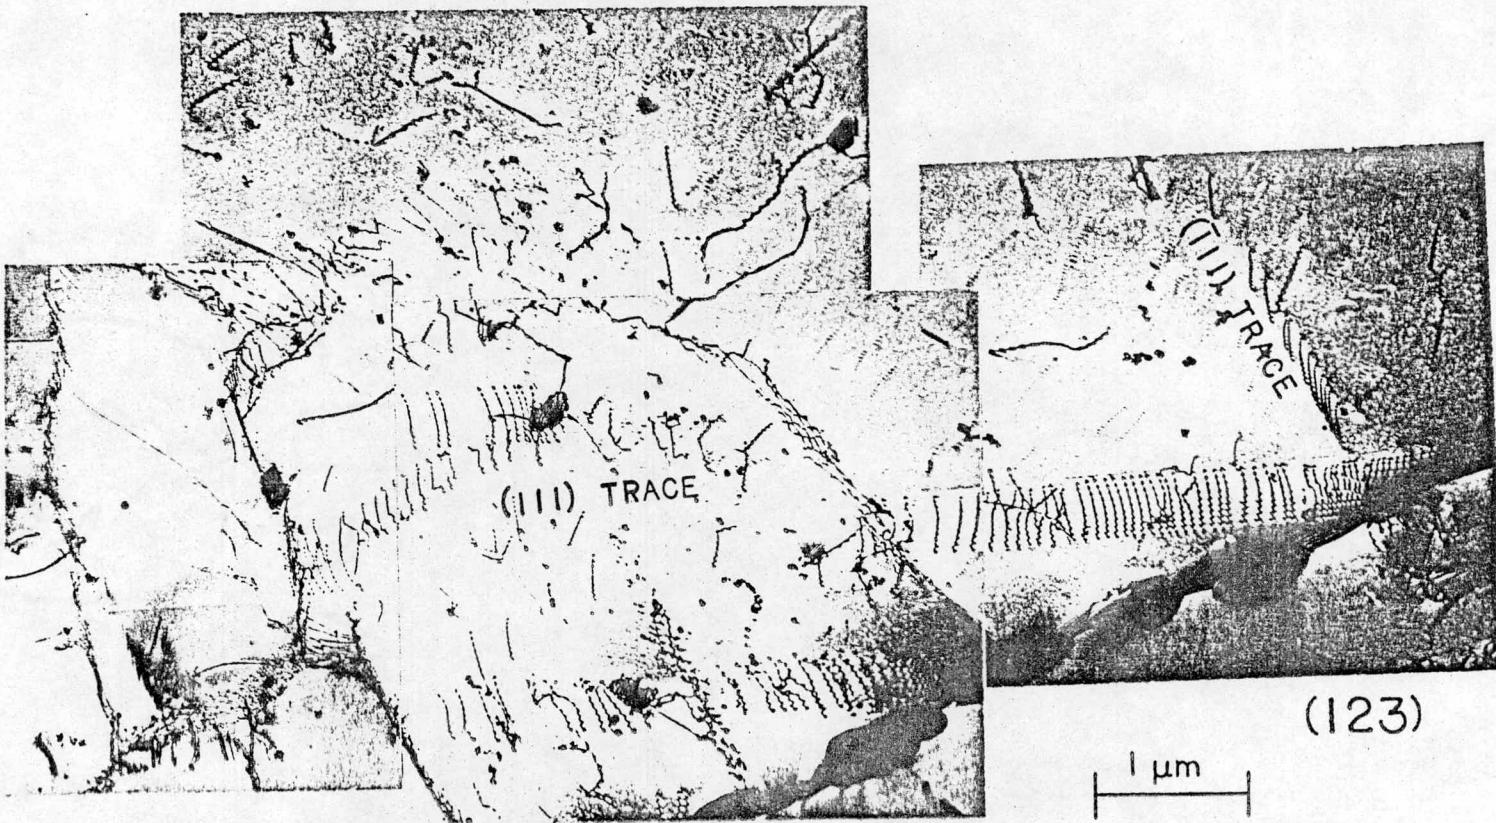
Fig. 8 Fatigue Substructure of Incoloy 800 in Specimen 2H32 at 760°C.

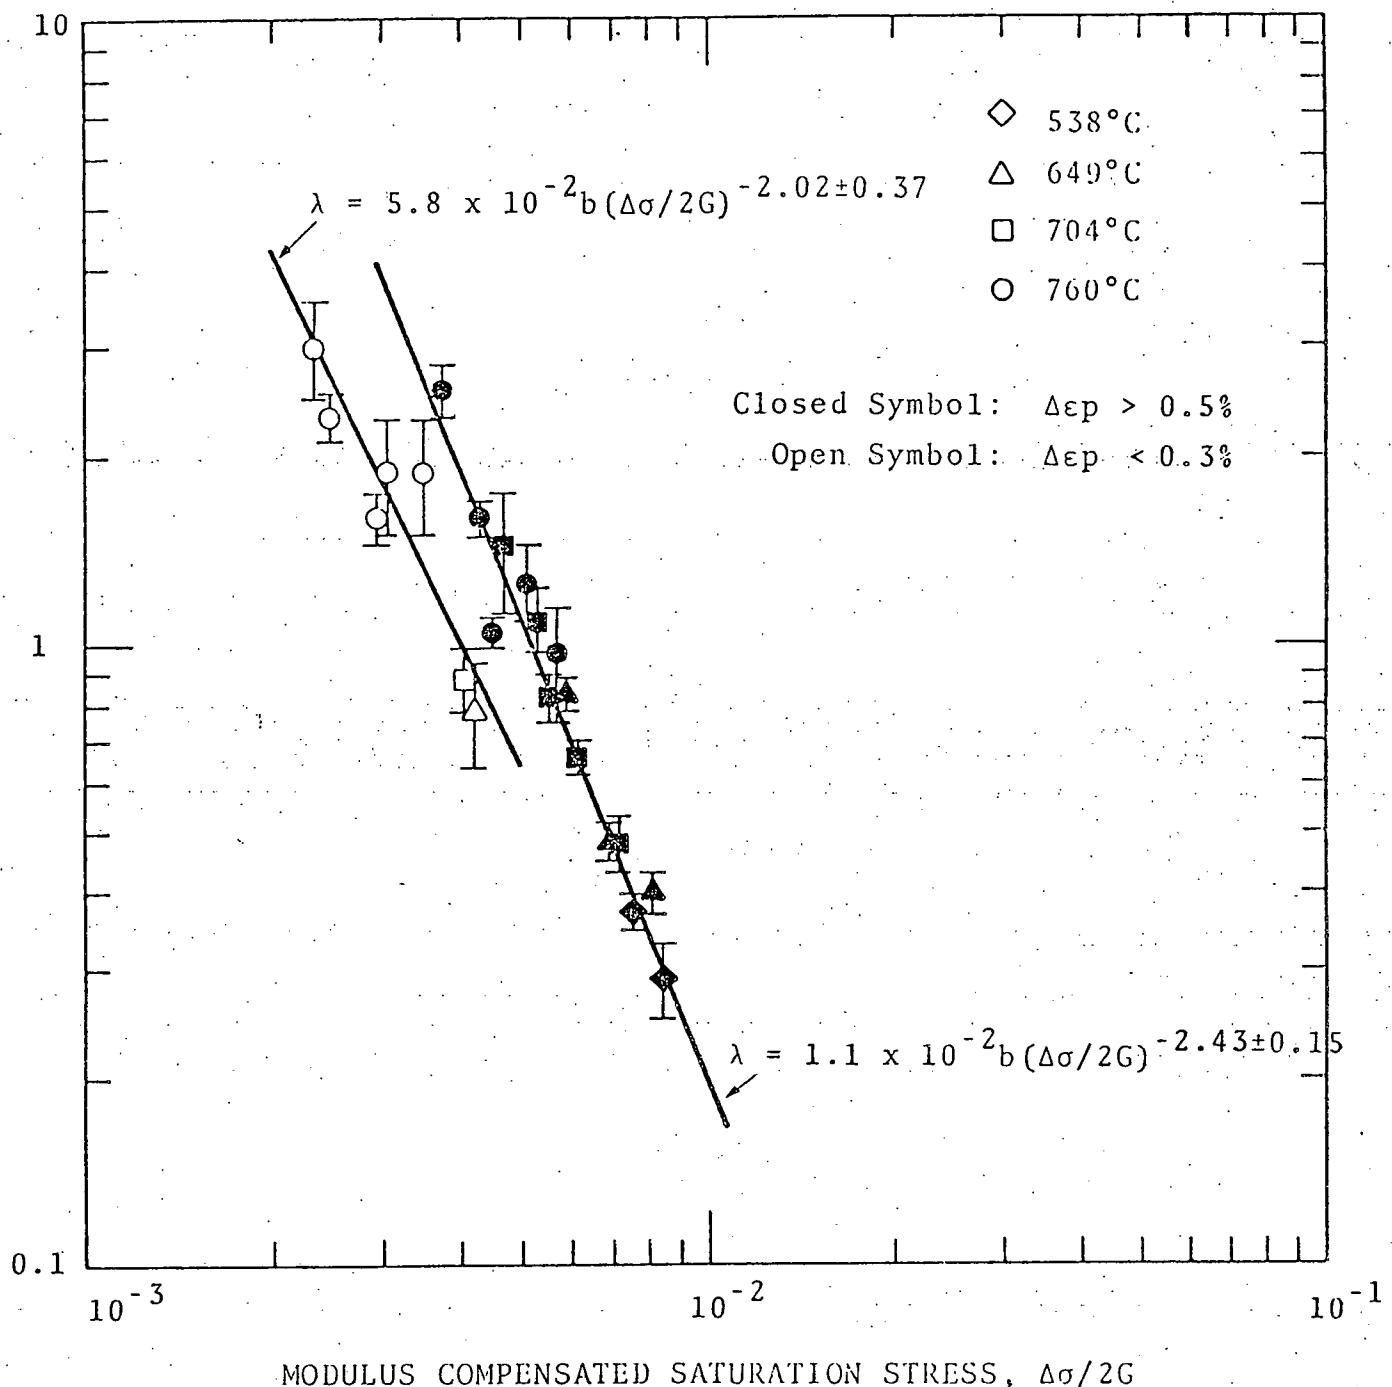
Fig. 9 The Subboundary Intercept Size, λ , as a Function of the Shear Modulus Compensated Saturation Stress $\Delta\sigma/2G$ for Incoloy 800.

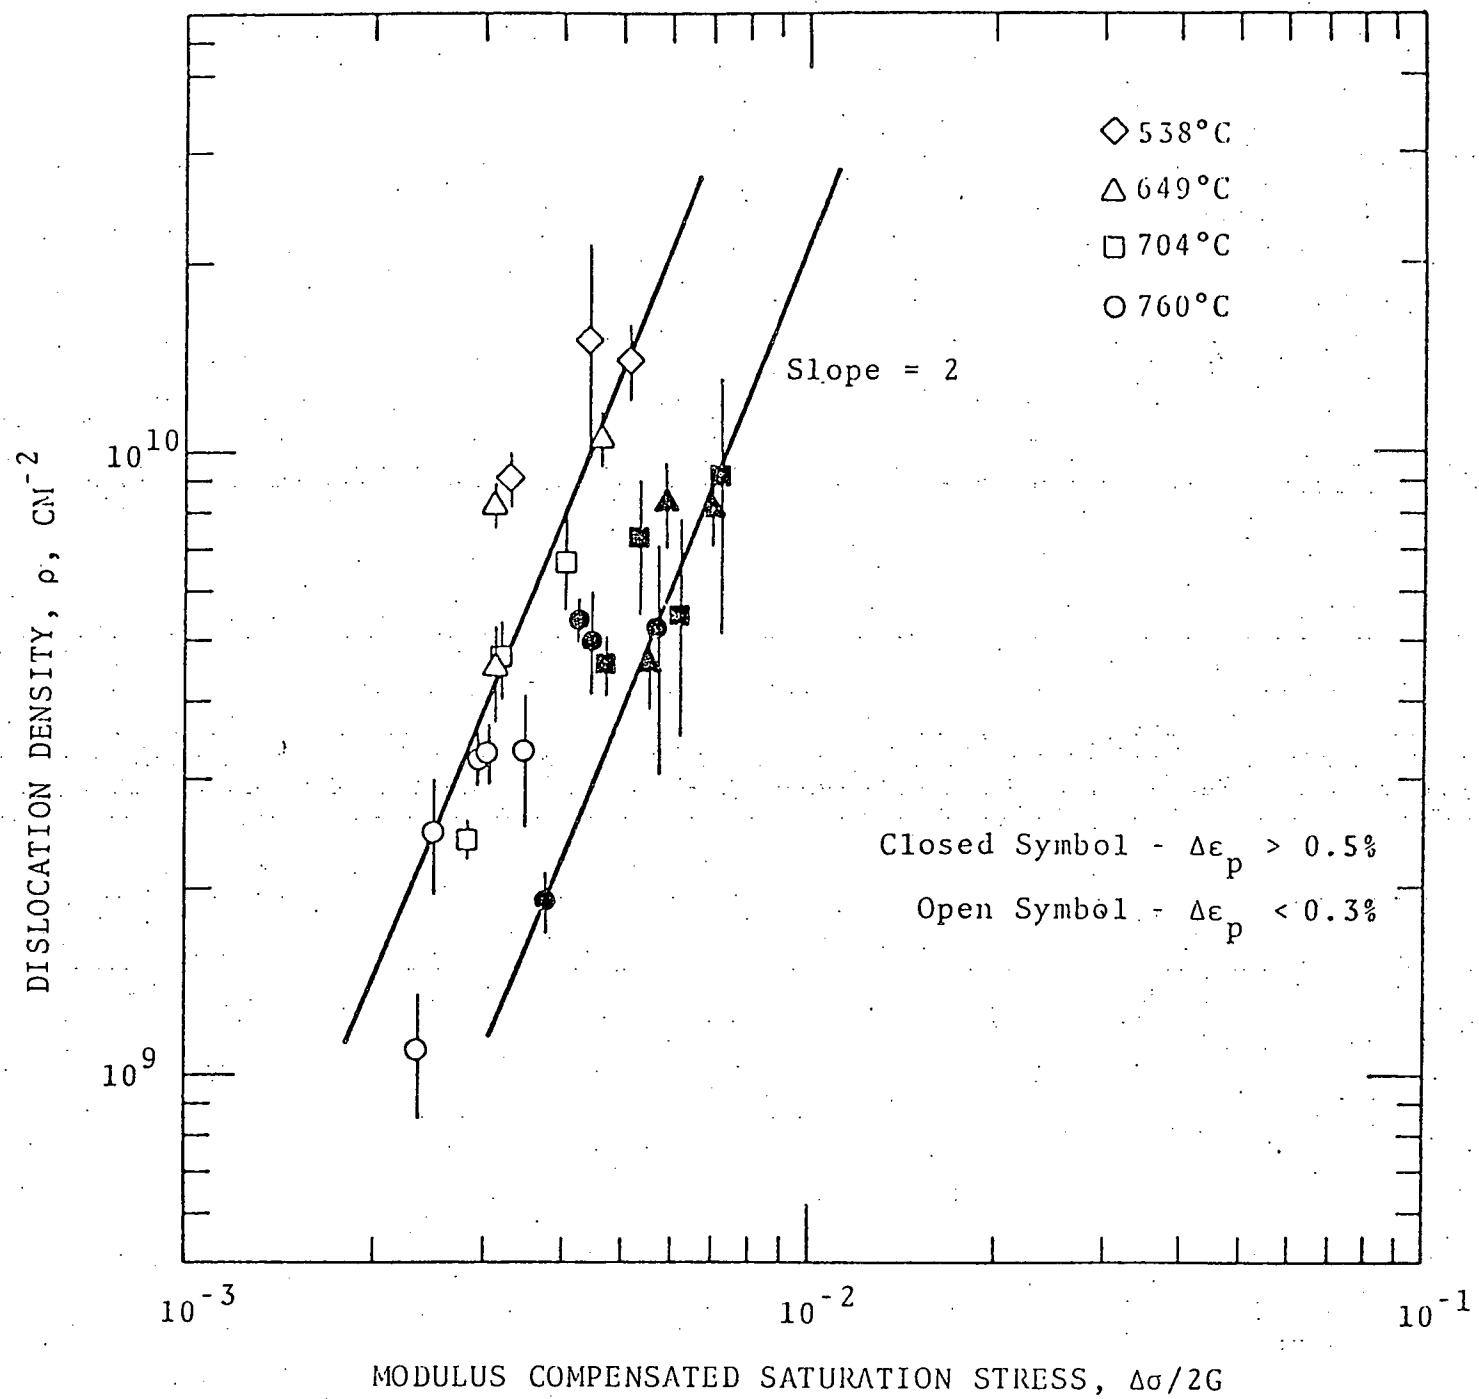
Fig. 10 The Dislocation Density, ρ , as a Function of the Shear Modulus Compensated Saturation Stress, $\Delta\sigma/2G$, for Incoloy 800.

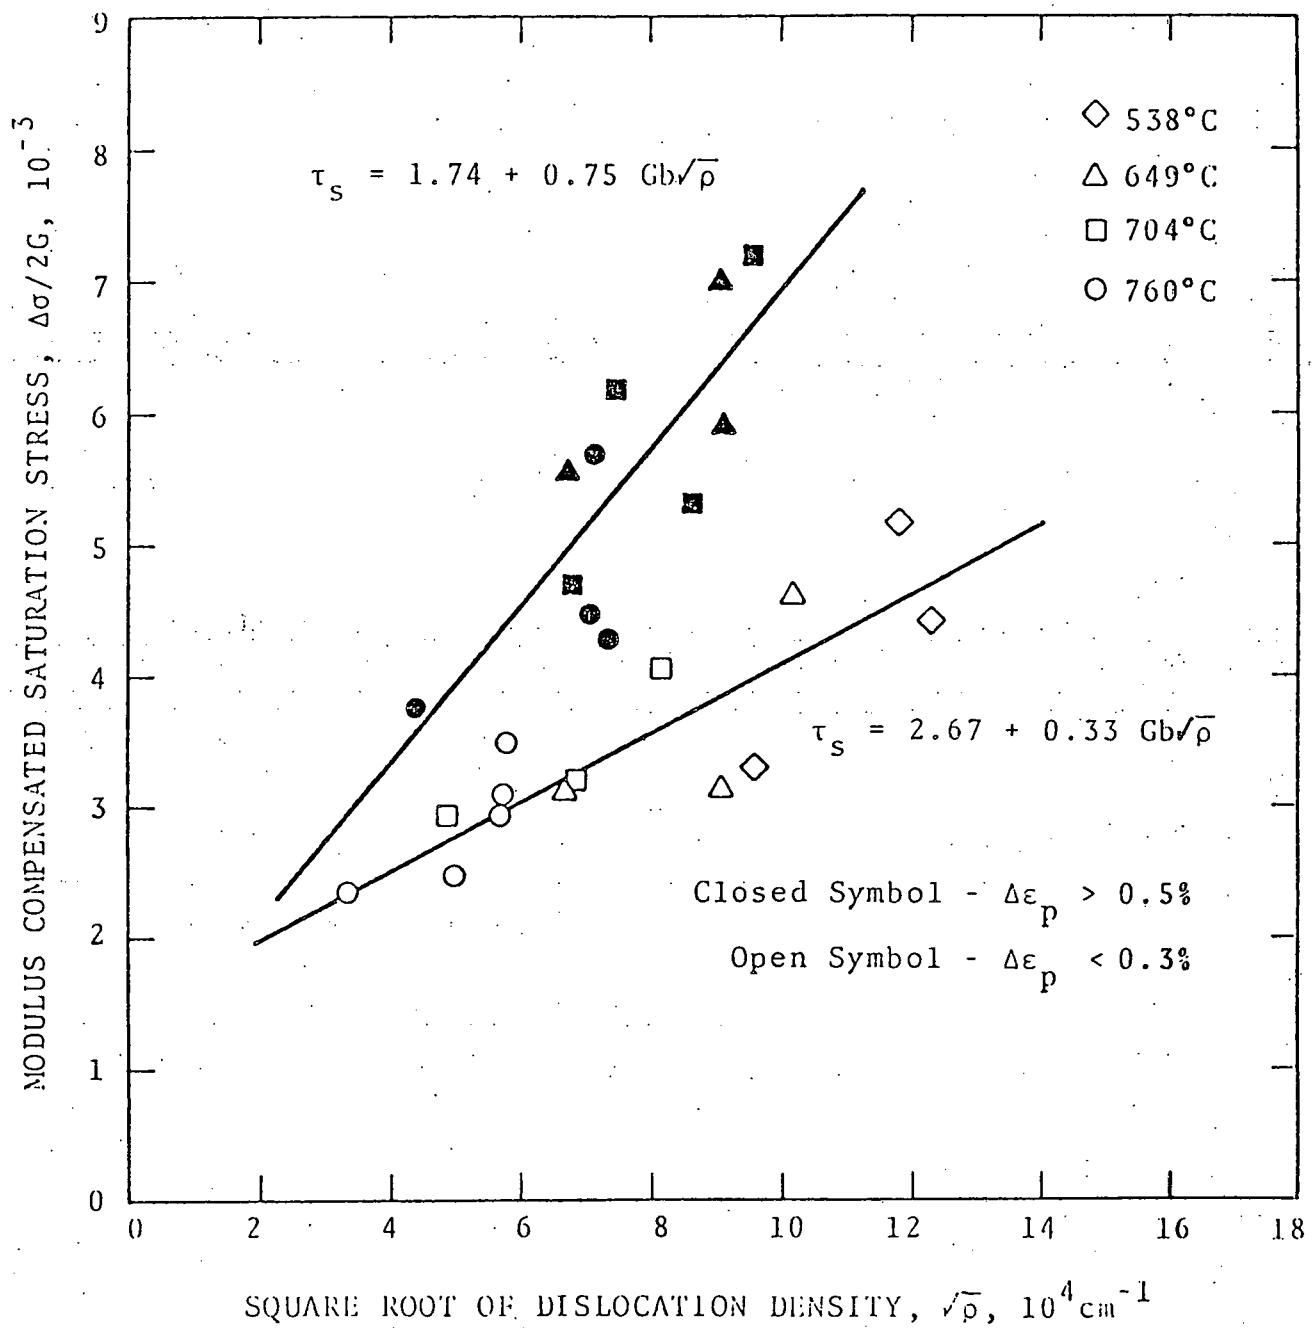
Fig. 11 The Shear Modulus Compensated Saturation Stress, $\Delta\sigma/2G$, as a Function of the Square Root of the Dislocation Density $\sqrt{\rho}$, for Incoloy 800.

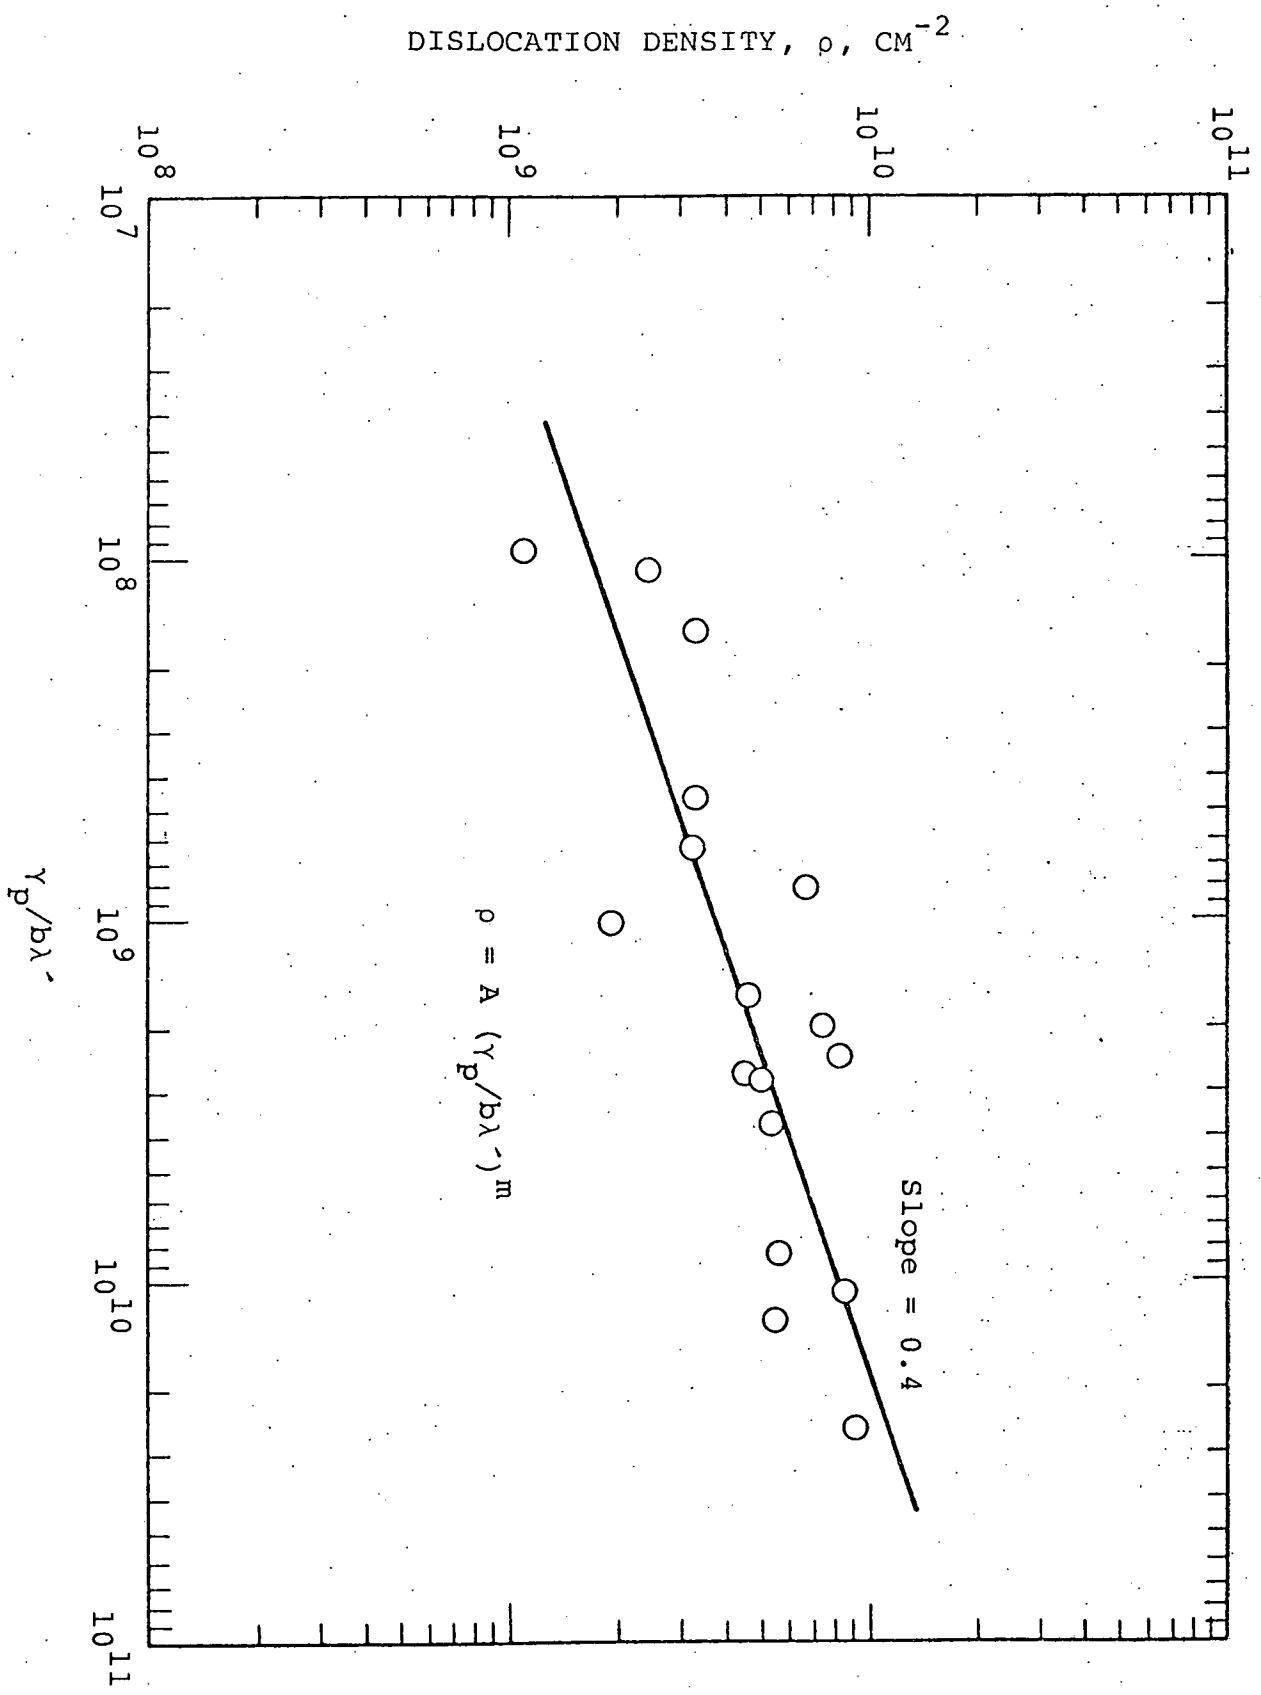
Fig. 1. Correlation of the Dislocation Density, ρ , with the Parameter $(\gamma_p/b\lambda')$

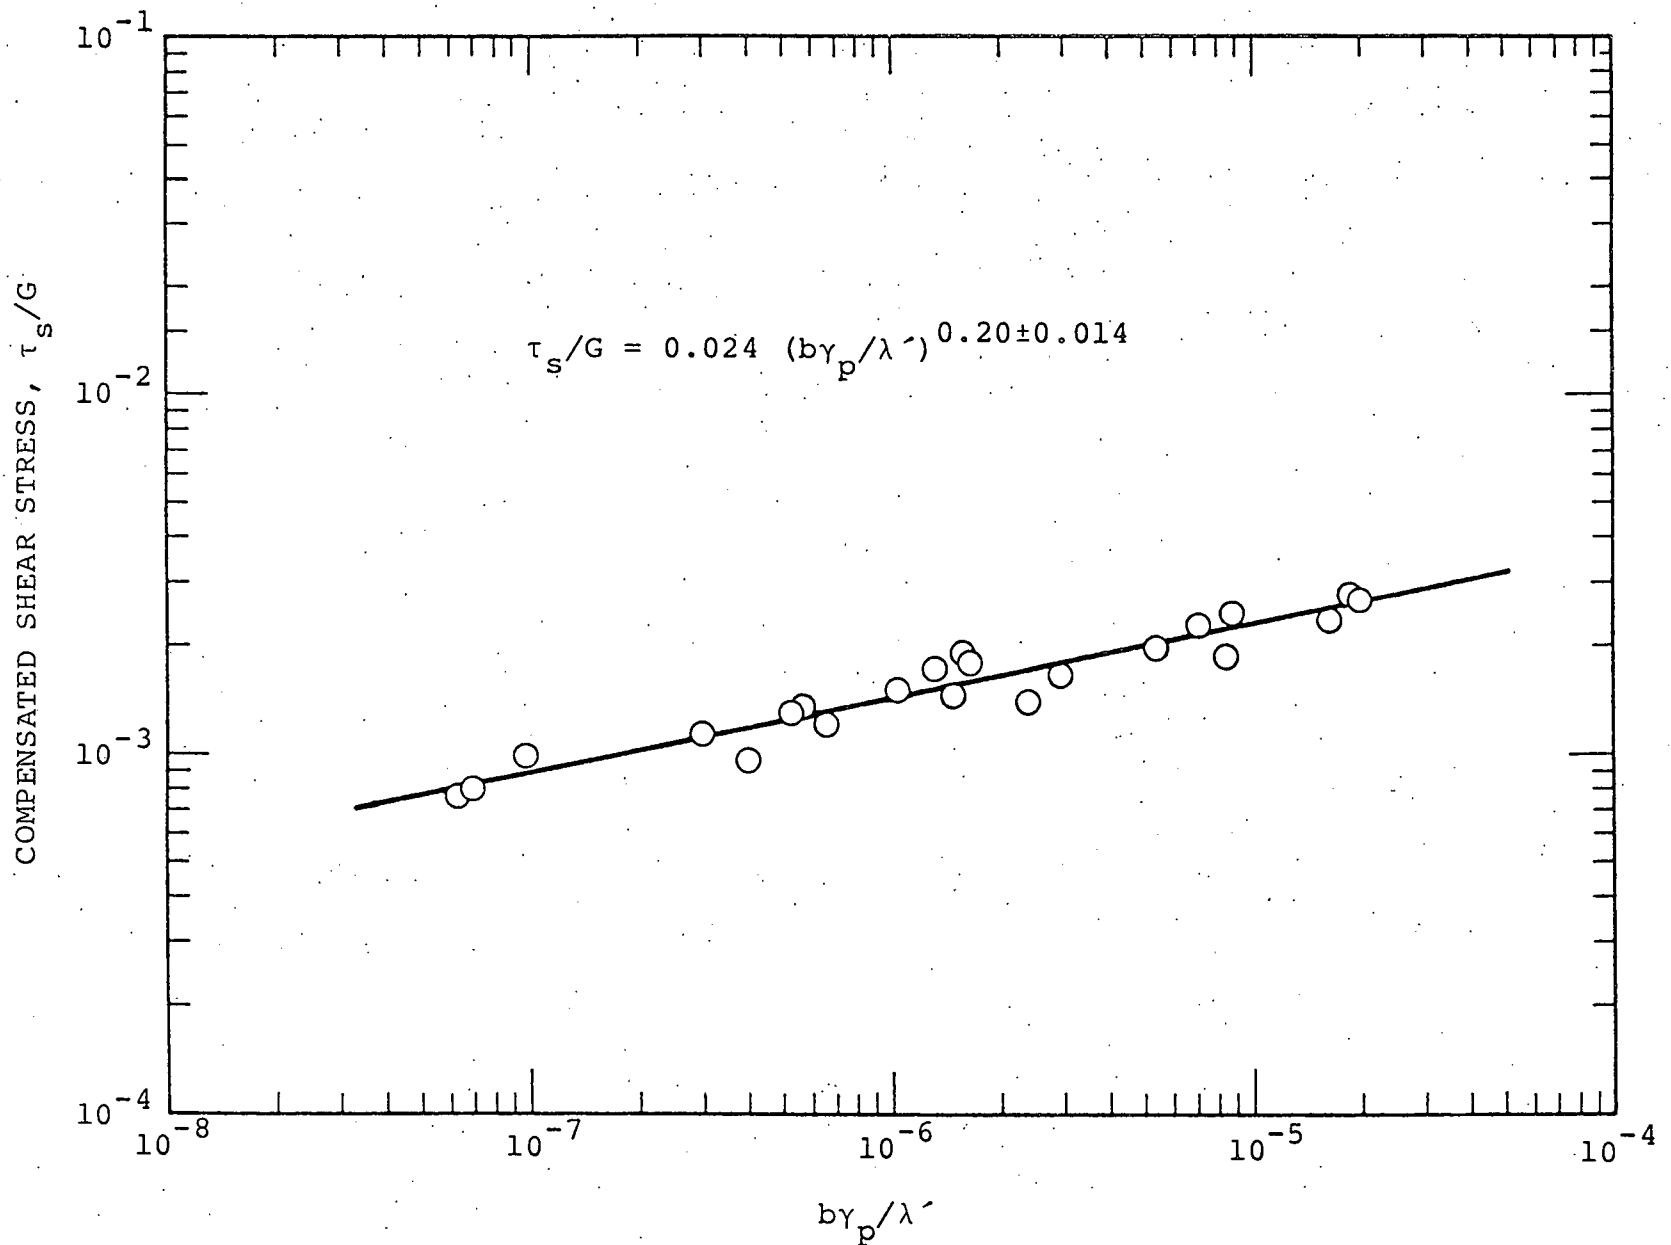
Fig. 2. Correlation of the Shear Modulus Compensated Saturation Shear Stress, τ_s

with the Parameter $b\gamma_p/\lambda'$

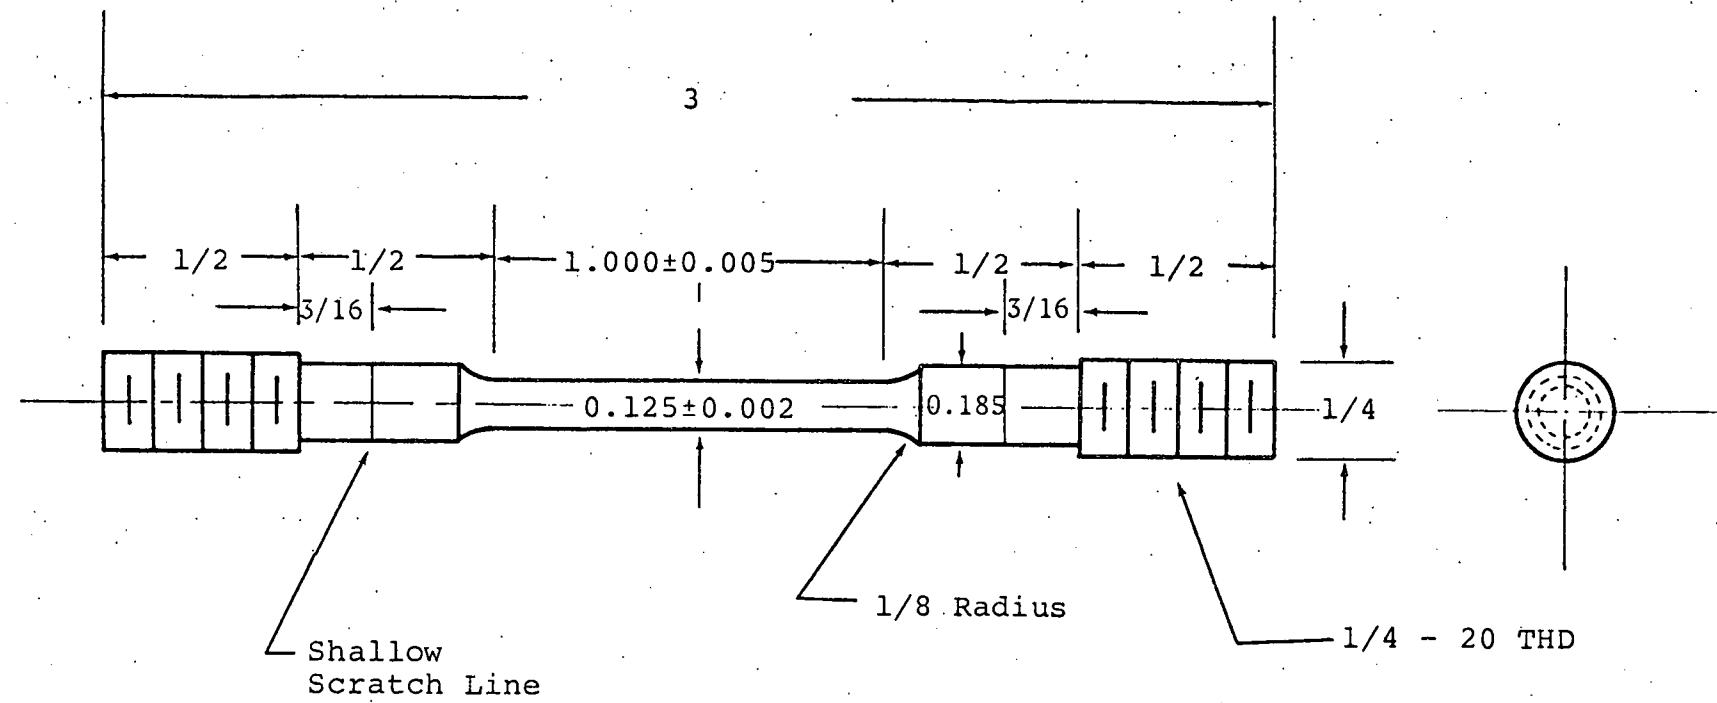
Fig. 4. Drawings of AISI 330 Stainless Steel Creep Test Specimen. (The dimensions are given in inches).

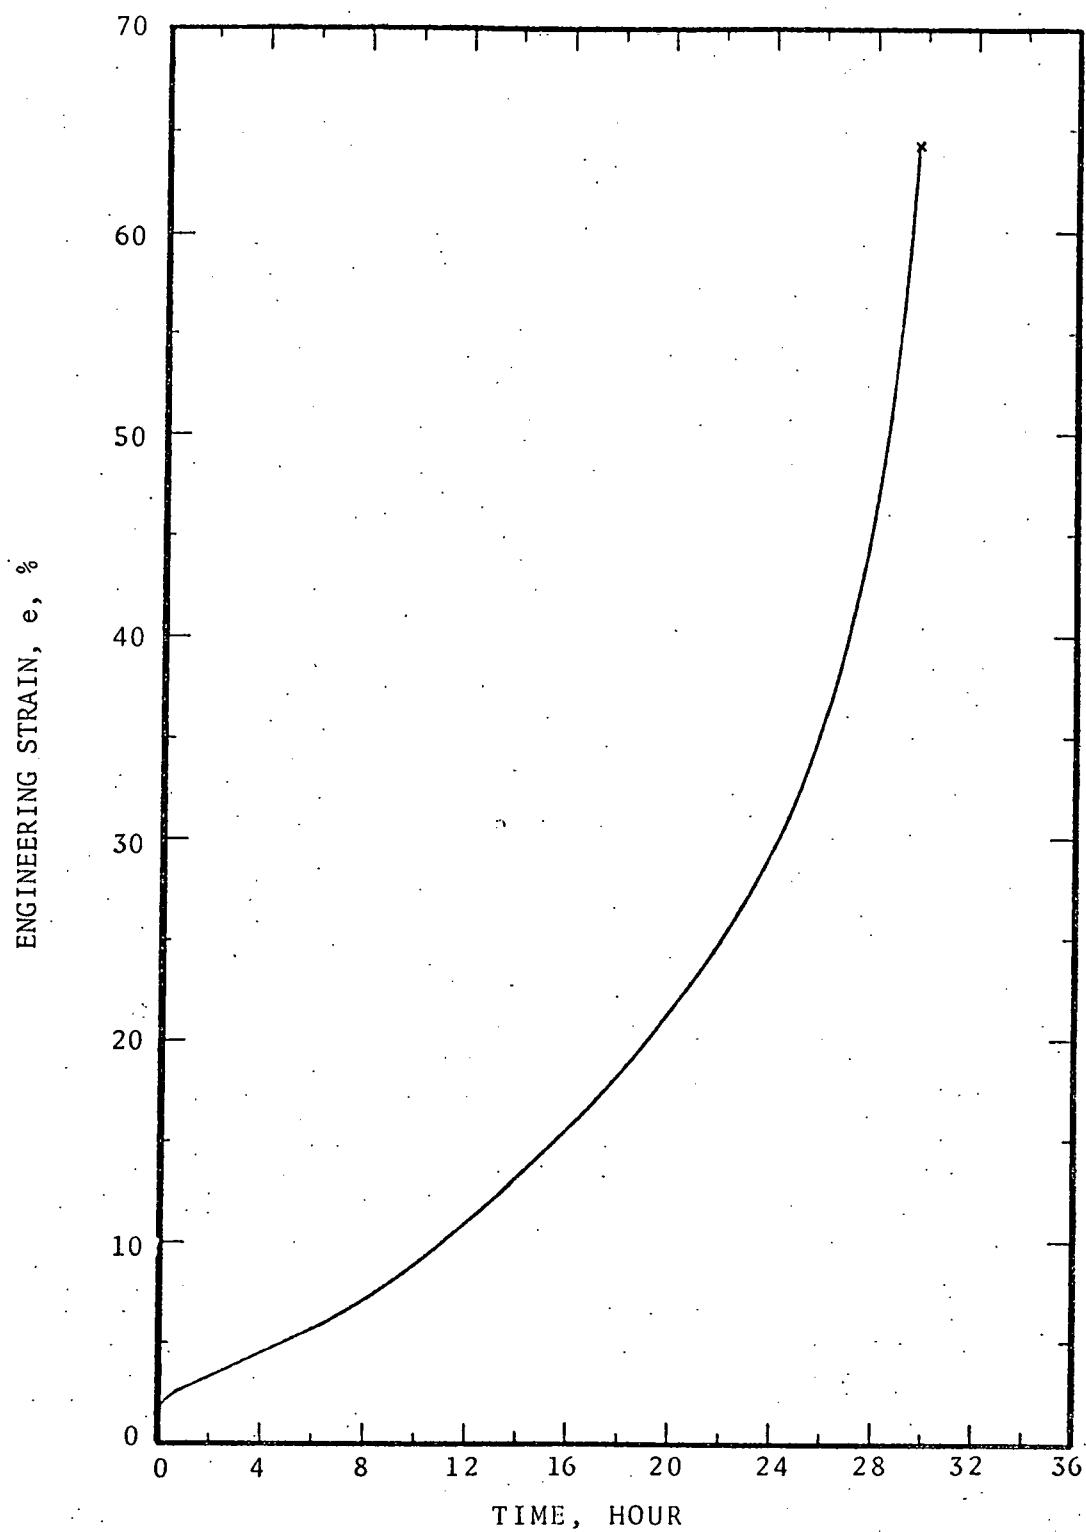
Fig. 5. Creep-Rupture Curve of AISI 330 Stainless Steel

Tested at 649°C with an Applied Stress of 30,000
psi.

A constant load creep rupture test was performed on AISI 330 stainless steel at 649°C with an applied stress of 30,000 psi. The minimum creep rate was $1.04 \times 10^{-4} \text{ sec}^{-1}$ and the rupture life and the rupture strain were 29.6 hours and 64.3%, respectively (Appendix B).

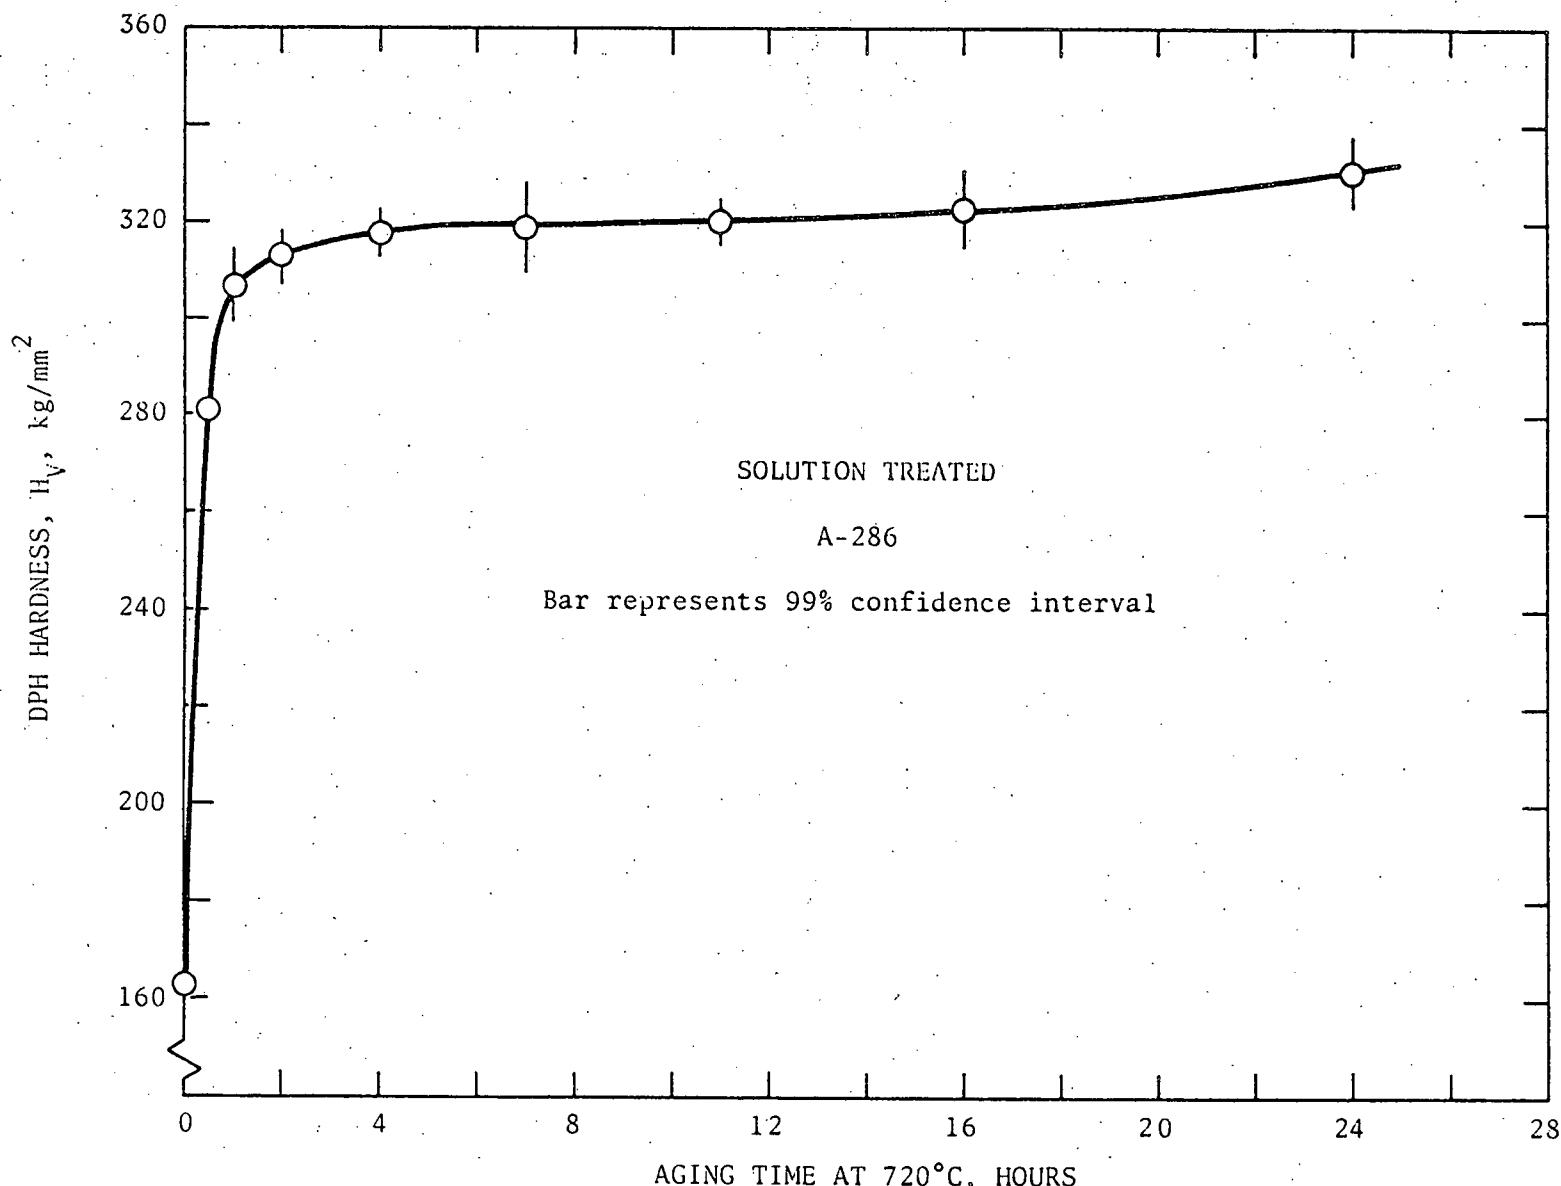
Fig. 6. DPH Hardness versus Aging Time at 720°C for Solution-Treated A-286

A set of A-286 specimens was solid-solution annealed at 900°C for 2 hours and aged at 720°C for various times. It was found that rapid hardening occurs during the initial ageing period, the hardness increasing slowly thereafter (Appendix B).
