CORRELATION OF SUBSTRUCTURE WITH MECHANICAL PROPERTIES
OF PLASTICALLY DEFORMED REACTOR STRUCTURAL MATERIALS

Progress Report
for Period January 1, 1976 - June 30, 1977

J. Motteff

Materials Science and Metallurgical Engineering
University of Cincinnati
Cincinnati, Ohio 45221

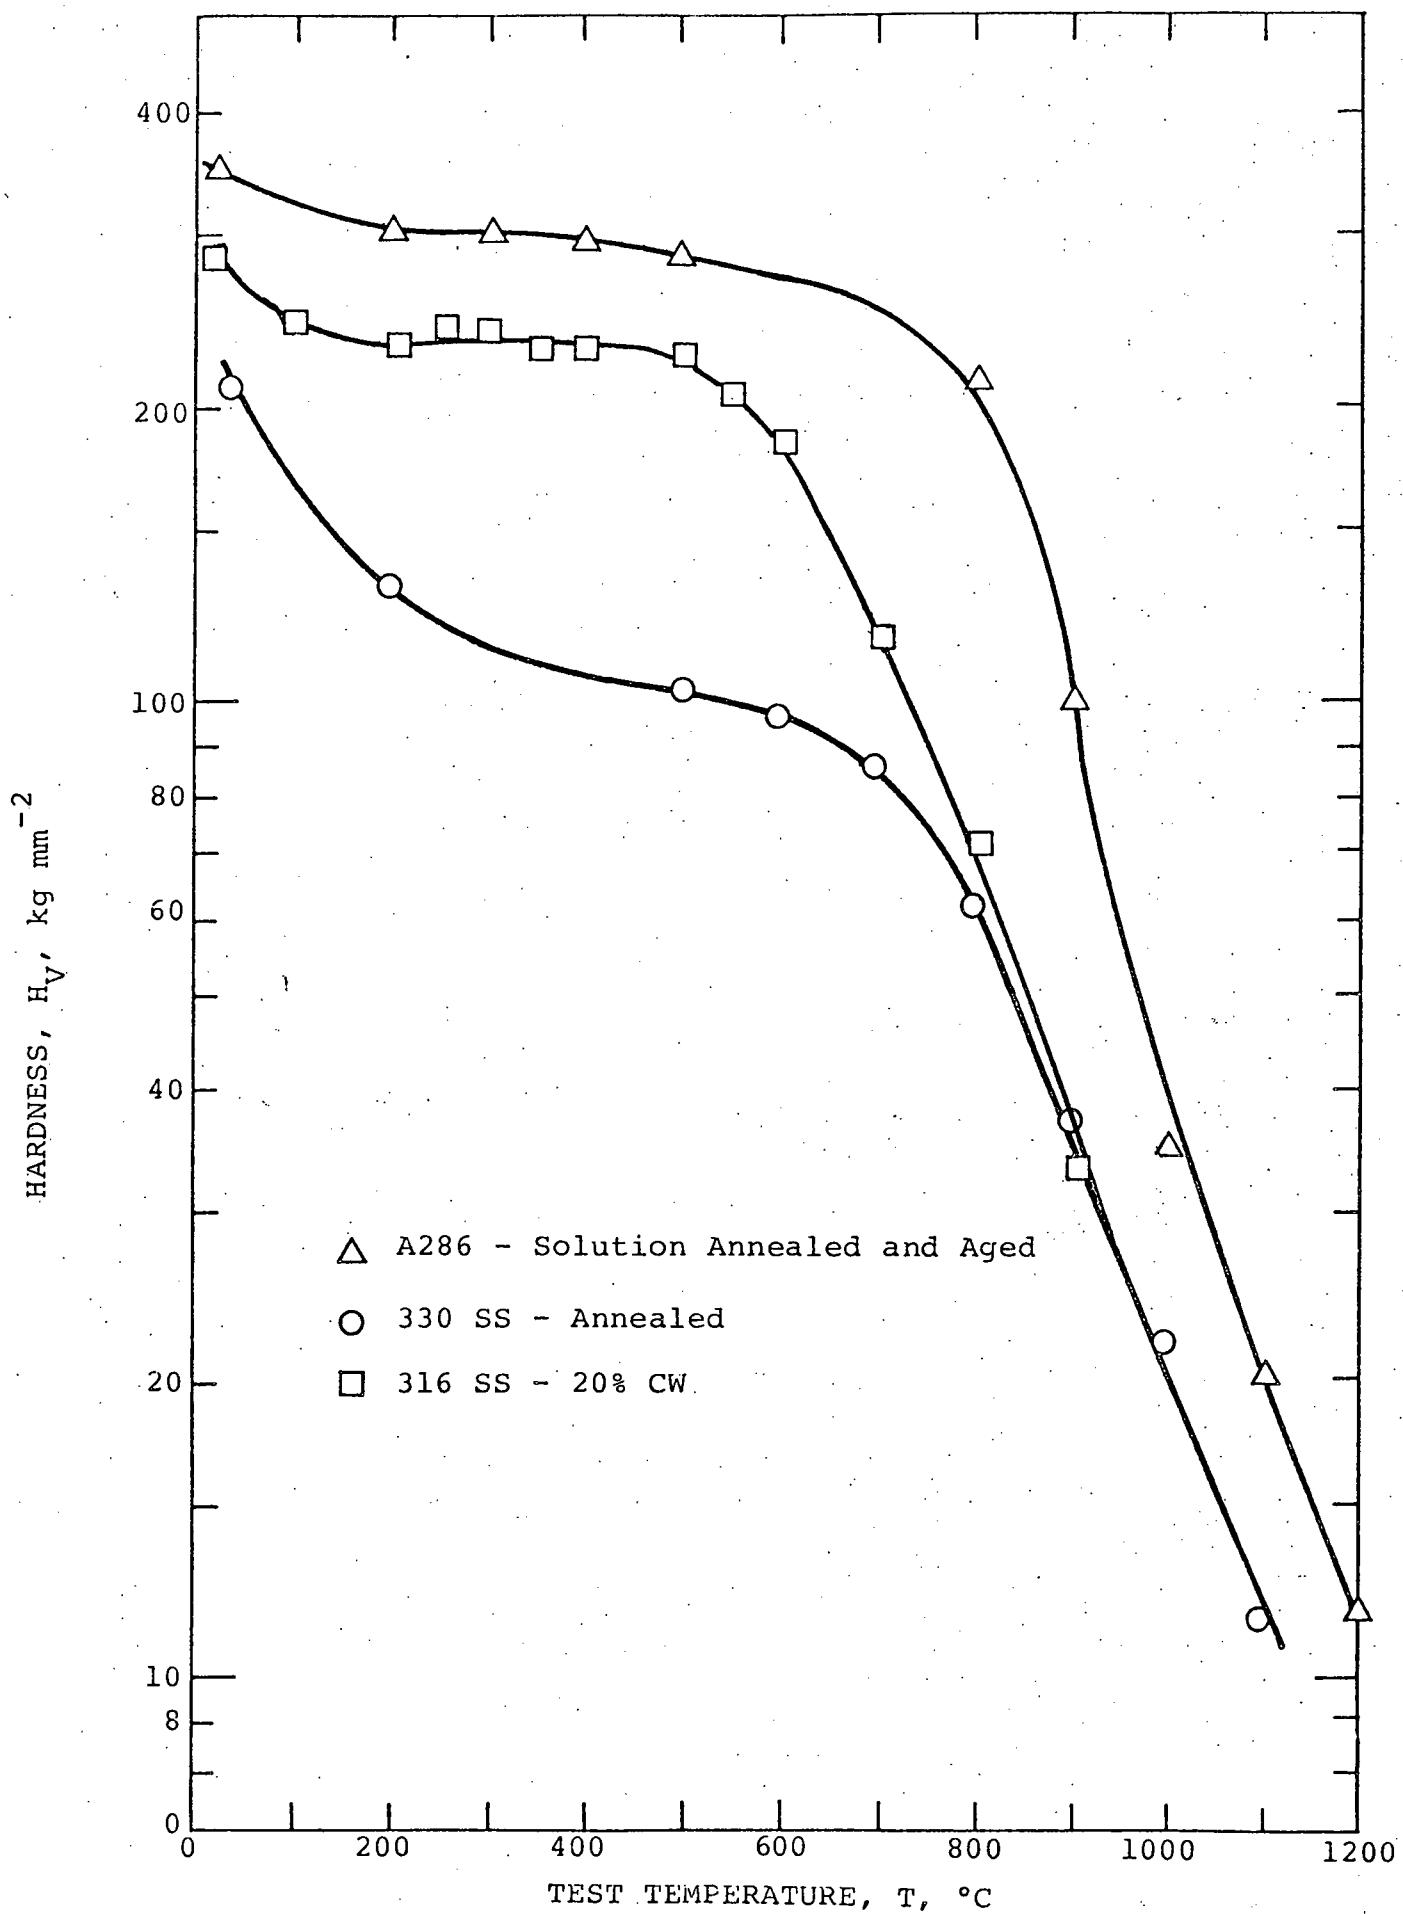
Fig. 7. Plot of Hardness versus Temperature for Several High Temperature Alloys.

A comparison of the hot-hardness values of aged A-286 and solutioned AISI 330 stainless steel shows that A-286 is about three times harder than 330 SS in the temperature region of 200 to 900°C (Appendix B).

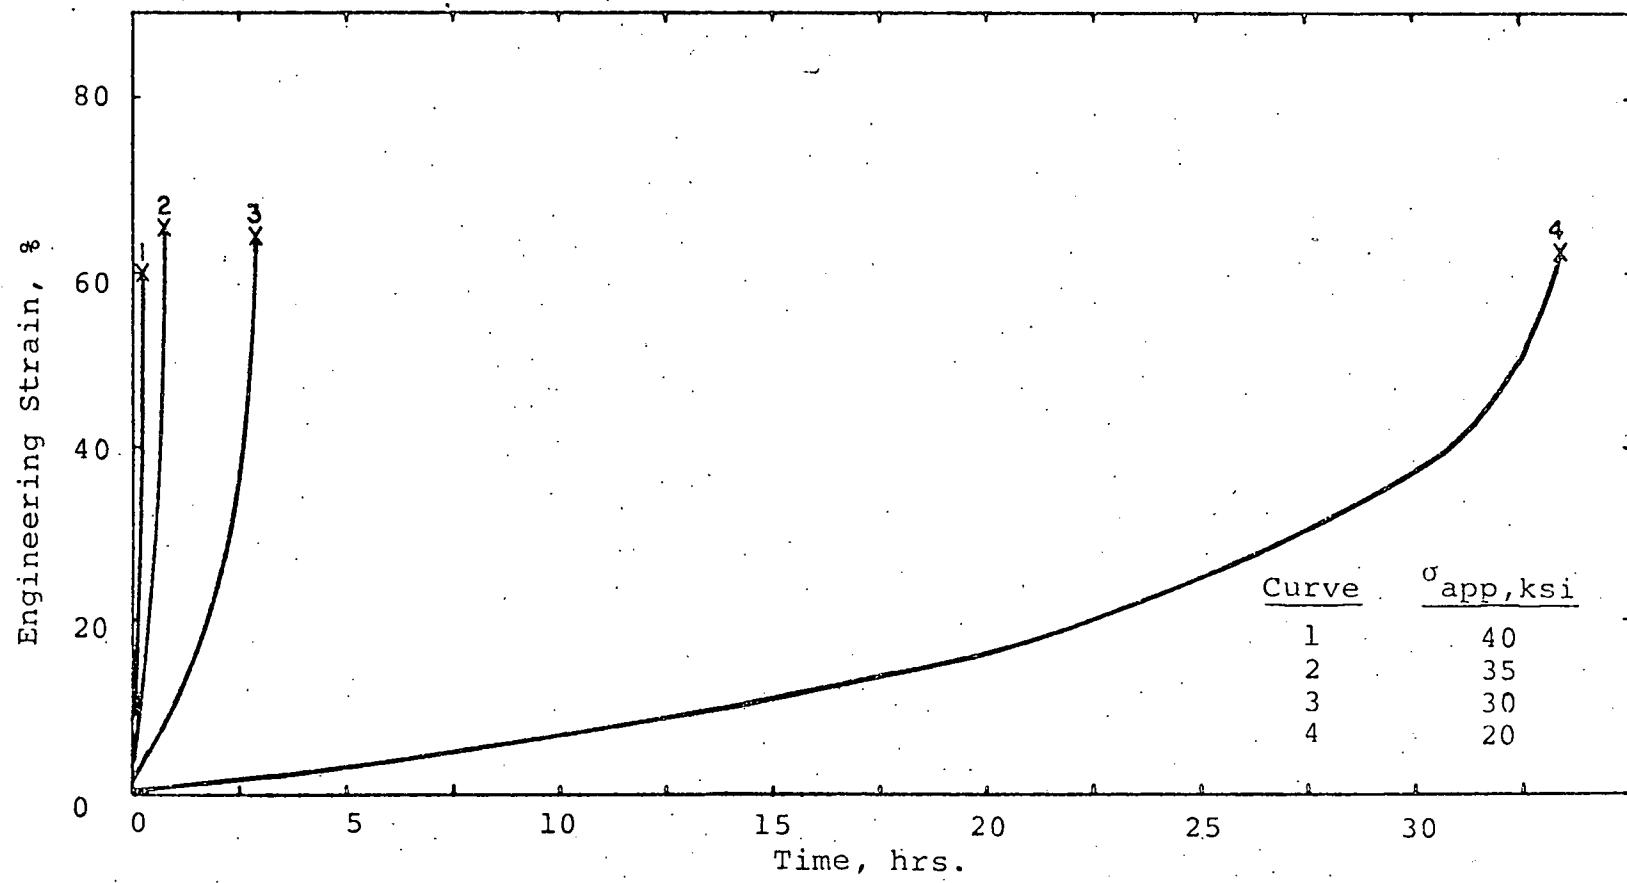
Fig. 7.1. Constant Load Creep-Rupture Curves for AISI 330 Stainless Steel
Tested at Various Applied Stresses (σ_{app}) at 701°C.

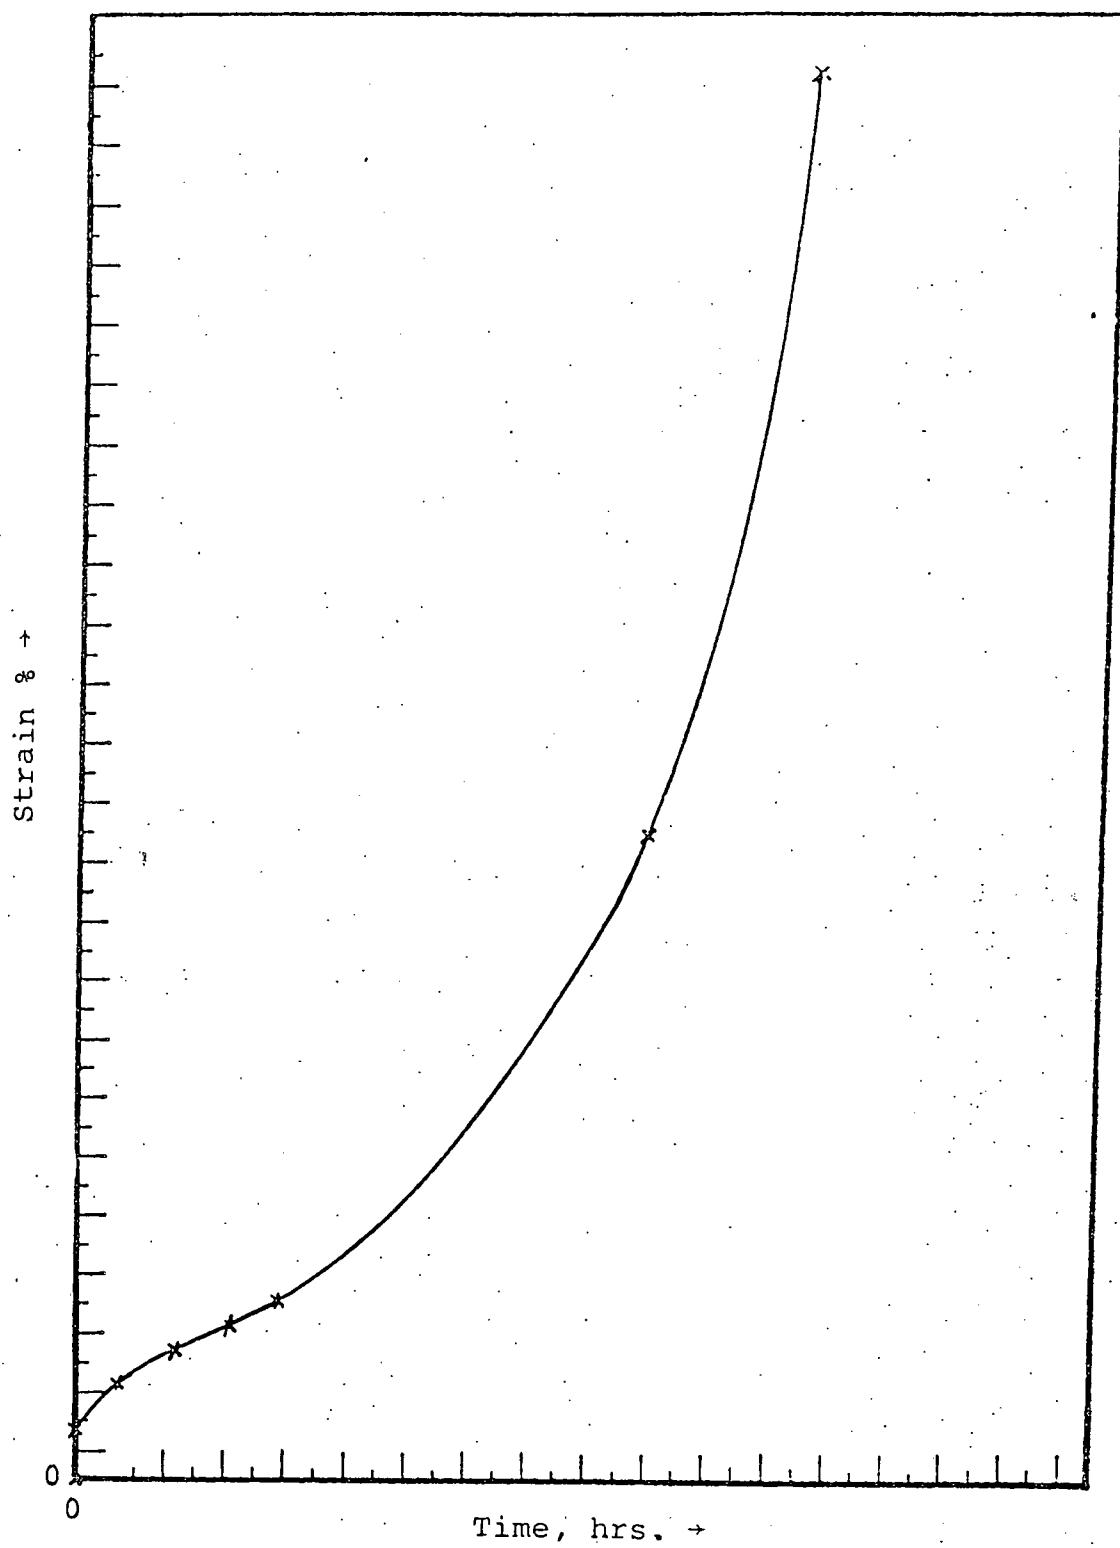
Fig. 7.2. Typical Creep Curve for AISI 330 Stainless Steel. X Denotes Strain Levels at Which Substructure Studies will be made.

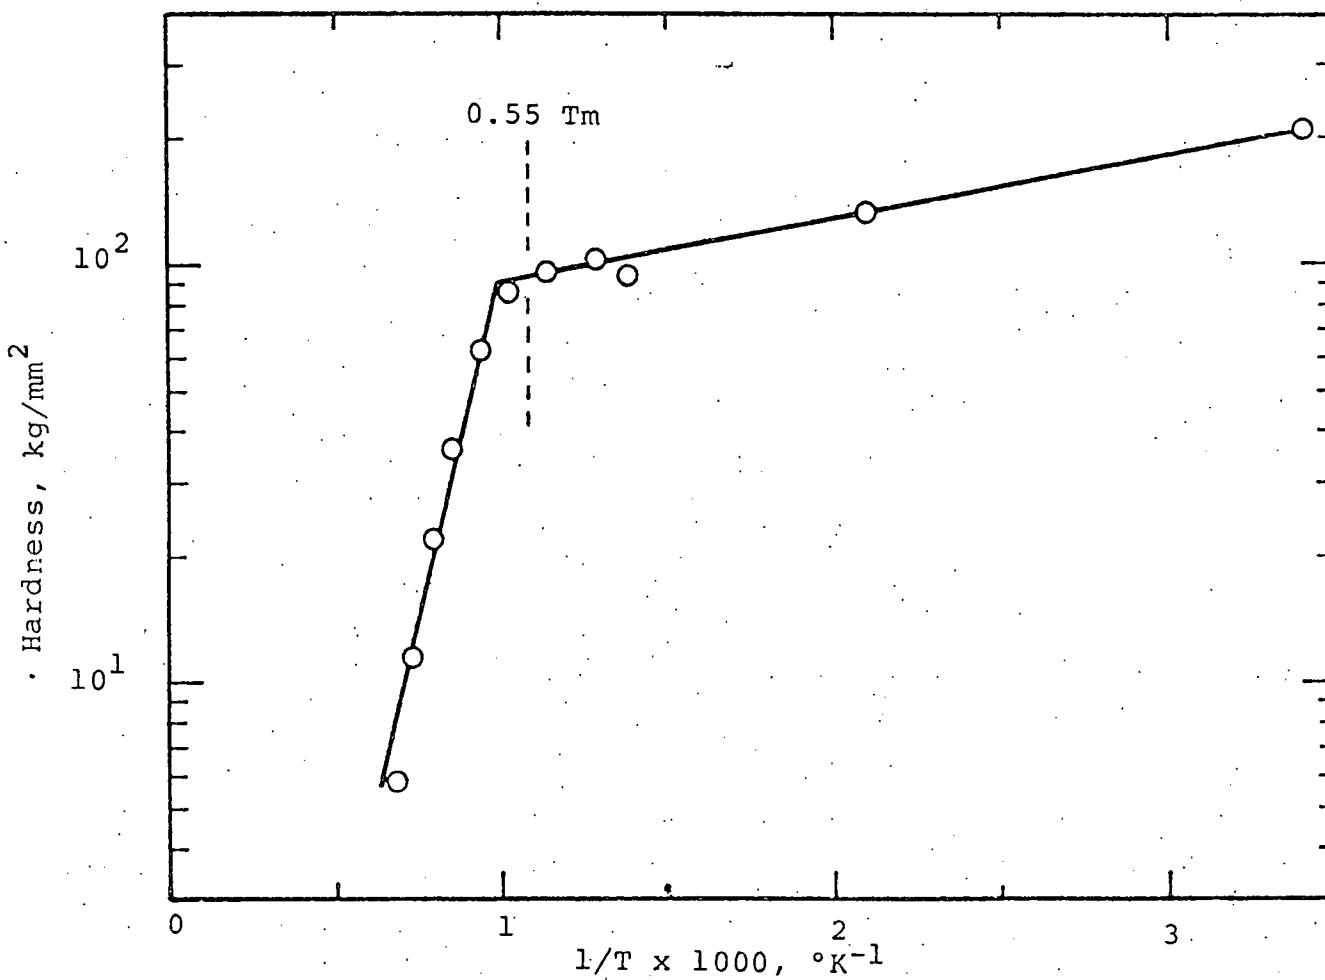
Fig. 7.3. Log Hardness of AISI 330 Stainless Steel Plotted Against 1/T.

The influence of temperature on the hardness of AISI 330 SS is shown in Fig. 3. The logarithmic scale of hardness vs. $1/T$ is used in accordance with Equation 7.2. The shape of the hardness/temperature curve can be described as two straight lines intersecting at about $0.55 T_m$. The inflection of the curve at around $0.5 T_m$ has been observed in many other metals, and it has been attributed to a change in the deformation mechanism from normal slip processes below the inflection to diffusion-controlled processes above the inflection. From

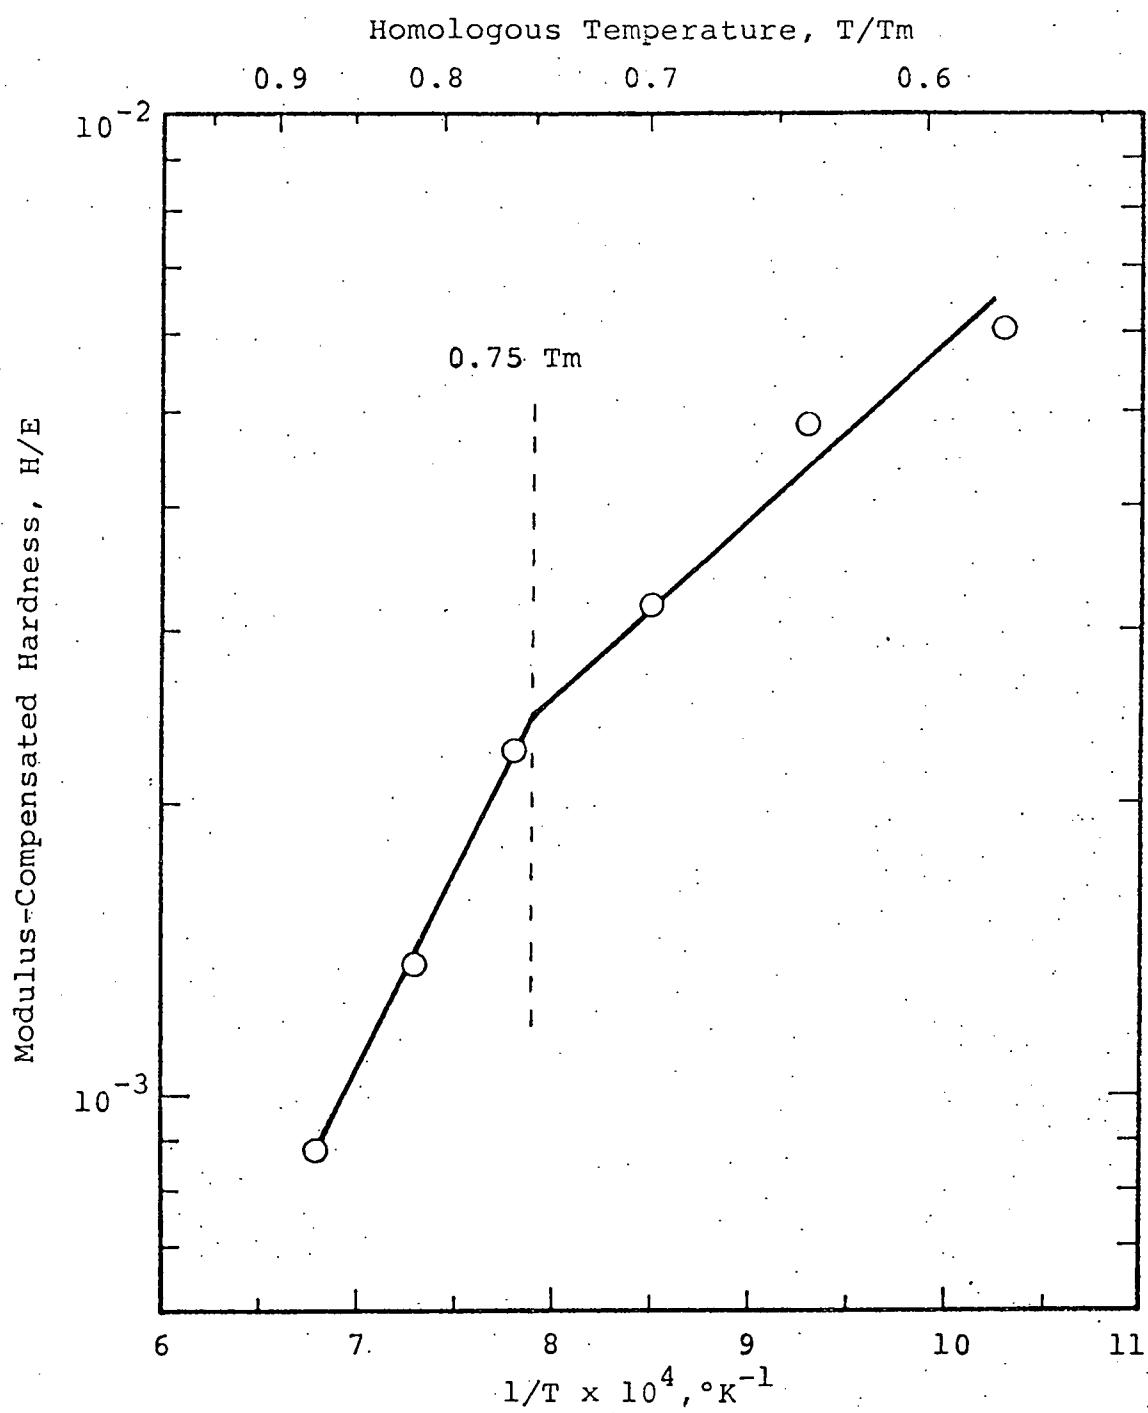
Fig. 7.4. Modulus-Compensated Hardness vs. $1/T$ of AISI 330 Stainless Steel.

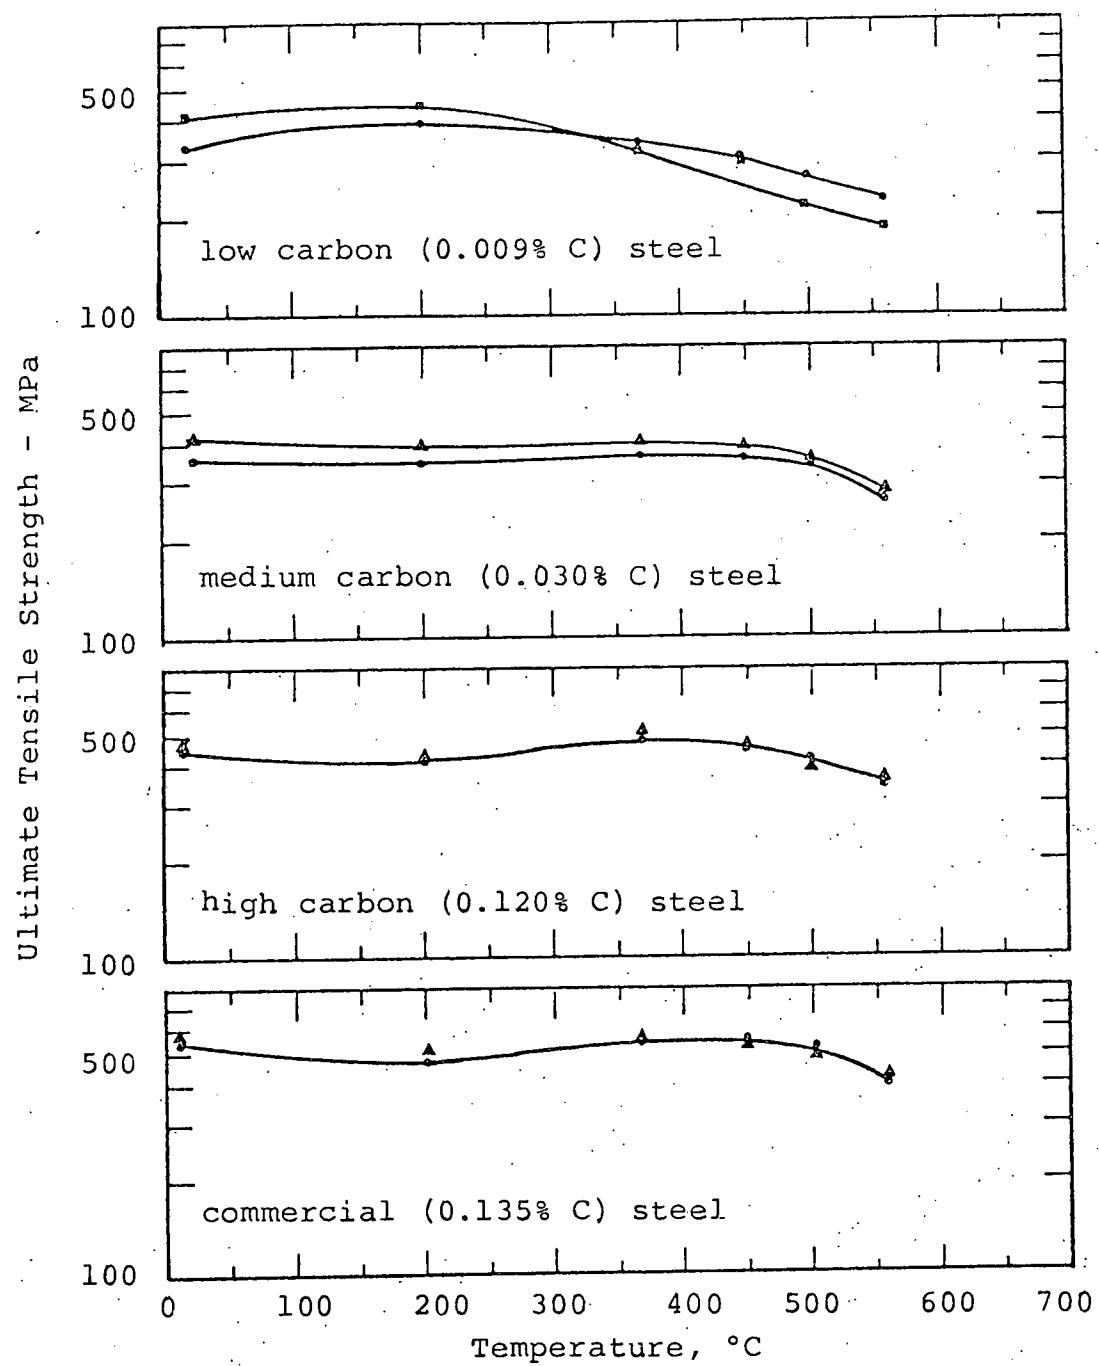
Fig. 7.5. Ultimate Tensile Strength of 2 1/4 Cr - 1 Mo Steels with Varying Carbon Contents Plotted Against Temperature. (• - Experimental Data From R. L. Klueh; ▲, ■ - Calculated Values Based on Hot-Hardness Data)

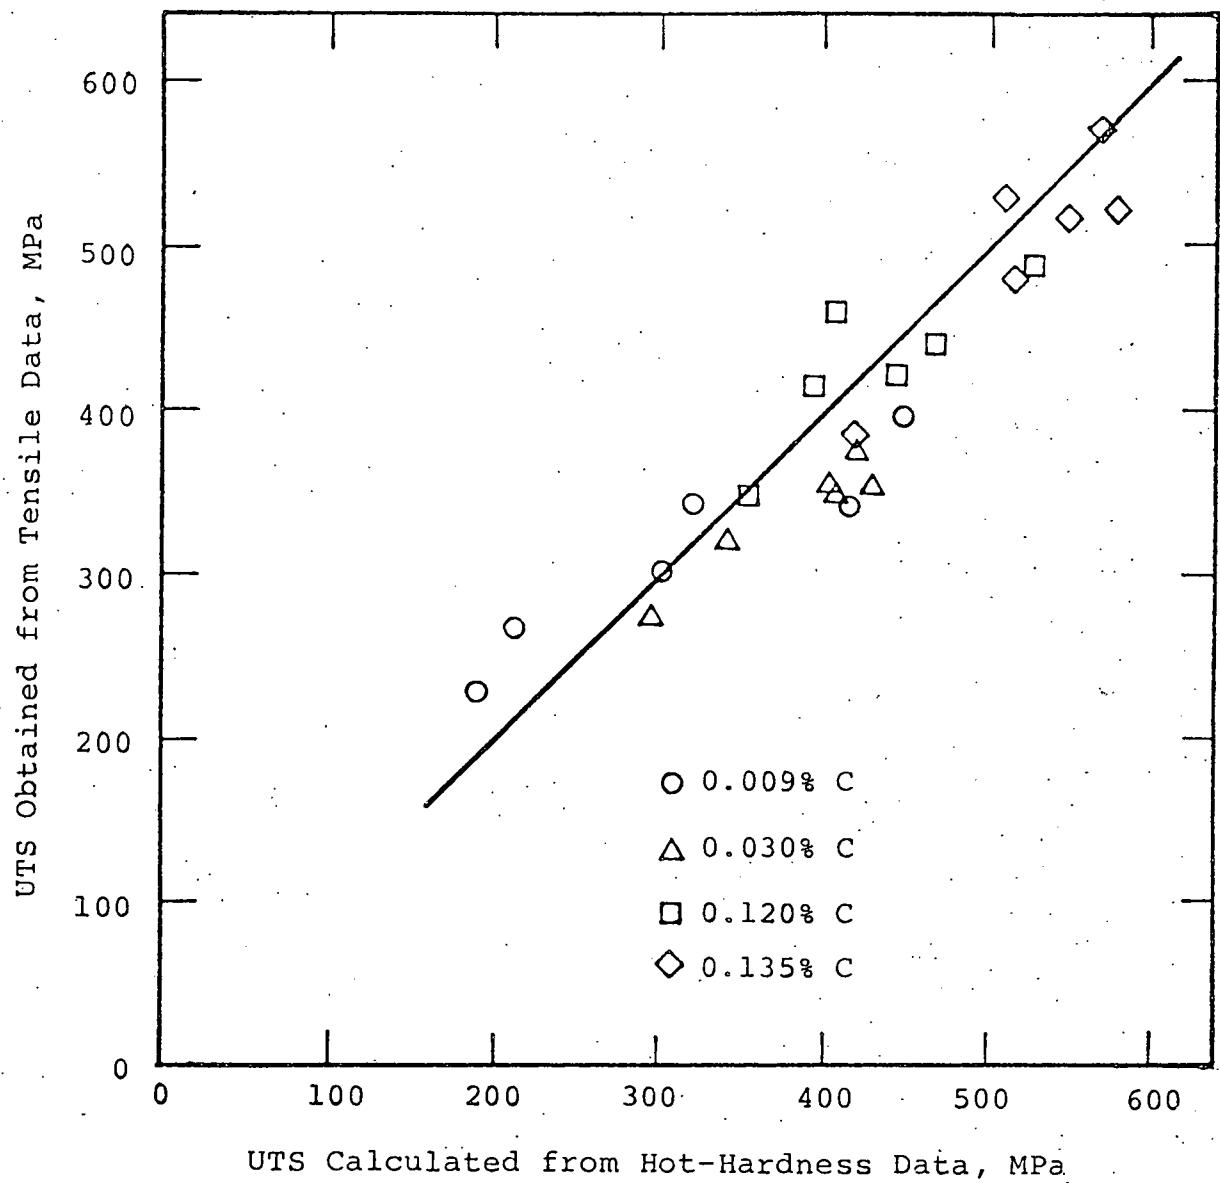
Fig. 7.6. Comparison of the Calculated and Experimental Tensile Strength of 2 1/4 Cr - 1 Mo Steels with Varying Carbon Contents in the Temperature Range of RT \sim 565°C.

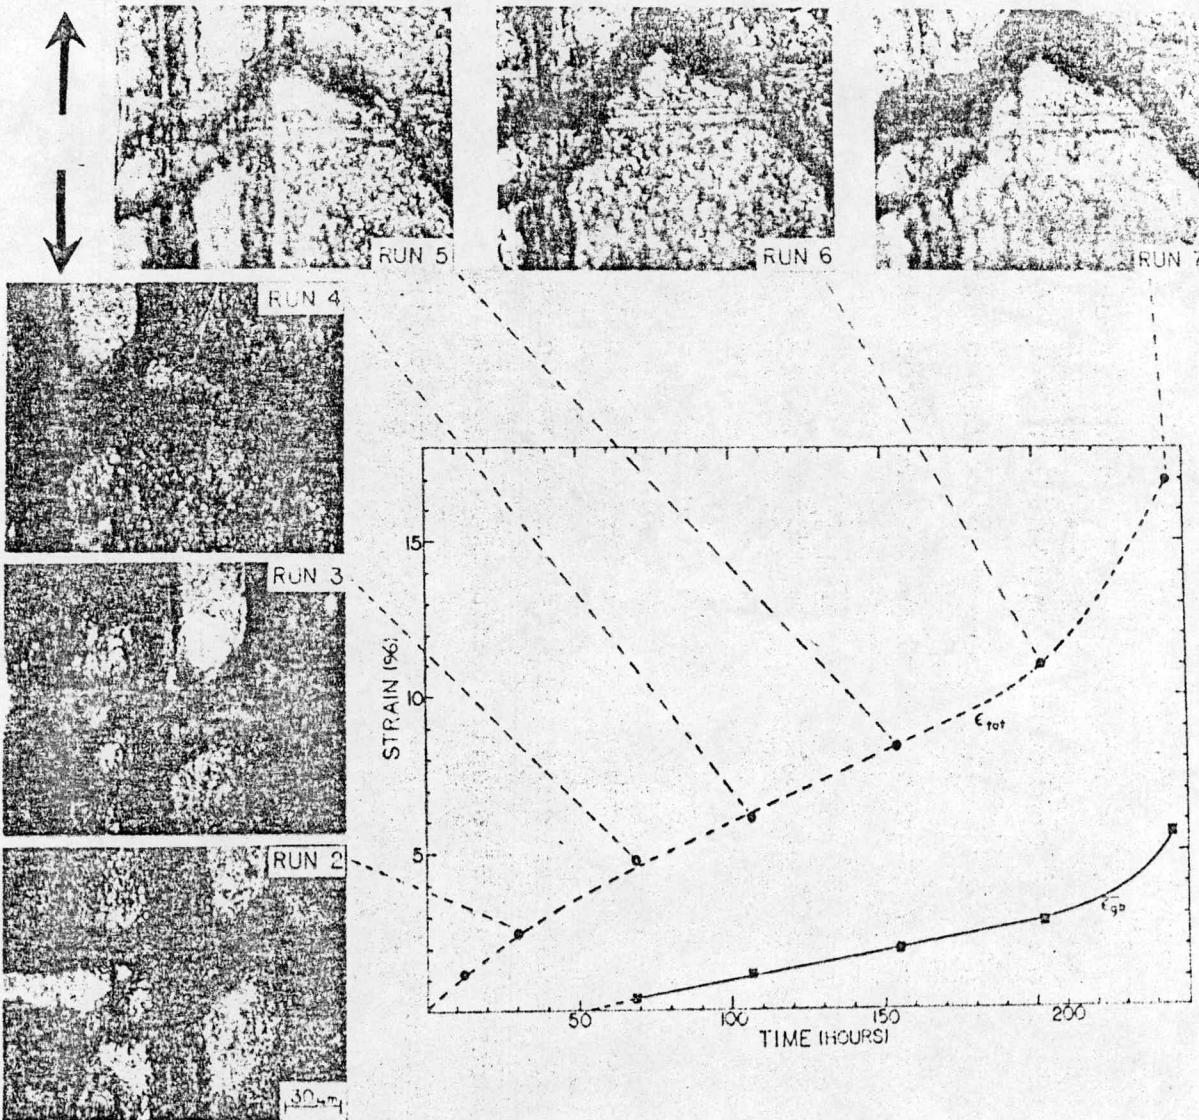
Fig. 7.7. Total Strain and Grain Boundary Sliding Behavior in AISI Stainless Steel Creep Tested at 9 ksi and 750°C.

A controlled-atmosphere, direct-loading creep testing machine has been constructed for the grain boundary sliding experiments. A preliminary result obtained from AISI 304 stainless steel tested at 750°C with an applied stress of 9,000 psi is in agreement with the data which has been reported in the literature. More detailed experiments are being planned (Appendix C).

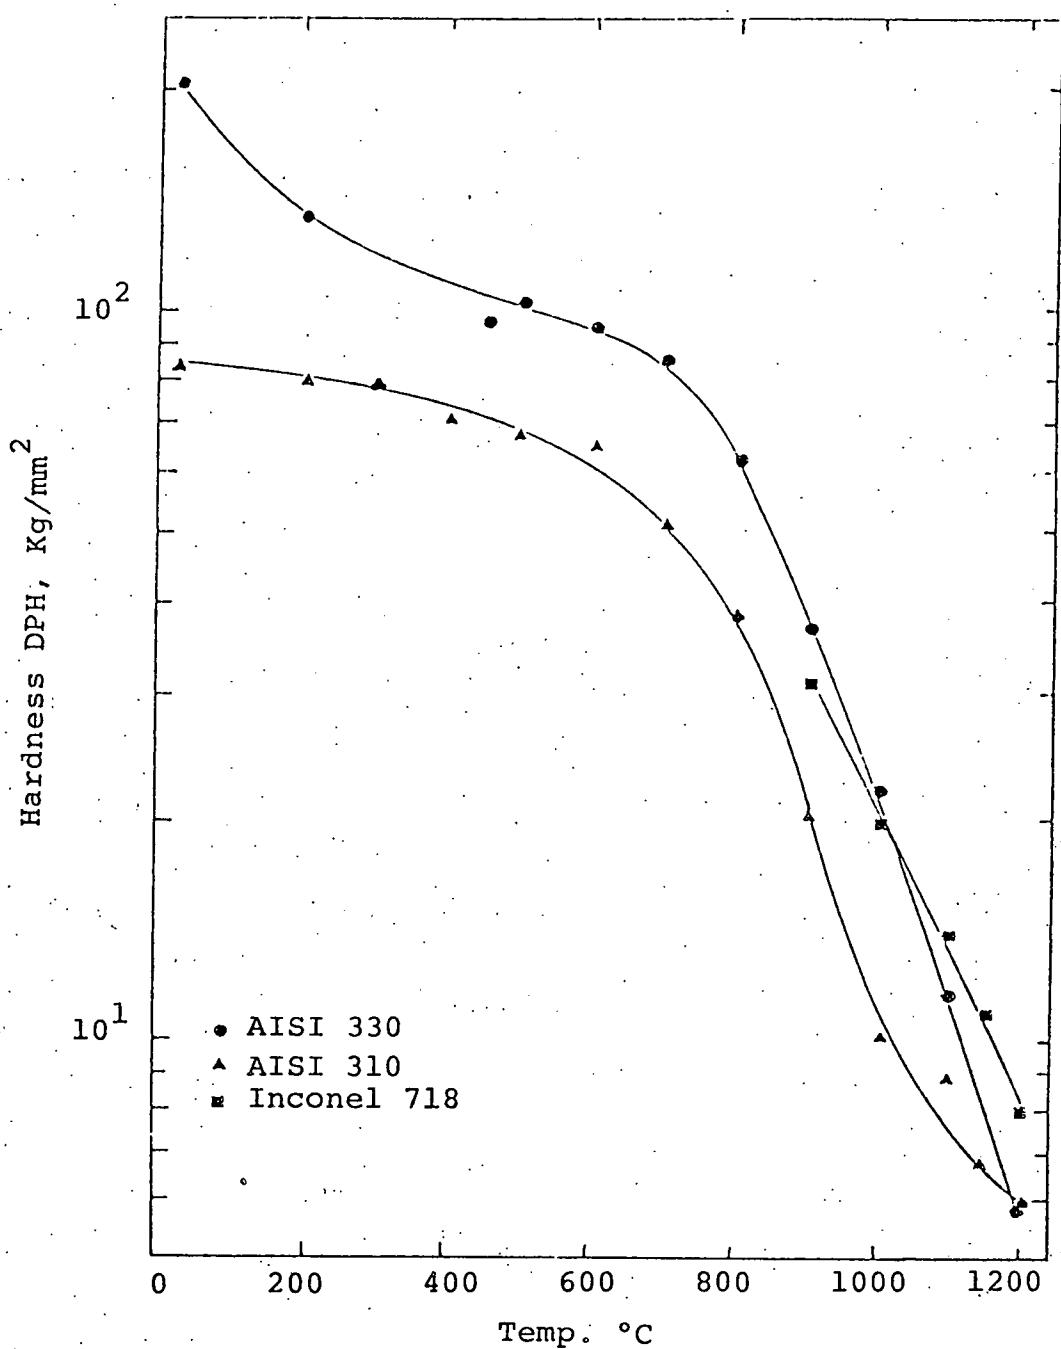
Fig. 7.1. Hardness versus Temperature for AISI 310 and Inconel 718 Compared to AISI 330.

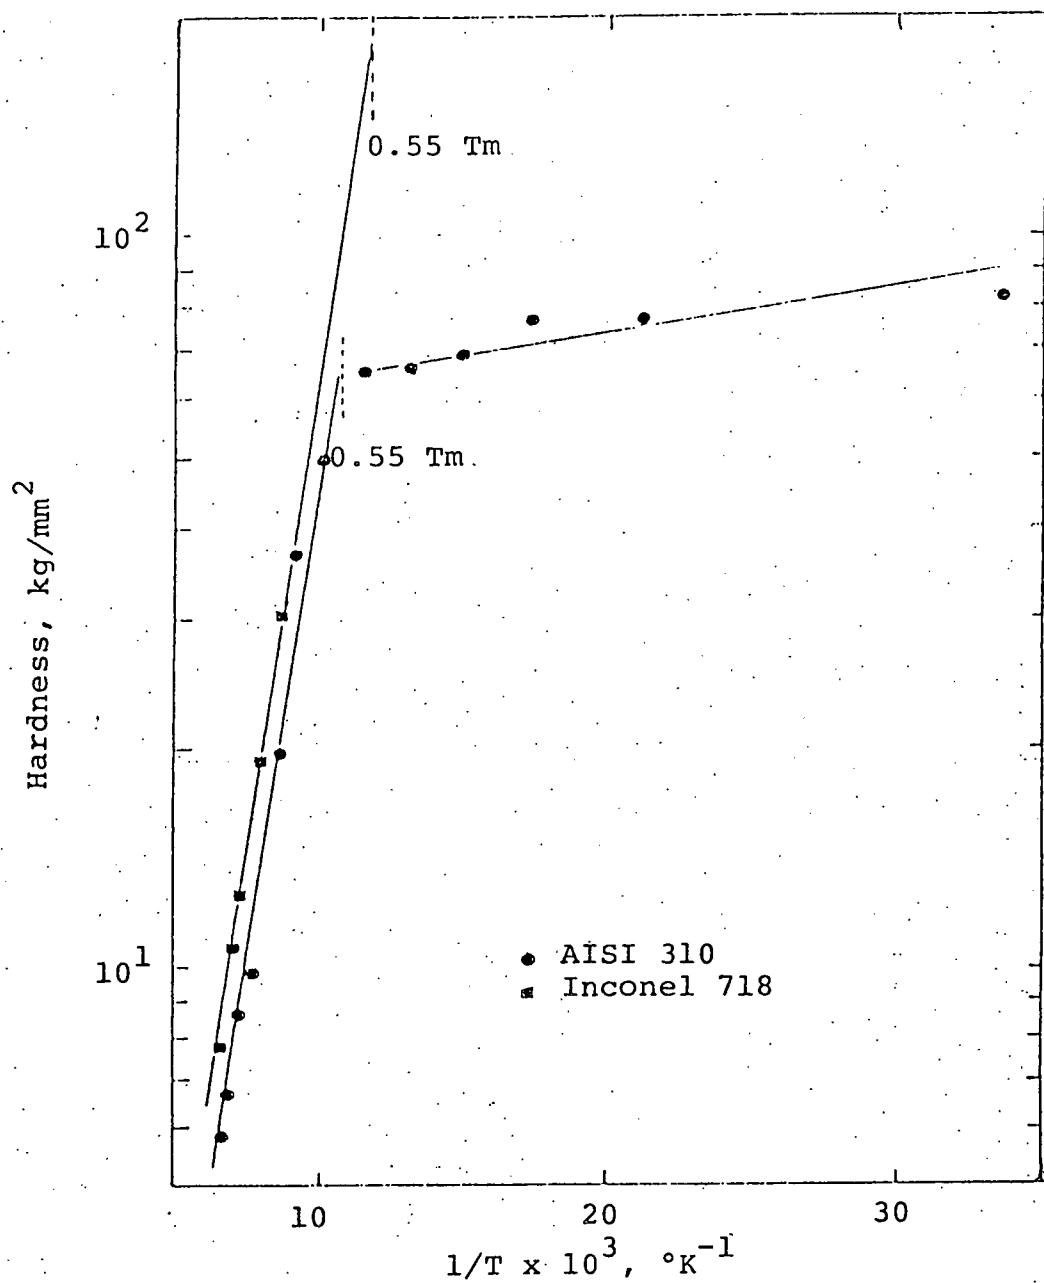
Fig. 7.2. Log Hardness versus $1/T$ for AISI 310 and Inconel 718.

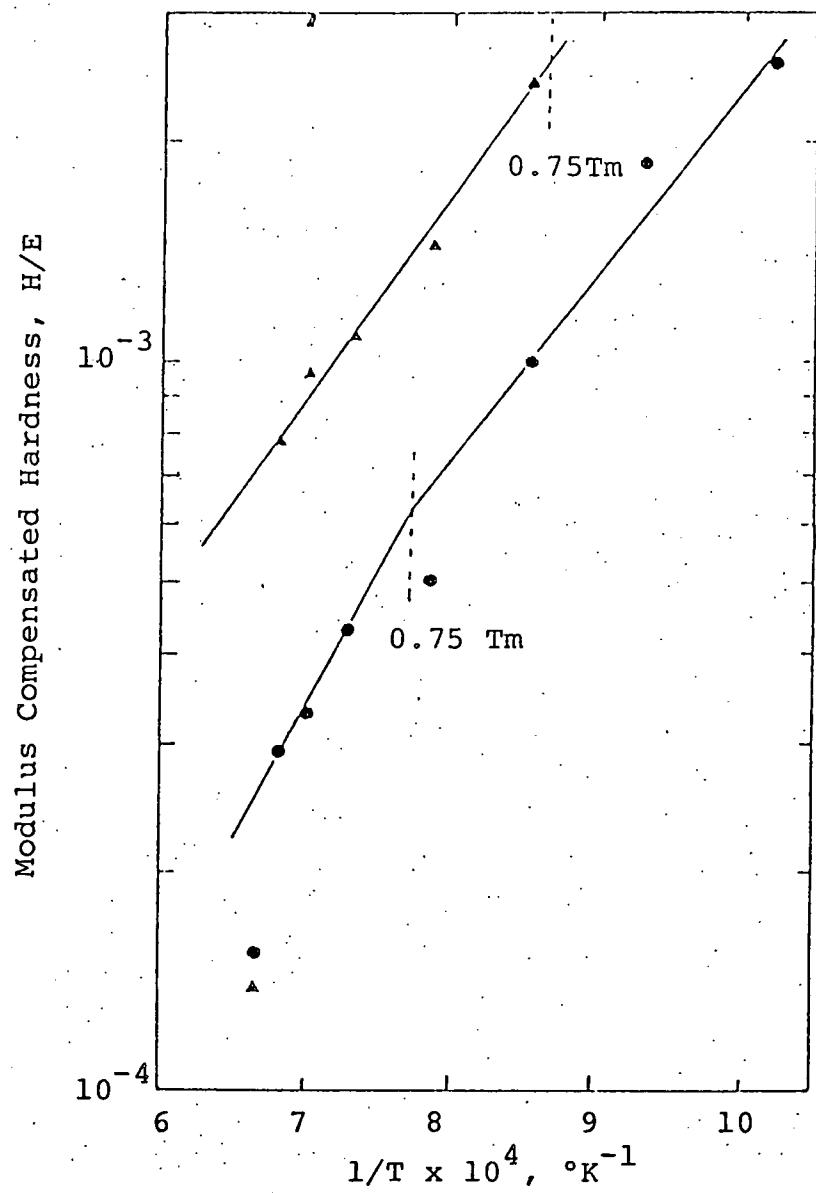
Fig. 7.3. Modulus Compensated Hardness versus $1/T$ for AISI 310 and Inconel 718.

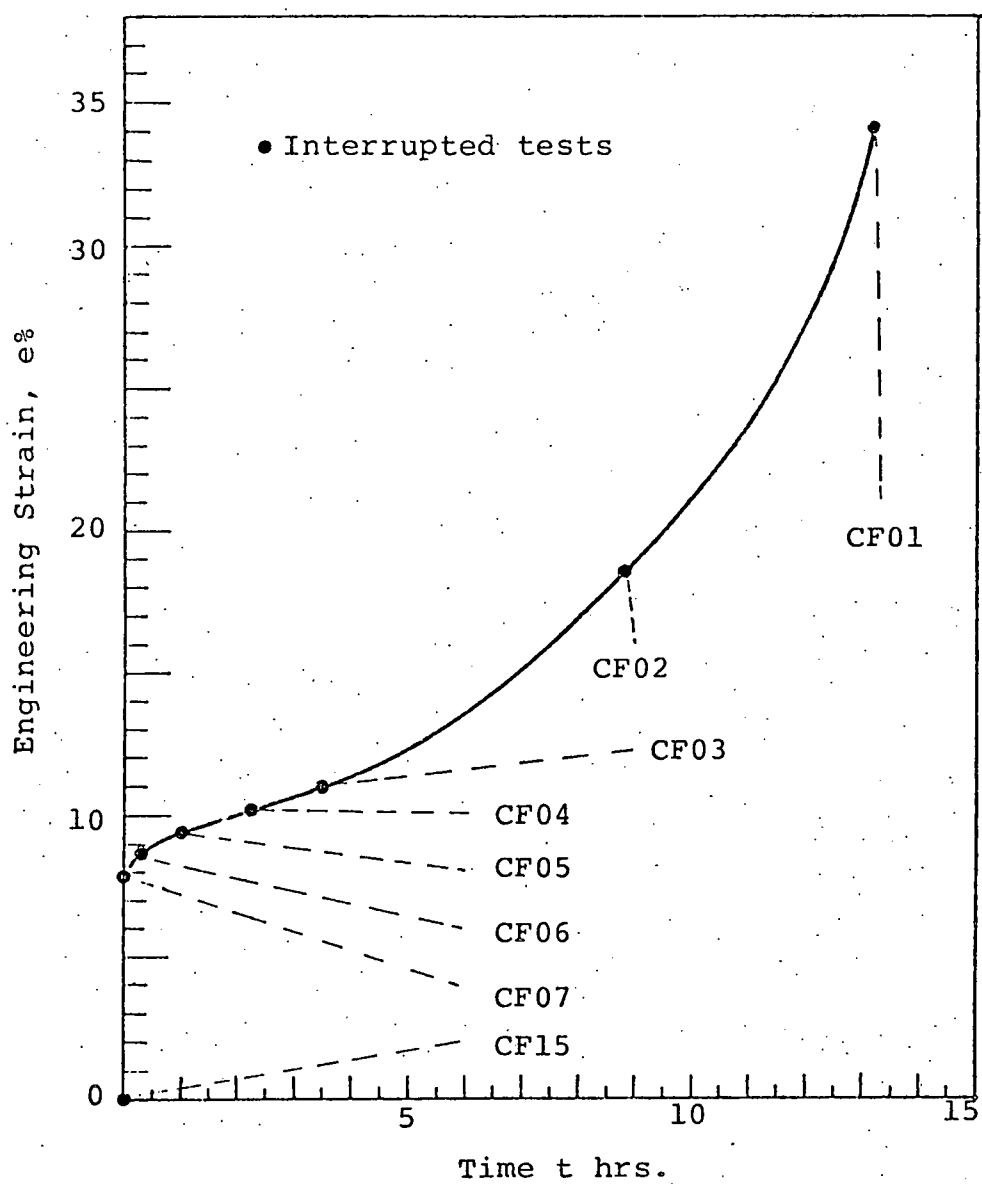
Fig. 7.4. Strain Behavior of AISI 330 Stainless Steel at 652°C and 35 ksi Applied Stress.

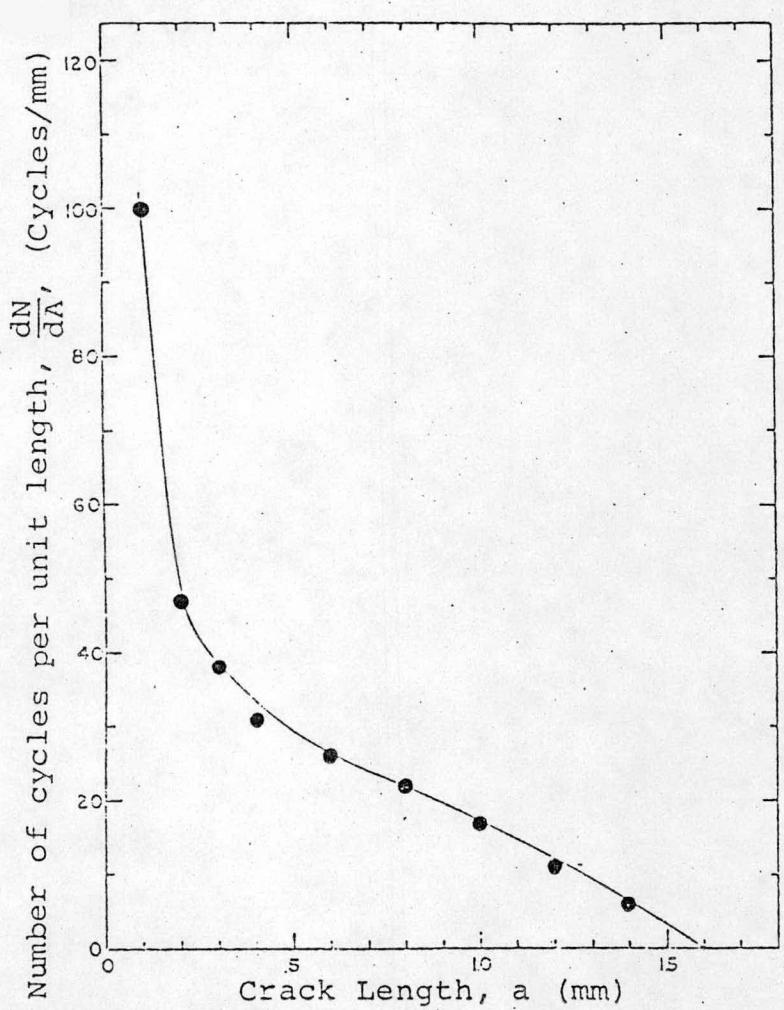
Fig. 7.6 a. Striation Density (dN/da) or the Number of Cycles per Unit Length Plotted Against Crack Length, a .

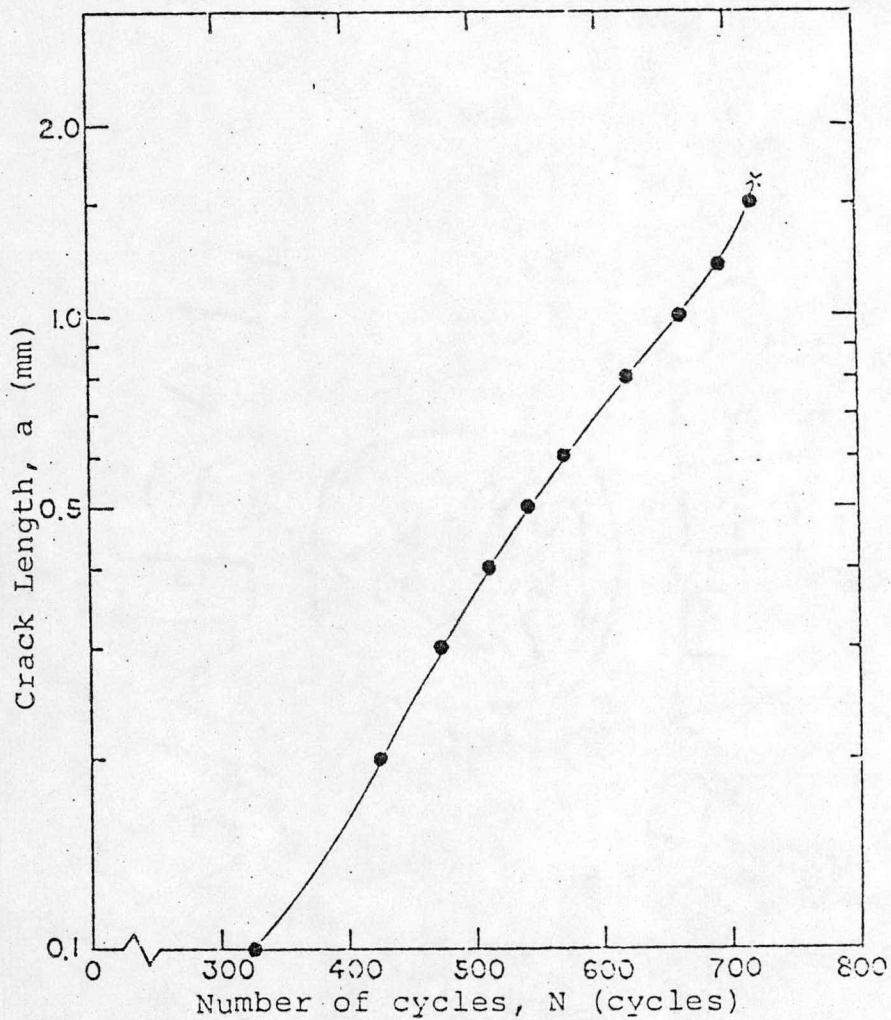
Fig. 7.6 b. $\ln a$ Versus N Plots of AISI 304 SS at 649°C in Air.

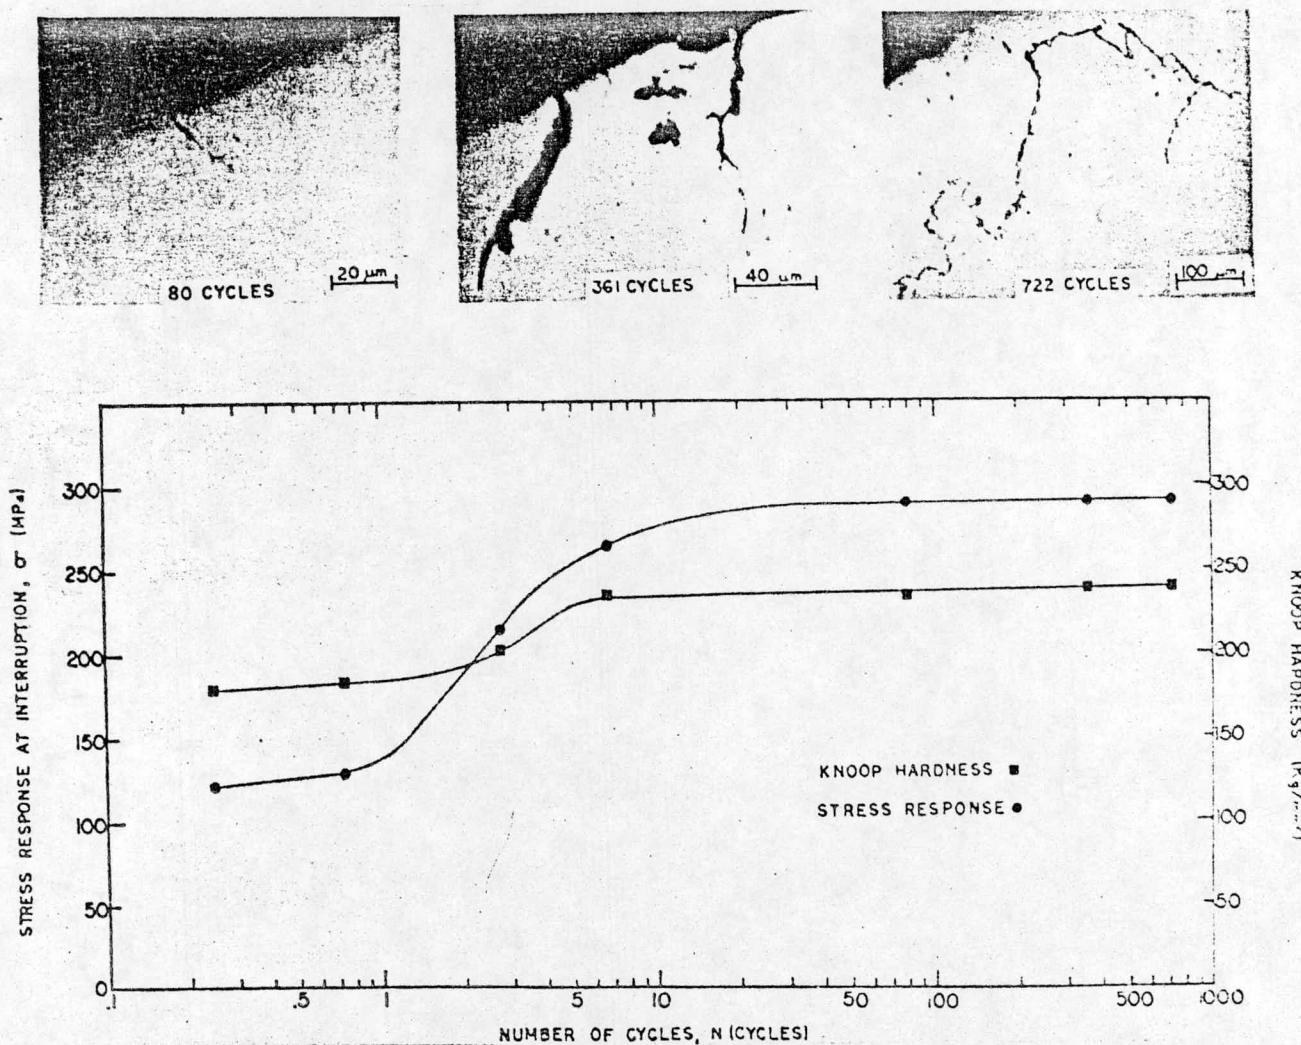
Fig. 7.7. Unetched Metallographic Specimens, Interrupted Before Failure, Showing the Development of a Crack During Crack Initiation and Propagation Periods. Plots Correlating Microhardness and Stress Response as a Function of N (Cycles).
