CORRELATION OF SUBSTRUCTURE WITH MECHANICAL PROPERTIES
OF PLASTICALLY DEFORMED REACTOR STRUCTURAL MATERIALS

Progress Report
for Period January 1, 1976 - June 30, 1977

J. Motteff

Materials Science and Metallurgical Engineering
University of Cincinnati
Cincinnati, Ohio 45221

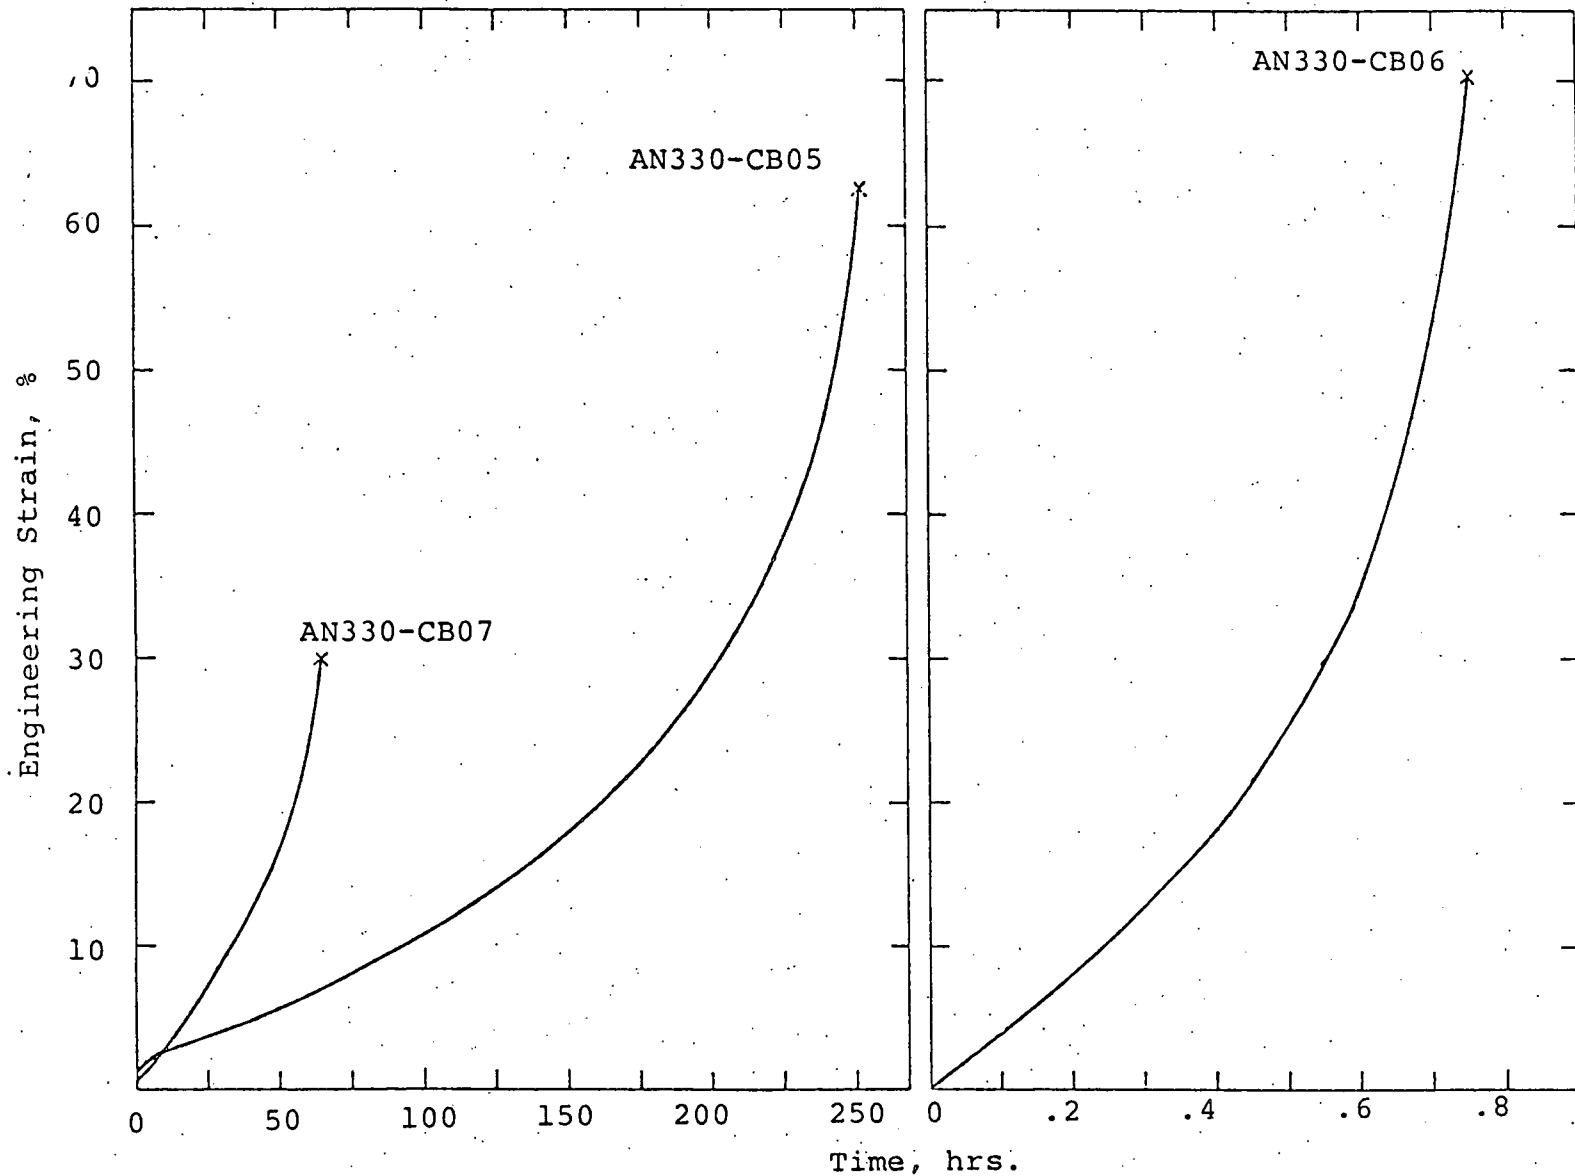
Fig. 7.8. Constant Load Creep-Rupture Curves for AISI 330 Stainless Steel
Tested Various Conditions.

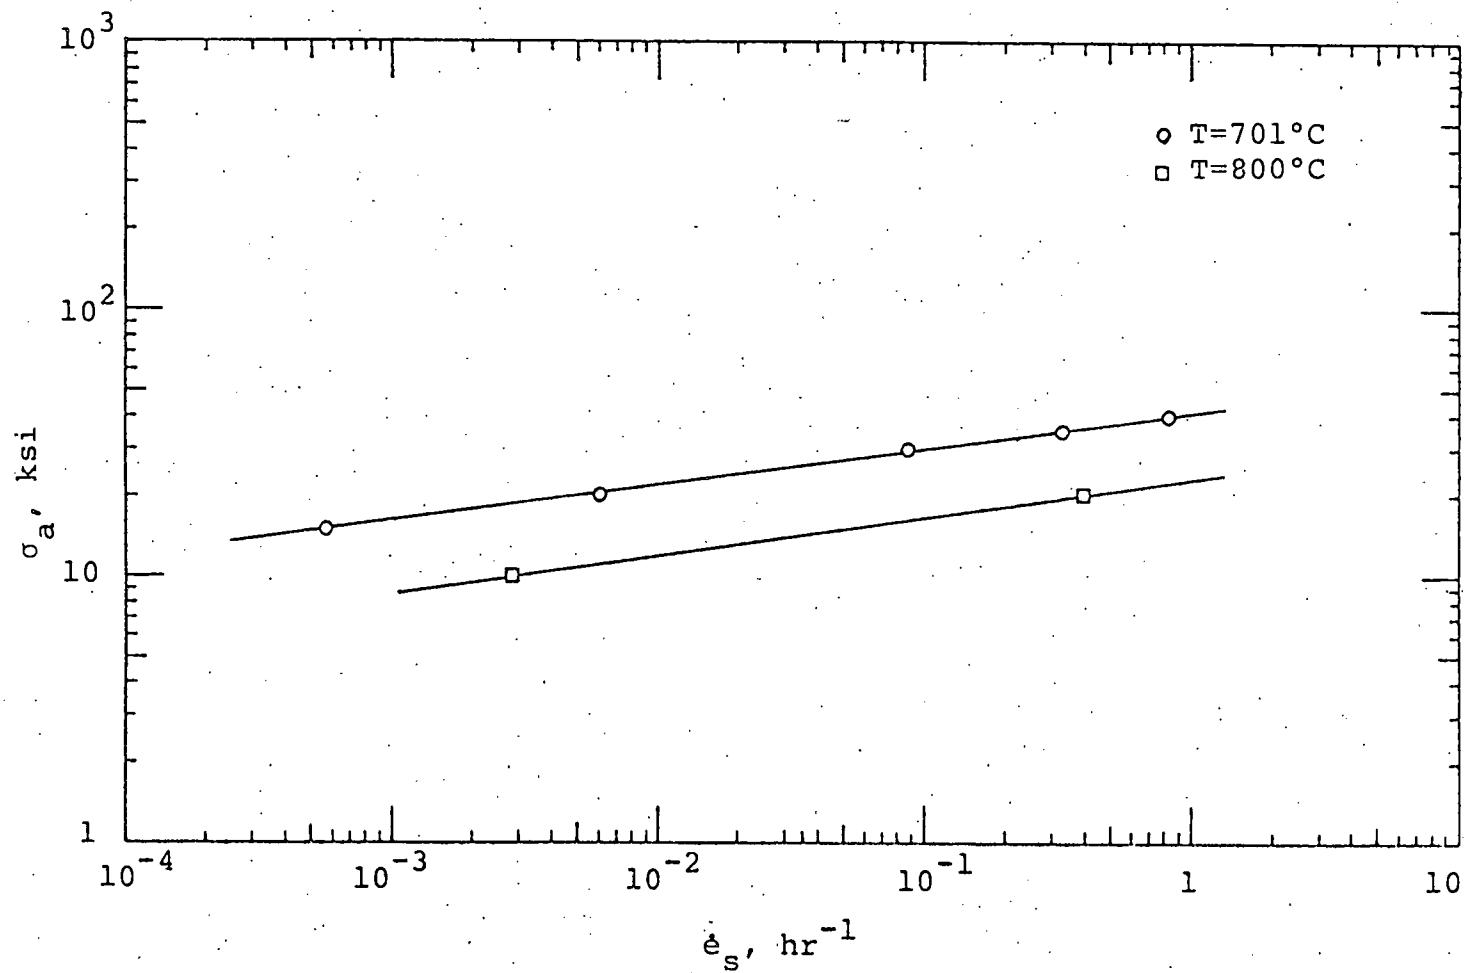
Fig. 7.9. Applied Stress, σ_a , versus Steady State Creep Rate, $\dot{\epsilon}_s$, for AISI 330 Stainless Steel Crept at Various Temperatures and Stresses.

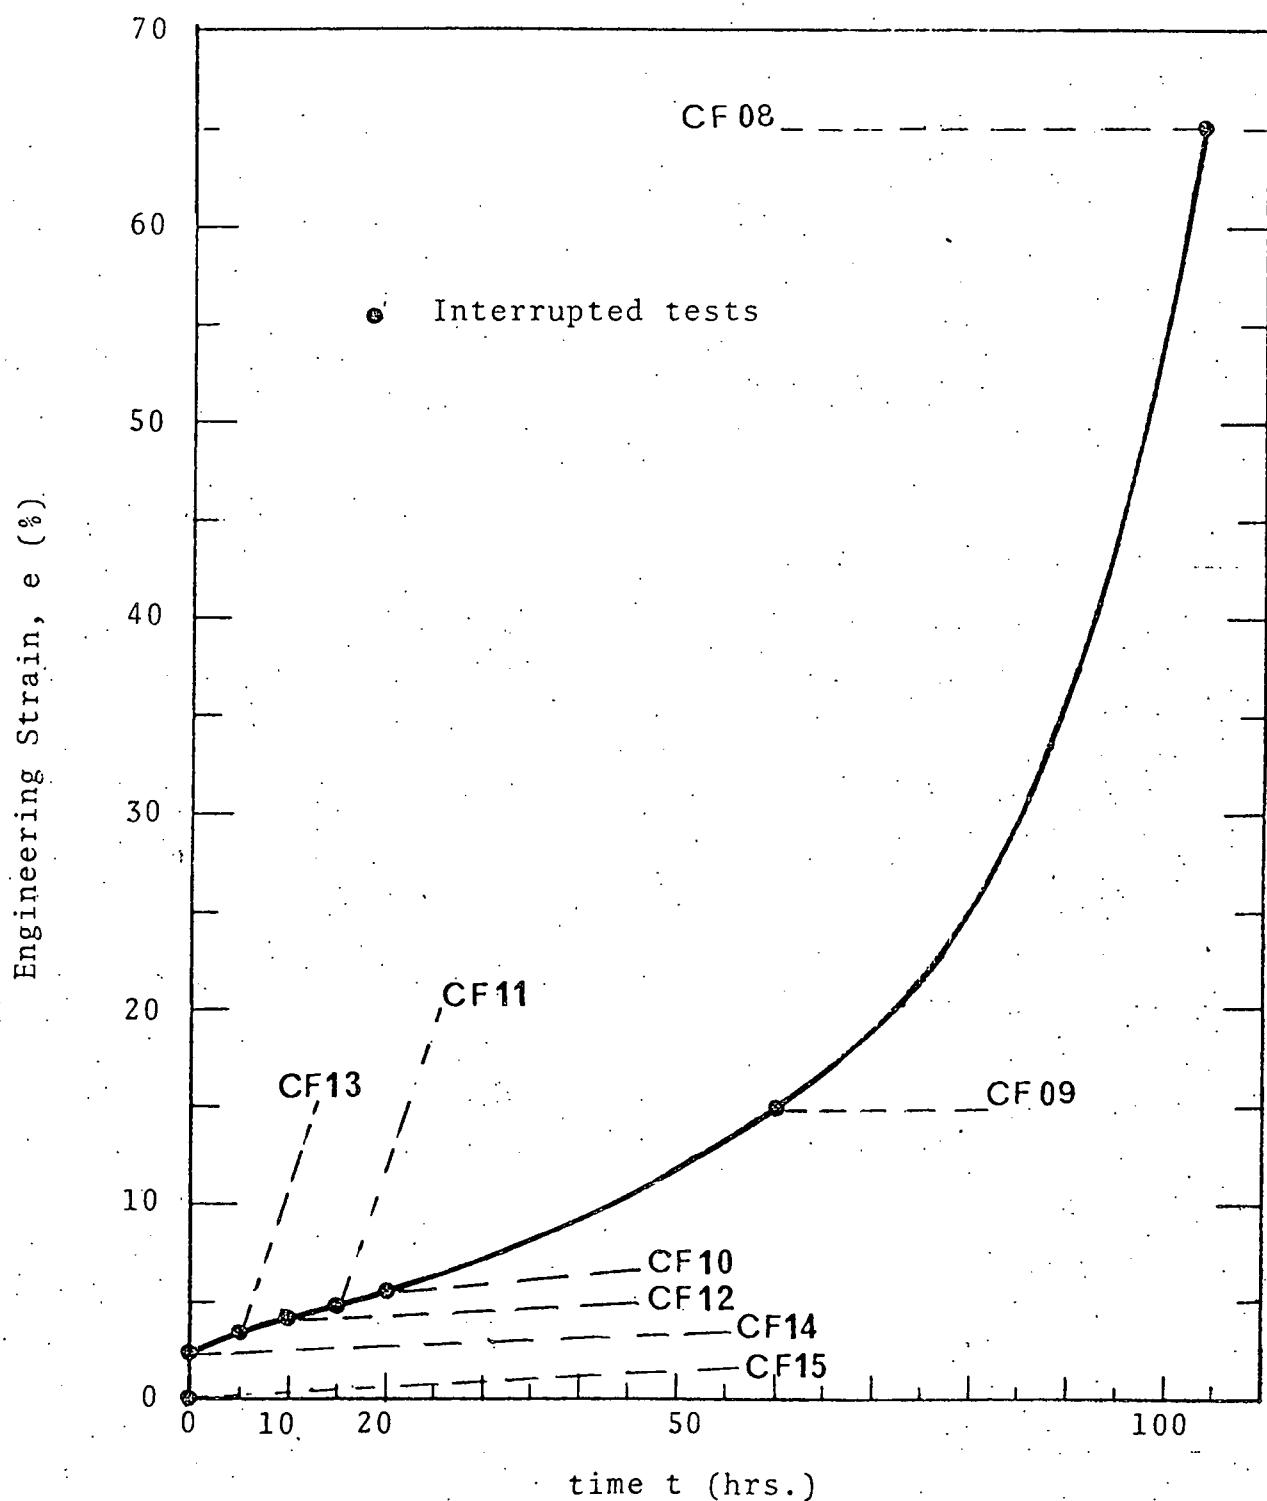
Fig. 7.1 Strain behavior of AISI 330 stainless steel at 652°C and 25 ksi applied stress.

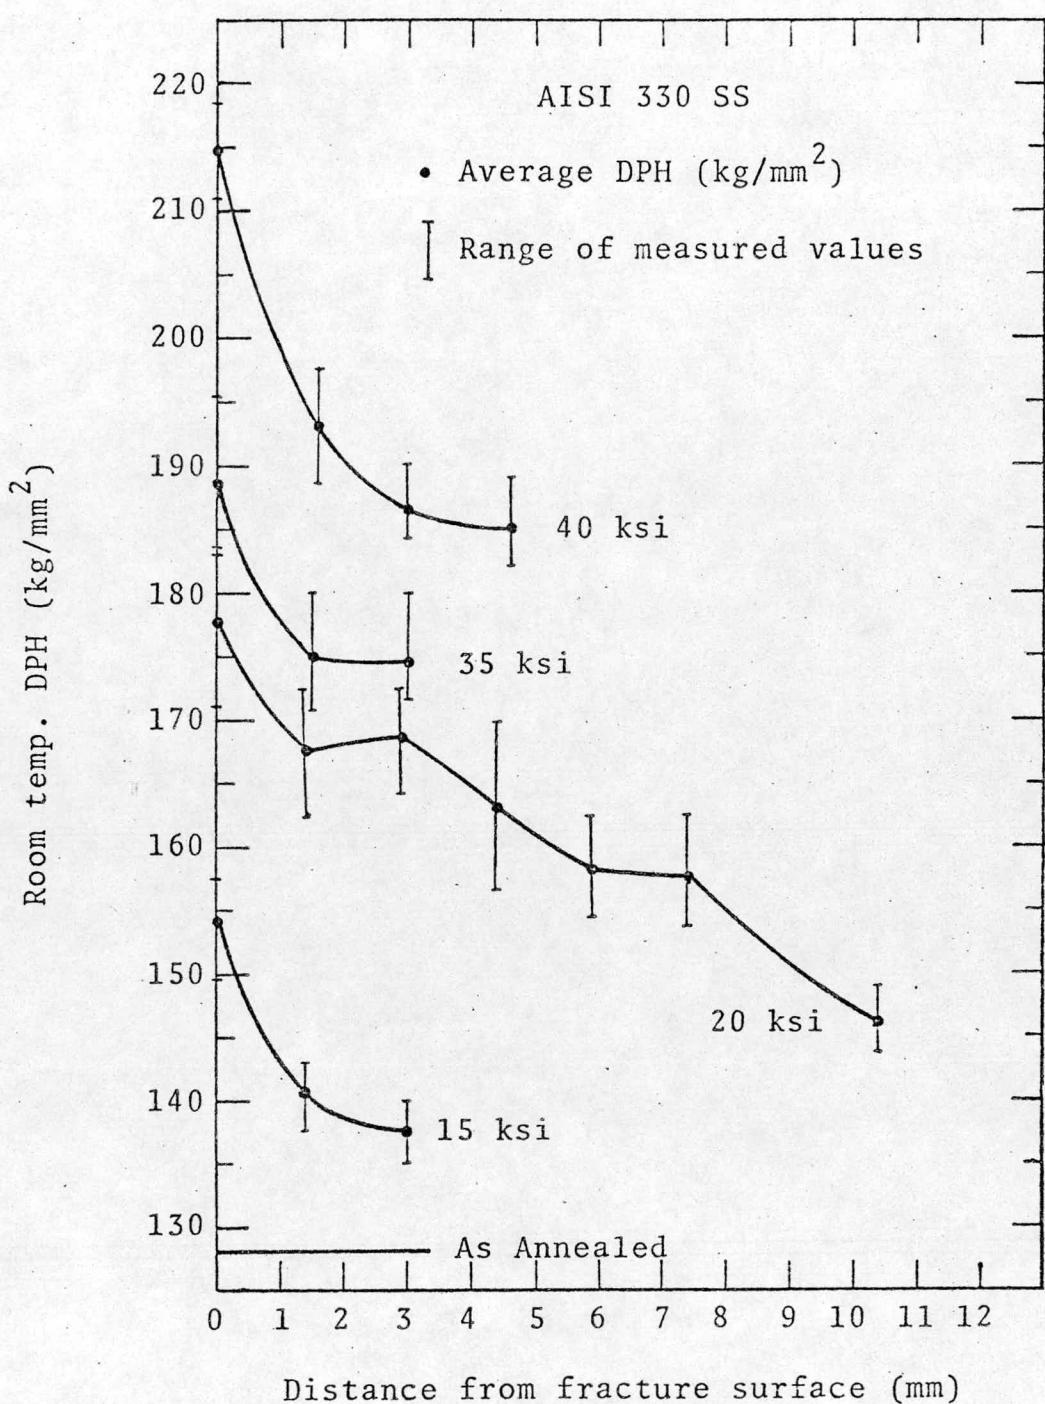
Fig. 7.5 Room temperature microhardness as a function of distance from the fracture surface for various applied stresses at 701°C .

On a series of ruptured specimens, tested at 701°C and at several stress levels ranging from 15 to 40 ksi, room temperature microhardness measurements were made at various locations from the fracture surface along the longitudinal sections. At a given stress level the hardness decreased to a constant value as a function of distance from the fracture surface, and the hardness profiles for different stress levels were quite similar to one another (Appendix E).

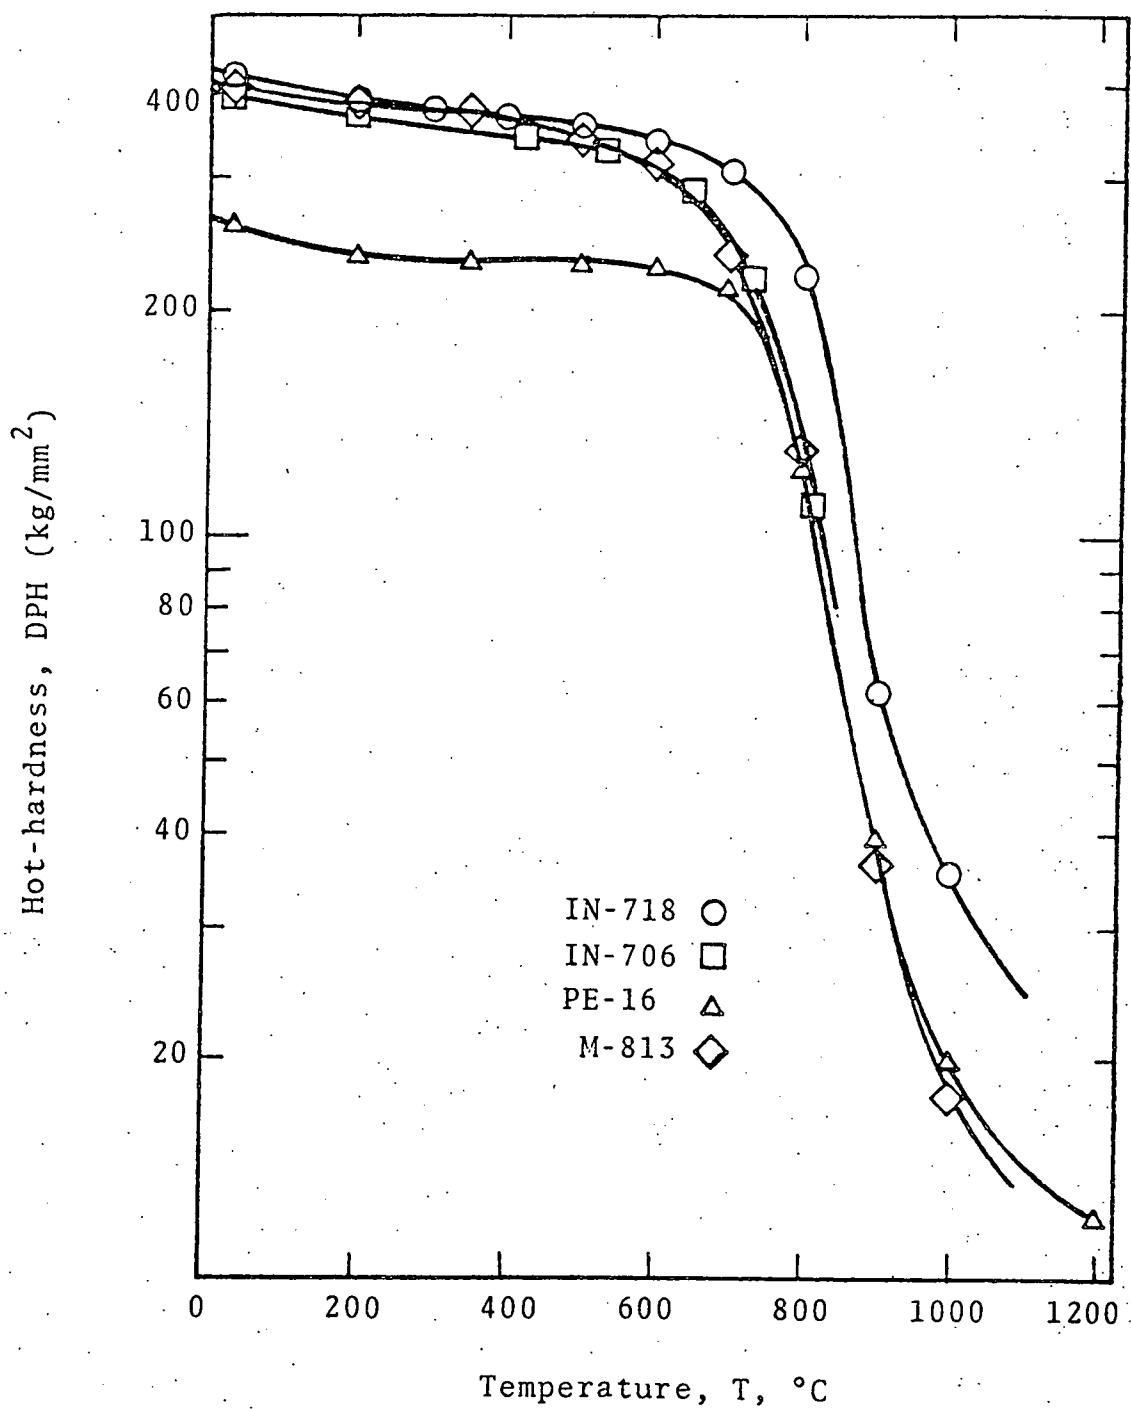
Fig. 7.7 Hot-hardness of several engineering alloys as a function of test temperature.

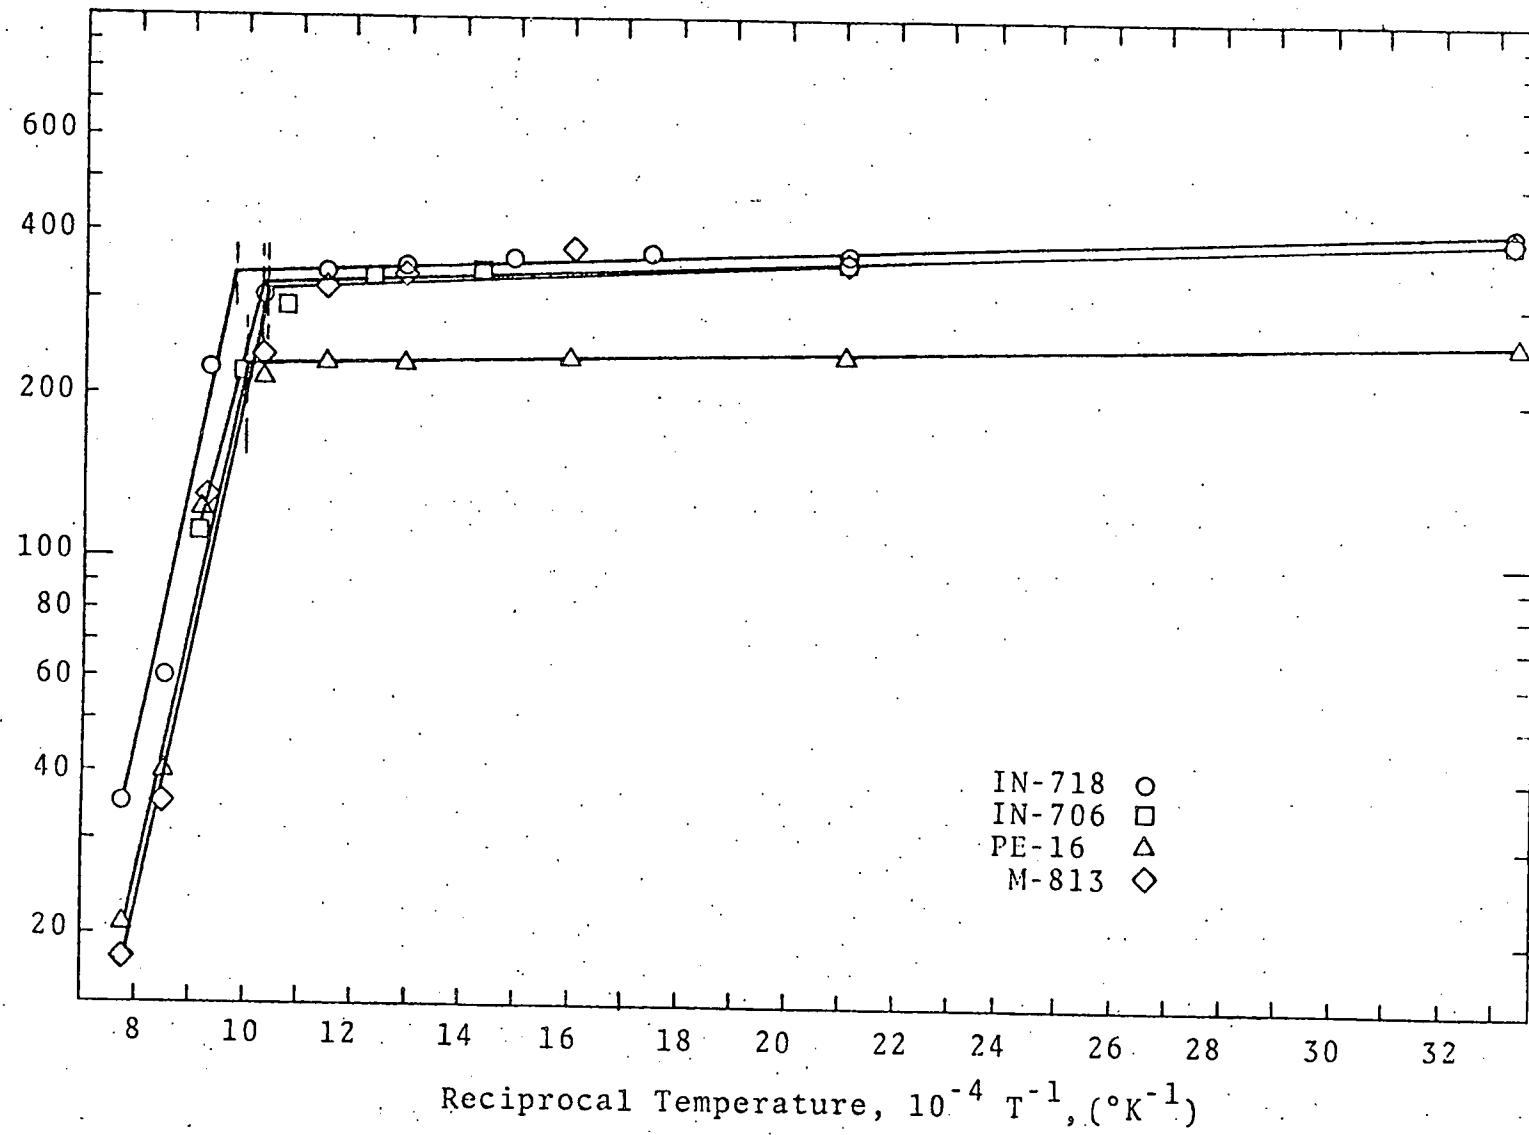
Fig. 7.8 Hot-hardness of several engineering alloys as a function of reciprocal absolute temperature.

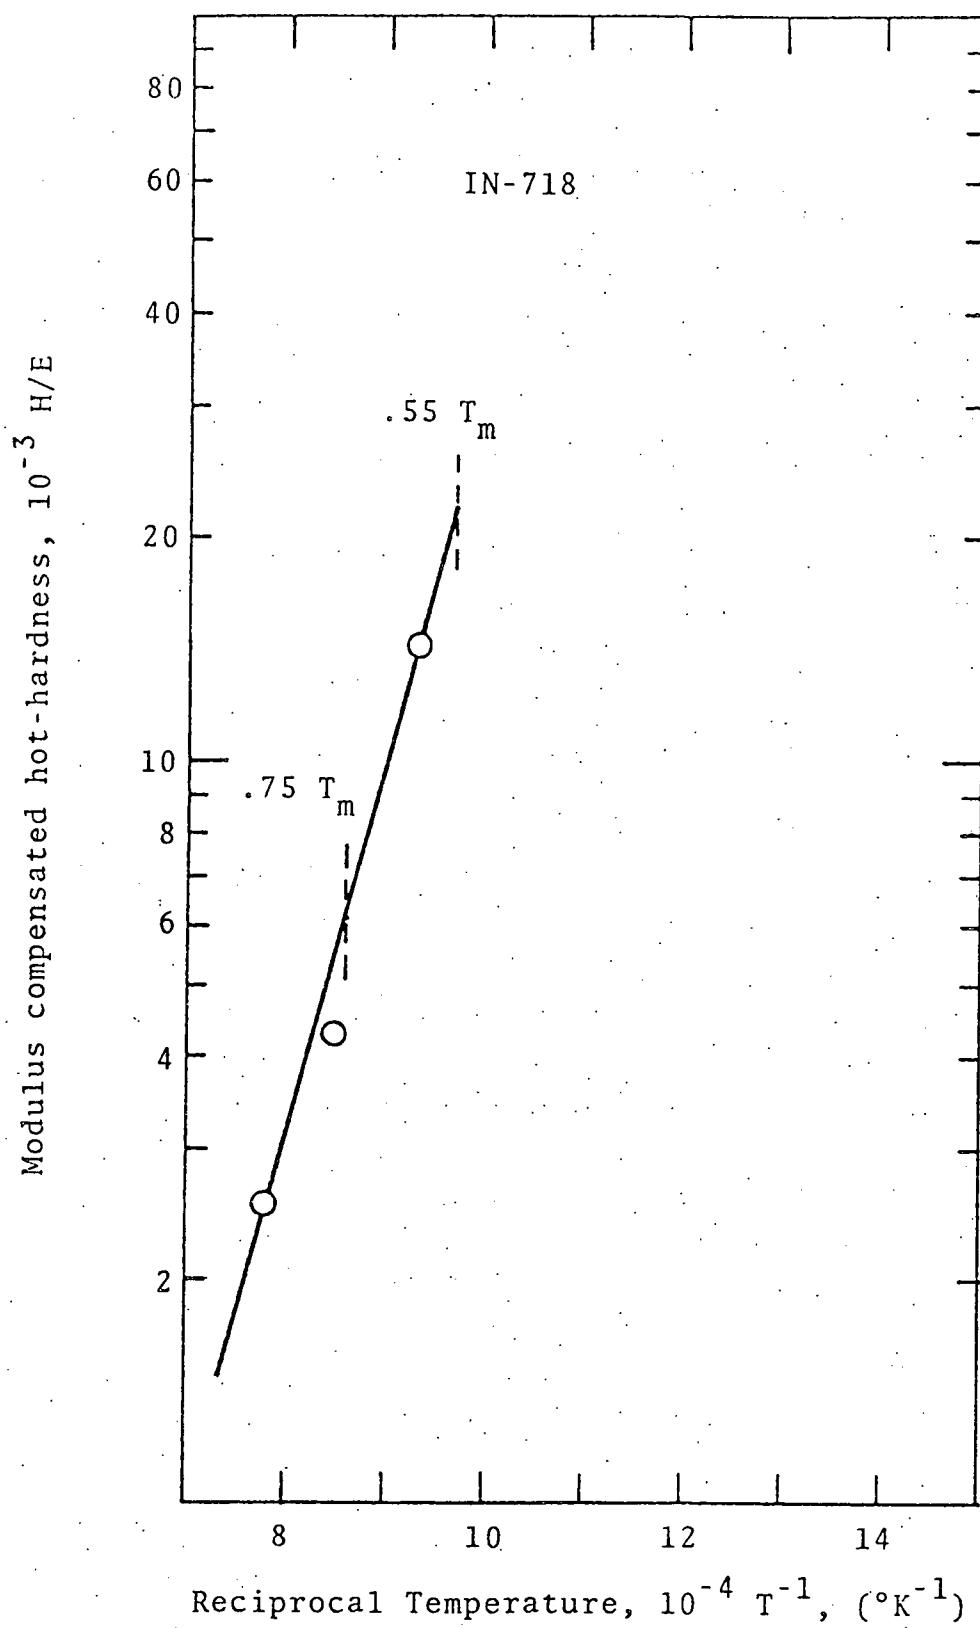
Fig. 7.9 Modulus compensated hot-hardness of IN-718 as a function of reciprocal absolute temperature.

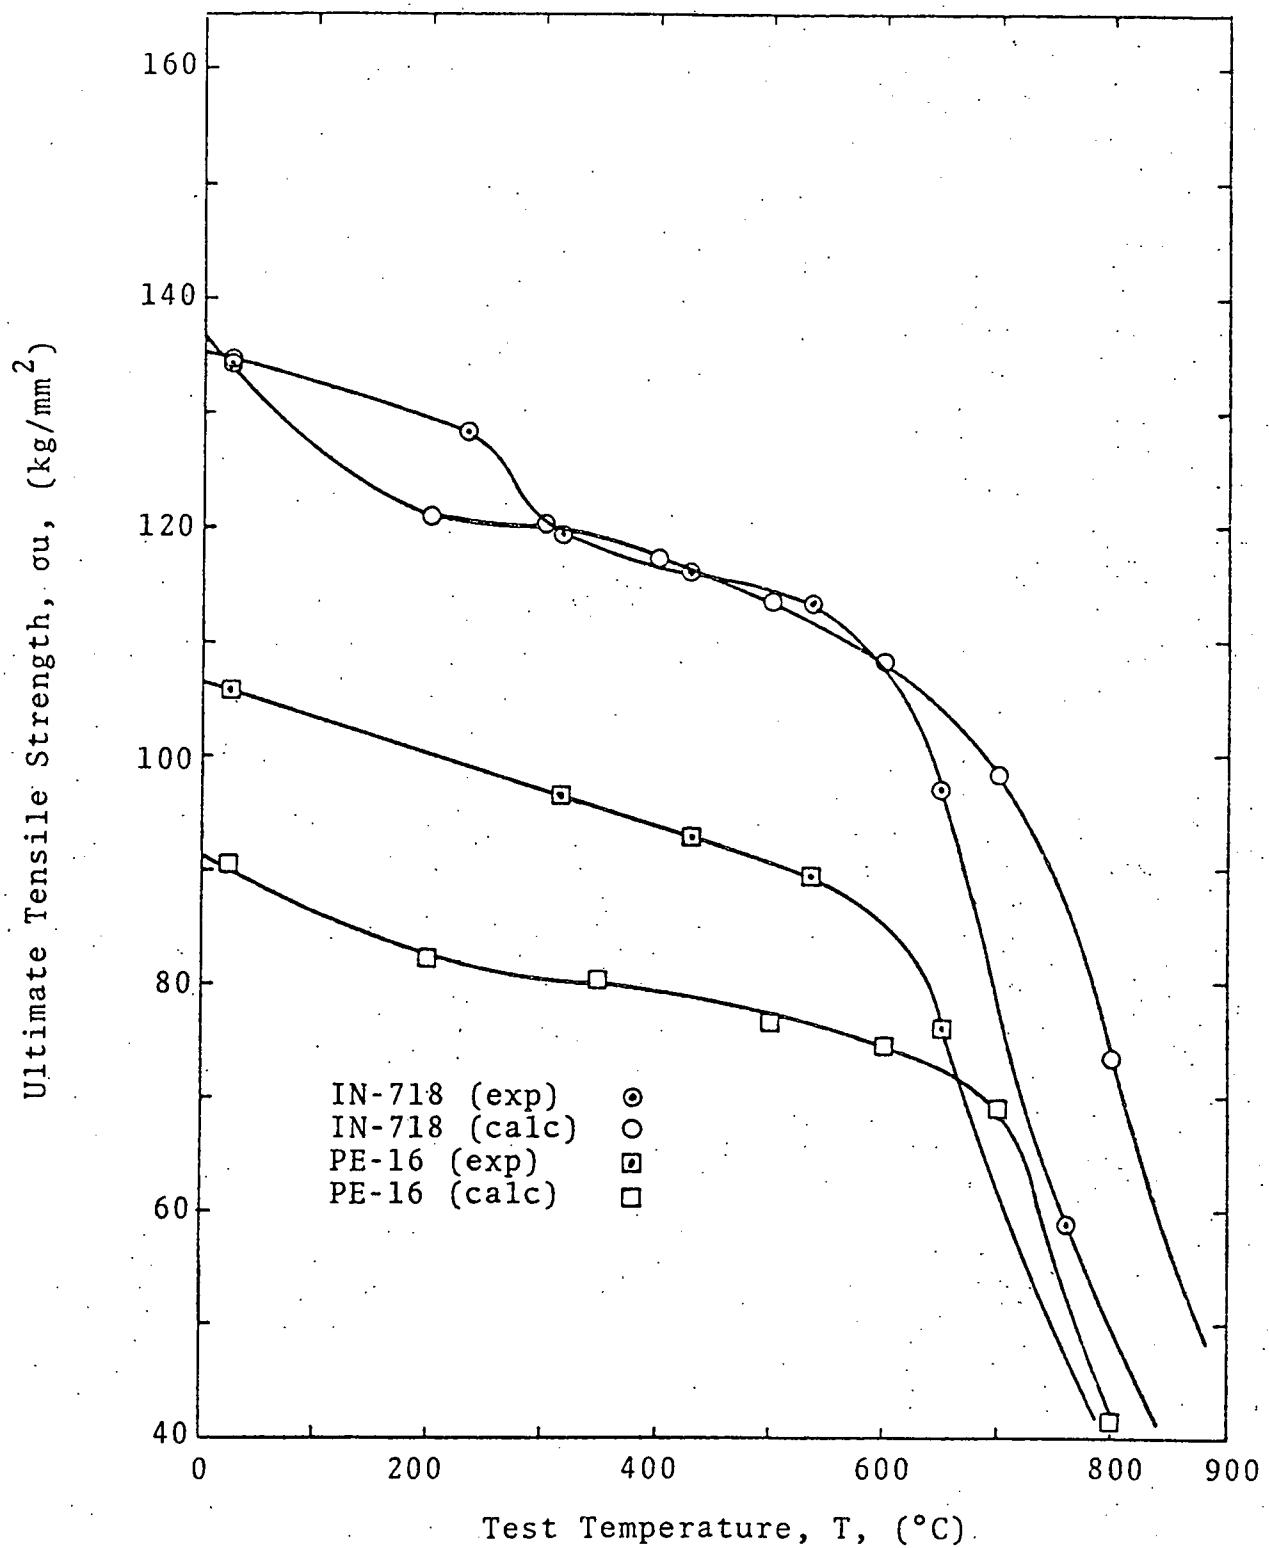
Fig. 7.10 Calculated and experimental ultimate tensile strength of IN-718 and PE-16 as a function of temperature.

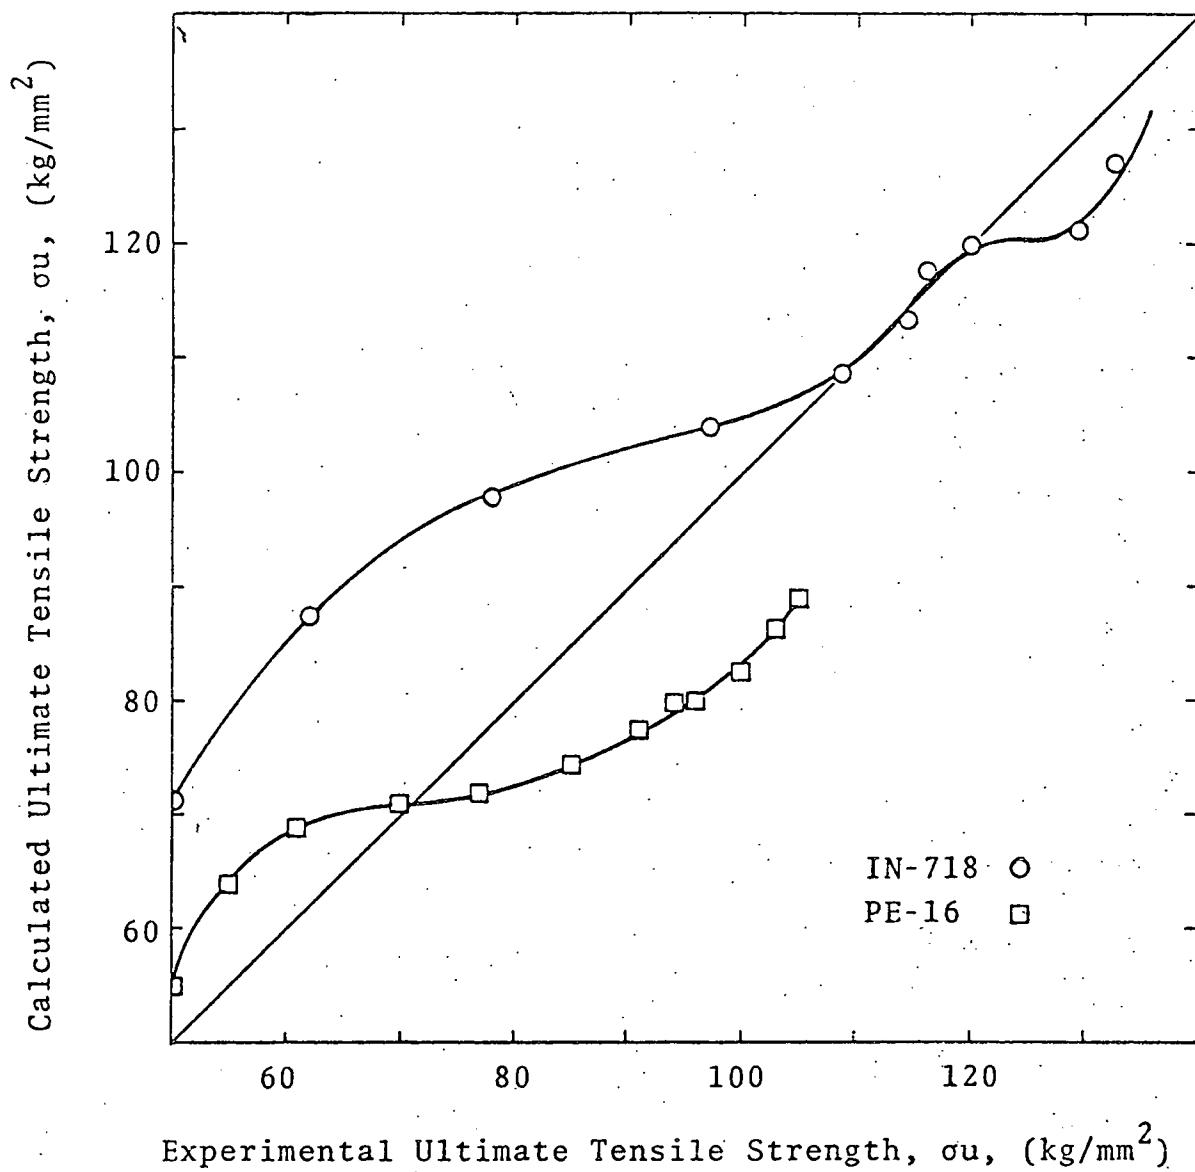
Fig. 7.11 Comparison of the calculated and experimental tensile strengths of IN-718 and PE-16 for various test temperatures.

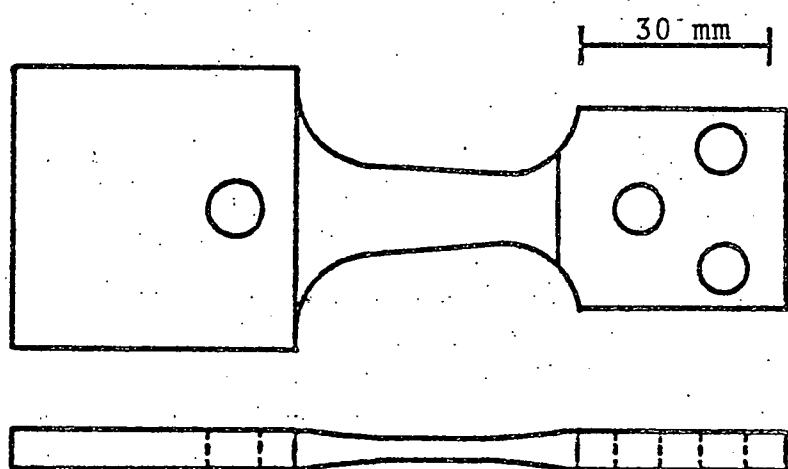
(b) BEND-FATIGUE SPECIMEN

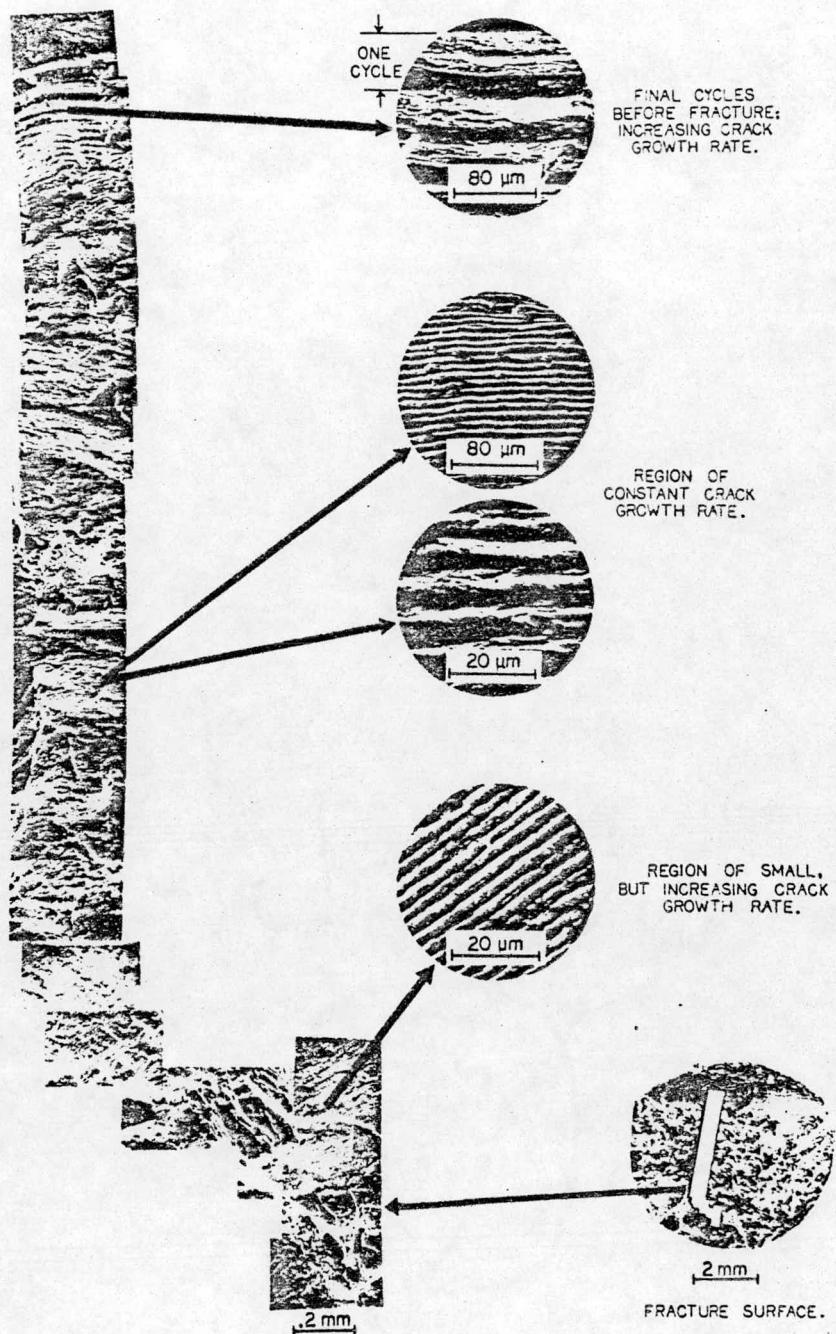
Figure 7.2a Montage of the Push-Pull Specimen No. 2W23;
Incoloy 800, 760°C, 0.5% Strain Range.

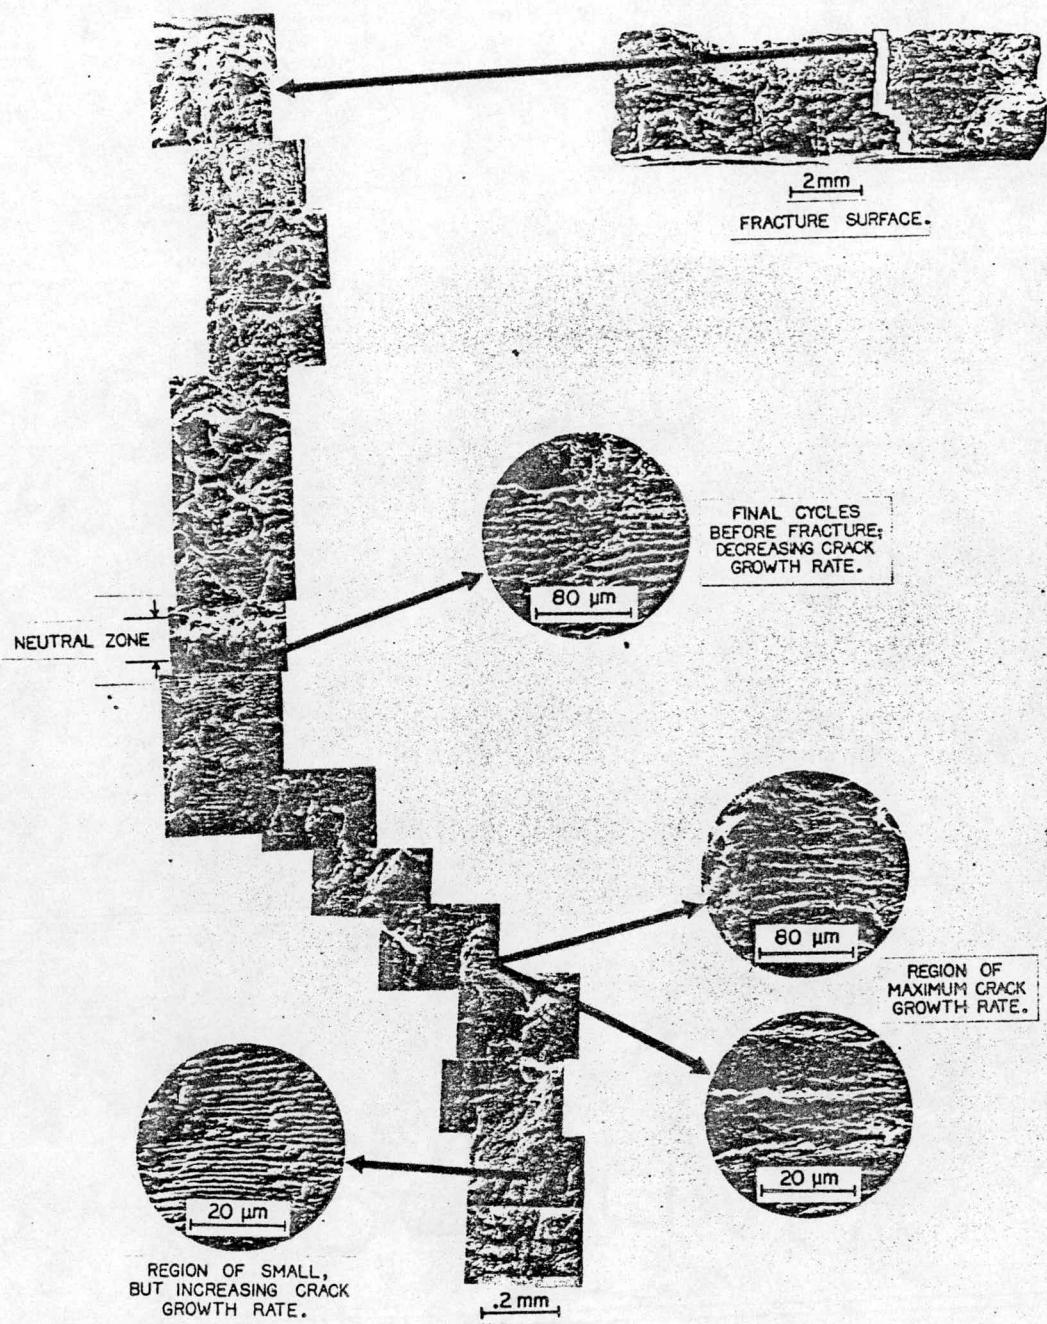
Figure 7.2b Montage of the Bend-Fatigue Specimen No. H-12-2-3;
Incoloy 800, 704°C, 2.0% Strain Range.

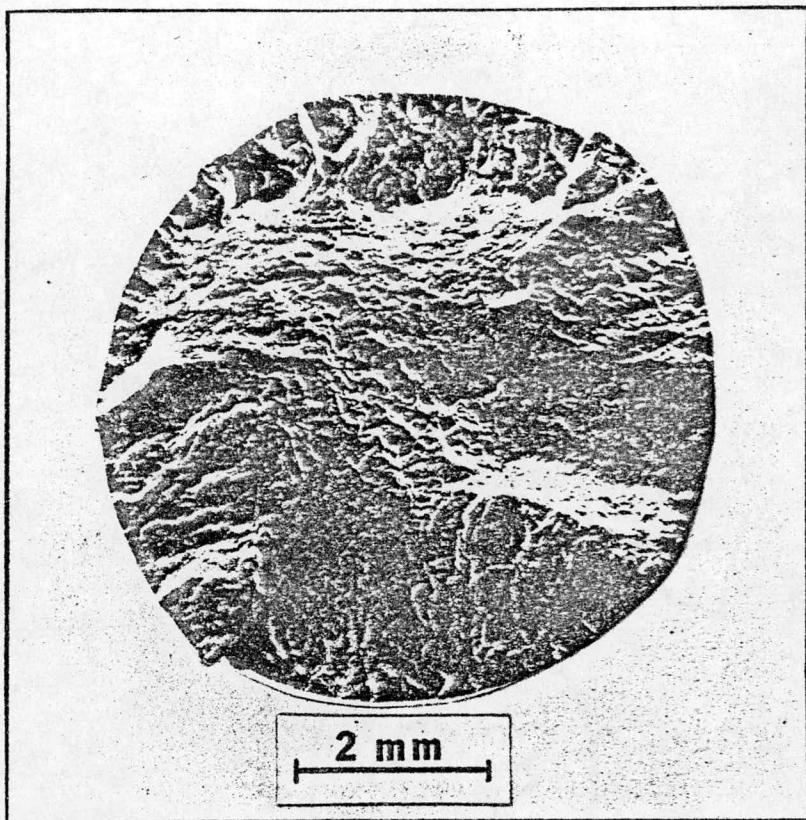
Figure 7.3 Fractured Surface of the Push-Pull Specimen No. 2A73 Showing Multi-Crack Failure; Incoloy 800, 649°C, 2.0% Strain Range.

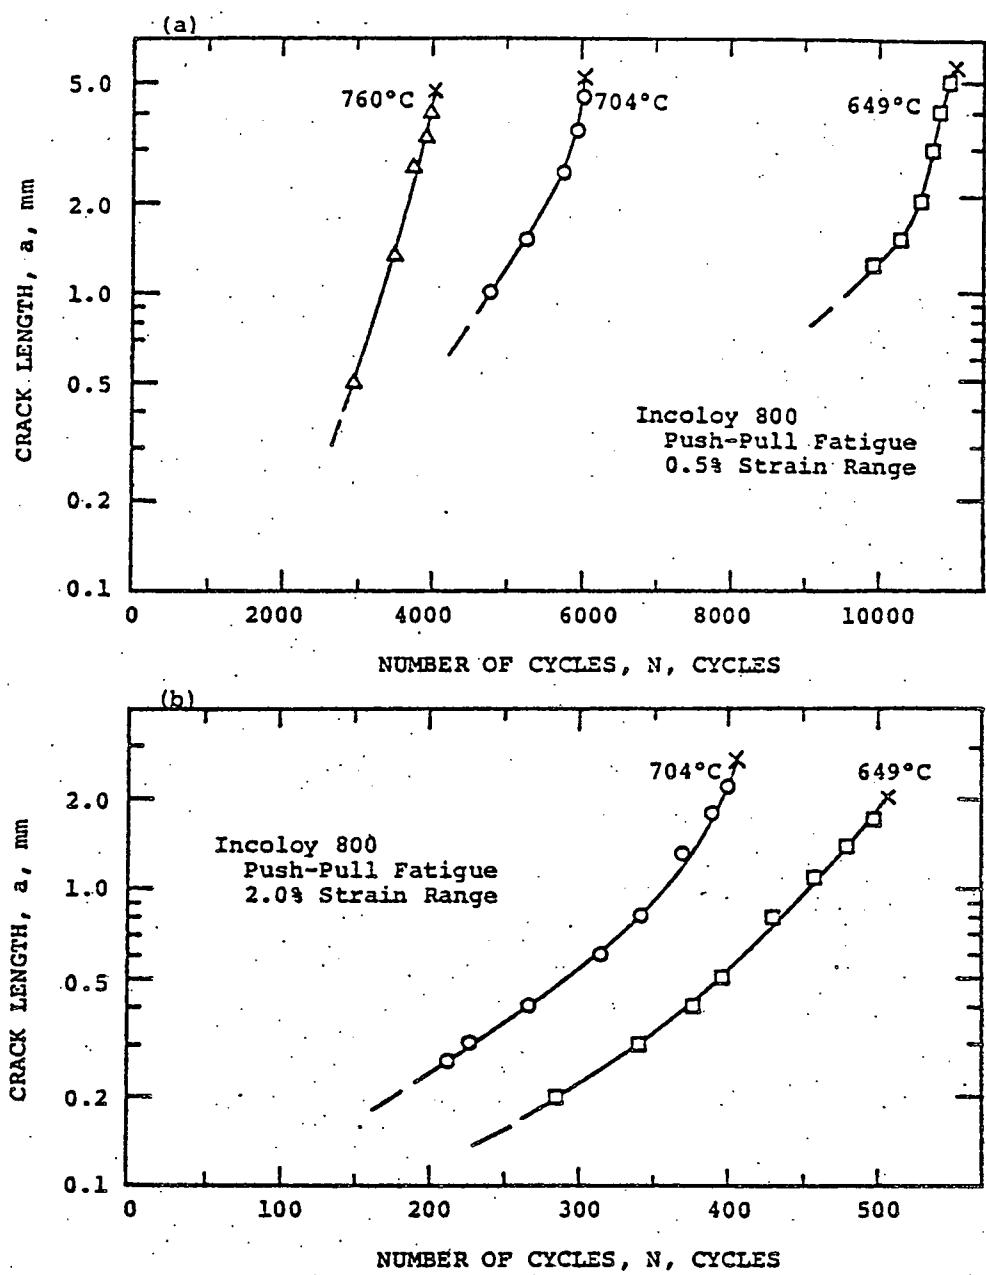
Figure 7.4 Crack Length vs. Number of Cycles for Incoloy 800 Push-Pull Specimens at (a) 0.5% Strain Range and (b) 2.0% Strain Range.

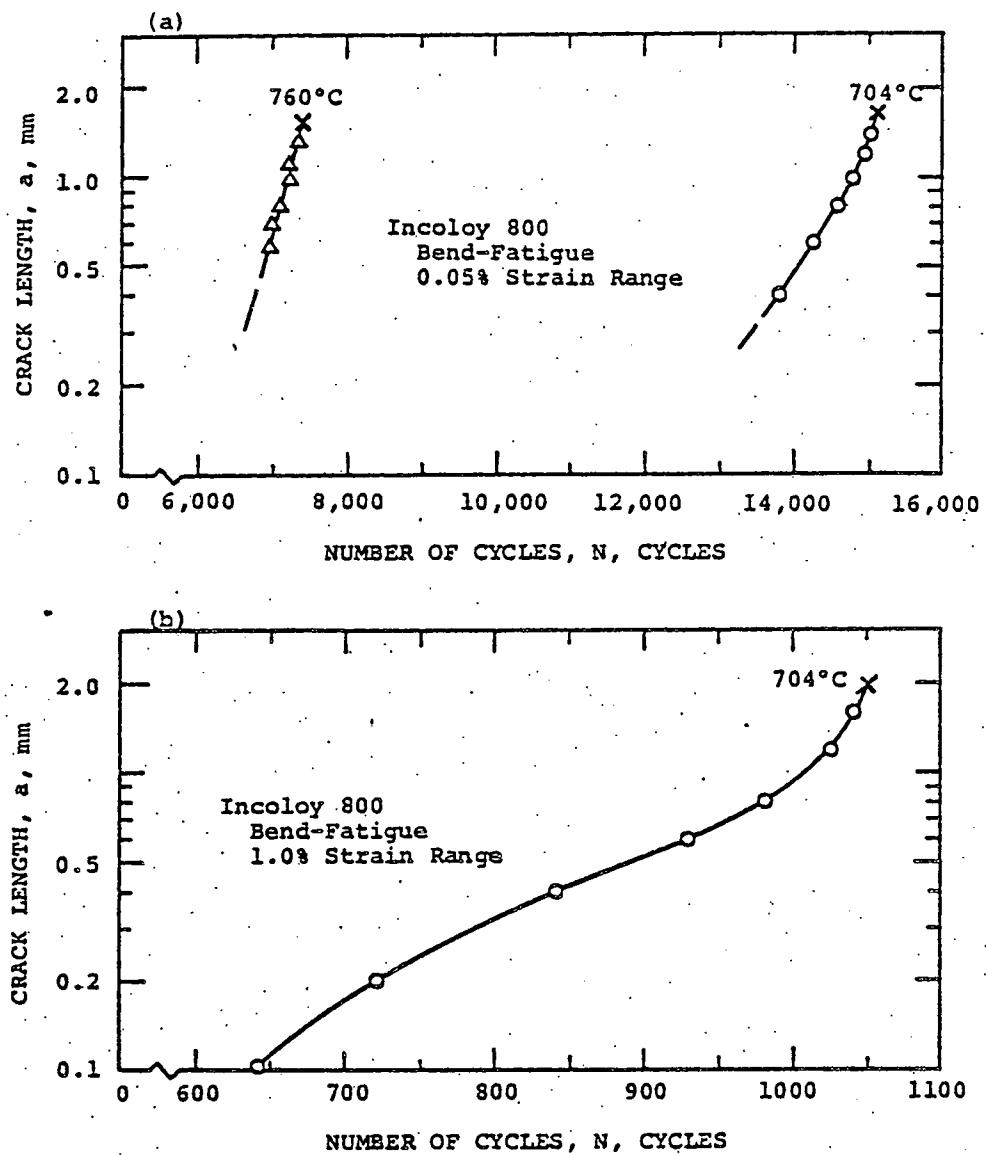
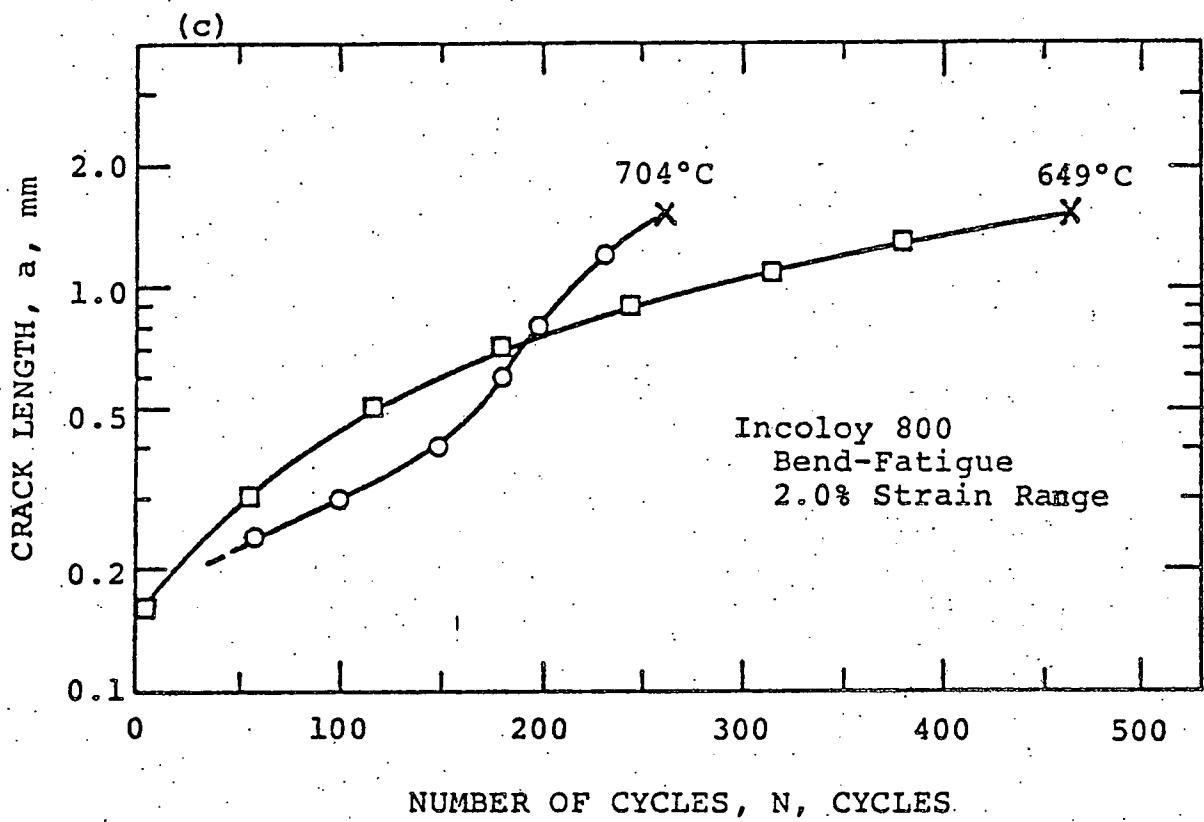
Figure 7.5 Crack Length vs. Number of Cycles for Incoloy 800 Bend Specimens at (a) 0.5% Strain Range, (b) 1.0% Strain Range, and (c) 2.0% Strain Range.
