CORRELATION OF SUBSTRUCTURE WITH MECHANICAL PROPERTIES
OF PLASTICALLY DEFORMED REACTOR STRUCTURAL MATERIALS

Progress Report
for Period January 1, 1976 - June 30, 1977

J. Motteff

Materials Science and Metallurgical Engineering
University of Cincinnati
Cincinnati, Ohio 45221

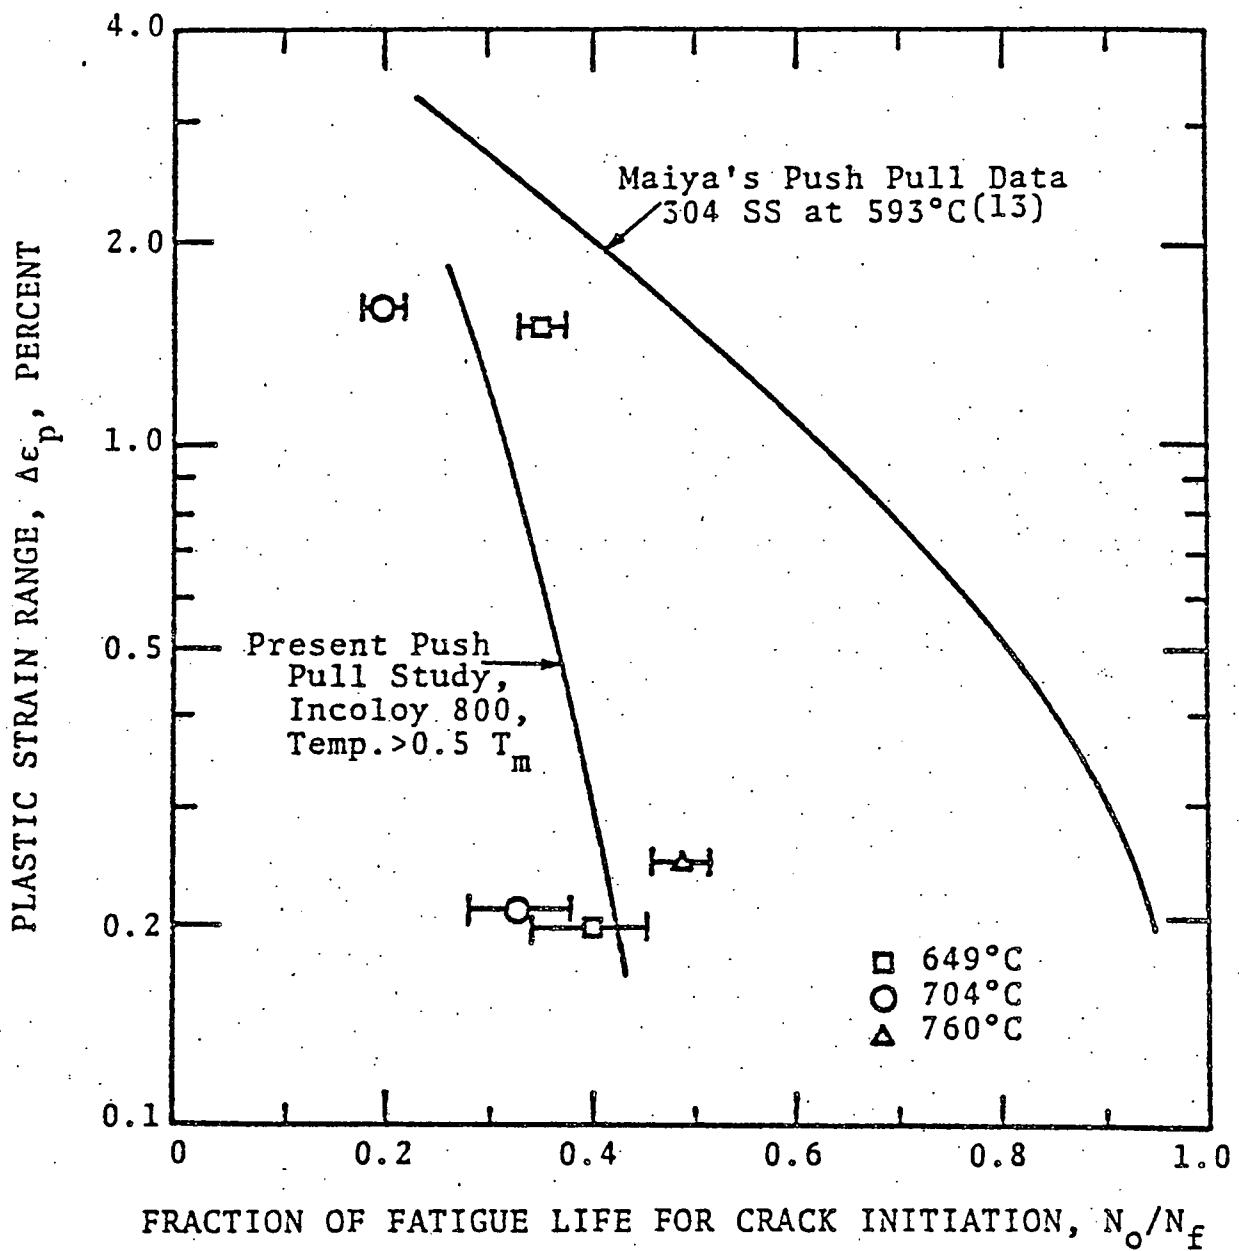
Figure 7.6 Plastic Strain Range vs. Fraction of Fatigue Life for Crack Initiation, Assuming an Initial Crack Length of 0.1 mm.

- 1) the fraction of fatigue life to initiate a 0.1 mm crack is strongly dependent on the plastic strain range in the bend specimens and only slightly dependent in the push-pull specimens, but insensitive to the temperatures in both types of specimens,
- 2) the crack growth rate in the bend specimens initially increases and then decreases, while that in the push-pull specimens generally increases continuously (Appendix F).

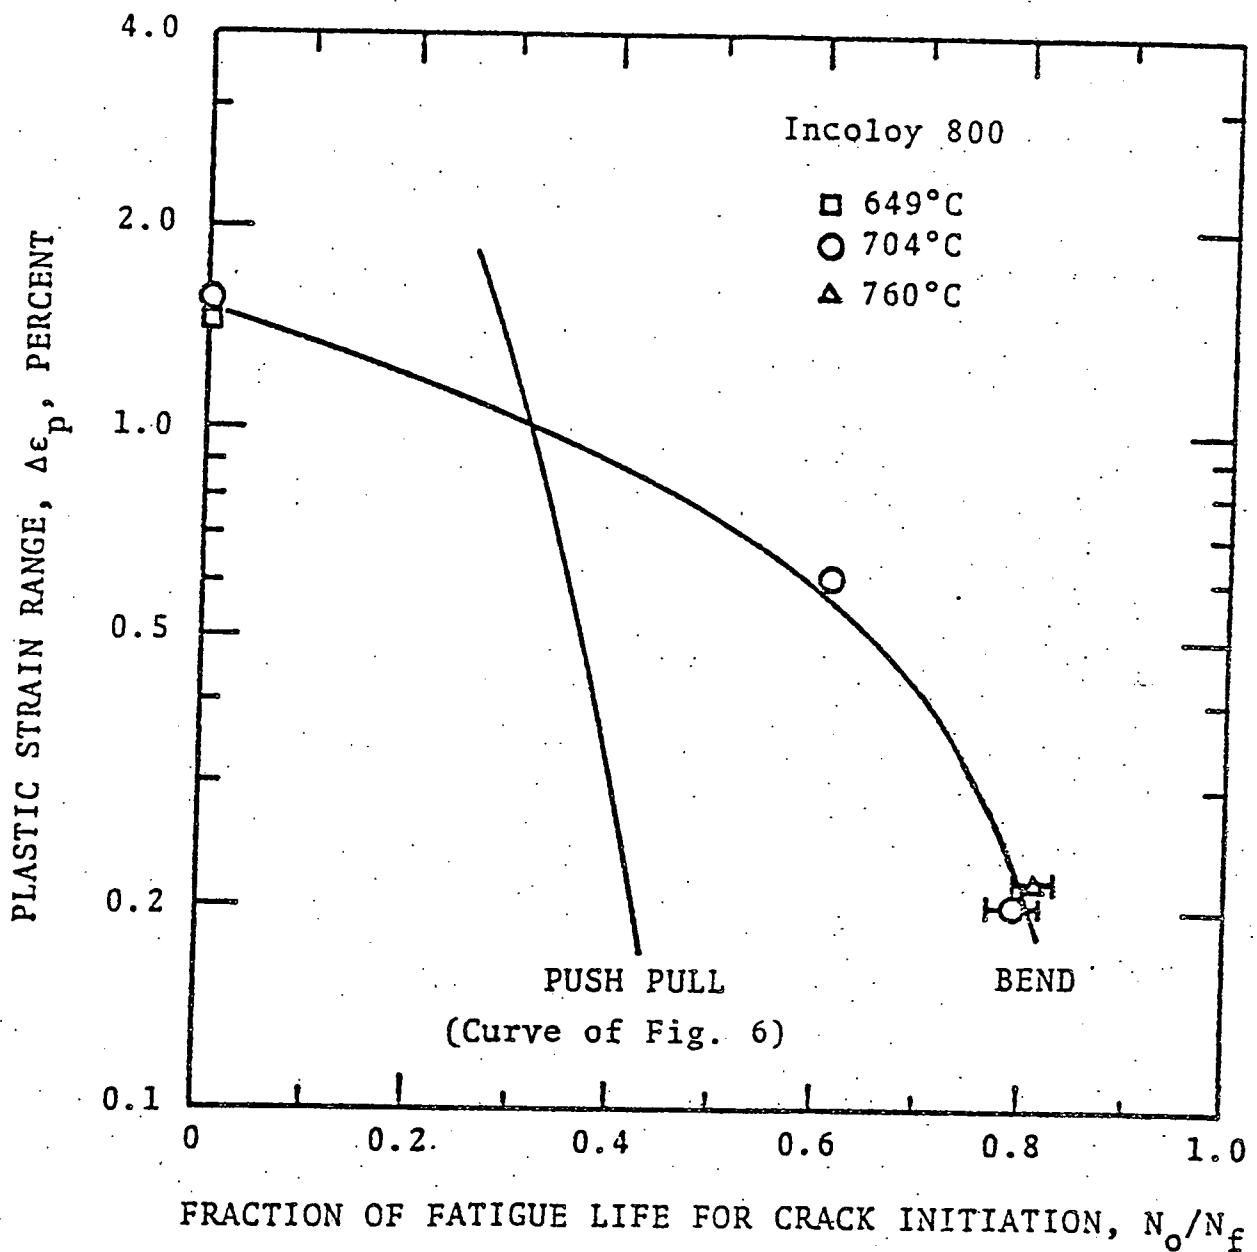
Figure 7.7 Plastic Strain Range vs. Fraction of Fatigue Life for Crack Initiation for Incoloy 800, Assuming an Initial Crack Length of 0.1 mm.

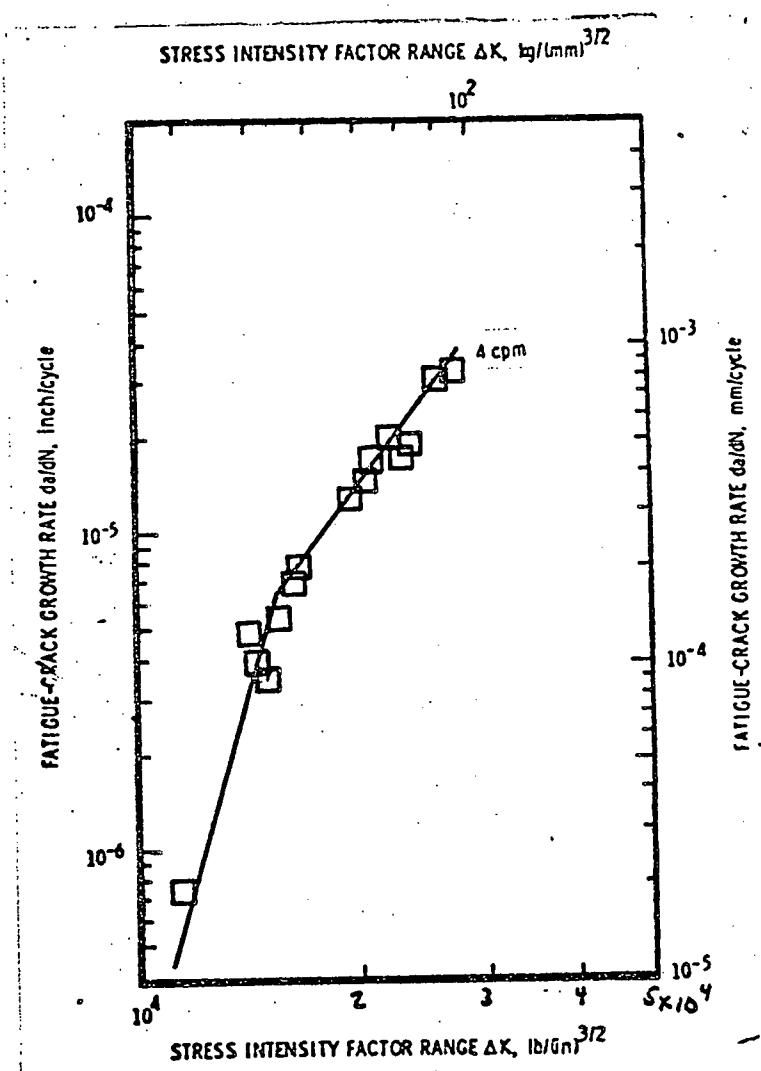
Figure 7.8 The Effect of Frequency on the Crack Growth Behavior of Solution-Annealed Type 304 Stainless Steel at 1000 F.

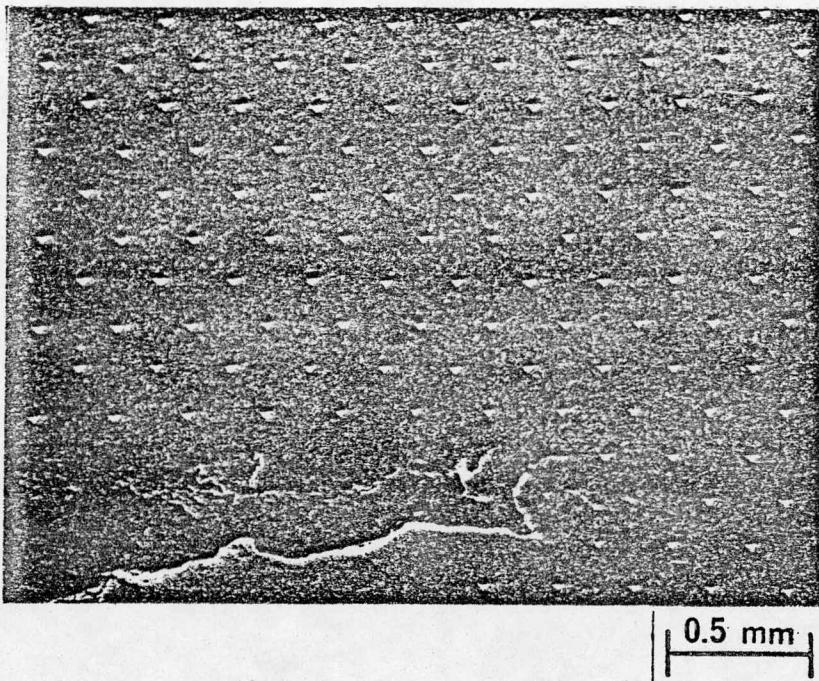
Figure 7.9 Micro-Hardness indents (DPH, 200 gm.) near the crack tip of a 304 SS specimen used for elevated temperature fatigue crack growth study.

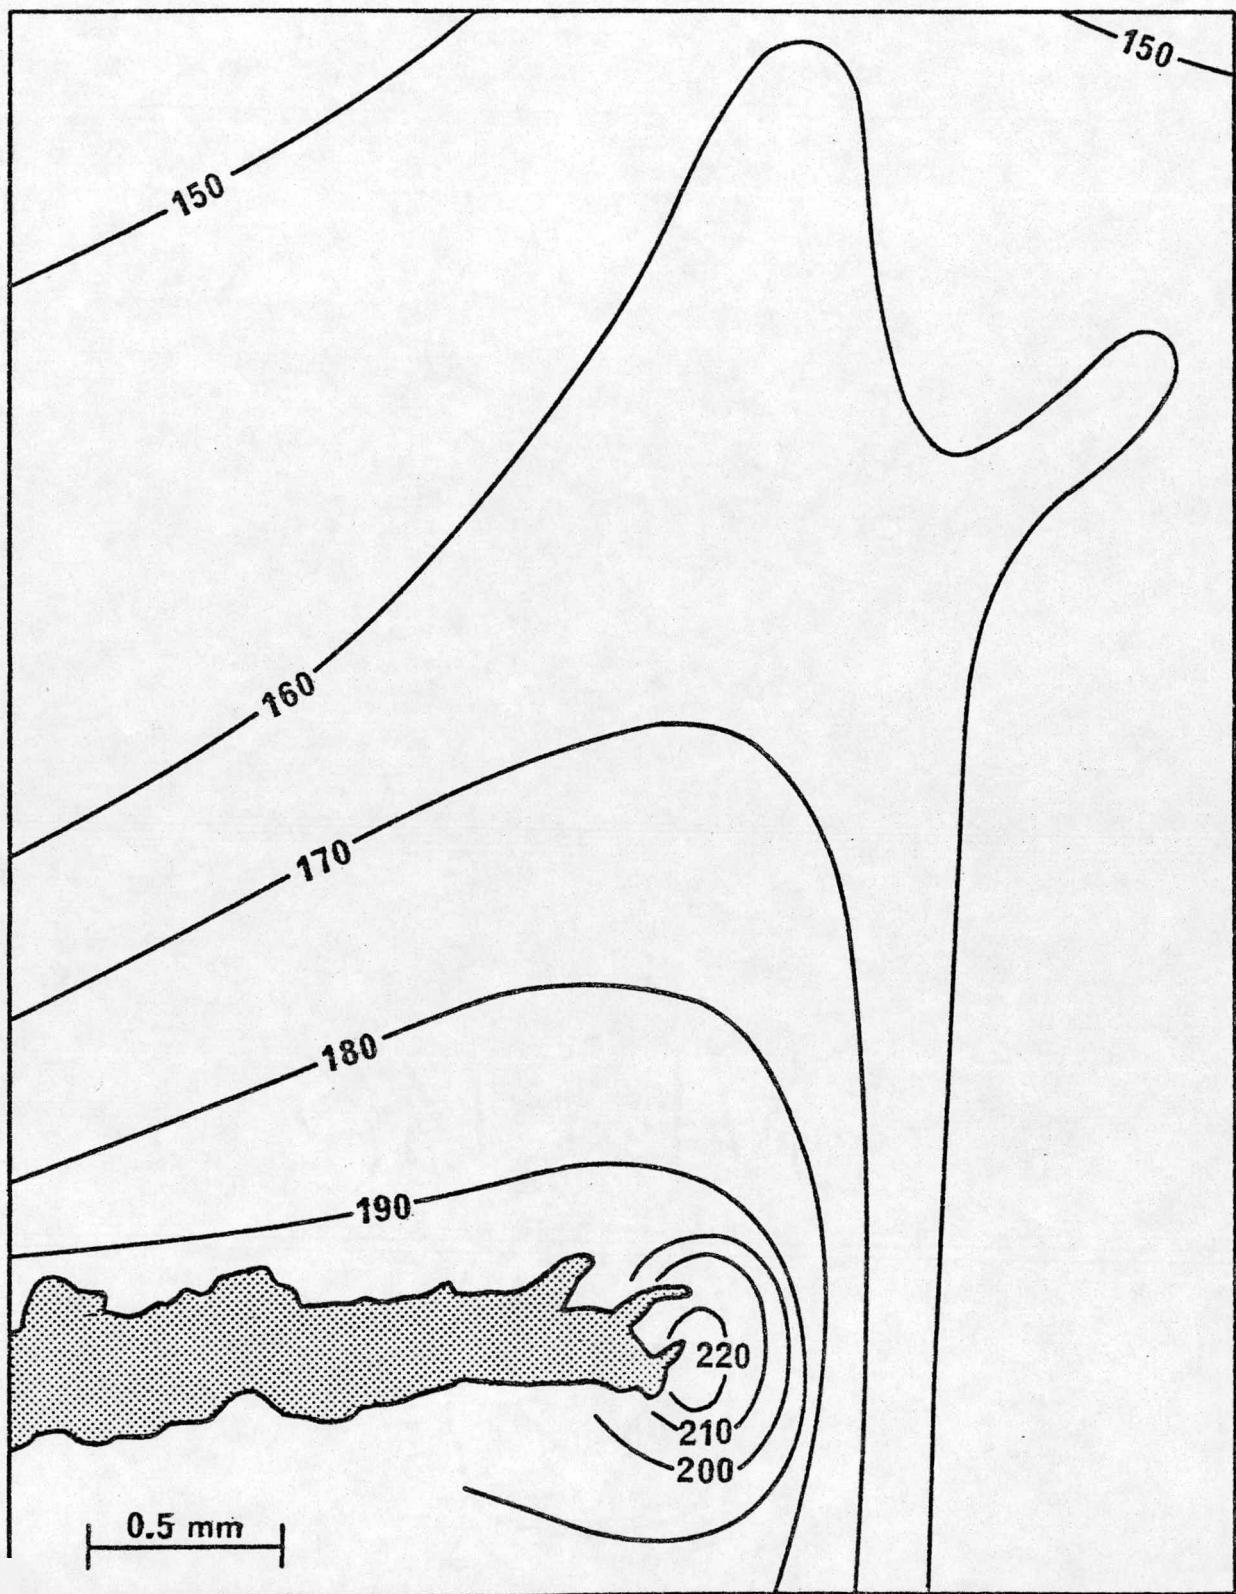
FIGURE 7.10

Room Temperature Hardness (Kg/mm²) Contours
in the Vicinity of a Crack Tip of 304 SS.

A study of the plastic zone around a fatigue crack in a 304 SS compact tension specimen has been initiated. The specimen was tested at 538°C with a stress ratio of 0.05 and a frequency of 0.067 s^{-1} . This study employs three experimental techniques: microhardness measurements, SEM and TEM. At the present time, the microhardness measurements and SEM work have been completed, and the results are presented in this report, including a hardness contour map around the crack tip (Appendix F).

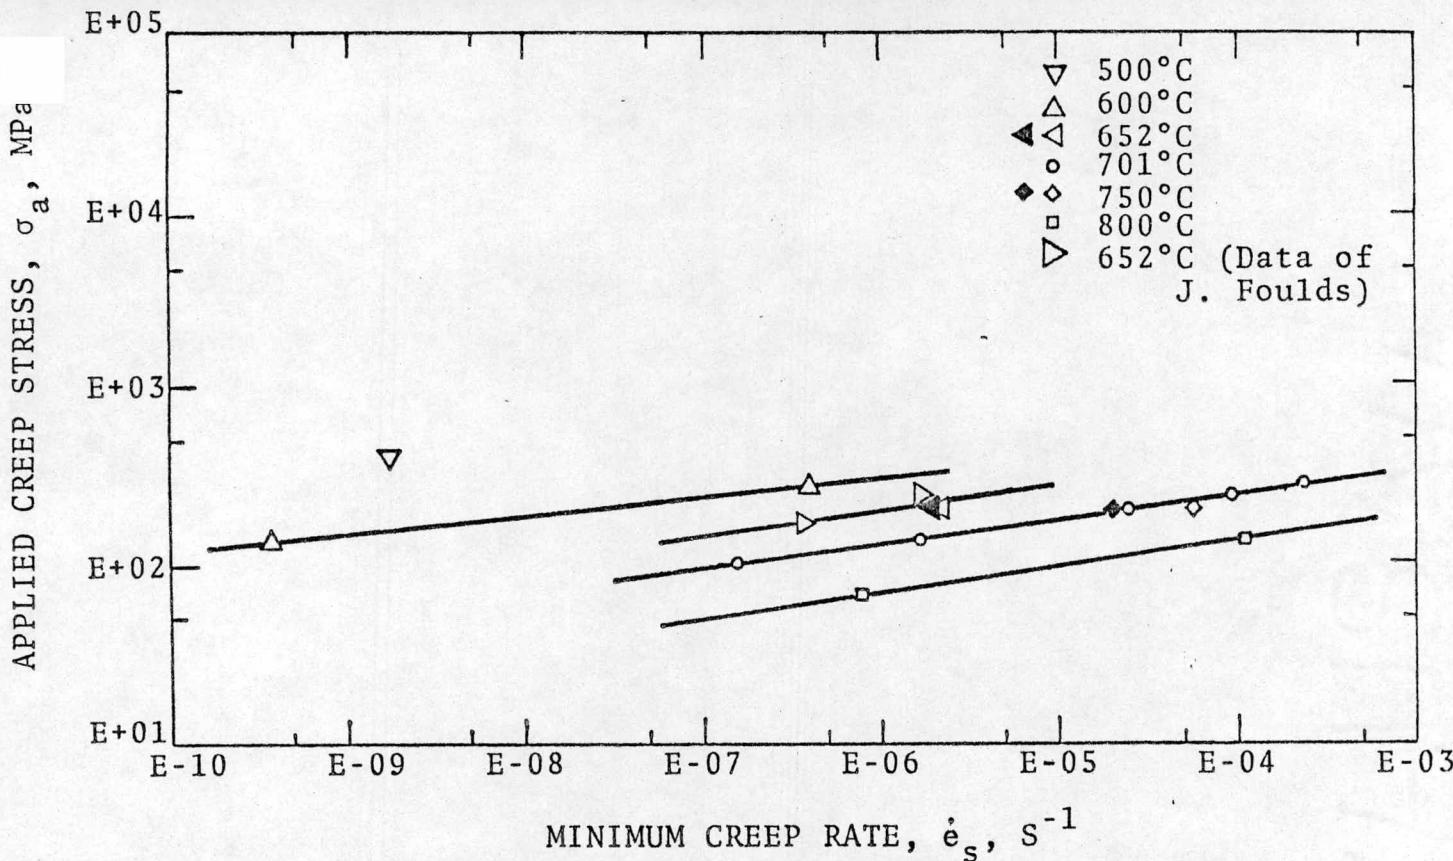
Figure 7.11 Log Applied Creep Stress versus Log Minimum Creep Rate for A.I.S.I. 330 Stainless Steel Crept at Various Temperatures.
Pre-test solution heat treatments: 1100°C , 1800s , 1.33×10^{-3} Pa,
fast furnace cool, (open symbols) or 1100°C , 1800s , 1.33×10^{-3} Pa, water quench (closed symbols).

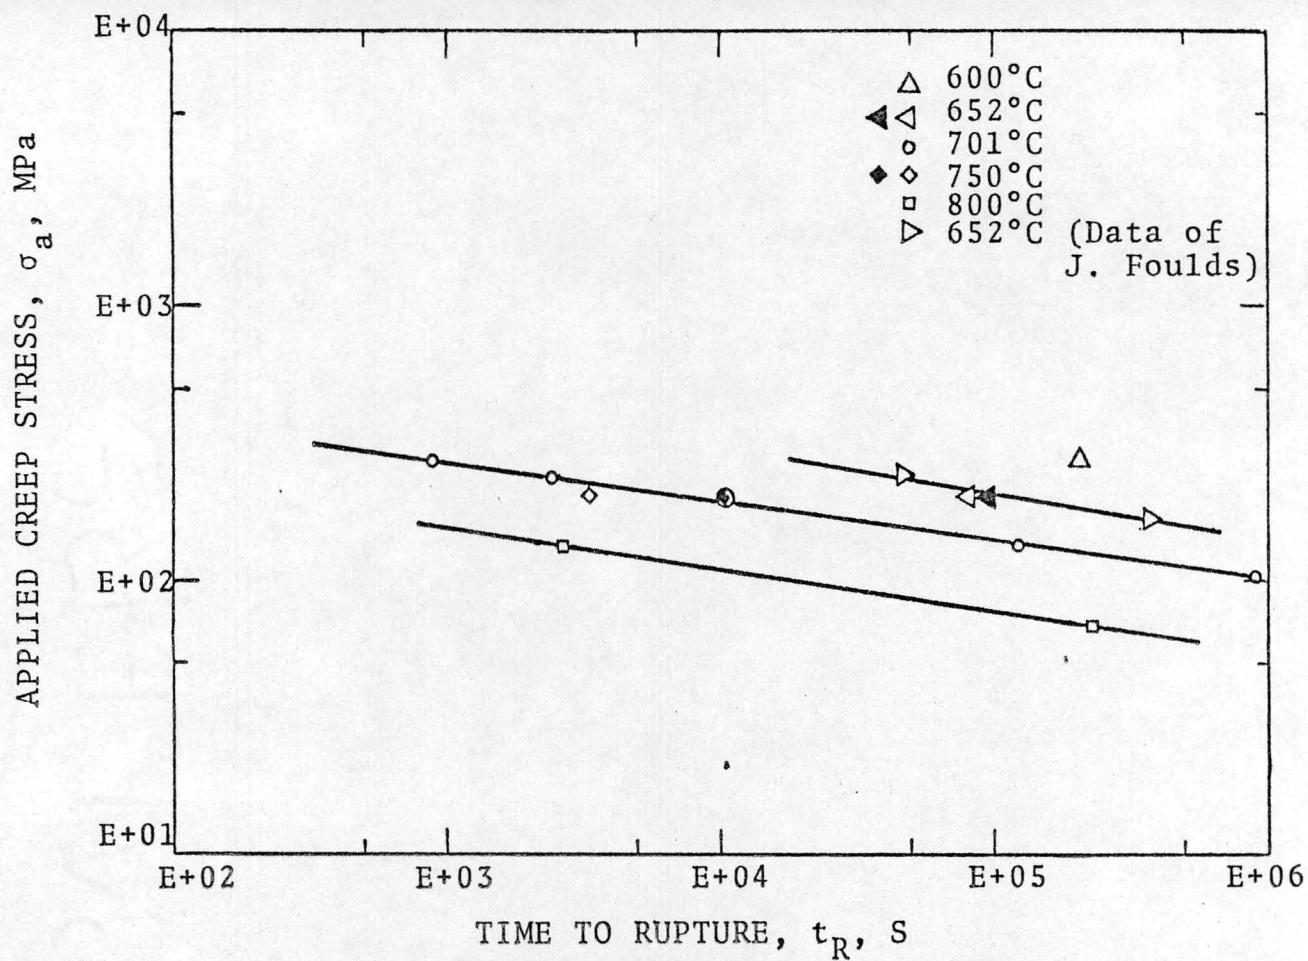
Figure 7.12 Log Applied Creep Stress versus Log Time to Rupture for A.I.S.I. 330 Stainless Steel Crept at Various Temperatures.
Pre-test solution heat treatments: 1100°C, 1800 s , 1.33 E-03 Pa,
fast furnace cool (open symbols) or 1100°C, 1800 s ,
1.33 E-03 Pa, water quench (closed symbols).

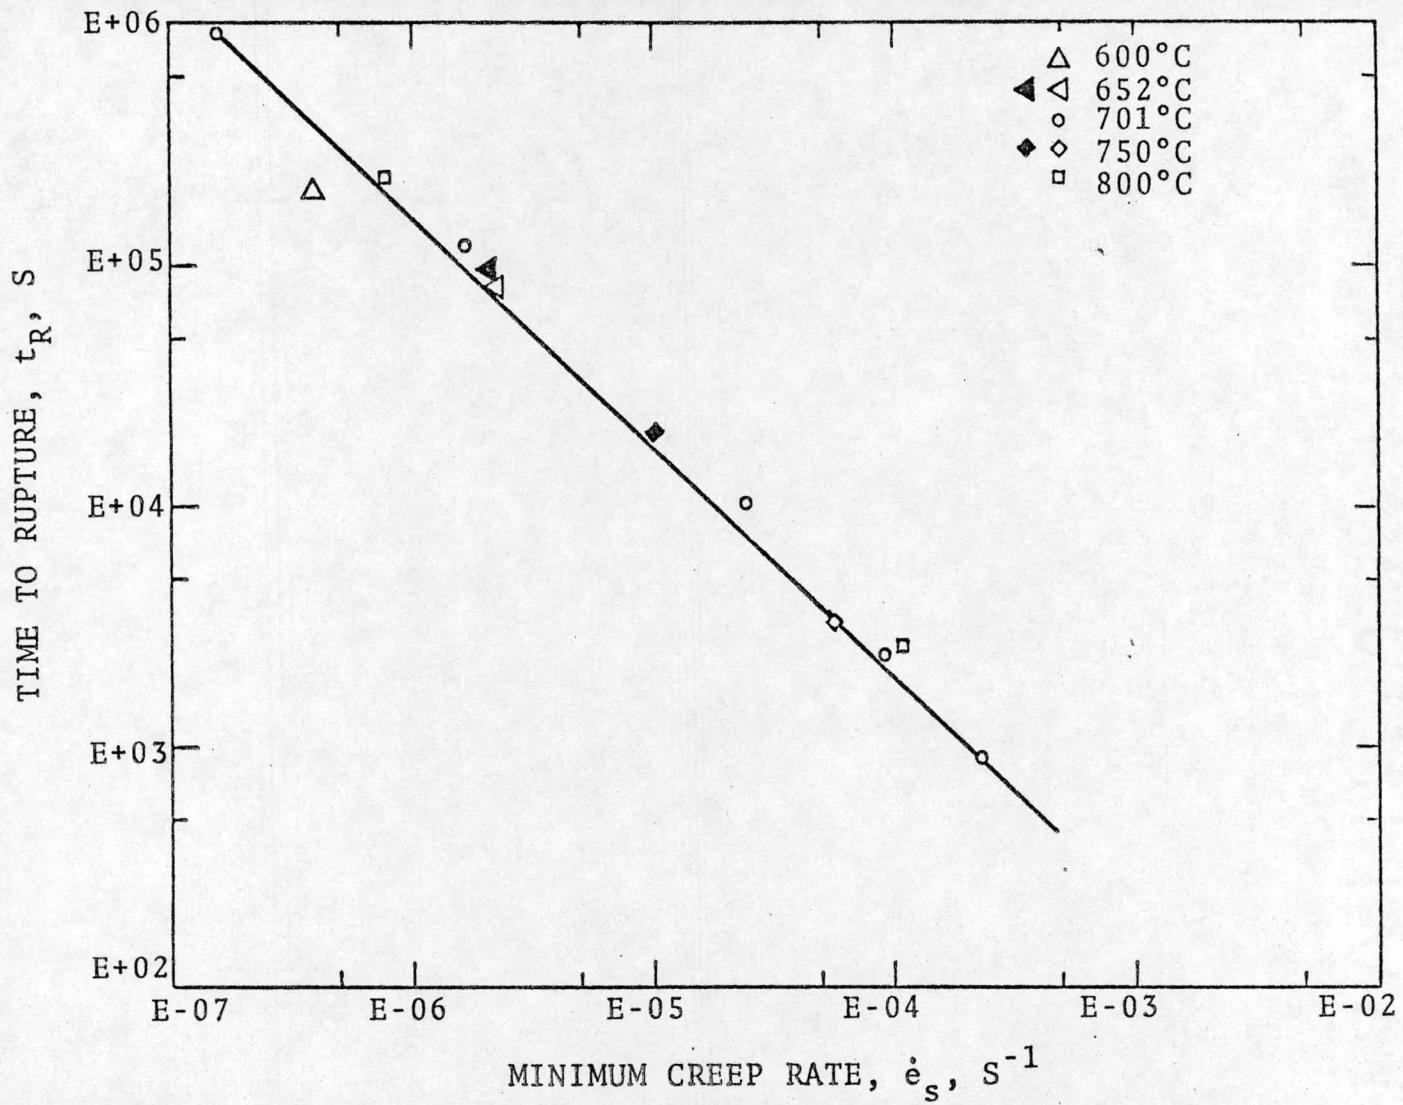
Figure 7.13 Log Time to Rupture versus Log Minimum Creep Rate for A.I.S.I. 300 Stainless Steel Crept at Various Temperatures. Pre-test solution heat treatment: 1100°C , 1800s , 1.33×10^{-3} Pa, fast furnace cool (open symbols) or 1100°C , 1800s , 1.33×10^{-3} Pa, water quench (closed symbols).

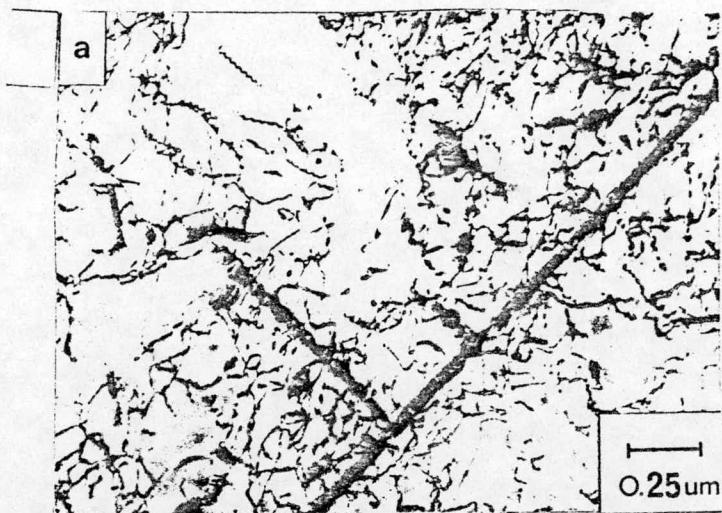
Figure 7.15 Mobile Dislocation Structure and Precipitate Morphology in A.I.S.I. 300 Stainless Steel Crept at 701 C for Two Stresses. a) 241.3 MPa
b) 103.4 MPa.

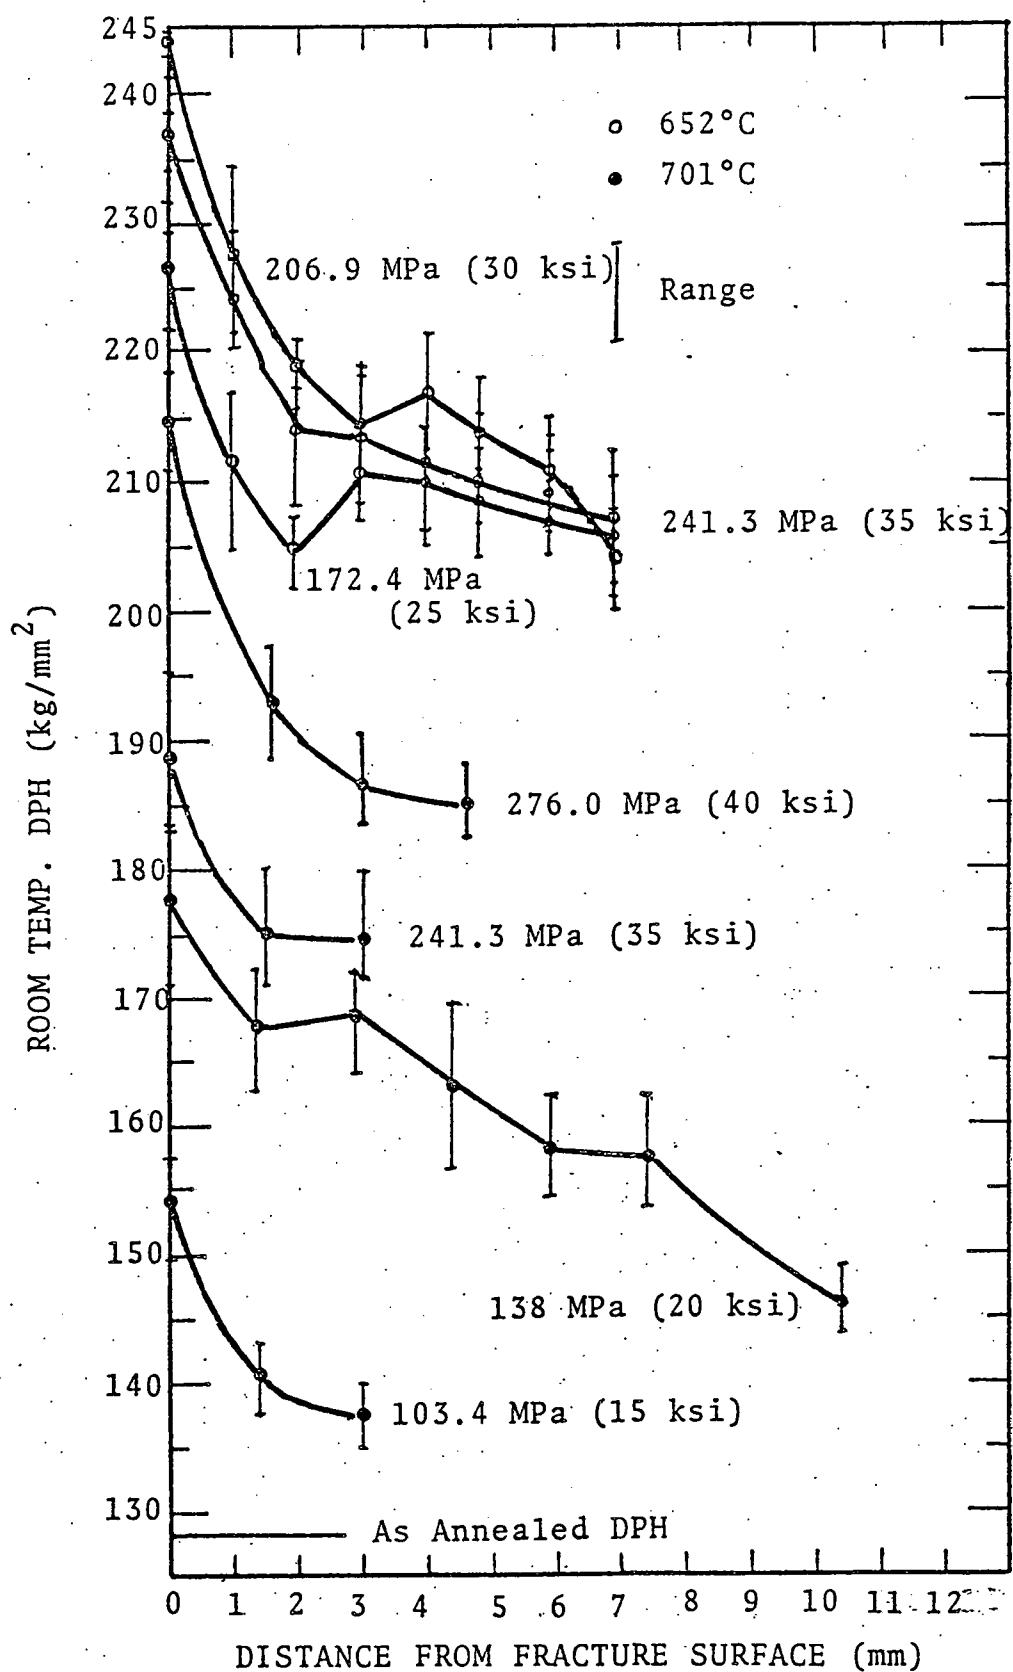
Figure 7.17 Room temperature microhardness as a function of distance from the fracture surface for various applied stresses at 652°C and 701°C.
