**Test of 6-In.-Thick Pressure Vessels.
Series 3: Intermediate Test Vessel V-7**

OAK RIDGE NATIONAL LABORATORY

ORNL/NUPEG-1
Dist. Category NRC-5

The test of intermediate test vessel V-7 was a crack-initiation fracture test of a 152-mm-thick (6-in.), 990-mm-OD (39-in.) vessel of ASTM A533, grade B, class 1 steel plate with a sharp outside surface flaw 457 mm (18 in.) long and about 135 mm (5.3 in.) deep. The vessel was heated to 91 °C (196°F) and pressurized hydraulically until leakage through the flaw terminated the test at a peak pressure of 147 MPa (21,350 psi). Fracture toughness data obtained by testing precracked Charpy-V and compact-tension specimens machined from a prolongation of the cylindrical test shell were used in pretest analyses of the flawed vessel. The vessel, as expected, did not burst. Upon depressurization, the ruptured ligament closed so as to maintain static pressure without leakage at about 129 MPa (18,700 psi).

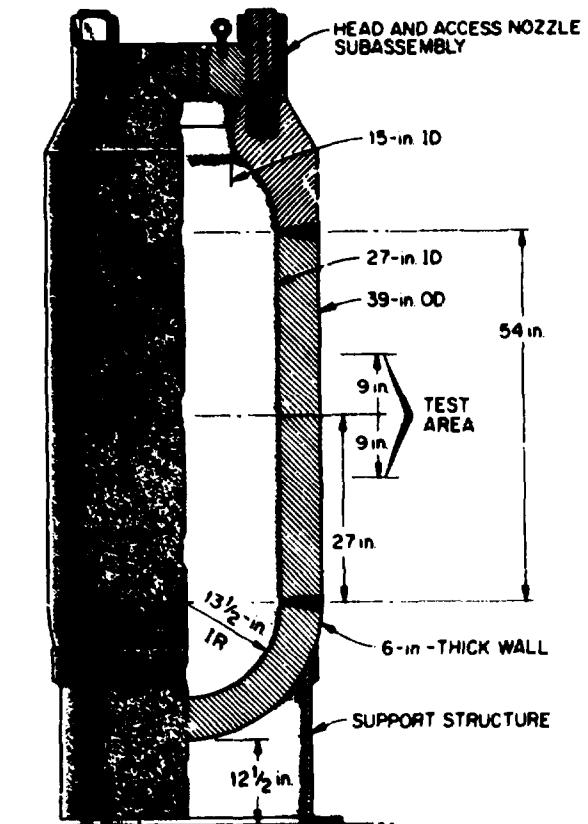
Fig. 2.1. HSST intermediate vessel.

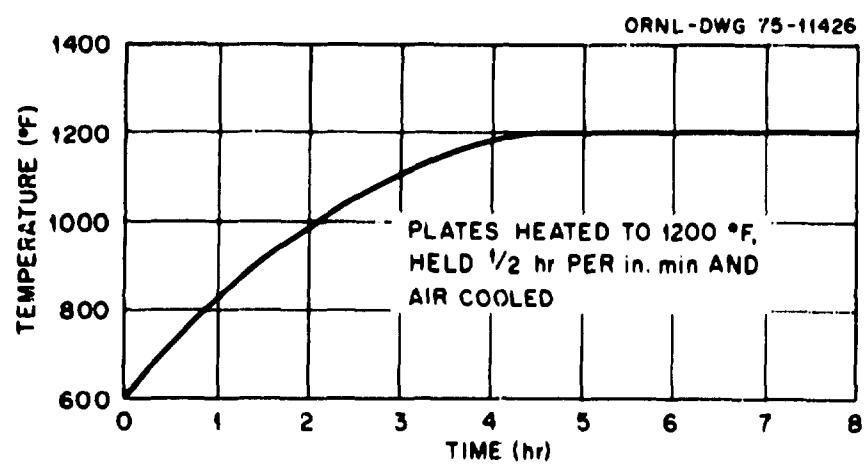
Fig. 2.2. Post-roll stress-relieving cycle for plate.

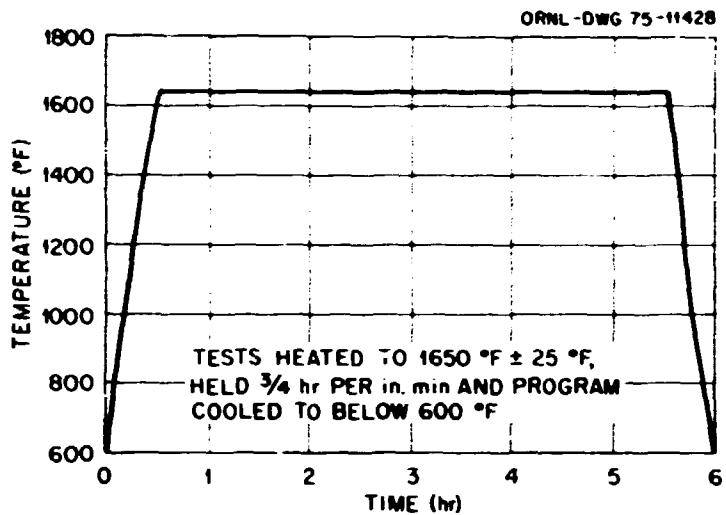
Fig. 2.3. Austenitizing and cooling cycle for plate for cylindrical shell courses for vessels V-7 through V-10.

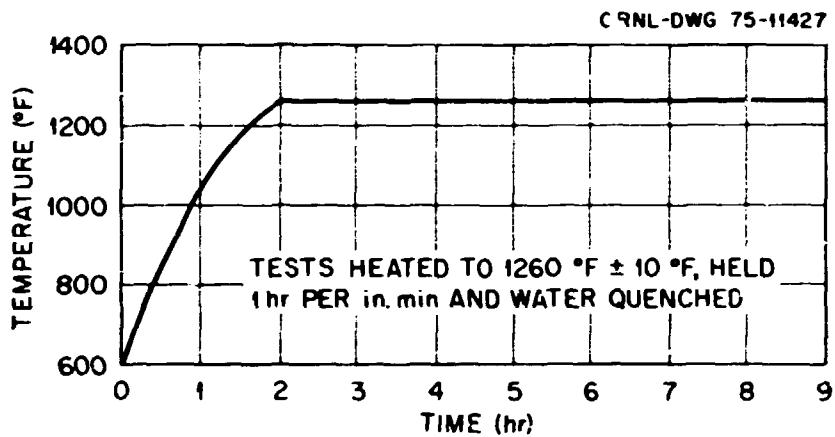
Fig. 2.4. Tempering cycle for plate for cylindrical shell courses for vessels V-7 through V-10.

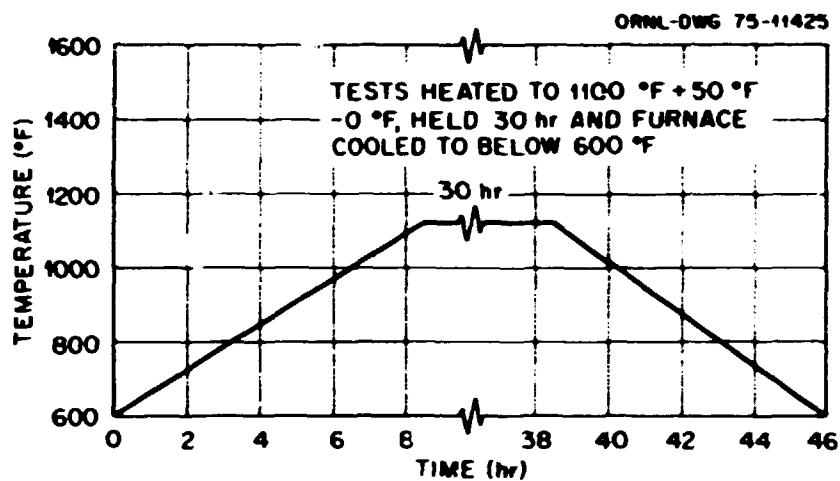
Fig. 2.5. Stress-relieving cycle for plate for cylindrical shell courses for vessels V-7 through V-10.

at 682°C (1260°F) for 6½ hr and air cooling, and stress relieving at 621°C (1150°F) for 30 hr. They were then furnace cooled at 56 K/hr (100°F/hr) to 316°C (600°F) and air cooled to ambient temperature. In order to expedite fracture mechanics testing of the V-7 prolongation material, it was heat treated separately from the shell course and did not receive the same amount of postweld heat treatment. The V-7 prolongation received a total of 30 hr postweld heat treatment, the weld test plates for V-7 through V-10 received 20½ hr, and V-7 shell course received 10 hr.

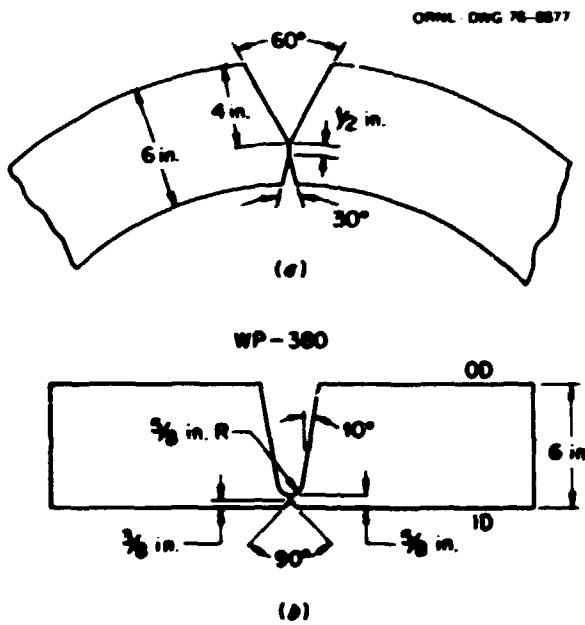
Fig. 2.6. Joint preparations for Taylor Forge welding procedures.

Before rolling, the plate segments for the shells and prolongations were cut to the proper dimensions and provided with the weld joint preparation shown in Fig. 2.6 and were then heated along the edges and

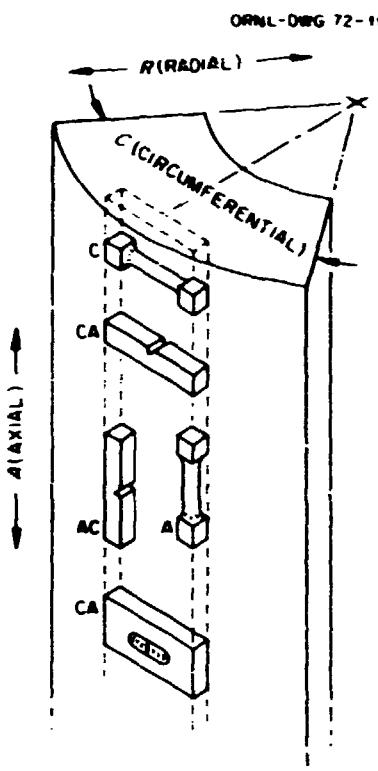
Fig. 2.7. Specimen orientation notation for HSST intermediate vessel materials showing tensile, Charpy V-notch, and drop-weight specimens.

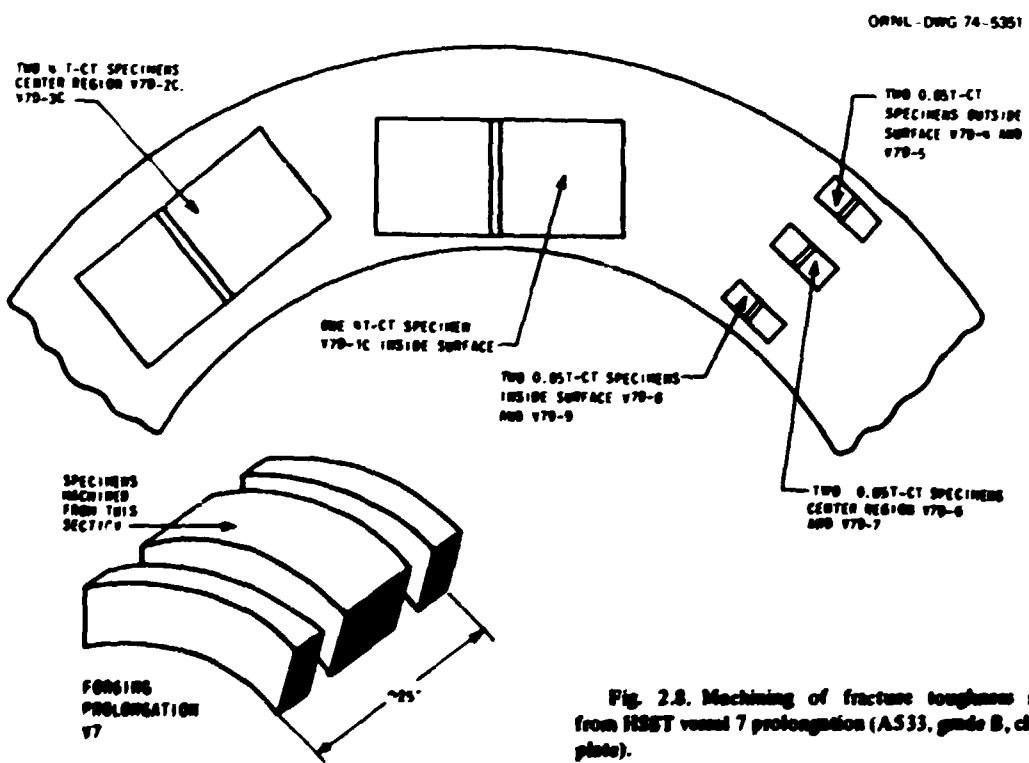
Fig. 2.8. Machining of fracture toughness specimens from HSST vessel 7 prolongation (A533, grade B, class I steel plate).

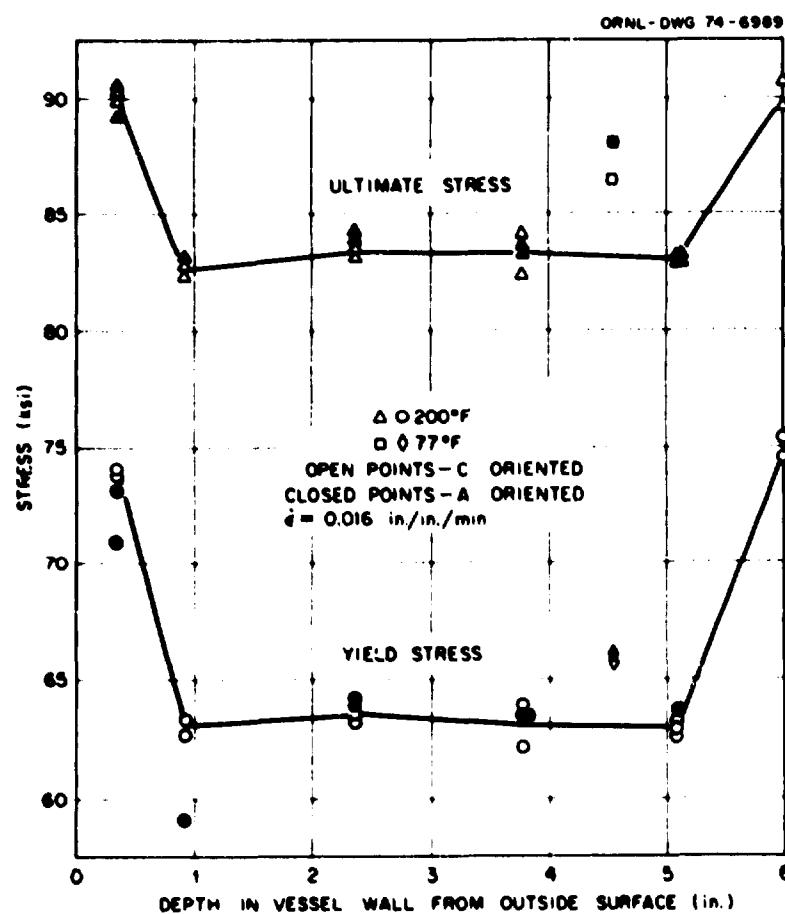
Fig. 2.9. Tensile properties of intermediate vessel V-7 using C- and A-oriented subsize tensile specimens from 152-mm-thick (6-in.) ASTM A533, grade B, class 1 carbon steel (1 ksi = 6.895 MPa; 1 in. = 25.4 mm).

Yield and ultimate stresses at 93°C (200°F) appear to be 503 and 621 MPa (73 and 90 ksi) at 7.6 mm (0.3 in.) and 434 and 572 MPa (63 and 83 ksi) through the 23- to 127-mm (0.9- to 5-in.) depths. The reduction in area results indicate that the ductility of the A-oriented specimens is 5% lower near the

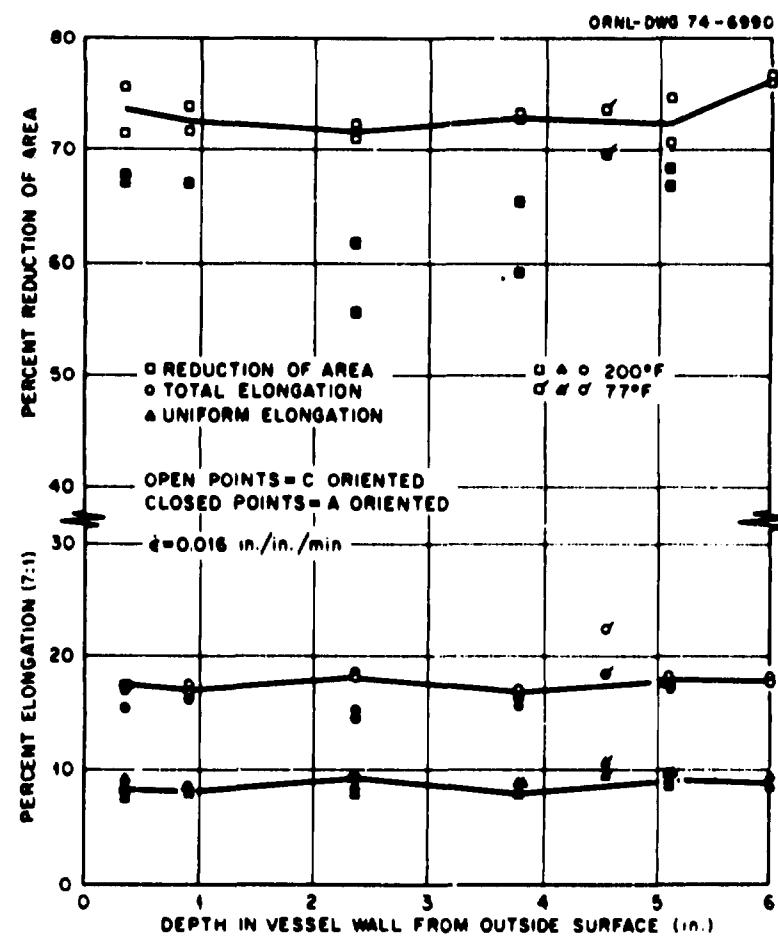
Fig. 2.10. Tensile properties of intermediate vessel V-7 using C- and A-oriented subsize tensile specimens from 152-mm-thick (6-in.) ASTM A533, grade B, class 1 carbon steel.

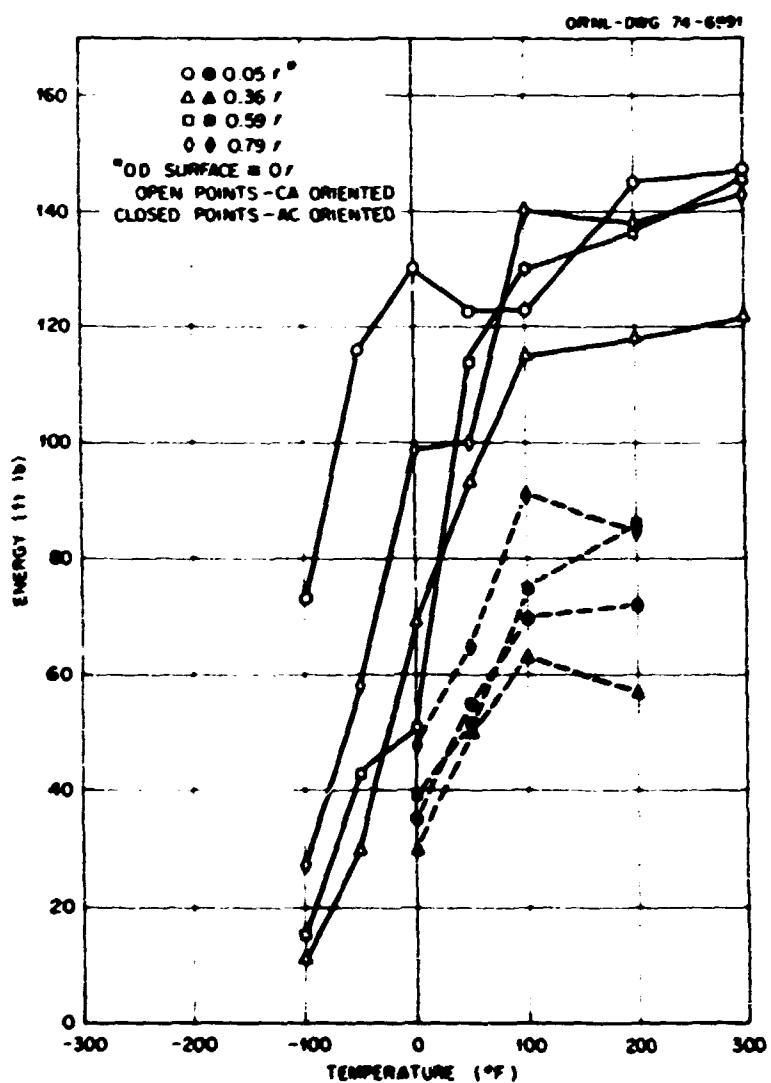
Fig. 2.11. Charpy-V impact properties of intermediate vessel V-7 using CA- and AC-oriented specimens from 152-mm-thick (6-in) ASTM A533, grade B, class 1 carbon steel (1 ft-lb = 1.356 J).

Charpy impact results from CA- and AC-oriented specimens indicate that the AC specimens have lower upper-shelf energies and transition regions occurring at higher temperatures. Both orientations indicate that the lowest energy values were obtained at the 54-mm (2 $\frac{1}{8}$ -in.) depth (from outer surface), that the inner half (0.59 and 0.79T) shows higher shelf energies than the outer half (0.05 and 0.36T), that the energy and lateral expansion transitions of all inner materials (0.36 to 0.79T) occur below 38°C (100°F), and that the upper shelf was attained at about 93°C (200°F). Figures 2.11 and 2.12 illustrate the distribution of both the energy and lateral expansion with temperature at selected depths.

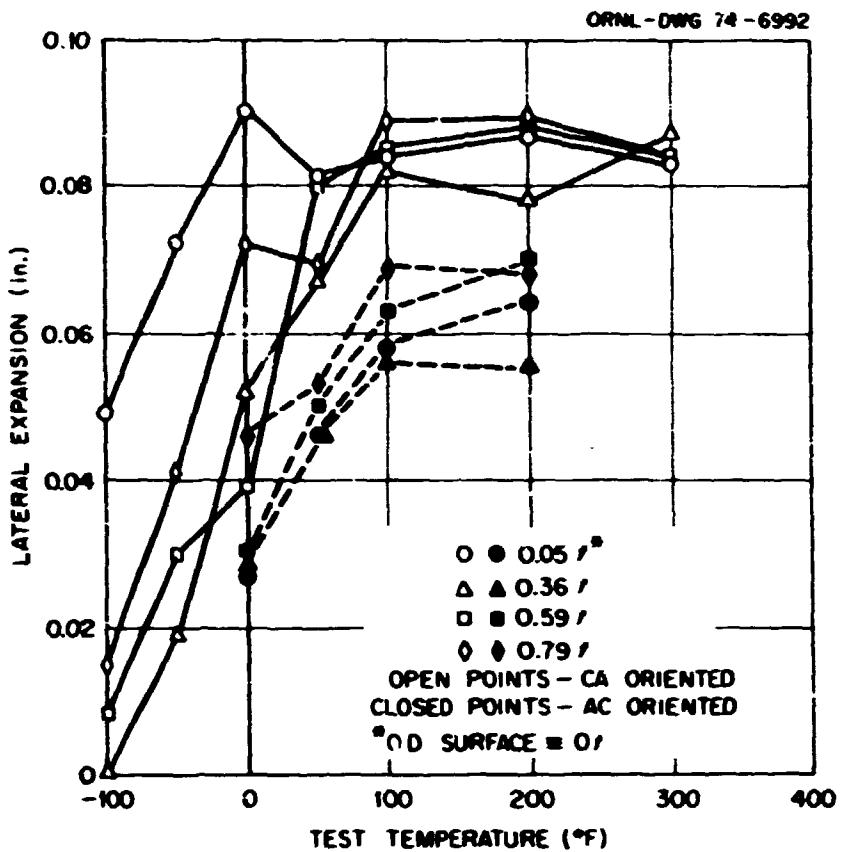
Fig. 2.12. Charpy-V impact properties of intermediate vessel V-7 using CA- and AC-oriented specimens from 152-mm-thick (6-in.) ASTM A533, grade B, class I carbon steel.

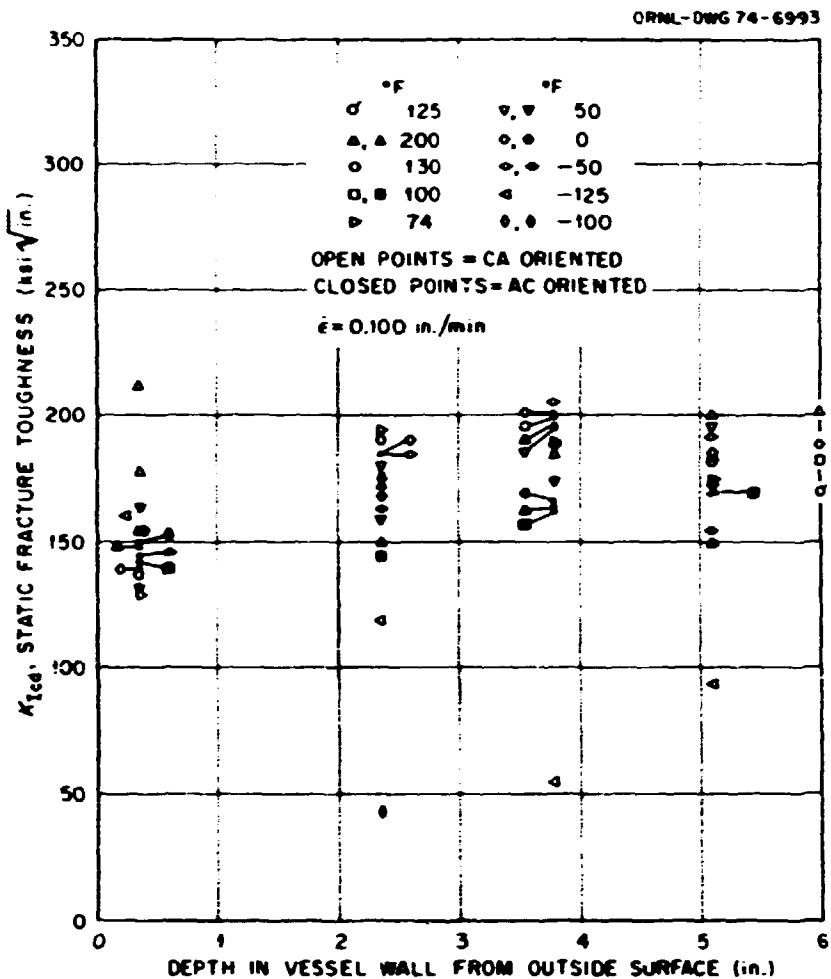
Fig. 2.13. Lower-bound fracture toughness values obtained from intermediate vessel V-7 using CA- and AC-oriented precracked Charpy-V specimens from 152-mm-thick (6-in.) ASTM A533, grade B, class 1 carbon steel.

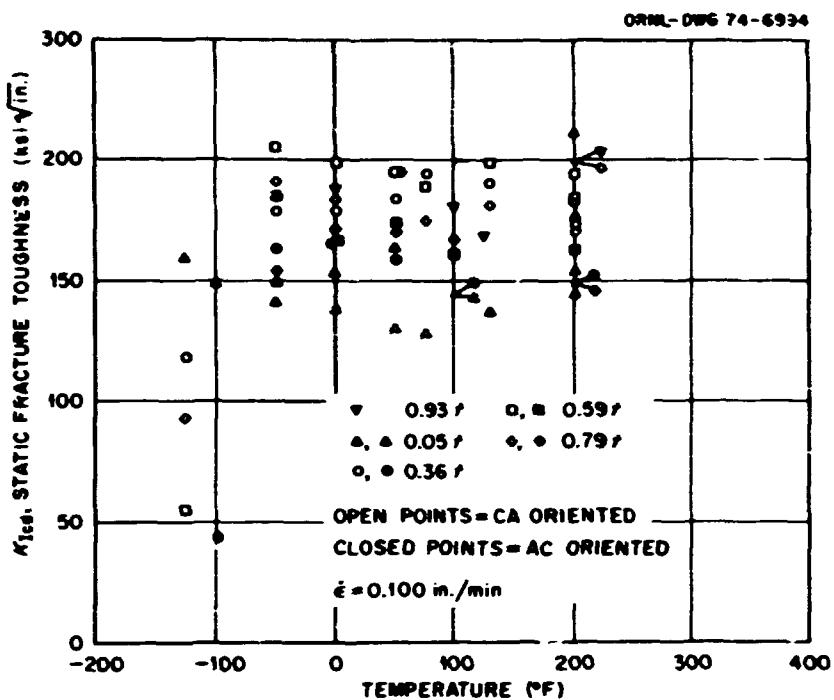
Fig. 2.14. Lower-bound fracture toughness values obtained from intermediate vessel V-7 using CA- and AC-oriented precracked Charpy-V specimens from 152-mm-thick (6-in.) ASTM A533, grade B, class ' carbon steel.

The fracture toughness data obtained by Mager for the prolongation material from intermediate test vessel V-7 are given in Table 2.5. The toughness of the base plate material from vessel V-7 is comparable to that of the forging prolongations of the first six intermediate vessels. Also, the fracture toughness through the thickness (inside surface, midthickness, and outside surface) of intermediate vessel V-7 appears to be homogeneous at 93°C.

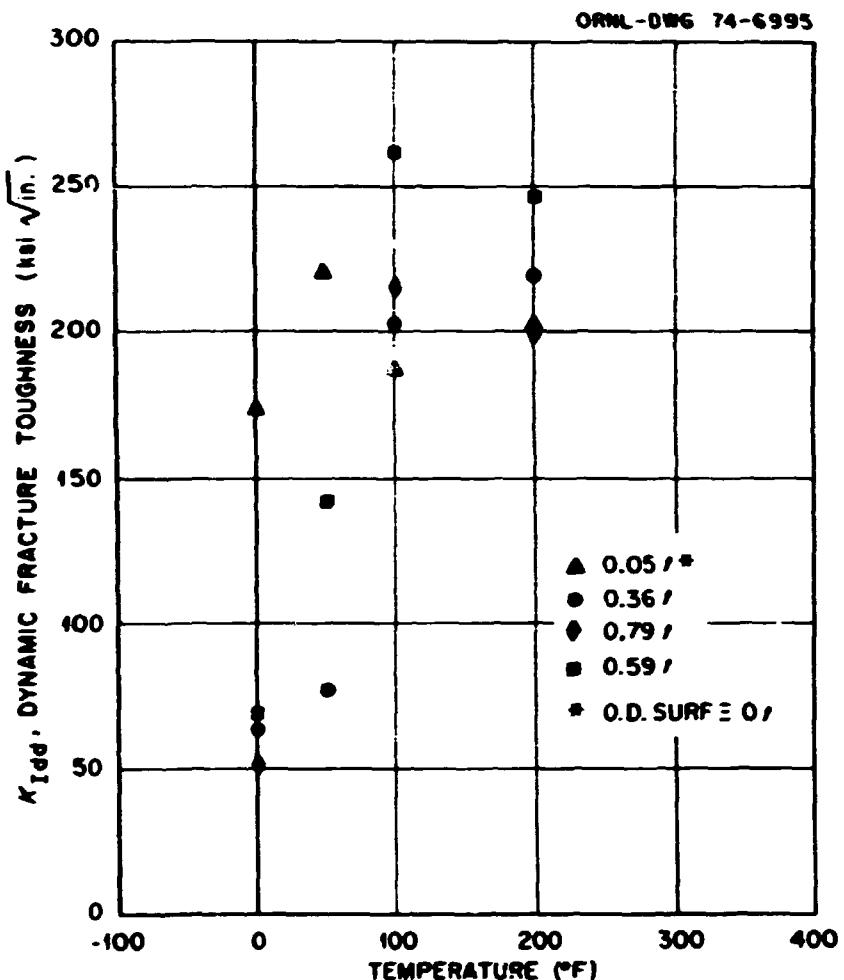
Fig. 2.15. Lower-bound fracture toughness values obtained from intermediate vessel V-7 using CA-oriented, precracked Charpy-V specimens from 152-mm-thick (6-in.) ASTM A533, grade B, class 1 carbon steel.

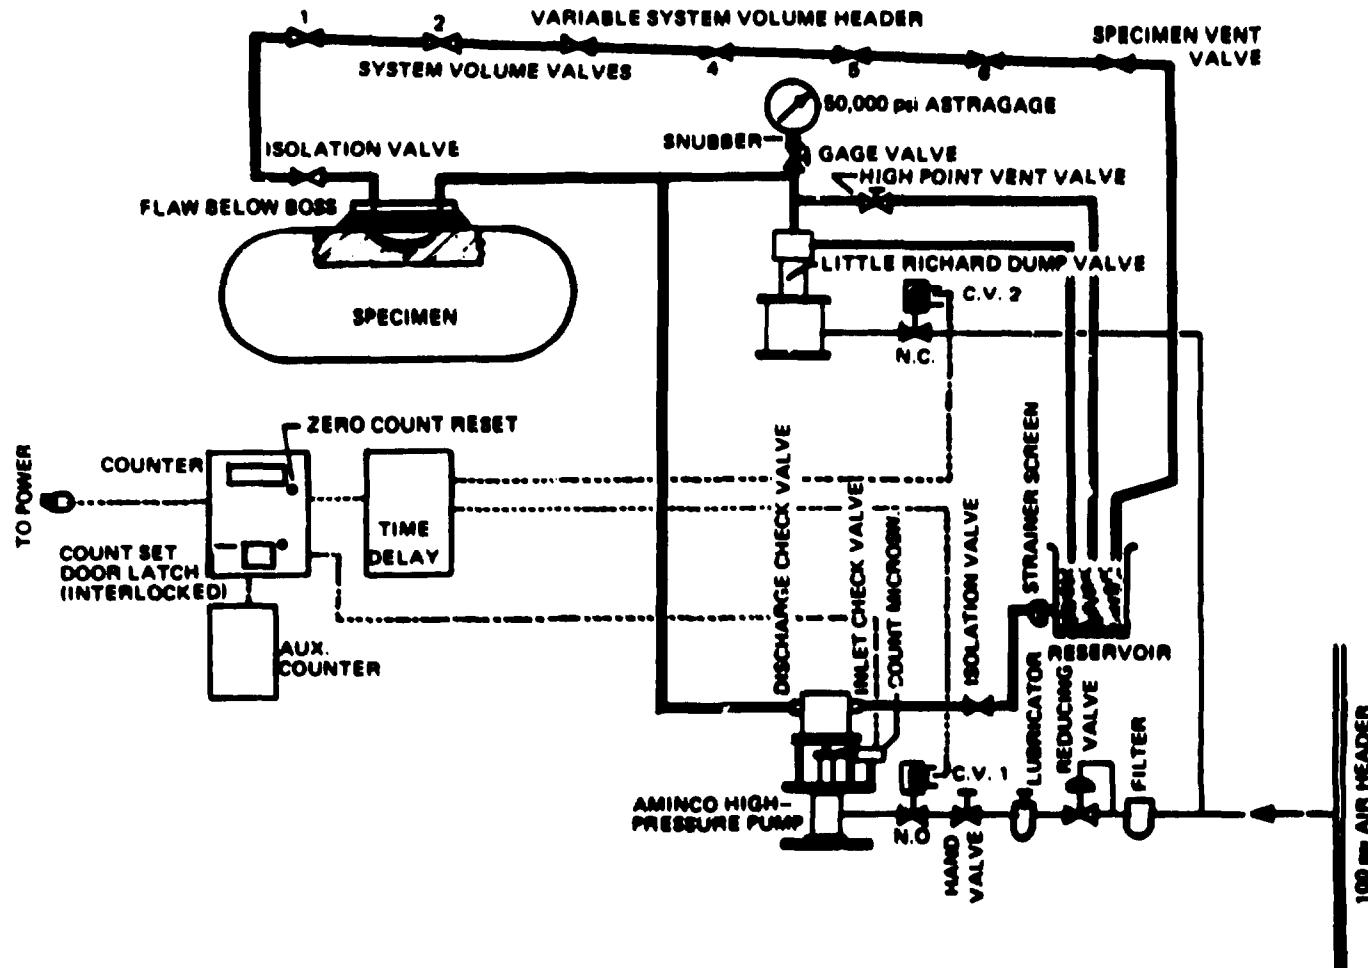
Fig. 3.1. High-pressure hydraulic pumping system for pump-dump cycling.

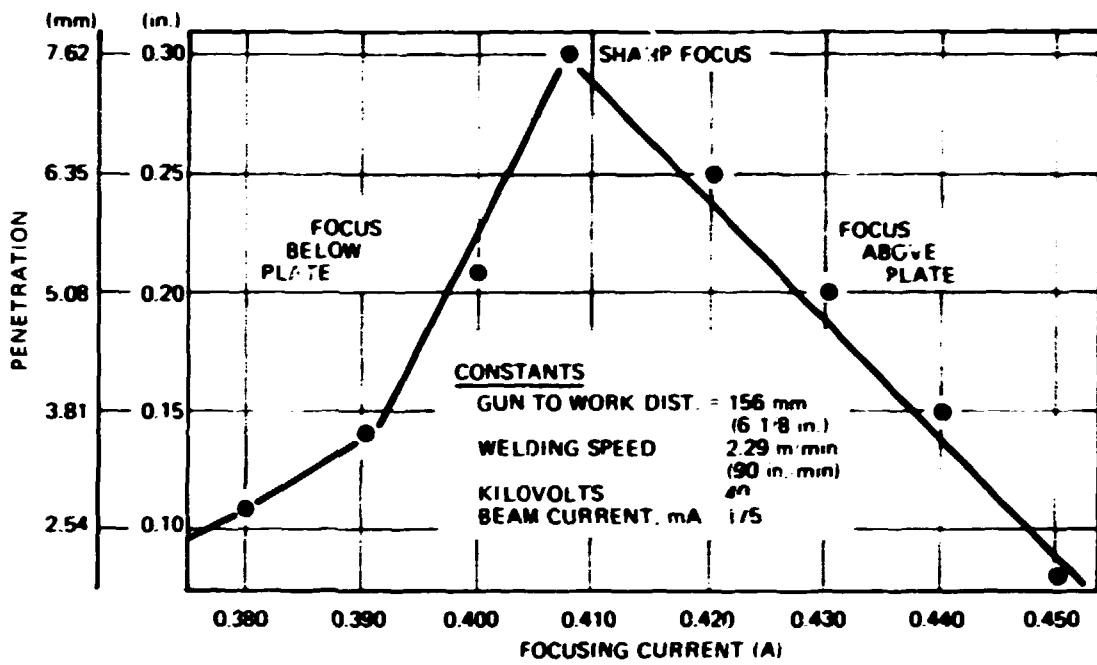
Fig. 3.3. Partial penetration autogenous electron-beam welds on AS33, grade B, class I steel plate.

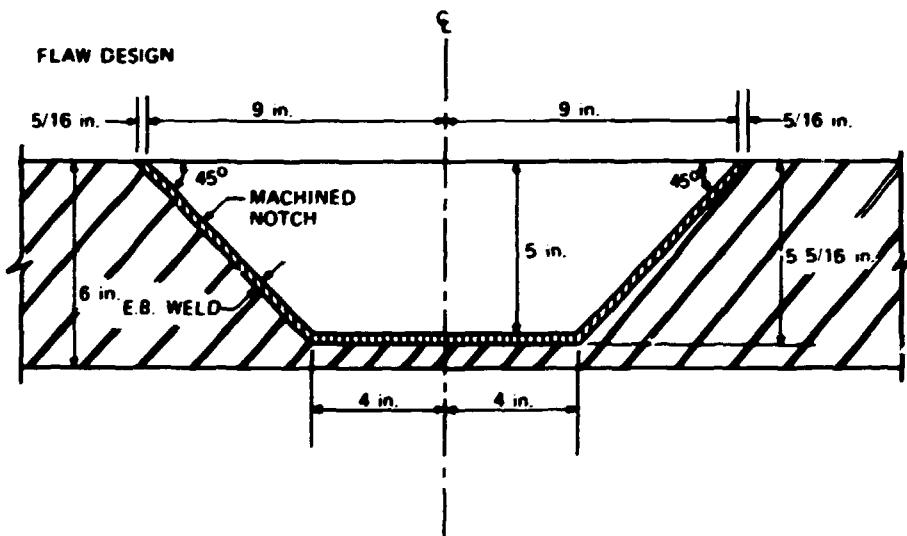
Fig. 3.4. Flaw design for HSST program intermediate test vessel V-7.

The flaw selected for V-7 was an external trapezoidal surface flaw having machined dimensions of 457-mm (18-in.) surface length, a depth of 127 mm (5 in.), and a bottom length of 203 mm (8 in.) as shown in Fig. 3.4.

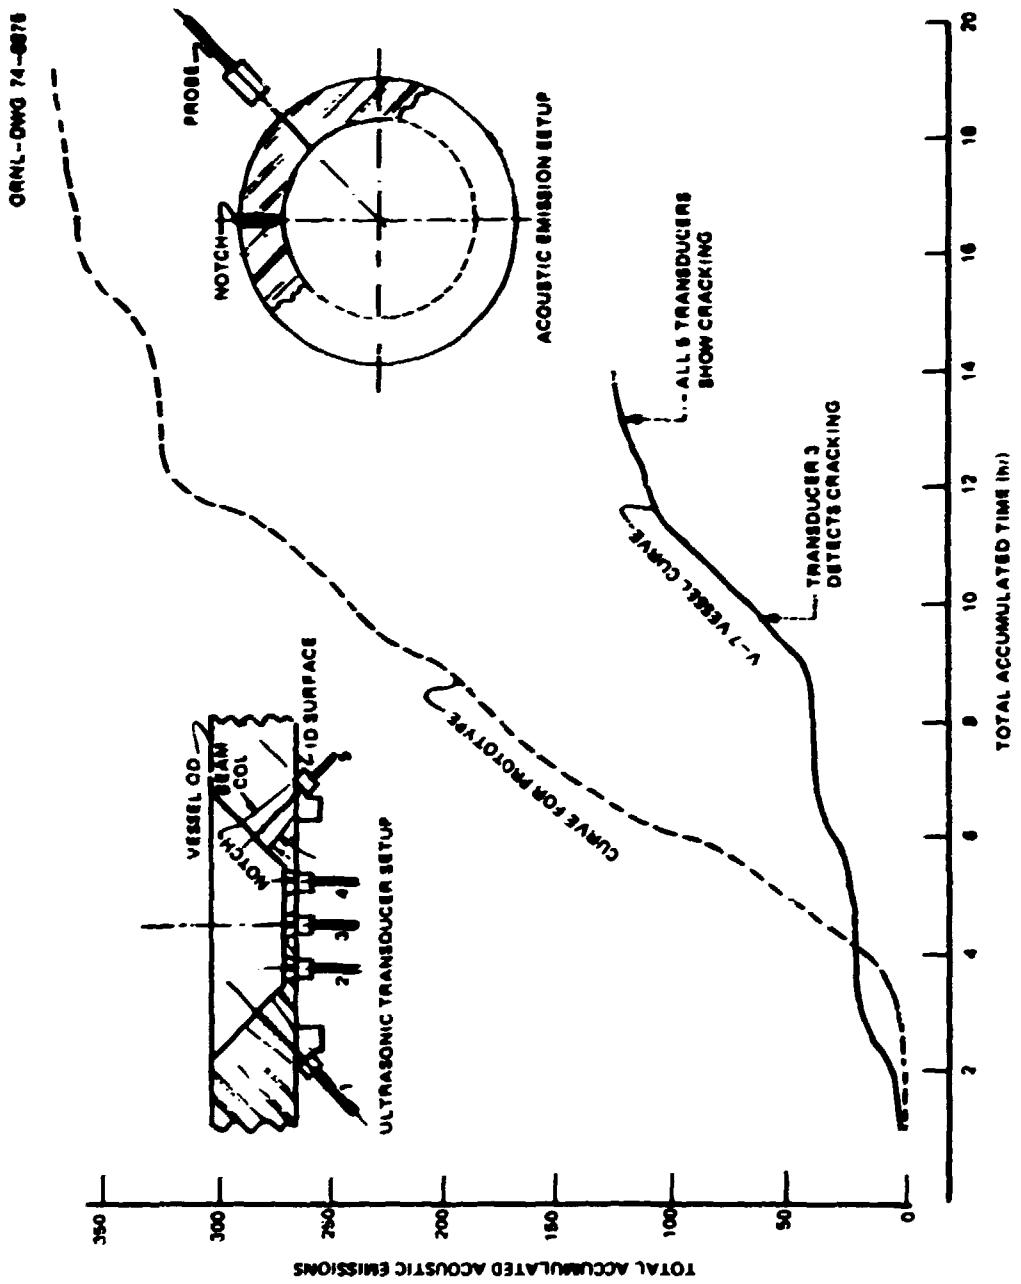
Fig. 3.8. Weld crack monitor arrangement.

During hydrogen charging of the EB weld, it is imperative that the time of cracking be known in order to know when to remove the acid electrolyte. Prolonged acid exposure to a cracked weld tends to widen an otherwise hairline crack. Two techniques can be applied to monitor a weld during charging: acoustic-emission monitoring and a pulse-echo ultrasonic setup with multiple transducer pickups strategically placed about the weld. Composite Fig. 3.8 illustrates the ultrasonic and acoustic-emission setup used to detect EB weld cracking for both the prototype and the actual vessel. The ultrasonic devices confirm cracks at their respective positions and are helpful in monitoring crack growth, which, in these cases, started at approximately the longitudinal center of the weld and progressed toward both ends. Acoustic-emission signals register continuous crack growth; the frequency of emission in the prototype weld differed radically from that of the actual vessel weld. It had been hoped that the emission information obtained from the prototype specimen would furnish guidance for subsequent vessel monitoring. The different acoustic-emission characteristics shown in Fig. 3.8 may be attributable to overall shape and restraint factors which differ greatly between specimen and vessel. More experimentation will be required before more conclusive interpretations can be reached. The final and most conclusive confirmation that cracking has occurred by electrolytic hydrogen charging is by detailed microscopic visual observation. It entails emptying the electrolyte and drying the surface of the weld bead; hence it is impractical except during the latter stages of the charging operation. We have noted that whenever cracks do show up on the weld surface, they then extend throughout the entire weld depth.

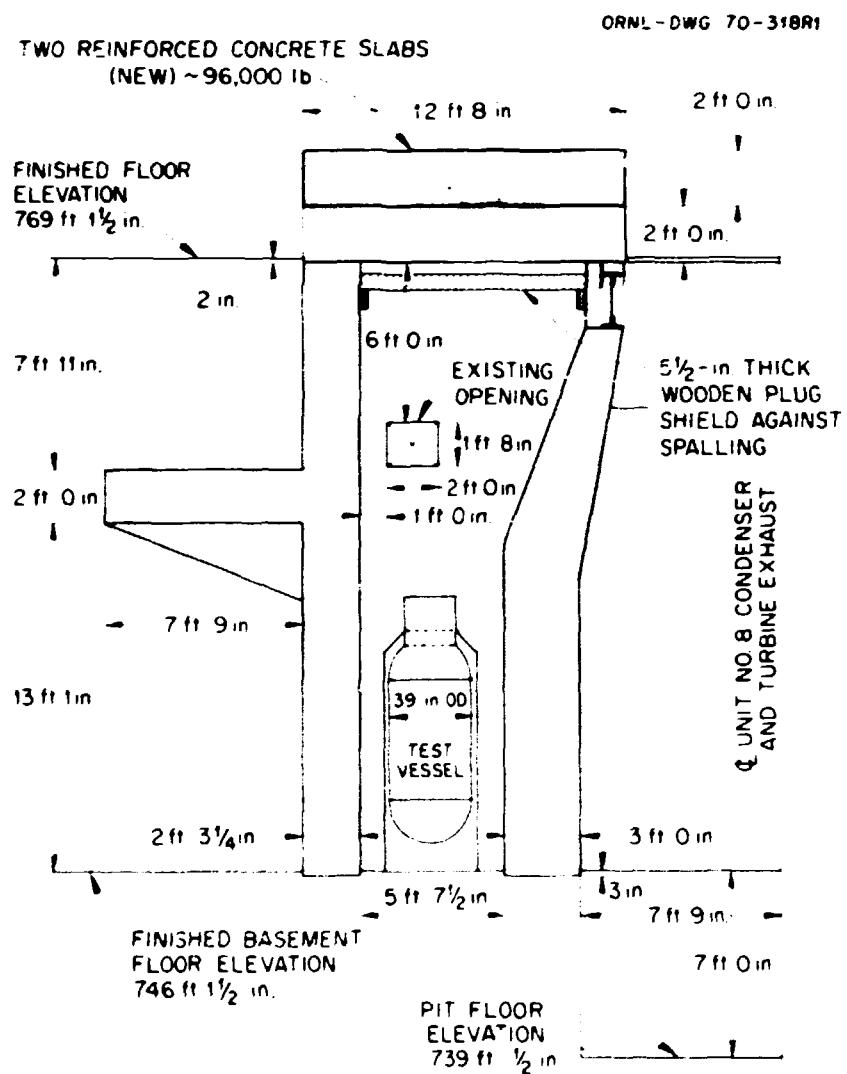
Fig. 4.1. Sectional view of intermediate vessel test pit.

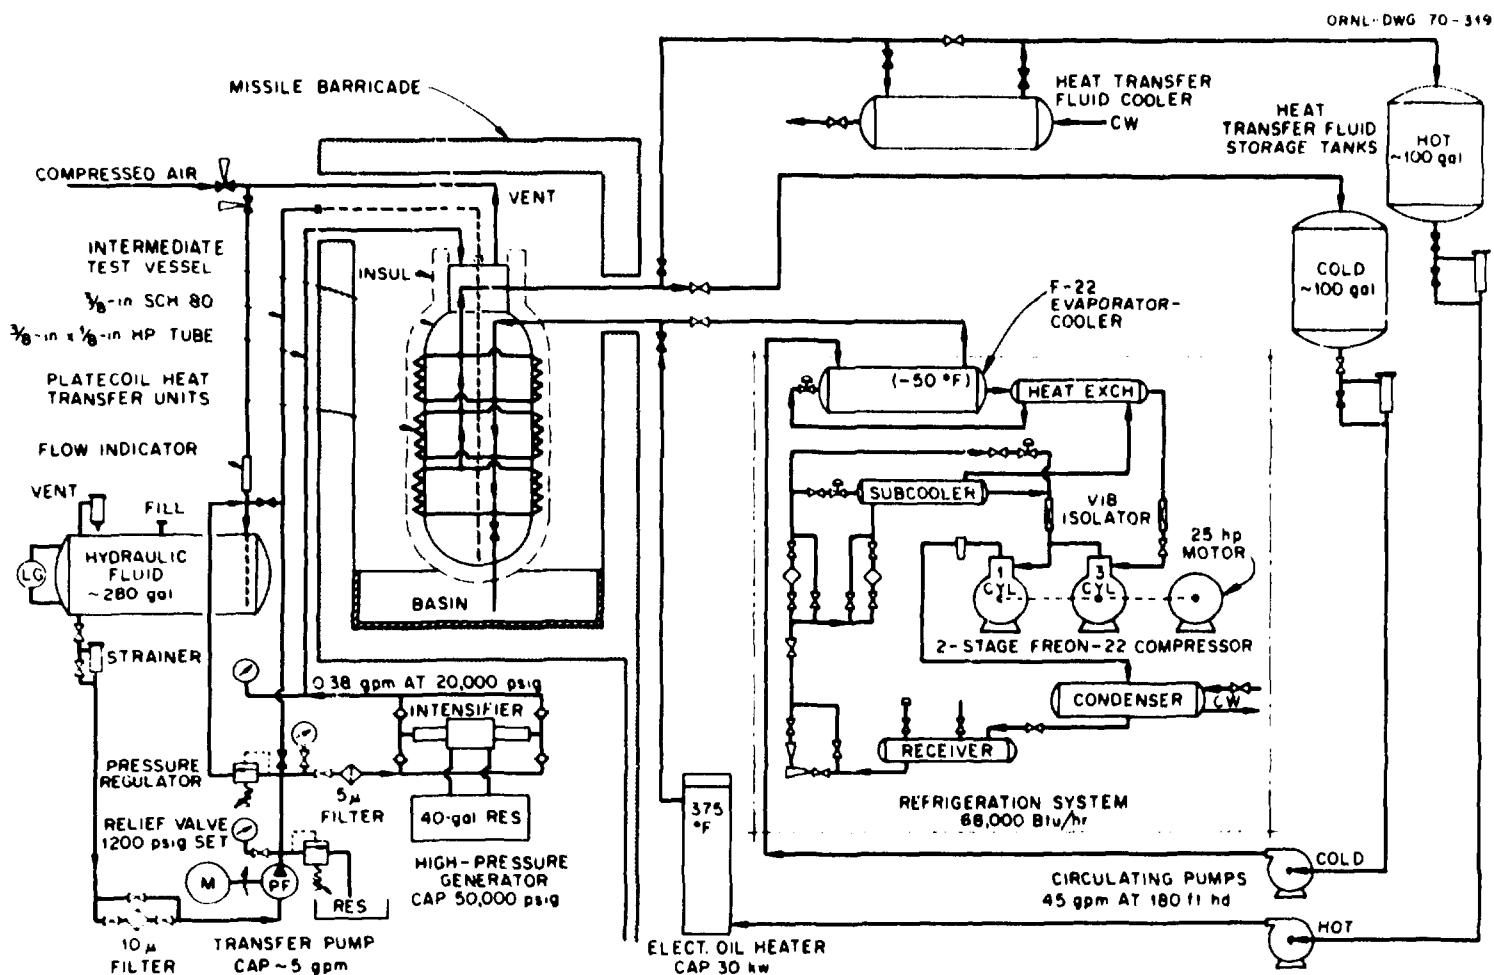
Fig. 4.3. Schematic flow diagram of intermediate vessel test facility.

The test facility is capable of controlling vessel temperatures from -46 to 177°C (-50 to 350°F) and pressurization output to 345 MPa (50,000 psi). Figure 4.3 is a schematic flow diagram of the facility.

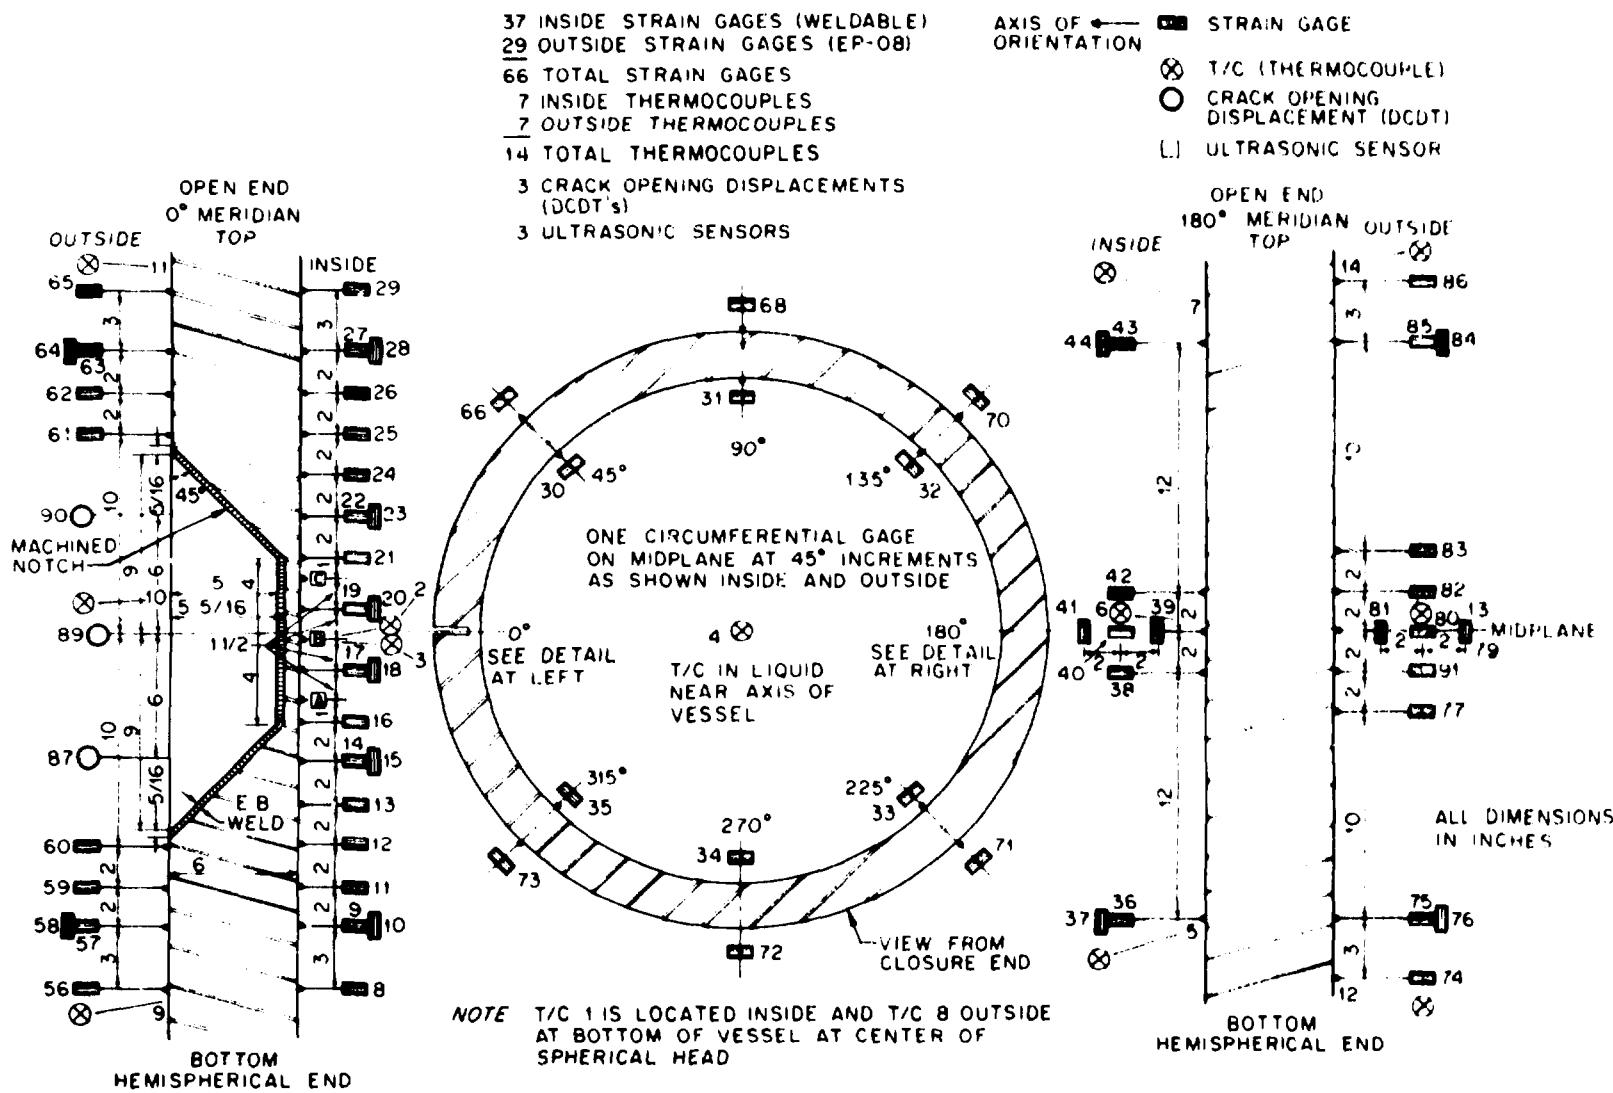
Fig. 4.4. Location of instrumentation on intermediate test vessel V-7.

After the vessel was flawed (see Chapter 3), it was transported to another Y-12 facility of the Reactor Division for instrumentation.² After all inside and part of the outside instrumentation was complete, the head was installed and the vessel sealed. The vessel was then moved to the test site and installed in the test pit. Figure 4.6 shows the instrumented vessel after exterior instrumentation was complete. Heating-cooling plates were installed, the instrumentation lead wires to the control room were connected, and insulation was applied to the vessel. It was then ready to be filled with demineralized water, followed by the connection of the pressurization lines. During the filling operation and while the vessel was being brought to the test temperature, installation of television, acoustic-emission, and ultrasonic monitoring equipment was completed. After final checks on all recording equipment, the vessel was ready to test.

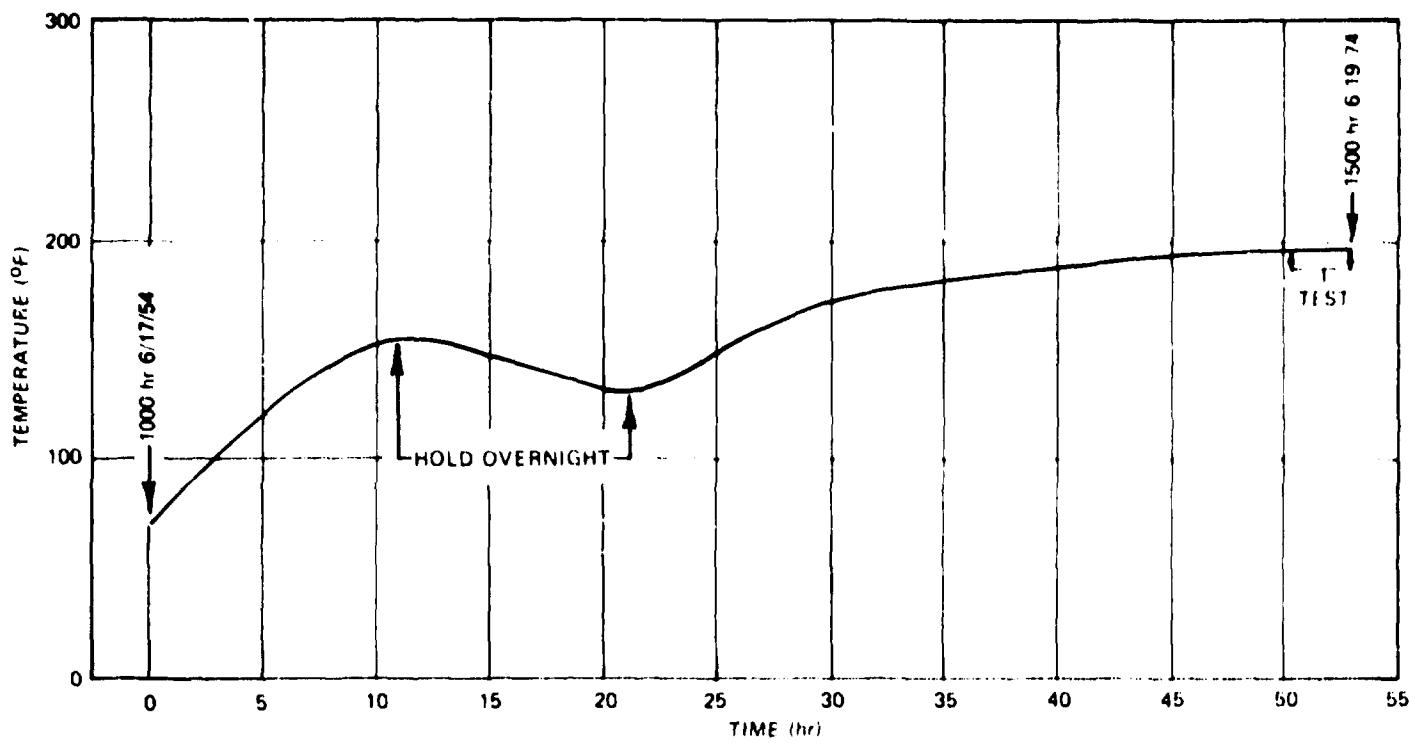
Fig. 4.7. Time vs temperature for location at thermocouple.

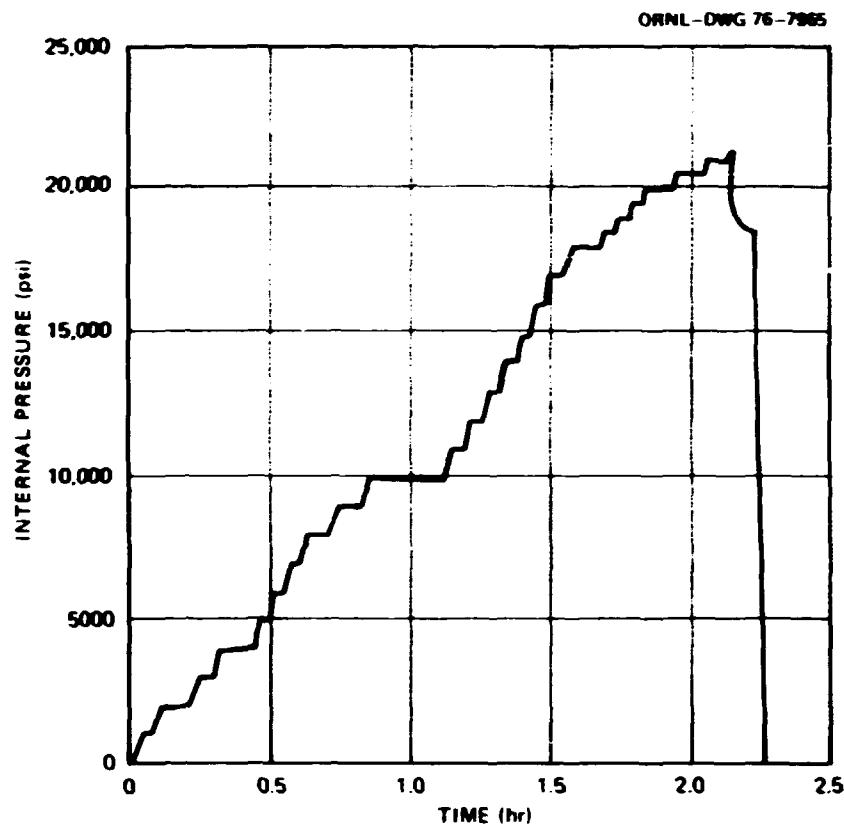
Fig. 4.8. Time vs pressure for test vessel V-7.

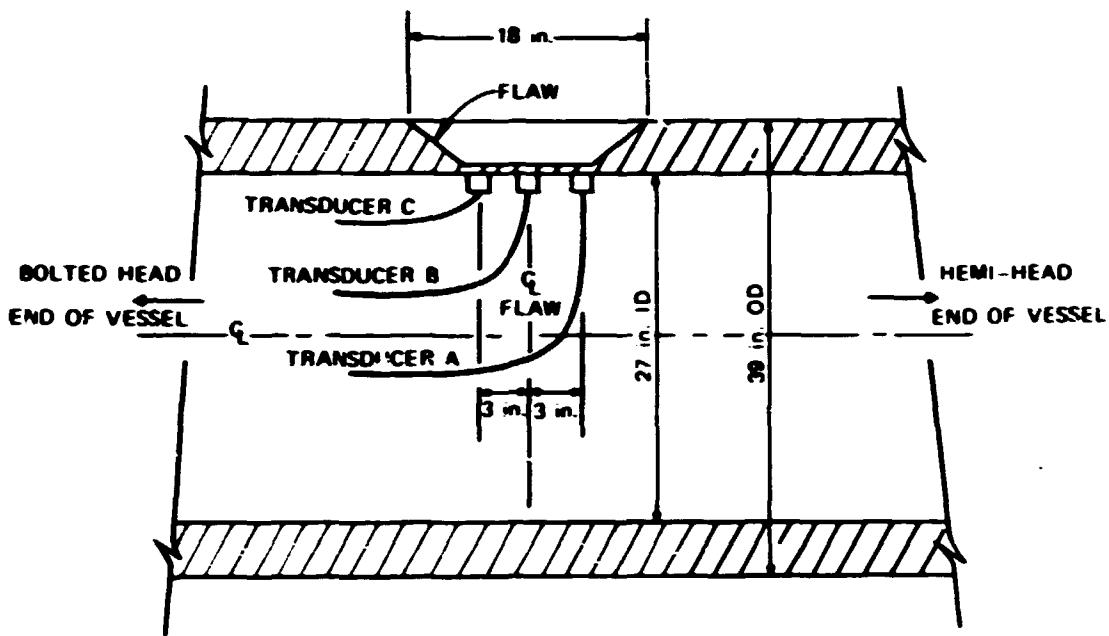
Fig. 4.9. Ultrasonic transducer placement in vessel V-7.

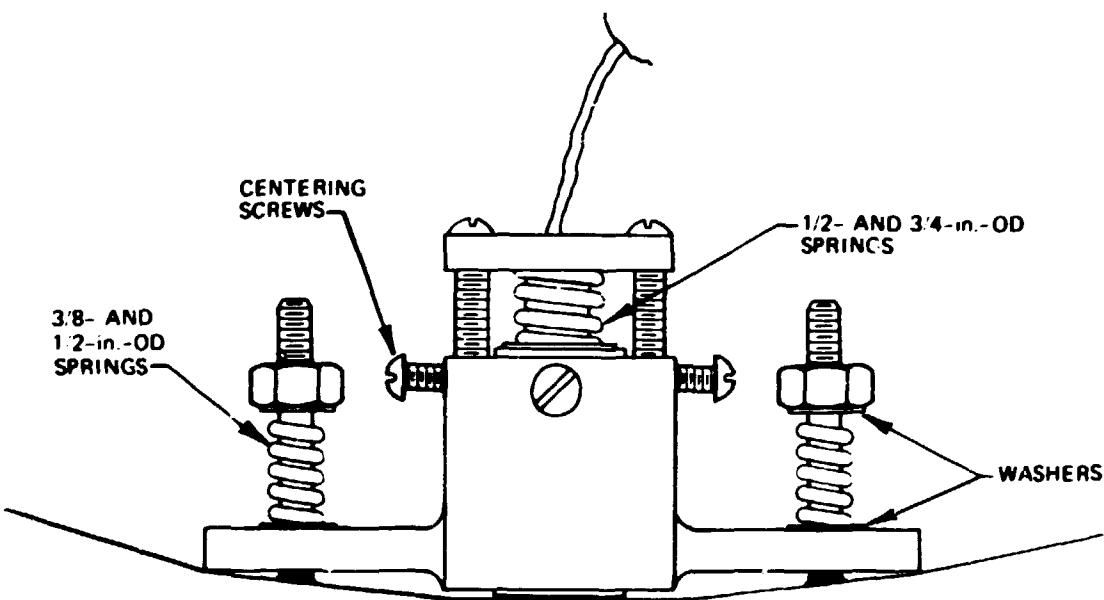
Fig. 4.10. Transducer holder for vessel V-7.
