**Test of 6-In.-Thick Pressure Vessels.
Series 3: Intermediate Test Vessel V-7**

OAK RIDGE NATIONAL LABORATORY

ORNL/NUPEG-1
Dist. Category NRC-5

The test of intermediate test vessel V-7 was a crack-initiation fracture test of a 152-mm-thick (6-in.), 990-mm-OD (39-in.) vessel of ASTM A533, grade B, class 1 steel plate with a sharp outside surface flaw 457 mm (18 in.) long and about 135 mm (5.3 in.) deep. The vessel was heated to 91 °C (196°F) and pressurized hydraulically until leakage through the flaw terminated the test at a peak pressure of 147 MPa (21,350 psi). Fracture toughness data obtained by testing precracked Charpy-V and compact-tension specimens machined from a prolongation of the cylindrical test shell were used in pretest analyses of the flawed vessel. The vessel, as expected, did not burst. Upon depressurization, the ruptured ligament closed so as to maintain static pressure without leakage at about 129 MPa (18,700 psi).

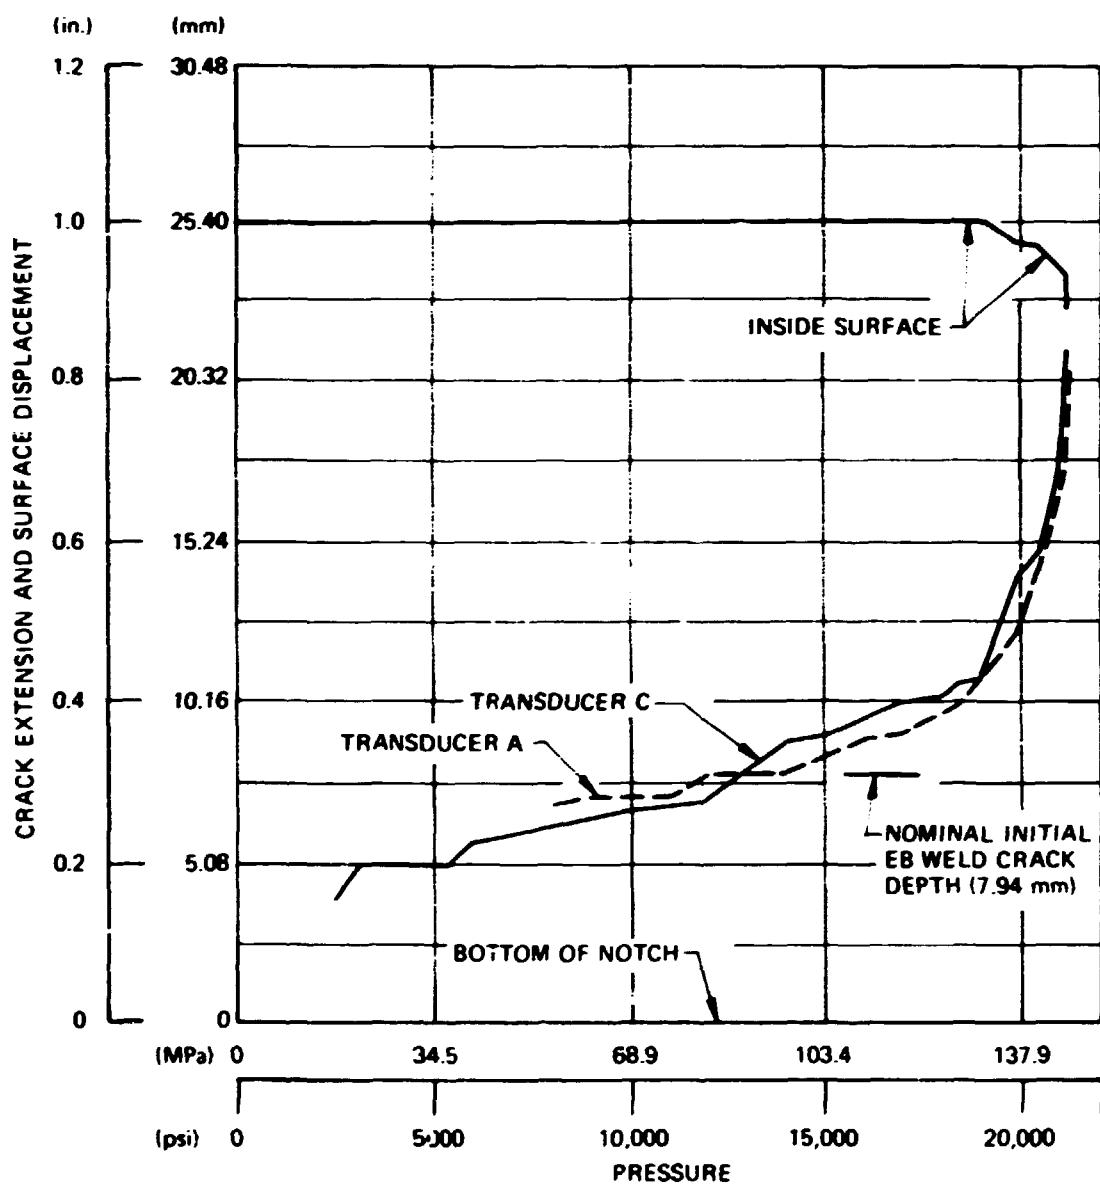
ORNL DWG 76-6742

Fig. 4.11. Crack depth and inside surface deformation vs pressure measured ultrasonically in vessel V-7.

Prior to vessel pressurization, the ultrasonic instruments were calibrated for depth measurement with the bottom surface of the machined notch as the datum. This was necessary because the EB weld crack was not visible on the scope at zero pressure; therefore all the depth readings include the initial EB weld crack depth. The composite crack depth is shown in Fig. 4.11 as a function of pressure. The EB weld crack produced no indication until between 14 and 20 MPa (2000 and 3000 psi), at which time a perceptible indication appeared at a depth of 4 mm (0.16 in.). At 20 MPa (3000 psi), a positive indication of the crack was showing at 5 mm (0.20 in.) where it remained stationary in depth until after 34 MPa (5000 psi) pressure. Between 34 and 131 MPa (5000 and 19,000 psi), the crack depth increased with pressure at a relatively uniform rate during the pressurization periods. After 131 MPa, the crack depth increased more rapidly with each increase in pressure. After 138 MPa (20,000 psi), the crack indication continued to move for a short time after the pressure pumps were shut off, indicating an increase in depth with no increase in pressure.

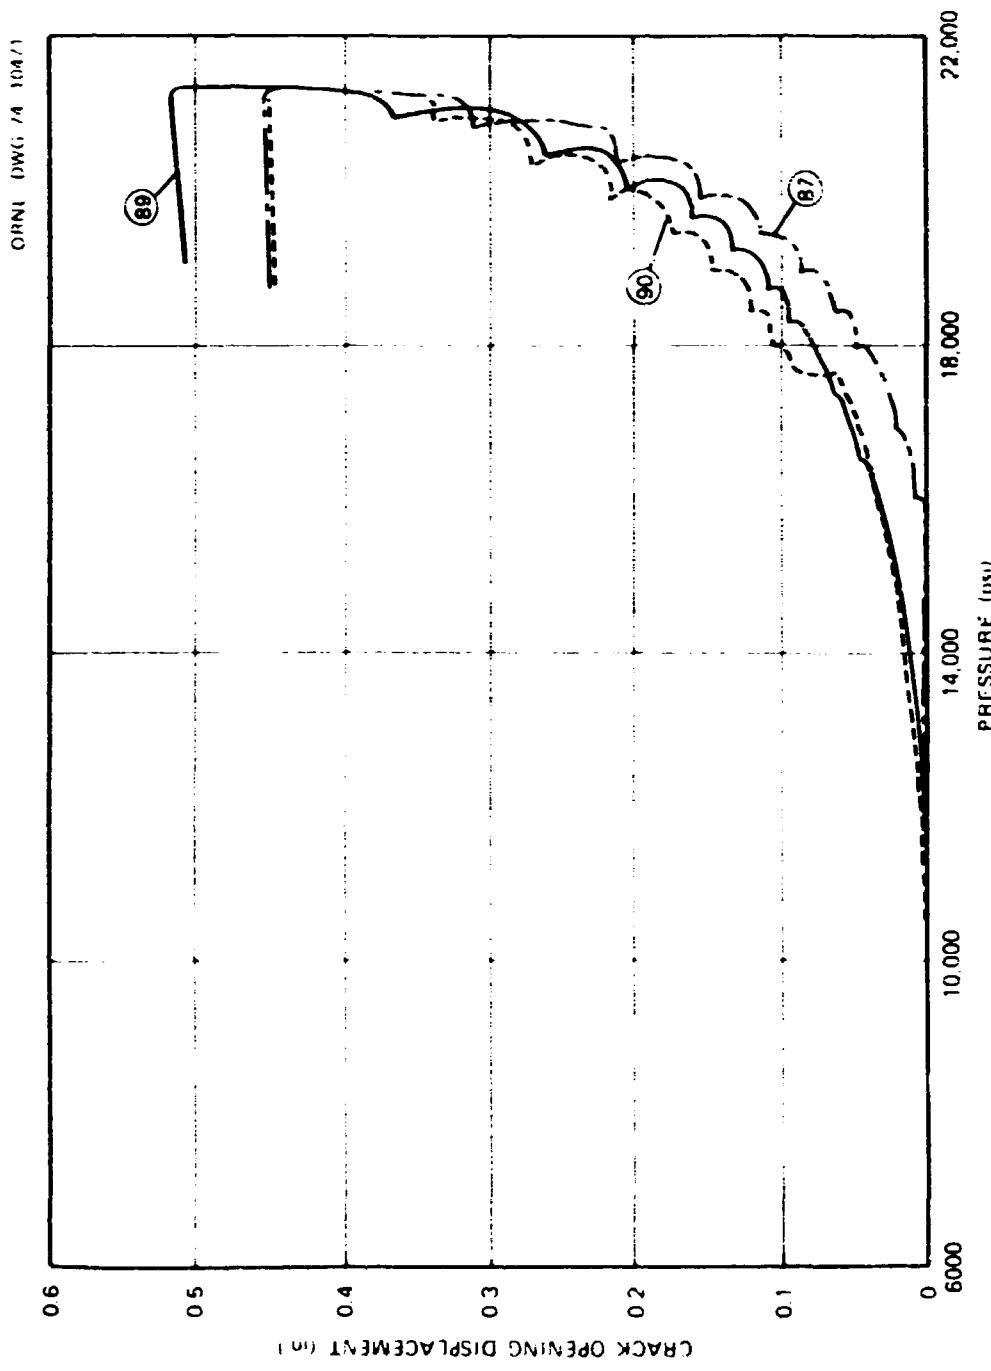
Fig. 4.12. Crack-opening displacement vs pressure for vessel V-7.

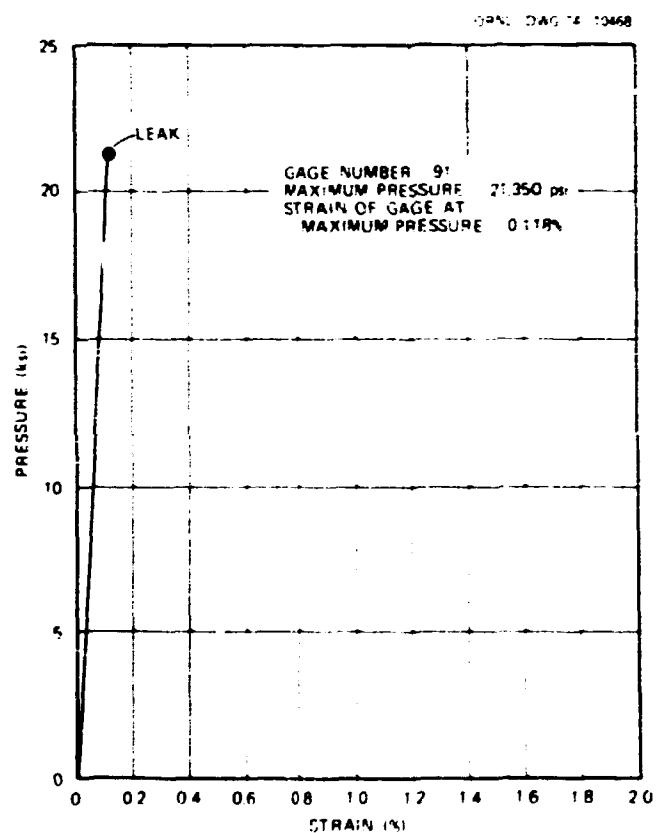
Fig. 4.13. Pressure vs outside surface circumferential strain 180° from flaw for test of vessel V-7.

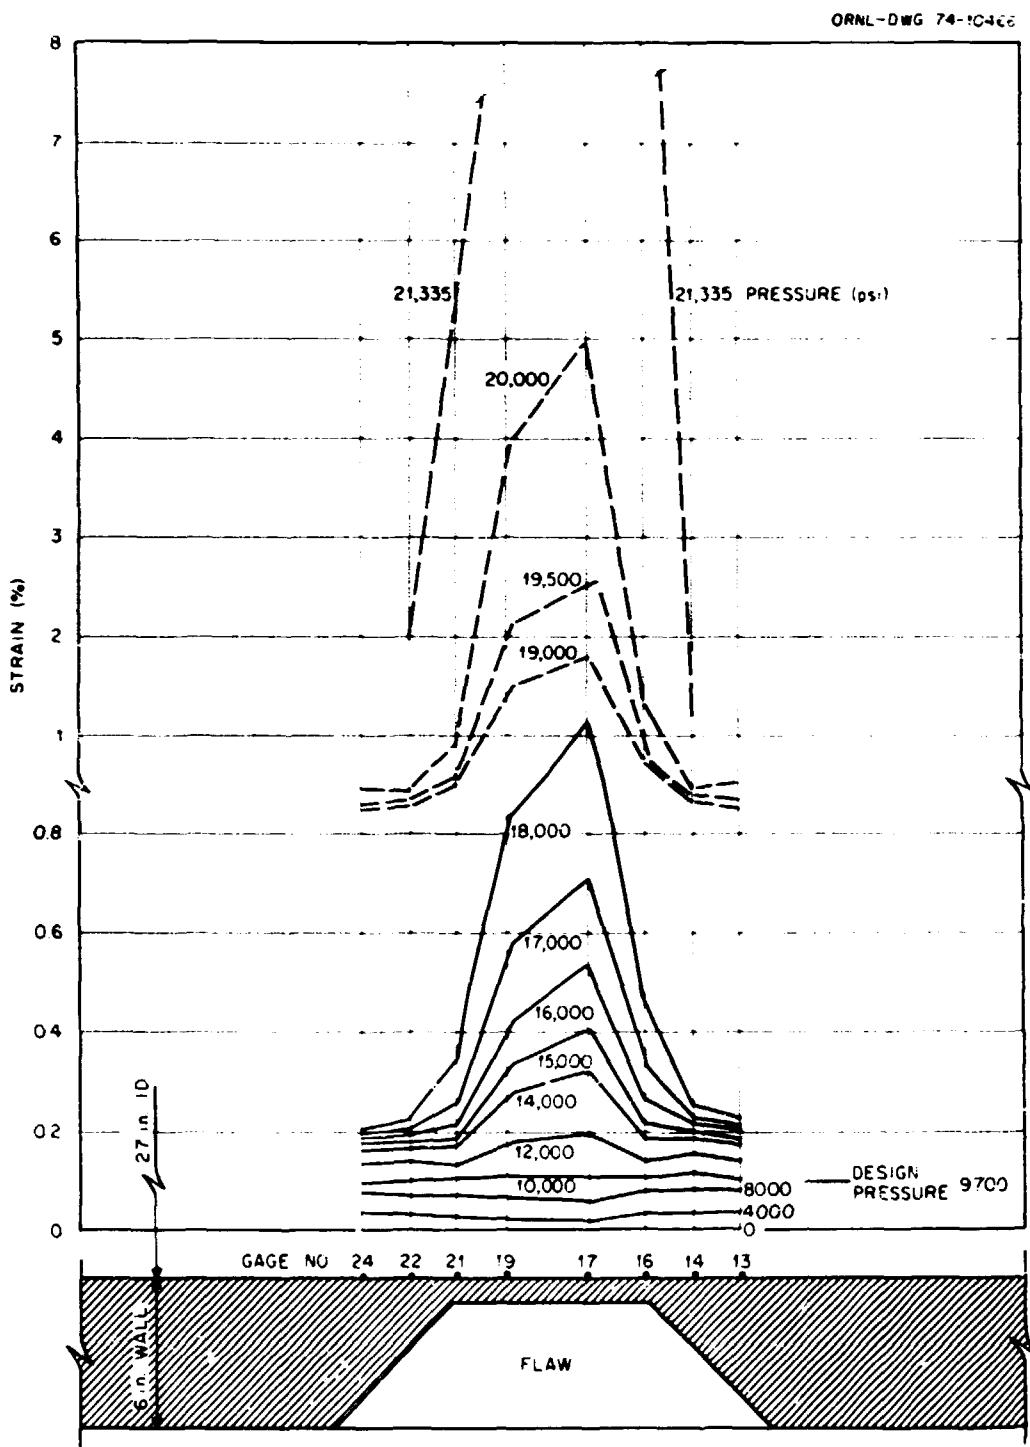
Fig. 4.14. Circumferential strain vs ligament location as a function of pressure. Test of intermediate vessel V-7.

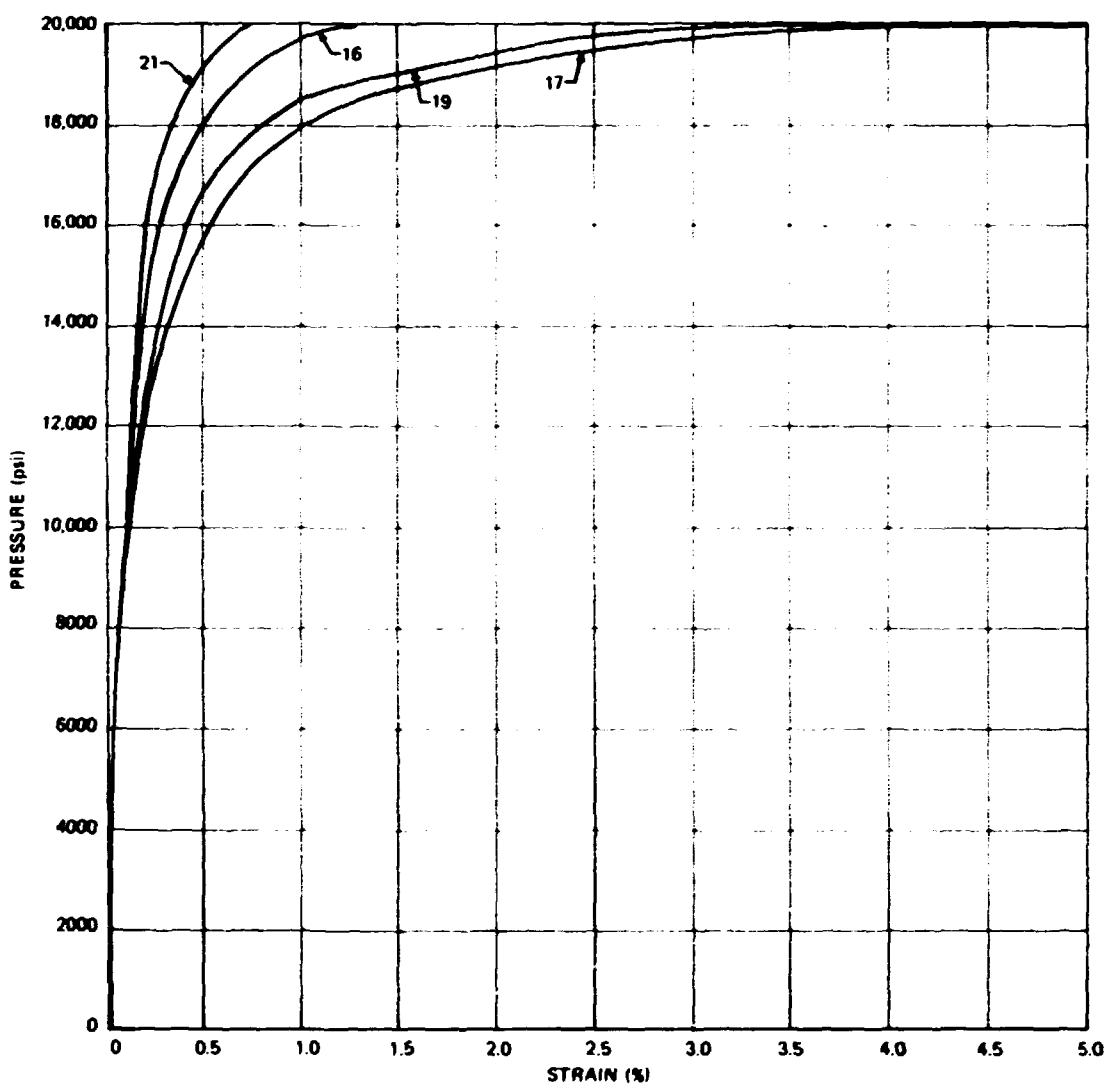
ORNL-DWG 76-7967

Fig. 4.15. Circumferential strain vs pressure as a function of ligament location. Test of intermediate vessel V-7.

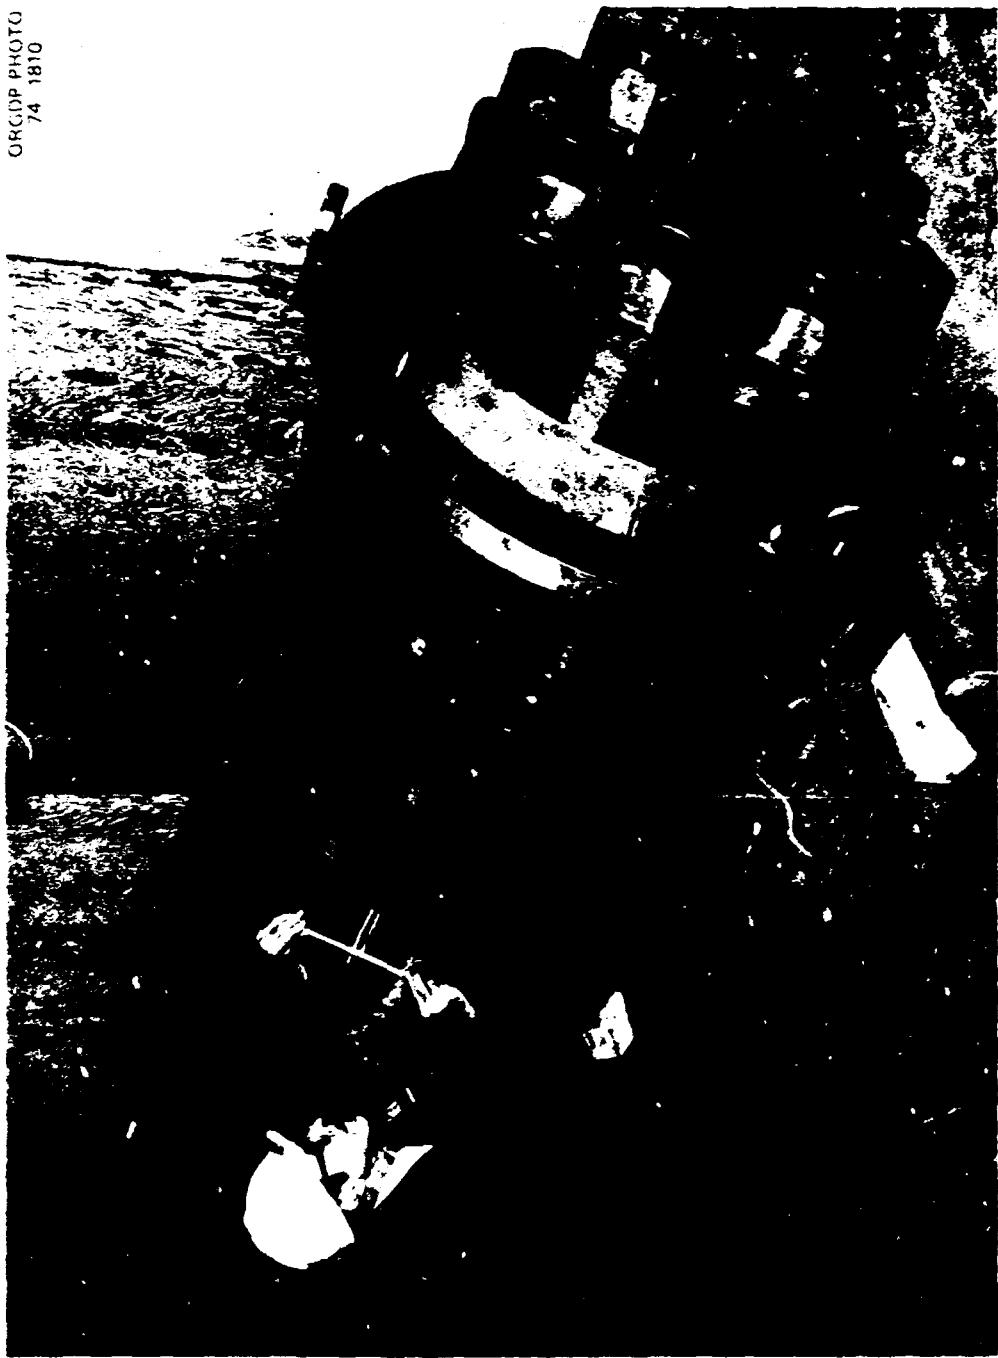
ORCID PHOTO
74 1810

Fig. 4.16. Intermediate vessel V-7 after testing.

A posttest view of vessel V-7 is given in Fig. 4.16, where the permanent crack opening is visible along the base of the machined notch. This opening is shown more clearly in Fig. 4.17. The crack was probed with a sharp thin instrument to determine the depth of the visibly open crack. The contour of the crack determined in this way is given in Fig. 4.18. The actual precracked depth was also verified approximately by visual examination of the flaw. The inside surface of the vessel beneath the notch is shown in Fig. 4.19.

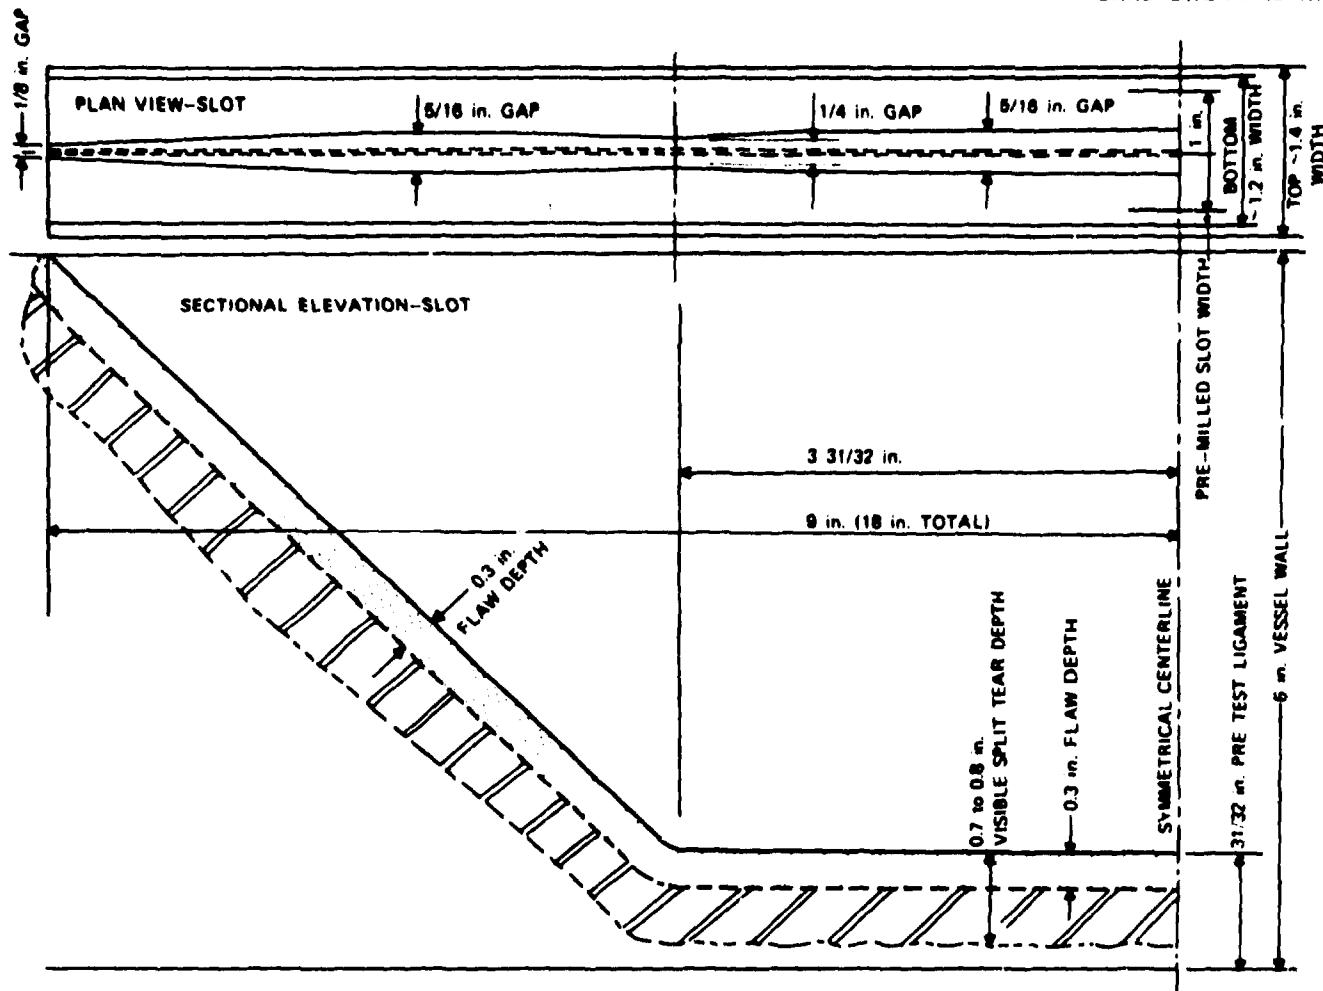
Fig. 4.18. Contour of visible crack in vessel V-7 after test.

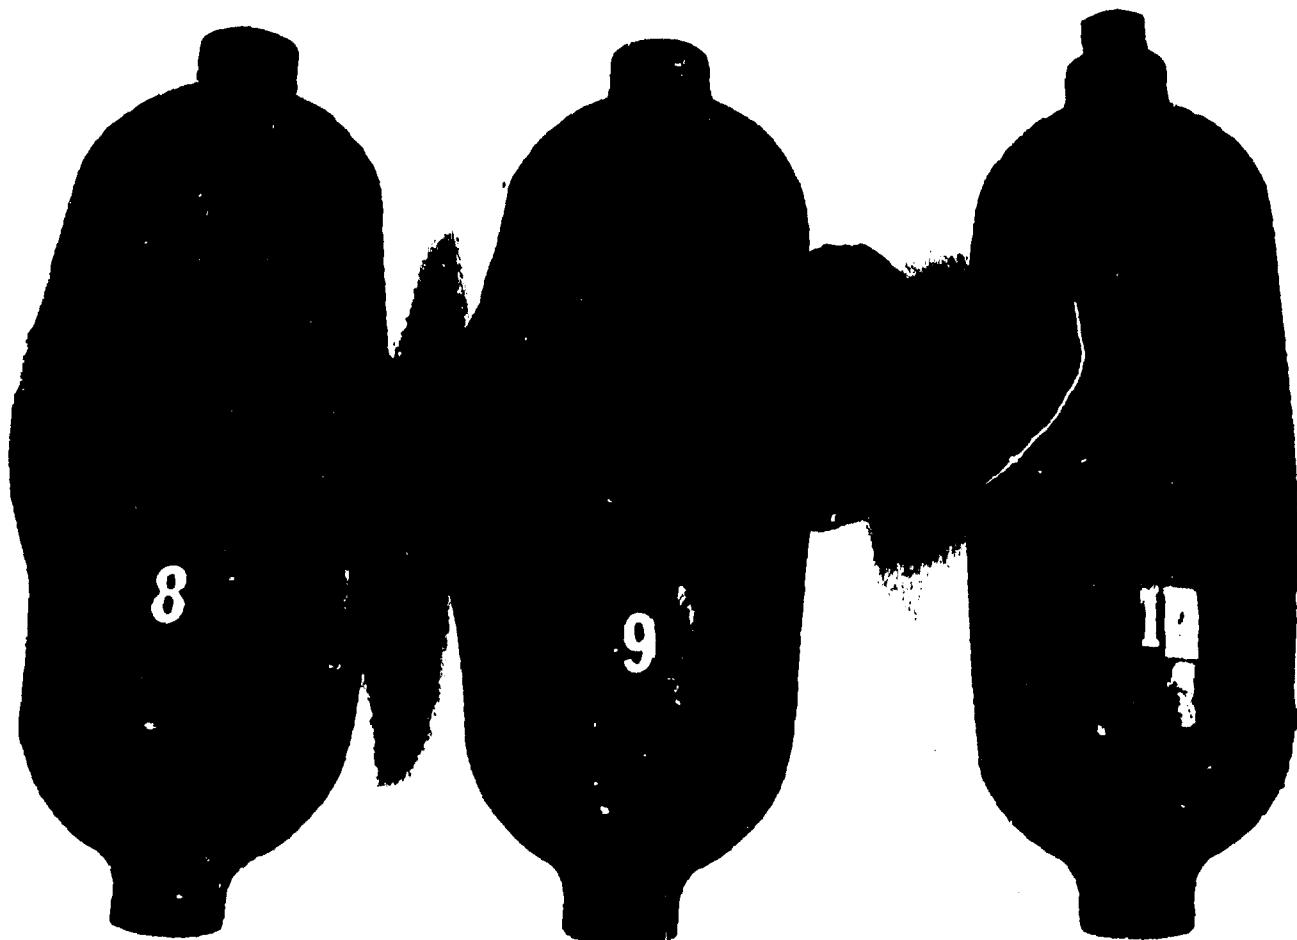
PHOTO 78988

Fig. 5.2. Posttest photograph of three flawed 76.2 mm-diam (3-in.) steel models tested pneumatically at about 260 °C (500 °F). Model 9 contained the smallest flaw, model 10 contained the largest flaw.

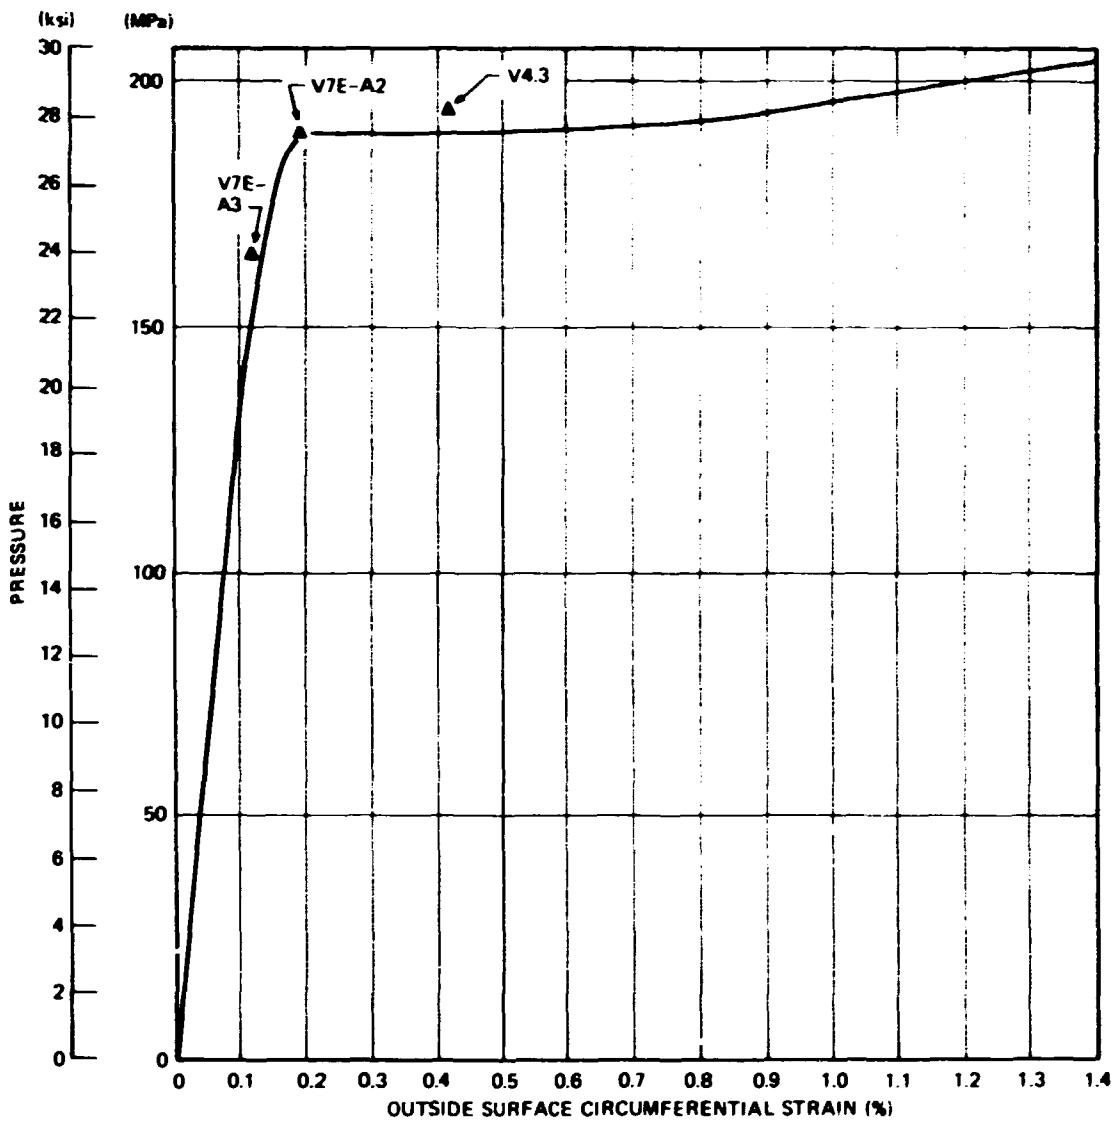
Fig. 5.6. Calculated pressure-strain curve and measured failure conditions for models V4.3, V7E-A2, and V7E-A3.

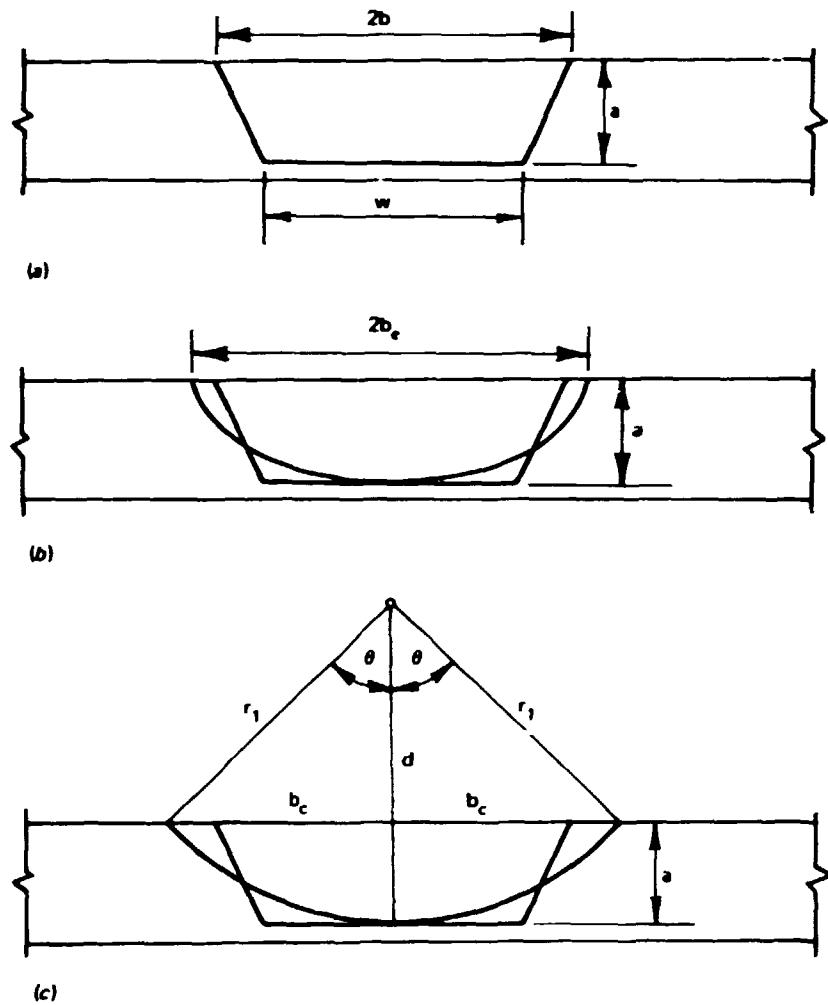
ORNL-DWG 76-7969

Fig. 5.7. Actual trapezoidal, equivalent semielliptical and equivalent part-circular crack configurations for model V7E-A3.

where θ is defined in Fig. 5.7c. The other dimensions related to the equivalent part-circular surface crack

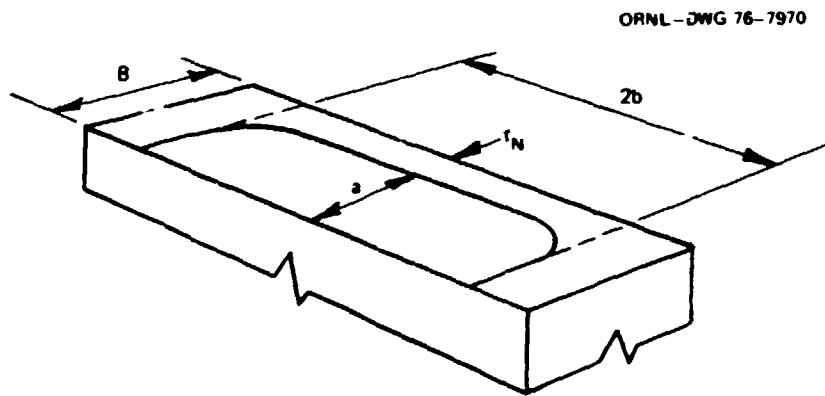
Fig. 5.8. Net section flaw configuration for COD analyses.

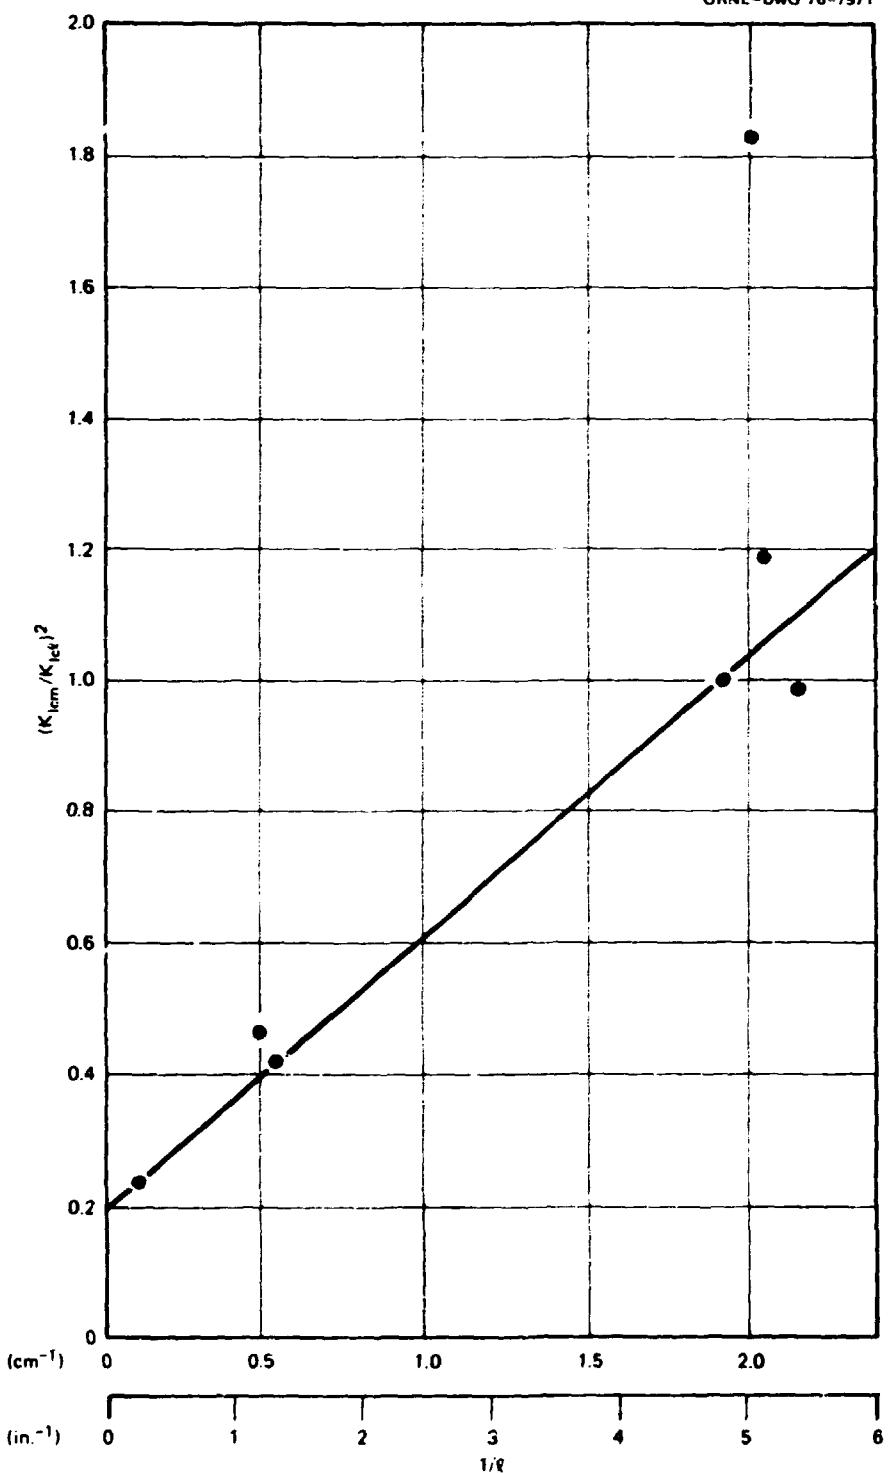
ORNL-DWG 76-7971

Fig. 5.9. Plot for determination of upper-shelf fracture toughness at 93°C (200°F) vs ligament thickness for intermediate test vessel Y-7.

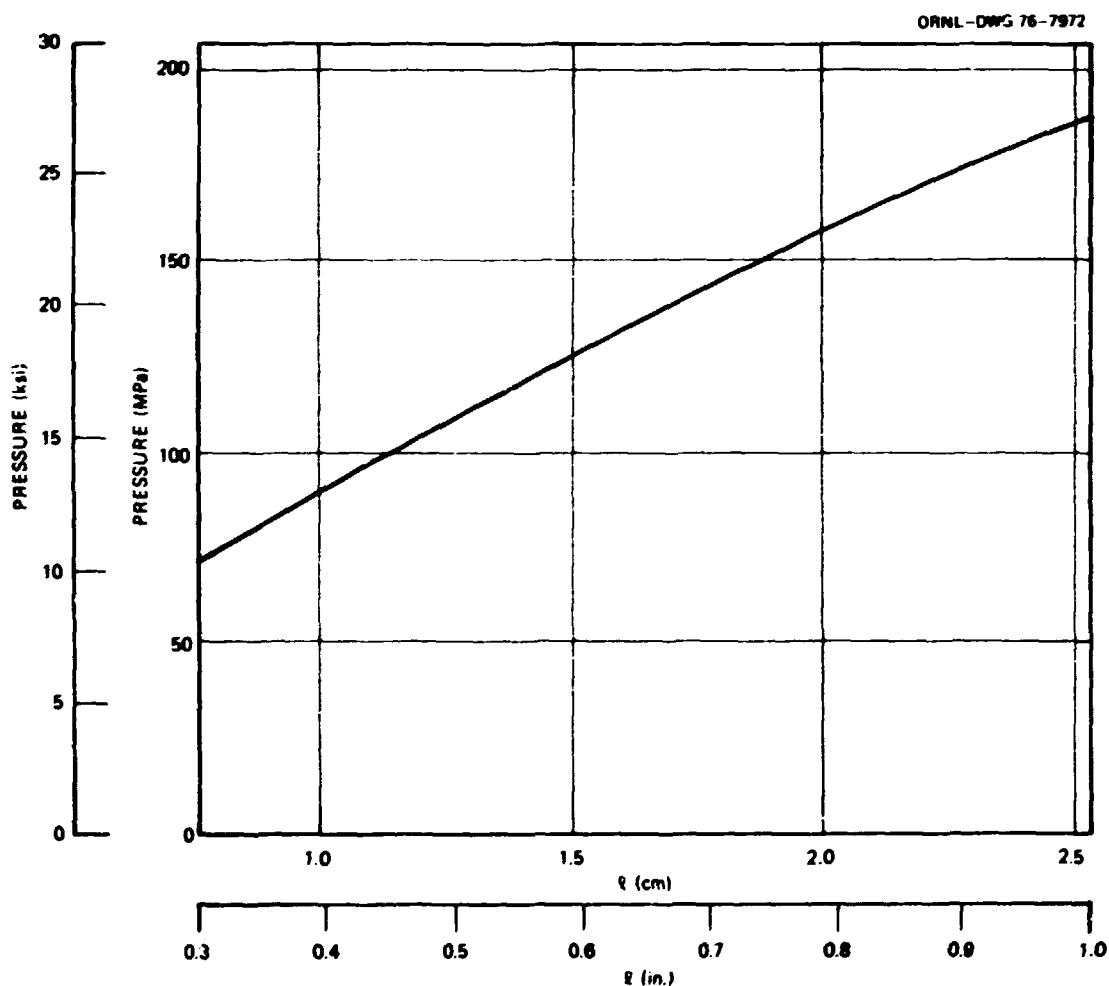
Fig. 5.10. Approximate failure pressure vs ligament thickness for intermediate test vessel V-7.

Ligament thickness [mm (in.)]	Pressure [MPa (ksi)]
25.4 (1.0)	189 (27.4)
22.9 (0.9)	174 (25.3)
20.3 (0.8)	159 (23.1)
17.8 (0.7)	143 (20.8)
15.2 (0.6)	127 (18.4)
12.7 (0.5)	110 (15.9)
10.2 (0.4)	91 (13.2)
7.6 (0.3)	71 (10.3)

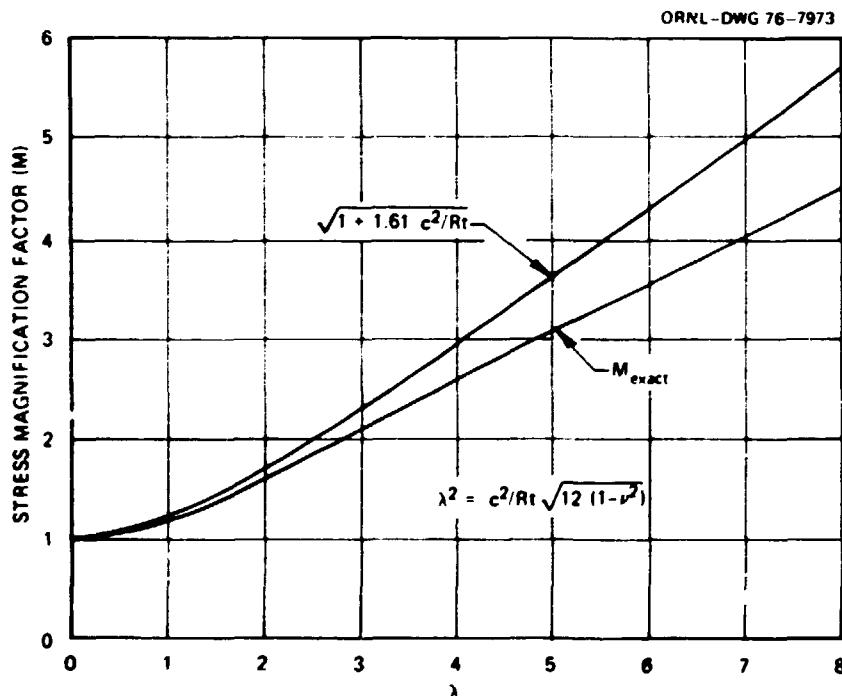
Fig. 5.11. Stress-intensity factor magnification due to bulging for a longitudinal crack of half length c in a cylindrical shell of mean radius R and thickness t under internal pressure loading.²⁸

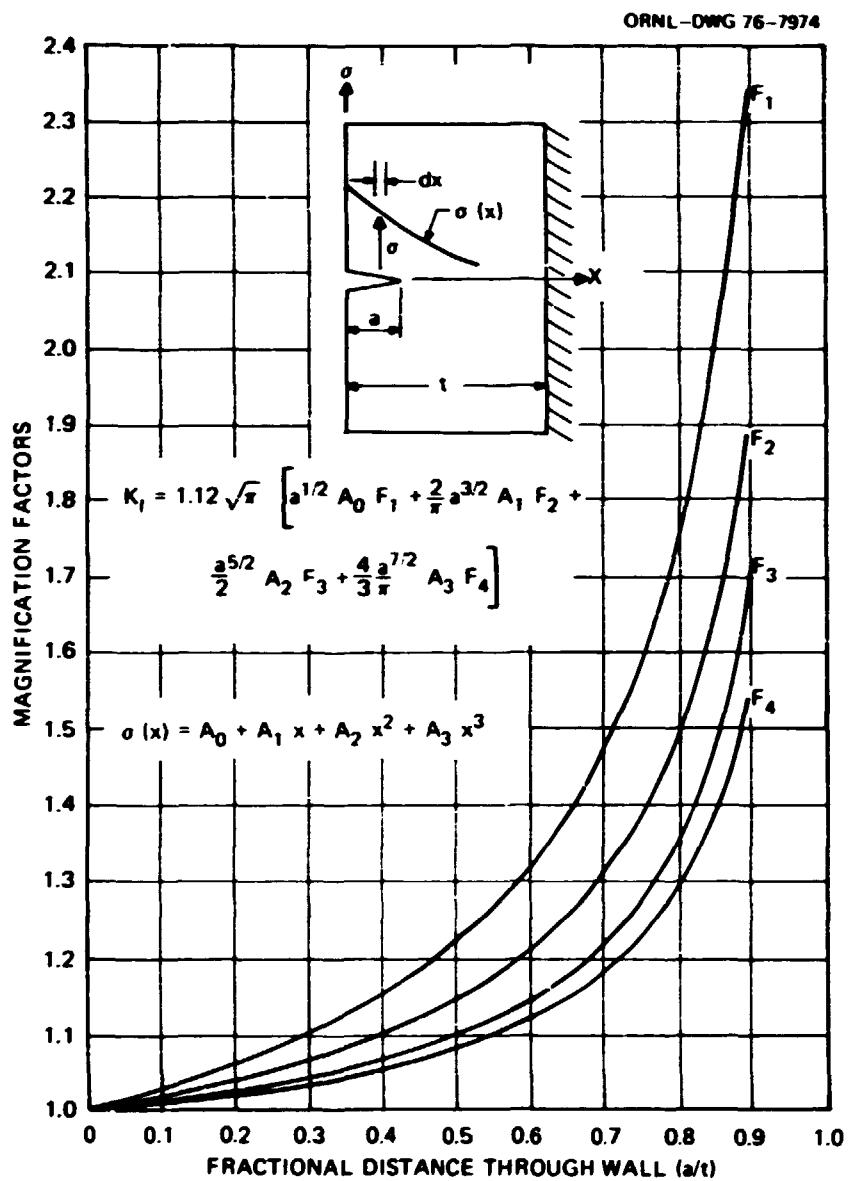
Fig. 5.12. Finite-thickness stress-intensity factor magnification curves for a continuous edge crack in a plate restrained against back surface curvature and subjected to a nominal stress distribution described by a cubic polynomial.²⁹

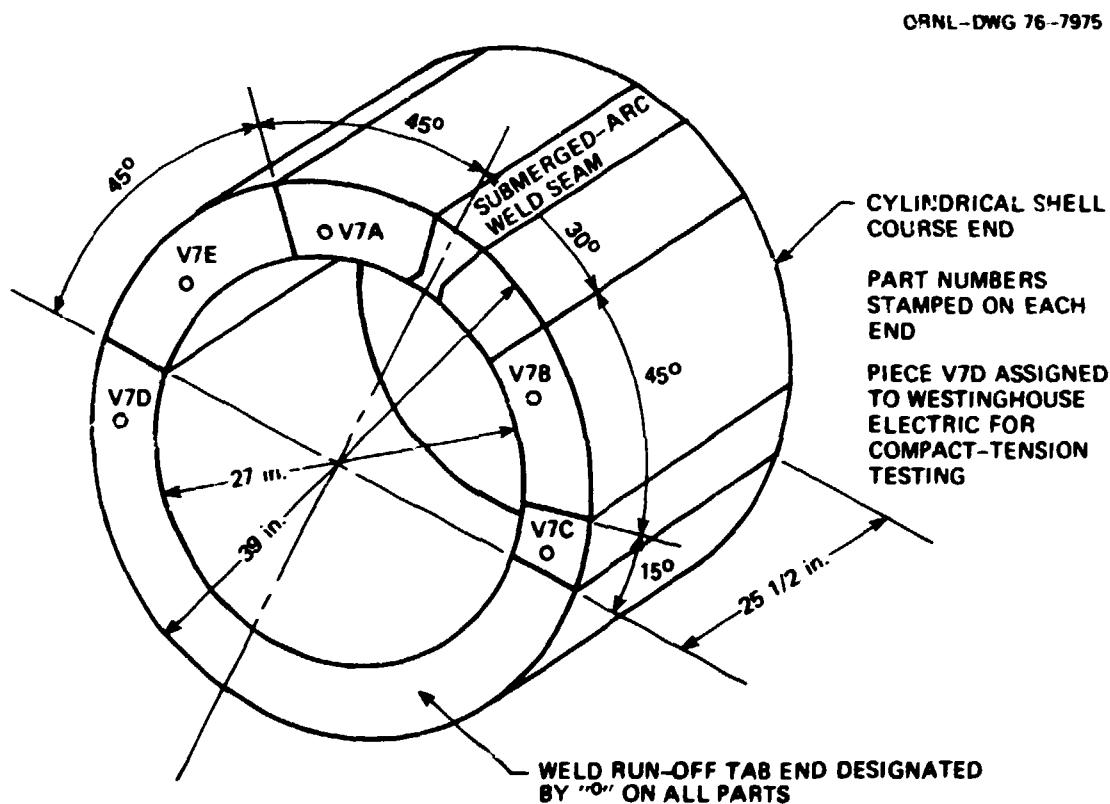
Fig. A-1. Cutting plan for prolongation of vessel V-7.

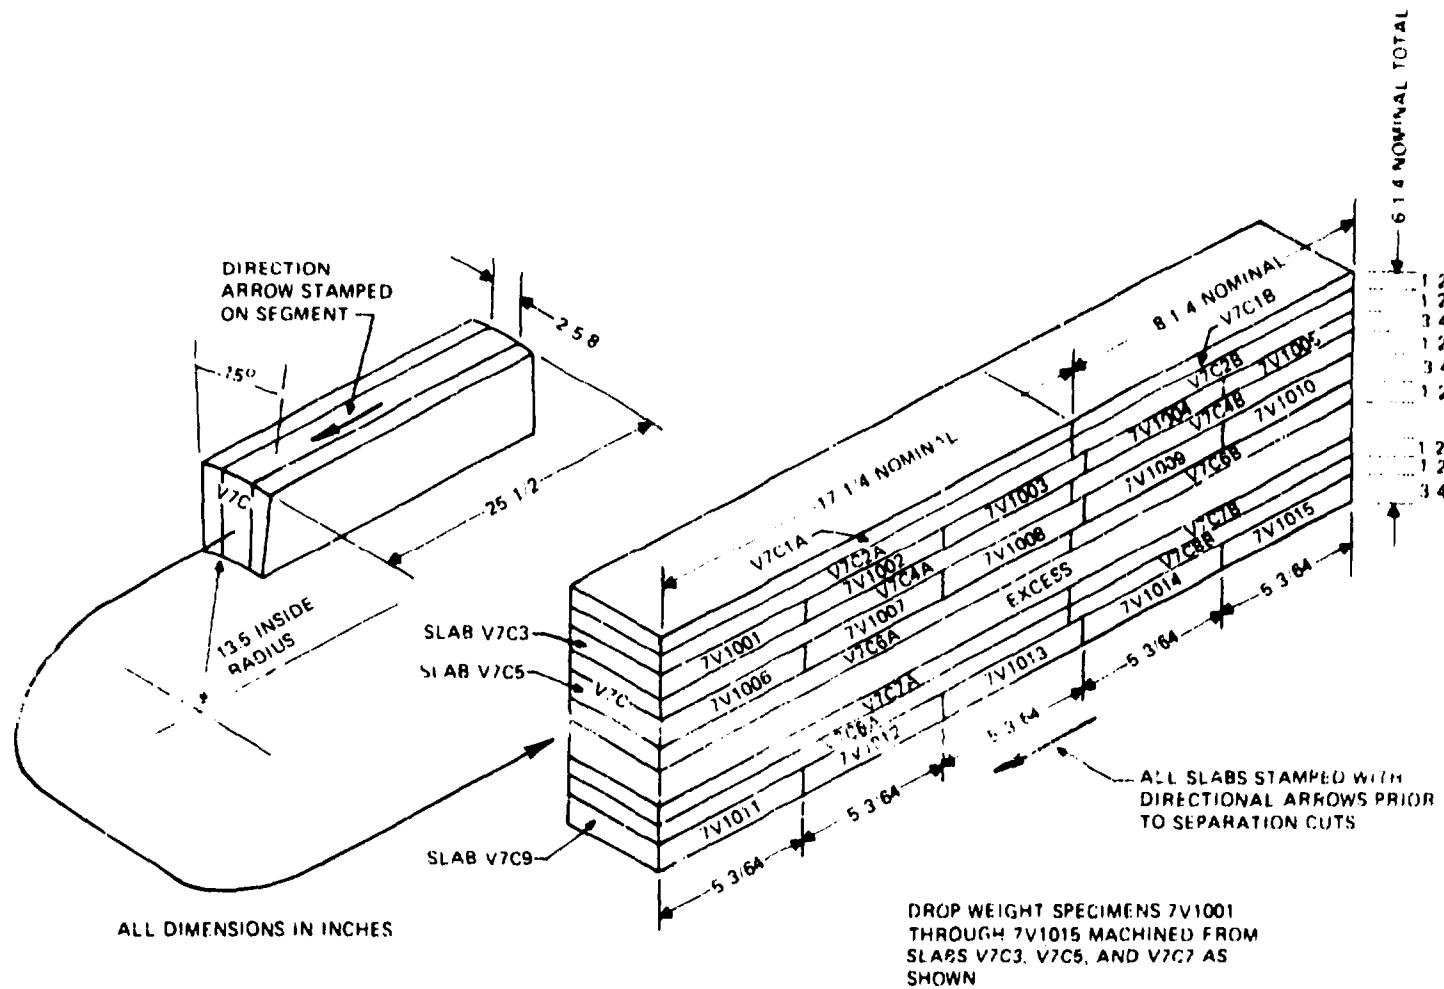
Fig. A-2. Cutting plan for segment V7C from prolongation of vessel V-7.

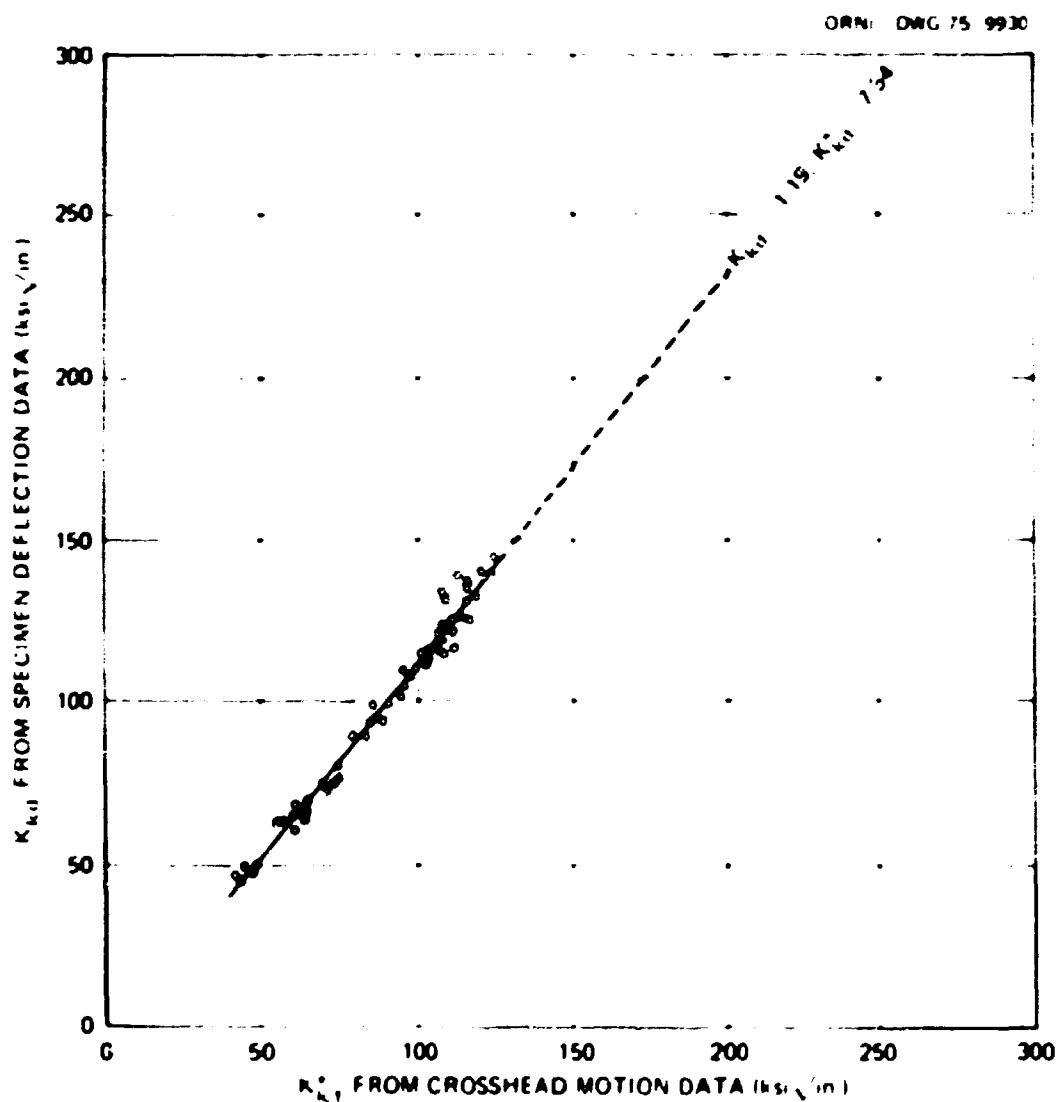
Fig. A-4. Comparison of static fracture toughness as computed from deflectometer measurements and crosshead motion.

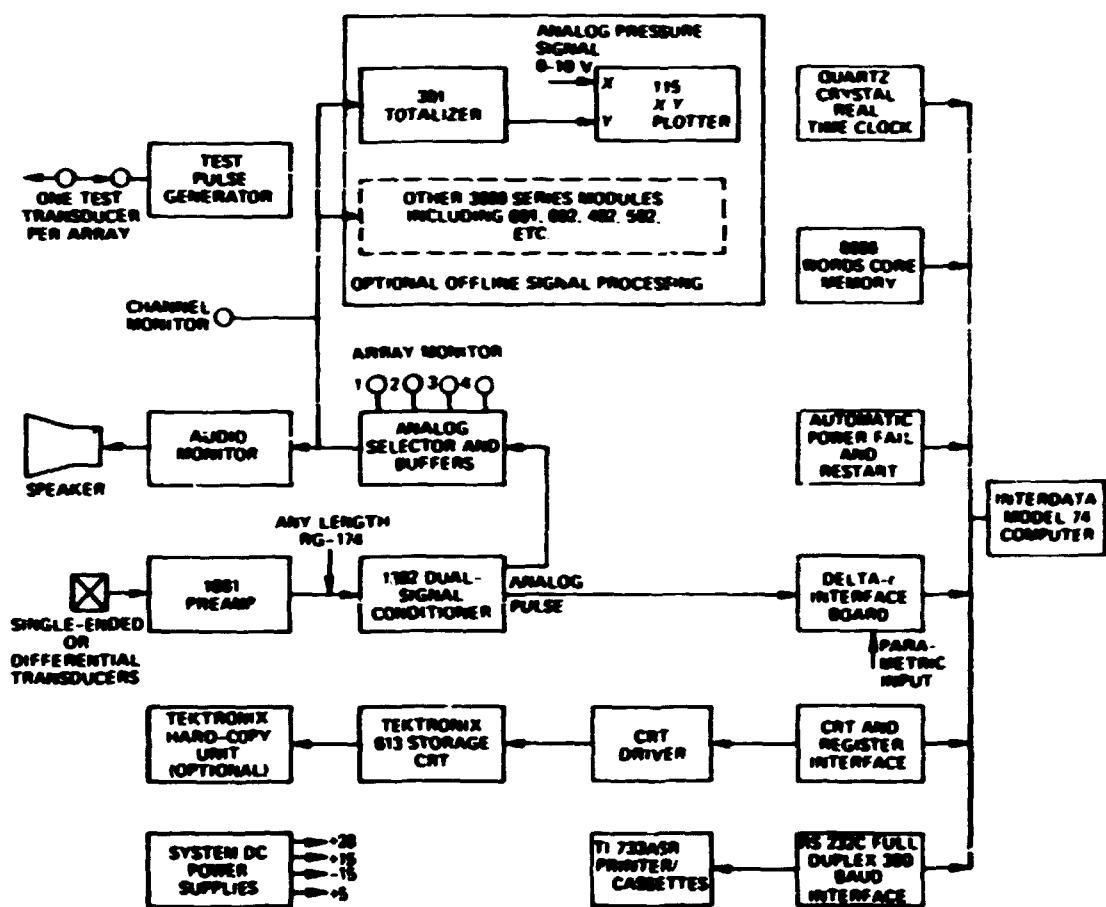
Fig. D-1. 1032 Block diagram.
