**Test of 6-In.-Thick Pressure Vessels.
Series 3: Intermediate Test Vessel V-7**

OAK RIDGE NATIONAL LABORATORY

ORNL/NUPEG-1
Dist. Category NRC-5

The test of intermediate test vessel V-7 was a crack-initiation fracture test of a 152-mm-thick (6-in.), 990-mm-OD (39-in.) vessel of ASTM A533, grade B, class 1 steel plate with a sharp outside surface flaw 457 mm (18 in.) long and about 135 mm (5.3 in.) deep. The vessel was heated to 91 °C (196°F) and pressurized hydraulically until leakage through the flaw terminated the test at a peak pressure of 147 MPa (21,350 psi). Fracture toughness data obtained by testing precracked Charpy-V and compact-tension specimens machined from a prolongation of the cylindrical test shell were used in pretest analyses of the flawed vessel. The vessel, as expected, did not burst. Upon depressurization, the ruptured ligament closed so as to maintain static pressure without leakage at about 129 MPa (18,700 psi).

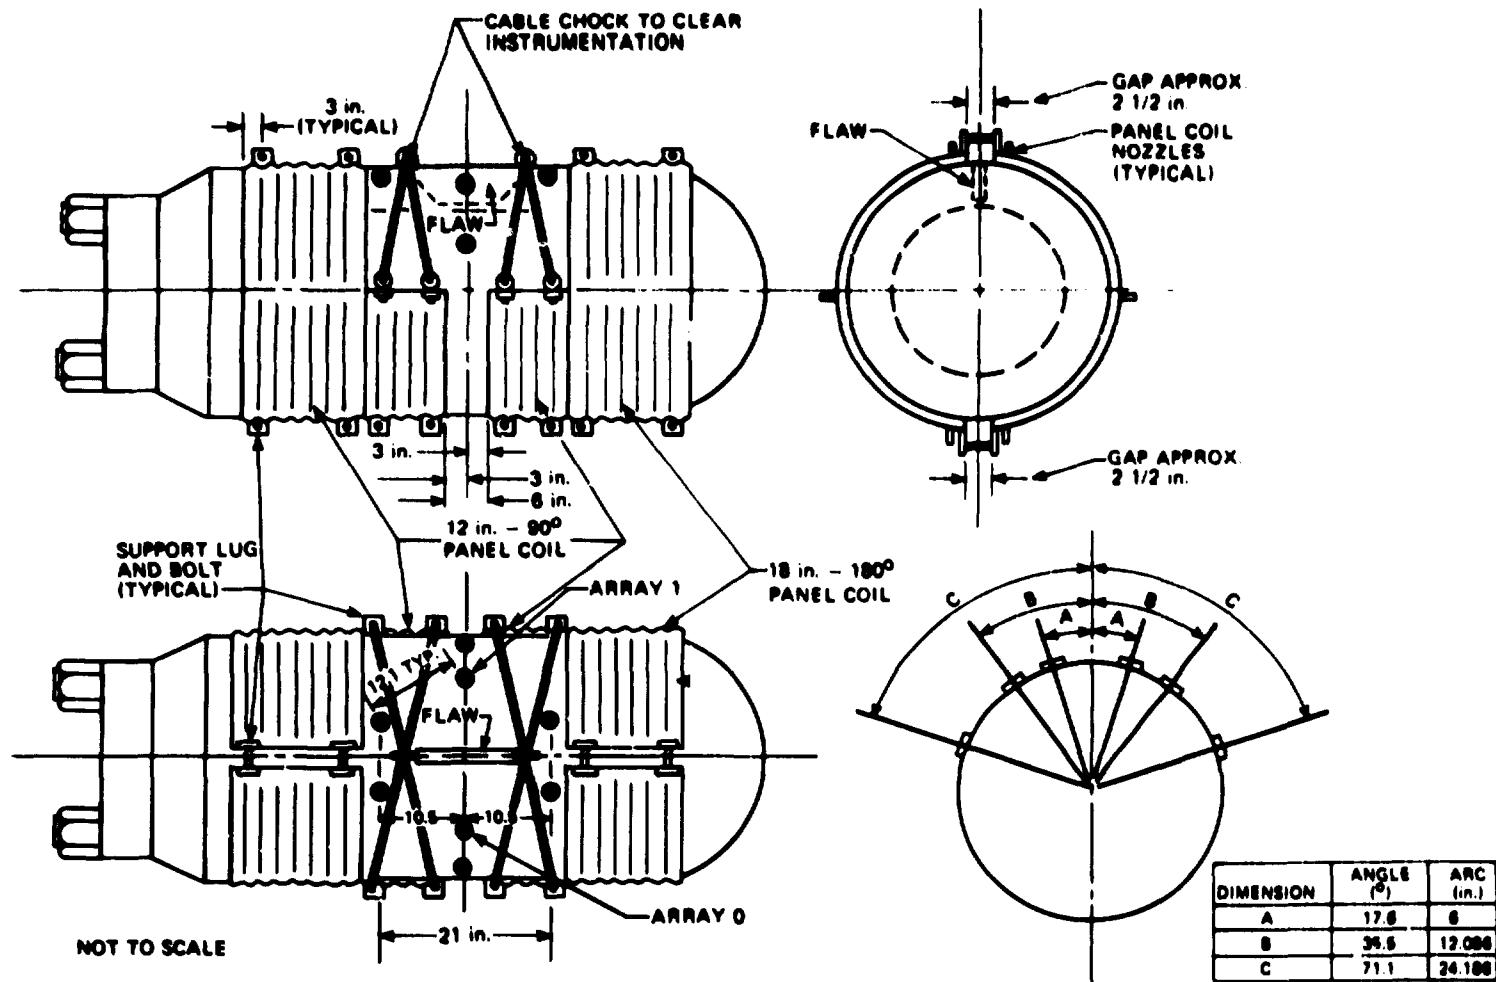
Fig. D-2. Approximate location of Dunegan/Endevco sensors with respect to flow.

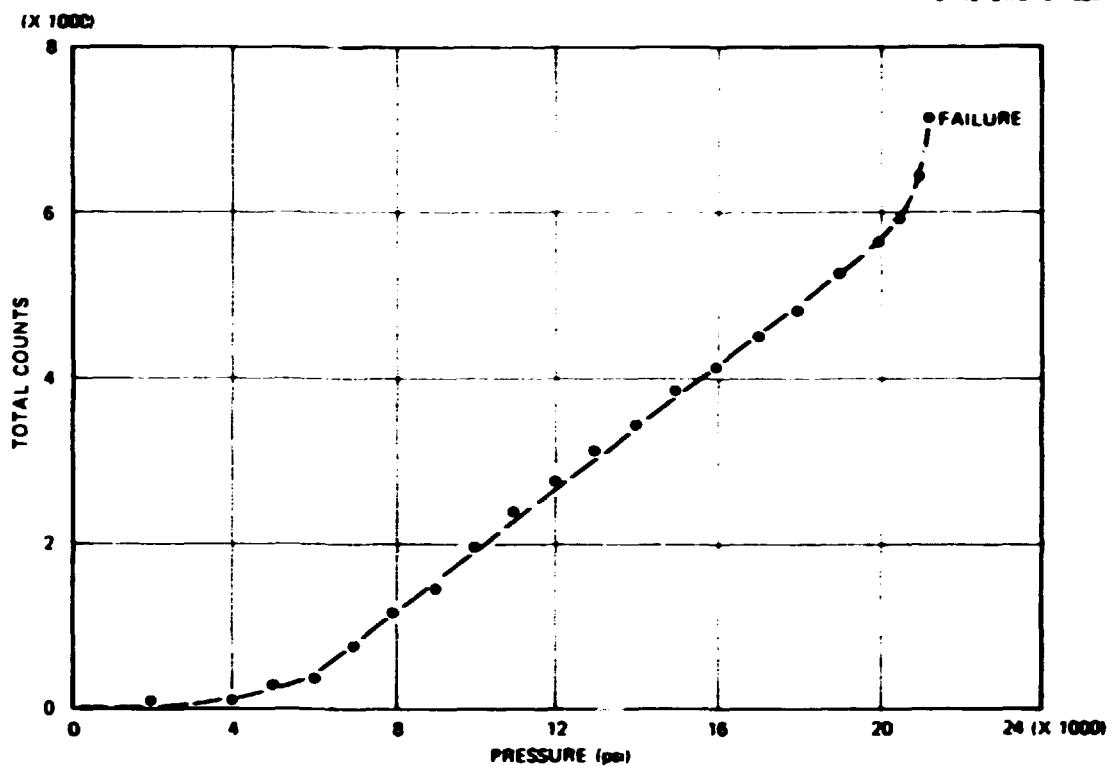
Fig. D-3. Summation of counts as a function of pressure for V-7.

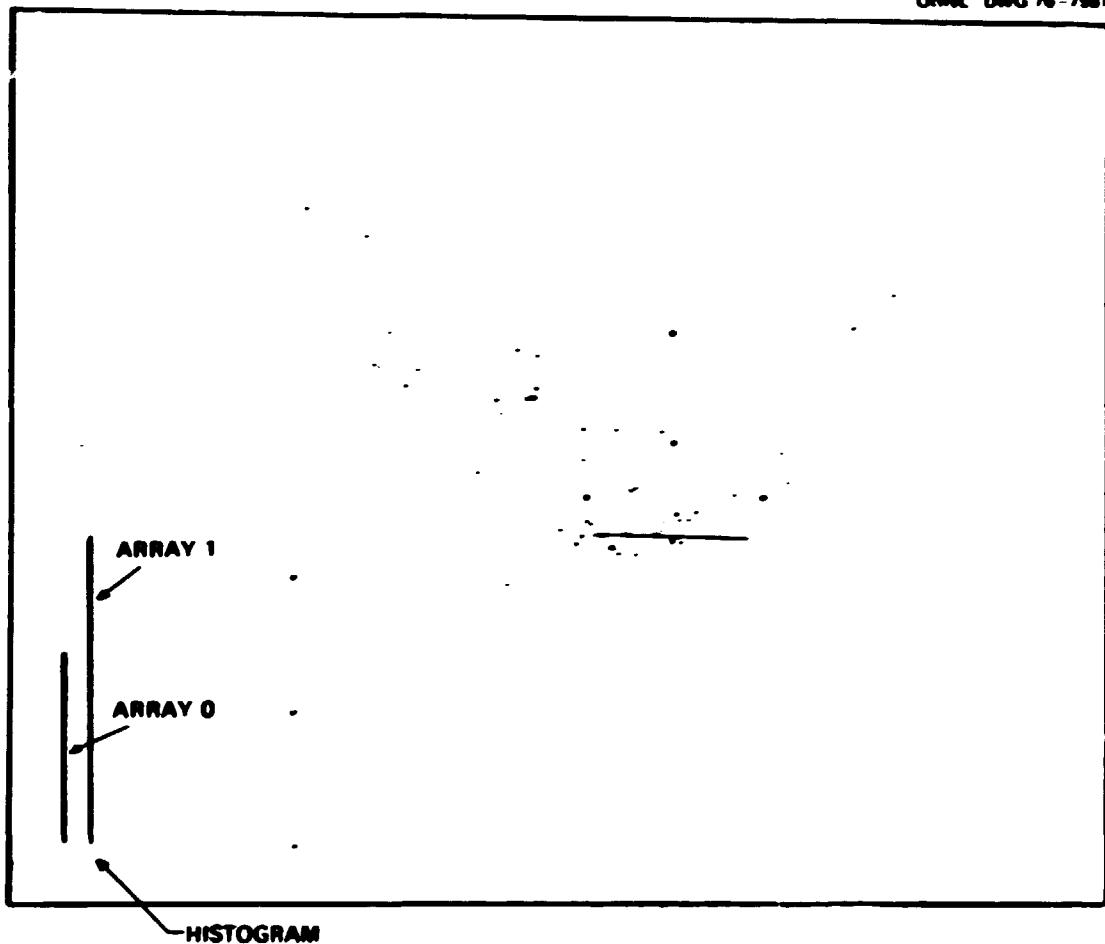
Fig. D-4. Source activity for array 0.

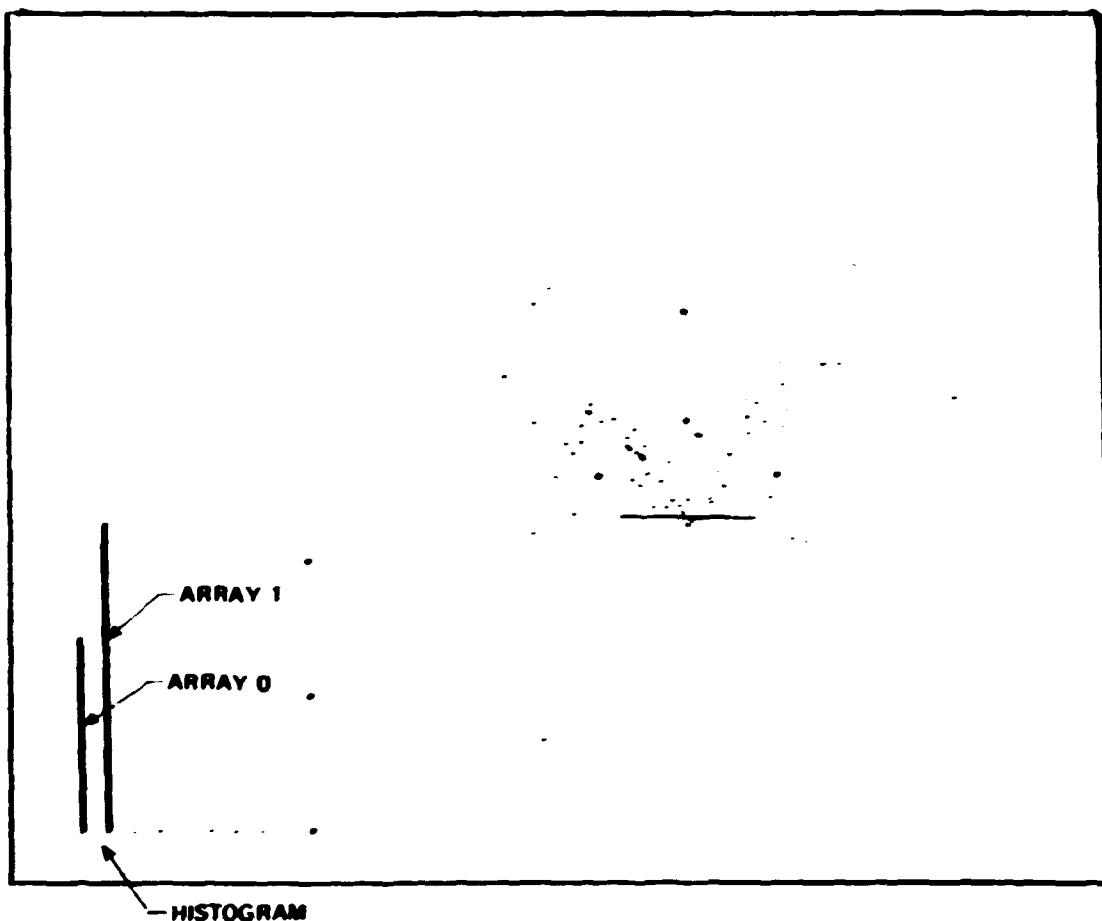
Fig. D-5. Source activity for array 1.
