INTERACTIONS OF CERTAIN REFRACTORY MATERIALS WITH SODIUM

ANL-75-74

ARGONNE NATIONAL LABORATORY
9700 South Cass Avenue
Argonne, Illinois 60439

May 1976

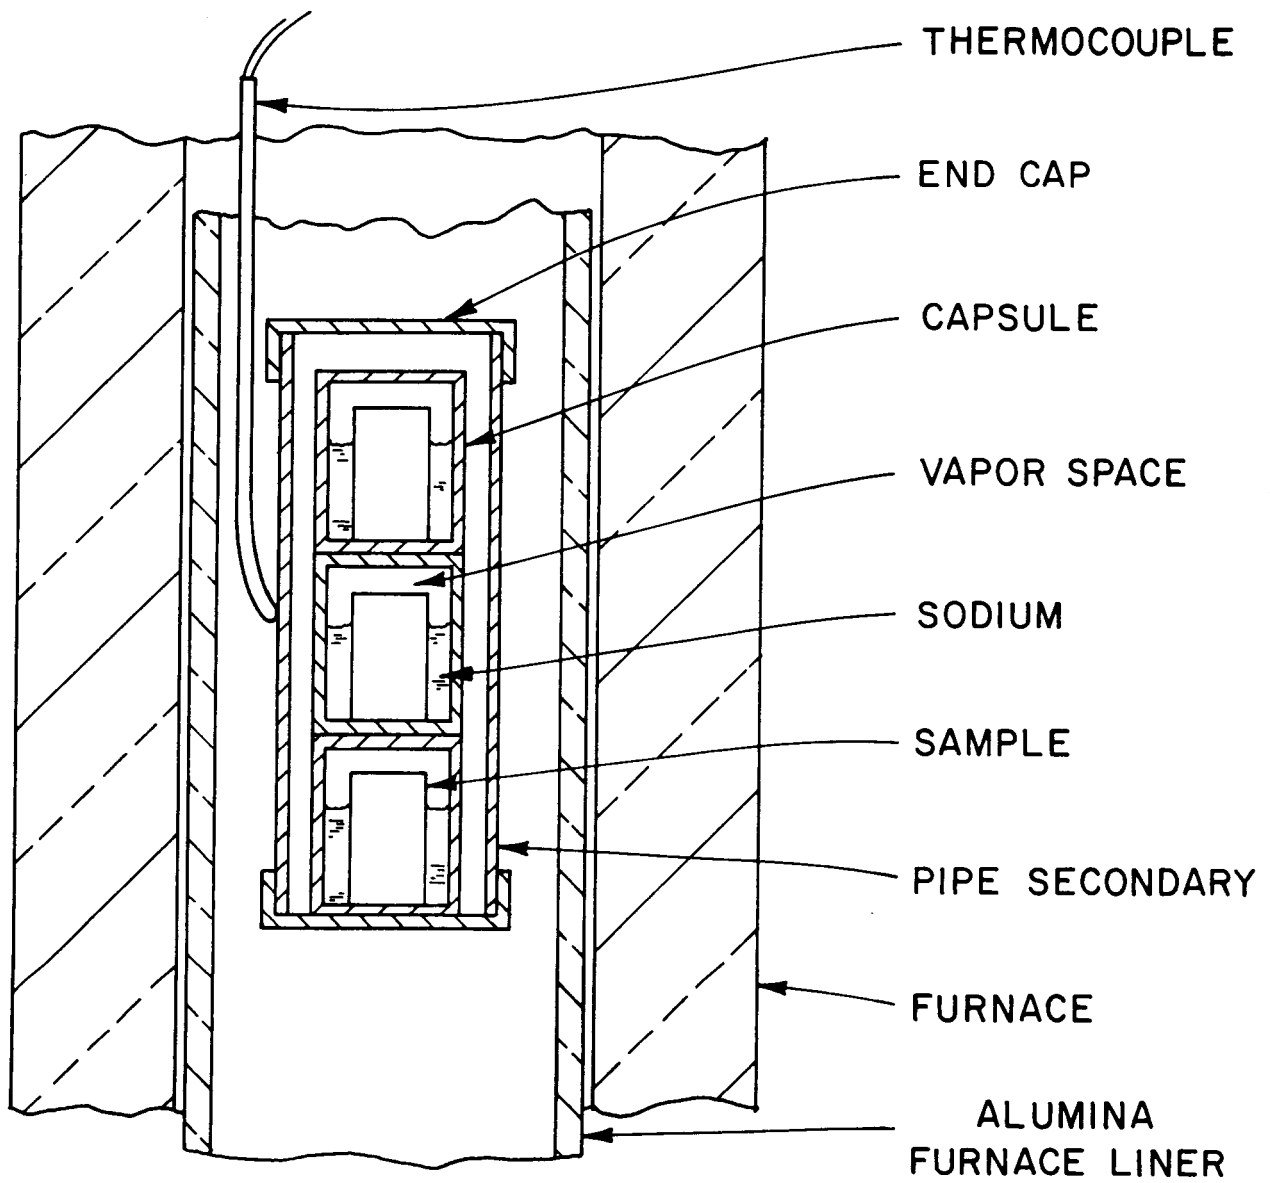
Fig. 1. Diagram of Test Assembly used for Static Sodium Exposure Tests

The loading of the samples into the test capsules was carried out in an argon atmosphere glove box. Each sample was placed in a 5-cm long, stainless steel capsule made from 1-in. Sch 40 pipe with a welded bottom. In the case of rods and bricks, a sufficient amount of reagent-grade sodium was added to each capsule to allow, at the test temperature, two-thirds of the sample to be immersed in liquid sodium and one-third of the sample to remain in the vapor space. When a sample in the form of a crucible was tested, the crucible was filled with sodium, and sufficient sodium was added to the capsule so that it reached two-thirds of the way up the crucible at the test temperature. Each capsule was welded shut. Three capsules were stacked in a secondary container made from a 13.97-cm long piece of nominal 1-1/2-in. Sch 40 pipe fitted with end caps. For stability, the annular space between the capsules and the secondary container was packed with stainless steel helices. The secondary container was placed in the maximum temperature zone of a platinum-wound tube furnace having a heated zone 40 cm in length. A schematic diagram of the test assembly is shown in Fig. 1. Prior to the runs with sodium, the maximum temperature region and the temperature spread in the heated zone were determined, using a mockup of the capsule assembly. It was found that the temperature spread in the region of the sample capsules was less than 20°C. The monitoring thermocouple located on the outside surface of the secondary container had been calibrated against a thermocouple placed inside the mockup capsule assembly.

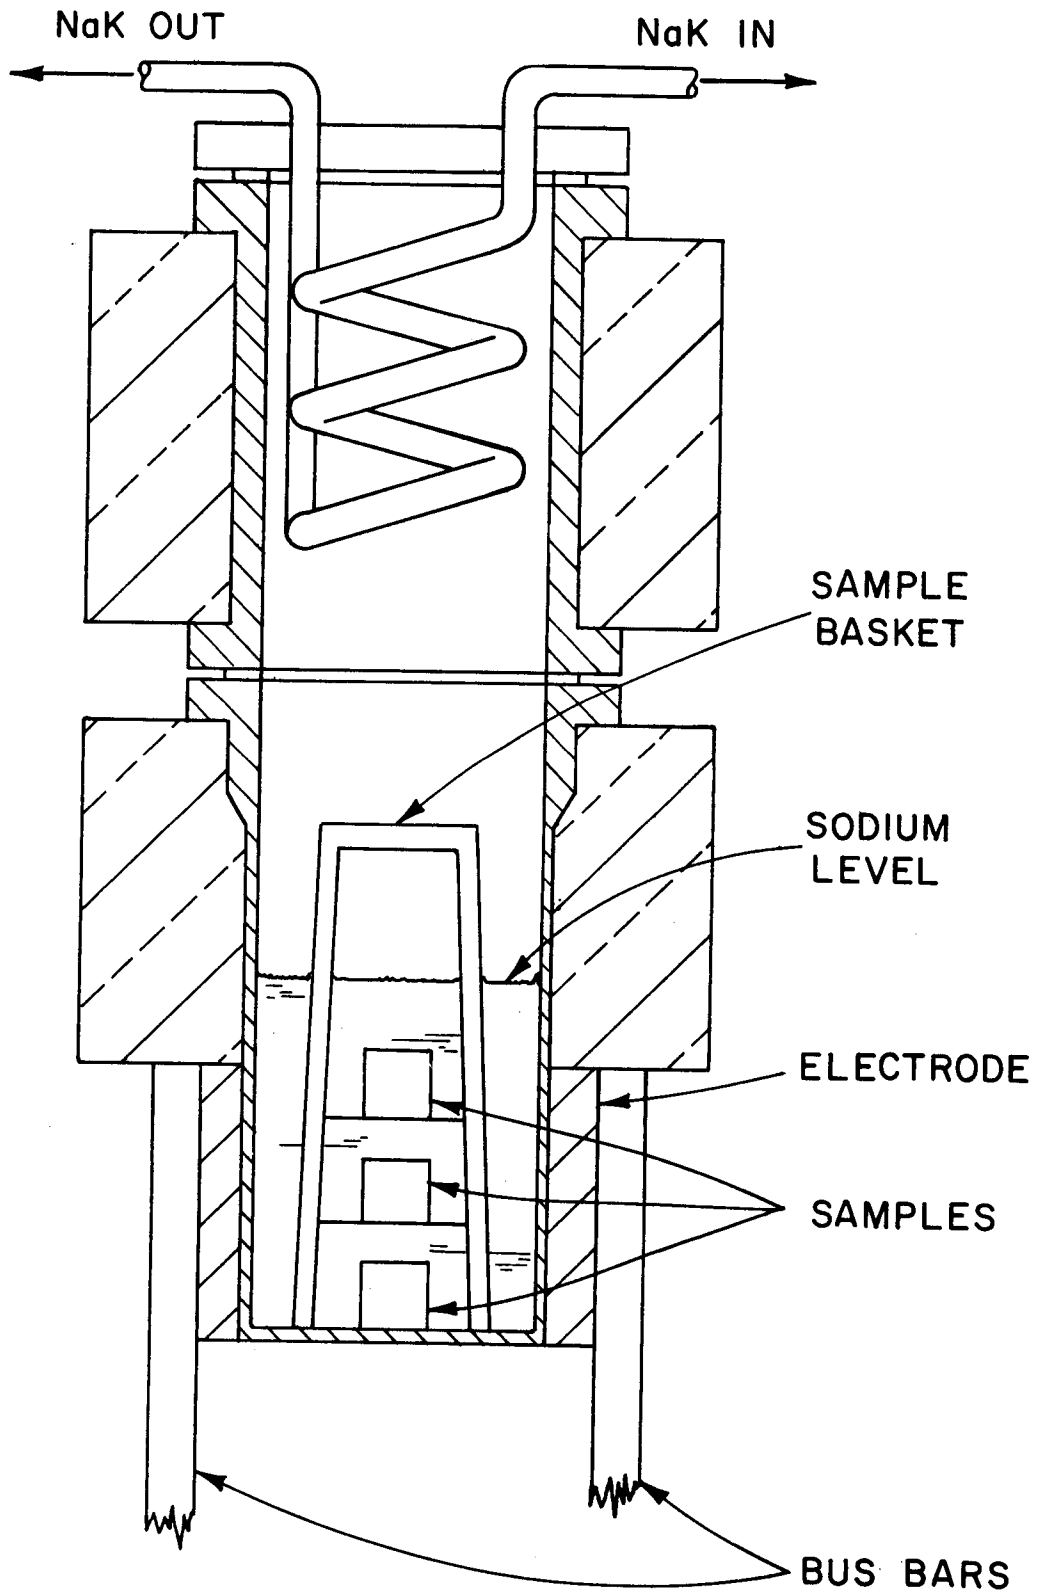
Fig. 2. Diagram of Apparatus used for Boiling Sodium Exposure Tests

The apparatus used for the compatibility tests with boiling sodium was also used for studies of heat transfer in volume-heated UO₂-sodium debris beds and is described in detail elsewhere.⁸ Figure 2 shows a schematic diagram of the apparatus.

Three samples were placed in a three-tier stainless steel basket in an inert-atmosphere glovebox. This basket was inserted in the debris container and sufficient sodium was added so that the samples were completely immersed. The container was removed from the glovebox and mounted in the apparatus as in Fig. 2. The sodium was heated by passage of a 10,000 amp, 60 Hz current through the container by means of copper bus bars which were connected to a single-turn secondary of two transformers connected in parallel. By controlling the input voltage to the transformers, the samples could be subjected to various levels of specific power. The specific power generation is defined in this report as the heat energy developed per cubic centimeter of sodium and is expressed as cal/s-cm³ of sodium. This type of heating is significant in terms of its effect on the sodium that has permeated the interior of the sample. Passage of the current through the internal sodium channels produced *in situ* boiling of sodium. Thus, the samples were exposed to conditions that were more severe than those that would have resulted from simple immersion of the samples in boiling sodium, since interior capillary channels retard the boiling of the sodium. Consequently, a degree of superheat is required before transformation of the liquid to a vapor. The sample interiors, then, are exposed to a higher temperature sodium, as well as to the potential mechanical disruptive effects of expanding vapor and of liquid metal being ejected through the channels. It is believed that this condition more closely represents reactor conditions under which sodium would invade the ceramic structure, and then be subjected to heating from overlying or adjacent heat-generating pools. Increased power levels were accommodated by increased refluxing between the pool and the NaK cooling coil.

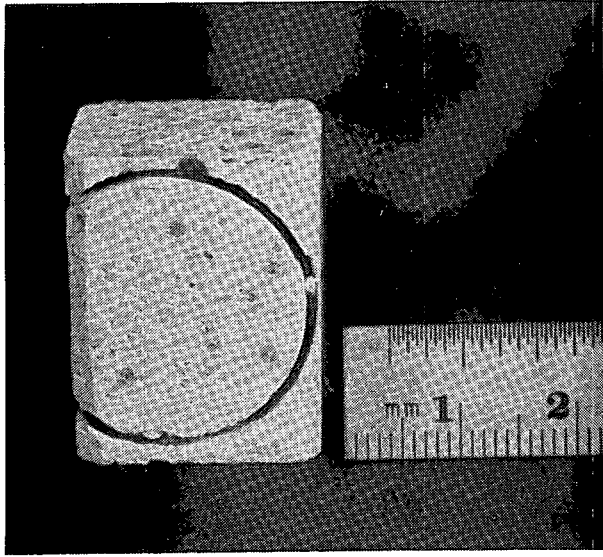
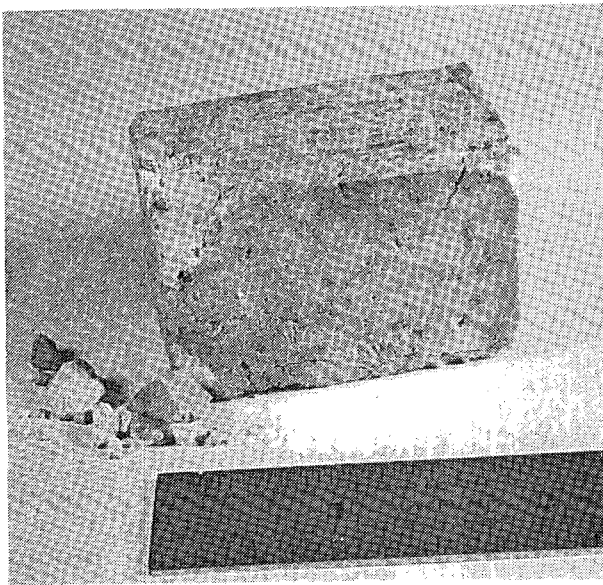
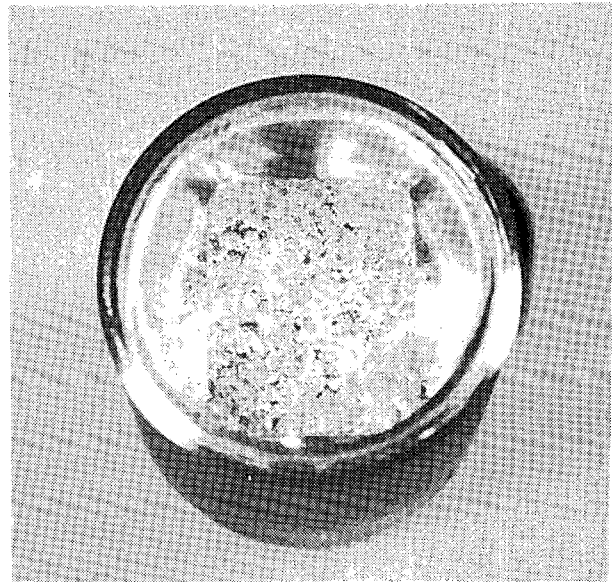
a. Before Sodium Exposure

b. After Exposure to Boiling Sodium;
Before Sodium Removal

c. After Exposure to Boiling Sodium;
After Sodium Removal

d. After Exposure to Static Sodium at 850°C

Fig. 3. High Magnesia Material, Harklase, before and after Sodium Exposure

Of the four refractories containing a large percentage of magnesia, three (Harklase, Oxibak H, and HW Magnesite) were subjected to both types of tests. The fourth high-magnesia refractory, MN 197, was subjected only to the boiling sodium test. All the samples survived intact after exposure to sodium by either method. This is in agreement with the results for high-magnesia samples tested at WARD.⁷ Figures 3 through 5 show Harklase, Oxibak H, and HW Magnesite after exposure to boiling sodium both before and after sodium removal. These three samples were firm and in good condition before sodium removal. After sodium removal by the ethyl alcohol and water treatment previously described, cracking was evident. HW Magnesite underwent much cracking and lost some of its structural integrity, whereas Harklase and Oxibak H experienced some cracking, but remained intact. This cracking is quite likely due to the removal of sodium compounds, such as sodium silicates, that may have formed. Different samples of Harklase and HW Magnesite were exposed to high-power and low-power levels in the sodium boiling experiments. No difference in the final condition of the samples was observed for the two power levels. MN 197 survived intact (Fig. 6).

All of the high magnesia samples treated by exposure to sodium at 850°C for five hours survived intact with no apparent interaction. Figures 3 through 5 show the samples before and after exposure to sodium in the static tests. It is interesting to note that the fine geometric imperfections on the surface of the samples originally present are still visible under the sodium coating. It should also be noted that the walls of the stainless steel capsules are wetted with clean sodium, thereby indicating that no extensive interaction occurred.

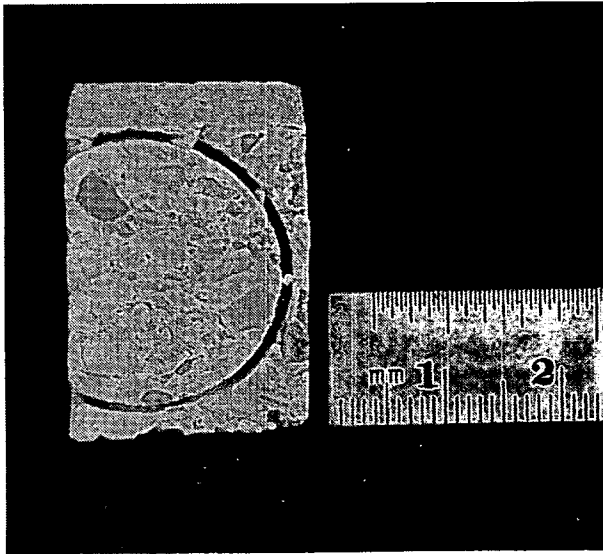
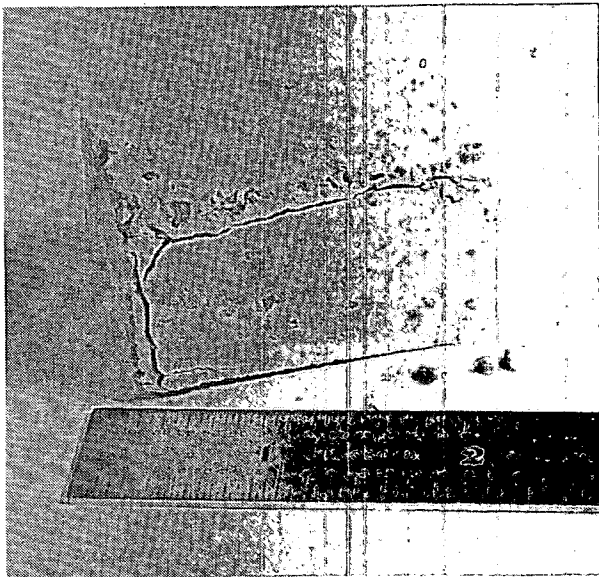
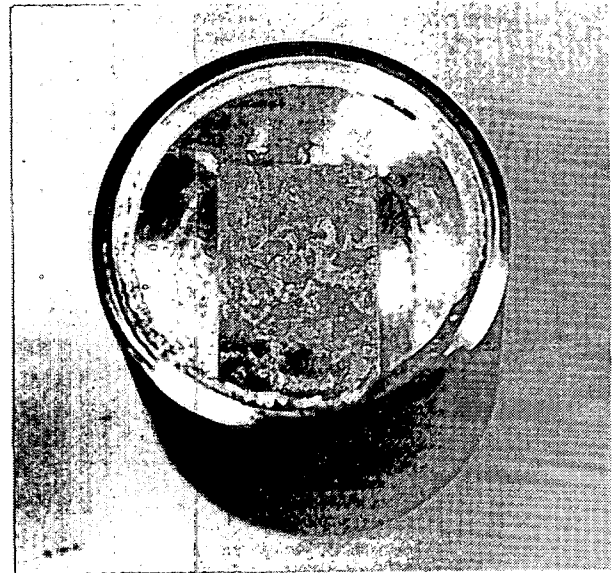
a. Before Sodium Exposure

b. After Exposure to Boiling Sodium;
Before Sodium Removal

c. After Exposure to Boiling Sodium;
After Sodium Removal

d. After Exposure to Static Sodium at 850°C

Fig. 4. High Magnesia Material, Oxibak H, before and after Sodium Exposure

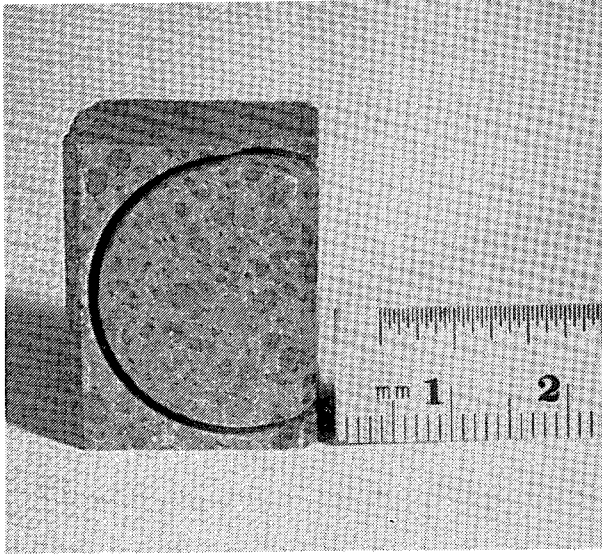
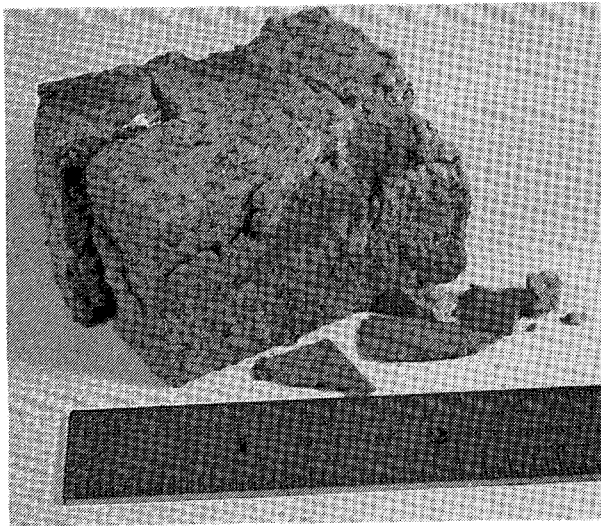
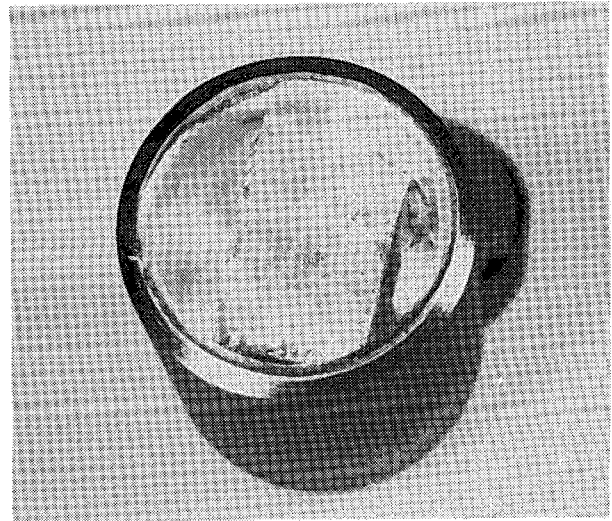
a. Before Sodium Exposure

b. After Exposure to Boiling Sodium;
Before Sodium Removal

c. After Exposure to Boiling Sodium;
After Sodium Removal

d. After Exposure to Static Sodium at 850°C

Fig. 5. High Magnesia Material, HW Magnesite, before and after Sodium Exposure

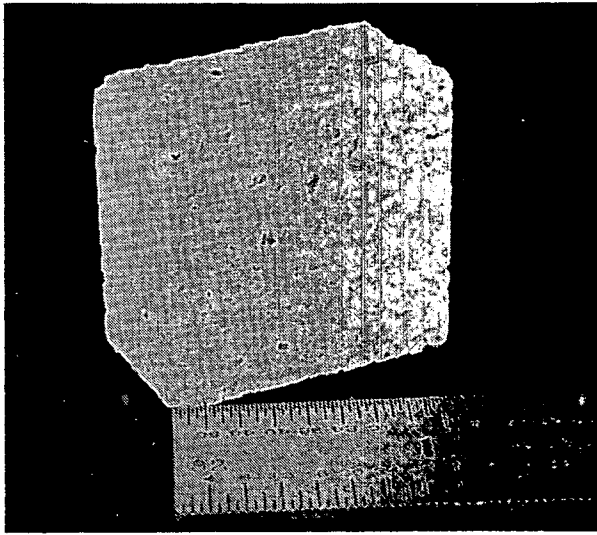
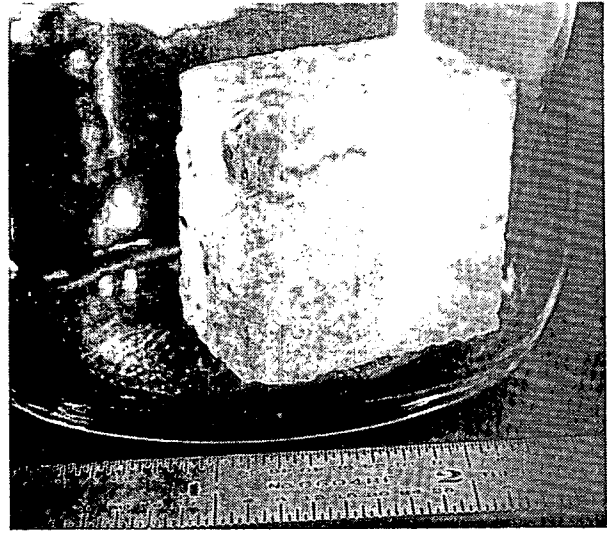
a. Before Sodium Exposure

b. After Exposure to Boiling Sodium;
Before Sodium Removal

Fig. 6. High Magnesia Material, MN 197, before and after Exposure to Boiling Sodium

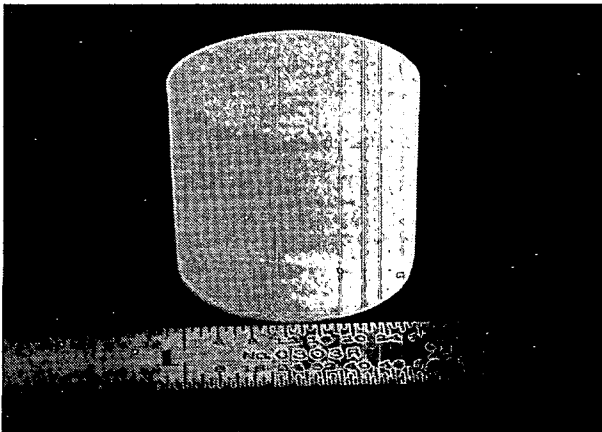
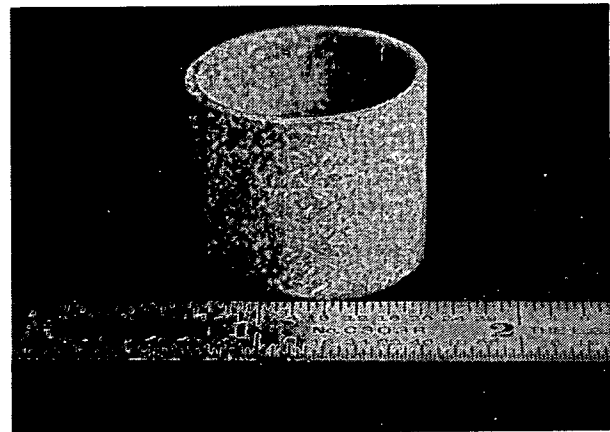
a. Before Sodium Exposure

b. After Exposure to Boiling Sodium;
After Sodium Removal

Fig. 7. High-fired Recrystallized Alumina Crucible before and after Exposure to Boiling Sodium

Three samples with high alumina contents, HW Corundum, Korundal XD, and HW Ruby, were tested by both experimental procedures. The remaining high-alumina samples (a high-fired alumina crucible, A-414, AH 199B, AN 199B, SR 504-C, and a 99% alumina brick from FFTF) were tested only by exposure to boiling sodium. The crucible of high-fired recrystallized alumina was boiled in sodium for about 1-1/2 hours and survived in excellent condition, with only a slight darkening and a slight weight loss (see Fig. 7). Although a section of a 99% alumina brick survived substantially intact, some intergranular attack was apparent (Fig. 8), and about one-fourth of the sample was lost by dissolution in sodium.

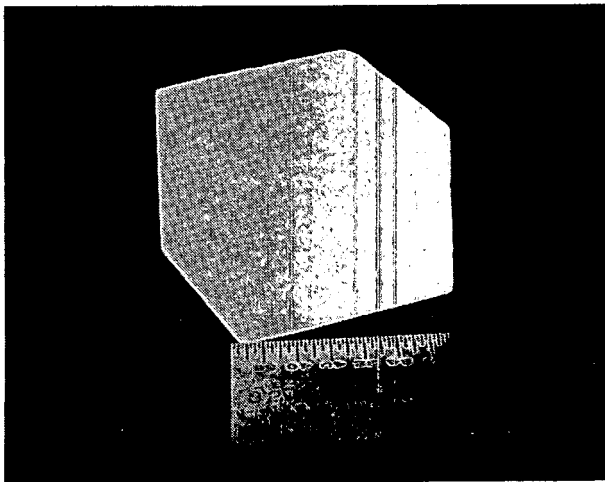
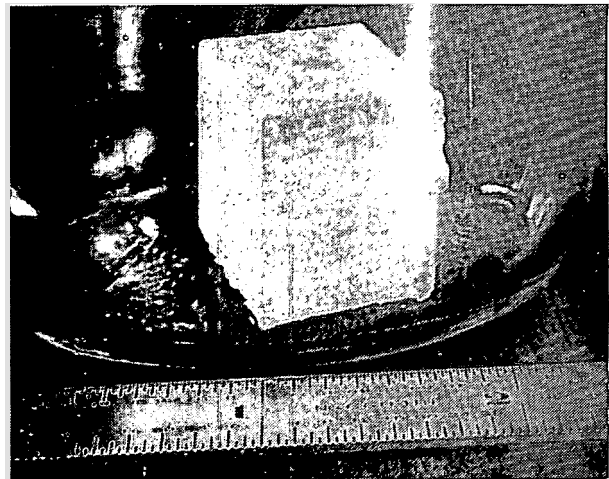
a. Before Sodium Exposure

b. After Exposure to Boiling Sodium;
Before Sodium Removal

Fig. 9. High Alumina Material, A-414, before and after Exposure to Boiling Sodium

The high-alumina samples containing little or no silica and no chromic oxide (Cr_2O_3), A-414, AH 199B, AN 199B, SR-504C, and HW Corundum, survived sodium exposure in good condition, with no apparent interaction (see Figs.

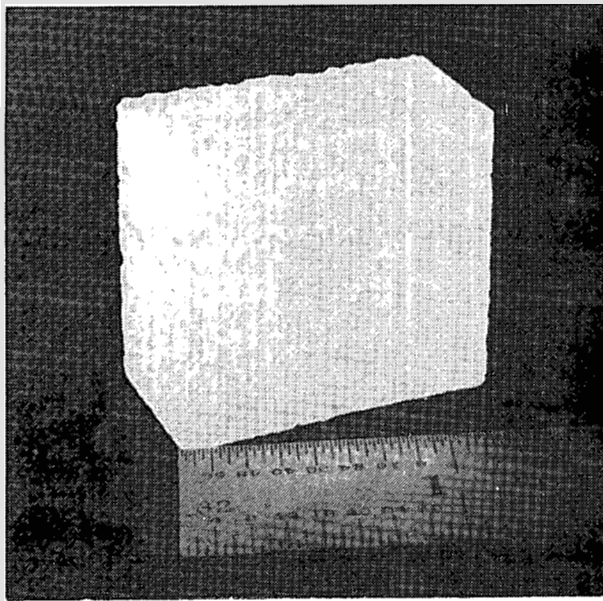
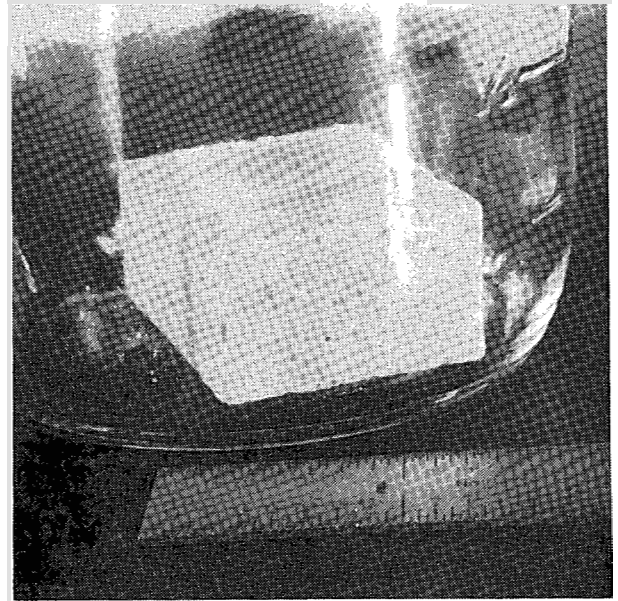
a. Before Sodium Exposure

b. After Exposure to Boiling Sodium;
Before Sodium Removal

Fig. 10. High Alumina Material, AH 199B, before and after Exposure to Boiling Sodium

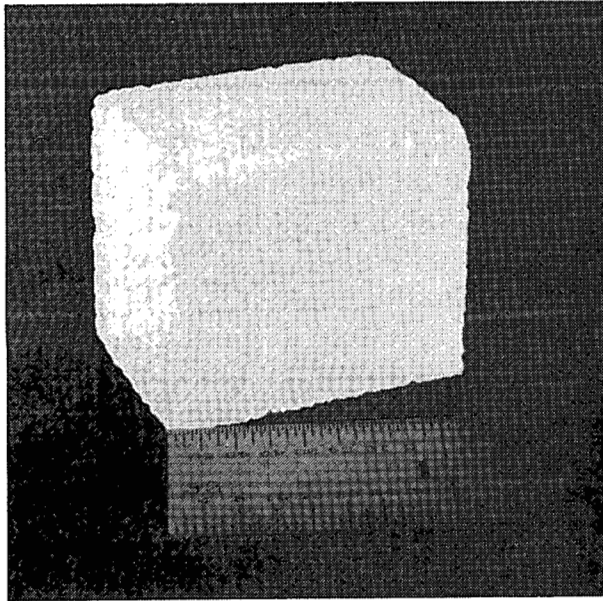
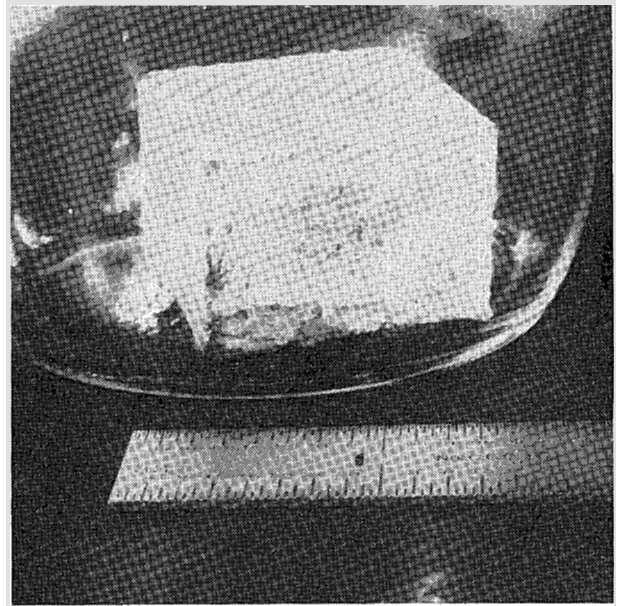
a. Before Sodium Exposure

b. After Exposure to Boiling Sodium;
Before Sodium Removal

Fig. 11. High Alumina Material, AN 199B, before and after Exposure to Boiling Sodium

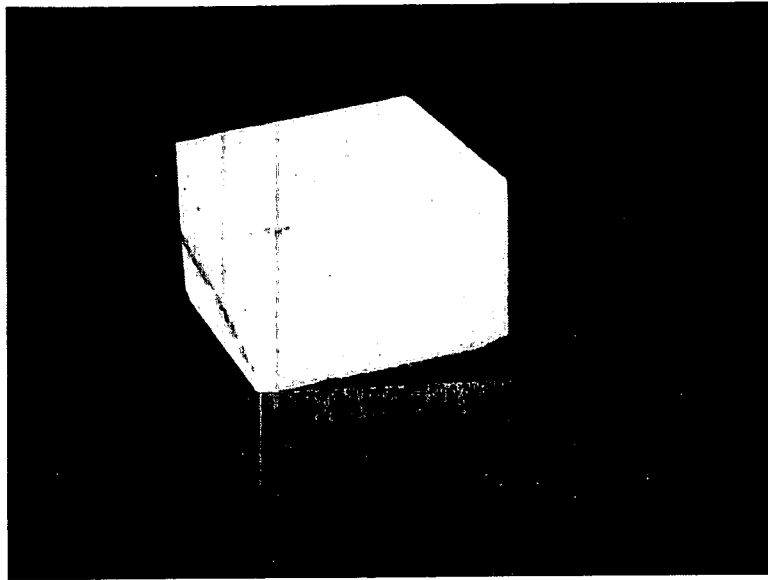
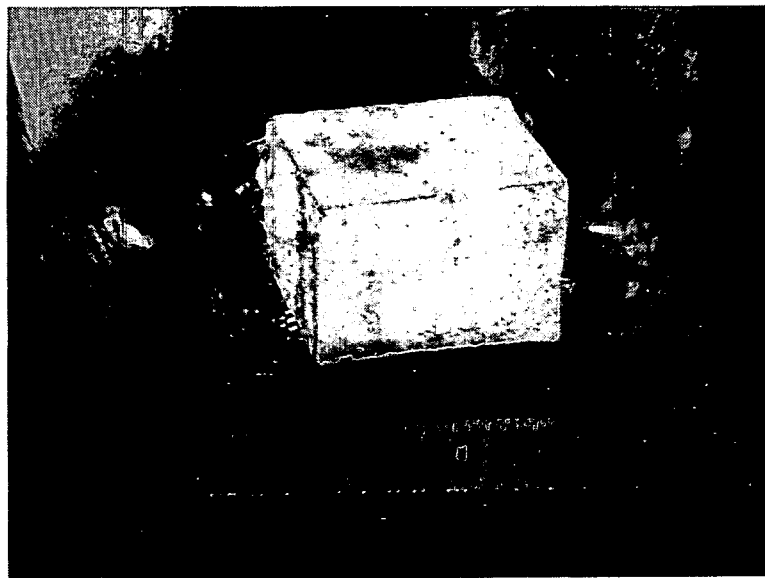
a. Before Sodium Exposure

b. After Exposure to Boiling Sodium;
Before Sodium Removal

Fig. 12. High Alumina Material, SR-504C, before and after Exposure to Boiling Sodium

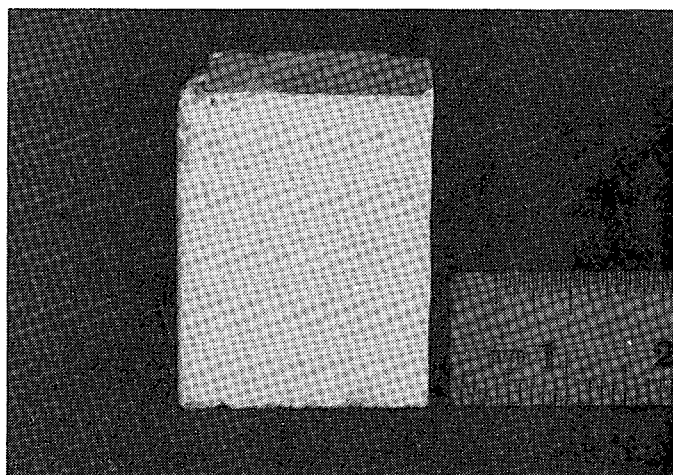
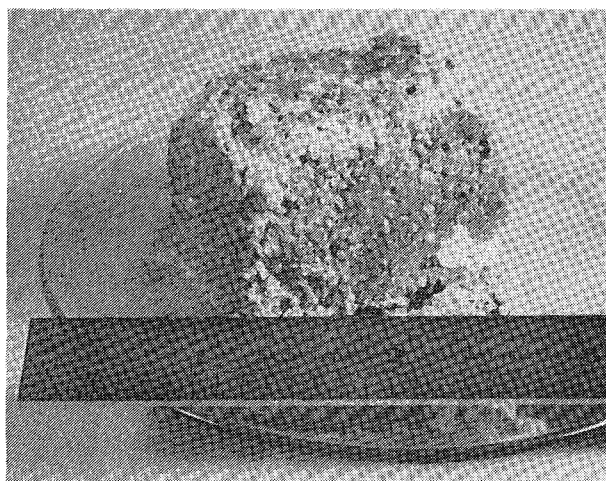
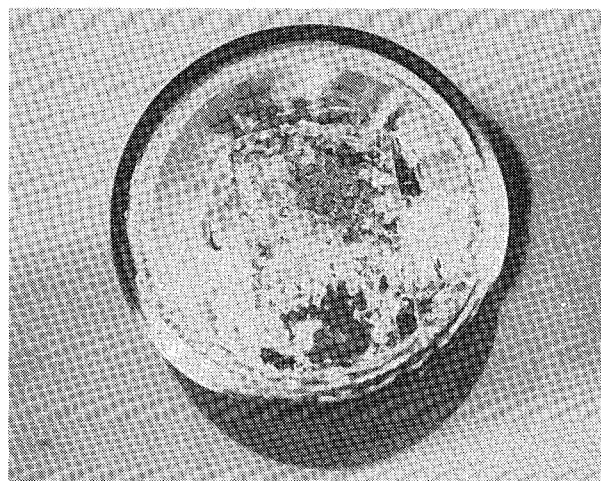
a. Before Sodium Exposure

b. After Exposure to Boiling Sodium;
After Sodium Removal

c. After Exposure to Static Sodium at 850°C

Fig. 13. High Alumina Material, HW Corundum, before and after Sodium Exposure

9-12). Samples of HW Corundum were subjected to boiling sodium at high and low power levels. In both cases, the samples retained their shape after sodium removal but a fair amount of spallation had occurred. Figure 13 shows a sample of HW Corundum after sodium was removed and a sample of HW Corundum that was exposed to sodium at 850°C for five hours.

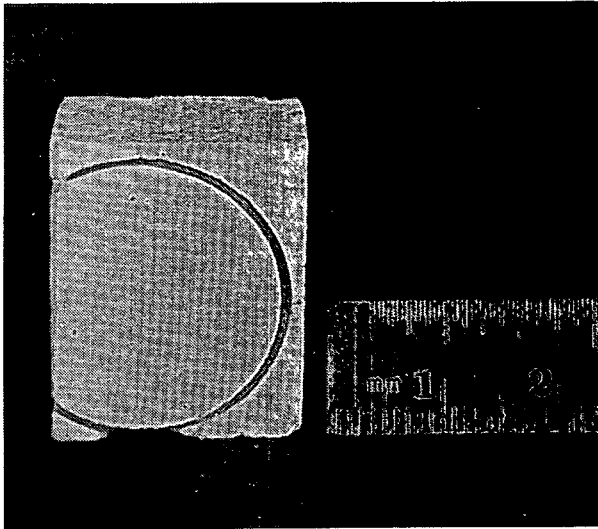
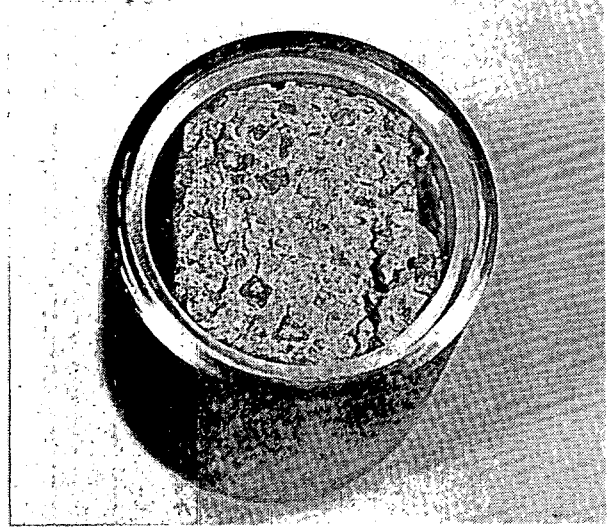
a. Before Sodium Exposure

b. After Exposure to Static Sodium

Fig. 14. High Alumina Material, Korundal XD, before and after Exposure to Static Sodium at 850°C

Further evidence of the effect of silica is indicated by the failure of Korundal XD, which contained 8.5% silica. The sample of Korundal XD after exposure to sodium at 850°C (Fig. 14) was grey and deformed, and had swelled to such an extent that it appeared to have pressed against the capsule lid. When probed with a spatula, it was found to be similar to metallic sodium in softness. The Korundal XD sample and the HW Ruby sample totally disintegrated when exposed to boiling sodium. The sample of HW Ruby exposed to sodium at 850°C for five hours completely lost its shape and was very dark in color (Fig. 15). When probed with a spatula, it also had a softness similar to that of metallic sodium. HW Ruby did not contain silica; however, it contained chromic oxide (Cr_2O_3), which was not present in the surviving alumina samples.

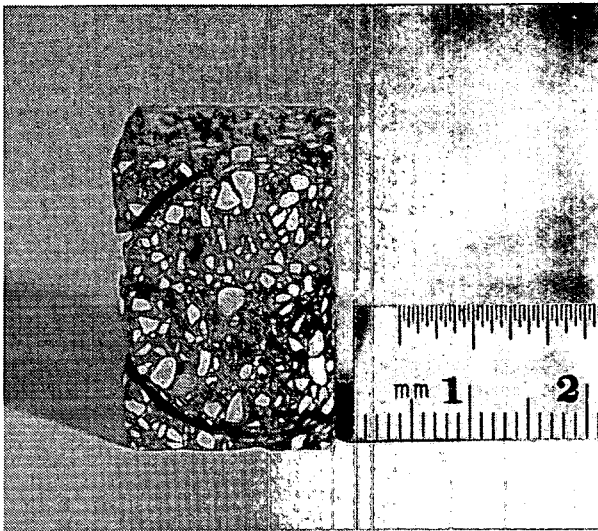
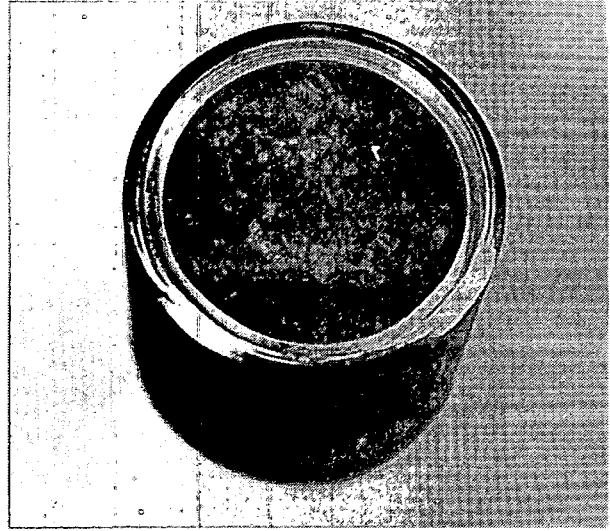
a. Before Sodium Exposure

b. After Exposure to Static Sodium

Fig. 15. High Alumina Material with 10% Cr_2O_3 , HW Ruby, before and after Exposure to Static Sodium at 850°C

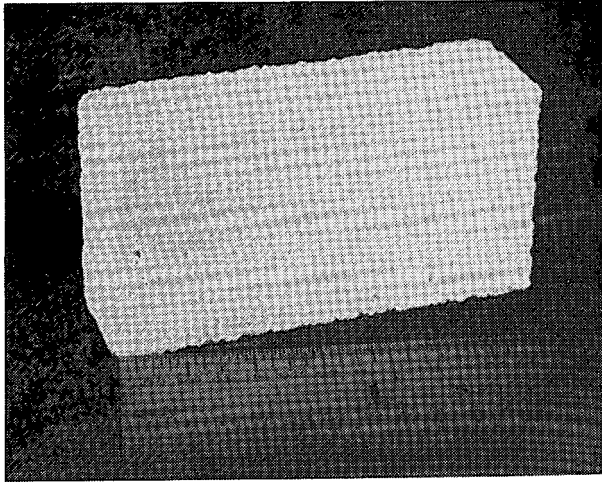
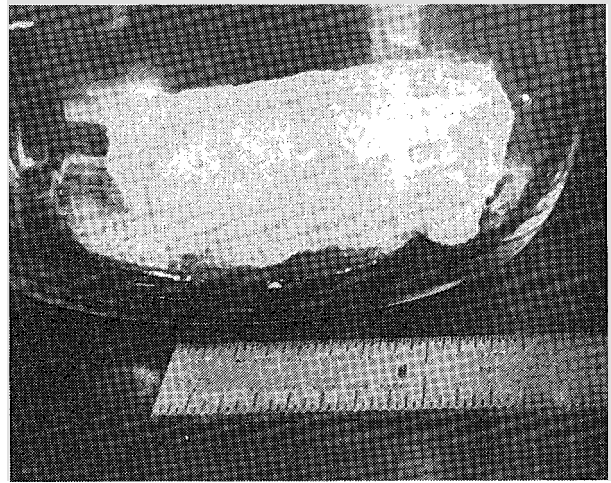
a. Before Sodium Exposure

b. After Exposure to Boiling Sodium;
Before Sodium Removal

Fig. 16. Zirconia Brick Sample, ZH 192A, before and after Exposure to Boiling Sodium

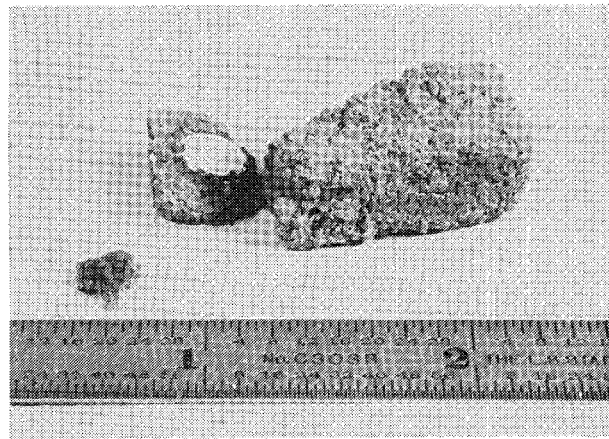
b. After Exposure to Boiling Sodium;
After Sodium Removal

Fig. 17. High-fired Zirconia Crucible Piece before and after Exposure to Boiling Sodium

In contrast with the failure of the zirconia bricks, the crucible of high-fired zirconia exposed to boiling sodium survived, with only a small crack developing. Sodium penetrated the crack, but after sodium removal, the crucible weight loss was only 0.2%. After exposure to static sodium at 850°C for five hours, the high-fired crucible of Norton Mix Z-302 zirconia appeared to be unreacted and was thoroughly wetted with clean sodium. Figures 17 and 18 show the crucibles before and after exposure. Crushing tests were not performed on the crucibles. Although the crucible of Norton Mix Z-302 had the same chemical composition as the samples of ZH 392C and ZH 192A, it differed from them by being a fine-grained high-fired crucible, whereas they were dense, fused, lime-stabilized bricks and were of coarser grain. Thus, the difference in compatibility between the bricks and crucibles with high-temperature sodium is likely due to differences in fabrication.

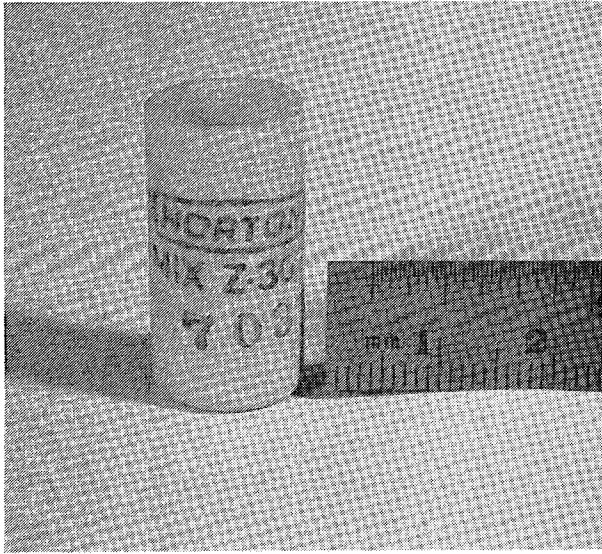
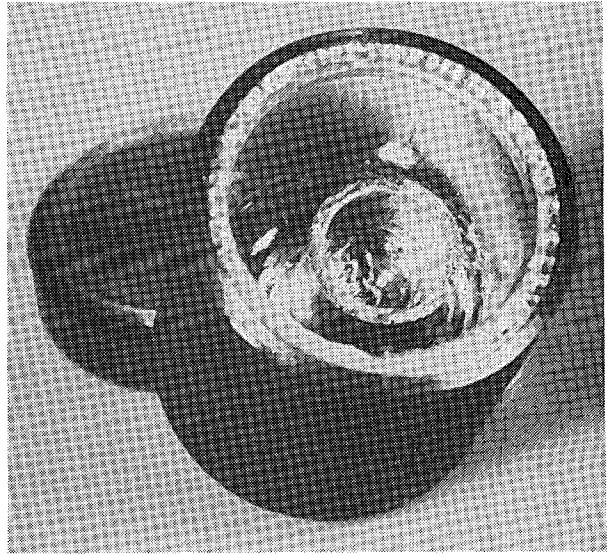
a. Before Sodium Exposure

b. After Exposure to Static Sodium

Fig. 18. High-fired Zirconia Crucible, Norton Mix Z-302, before and after Exposure to Static Sodium at 850°C

The failure of samples of zirconia containing large amounts of silica can be attributed to the presence of silica. However, zirconia bricks containing less than 1% silica also failed. Since the zirconia crucible (Norton Mix Z-302), which had the same chemical composition as the bricks (ZH 192A and ZH 392C), did not fail, the failure of the bricks may be due to some factor introduced by the difference in fabricating procedures for bricks and high-fired crucibles. Although our tests indicate that high-fired zirconia materials are compatible with high-temperature and boiling sodium and bricks of high zirconia content are not, these results are not conclusive, because, at WARD, samples of the same high-zirconia bricks as those tested at ANL survived exposure to sodium, with only some discoloration and surface powdering.⁷

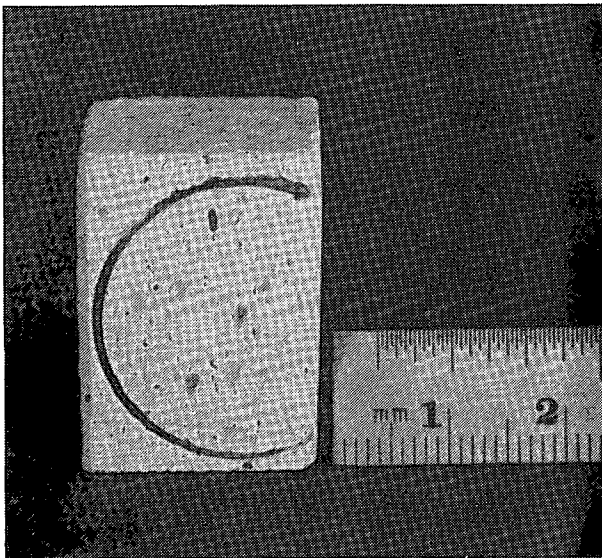
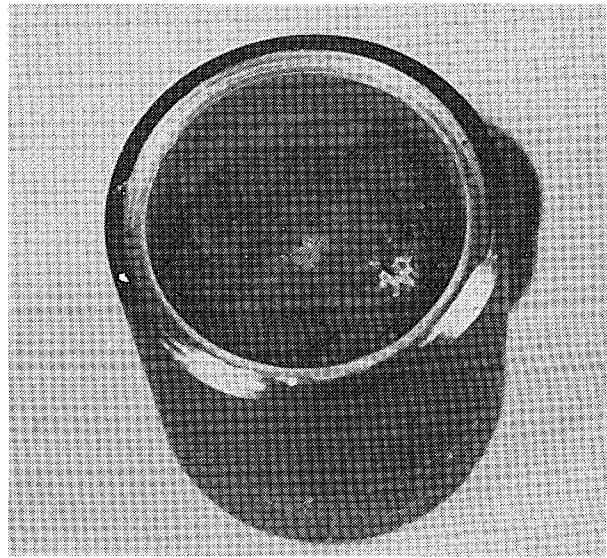
a. Before Sodium Exposure

b. After Exposure to Static Sodium

Fig. 19. Sample of Duro Fireclay Acid Brick before and after Exposure to Static Sodium at 850°C

The refractory materials containing large percentages of alumina and silica (Duro Fireclay Acid Brick and Varnon BF Hard Burned Super Duty Fireclay) experienced significant reaction in both types of experiments performed at ANL and in the experiments performed at WARD. The samples exposed to static sodium at 850°C for five hours are shown before and after exposure in Figs. 19 and 20. After exposure, the sample of Duro Fireclay was dark in color, and was hard but crumbly. Varnon BF was dark, but not hard. It swelled to such an extent that it pressed against the top of the capsule during the test, as evidenced by the attachment of some of the sample to the lid of the capsule (see photo at lower right in Fig. 20). In the boiling sodium experiment, the samples experienced such a gross structural breakdown that they no longer resembled the initial samples; most of the material was present as a slurry with the sodium. The complete failure of these samples is attributed to their large silica content; they contained more than 50% silica.

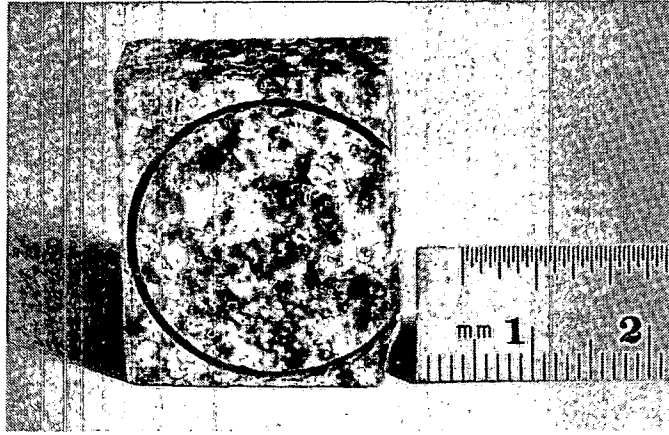
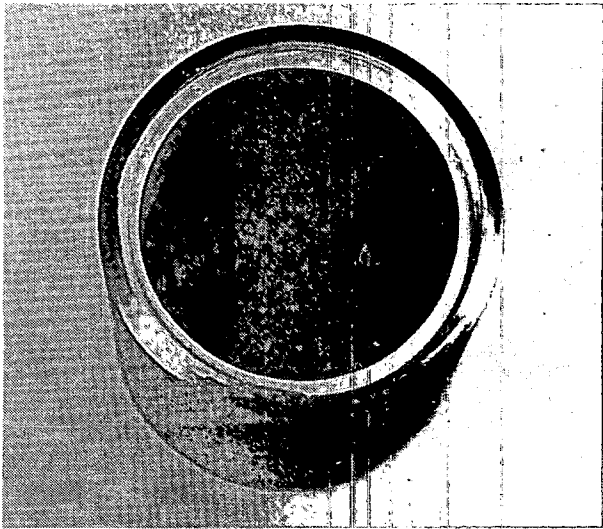
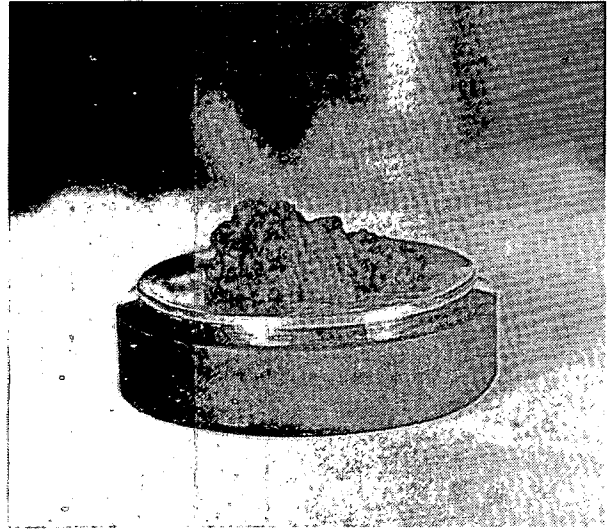
a. Before Sodium Exposure

b. After Exposure to Static Sodium (two views)

Fig. 20. Sample of Varnon BF Hard Burned Super Duty Fireclay before and after Exposure to Static Sodium at 850°C

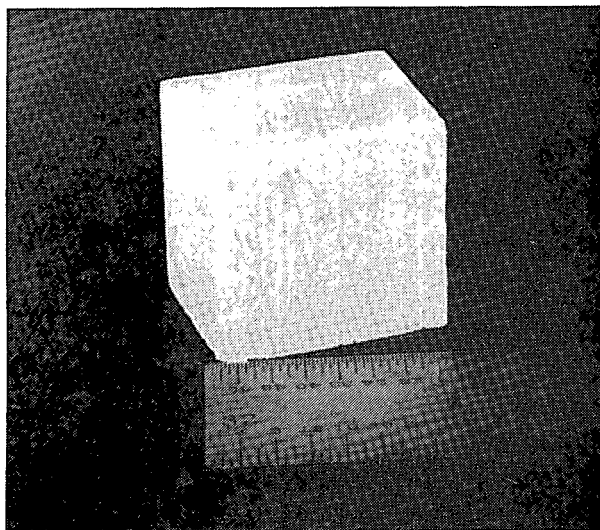
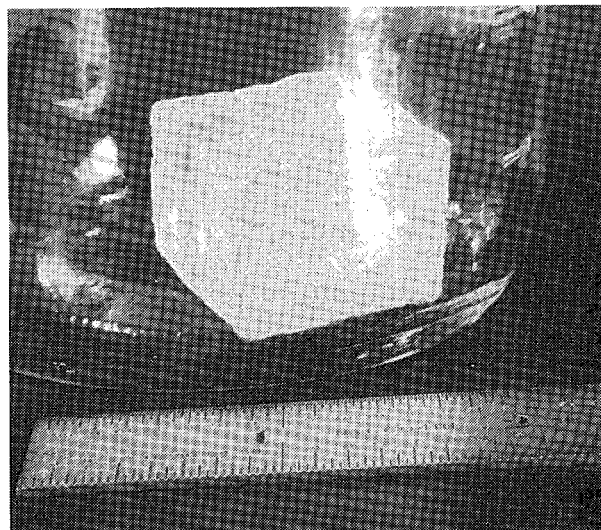
a. Before Sodium Exposure

b. After Exposure to Boiling Sodium;
Before Sodium Removal

Fig. 21. Magnesia-Alumina Based Material, X-317, before and after Exposure to Boiling Sodium

Samples of X-317, C-104, and RFG were exposed to boiling sodium for one hour. The magnesia-alumina material, X-317, survived intact (Fig. 21). However, a comparison in crushing strength could not be made because the unexposed sample was considered to be nonrepresentative, as is evident from Fig. 22. Although the chemical compositions of C-104 and RFG are almost identical, C-104 survived intact (Fig. 23) and retained about 76% of its crushing strength, whereas RFG was invaded by sodium, which created a coarse structure in the sample. The exposed RFG sample, which is shown in Fig. 24, retained only about 34% of its crushing strength. In experiments at WARD, X-317, C-104, and RFG remained intact after sodium removal; the corners and edges of RFG had fractured, whereas X-317 and C-104 were not visibly changed.⁷

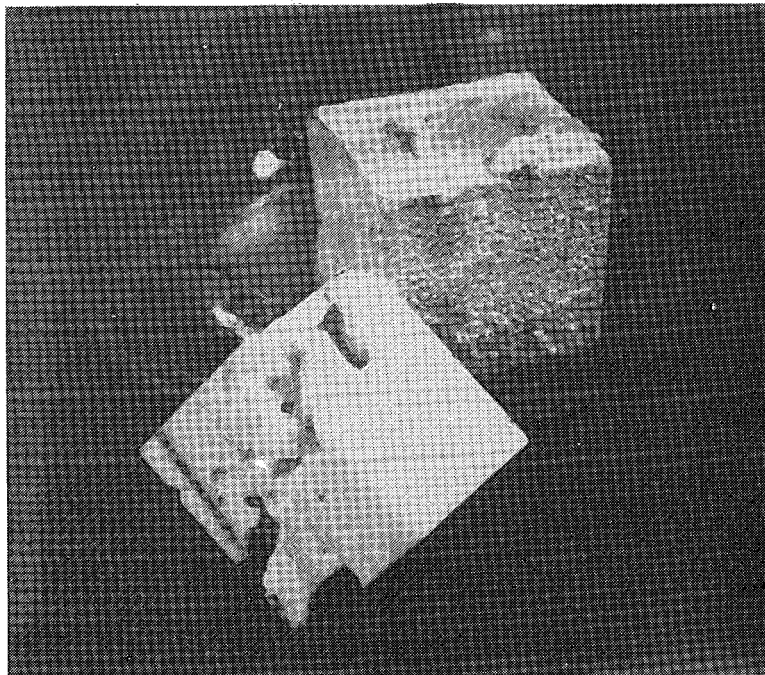
Fig. 22. Samples of X-317: Unexposed Sample (lower left) and Sample after Exposure to Boiling Sodium (upper right)

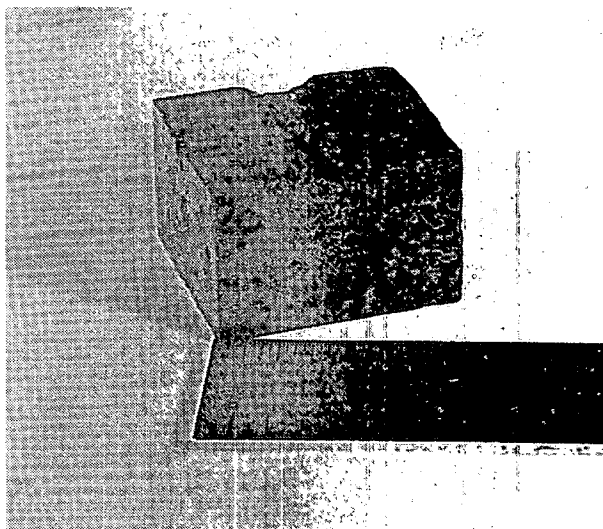
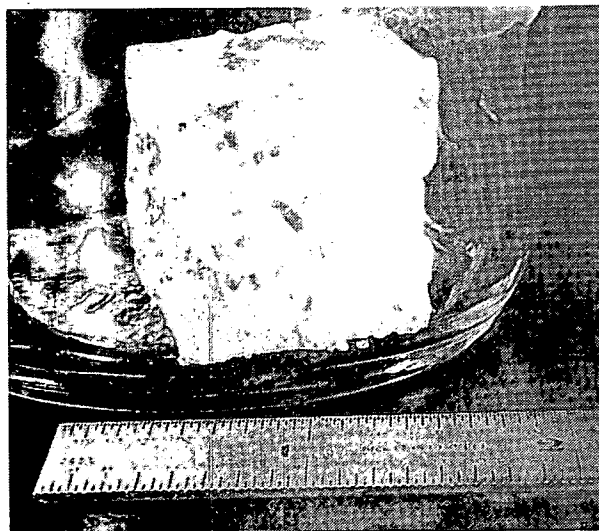
a. Before Sodium Exposure

b. After Exposure to Boiling Sodium;
Before Sodium Removal

Fig. 23. Magnesia Based Mixed Refractory, C-104, before and after Exposure to Boiling Sodium

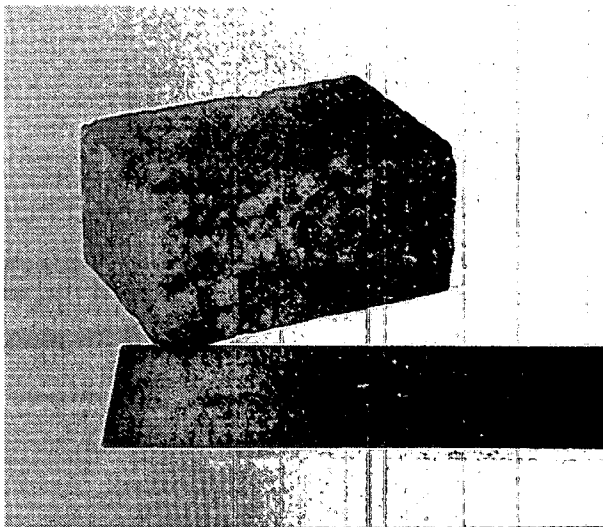
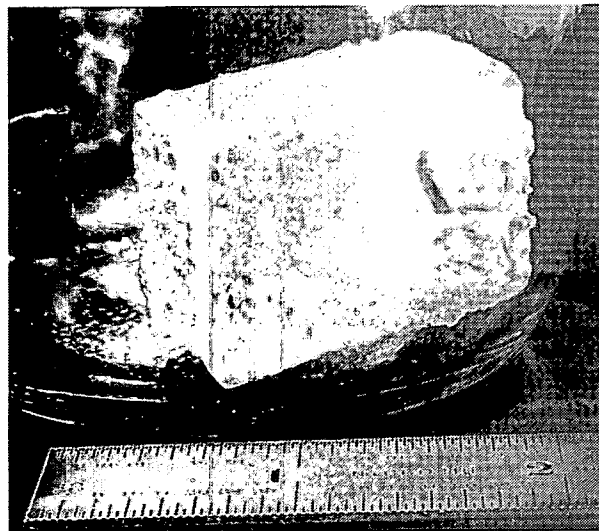
a. Before Sodium Exposure

b. After Exposure to Boiling Sodium

Fig. 24. Magnesia Based Mixed Refractory, RFG, before and after Exposure to Boiling Sodium
