INTERACTIONS OF CERTAIN REFRACTORY MATERIALS WITH SODIUM

ANL-75-74

ARGONNE NATIONAL LABORATORY
9700 South Cass Avenue
Argonne, Illinois 60439

May 1976

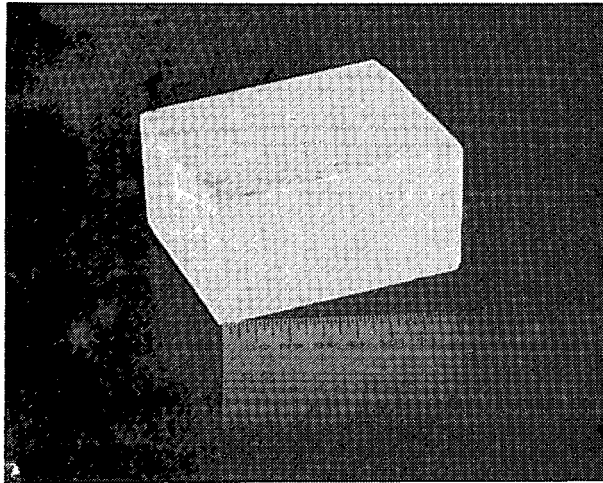
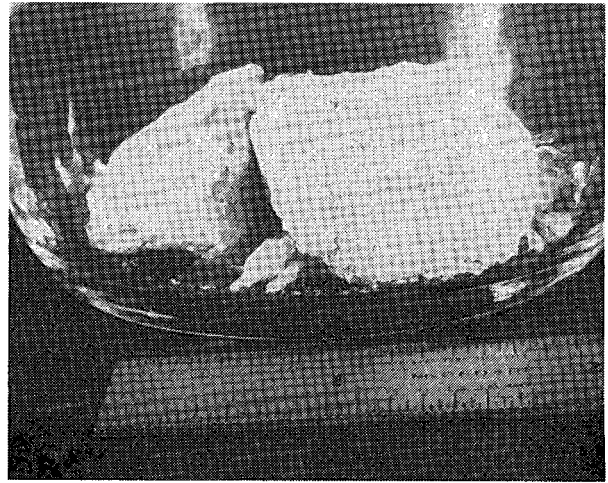
a. Before Sodium Exposure

b. After Exposure to Boiling Sodium;
Before Sodium Removal

Fig. 25. Alumina-Zirconia Mixed Refractory, UNICOR I, before and after Exposure to Boiling Sodium

Zirconia-based mixed ceramic oxides UNICOR I and ZS 1300 were exposed to boiling sodium for about one hour. UNICOR I, an alumina-zirconia refractory brick with a large fraction of silica, partially disintegrated and broke into two pieces, each of which was partially disintegrated (Fig. 25). One of these pieces was crushed to determine its residual strength. Only 18% of the unexposed sample's crushing strength was retained, which further indicated the structural degradation of the sample. The zirconia-silica sample, ZS 1300, showed considerable disintegration after exposure to boiling sodium (Fig. 26). Samples of UNICOR I and ZS 1300 also failed to withstand exposure to boiling sodium in experiments performed at WARD.⁷ The failure of UNICOR I and ZS 1300 is further evidence that refractory materials with high silica content cannot withstand exposure to boiling sodium.

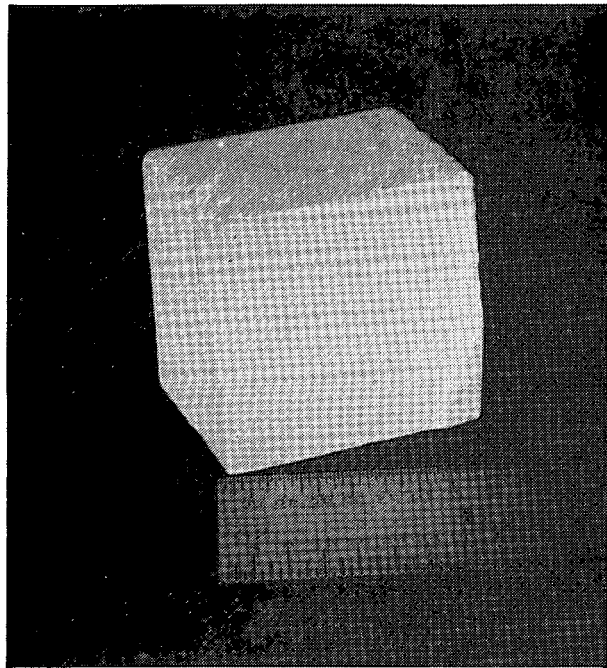
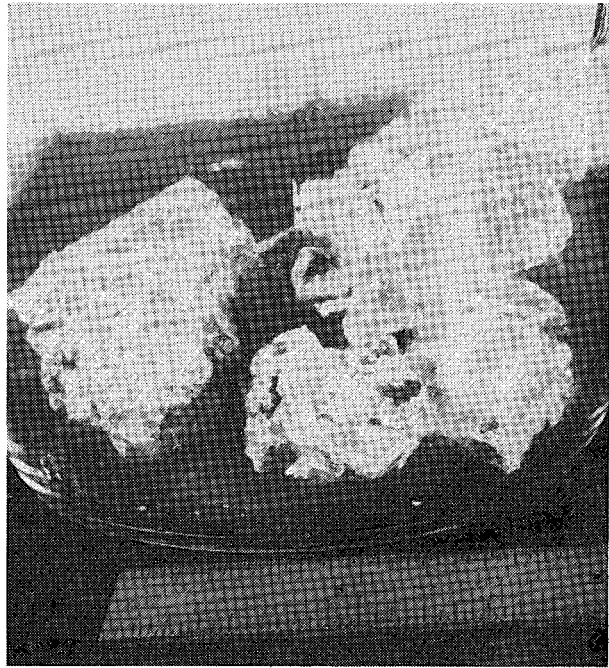
a. Before Sodium Exposure

b. After Exposure to Boiling Sodium

Fig. 26. Zirconia-Silica Mixed Refractory, ZS 1300, before and after Exposure to Boiling Sodium

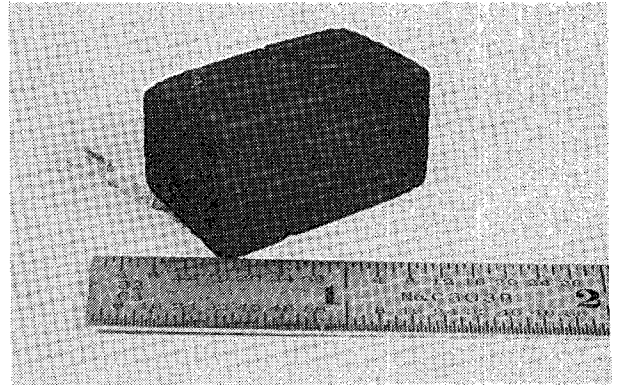
b. After Exposure to Boiling Sodium;
After Sodium Removal

Fig. 27. High-density Graphite Brick before and after Exposure to Boiling Sodium

A high-density graphite brick was exposed to boiling sodium for about one hour, and various grades of graphite and a sample of a vitreous carbon rod were exposed to sodium at 850°C for five hours. The graphite brick exposed to boiling sodium survived intact, but some surface powdering was evident after sodium removal (Fig. 27). Its weight loss was 1%. After several weeks of exposure to air, the graphite split along parallel planes. Alkali metal atoms are known to diffuse into graphite, positioning themselves between the hexagonal layer planes.¹⁰ This causes a change in density and can cause internal strains. Subsequently, the material splits in response to these strains. Figures 28 through 31 show samples of graphite and vitreous carbon before and after the five-hour exposure to static sodium at 850°C. None of the samples appeared to undergo interaction, and all were wetted with clean sodium following exposure. There was no subsequent splitting similar to that of the graphite tested by exposure to boiling sodium. It should be noted that these samples were tested by a different experimental procedure. Moreover, these materials were not treated with ethyl alcohol and water to remove the sodium and were not exposed to air, because it was found that the sodium-removal procedure and exposure to air caused deterioration in other materials. No crushing strength tests were performed on the graphites or on the vitreous carbon.

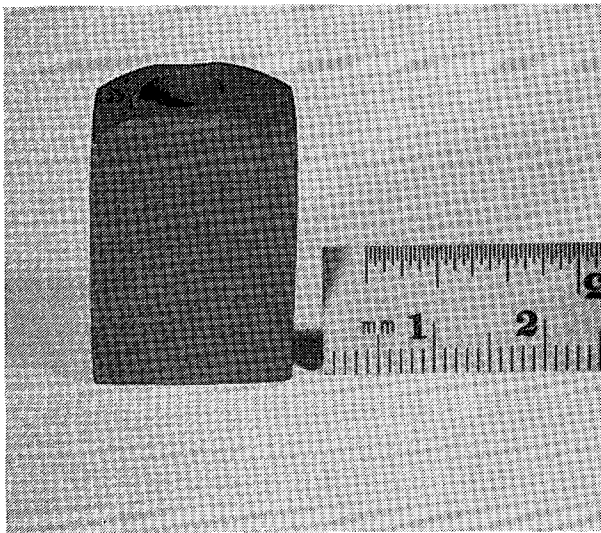
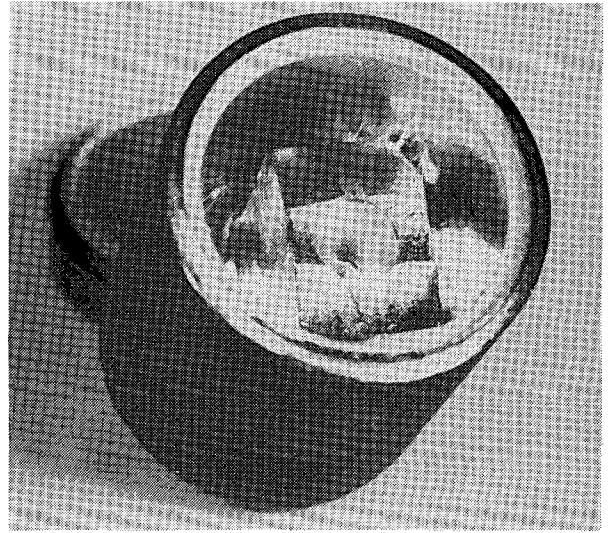
a. Before Sodium Exposure

b. After Exposure to Static Sodium

Fig. 28. Sample of ATJ Graphite before and after Exposure to Static Sodium at 850°C

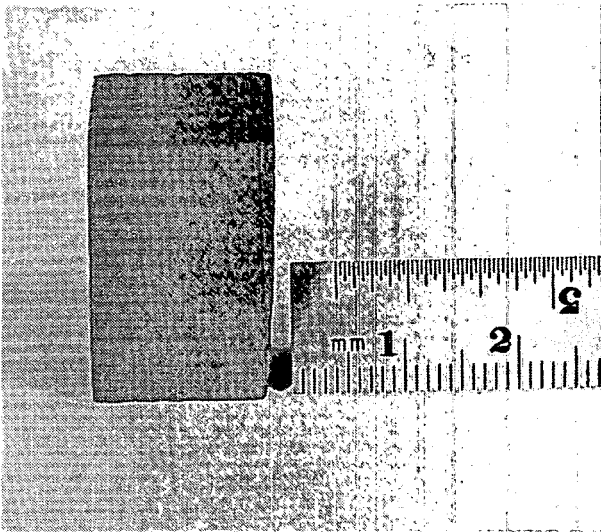
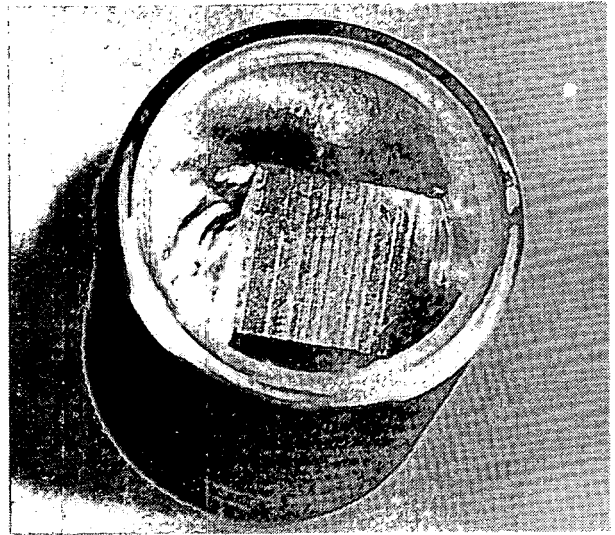
a. Before Sodium Exposure

b. After Exposure to Static Sodium

Fig. 29. Reactor Grade Graphite, AGOT, before and after Exposure to Static Sodium at 850°C

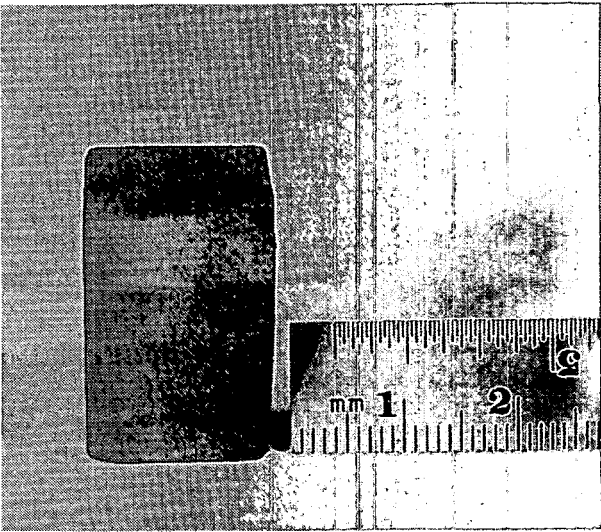
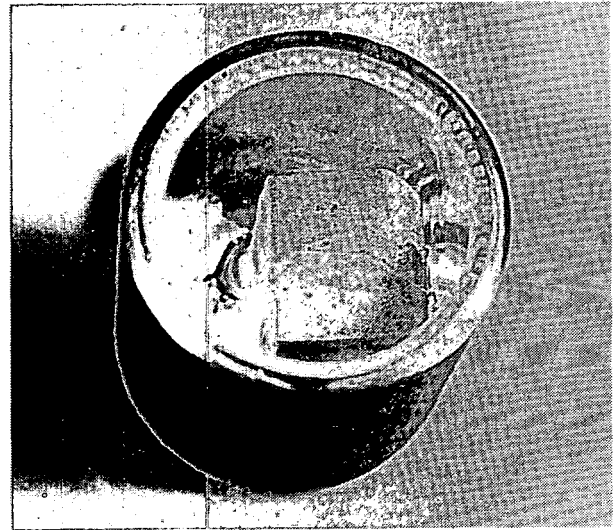
a. Before Sodium Exposure

b. After Exposure to Static Sodium

Fig. 30. Sample of FC-14 Graphite before and after Exposure to Static Sodium at 850°C

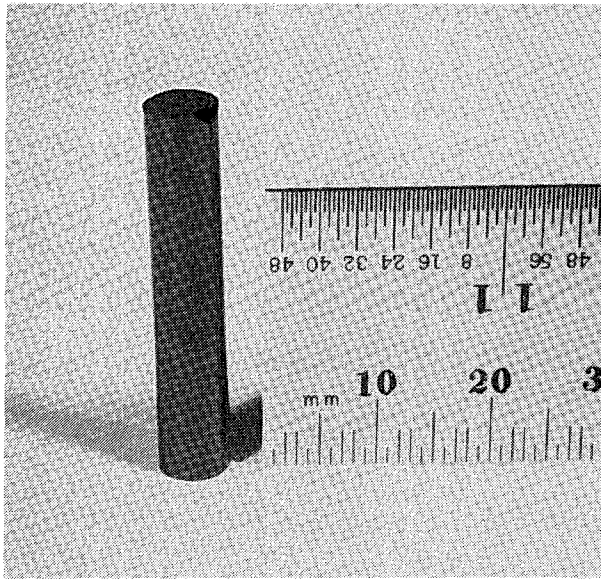
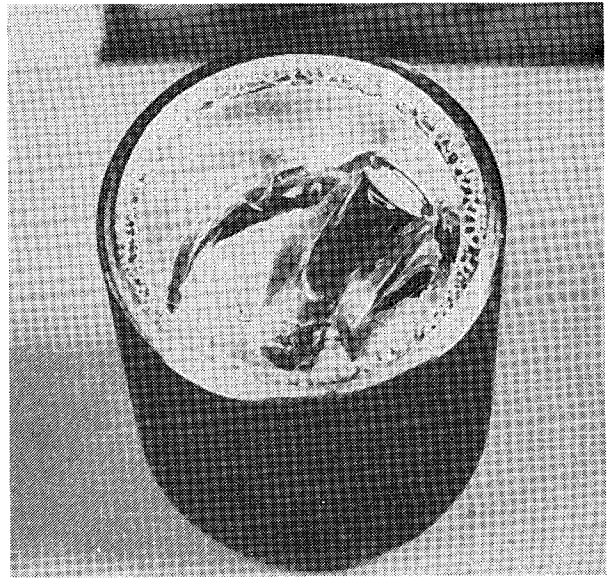
a. Before Sodium Exposure

b. After Exposure to Static Sodium

Fig. 31. Vitreous Carbon Rod before and after Exposure to Static Sodium at 850°C

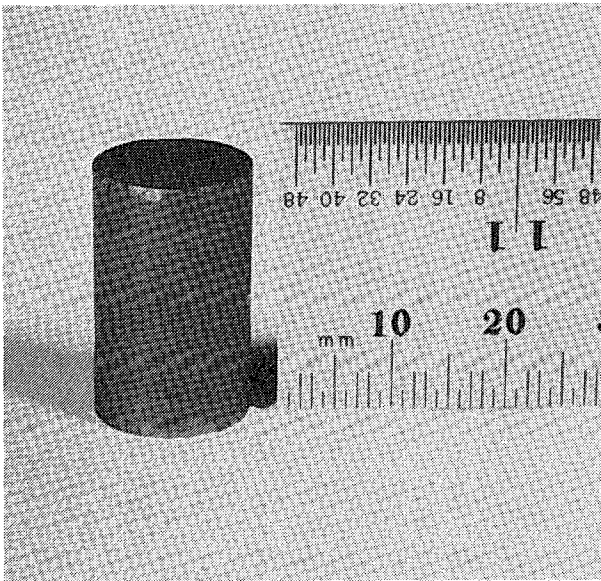
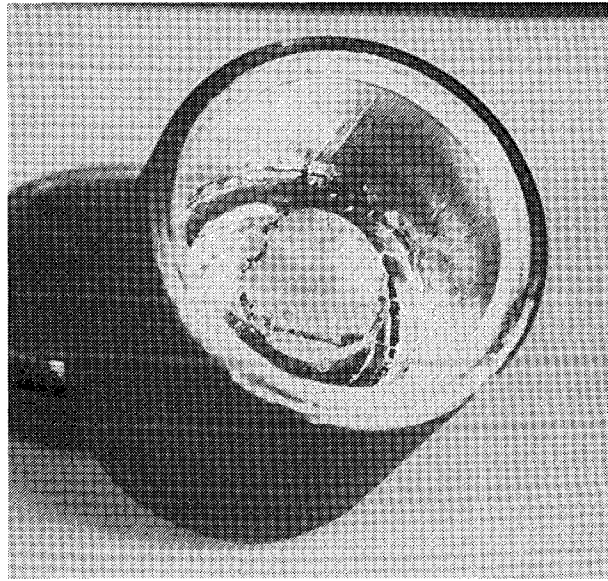
a. Before Sodium Exposure

b. After Exposure to Static Sodium

Fig. 32. Boron Carbide (B_4C) Rod before and after Exposure to Static Sodium at 850°C

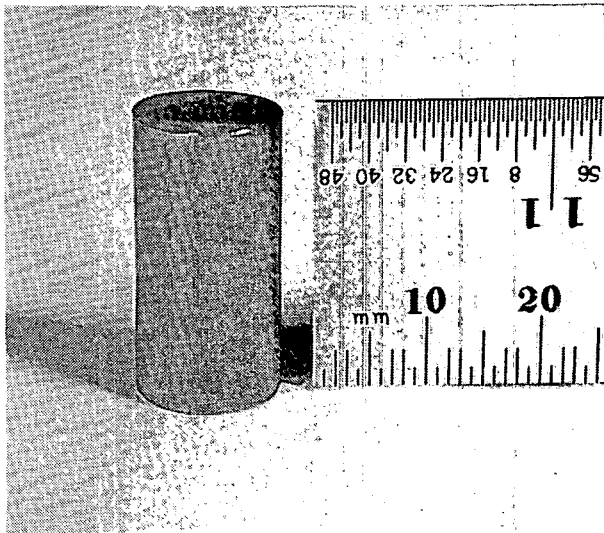
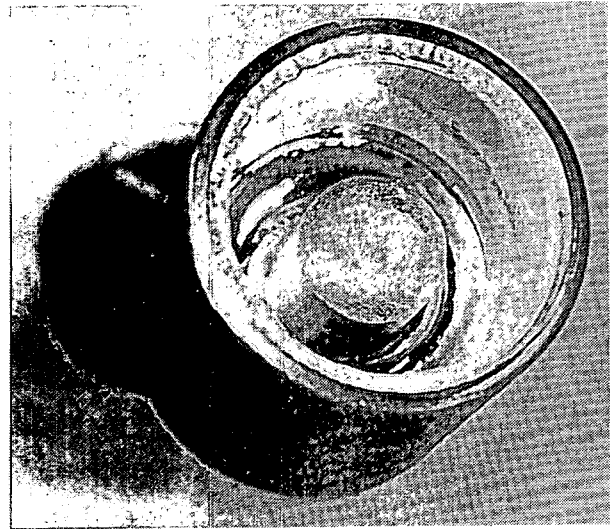
a. Before Sodium Exposure

b. After Exposure to Static Sodium

Fig. 33. Tantalum Rod before and after Exposure to Static Sodium at 850°C

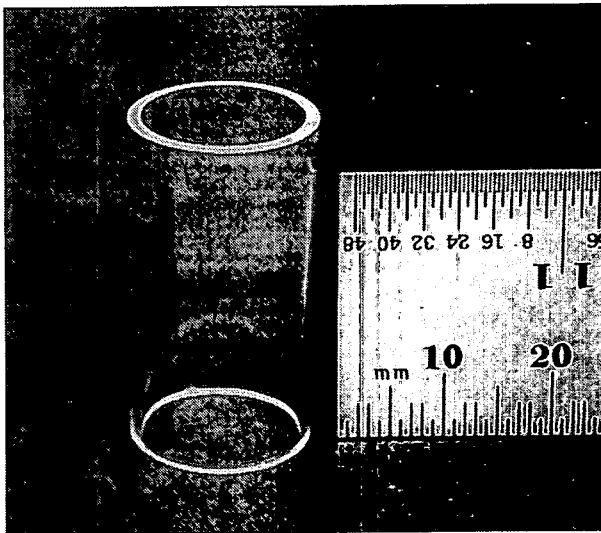
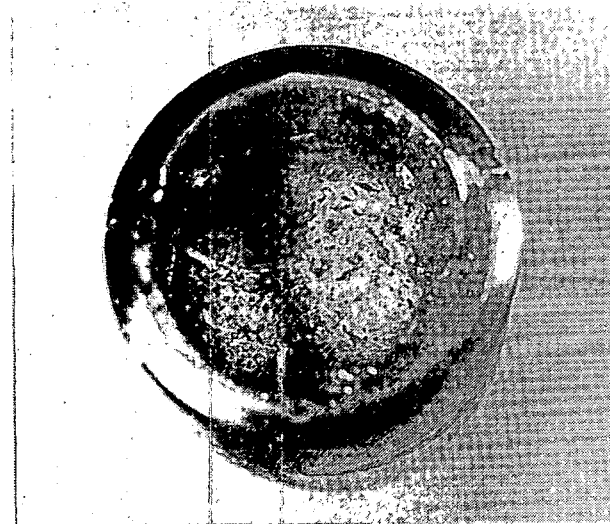
a. Before Sodium Exposure

b. After Exposure to Static Sodium

Fig. 34. Quartz Tube before and after Exposure to Static Sodium at 850°C

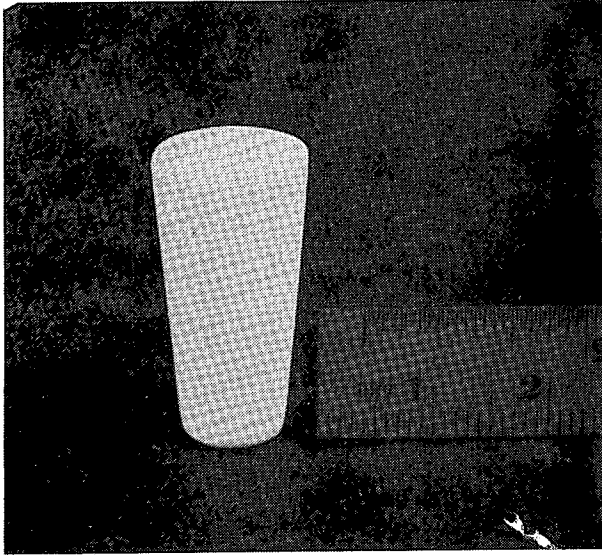
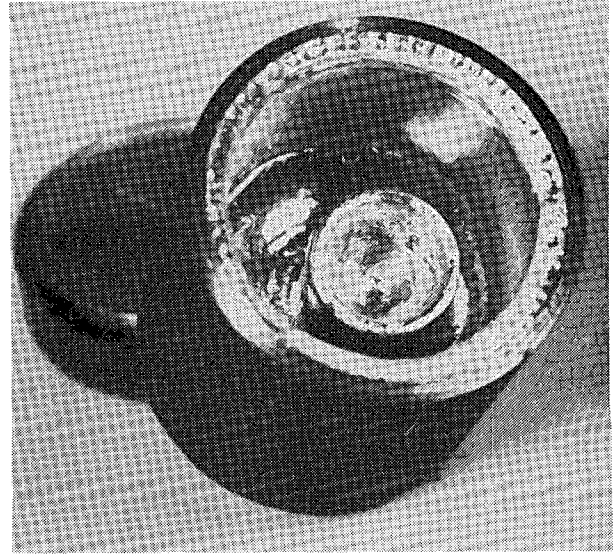
a. Before Sodium Exposure

b. After Exposure to Static Sodium

Fig. 35. Beryllia Crucible before and after Exposure to Static Sodium at 850°C

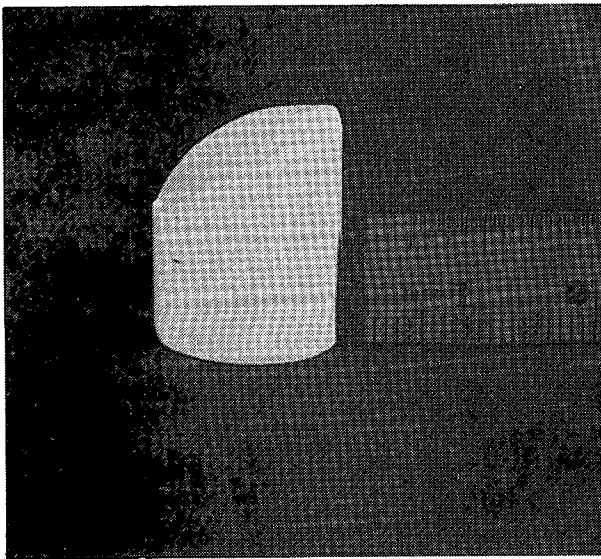
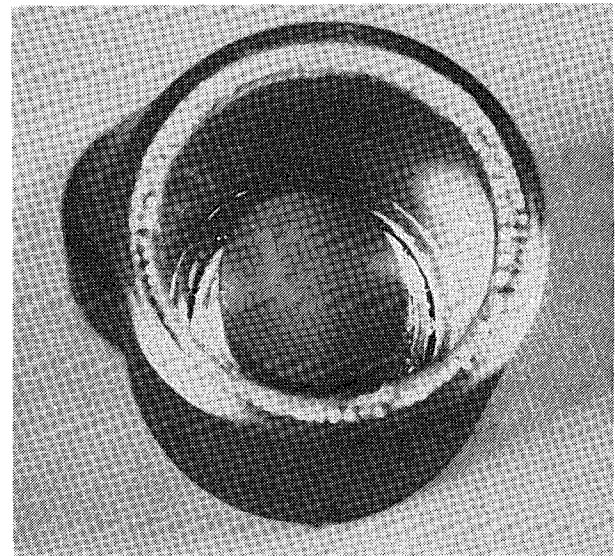
a. Before Sodium Exposure

b. After Exposure to Static Sodium

Fig. 36. Thoria Rod before and after Exposure to Static Sodium at 850°C
