206-74  
5-26-74  
1988  
JLC  
JKT  
IRRADIATION BEHAVIOR OF UNENCAPSULATED  
EBR-II MARK-II DRIVER FUEL TO A  
MAXIMUM BURNUP OF 6 at. %

G. L. Hofman, W. N. Beck, R. V. Strain,  
G. O. Hayner, and C. M. Walter

ARGONNE NATIONAL LABORATORY, ARGONNE, ILLINOIS

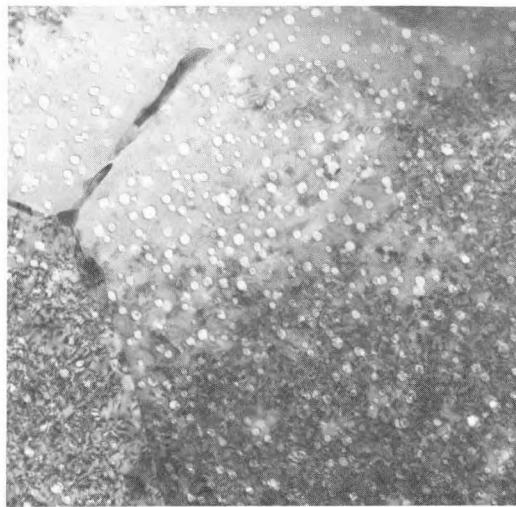
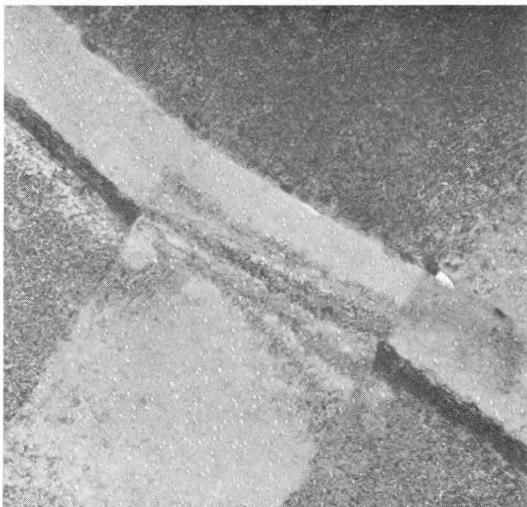
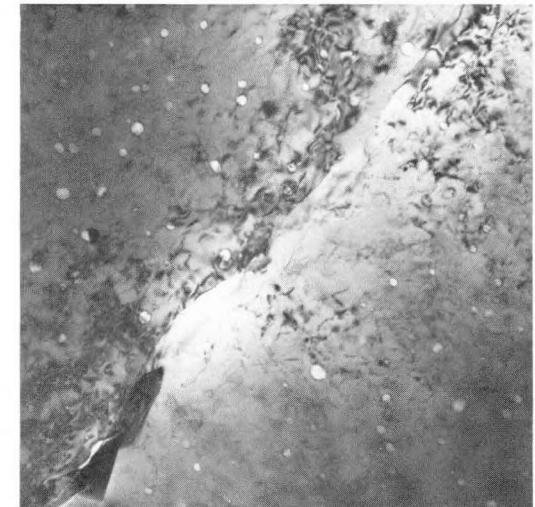
Fig. 29. TEM Micrographs of Types 304L (top) and 316 Stainless Steel (bottom) Mark-II Cladding, Showing Voids and Precipitates. Mag. 27,000X.

Examples of the precipitates are shown in the TEM micrographs of the Type 304L stainless steel cladding in Fig. 29. The precipitates, which have been identified to be composed of both  $M_{23}C_6$  and sigma phase, often exhibit a strung-out pattern along grain boundaries. This feature of the precipitates may become significant in the propagation of eventual cladding failures at higher burnups. Figure 29 also shows the effect of temperature on the irradiation damage in general. The void morphology changes drastically going from the bottom to the top of the elements. The voids are small and densely spaced at the bottom, but become progressively larger and more widely spaced at the top of the elements.

The Type 316 stainless steel cladding exhibits a smaller void size throughout the element as compared with the Type 304L stainless steel cladding. This is reflected in the lower swelling rate of the Type 316 material. The size and density distribution of the irradiation-induced defects is also reflected in the mechanical properties of the cladding; for example, see the microhardness profile in Fig. 30.

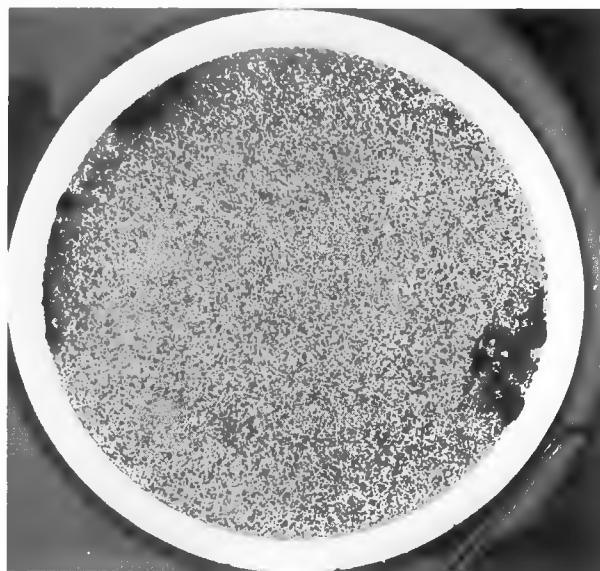
Fig. B.14. Cross Sections of Element E-46, Subassembly C-2203S, at 1/2, 3, 6-3/4, and 10 in. from Bottom of Fuel; ~3 at. % Burnup. Large darkened areas are caused by sodium residue on specimen surface. As polished. Mag. 17X. HFFEF Met. Lab. Neg. Nos. 85C4-1, 85C3-1, 85C2-1, and 85C1-1.

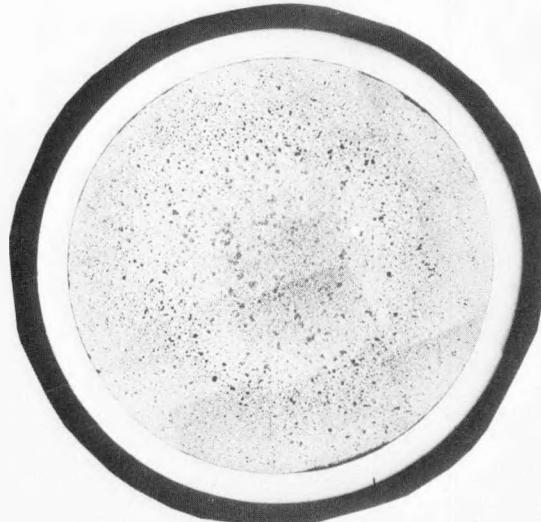
Fig. B.38. Cross Section of Element E-18, Subassembly C-2236S: 1 in. from Bottom of Fuel; ~6 at. % Burnup. As polished. Mag. 15X. Neg. No. MSD-163602.

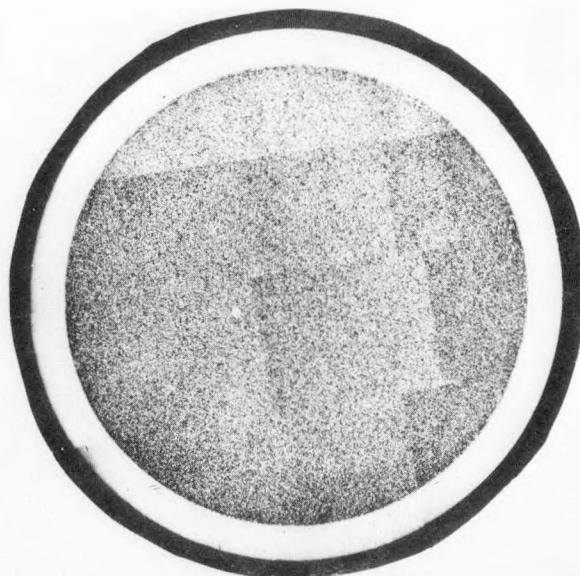
Fig. B.40  
Cross Section of Element E-18, Subassembly C-2236S: 14 in. from Bottom of Fuel; ~6 at. % Burnup. As polished. Mag. 15X. Neg. No. MSD-163604.
