Phase structure within a fracture network beneath a surface

pond: Field experiment

R.J. Glass¹ and M.J. Nicholl²¹Flow Visualization and Processes Laboratory

Sandia National Laboratories

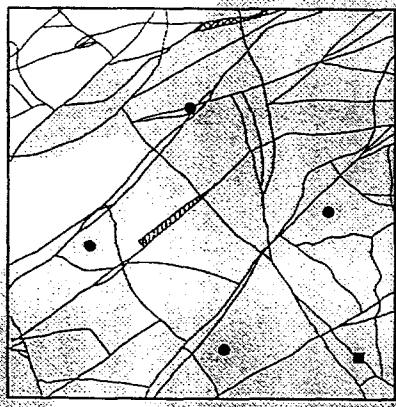
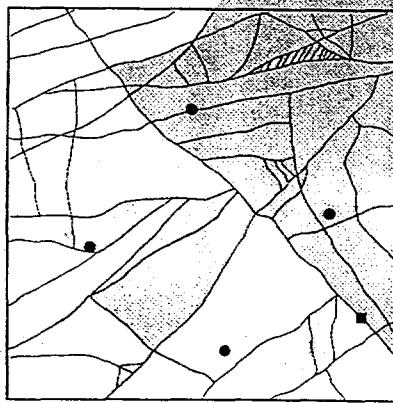
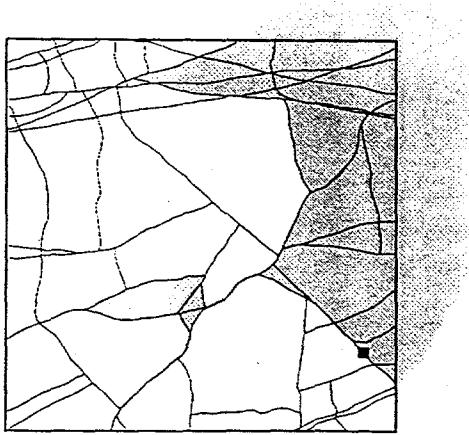
Figure 2: Fracture pavement maps for levels 0 through 11; areas in which tracer was observed are shown in gray. Level 0 is the infiltration surface, where mapping was limited to areas within the infiltration basin. At each level, the mapped region is outlined; estimates of tracer location outside that region are based on 35 mm slides and notes taken during the excavation process. The ERT array is shown as solid circles; the smaller circles shown at level 0 represent the surface electrodes, and numbers adjacent to the larger circles represent the string numbers (1-4) for the primary array. Also, the location of a persistent near vertical fracture trending NE-SW is marked with a black square.

Following infiltration, data was collected in the form of pavement maps, 35 mm slides of the excavation, and visual observations. Fracture traces at each excavation level are shown in figure 2; gray regions on the maps denote zones where dyed fractures were found. The pavement maps clearly delineate fracture traces and distribution of tracer within the $\sim 6 \text{ m}^2$ mapped region directly beneath the infiltration surface (figure 3). Outside that region, we have estimated lateral extent of the tracer from the remaining data (35 mm slides and visual observations). This was an imperfect process, as the surrounding pavement was mostly covered in rubble and varied significantly in elevation. Because of the limitations on this data, we have simply outlined areas in which dye was found, and not attempted to depict structure within those areas. The phase structure clearly spread beyond the region of detailed mapping to produce an irregular structure that occupied $\sim 35 \text{ m}^3$ of the excavated rock mass and obviously extended below the 5 m depth of excavation. Within the dyed zone, complication of the dye structure varied from pervasive stain near the infiltration surface to more fragmented structures at depths of 2-5 m. In the following, we first consider our map data to describe in detail the fracture network geometry and dye tracer structure. ERT results are then presented followed by estimates for the mean hydraulic aperture for the fractures adjacent to the pond and the total volume of rock that the test may have interrogated. Based on these results, we end this section with a suggestion for a future experiment.

Pavement maps (figure 2) yielded measurements of trace length for 741 fractures, and orientation (dip/dip direction) for 572 fractures. Dip measurements were not recorded in the field if neither fracture surface was exposed ($\sim 23\%$ of all fractures), which was most likely
