FRACTURE TOUGHNESS OF ALLOY 600 AND EN82H WELD IN AIR AND WATER

W. J. Mills and C. M. Brown

June 1999

BETTIS ATOMIC POWER LABORATORY

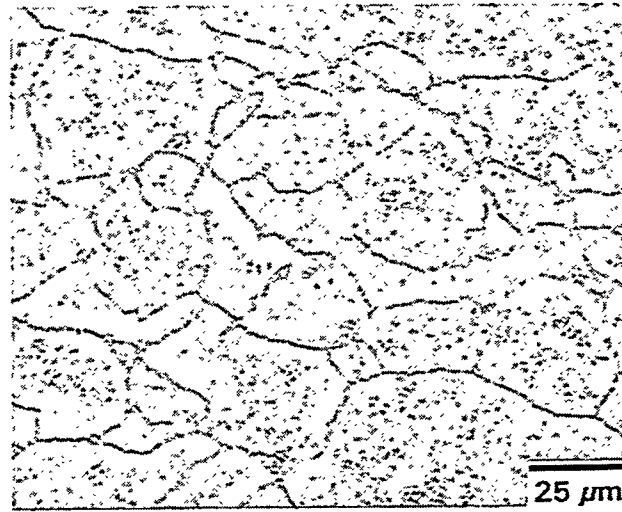
Figure 2. Representative microstructures for (a) Alloy 600 and (b) EN82H weld.

Representative microstructures for the test materials are shown in Figure 2. The Alloy 600 plate has a duplex grain size where fine grains with a mean grain diameter of ~20 µm surround isolated unrecrystallized grains with a mean diameter of ~120 µm. Intergranular and intragranular  $M_7C_3$  carbides are observed in both the fine and coarse grain regions and there is evidence of coarse MC-type inclusions. This heat also exhibits a pronounced hot deformation substructure with dislocation subgrains.<sup>(5)</sup>

The EN82H welds have well-defined grain boundaries separating colonies of similarly oriented dendrites. The grain structure is anisotropic, particularly in the weld root region, where columnar grains are aligned in the transverse direction. Grain boundaries are decorated with fine niobium and titanium-rich MC carbides. Small and intermediate size titanium nitrides are also observed along grain boundaries and in the interdendritic regions.

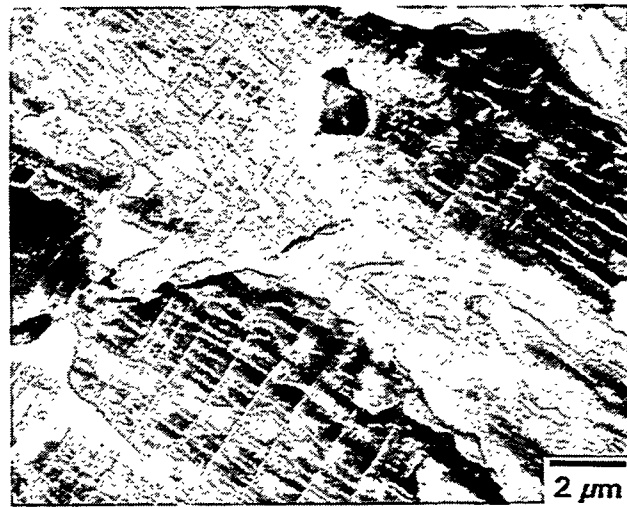
Figure 14. SEM fractographs of EN82H welds showing planar slip offsets superimposed on transgranular facets. (a) Non-precharged specimen tested in 54°C water. (b) Hydrogen-precharged specimen tested in water.

The presence of periodic slip offsets superimposed on the transgranular facets in both the hydrogen-precharged specimen and non-precharged specimen tested in water (Figure 14) provides additional evidence that a hydrogen embrittlement mechanism is active in low temperature water. This observation indicates that hydrogen in the lattice promotes planar slip. Thus, hydrogen appears to play a dual role in degrading cracking resistance; it reduces grain boundary cohesive strength and promotes planar slip which localizes strain concentrations along

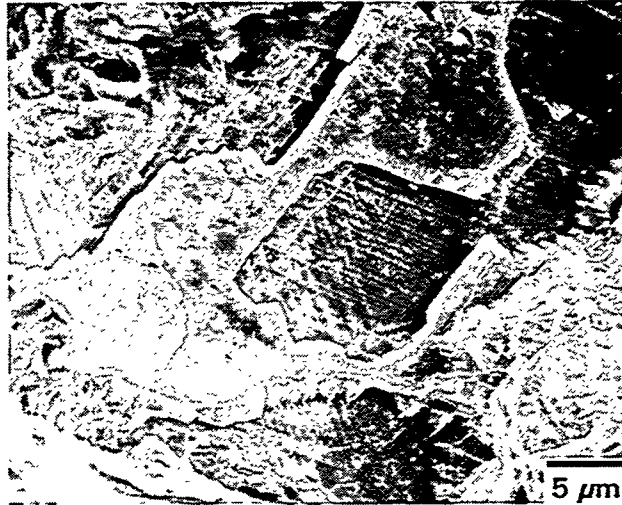
Figure 15. Fracture surface of hydrogen-precharged Alloy 600 showing slip offsets superimposed on crystallographic facets.

The facets found in precharged Alloy 600 have a very crisp crystallographic appearance and often contain planar slip offsets (Figure 15). There is limited evidence of poorly defined void sheets, but these shallow voids have a faceted appearance. The combination of crystallographic facets and planar slip offsets indicates that hydrogen promotes heterogeneous slip and localized failure along the slip bands, which is consistent with the EN82H behavior. In the welds, this mechanism is usually preempted by intergranular cracking, except in isolated regions that resist grain boundary separation. By contrast, Alloy 600 grain boundaries are immune to cracking, at least at ~80 ppm hydrogen, so the crystallographic faceting mode is dominant.
